Your Ref: BMW 740Li  
(chassis number WBA7T22040CE38095)  
Our Ref : CI/TP21009901/D

22 September 2021

**INSPECTION REPORT OF AN UNREGISTERED BMW 740Li MOTOR CAR  
WITH CHASSIS NUMBER WBA7T22040CE38095**

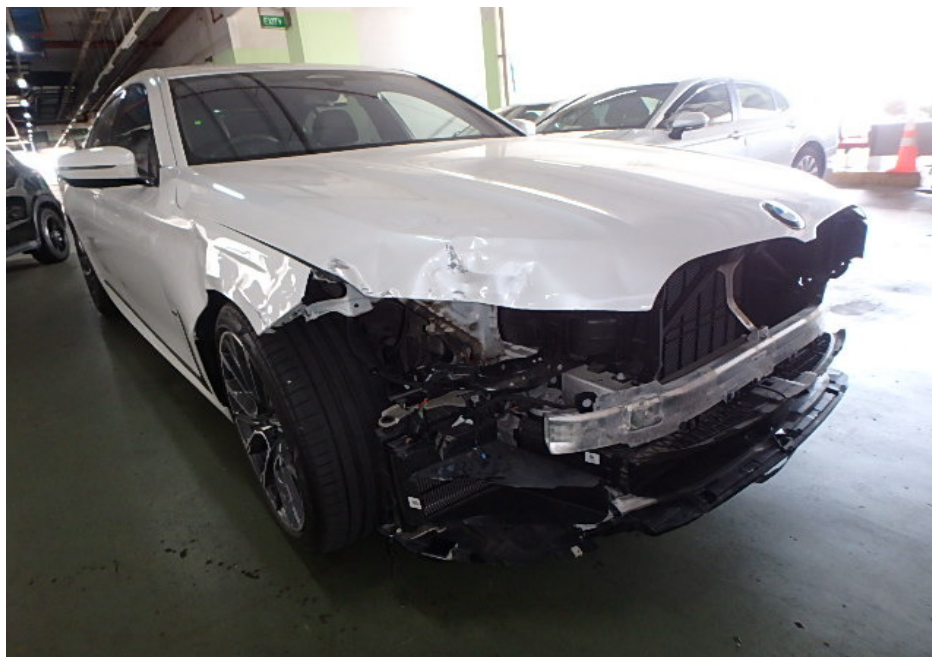
**Photo 1** shows the front right body of the Motor Car (photograph provided to me). The Motor Car was observed to have sustained damage at its front right portion. The front bumper reinforcement, front bonnet and front right fender were amongst the body parts that were observed to be damaged. The front right headlamp, front bumper and all its related parts and attachments were observed to be damaged/missing/dislodged.

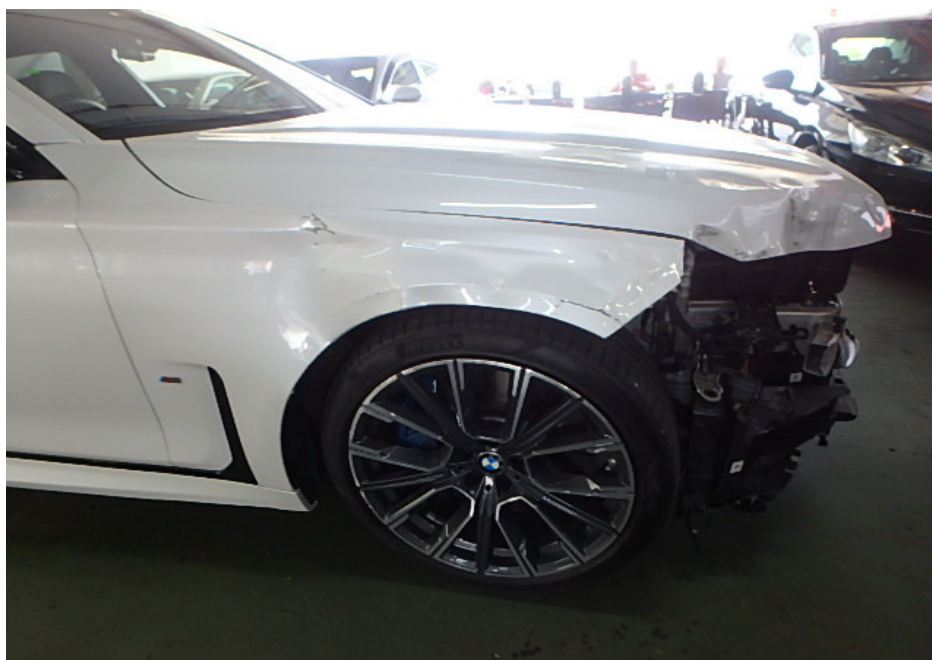
**Photo 2** shows another view of the front right body of the Motor Car (photograph provided to me). The front bonnet and front right fender were amongst the body parts that were observed to be damaged.

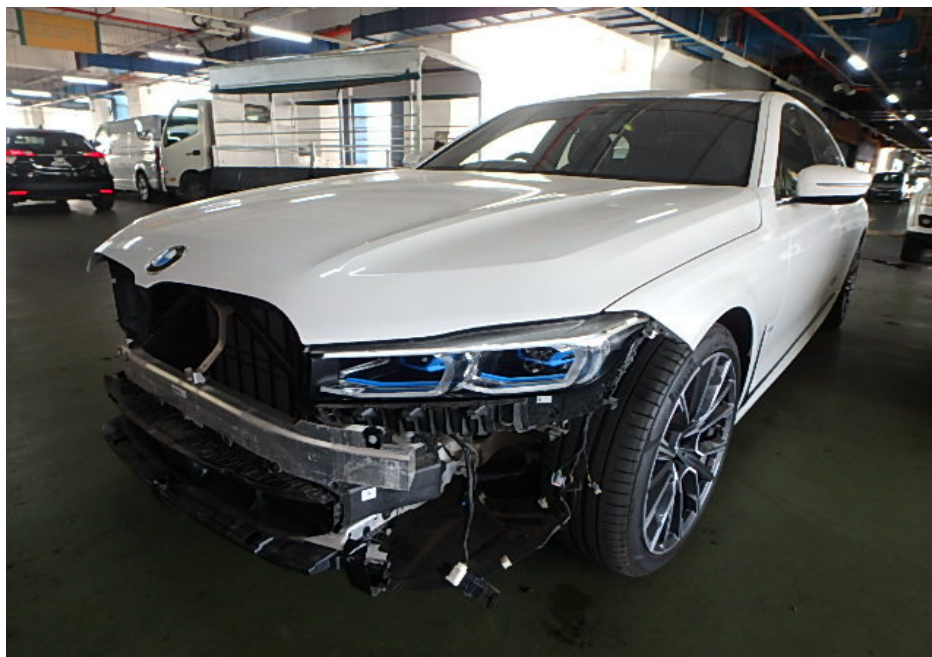
**Photo 3** shows the front left body of the Motor Car (photograph provided to me). The front bumper and all its related parts and attachments like the front bumper centre lower grille, front bumper left and right lower grilles, front bumper left and right lower grille garnishes amongst others, front right headlamp and radiator grilles were damaged/missing/dislodged (refer to photograph 1 above).

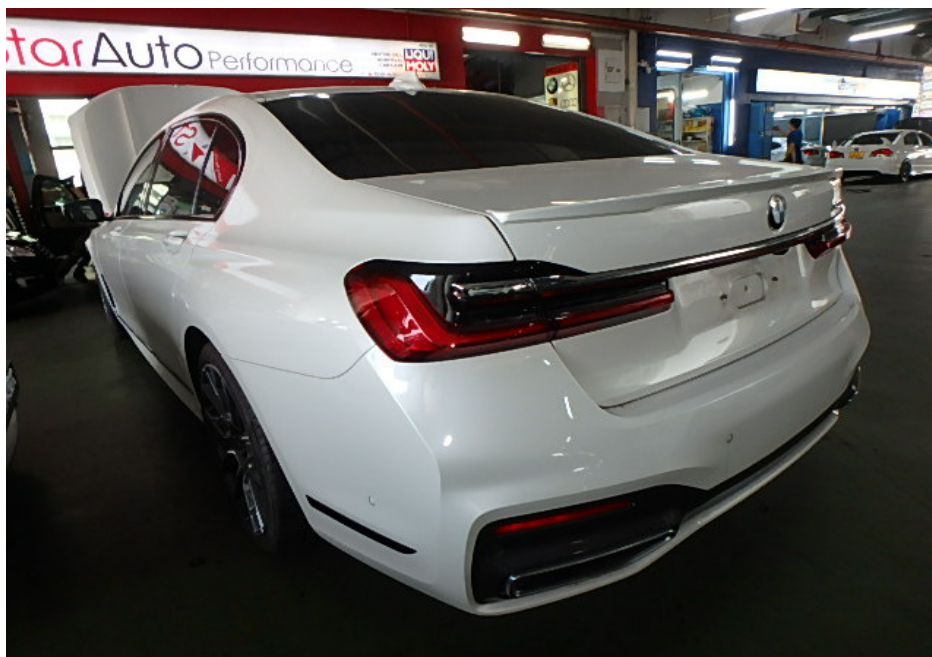
**Photo 4** shows the rear left body of the Motor Car (photograph provided to me). Apart for the front right portion, there was no physical damage observed to other areas of the Motor Car. The airbags were also not deployed as seen from the photographs that were provided to me.

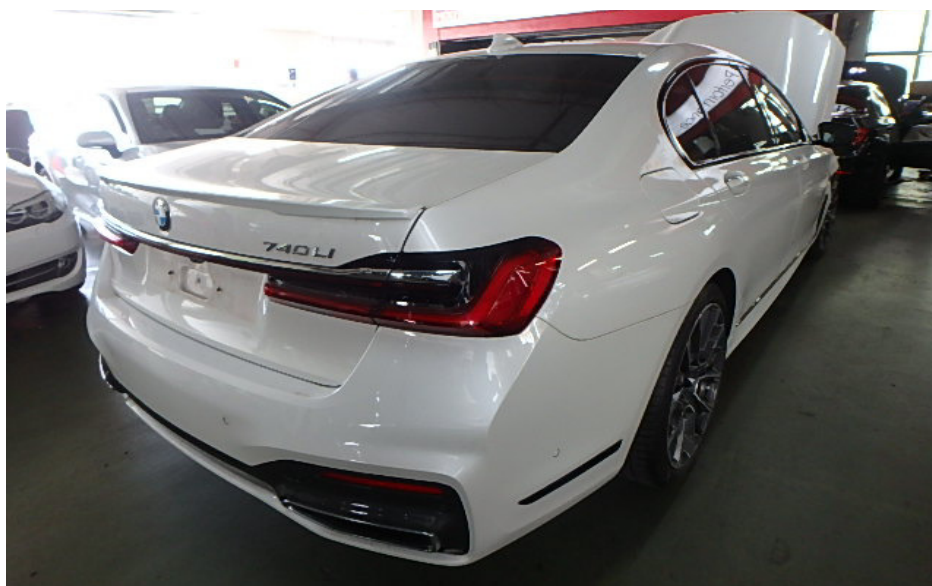
**Photo 5** shows the rear right body of the Motor Car (photograph provided to me). Apart for the front right portion, there was no physical damage observed to other areas of the Motor Car. The airbags were also not deployed as seen from the photographs that were provided to me.

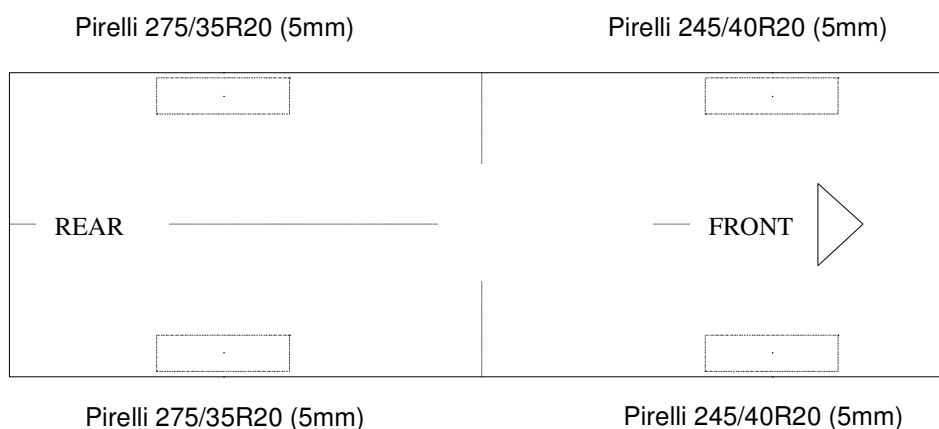
8. It was fitted with 20inch sport wheel rims that were wrapped with tyres that were observed to be of serviceable condition. The tyres were also sufficiently inflated for vehicular operation. The tyre brand, tyre size and approximate remaining tread depth of the 4 tyres of the Motor Car were recorded as follows: -

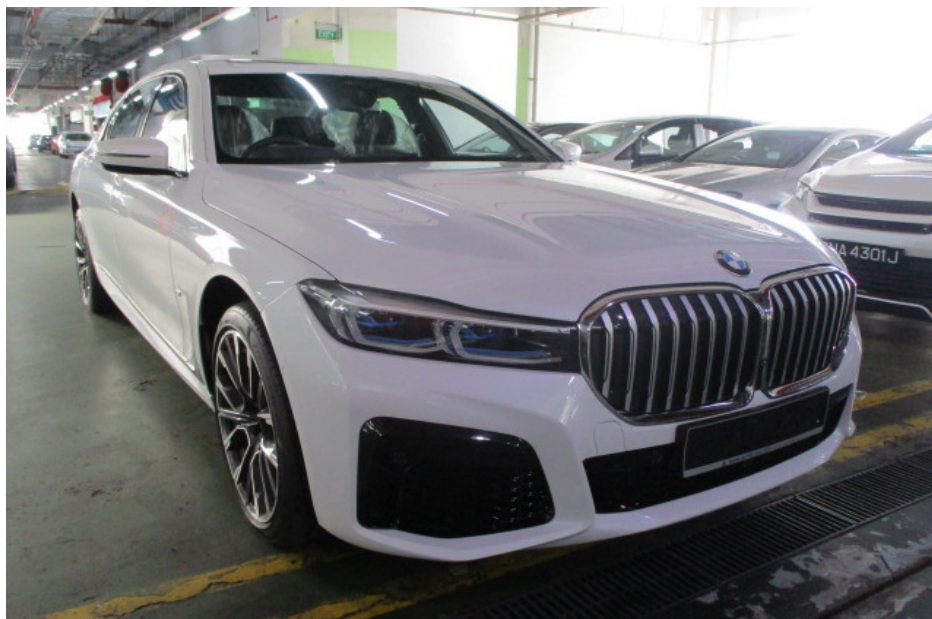
**Photo 6** shows a general view of the front right body of the Motor Car at the time of my inspection. The Motor Car was observed to be in a relatively good general condition with no loose exterior fittings observed. The body parts at the front right portion of the Motor Car were visually examined, and it was observed that the repair/restoration works carried out to the damaged area of the Motor Car (refer to photograph 1 - 3) were reasonably adequate and in order.

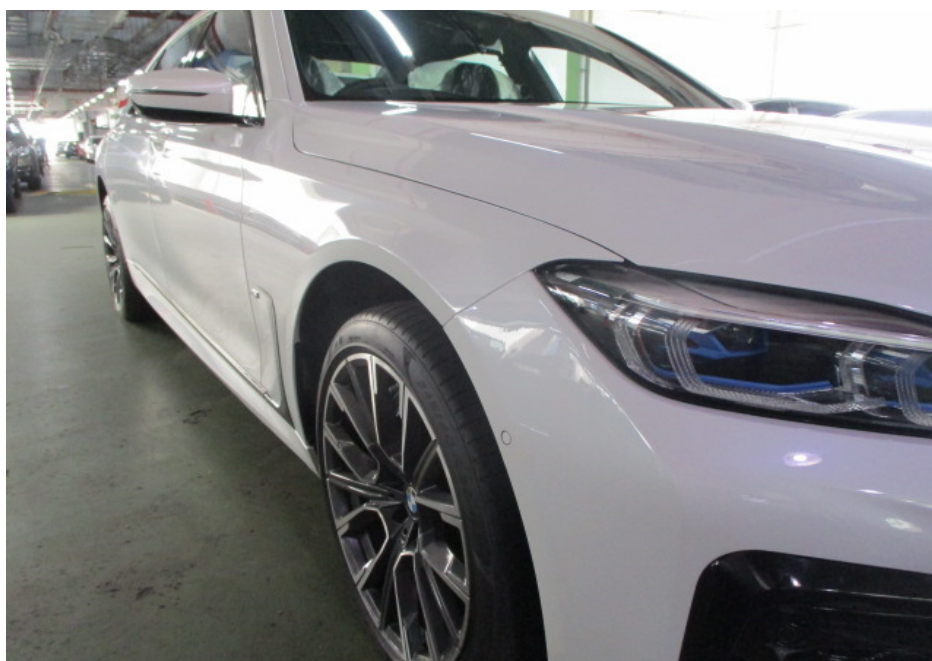
**Photo 7** shows a closer view of the Motor Car's front bumper, front right headlamp, front bonnet and front right fender at the time of my inspection. The body parts at the front right portion of the Motor Car were visually examined, and it was observed that the repair/restoration works carried out to the damaged area of the Motor Car (refer to photograph 1 & 2 above) were reasonably adequate and in order.

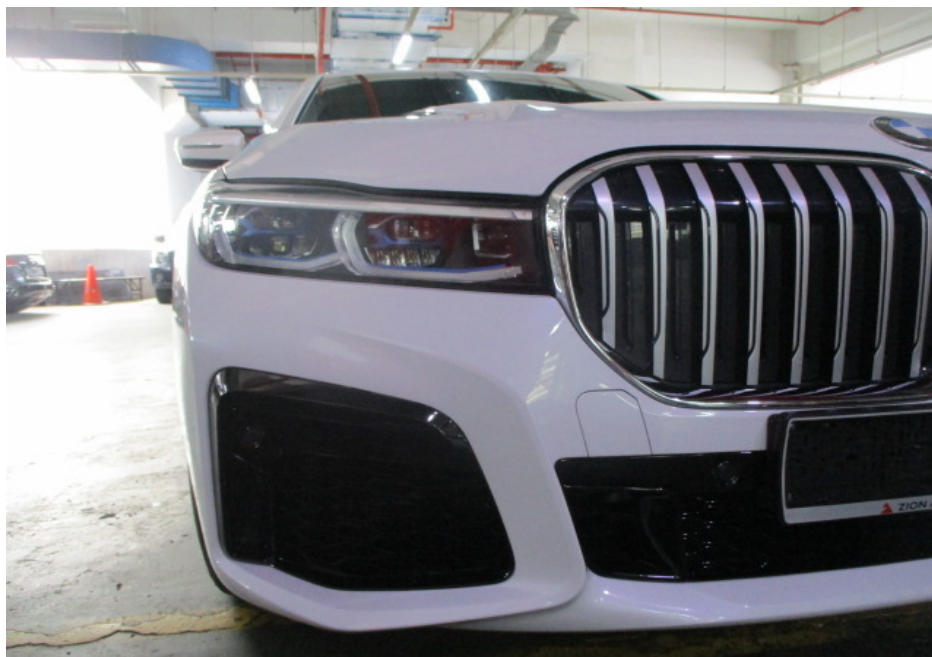
**Photo 8** shows a closer view of the Motor Car's front bumper, front bumper right lower grille, front bumper right lower grille garnish and front right headlamp at the time of my inspection. The body parts at the front right portion of the Motor Car were visually examined, and it was observed that the repair/restoration works carried out to the damaged area of the Motor Car (refer to photograph 1 & 2 above) were reasonably adequate and in order.

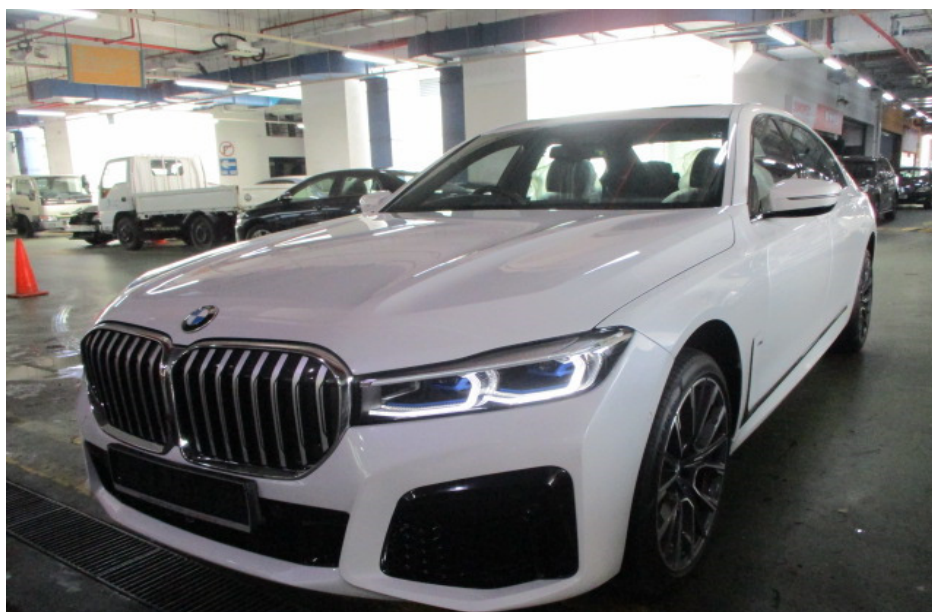
**Photo 9** shows a general view of the front left body of the Motor Car at the time of my inspection. The Motor Car was observed to be in a relatively good general condition with no loose exterior fittings observed. The body parts at the frontal portion of the Motor Car were visually examined, and it was observed that the repair/restoration works carried out to the damaged area of the Motor Car (refer to photograph 1 - 3) were reasonably adequate and in order.

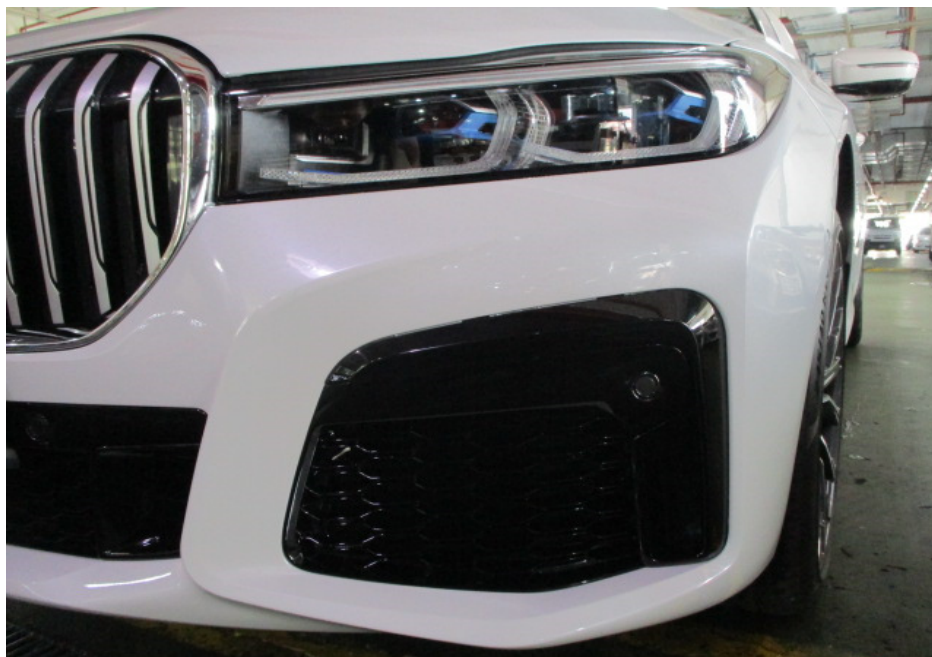
**Photo 10** shows a closer view of the Motor Car's front bumper, front bumper left lower grille, front bumper left lower grille garnish and front left headlamp at the time of my inspection. The body parts at the frontal portion of the Motor Car were visually examined, and it was observed that the repair/restoration works carried out to the damaged area of the Motor Car (refer to photograph 3 above) were reasonably adequate and in order.

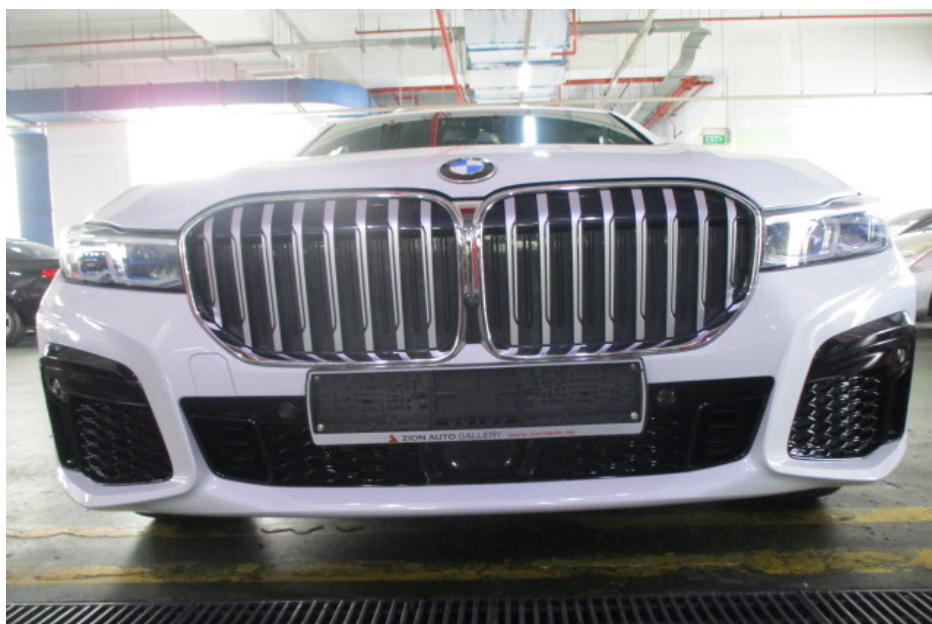
**Photo 11** shows a closer view of the Motor Car's front bumper, front bumper centre lower grille, radiator grilles and front headlamps at the time of my inspection. The body parts at the frontal portion of the Motor Car were visually examined, and it was observed that the repair/restoration works carried out to the damaged area of the Motor Car (refer to photograph 1 & 3 above) were reasonably adequate and in order.

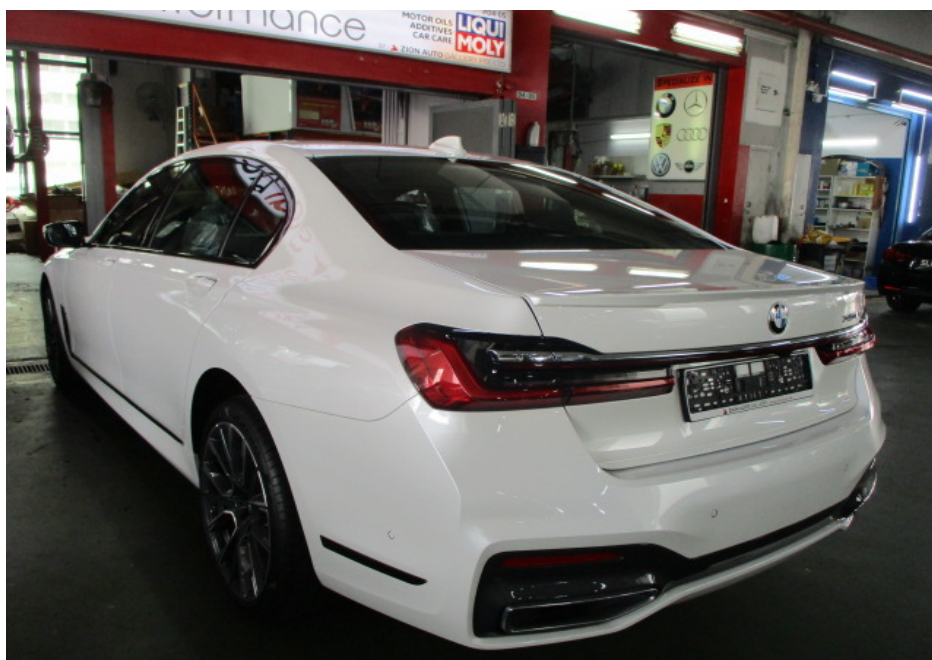
**Photo 12** shows a general view of the rear left body of the Motor Car at the time of my inspection. The Motor Car was observed to be in a relatively good general condition with no loose exterior fittings observed. The mileage of the Motor Car recorded at the time of my inspection was 8,835km.

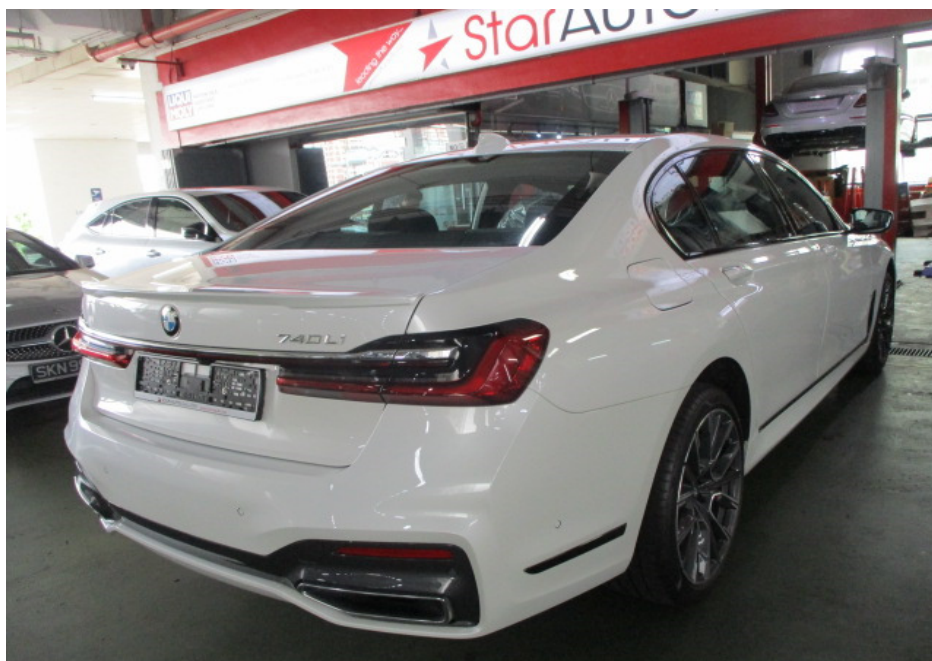
**Photo 13** shows a general view of the rear right body of the Motor Car at the time of my inspection. The Motor Car was observed to be in a relatively good general condition with no loose exterior fittings observed. The mileage of the Motor Car recorded at the time of my inspection was 8,835km.

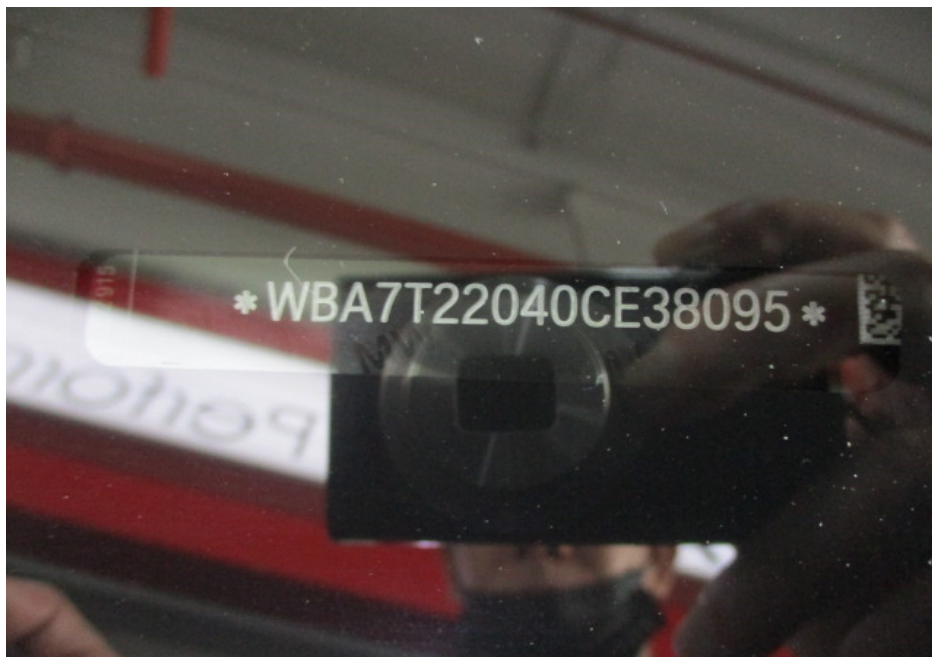
**Photo 14** shows the chassis number of the Motor Car. The chassis number recorded was WBA7T22040CE38095.

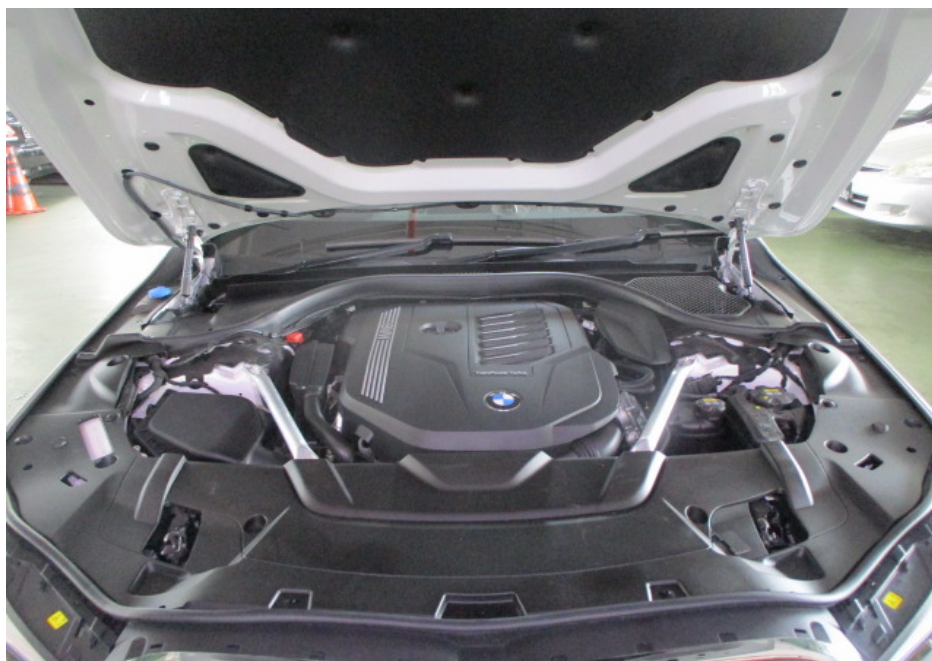
**Photo 15** shows a general view of the engine compartment of the Motor Car at the time of my inspection. The various parts and components inside the engine compartment were all observed to be intact and properly fitted. There was also no sign(s) or indication(s) of fluid leak and/or fluid stain found inside the engine compartment.

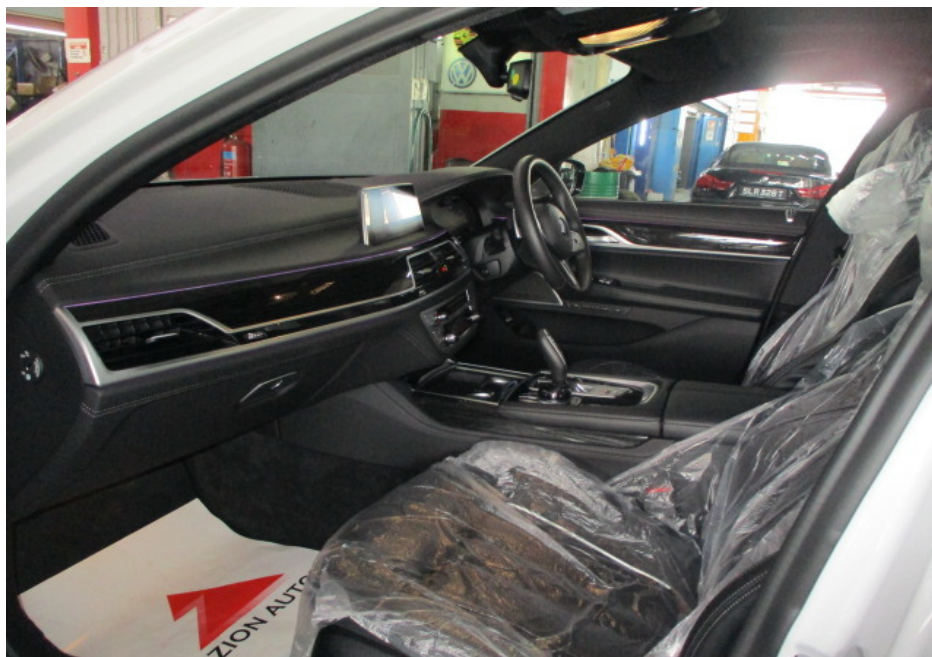
**Photo 16** shows the interior compartment of the Motor Car at the time of my inspection. The various parts and components, trims, carpet and upholstery inside the interior compartment were all observed to be intact and properly fitted.

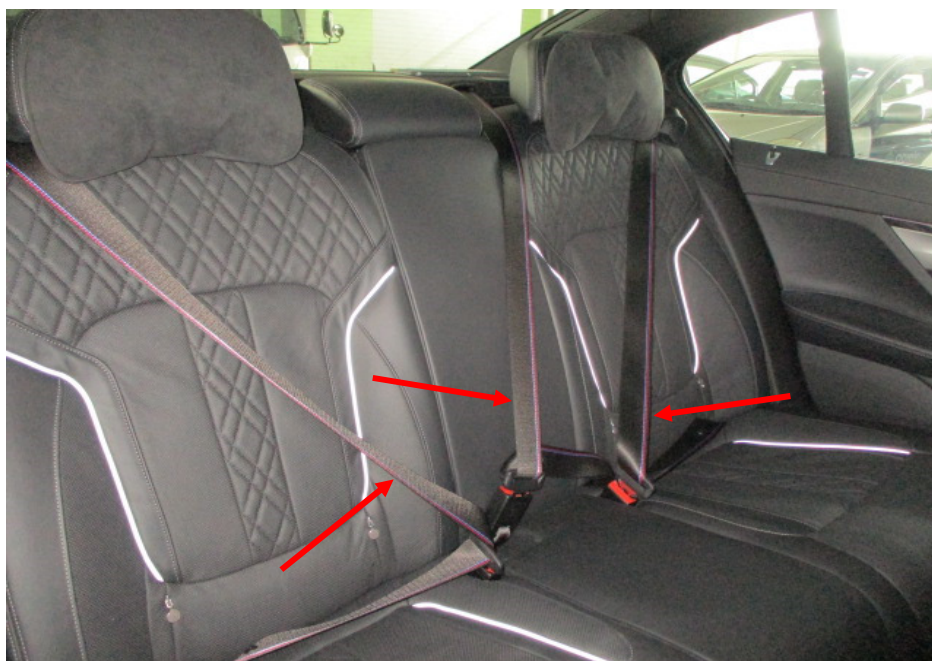
**Photo 17** shows the rear seats of the Motor Car. All the seats of the Motor Car were secured via seat rails to the floorboard. They were also fitted with a retractable seat belt reel and a pre-tensioner. The seat belts (arrowed) were tested and were able to be fastened into the respective pre-tensions that were fitted on the side of each individual seat.

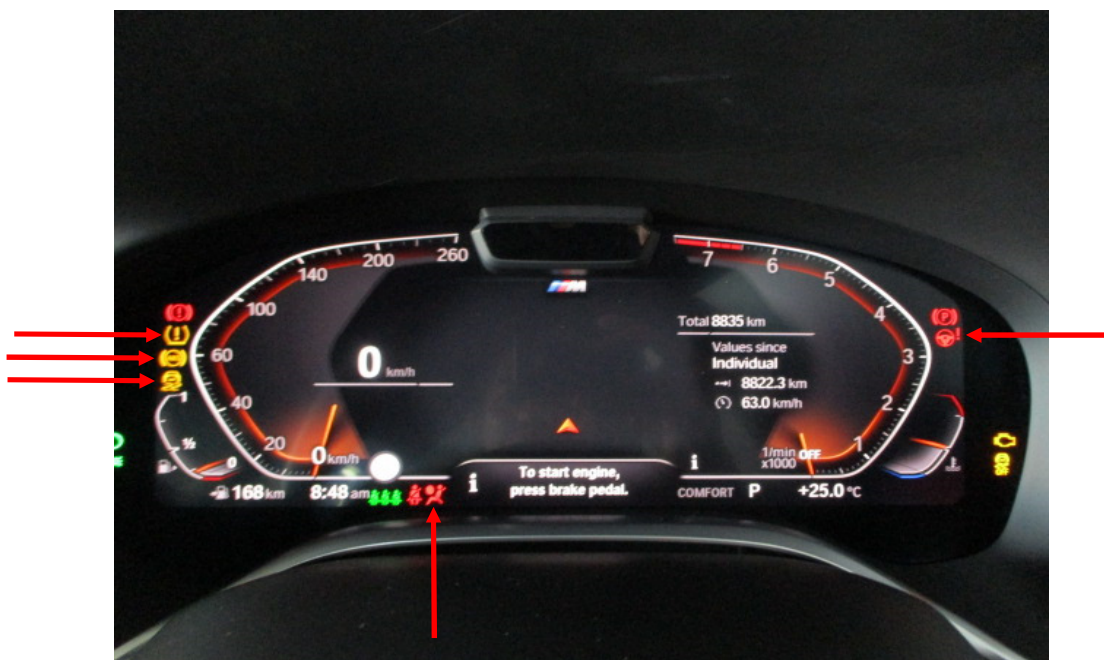
**Photo 18** shows the warning lights for the various electronic safety features appearing on the instrument panel of the Motor Car during its self-test when the engine is cranked, in particular the ABS, SRS, IAS, TPM and DSC lights (arrowed).

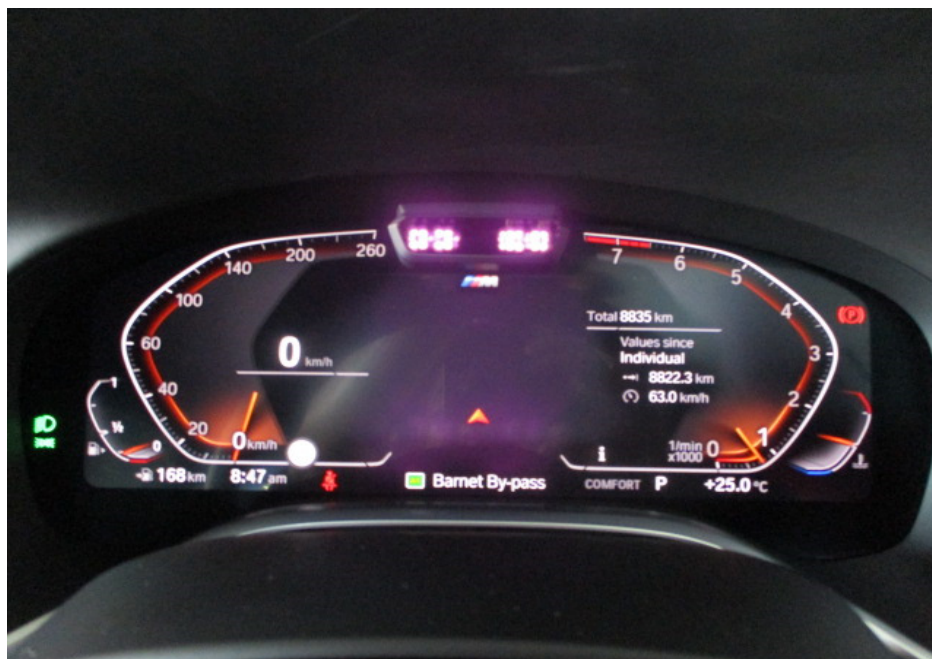
**Photo 19** shows the respective warning lights no longer illuminated, indicating that there is no fault detected to the ABS, SRS, IAS, TPM and DSC systems of the Motor Car during the self-test. These electronic systems were hence in working condition at the time of my inspection.

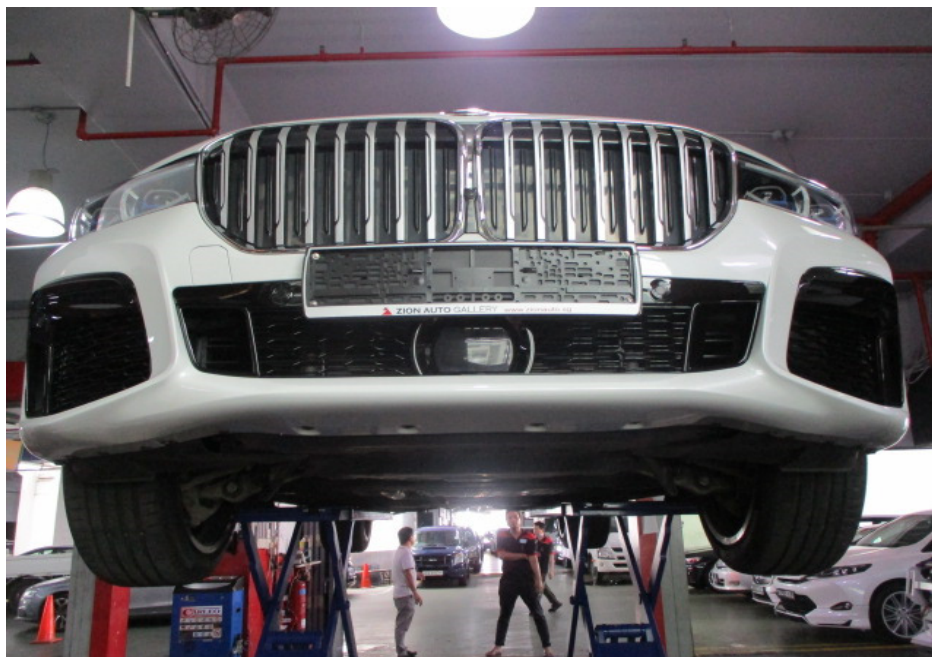
**Photo 20** shows the Motor Car hoisted up for checks on its undercarriage. There was no sign(s) or indication(s) of fluid leakage and/or fluid stain(s) on the underside of the Motor Car. The undercarriage components of the Motor Car were also all observed to be intact and secured in an appropriate manner.

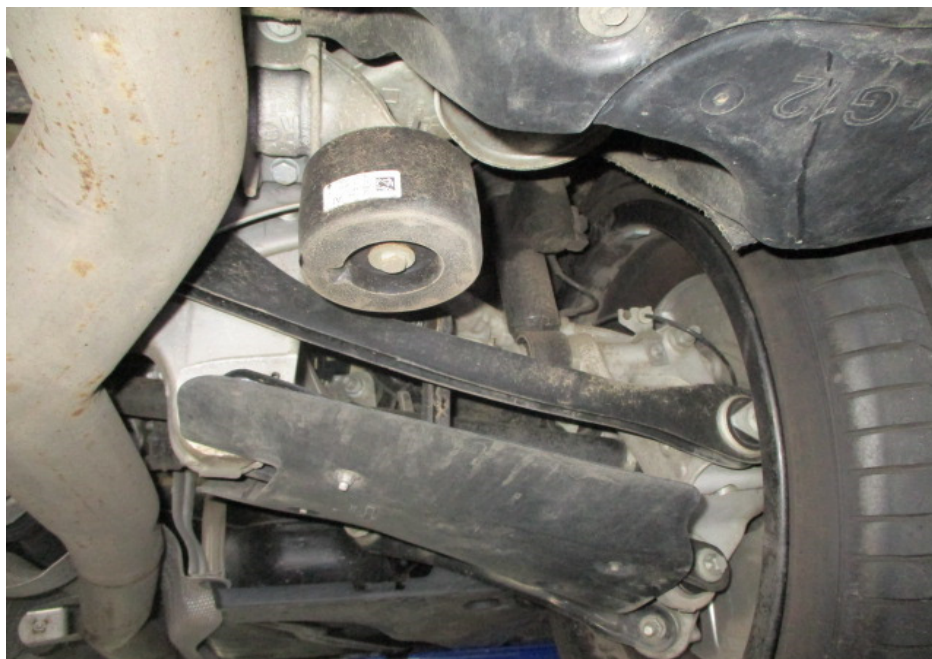
**Photo 21** shows a general view of the control arms and linkages at the rear right wheel of the Motor Car. I did not observe any fluid leak and/or fluid stain on the underside of the Motor Car. All of the Motor Car's undercarriage components were observed to be intact and secured in an appropriate manner.

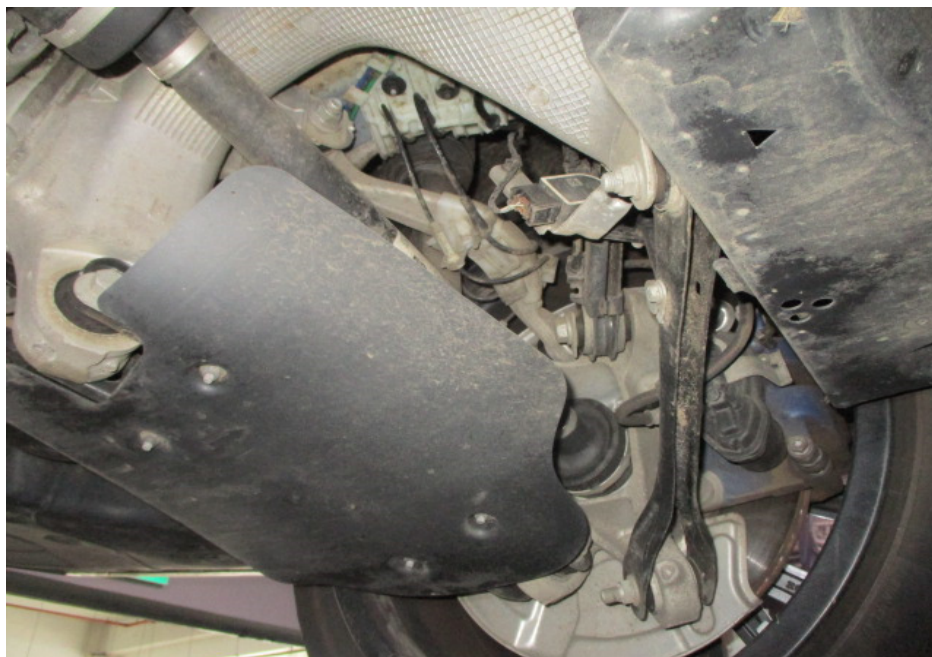
**Photo 22** shows a general view of the control arms and linkages at the rear left wheel of the Motor Car. I did not observe any fluid leak and/or fluid stain on the underside of the Motor Car. All of the Motor Car's undercarriage components were observed to be intact and secured in an appropriate manner.

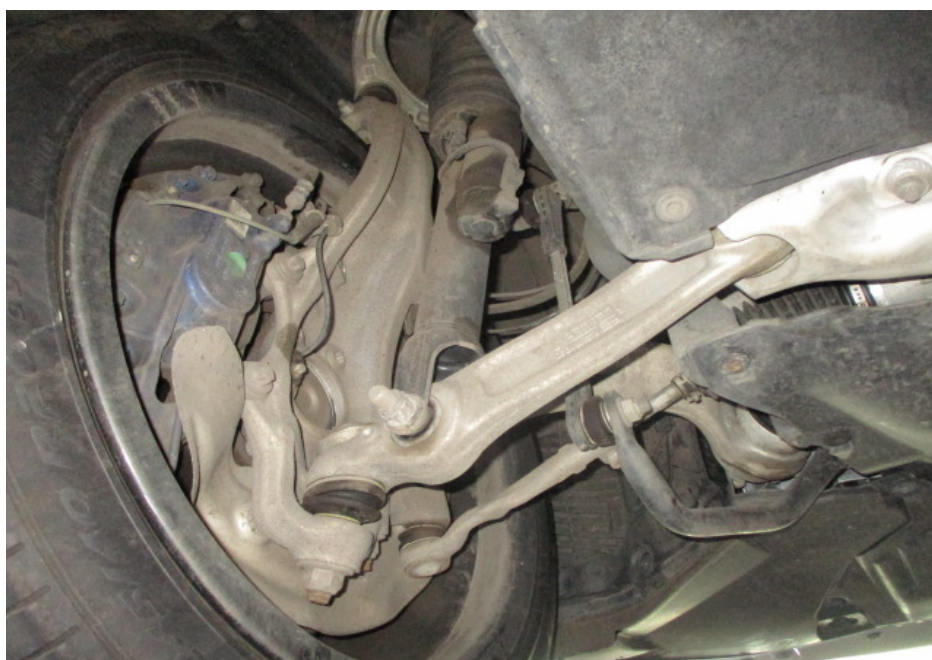
**Photo 23** shows the various undercarriage components at the front left wheel of the Motor Car. The mechanical components, control arms and linkages were all found to be intact and secured in an appropriate manner.

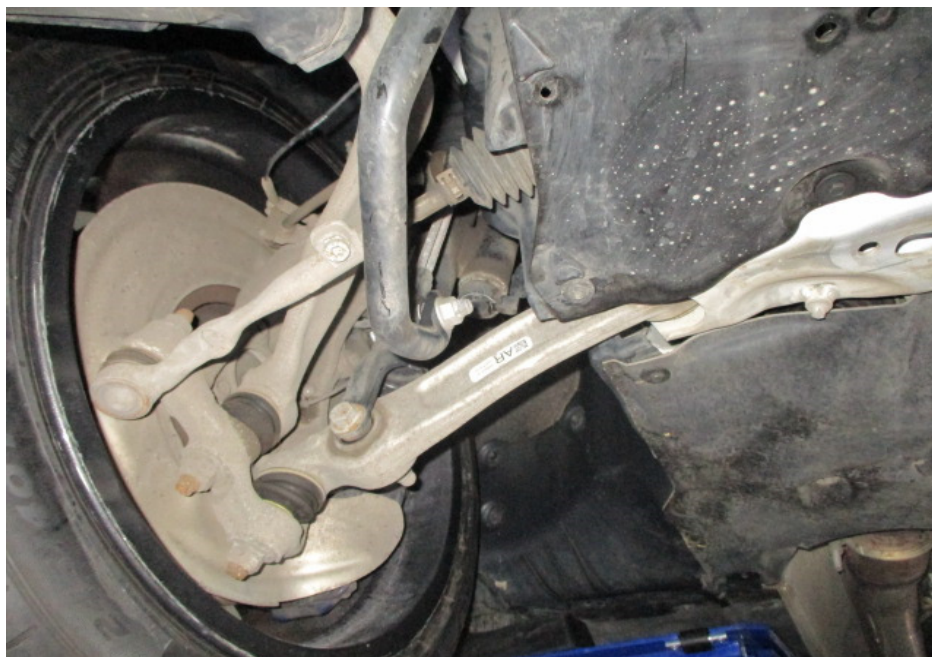
**Photo 24** shows the various undercarriage components at the front right wheel of the Motor Car. The mechanical components, control arms and linkages were all found to be intact and secured in an appropriate manner. I also did not observe any fluid leak and/or fluid stain on the underside of the Motor Car.

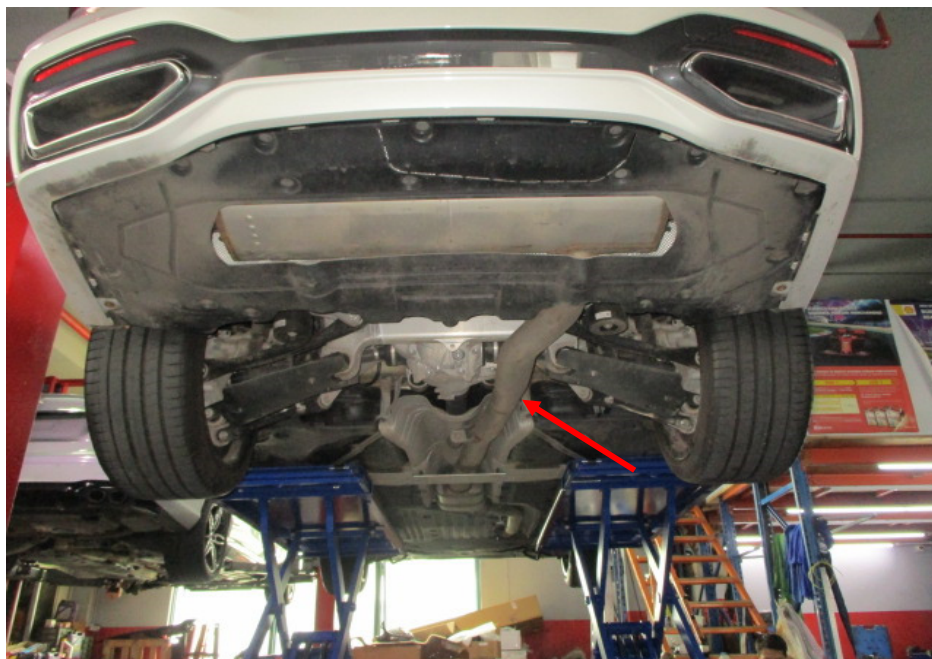
**Photo 25** shows a general view of the rear section of the Motor Car's exhaust system. My examination of the Motor Car's exhaust system revealed no sign(s) or indication(s) of any cut or weld marks along its exhaust pipes (arrowed), on its centre resonator box, on its catalytic converter and on its rear muffler.

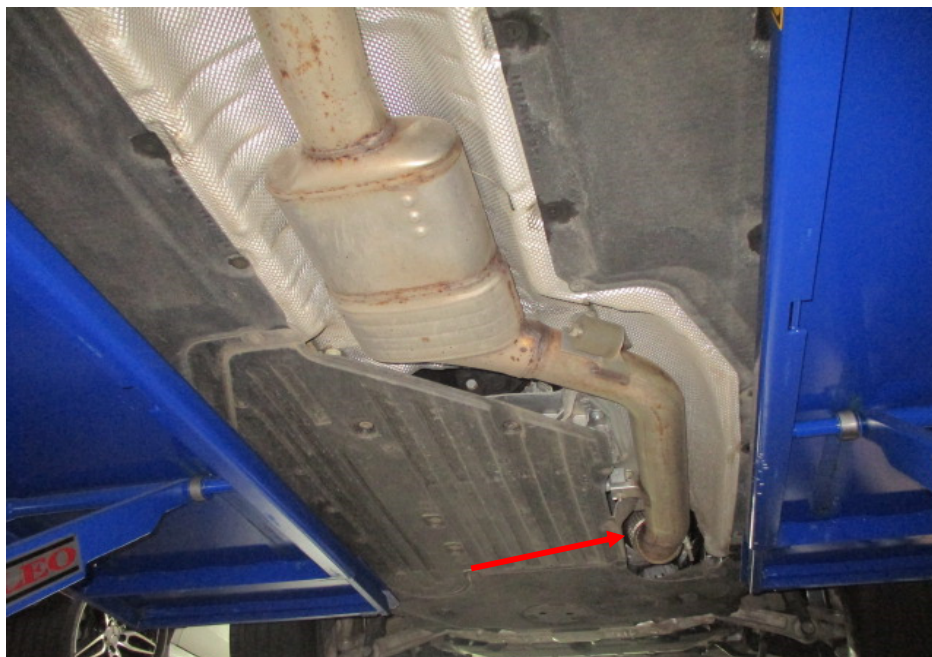
**Photo 26** shows a general view of the front section of the Motor Car's exhaust system. My examination of the Motor Car's exhaust system revealed no sign(s) or indication(s) of any cut or weld marks along its exhaust pipes, on its centre resonator box, on its catalytic converter (arrowed) and on its rear muffler.

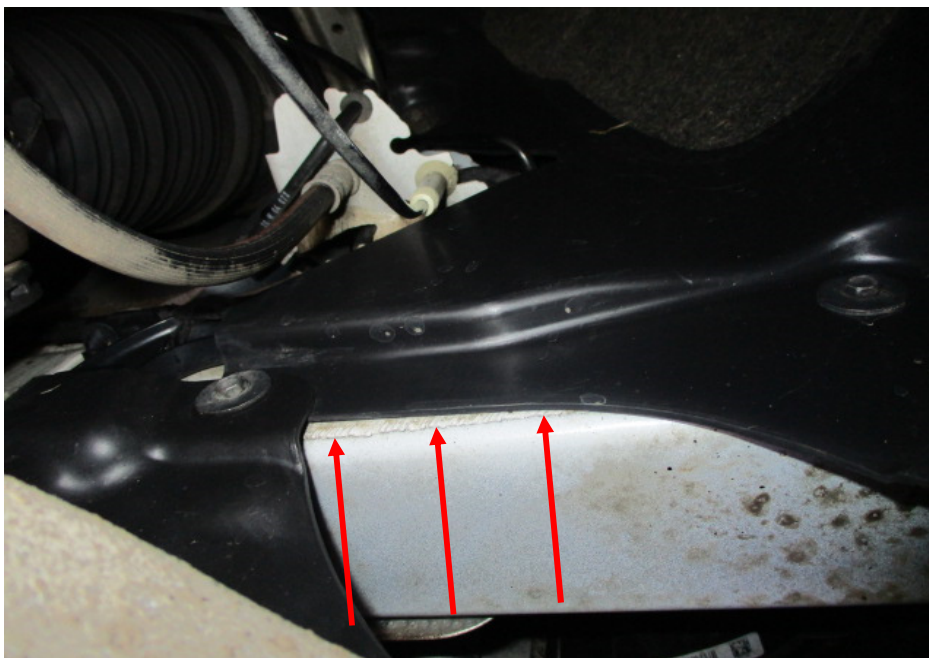
**Photo 27** shows the chassis/structural body at the underside front right of the Motor Car. I did not find any weld marks other than original spot weld marks on the chassis/structural body of the Motor Car. The original factory sealant (arrowed) at the joints along the chassis/structural body was untouched, indicating no work was done on the chassis/structural body of the Motor Car and that the chassis/structural body was originally fitted.

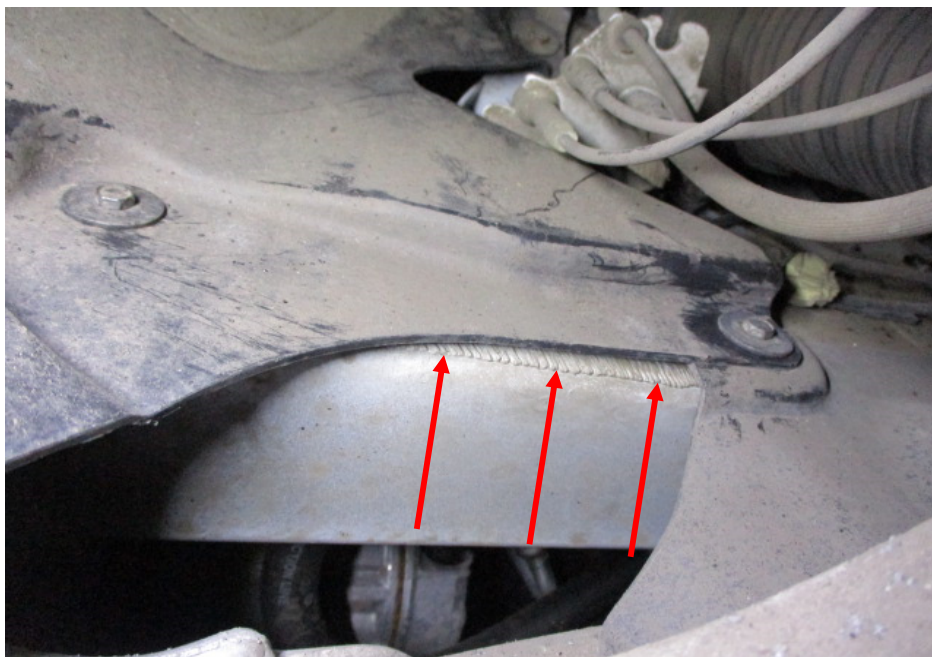
**Photo 28** shows the chassis/structural body at the underside front left of the Motor Car. The original factory sealant (arrowed) at the joints along the chassis/structural body was observed to be untouched. In general, I had found no work was carried out on the chassis/structural body of the Motor Car. The chassis/structural body of the Motor Car was originally fitted.

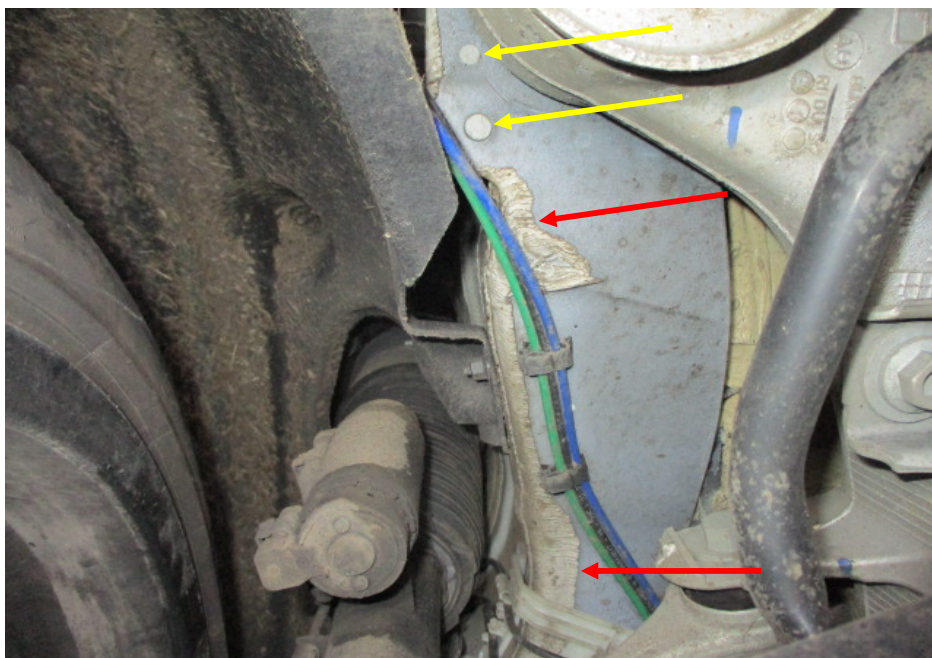
**Photo 29** shows the chassis/structural body at the underside rear left of the Motor Car. I did not find any weld marks other than original spot weld marks (yellow arrow) on the chassis/structural body of the Motor Car. The original factory sealant (red arrow) at the joints along the chassis/structural body was untouched, indicating no work was done on the chassis/structural body of the Motor Car and that the chassis/structural body was originally fitted.

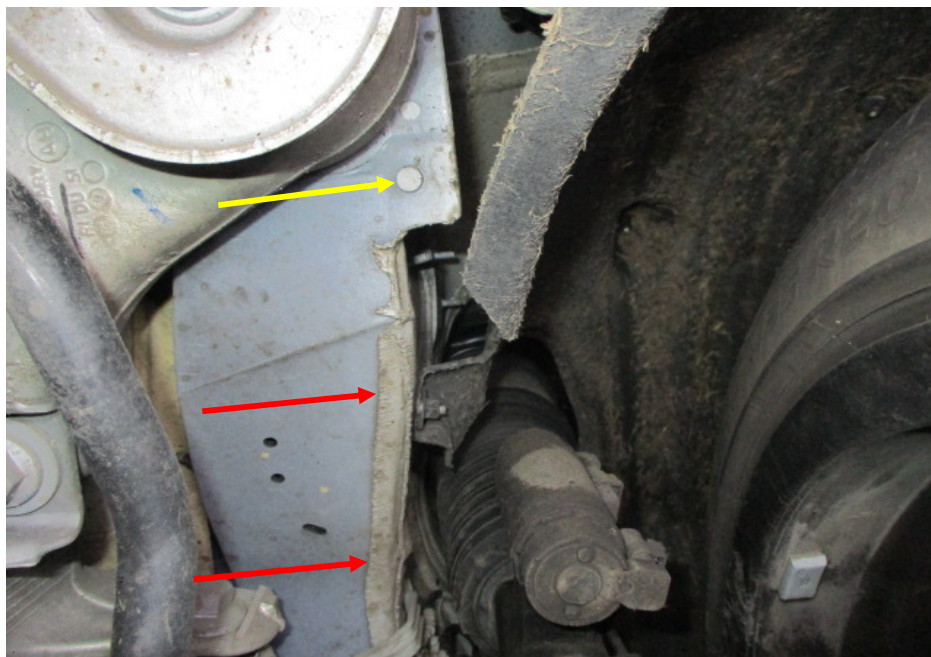
**Photo 30** shows the chassis/structural body at the underside rear right of the Motor Car. I did not find any weld marks other than original spot weld marks (yellow arrow) on the chassis/structural body of the Motor Car. The original factory sealant (red arrow) at the joints along the chassis/structural body was untouched, indicating no work was done on the chassis/structural body of the Motor Car and that the chassis/structural body was originally fitted.

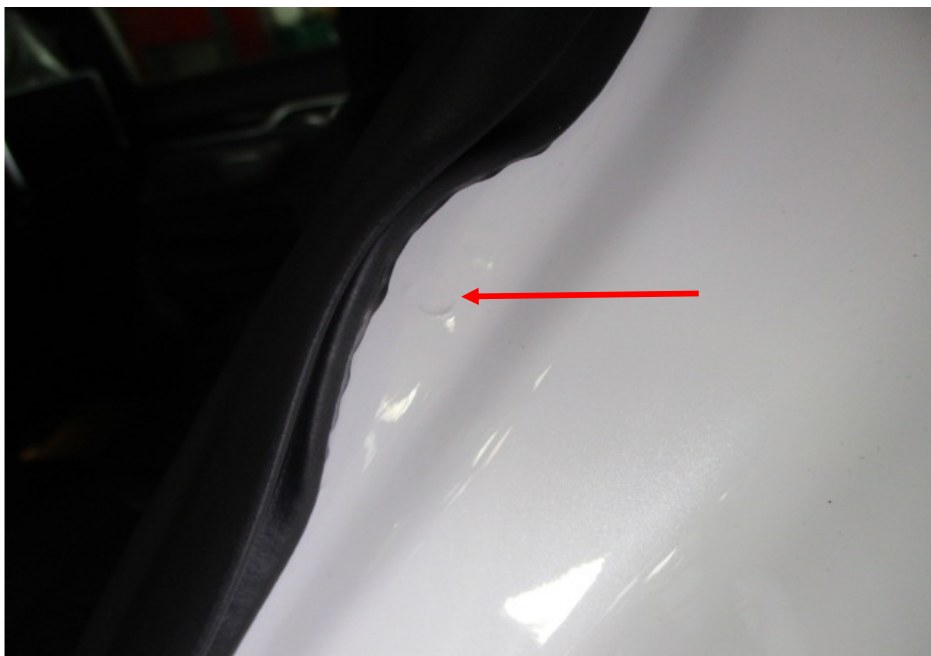
**Photo 31** shows the left side "C" pillar of the Motor Car. I did not find any weld marks other than original spot weld marks (arrowed) on the left side "C" pillar of the Motor Car which, indicates that there was no re-welding works carried out. In general, I had found all the non-detachable body panels of the Motor Car to be originally fitted at the time of my inspection.
