Your Ref: BMW 740Li  
(chassis number WBA7T22040CE38095)  
Our Ref : CI/TP21009901/D

22 September 2021

**INSPECTION REPORT OF AN UNREGISTERED BMW 740Li MOTOR CAR  
WITH CHASSIS NUMBER WBA7T22040CE38095**

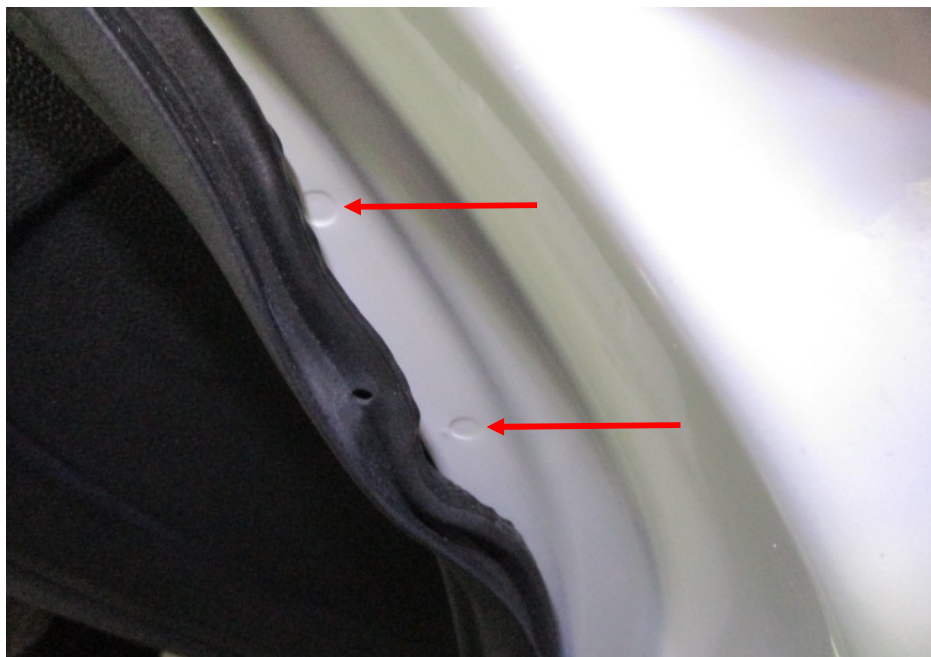
**Photo 32** shows the right side "A" pillar of the Motor Car. I did not find any weld marks other than original spot weld marks (arrowed) on the right side "A" pillar of the Motor Car which, indicates that there was no re-welding works carried out. In general, I had found all the non-detachable body panels of the Motor Car to be originally fitted at the time of my inspection.
