Your Ref: S1M031BE
Our Ref : CS4/ASM21009921/D

**TECHNICAL INVESTIGATION REPORT OF FIRE INCIDENT INVOLVING THE
INSURED VEHICLE YL 8552L ON 17 SEPTEMBER 2021**

Vehicle Registration No.	: YL 8552L
Make / Model	: Nissan Cabstar
Chassis No	: JN1SF4F23Z0853148
Year of Registration	: 2004 (November)
Mileage	: 452,979km

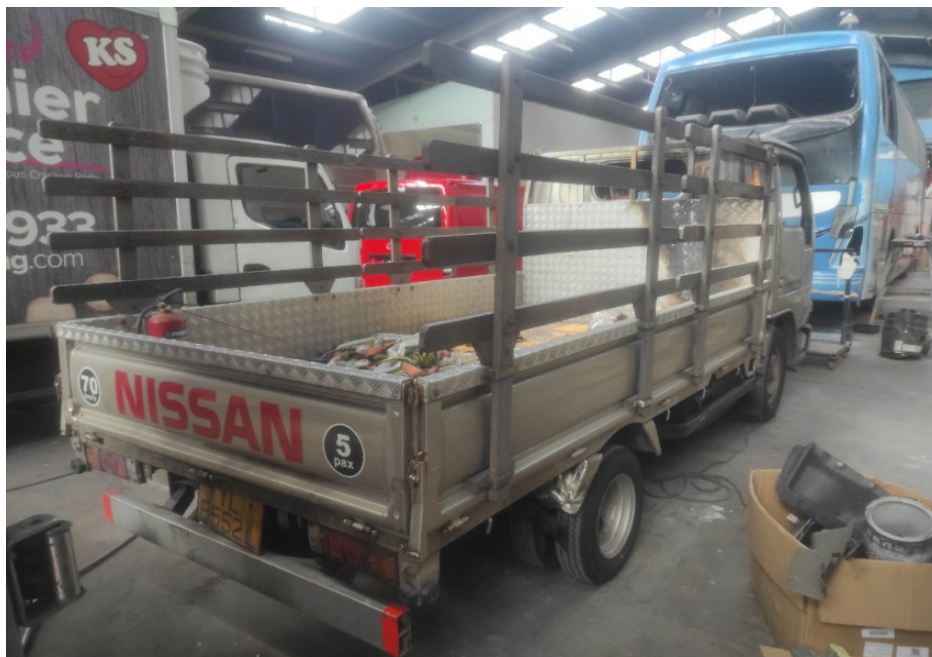
Photo 1 shows a general view of the rear right body of the Insured Vehicle at the time of inspection. The Insured Vehicle was observed to have sustained fire damage at its rear deck. This was at the right side front of the rear deck, directly behind the right side of the Insured Vehicle's front cabin.

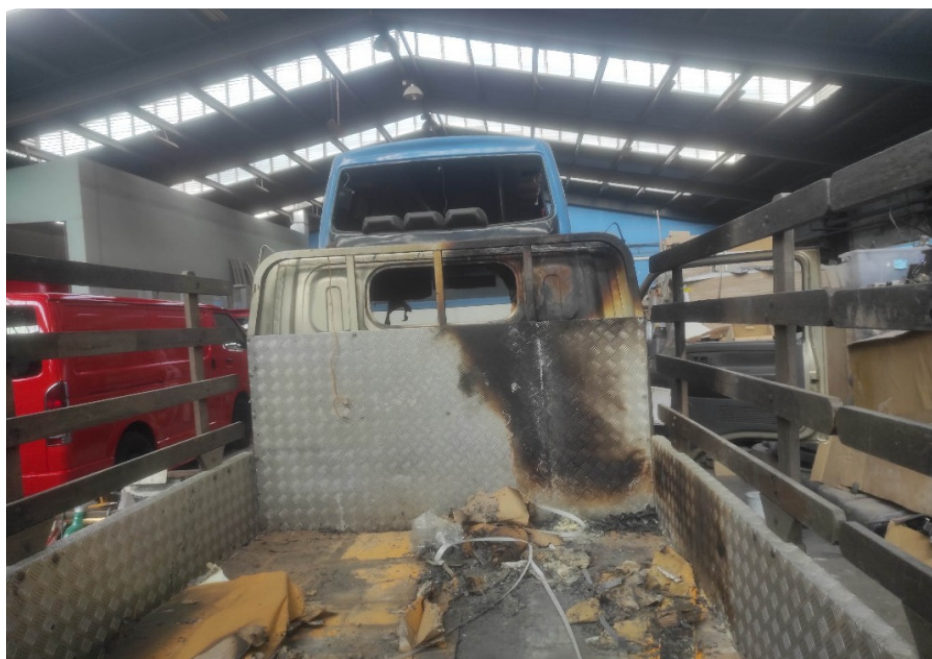
Photo 2 shows a general view of the right side front of the Insured Vehicle's rear deck. The Insured Vehicle was observed to have sustained fire damage at its rear deck. This was at the right side front of the rear deck, directly behind the right side of the Insured Vehicle's front cabin. The aluminium plates surrounding the right side front of the rear deck, the vertical wooden side gate extension at the right side front of the Insured Vehicle and the rear exterior of the front cabin at the right side amongst others, were found with fire damage.

19. For this case, it can be established from the video recordings and incident scene photographs that the fire to the Insured Vehicle had originated outside of the Insured Vehicle, from one of the new air conditioning compressors at the right side front of the Insured Vehicle's rear deck. Correspondingly, the fire damage to the Insured Vehicle seen at the time of inspection was also confined to the various parts of the Insured Vehicle surrounding this same area. Refer to photograph 2 to 7 above.

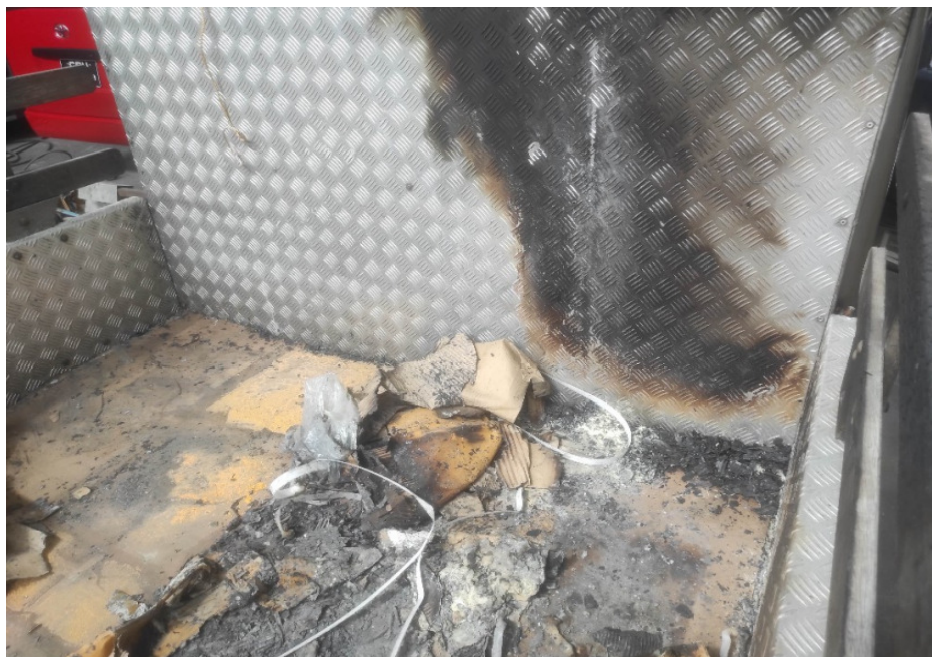
Photo 3 shows a closer view of the partially burnt aluminium plates surrounding the right side front of the Insured Vehicle's rear deck.

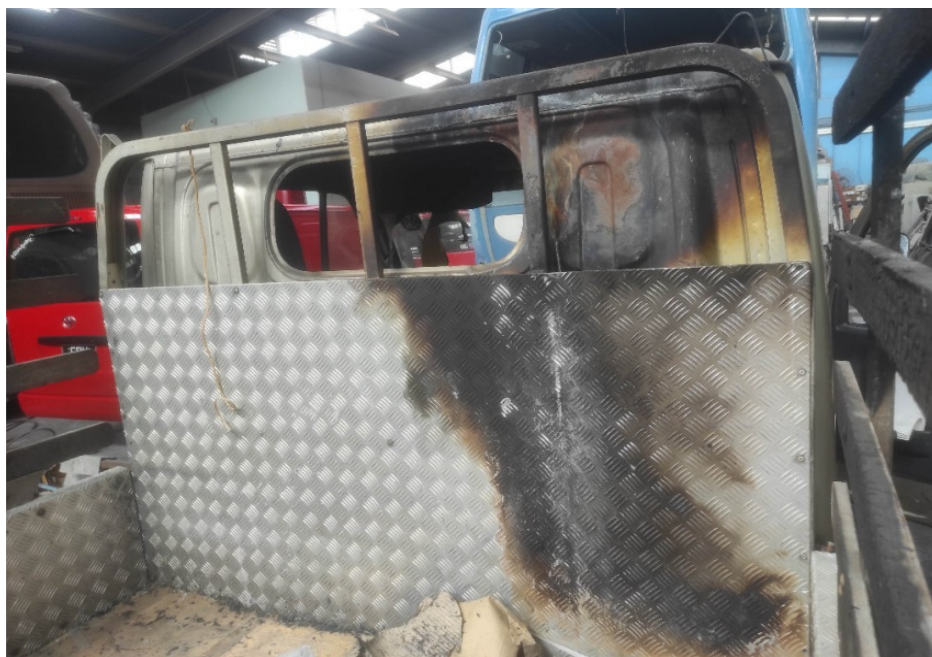
Photo 4 shows another view of the partially burnt aluminium plates surrounding the right side front of the Insured Vehicle's rear deck. The rear exterior of the front cabin at the right side was also observed to be partially burnt. The front cabin glass window was shattered as a result of the fire.

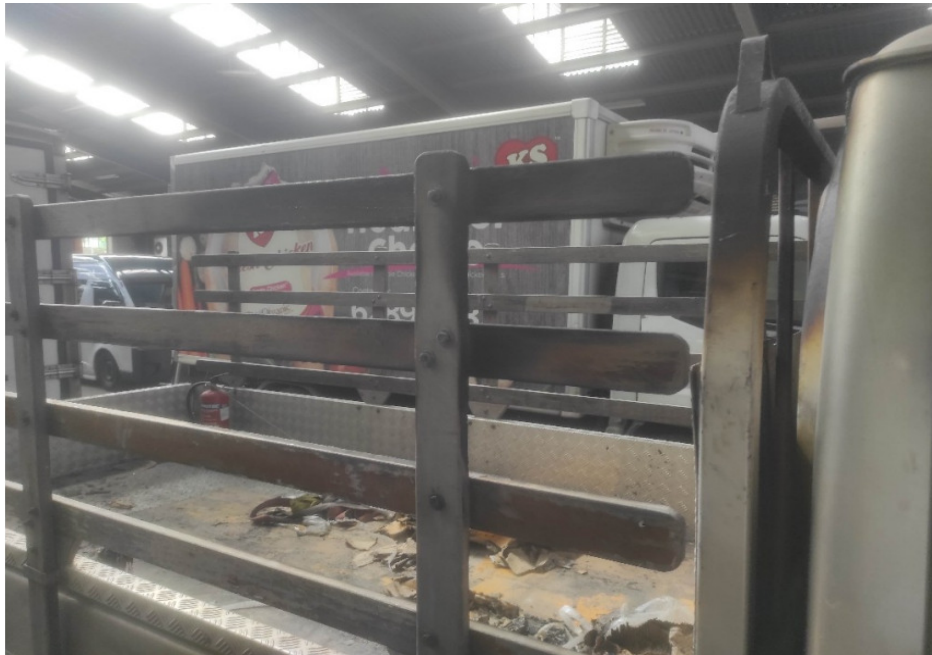
Photo 5 shows a closer view of the partially burnt vertical wooden side gate extension at the right side front of the Insured Vehicle.

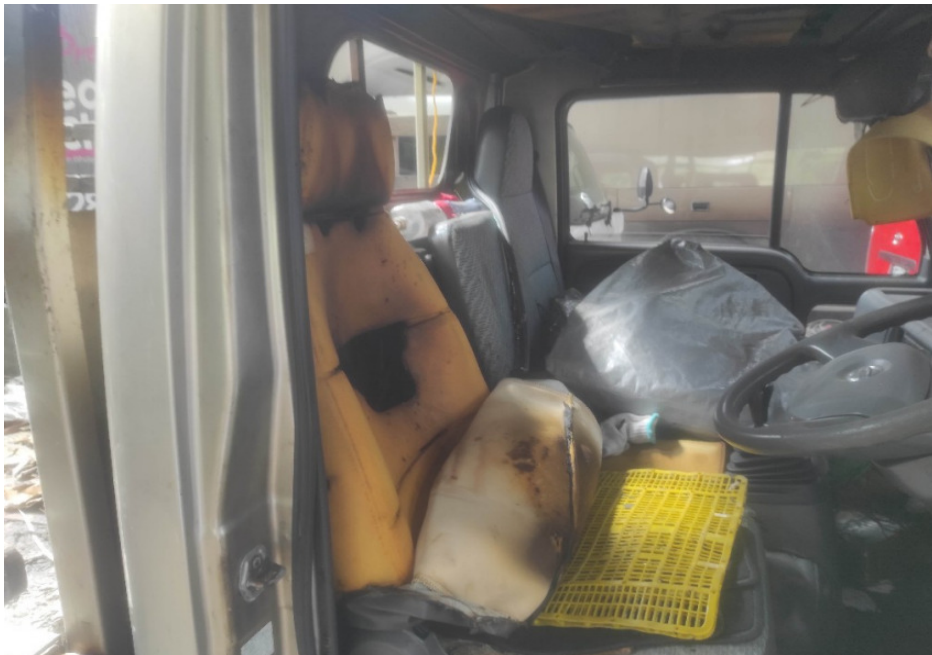
Photo 6 shows a closer view of the partially burnt driver's seat in the interior compartment of the Insured Vehicle's front cabin. The driver's seat and roof upholstery amongst others in the interior compartment of the front cabin was affected by the fire.

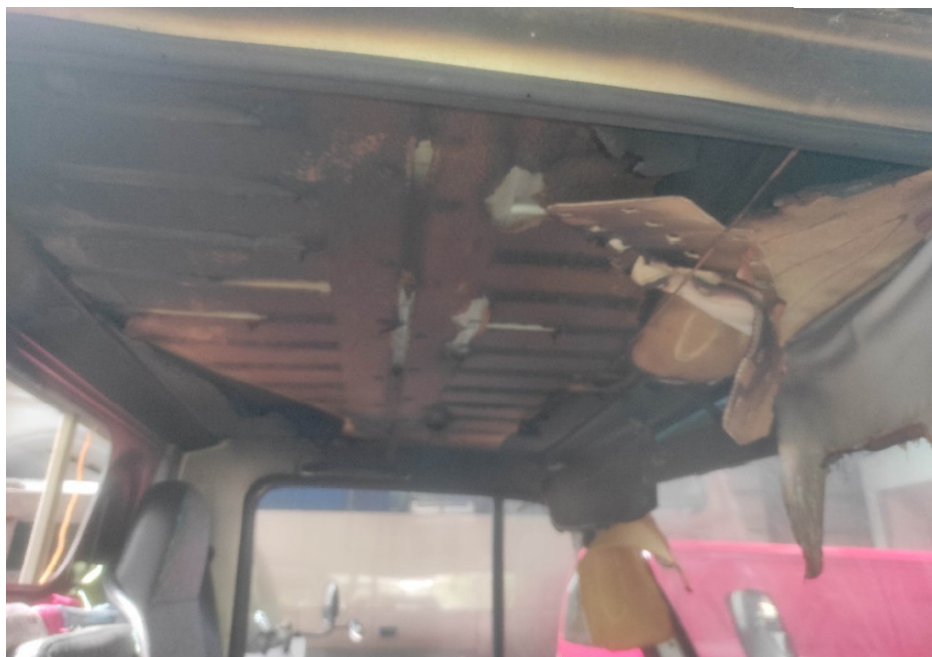
Photo 7 shows a closer view of the partially burnt roof upholstery in the interior compartment of the Insured Vehicle's front cabin. The driver's seat and roof upholstery amongst others in the interior compartment of the front cabin was affected by the fire.

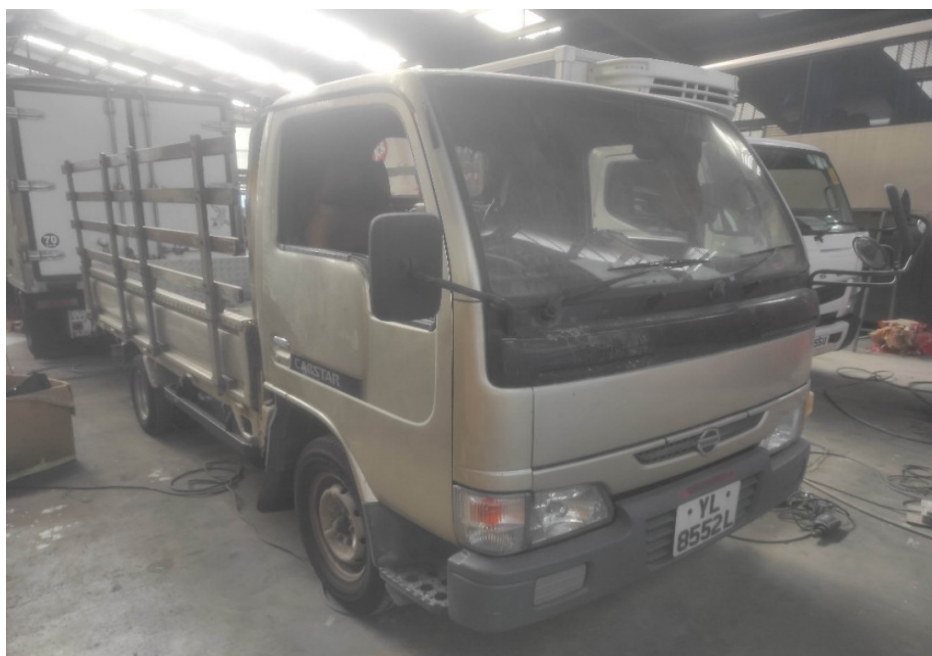
Photo 8 shows a general view of the front right body of the Insured Vehicle. No fire damage was observed to other areas of the Insured Vehicle except for the right side front of the rear deck, directly behind the right side of the Insured Vehicle's front cabin. The interior compartment of the Insured Vehicle's front cabin was also affected.

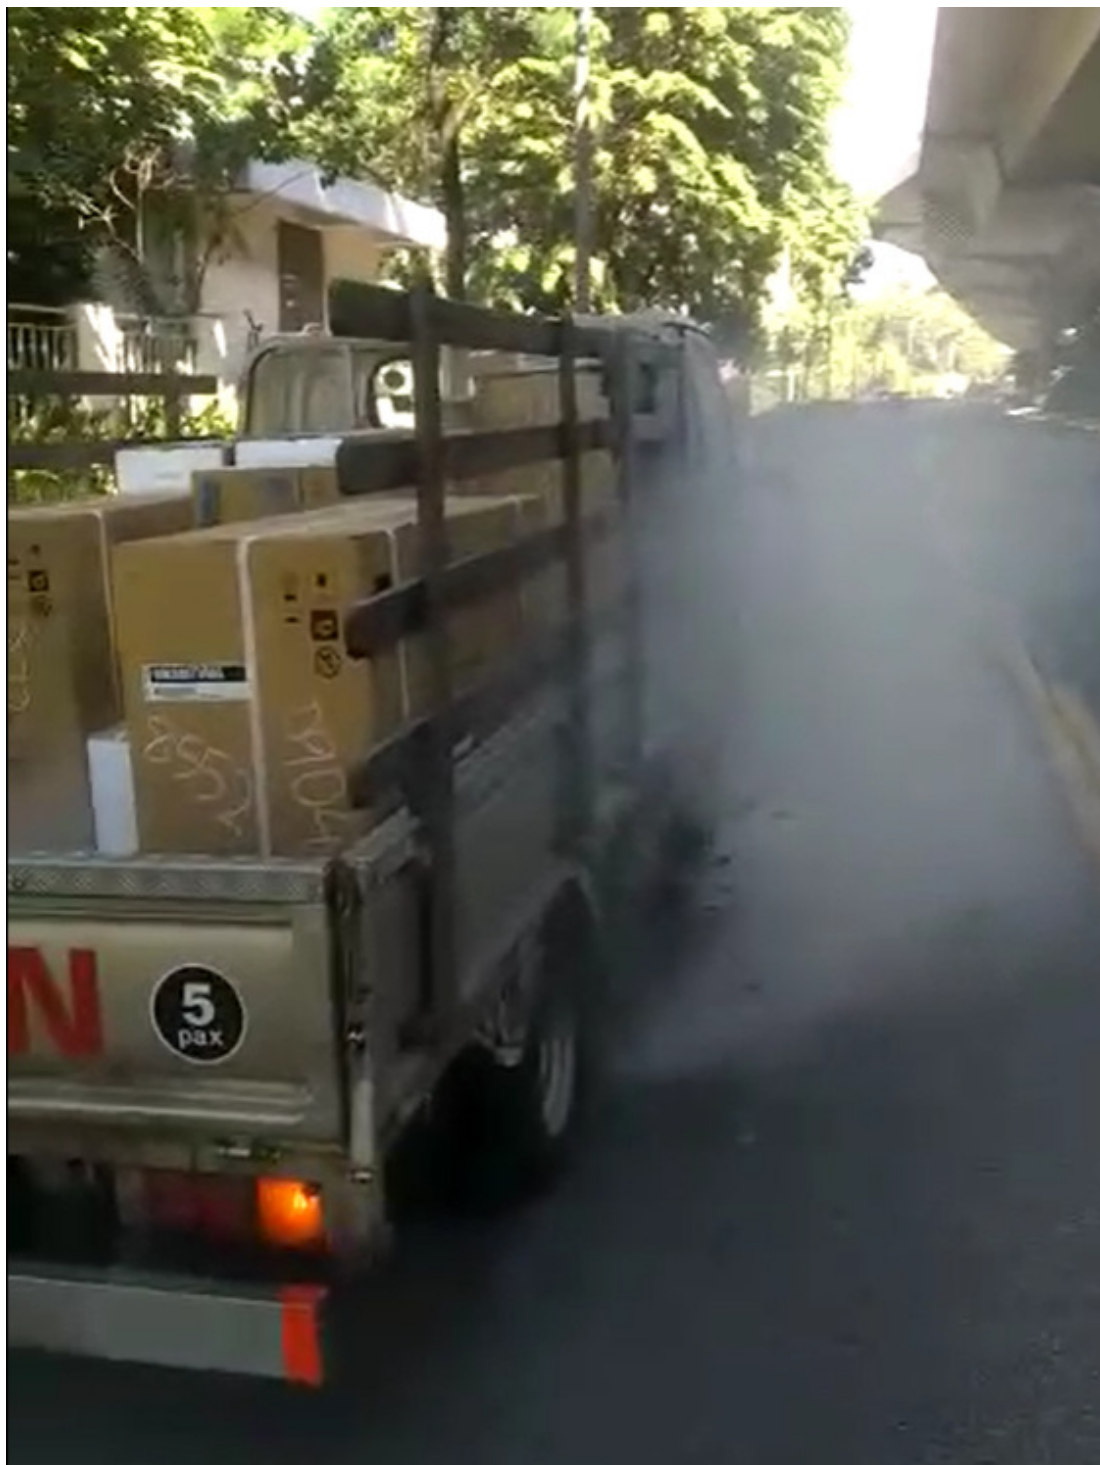
Photo 9 shows a screenshot extracted from one of the video recordings that were provided to me by Mr Leong. The Insured Vehicle can be seen stopped on the left lane with white smoke coming out from one of the new air conditioning compressors at the right side front of the Insured Vehicle's rear deck. Hissing sound was also heard in one of the video recordings.

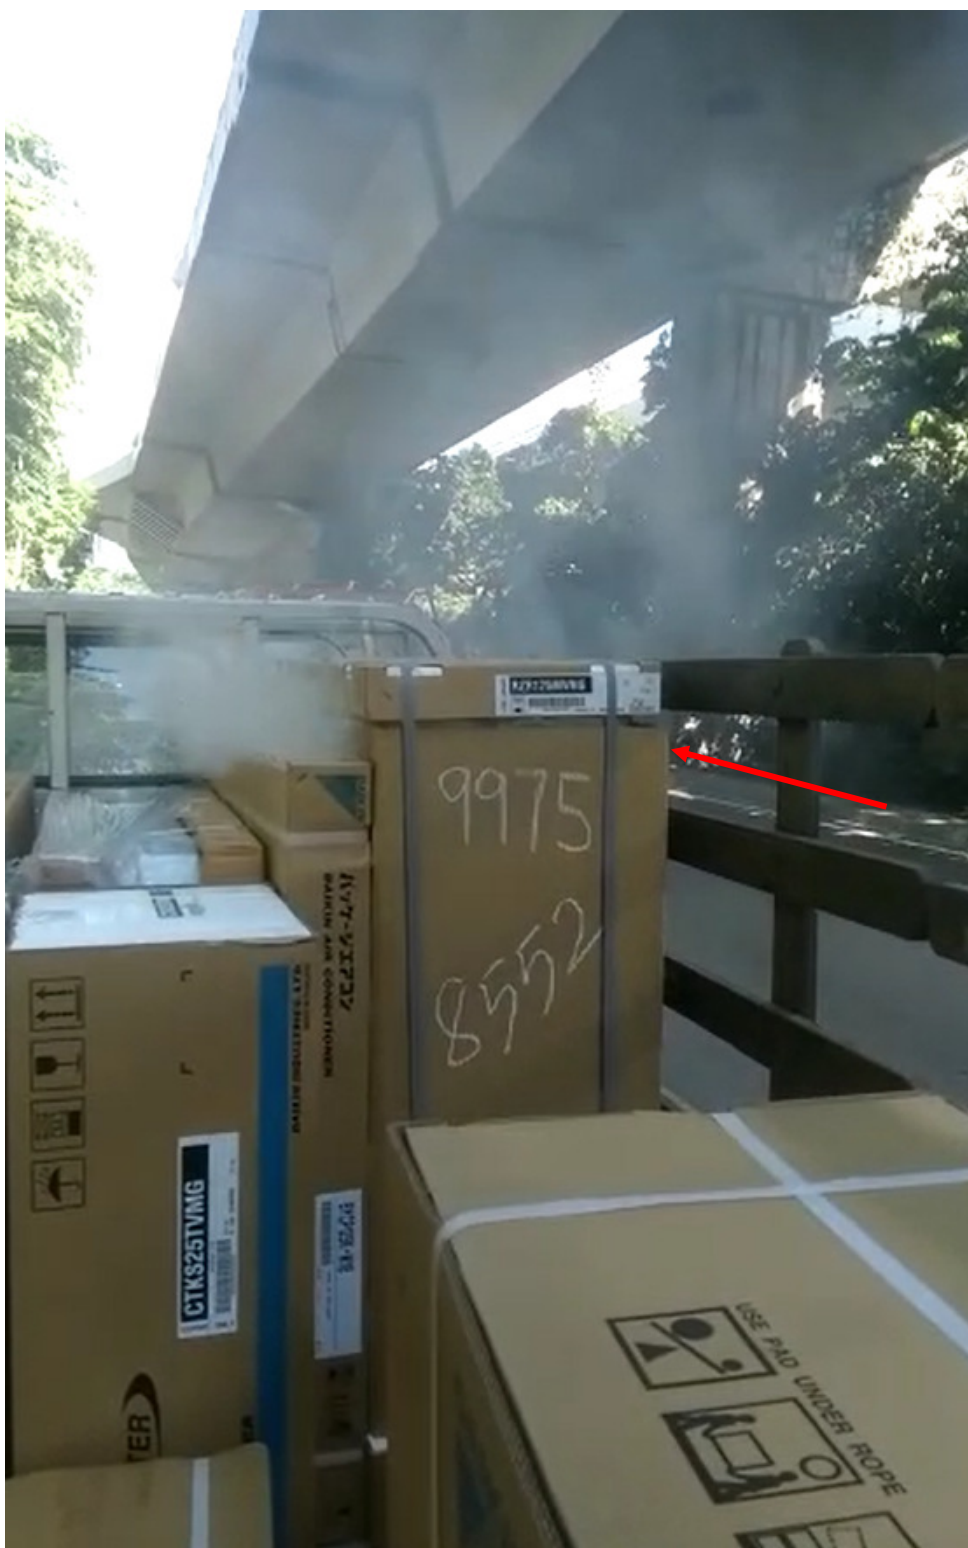
Photo 10 shows a screenshot extracted from one of the video recordings that were provided to me by Mr Leong. White smoke can be seen coming out from one of the new air conditioning compressors (arrowed) at the right side front of the Insured Vehicle's rear deck. Hissing sound was also heard in one of the video recordings.

20. The Insured Vehicle was carrying several new air conditioning equipment(s) that include new compressor units (outdoor) and new evaporator units (indoor) amongst others on its rear deck at the material time of incident. The hissing sounds heard in the video recording before the fire was seen is a sign of pressurized refrigerant leakage from the burnt new air conditioning compressor. The white smoke seen in photograph 9 above is leaked refrigerant gases instead of white smoke associated with heat, given that the dissipation was sideways and not upwards. For completeness, one of the characteristics of heat is that it rises upwards hence smoke associated with heat will have an upward dissipation as shown in photograph 10 to 12 above.

21. The refrigerant gases could have leaked due to failure of a valve(s) of the burnt new air conditioning compressor. The leaked pressurized refrigerant gases then self-ignited upon mixture with air (oxygen), which lowered the flash point temperature of the refrigerant gases. Our high local humidity weather condition had also likely accelerated the self-ignition process leading to the occurrence of the fire for this case.

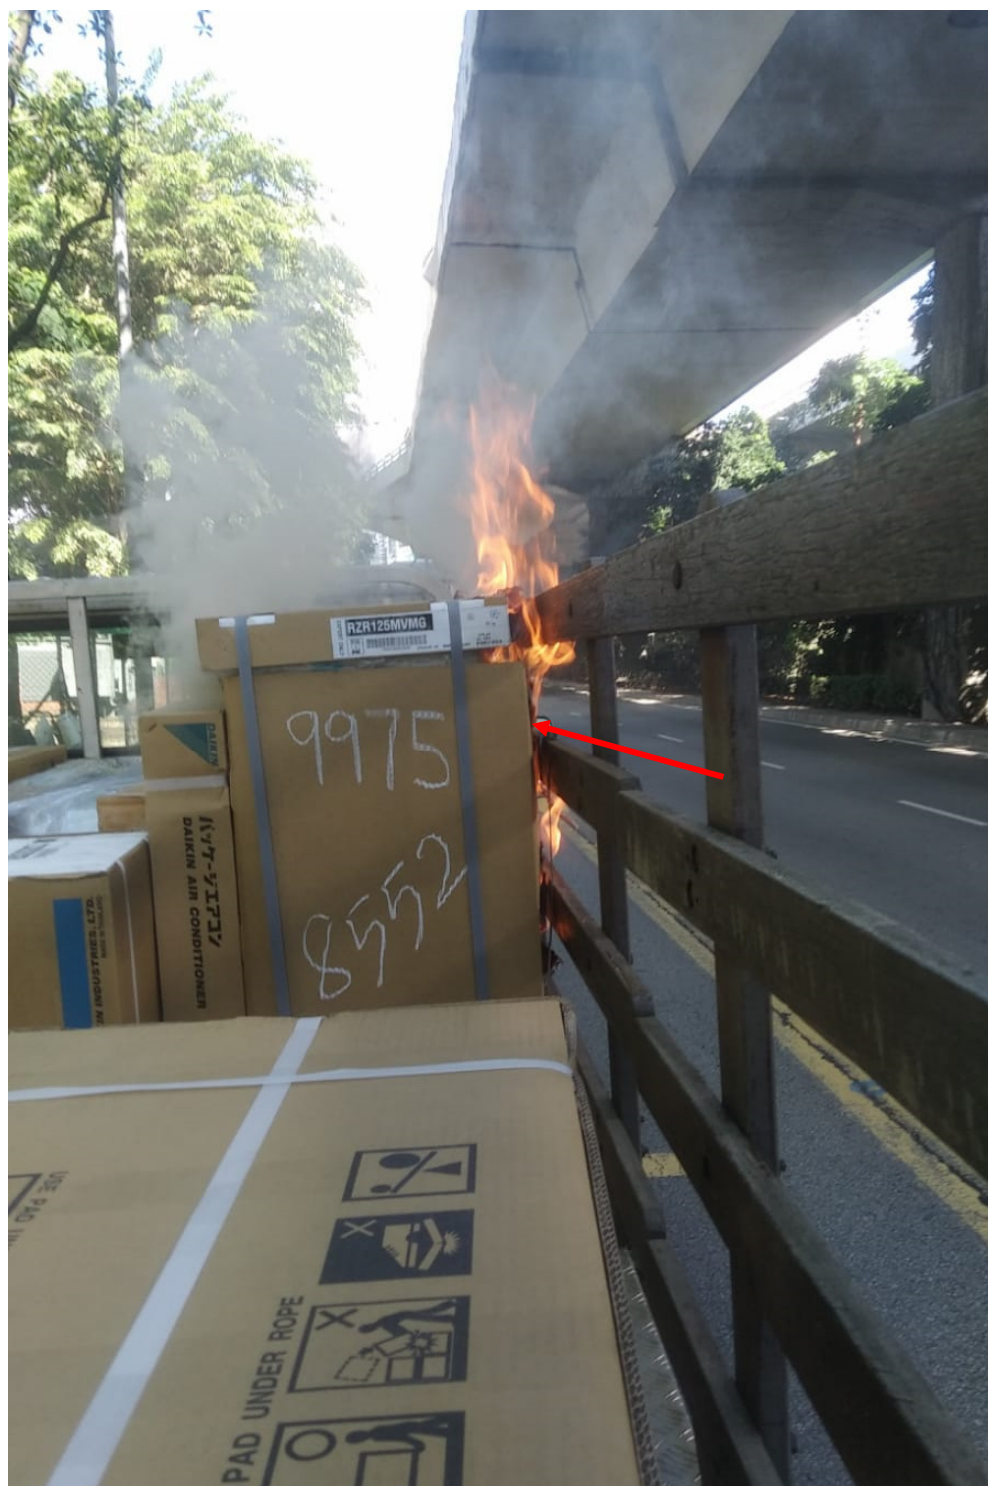
Photo 11 shows the Insured Vehicle at the incident scene (photograph extracted from Mr Leong's Singapore Accident Statement). Fire can be seen engulfing the same new air conditioning compressor (arrowed) that had emitted the white smoke that was seen in the video recordings (refer to photograph 10 above). The brand of the new air conditioning equipment(s) loaded on the rear deck of the Insured Vehicle was observed to be Daikin.

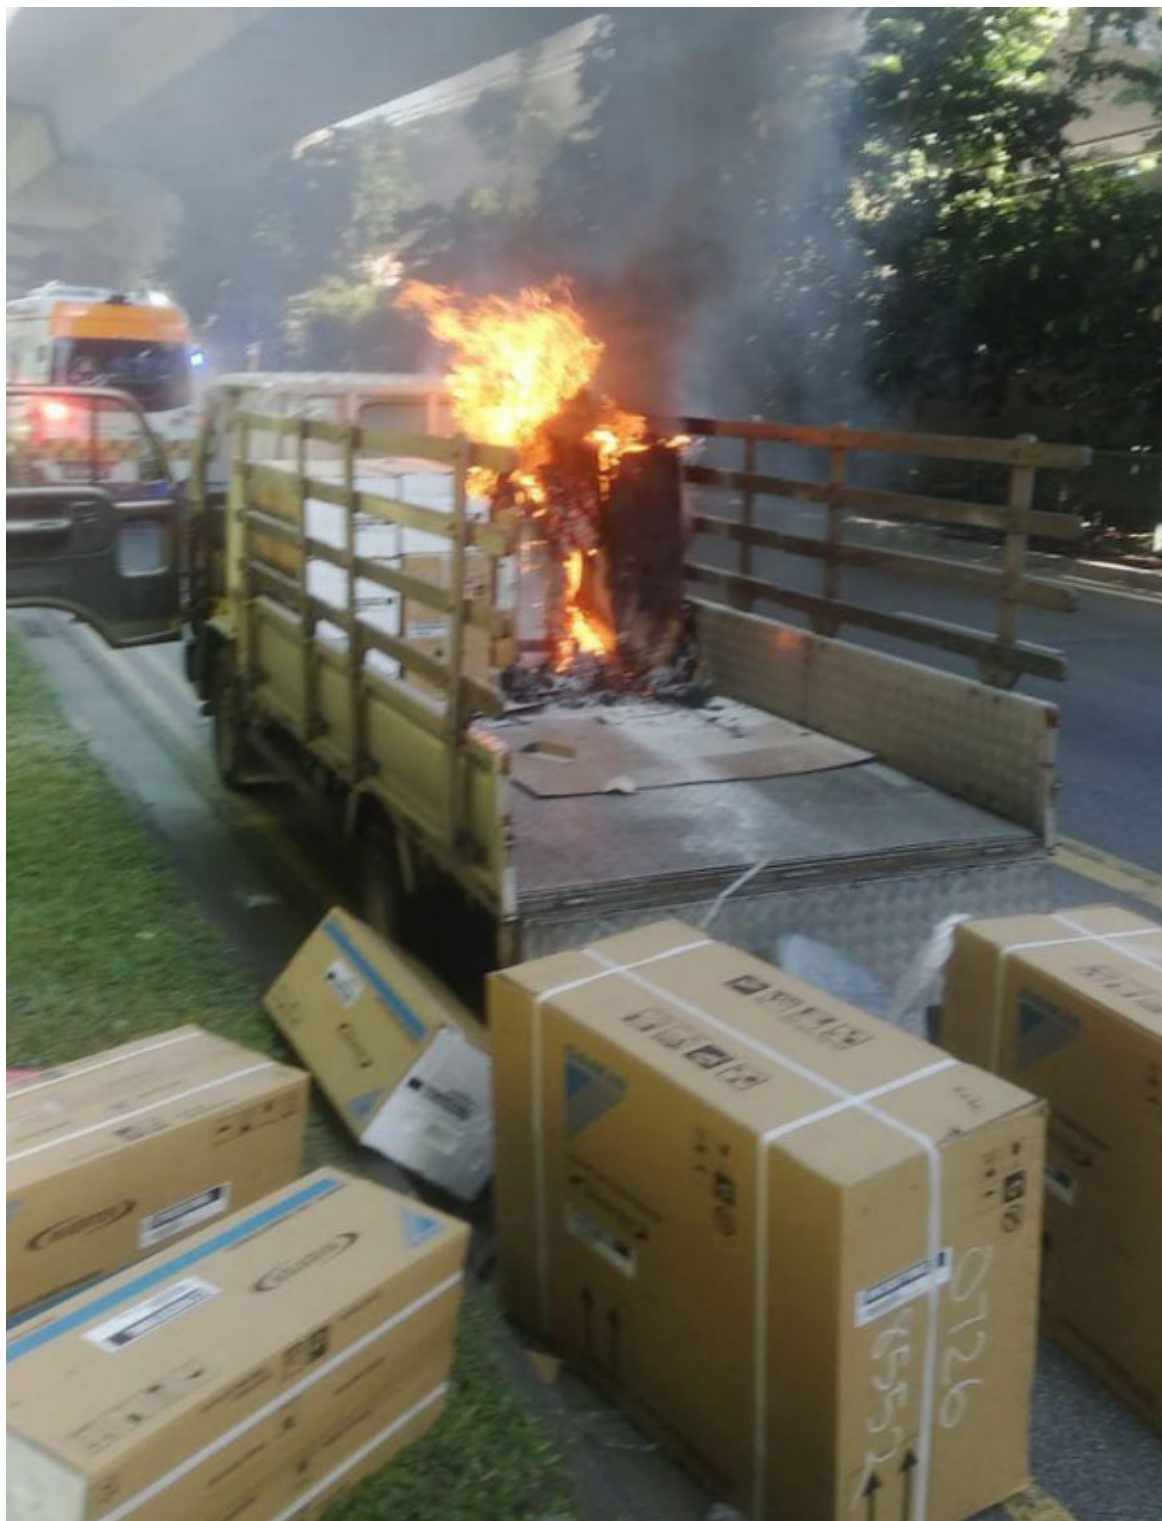
Photo 12 shows the Insured Vehicle at the incident scene (photograph extracted from Mr Leong's Singapore Accident Statement). Fire can be seen engulfing the same new air conditioning compressor that had emitted the white smoke that was seen in the video recordings (refer to photograph 10 above). This new air conditioning compressor was noted to be at the right side front of the Insured Vehicle's rear deck.
