Your Ref: BMW 840i  
(chassis number WBAGV22000CD99273)  
Our Ref : CI/TP21009985/D

27 September 2021

**INSPECTION REPORT OF AN UNREGISTERED BMW 840i MOTOR CAR  
WITH CHASSIS NUMBER WBAGV22000CD99273**

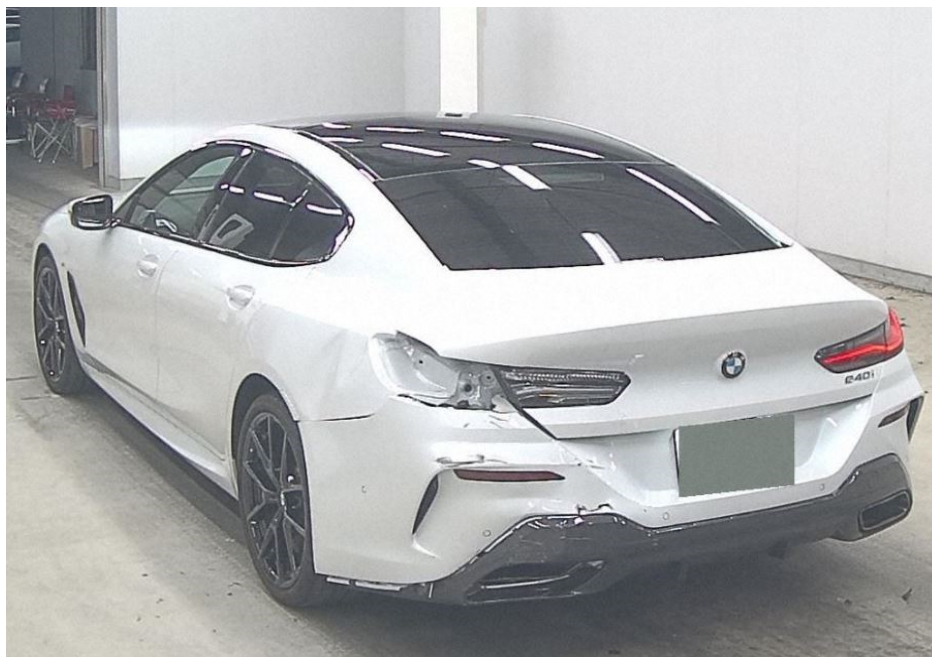
3. The photographs provided to me had showed relatively minor damage to the Motor Car's rear left portion. Body parts damaged include the rear bumper, rear bumper lower cover, rear left exhaust garnish, rear left taillamp, rear left bootlid lamp, rear bootlid and rear left fender amongst others.
4. No physical damage was observed to other areas of the Motor Car. The airbags of the Motor Car were also not deployed as seen from the photographs that were provided to me. See photo 1 – 4 below.

**Photo 1** shows a general view of the rear left body of the Motor Car (photograph provided to me). The Motor Car was observed to have sustained relatively minor damage at its rear left portion. Body parts damaged include the rear bumper, rear bumper lower cover, rear left exhaust garnish, rear left taillamp, rear bootlid and rear left fender amongst others.

22. The body parts at the rear left portion of the Motor Car were visually examined, and it was noted that the repair/restoration works carried out to the damaged area of the Motor Car (refer to photograph 1 above) were reasonably adequate and in order.

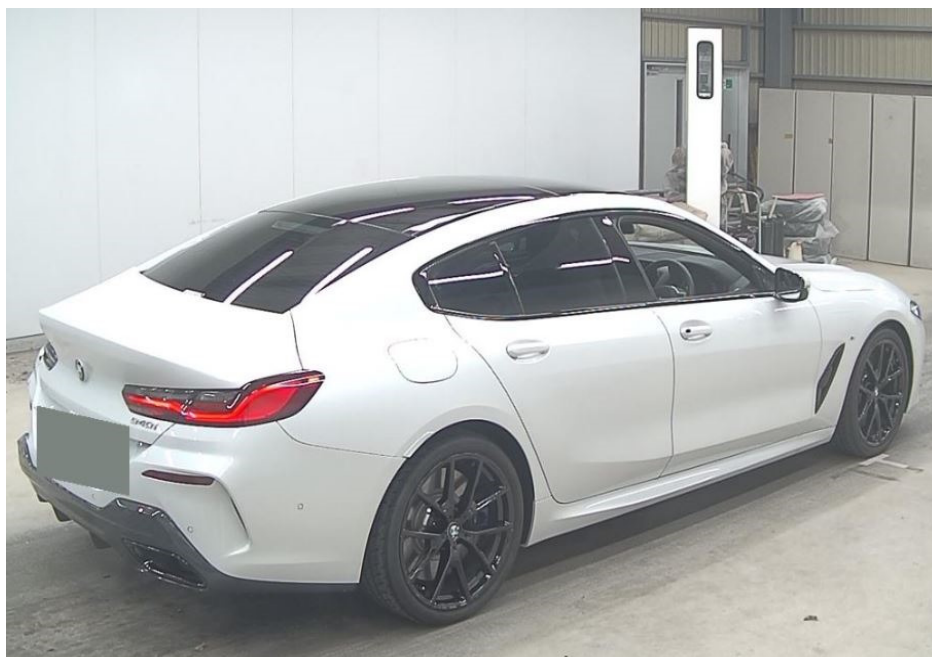
**Photo 2** shows a general view of the rear right body of the Motor Car (photograph provided to me). The rear right portion of the Motor Car was observed to be without any physical damage.

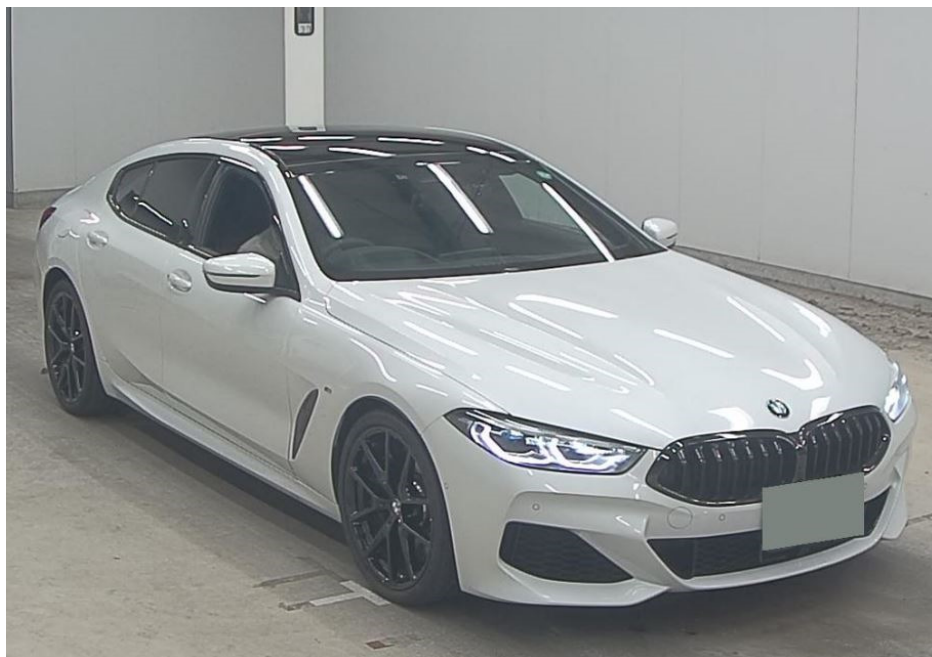
**Photo 3** shows the front right body of the Motor Car (photograph provided to me). Apart for the rear left portion, there was no physical damage seen to other areas of the Motor Car. The airbags of the Motor Car were also not deployed.

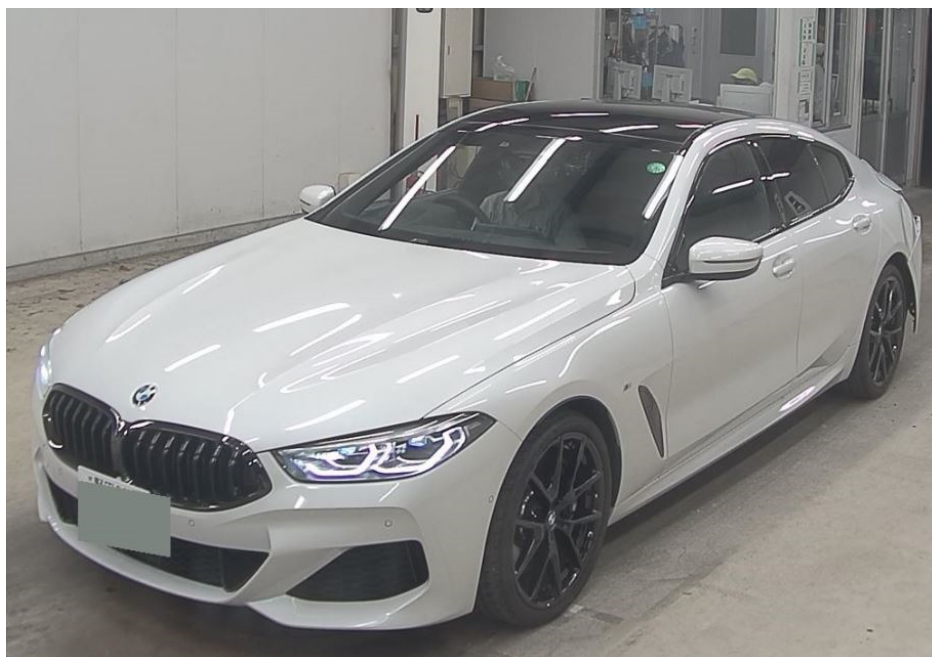
**Photo 4** shows the front left body of the Motor Car (photograph provided to me). Apart for the rear left portion, there was no physical damage seen to other areas of the Motor Car. The airbags of the Motor Car were also not deployed.

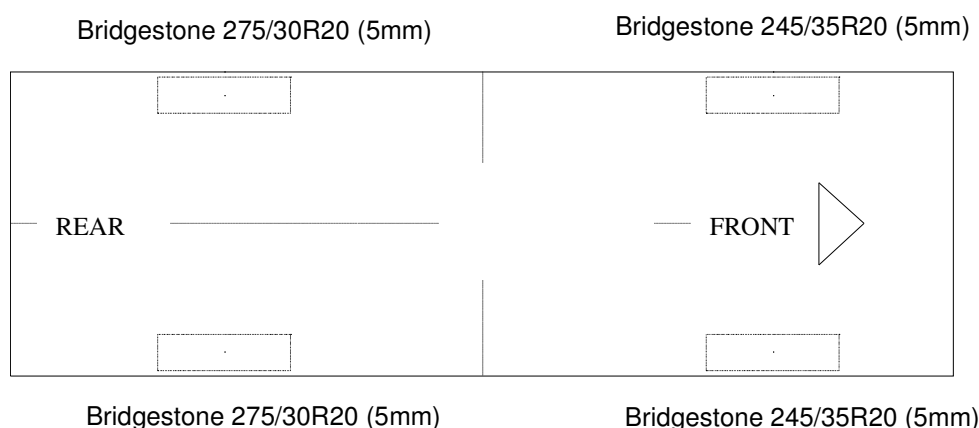
8. It was fitted with 20inch sport wheel rims that were wrapped with tyres that were observed to be of serviceable condition. The tyres were also sufficiently inflated for vehicular operation. The tyre brand, tyre size and approximate remaining tread depth of the 4 tyres of the Motor Car were recorded as follows: -

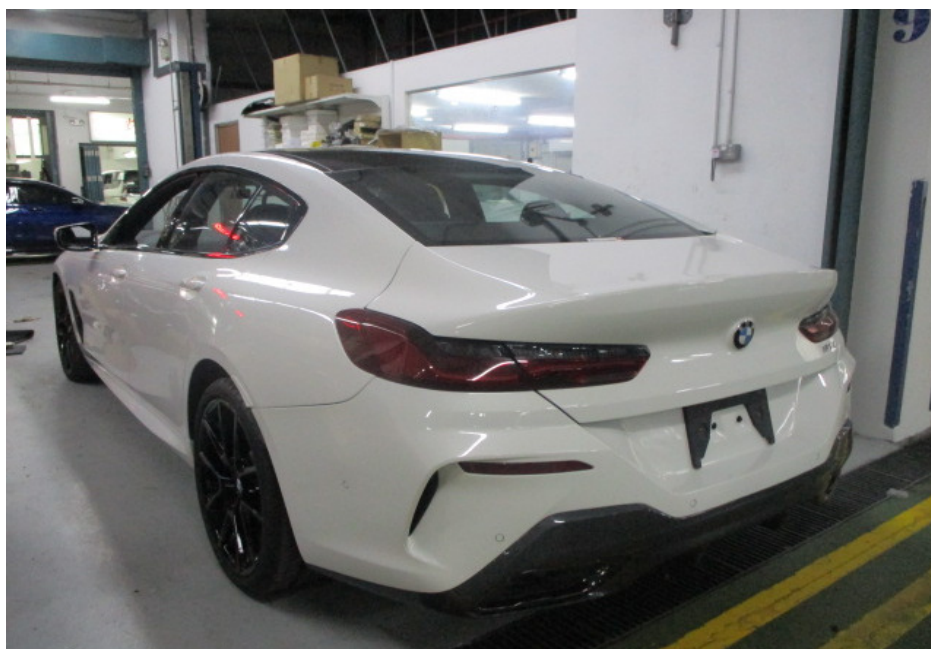
**Photo 5** shows a general view of the rear left body of the Motor Car at the time of my inspection. The Motor Car was observed to be in a relatively good general condition with no loose exterior fittings observed. The body parts at the rear left portion of the Motor Car were visually examined and it was observed that the repair/restoration works carried out to the damaged area of the Motor Car (refer to photograph 1 above) were reasonably adequate and in order.

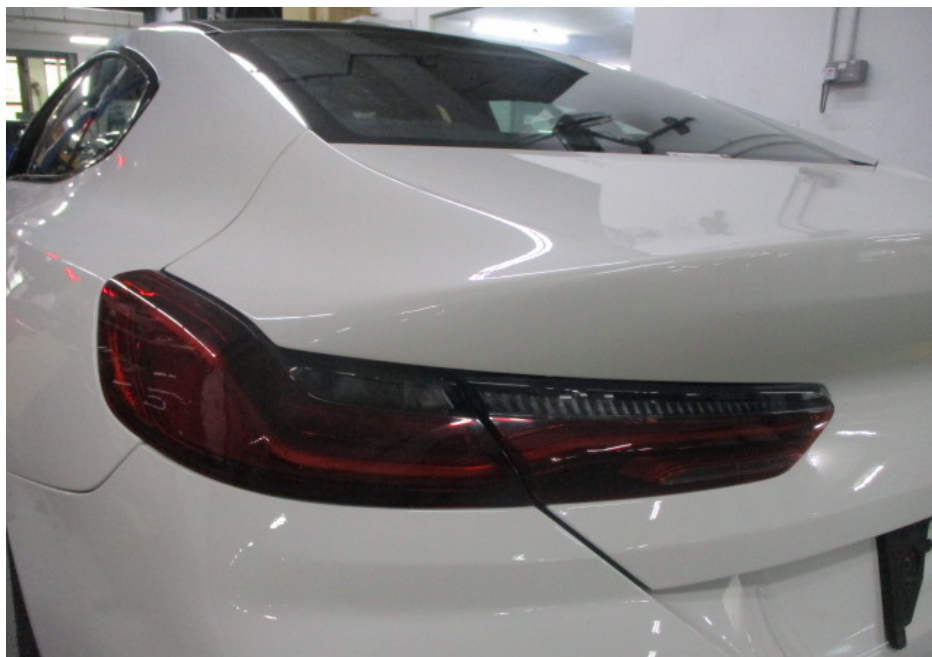
**Photo 6** shows a closer view of the Motor Car's rear bootlid, rear left bootlid lamp and rear left taillamp. The body parts at the rear left portion of the Motor Car were visually examined and it was observed that the repair/restoration works carried out to the damaged area of the Motor Car (refer to photograph 1 above) were reasonably adequate and in order.

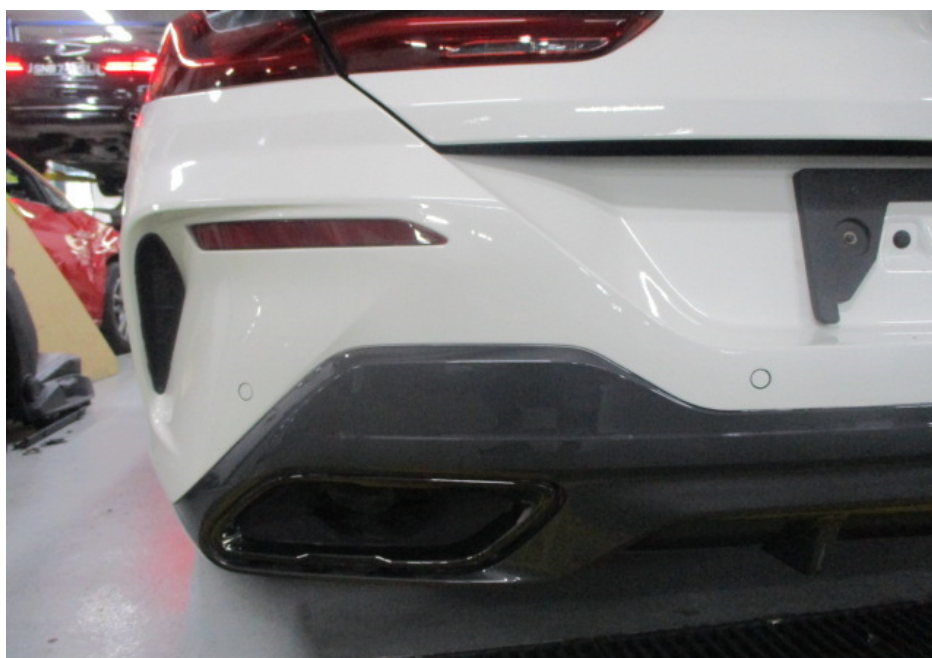
**Photo 7** shows a closer view of the Motor Car's rear bumper, rear bumper lower cover and rear left exhaust garnish. The body parts at the rear left portion of the Motor Car were visually examined and it was observed that the repair/restoration works carried out to the damaged area of the Motor Car (refer to photograph 1 above) were reasonably adequate and in order.

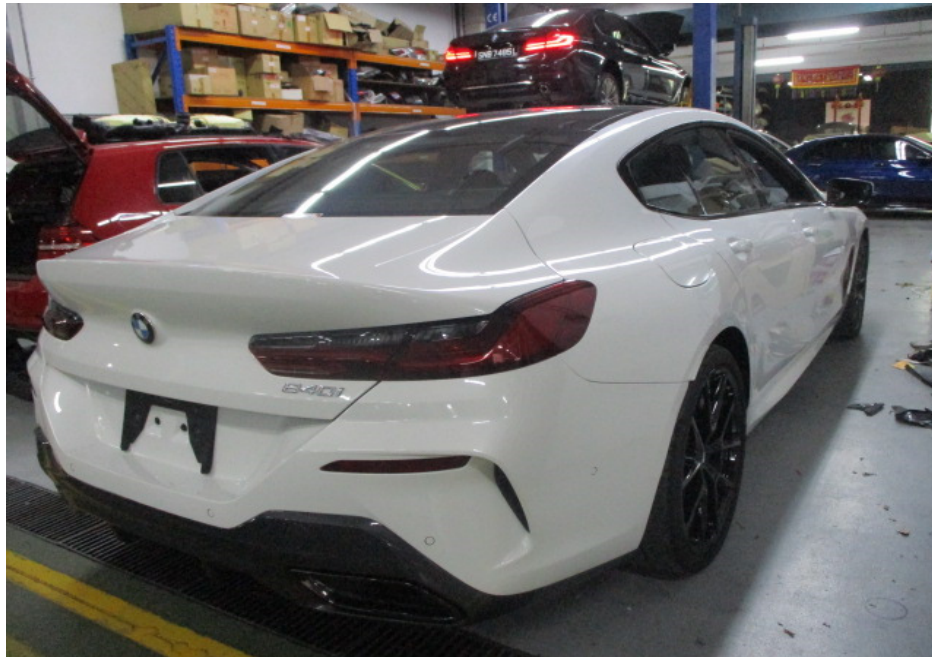
**Photo 8** shows a general view of the rear right body of the Motor Car at the time of my inspection. The Motor Car was observed to be in a relatively good general condition with no loose exterior fittings observed. The mileage of the Motor Car recorded at the time of my inspection was 3,934km.

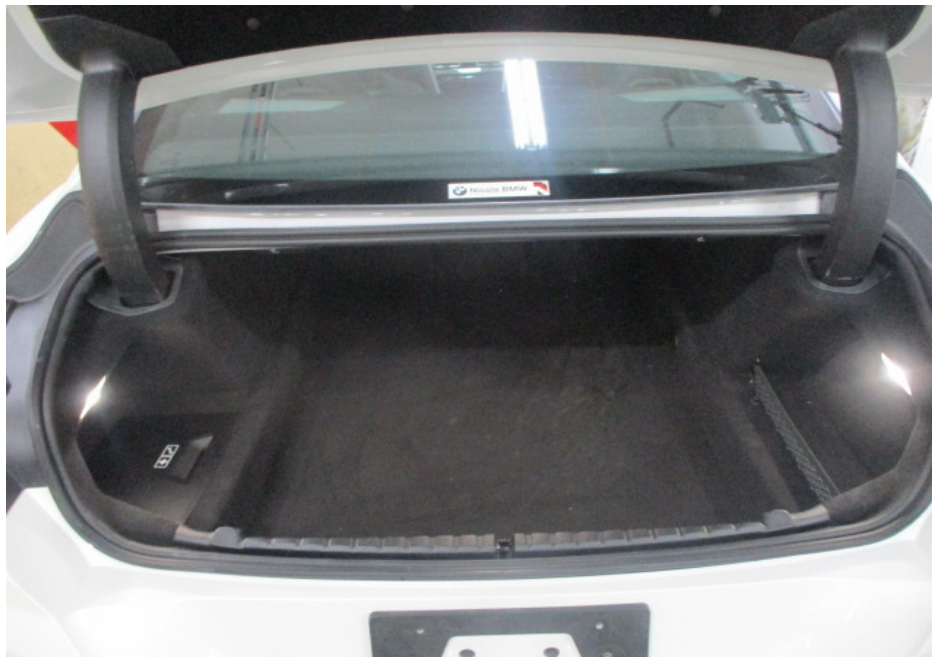
**Photo 9** shows a general of the Motor Car's rear boot compartment at the time of my inspection. The various parts and components, inner trims, carpet and upholstery inside the rear boot compartment were all observed to be intact and properly fitted.

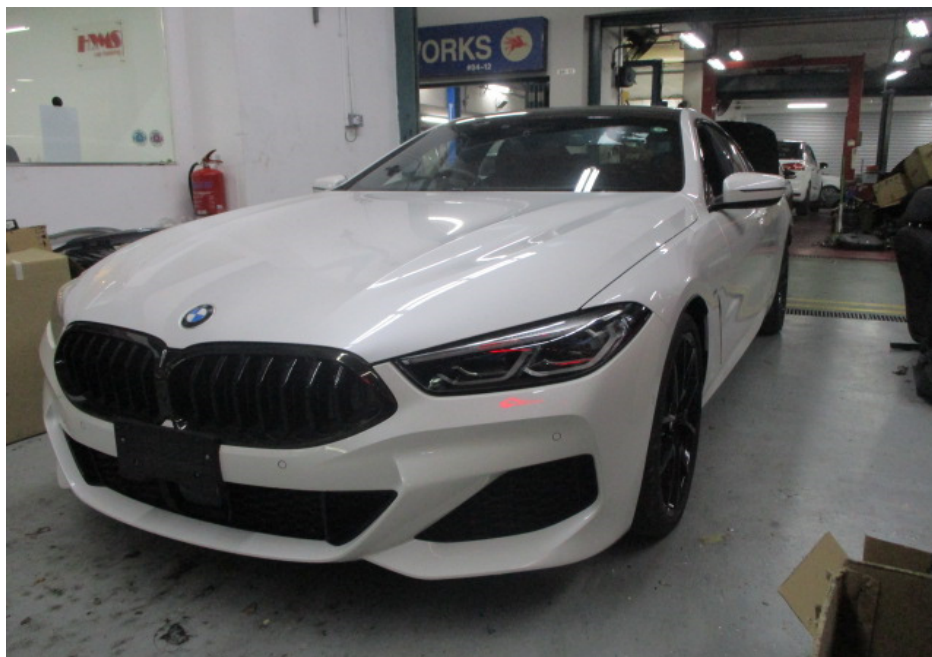
**Photo 10** shows a general view of the front left body of the Motor Car at the time of my inspection. The Motor Car was observed to be in a relatively good general condition with no loose exterior fittings observed. The mileage of the Motor Car recorded at the time of my inspection was 3,934km.

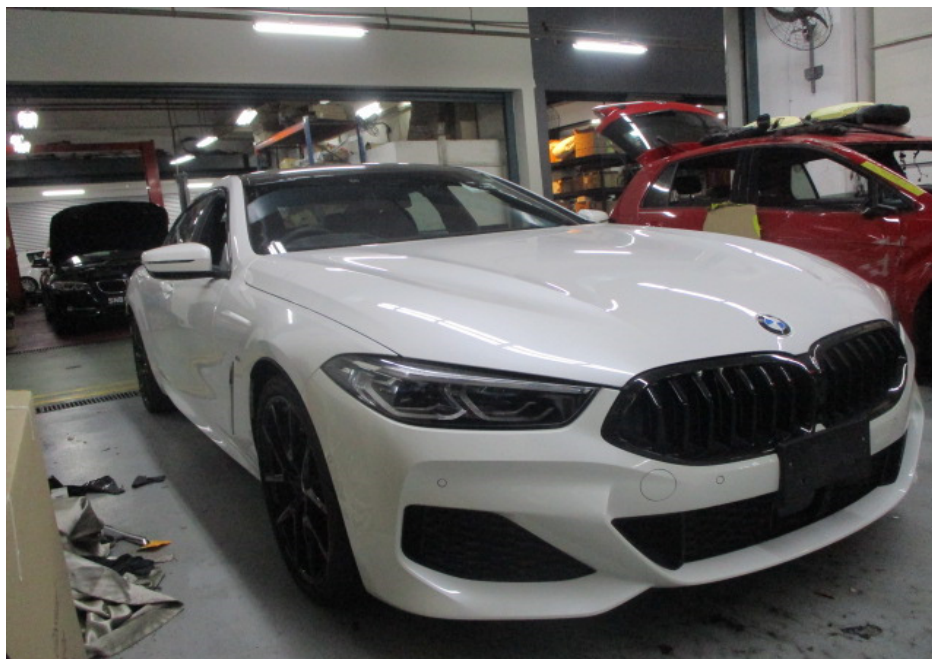
**Photo 11** shows a general view of the front right body of the Motor Car at the time of my inspection. The Motor Car was observed to be in a relatively good general condition with no loose exterior fittings observed. The mileage of the Motor Car recorded at the time of my inspection was 3,934km.

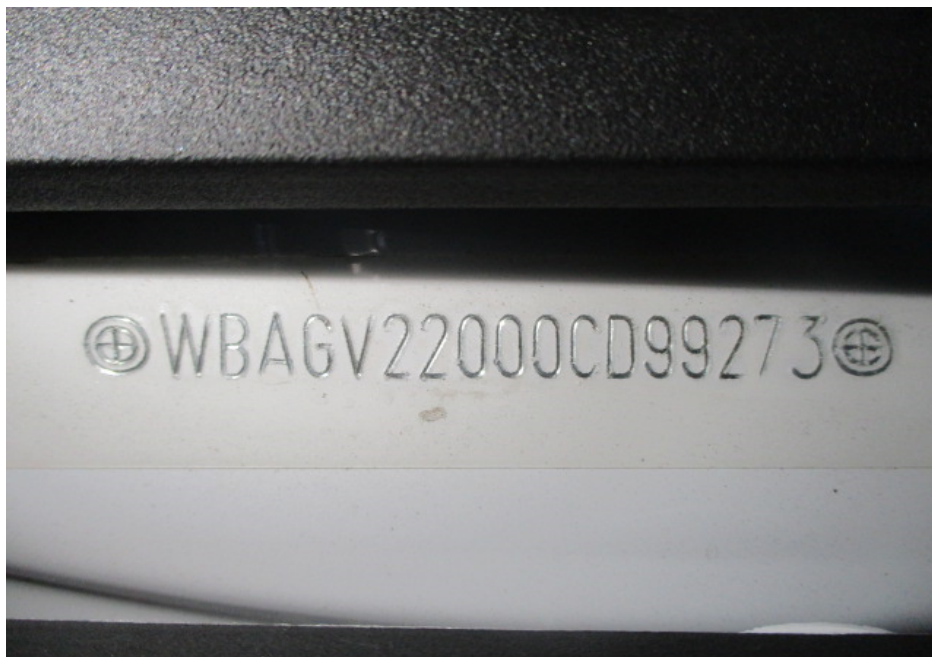
**Photo 12** shows the chassis number of the Motor Car. The chassis number recorded was WBAGV22000CD99273.

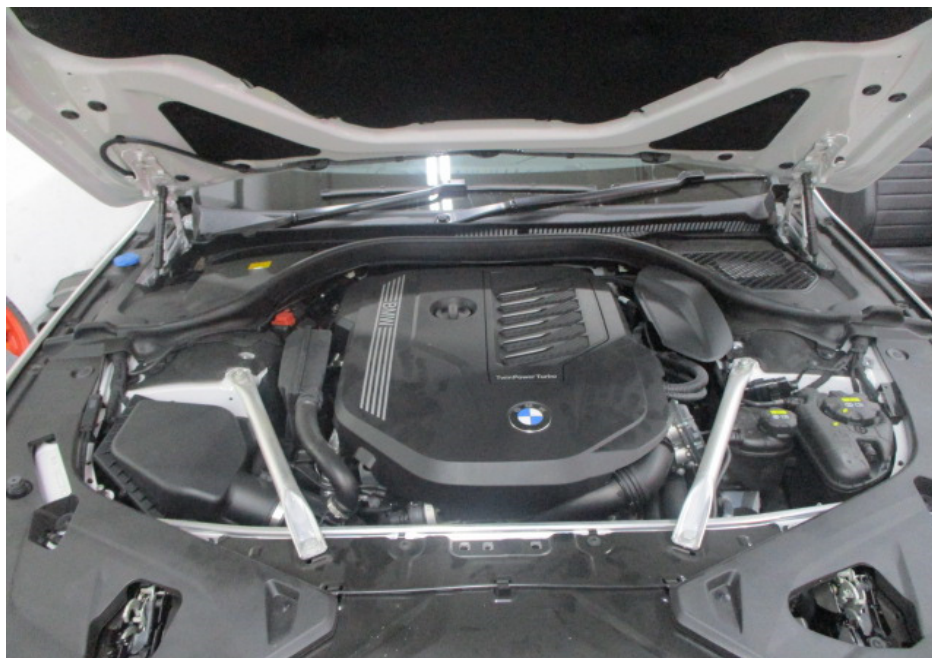
**Photo 13** shows a general view of the engine compartment of the Motor Car at the time of my inspection. The various parts and components inside the engine compartment were all observed to be intact and properly fitted. There was also no sign(s) or indication(s) of fluid leak and/or fluid stain found inside the engine compartment.

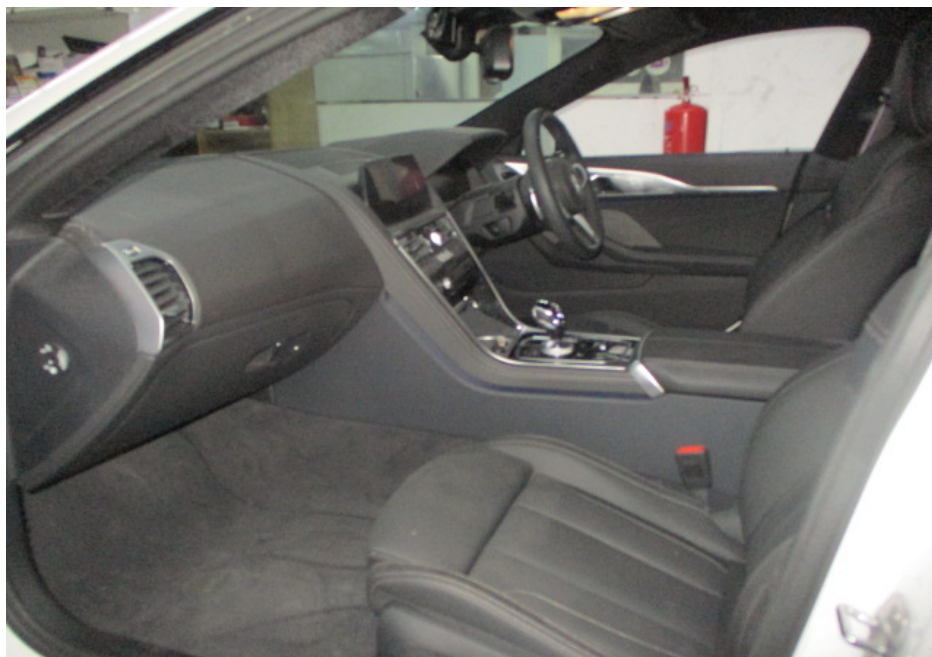
**Photo 14** shows the interior compartment of the Motor Car at the time of my inspection. The various parts and components, trims, carpet and upholstery inside the interior compartment were all observed to be intact and properly fitted.

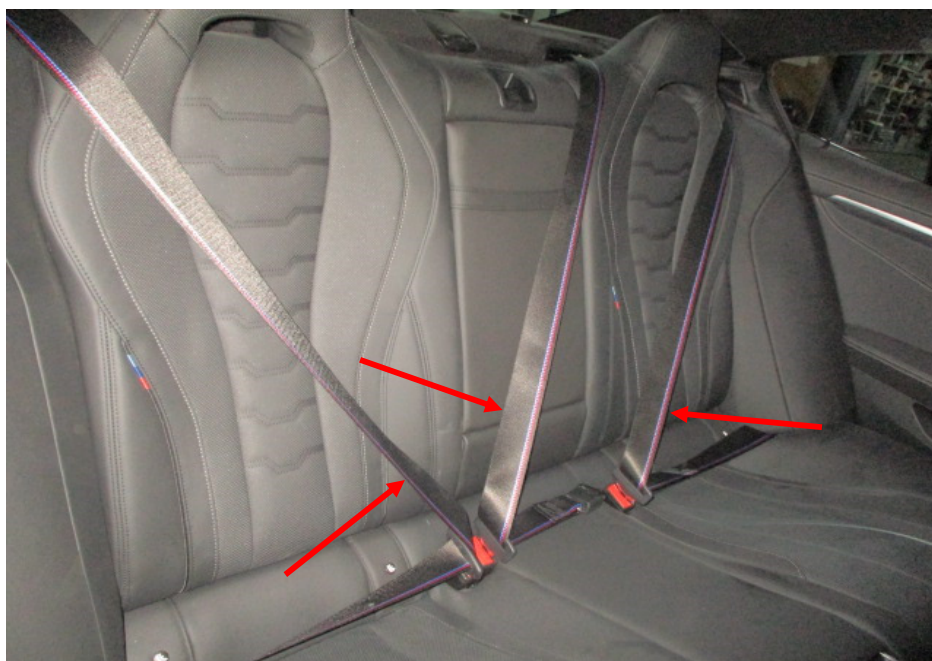
**Photo 15** shows the rear seats of the Motor Car. All the seats of the Motor Car were secured via seat rails to the floorboard. They were also fitted with a retractable seat belt reel and a pre-tensioner. The seat belts (arrowed) were tested and were able to be fastened into the respective pre-tensions that were fitted on the side of each individual seat.

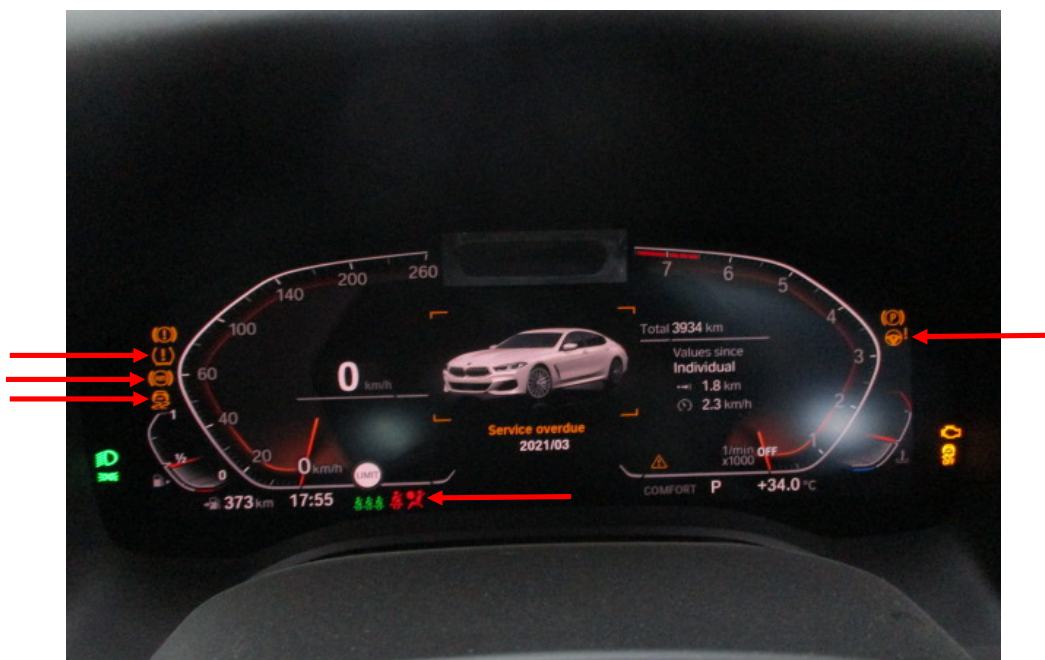
**Photo 16** shows the warning lights for the various electronic safety features appearing on the instrument panel of the Motor Car during its self-test when the engine is cranked, in particular the ABS, SRS, IAS, TPM and DSC lights (arrowed).

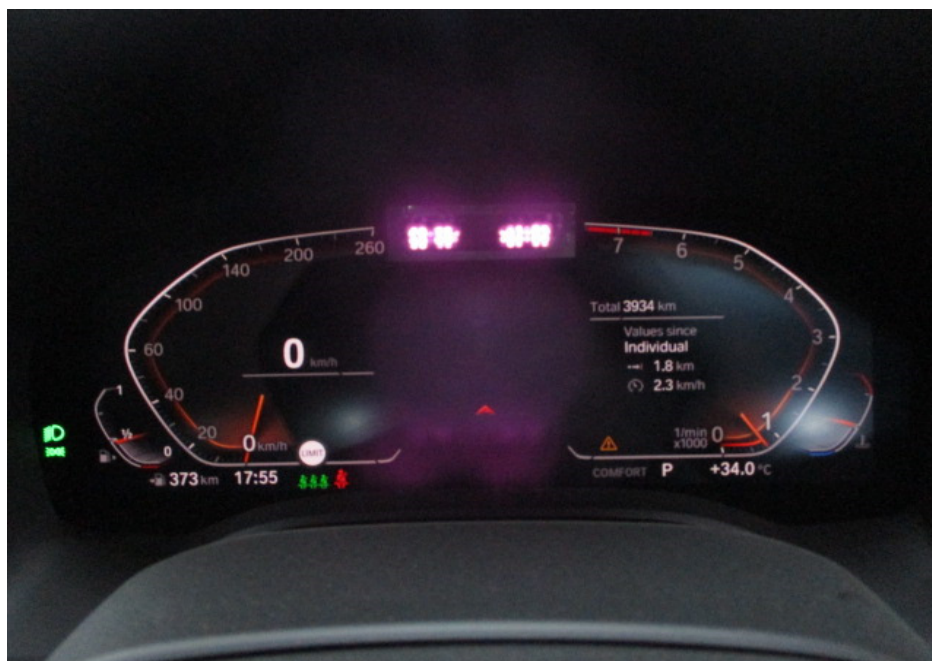
**Photo 17** shows the respective warning lights no longer illuminated, indicating that there is no fault detected to the ABS, SRS, IAS, TPM and DSC systems of the Motor Car during the self-test. These electronic systems were hence in working condition at the time of my inspection.

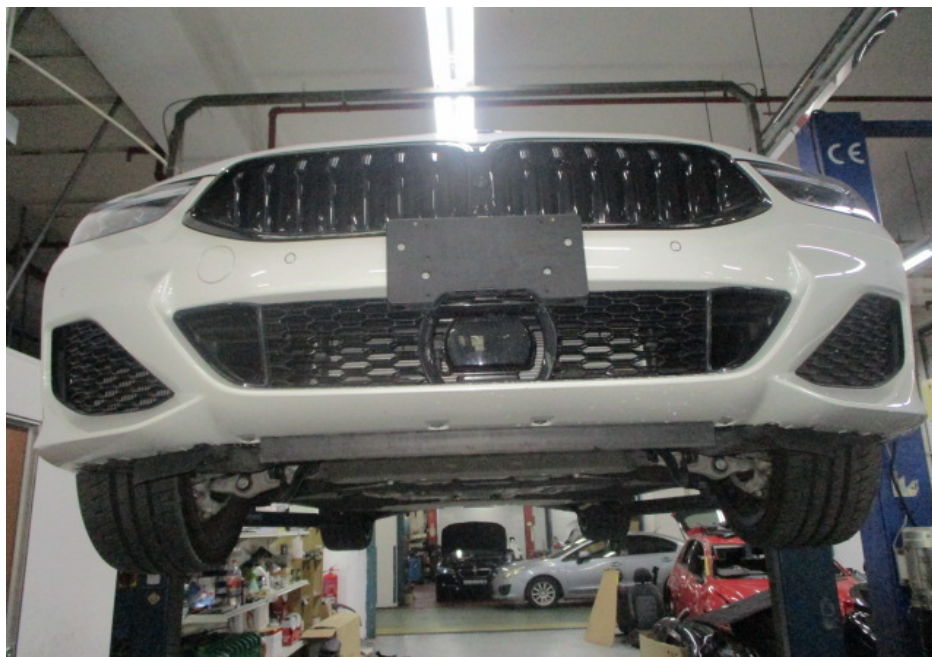
**Photo 18** shows the Motor Car hoisted up for checks on its undercarriage. There was no sign(s) or indication(s) of fluid leakage and/or fluid stain(s) on the underside of the Motor Car. The undercarriage components of the Motor Car were also all observed to be intact and secured in an appropriate manner.

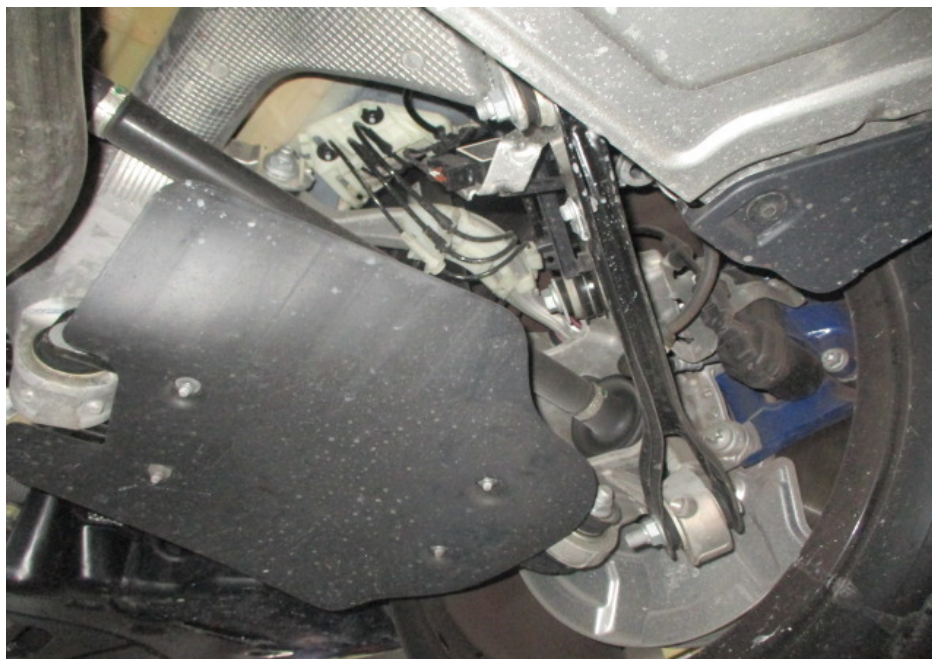
**Photo 19** shows a general view of the control arms and linkages at the rear left wheel of the Motor Car. I did not observe any fluid leak and/or fluid stain on the underside of the Motor Car. All of the Motor Car's undercarriage components were observed to be intact and secured in an appropriate manner.

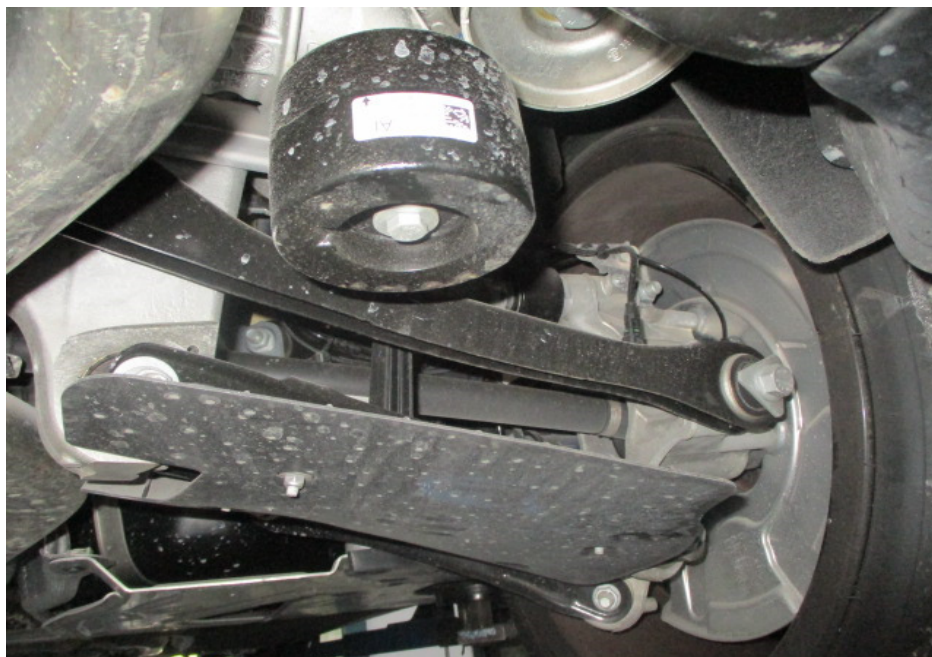
**Photo 20** shows a general view of the control arms and linkages at the rear right wheel of the Motor Car. I did not observe any fluid leak and/or fluid stain on the underside of the Motor Car. All of the Motor Car's undercarriage components were observed to be intact and secured in an appropriate manner.

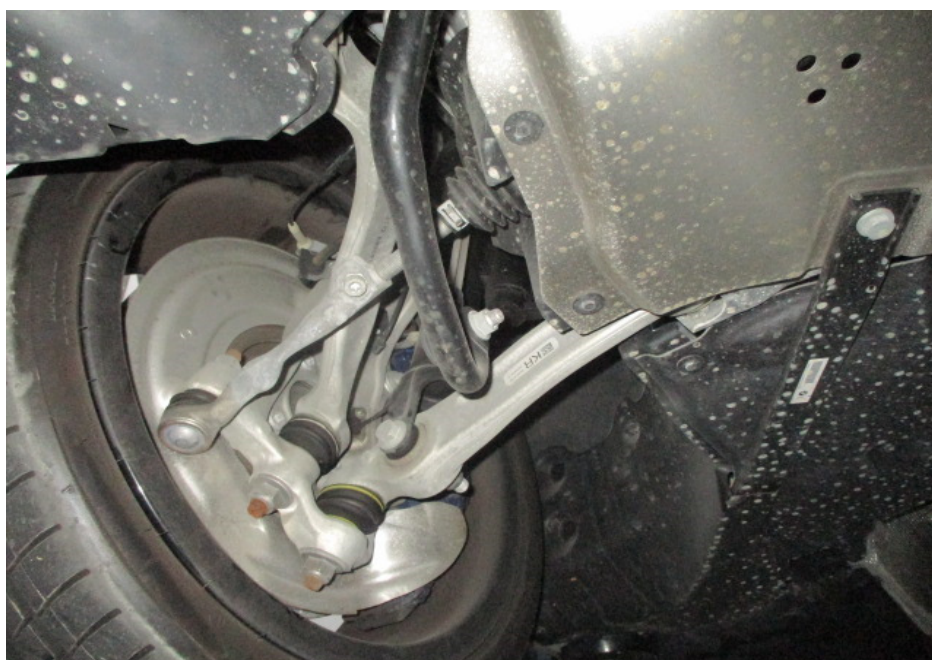
**Photo 21** shows the various undercarriage components at the front right wheel of the Motor Car. The mechanical components, control arms and linkages were all found to be intact and secured in an appropriate manner.

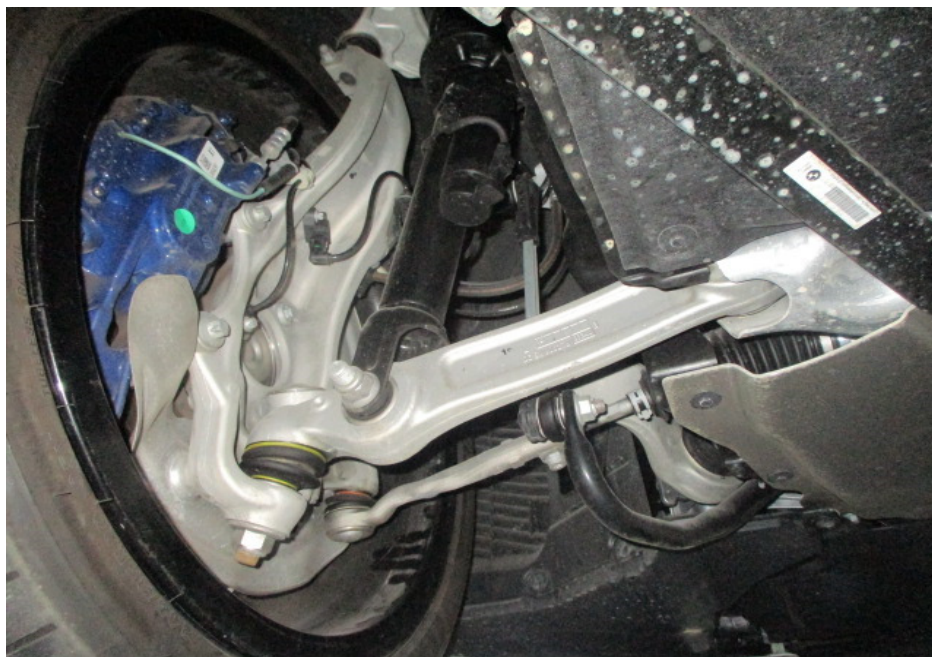
**Photo 22** shows the various undercarriage components at the front left wheel of the Motor Car. The mechanical components, control arms and linkages were all found to be intact and secured in an appropriate manner. I also did not observe any fluid leak and/or fluid stain on the underside of the Motor Car.

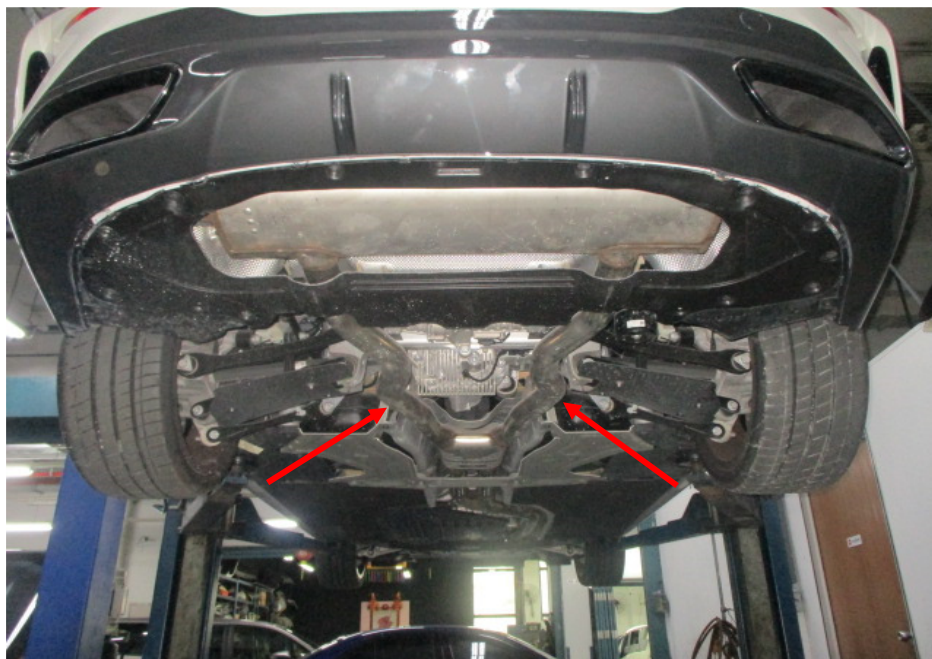
**Photo 23** shows the rear section of the Motor Car's exhaust system. My examination of the Motor Car's exhaust system revealed no sign(s) or indication(s) of any cut or weld marks along its exhaust pipes (arrowed), on its centre resonator box, on its rear muffler and on its catalytic converter.

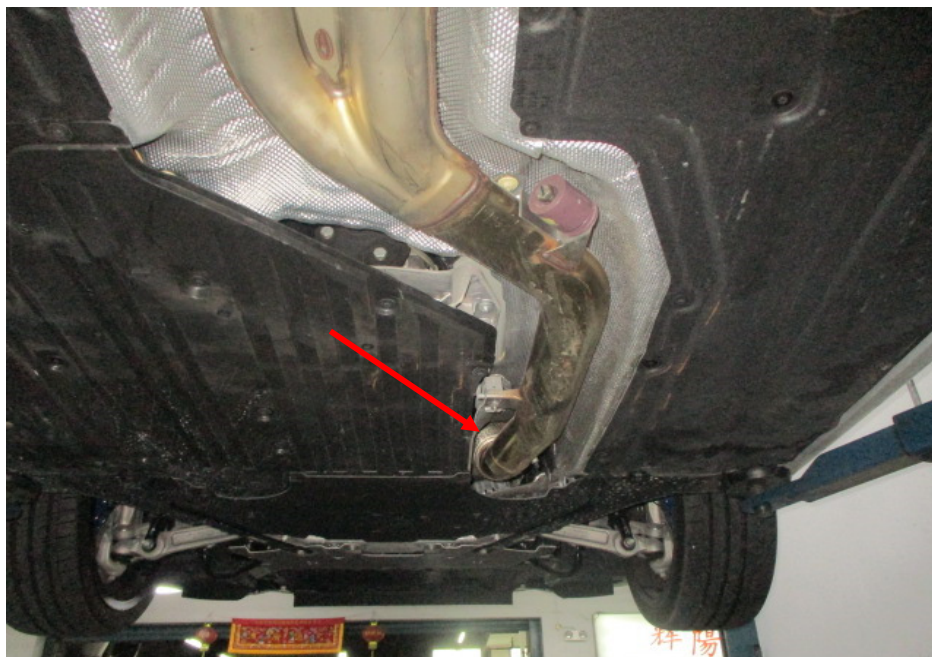
**Photo 24** shows the front section of the Motor Car's exhaust system. My examination of the Motor Car's exhaust system revealed no sign(s) or indication(s) of any cut or weld marks along its exhaust pipes, on its centre resonator box, on its rear muffler and on its catalytic converter (arrowed).

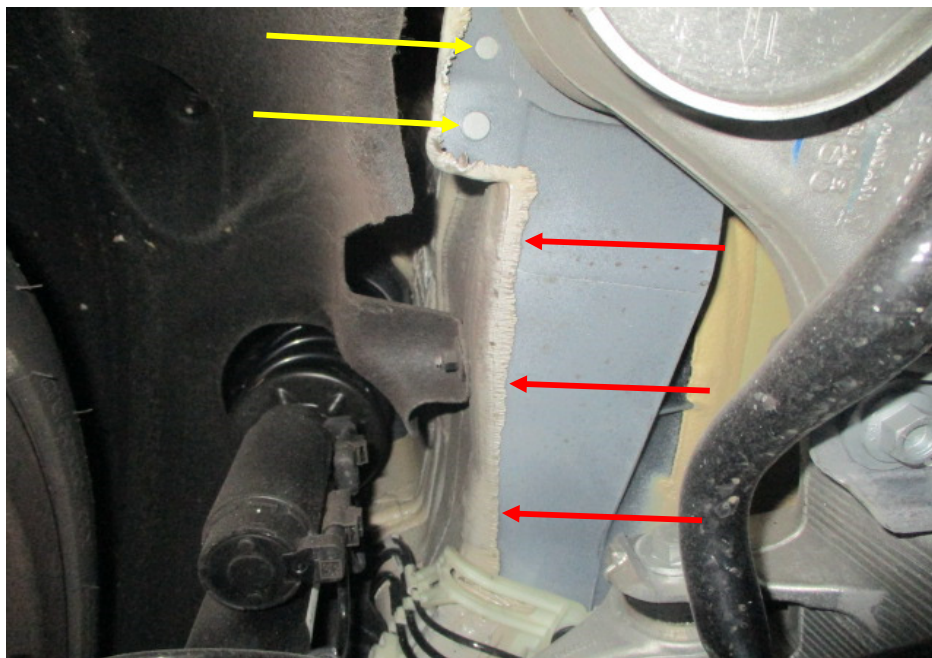
**Photo 25** shows the chassis/structural body at the underside rear left of the Motor Car. I did not find any weld marks other than original spot weld marks (yellow arrow) on the chassis/structural body of the Motor Car. The original factory sealant (red arrow) at the joints along the chassis/structural body was also untouched, indicating no work was done on the chassis/structural body of the Motor Car and that the chassis/structural body was originally fitted.

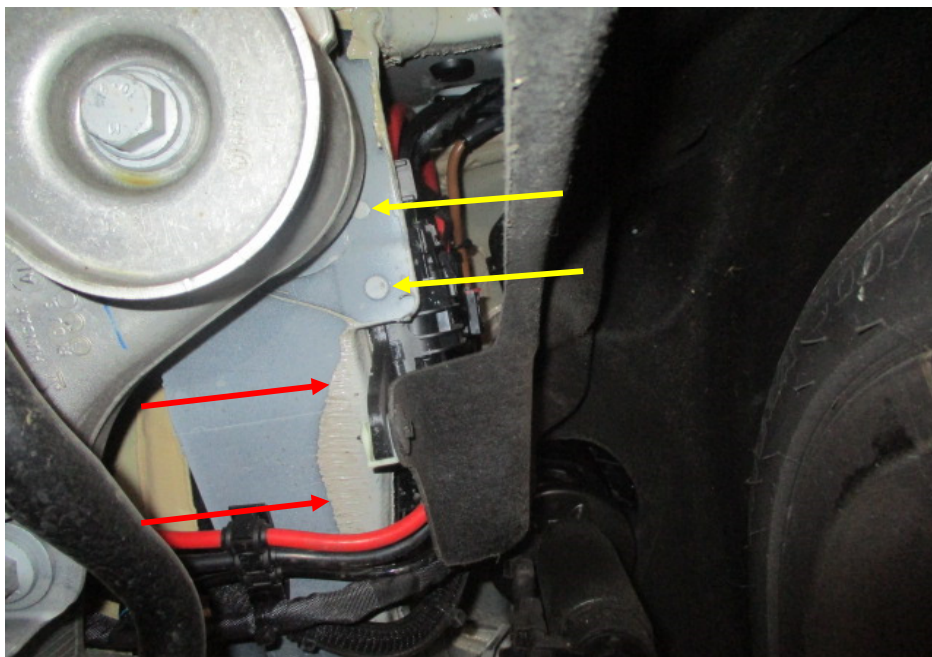
**Photo 26** shows the chassis/structural body at the underside rear right of the Motor Car. I did not find any weld marks other than original spot weld marks (yellow arrow) on the chassis/structural body of the Motor Car. The original factory sealant (red arrow) at the joints along the chassis/structural body was also untouched, indicating no work was done on the chassis/structural body of the Motor Car and that the chassis/structural body was originally fitted.

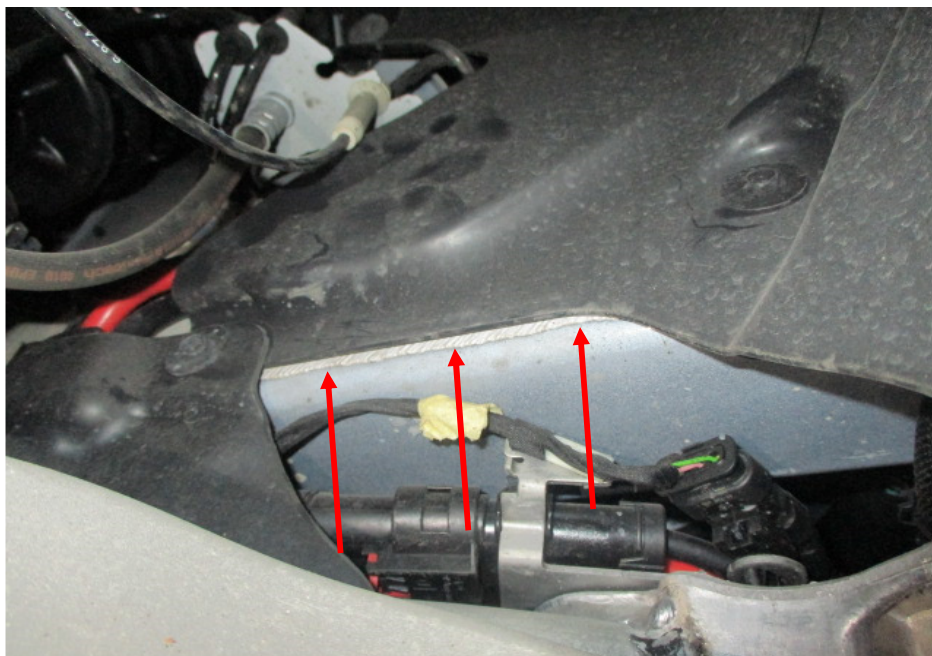
**Photo 27** shows the chassis/structural body at the underside front right of the Motor Car. The original factory sealant (arrowed) at the joints along the chassis/structural body was observed to be untouched. In general, I had found no work was carried out on the chassis/structural body of the Motor Car. The chassis/structural body of the Motor Car was originally fitted.

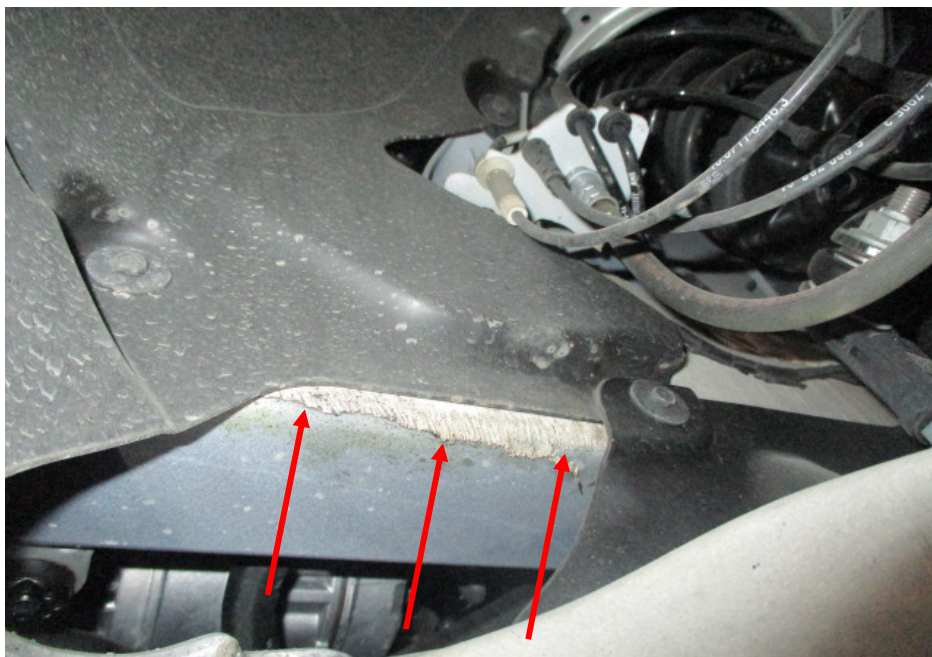
**Photo 28** shows the chassis/structural body at the underside front left of the Motor Car. The original factory sealant (arrowed) at the joints along the chassis/structural body was observed to be untouched. In general, I had found no work was carried out on the chassis/structural body of the Motor Car. The chassis/structural body of the Motor Car was originally fitted.

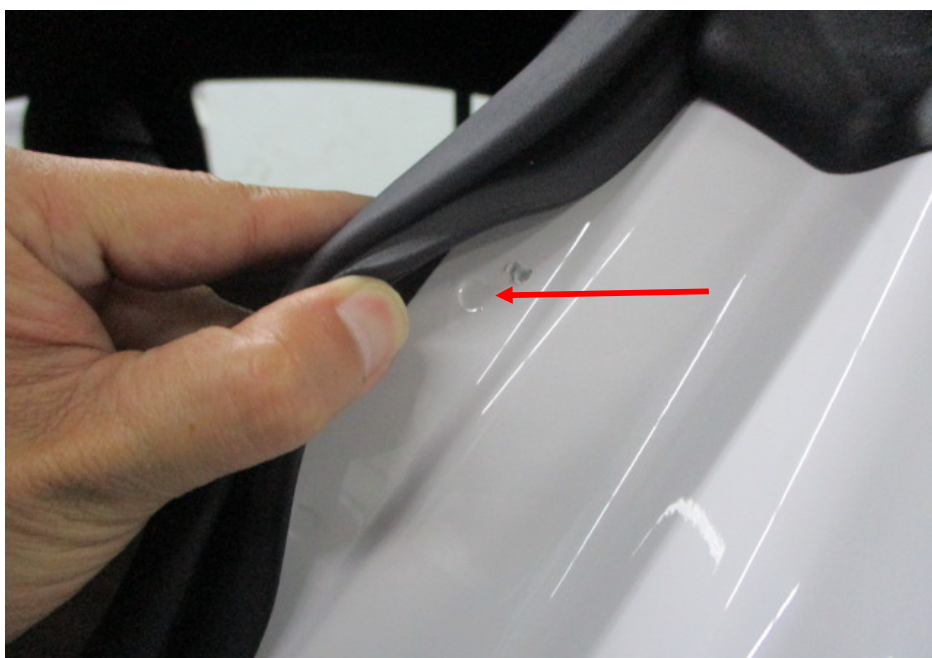
**Photo 29** shows the left side "C" pillar of the Motor Car. I did not find any weld marks other than original spot weld marks (arrowed) on the left side "C" pillar of the Motor Car which, indicates that there was no re-welding works carried out. In general, I had found all the non-detachable body panels of the Motor Car to be originally fitted at the time of my inspection.

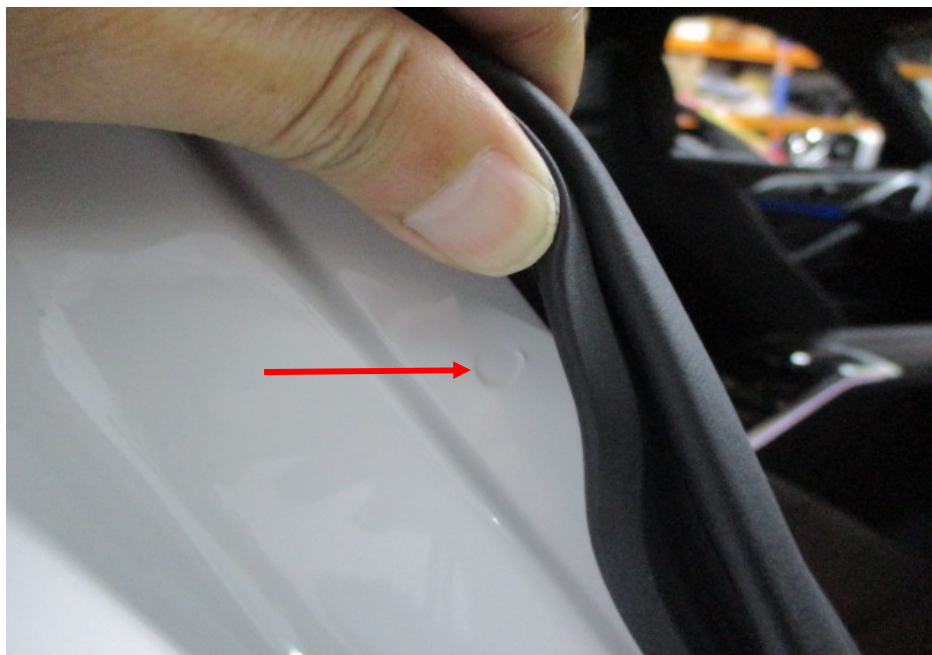
**Photo 30** shows the right side “C” pillar of the Motor Car. I did not find any weld marks other than original spot weld marks (arrowed) on the right side “C” pillar of the Motor Car which, indicates that there was no re-welding works carried out. In general, I had found all the non-detachable body panels of the Motor Car to be originally fitted at the time of my inspection.
