Your Ref: Mercedes C200 Cabriolet
(chassis number W1K2054802F992221)

Our Ref : CI/TP21009987/D

INSPECTION REPORT OF AN UNREGISTERD MERCEDES BENZ C200 CABRIOLET MOTOR CAR WITH CHASSIS NUMBER W1K2054802F992221

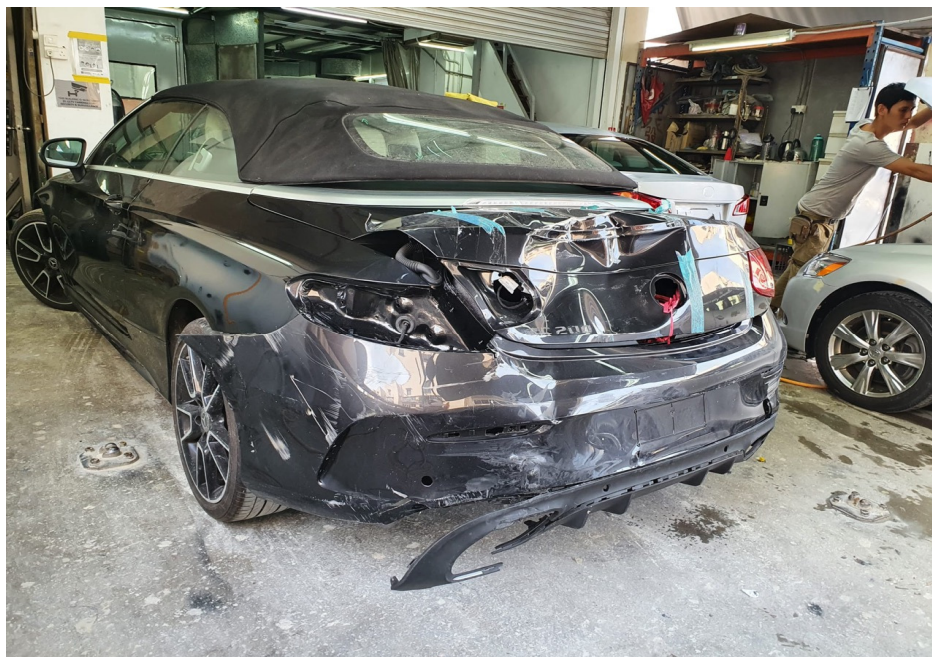
Photo 1 shows the rear left body of the Motor Car (photograph provided to me). The Motor Car was observed to have sustained damage at its rear portion. Body parts damaged include the rear bumper, rear bumper lower cover, rear bumper left reflector, rear bumper sensors, rear left exhaust garnish, rear bootlid, rear bootlid lock and rear bootlid emblem amongst others.

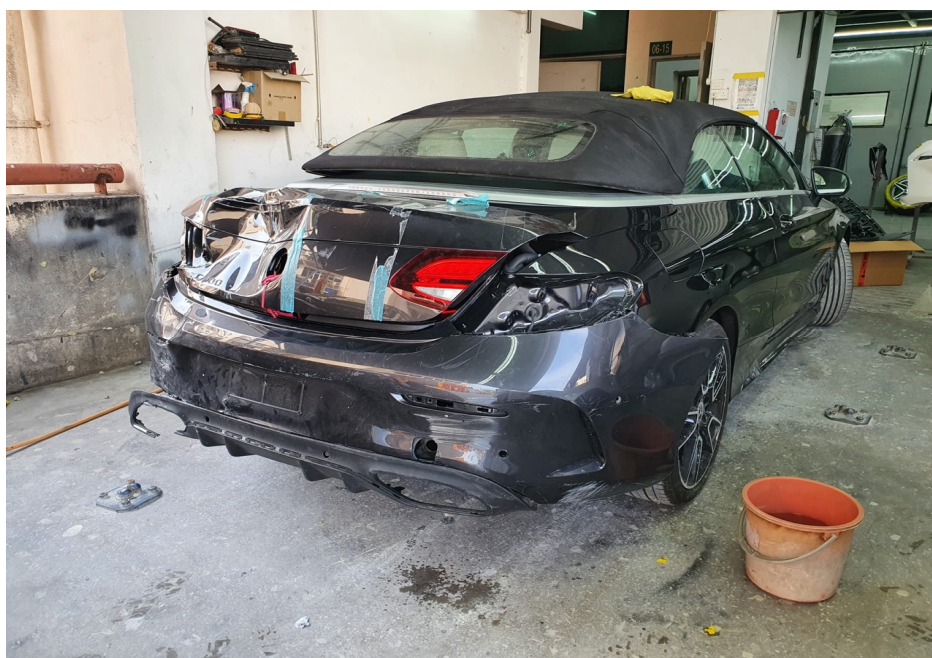
Photo 2 shows the rear right body of the Motor Car (photograph provided to me). The Motor Car was observed to have sustained damage at its rear portion. Body parts damaged include the rear bumper, rear bumper lower cover, rear bumper tow hook cover, rear bumper right reflector, rear bumper sensors, rear right exhaust garnish, rear bootlid and rear bootlid emblem amongst others.

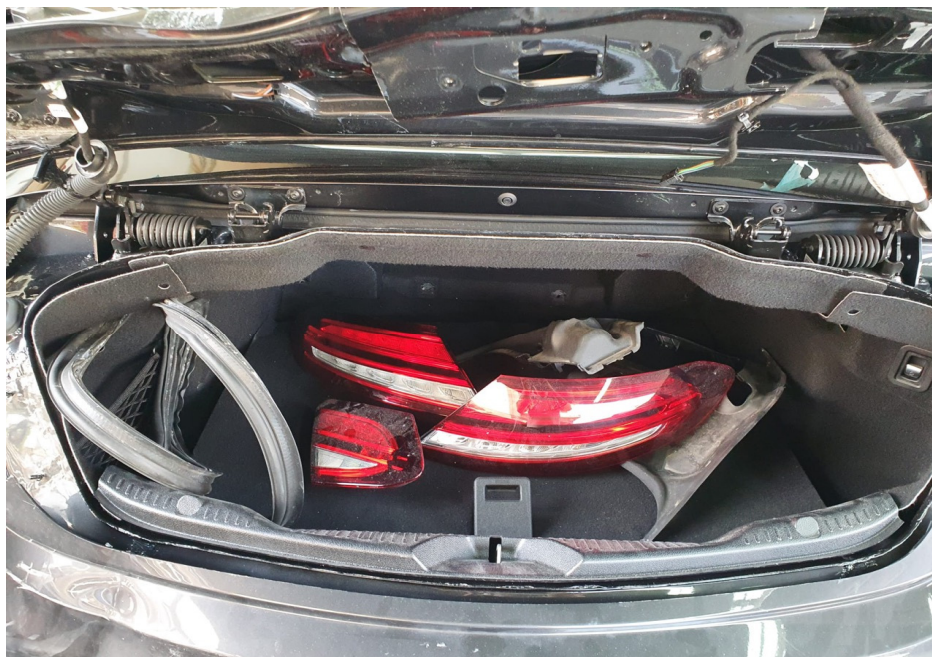
Photo 3 shows the rear boot compartment of the Motor Car (photograph provided to me). The rear right taillamp, rear left taillamp and rear left bootlid lamp placed in the rear boot compartment appears to be not damaged as seen from the photograph.

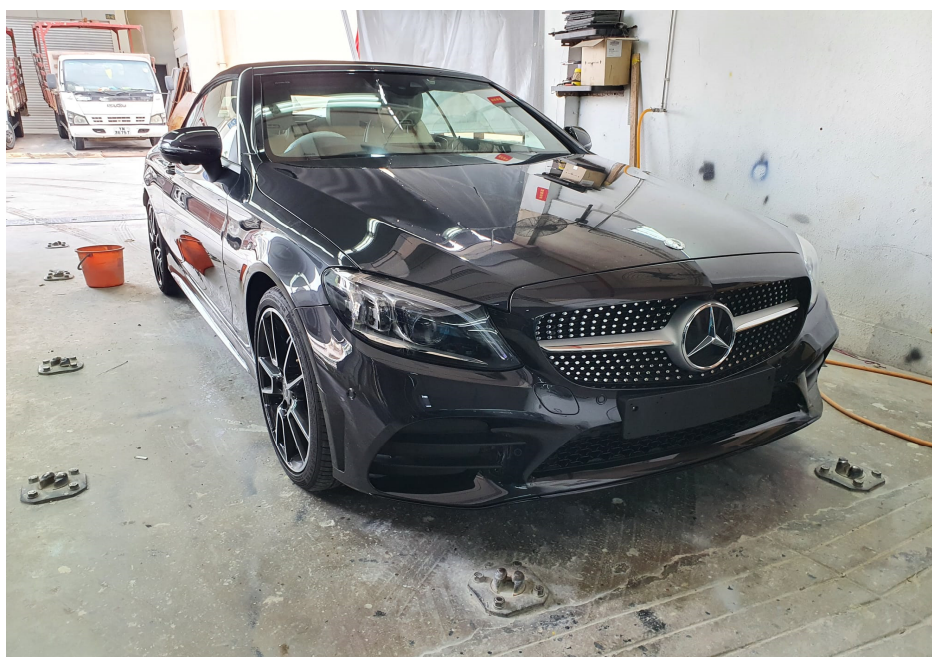
Photo 4 shows the front right body of the Motor Car (photograph provided to me). Apart for the rear portion, there was no physical damage seen to other areas of the Motor Car. The airbags were also not deployed.

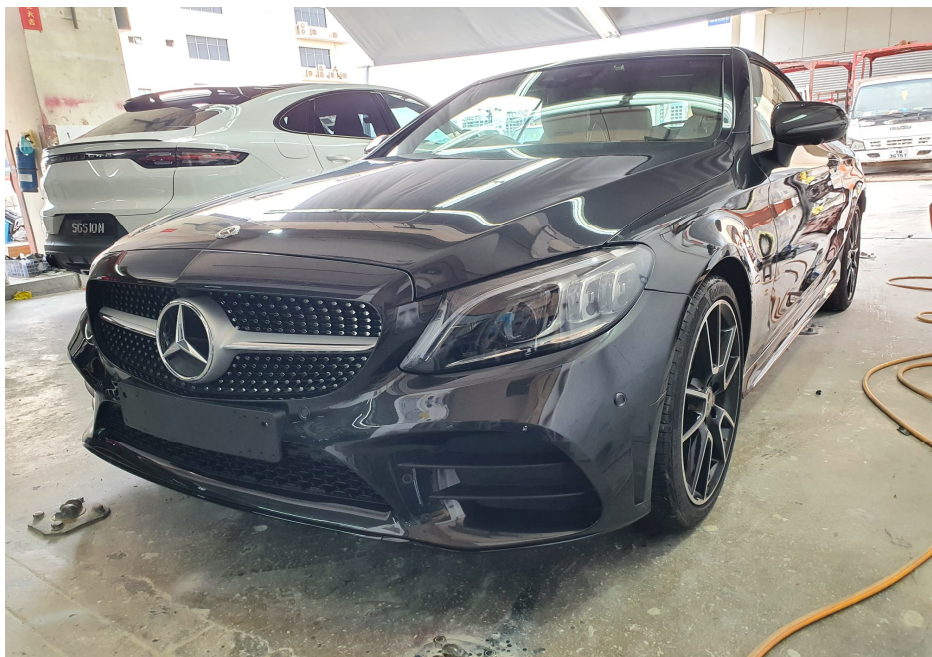
Photo 5 shows the front left body of the Motor Car (photograph provided to me). Apart for the rear portion, there was no physical damage seen to other areas of the Motor Car. The airbags were also not deployed.

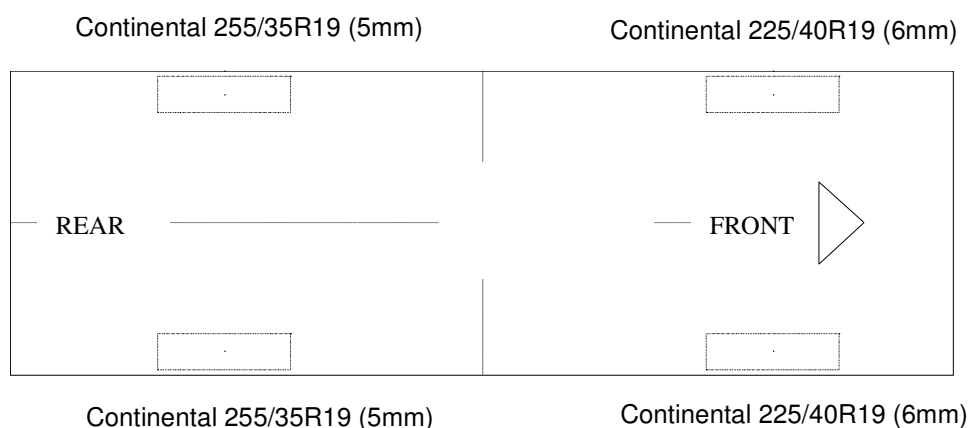
9. The Motor Car was fitted with 19inch sport wheel rims that were wrapped with tyres that were observed to be of serviceable condition. The tyres were also sufficiently inflated for vehicular operation. The tyre brand, tyre size and approximate remaining tread depth of the 4 tyres of the Motor Car were recorded as follows: -

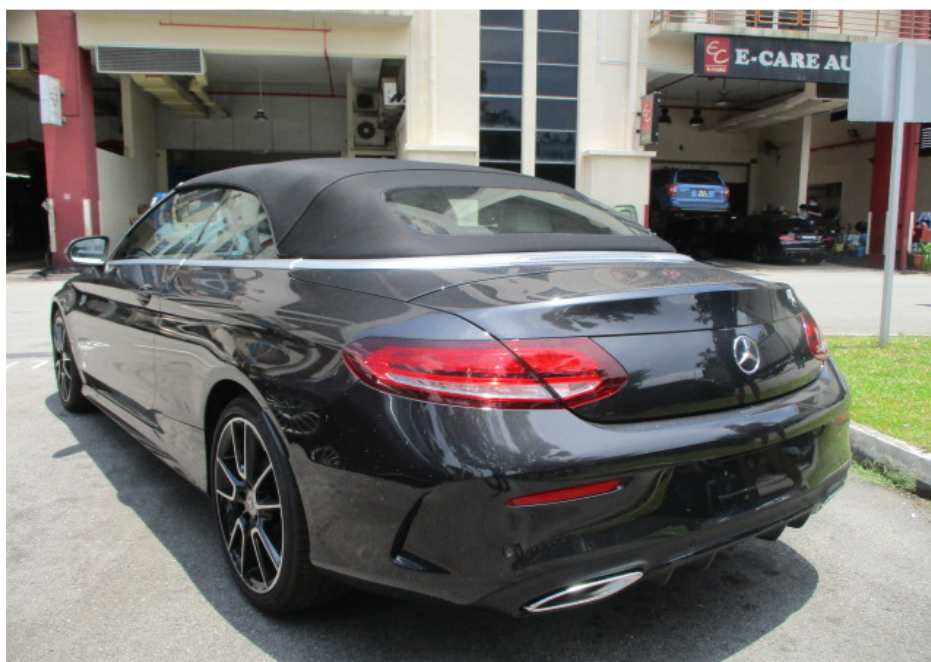
Photo 6 shows a general view of the rear left body of the Motor Car at the time of my inspection. The Motor Car was observed to be in a relatively good general condition with no loose exterior fittings observed. The body parts at the rear portion of the Motor Car were visually examined and it was observed that the repair/restoration works carried out to the damaged area of the Motor Car (refer to photograph 1 & 2 above) were reasonably adequate and in order.

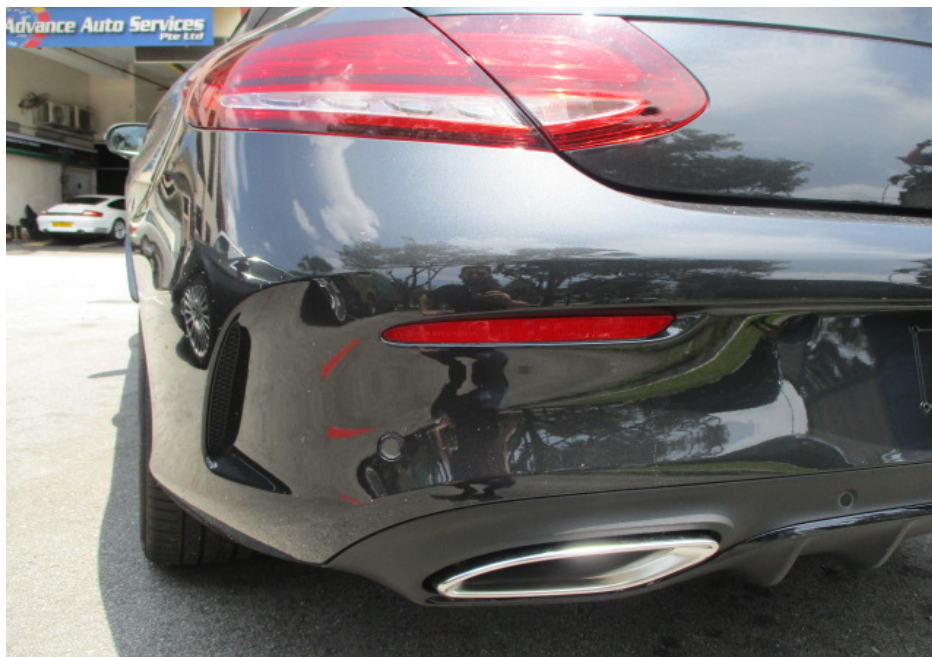
Photo 7 shows a closer view of the Motor Car's rear bumper, rear bumper left reflector, rear left exhaust garnish, rear left taillamp and rear left bootlid lamp. The body parts at the rear portion of the Motor Car were visually examined and it was observed that the repair/restoration works carried out to the damaged area of the Motor Car (refer to photograph 1 & 2 above) were reasonably adequate and in order.

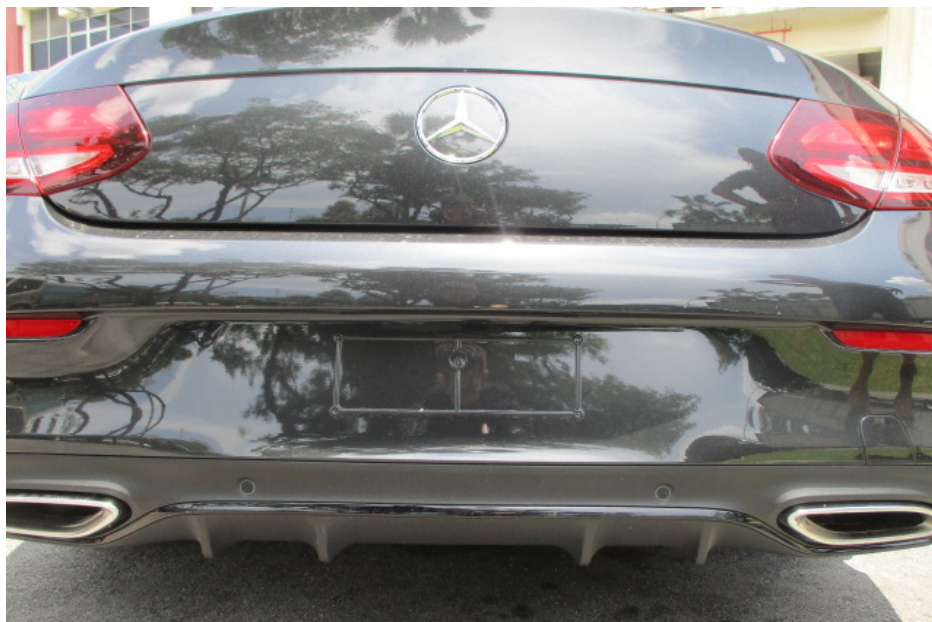
Photo 8 shows a closer view of the Motor Car's rear bumper, rear bumper lower cover, rear bumper sensors, rear exhaust garnishes and rear bootlid. The body parts at the rear portion of the Motor Car were visually examined and it was observed that the repair/restoration works carried out to the damaged area of the Motor Car (refer to photograph 1 & 2 above) were reasonably adequate and in order.

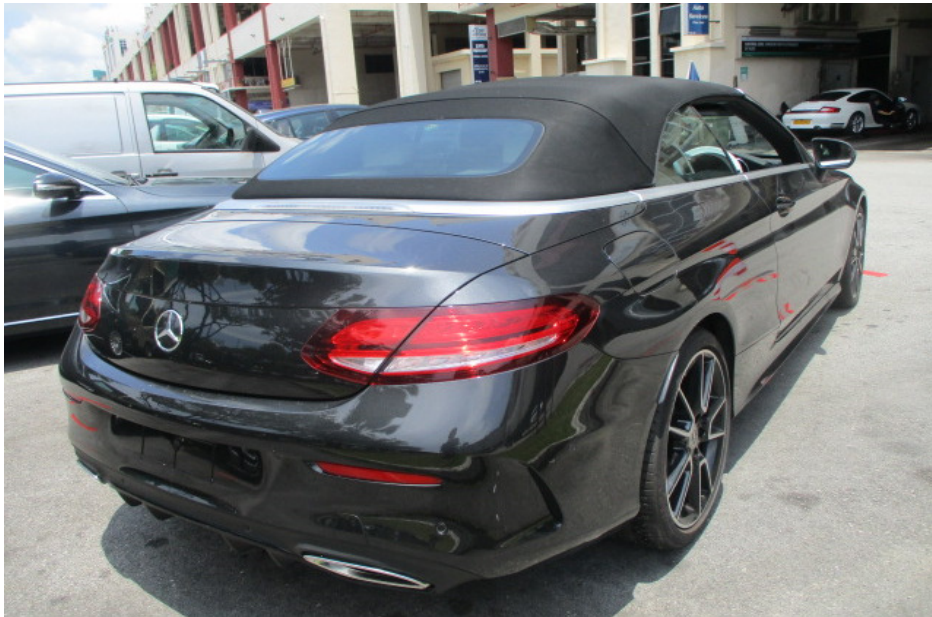
Photo 9 shows a general view of the rear right body of the Motor Car at the time of my inspection. The Motor Car was observed to be in a relatively good general condition with no loose exterior fittings observed. The body parts at the rear portion of the Motor Car were visually examined and it was observed that the repair/restoration works carried out to the damaged area of the Motor Car (refer to photograph 1 & 2 above) were reasonably adequate and in order.

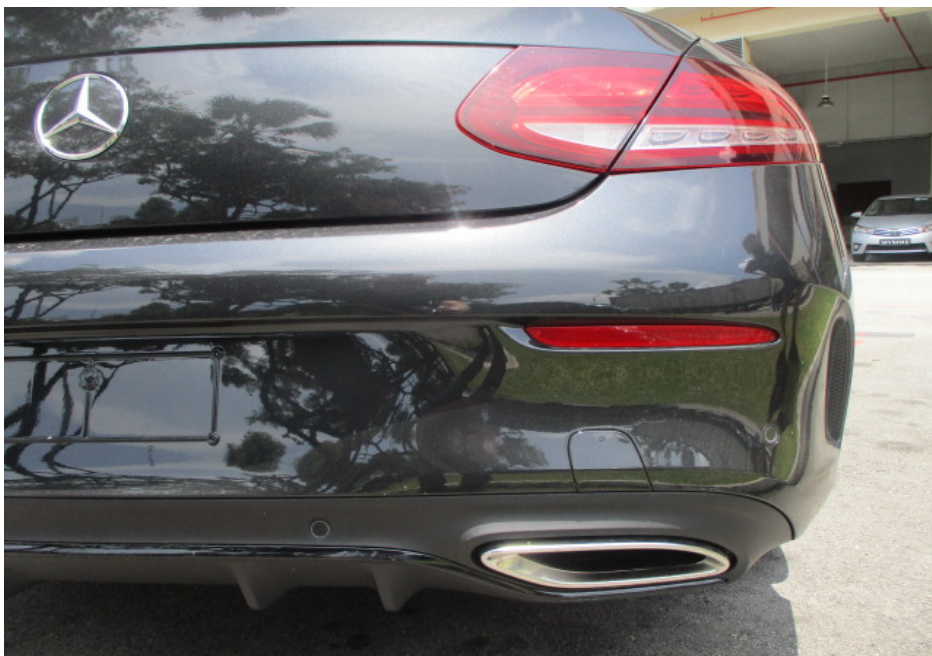
Photo 10 shows a closer view of the Motor Car's rear bumper, rear bumper right reflector, rear right exhaust garnish, rear right taillamp and rear right bootlid lamp. The body parts at the rear portion of the Motor Car were visually examined and it was observed that the repair/restoration works carried out to the damaged area of the Motor Car (refer to photograph 1 & 2 above) were reasonably adequate and in order.

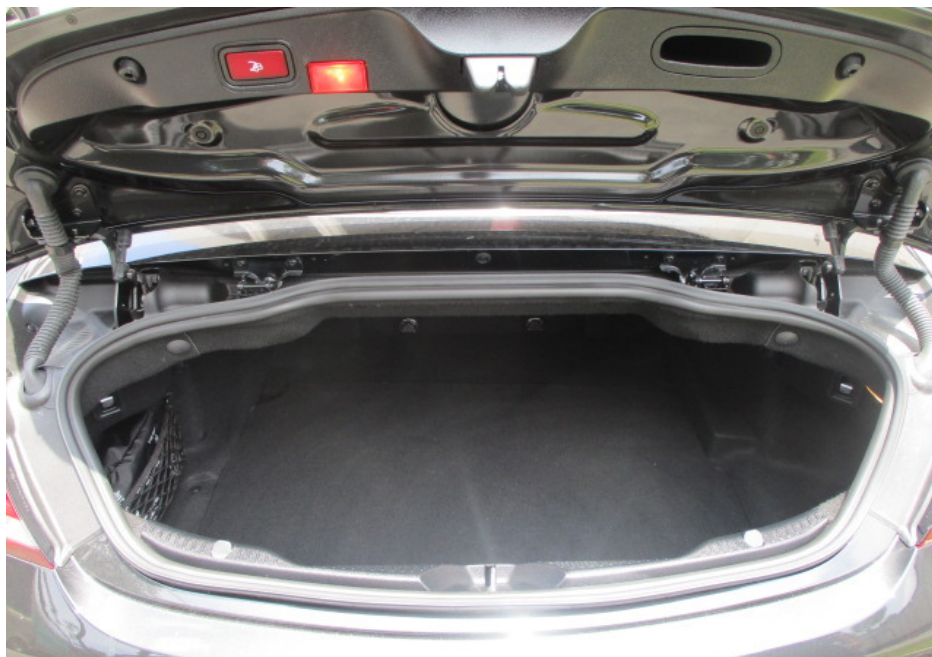
Photo 11 shows a general of the Motor Car's rear boot compartment at the time of my inspection. The various parts and components, inner trims, carpet and upholstery inside the rear boot compartment were all observed to be intact and properly fitted.

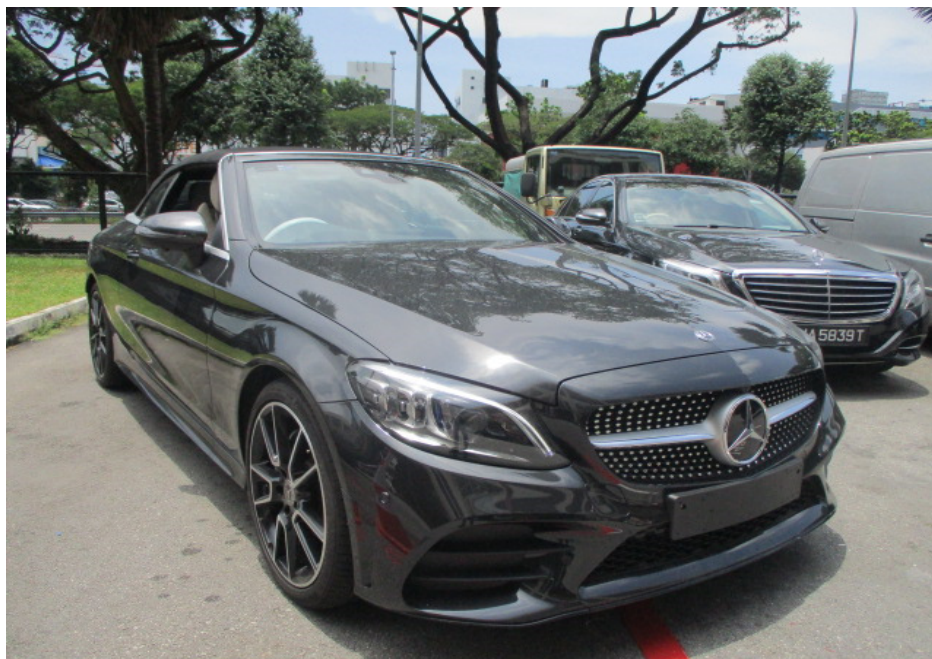
Photo 12 shows a general view of the front right body of the Motor Car at the time of my inspection. The Motor Car was observed to be in a relatively good general condition with no loose exterior fittings observed. The mileage of the Motor Car recorded at the time of my inspection was 11,086km.

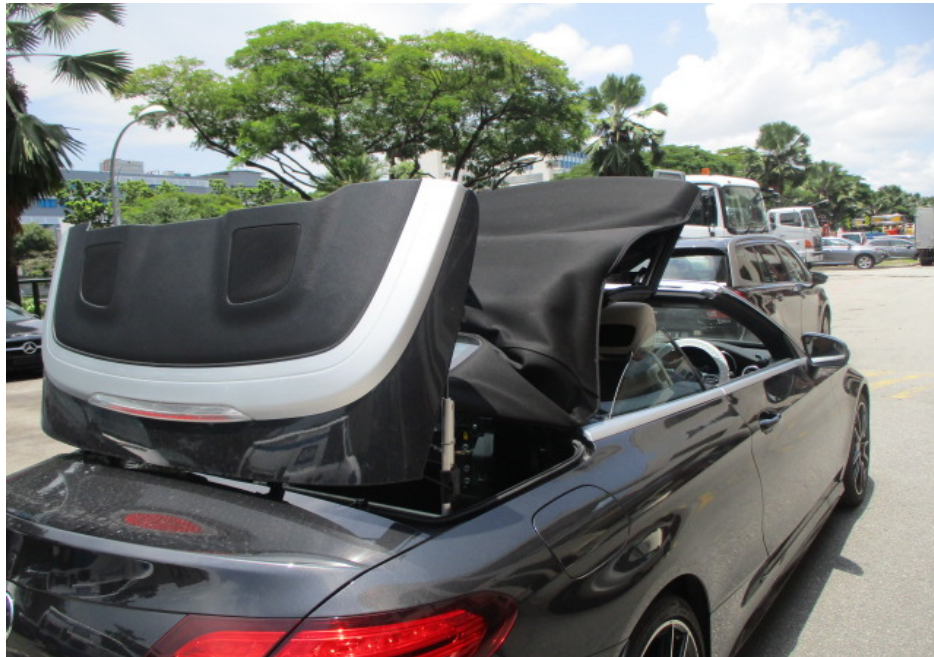
Photo 13 shows the Motor Car's soft top being tested. It was observed that as a safety feature, the soft top could only open and close when the Motor Car was in a stationary position. When opened, the soft top is completely folded into the rear storage compartment with no parts protruding out of the Motor Car's body. The soft top was also found adequately secured to the "A" pillar after closing.

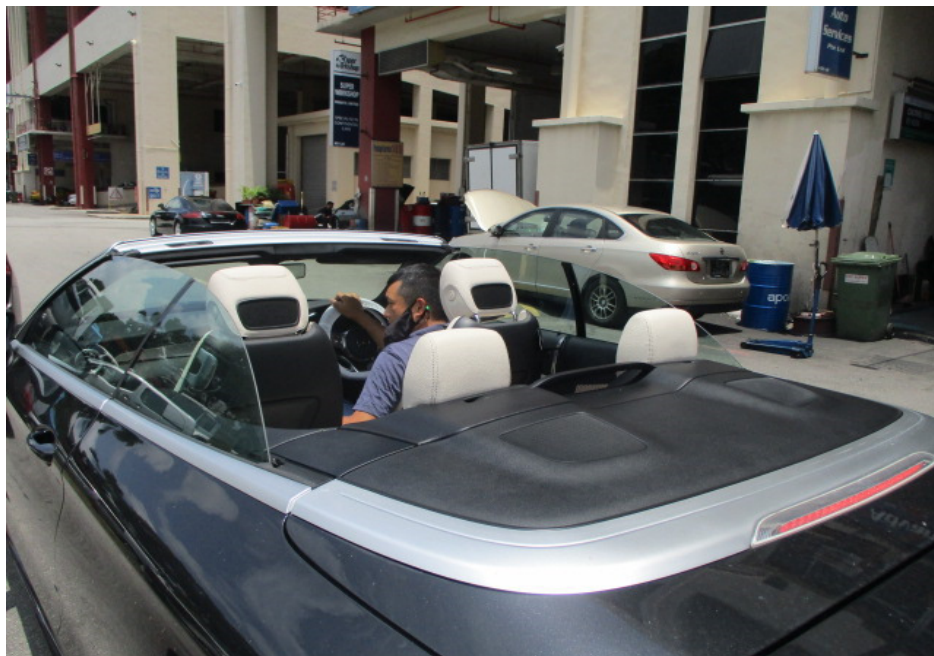
Photo 14 shows the Motor Car with its soft top completely folded. It was observed that as a safety feature, the soft top could only open and close when the Motor Car was in a stationary position. When opened, the soft top is completely folded into the rear storage compartment with no parts protruding out of the Motor Car's body. The soft top was also found adequately secured to the "A" pillar after closing.

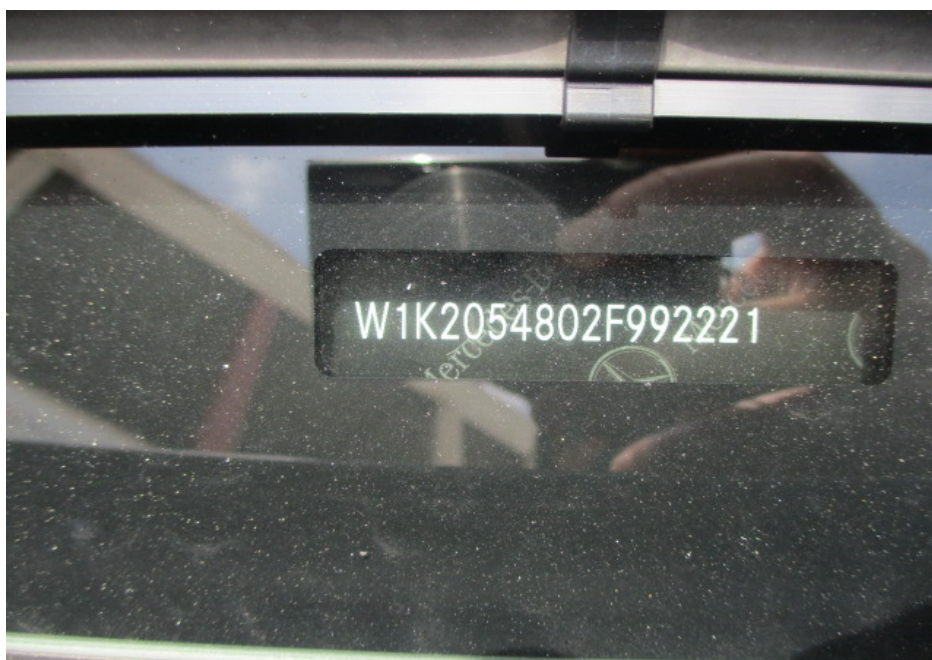
Photo 15 shows the chassis number of the Motor Car. The chassis number recorded was W1K2054802F992221.

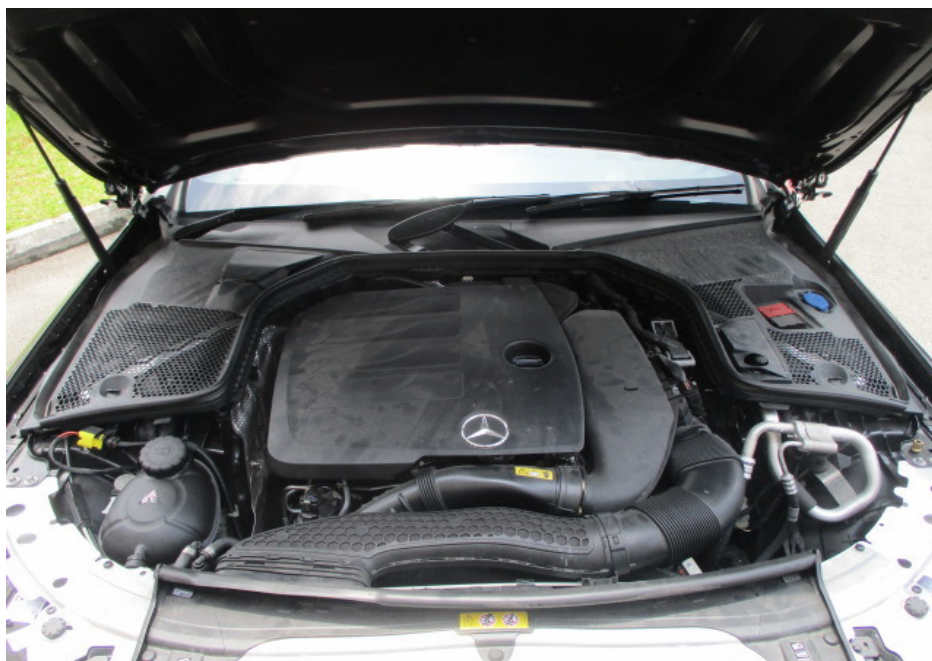
Photo 16 shows a general view of the engine compartment of the Motor Car at the time of my inspection. The various parts and components inside the engine compartment were all observed to be intact and properly fitted. There was also no sign(s) or indication(s) of fluid leak and/or fluid stain found inside the engine compartment.

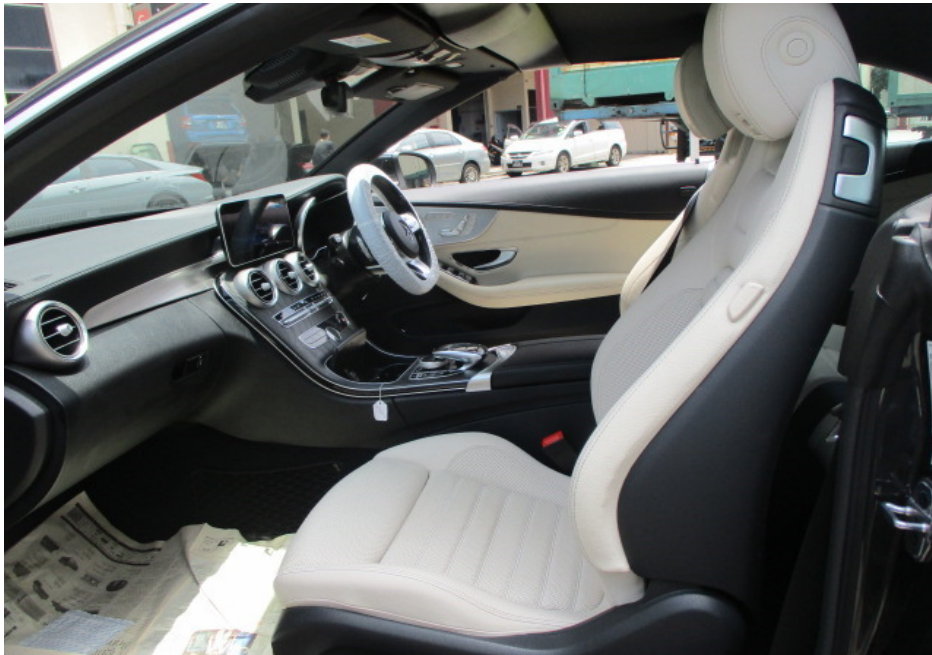
Photo 17 shows the interior compartment of the Motor Car at the time of my inspection. The various parts and components, trims, carpet and upholstery inside the interior compartment were all observed to be intact and properly fitted.

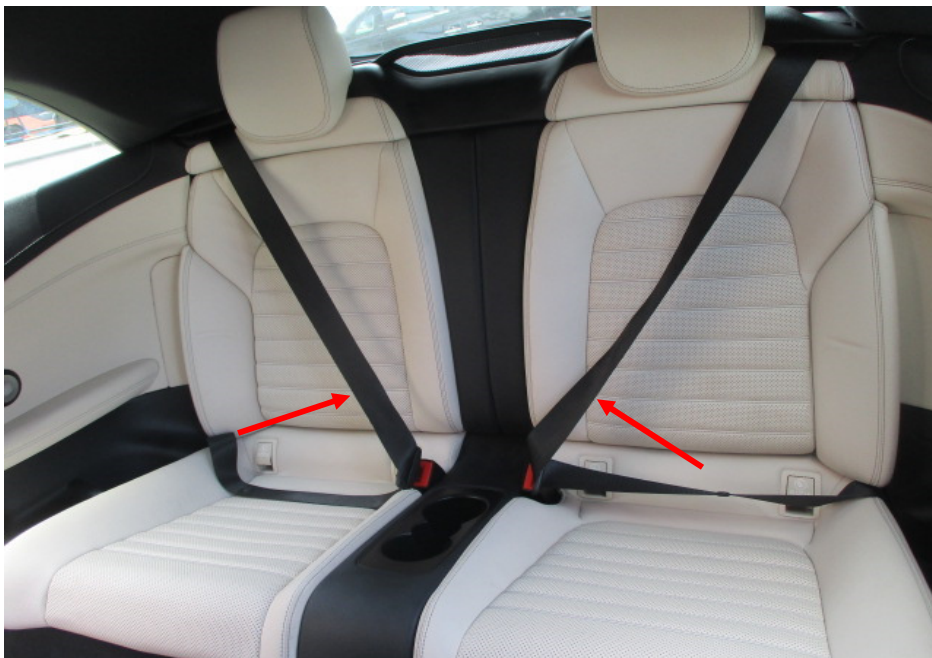
Photo 18 shows the rear seats of the Motor Car. All the seats of the Motor Car were secured via seat rails to the floorboard. They were also fitted with a retractable seat belt reel and a pre-tensioner. The seat belts (arrowed) were tested and were able to be fastened into the respective pre-tensions that were fitted on the side of each individual seat.

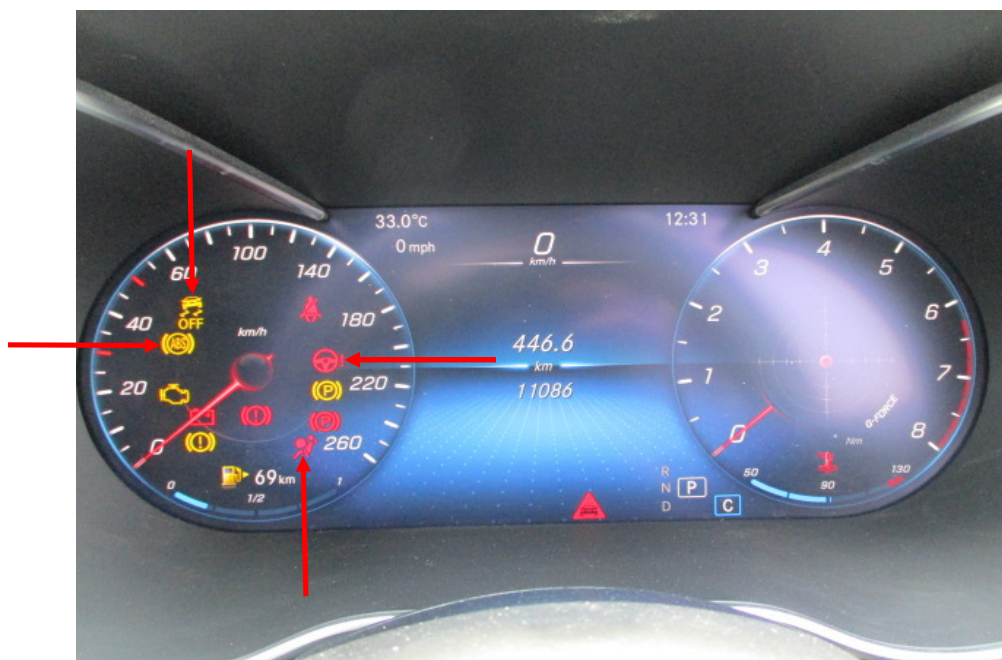
Photo 19 shows the warning lights for the various electronic safety features appearing on the instrument panel of the Motor Car during its self-test when the engine is cranked, in particular the ABS, SRS, EPS and TCS lights (arrowed).

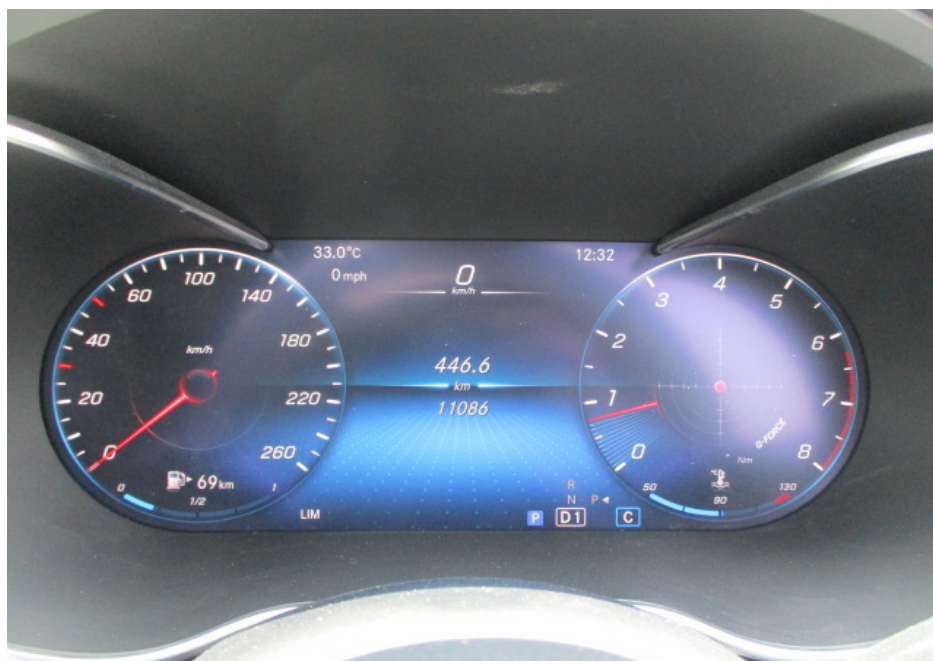
Photo 20 shows the respective warning lights no longer illuminated, indicating that there is no fault detected to the ABS, SRS, EPS TCS systems of the Motor Car during the self-test. These electronic systems were hence in working condition at the time of my inspection.

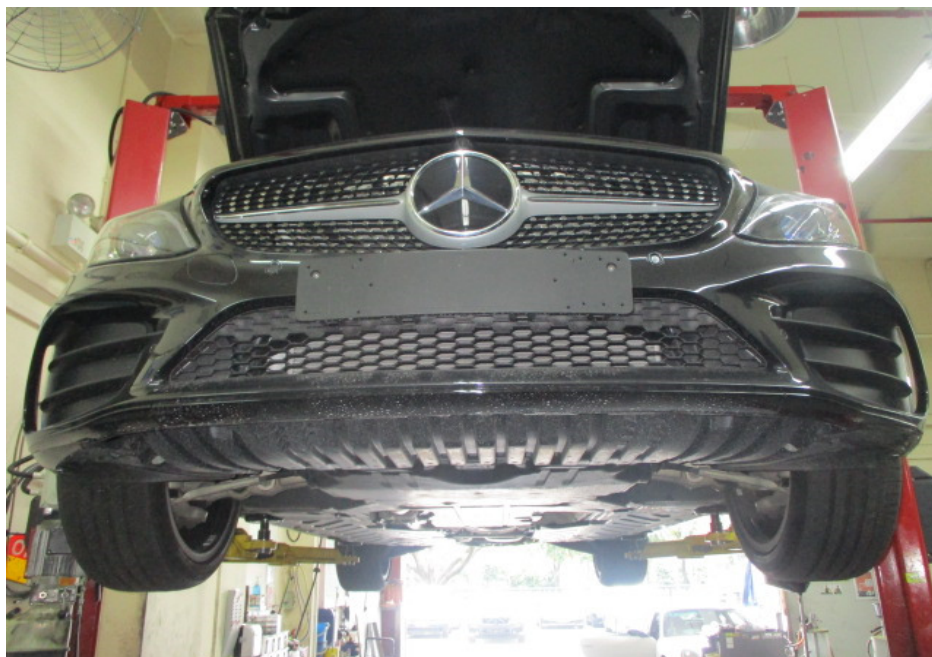
Photo 21 shows the Motor Car hoisted up for checks on its undercarriage. There was no sign(s) or indication(s) of fluid leakage and/or fluid stain(s) on the underside of the Motor Car. The undercarriage components of the Motor Car were also all observed to be intact and secured in an appropriate manner.

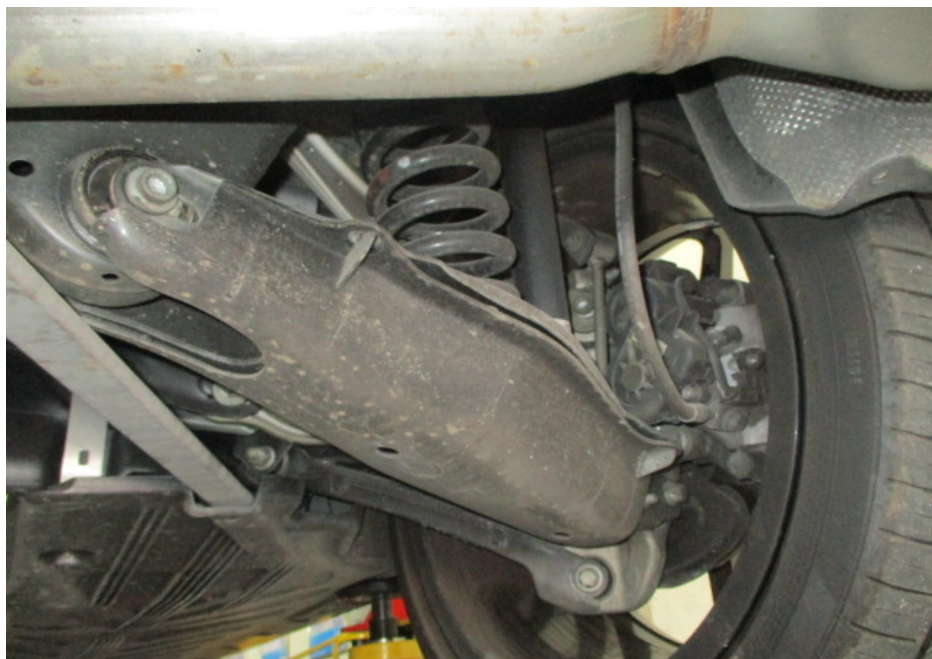
Photo 22 shows a general view of the control arms and linkages at the rear right wheel of the Motor Car. I did not observe any fluid leak and/or fluid stain on the underside of the Motor Car. All of the Motor Car's undercarriage components were observed to be intact and secured in an appropriate manner.

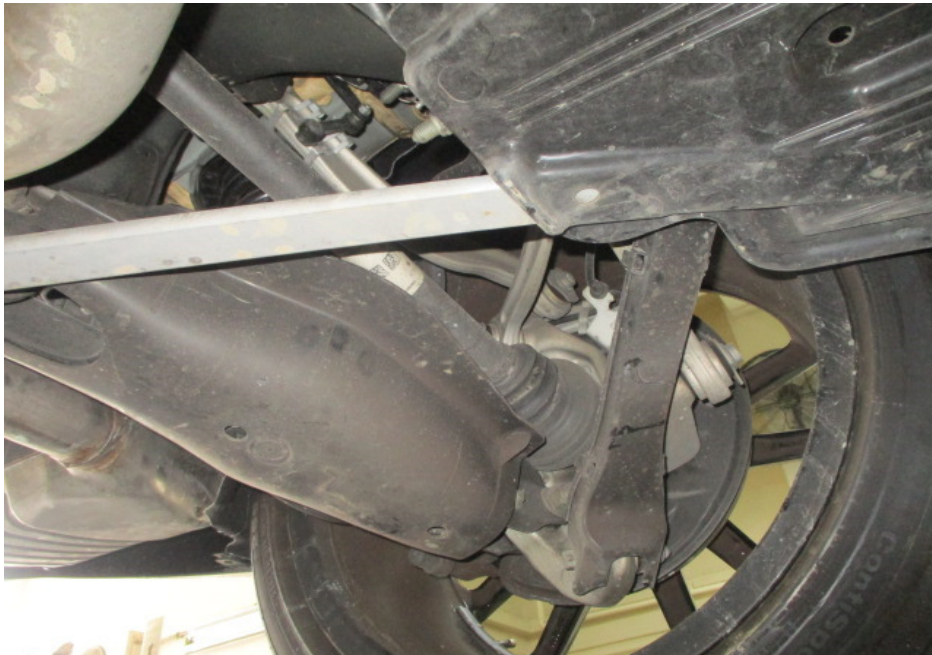
Photo 23 shows a general view of the control arms and linkages at the rear left wheel of the Motor Car. I did not observe any fluid leak and/or fluid stain on the underside of the Motor Car. All of the Motor Car's undercarriage components were observed to be intact and secured in an appropriate manner.

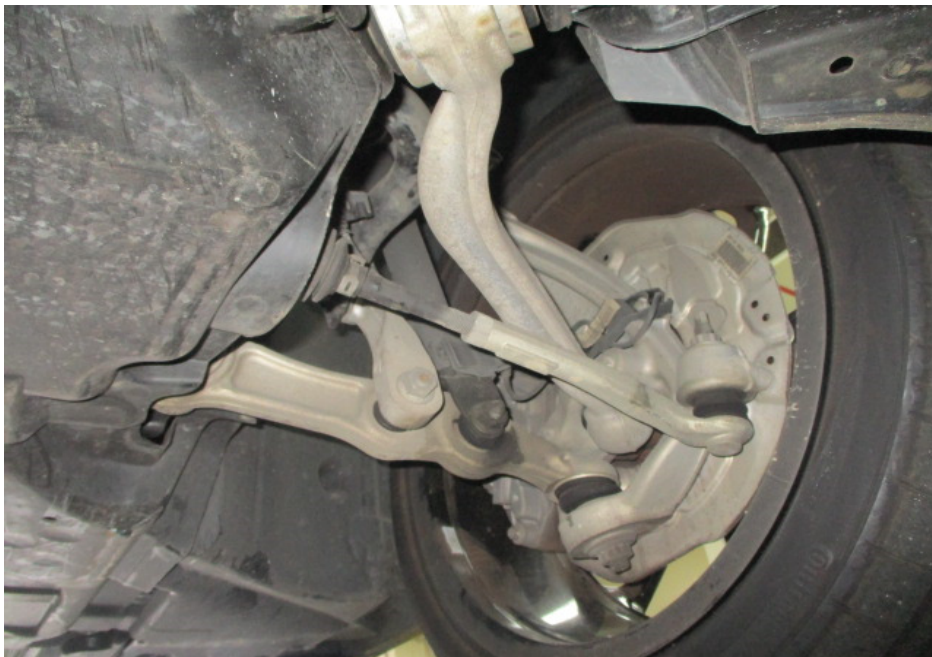
Photo 24 shows the various undercarriage components at the front left wheel of the Motor Car. The mechanical components, control arms and linkages were all found to be intact and secured in an appropriate manner.

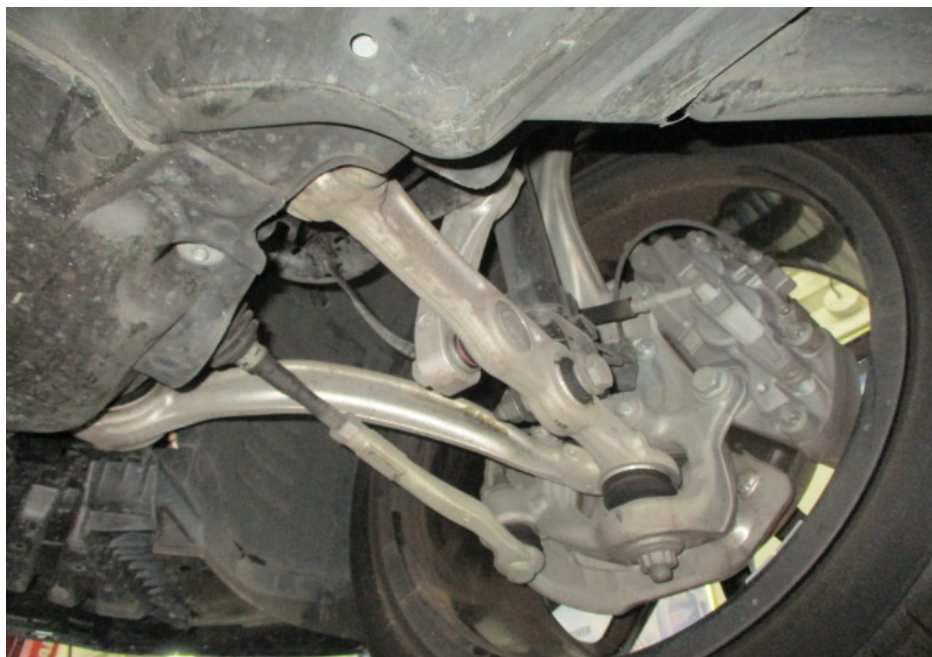
Photo 25 shows the various undercarriage components at the front right wheel of the Motor Car. The mechanical components, control arms and linkages were all found to be intact and secured in an appropriate manner. I also did not observe any fluid leak and/or fluid stain on the underside of the Motor Car.

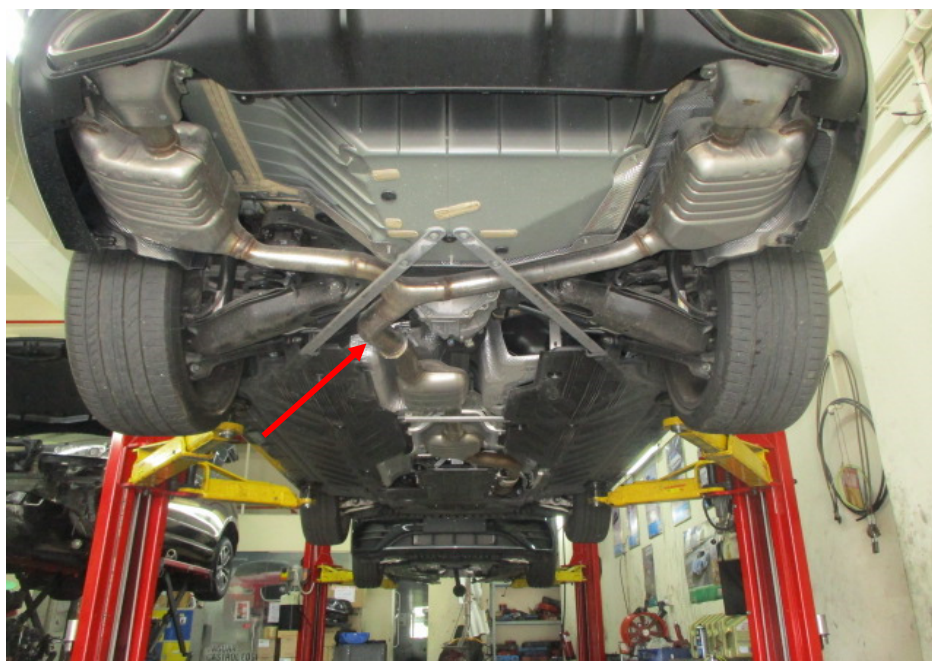
Photo 26 shows the rear section of the Motor Car's exhaust system. My examination of the Motor Car's exhaust system revealed no sign(s) or indication(s) of any cut or weld marks along its exhaust pipes (arrowed), on its centre resonator boxes, on its rear mufflers and on its catalytic converter.

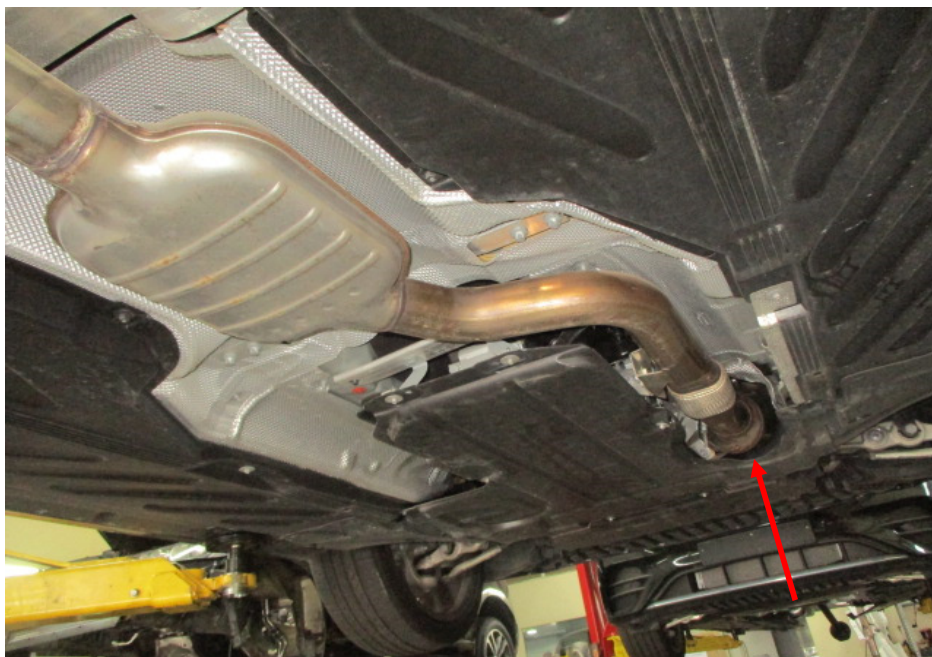
Photo 27 shows the front section of the Motor Car's exhaust system. My examination of the Motor Car's exhaust system revealed no sign(s) or indication(s) of any cut or weld marks along its exhaust pipes, on its centre resonator boxes, on its rear mufflers and on its catalytic converter (arrowed).

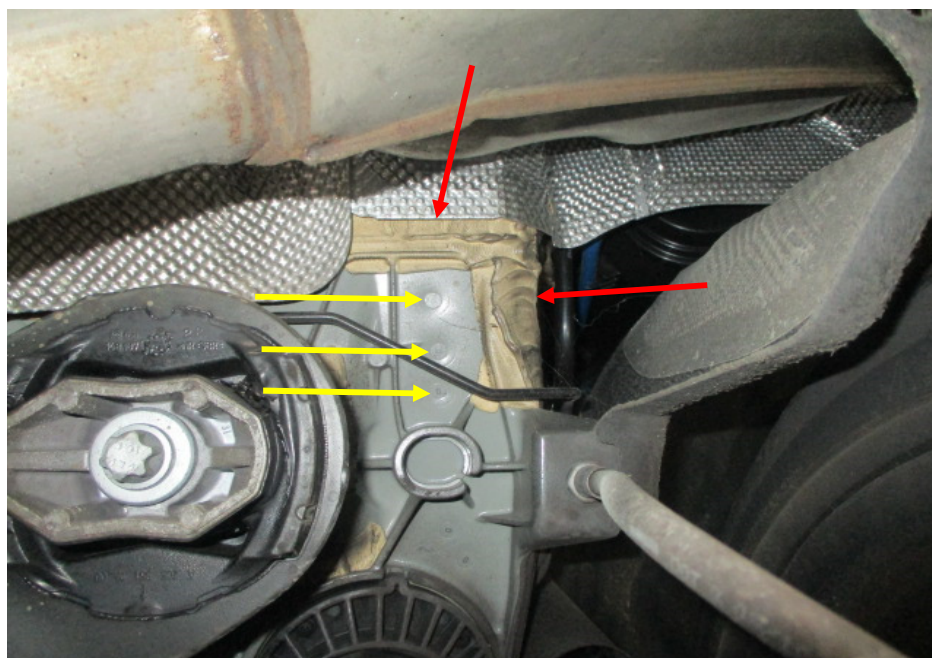
Photo 28 shows the chassis/structural body at the underside rear right of the Motor Car. I did not find any weld marks other than original spot weld marks (yellow arrow) on the chassis/structural body of the Motor Car. The original factory sealant (red arrow) at the joints along the chassis/structural body was also untouched, indicating no work was done on the chassis/structural body of the Motor Car and that the chassis/structural body was originally fitted.

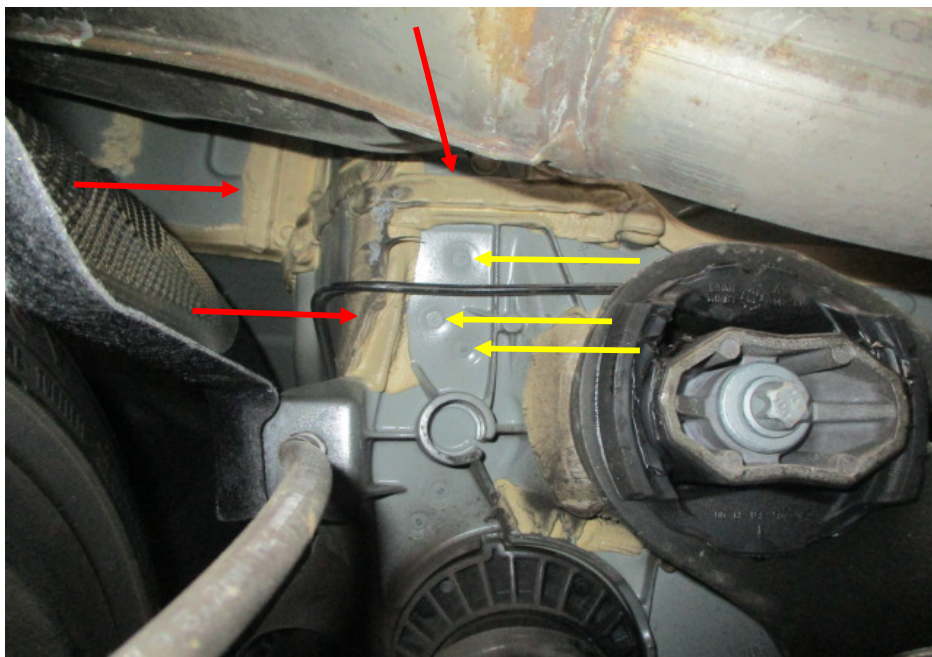
Photo 29 shows the chassis/structural body at the underside rear left of the Motor Car. I did not find any weld marks other than original spot weld marks (yellow arrow) on the chassis/structural body of the Motor Car. The original factory sealant (red arrow) at the joints along the chassis/structural body was also untouched, indicating no work was done on the chassis/structural body of the Motor Car and that the chassis/structural body was originally fitted.

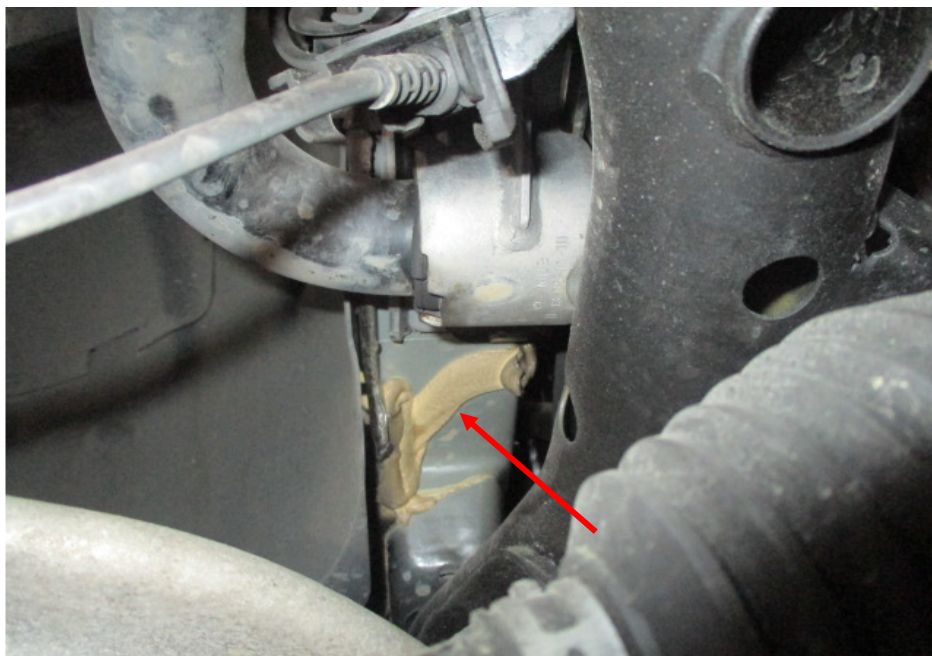
Photo 30 shows the chassis/structural body at the underside front left of the Motor Car. The original factory sealant (arrowed) at the joints along the chassis/structural body was observed to be untouched. In general, I had found no work was carried out on the chassis/structural body of the Motor Car. The chassis/structural body of the Motor Car was originally fitted.

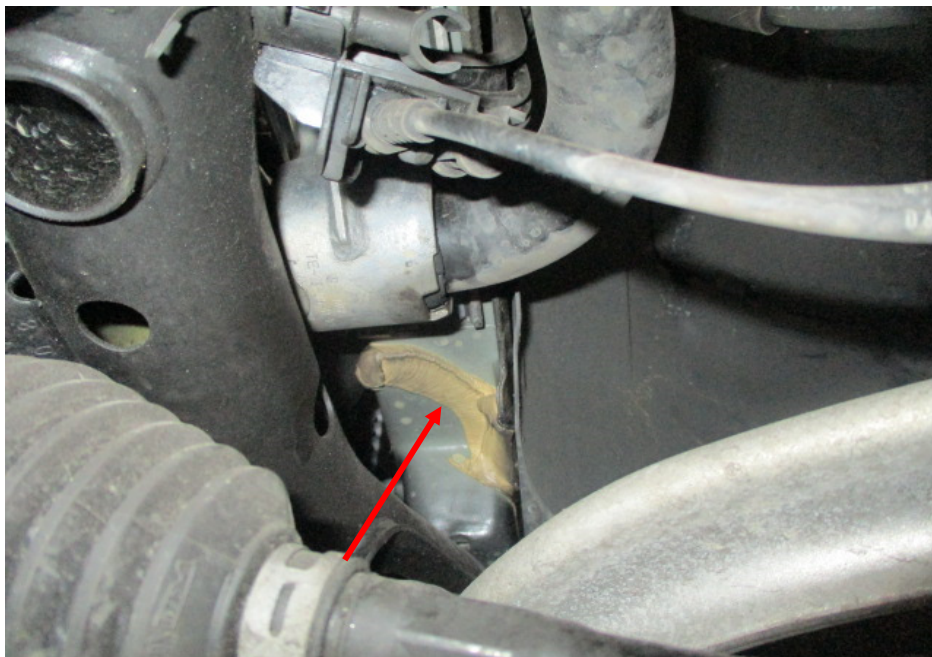
Photo 31 shows the chassis/structural body at the underside front right of the Motor Car. The original factory sealant (arrowed) at the joints along the chassis/structural body was observed to be untouched. In general, I had found no work was carried out on the chassis/structural body of the Motor Car. The chassis/structural body of the Motor Car was originally fitted.

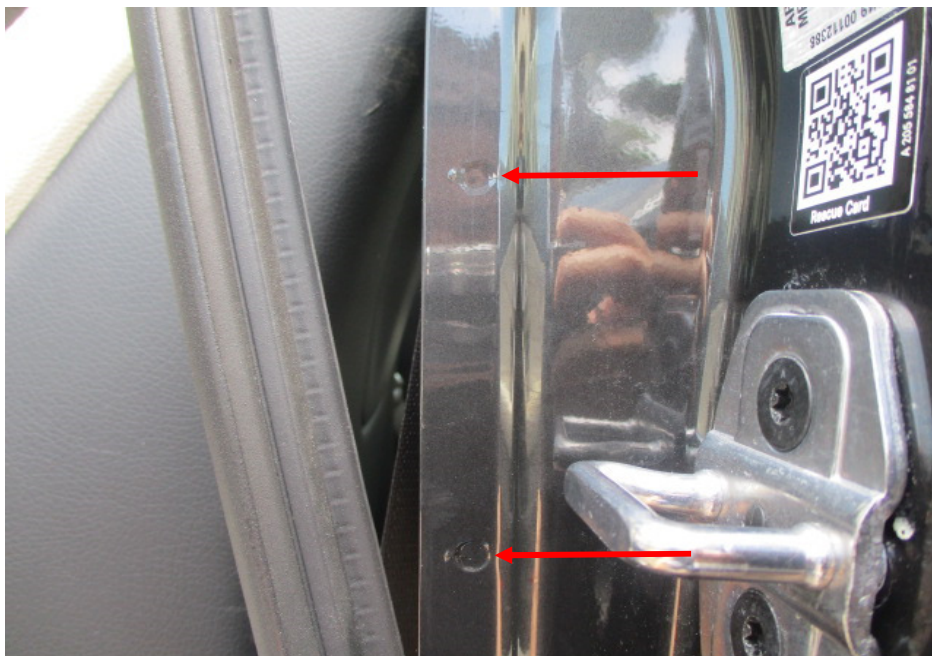
Photo 32 shows the left side rear body panel of the Motor Car. I did not find any weld marks other than original spot weld marks (arrowed) on the left side rear body panel of the Motor Car which, indicates that there was no re-welding works carried out. In general, I had found all the non-detachable body panels of the Motor Car to be originally fitted at the time of my inspection.
