Your Ref: Mercedes C200 Cabriolet
(chassis number W1K2054802F992221)

Our Ref : CI/TP21009987/D

INSPECTION REPORT OF AN UNREGISTERD MERCEDES BENZ C200 CABRIOLET MOTOR CAR WITH CHASSIS NUMBER W1K2054802F992221

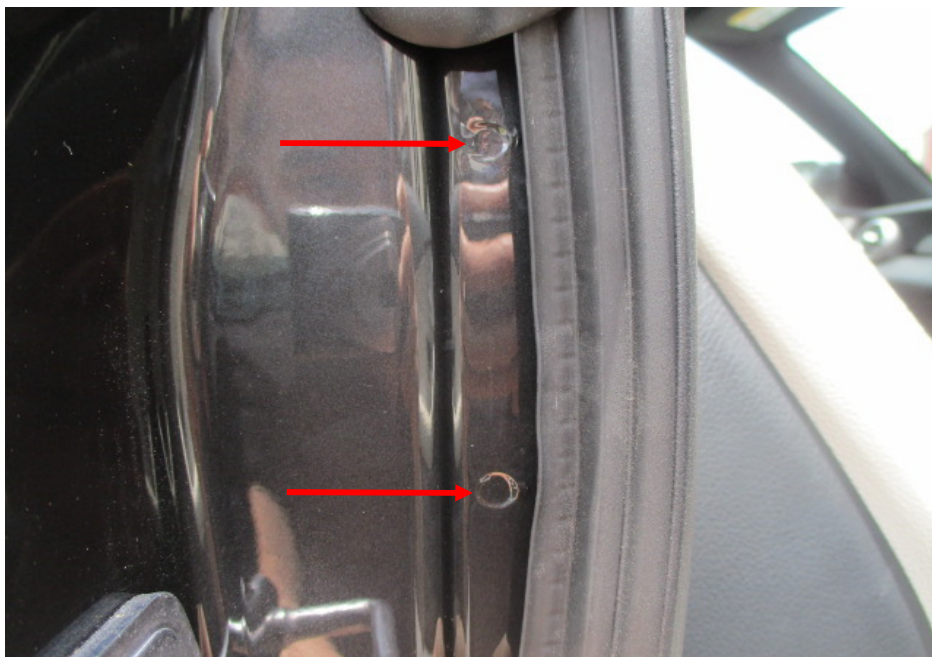
Photo 33 shows the right side rear body panel of the Motor Car. I did not find any weld marks other than original spot weld marks (arrowed) on the right side rear body panel of the Motor Car which, indicates that there was no re-welding works carried out. In general, I had found all the non-detachable body panels of the Motor Car to be originally fitted at the time of my inspection.
