Your Ref: Mercedes Benz A35
(chassis number WDD1771512J162594)
Our Ref : CI/TP21009990/D

27 September 2021

INSPECTION REPORT OF AN UNREGISTERED MERCEDES A35 MOTOR CAR WITH CHASSIS NUMBER WDD1771512J162594

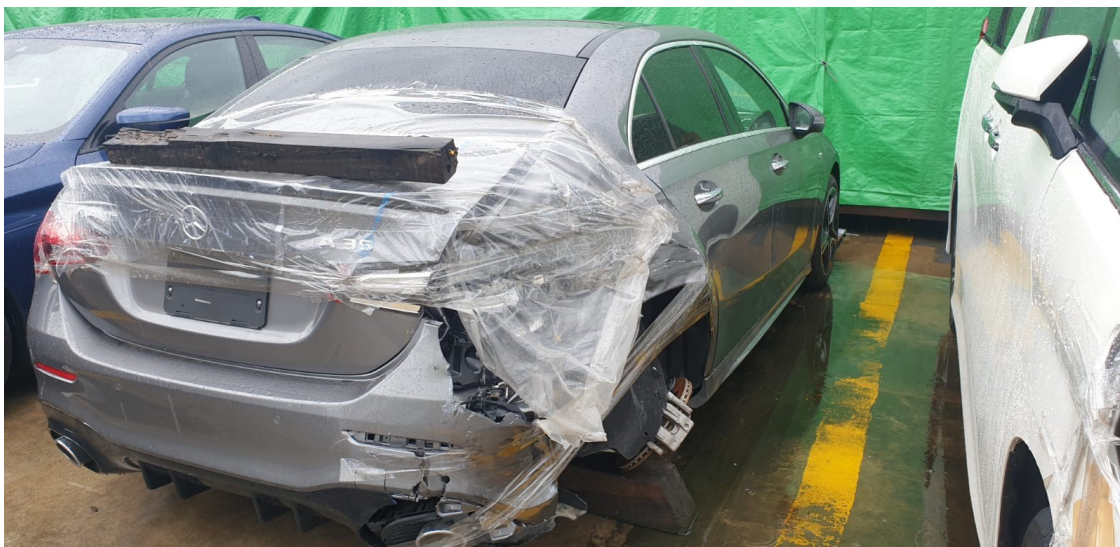
3. The photographs provided to me had showed damage to the rear right portion of the Motor Car. Body parts damaged include the rear bumper, rear bumper lower cover, rear bumper right reflector, rear bumper right sensor, rear bumper right bracket, rear bumper right corner garnish, rear right exhaust, rear right exhaust garnish, rear right lower undercover, rear right taillamp, rear right bootlid lamp, rear bootlid, rear right fender, rear right fender inner shield and rear right door amongst others.

4. The rear right wheel rim and rear right tyre were also observed to have been dislodged, suggesting damage to the rear right undercarriage parts. The rear right lower arm, rear right knuckle arm, rear right trailing arm, rear right drive shaft and rear right shock absorber amongst others are undercarriage parts that may possibly be damaged.

Photo 1 shows the rear right body of the Motor Car (photograph provided to me). The Motor Car was observed to have sustained damage at its rear right portion. Body parts damaged include the rear bumper, rear bumper lower cover, rear bumper right reflector, rear bumper right sensor, rear bumper right bracket, rear bumper right corner garnish, rear right exhaust, rear right exhaust garnish, rear right lower undercover, rear right taillamp, rear right bootlid lamp, rear bootlid, rear right fender, rear right fender inner shield and rear right door amongst others. The rear right wheel rim and rear right tyre were also observed to have been dislodged, suggesting damage to the rear right undercarriage parts of the Motor Car.

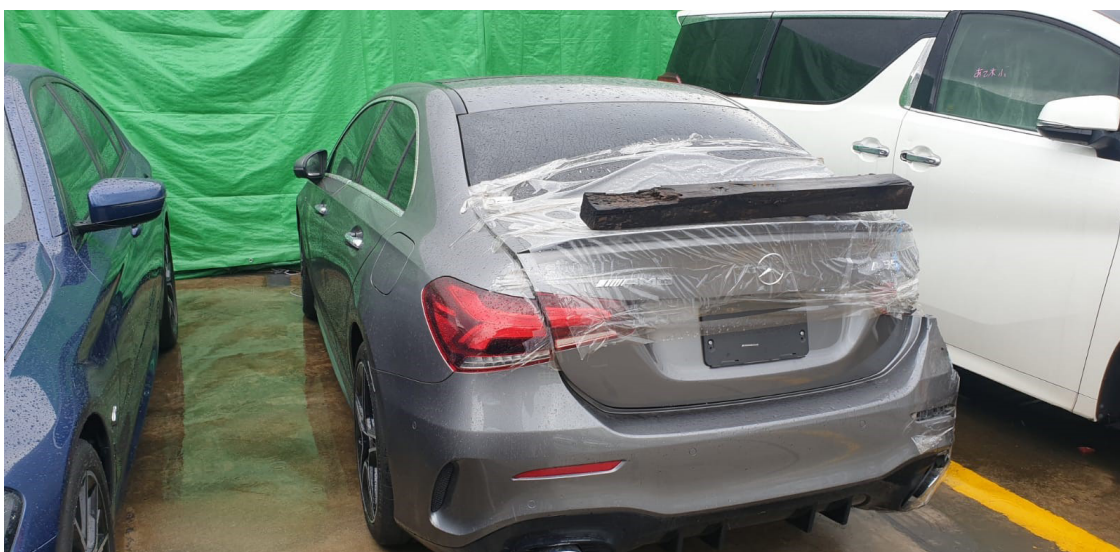
Photo 2 shows a general view of the rear left body of the Motor Car (photograph provided to me). The rear left portion of the Motor Car was observed to be without any physical damage.

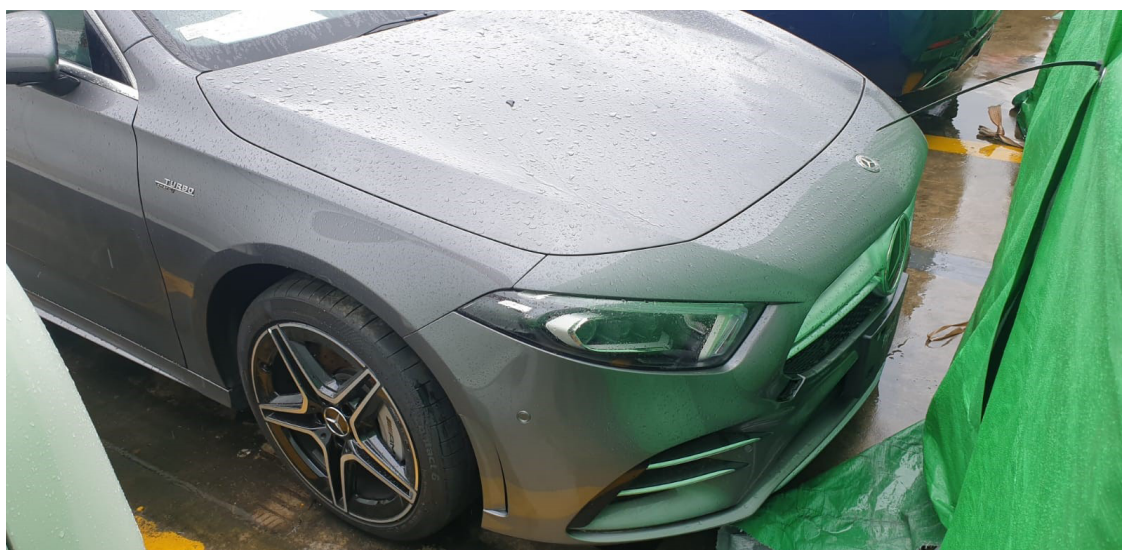
Photo 3 shows the front right body of the Motor Car (photograph provided to me). Apart for the rear right portion, there was no physical damage seen to other areas of the Motor Car.

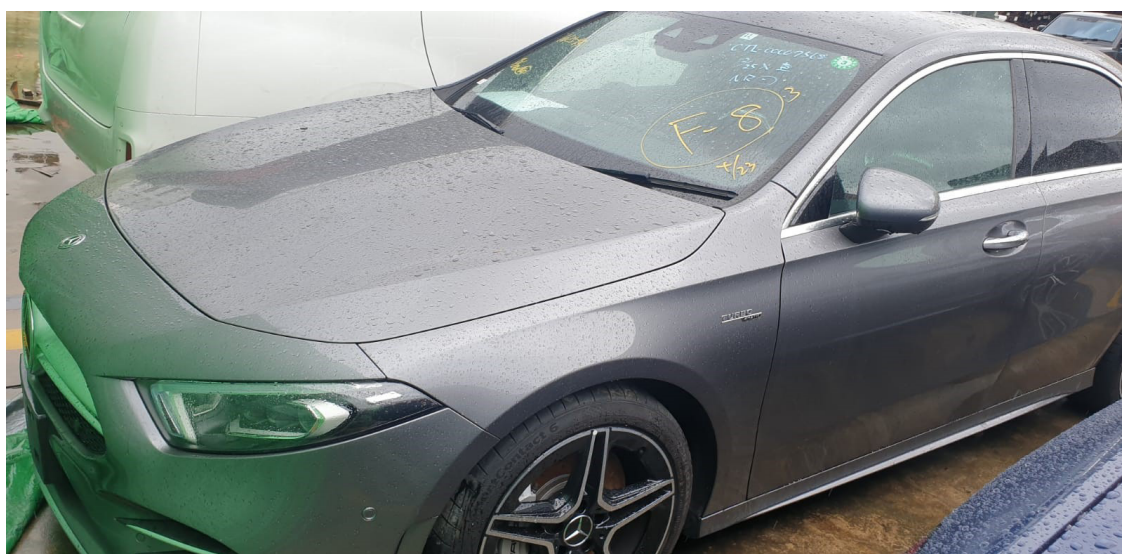
Photo 4 shows the front left body of the Motor Car (photograph provided to me). Apart for the rear right portion, there was no physical damage seen to other areas of the Motor Car. The airbags of the Motor Car were also not deployed as seen from the photographs that were provided to me.

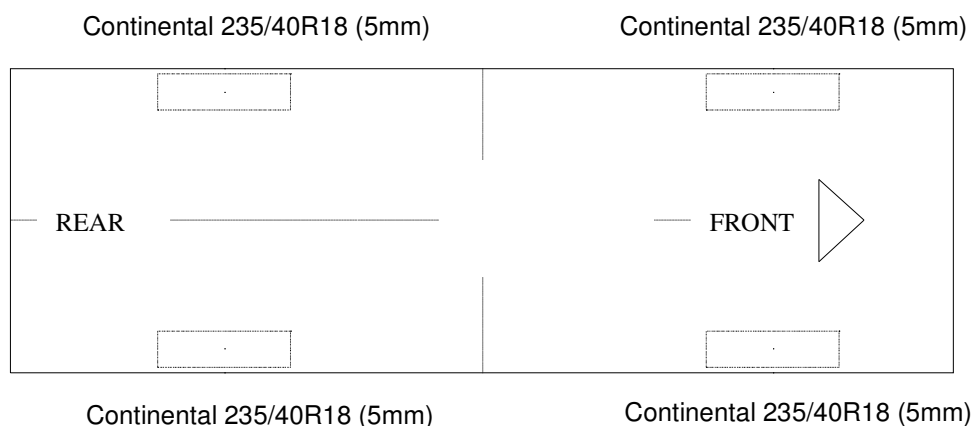
9. It was fitted with 18inch sport wheel rims that were wrapped with tyres that were observed to be of serviceable condition. The tyres were also sufficiently inflated for vehicular operation. The tyre brand, tyre size and approximate remaining tread depth of the 4 tyres of the Motor Car were recorded as follows: -

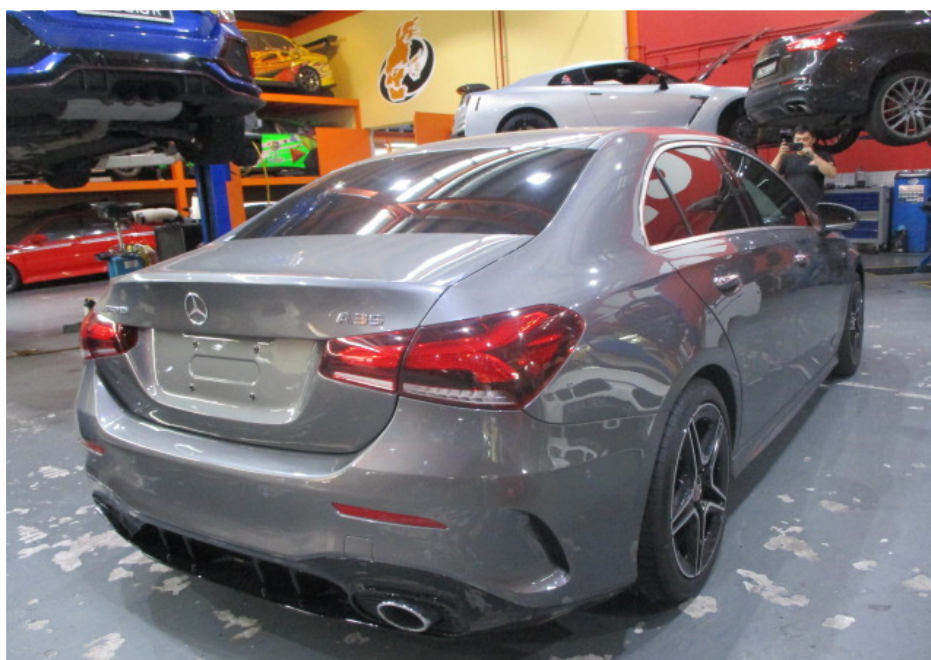
Photo 5 shows a general view of the rear right body of the Motor Car at the time of my inspection. The Motor Car was observed to be in a relatively good general condition with no loose exterior fittings observed. The body parts at the rear right portion of the Motor Car were visually examined and it was observed that the repair/restoration works carried out to the damaged area of the Motor Car (refer to photograph 1 above) were reasonably adequate and in order.

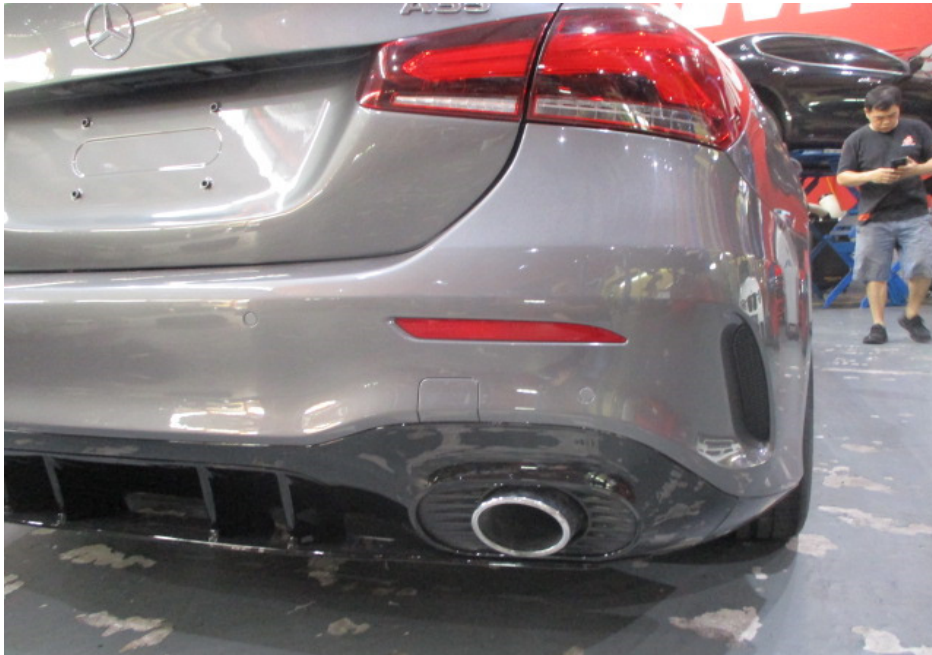
Photo 6 shows a closer view of the Motor Car's rear bumper, rear bumper lower cover, rear bumper right reflector, rear bumper right corner grille, rear right exhaust and rear right exhaust garnish. The body parts at the rear right portion of the Motor Car were visually examined and it was observed that the repair/restoration works carried out to the damaged area of the Motor Car (refer to photograph 1 above) were reasonably adequate and in order.

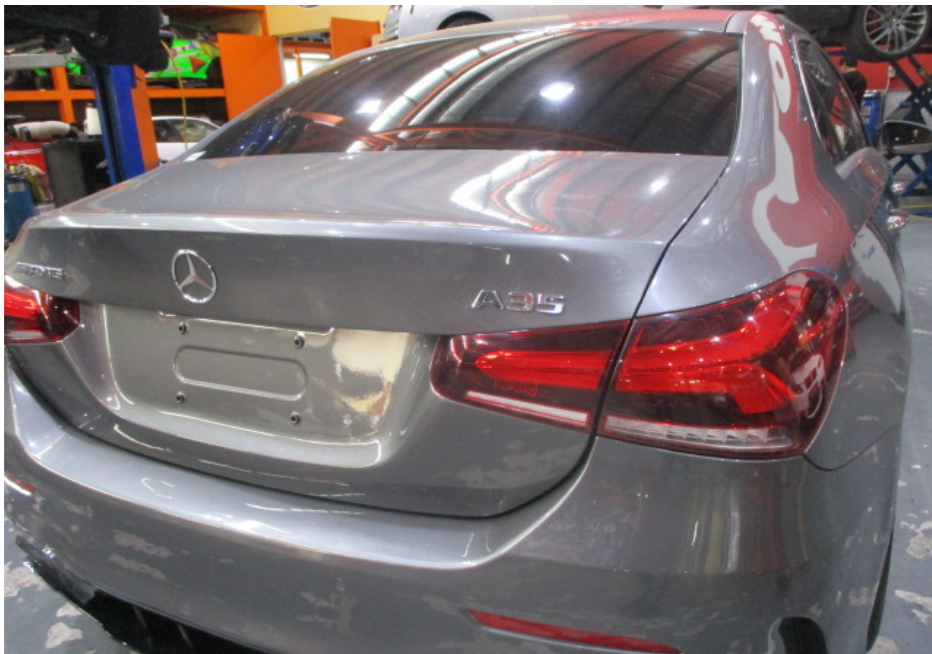
Photo 7 shows a closer view of the Motor Car's rear bootlid, rear right bootlid lamp and rear right taillamp. The body parts at the rear right portion of the Motor Car were visually examined and it was observed that the repair/restoration works carried out to the damaged area of the Motor Car (refer to photograph 1 above) were reasonably adequate and in order.

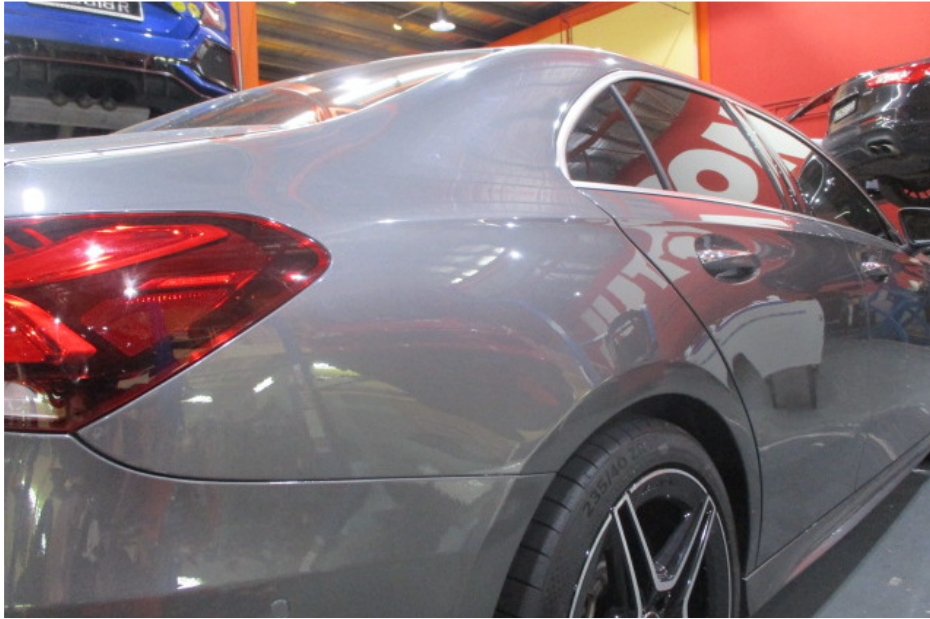
Photo 8 shows a closer view of the Motor Car's rear right fender and rear right door at the time of my inspection. The body parts at the rear right portion of the Motor Car were visually examined and it was observed that the repair/restoration works carried out to the damaged area of the Motor Car (refer to photograph 1 above) were reasonably adequate and in order.

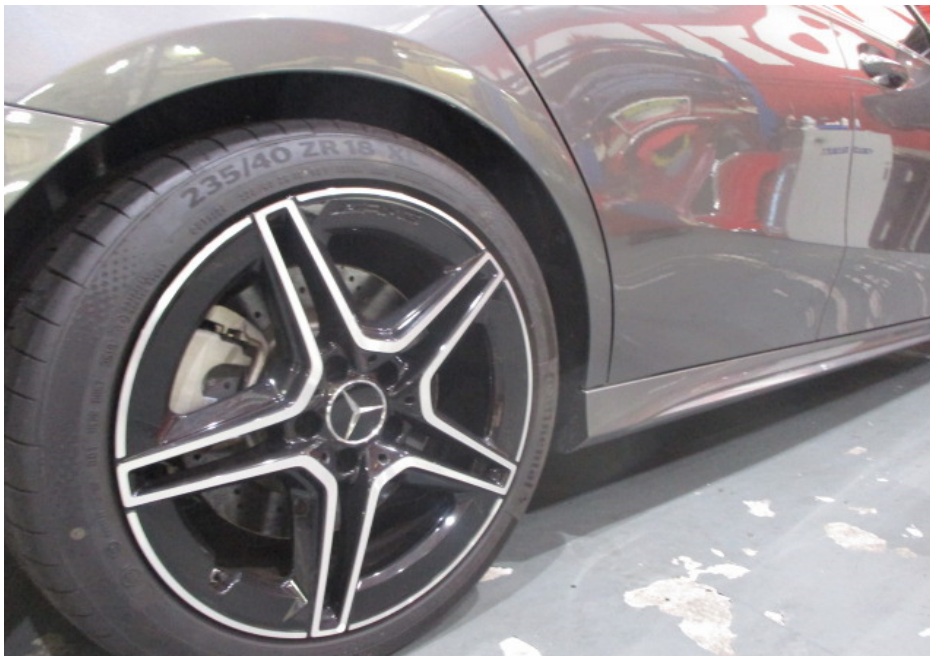
Photo 9 shows a closer view of the Motor Car's rear right wheel rim and rear right tyre. The body parts at the rear right portion of the Motor Car were visually examined and it was observed that the repair/restoration works carried out to the damaged area of the Motor Car (refer to photograph 1 above) were reasonably adequate and in order. The undercarriage parts at the rear right of the Motor Car were also visually check and found to be intact and secured in an appropriate manner (refer to photograph 19 below).

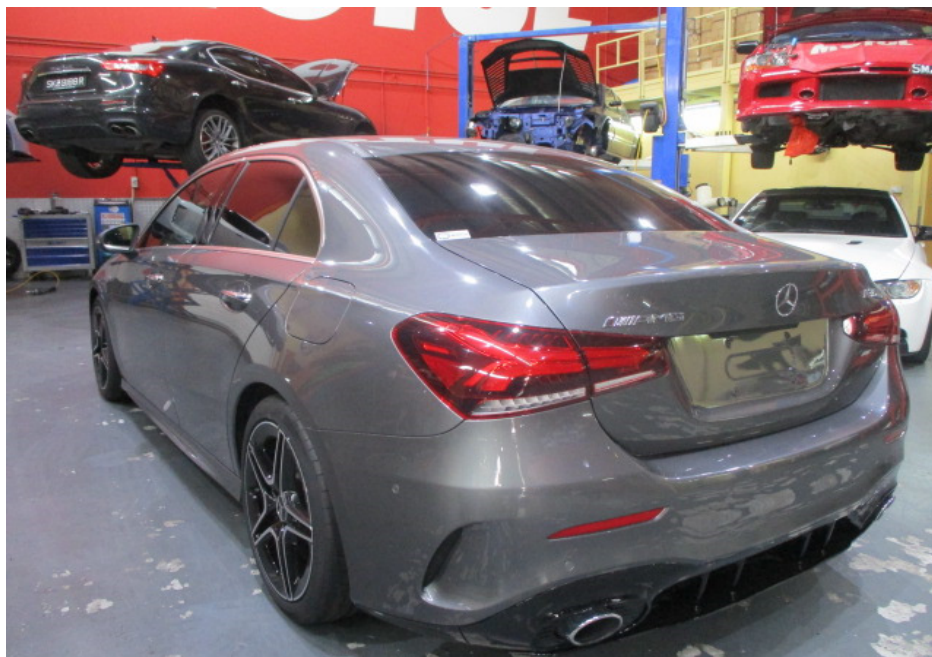
Photo 10 shows a general view of the rear left body of the Motor Car at the time of my inspection. The Motor Car was observed to be in a relatively good general condition with no loose exterior fittings observed. The mileage of the Motor Car recorded at the time of my inspection was 5,376km.

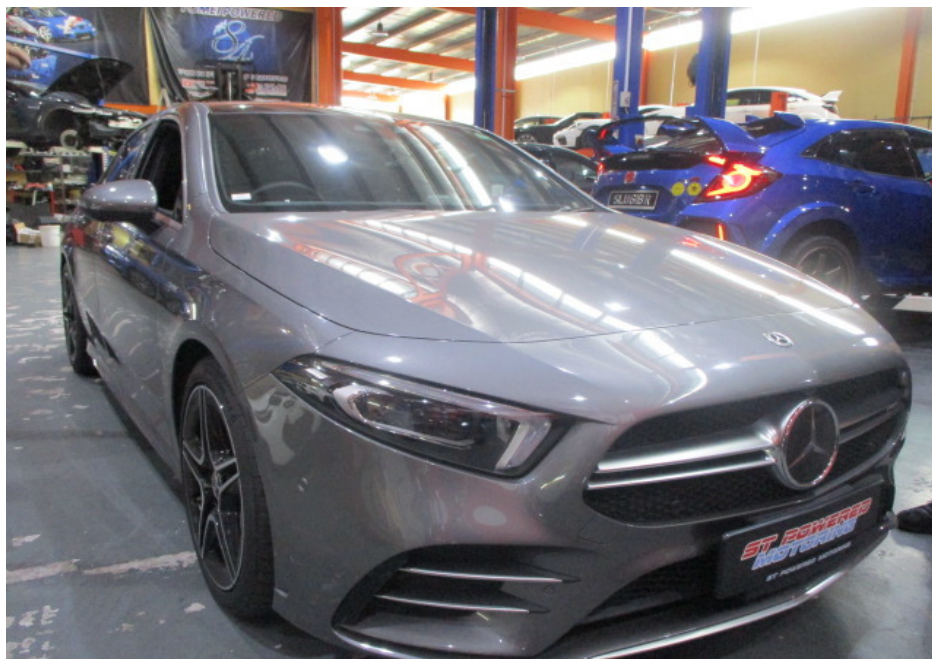
Photo 11 shows a general view of the front right body of the Motor Car at the time of my inspection. The Motor Car was observed to be in a relatively good general condition with no loose exterior fittings observed. The mileage of the Motor Car recorded at the time of my inspection was 5,376km.

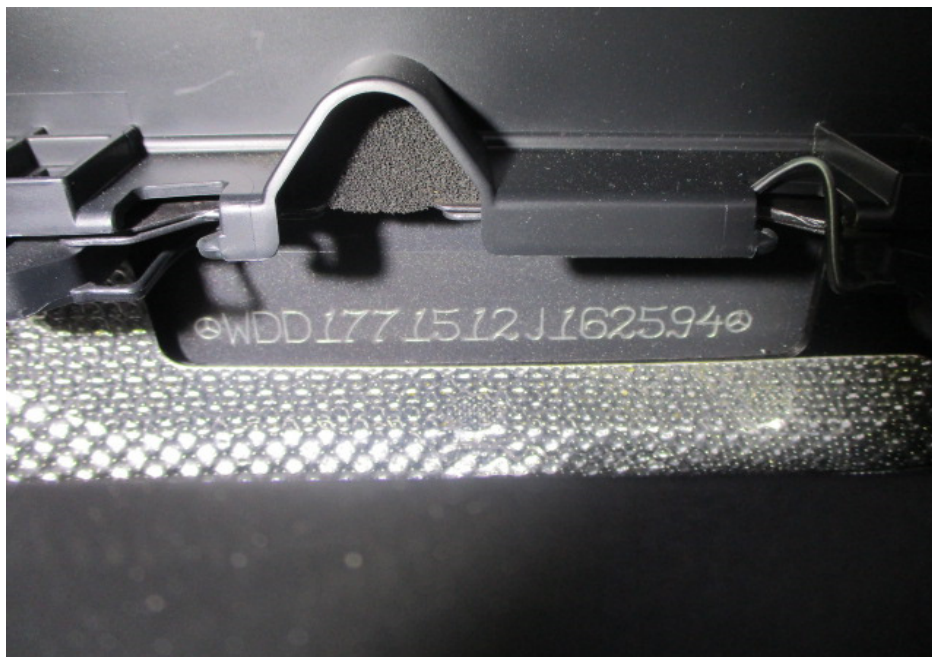
Photo 12 shows the chassis number of the Motor Car. The chassis number recorded was WDD1771512J162594.

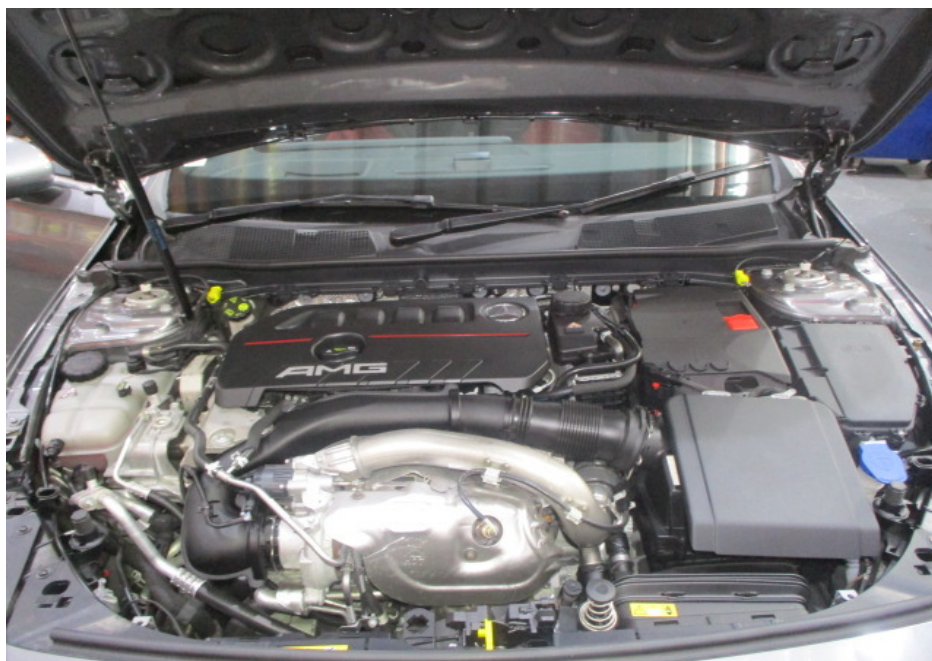
Photo 13 shows a general view of the engine compartment of the Motor Car at the time of my inspection. The various parts and components inside the engine compartment were all observed to be intact and properly fitted. There was also no sign(s) or indication(s) of fluid leak and/or fluid stain found inside the engine compartment.

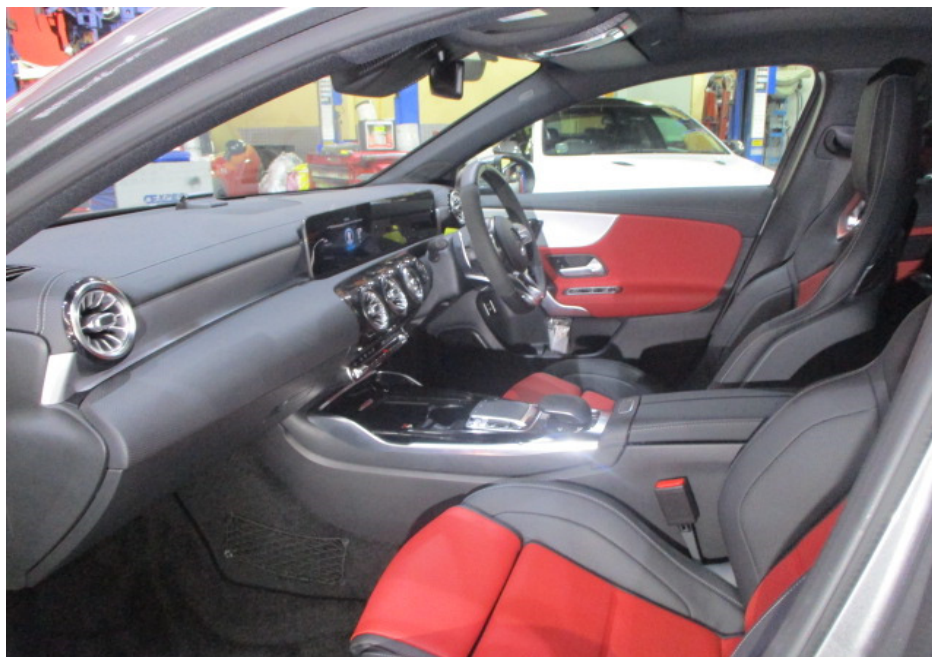
Photo 14 shows the interior compartment of the Motor Car at the time of my inspection. The various parts and components, trims, carpet and upholstery inside the interior compartment were all observed to be intact and properly fitted.

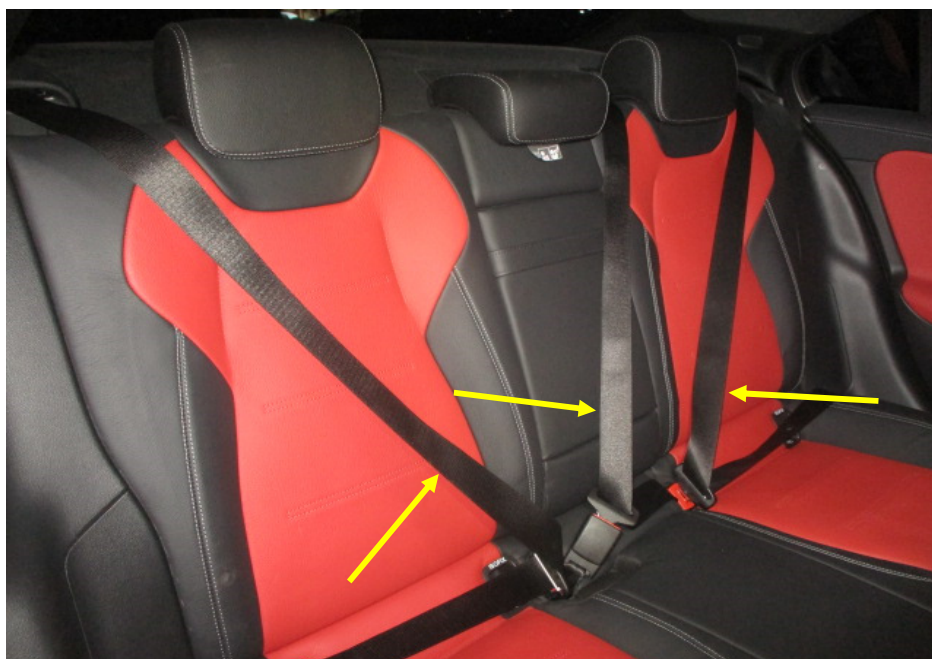
Photo 15 shows the rear seats of the Motor Car. All the seats of the Motor Car were secured via seat rails to the floorboard. They were also fitted with a retractable seat belt reel and a pre-tensioner. The seat belts (arrowed) were tested and were able to be fastened into the respective pre-tensions that were fitted on the side of each individual seat.

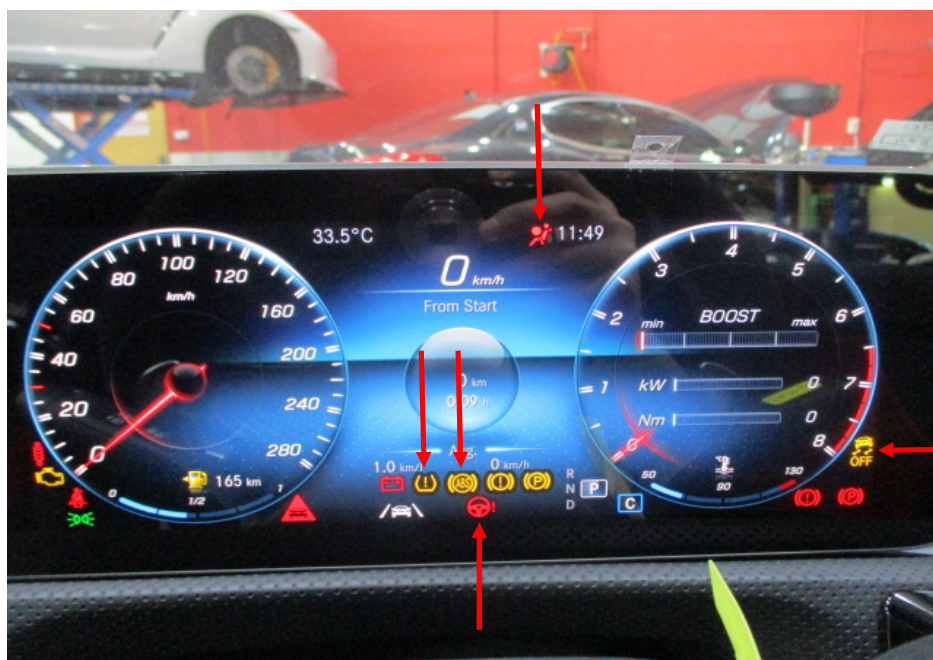
Photo 16 shows the warning lights for the various electronic safety features appearing on the instrument panel of the Motor Car during its self-test when the engine is cranked, in particular the ABS, SRS, EPS, TPM and TCS lights (arrowed).

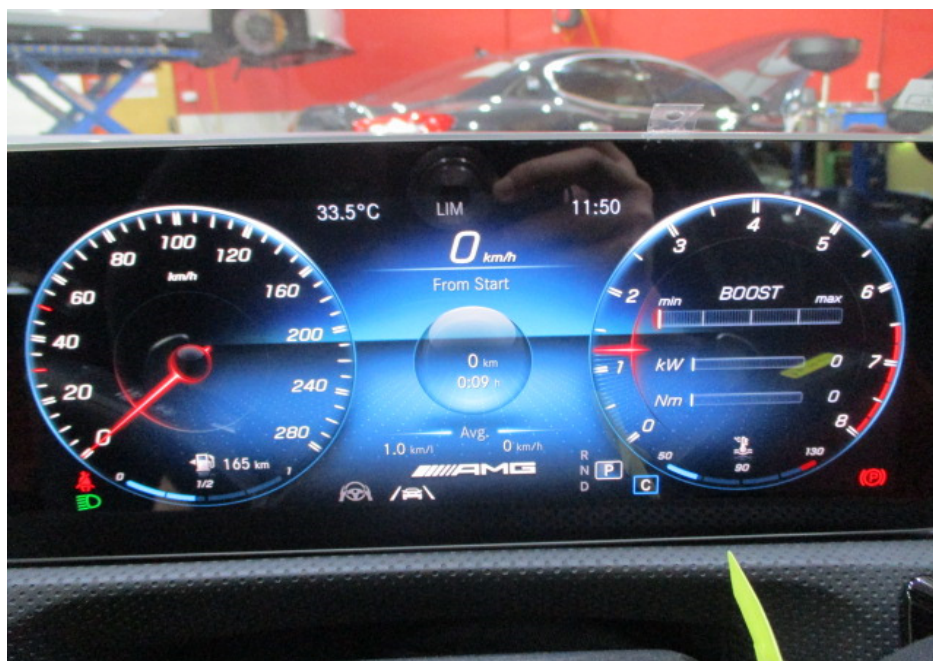
Photo 17 shows the respective warning lights no longer illuminated, indicating that there is no fault detected to the ABS, SRS, EPS, TPM and TCS systems of the Motor Car during the self-test. These electronic systems were hence in working condition at the time of my inspection.

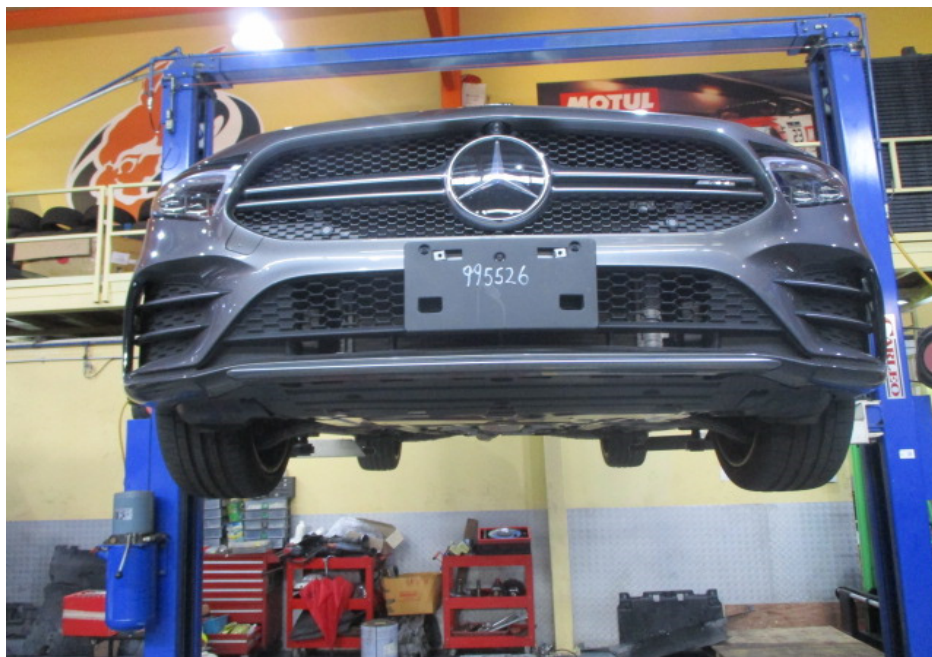
Photo 18 shows the Motor Car hoisted up for checks on its undercarriage. There was no sign(s) or indication(s) of fluid leakage and/or fluid stain(s) on the underside of the Motor Car. The undercarriage components of the Motor Car were also all observed to be intact and secured in an appropriate manner.

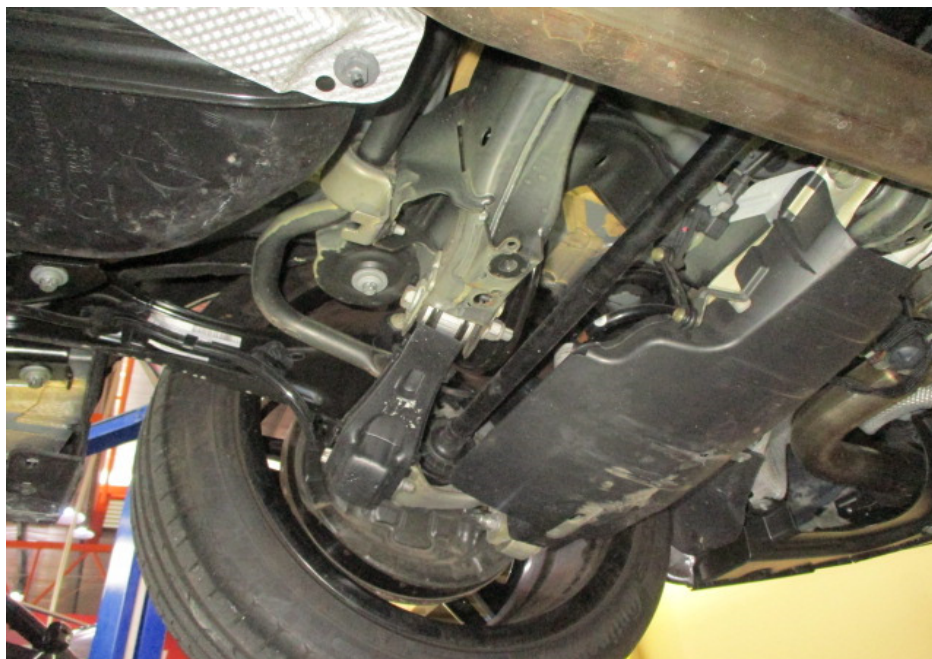
Photo 19 shows a general view of the control arms and linkages at the rear right wheel of the Motor Car. I did not observe any fluid leak and/or fluid stain on the underside of the Motor Car. All of the Motor Car's undercarriage components were observed to be intact and secured in an appropriate manner.

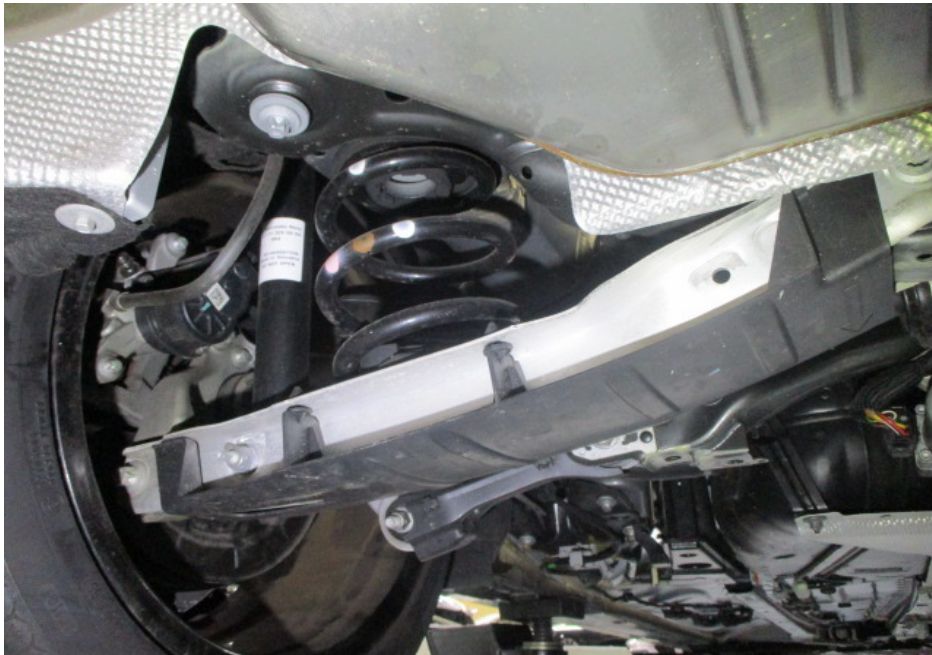
Photo 20 shows a general view of the control arms and linkages at the rear left wheel of the Motor Car. I did not observe any fluid leak and/or fluid stain on the underside of the Motor Car. All of the Motor Car's undercarriage components were observed to be intact and secured in an appropriate manner.

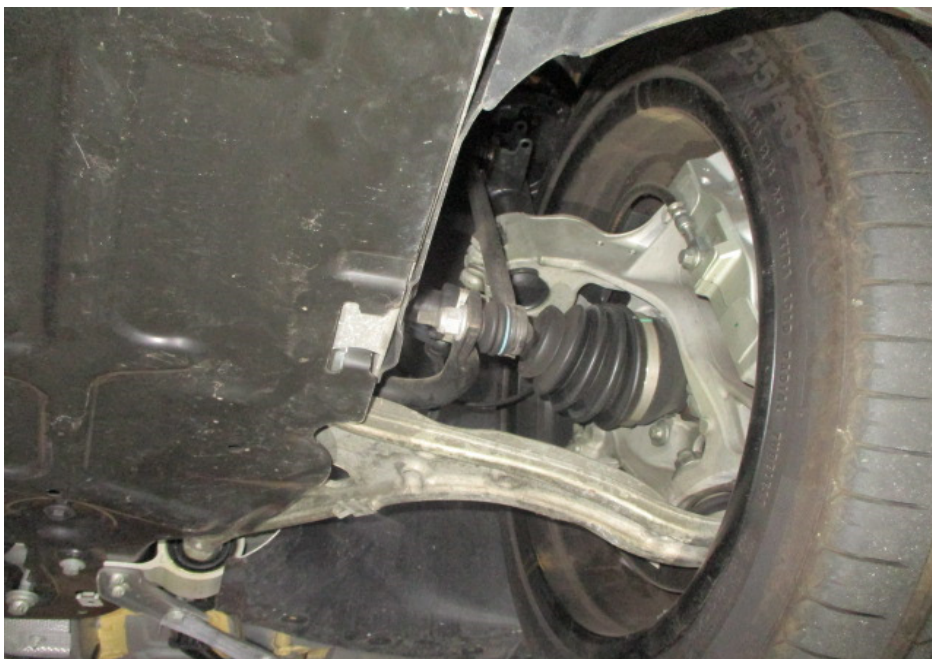
Photo 21 shows the various undercarriage components at the front left wheel of the Motor Car. The mechanical components, control arms and linkages were all found to be intact and secured in an appropriate manner.

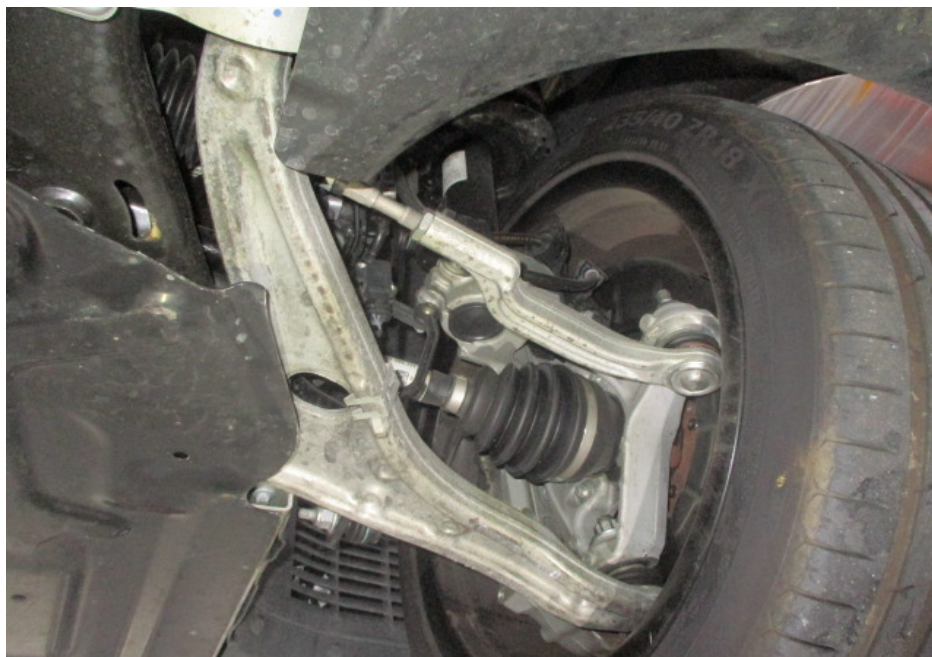
Photo 22 shows the various undercarriage components at the front right wheel of the Motor Car. The mechanical components, control arms and linkages were all found to be intact and secured in an appropriate manner. I also did not observe any fluid leak and/or fluid stain on the underside of the Motor Car.

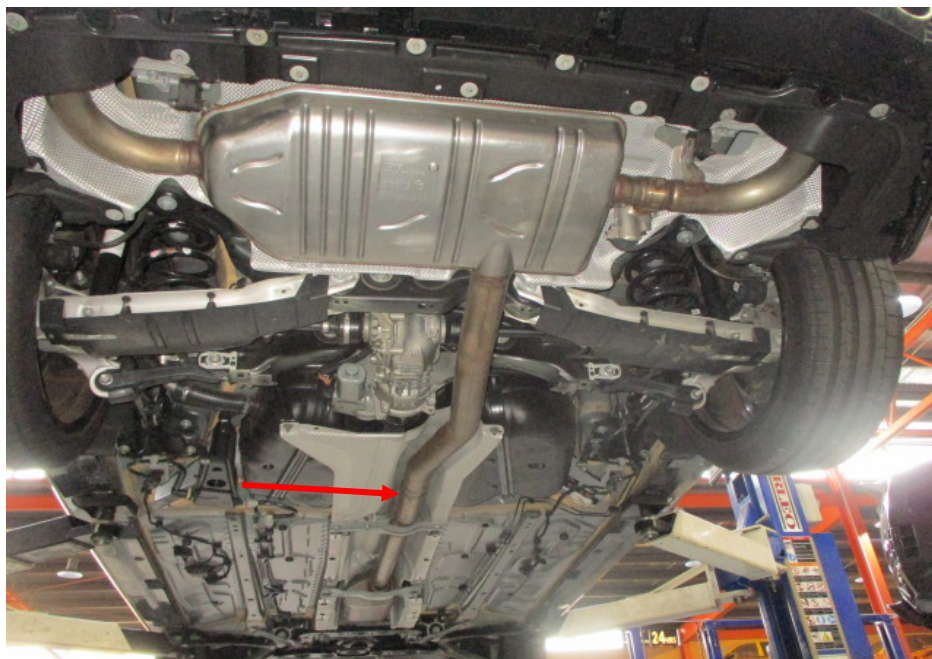
Photo 23 shows a general view of the rear section of the Motor Car's exhaust system. My examination of the Motor Car's exhaust system revealed no sign(s) or indication(s) of any cut or weld marks along its exhaust pipe (arrowed), on its catalytic converter, centre resonator box and on its rear muffler.

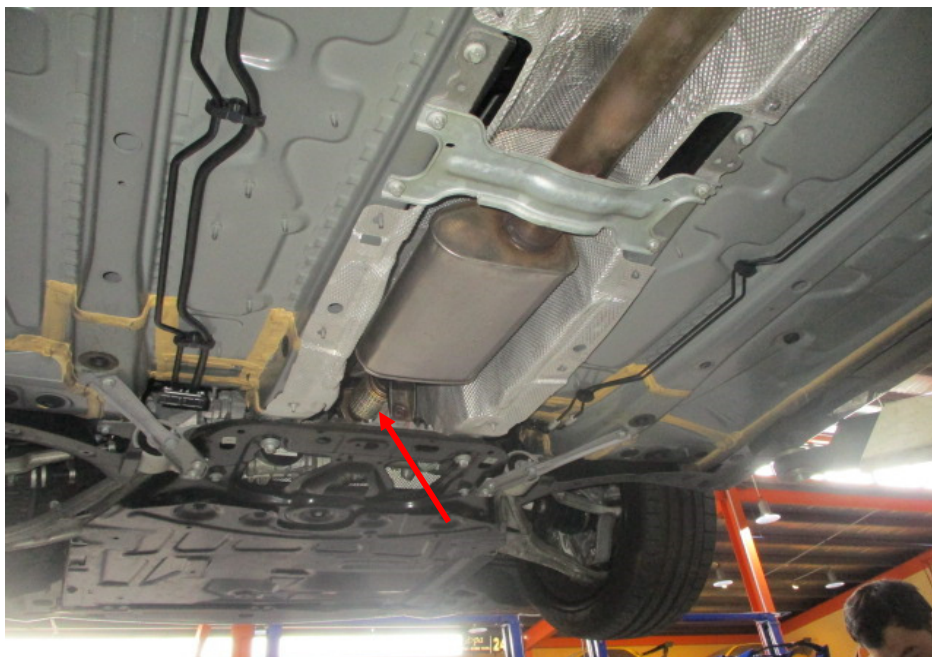
Photo 24 shows a general view of the front section of the Motor Car's exhaust system. My examination of the Motor Car's exhaust system revealed no sign(s) or indication(s) of any cut or weld marks along its exhaust pipe, on its catalytic converter (arrowed), centre resonator box and on its rear muffler.

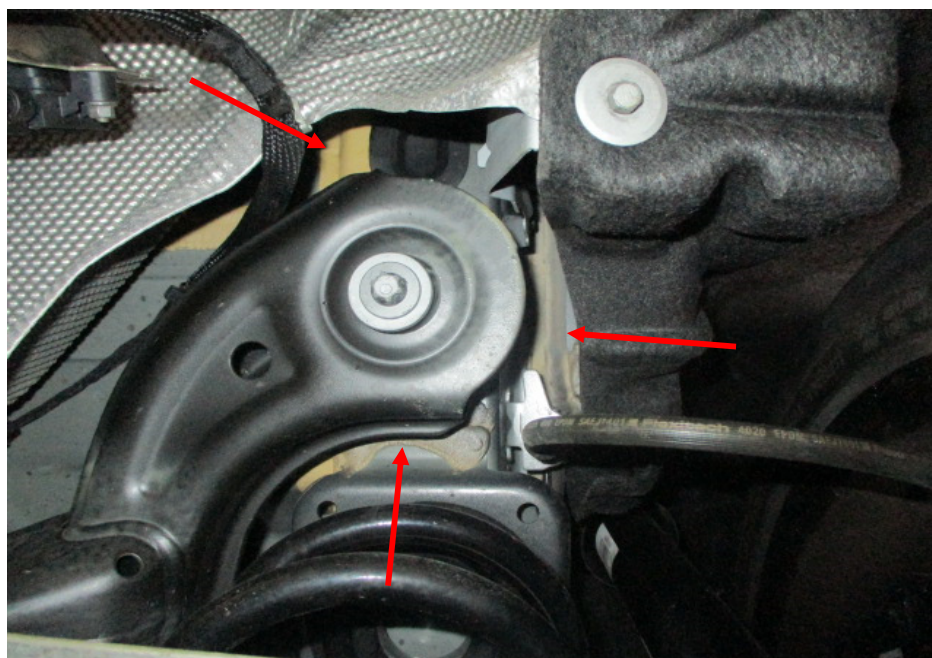
Photo 25 shows the chassis/structural body at the underside rear right of the Motor Car. I did not find any weld marks other than original spot weld marks on the chassis/structural body of the Motor Car. The original factory sealant (arrowed) at the joints along the chassis/structural body was untouched, indicating no work was done on the chassis/structural body of the Motor Car and that the chassis/structural body was originally fitted.

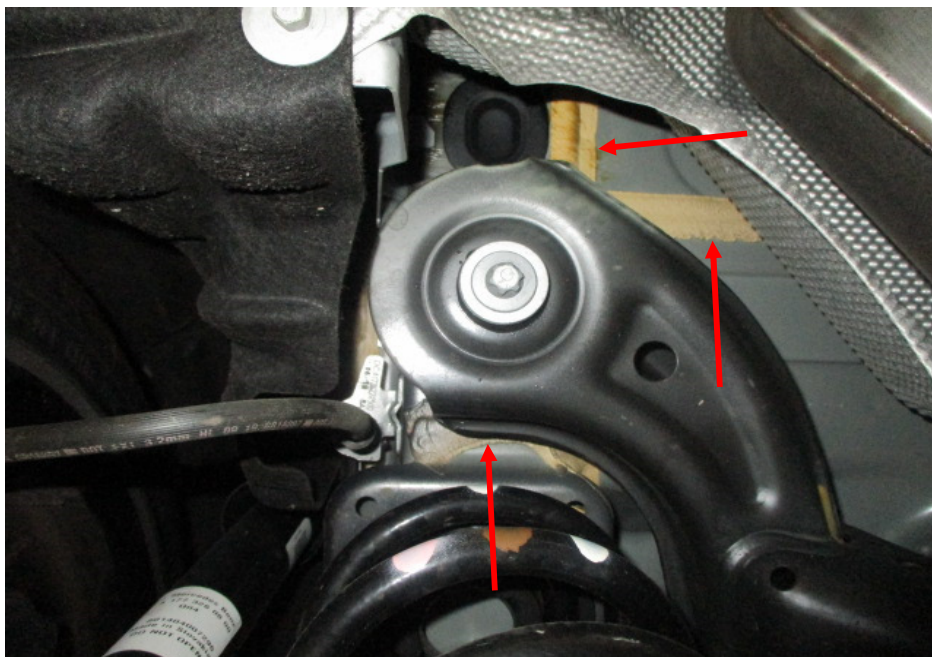
Photo 26 shows the chassis/structural body at the underside rear left of the Motor Car. The original factory sealant (arrowed) at the joints along the floorboard was observed to be untouched. In general, I had found all the non-detachable body panels of the Motor Car to be originally fitted at the time of my inspection.

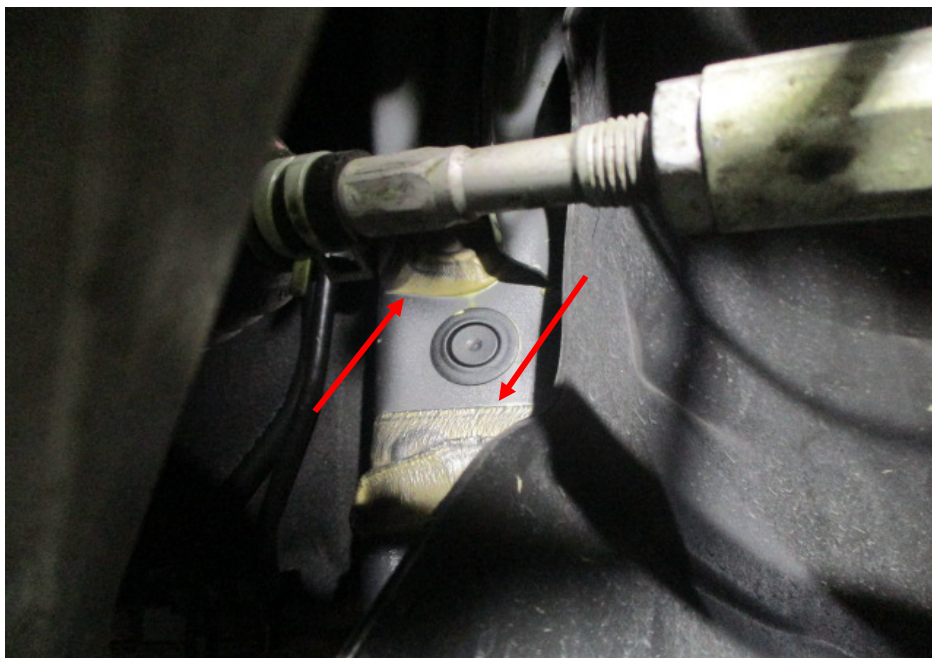
Photo 27 shows the chassis/structural body at the underside front left of the Motor Car. I did not find any weld marks other than original spot weld marks on the chassis/structural body of the Motor Car. The original factory sealant (arrowed) at the joints along the chassis/structural body was untouched, indicating no work was done on the chassis/structural body of the Motor Car and that the chassis/structural body was originally fitted.

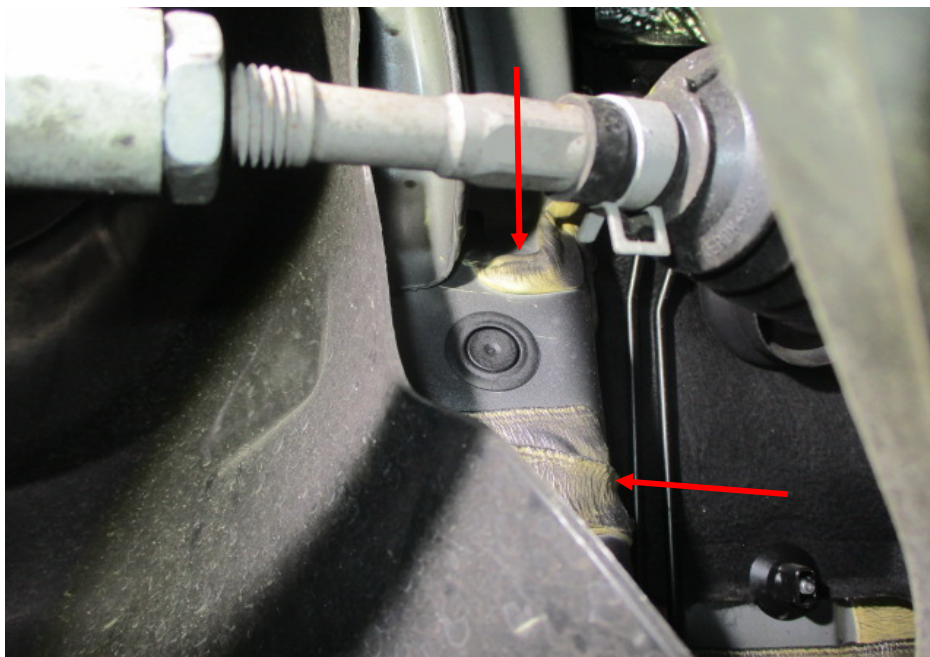
Photo 28 shows the chassis/structural body at the underside front right of the Motor Car. The original factory sealant (arrowed) at the joints along the chassis/structural body was observed to be untouched. In general, I had found no work was carried out on the chassis/structural body of the Motor Car. The chassis/structural body of the Motor Car was originally fitted.

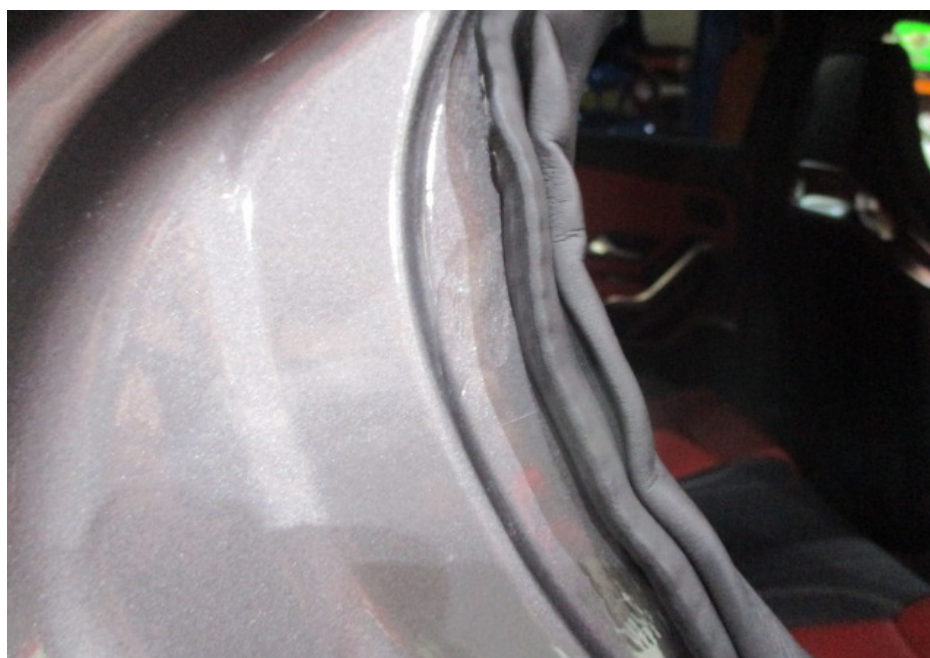
10. The detachable body panels of the Motor Car like the front fenders, front bumper, rear bumper, doors, bonnet and rear bootlid amongst others were all found to be fitted securely.
11. Checks on the non-detachable body panels like the rear fenders, floorboard, roof panel, pillars and rocker panels amongst others, revealed that these body panels were spot welded onto the chassis/structural body of the Motor Car. The original factory sealant at the joints of the non-detachable body panels was all untouched indicating no replacement of the non-detachable body panels was carried out; and that these body panels were all originally fitted except for the rear right fender, which was found to be replaced (refer to photograph 29 below).

Photo 29 shows the right side "C" pillar of the Motor Car. I did not find any original weld marks at the right side "C" pillar of the Motor Car, indicating that the rear right fender of the Motor Car was replaced. The lack of original weld marks seen was due to replacement work when the replaced rear right fender was re-welded onto the Motor Car and smoothen for re-spraying work.

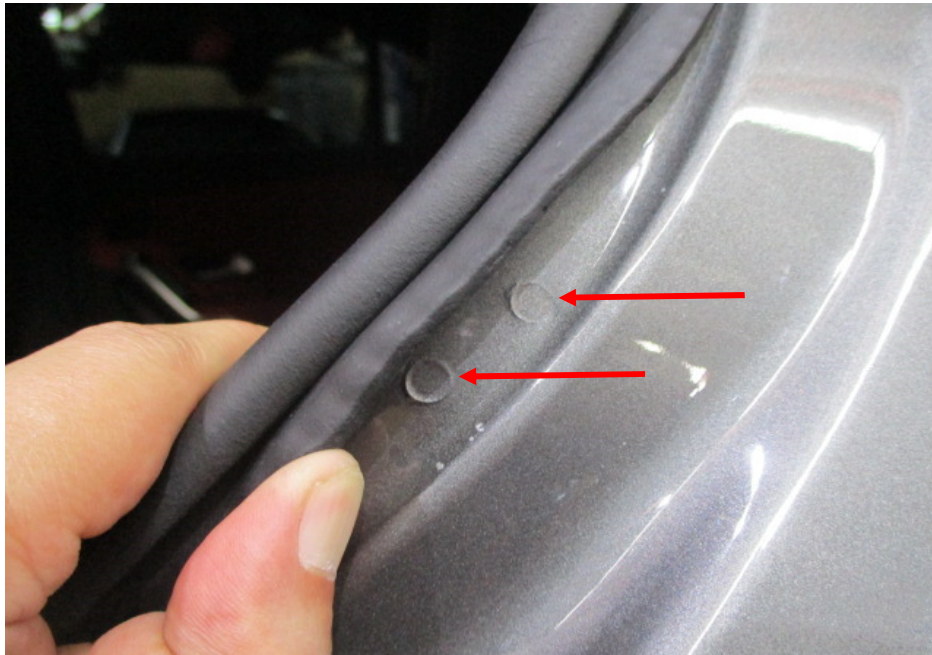
Photo 30 shows the left side "C" pillar of the Motor Car. I did not find any weld marks other than original spot weld marks (arrowed) on the left side "C" pillar of the Motor Car, which indicates that there was no re-welding works carried out. In general, I had found all the non-detachable body panels of the Motor Car to be originally fitted at the time of my inspection.
