You're Ref: TP/IP/32687/2021  
Our Ref: CI/TPD21010013/P

**Fatal Accident Investigation Team**

Traffic Police Department  
Singapore Police Force  
10 Ubi Avenue 3  
Singapore 408865

**MECHANICAL INSPECTION REPORT OF MOTOR CAR SFW 87H**

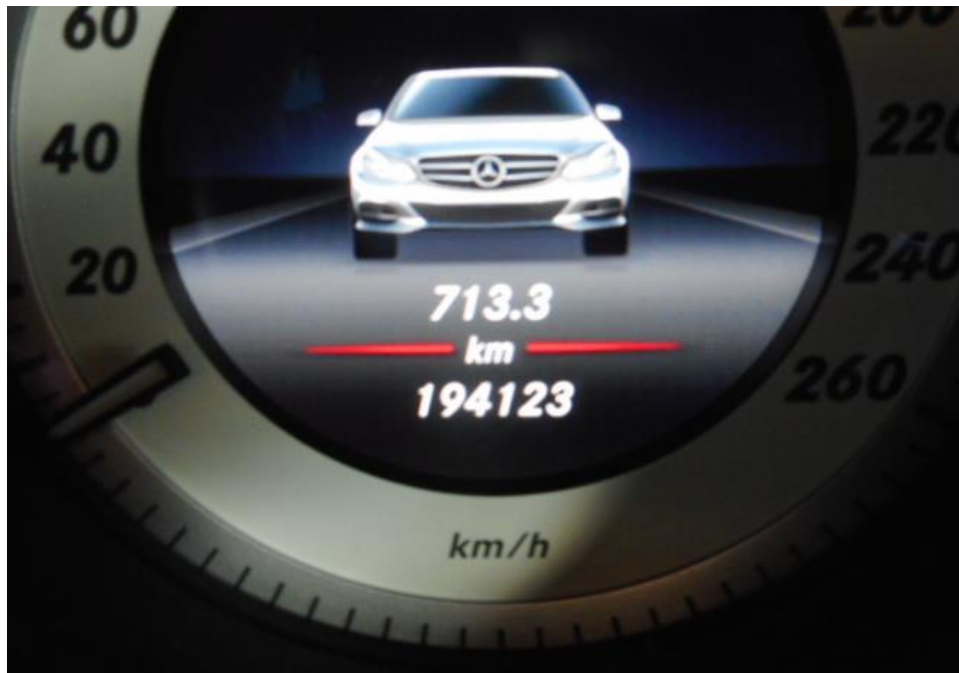
4. The mileage of the Motor Car at the time of my inspection was 194,123km.
5. The Motor Car was observed to have sustained damage at its rear portion. Its rear bonnet, rear left brake lamp and rear bumper was the body parts that were damaged as a result of the accident.

**Photo 1** shows the mileage of the Motor Car at the time of my inspection. The mileage observed was 194,123km.

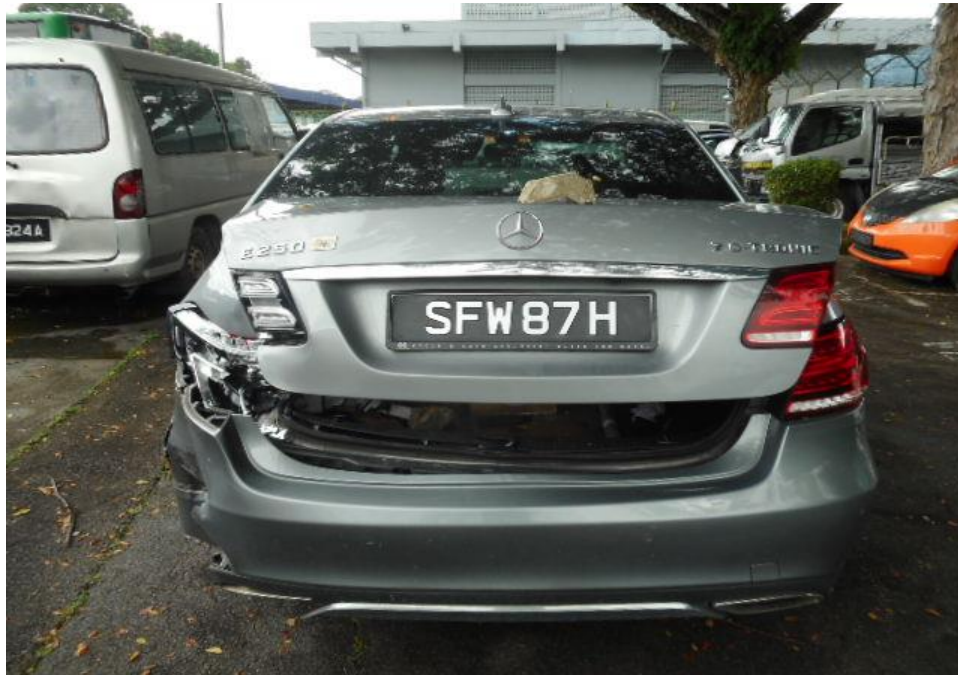
**Photo 2** shows a general view of the Motor Car's rear body at the time of my inspection. The rear portion. Its rear bonnet, rear left brake lamp and rear bumper was the body parts that were damaged as a result of the accident.

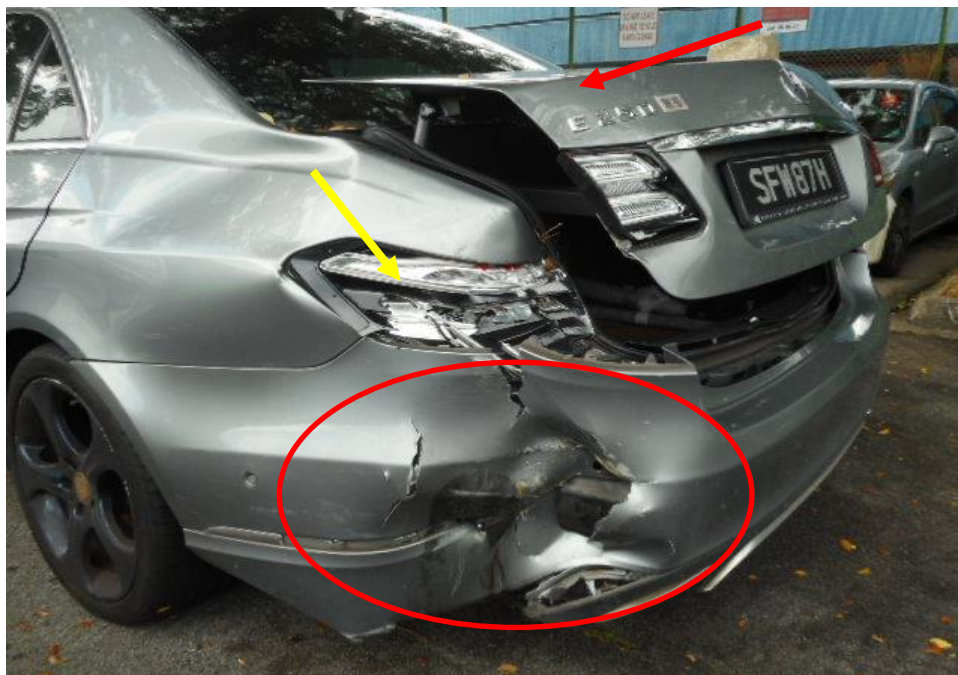
**Photo 3** shows a close up view of the Motor Car's rear body at the time of my inspection. The rear portion of the Motor Car was observed to have sustained damage. Its rear bonnet (circled), rear left brake light (yellow arrow) and rear bonnet (red arrow) was the body parts that were damaged as a result of the accident.

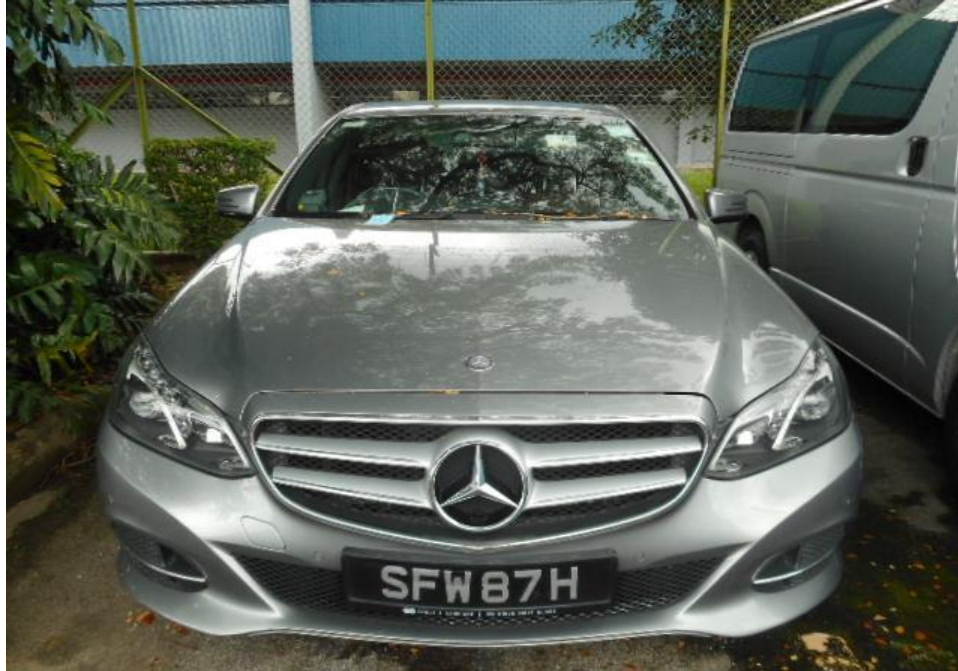
**Photo 4** shows a general view of the Motor Car's front body at the time of my inspection. The front portion of the Motor Car was observed to have been unaffected by the accident.

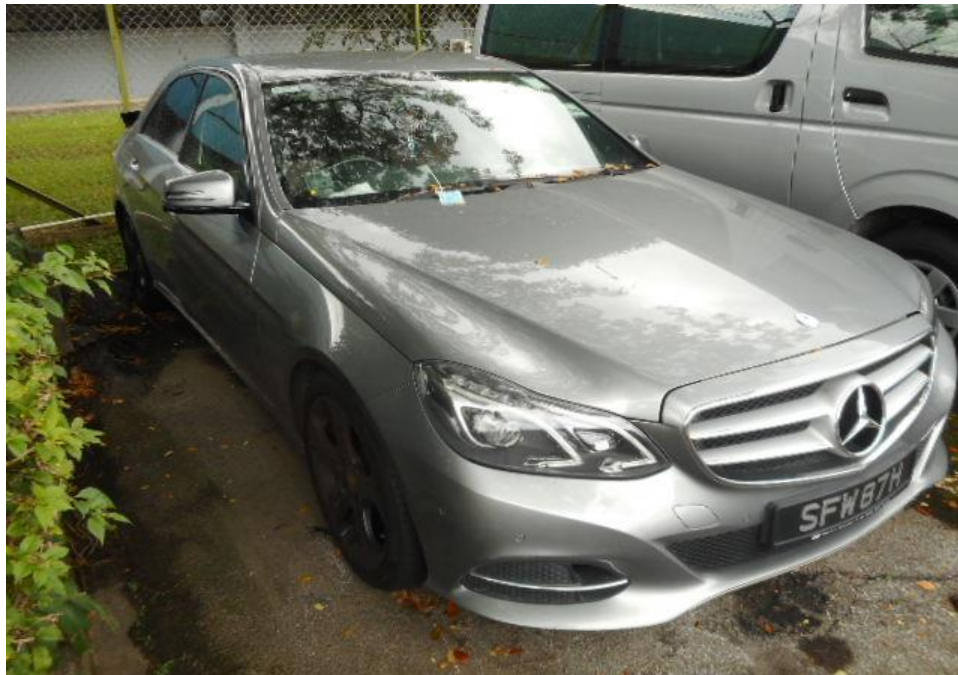
**Photo 5** shows a general view of the Motor Car's right body at the time of my inspection. The right portion of the Motor Car was observed to have been unaffected by the accident.

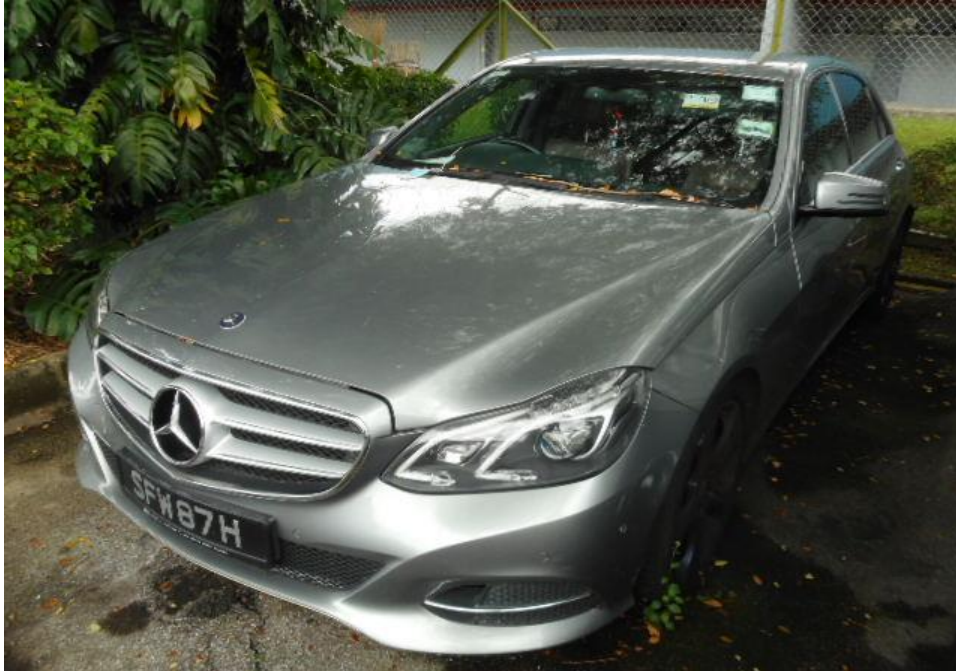
**Photo 6** shows a general view of the Motor Car's left body at the time of my inspection. The left portion of the Motor Car was observed to have been unaffected by the accident.

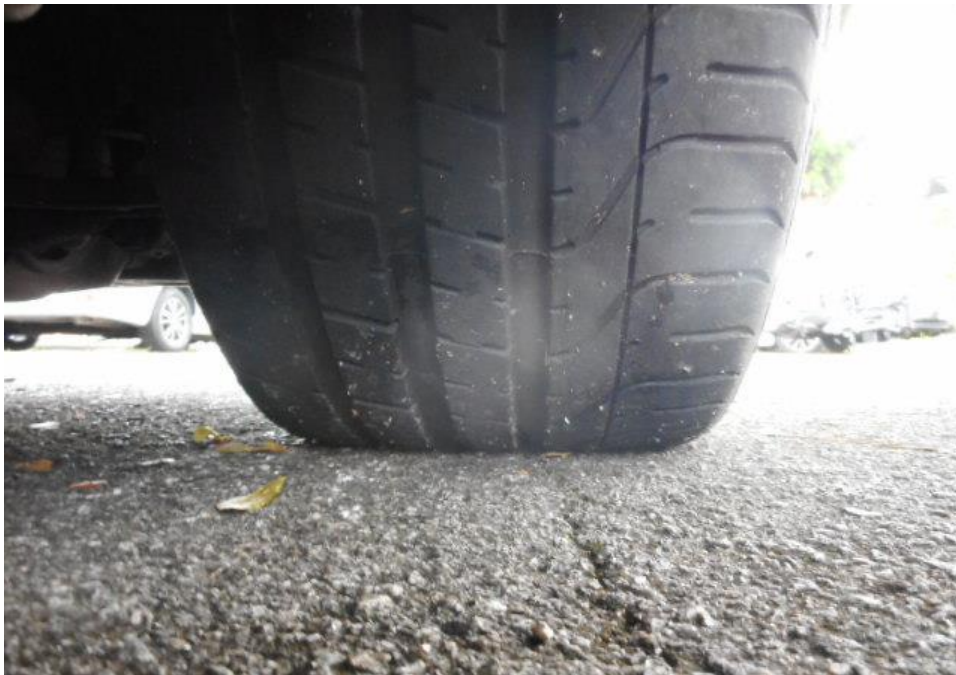
**Photo 7** shows the condition of the front right tyre of the Motor Car, which was observed to be in serviceable condition with remaining tread depth of approximately 5.5mm. The tyre was sufficiently inflated for vehicular operation with no tear, cut or burst mark(s) on the outer and the inner sidewalls as well as across the tread. The 4 tyres of the Motor Car were wrapped around standard steel wheel rims without any damage.

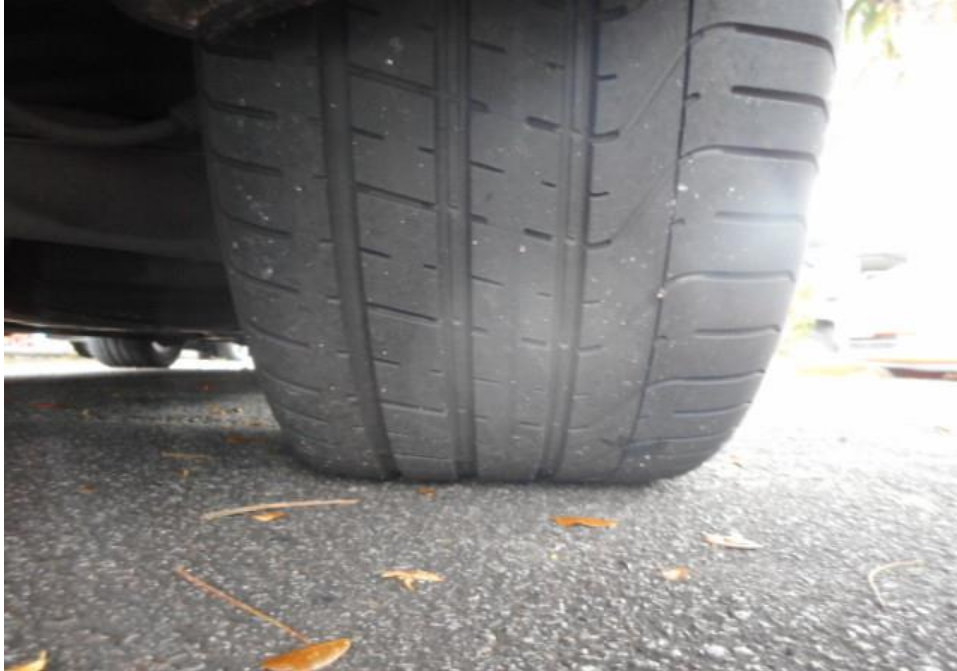
**Photo 8** shows the condition of the rear right tyre of the Motor Car, which was observed to be in serviceable condition with remaining tread depth of approximately 4.9mm. The tyre was also observed to be sufficiently inflated for vehicular operation with no tear, cut or burst mark(s).

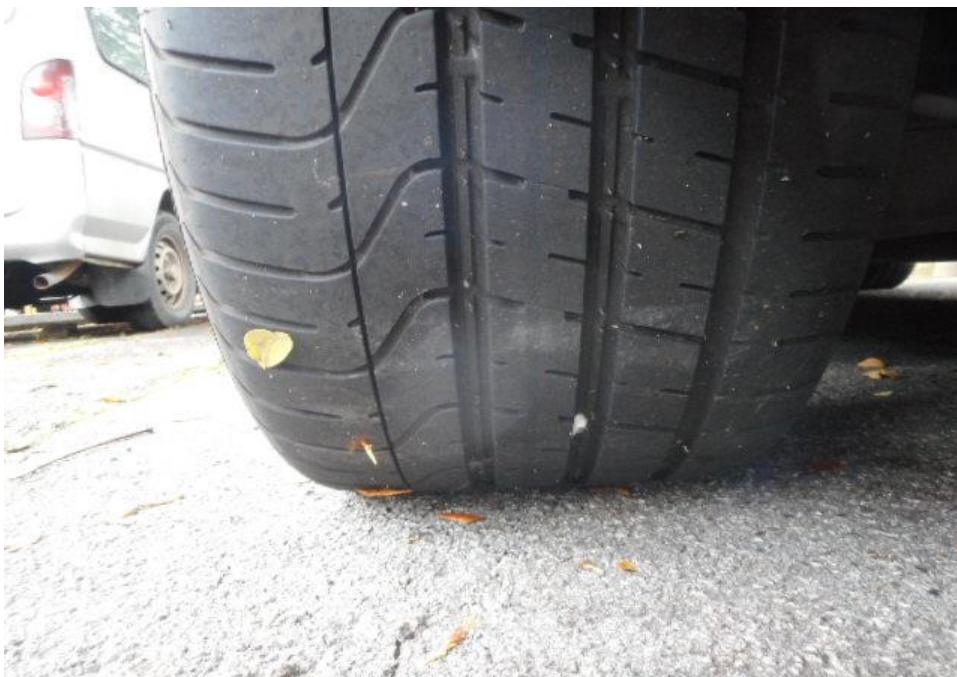
**Photo 9** shows the condition of the rear left tyre of the Motor Car, which was observed to be in serviceable condition with remaining tread depth of approximately 5mm. The tyre, which was wrapped around steel wheel rim, was also observed to be sufficiently inflated for vehicular operation. The 4 tyres of the Motor Car were wrapped around standard steel wheel rims.

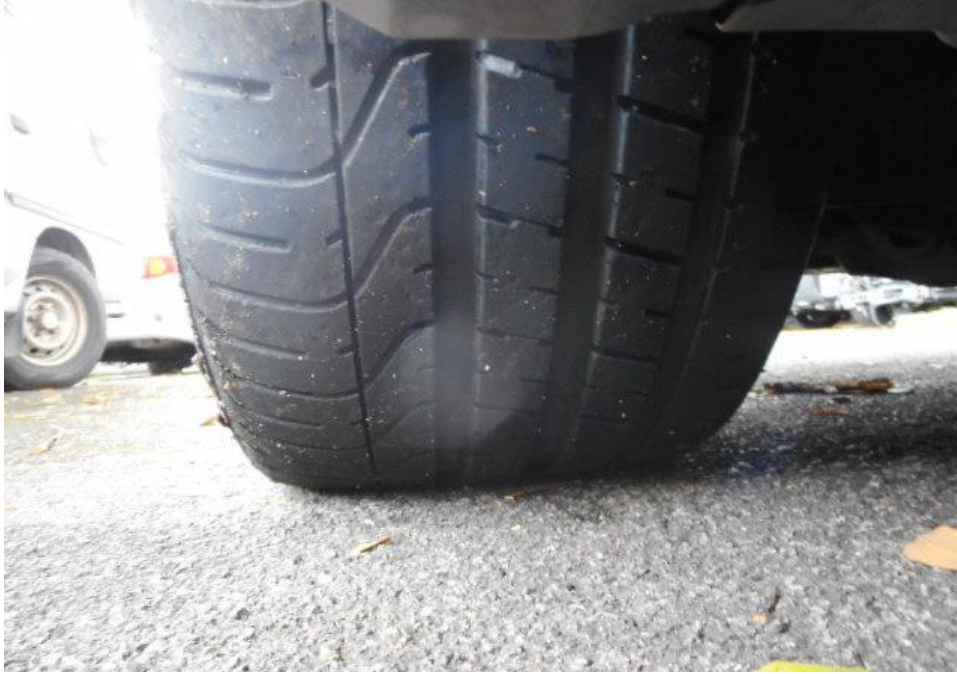
**Photo 10** shows the condition of the front left tyre of the Motor Car, which was observed to be in serviceable condition with remaining tread depth of approximately 5.9mm. There was also no tear, cut or burst mark(s) on the outer and the inner sidewalls as well as across the tread of the Motor Car's 4 tyres.

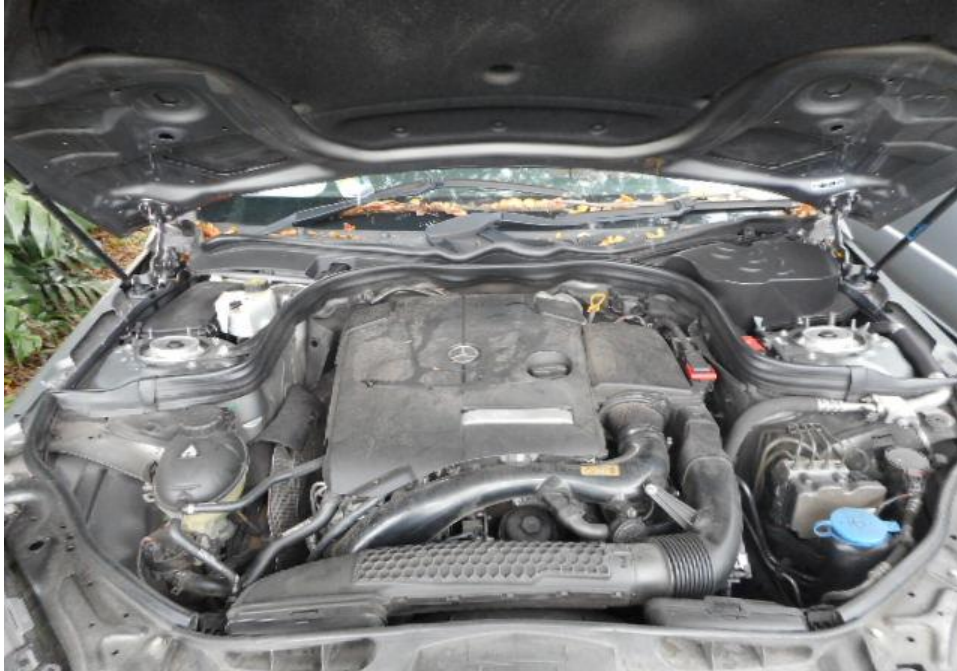
**Photo 11** shows a general view of the Motor Car's engine compartment. The various parts and components inside the engine compartment were unaffected by the accident. There was also no sign(s) or indication(s) of fluid leakage and/or fluid stain within the engine compartment.

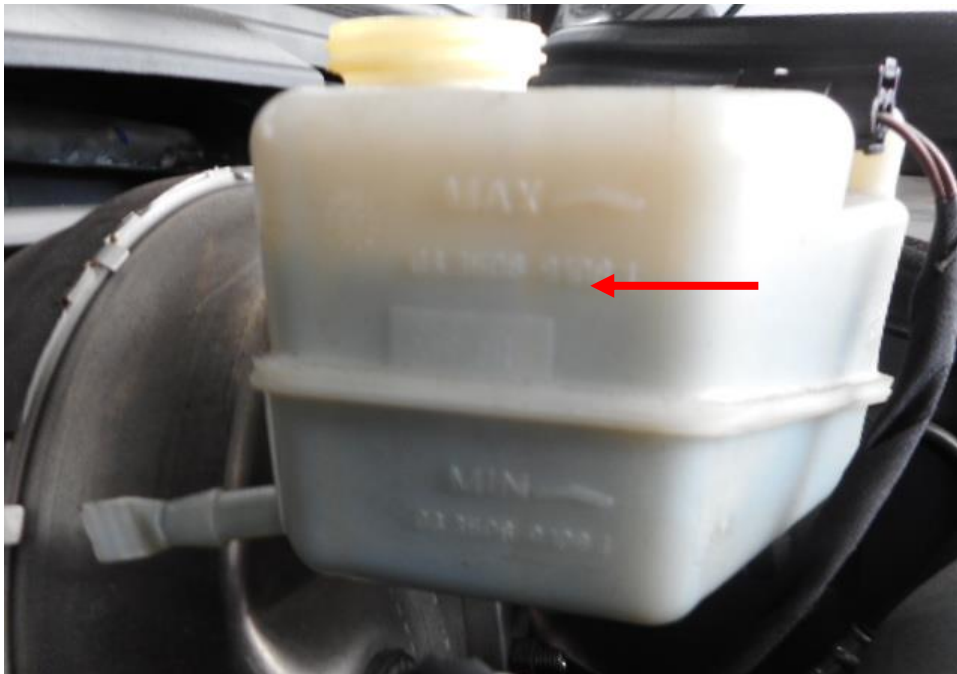
**Photo 12** shows the brake fluid reservoir of the Motor Car at the time of my inspection. The brake fluid was observed to be of sufficient level (arrowed) and without any visible contamination.

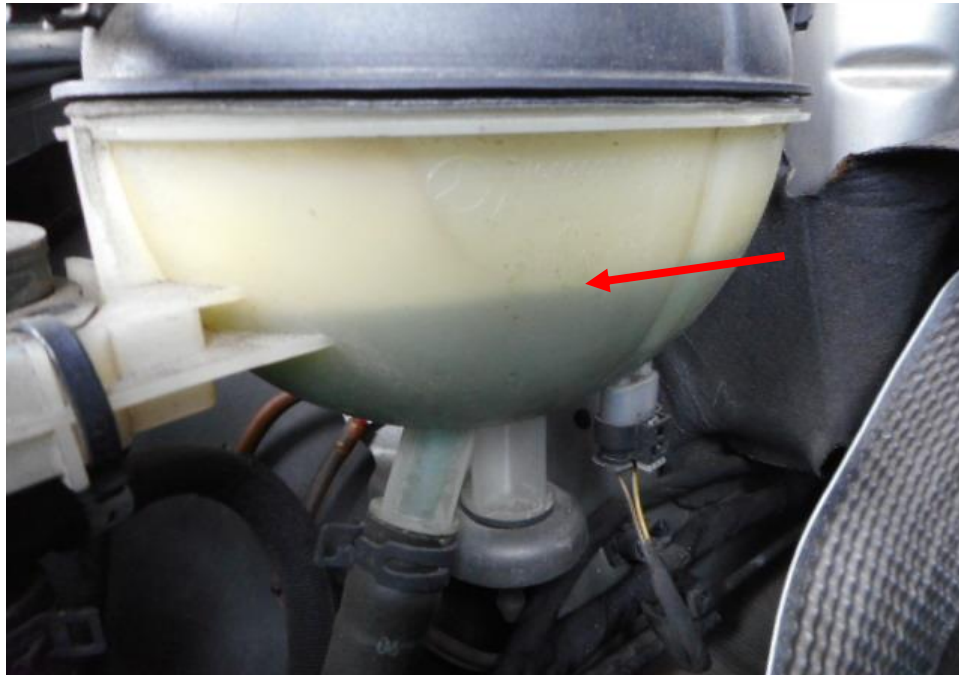
**Photo 13** shows checks being carried out to the engine coolant of the Motor Car at the time of my inspection. The engine coolant was observed to be of sufficient level (arrowed) and without any visible contamination.

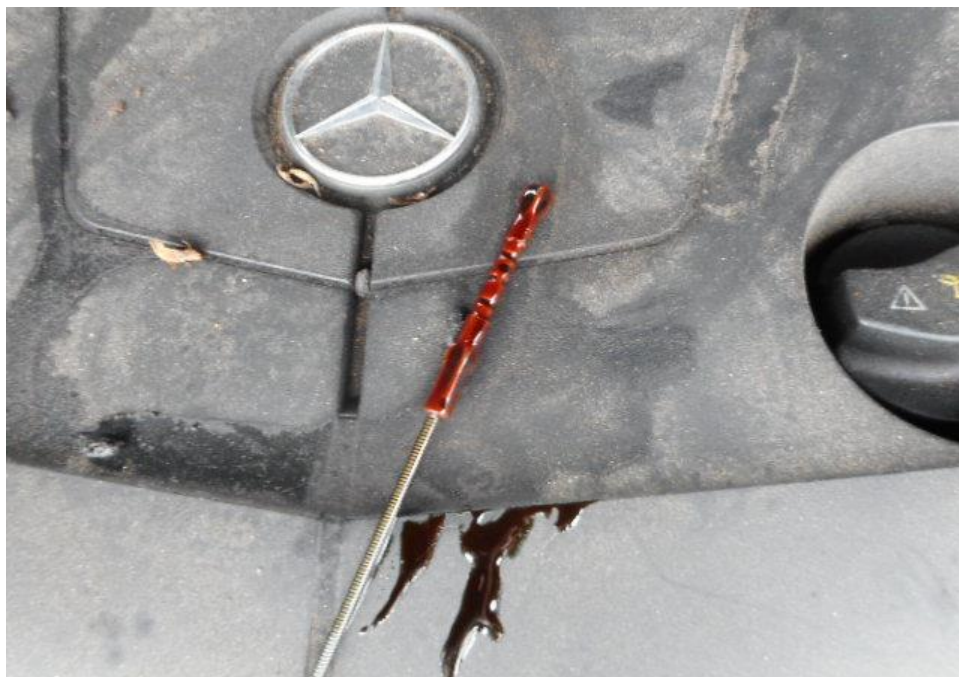
**Photo 14** shows the engine oil dipstick of the Motor Car at the time of my inspection. The engine oil was observed to be of sufficient level and without any visible contamination.

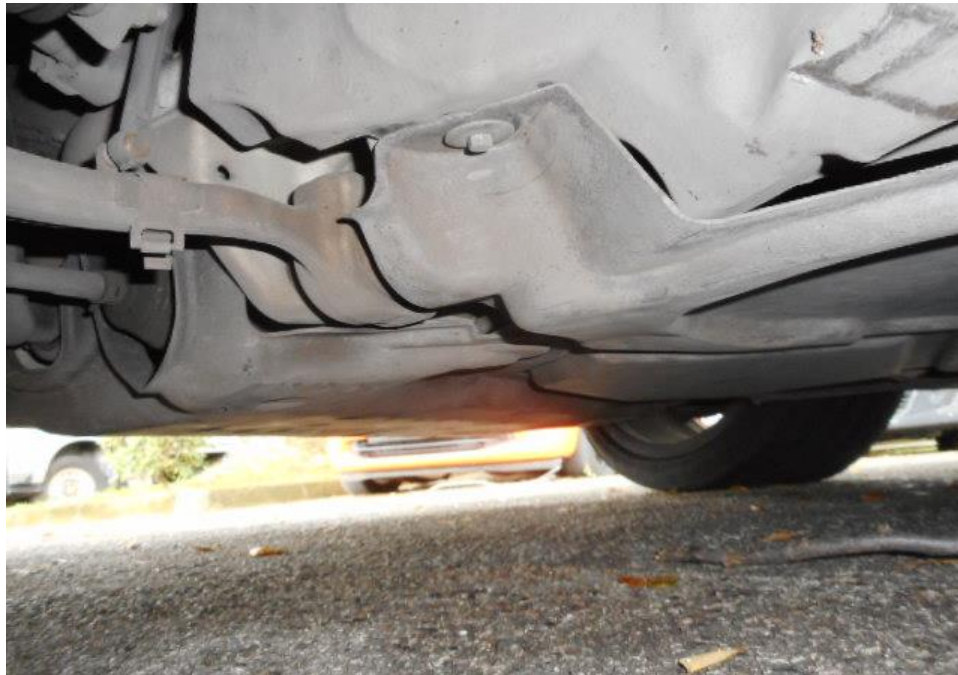
**Photo 15** shows the undercarriage of the Motor Car, at the area where the engine housing and transmission housing are located. I did not find any sign(s) or indication(s) of fluid leak and/or fluid stain(s) on the underside of the Motor Car.

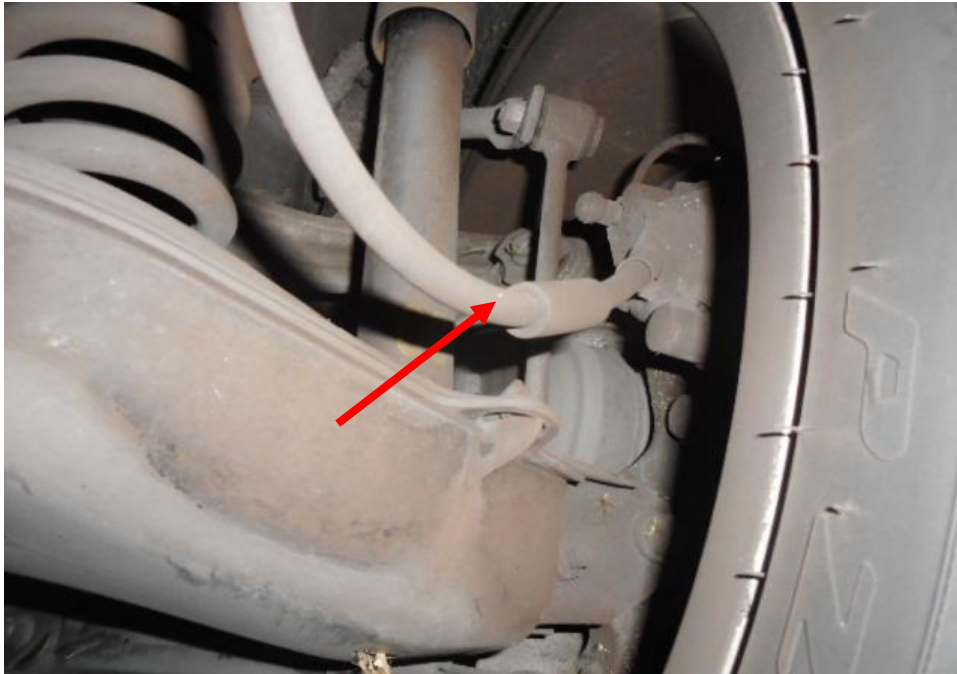
**Photo 16** shows the brake hose/pipe (arrowed) at the rear right wheel of the Motor Car. No leakage of brake fluid was observed. Visual examination of the various components of the braking system like the drum brake, brake booster, brake pedal etc. had revealed all to be intact and without visible damage.

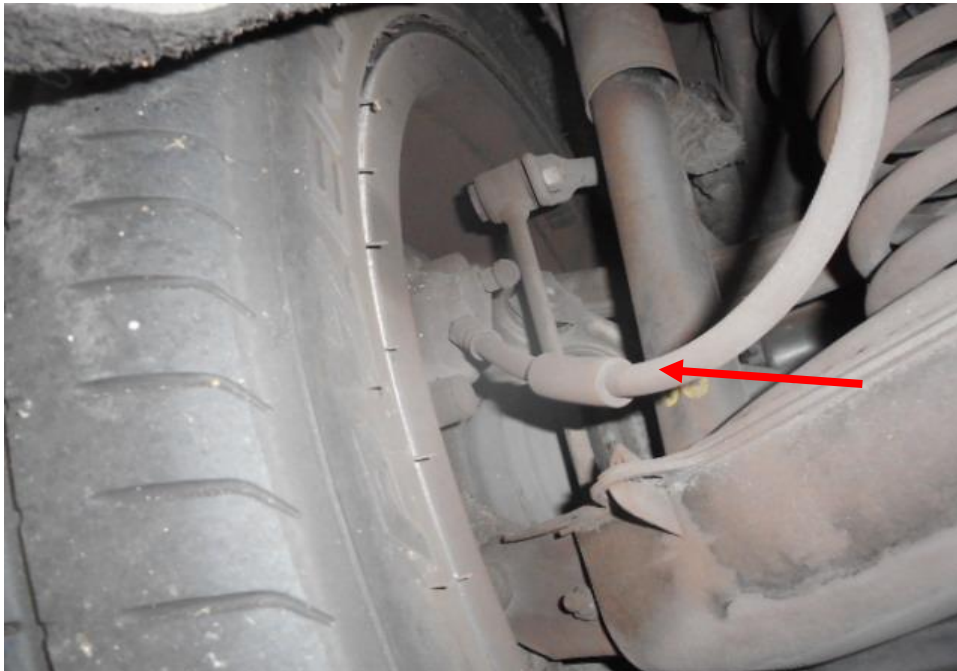
**Photo 17** shows the brake hose/pipe (arrowed) at the rear left wheel of the Motor Car. I did not observe any leakage of brake fluid at the time of my inspection of the Motor Car. Static tests of the Motor Car's braking system had indicated that there was no internal leakage of pressure/vacuum. The undercarriage components of the Motor Car were also all found to be intact and without any visible damage.

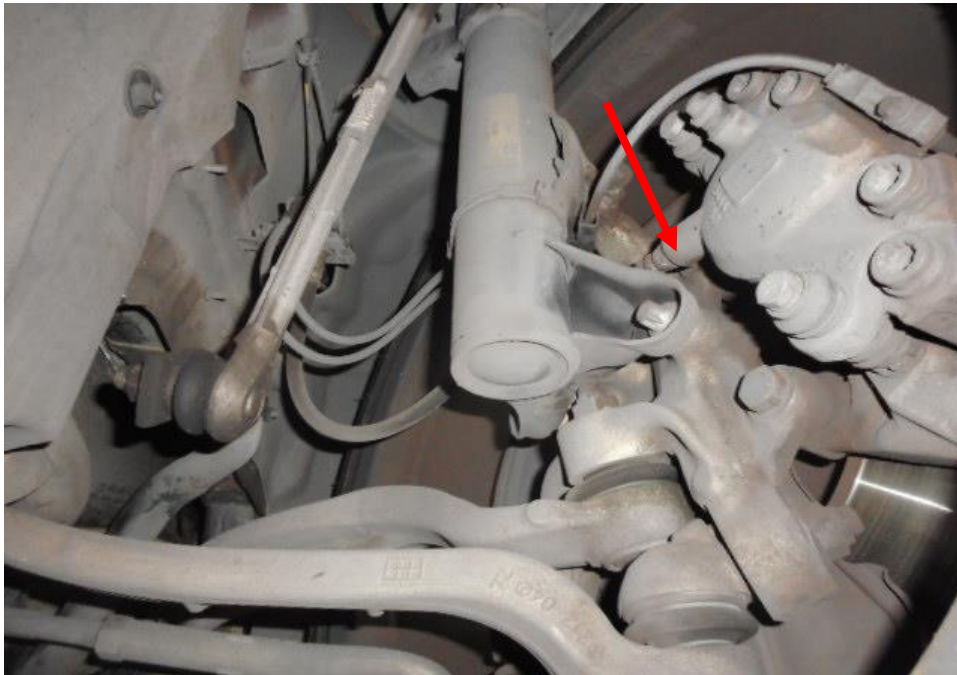
**Photo 18** shows the brake hose/pipe (arrowed) at the front right wheel of the Motor Car. I did not observe any leakage of brake fluid at the time of my inspection of the Motor Car. Static tests of the Motor Car's braking system had indicated that there was no internal leakage of pressure/vacuum. The undercarriage components of the Motor Car were also all found to be intact and without any visible damage.

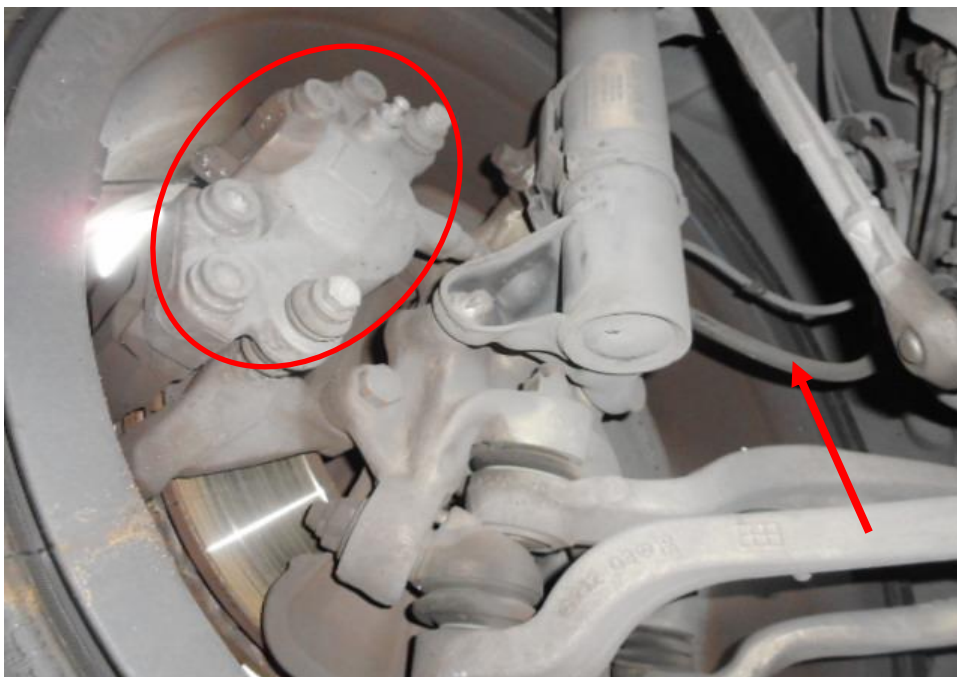
**Photo 19** shows the brake hose/pipe (arrowed) at the front left wheel of the Motor Car. No leakage of brake fluid was observed. Visual examination of the various components of the braking system like the brake caliper (circled), brake booster, brake pedal etc had revealed all to be intact and without visible damage.

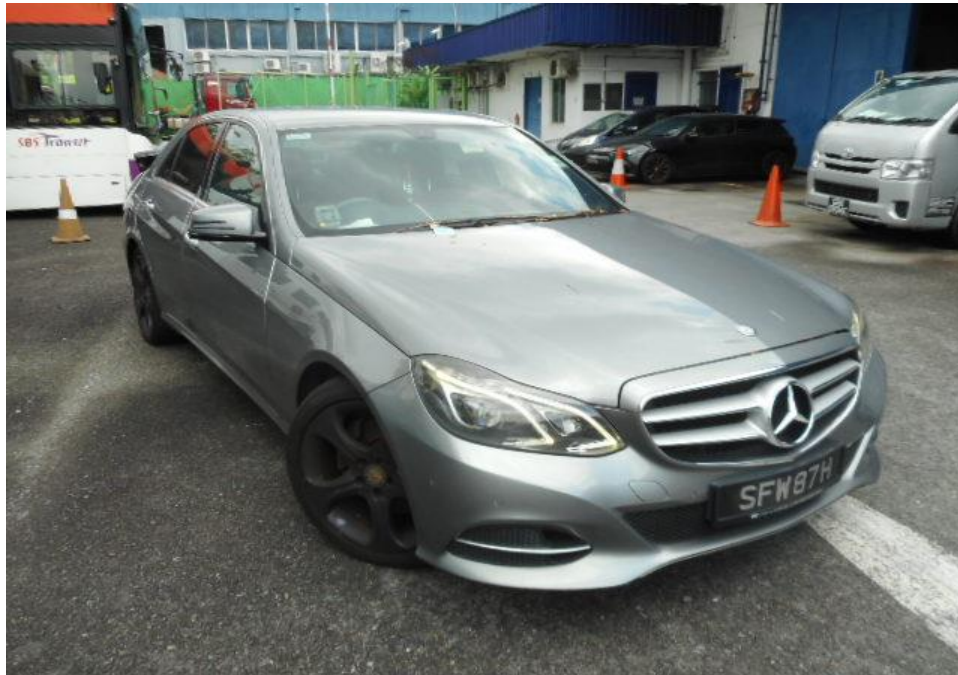
**Photo 20** shows the front right wheel of the Motor Car turned to its full left. During my steering system test, I did not experience any abnormal free play and/or resistance when I had turned the steering wheel towards the left and right. This would suggest that the steering system of the Motor Car was likely to be in serviceable condition at the material time of accident.

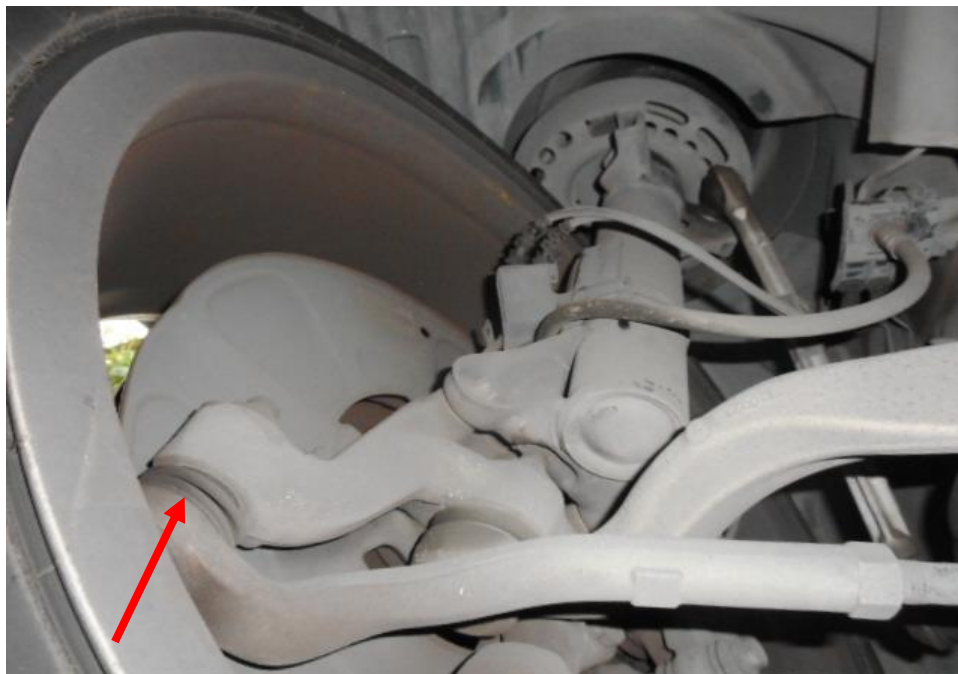
**Photo 21** shows the various undercarriage components at the front right wheel of the Motor Car, in particular the steering tie rod (red arrow). The various steering components were all found to be intact, suggesting that the steering system of the Motor Car was likely to be in serviceable condition at the material time of accident. There was also no sign of fluid stain observed on the various undercarriage components at the front right wheel of the Motor Car.

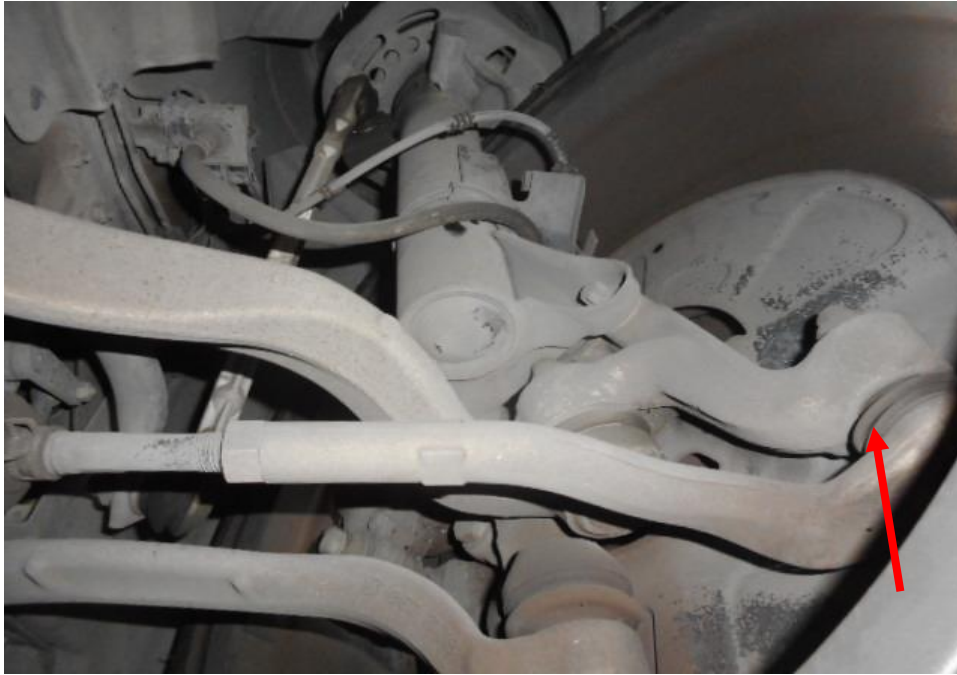
**Photo 22** shows the various undercarriage components at the front left wheel of the Motor Car, which had included the steering tie rod (red arrow). The various undercarriage components of the Motor Car were all found to be intact without any visible damage.

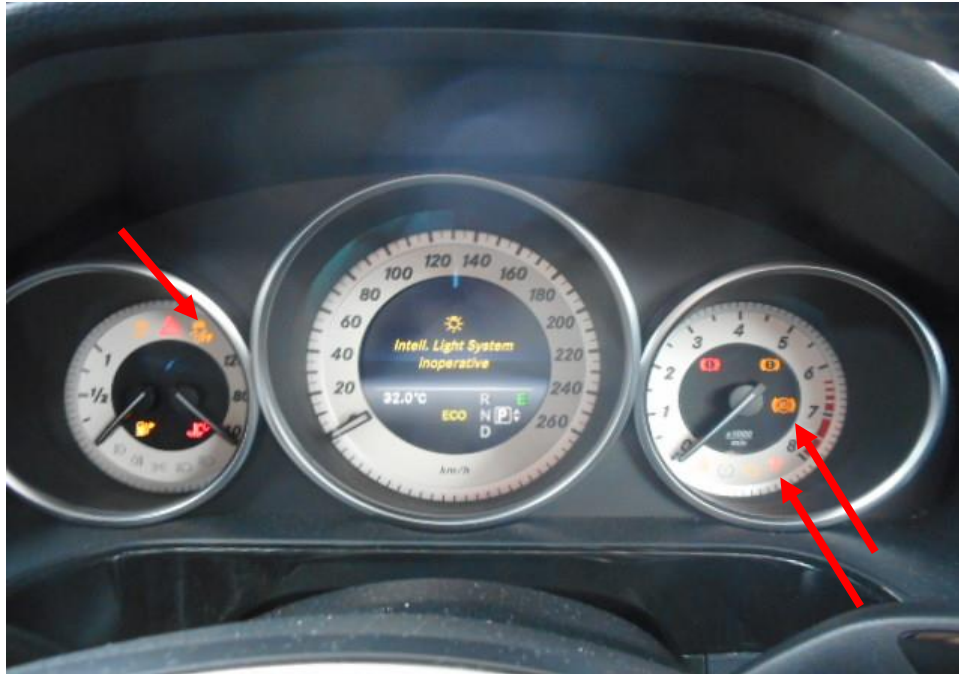
**Photo 23** shows the warning light for Anti-Lock Brake System (ABS), Traction Control System (TCS) and Supplemental Restraint System (SRS) (arrowed) appearing on the instrument panel of the Motor Car during the self-test of its various electronic operating systems when its engine was cranked.

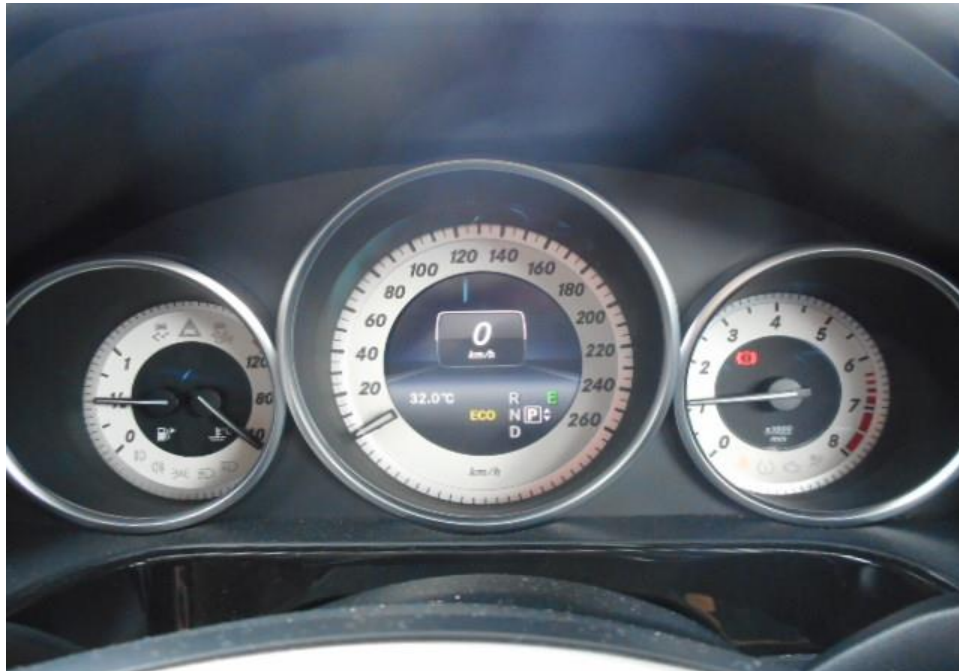
**Photo 24** shows no warning lights illuminated on the instrument panel of the Motor Car after the engine was cranked. This would suggest that there was no abnormality to the electronic operating system of the Motor Car, like the ABS, TCS and SRS etc.
