Your Ref: TP/IP/40473/2021  
Our Ref : CI/TPD21010014/P

**MECHANICAL INSPECTION REPORT OF MOTOR BUS SG 5051H**

1. I refer to your request on 22<sup>nd</sup> September 2021 to conduct a physical inspection of a Motor Bus bearing registration number SG 5051H (herein referred to as “**Motor Bus**”), which was involved in a fatal road traffic accident on 25<sup>th</sup> August 2021.
2. The objective of this inspection is to determine if there was any possible mechanical failure to the Motor Bus that may have contributed to the accident.
3. Following the request, I had carried out a physical inspection of the Motor Bus on 7<sup>th</sup> December 2021 at the premises of Traffic Police vehicle pound, 517 Airport Road Singapore 539942. I now set out below my observations and comments with respect to this inspection.

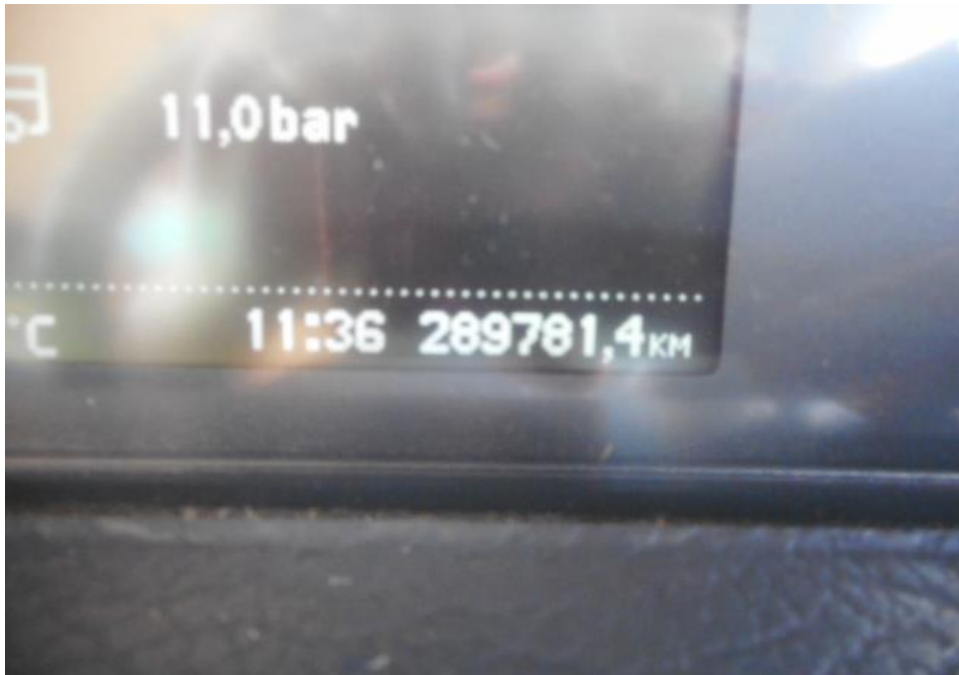
4. The mileage of the Motor Bus at the time of my inspection was 289,781km.
5. There was no visible damage observed on Motor Bus at the time of my inspection.

**Photo 1** shows a general view of the instrument cluster of the Motor Bus at the time of my inspection. The mileage of the Motor Bus was 289,781km

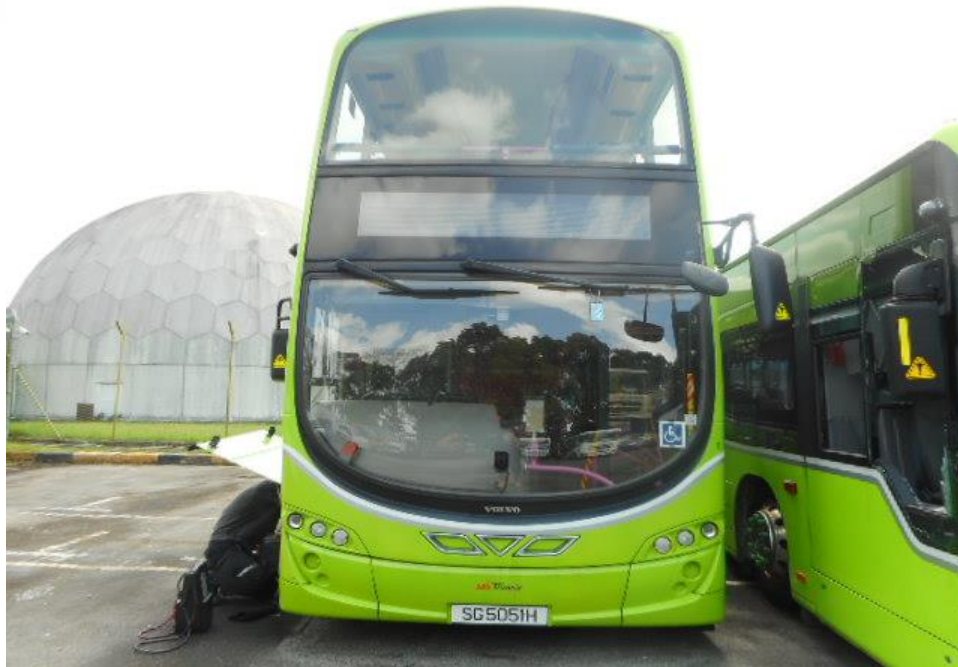
**Photo 2** shows a general view of the front body of the Motor Bus at the time of my inspection. The Motor Bus was observed to be intact and unaffected by the accident.

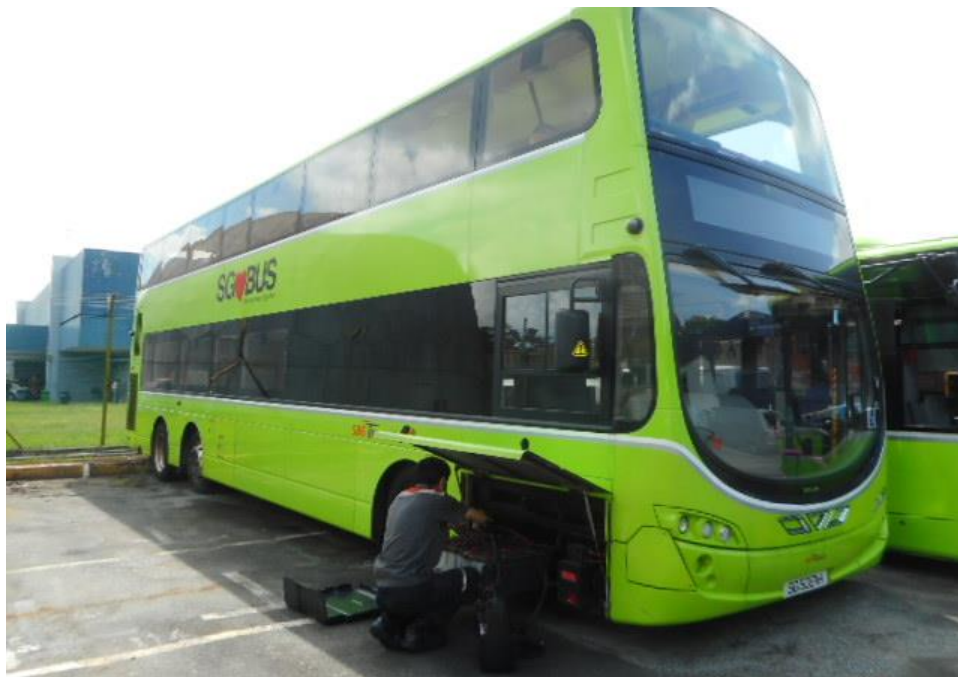
**Photo 3** shows a general view of the right body of the Motor Bus at the time of my inspection. The Motor Bus was observed to be intact and unaffected by the accident.

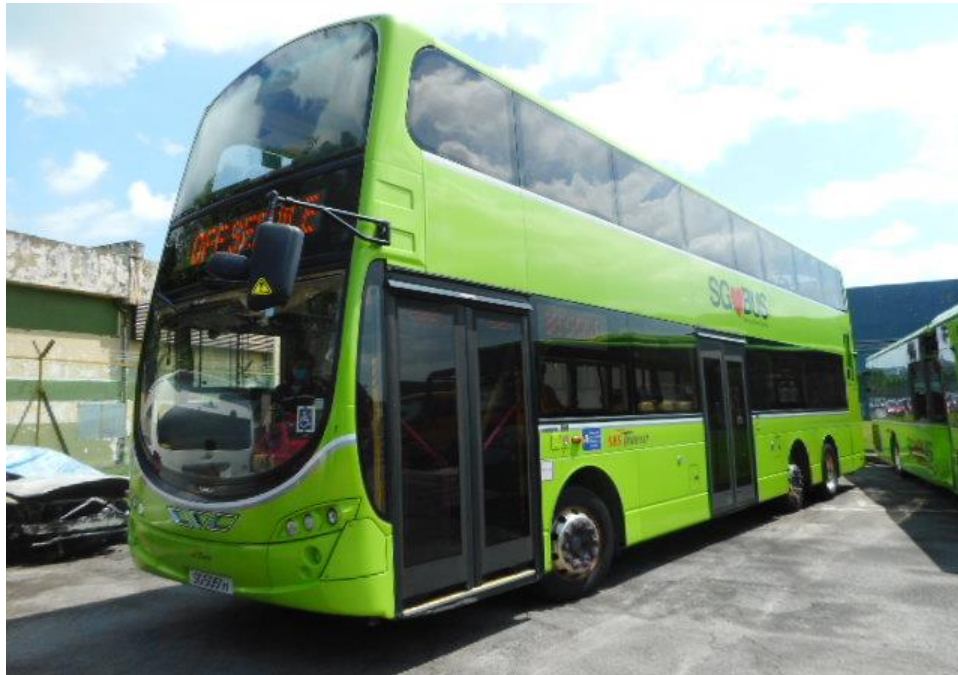
**Photo 4** shows a general view of the left body of the Motor Bus at the time of my inspection. The Motor Bus was observed to be intact and unaffected by the accident.

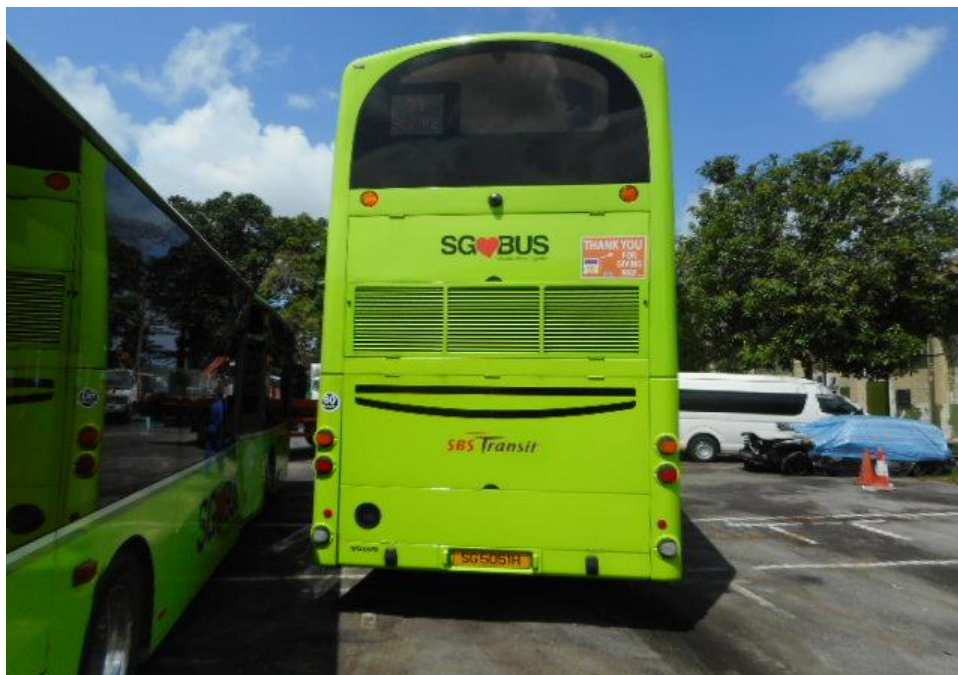
**Photo 5** shows a general view of the rear body of the Motor Bus at the time of my inspection. The Motor Bus was observed to be intact and unaffected by the accident.

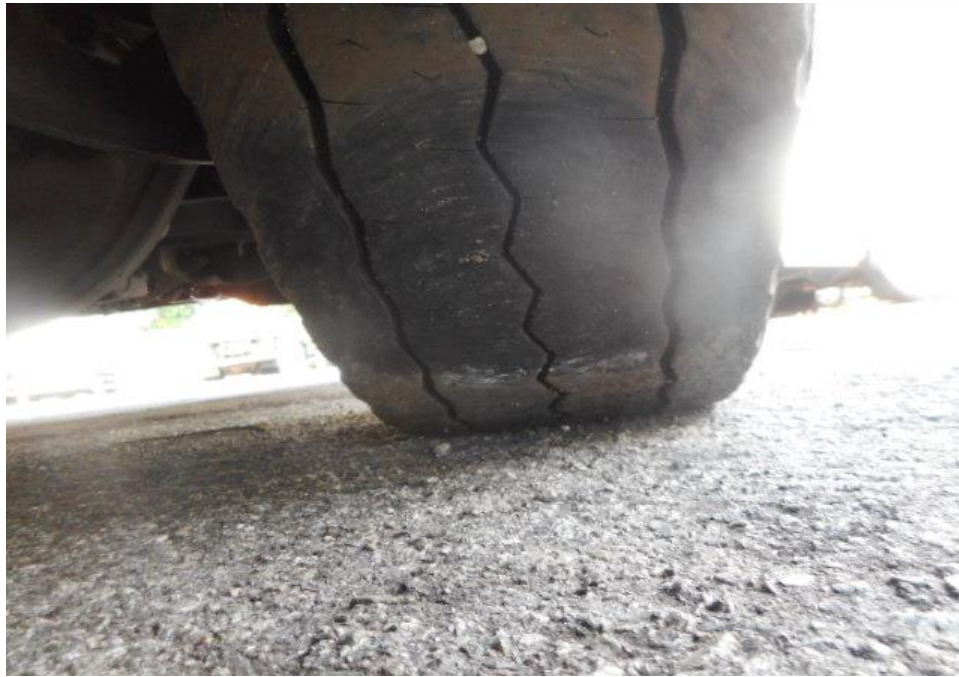
**Photo 6** shows the condition of the front right tyre of the Motor Bus, which was observed to be in serviceable condition with remaining tread depth of approximately 9.8mm. The tyre, which was wrapped around standard steel wheel rim, was also observed to be sufficiently inflated for vehicular operation. There was no tear, cut or burst mark(s) on the outer and the inner sidewalls as well as across the tread of the 8 tyres that were fitted on the Motor Bus.

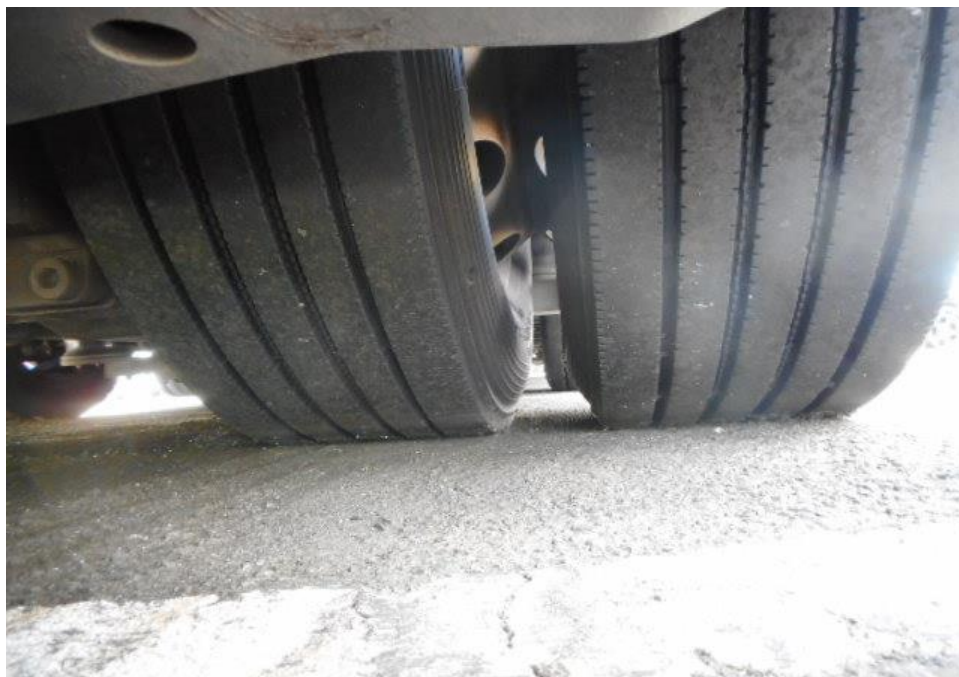
**Photo 7** shows the condition of the rear right tyre of the Motor Bus, which was observed to be in serviceable condition with remaining tread depth of approximately 10mm. The tyre, which was wrapped around standard steel wheel rim, was also observed to be sufficiently inflated for vehicular operation.

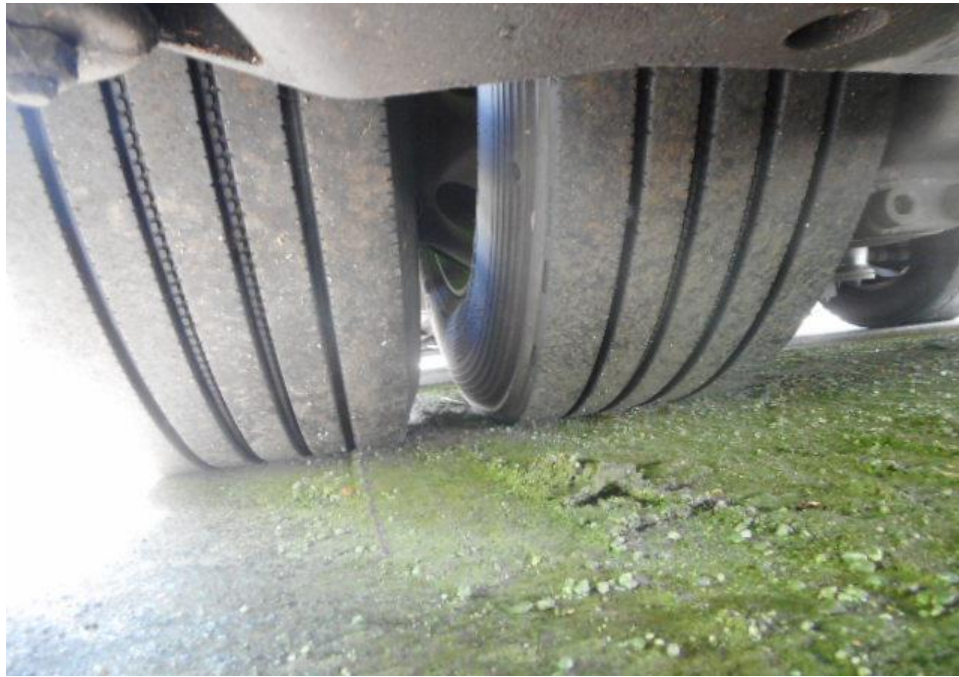
**Photo 8** shows the condition of the rear left tyres of the Motor Bus, which was observed to be in serviceable condition with remaining tread depth of approximately 9.5mm. The tyres, which were wrapped around standard steel wheel rim, were also observed to be sufficiently inflated for vehicular operation. There was also no damage found on all 8 steel wheel rims of the Motor Bus.

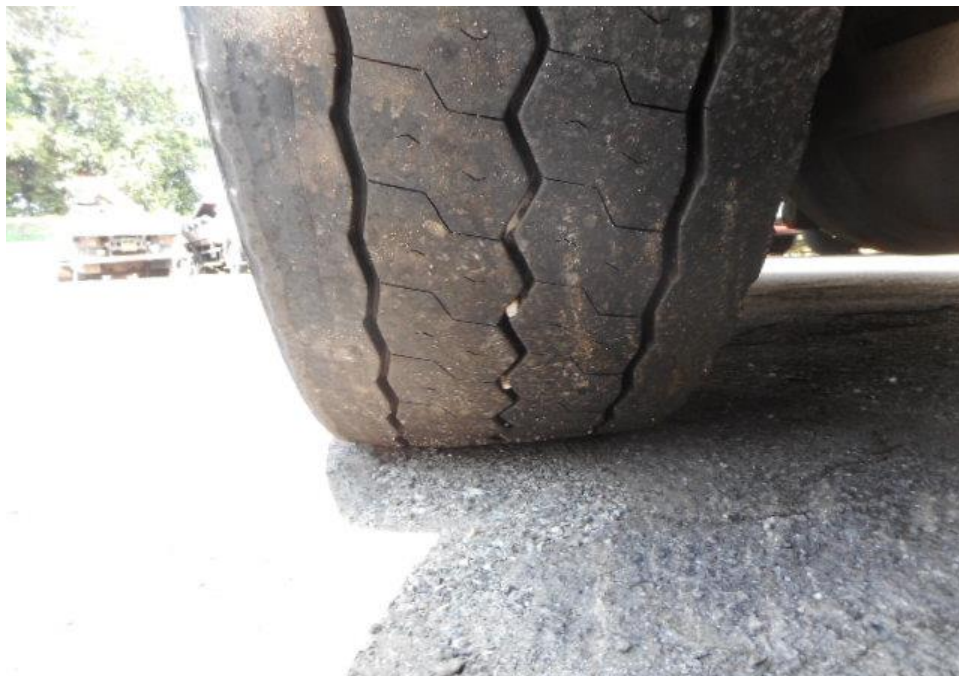
**Photo 9** shows the condition of the front left tyres of the Motor Bus, which were observed to be in serviceable condition with remaining tread depth of approximately 9.1mm. There was also no tear, cut or burst mark(s) on the outer and the inner sidewalls as well as across the tread of the 8 tyres that were fitted on the Motor Bus.

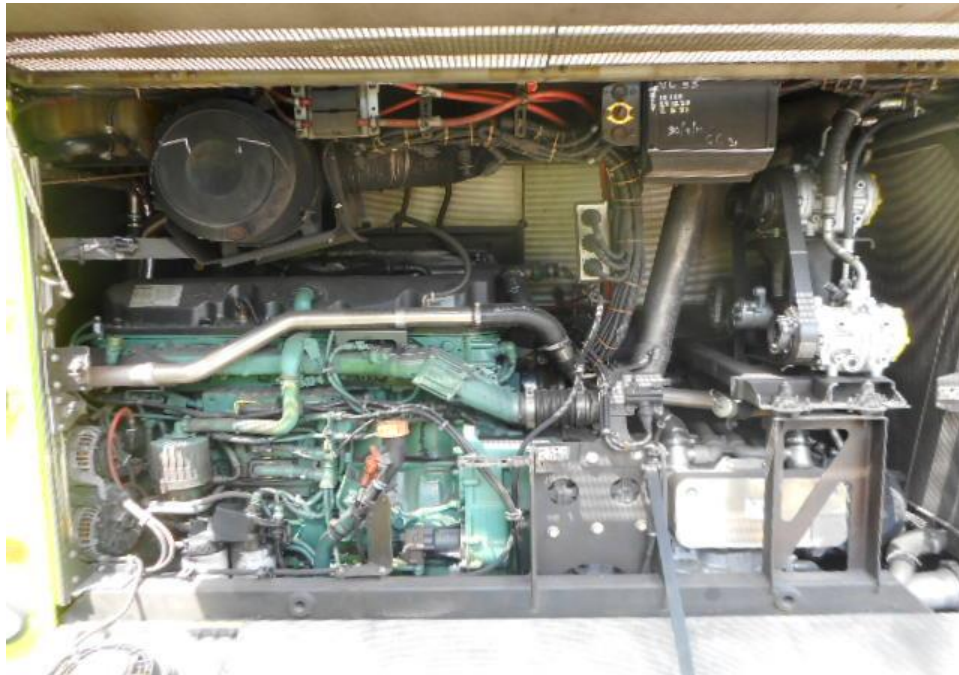
**Photo 10** shows a general view of the Motor Bus's engine compartment, which was accessed by lifting the rear of the Motor Bus. The various parts and components inside the engine compartment were unaffected by the accident. There was also no sign(s) or indication(s) of fresh fluid leakage and/or fluid stain within the engine compartment

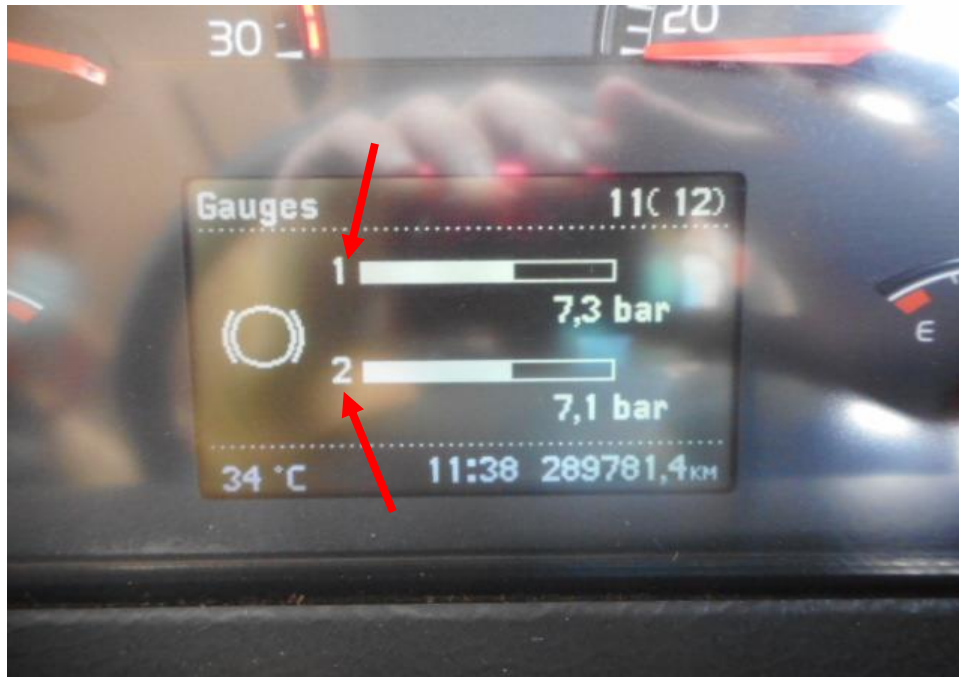
**Photo 11** shows the air in the air brake cylinder of the Motor Bus at the time of my inspection. The air in the cylinder was observed to be of sufficient level & serviceable at the time of the accident.

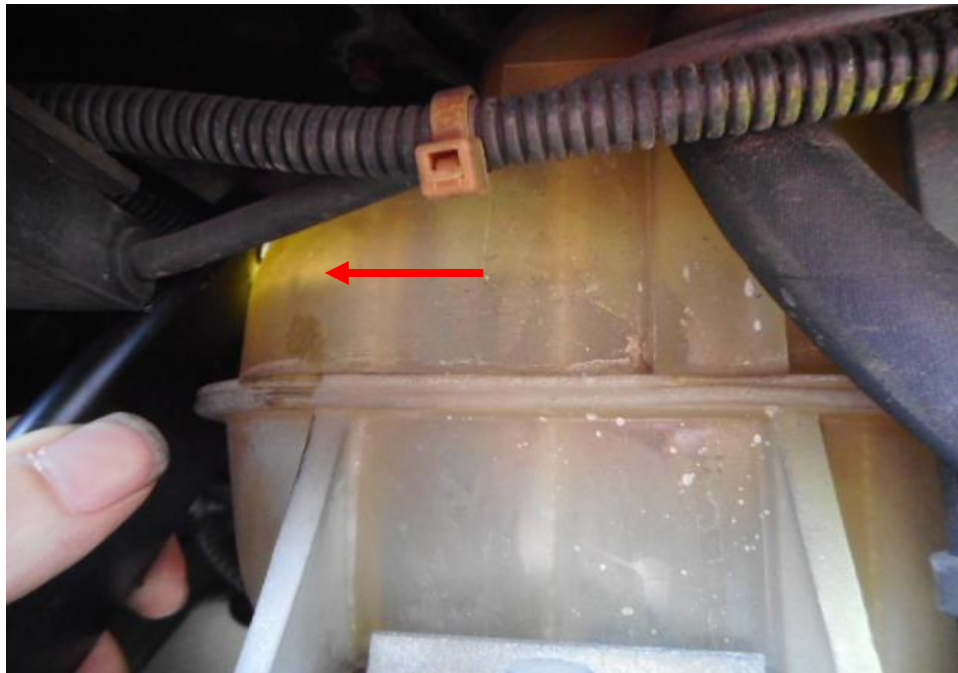
**Photo 12** shows the engine coolant reservoir of the Motor Bus at the time of my inspection. The engine coolant was observed to be of sufficient level (arrowed) and without any visible contamination.

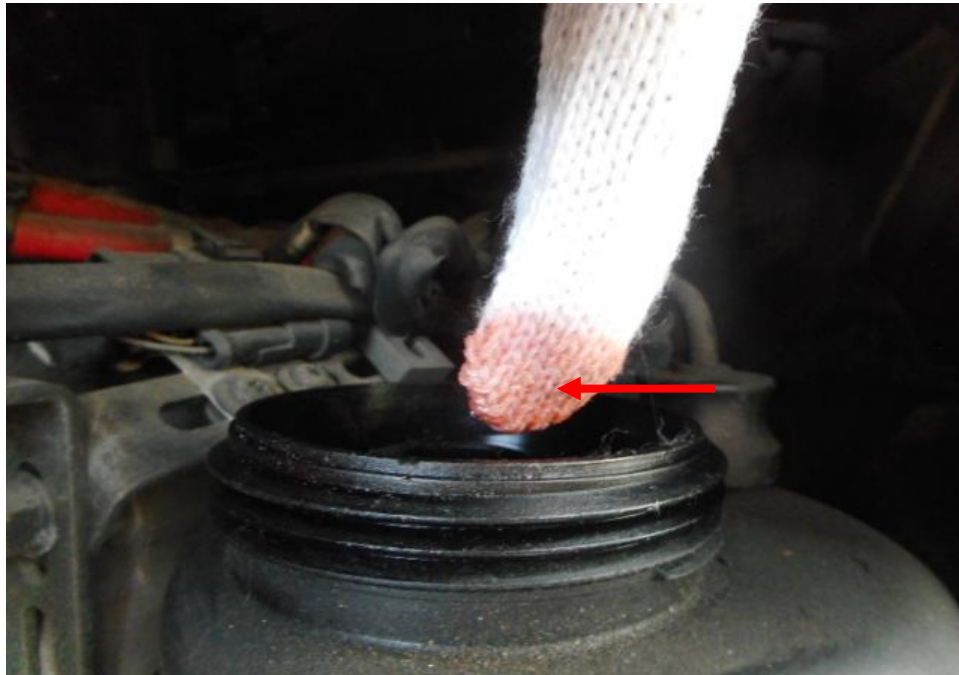
**Photo 13** shows the power steering fluid reservoir of the Motor Bus at the time of my inspection. The power steering fluid was observed to be of sufficient level and without any visible contamination.

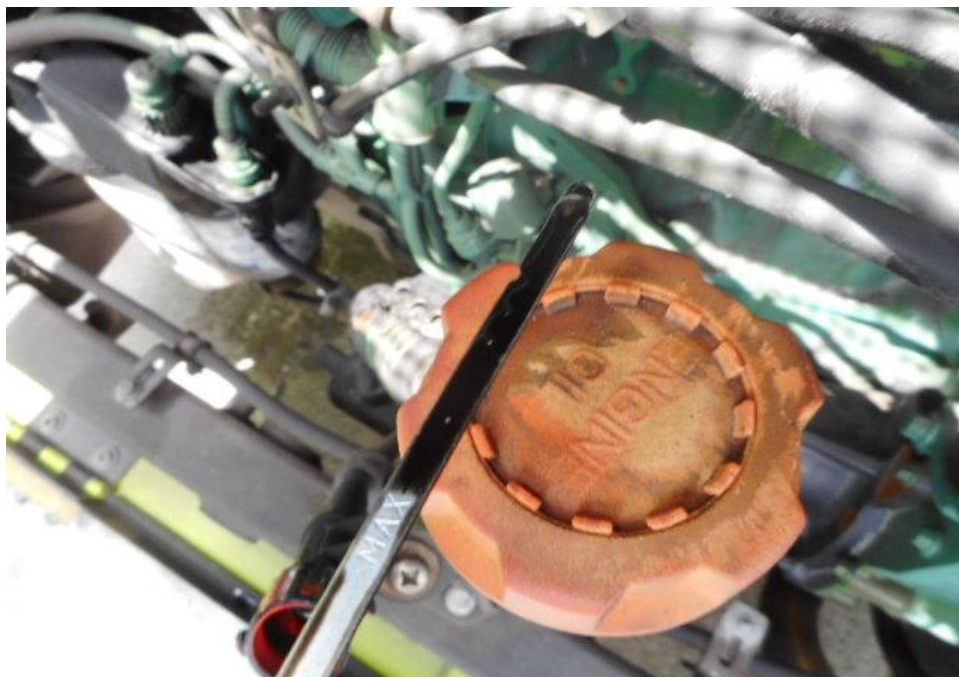
**Photo 14** shows the engine oil dip stick system of the Motor Bus at the time of my inspection. The engine oil was observed to be sufficient for operation and without any visible contamination.

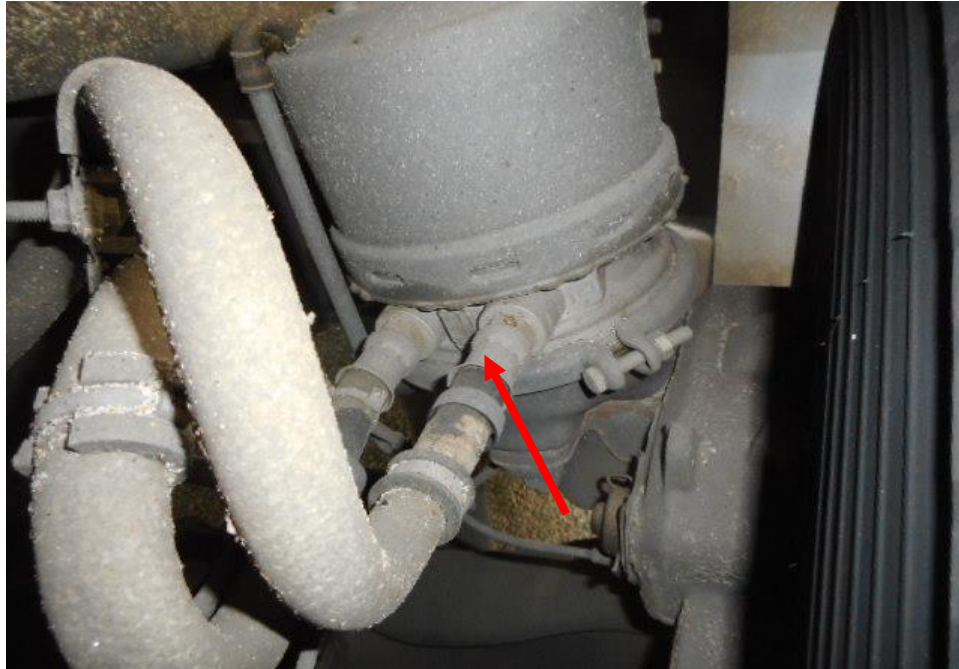
**Photo 15** shows the brake pipe (arrowed) at the rear right wheel of the Motor Bus. I did not observe any leakage of brake fluid at the time of my inspection of the Motor Bus. My static tests of the Motor Bus's braking system, along with my visual examination of the various mechanical components in the braking system, had indicated that there was no internal leakage of pressure/vacuum. Hence the braking system of the Motor Bus was likely to be in serviceable condition at the material time of accident.

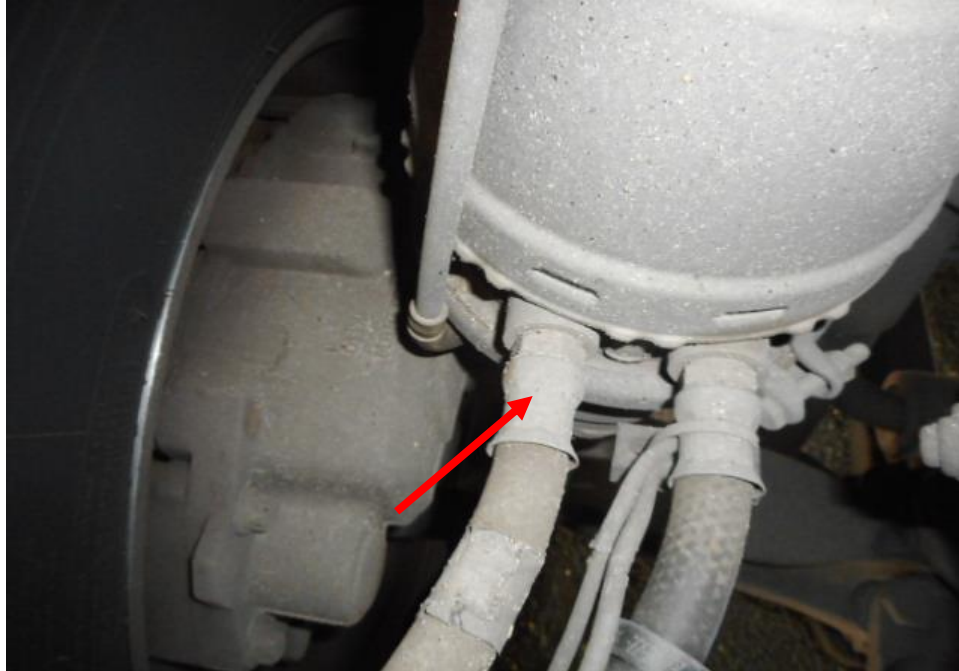
**Photo 16** shows the brake pipe (arrowed) at the rear left wheel of the Motor Bus. I did not observe any leakage of brake fluid at the time of my inspection of the Motor Bus. My static tests of the Motor Bus's braking system, along with my visual examination of the various mechanical components in the braking system, had indicated that there was no internal leakage of pressure/vacuum. Hence the braking system of the Motor Bus was likely to be in serviceable condition at the material time of accident.

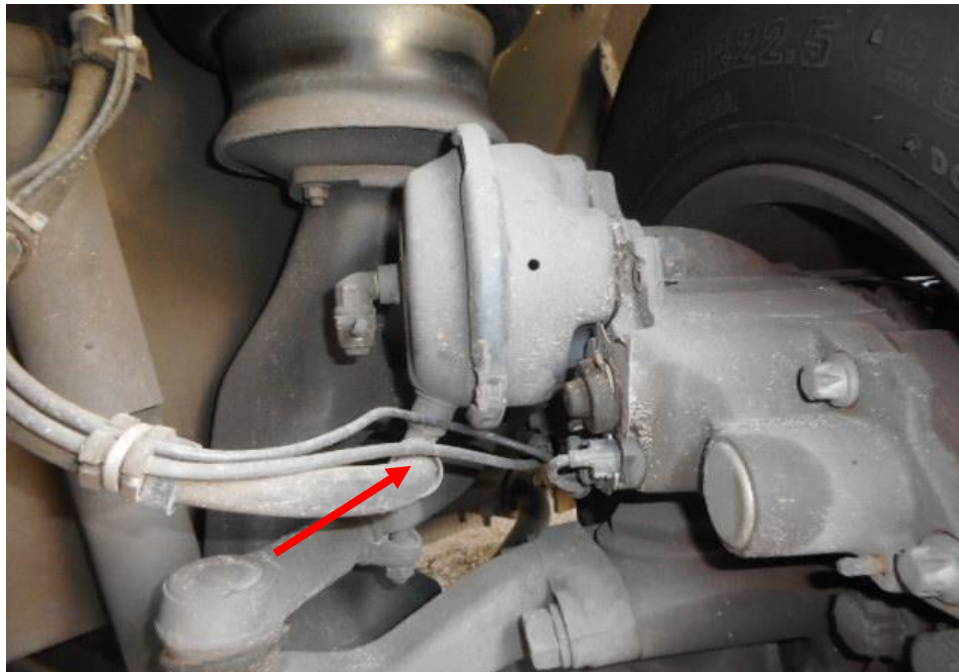
**Photo 17** shows the brake pipe (arrowed) at the front right wheel of the Motor Bus. I did not observe any leakage of brake fluid at the time of my inspection of the Motor Bus. My static tests of the Motor Bus's braking system, along with my visual examination of the various mechanical components in the braking system, had indicated that there was no internal leakage of pressure/vacuum. Hence the braking system of the Motor Bus was likely to be in serviceable condition at the material time of accident.

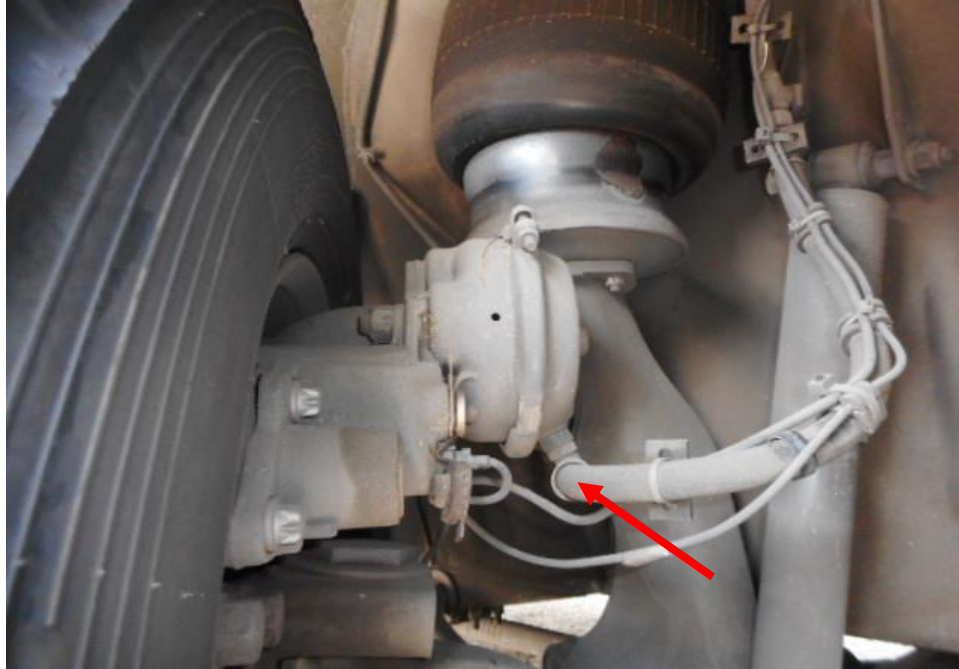
**Photo 18** shows the brake pipe (arrowed) at the front left wheel of the Motor Bus. I did not observe any leakage of brake fluid at the time of my inspection of the Motor Bus. My static tests of the Motor Bus's braking system, along with my visual examination of the various mechanical components in the braking system had indicated that there was no internal leakage of pressure/vacuum. Hence the braking system of the Motor Bus was likely to be in serviceable condition at the material time of accident.

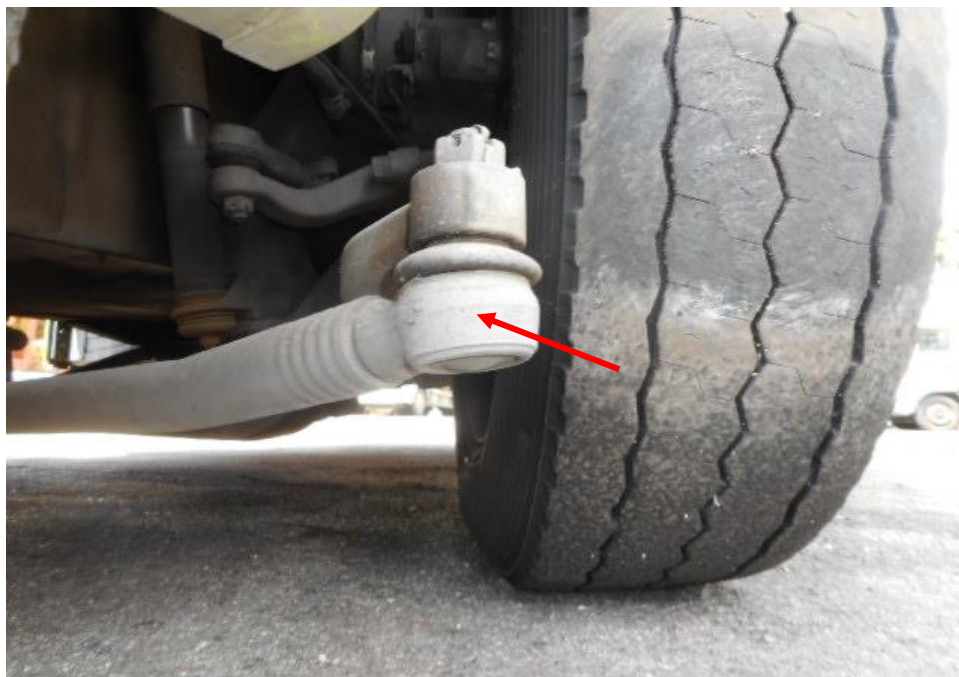
**Photo 19** shows the various undercarriage components at the front right wheel of the Motor Bus, in particular the steering tie rod end (arrowed). The various steering components were all found to be intact, suggesting that the steering system of the Motor Bus was likely to be in serviceable condition at the material time of accident. There was also no sign of fluid stain(s) observed on the various undercarriage components.

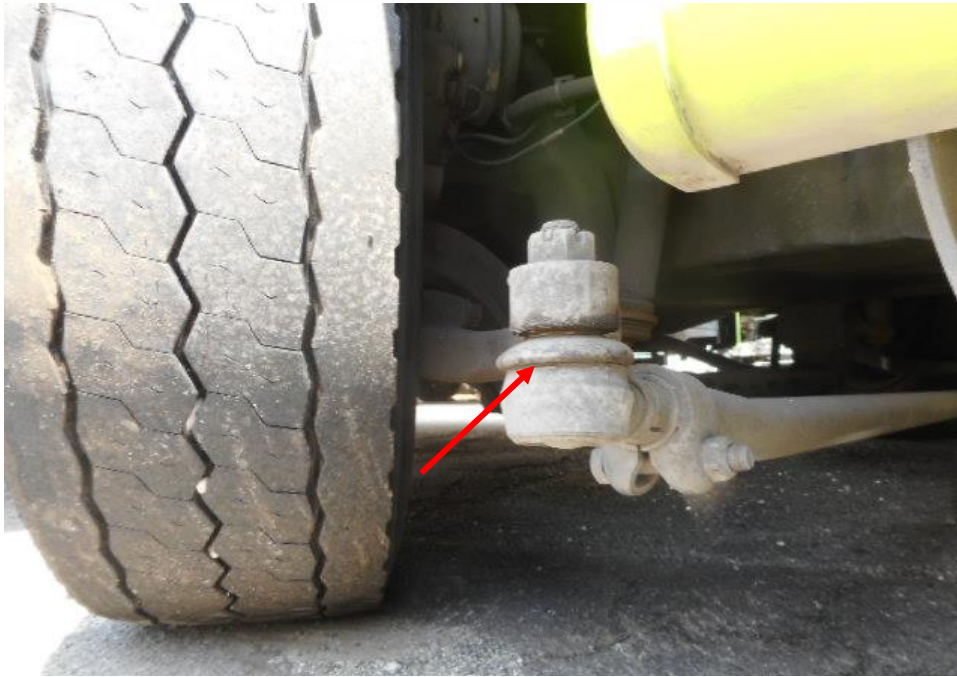
**Photo 20** shows the various undercarriage components at the front left wheel of the Motor Bus, in particular the steering tie rod end (arrowed). The various undercarriage components of the Motor Bus were all found to be intact without any visible damage. There was also no sign of fluid stain(s) observed on the various undercarriage components.

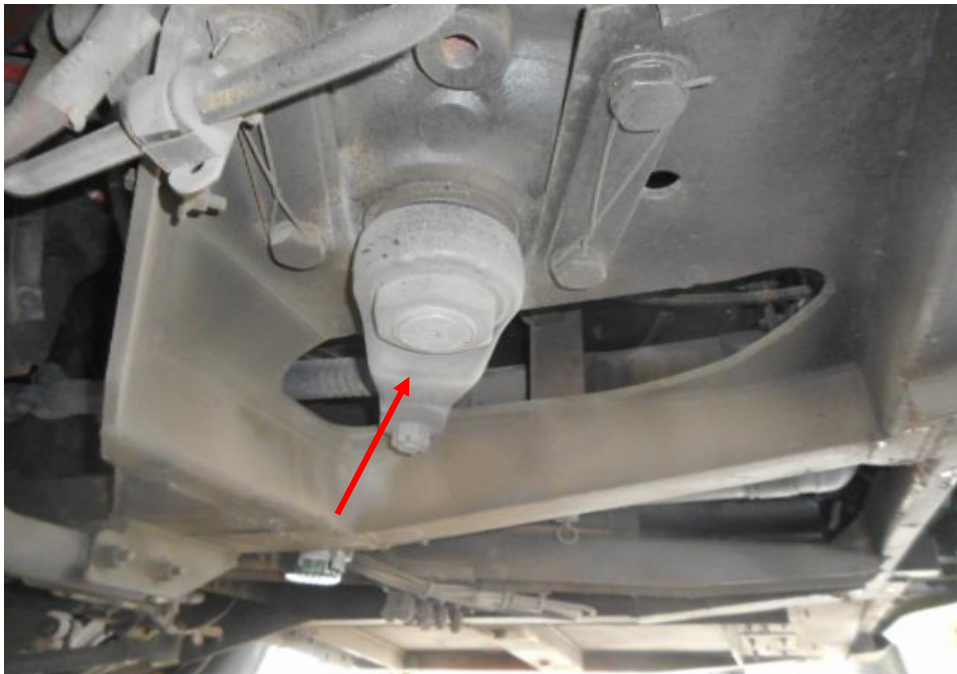
**Photo 21** shows the steering box component (arrowed) at the undercarriage of the Motor Bus was found to be intact without any visible damage. There was also no sign of fluid stain(s) observed on the various undercarriage components.

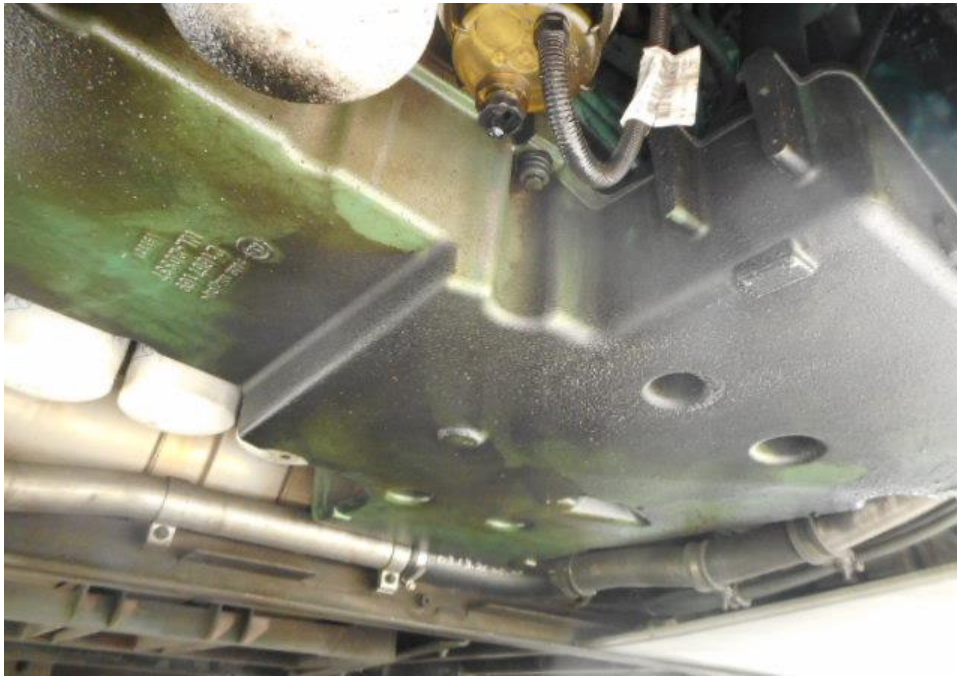
**Photo 22** shows the undercarriage of the Motor Bus, at the area where the engine housing and transmission housing are located. I did not find any sign(s) or indication(s) of fluid leak and/or fluid stain(s) on the underside of the Motor Bus.

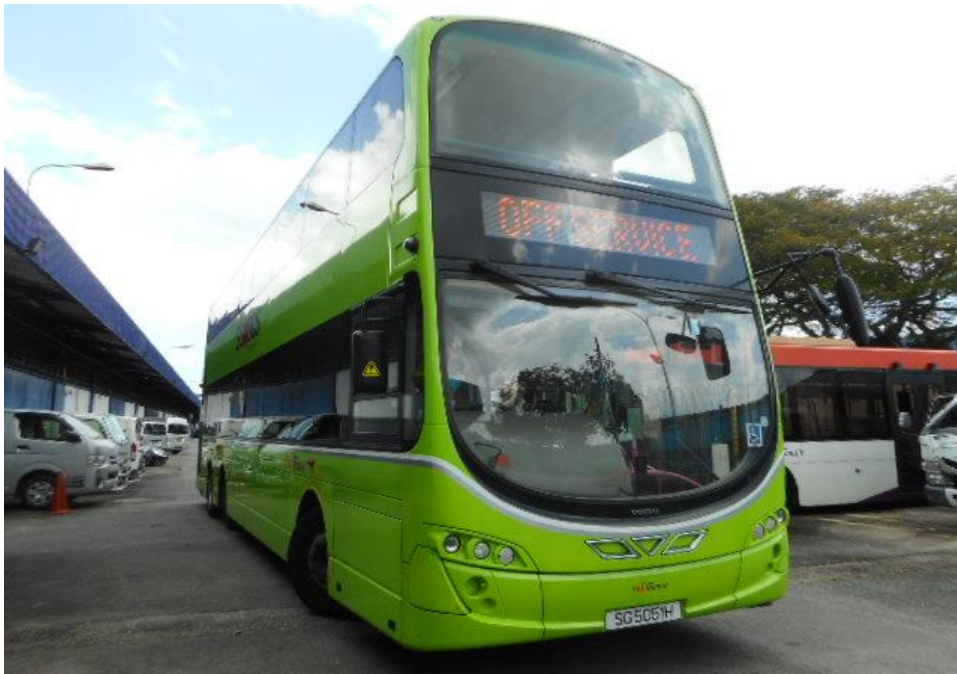
**Photo 23** shows the front right wheel of the Motor Bus turned to its full left. During my steering system test, I did not experience any abnormal free play and/or resistance when I had turned the steering wheel towards full left and full right. This would suggest that the steering system of the Motor Bus was likely to be in serviceable condition at the material time of accident.

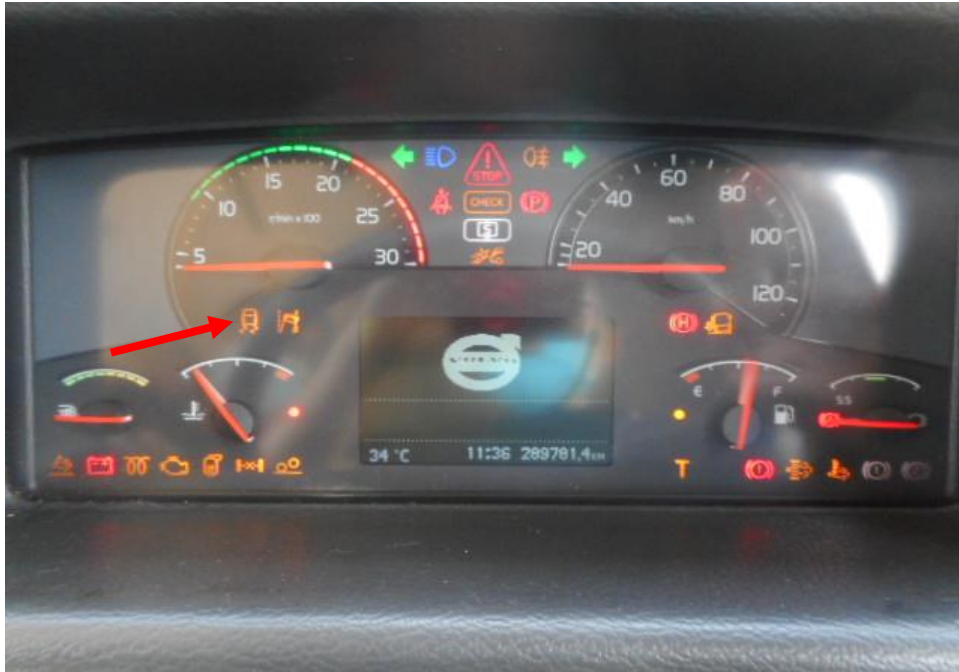
**Photo 24** shows the warning light for Traction Control System (TCS) appearing on the instrument panel of the Motor Bus during the self-test of its various electronic operating systems when its engine was cranked.

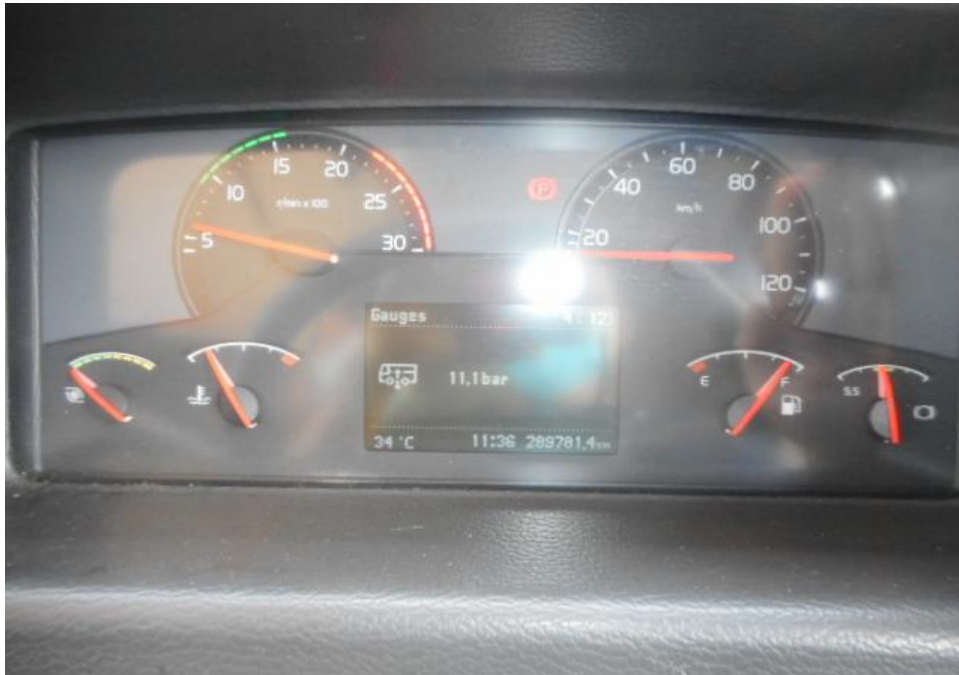
**Photo 25** shows no warning lights illuminated on the instrument panel of the Motor Bus after the engine was cranked. This would suggest that there was no abnormality to the various electronic operating systems of the Motor Bus, like the TCS and etc.
