Your Ref: TP/IP/43293/2021
Our Ref : CI/TPD21010015/P

22nd September 2021

MECHANICAL INSPECTION REPORT OF MOTOR CAR SJM 7807G

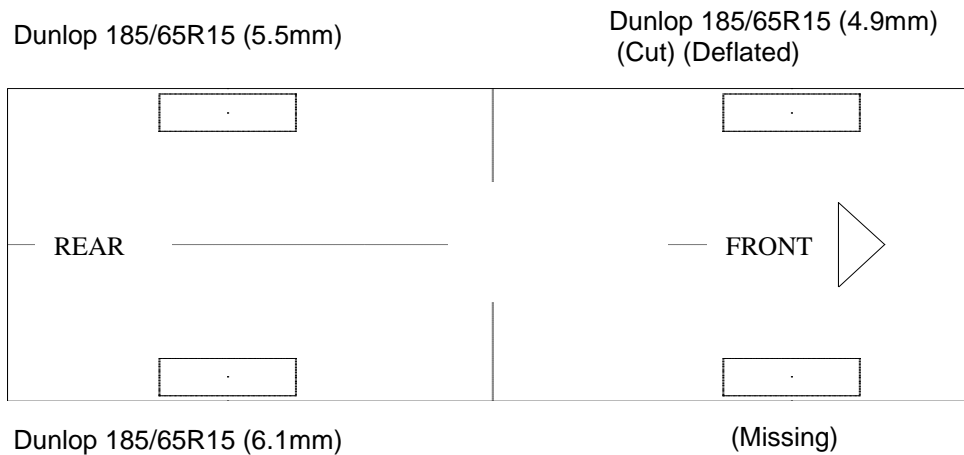
6. The condition of the Motor Car's front right tyre and wheel rim was observed to be missing and its front left tyre was also observed to be damaged as a result of the accident. However, the other 2 tyres was observed to be in serviceable condition. I did not find any tear, cut or burst mark(s) on the outer and the inner sidewalls as well as across the tread of the 2 tyres. The 2 tyres were also observed to be sufficiently inflated for vehicular operation. The tyre brand, tyre size and remaining tread depth of the 3 tyres were recorded as follows:-

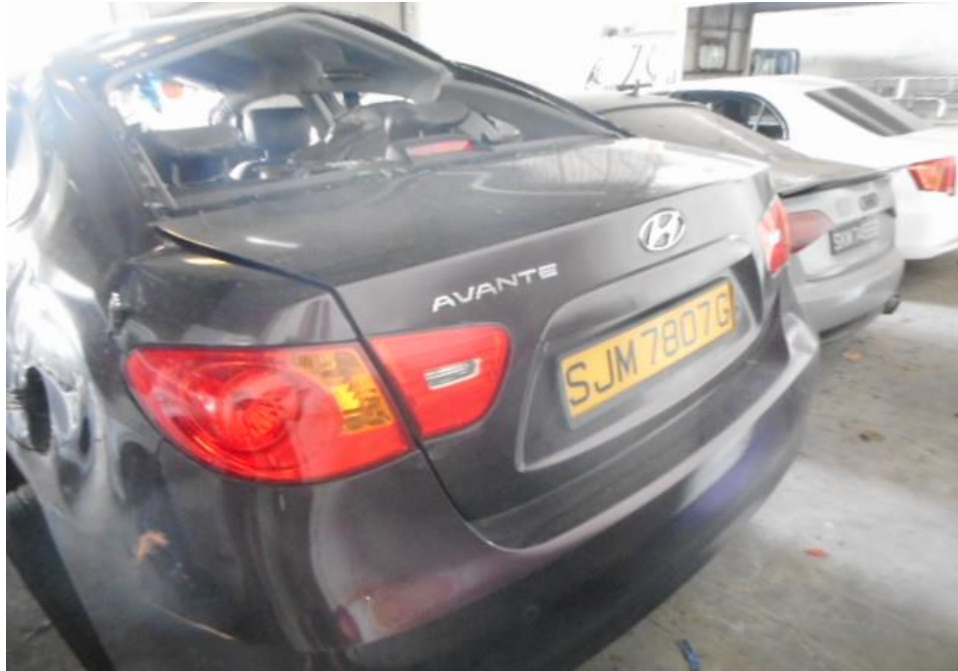
Photo 1 shows the general view of the Motor Car's rear body at the time of my inspection. The Motor Car was observed to have sustained damage at its rear portion. Its rear windscreen and roof panel were amongst the body parts that were damaged as a result of the accident.

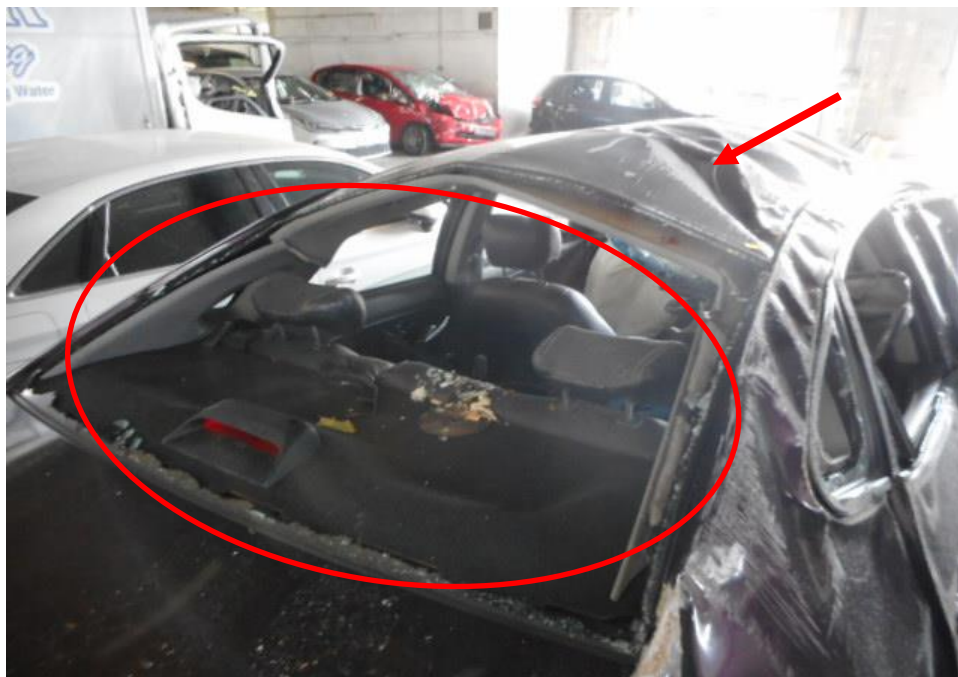
Photo 2 shows the close up view of the Motor Car's rear body at the time of my inspection. The Motor Car was observed to have sustained damage at its rear portion. Its rear windscreen (circled) and roof panel (arrowed) were amongst the body parts that were damaged as a result of the accident.

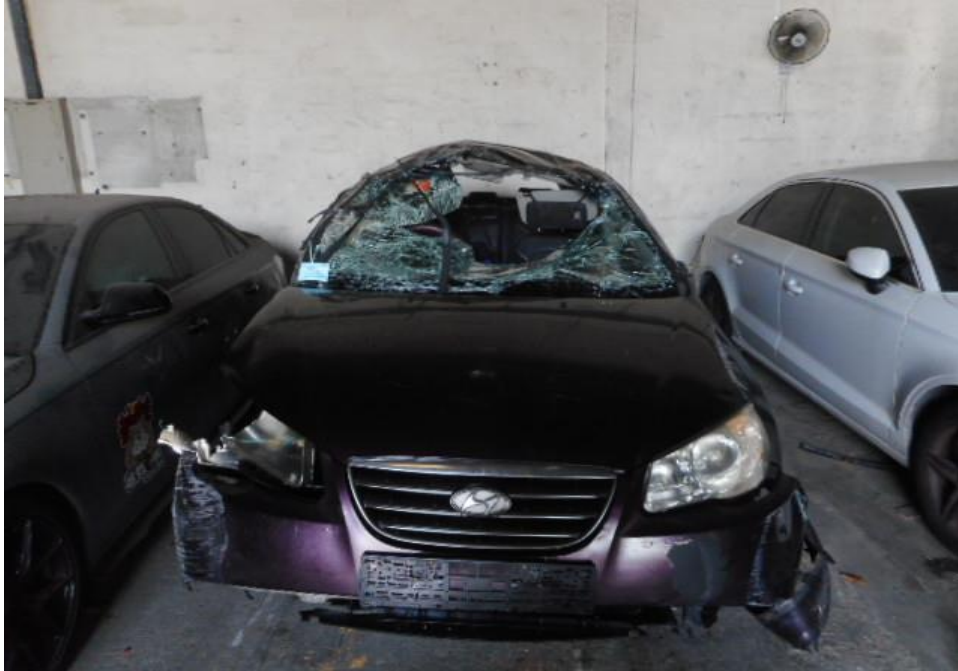
Photo 3 shows a general view of the Motor Car's front body at the time of my inspection. The Motor Car was observed to have sustained damage at its front portion. Its front windscreen, front bumper, front right headlight were amongst the body parts that were damaged as a result of the accident.

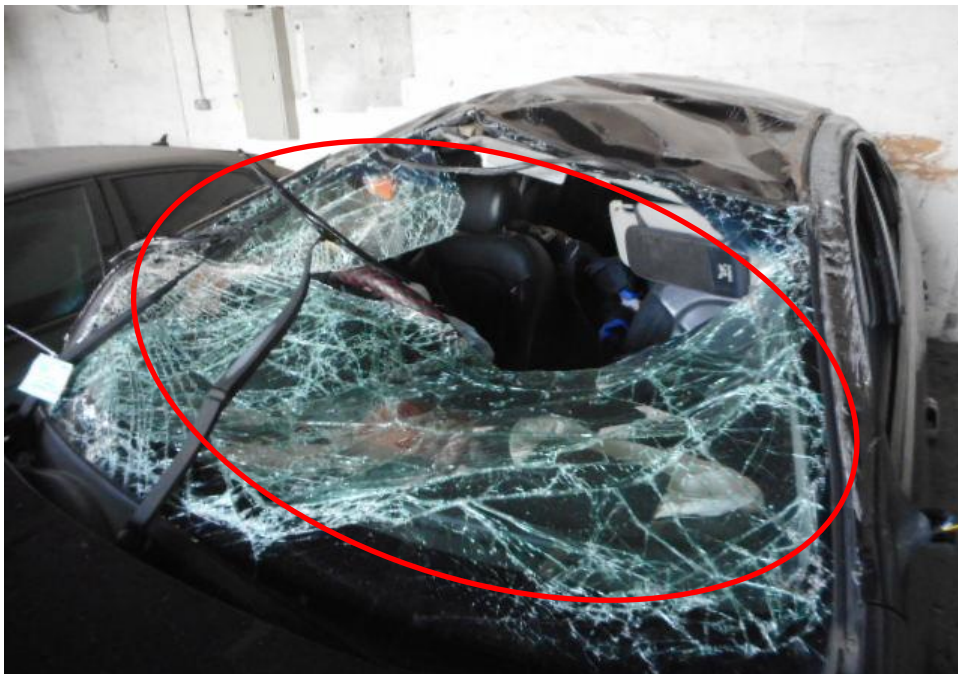
Photo 4 shows the close up view of the Motor Car's front body at the time of my inspection. The Motor Car was observed to have sustained damage at its front portion. Its front windscreen (circled) were amongst the body parts that were damaged as a result of the accident.

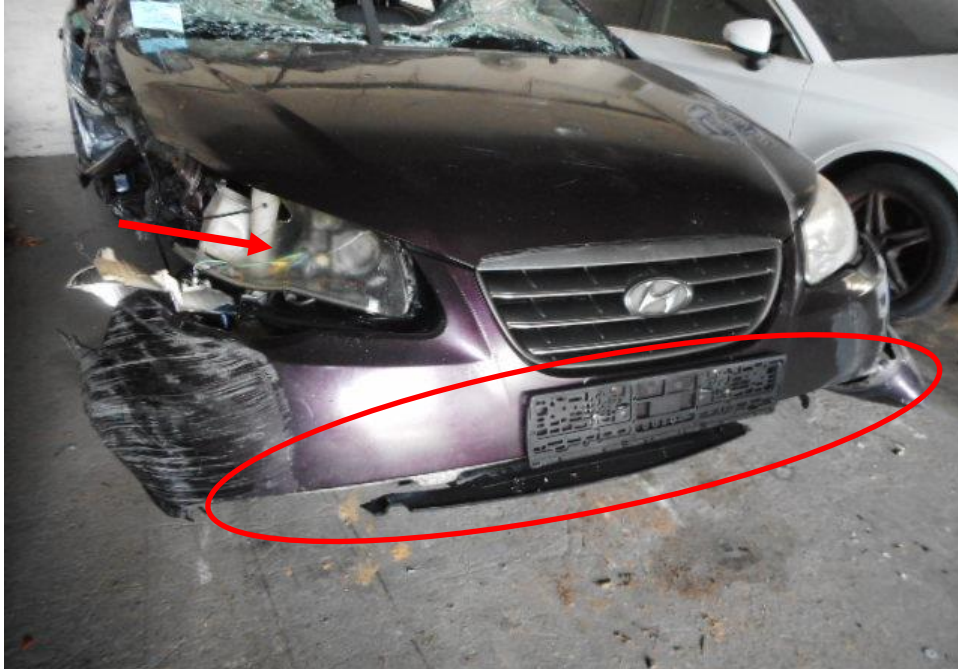
Photo 5 shows the close up view of the Motor Car's front body at the time of my inspection. The Motor Car was observed to have sustained damage at its front portion. Its front bumper (circled) and front right headlight (arrowed) were amongst the body parts that were damaged as a result of the accident.

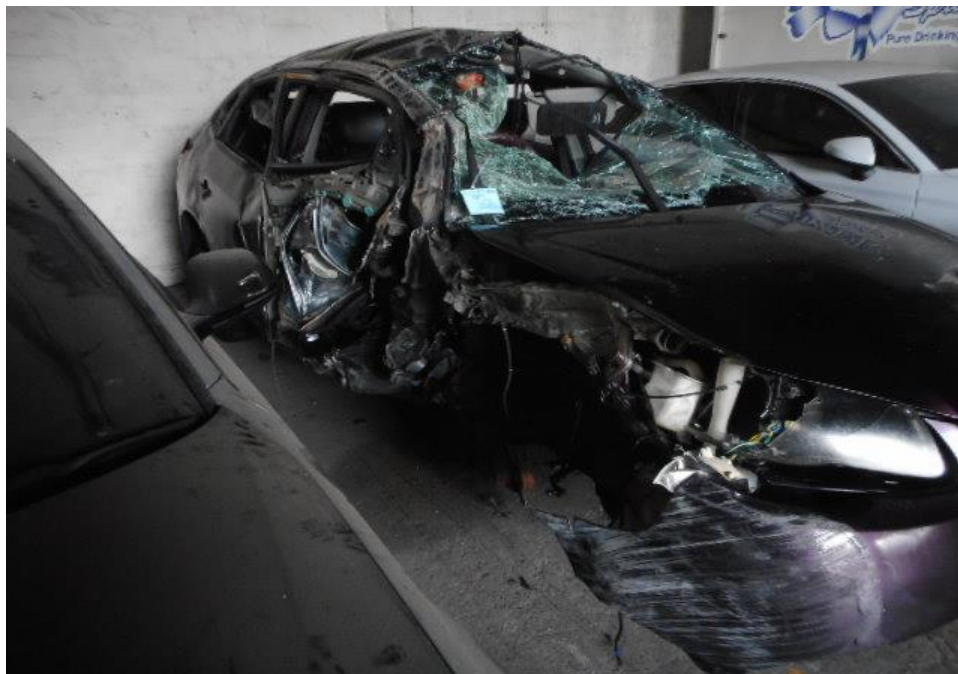
Photo 6 shows a general view of the Motor Car's right body at the time of my inspection. The Motor Car was observed to have sustained damage at its right portion. Its right body panels were amongst the body parts that were damaged as a result of the accident.

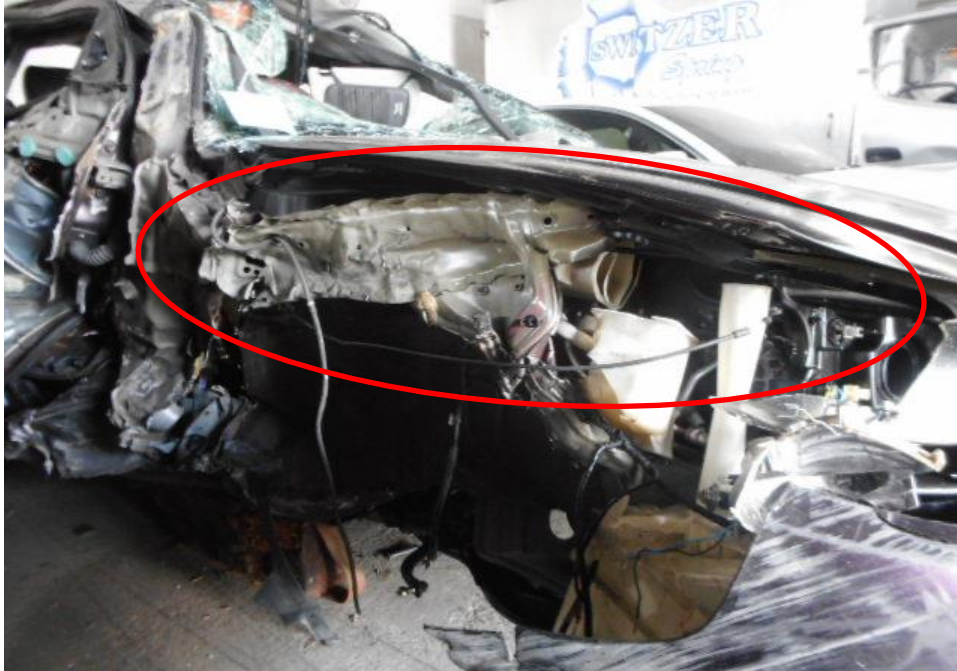
Photo 7 shows a close up view of the Motor Car's right body at the time of my inspection. The Motor Car was observed to have sustained damage at its right portion. Its right body panels (circled) were amongst the body parts that were damaged as a result of the accident.

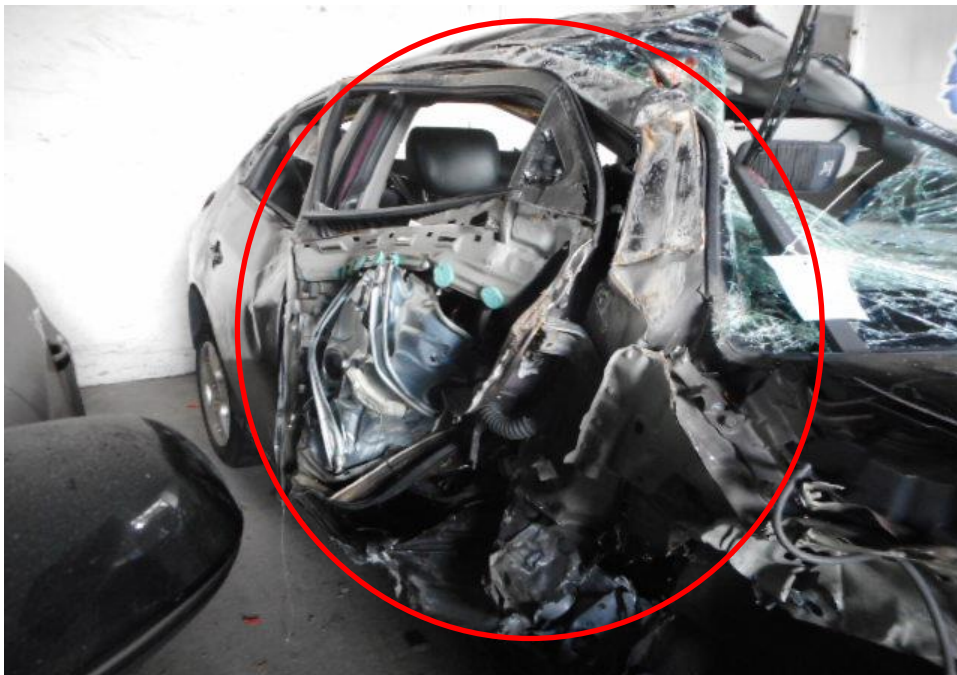
Photo 8 shows a close up view of the Motor Car's right body at the time of my inspection. The Motor Car was observed to have sustained damage at its right portion. Its right body panels (circled) were amongst the body parts that were damaged as a result of the accident.

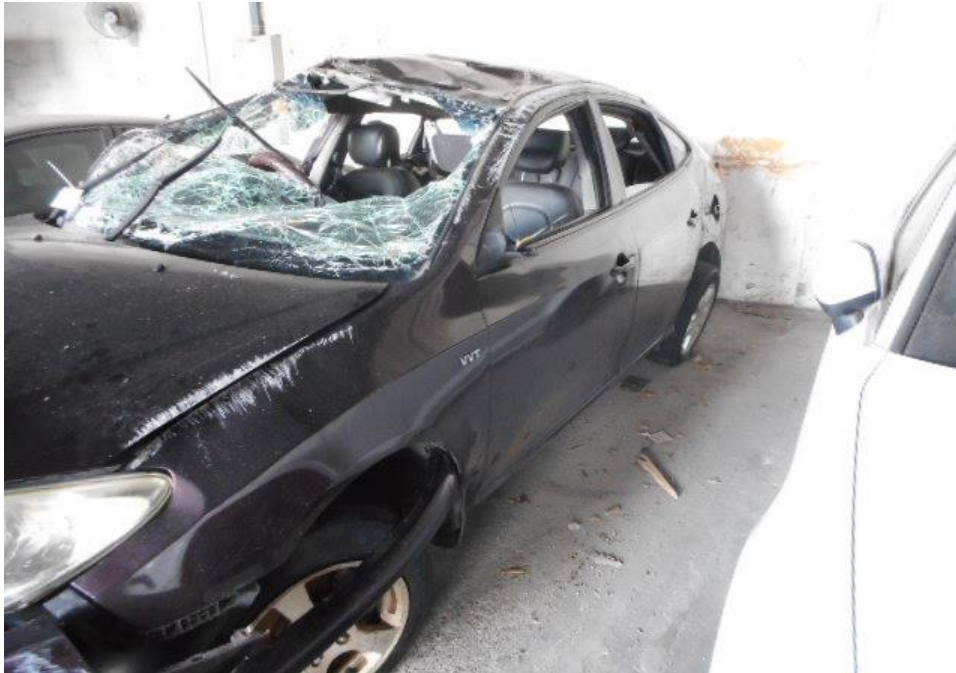
Photo 9 shows a general view of the Motor Car's right body at the time of my inspection. The Motor Car was observed to have sustained damage at its front portion. Its right body panel were amongst the body parts that were damaged as a result of the accident.

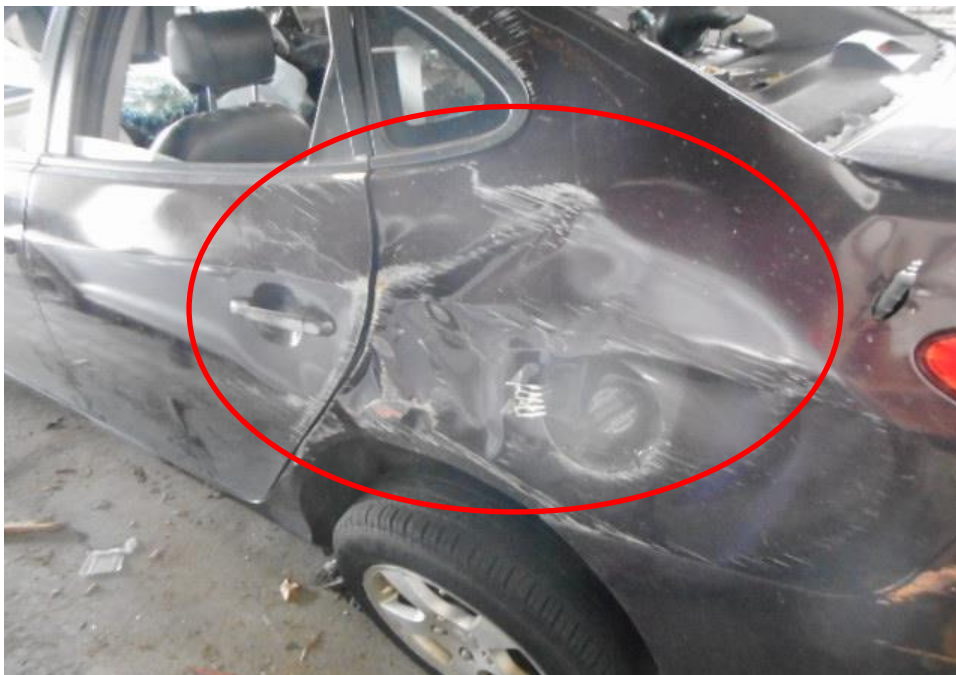
Photo 10 shows a general view of the Motor Car's right body at the time of my inspection. The Motor Car was observed to have sustained damage at its front portion. Its right body panel were amongst the body parts that were damaged as a result of the accident.

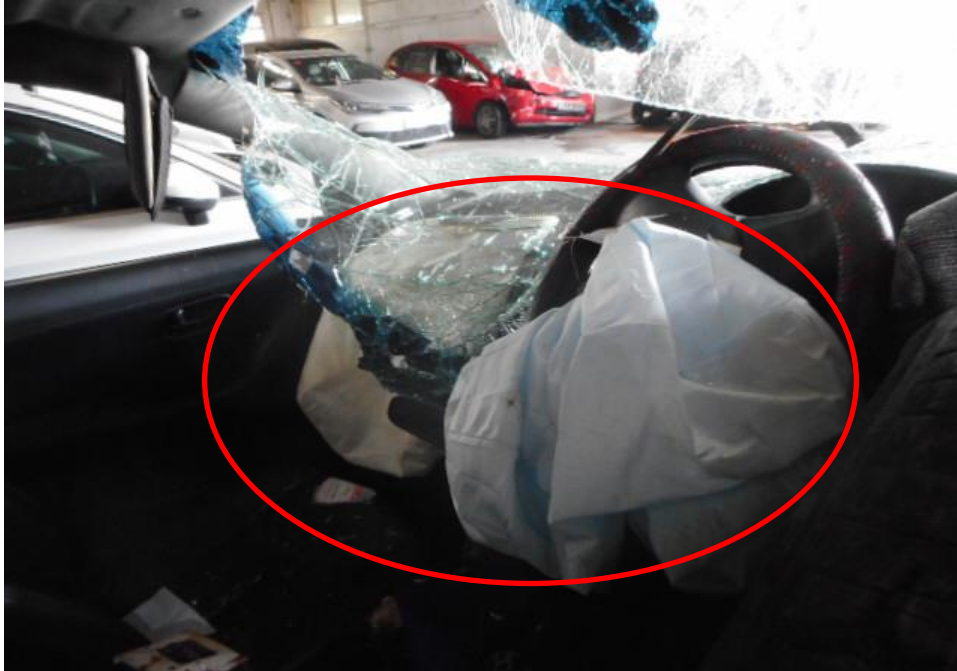
Photo 11 shows the airbag (circled) of the Supplemental Restraint System in the Motor Car's was deployed as a result of the accident at the time of my inspection.

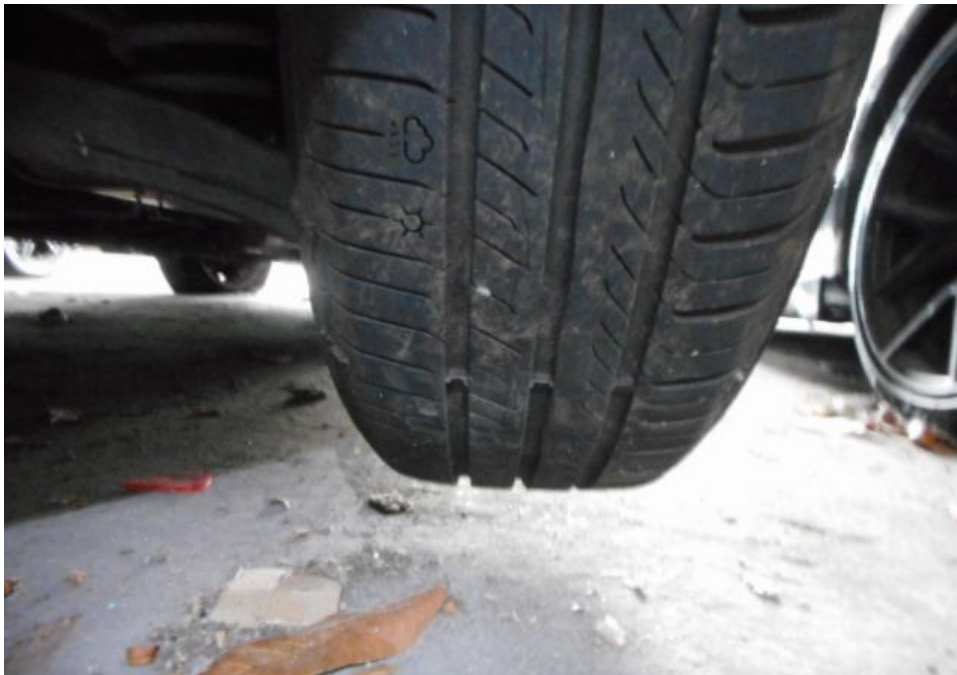
Photo 12 shows the condition of the rear left tyre of the Motor Car, which was observed to be in serviceable condition with remaining tread depth of approximately 6.1mm. The tyre was observed with cut marks and wheel rim damage as a result of the accident, however it was observed to be sufficiently inflated for vehicular operation

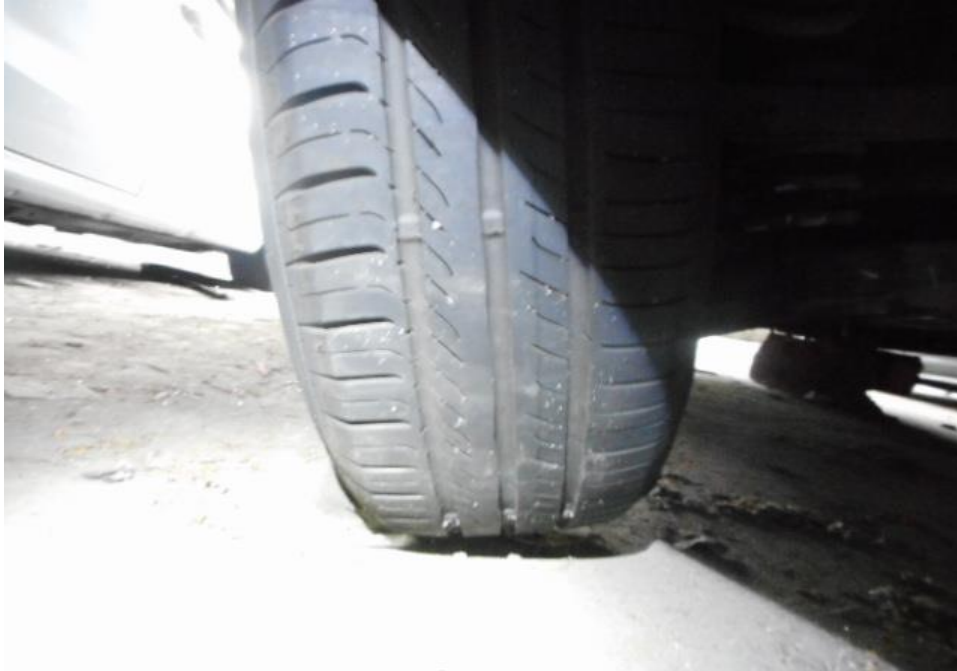
Photo 13 shows the condition of the rear right tyre of the Motor Car, which was observed to be in serviceable condition with remaining tread depth of approximately 5.5mm. The tyre was observed with cut marks and wheel rim damage as a result of the accident, however it was observed to be sufficiently inflated for vehicular operation

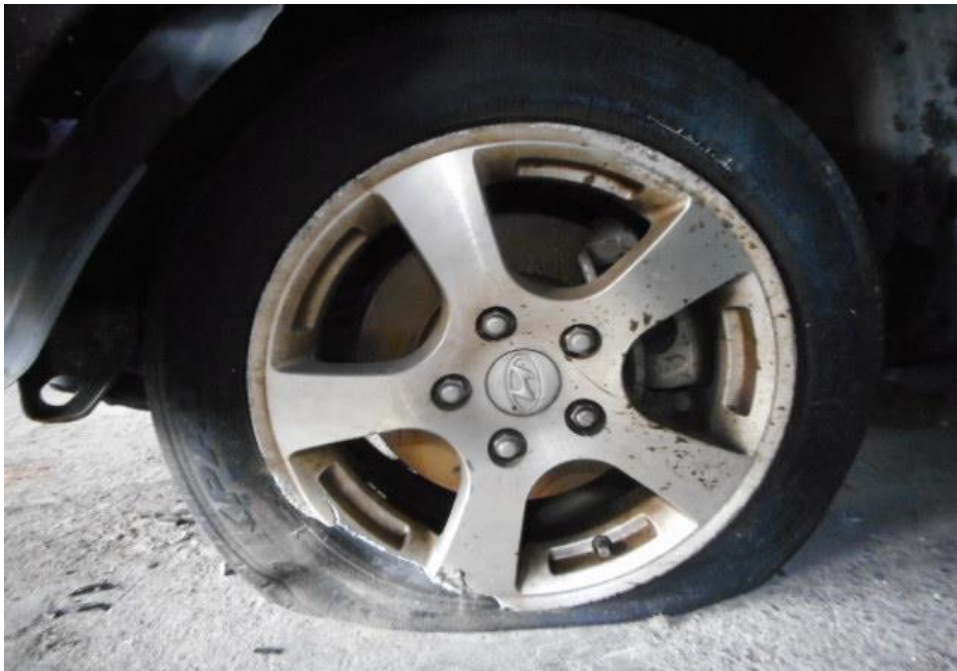
Photo 14 shows the condition of the front right tyre of the Motor Car, which was observed to be in serviceable condition with remaining tread depth of approximately 4.9mm. The tyre was observed with cut marks and wheel rim damage as a result of the accident, however it was observed to be sufficiently inflated for vehicular operation

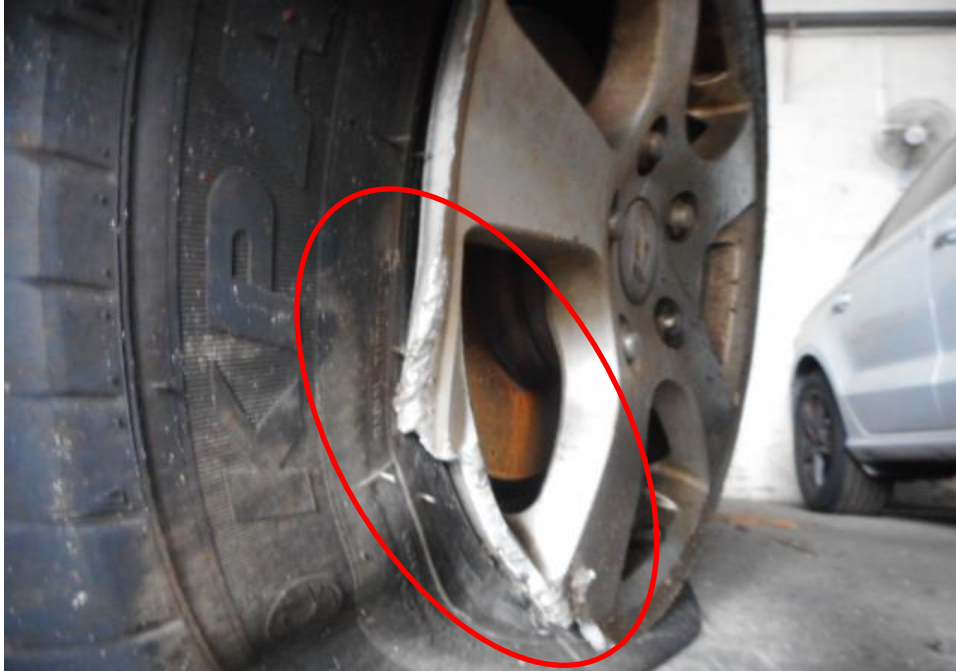
Photo 15 shows the close up view of the condition of the front left tyre of the Motor Car, which was observed to be unserviceable condition. The tyre was observed with cut mark(s) on the outer sidewalls and there was damage observed on the wheel rims (circled) as a result of the accident.

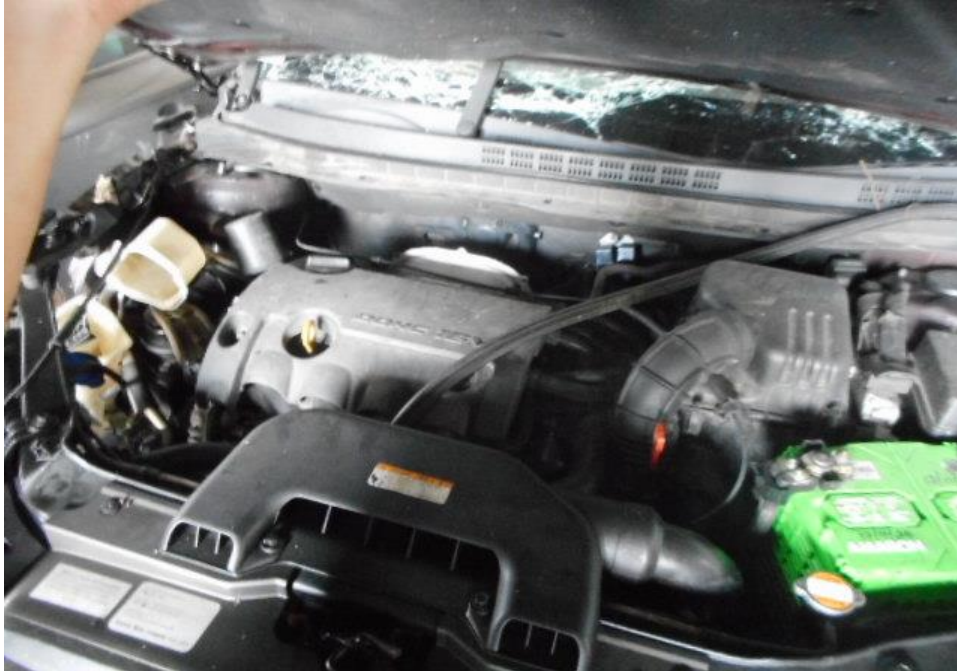
8. Upon examination of the engine compartment of the Motor Car, I had observed coolant reservoir inside the engine compartment to be damaged as a result of the accident. The engine oil and were all found to be of sufficient level for operating purposes. Visually, there was also no contamination found to these fluids. However the engine coolant and the brake fluid some observed to be insufficient as a result of the damaged coolant reservoir of the missing brake system of the front right wheel as a result of the accident.

Photo 16 shows a general view of the Motor Car's engine compartment. The coolant reservoir was observed to be damaged as a result of the accident. However the other various parts and components inside the engine compartment were unaffected by the accident. There was also no sign(s) or indication(s) of fluid leakage and/or fluid stain within the engine compartment.

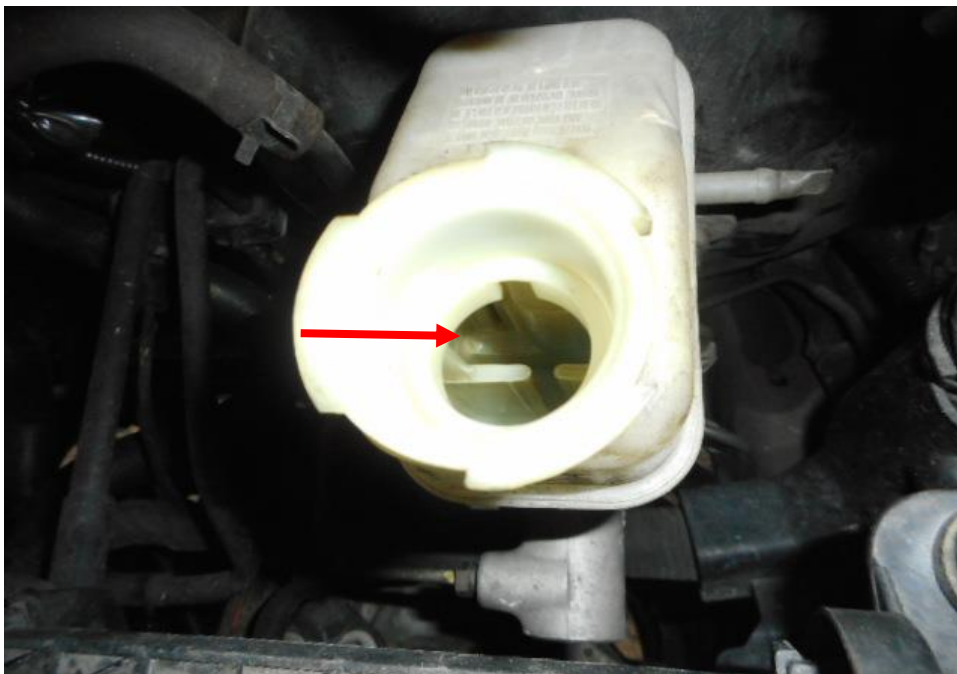
Photo 17 shows the brake fluid reservoir of the Motor Car at the time of my inspection. The brake fluid was observed to be of insufficient level (arrowed) as a result of the missing braking system of the front right braking system due to the result of the accident.

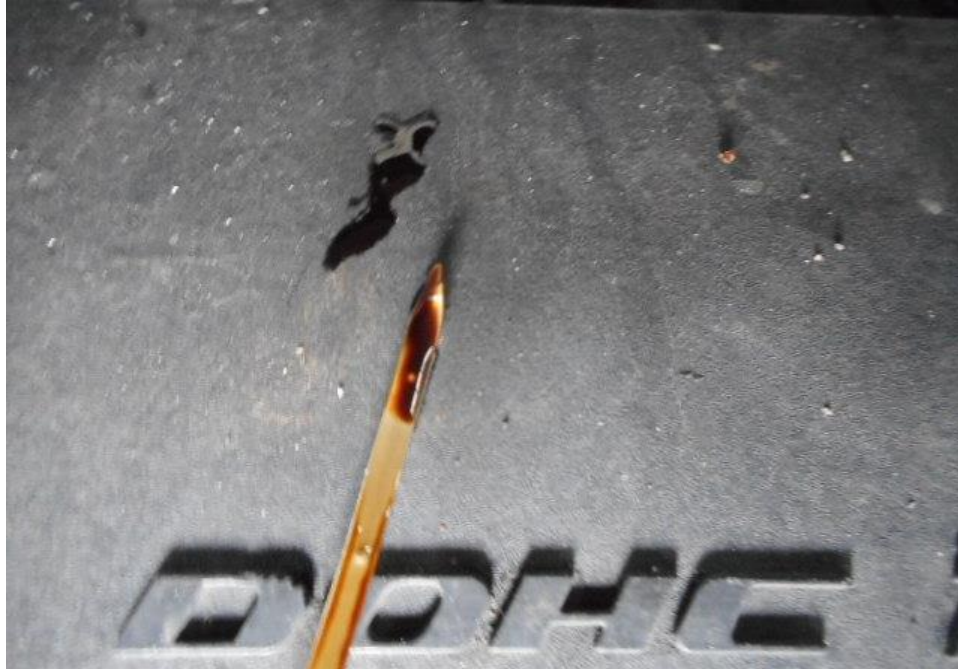
Photo 18 shows the engine oil dip stick of the Motor Car at the time of my inspection. The engine oil was observed to be of sufficient level and without any visible contamination.

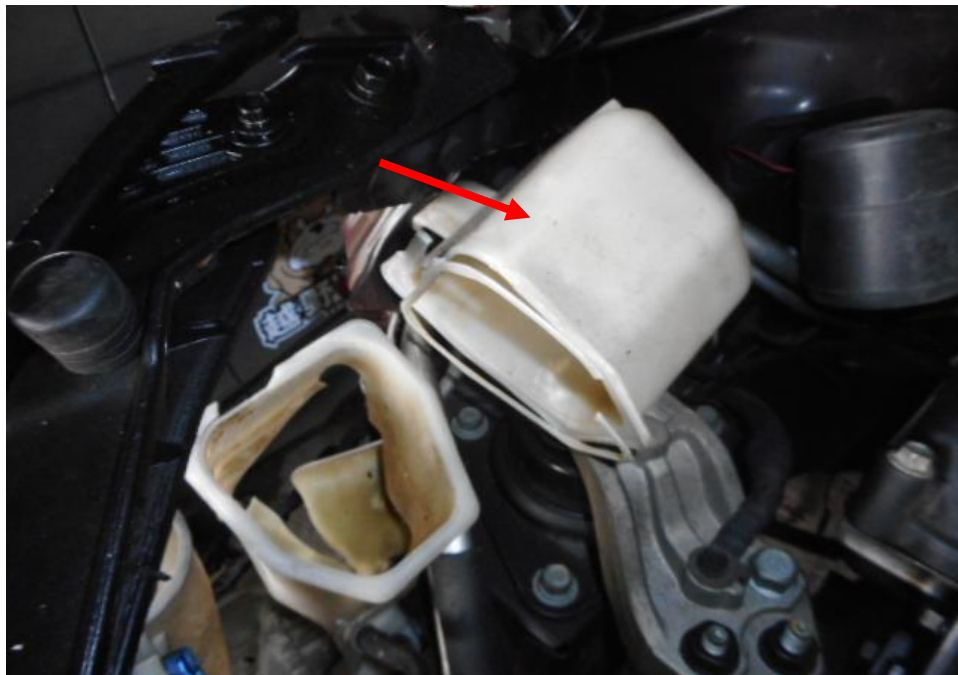
Photo 19 shows checks being carried out to the engine coolant of the Motor Car at the time of my inspection. The coolant was observed to be of insufficient level as a result of the damaged coolant reservoir (arrowed) as the result of the accident.

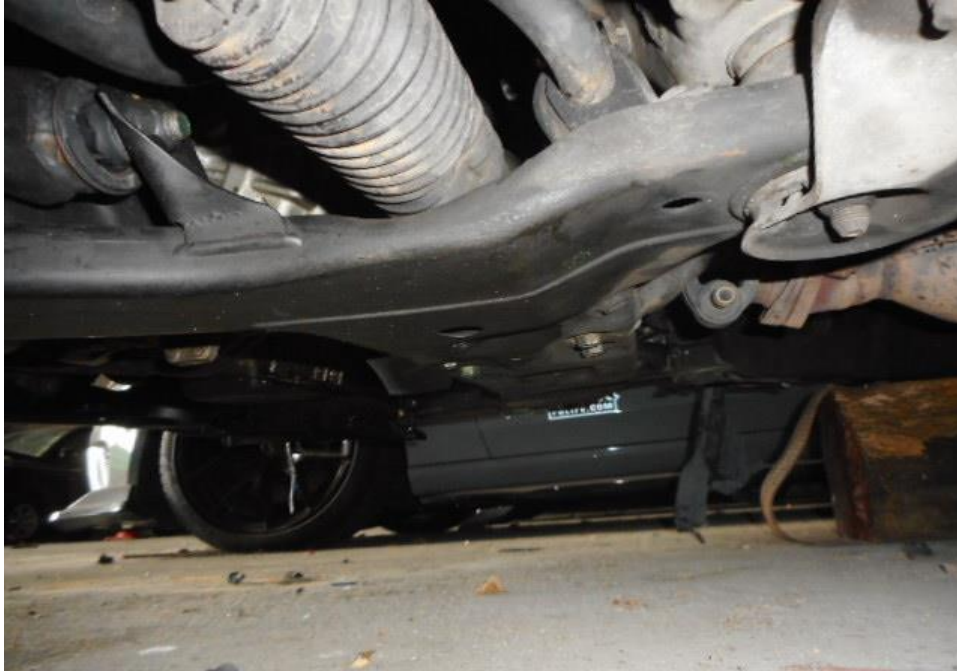
10. My subsequent checks on the underside of the Motor Car also revealed no sign(s) or indication(s) of fluid leak and/or fluid stain(s). Visually, the various undercarriage components of the Motor Car were all observed to be intact and without any visible damage. See photo 16 – 20 below.

Photo 20 shows the undercarriage of the Motor Car, at the area where the engine housing and transmission housing are located. I did not find any sign(s) or indication(s) of fluid leak and/or fluid stain(s) on the underside of the Motor Car.

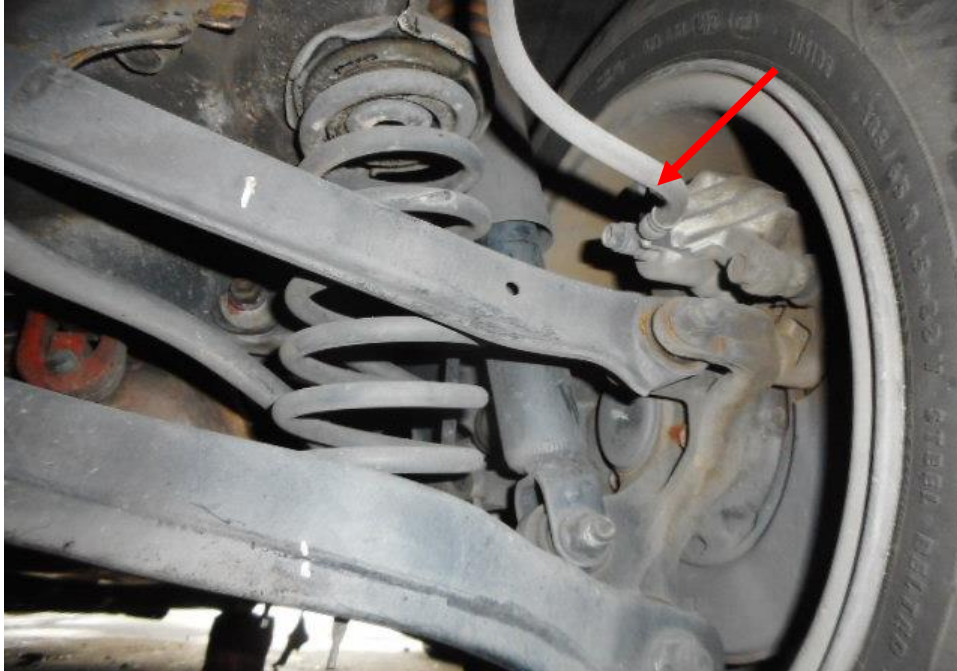
Photo 21 shows the brake hose/pipe (arrowed) at the rear right wheel of the Motor Car. No leakage of brake fluid was observed. Visual examination of the various components revealed to be intact and without visible damage.

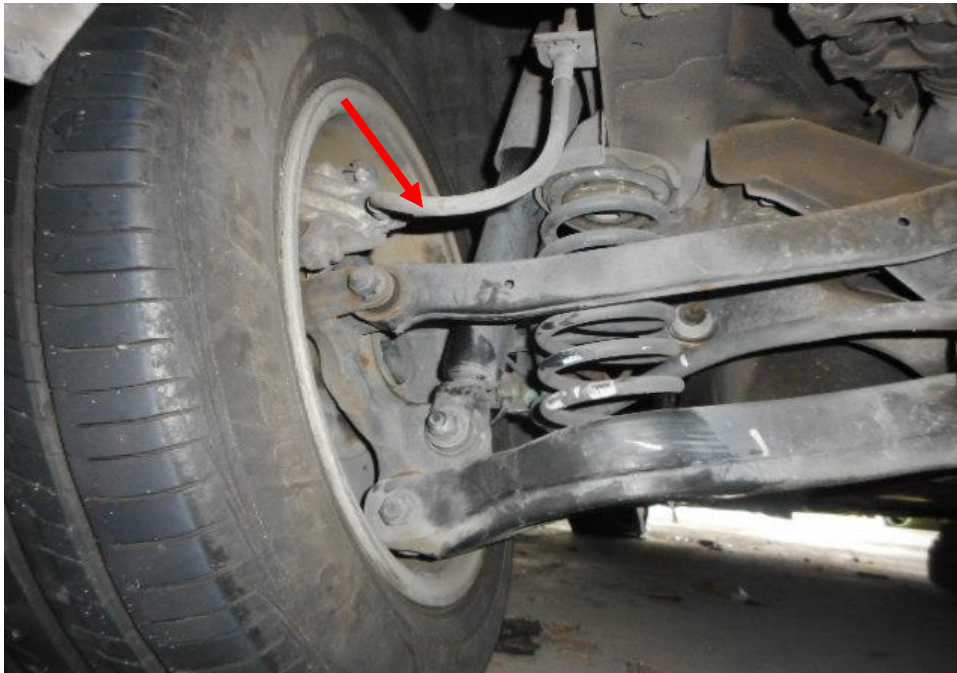
Photo 22 shows the brake hose/pipe (arrowed) at the rear left wheel of the Motor Car. No leakage of brake fluid was observed. Visual examination of the various components revealed to be intact and without visible damage.

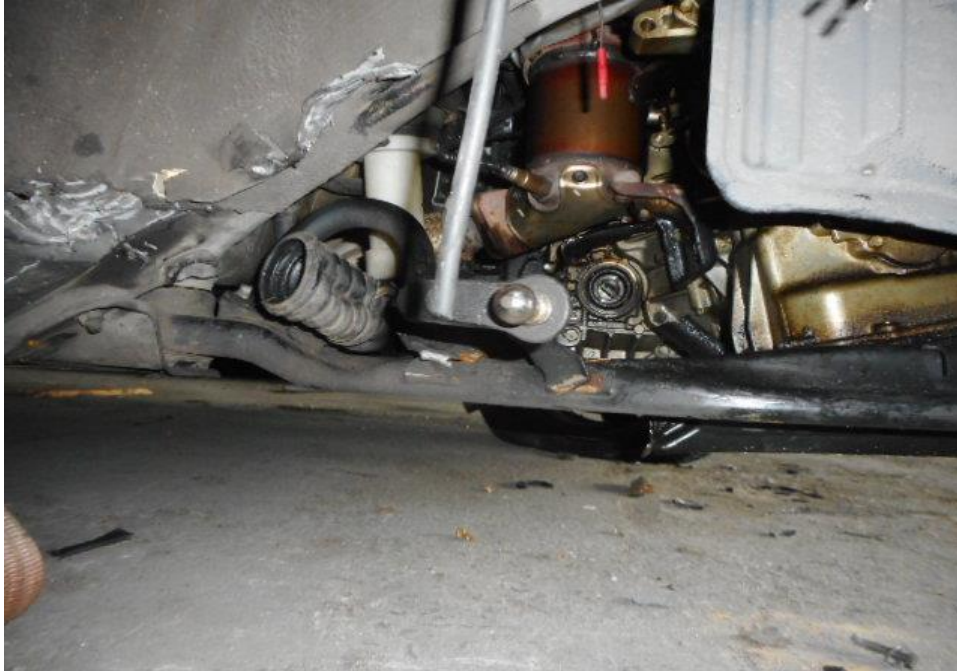
11. Static brake tests was not conducted on the Motor Car as the front right braking system was missing as a result of the accident. However our the visual inspection to the front left, rear left and right braking components observed to be intact and there was no sign(s) of brake fluid leakage along the brake hoses and brake pipes .
12. Static test on the steering system of the Motor Car was not conducted as we observed that the front right driveshaft and the tie rod was missing as a result of the accident. However, my visual examination of the other various steering components which had included the steering rack and pinion, the right tie rod ends and ball joints of the front left side revealed that these components were all generally intact. See photo 21 - 26 below.

Photo 23 shows the missing front right braking system due to the result of the accident.

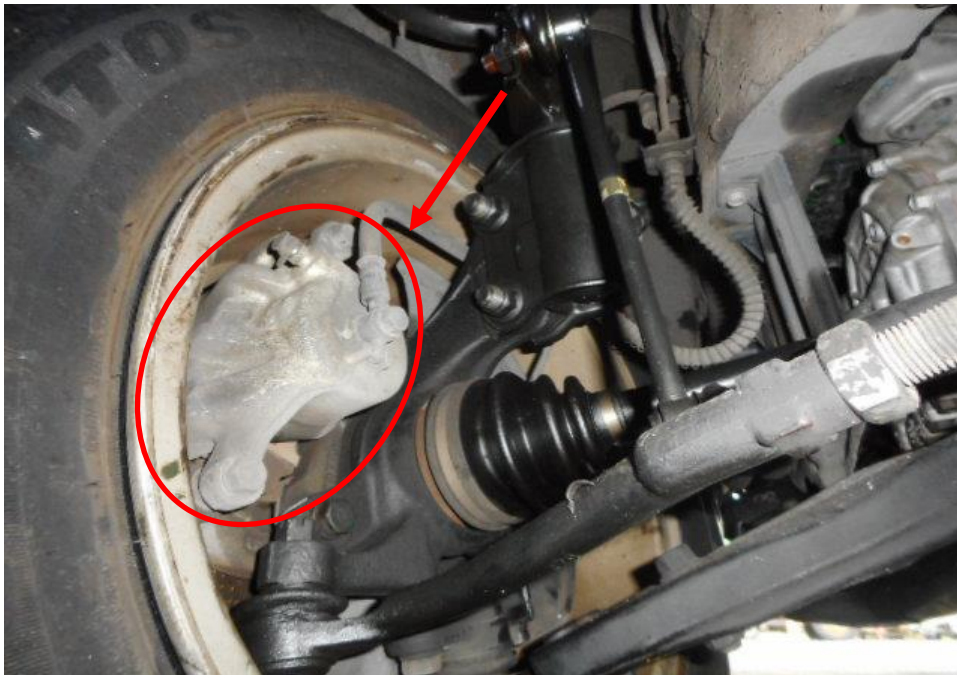
Photo 24 shows the brake hose/pipe (arrowed) at the front left wheel of the Motor Car. No leakage of brake fluid was observed. Visual examination of the various components of the braking system like the brake caliper (circled) revealed to be intact and without visible damage.

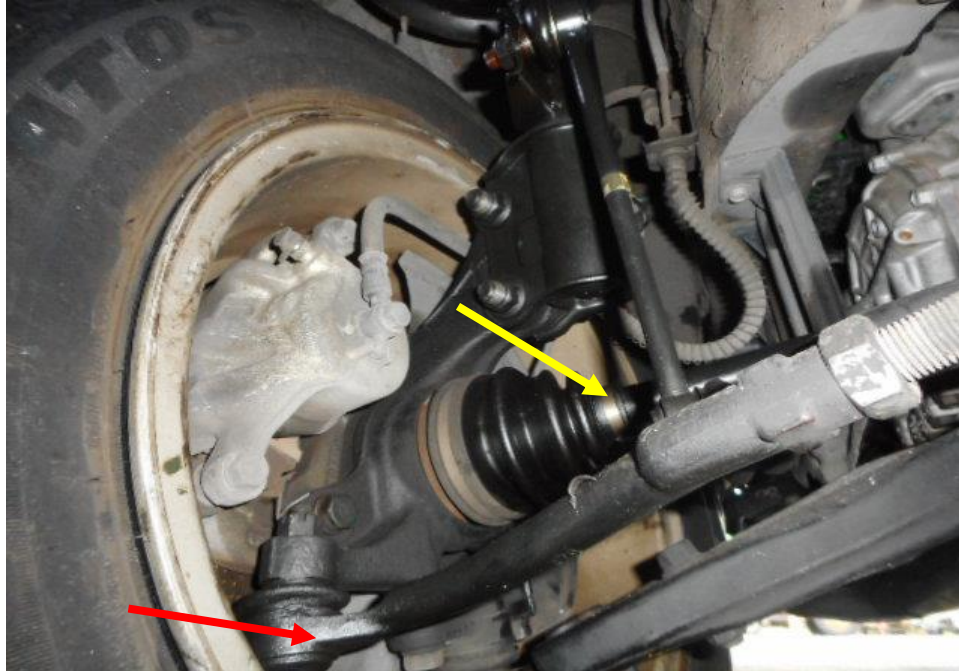
Photo 25 shows the various undercarriage components at the front left wheel of the Motor Car, in particular the steering tie rod (red arrow) and the driveshaft (yellow arrow). The various steering components were all found to be intact and undamaged by the accident.

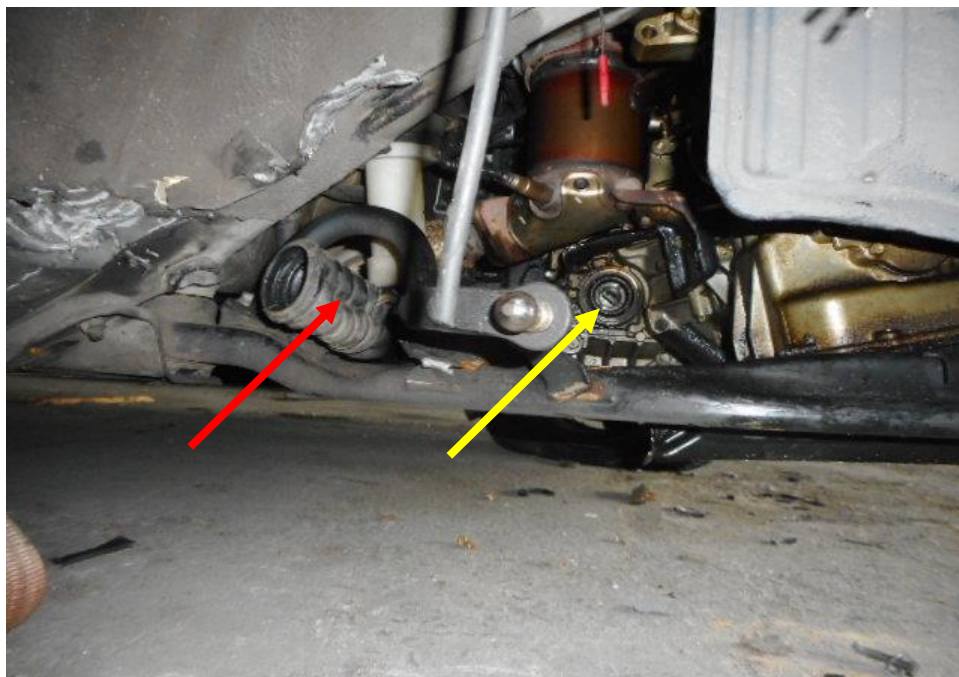
Photo 26 shows the various undercarriage components at the front right wheel of the Motor Car, in particular the steering tie rod (red arrow) and the right driveshaft (yellow arrow). The various steering components were all found to be missing as a result of the accident.

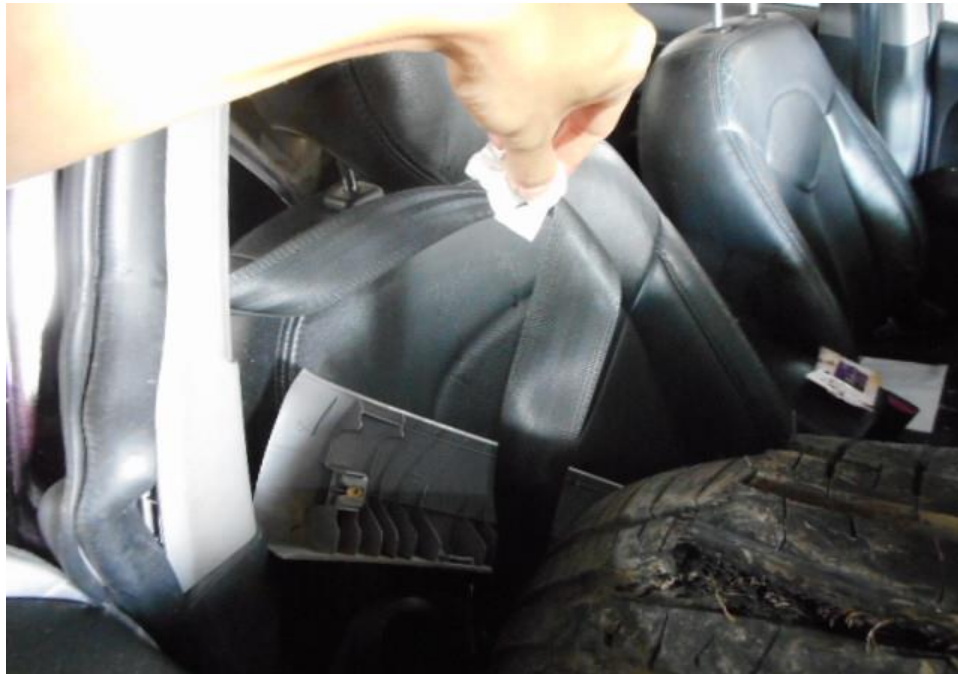
Photo 27 shows that the seat belt on the front right seat was worn at the material time of accident as the safety pre-tensioners were activated at the moment of impact and caused the seat belt to be locked into the last position.

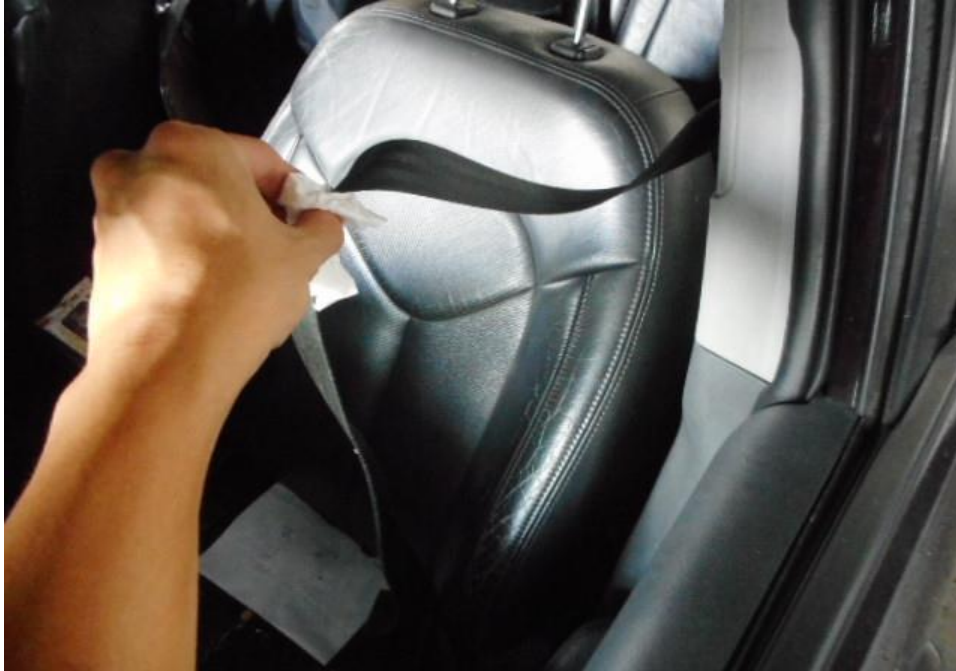
Photo 28 shows that the seat belt on the front left seat was worn at the material time of accident as the safety pre-tensioners was activated at the moment of impact and caused the seat belt to be locked into the last position.
