Your Ref: TP/IP/44019/2021
Our Ref : CI/TPD21010016/P

28th September 2021

MECHANICAL INSPECTION REPORT OF MOTOR CAR SMN 5166U

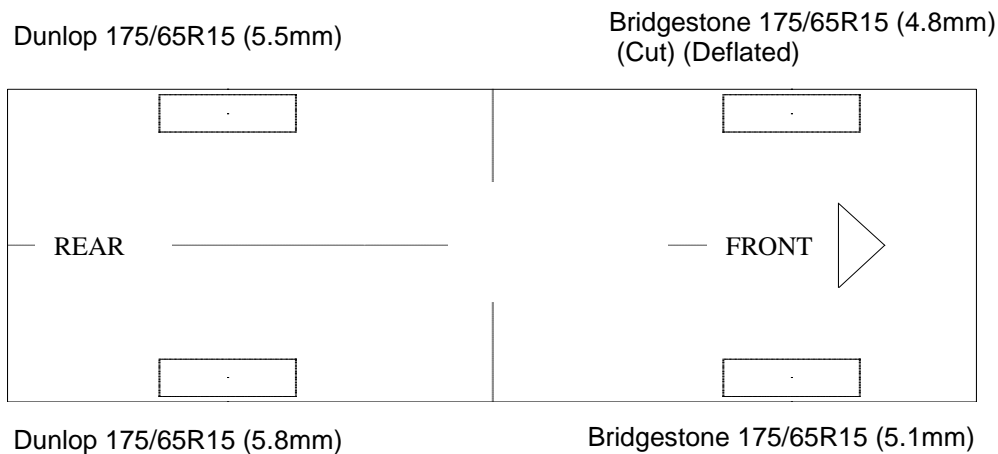
6. The condition of the Motor Car's front right tyre was observed to be in damaged as a result of the accident. However, the other 3 tyres was observed to be in serviceable condition. I did not find any tear, cut or burst mark(s) on the outer and the inner sidewalls as well as across the tread of the 3 tyres. The 3 tyres were also observed to be sufficiently inflated for vehicular operation. The tyre brand, tyre size and remaining tread depth of the 4 tyres were recorded as follows:-

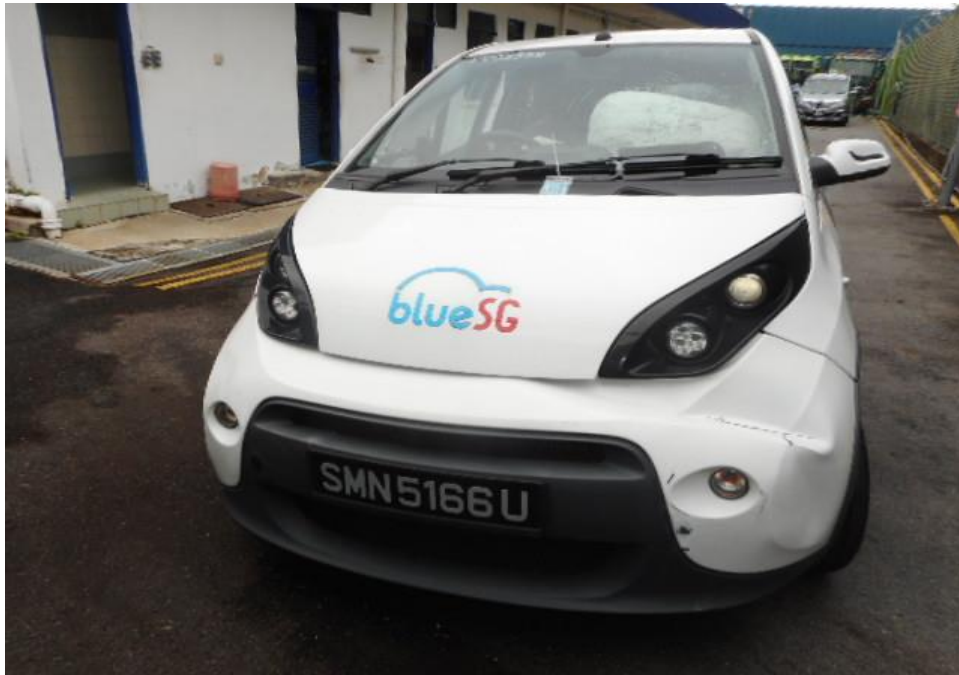
Photo 1 shows a general view of the Motor Car's front body at the time of my inspection. The Motor Car was observed to have sustained damage at its front and left portion. Its front windscreen, front bumper and front right fender were amongst the body parts that were damaged as a result of the accident.

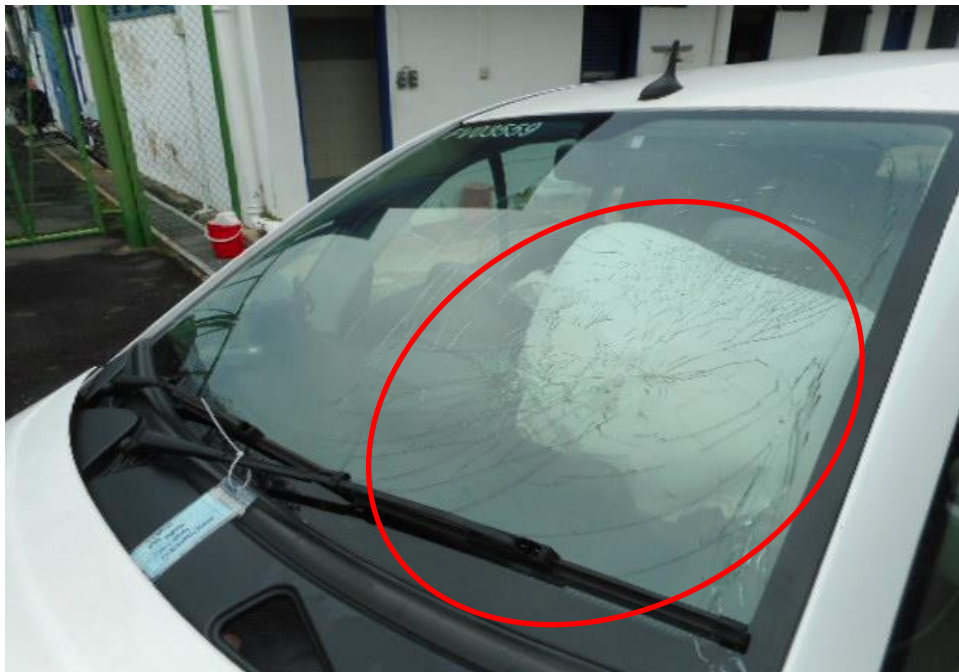
Photo 2 shows the close up view of the Motor Car's front body at the time of my inspection. The Motor Car was observed to have sustained damage at its front portion. Its front windscreen (circled) were amongst the body parts that were damaged as a result of the accident.

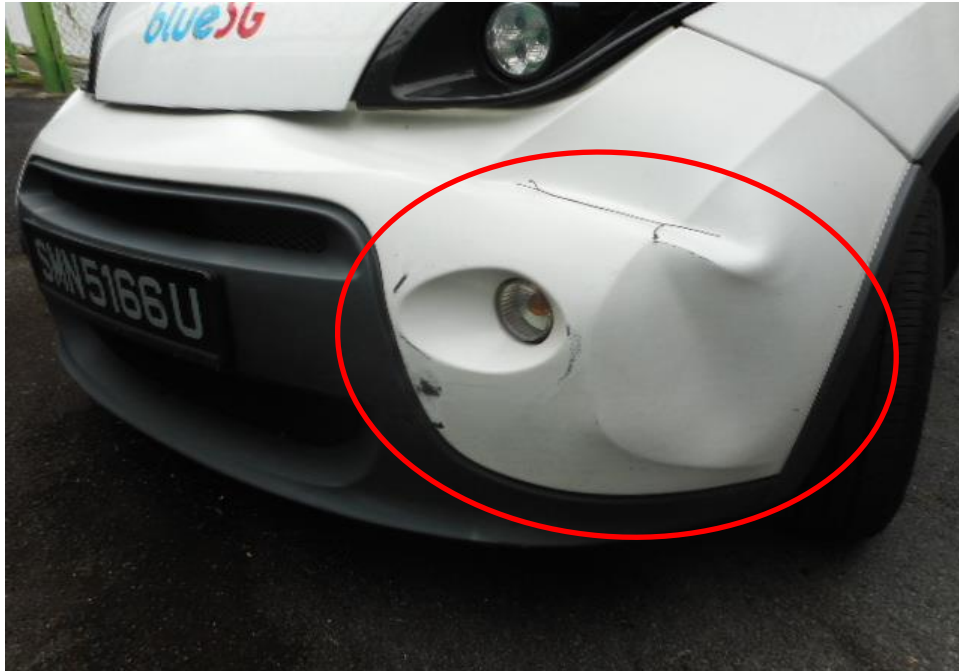
Photo 3 shows the close up view of the Motor Car's front body at the time of my inspection. The Motor Car was observed to have sustained damage at its front portion. Its front bumper (circled) were amongst the body parts that were damaged as a result of the accident.

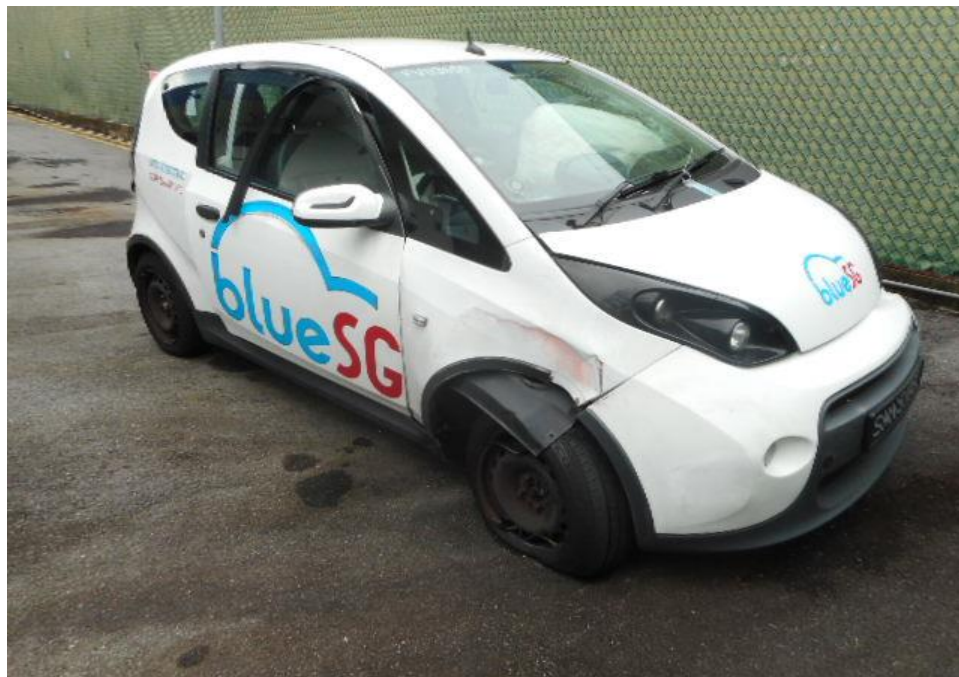
Photo 4 shows a general view of the Motor Car's front body at the time of my inspection. The Motor Car was observed to have sustained damage at its front portion. Its front right fender were amongst the body parts that were damaged as a result of the accident.

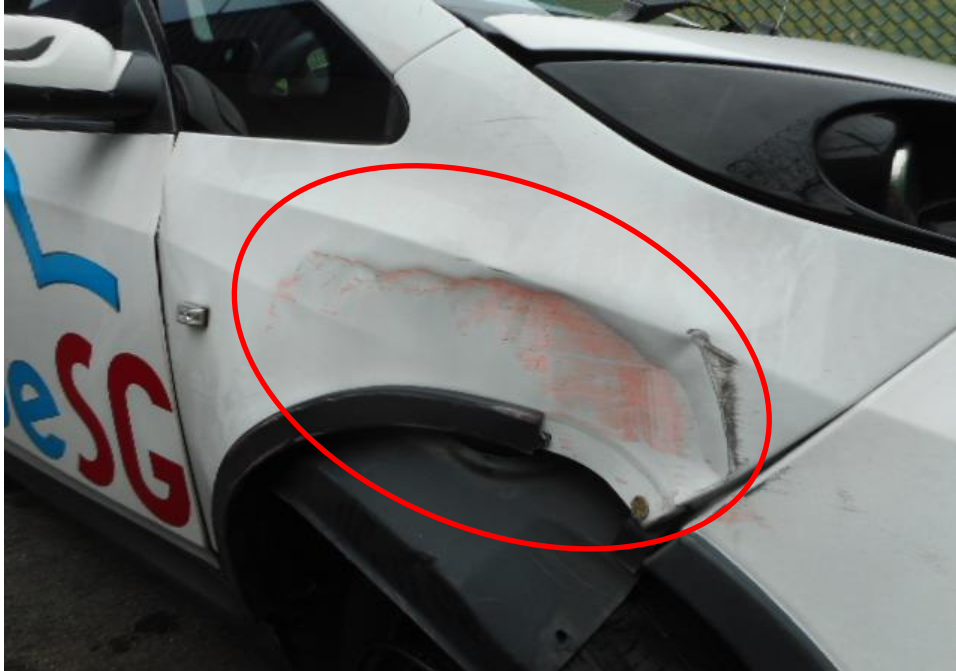
Photo 5 shows a general view of the Motor Car's front body at the time of my inspection. The Motor Car was observed to have sustained damage at its front portion. Its front right fender (circled) were amongst the body parts that were damaged as a result of the accident.

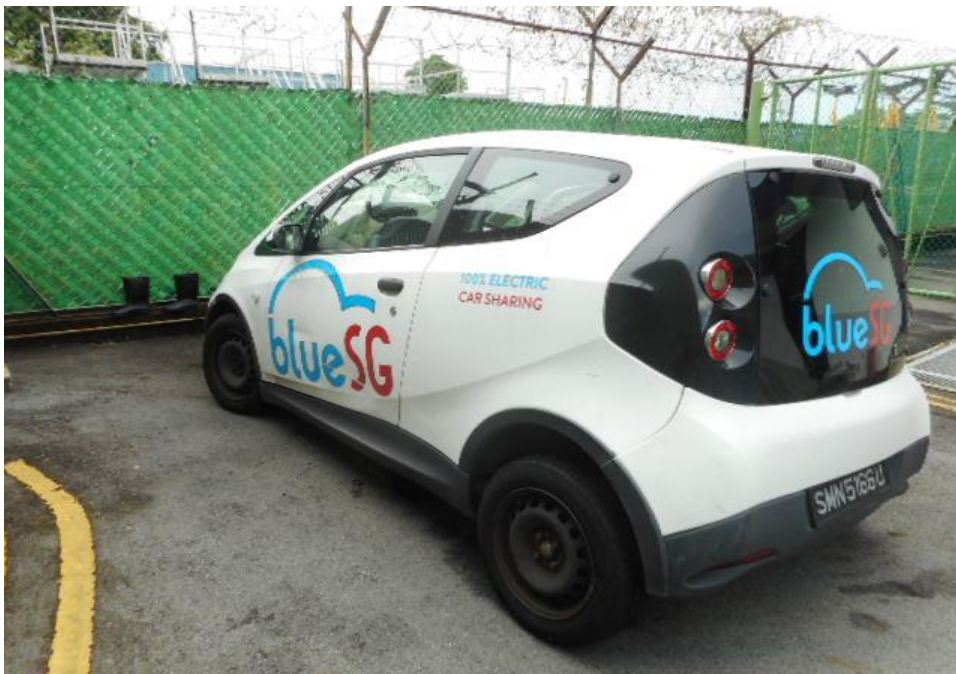
Photo 6 shows a general view of the Motor Car's left body at the time of my inspection. The Motor Car left was observed to be unaffected by the accident.

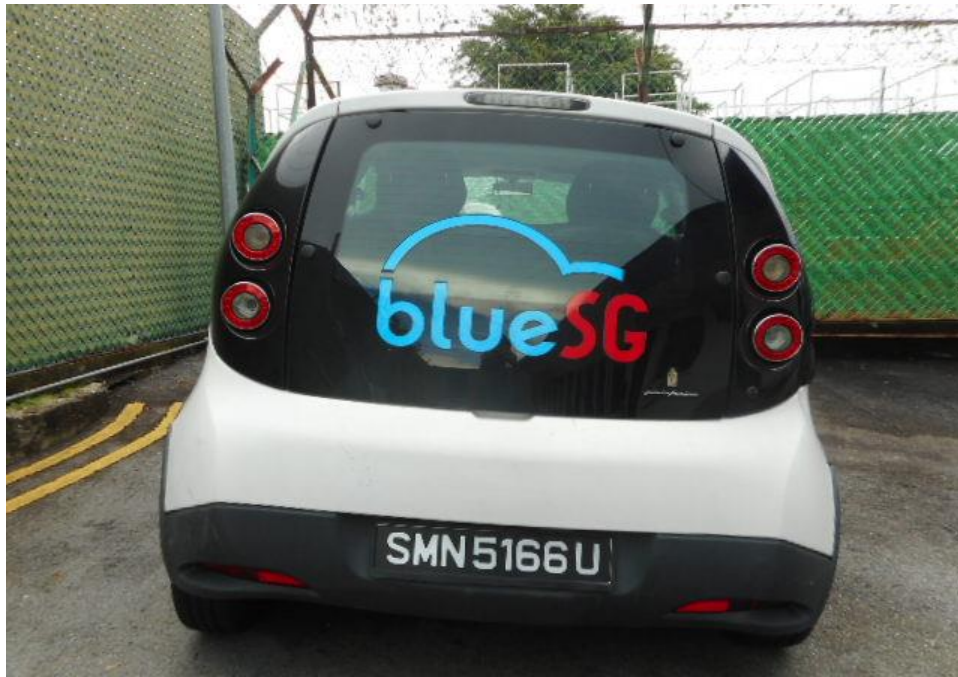
Photo 7 shows the general view of the Motor Car's rear body at the time of my inspection. The Motor Car rear was observed to be unaffected by the accident.

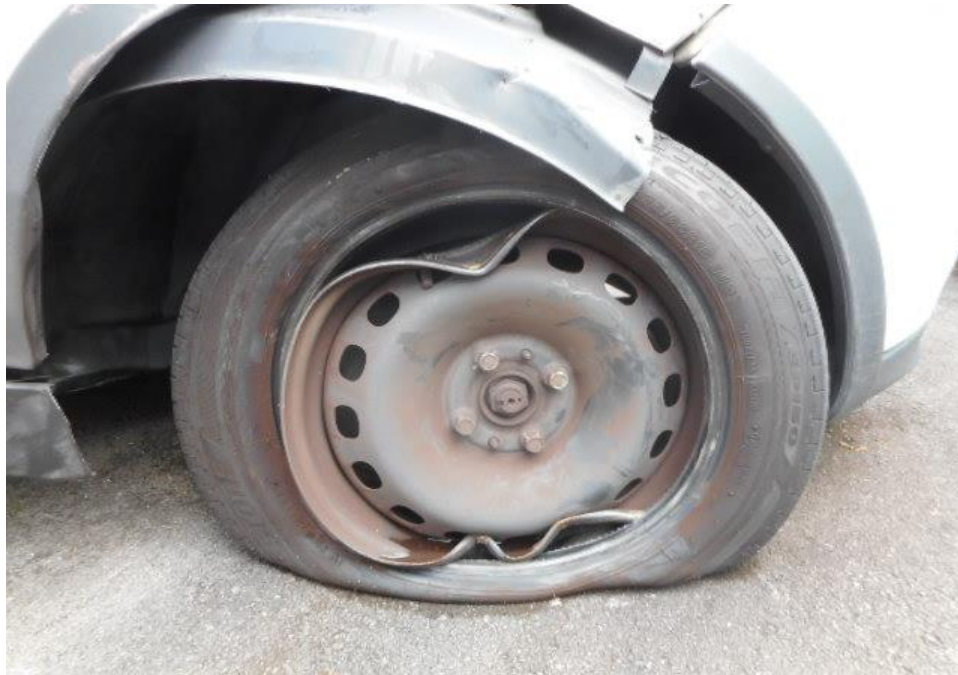
Photo 8 shows the condition of the front right tyre of the Motor Car, which was observed to be unserviceable condition with remaining tread depth of approximately 5.1mm. The tyre was observed with cut mark(s) on the outer sidewalls and there was damage observed on the wheel rims as a result of the accident.

19. The front right tyre and rim of the Motor Car were found to be damaged as a result of the accident. However, the other 3 tyres were found to be serviceable condition as I did not find any tear, cut or burst mark(s) on the outer and the inner sidewalls as well as across the tread of the 3 tyres. The 4 tyres were also observed with remaining tread depth of approximately 4.8mm to 5.8mm.

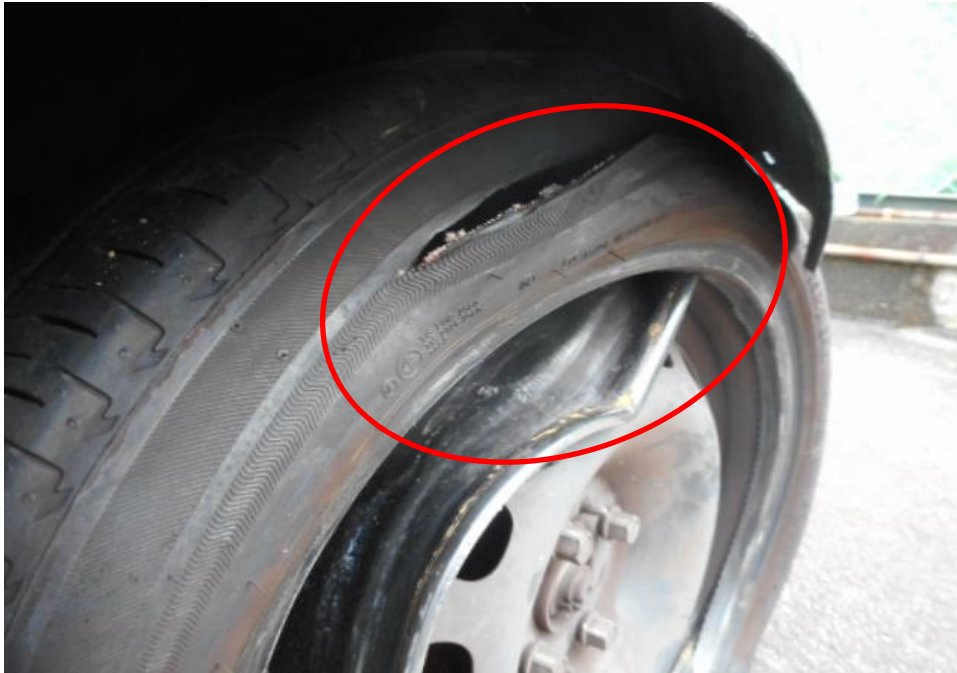
Photo 9 shows the close up view of the condition of the front right tyre of the Motor Car, which was observed to be unserviceable condition. The tyre was observed with cut mark(s) on the outer sidewalls and there was damage observed on the wheel rims (circled) as a result of the accident.

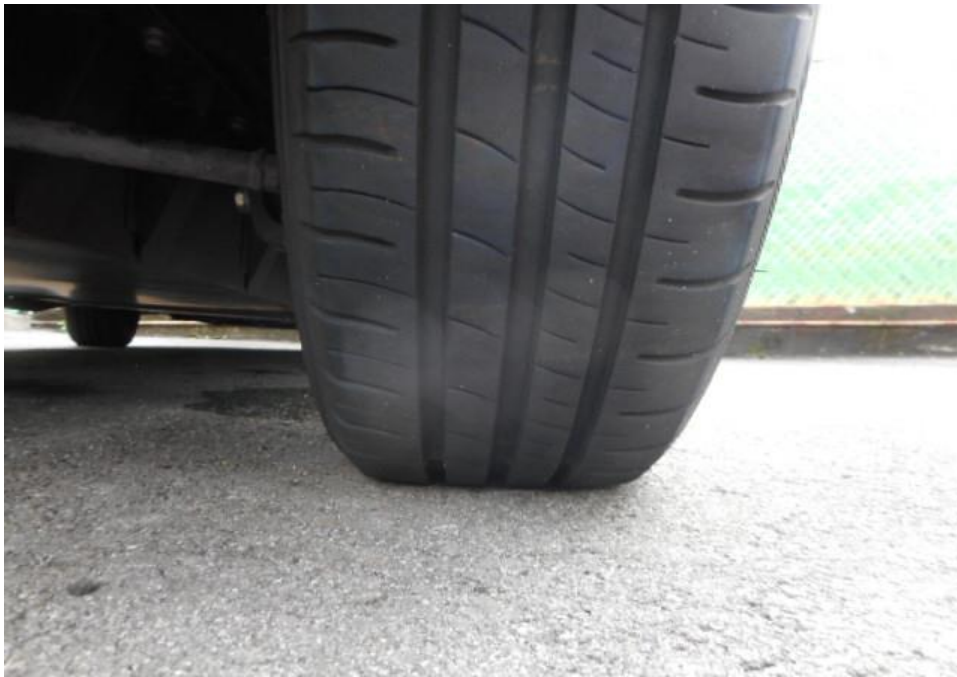
Photo 10 shows the condition of the rear right tyre of the Motor Car, which was observed to be in serviceable condition with remaining tread depth of approximately 5.8mm. The tyre was observed with cut marks and wheel rim damage as a result of the accident, however it was observed to be sufficiently inflated for vehicular operation

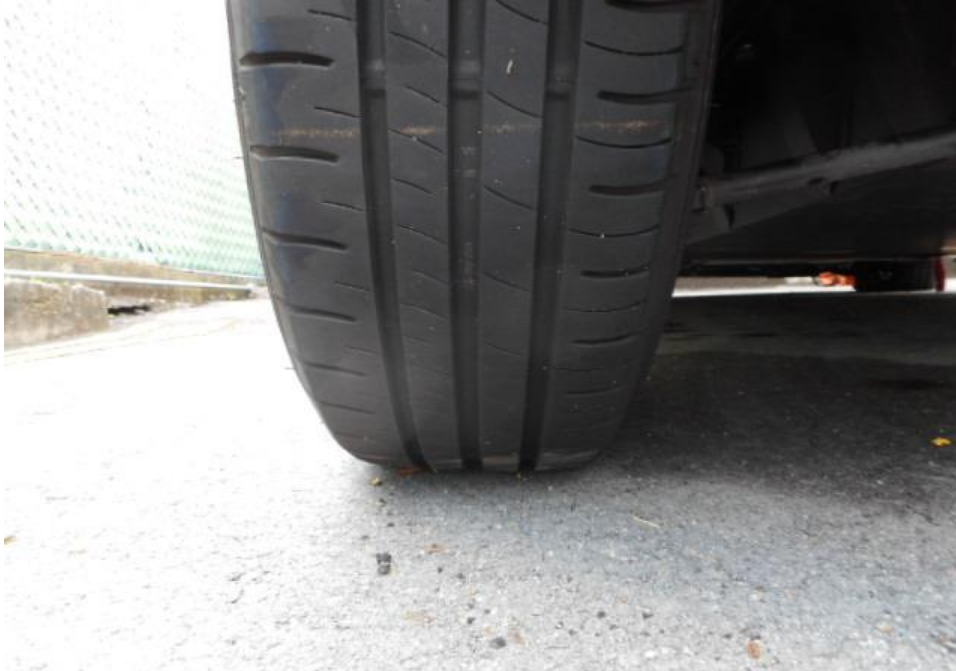
Photo 11 shows the condition of the rear left tyre of the Motor Car, which was observed to be in serviceable condition with remaining tread depth of approximately 5.5mm. The tyre was observed with cut marks and wheel rim damage as a result of the accident, however it was observed to be sufficiently inflated for vehicular operation

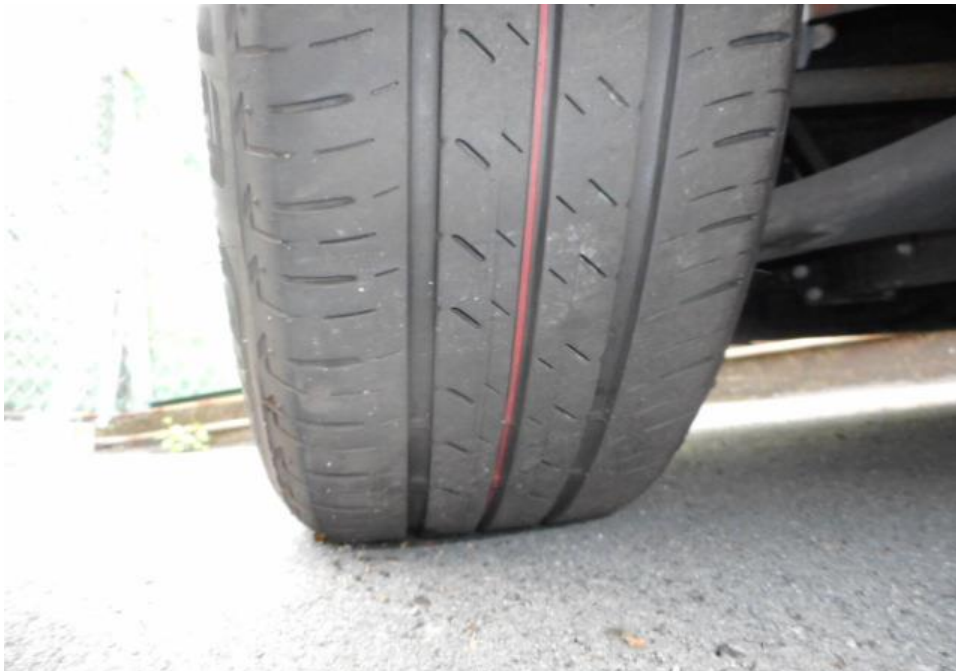
Photo 12 shows the condition of the front left tyre of the Motor Car, which was observed to be in serviceable condition with remaining tread depth of approximately 4.8mm. The tyre was observed with cut marks and wheel rim damage as a result of the accident, however it was observed to be sufficiently inflated for vehicular operation

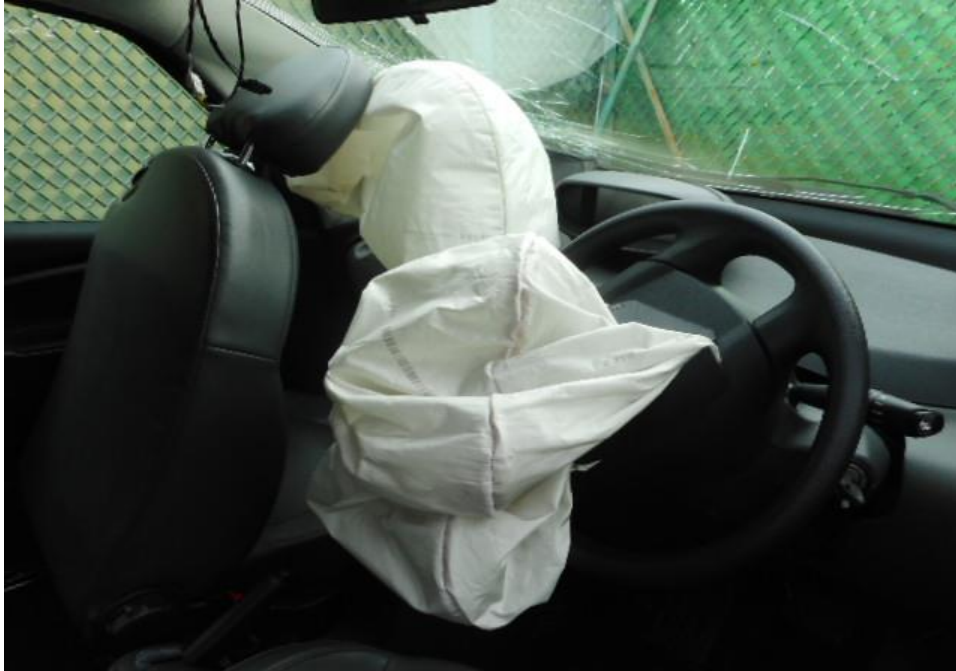
Photo 13 shows the deployment of the Supplemental Restraint System (SRS) airbag in the Motor Car as a result of the accident.

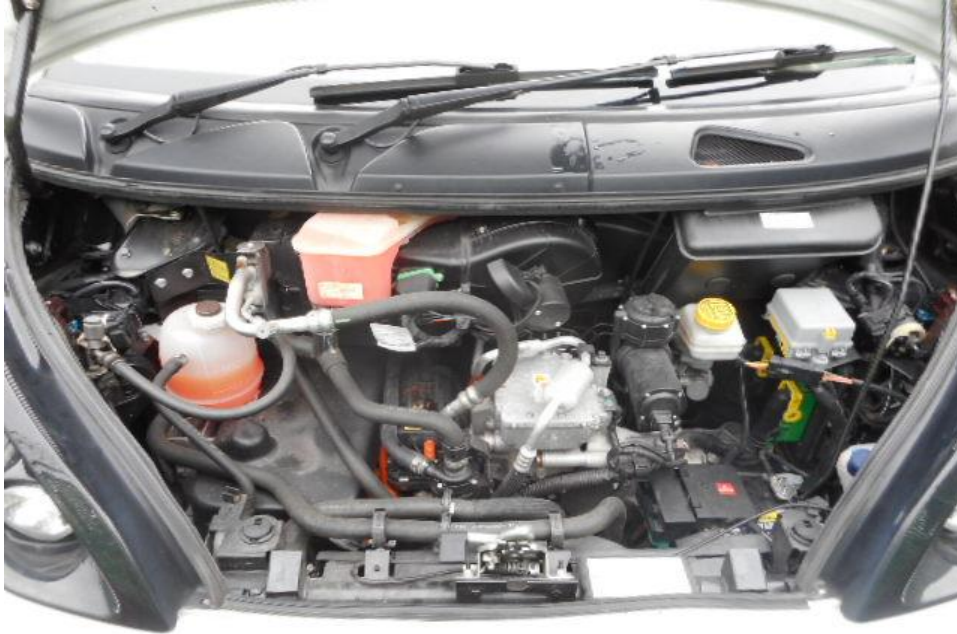
Photo 13 shows a general view of the Motor Car's engine compartment. The various parts and components inside the engine compartment were unaffected by the accident. There was also no sign(s) or indication(s) of fluid leakage and/or fluid stain within the engine compartment.

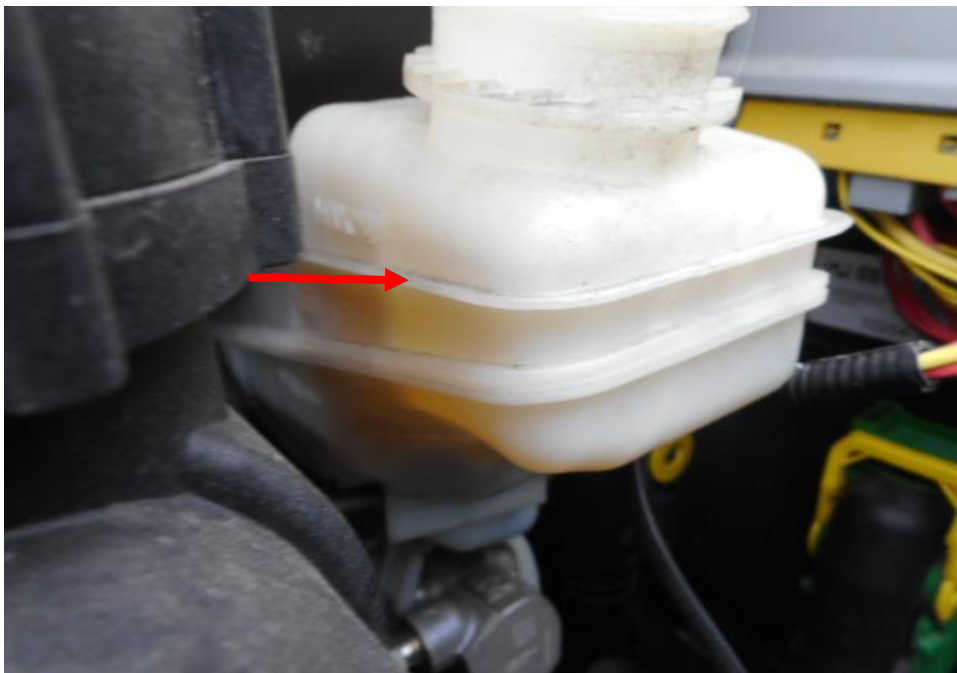
Photo 14 shows the brake fluid reservoir of the Motor Car at the time of my inspection. The brake fluid was observed to be of sufficient level (arrowed) and without any visible contamination.

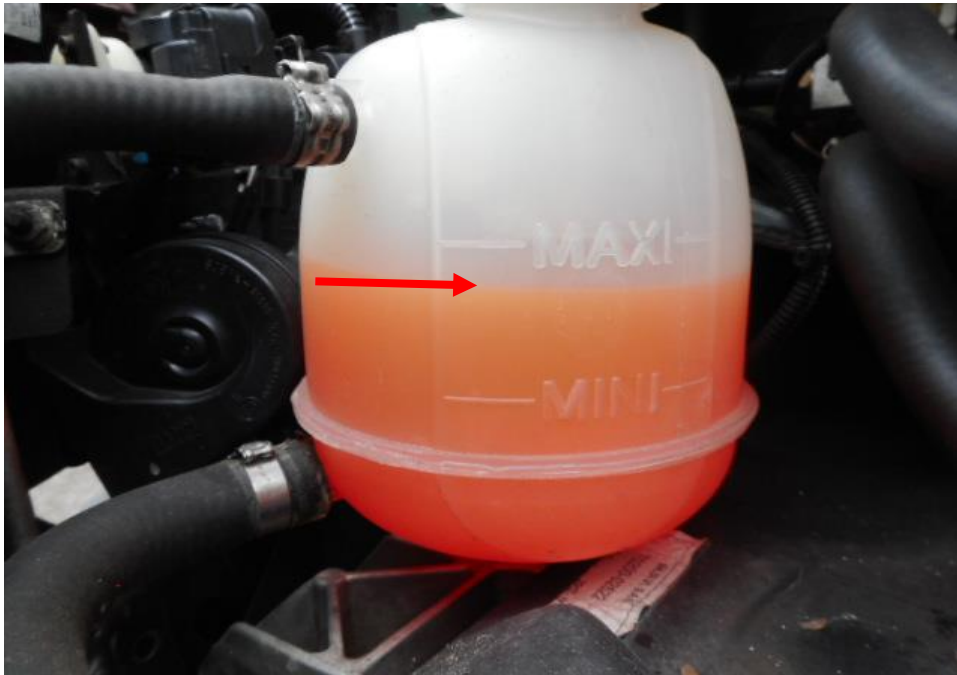
Photo 15 shows checks being carried out to the engine coolant of the Motor Car at the time of my inspection. The engine coolant was observed to be of sufficient level (arrowed) and without any visible contamination.

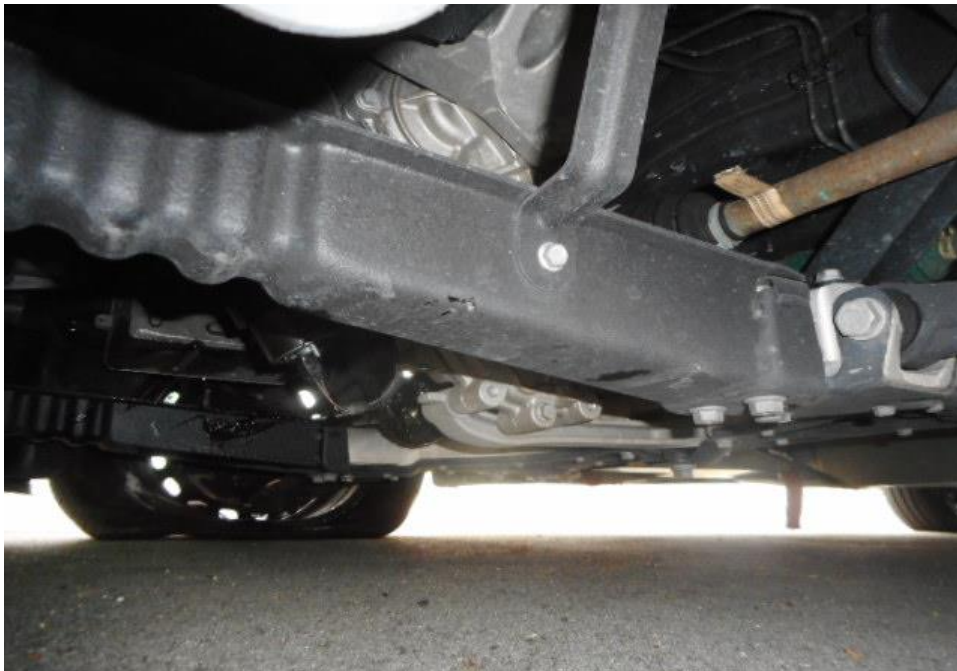
Photo 16 shows the undercarriage of the Motor Car, at the area where the engine housing and transmission housing are located. I did not find any sign(s) or indication(s) of fluid leak and/or fluid stain(s) on the underside of the Motor Car.

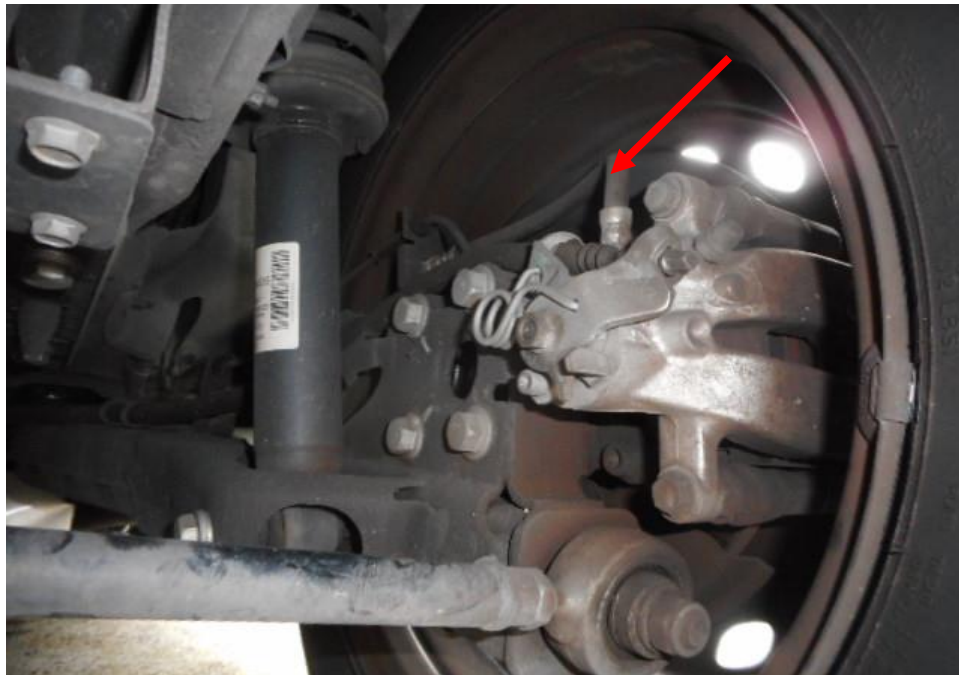
Photo 17 shows the brake hose/pipe (arrowed) at the rear right wheel of the Motor Car. No leakage of brake fluid was observed. Visual examination of the various components of the braking system like the drum brake, brake booster, brake pedal etc. had revealed all to be intact and without visible damage.

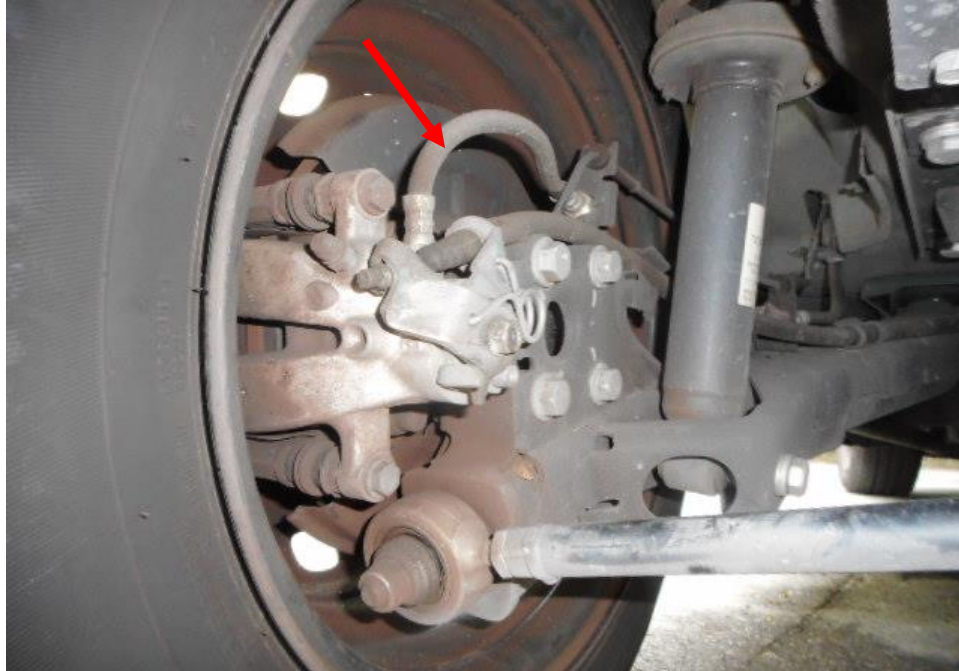
Photo 18 shows the brake hose/pipe (arrowed) at the rear left wheel of the Motor Car. I did not observe any leakage of brake fluid at the time of my inspection of the Motor Car. The undercarriage components of the Motor Car were also all found to be intact and without any visible damage.

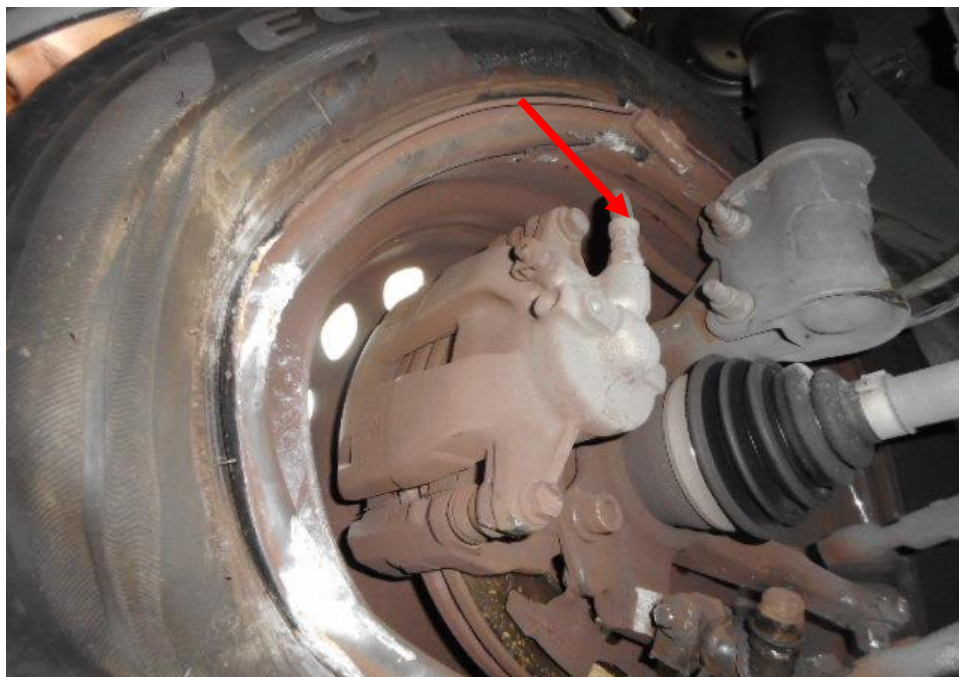
Photo 19 shows the brake hose/pipe (arrowed) at the front right wheel of the Motor Car. I did not observe any leakage of brake fluid at the time of my inspection of the Motor Car. The undercarriage components of the Motor Car were also all found to be intact and without any visible damage.

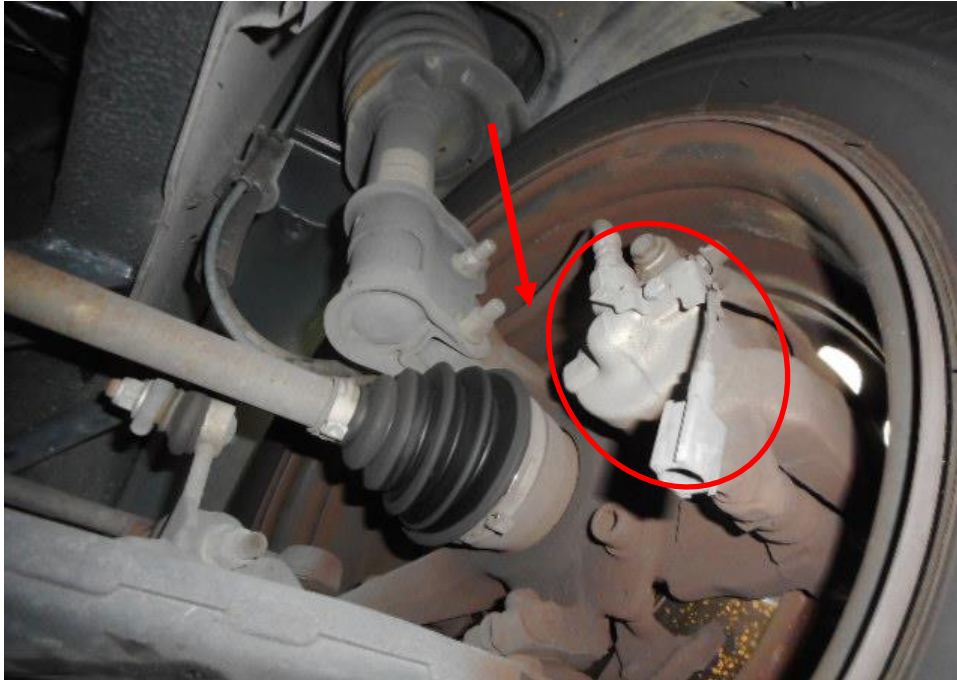
Photo 20 shows the brake hose/pipe (arrowed) at the front left wheel of the Motor Car. No leakage of brake fluid was observed. Visual examination of the various components of the braking system like the brake caliper (circled), brake booster, brake pedal etc had revealed all to be intact and without visible damage.

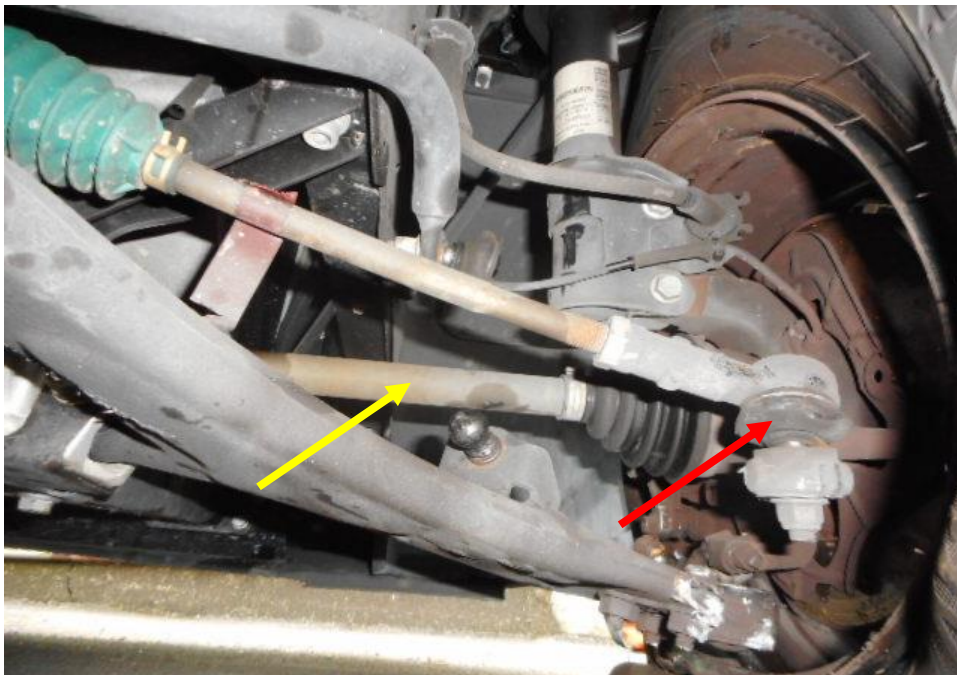
Photo 21 shows the various undercarriage components at the front right wheel of the Motor Car, in particular the steering tie rod (red arrow) and its driveshaft (yellow arrow). The various steering components were all found to be intact. There was also no sign of fluid stain observed on the various undercarriage components at the front right wheel of the Motor Car.

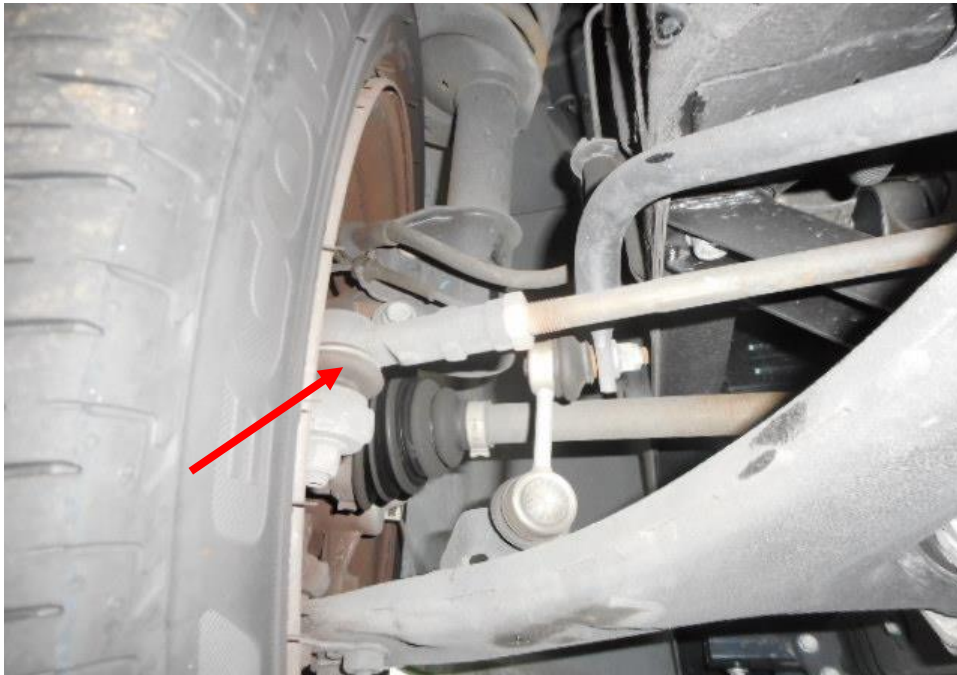
Photo 22 shows the various undercarriage components at the front left wheel of the Motor Car, in particular the steering tie rod (red arrow). The various steering components were all found to be intact. There was also no sign of fluid stain observed on the various undercarriage components at the front right wheel of the Motor Car.

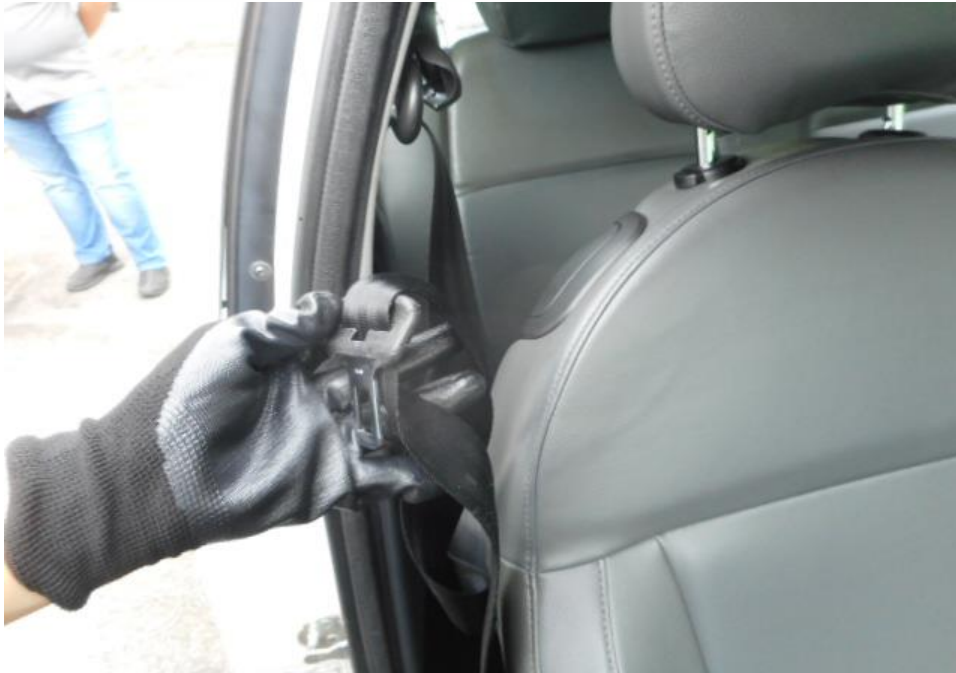
Photo 23 shows that the seat belt on the right seat was worn at the material time of accident as the safety pre-tensioners was activated at the moment of impact and caused the seat belt to be locked into the last position.

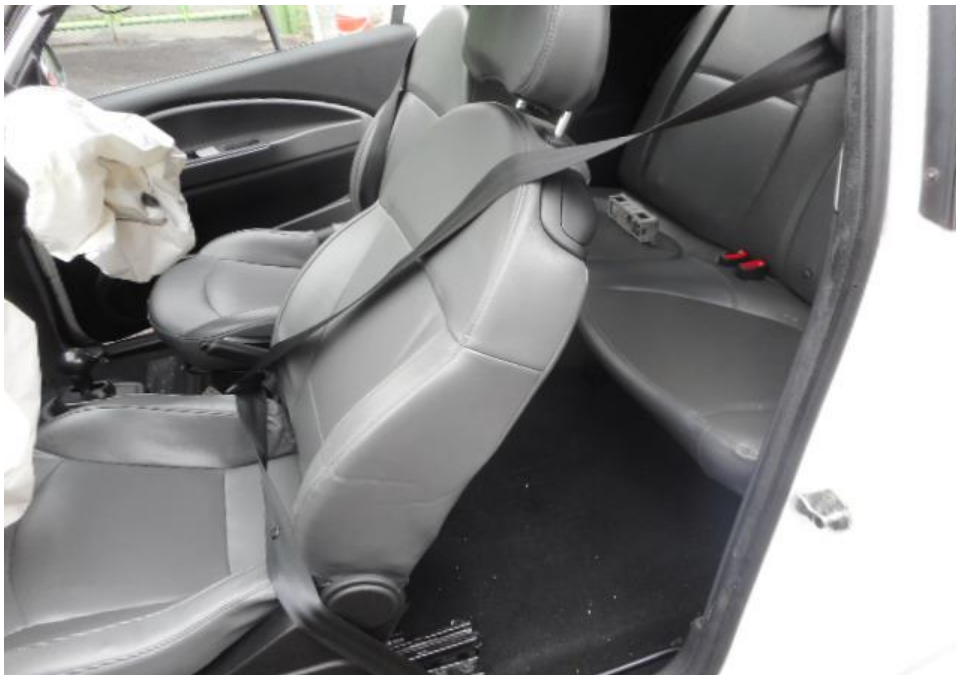
Photo 24 shows that the seat belt on the left seat tested and were able to be fastened securely into the respective pre-tensioners that were fitted at the sides of each seat.
