Your Ref: TP/IP/26221/2021
Our Ref : CI/TPD21010017/P

MECHANICAL INSPECTION REPORT OF PRIME MOVER, XE 2159C

1. I refer to your request on 22nd September 2021 to conduct a physical inspection of a Prime Mover bearing registration number XE 2159C (herein referred to as "**Prime Mover**"), which was involved in a fatal road traffic accident on 28th May 2021.
2. The objective of this inspection is to determine if there was any possible mechanical failure to the Prime Mover that may have contributed to the accident.
3. Following the request, I had carried out a physical inspection of the Prime Mover on 26th October 2021 at the premises of Traffic Police vehicle pound, 517 Airport Road Singapore 539942. I now set out below my observations and comments with respect to this inspection.

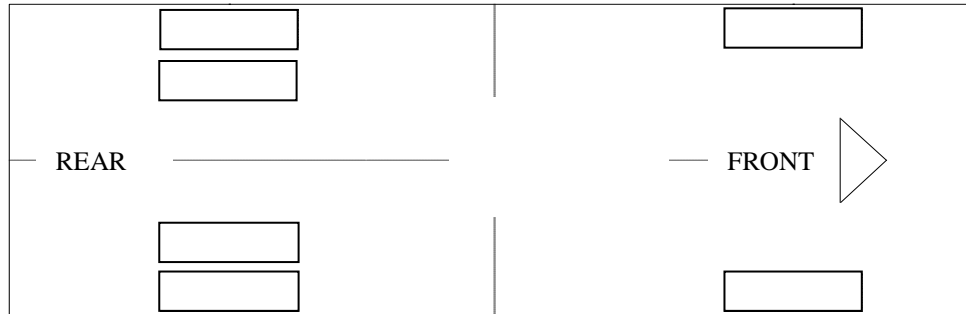
6. The 2 front tyres and 4 rear tyres of the Prime Mover were observed to be in serviceable condition and sufficiently inflated for vehicular operation. I did not find any tear, cut or burst mark(s) on the outer and the inner sidewalls as well as across the tread of the 6 tyres of the Prime Mover. The tyre brand, tyre size and remaining tread depth of the 6 tyres of the Prime Mover were recorded as follows:-

Hilo 295/80 R22.5 (8.9mm)

Hankook 295/80 R22.5 (12.7mm)

Hilo 295/80 R22.5 (11mm)

Hankook 295/80 R22.5 (12.4mm)

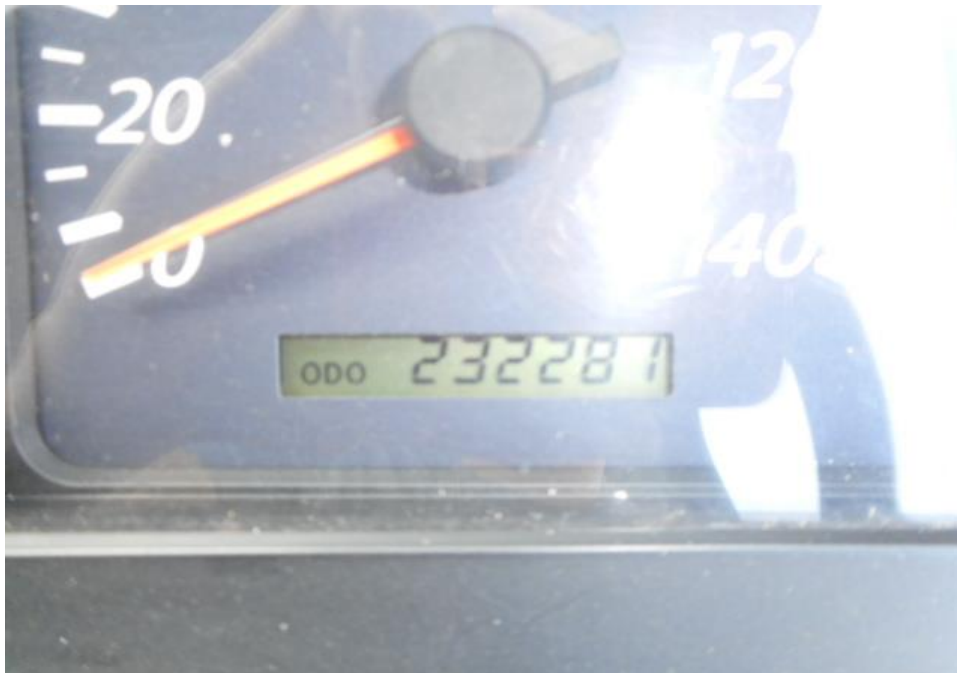
Photo 1 shows a general view of the instrument cluster of the Prime Mover at the time of my inspection. The mileage of the Prime Mover was 232,281km

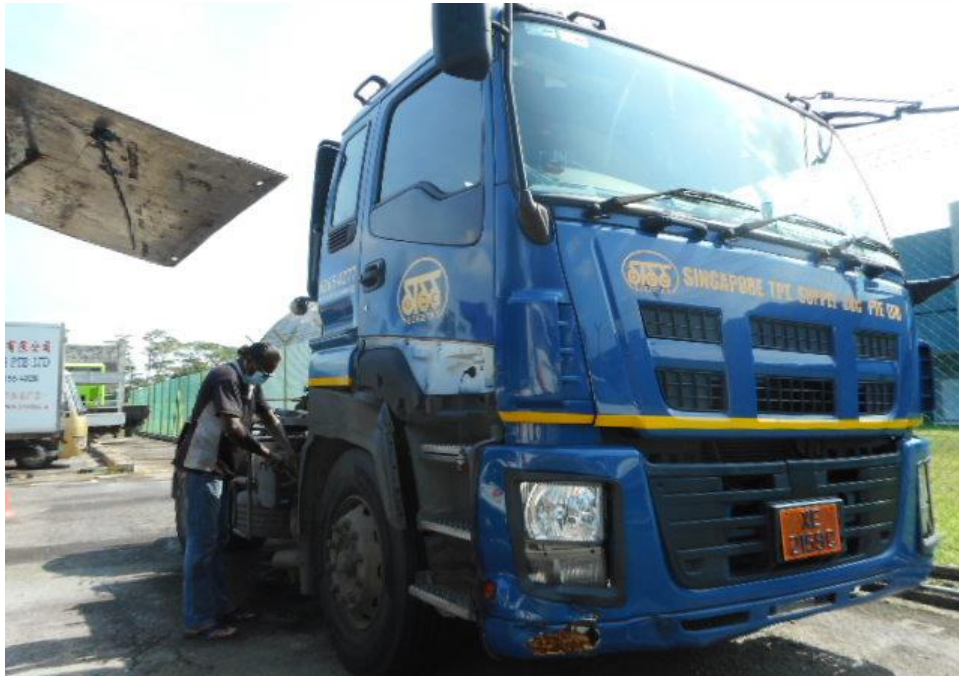
4. The mileage of the Prime Mover at the time of my inspection was 232,281km.
5. The Prime Mover was observed to have sustained damage at its right portion. Its right door panel was the body part that were damaged as a result of the accident.

Photo 2 shows a general view of the right body of the Prime Mover at the time of my inspection. The right portion of the Prime Mover was observed to sustained damage at the time of inspection. Its right door panel was amongst the body parts that were damaged as a result of the accident.

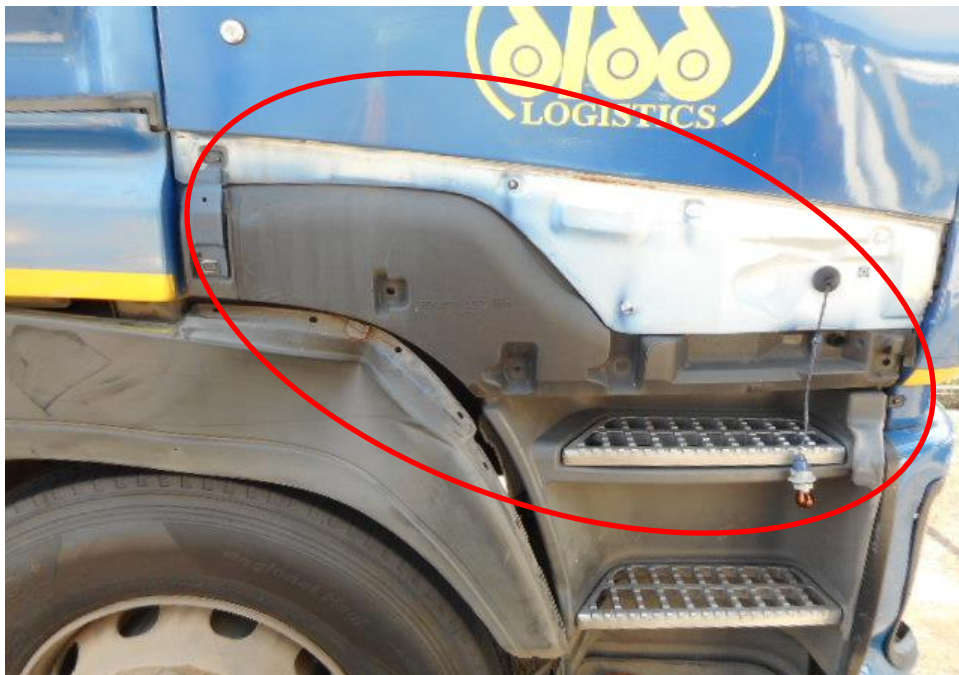
Photo 3 shows a close up view of the right body of the Prime Mover at the time of my inspection. The right portion of the Prime Mover was observed to sustained damage at the time of inspection. Its right door panel (circled) was amongst the body parts that were damaged as a result of the accident.

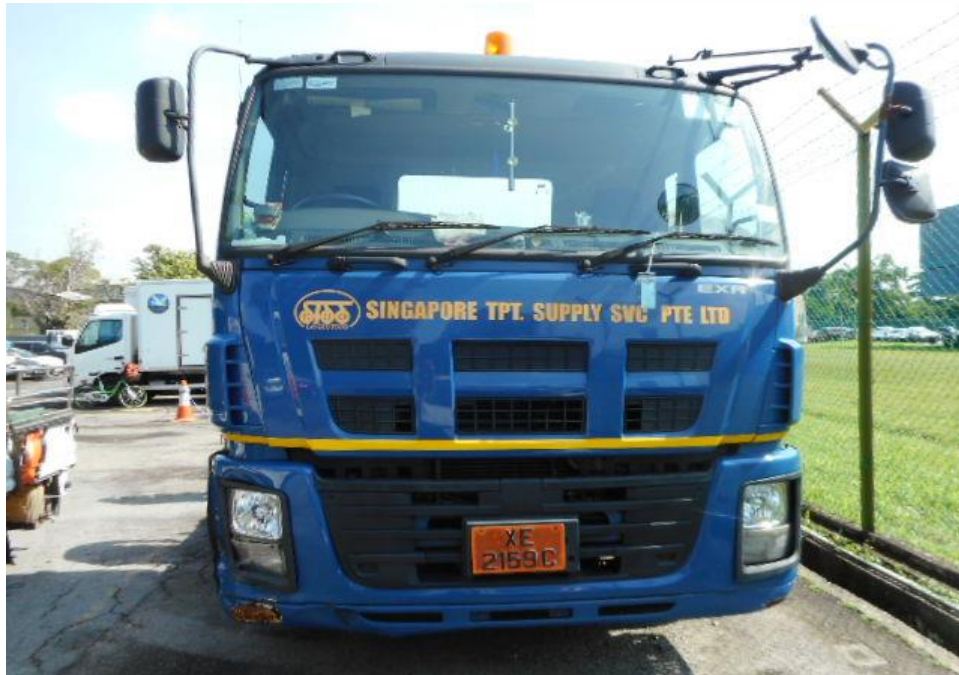
Photo 4 shows a general view of the front body of the Prime Mover at the time of my inspection. The Prime Mover was observed to be intact and unaffected by the accident.

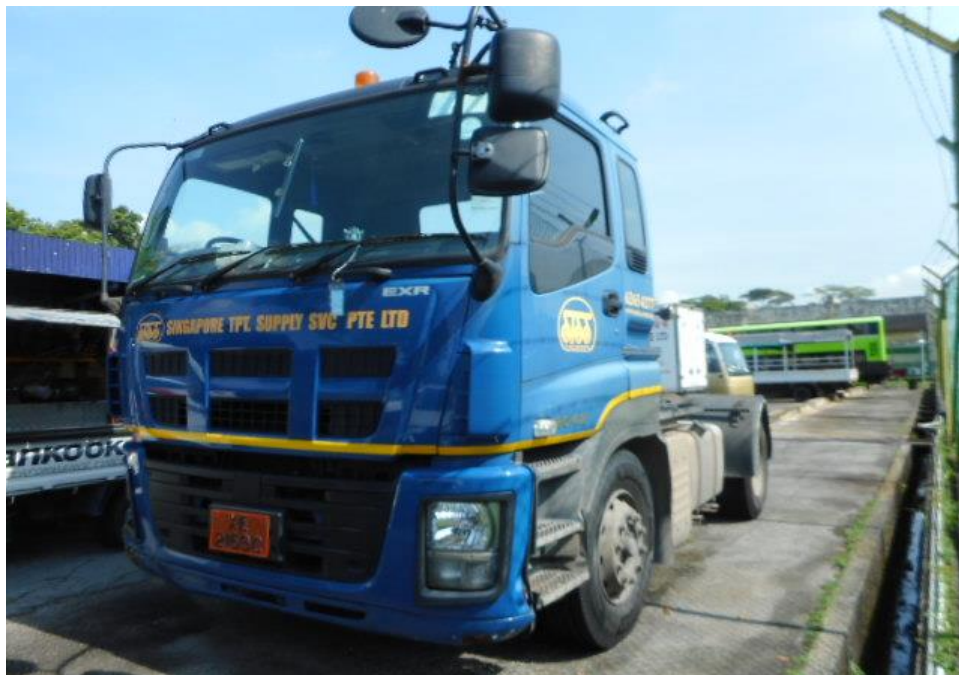
Photo 5 shows a general view of the front left body of the Prime Mover at the time of my inspection. The Prime Mover was observed to be intact and unaffected by the accident.

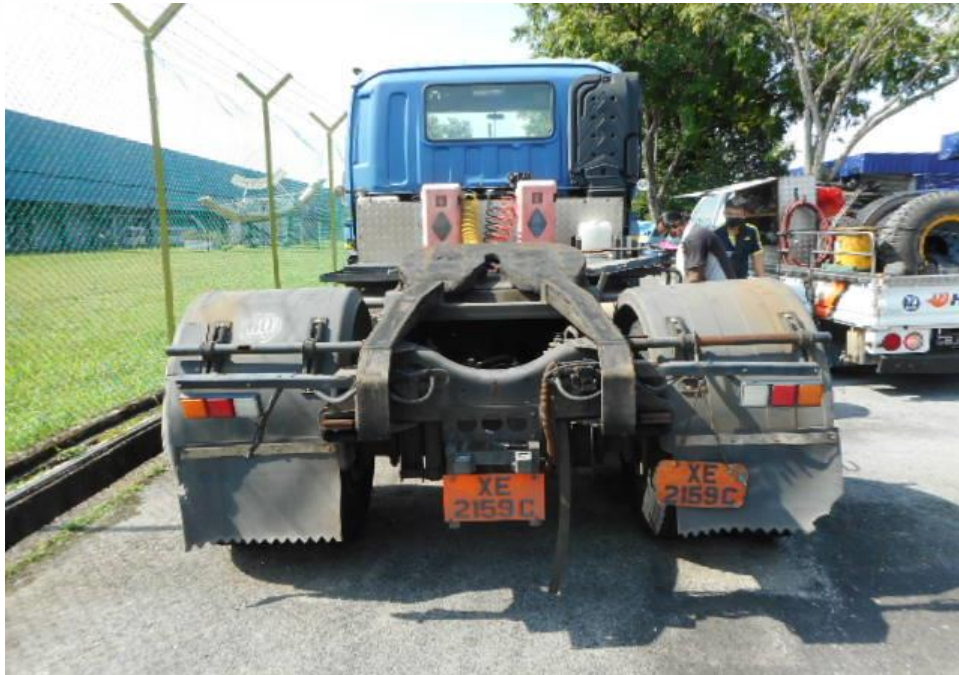
Photo 6 shows a general view of the Prime Mover's rear body at the time of my inspection. The Prime Mover was observed to be intact and unaffected by the accident.

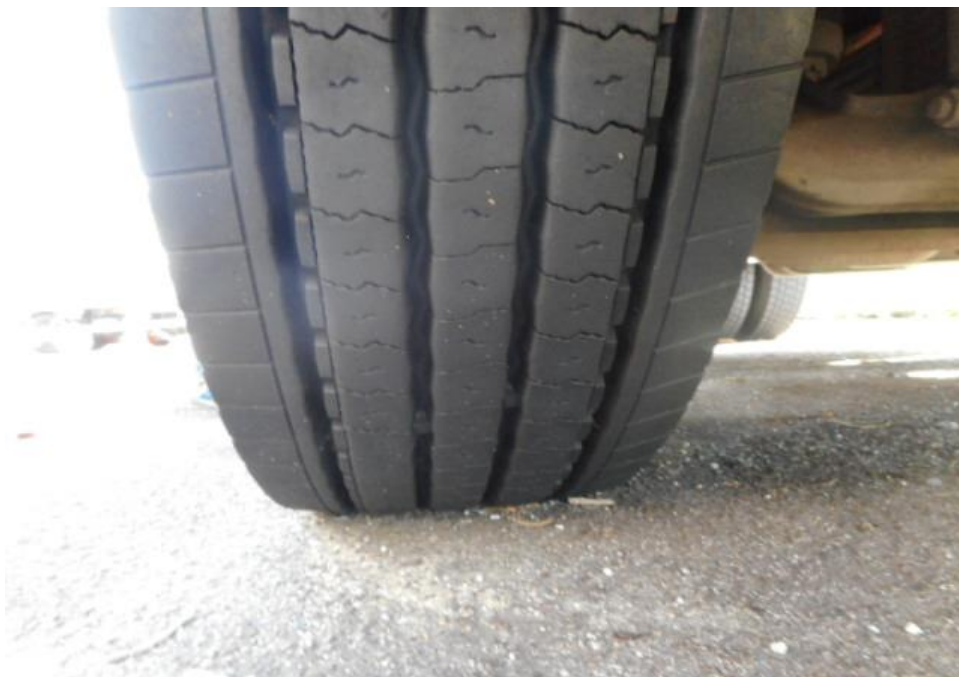
Photo 7 shows the condition of the front right tyre of the Prime Mover, which was observed to be in serviceable condition with remaining tread depth of approximately 12.4mm. The tyre, which was wrapped around standard steel wheel rim, was also observed to be sufficiently inflated for vehicular operation. There was no tear, cut or burst mark(s) on the outer and the inner sidewalls as well as across the tread of the 6 tyres that were fitted on the Prime Mover.

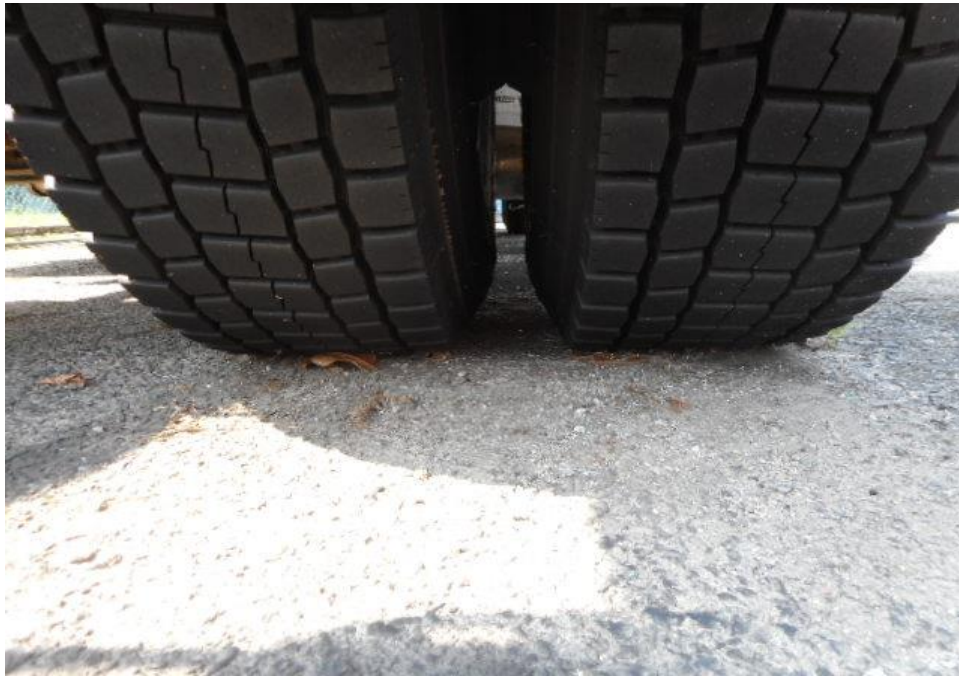
Photo 8 shows the condition of the rear right tyre of the Prime Mover, which was observed to be in serviceable condition with remaining tread depth of approximately 11mm. The tyre, which was wrapped around standard steel wheel rim, was also observed to be sufficiently inflated for vehicular operation.

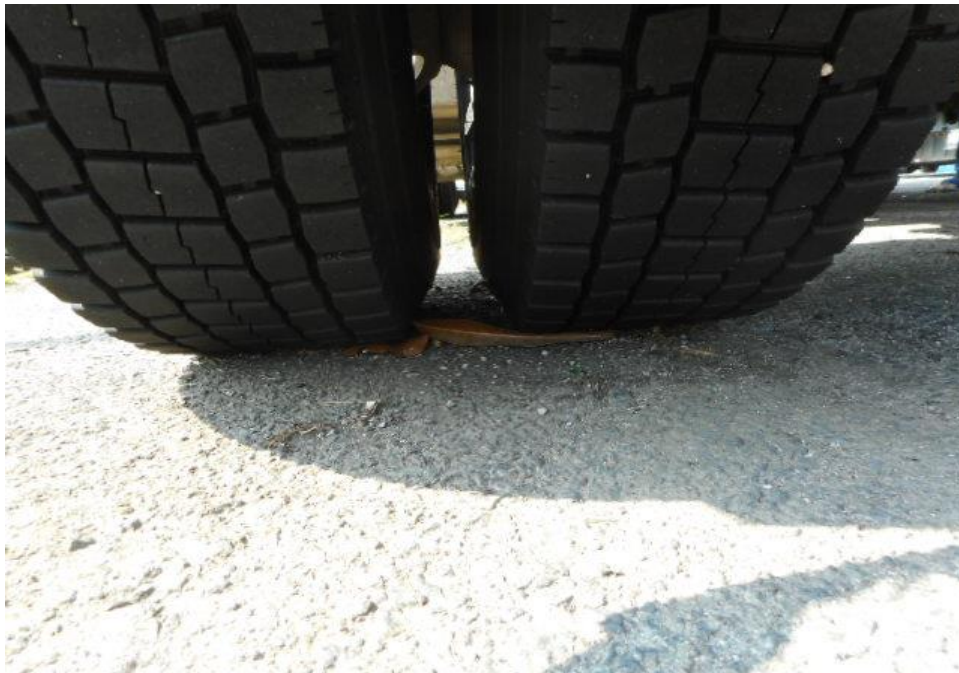
Photo 9 shows the condition of the rear left tyres of the Prime Mover, which was observed to be in serviceable condition with remaining tread depth of approximately 8.9mm. The tyres, which were wrapped around standard steel wheel rim, were also observed to be sufficiently inflated for vehicular operation. There was also no damage found on all 6 steel wheel rims of the Prime Mover.

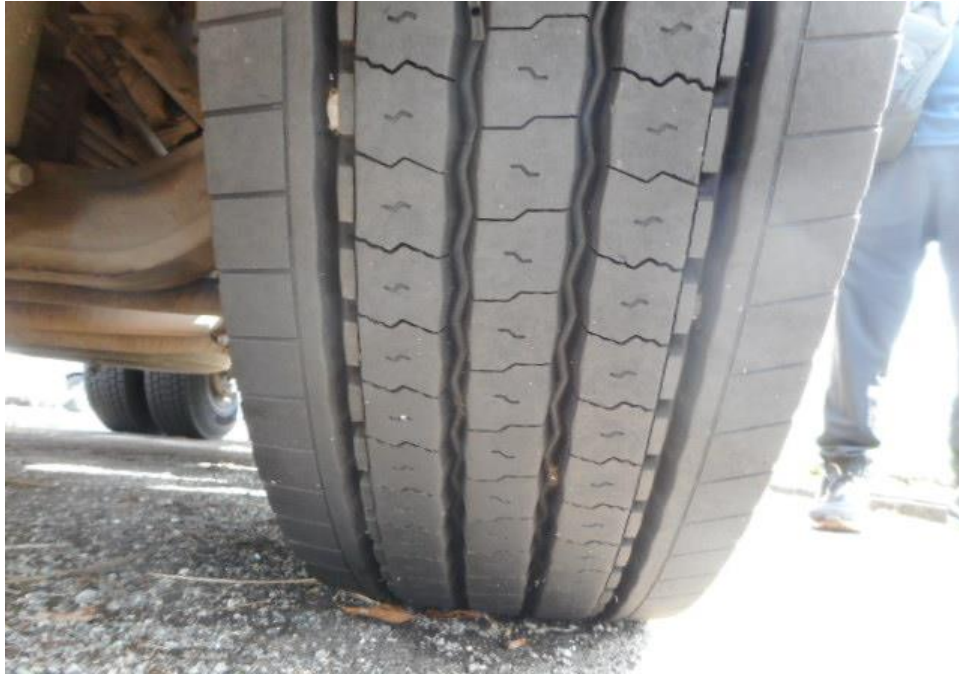
Photo 10 shows the condition of the front left tyres of the Prime Mover, which were observed to be in serviceable condition with remaining tread depth of approximately 12.7mm. There was also no tear, cut or burst mark(s) on the outer and the inner sidewalls as well as across the tread of the 6 tyres that were fitted on the Prime Mover.

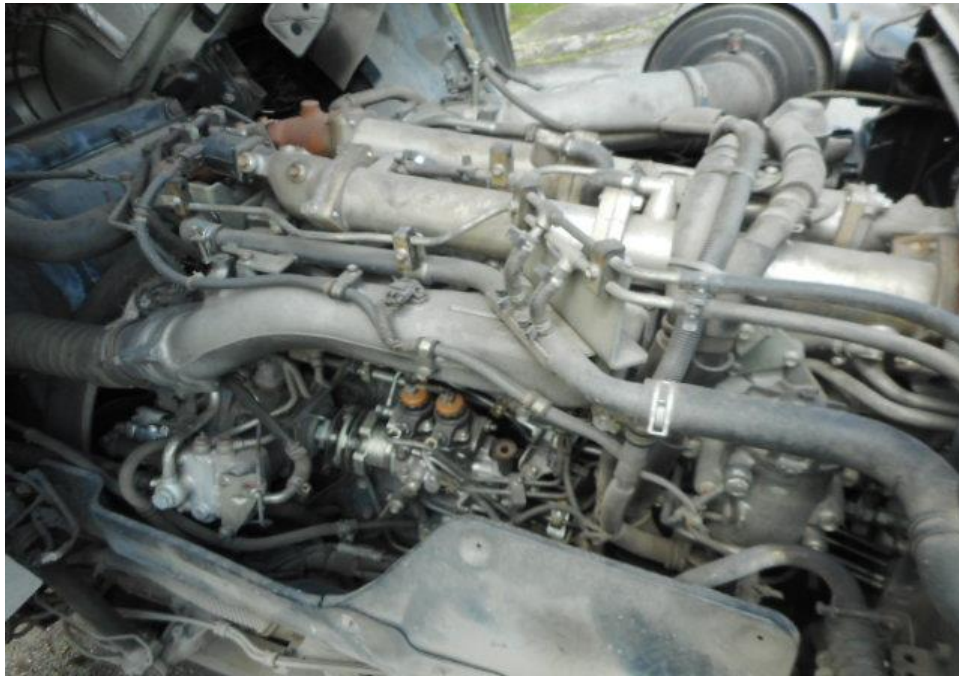
Photo 11 shows a general view of the Prime Mover's engine compartment, which was accessed by lifting the front cabin of the Prime Mover. The various parts and components inside the engine compartment were unaffected by the accident. There was also no sign(s) or indication(s) of fresh fluid leakage and/or fluid stain within the engine compartment

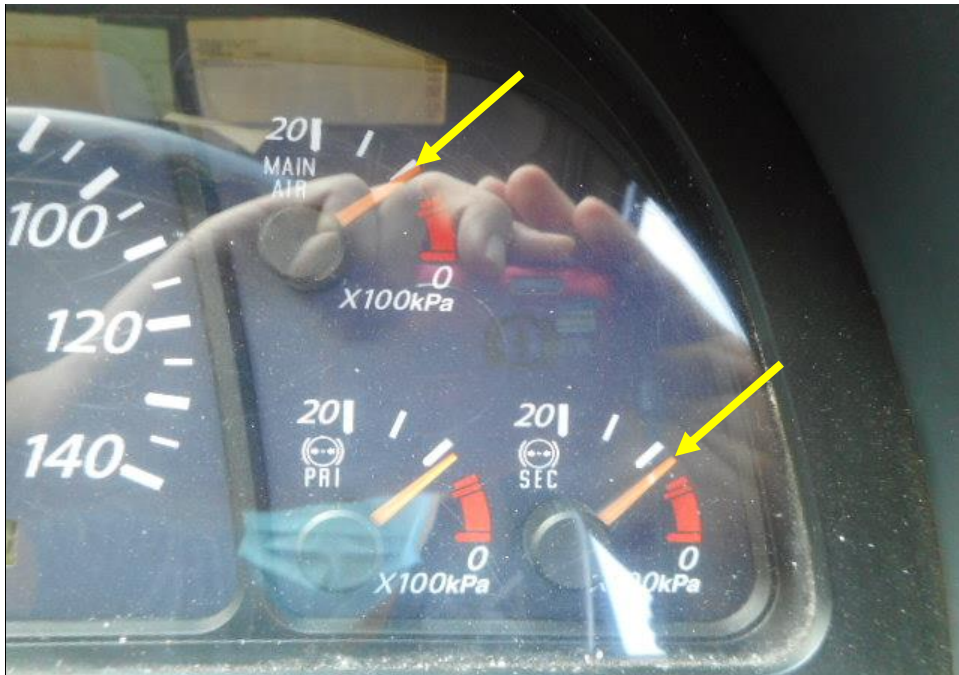
Photo 12 shows the air in the air brake cylinders of the Prime Mover at the time of my inspection. The air in the cylinder was observed to be of sufficient level & serviceable at the time of the accident.

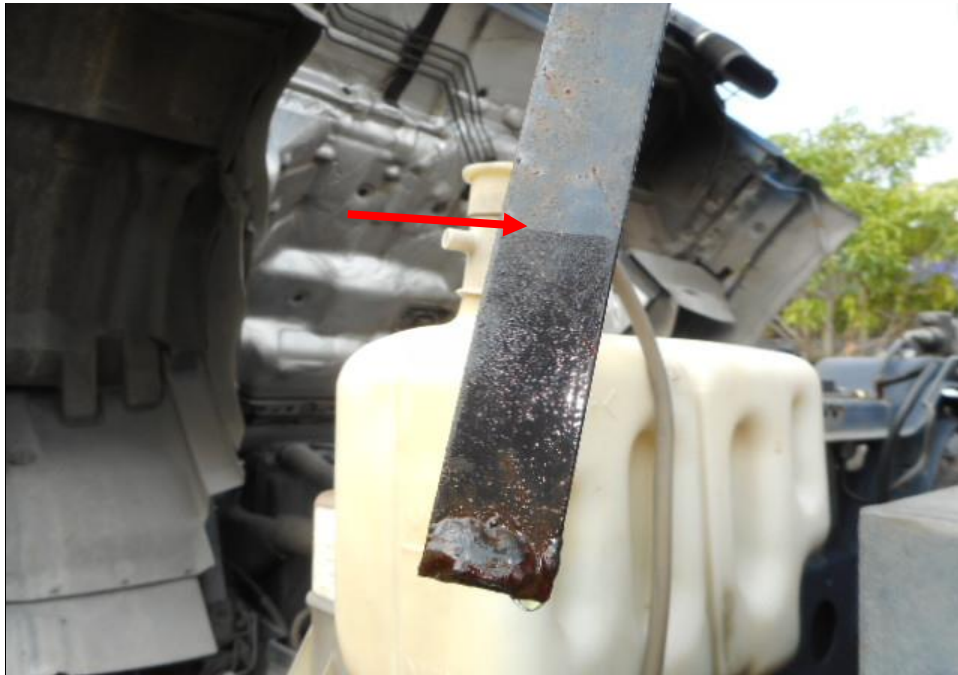
Photo 13 shows the engine coolant reservoir of the Prime Mover at the time of my inspection. The engine coolant was observed to be of sufficient level (arrowed) and without any visible contamination.

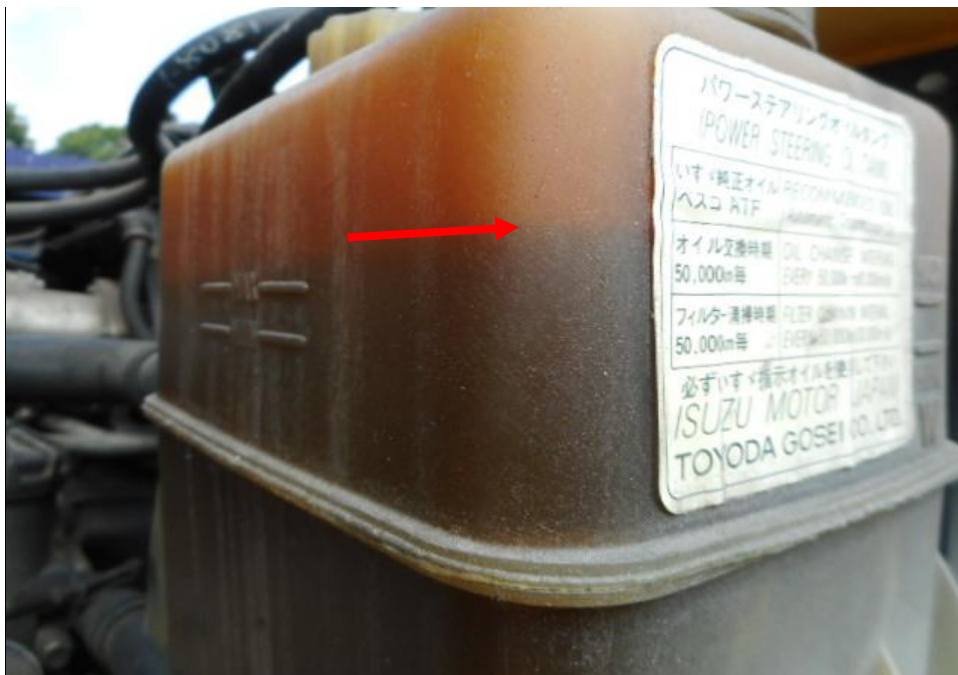
Photo 14 shows the power steering fluid reservoir of the Prime Mover at the time of my inspection. The power steering fluid was observed to be of sufficient level (arrowed) and without any visible contamination.

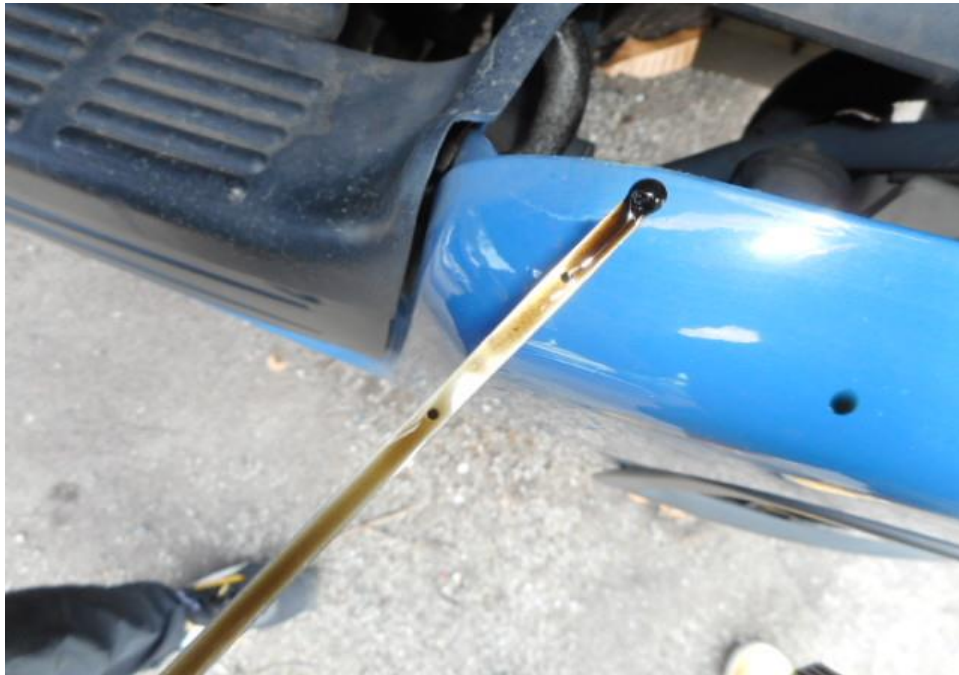
Photo 15 shows the engine oil dip stick of the Prime Mover at the time of my inspection. The engine oil was observed to be of insufficient level at the time of our inspection.

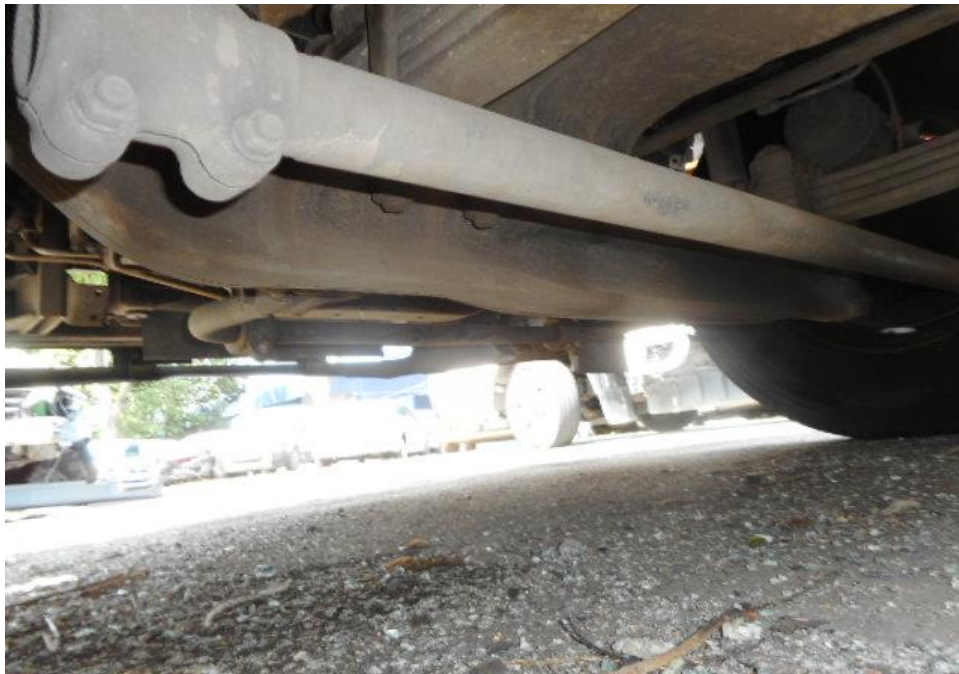
Photo 16 shows the undercarriage of the Prime Mover, at the area where the engine housing located. I did not find any sign(s) or indication(s) of fluid leak, however old fluid stain(s) was observed on the underside of the Prime Mover.

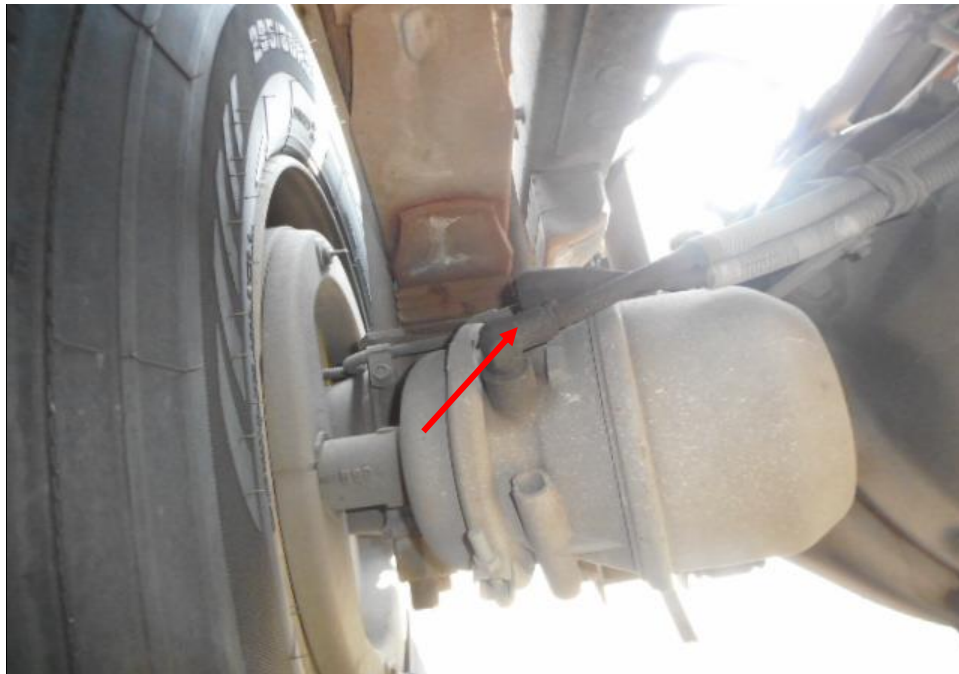
Photo 17 shows the brake pipe (arrowed) at the rear right wheel of the Prime Mover. I did not observe any leakage of brake fluid at the time of my inspection of the Prime Mover. My static tests of the Prime Mover's braking system, along with my visual examination of the various mechanical components in the braking system, had indicated that there was no internal leakage of pressure/vacuum. Hence the braking system of the Prime Mover was likely to be in serviceable condition at the material time of accident.

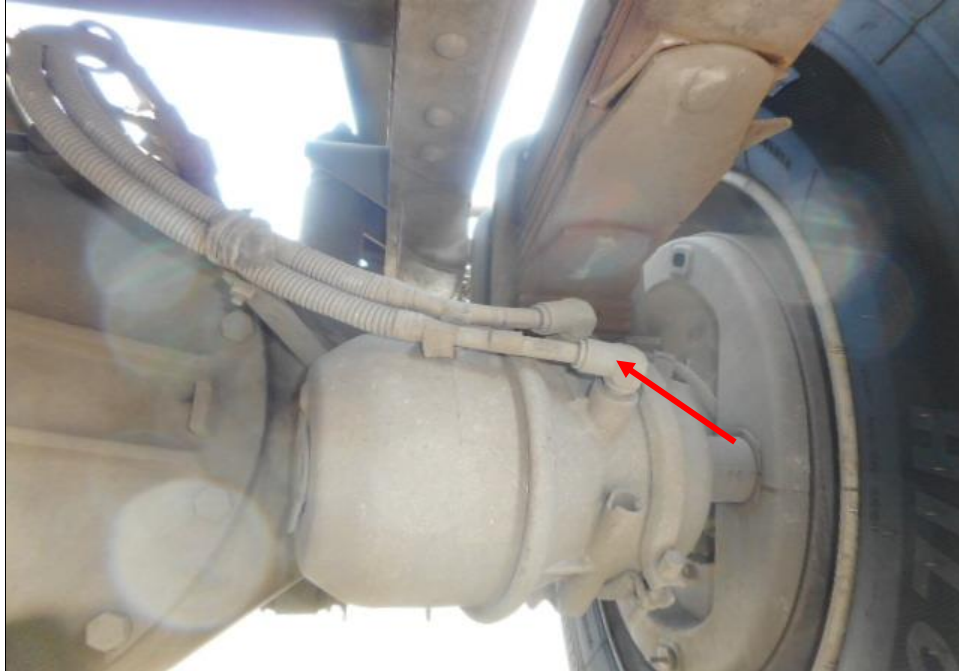
Photo 18 shows the brake pipe (arrowed) at the rear left wheel of the Prime Mover. I did not observe any leakage of brake fluid at the time of my inspection of the Prime Mover. My static tests of the Prime Mover's braking system, along with my visual examination of the various mechanical components in the braking system, had indicated that there was no internal leakage of pressure/vacuum. Hence the braking system of the Prime Mover was likely to be in serviceable condition at the material time of accident.

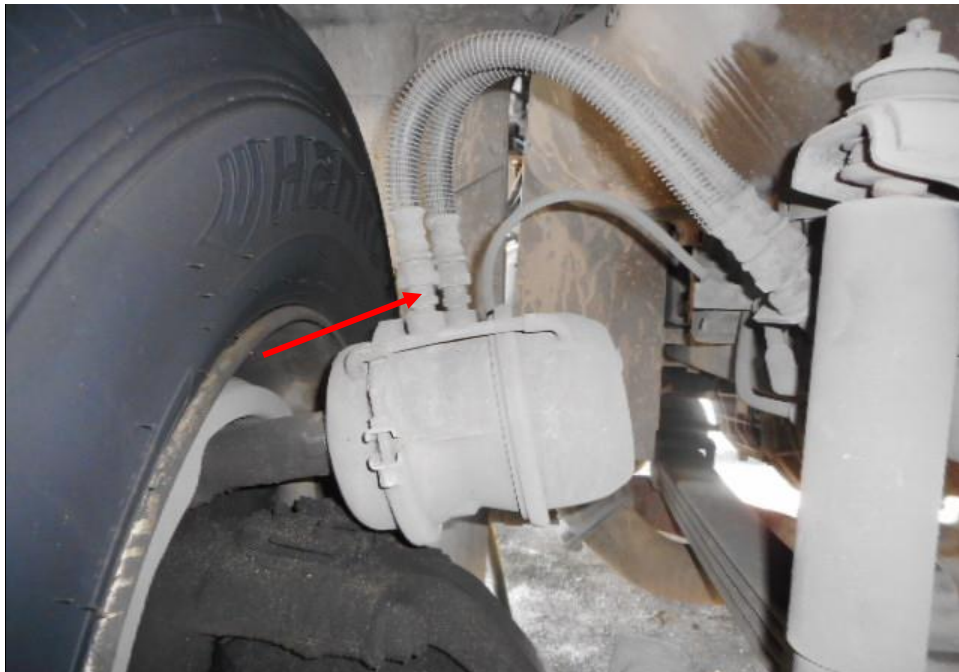
Photo 19 shows the brake pipe (arrowed) at the front right wheel of the Prime Mover. I did not observe any leakage of brake fluid at the time of my inspection of the Prime Mover. My static tests of the Prime Mover's braking system, along with my visual examination of the various mechanical components in the braking system, had indicated that there was no internal leakage of pressure/vacuum. Hence the braking system of the Prime Mover was likely to be in serviceable condition at the material time of accident.

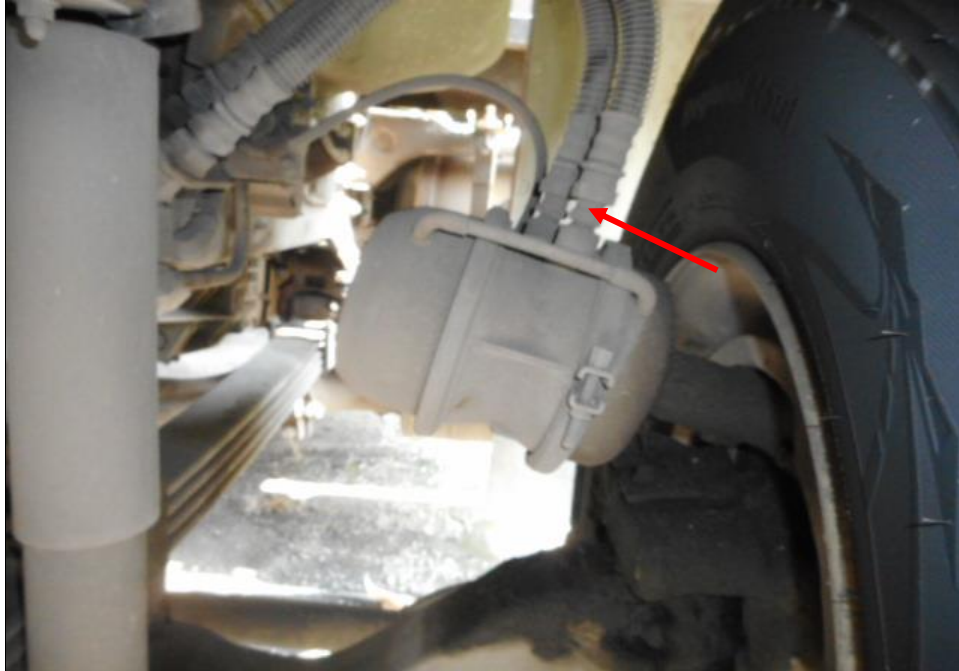
Photo 20 shows the brake pipe (arrowed) at the front left wheel of the Prime Mover. I did not observe any leakage of brake fluid at the time of my inspection of the Prime Mover. My static tests of the Prime Mover's braking system, along with my visual examination of the various mechanical components in the braking system had indicated that there was no internal leakage of pressure/vacuum. Hence the braking system of the Prime Mover was likely to be in serviceable condition at the material time of accident.

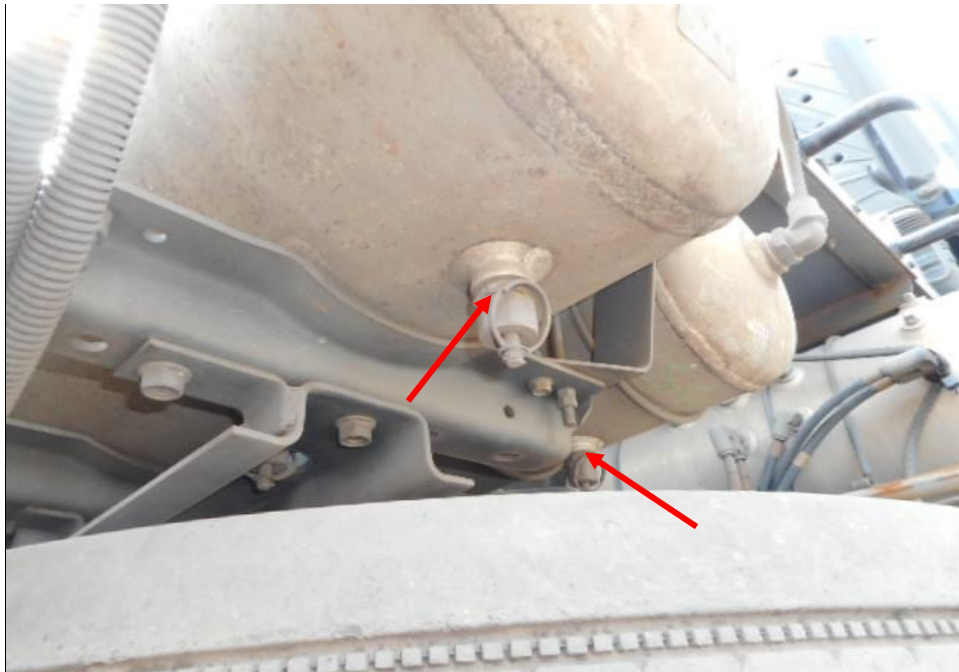
Photo 21 shows the air brake cylinders (arrowed) at the undercarriage of the Prime Mover. I did not observe any leakage of air brake fluid at the time of my inspection of the Prime Mover. My static tests of the Prime Mover's braking system, along with my visual examination of the various mechanical components in the braking system had indicated that there was no internal leakage of pressure/vacuum. Hence the braking system of the Prime Mover was likely to be in serviceable condition at the material time of accident.

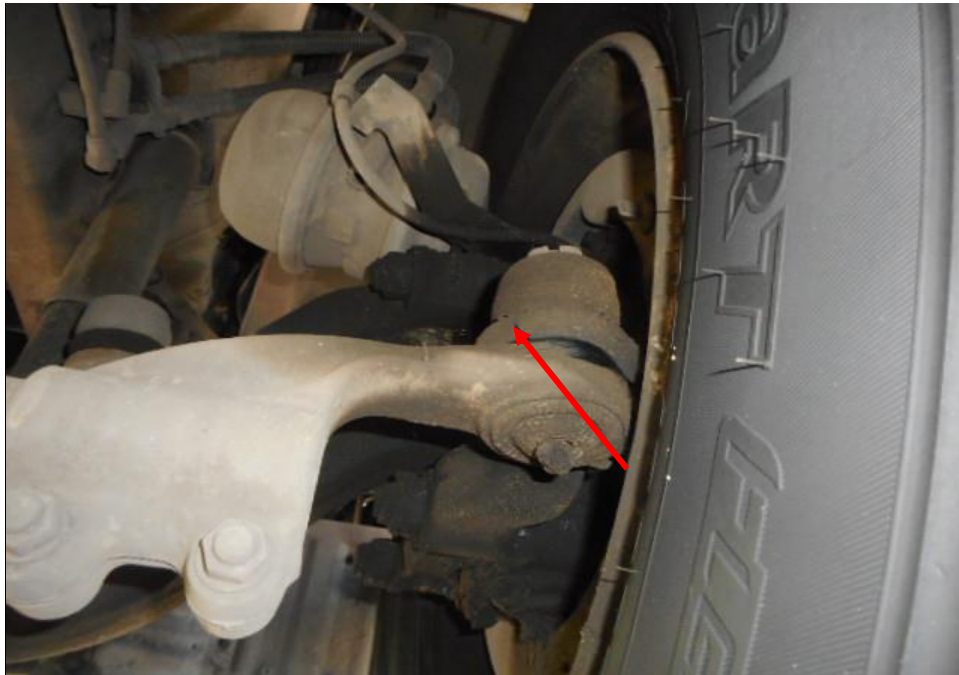
Photo 22 shows the various undercarriage components at the front right wheel of the Prime Mover, in particular the steering tie rod end (arrowed). The various steering components were all found to be intact, suggesting that the steering system of the Prime Mover was likely to be in serviceable condition at the material time of accident. There was also no sign of fluid stain(s) observed on the various undercarriage components.

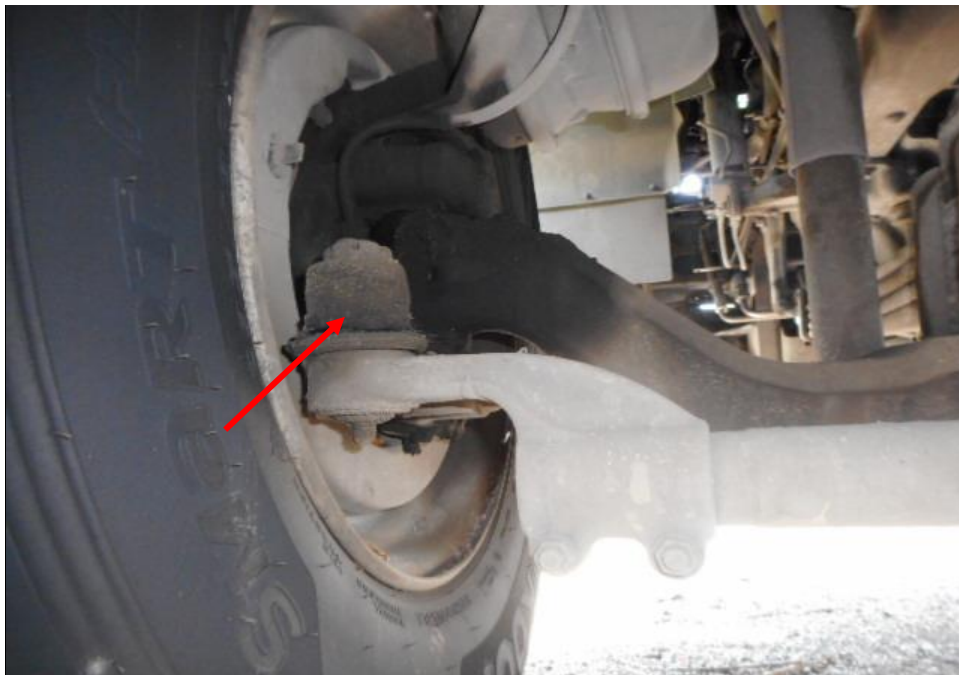
Photo 23 shows the various undercarriage components at the front left wheel of the Prime Mover, in particular the steering tie rod end (arrowed). The various undercarriage components of the Prime Mover were all found to be intact without any visible damage. There was also no sign of fluid stain(s) observed on the various undercarriage components.

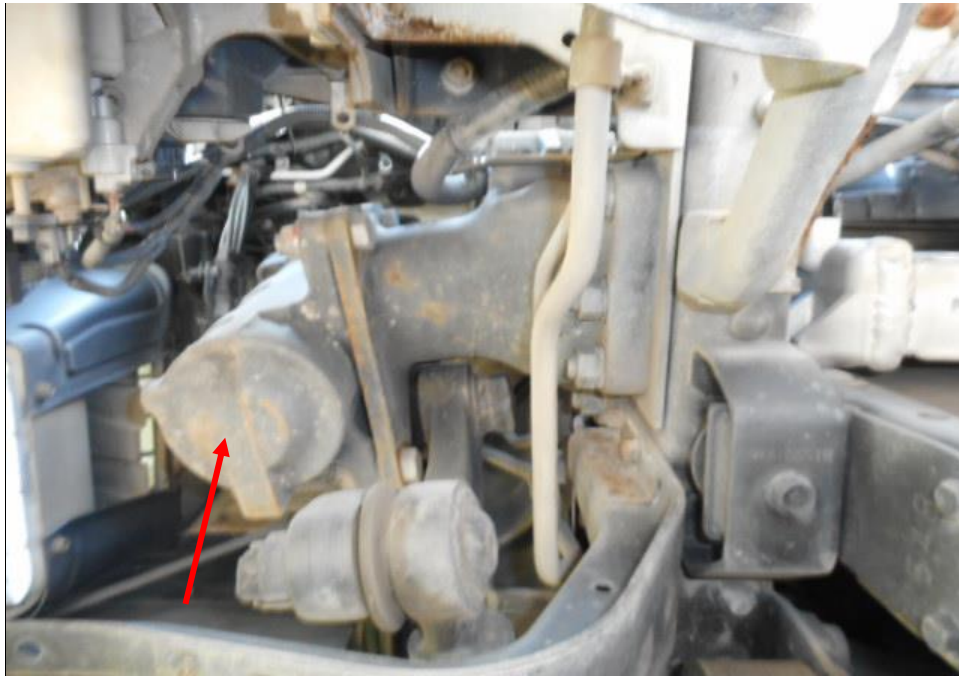
Photo 24 shows the steering box component (arrowed) at the undercarriage of the Prime Mover was found to be intact without any visible damage. There was also no sign of fluid stain(s) observed on the various undercarriage components.

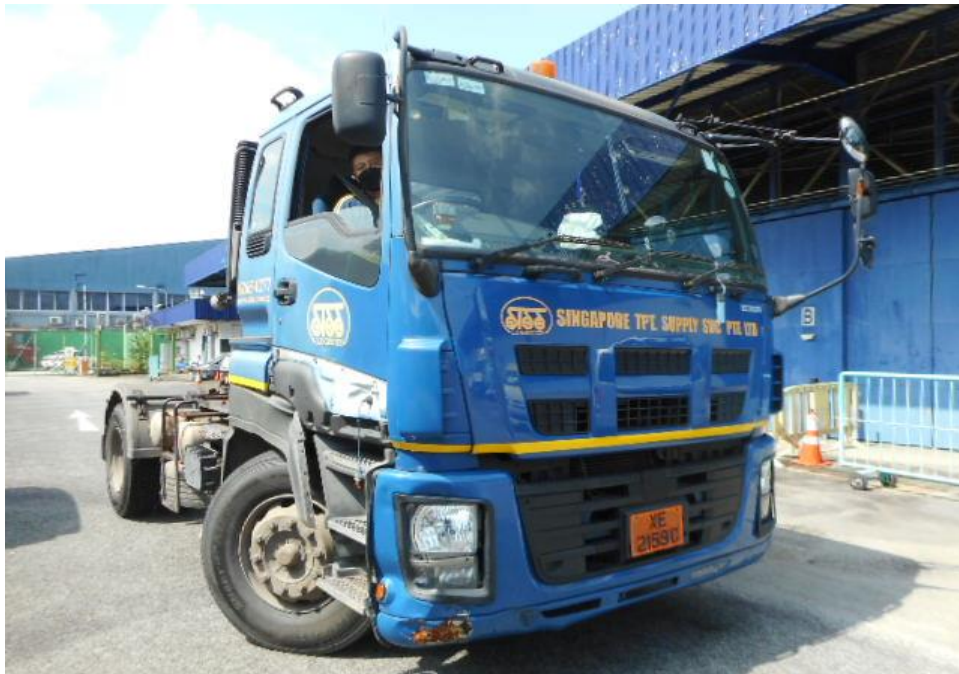
Photo 25 shows the front right wheel of the Prime Mover turned to its full left. During my steering system test, I did not experience any abnormal free play and/or resistance when I had turned the steering wheel towards full left and full right. This would suggest that the steering system of the Prime Mover was likely to be in serviceable condition at the material time of accident.

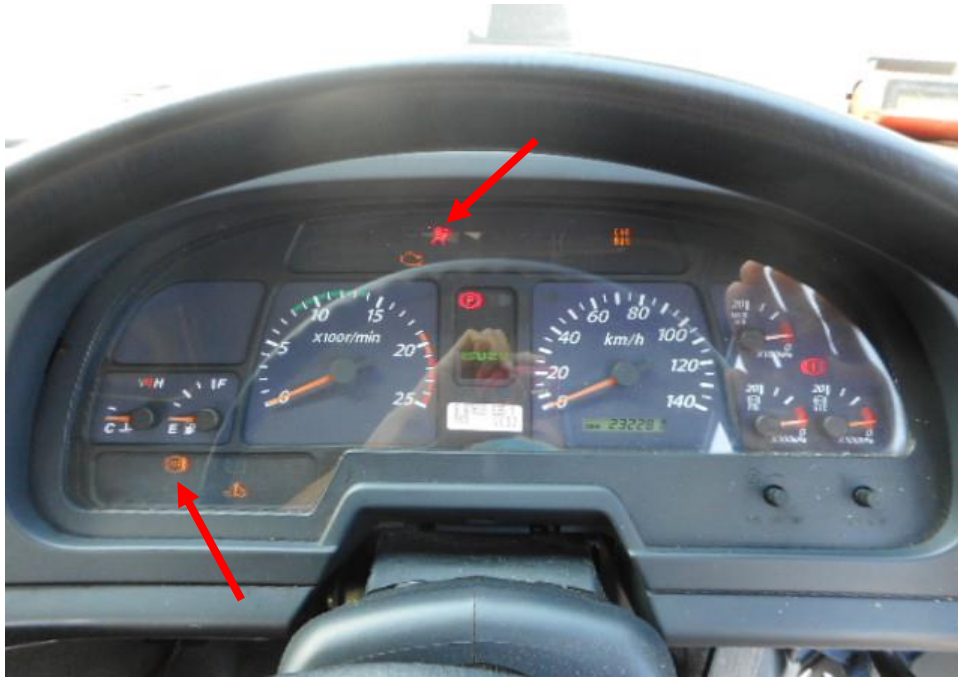
Photo 26 shows the warning light for Anti-Lock Brake System (ABS) and Supplemental Restraint System (SRS) (arrowed) appearing on the instrument panel of the Prime Mover during the self-test of its various electronic operating systems when its engine was cranked.

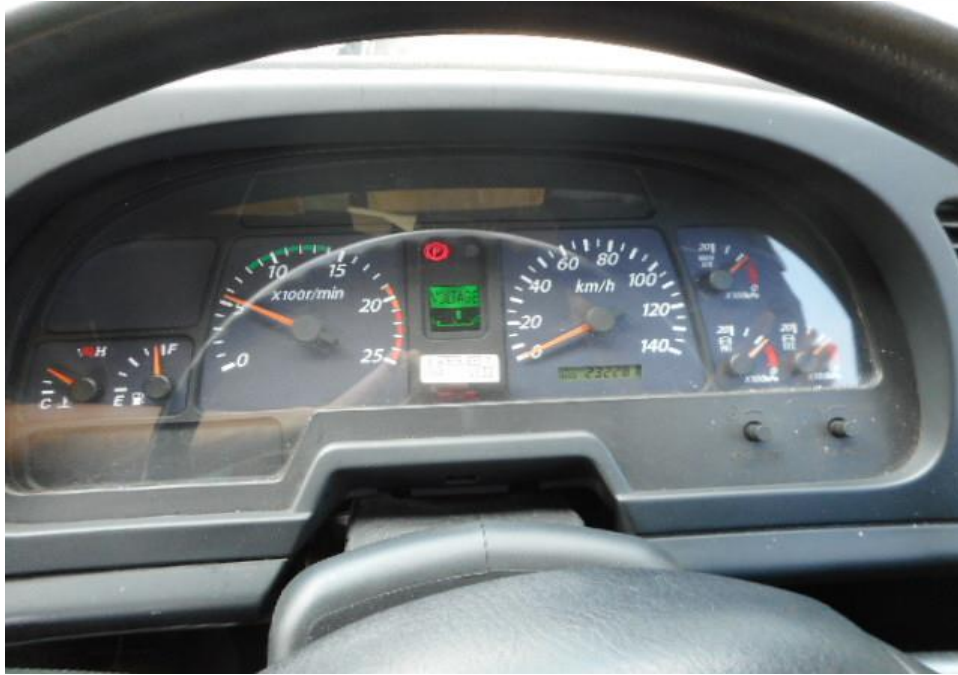
Photo 27 shows no warning lights illuminated on the instrument panel of the Prime Mover after the engine was cranked. This would suggest that there was no abnormality to the electronic operating system of the Prime Mover, like the ABS, SRS and etc.
