You're Ref: TP/IP/37441/2021
Our Ref: CI/TPD21010018/P

29th September 2021

Fatal Accident Investigation Team

MECHANICAL INSPECTION REPORT OF MOTOR CAR SGW 32D

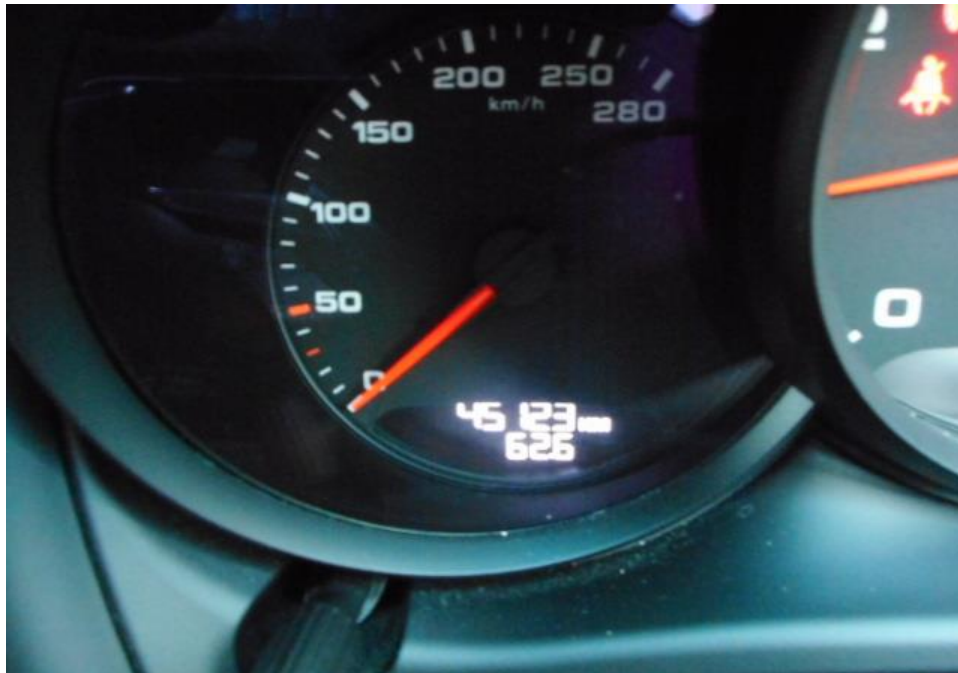
Photo 1 shows the mileage of the Motor Car at the time of my inspection. The mileage observed was 45,123km.

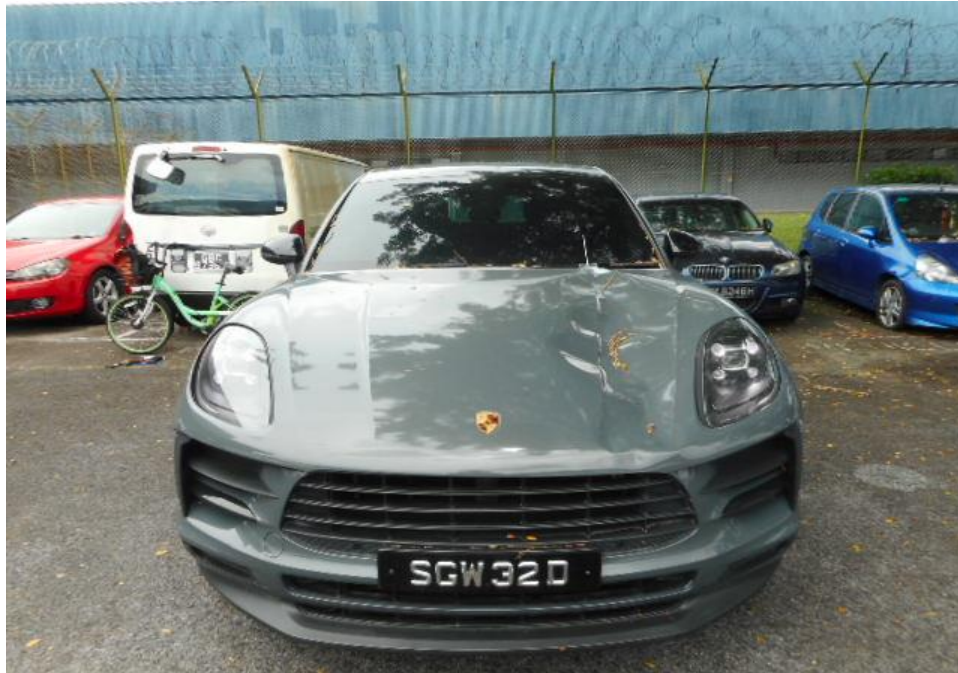
Photo 2 shows a general view of the Motor Car's front body at the time of my inspection. The front portion of the Motor Car was observed to have sustained damage. Its front bonnet was the body part that were damaged as a result of the accident.

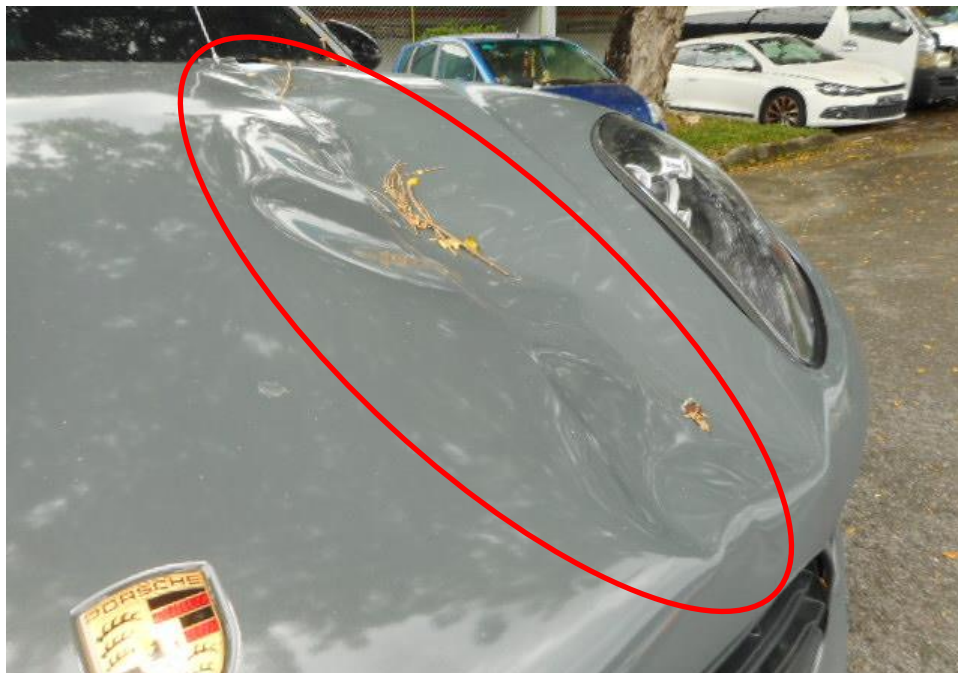
Photo 3 shows a close up view of the Motor Car's front body at the time of my inspection. The front portion of the Motor Car was observed to have sustained damage. Its front bonnet (circled) was the body part that were damaged as a result of the accident.

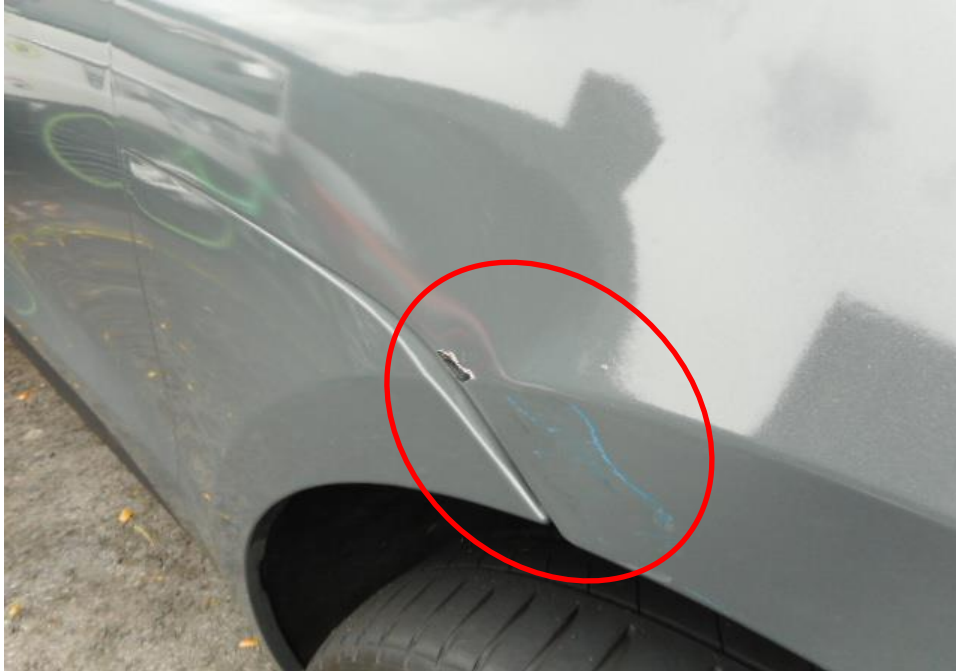
Photo 4 shows a close up view of the Motor Car's front body at the time of my inspection. The front portion of the Motor Car was observed to have sustained damage. Its front bonnet (circled) was the body part that were damaged as a result of the accident.

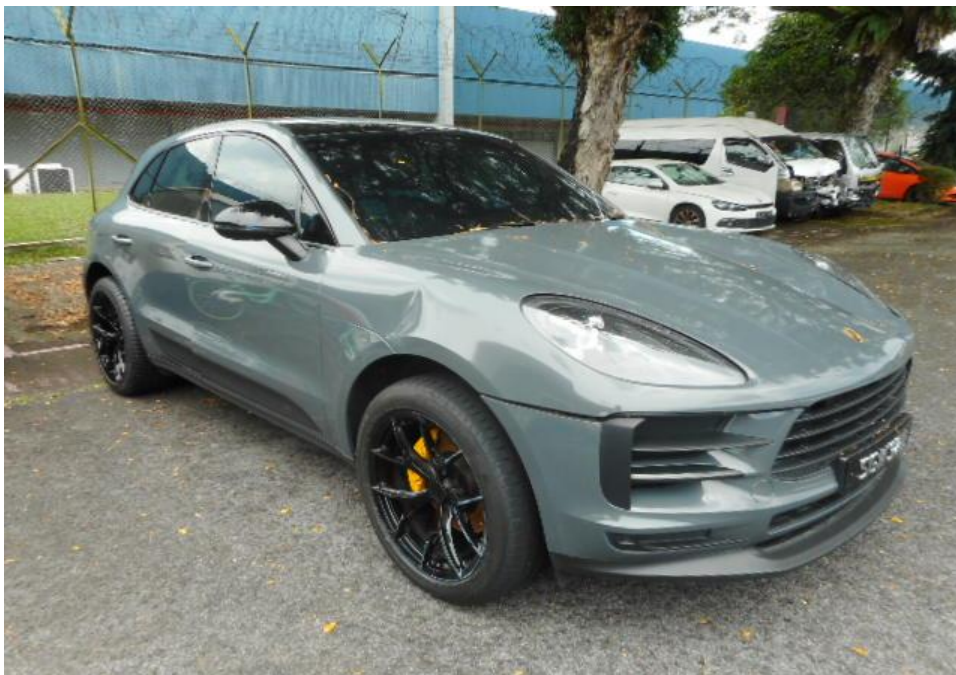
Photo 5 shows a general view of the Motor Car's right body at the time of my inspection. The right portion of the Motor Car was observed to have sustained damage. Its front bonnet (circled) was the body part that were damaged as a result of the accident.

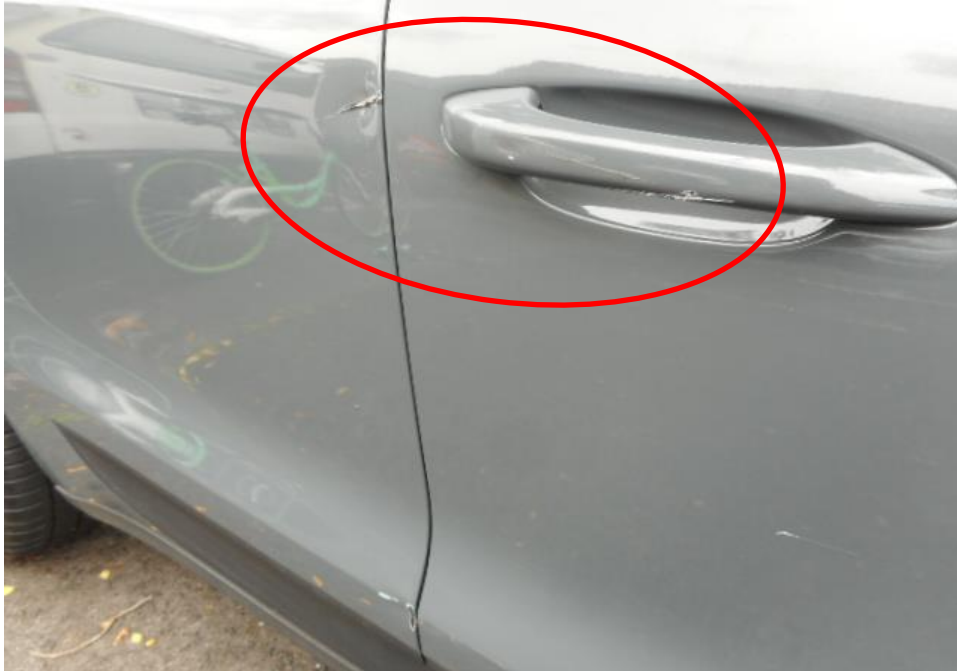
Photo 6 shows a close up view of the Motor Car's right body at the time of my inspection. The right portion of the Motor Car was observed to have sustained damage. Its right body panels (circled) was the body part that were damaged as a result of the accident.

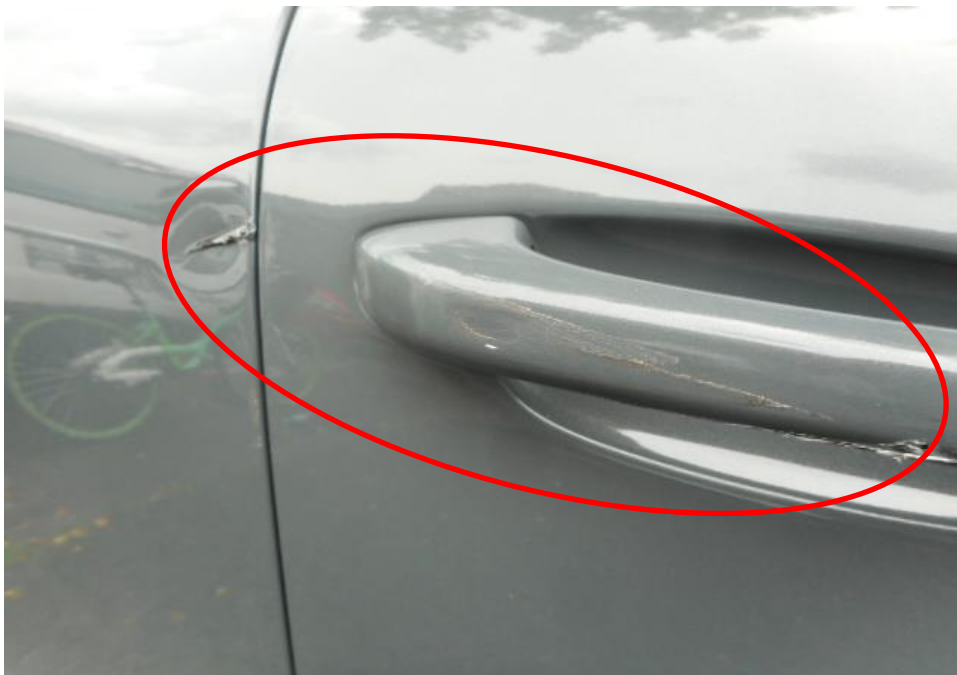
Photo 7 shows a close up view of the Motor Car's right body at the time of my inspection. The right portion of the Motor Car was observed to have sustained damage. Its right body panels (circled) was the body part that were damaged as a result of the accident.

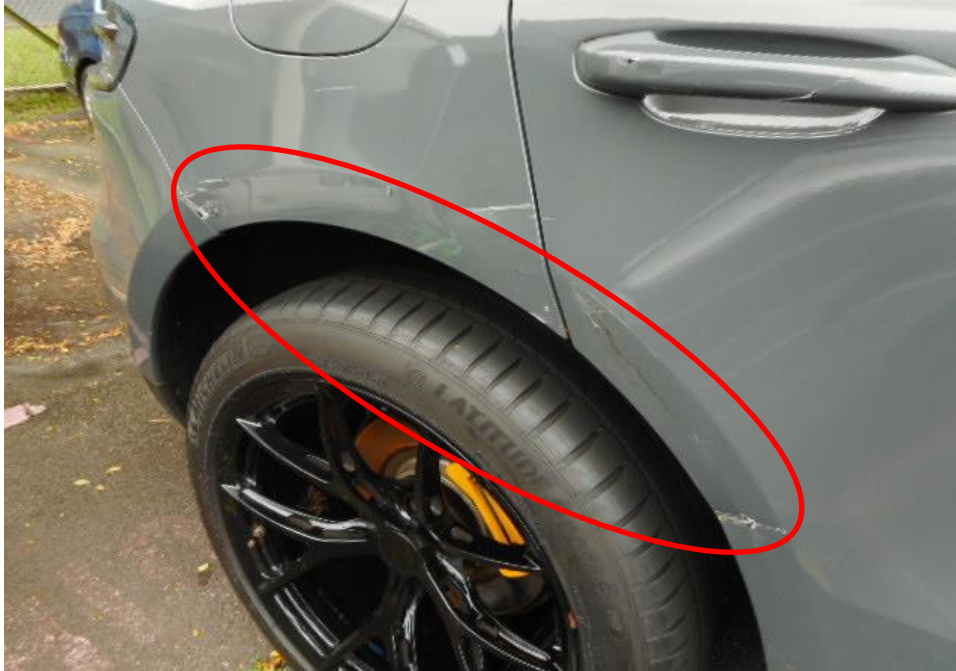
Photo 8 shows a close up view of the Motor Car's right body at the time of my inspection. The right portion of the Motor Car was observed to have sustained damage. Its right body panels (circled) was the body part that were damaged as a result of the accident.

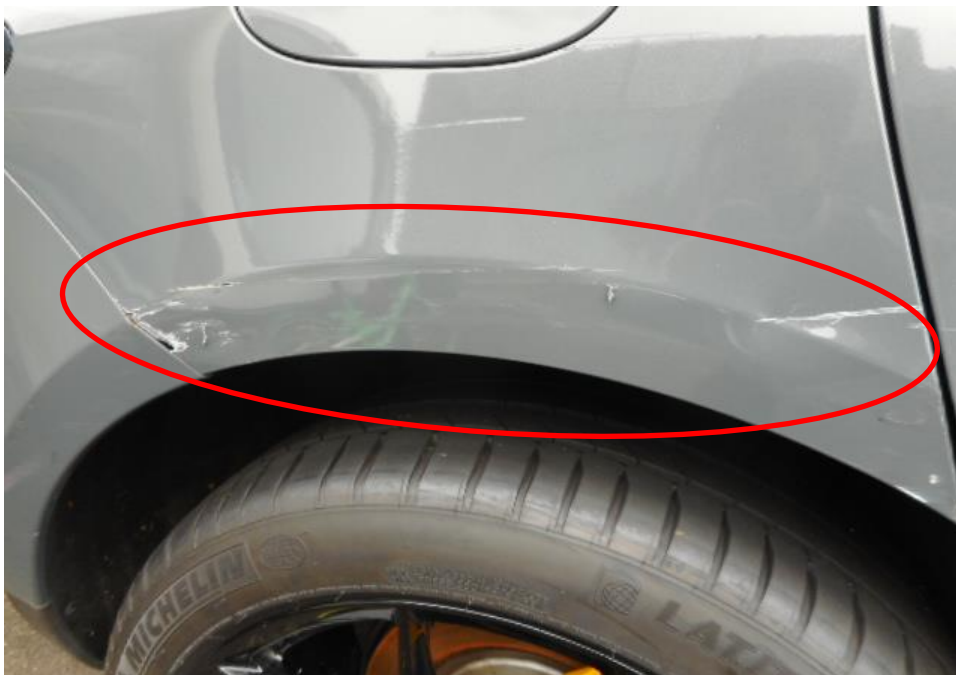
Photo 9 shows a close up view of the Motor Car's right body at the time of my inspection. The right portion of the Motor Car was observed to have sustained damage. Its right body panels (circled) was the body part that were damaged as a result of the accident.

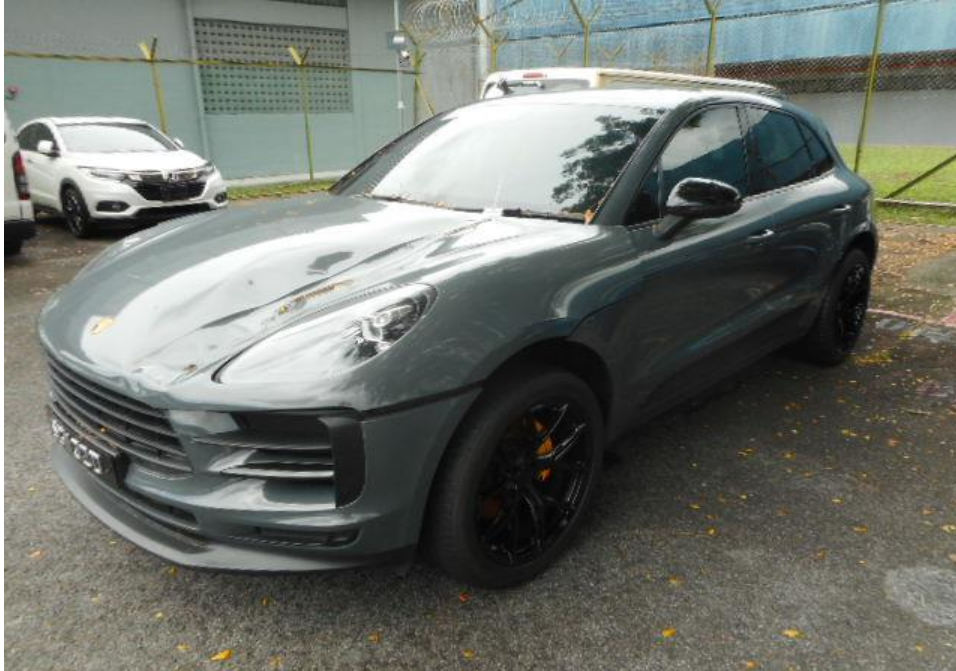
Photo 10 shows a general view of the Motor Car's left body at the time of my inspection. The left portion of the Motor Car was observed to have been unaffected by the accident.

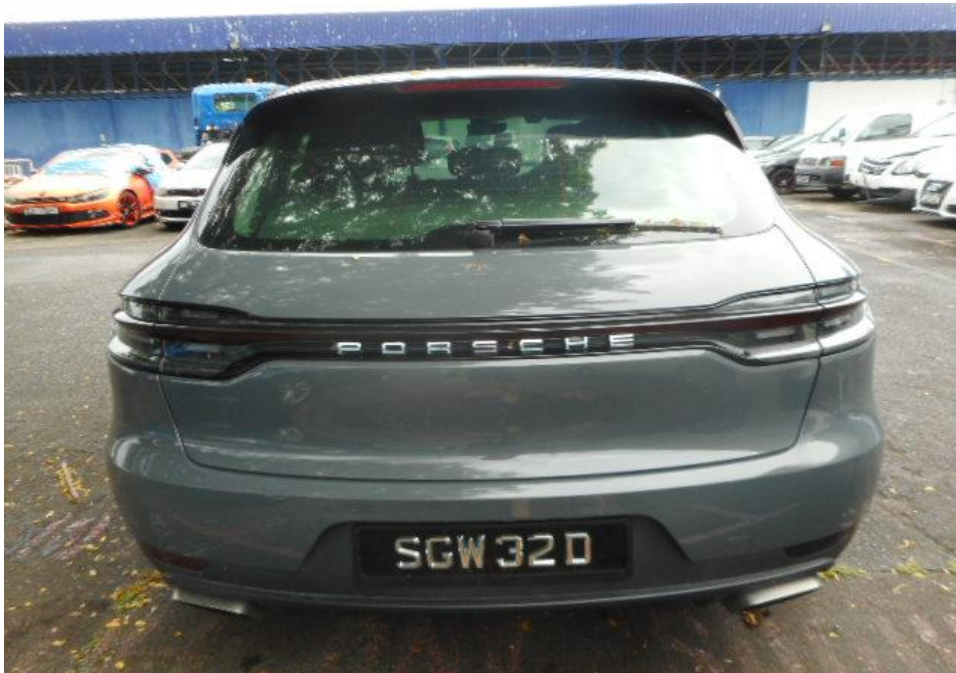
Photo 11 shows the general view of the Motor Car's rear body at the time of my inspection. The Motor Car rear was observed to be unaffected by the accident.

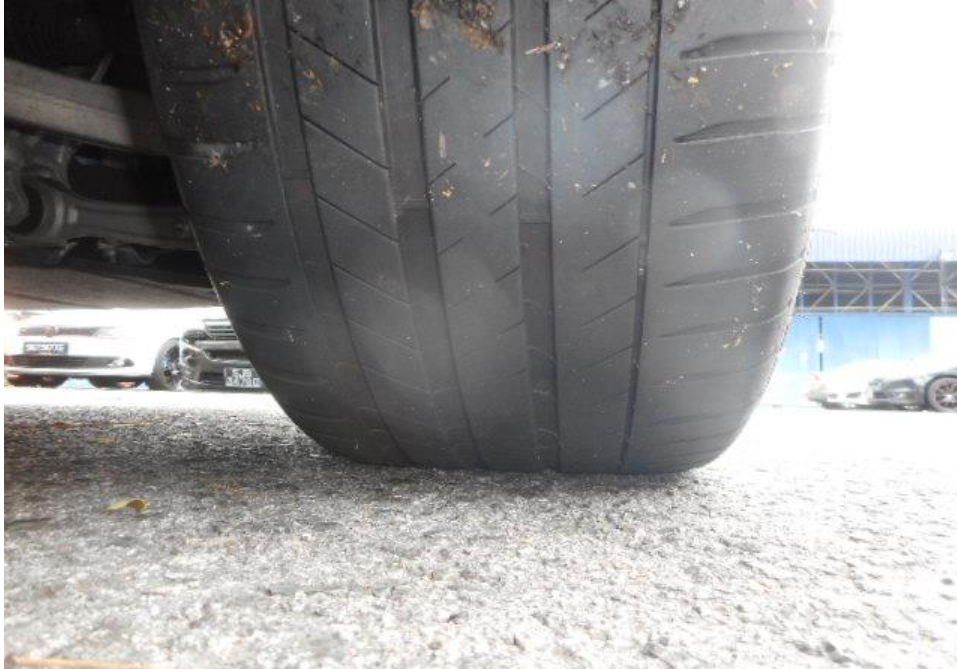
Photo 12 shows the condition of the front right tyre of the Motor Car, which was observed to be in serviceable condition with remaining tread depth of approximately 4.8mm. The tyre was sufficiently inflated for vehicular operation with no tear, cut or burst mark(s) on the outer and the inner sidewalls as well as across the tread. The 4 tyres of the Motor Car were wrapped around standard steel wheel rims without any damage.

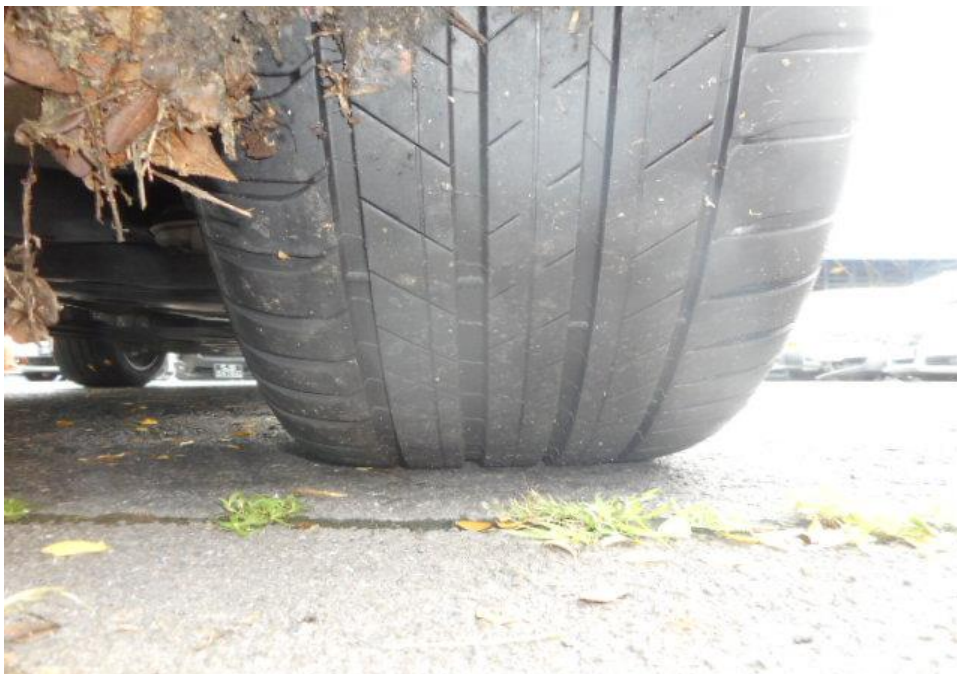
Photo 13 shows the condition of the rear right tyre of the Motor Car, which was observed to be in serviceable condition with remaining tread depth of approximately 6.1mm. The tyre was also observed to be sufficiently inflated for vehicular operation with no tear, cut or burst mark(s).

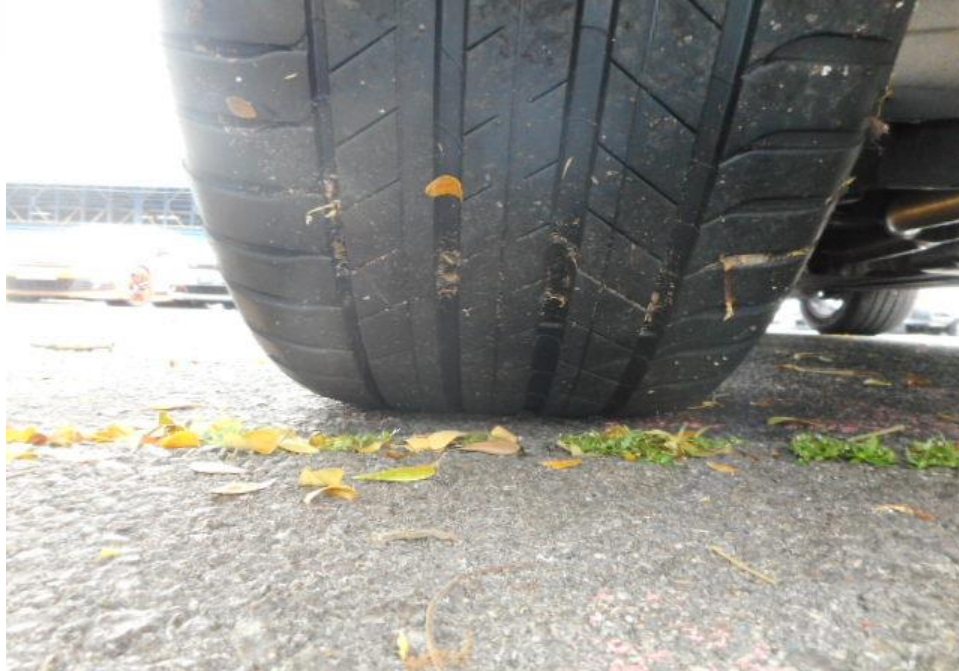
Photo 14 shows the condition of the rear left tyre of the Motor Car, which was observed to be in serviceable condition with remaining tread depth of approximately 6.2mm. The tyre, which was wrapped around steel wheel rim, was also observed to be sufficiently inflated for vehicular operation. The 4 tyres of the Motor Car were wrapped around standard steel wheel rims.

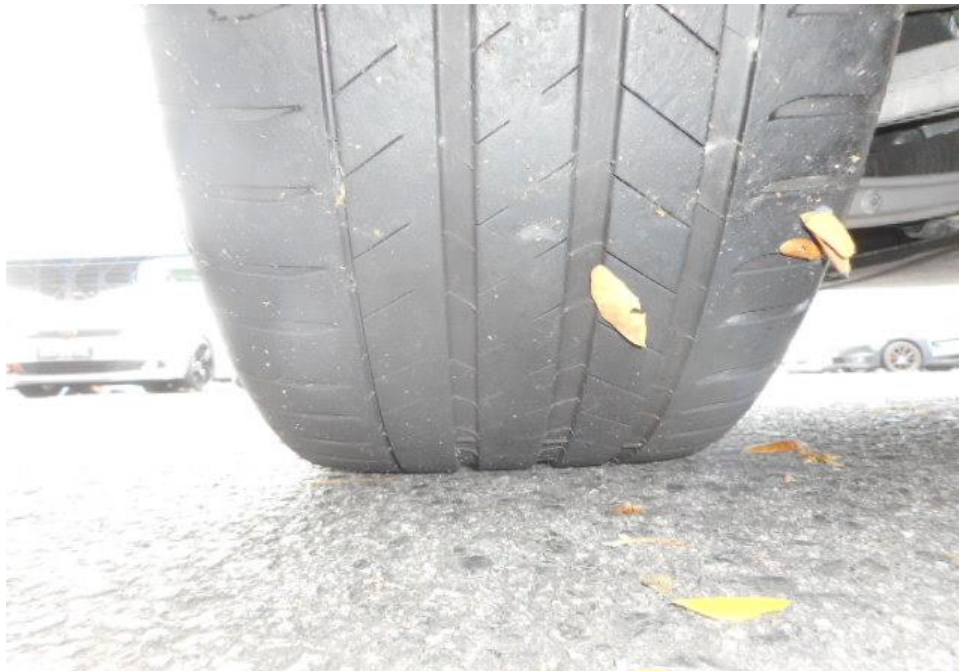
Photo 15 shows the condition of the front left tyre of the Motor Car, which was observed to be in serviceable condition with remaining tread depth of approximately 4.3mm. There was also no tear, cut or burst mark(s) on the outer and the inner sidewalls as well as across the tread of the Motor Car's 4 tyres.

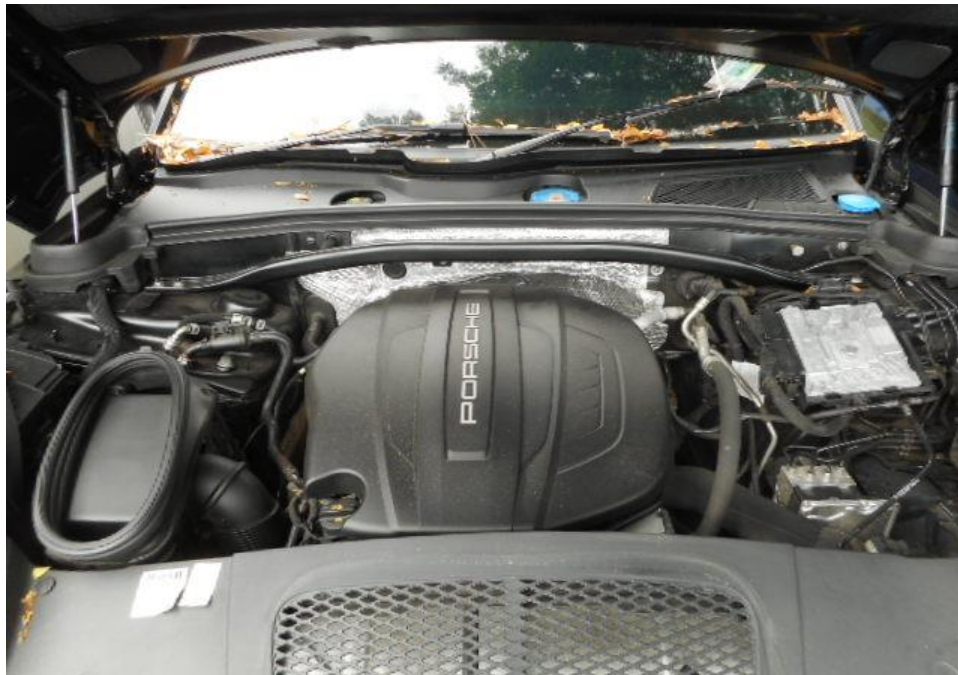
Photo 16 shows a general view of the Motor Car's engine compartment. The various parts and components inside the engine compartment were unaffected by the accident. There was also no sign(s) or indication(s) of fluid leakage and/or fluid stain within the engine compartment.

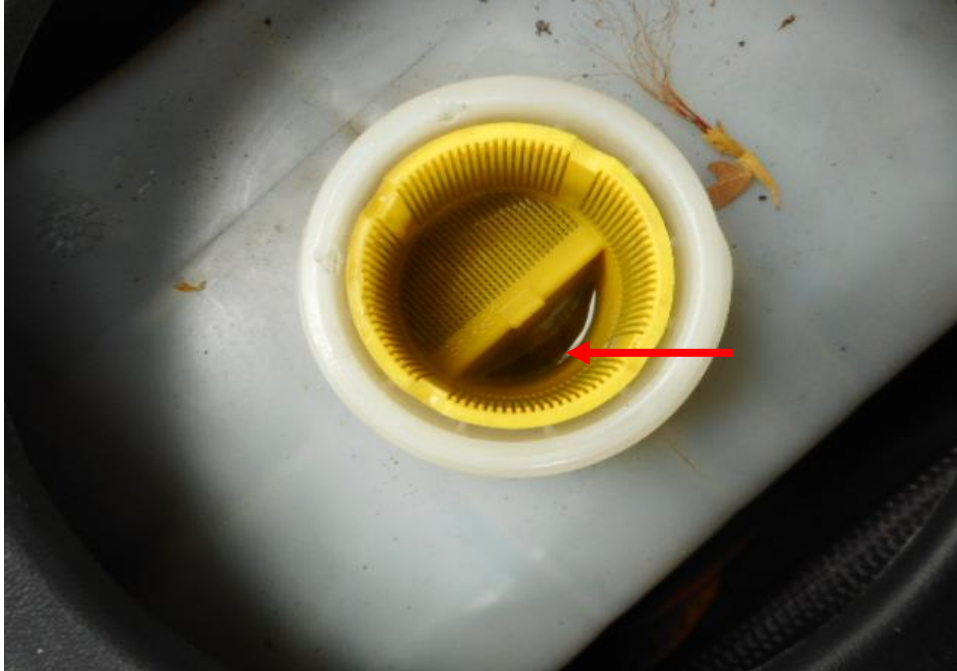
Photo 17 shows the brake fluid reservoir of the Motor Car at the time of my inspection. The brake fluid was observed to be of sufficient level (arrowed) and without any visible contamination.

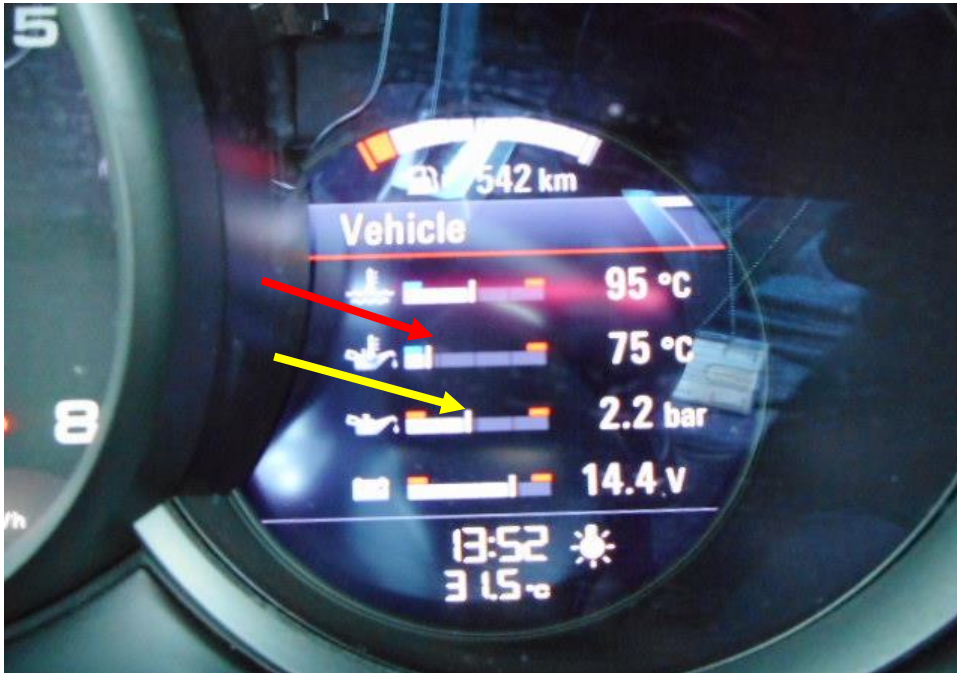
Photo 18 shows checks being carried out to the engine coolant and the engine oil on the instrument display of the Motor Car at the time of my inspection. The engine coolant (red arrow) and engine oil (yellow arrow) was observed to be of sufficient level and without any visible contamination.

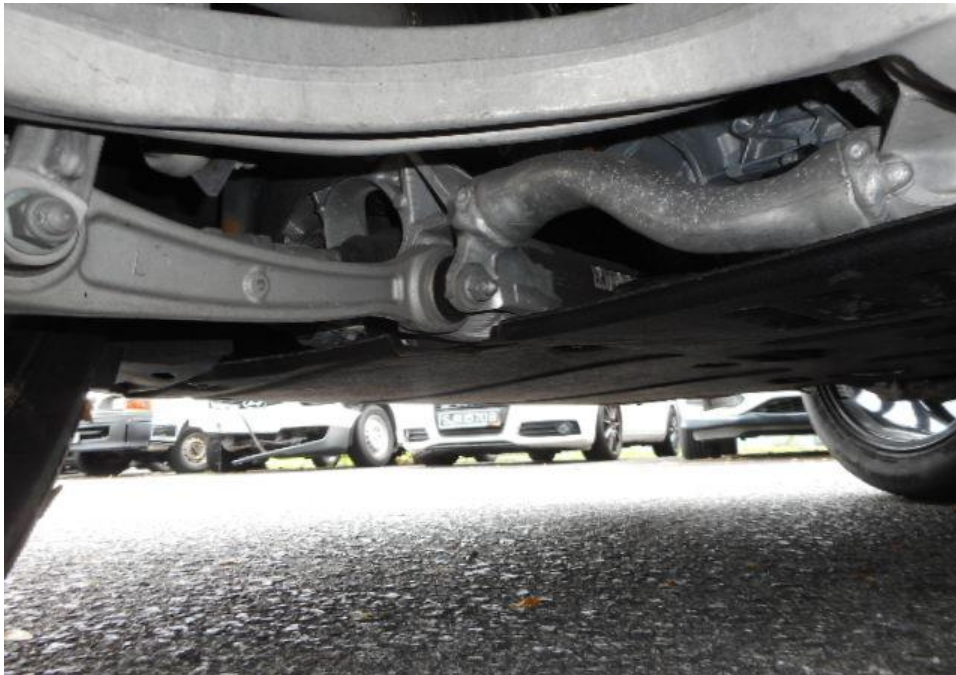
Photo 19 shows the undercarriage of the Motor Car, at the area where the engine housing and transmission housing are located. I did not find any sign(s) or indication(s) of fluid leak and/or fluid stain(s) on the underside of the Motor Car.

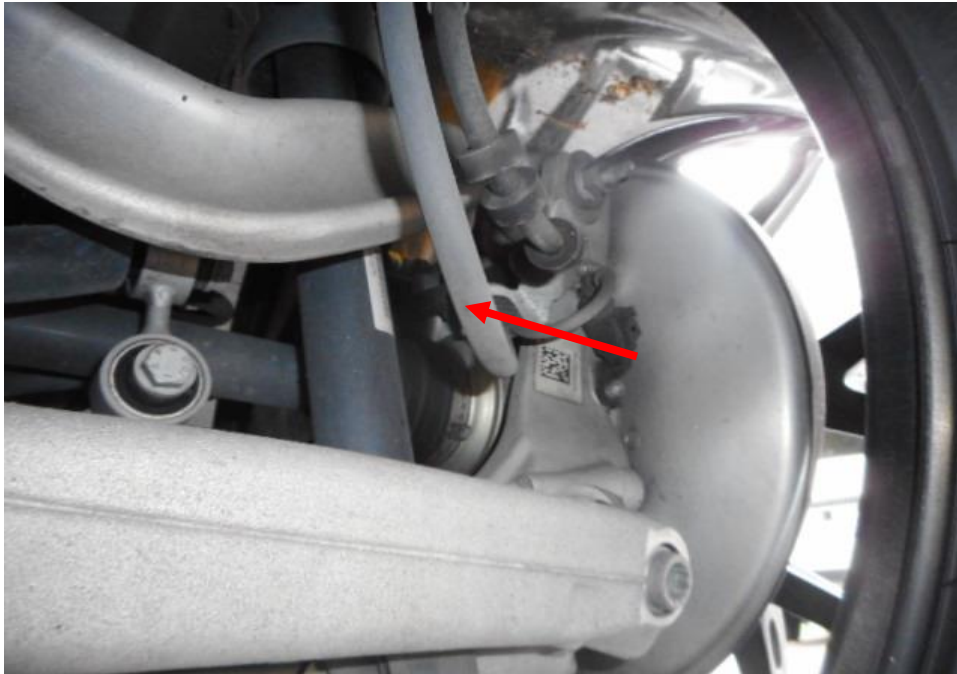
Photo 20 shows the brake hose/pipe (arrowed) at the rear right wheel of the Motor Car. No leakage of brake fluid was observed. Visual examination of the various components of the braking system like the drum brake, brake booster, brake pedal etc. had revealed all to be intact and without visible damage.

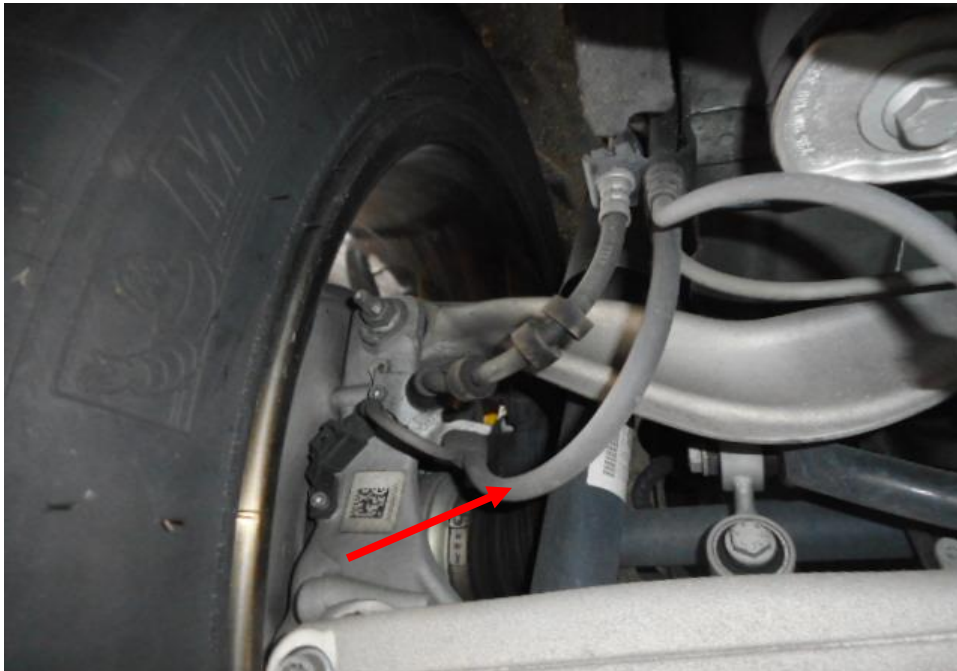
Photo 21 shows the brake hose/pipe (arrowed) at the rear left wheel of the Motor Car. I did not observe any leakage of brake fluid at the time of my inspection of the Motor Car. Static tests of the Motor Car's braking system had indicated that there was no internal leakage of pressure/vacuum. The undercarriage components of the Motor Car were also all found to be intact and without any visible damage.

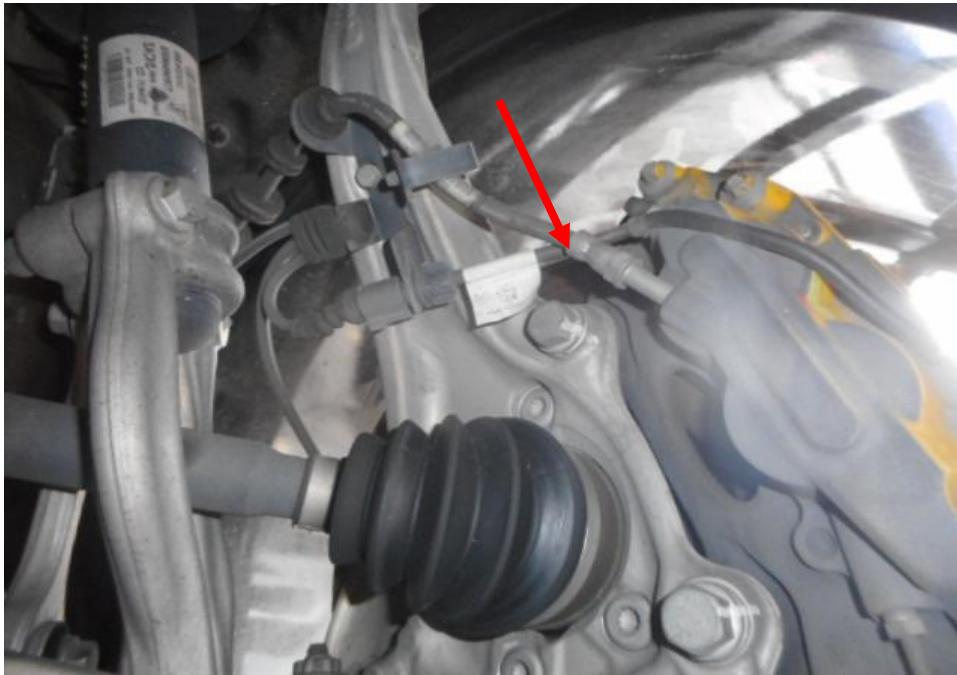
Photo 22 shows the brake hose/pipe (arrowed) at the front right wheel of the Motor Car. I did not observe any leakage of brake fluid at the time of my inspection of the Motor Car. Static tests of the Motor Car's braking system had indicated that there was no internal leakage of pressure/vacuum. The undercarriage components of the Motor Car were also all found to be intact and without any visible damage.

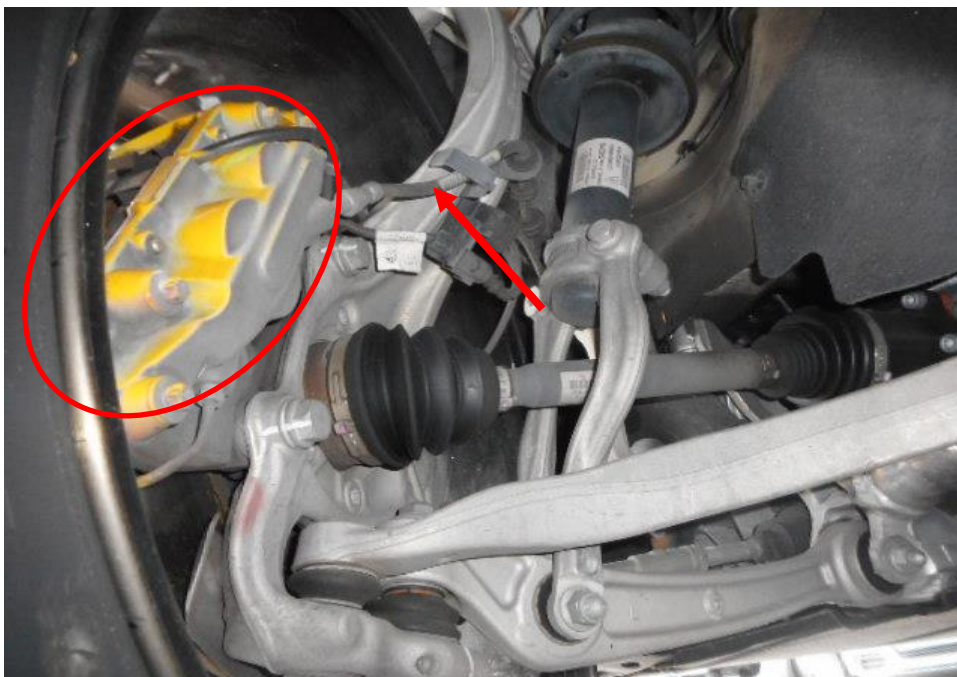
Photo 23 shows the brake hose/pipe (arrowed) at the front left wheel of the Motor Car. No leakage of brake fluid was observed. Visual examination of the various components of the braking system like the brake caliper (circled), brake booster, brake pedal etc had revealed all to be intact and without visible damage.

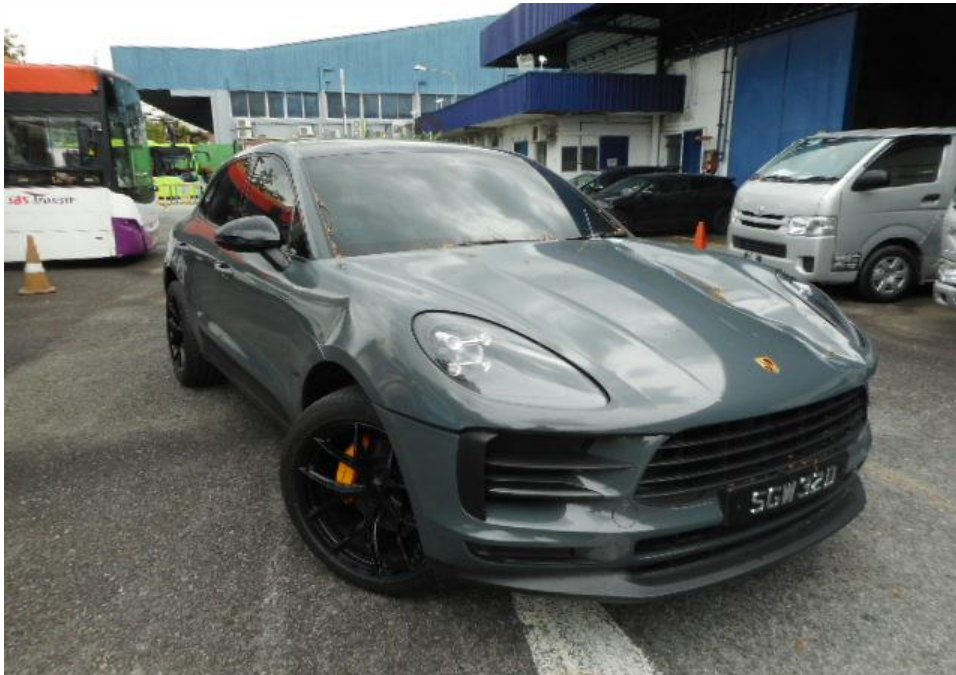
Photo 24 shows the front right wheel of the Motor Car turned to its full left. During my steering system test, I did not experience any abnormal free play and/or resistance when I had turned the steering wheel towards the left and right. This would suggest that the steering system of the Motor Car was likely to be in serviceable condition at the material time of accident.

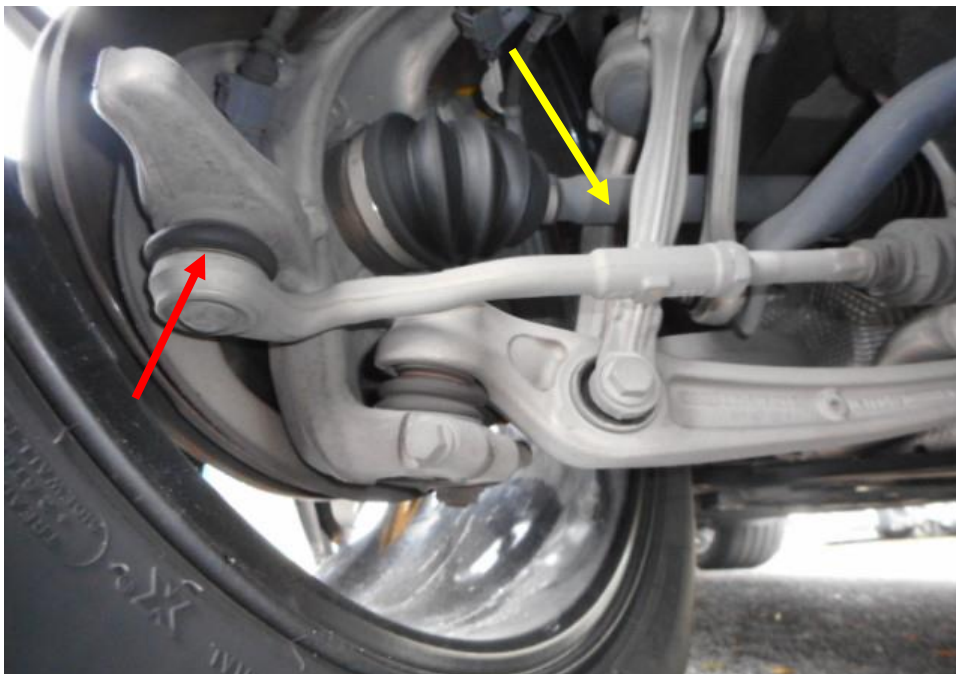
Photo 25 shows the various undercarriage components at the front right wheel of the Motor Car, in particular the steering tie rod (red arrow) and drive shaft (yellow arrow). The various steering components were all found to be intact, suggesting that the steering system of the Motor Car was likely to be in serviceable condition at the material time of accident. There was also no sign of fluid stain observed on the various undercarriage components at the front right wheel of the Motor Car.

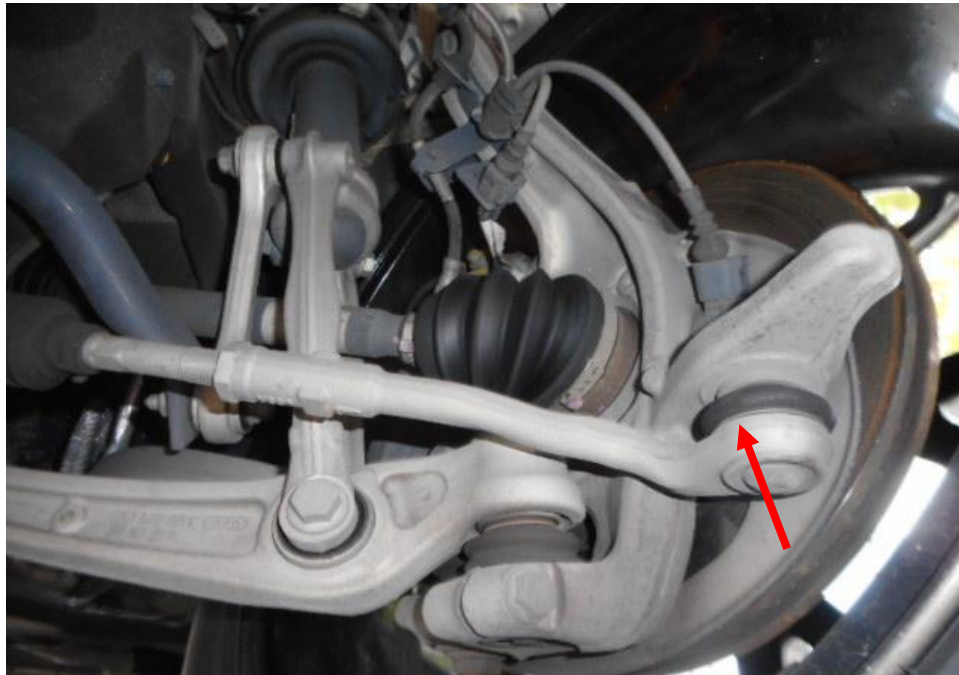
Photo 26 shows the various undercarriage components at the front left wheel of the Motor Car, which had included the steering tie rod (red arrow). The various undercarriage components of the Motor Car were all found to be intact without any visible damage.

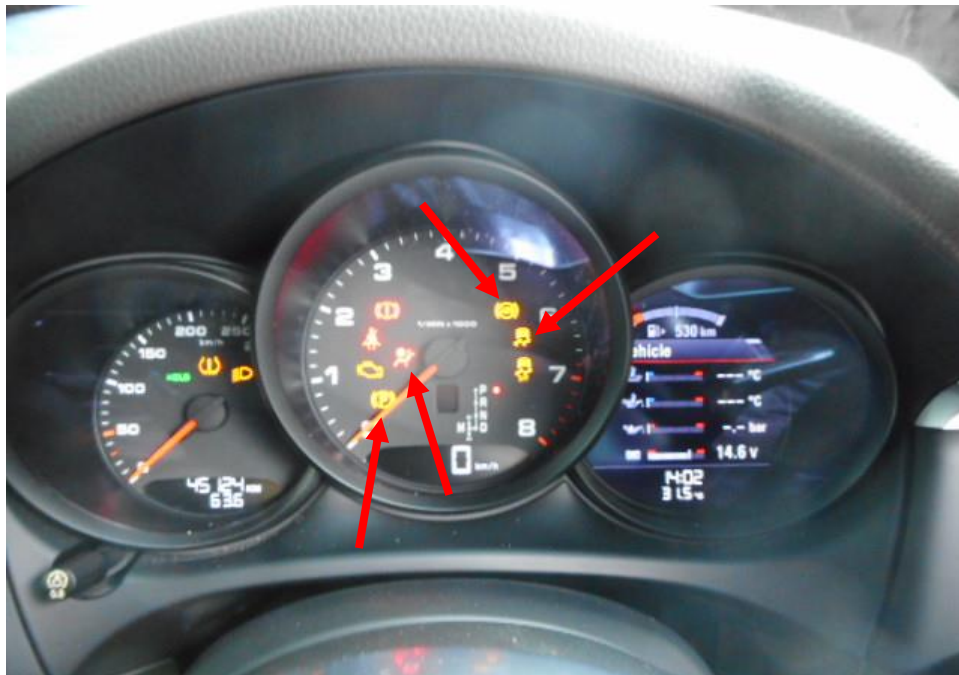
Photo 27 shows the warning light for Anti-Lock Brake System (ABS), Electric Power Steering System (EPS), Traction Control System (TCS) and Supplemental Restraint System (SRS) (arrowed) appearing on the instrument panel of the Motor Car during the self-test of its various electronic operating systems when its engine was cranked.

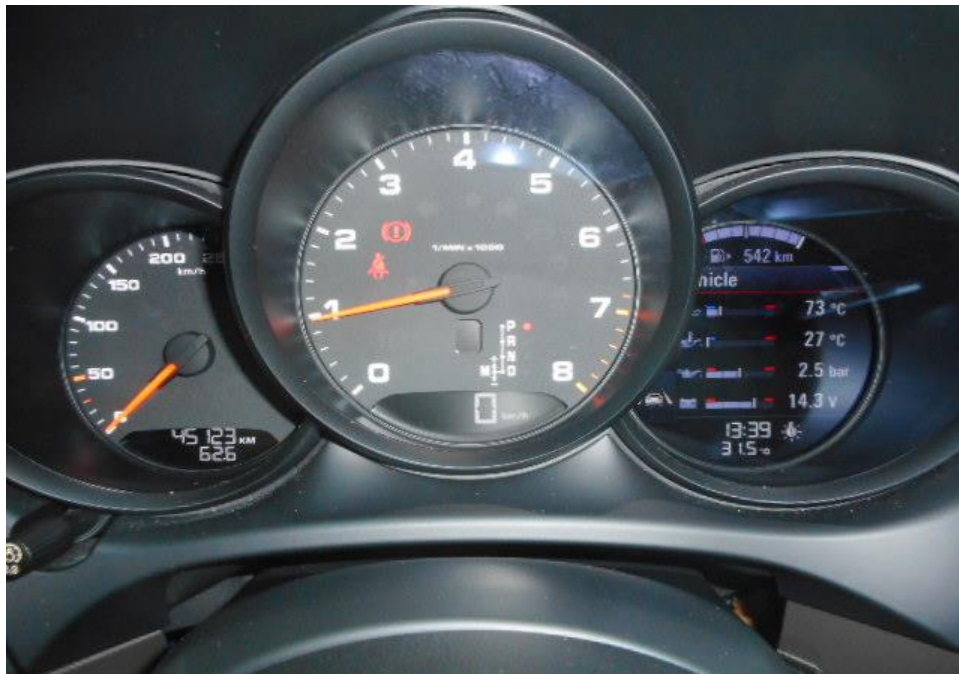
Photo 28 shows no warning lights illuminated on the instrument panel of the Motor Car after the engine was cranked. This would suggest that there was no abnormality to the electronic operating system of the Motor Car, like the ABS, EPS, TCS and SRS etc.
