Your Ref: TP/IP/37441/2021
Our Ref : CI/TPD21010019/P

29th September 2021

Fatal Accident Investigation Team

MECHANICAL INSPECTION REPORT OF MOTOR LORRY GX 2399C

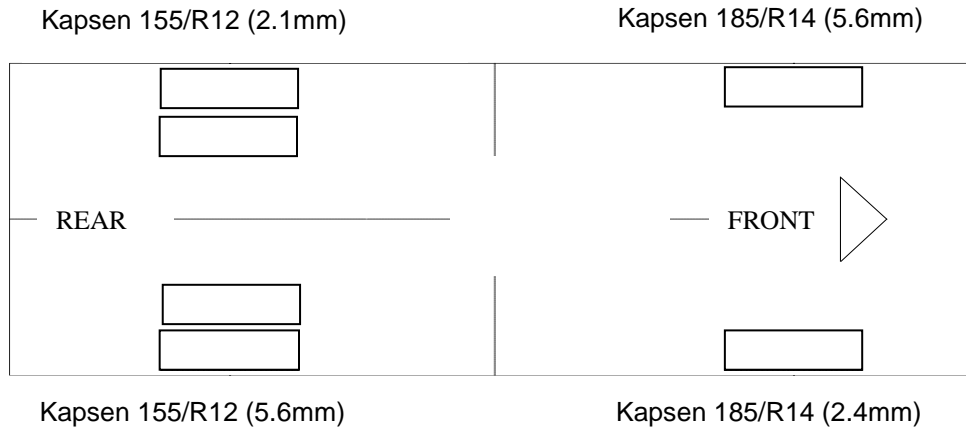
6. The 6 tyres of the Motor Lorry were observed to be in serviceable condition and sufficiently inflated for vehicular operation. I did not find any tear, cut or burst mark(s) on the outer and the inner sidewalls as well as across the tread of the 6 tyres. The tyre brand, tyre size and remaining tread depth of the 6 tyres of the Motor Lorry were recorded as follows:-

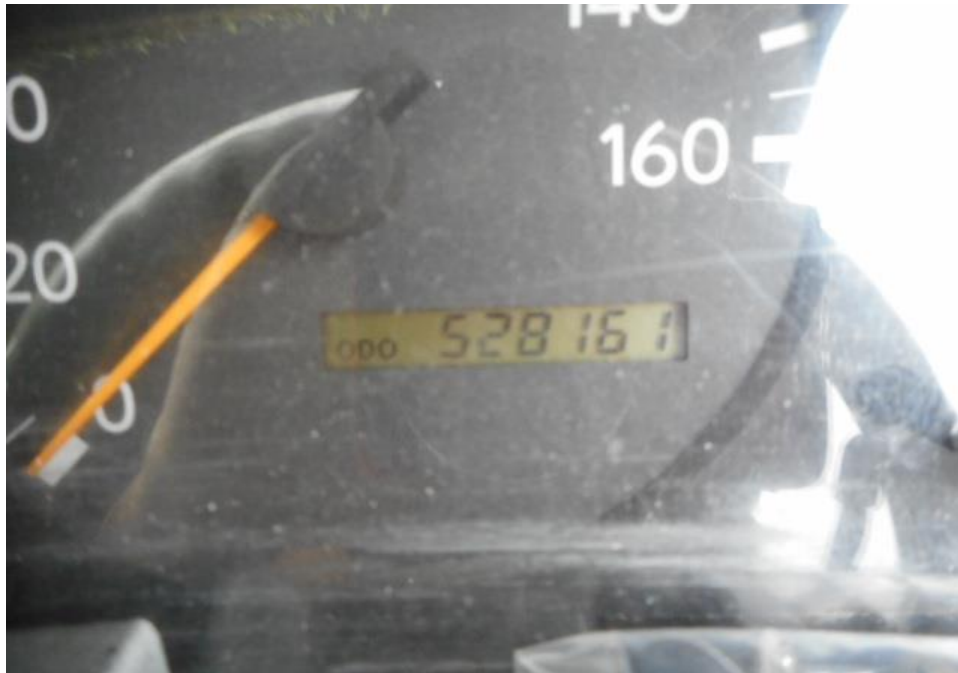
Photo 1 shows a general view of the instrument cluster of the Motor Lorry at the time of my inspection. The mileage of the Motor Lorry was 528,161 km

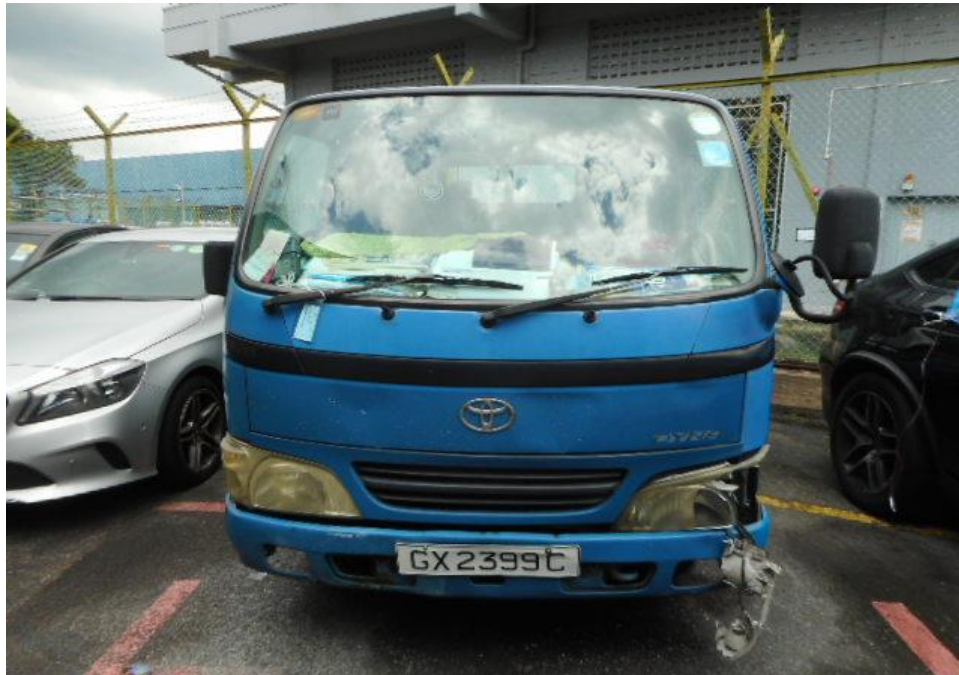
Photo 2 shows a general view of the Motor Lorry's frontal portion at the time of my inspection. It appeared to have sustained damage at its front portion. Its front body panel and front left headlamp were damaged at the time of my inspection as a result of the accident.

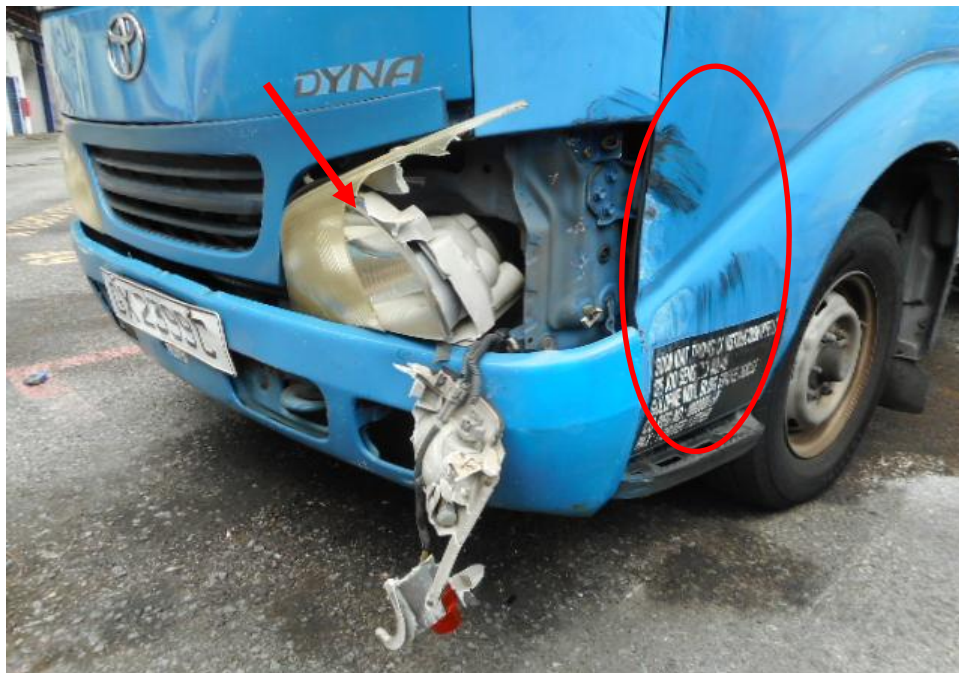
Photo 3 shows a close up view of the Motor Lorry's front portion at the time of my inspection. Its front body panel (circled) and front left headlamp (arrowed) was damaged at the time of my inspection as a result of the accident.

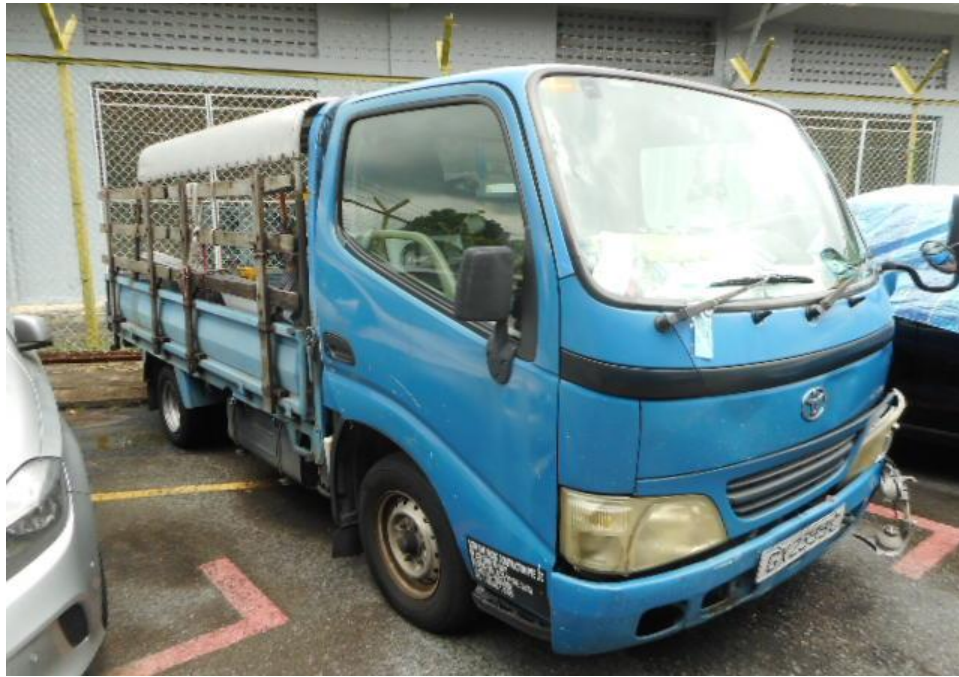
Photo 4 shows a general view of the right body of the Motor Lorry at the time of my inspection. The Motor Lorry was observed to be intact and unaffected by the accident.

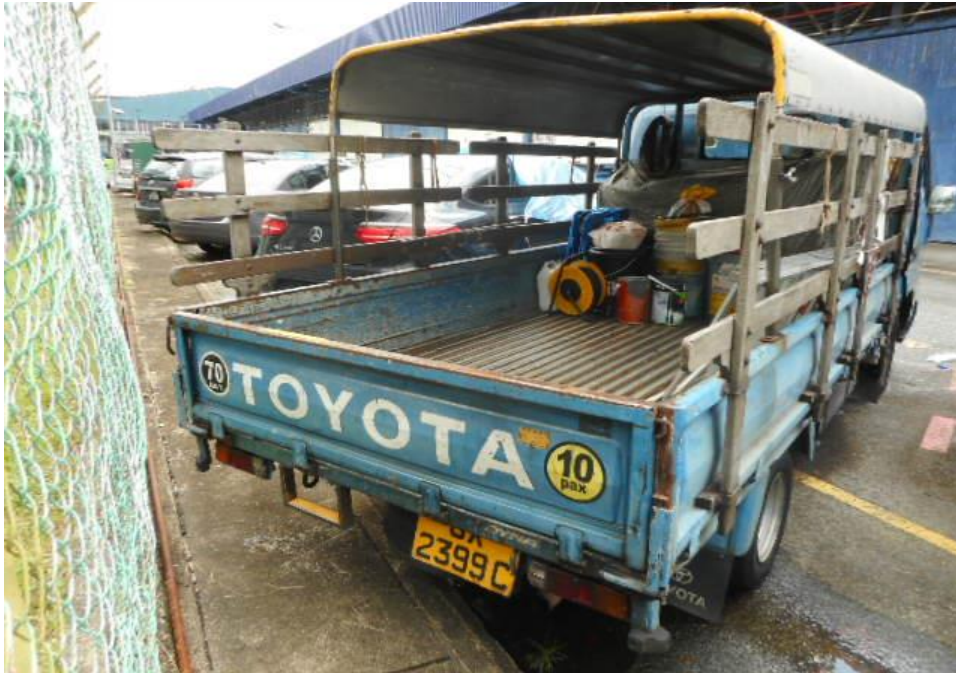
Photo 6 shows a general view of the rear body of the Motor Lorry at the time of my inspection. The Motor Lorry was observed to be intact and unaffected by the accident.

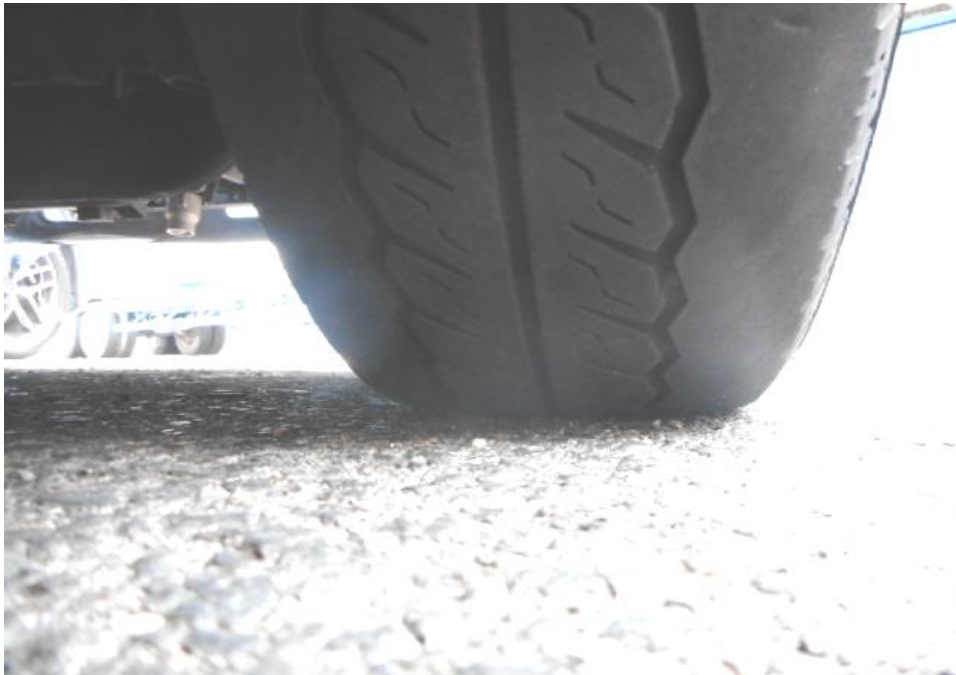
Photo 7 shows the condition of the front right tyre of the Motor Lorry, which was observed to be in serviceable condition with remaining tread depth of approximately 2.4mm. The tyre, which was wrapped around standard steel wheel rim, was also observed to be sufficiently inflated for vehicular operation. There was no tear, cut or burst mark(s) on the outer and the inner sidewalls as well as across the tread of the 6 tyres that were fitted on the Motor Lorry.

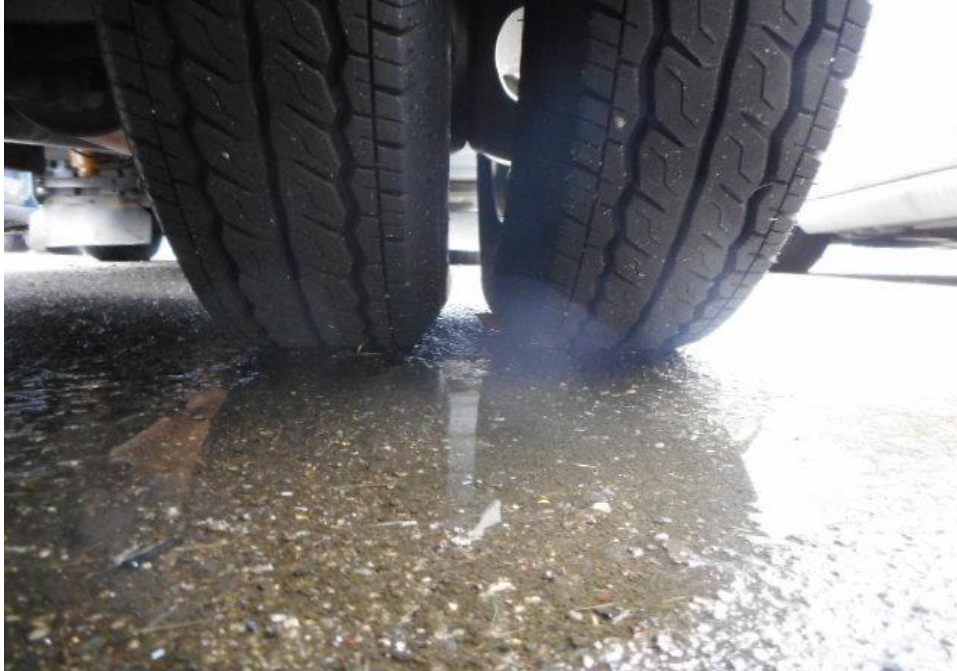
Photo 8 shows the condition of the rear right tyre of the Motor Lorry, which was observed to be in serviceable condition with remaining tread depth of approximately 5.6mm. The tyre, which was wrapped around standard steel wheel rim, it was observed to be sufficiently inflated for vehicular operation.

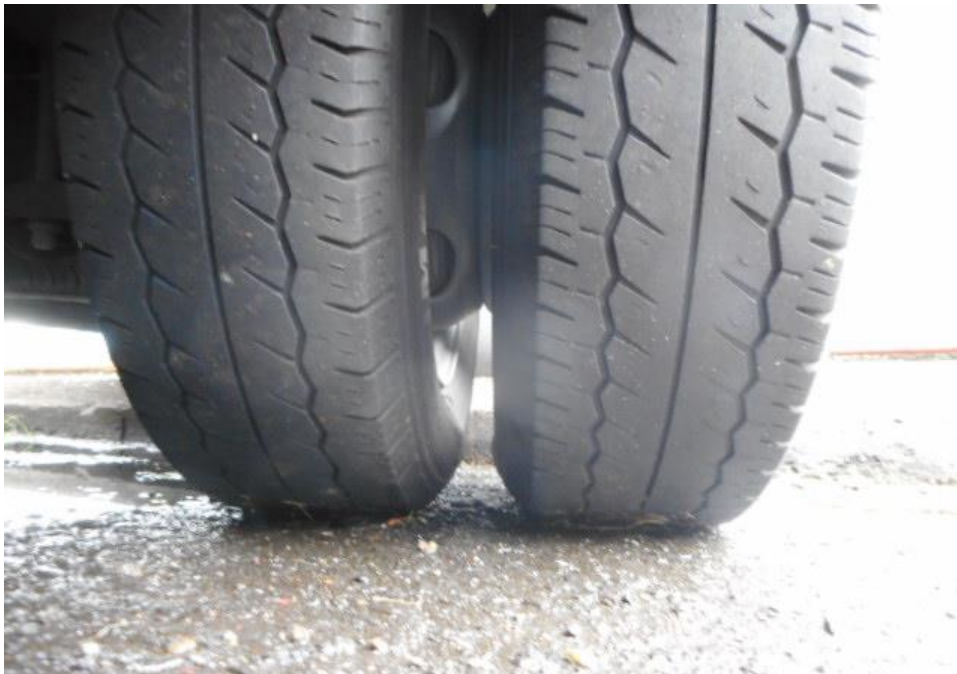
Photo 9 shows the condition of the rear left tyres of the Motor Lorry, which was observed to be in serviceable condition with remaining tread depth of approximately 2.1mm. The tyres, which were wrapped around standard steel wheel rim, were also observed to be sufficiently inflated for vehicular operation.

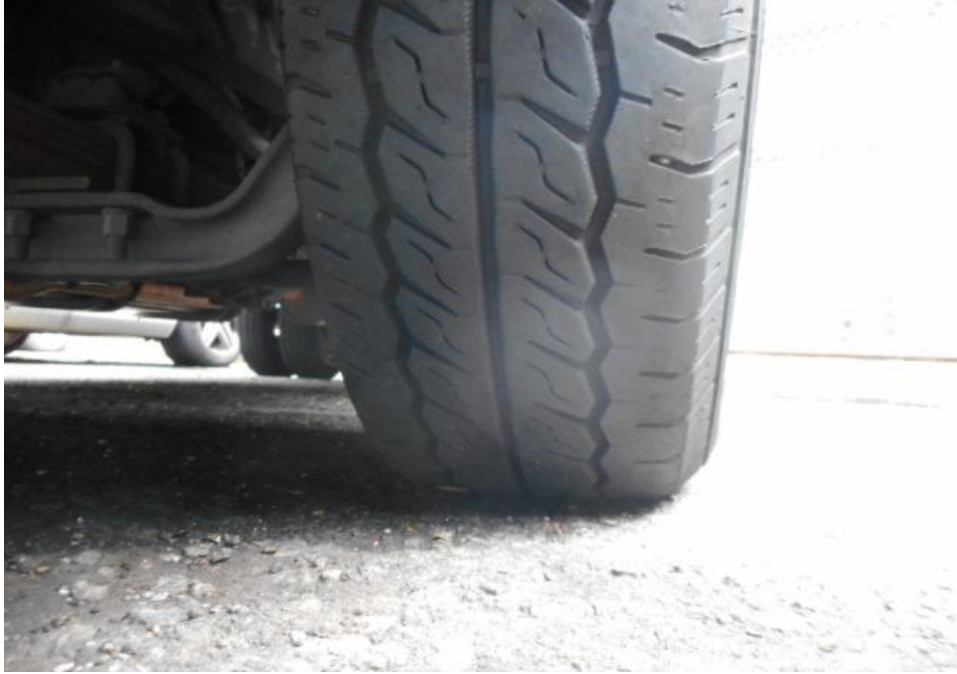
Photo 10 shows the condition of the rear right tyres of the Motor Lorry, which were observed to be in serviceable condition with remaining, tread depth of approximately 5.6mm. There was also no tear, cut or burst mark(s) on the outer and the inner sidewalls as well as across the tread of the 6 tyres that were fitted on the Motor Lorry.

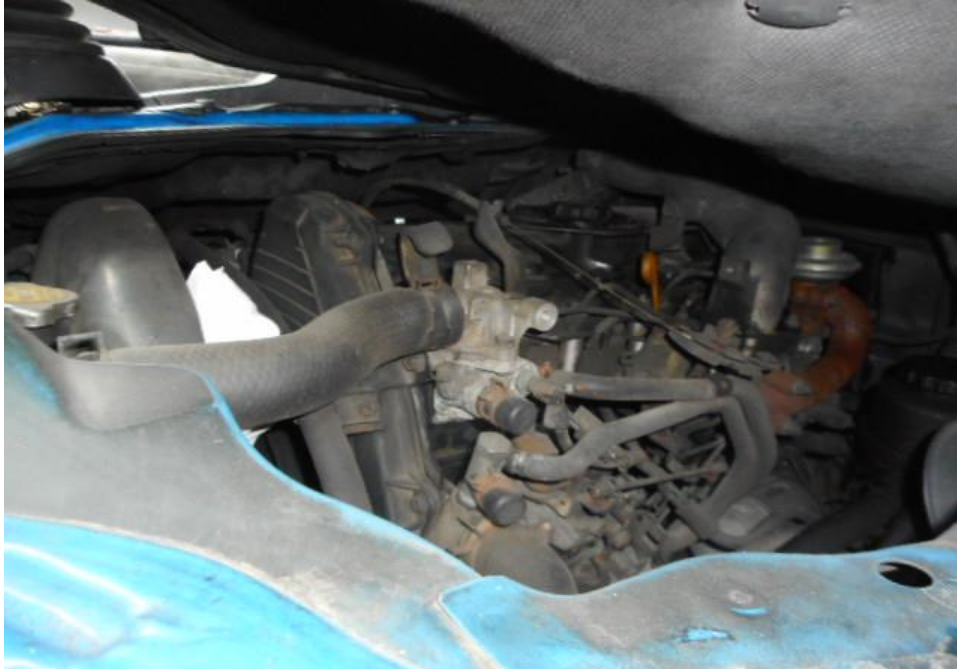
Photo 11 shows a general view of the Motor Lorry's engine compartment, which was accessed by lifting the front cabin of the Motor Lorry. The various parts and components inside the engine compartment were unaffected by the accident. There was also no sign(s) or indication(s) of fresh fluid leakage and/or fluid stain within the engine compartment

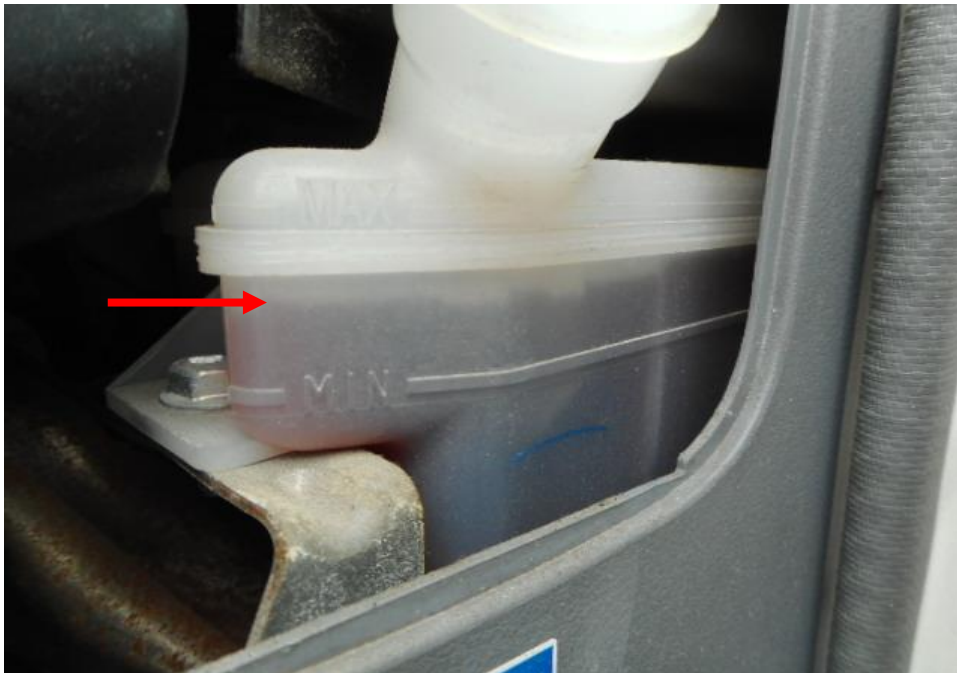
Photo 12 shows the brake fluid reservoir of the Motor Lorry at the time of my inspection. The brake fluid was observed to be of sufficient level (arrowed) and without any visible contamination.

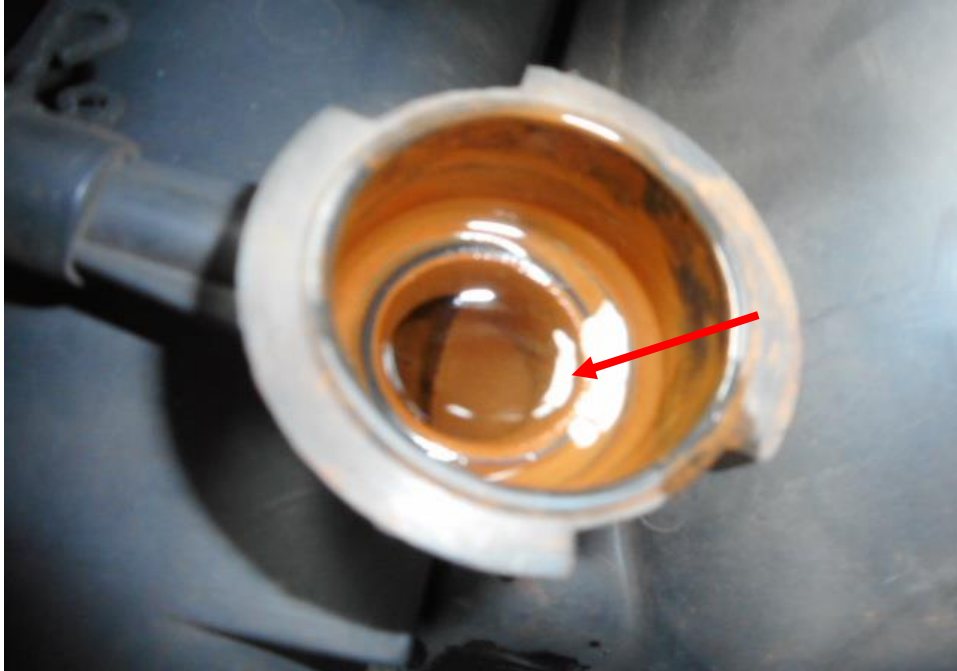
Photo 13 shows the engine coolant reservoir of the Motor Lorry at the time of my inspection. The engine coolant was observed to be of sufficient level (arrowed) and without any visible contamination.

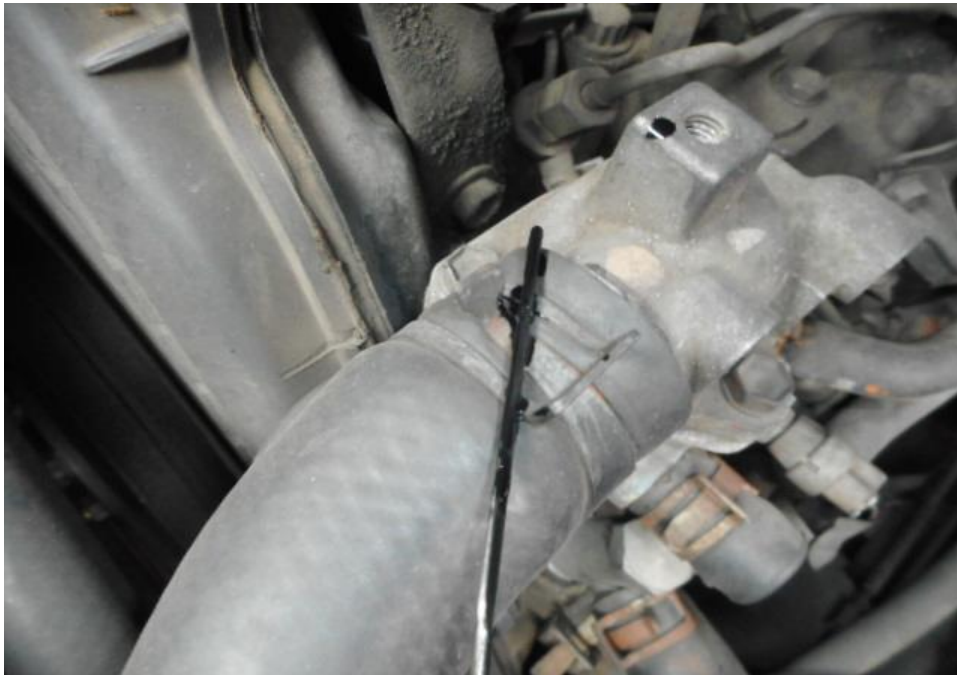
Photo 14 shows the engine oil dip stick of the Motor Lorry at the time of my inspection. The engine oil was observed to be of sufficient level and without any visible contamination.

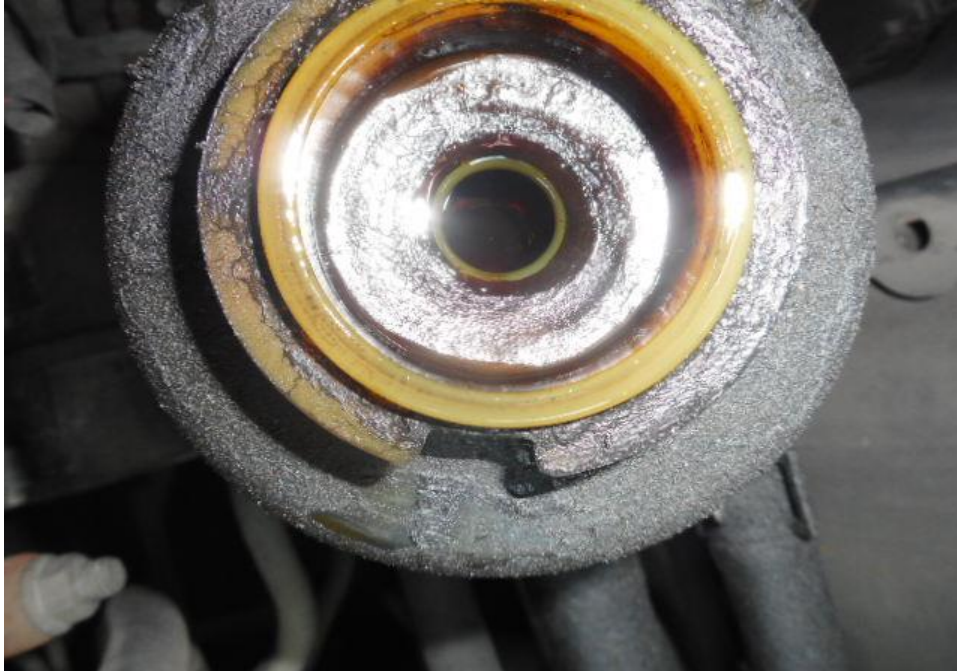
Photo 15 shows the power steering fluid reservoir of the Motor Lorry at the time of my inspection. The power steering fluid was observed to be of sufficient level and without any visible contamination.

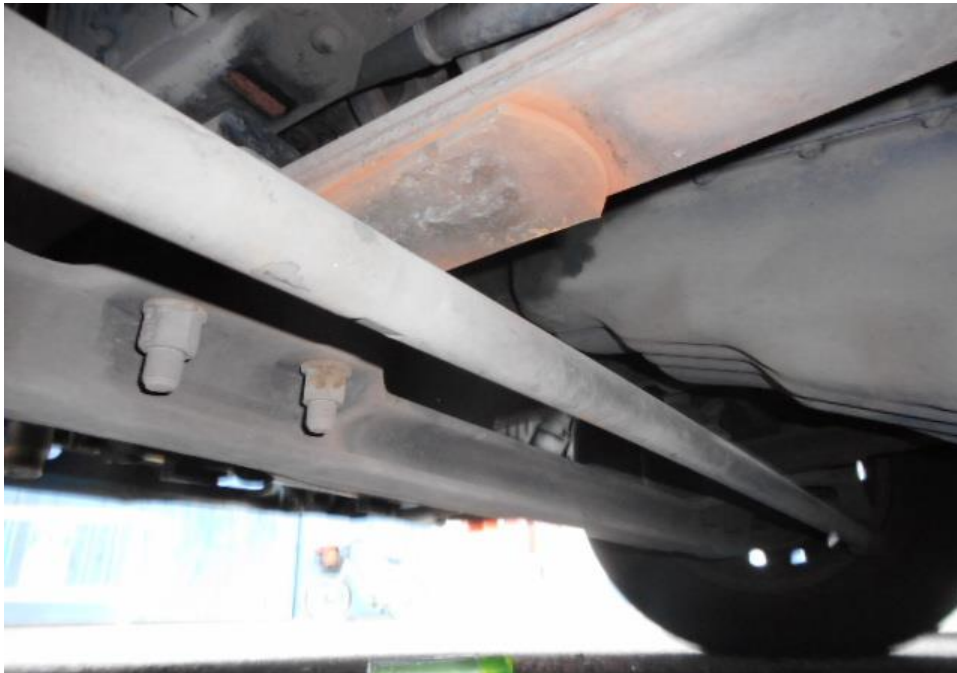
Photo 16 shows the undercarriage of the Motor Lorry, at the area where the engine housing and transmission housing are located. I did not find any sign(s) or indication(s) of fluid leak and/or fluid stain(s) on the underside of the Motor Lorry.

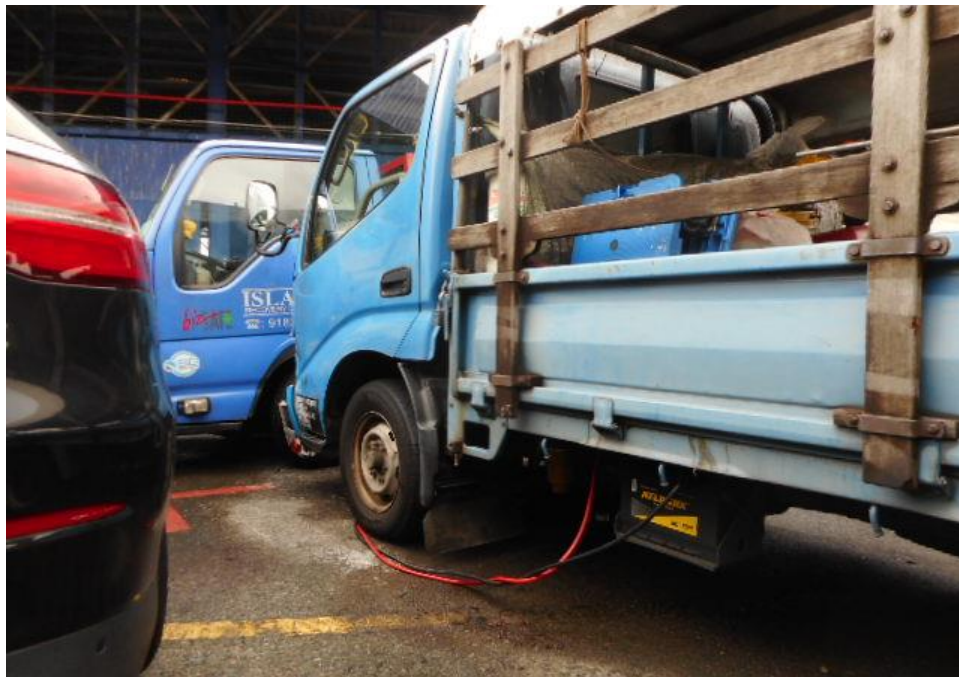
Photo 17 shows the jumpstarting process of the Motor Lorry's engine. The engine of the Motor Lorry's was unable to be jumpstarted up despite multiple attempts in starting it.

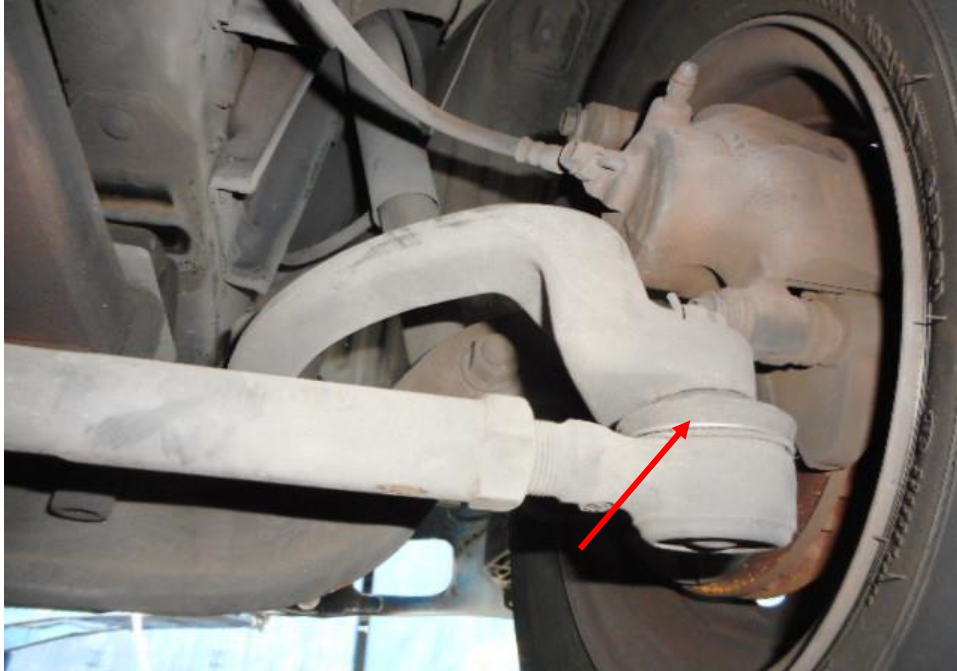
Photo 18 shows the various undercarriage components at the front right wheel of the Motor Lorry, in particular the steering tie rod end (arrowed). The various steering components were all found to be intact, suggesting that the steering system of the Motor Lorry was likely to be in serviceable condition at the material time of accident. There was also no sign of fluid stain(s) observed on the various undercarriage components.

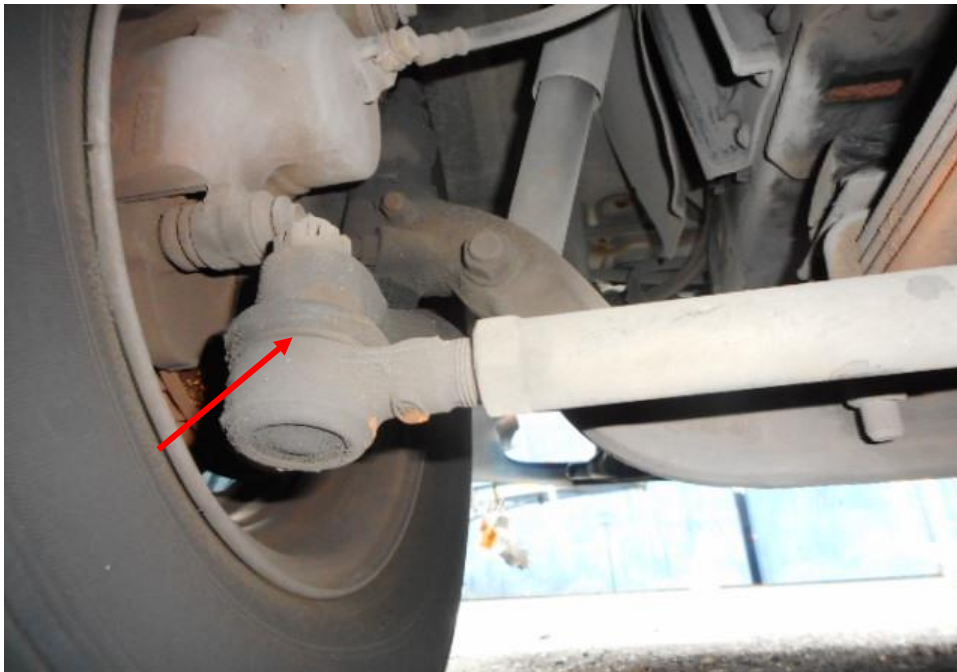
Photo 19 shows the various undercarriage components at the front left wheel of the Motor Lorry, in particular the steering tie rod end (arrowed). The various undercarriage components of the Motor Lorry were all found to be intact without any visible damage. There was also no sign of fluid stain(s) observed on the various undercarriage components.

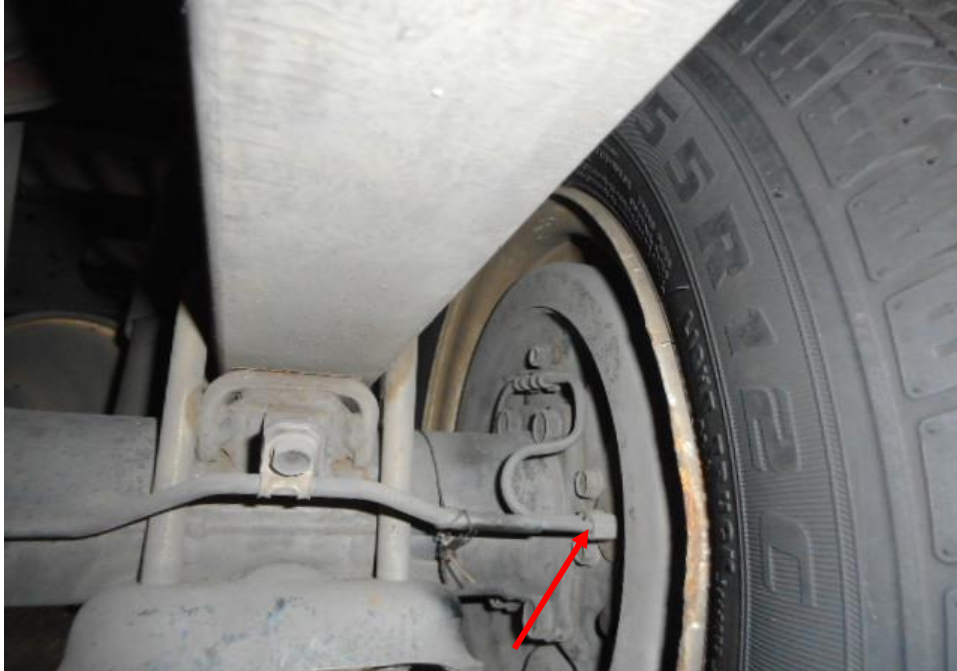
Photo 20 shows the brake pipe (arrowed) at the rear right wheel of the Motor Lorry. I did not observe any leakage of brake fluid at the time of my inspection of the Motor Lorry. My static tests of the Motor Lorry's braking system, along with my visual examination of the various mechanical components in the braking system, had indicated that there was no internal leakage of pressure/vacuum. Hence the braking system of the Motor Lorry was likely to be in serviceable condition at the material time of accident.

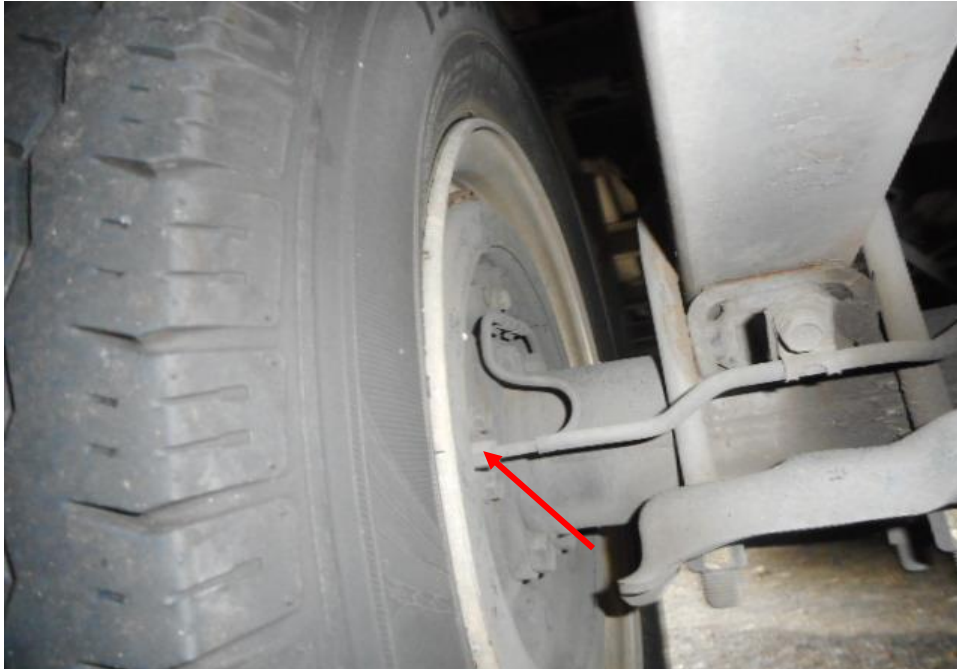
Photo 21 shows the brake pipe (arrowed) at the rear left wheel of the Motor Lorry. I did not observe any leakage of brake fluid at the time of my inspection of the Motor Lorry. My static tests of the Motor Lorry's braking system, along with my visual examination of the various mechanical components in the braking system had indicated that there was no internal leakage of pressure/vacuum. Hence the braking system of the Motor Lorry was likely to be in serviceable condition at the material time of accident.

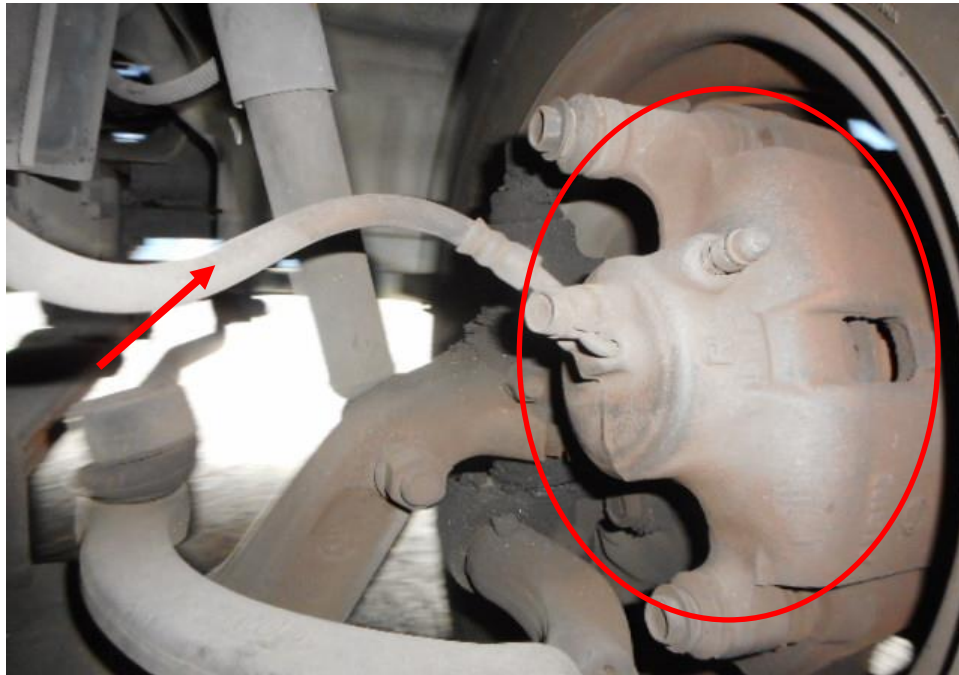
Photo 22 shows the brake hose/pipe (arrowed) at the front right wheel of the Motor Lorry. No leakage of brake fluid was observed. Visual examination of the various components of the braking system like the brake caliper (circled), brake booster, brake pedal etc had revealed all to be intact and without visible damage at the time of accident. There was also no sign of fluid stain(s) observed on the various undercarriage components.

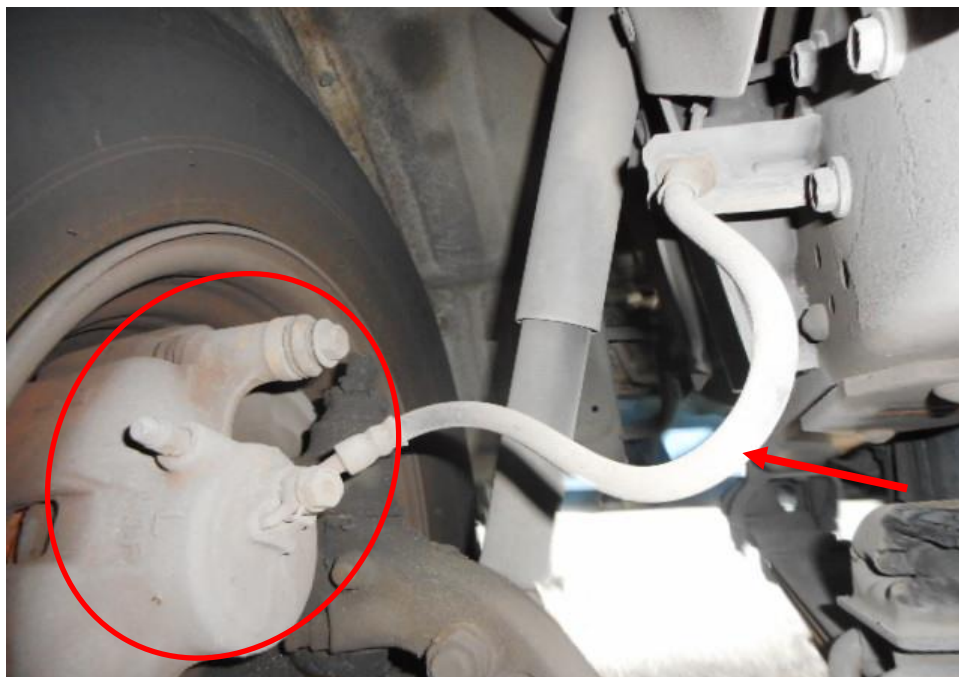
Photo 23 shows the brake hose/pipe (arrowed) at the front left wheel of the Motor Lorry. No leakage of brake fluid was observed. Visual examination of the various components of the braking system like the brake caliper (circled), brake booster, brake pedal etc had revealed all to be intact and without visible damage at the time of accident. There was also no sign of fluid stain(s) observed on the various undercarriage components.
