Your Ref: TP/IP/35321/2021  
Our Ref : CI/TPD21010020/P

30<sup>th</sup> September 2021

**Fatal Accident Investigation Team**

**MECHANICAL INSPECTION REPORT OF MOTOR CAR SGH 1678M**

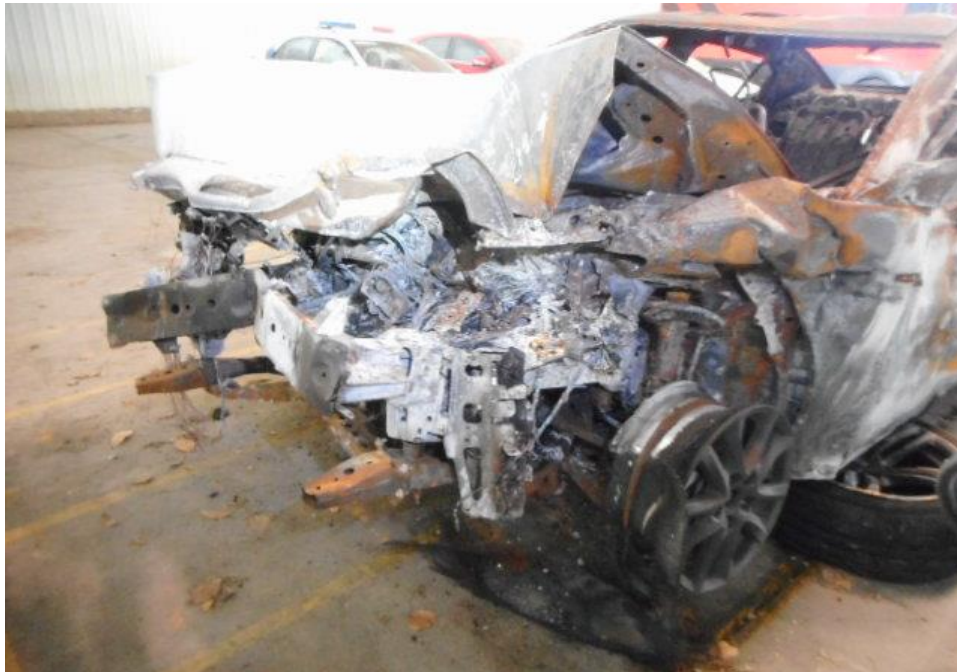
**Photo 1** shows a general view of the Motor Car's front body at the time of my inspection. Motor Car had caught fire and burned up, however we were still able to observe physically damages to it. We observed that the Motor Car had sustained damage all around the vehicle. Its front bonnet, left body panel and rear boot were amongst the body parts various components in the engine compartments were also damaged as a result of the accident.

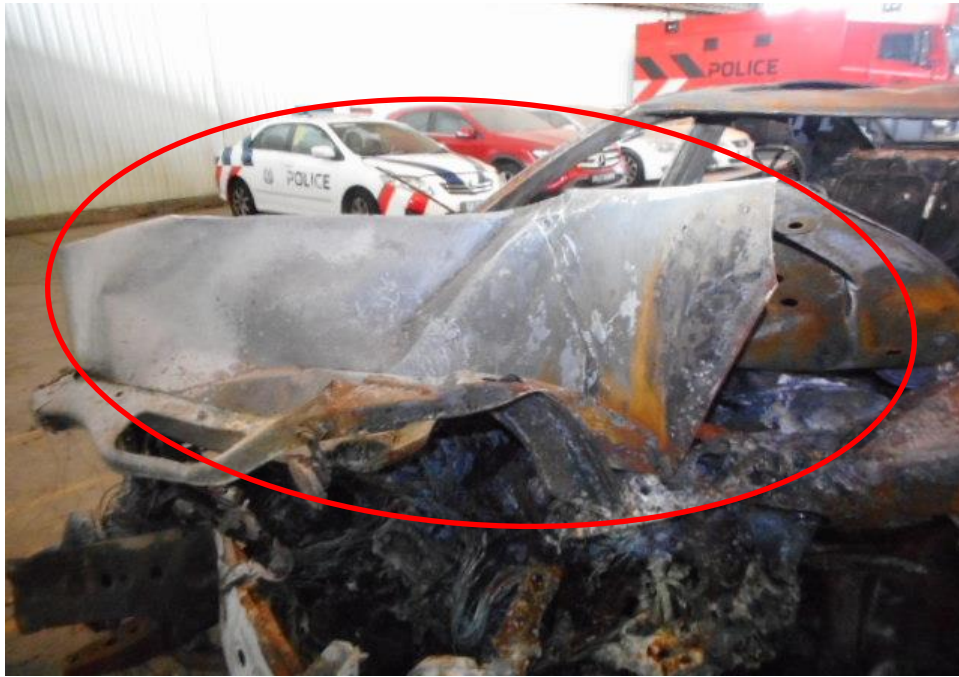
**Photo 2** shows the close up view of the Motor Car's front body at the time of my inspection. The Motor Car was observed to have sustained damage at its front portion. Its front bonnet (circled) were amongst the body parts that were damaged as a result of the accident.

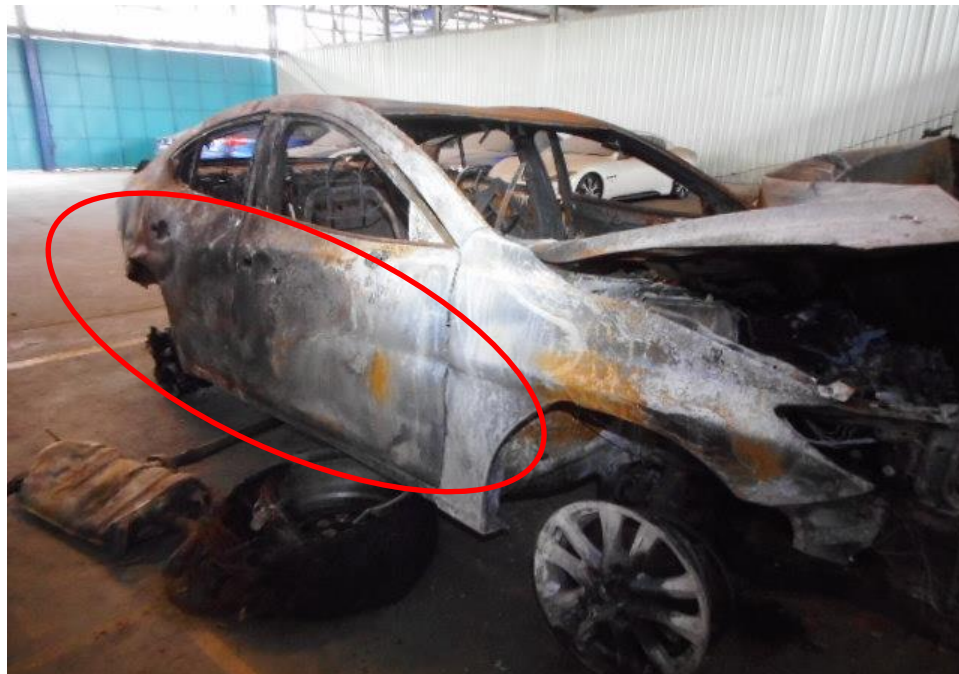
**Photo 3** shows a general view of the Motor Car's right body at the time of my inspection. The Motor Car was observed to have sustained damage at its right portion. Its right body panels (circled) were amongst the body parts that were burned and damaged as a result of the accident.

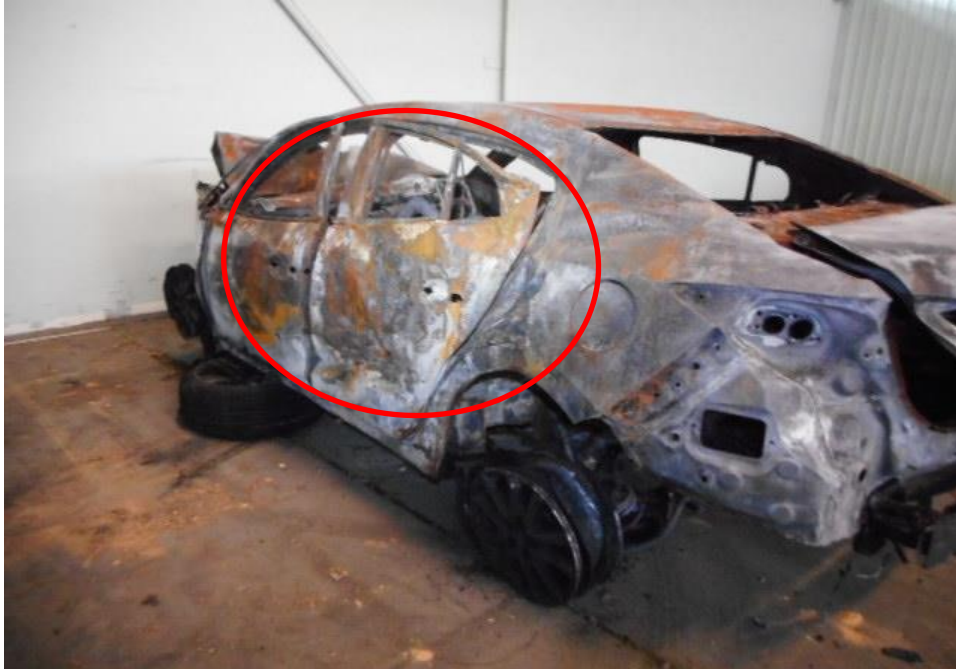
**Photo 4** shows a general view of the Motor Car's left at the time of my inspection. The Motor Car was observed to have sustained damage at its right portion. Its left body panels (circled) were amongst the body parts that were burned and damaged as a result of the accident.

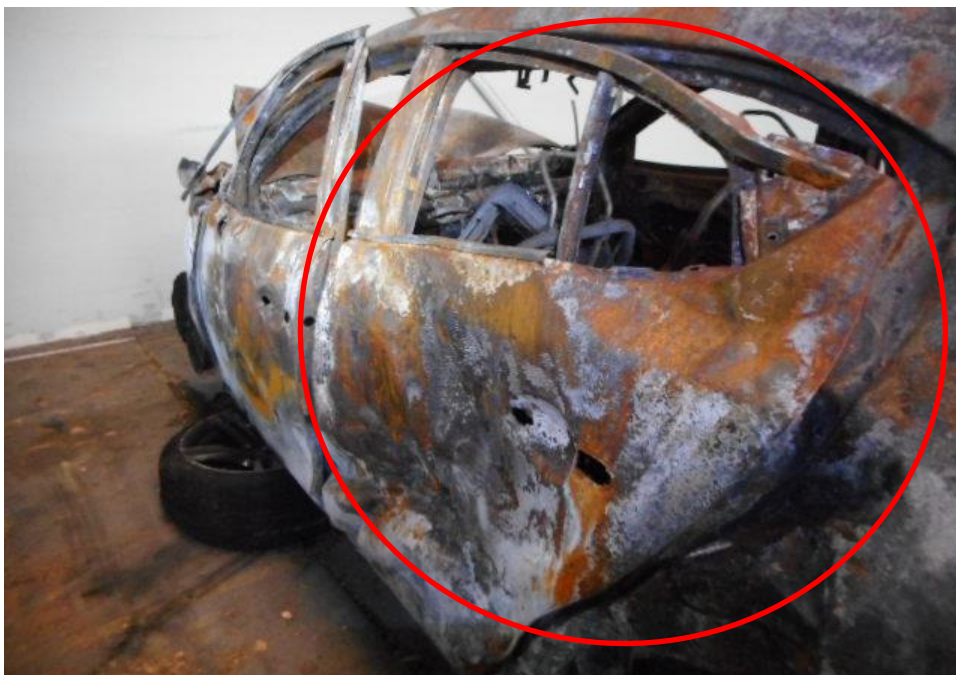
**Photo 5** shows a close up view of the Motor Car's left at the time of my inspection. The Motor Car was observed to have sustained damage at its left portion. Its left body panels (circled) were amongst the body parts that were burned and damaged as a result of the accident.

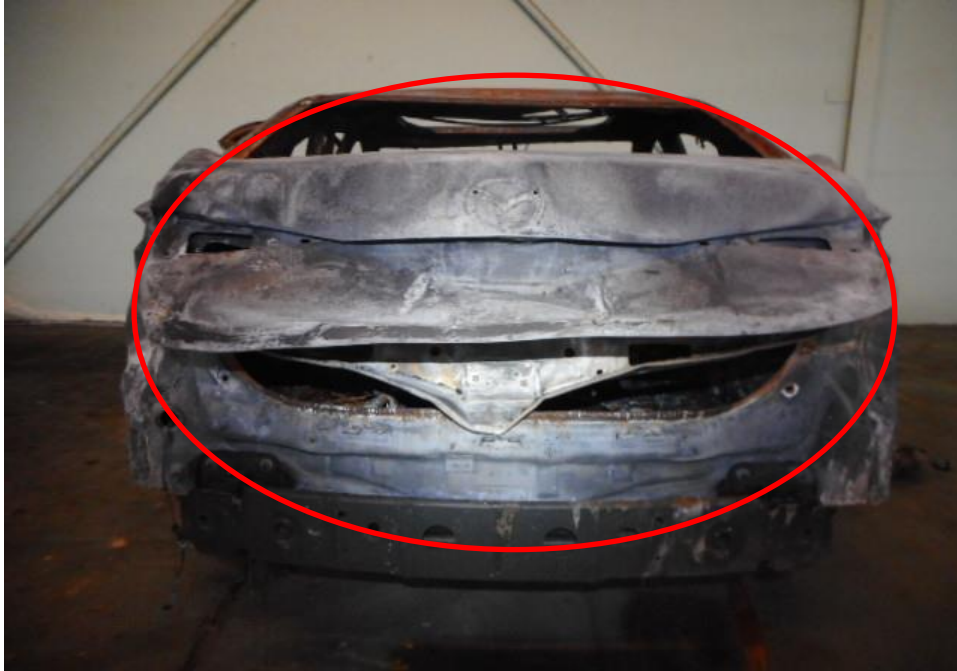
**Photo 6** shows a close up view of the Motor Car's rear at the time of my inspection. The Motor Car was observed to have sustained damage at its rear portion. Its rear body panels (circled) were amongst the body parts that were burned and damaged as a result of the accident.

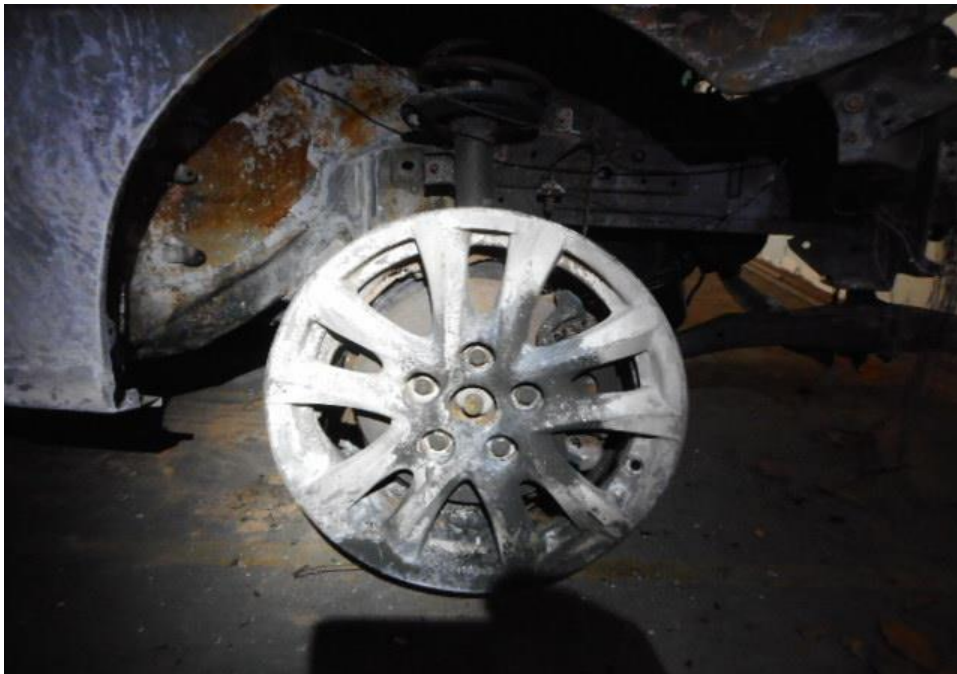
**Photo 7** shows the condition of the front right tyre and rim of the Motor Car, which was observed to be burned and damaged as a result of the accident.

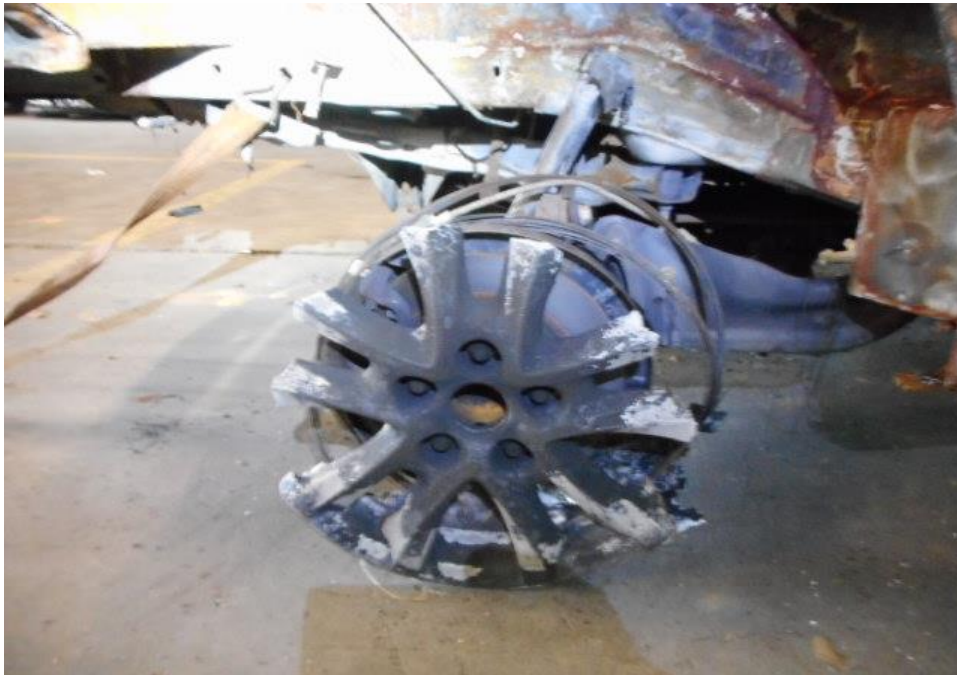
**Photo 8** shows the condition of the rear right tyre and rim of the Motor Car, which was observed to be burned, damaged and broken as a result of the accident.

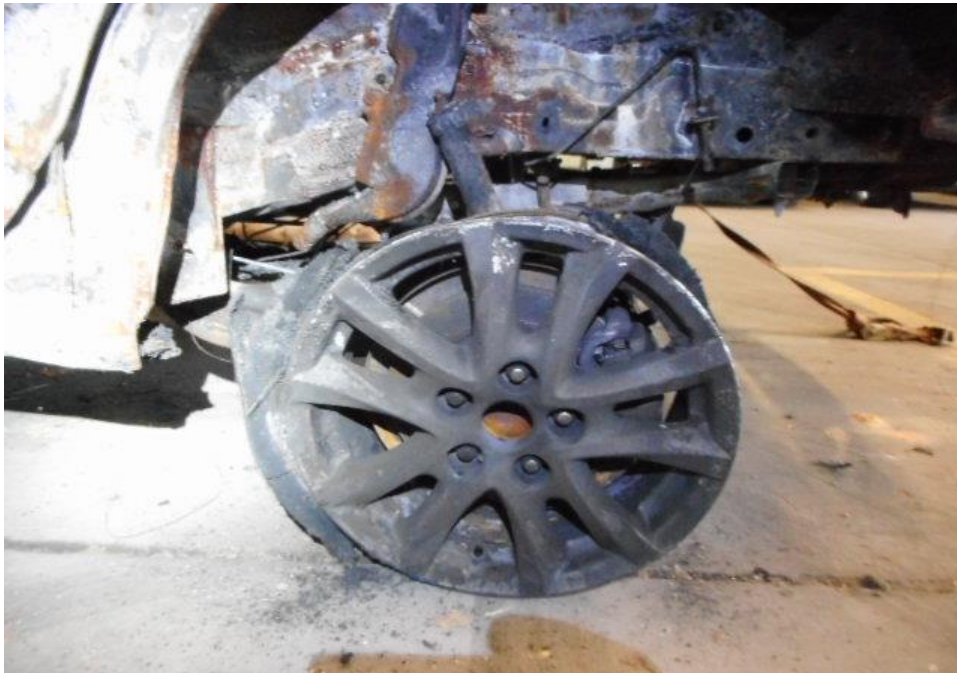
**Photo 9** shows the condition of the rear left tyre and rim of the Motor Car, which was observed to be burned and damaged as a result of the accident.

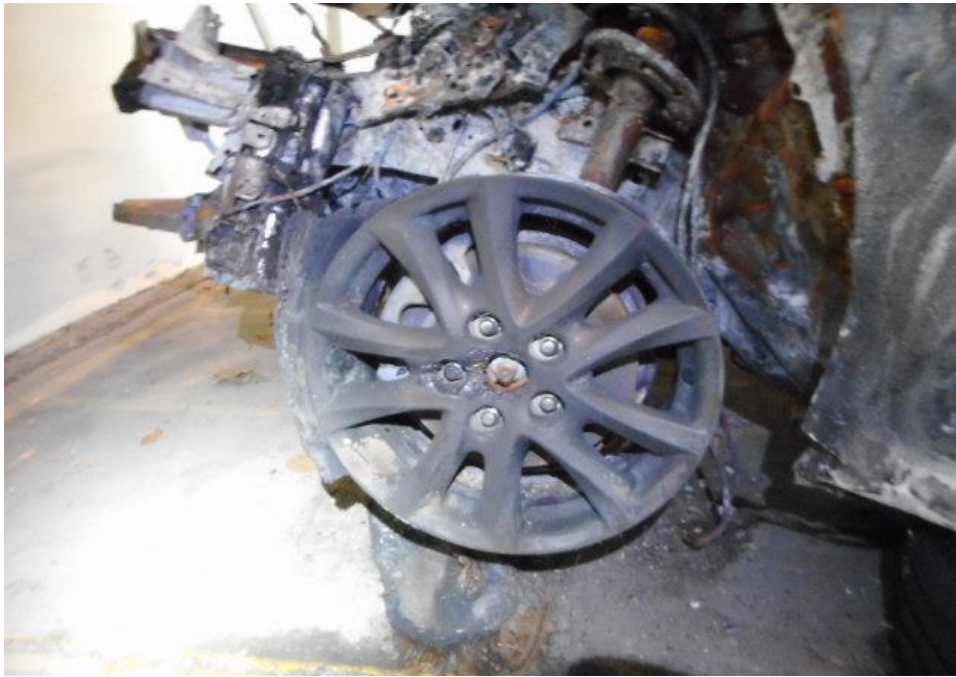
**Photo 10** shows the condition of the front left tyre and rim of the Motor Car, which was observed to be burned and damaged as a result of the accident.

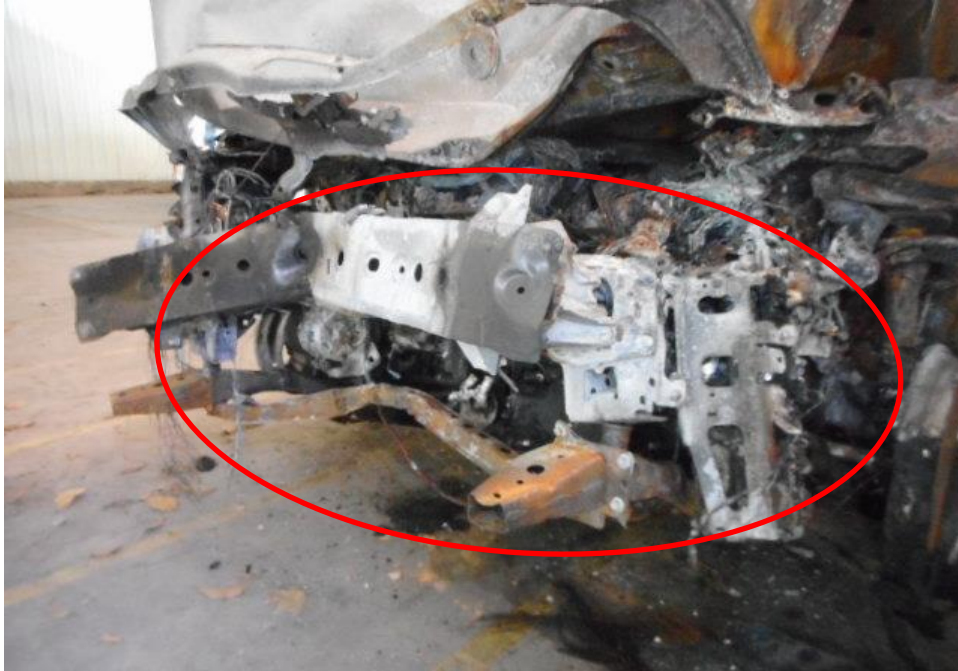
**Photo 11** shows the close up view of the Motor Car's front body at the time of my inspection. The Motor Car was observed to have sustained damage at its front portion. Its various components in the engine compartments (circled) were also damaged as a result of the accident.

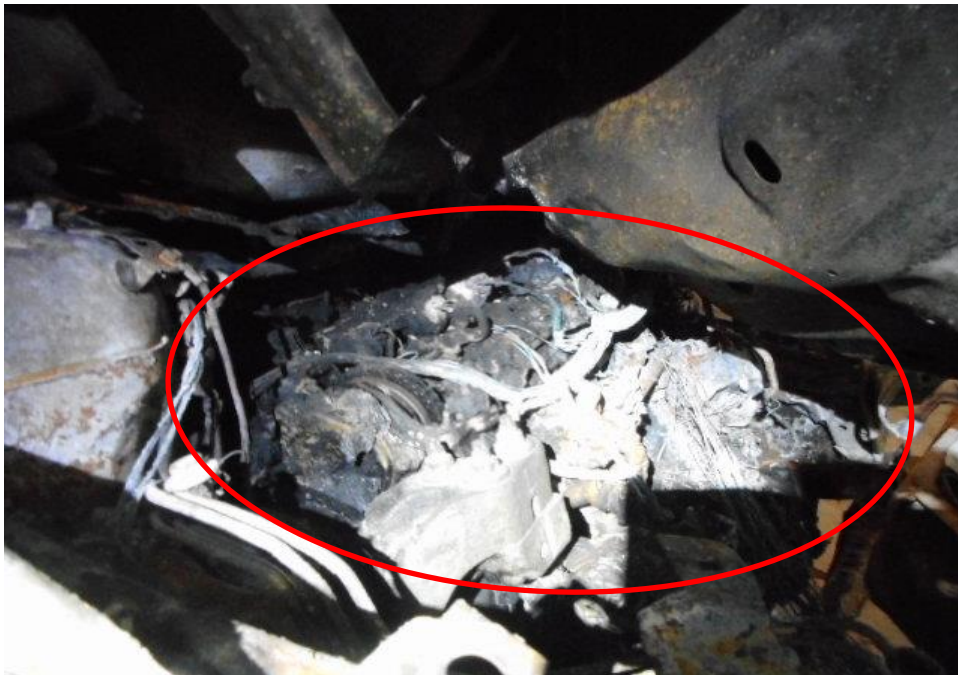
**Photo 12** shows the close up view of the Motor Car's engine compartments at the time of my inspection. Its engine and various components in the engine compartments (circled) were burned and damaged as a result of the accident.

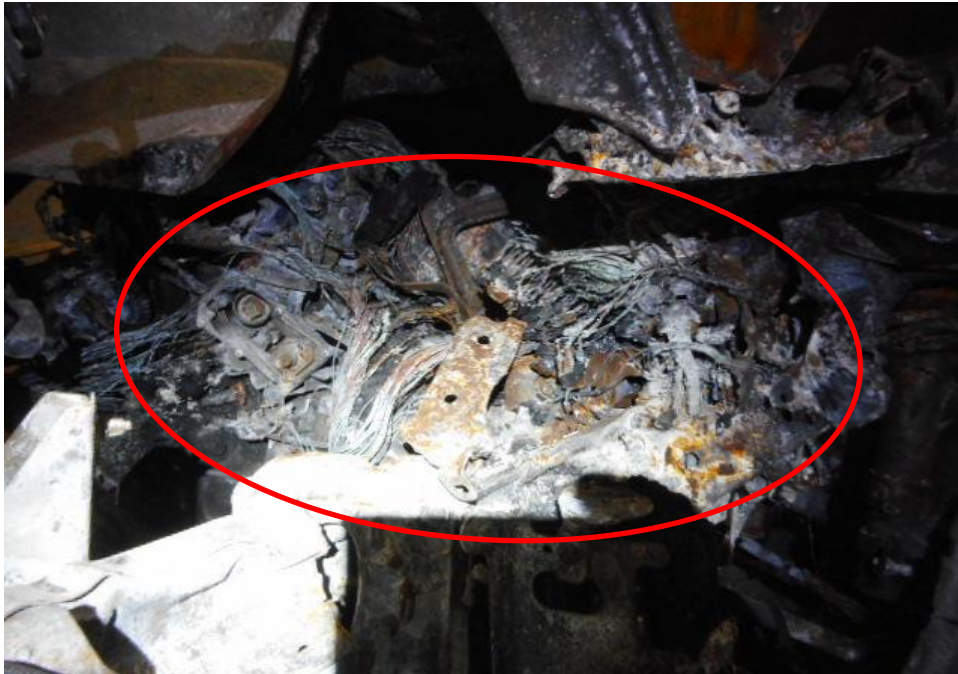
**Photo 13** shows the close up view of the Motor Car's engine compartments at the time of my inspection. Its engine and various components in the engine compartments (circled) were burned and damaged as a result of the accident.

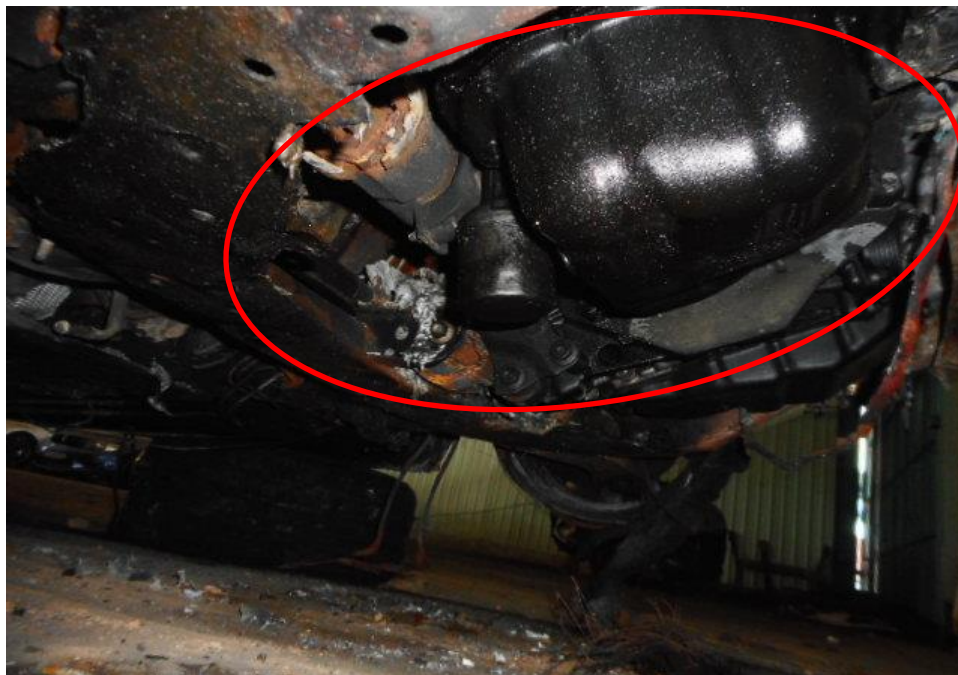
**Photo 14** shows the undercarriage of the Motor Car, at the area where the engine housing and transmission housing are located. I observed sign(s) of fluid leak and fluid stain(s) on the underside of the Motor Car as a result of the accident and fire damage.

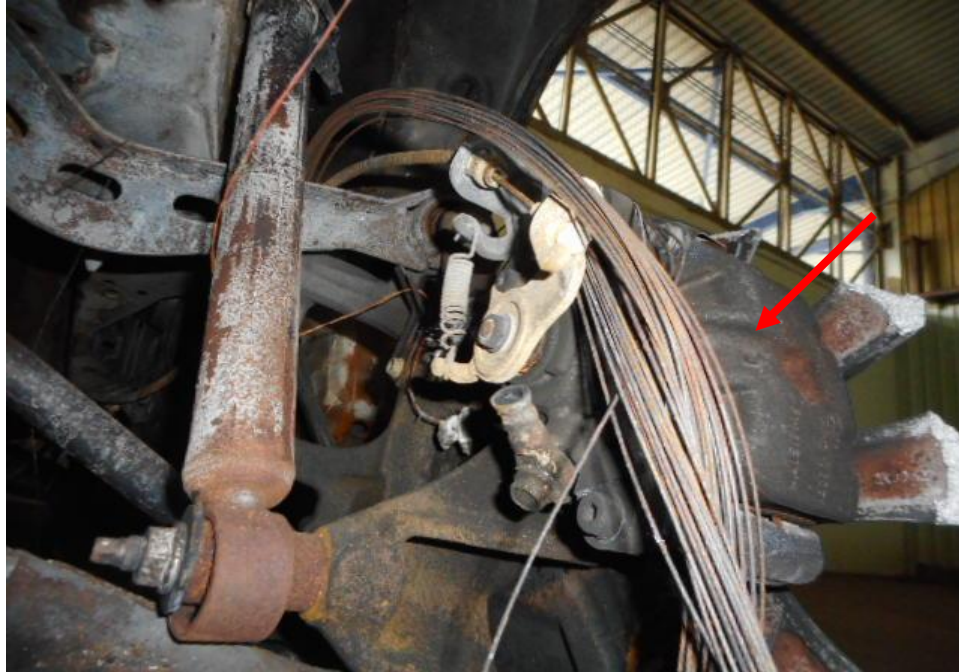
**Photo 15** shows the brake caliper (arrowed) at the rear right wheel of the Motor Car. The component was observed to sustain fire damage as a result of the accident.

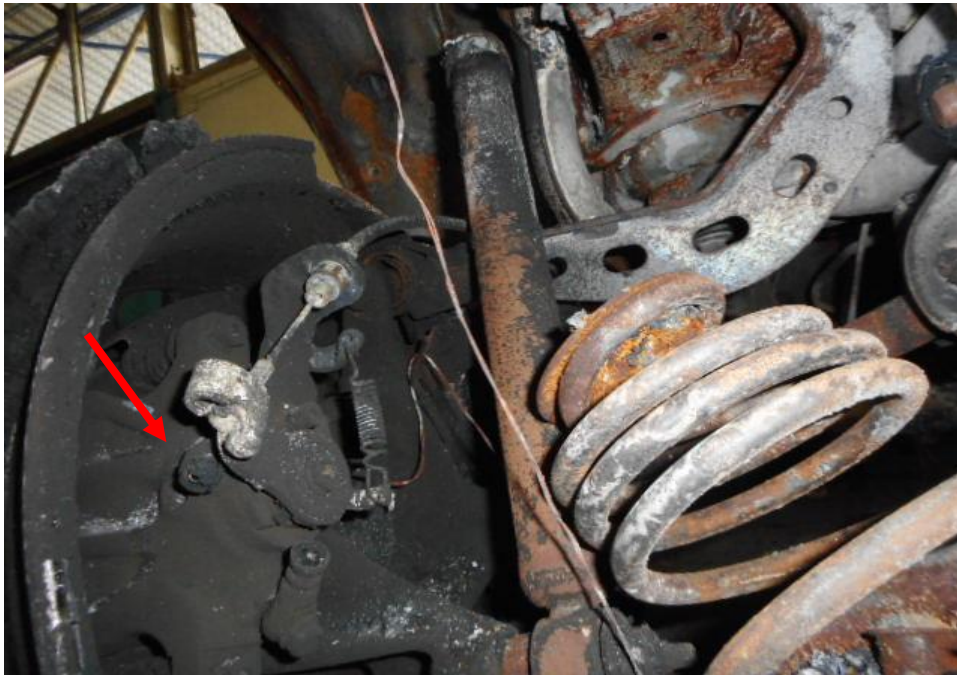
**Photo 16** shows the brake caliper (arrowed) at the rear left wheel of the Motor Car. The component was observed to sustain fire damage as a result of the accident.

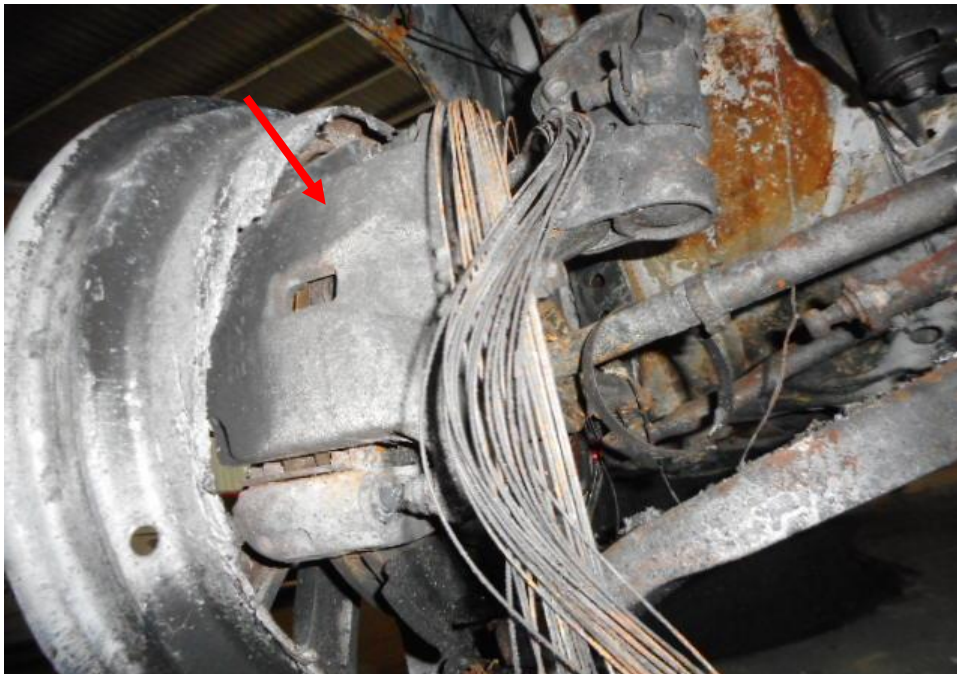
**Photo 17** shows the brake caliper (arrowed) at the front right wheel of the Motor Car. The component was observed to sustain fire damage as a result of the accident.

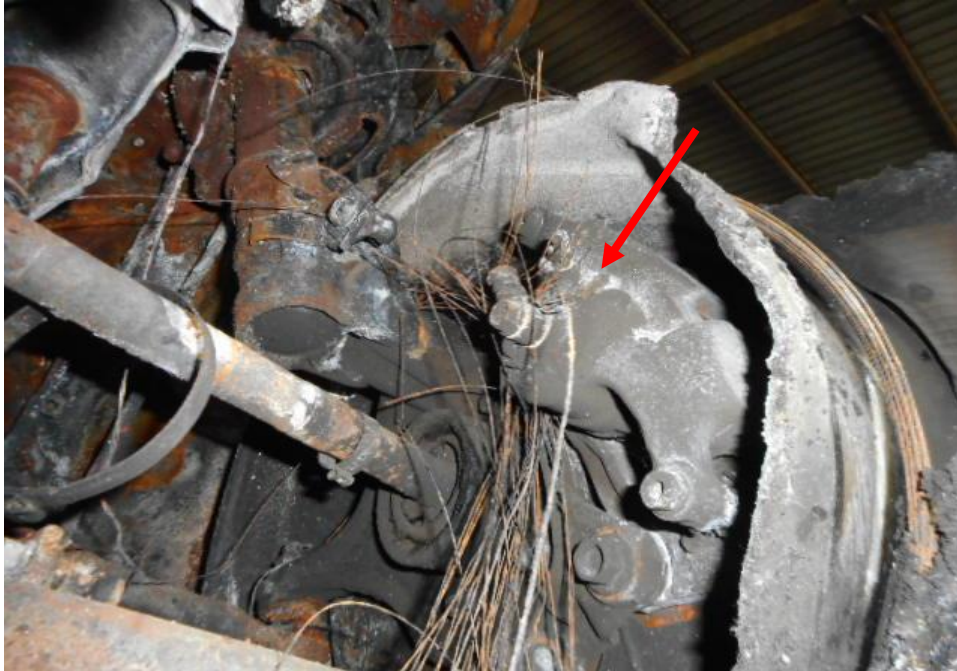
**Photo 18** shows the brake caliper (arrowed) at the front left wheel of the Motor Car. The component was observed to sustain fire damage as a result of the accident.

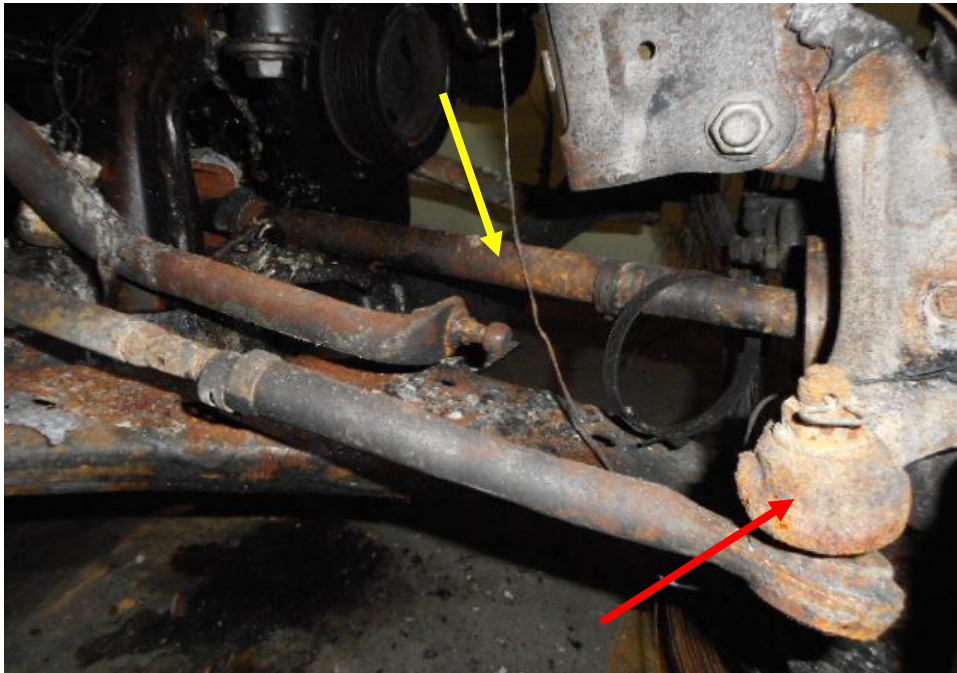
**Photo 19** shows the various undercarriage steering components at the front right wheel of the Motor Car. The steering tie rod (red arrow) and driveshaft (yellow arrow) was observed to sustain fire damage as a result of the accident.

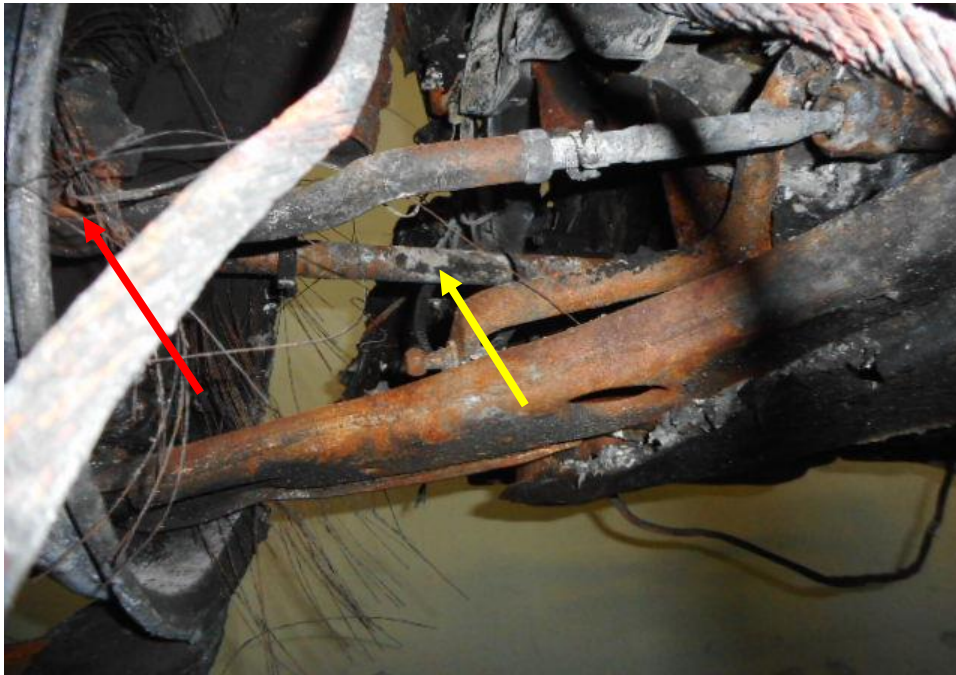
**Photo 20** shows the various undercarriage steering components at the front left wheel of the Motor Car, The steering tie rod (red arrow) and driveshaft (yellow arrow) was observed to sustain fire damage as a result of the accident.
