You're Ref: TP/IP/35321/2021  
Our Ref: CI/TPD21010021/P

**Fatal Accident Investigation Team**

**MECHANICAL INSPECTION REPORT OF MOTOR TAXI SHB 8077X**

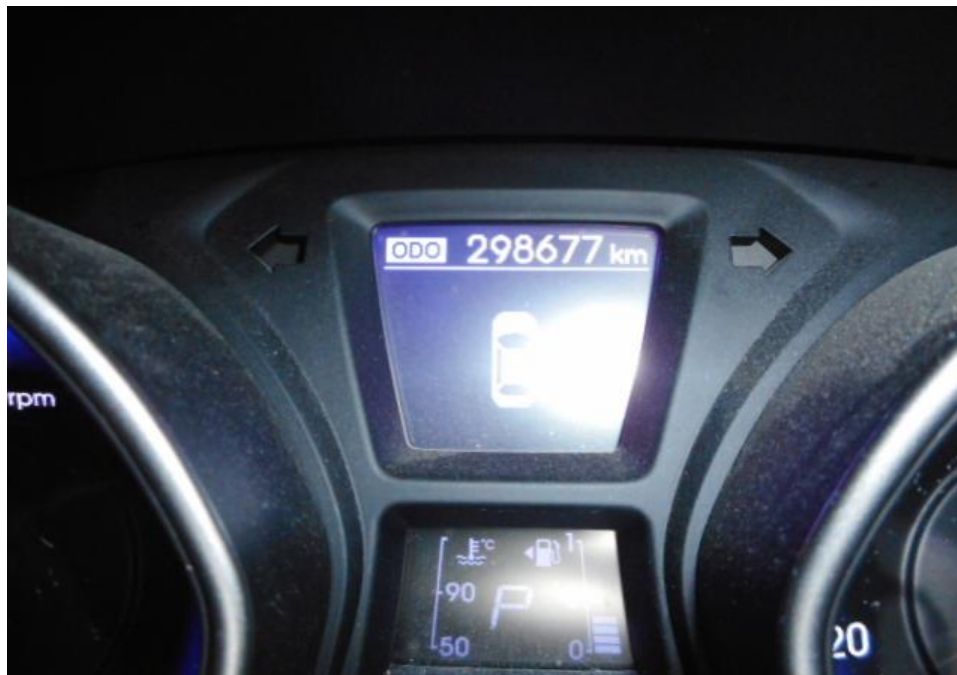
4. The mileage of the Motor Taxi at the time of my inspection was 298,677km.
5. The Motor Taxi was observed to have sustained damage at its front portion. Its front bumper and front number plate was the body parts that were damaged as a result of the accident.

**Photo 1** shows the mileage of the Motor Taxi at the time of my inspection. The mileage observed was 298,677km.

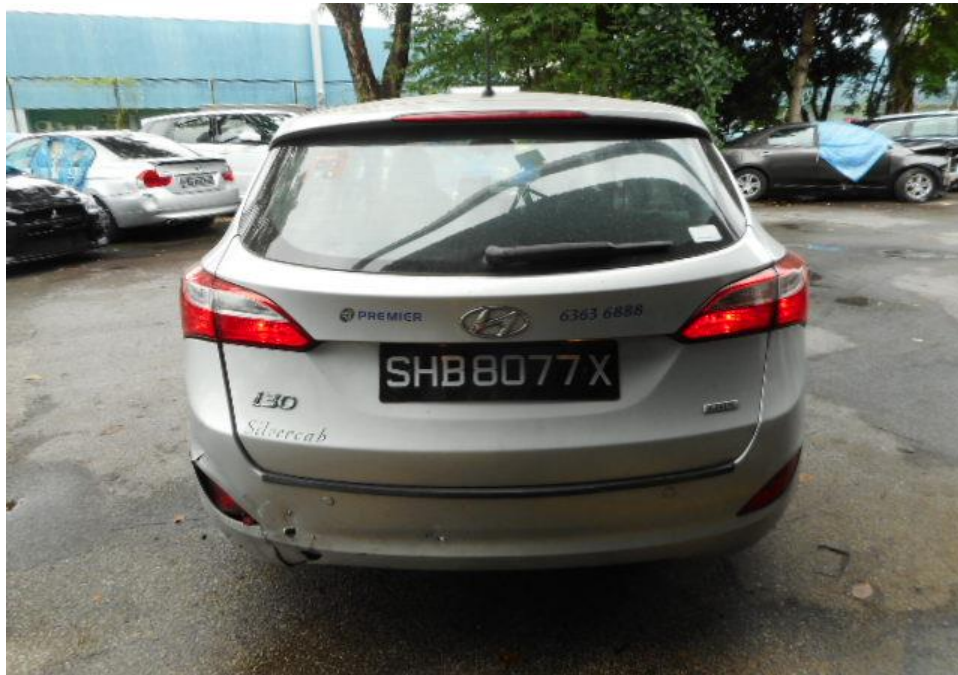
**Photo 2** shows the general view of the Motor Taxi's rear body at the time of my inspection. The Motor Taxi rear portion of the Motor Taxi was observed to have sustained damage. Its rear bumper was the body part that were damaged as a result of the accident.

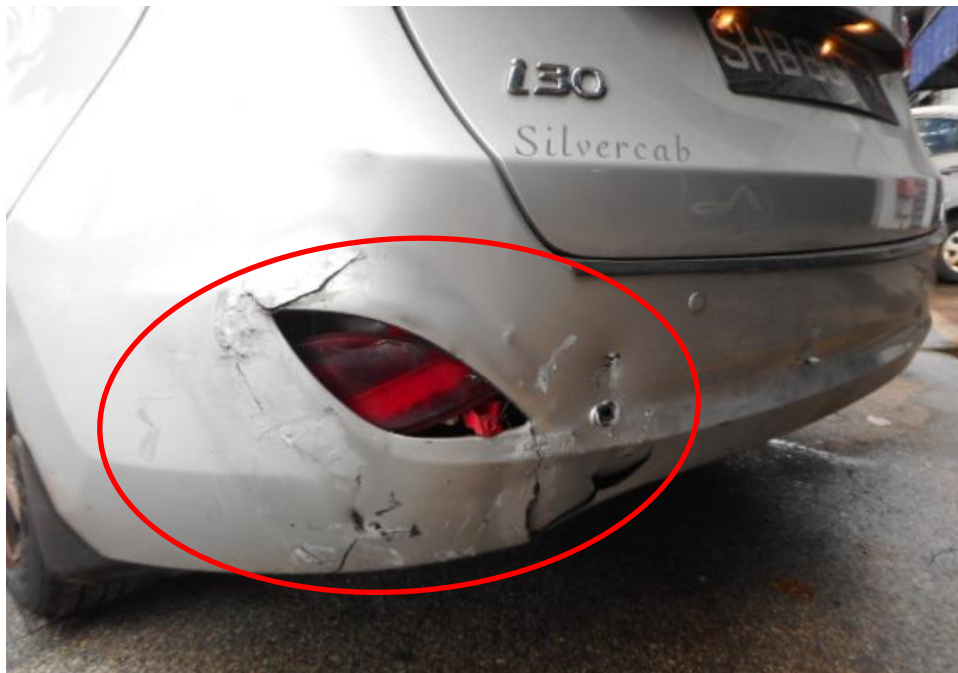
**Photo 3** shows the close up view of the Motor Taxi's rear body at the time of my inspection. The Motor Taxi was observed to have sustained damage at its rear bumper (circled) (arrowed) as a result of the accident.

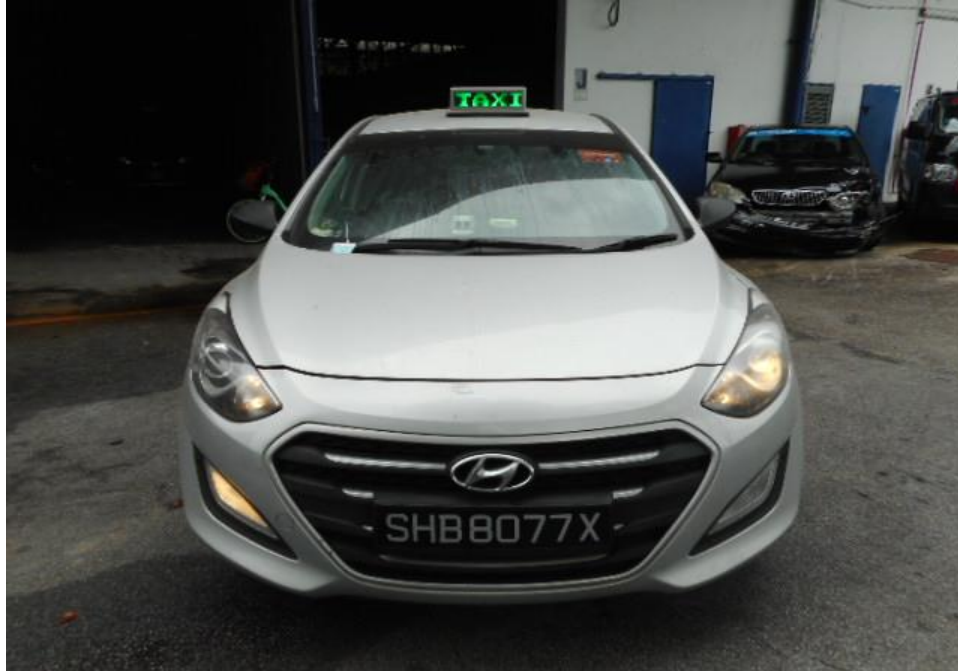
**Photo 4** shows a general view of the Motor Taxi's front body at the time of my inspection. The front portion of the Motor Taxi was observed to have been unaffected by the accident.

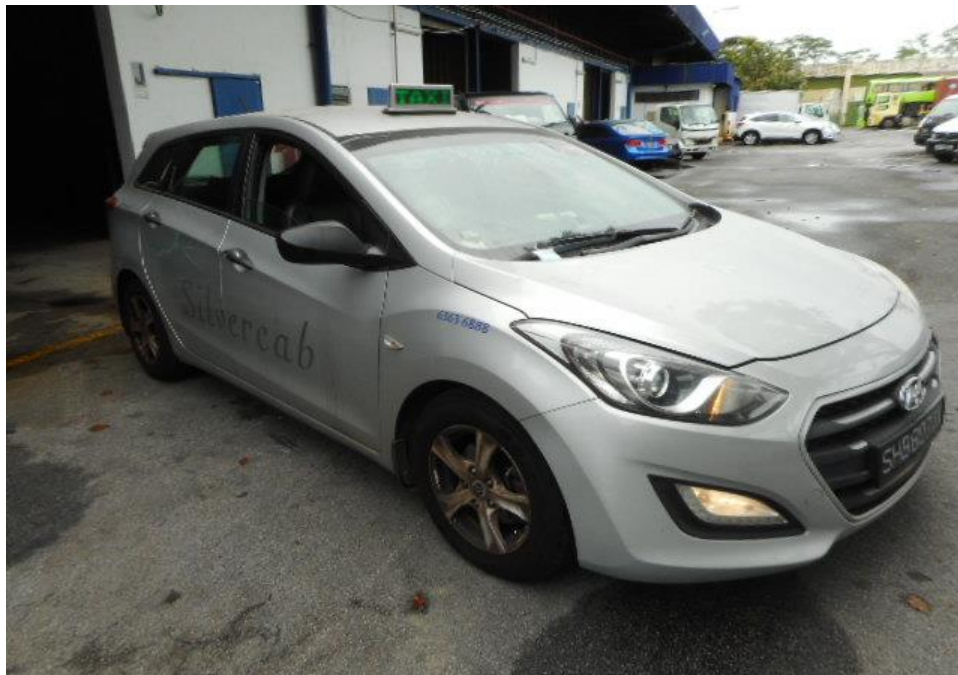
**Photo 5** shows a general view of the Motor Taxi's right body at the time of my inspection. The right portion of the Motor Taxi was observed to have been unaffected by the accident.

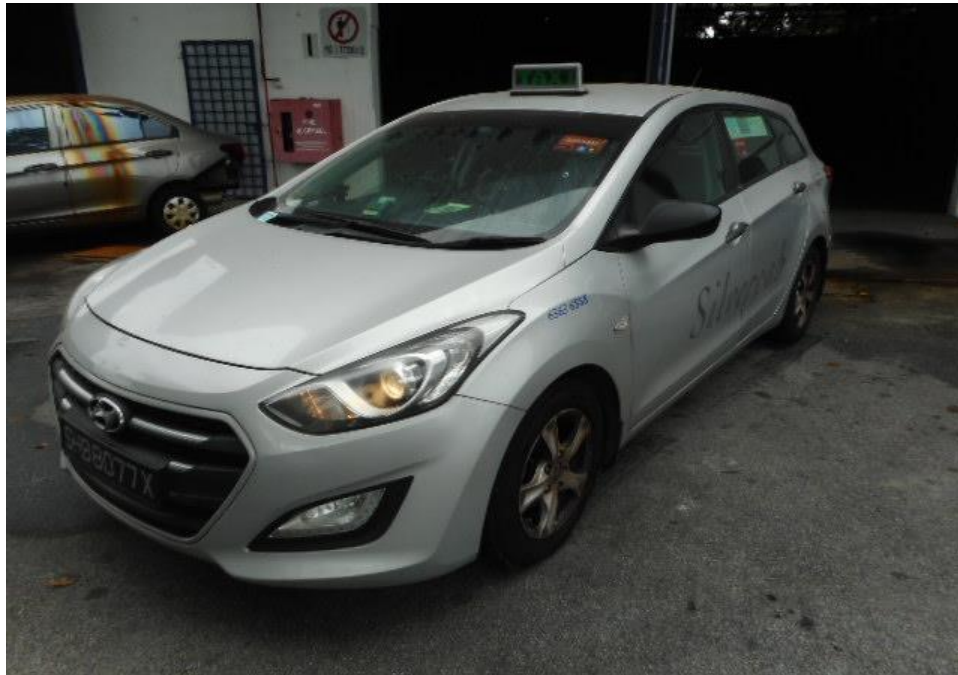
**Photo 6** shows a general view of the Motor Taxi's left body at the time of my inspection. The left portion of the Motor Taxi was observed to have been unaffected by the accident.

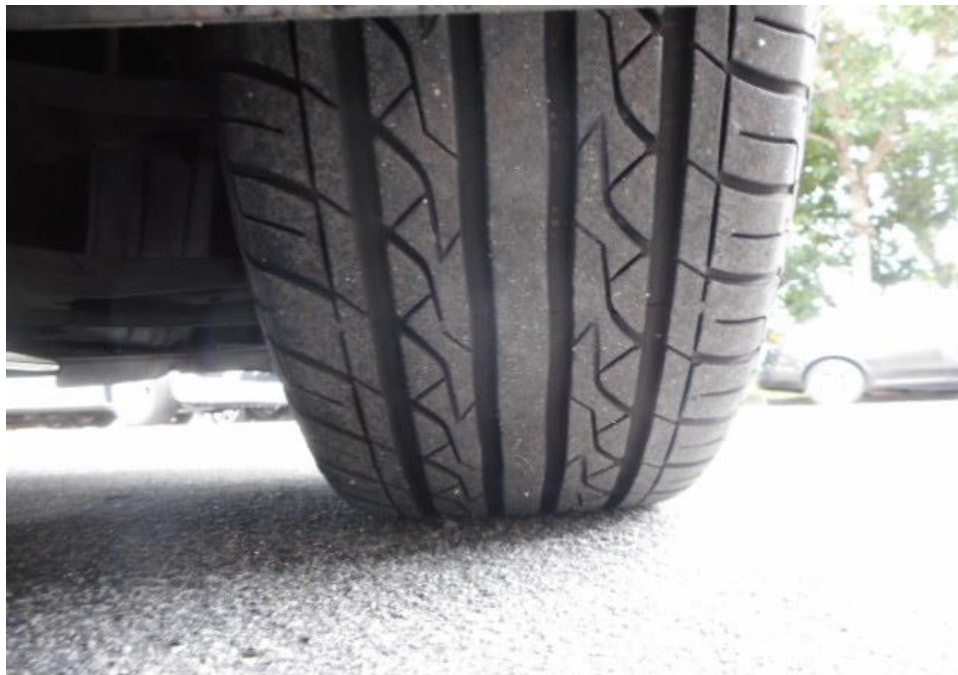
**Photo 7** shows the condition of the front right tyre of the Motor Taxi, which was observed to be in serviceable condition with remaining tread depth of approximately 5.1mm. The tyre was sufficiently inflated for vehicular operation with no tear, cut or burst mark(s) on the outer and the inner sidewalls as well as across the tread. The 4 tyres of the Motor Taxi were wrapped around standard steel wheel rims without any damage.

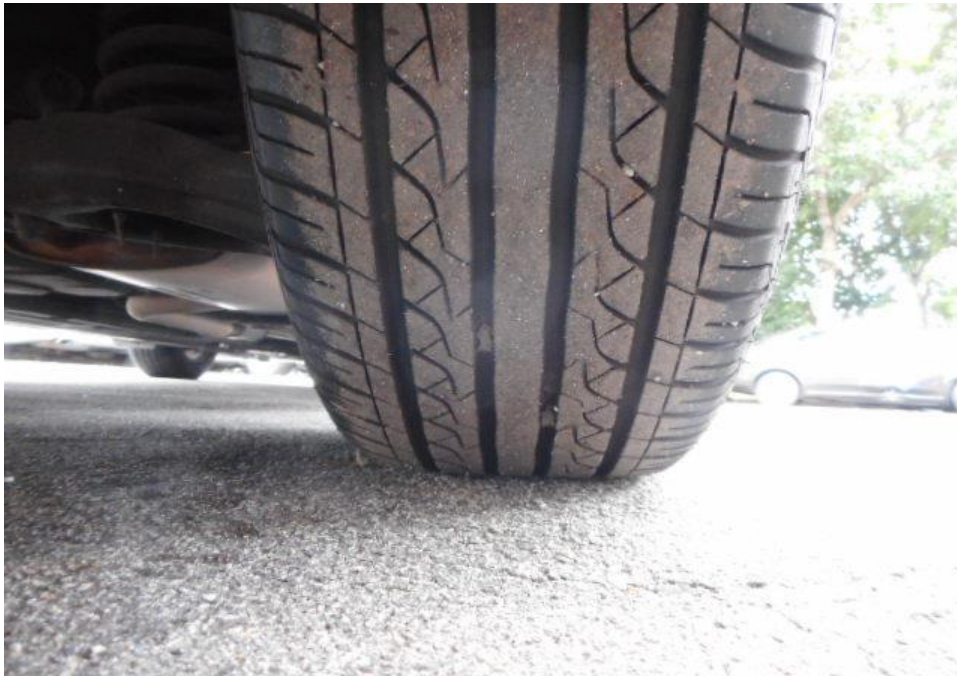
**Photo 8** shows the condition of the rear right tyre of the Motor Taxi, which was observed to be in serviceable condition with remaining tread depth of approximately 5mm. The tyre was also observed to be sufficiently inflated for vehicular operation with no tear, cut or burst mark(s).

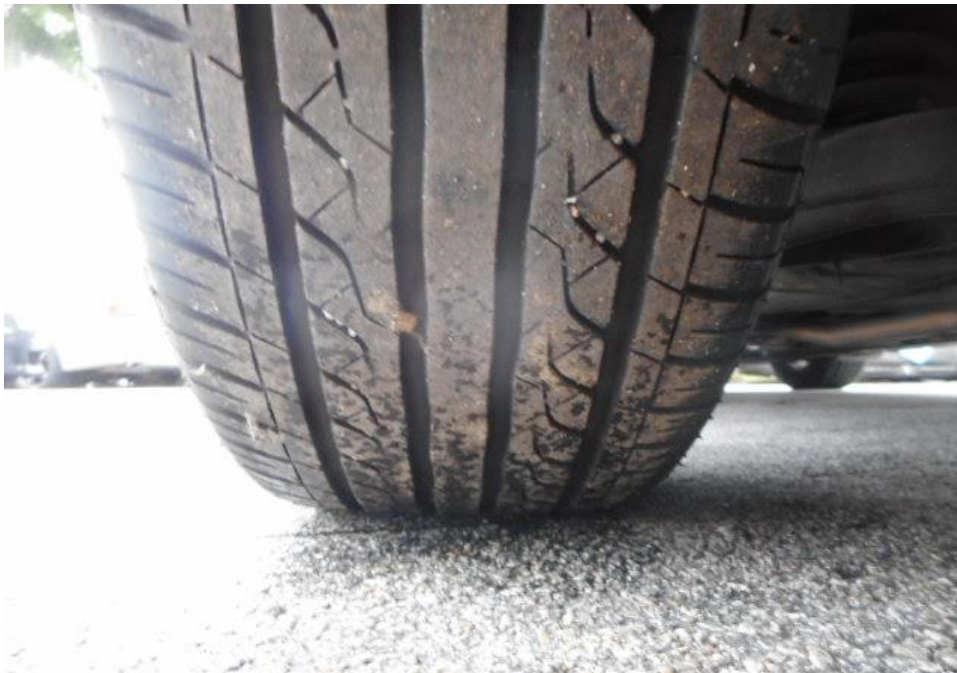
**Photo 9** shows the condition of the rear left tyre of the Motor Taxi, which was observed to be in serviceable condition with remaining tread depth of approximately 4.7mm. The tyre, which was wrapped around steel wheel rim, was also observed to be sufficiently inflated for vehicular operation. The 4 tyres of the Motor Taxi were wrapped around standard steel wheel rims.

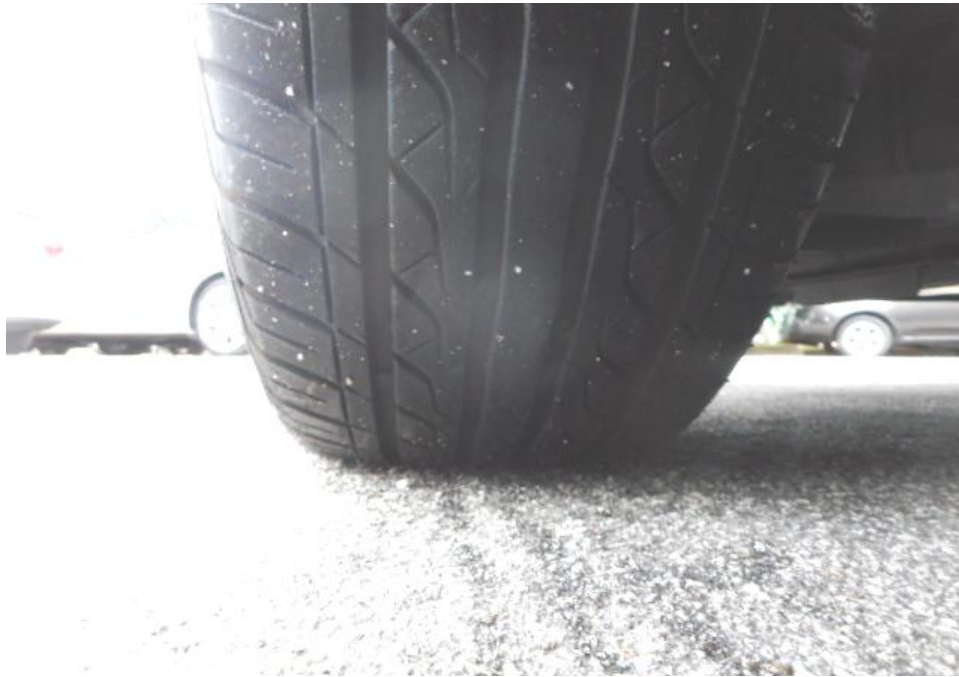
**Photo 10** shows the condition of the front left tyre of the Motor Taxi, which was observed to be in serviceable condition with remaining tread depth of approximately 5.1mm. There was also no tear, cut or burst mark(s) on the outer and the inner sidewalls as well as across the tread of the Motor Taxi's 4 tyres.

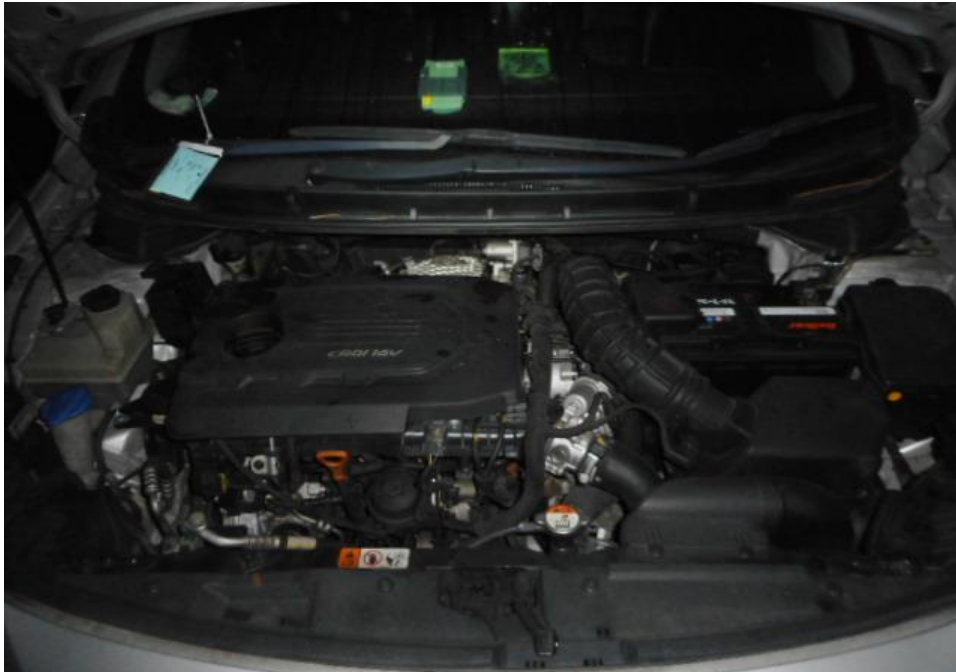
**Photo 11** shows a general view of the Motor Taxi's engine compartment. The various parts and components inside the engine compartment were unaffected by the accident. There was also no sign(s) or indication(s) of fluid leakage and/or fluid stain within the engine compartment.

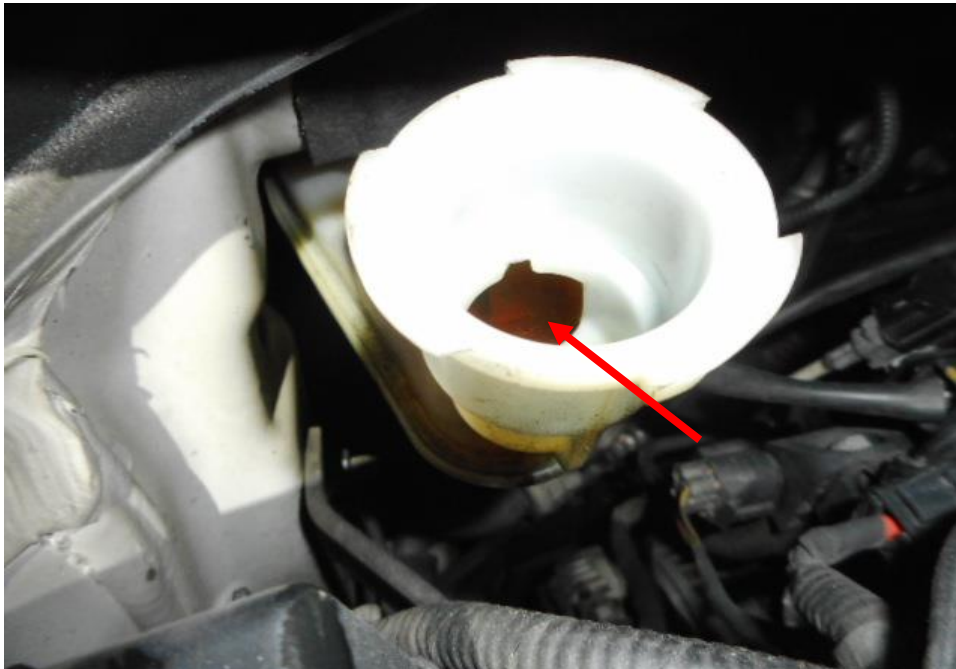
**Photo 12** shows the brake fluid reservoir of the Motor Taxi at the time of my inspection. The brake fluid was observed to be of sufficient level (arrowed) and without any visible contamination.

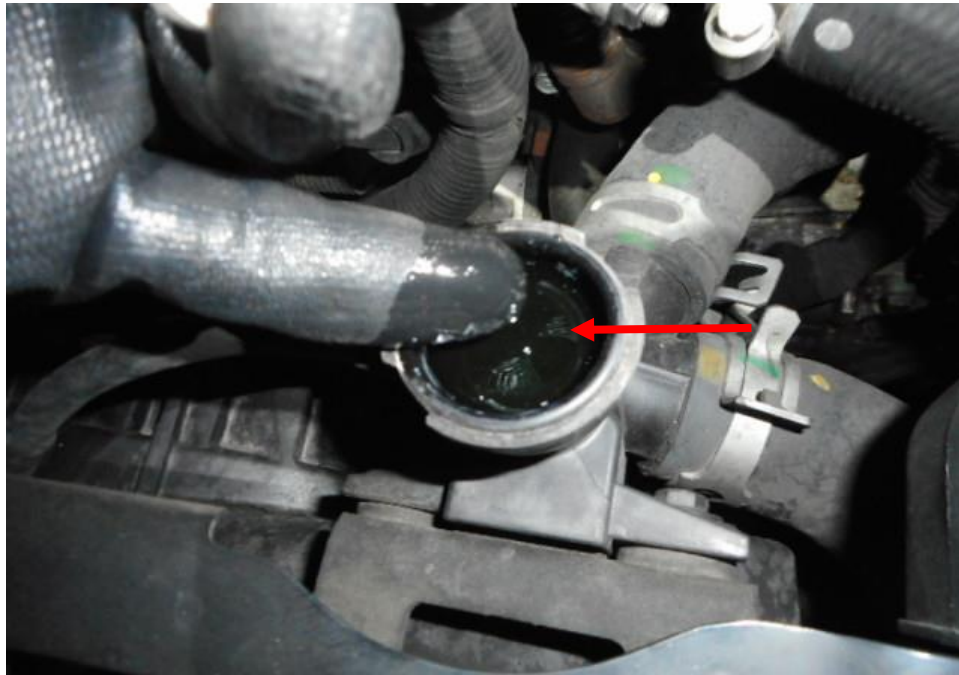
**Photo 13** shows checks being carried out to the engine coolant of the Motor Taxi at the time of my inspection. The engine coolant was observed to be of sufficient level (arrowed) and without any visible contamination.

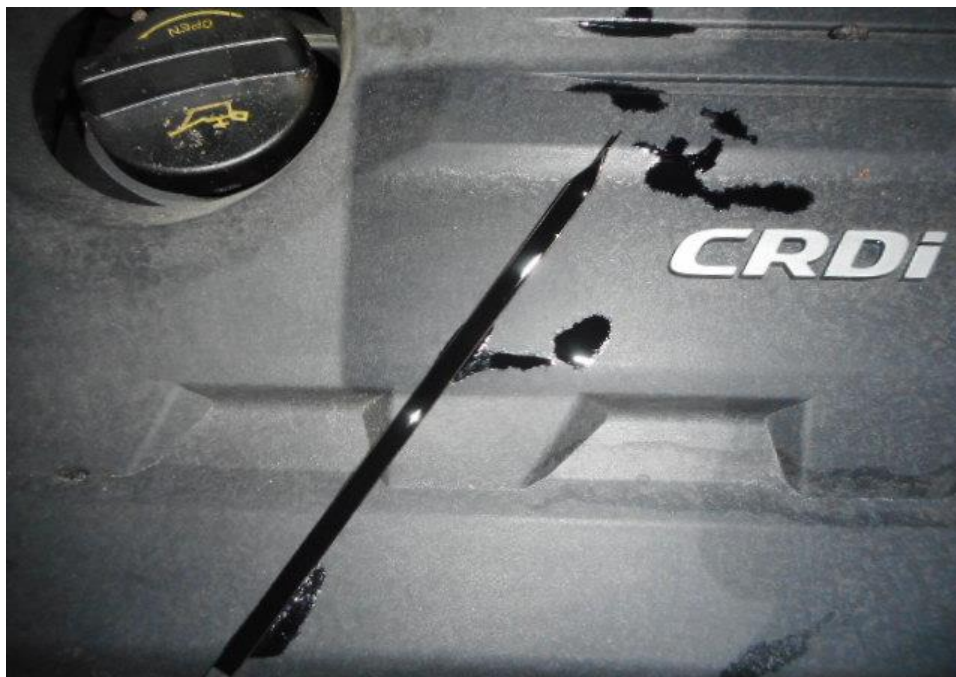
**Photo 14** shows the engine oil dip stick of the Motor Taxi at the time of my inspection. The engine oil was observed to be of sufficient level and without any visible contamination.

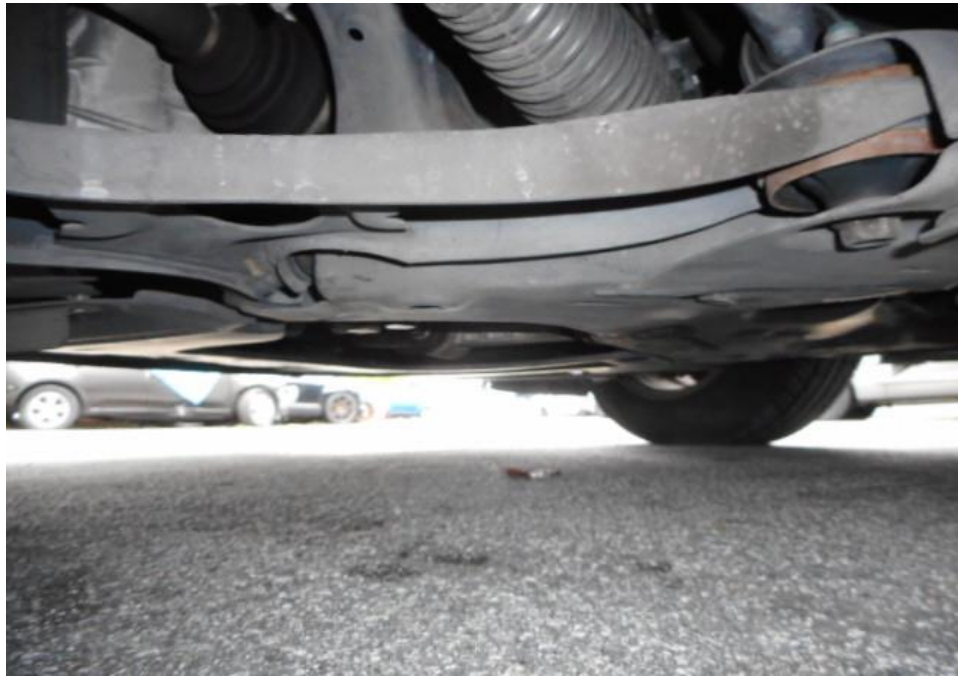
**Photo 15** shows the undercarriage of the Motor Taxi, at the area where the engine housing and transmission housing are located. I did not find any sign(s) or indication(s) of fluid leak and/or fluid stain(s) on the underside of the Motor Taxi.

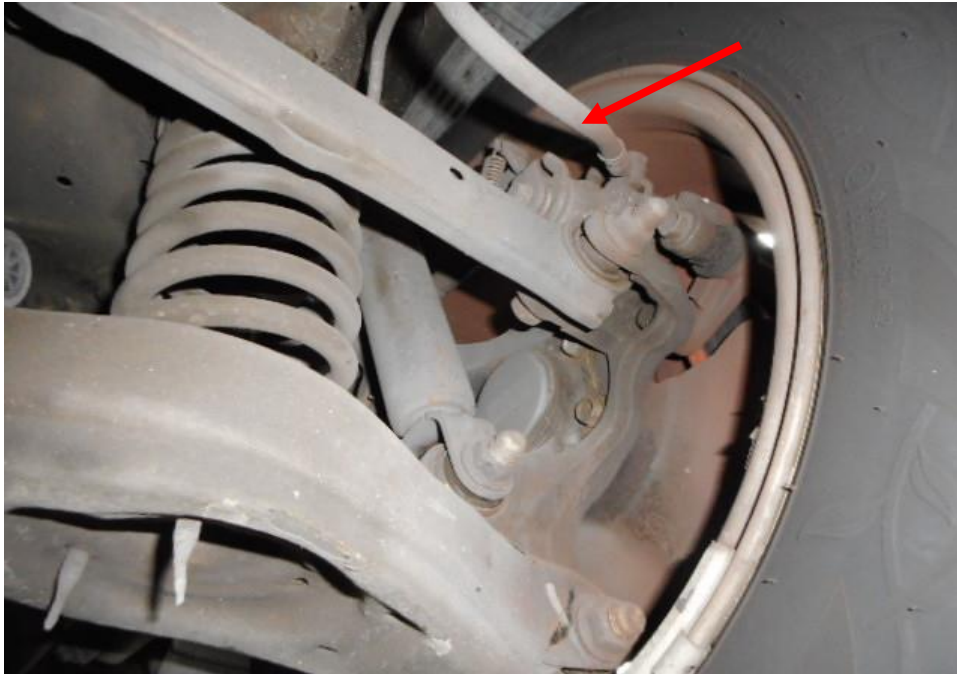
**Photo 16** shows the brake hose/pipe (arrowed) at the rear right wheel of the Motor Taxi. No leakage of brake fluid was observed. Visual examination of the various components of the braking system like the drum brake, brake booster, brake pedal etc. had revealed all to be intact and without visible damage.

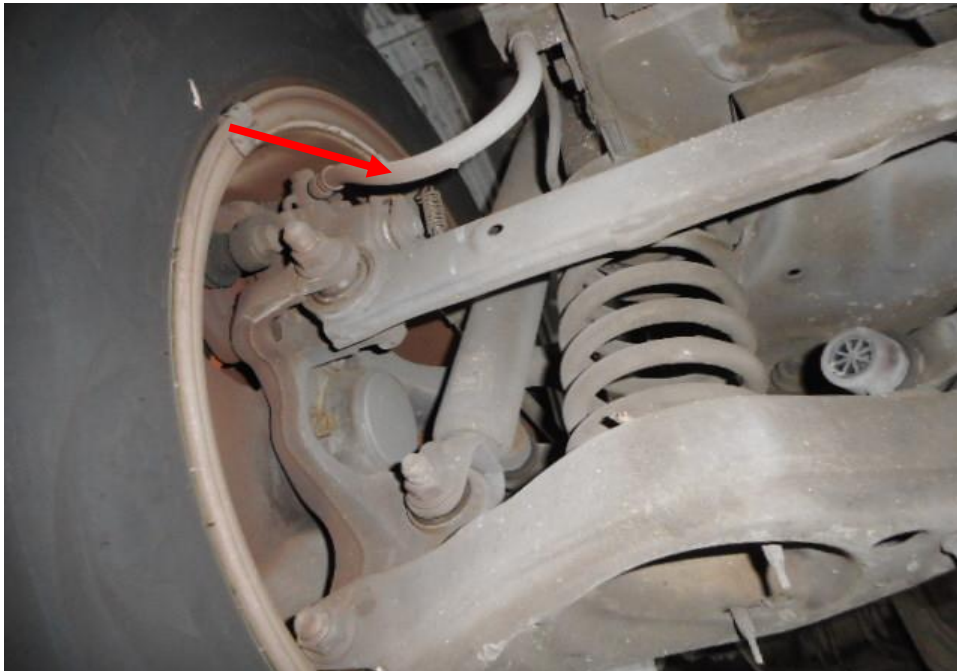
**Photo 17** shows the brake hose/pipe (arrowed) at the rear left wheel of the Motor Taxi. I did not observe any leakage of brake fluid at the time of my inspection of the Motor Taxi. Static tests of the Motor Taxi's braking system had indicated that there was no internal leakage of pressure/vacuum. The undercarriage components of the Motor Taxi were also all found to be intact and without any visible damage.

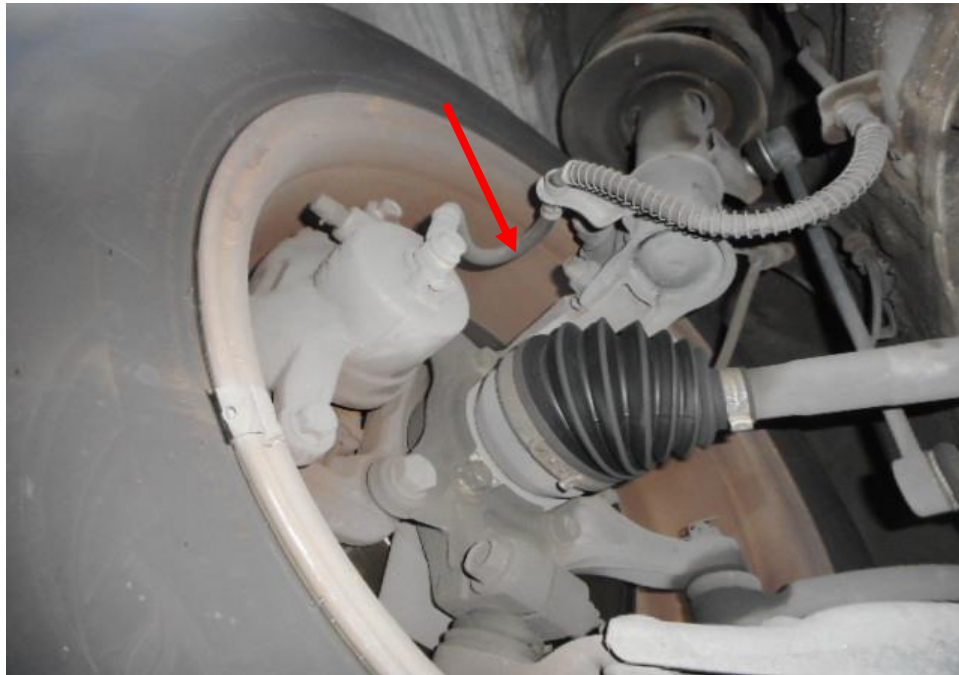
**Photo 18** shows the brake hose/pipe (arrowed) at the front right wheel of the Motor Taxi. I did not observe any leakage of brake fluid at the time of my inspection of the Motor Taxi. Static tests of the Motor Taxi's braking system had indicated that there was no internal leakage of pressure/vacuum. The undercarriage components of the Motor Taxi were also all found to be intact and without any visible damage.

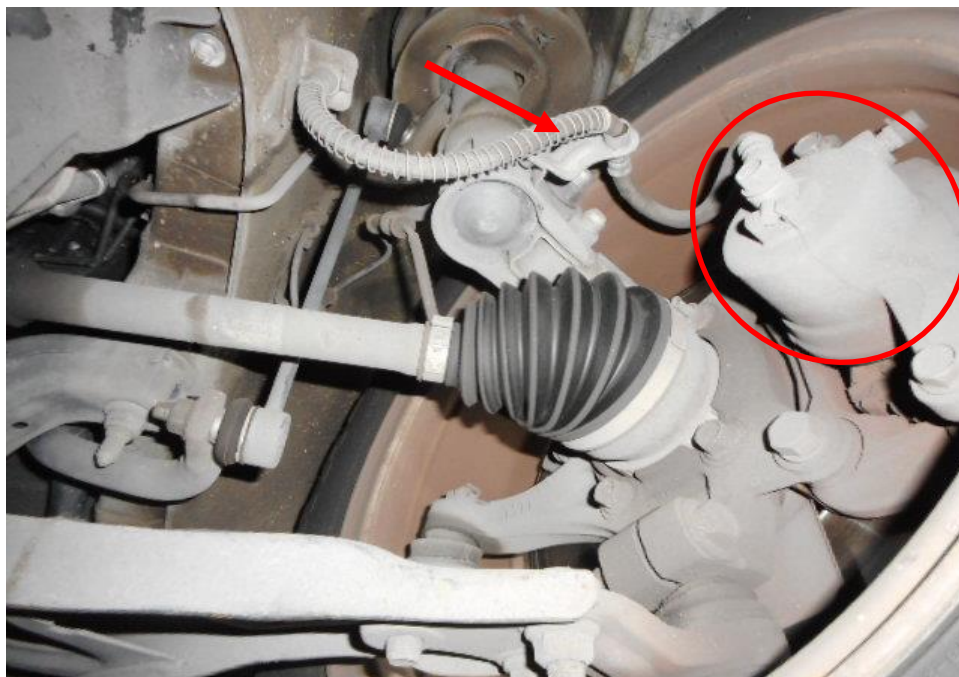
**Photo 19** shows the brake hose/pipe (arrowed) at the front left wheel of the Motor Taxi. No leakage of brake fluid was observed. Visual examination of the various components of the braking system like the brake caliper (circled), brake booster, brake pedal etc had revealed all to be intact and without visible damage.

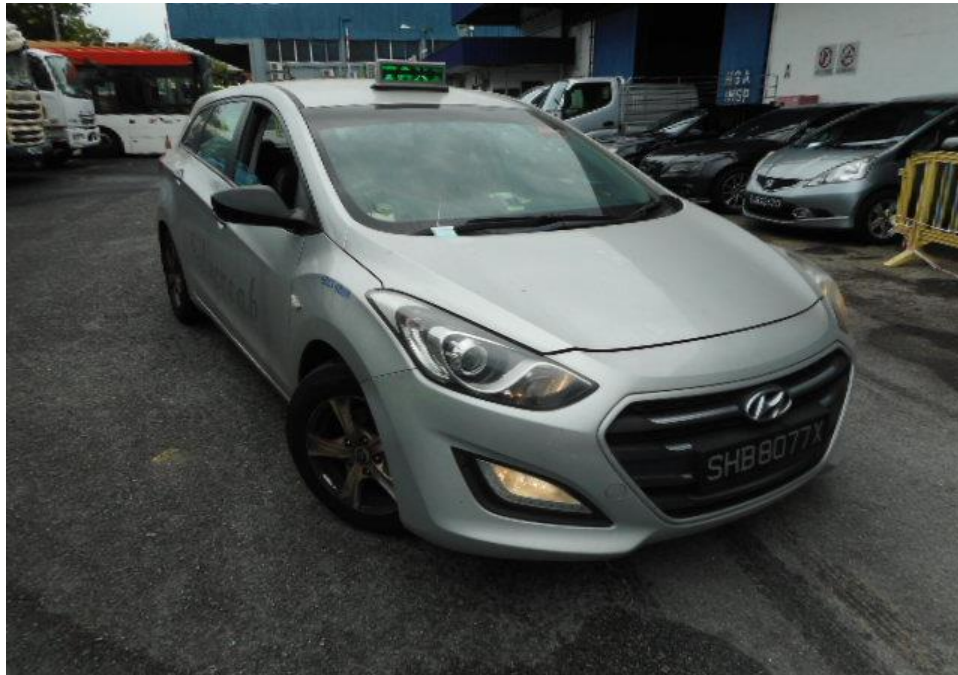
**Photo 20** shows the front right wheel of the Motor Taxi turned to its full left. During my steering system test, I did not experience any abnormal free play and/or resistance when I had turned the steering wheel towards the left and right. This would suggest that the steering system of the Motor Taxi was likely to be in serviceable condition at the material time of accident.

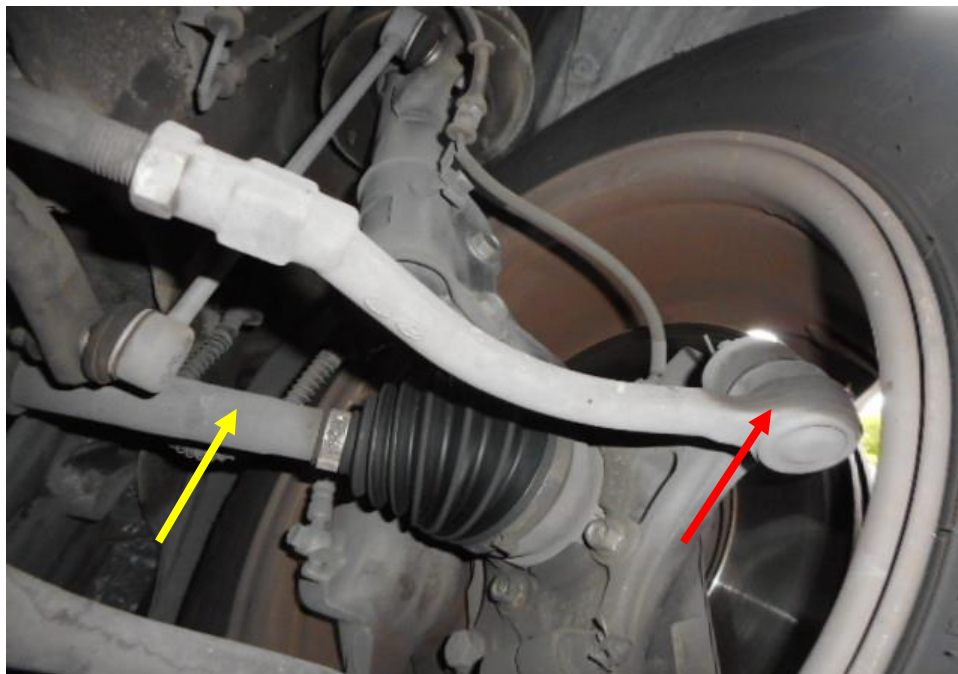
**Photo 21** shows the various undercarriage components at the front right wheel of the Motor Taxi, in particular the steering tie rod (red arrow) and drive shaft (yellow arrow). The various steering components were all found to be intact, suggesting that the steering system of the Motor Taxi was likely to be in serviceable condition at the material time of accident. There was also no sign of fluid stain observed on the various undercarriage components at the front right wheel of the Motor Taxi.

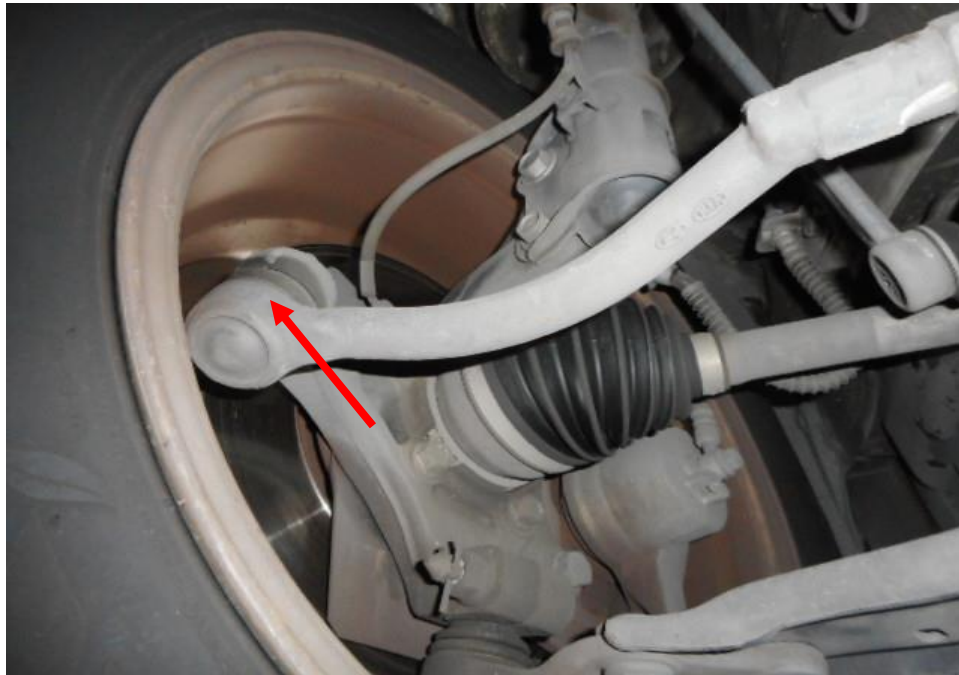
**Photo 22** shows the various undercarriage components at the front left wheel of the Motor Taxi, which had included the steering tie rod (red arrow). The various undercarriage components of the Motor Taxi were all found to be intact without any visible damage.

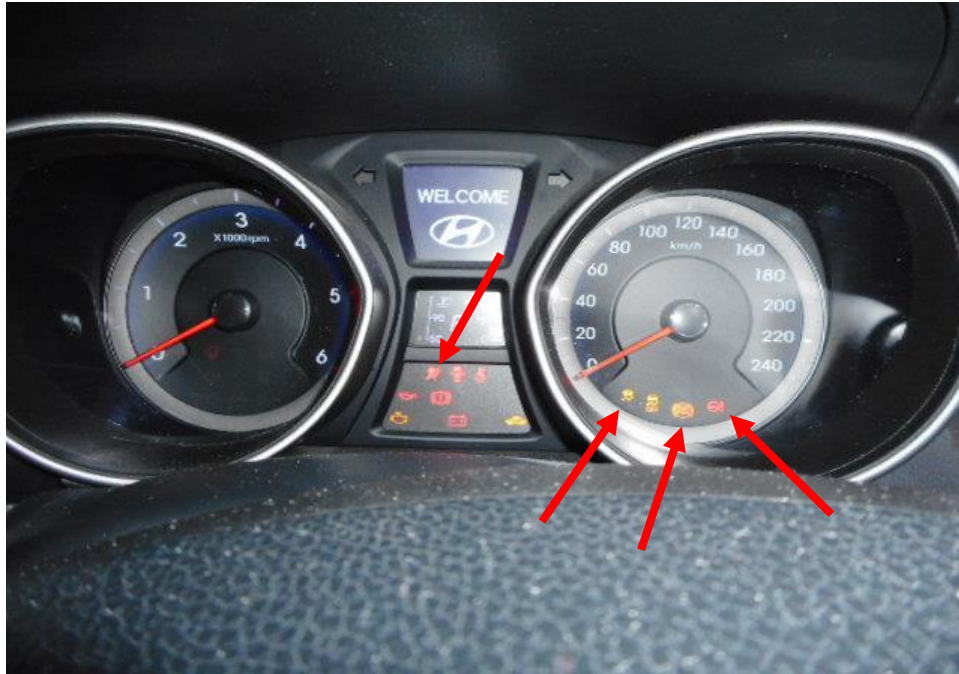
**Photo 23** shows the warning light for Anti-Lock Brake System (ABS) and Power Steering System (EPS), Supplemental Restraint System (SRS) and Traction Control (TC) (arrowed) appearing on the instrument panel of the Motor Taxi during the self-test of its various electronic operating systems when its engine was cranked.

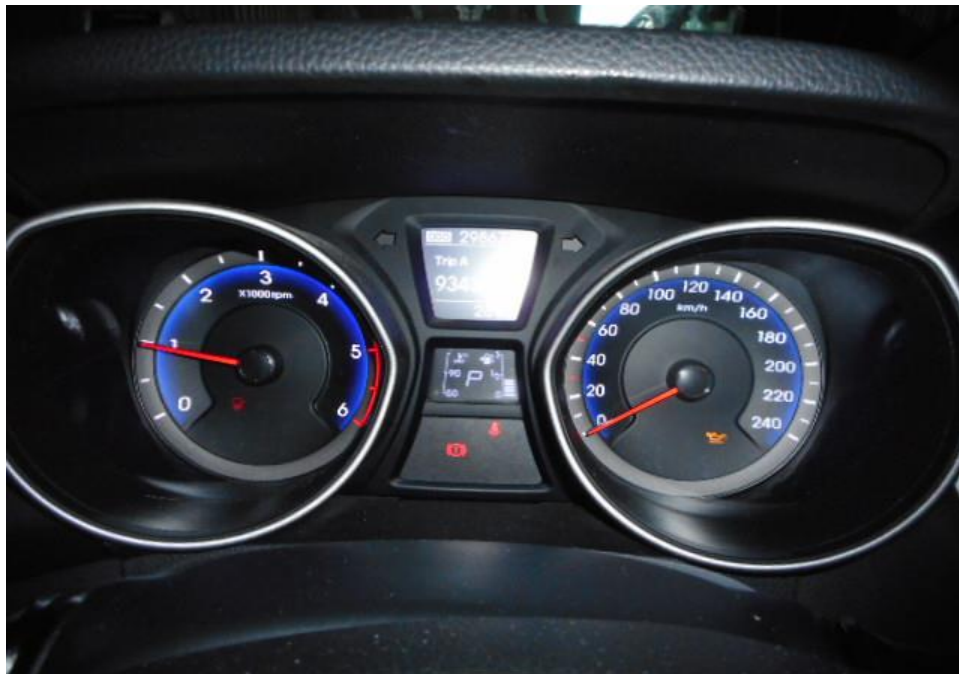
**Photo 24** shows no warning lights illuminated on the instrument panel of the Motor Taxi after the engine was cranked. This would suggest that there was no abnormality to the electronic operating system of the Motor Taxi, like the ABS, EPS, SRS, and TC etc.
