Your Ref: TP/IP/35321/2021
Our Ref : CI/TPD21010022/P

Fatal Accident Investigation Team

MECHANICAL INSPECTION REPORT OF MOTOR LORRY GBD 5455T

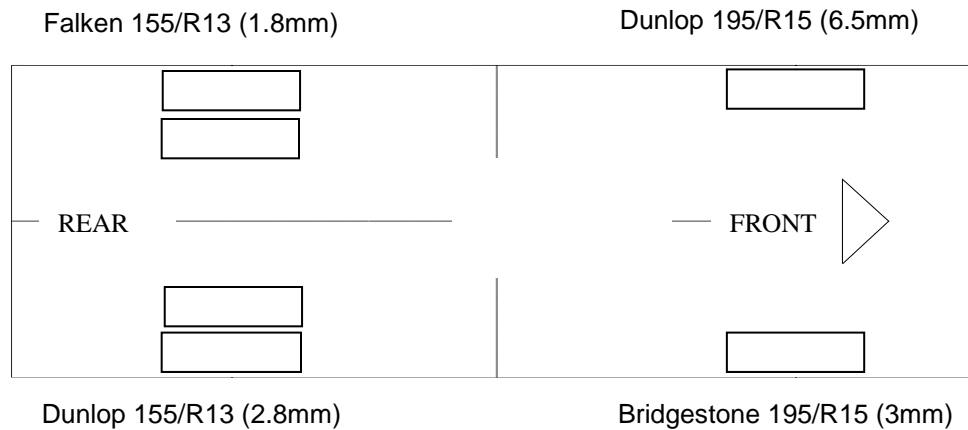
6. The 6 tyres of the Motor Lorry were observed to be in serviceable condition and sufficiently inflated for vehicular operation. I did not find any tear, cut or burst mark(s) on the outer and the inner sidewalls as well as across the tread of the 6 tyres. The tyre brand, tyre size and remaining tread depth of the 6 tyres of the Motor Lorry were recorded as follows:-

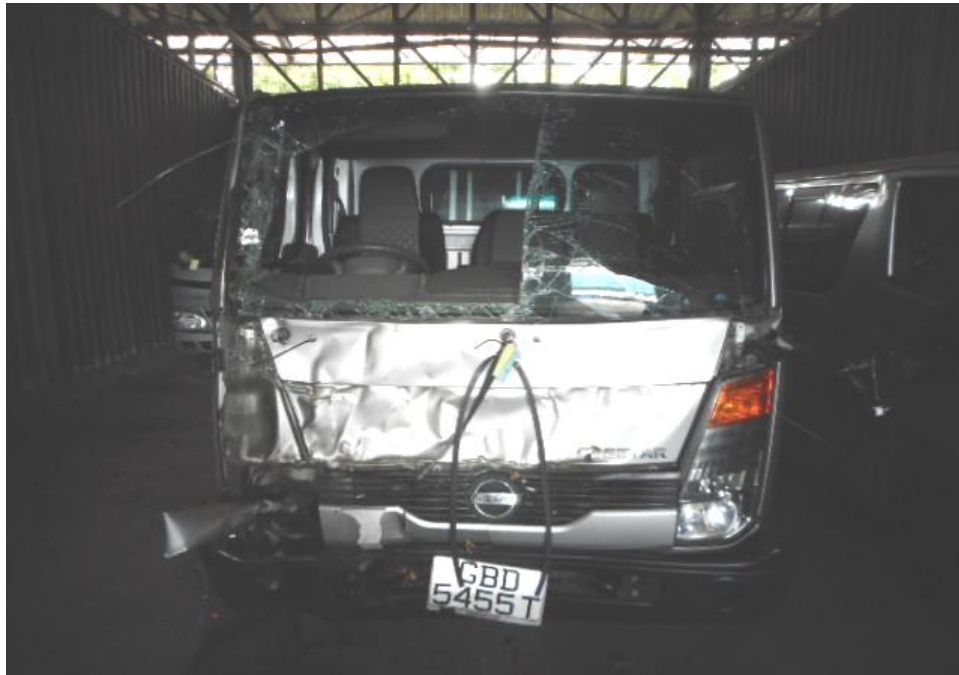
Photo 1 shows a general view of the Motor Lorry's frontal portion at the time of my inspection. It appeared to have sustained damage at its front portion. Its front, right and rear portion. Its front windscreen, front body panel, front right headlamp, front bumper, right door and rear body panel were damage at the time of my inspection as a result of the accident.

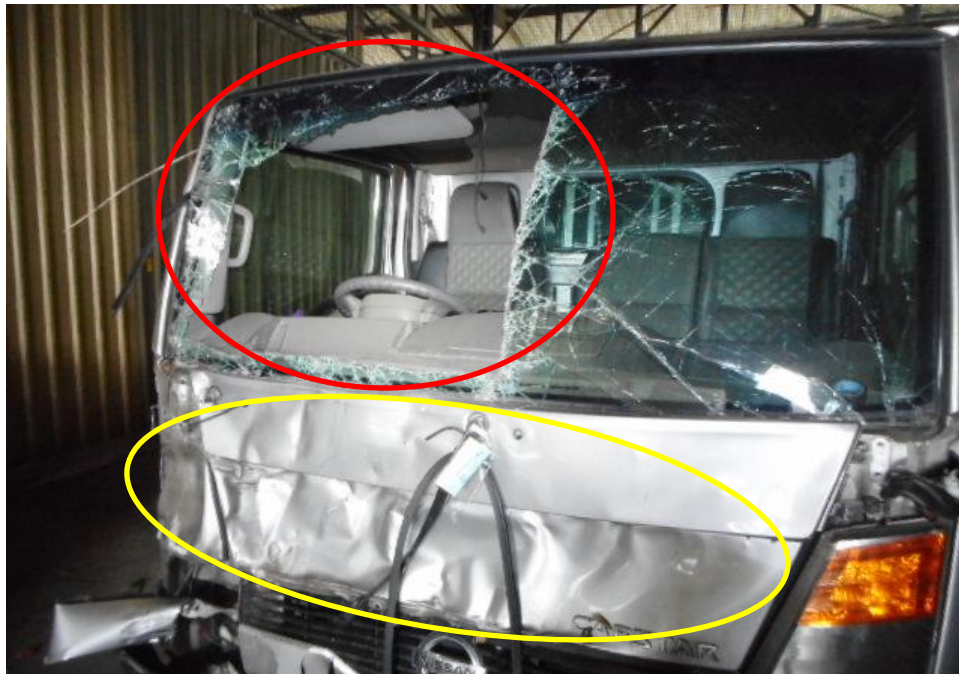
Photo 2 shows a close up view of the Motor Lorry's front portion at the time of my inspection. Its front windscreen (red circle) and front body panel (yellow circle) was damage at the time of my inspection as a result of the accident.

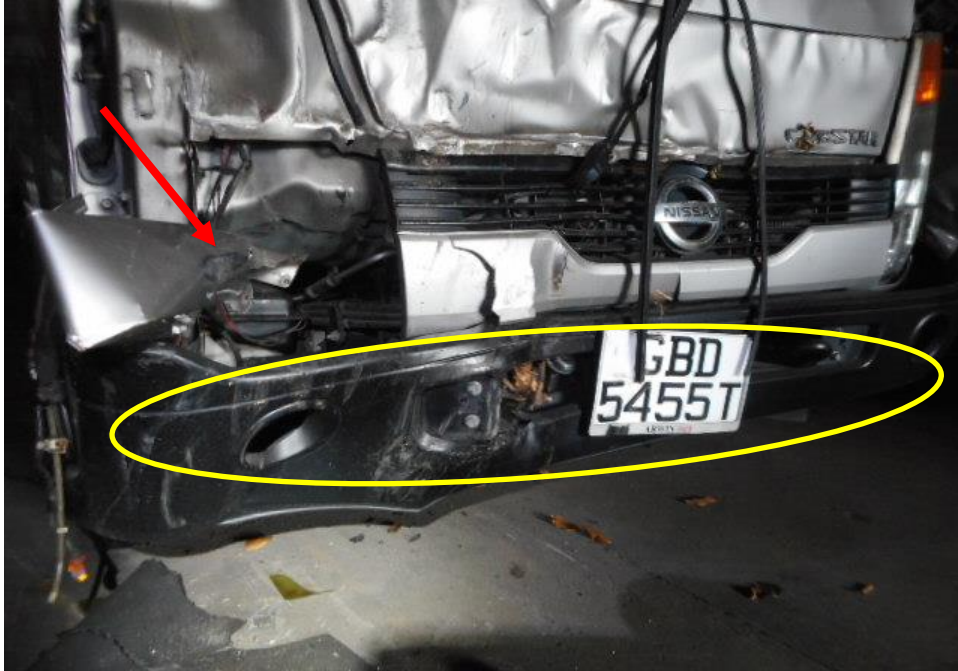
Photo 3 shows a close up view of the Motor Lorry's front portion at the time of my inspection. Its front right headlamp (arrowed) and front bumper (circled) was damage at the time of my inspection as a result of the accident.

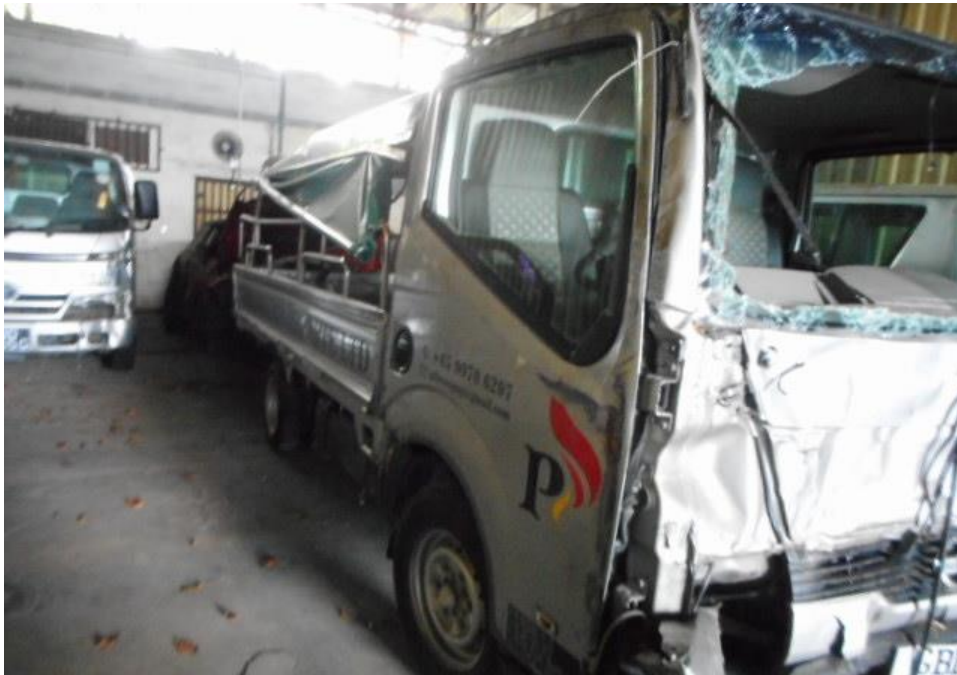
Photo 4 shows a general view of the right body of the Motor Lorry at the time of my inspection. Its right door was damage at the time of my inspection as a result of the accident.

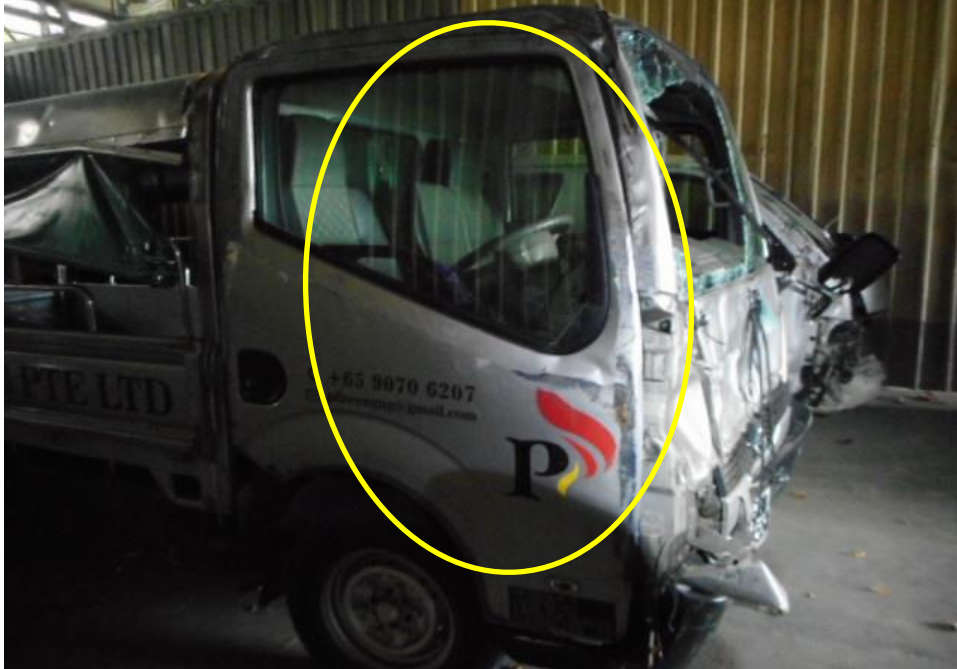
Photo 5 shows a close up view of the right body of the Motor Lorry at the time of my inspection. Its right door (circled) was damage at the time of my inspection as a result of the accident.

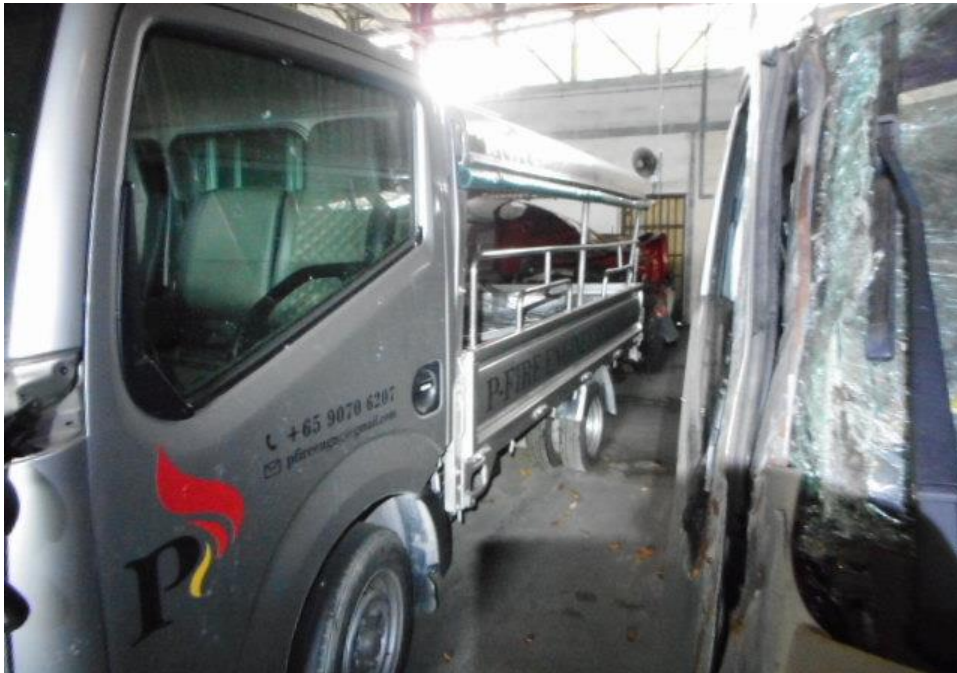
Photo 6 shows a general view of the left body of the Motor Lorry at the time of my inspection. The Motor Lorry was observed to be intact and unaffected by the accident.

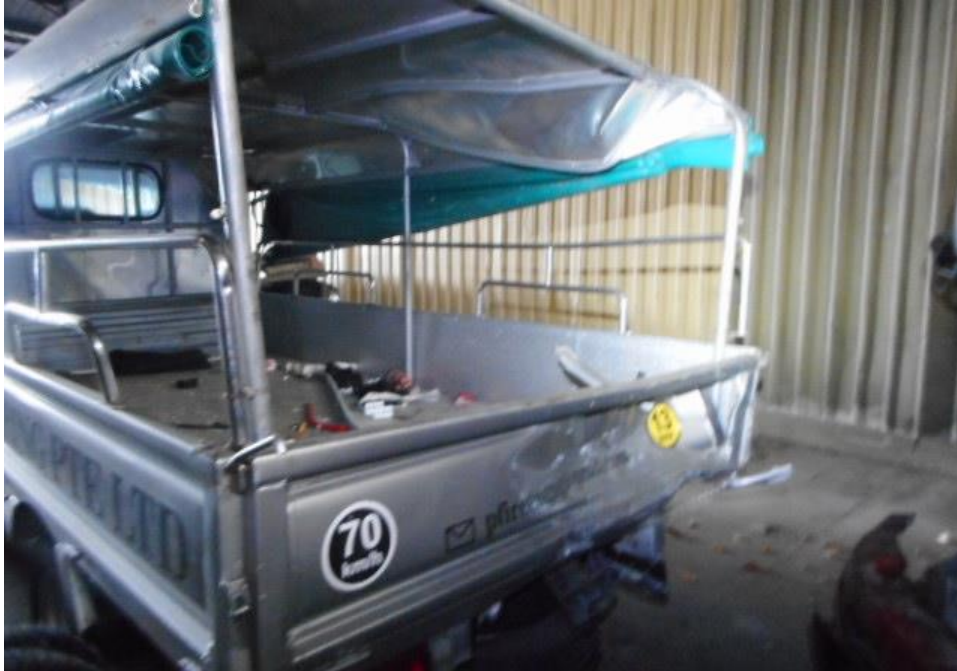
Photo 7 shows a general view of the rear body of the Motor Lorry at the time of my inspection. Its rear body panel (circled) was damage at the time of my inspection as a result of the accident.

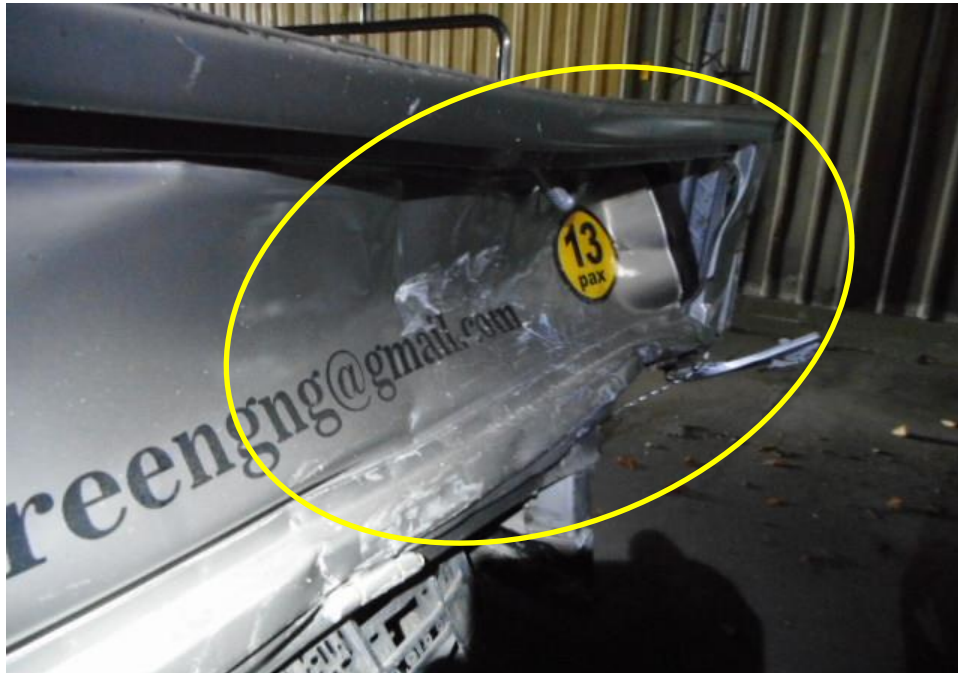
Photo 8 shows a close up view of the rear body of the Motor Lorry at the time of my inspection. Its rear body panel (circled) was damage at the time of my inspection as a result of the accident.

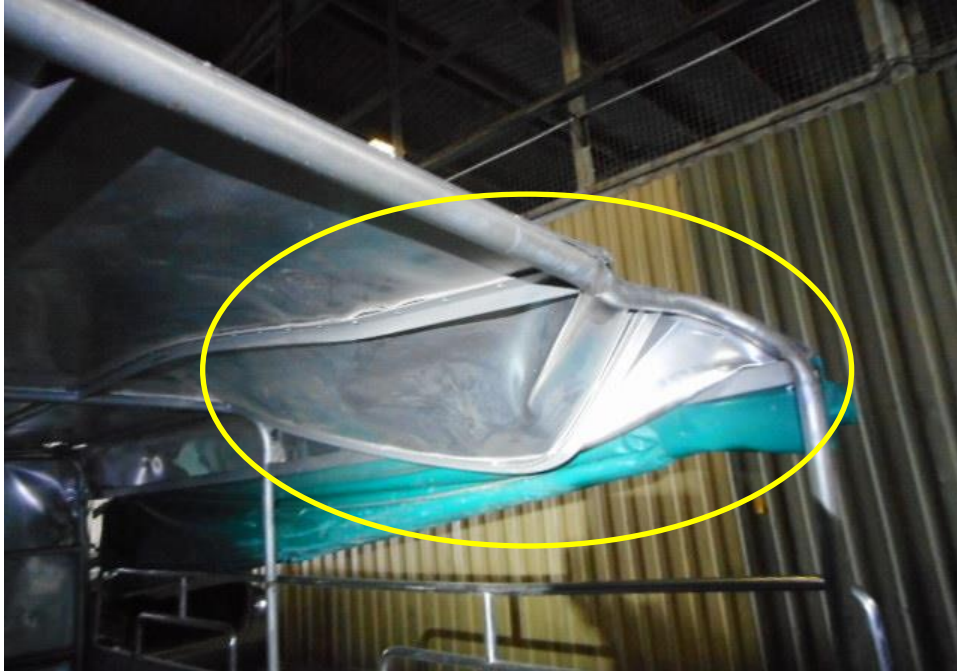
Photo 9 shows a close up view of the rear body of the Motor Lorry at the time of my inspection. Its rear body panel (circled) was damage at the time of my inspection as a result of the accident.

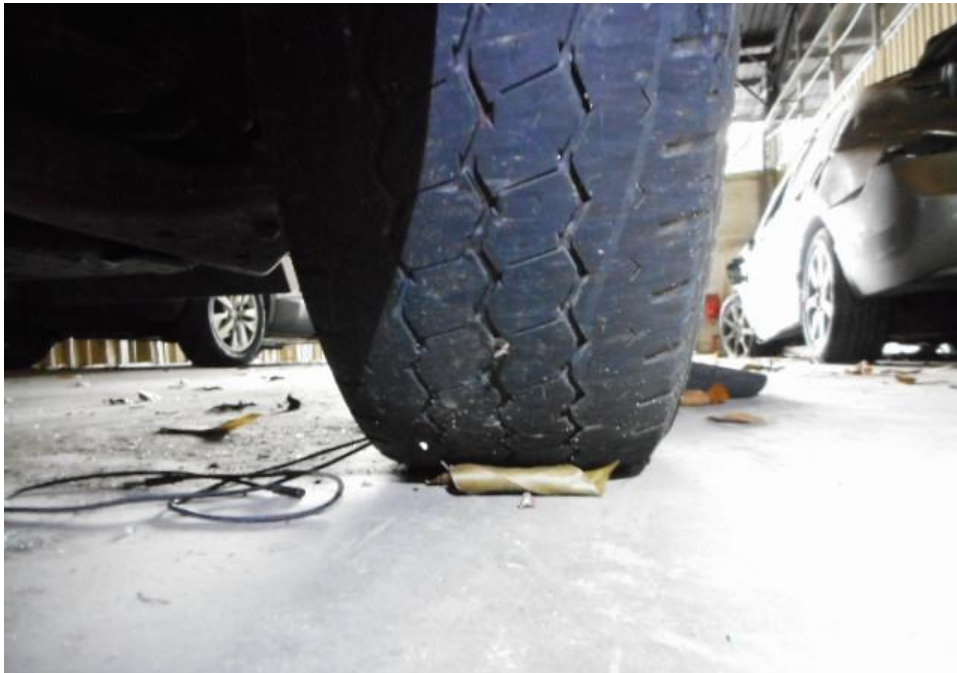
Photo 10 shows the condition of the front right tyre of the Motor Lorry, which was observed to be in serviceable condition with remaining tread depth of approximately 3mm. The tyre, which was wrapped around standard steel wheel rim, it was observed to be sufficiently inflated for vehicular operation.

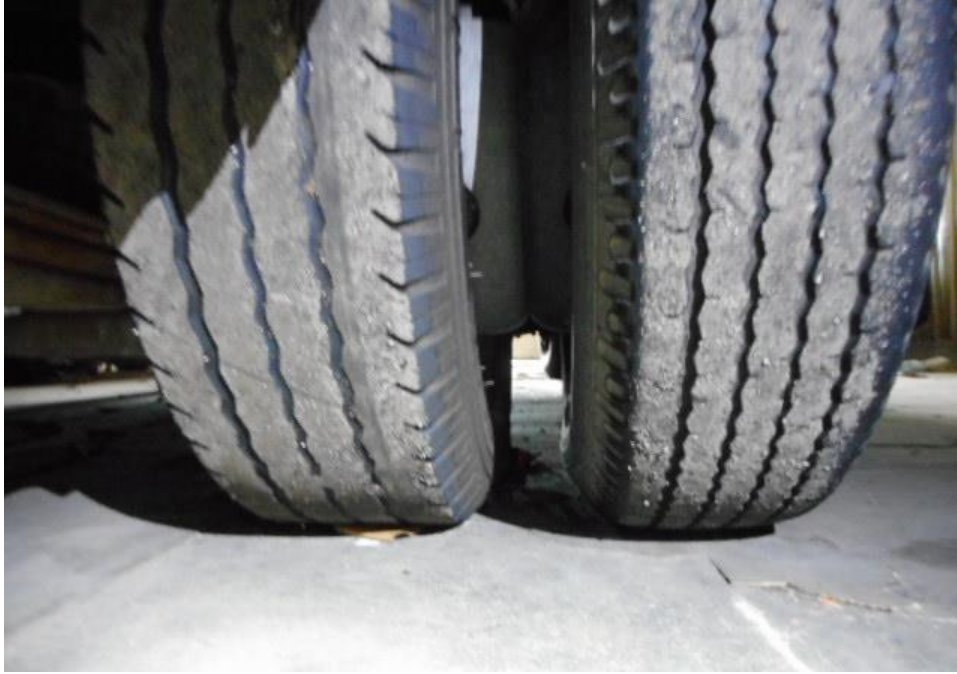
Photo 11 shows the condition of the rear right tyre of the Motor Lorry, which was observed to be in serviceable condition with remaining tread depth of approximately 2.8mm. The tyre, which was wrapped around standard steel wheel rim, it was observed to be sufficiently inflated for vehicular operation.

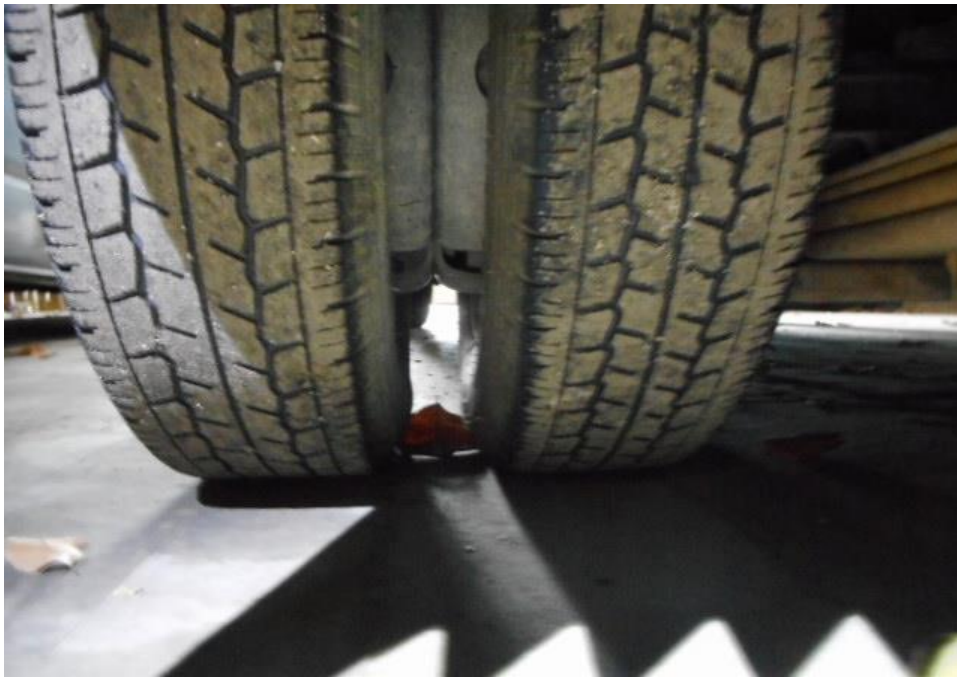
Photo 12 shows the condition of the rear left tyres of the Motor Lorry, which was observed to be in serviceable condition with remaining tread depth of approximately 1.8mm. The tyres, which were wrapped around standard steel wheel rim, were also observed to be sufficiently inflated for vehicular operation. There was also no damage found on all 6 steel wheel rims of the Motor Lorry.

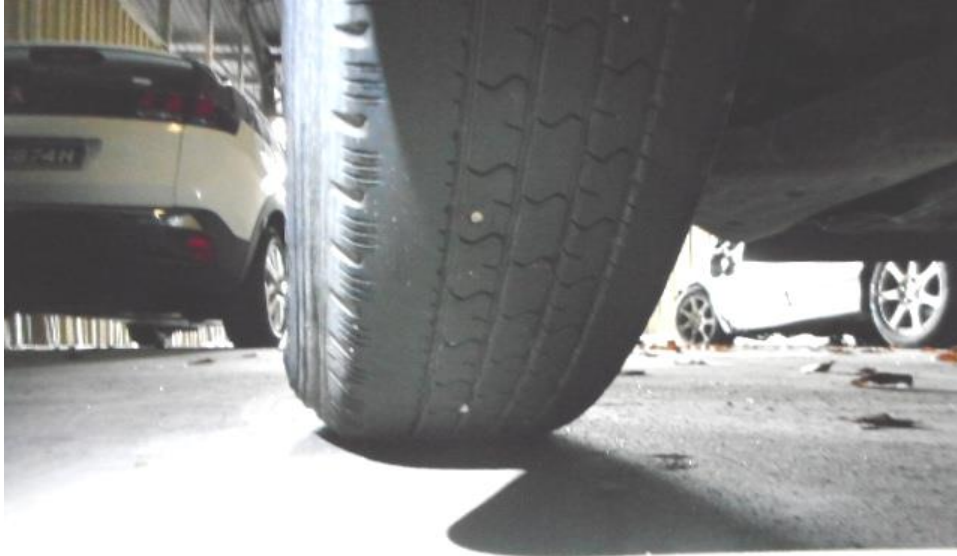
Photo 13 shows the condition of the rear right tyres of the Motor Lorry, which were observed to be in serviceable condition with remaining, tread depth of approximately 6.5mm. There was also no tear, cut or burst mark(s) on the outer and the inner sidewalls as well as across the tread of the 6 tyres that were fitted on the Motor Lorry.

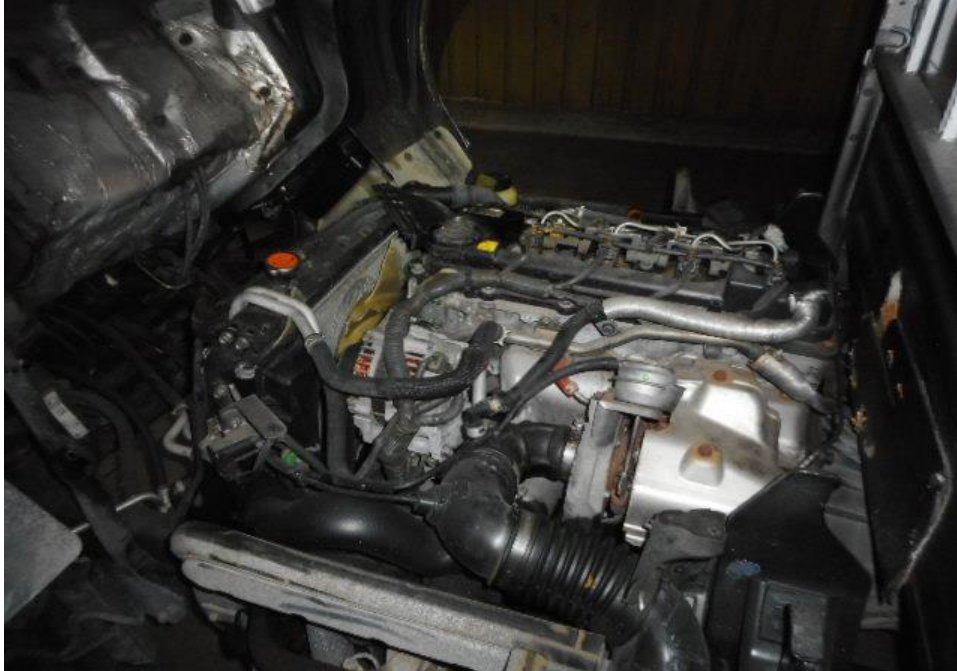
8. Upon examination of the Motor Lorry's engine compartment, I had observed the engine radiator to be damaged as a result of the accident. However, all the other parts and components inside the engine compartment to be intact and unaffected by the accident. The brake fluid, engine oil and were all found to be of sufficient level for operating purposes. Visually, there was also no contamination found to these fluids. Only the engine coolant was found to be insufficient as a result of the damaged to the engine radiator as a result of the accident.

Photo 14 shows a general view of the Motor Lorry's engine compartment, which was accessed by lifting the front cabin of the Motor Lorry. The engine radiator was found to be damaged due to the result of the accident. However, the other various parts and components inside the engine compartment were unaffected by the accident. There was also no sign(s) or indication(s) of fresh fluid leakage and/or fluid stain within the engine compartment.

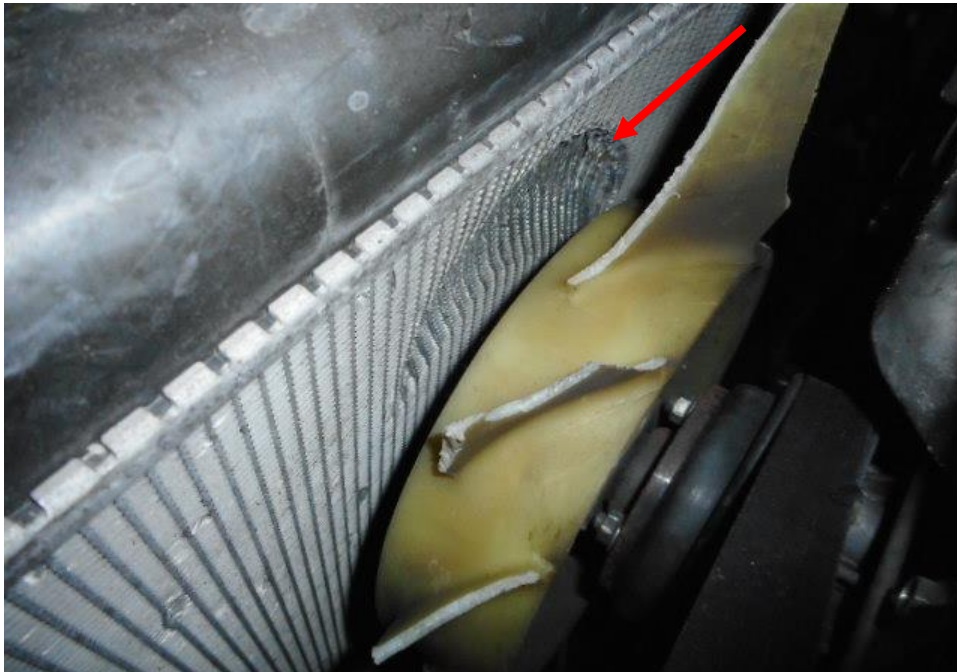
Photo 15 shows the engine coolant radiator of the Motor Lorry at the time of my inspection. The coolant radiator was observed to be damaged as a result of the accident (arrowed).

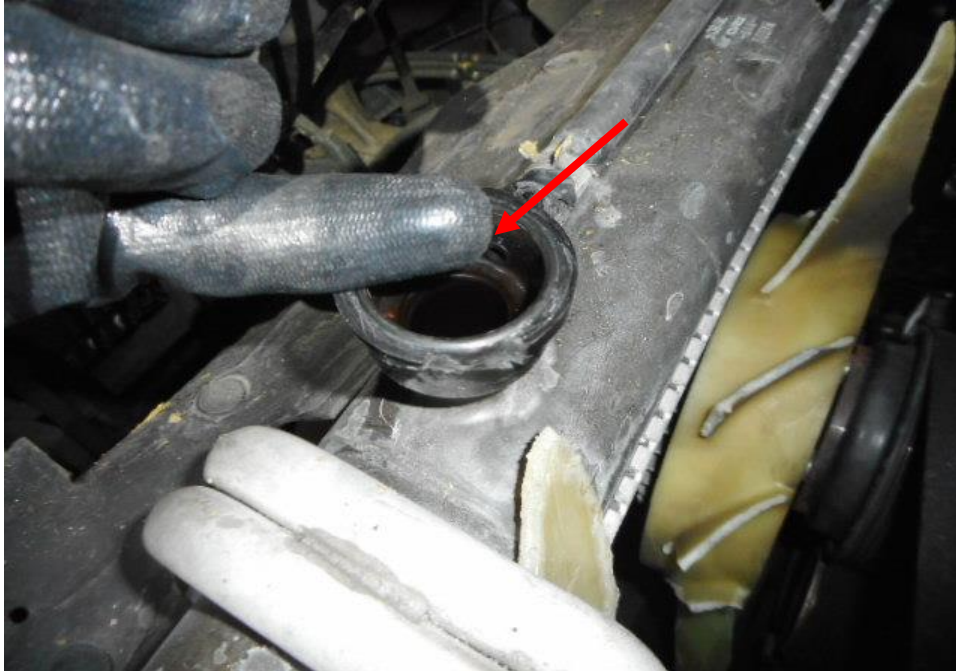
Photo 16 shows the engine coolant reservoir of the Motor Lorry at the time of my inspection. The engine coolant was observed to be of insufficient level (arrowed) as the radiator was damaged as a result of the accident.

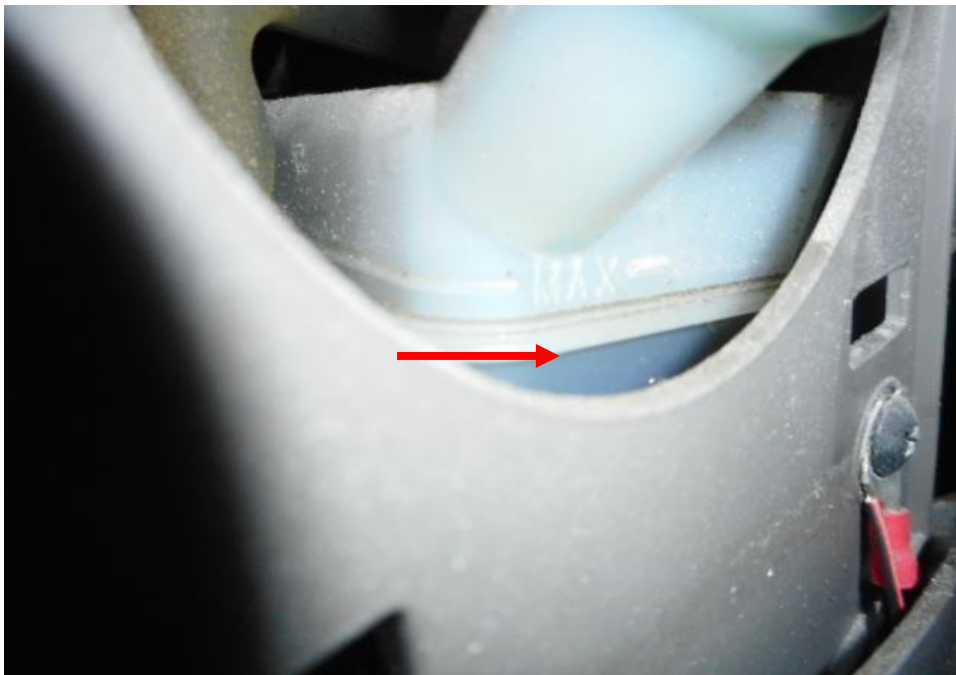
Photo 17 shows the brake fluid reservoir of the Motor Lorry at the time of my inspection. The brake fluid was observed to be of sufficient level (arrowed) and without any visible contamination.

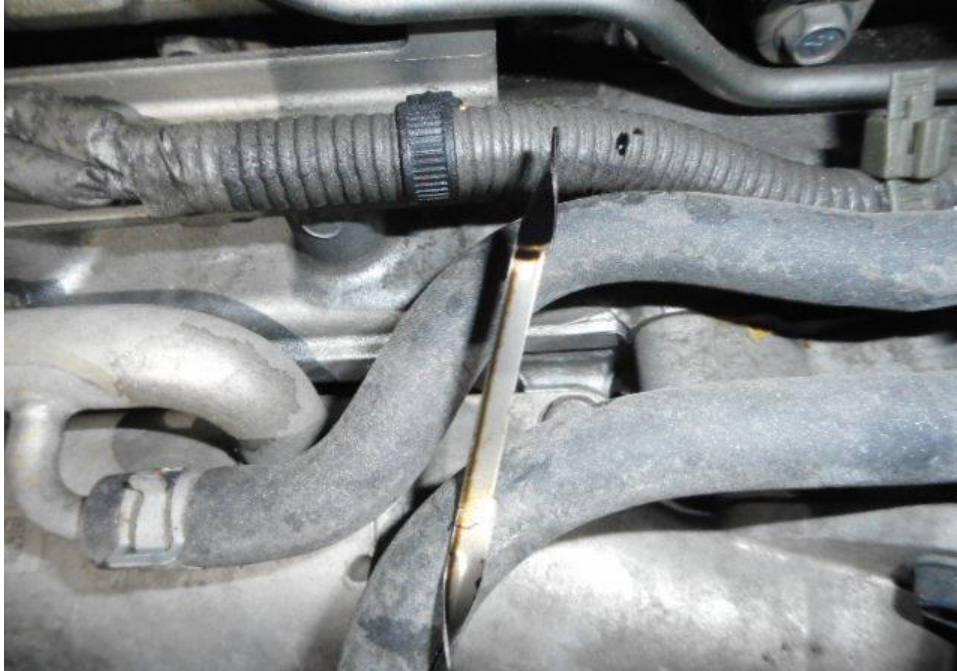
Photo 18 shows the engine oil dip stick of the Motor Lorry at the time of my inspection. The engine oil was observed to be of sufficient level and without any visible contamination.

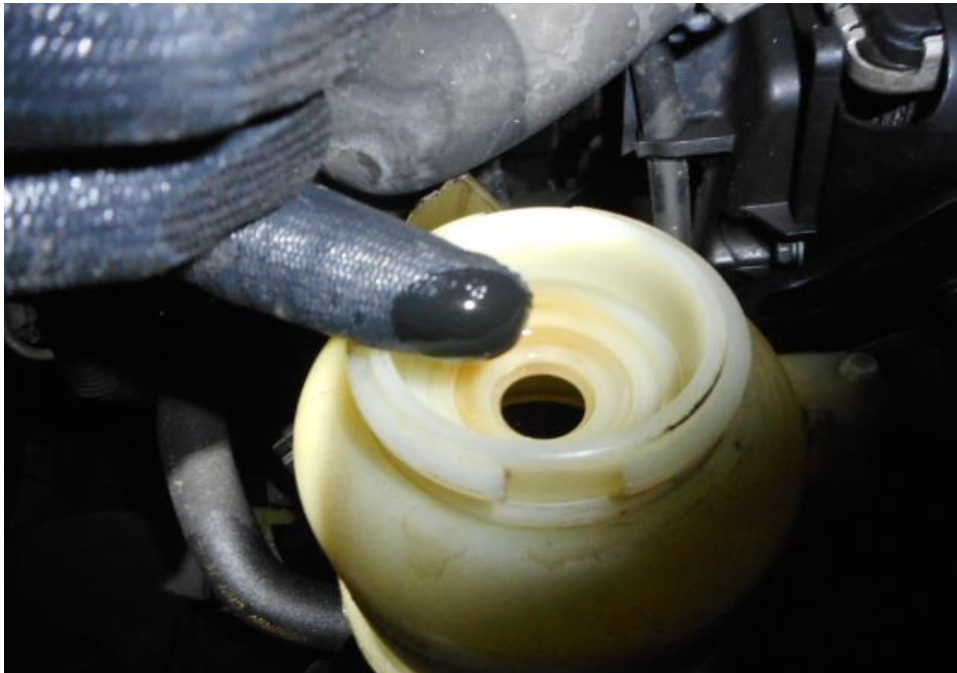
Photo 19 shows the power steering fluid reservoir of the Motor Lorry at the time of my inspection. The power steering fluid was observed to be of sufficient level (arrowed) and without any visible contamination.

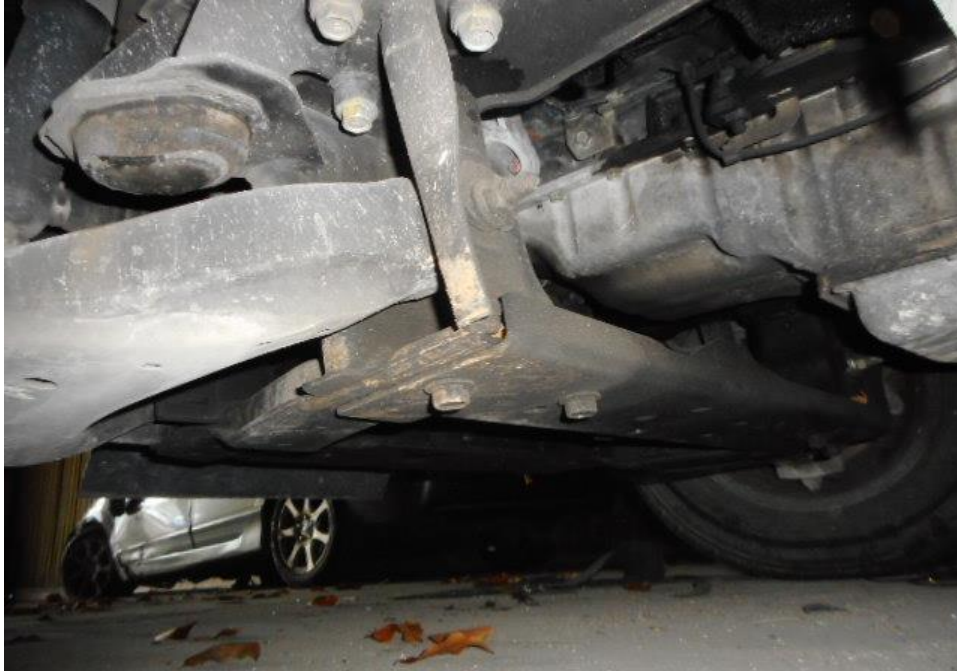
Photo 20 shows the undercarriage of the Motor Lorry, at the area where the engine housing and transmission housing are located. I did not find any sign(s) or indication(s) of fluid leak and/or fluid stain(s) on the underside of the Motor Lorry.

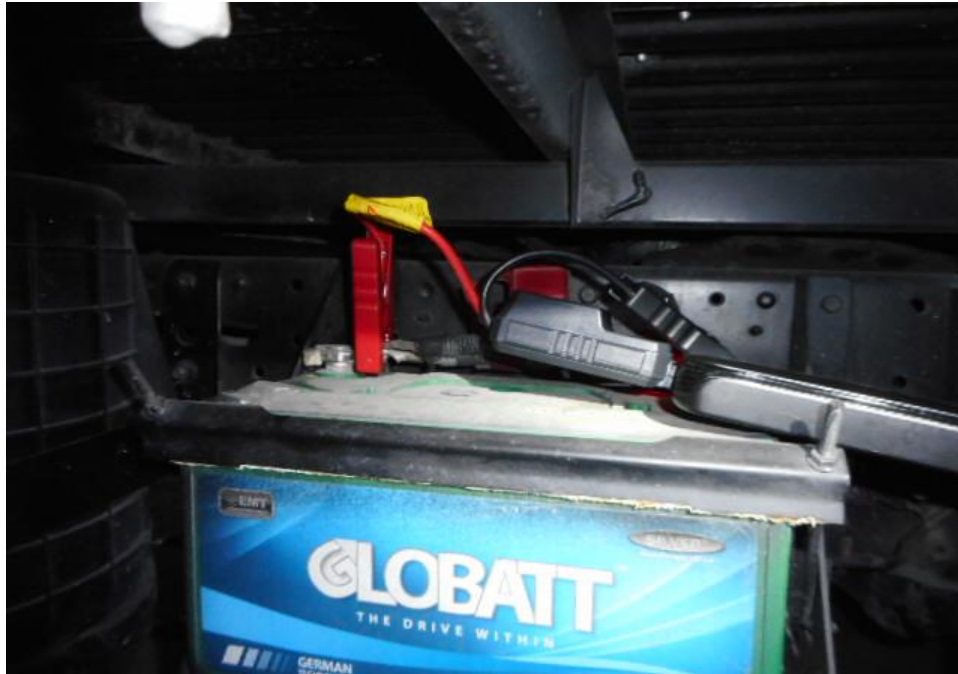
Photo 21 shows the jumpstarting process of the Motor Lorry's engine. The engine of the Motor Lorry's was unable to be jumpstarted up despite multiple attempts in starting it.

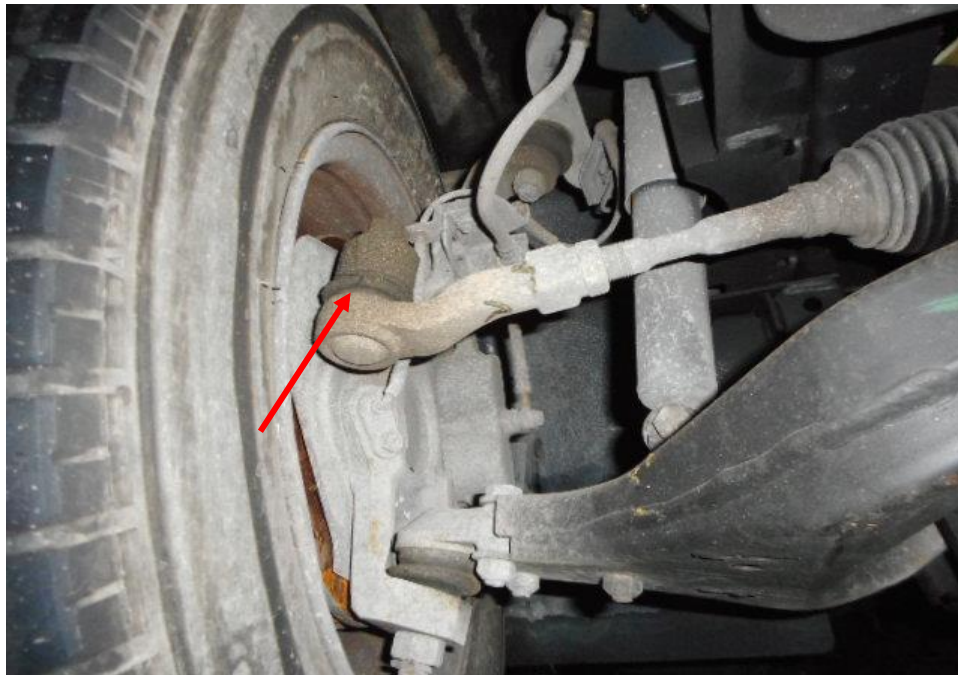
Photo 22 shows the various undercarriage components at the front right wheel of the Motor Lorry, in particular the steering tie rod end (arrowed). The various steering components were all found to be intact, suggesting that the steering system of the Motor Lorry was likely to be in serviceable condition at the material time of accident. There was also no sign of fluid stain(s) observed on the various undercarriage components.

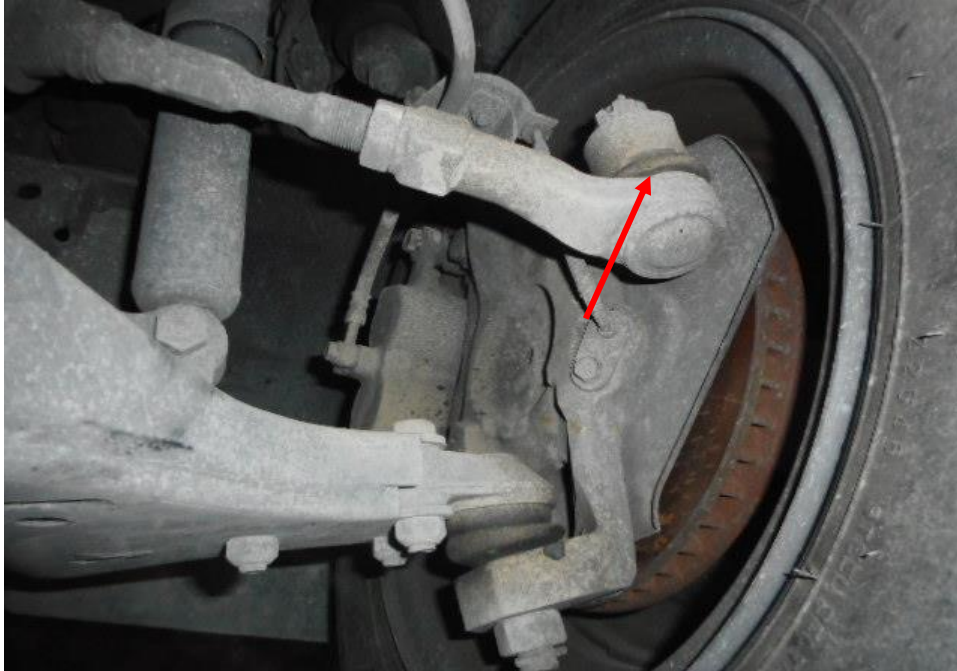
Photo 23 shows the various undercarriage components at the front left wheel of the Motor Lorry, in particular the steering tie rod end (arrowed). The various undercarriage components of the Motor Lorry were all found to be intact without any visible damage. There was also no sign of fluid stain(s) observed on the various undercarriage components.

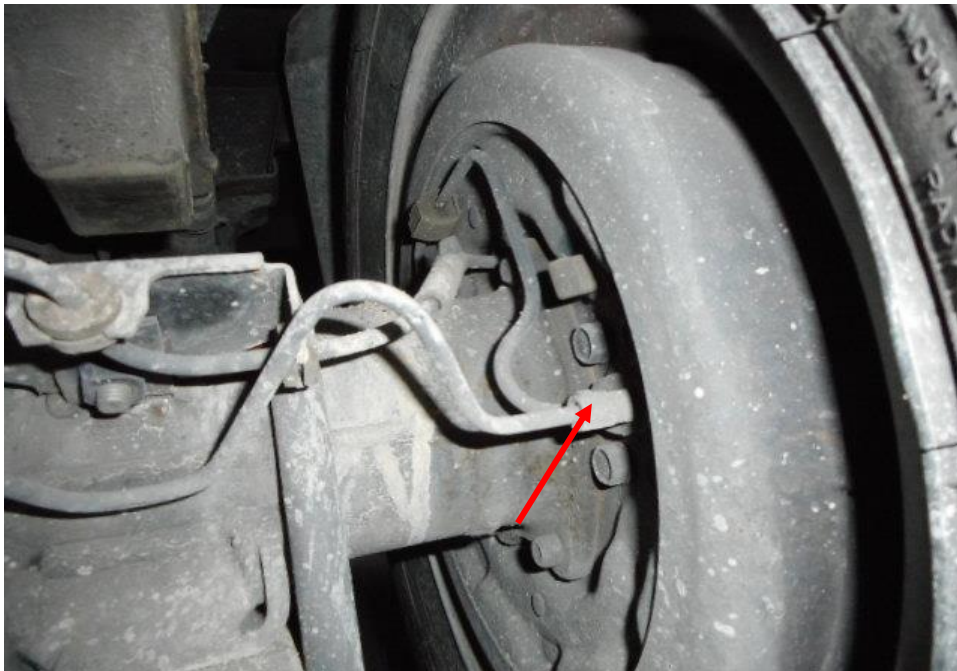
Photo 24 shows the brake pipe (arrowed) at the rear right wheel of the Motor Lorry. I did not observe any leakage of brake fluid at the time of my inspection of the Motor Lorry. My static tests of the Motor Lorry's braking system, along with my visual examination of the various mechanical components in the braking system, had indicated that there was no internal leakage of pressure/vacuum. Hence the braking system of the Motor Lorry was likely to be in serviceable condition at the material time of accident.

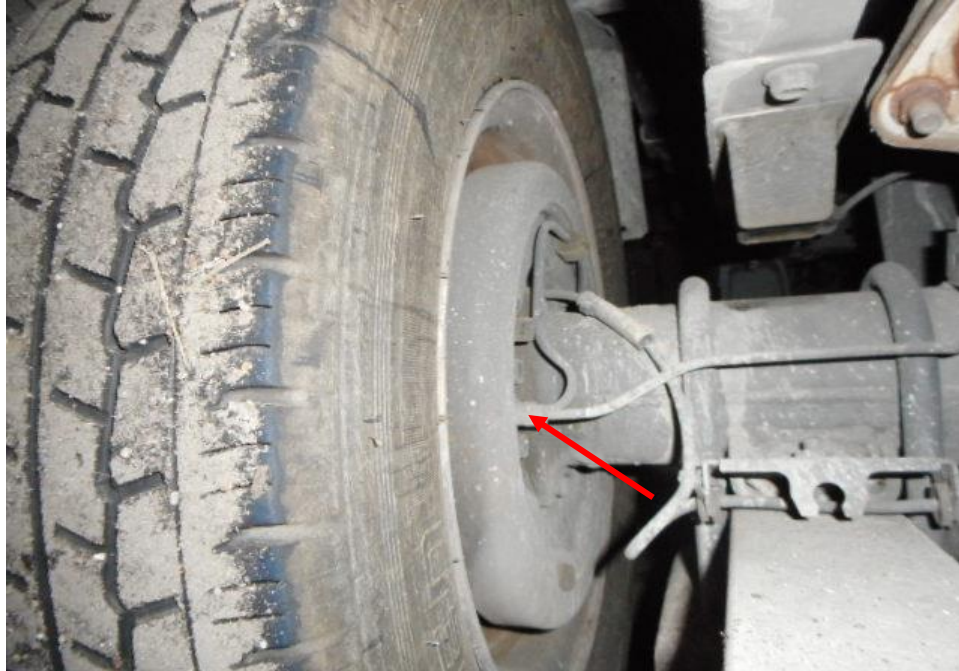
Photo 25 shows the brake pipe (arrowed) at the rear left wheel of the Motor Lorry. I did not observe any leakage of brake fluid at the time of my inspection of the Motor Lorry. My static tests of the Motor Lorry's braking system, along with my visual examination of the various mechanical components in the braking system had indicated that there was no internal leakage of pressure/vacuum. Hence the braking system of the Motor Lorry was likely to be in serviceable condition at the material time of accident.

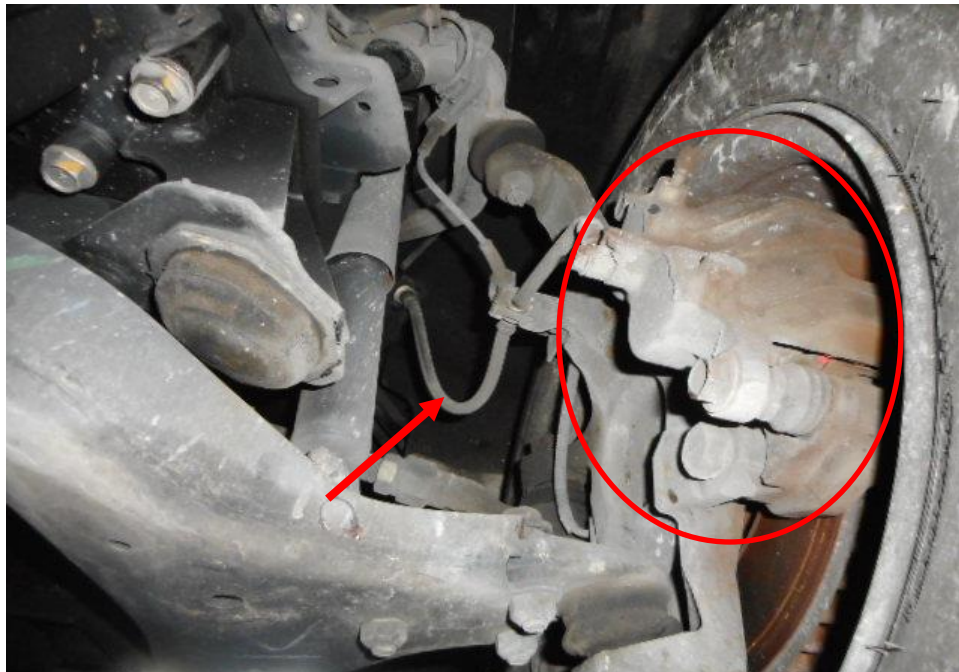
Photo 26 shows the brake hose/pipe (arrowed) at the front right wheel of the Motor Lorry. No leakage of brake fluid was observed. Visual examination of the various components of the braking system like the brake caliper (circled), brake booster, brake pedal etc had revealed all to be intact and without visible damage at the time of accident. There was also no sign of fluid stain(s) observed on the various undercarriage components.

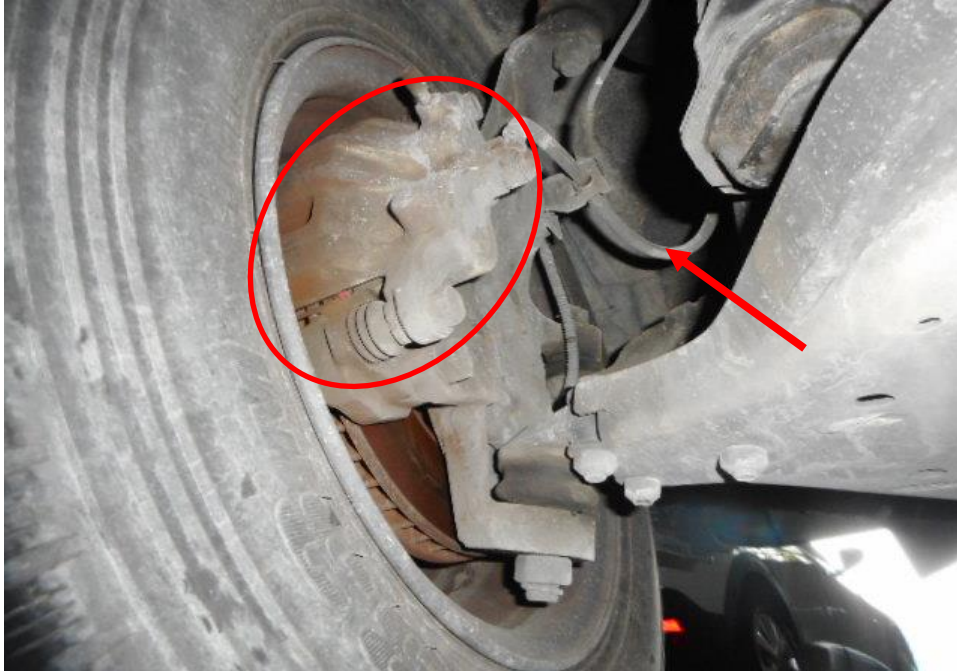
Photo 27 shows the brake hose/pipe (arrowed) at the front left wheel of the Motor Lorry. No leakage of brake fluid was observed. Visual examination of the various components of the braking system like the brake caliper (circled), brake booster, brake pedal etc had revealed all to be intact and without visible damage at the time of accident. There was also no sign of fluid stain(s) observed on the various undercarriage components.
