Your Ref: TP/IP/43407/2021
Our Ref : CI/TPD21010024/P

Fatal Accident Investigation Team

MECHANICAL INSPECTION REPORT OF MOTOR LORRY GBE 4524D

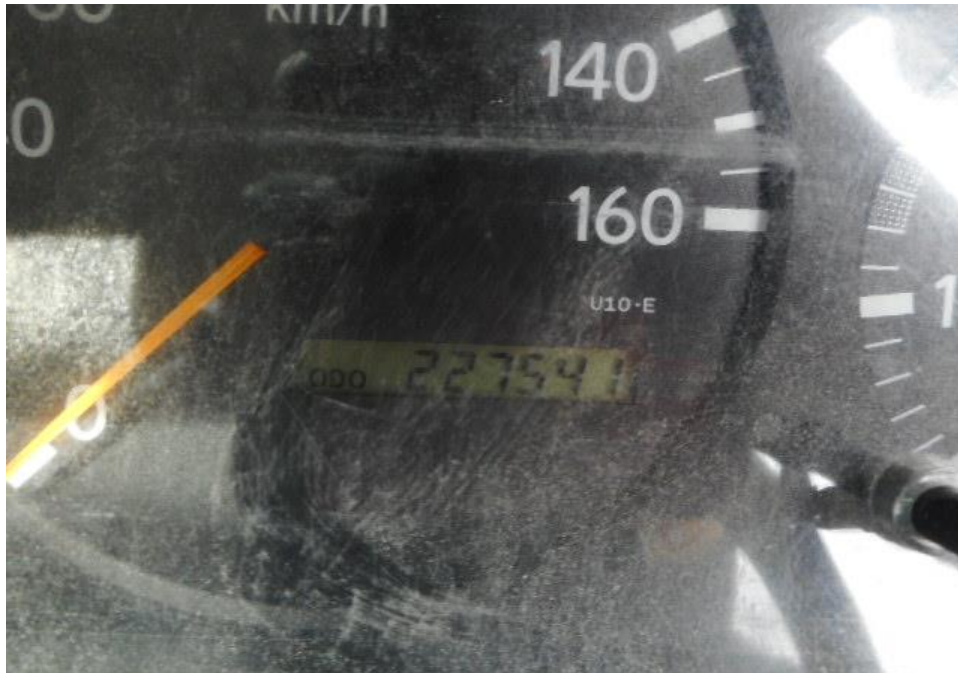
Photo 1 shows a general view of the instrument cluster of the Motor Lorry at the time of my inspection. The mileage of the Motor Lorry was 227,541 km

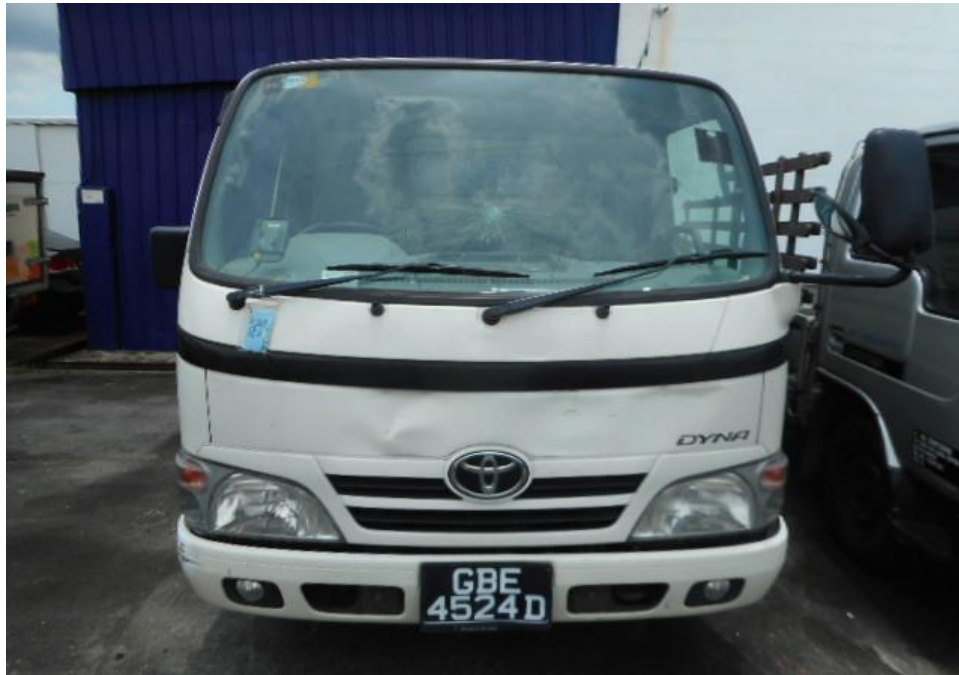
4. The mileage of the Motor Lorry at the time of my inspection was 227,541km.
5. The Motor Lorry was observed to sustained damage at its front portion. Its front windscreen and front body panel were damage at the time of my inspection as a result of the accident.

Photo 2 shows a general view of the Motor Lorry's frontal portion at the time of my inspection. It appeared to have sustained damage at its front portion. Its front windscreen, front bumper and front body panel were damage at the time of my inspection as a result of the accident.

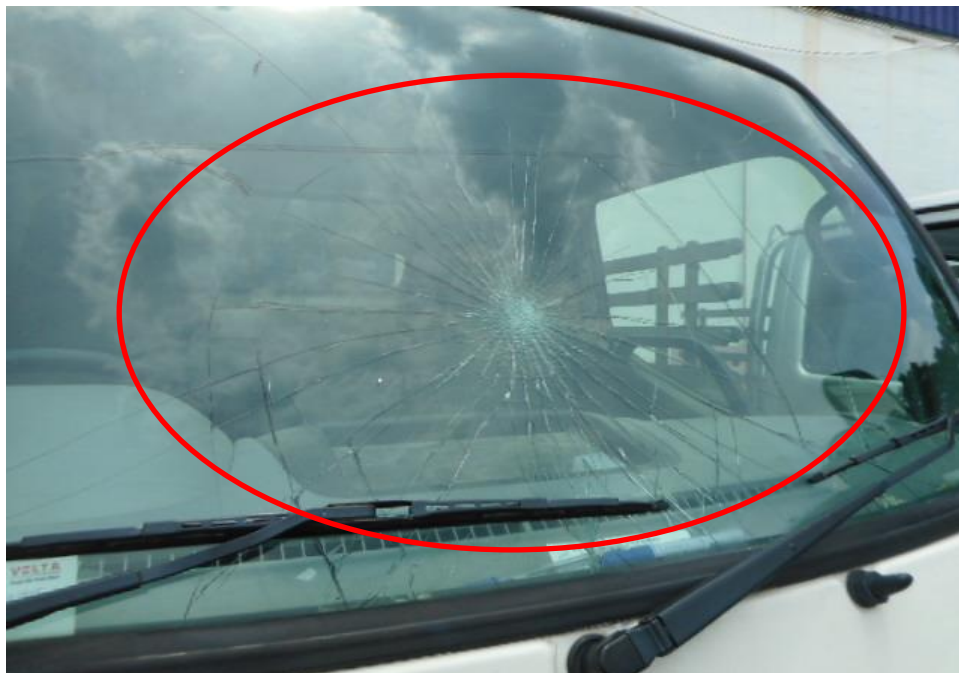
Photo 3 shows a close up view of the Motor Lorry's front portion at the time of my inspection. Its front windscreen (circled) was damage at the time of my inspection as a result of the accident.

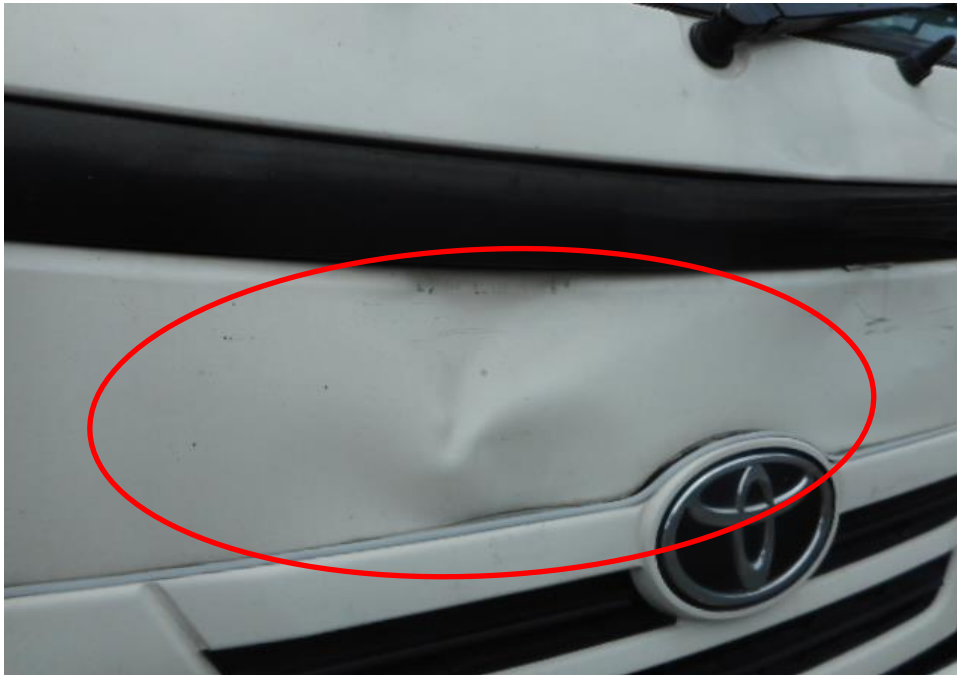
Photo 4 shows a close up view of the Motor Lorry's front portion at the time of my inspection. Its front bumper (circled) and front left headlamp (arrowed) was damage at the time of my inspection as a result of the accident.

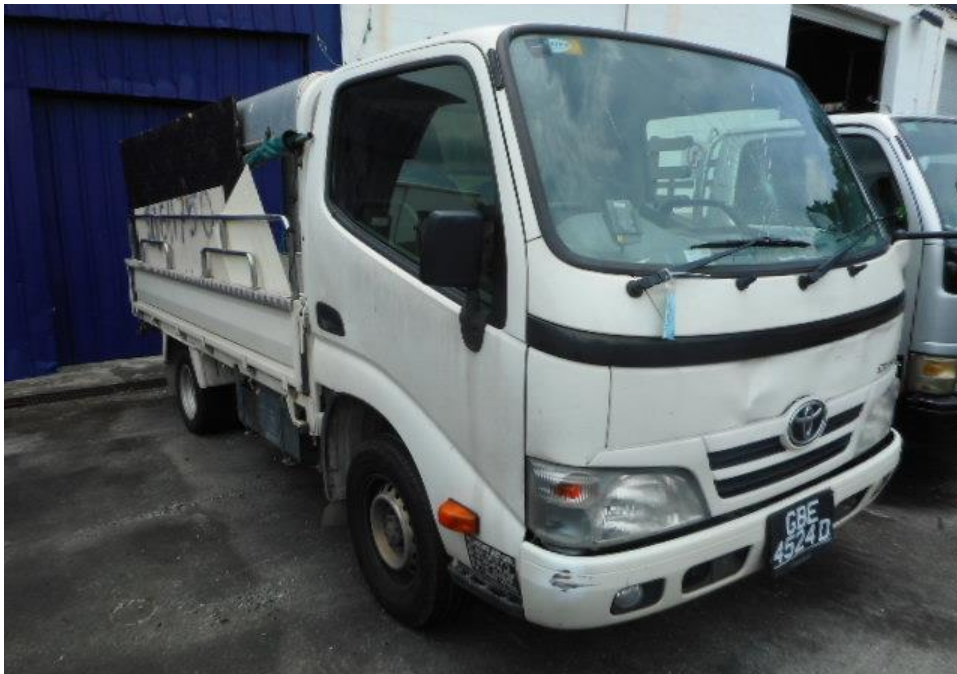
Photo 5 shows a general view of the right body of the Motor Lorry at the time of my inspection. The Motor Lorry was observed to be intact and unaffected by the accident.

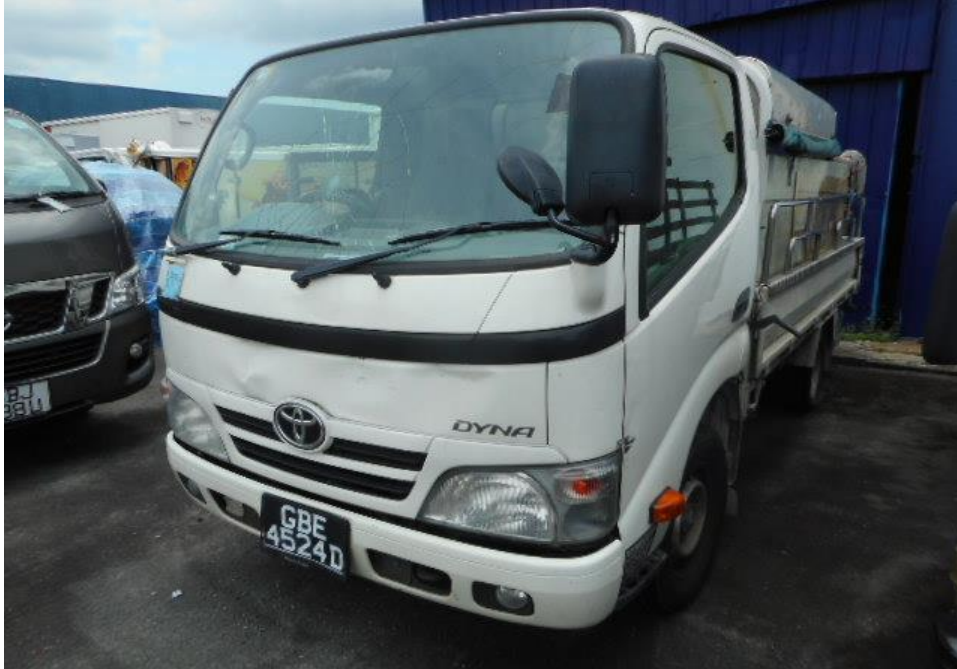
Photo 6 shows a general view of the left body of the Motor Lorry at the time of my inspection. The Motor Lorry was observed to be intact and unaffected by the accident.

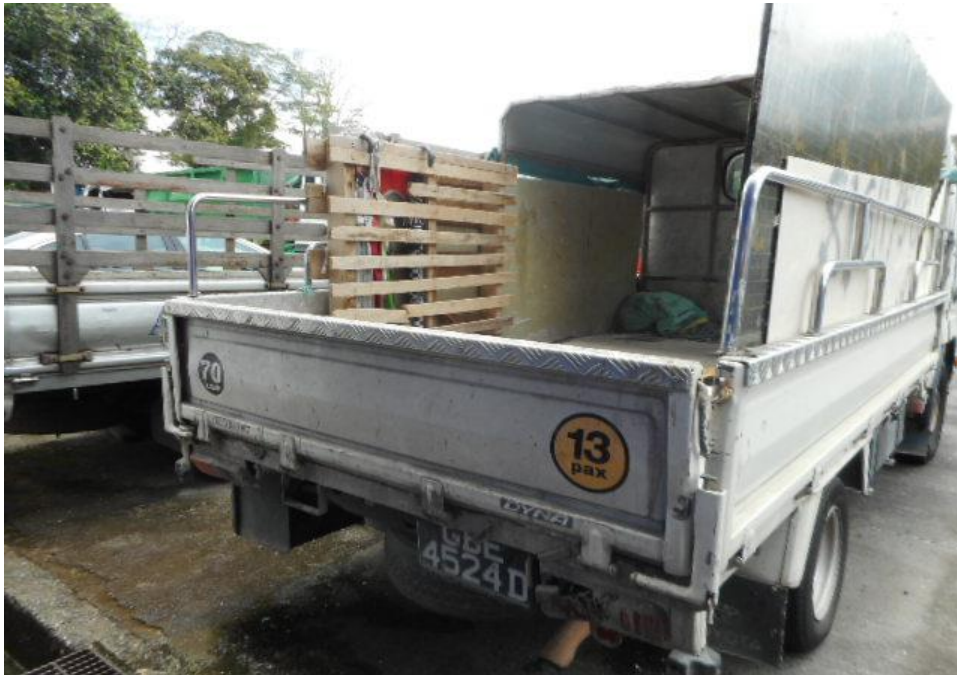
Photo 7 shows a general view of the rear body of the Motor Lorry at the time of my inspection. The Motor Lorry was observed to be intact and unaffected by the accident.

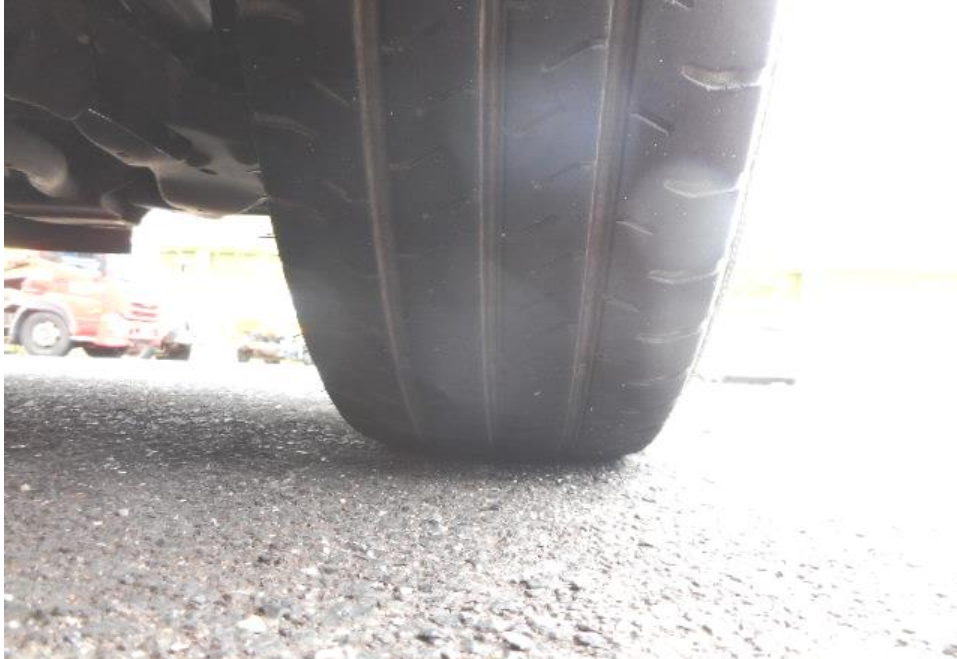
Photo 8 shows the condition of the front right tyre of the Motor Lorry, which was observed to be in serviceable condition with remaining tread depth of approximately 6mm. The tyre, which was wrapped around standard steel wheel rim, was also observed to be sufficiently inflated for vehicular operation. There was no tear, cut or burst mark(s) on the outer and the inner sidewalls as well as across the tread of the 6 tyres that were fitted on the Motor Lorry.

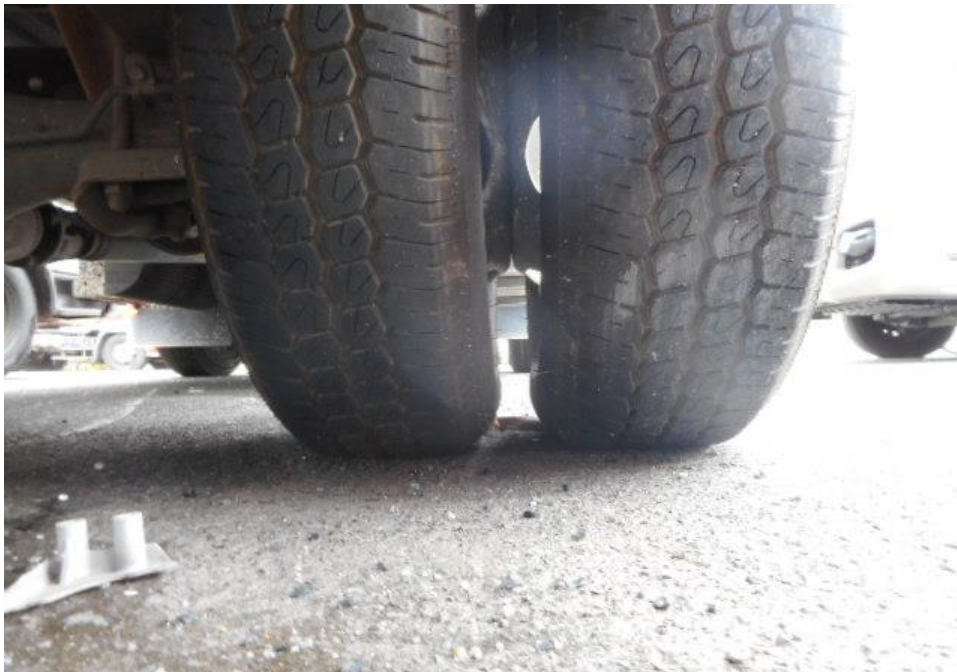
Photo 9 shows the condition of the rear right tyre of the Motor Lorry, which was observed to be in serviceable condition with remaining tread depth of approximately 5.7mm. The tyre, which was wrapped around standard steel wheel rim, it was observed to be sufficiently inflated for vehicular operation.

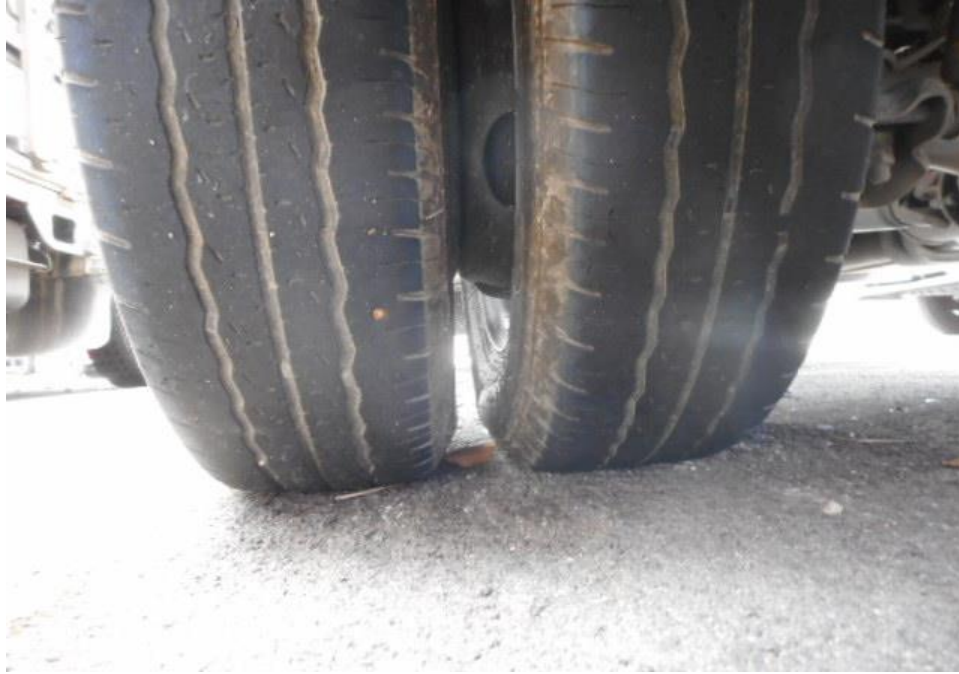
Photo 10 shows the condition of the rear left tyres of the Motor Lorry, which was observed to be in serviceable condition with remaining tread depth of approximately 3mm. The tyres, which were wrapped around standard steel wheel rim, were also observed to be sufficiently inflated for vehicular operation.

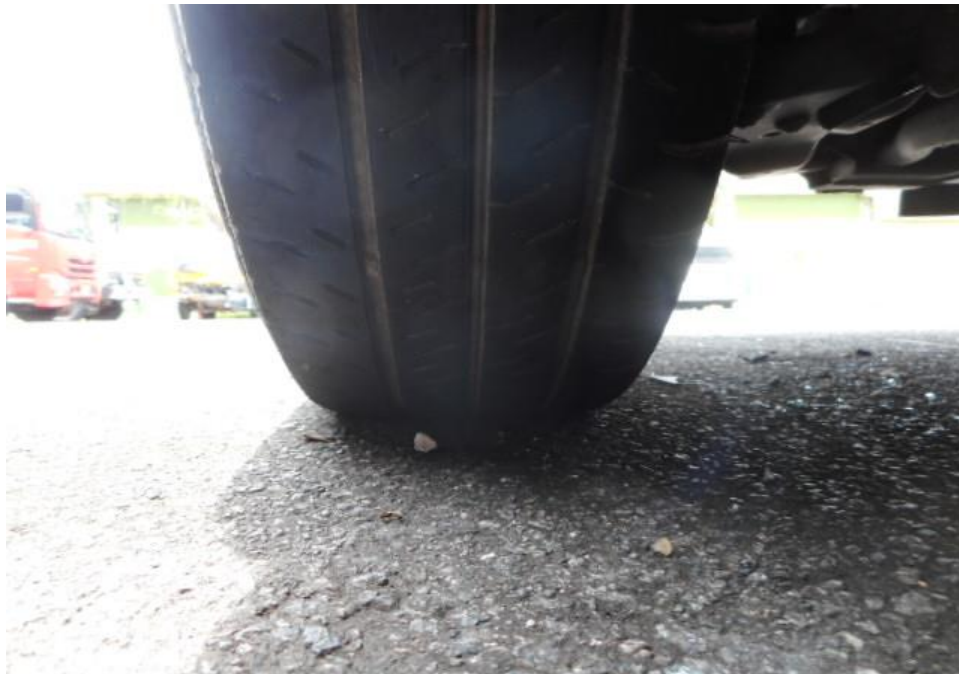
Photo 11 shows the condition of the rear right tyres of the Motor Lorry, which were observed to be in serviceable condition with remaining, tread depth of approximately 5.5mm. There was also no tear, cut or burst mark(s) on the outer and the inner sidewalls as well as across the tread of the 6 tyres that were fitted on the Motor Lorry.

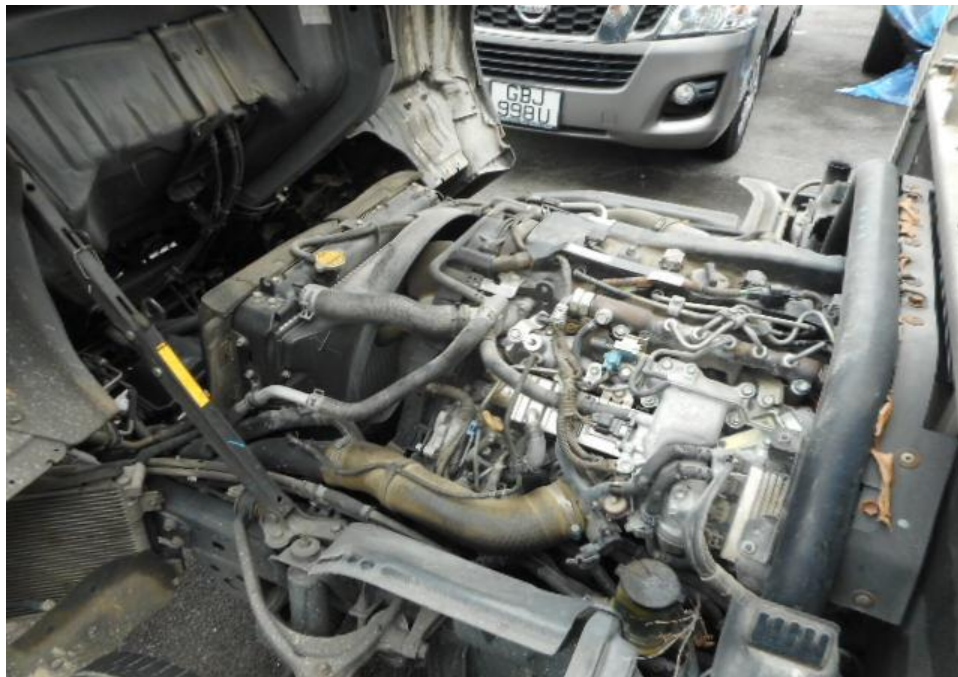
Photo 12 shows a general view of the Motor Lorry's engine compartment, which was accessed by lifting the front cabin of the Motor Lorry. The various parts and components inside the engine compartment were unaffected by the accident. There was also no sign(s) or indication(s) of fresh fluid leakage and/or fluid stain within the engine compartment

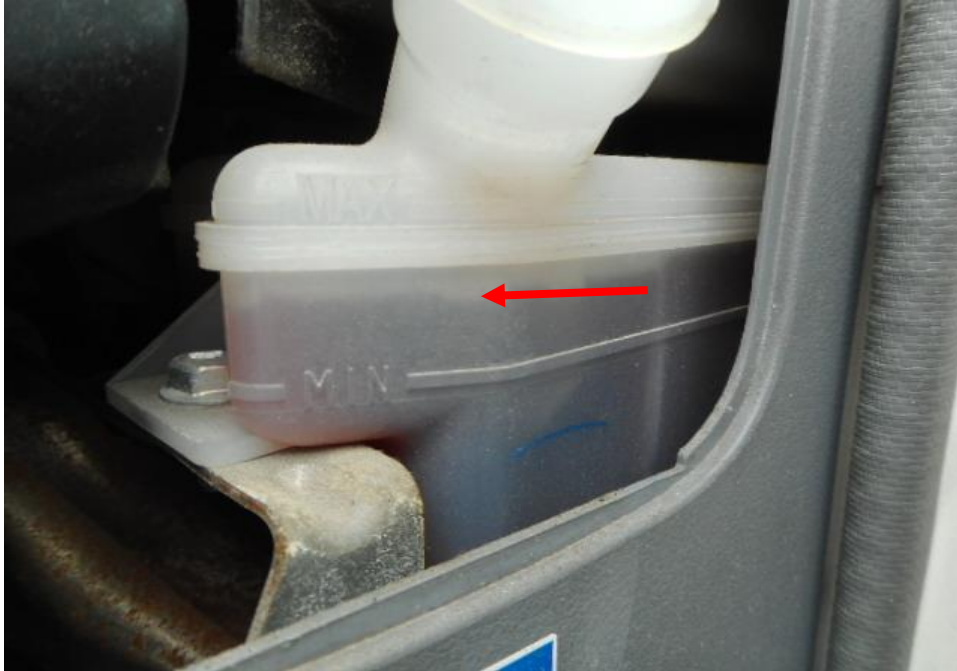
Photo 13 shows the brake fluid reservoir of the Motor Lorry at the time of my inspection. The brake fluid was observed to be of sufficient level (arrowed) and without any visible contamination.

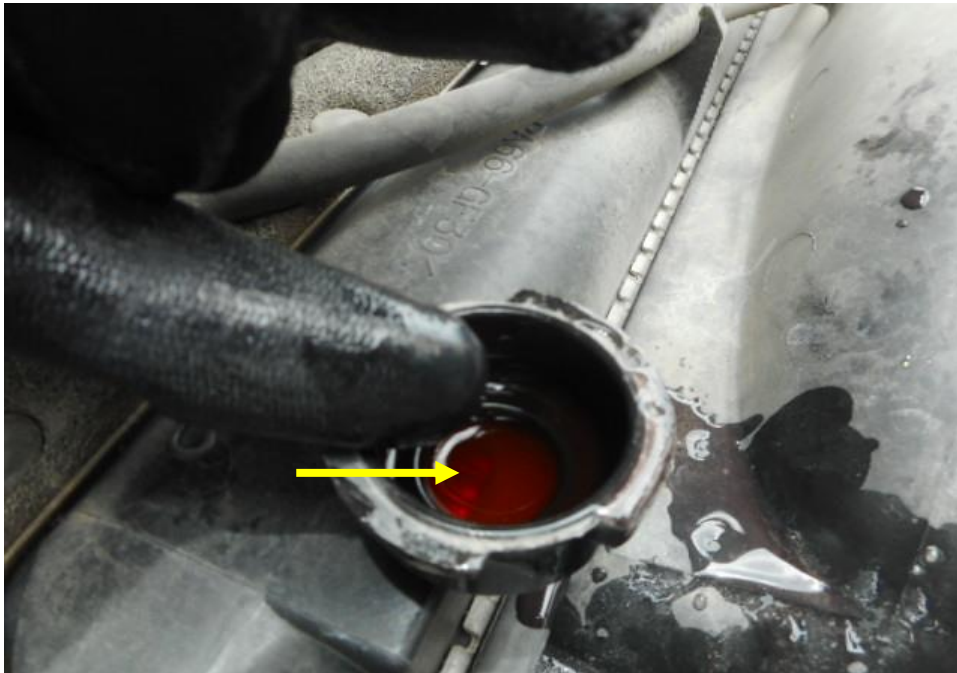
Photo 14 shows the engine coolant reservoir of the Motor Lorry at the time of my inspection. The engine coolant was observed to be of sufficient level (arrowed) and without any visible contamination.

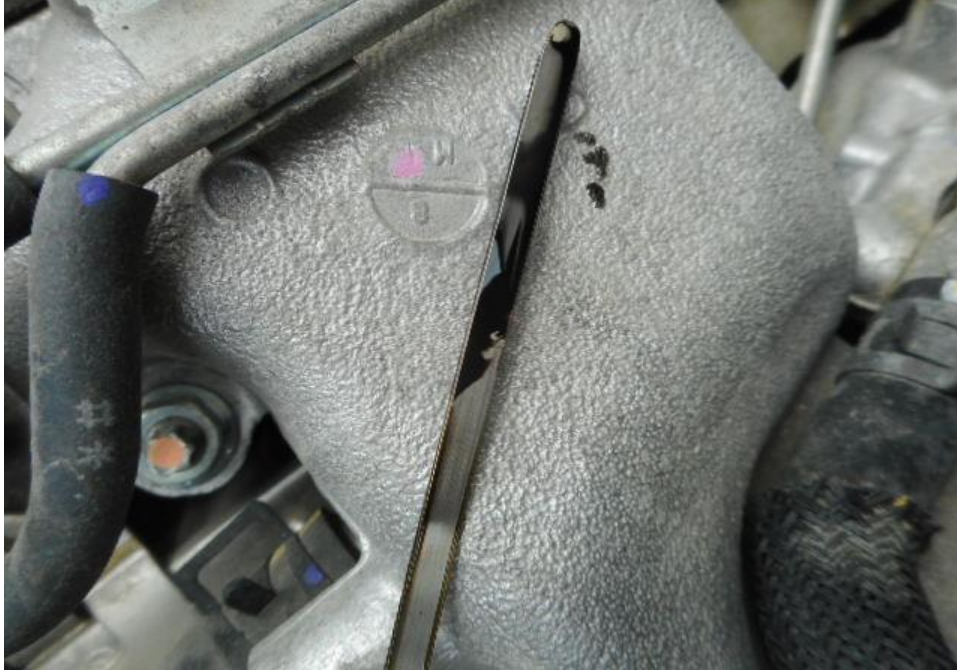
Photo 15 shows the engine oil dip stick of the Motor Lorry at the time of my inspection. The engine oil was observed to be of sufficient level and without any visible contamination.

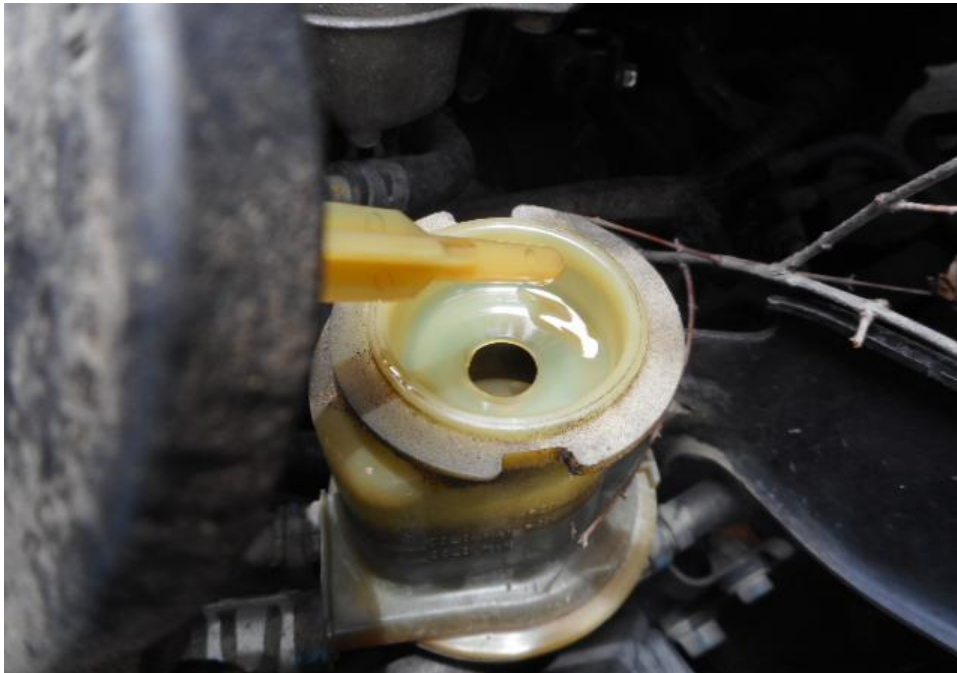
Photo 16 shows the power steering fluid reservoir of the Motor Lorry at the time of my inspection. The power steering fluid was observed to be of sufficient level and without any visible contamination.

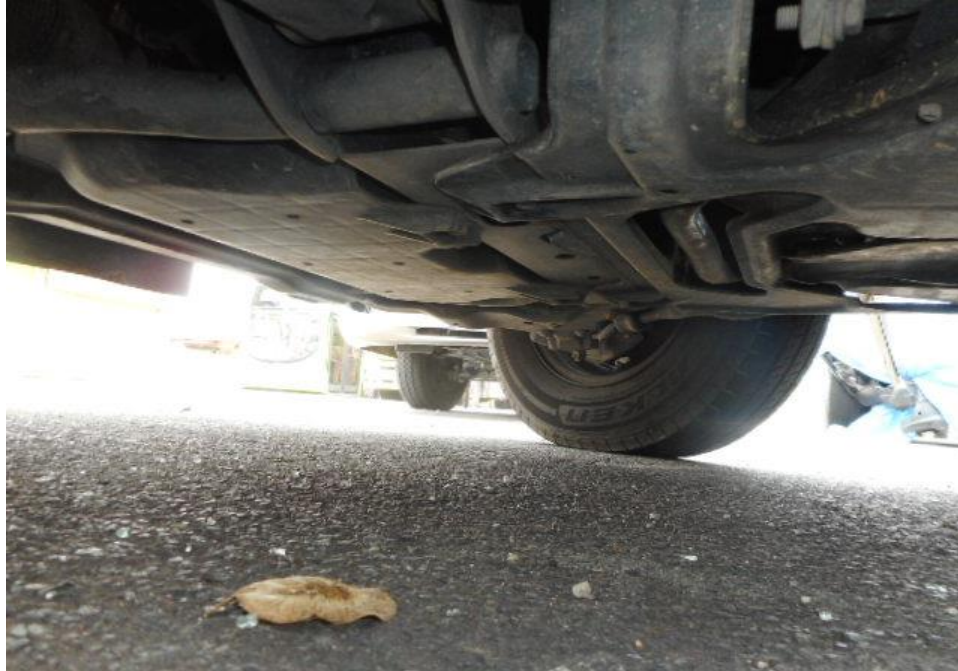
Photo 17 shows the undercarriage of the Motor Lorry, at the area where the engine housing and transmission housing are located. I did not find any sign(s) or indication(s) of fluid leak and/or fluid stain(s) on the underside of the Motor Lorry.

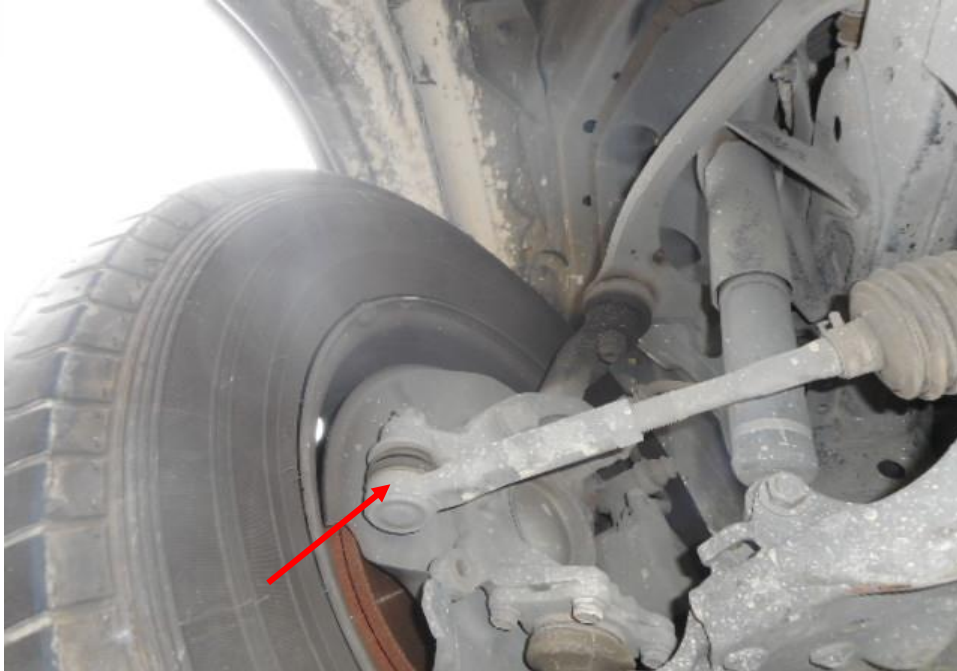
Photo 18 shows the various undercarriage components at the front right wheel of the Motor Lorry, in particular the steering tie rod end (arrowed). The various steering components were all found to be intact, suggesting that the steering system of the Motor Lorry was likely to be in serviceable condition at the material time of accident. There was also no sign of fluid stain(s) observed on the various undercarriage components.

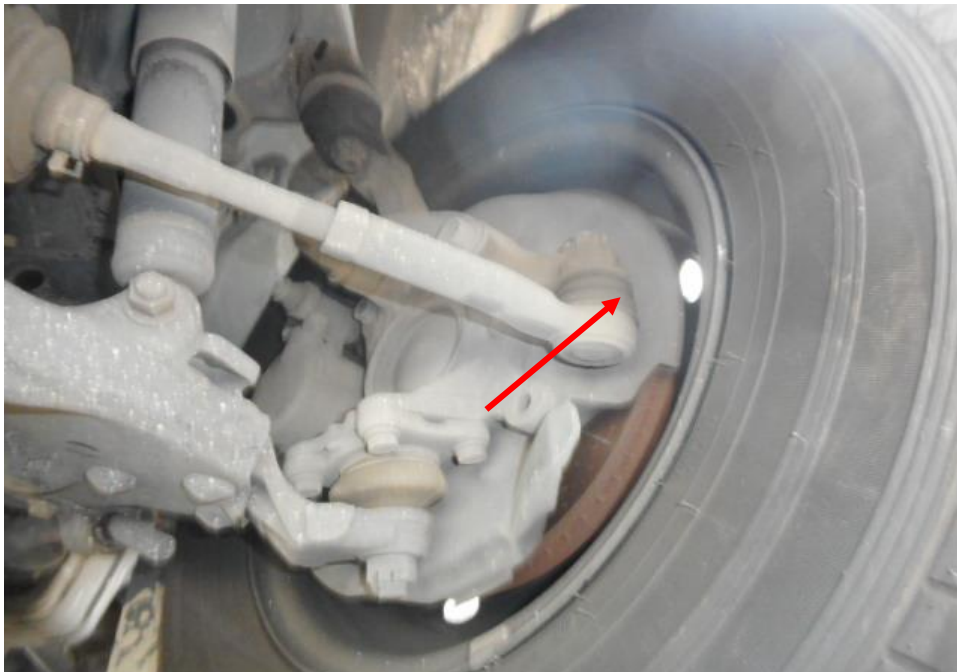
Photo 19 shows the various undercarriage components at the front left wheel of the Motor Lorry, in particular the steering tie rod end (arrowed). The various undercarriage components of the Motor Lorry were all found to be intact without any visible damage. There was also no sign of fluid stain(s) observed on the various undercarriage components.

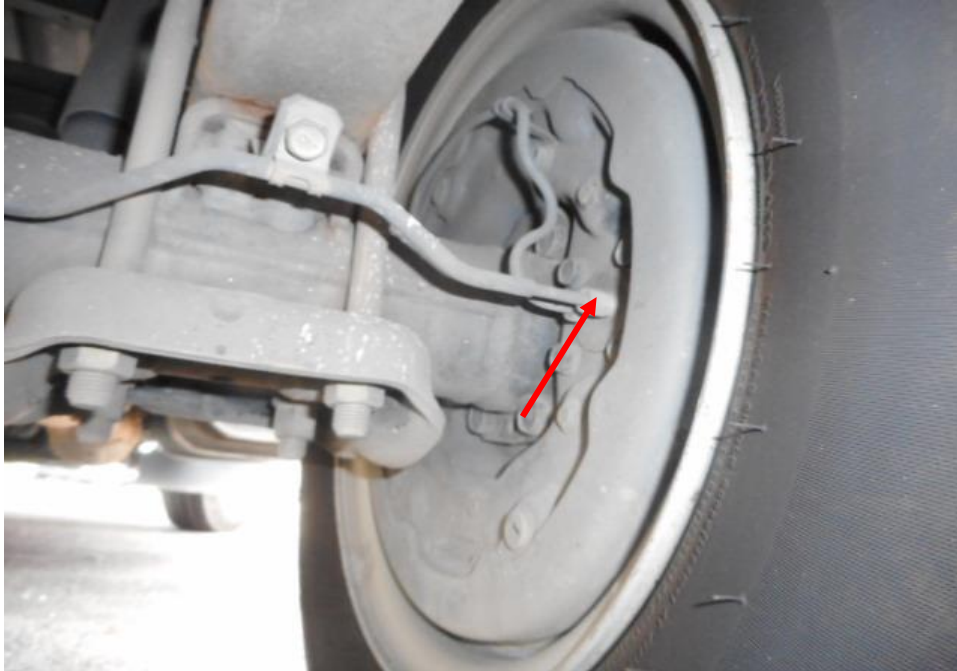
Photo 20 shows the brake pipe (arrowed) at the rear right wheel of the Motor Lorry. I did not observe any leakage of brake fluid at the time of my inspection of the Motor Lorry. My static tests of the Motor Lorry's braking system, along with my visual examination of the various mechanical components in the braking system, had indicated that there was no internal leakage of pressure/vacuum. Hence the braking system of the Motor Lorry was likely to be in serviceable condition at the material time of accident.

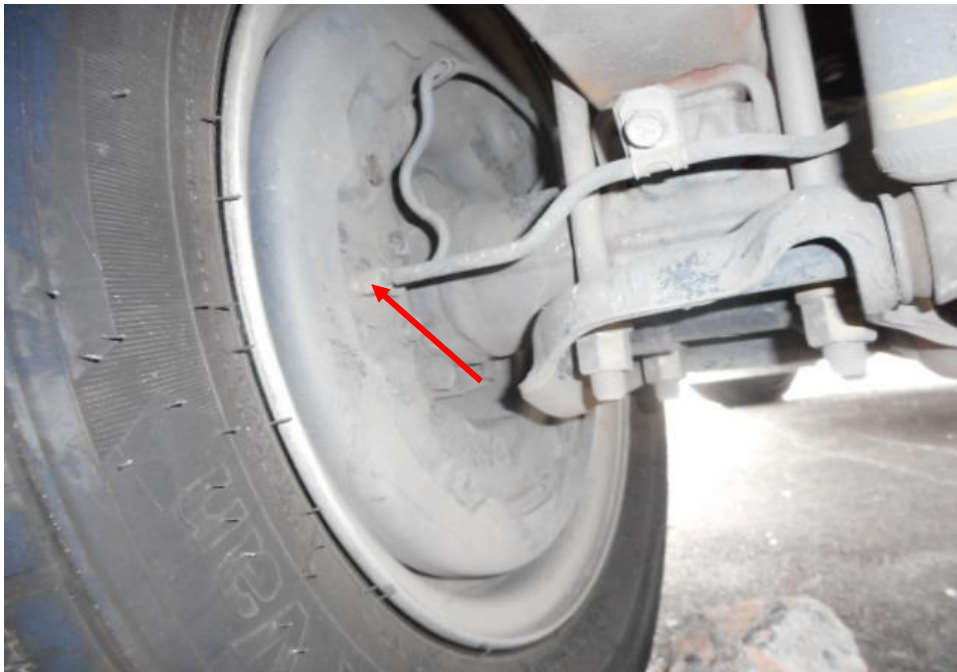
Photo 21 shows the brake pipe (arrowed) at the rear left wheel of the Motor Lorry. I did not observe any leakage of brake fluid at the time of my inspection of the Motor Lorry. My static tests of the Motor Lorry's braking system, along with my visual examination of the various mechanical components in the braking system had indicated that there was no internal leakage of pressure/vacuum. Hence the braking system of the Motor Lorry was likely to be in serviceable condition at the material time of accident.

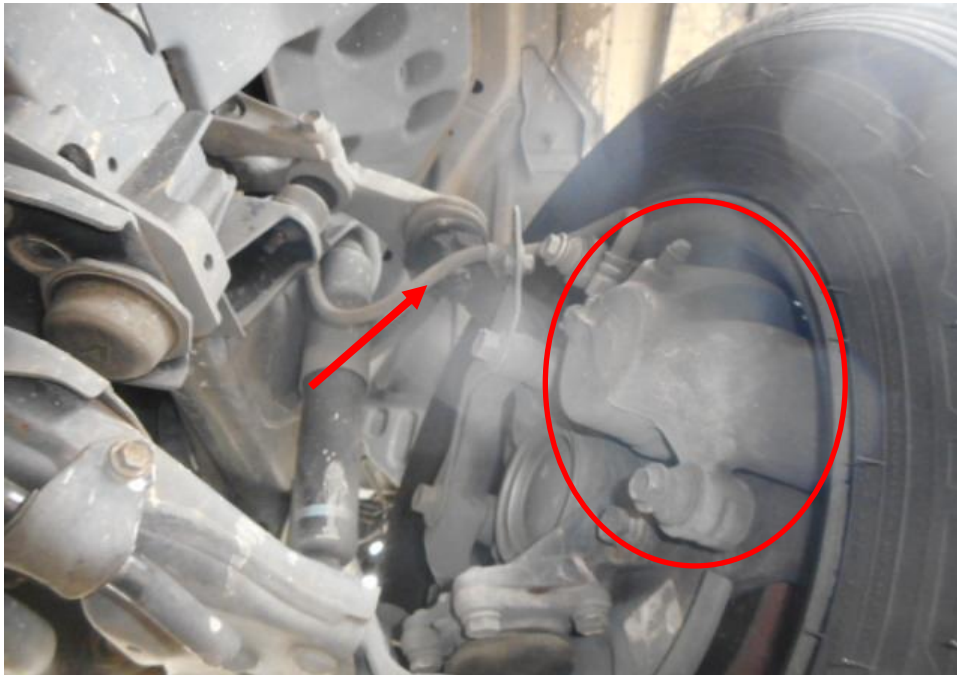
Photo 22 shows the brake hose/pipe (arrowed) at the front right wheel of the Motor Lorry. No leakage of brake fluid was observed. Visual examination of the various components of the braking system like the brake caliper (circled), brake booster, brake pedal etc had revealed all to be intact and without visible damage at the time of accident. There was also no sign of fluid stain(s) observed on the various undercarriage components.

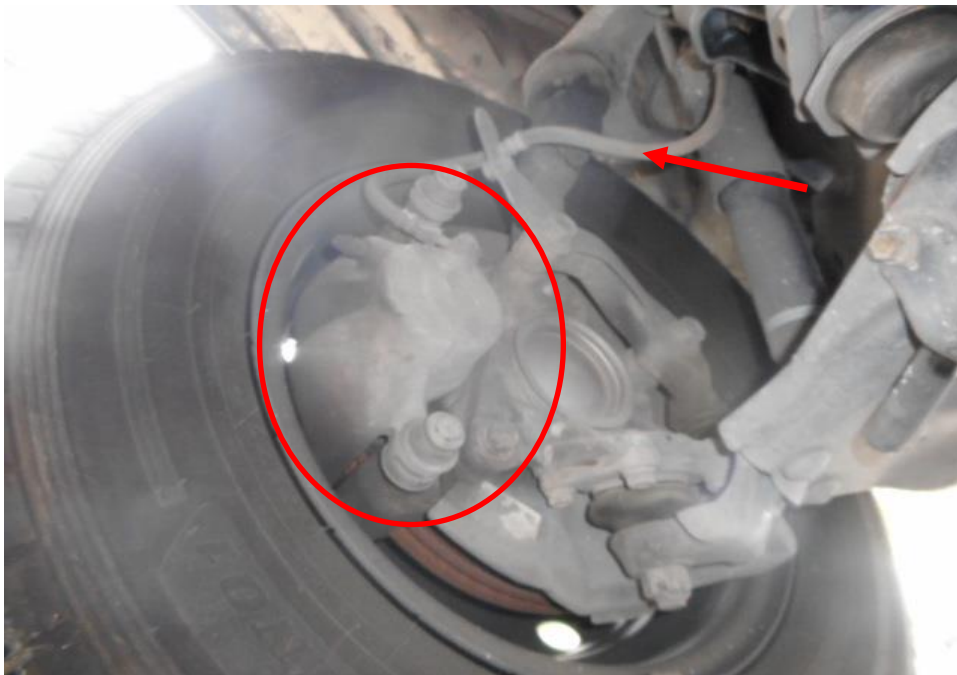
Photo 23 shows the brake hose/pipe (arrowed) at the front left wheel of the Motor Lorry. No leakage of brake fluid was observed. Visual examination of the various components of the braking system like the brake caliper (circled), brake booster, brake pedal etc had revealed all to be intact and without visible damage at the time of accident. There was also no sign of fluid stain(s) observed on the various undercarriage components.

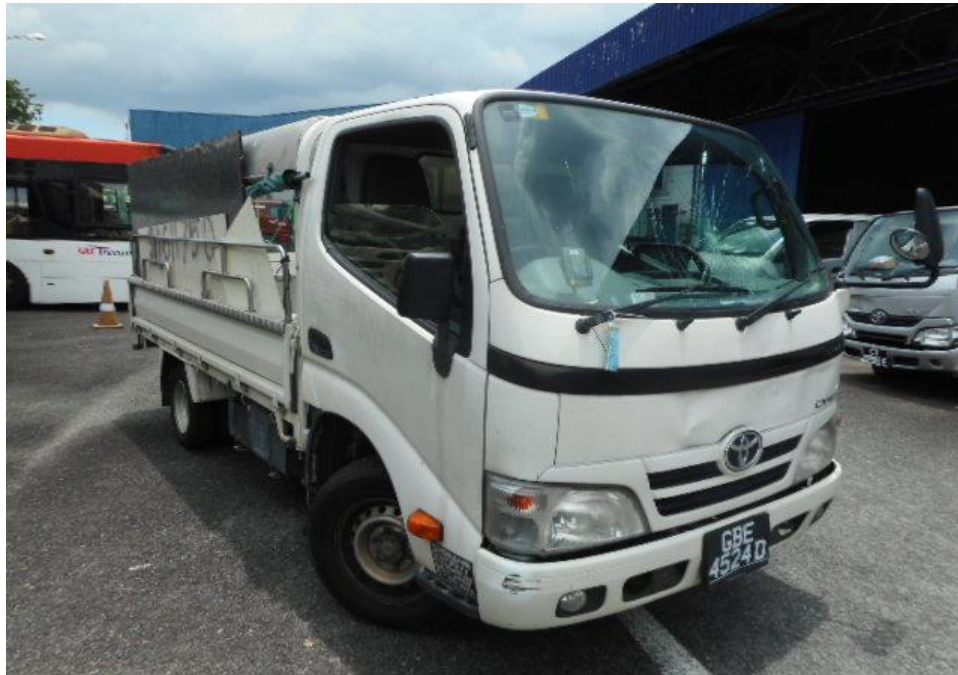
Photo 24 shows the front right wheel of the Motor Lorry turned to its full left. During my steering system test, I did not experience any abnormal free play and/or resistance when I had turned the steering wheel towards full left and full right. This would suggest that the steering system of the Motor Lorry was likely to be in serviceable condition at the material time of accident.
