PRE-REPAIR INSPECTION REPORT				
EQ INSURANCE COMPANY LTD 5 MAXWELL ROAD #17-00 TOWER BLOCK MND COMPLEX SINGAPORE 069110			Ref: CS3/EQI21010055/Gvf3e2 Date: 01/10/2021 Code: EQI

1. Policy Particulars :- (THIRD PARTY CLAIM)				
	Insured Veh.	GBH 4778Y	Veh. Inspected	SFK 9559S
	Policy No.		Coverage (\$)	0.00
	Claim No.	DM21HO01429/JT	Excess (\$)	0.00
	Assign From	JAIME TAY	Assign Date	28/09/2021

PHOTOGRAPHS FOR VEHICLE NO. SFK 9559S

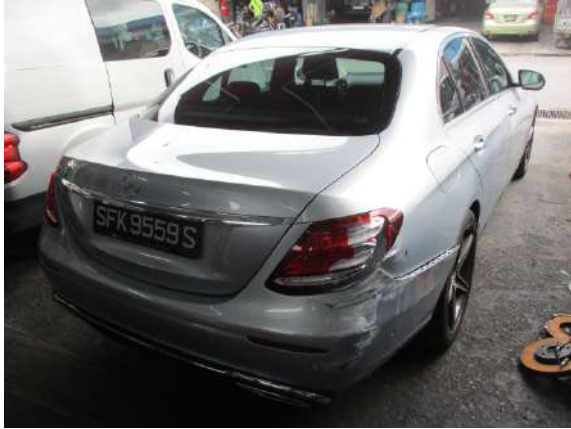
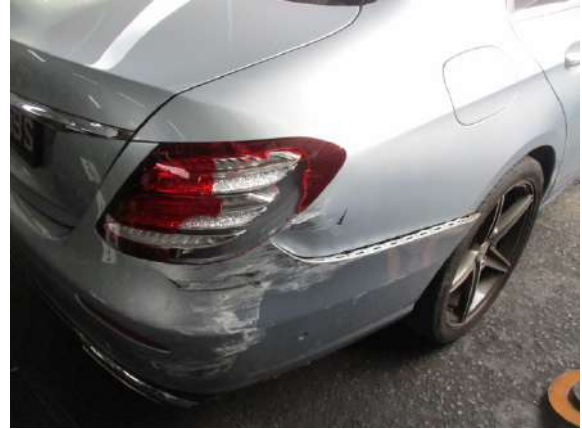
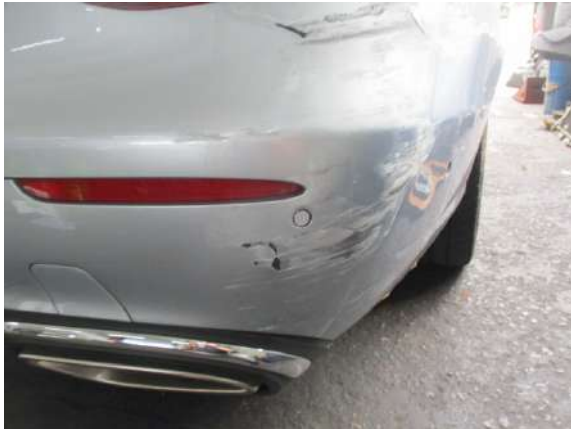
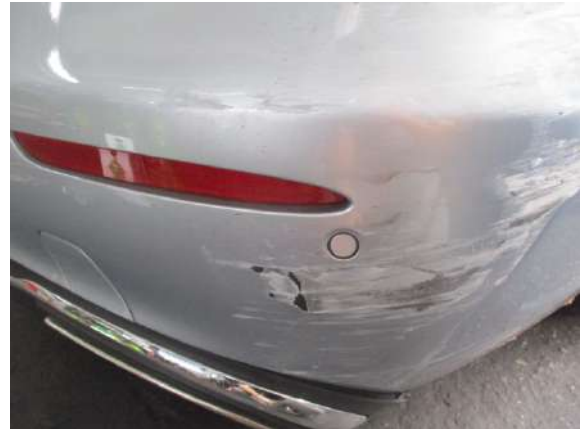
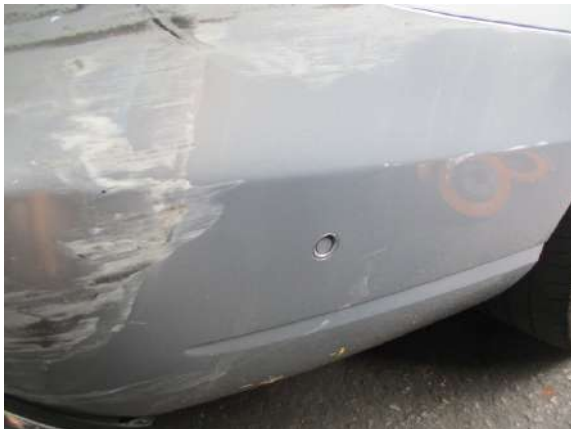
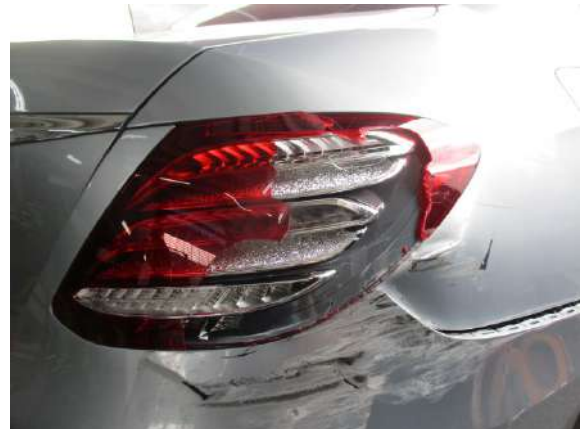
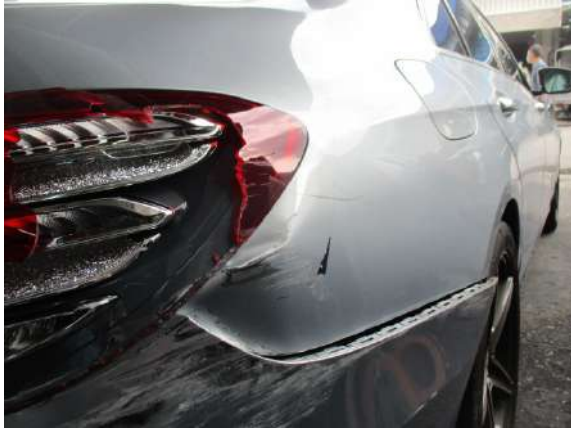
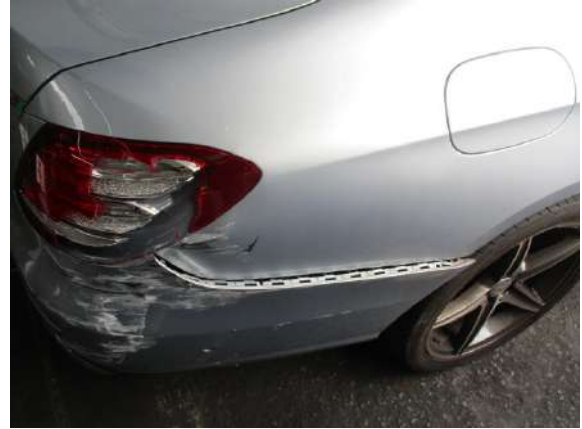
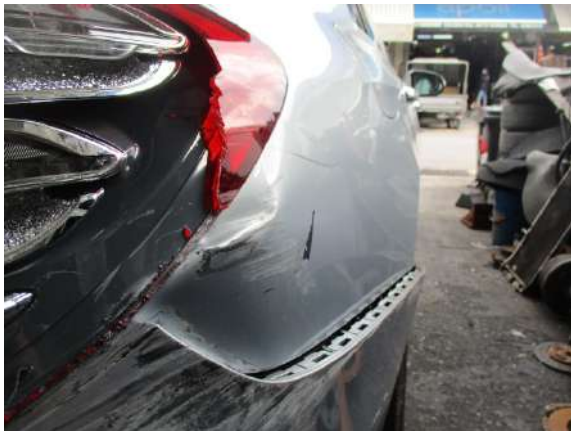
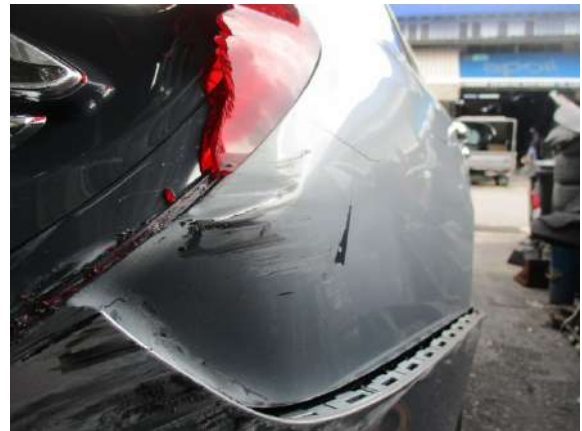
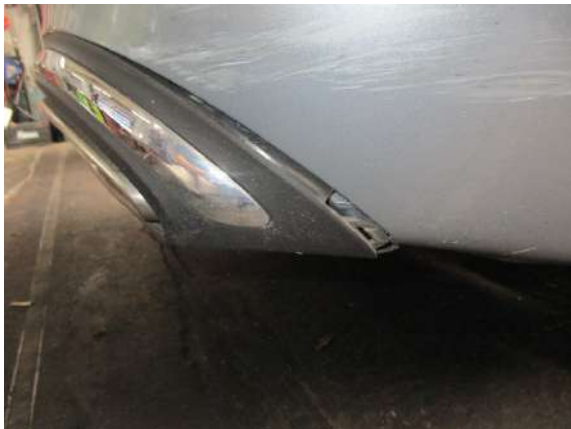
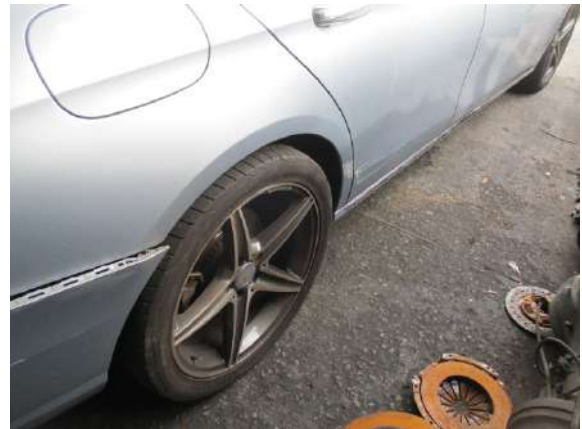
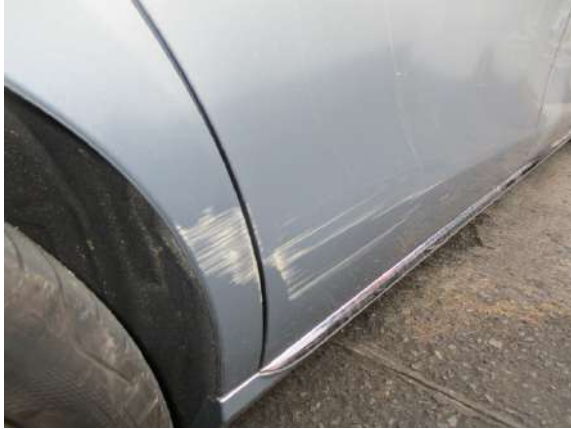
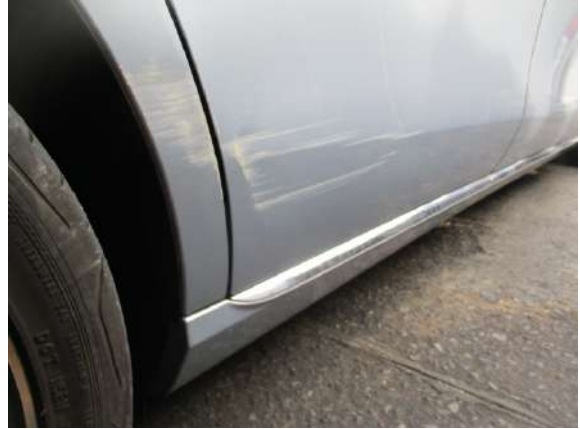
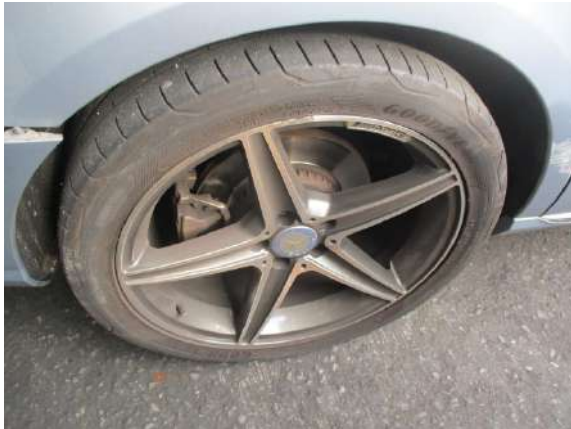
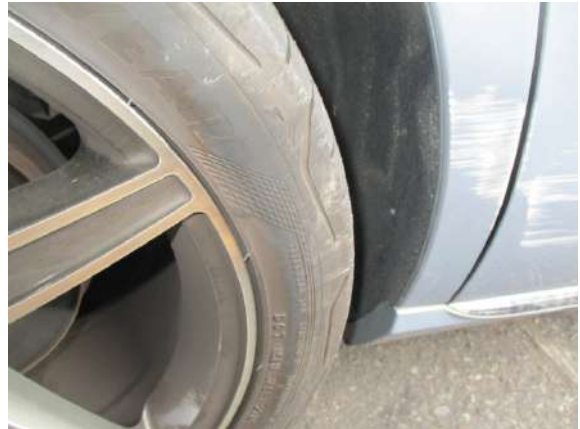
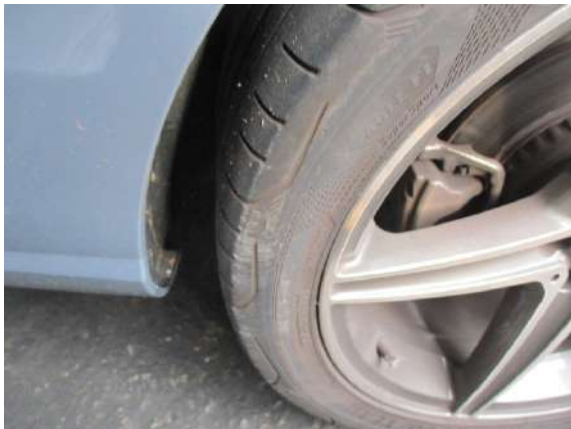
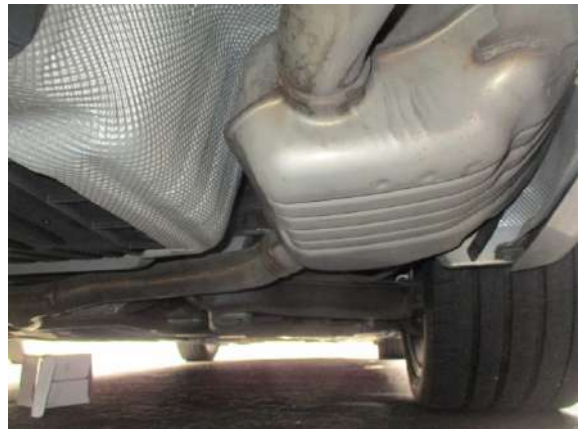
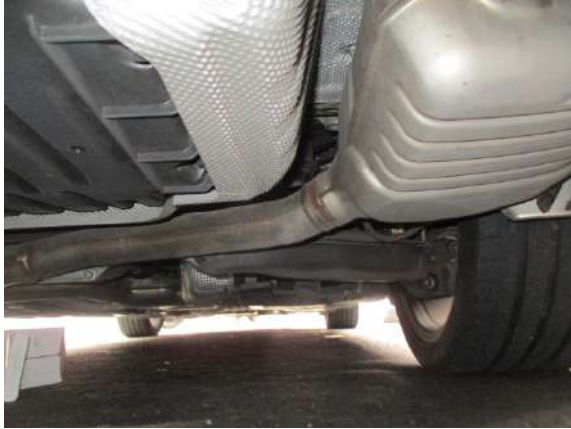
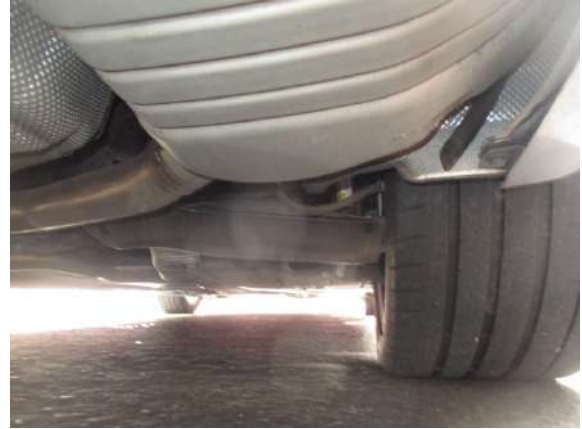
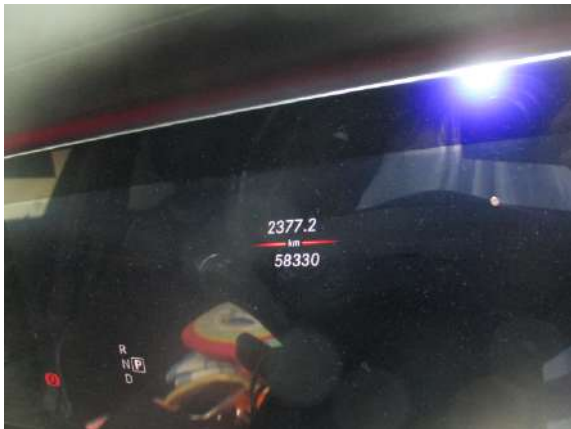
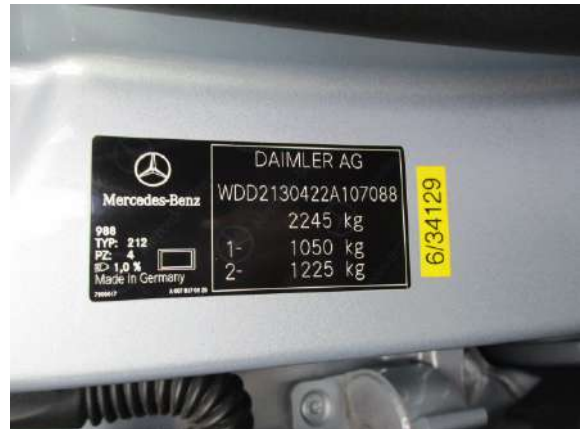
4. Description of Damages				
	THE VEHICLE SUSTAINED DAMAGES AT THE REAR O/S PORTION.

A) THE INSPECTION WAS CONDUCTED ON A "WITHOUT PREJUDICE" BASIS. B) THE REPAIR ESTIMATE WAS NOT PRESENTED AT THE TIME OF INSPECTION. THE REPAIRER WAS TOLD TO PREPARE THE ESTIMATE. C) ENCLOSED PLEASE FIND DAMAGED VEHICLE PHOTOGRAPHS. D) THE ESTIMATED REPAIR COST OF THE DAMAGED VEHICLE IS IN THE REGION OF \$3,000-\$4,000			
5b. Estimate Days of Repair				
	ESTIMATED NORMAL PERIOD FOR REPAIR:		5 Working Days
