Your Ref: BMW M5
(chassis number WBSJF02010GA04853)
Our Ref : CI/TP21010277/D

05 October 2021

INSPECTION REPORT OF AN UNREGISTERED BMW M5 MOTOR CAR WITH CHASSIS NUMBER WBSJF02010GA04853

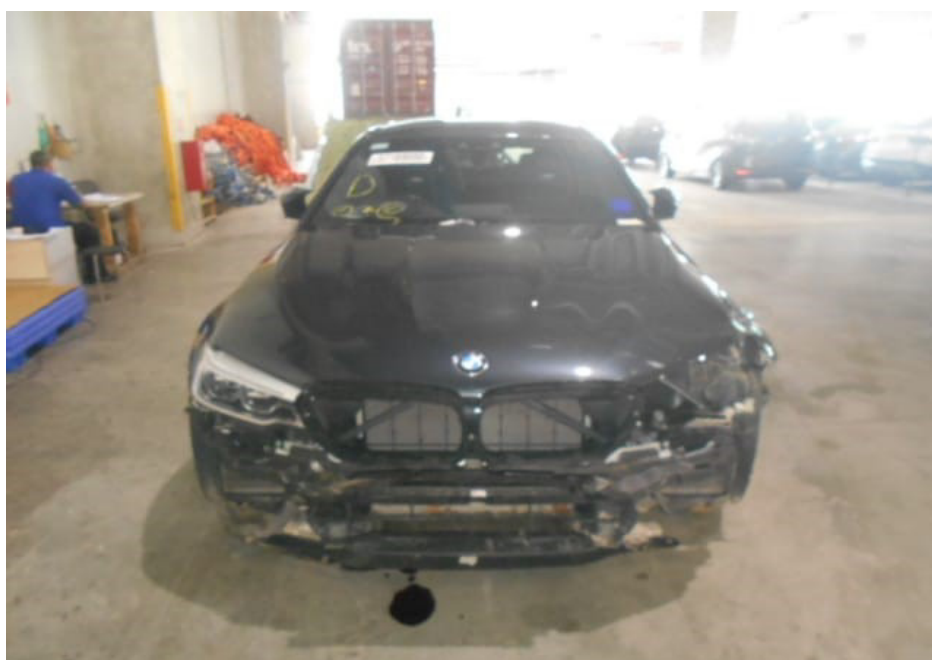
3. The photographs provided to me had showed damage to the front left portion and rear left portion of the Motor Car. The front left headlamp, radiator grilles, front bumper and all its related parts and attachments like the front bumper centre lower grille, front bumper left lower grille, front bumper right lower grille and front bumper sensors were damaged/missing/dislodged. Other than this, I had also observed damage to the front left fender and front left wheel rim. The front left tyre was further observed to have slipped out from the front left wheel rim.

4. The orientation of the front left wheel and front right wheel suggest damage to the front left undercarriage parts of the Motor Car. The front left lower arm, front left shock absorber, front left knuckle arm and front left steering tie rod end amongst others are undercarriage parts that may be possibly damaged. Accumulation of fluid on the ground at the front of the Motor Car suggest possible damage to the Motor Car's oil cooler.

Photo 1 shows the frontal body of the Motor Car (photograph provided to me). The Motor Car was observed to have sustained damage at its front left portion. The front left headlamp, radiator grilles, front bumper and all its related parts and attachments like the front bumper centre lower grille, front bumper left lower grille, front bumper right lower grille and front bumper sensors were damaged/missing/dislodged. Accumulation of fluid on the ground at the front of the Motor Car suggest possible damage to the Motor Car's oil cooler.

24. The body parts at the front left portion, rear left portion and the undercarriage parts at the front left wheel of the Motor Car were visually examined and it was noted that the repair/restoration works carried out to the damaged area of the Motor Car (refer to photograph 1, 2, 4 and 5 above) were reasonably adequate and in order.

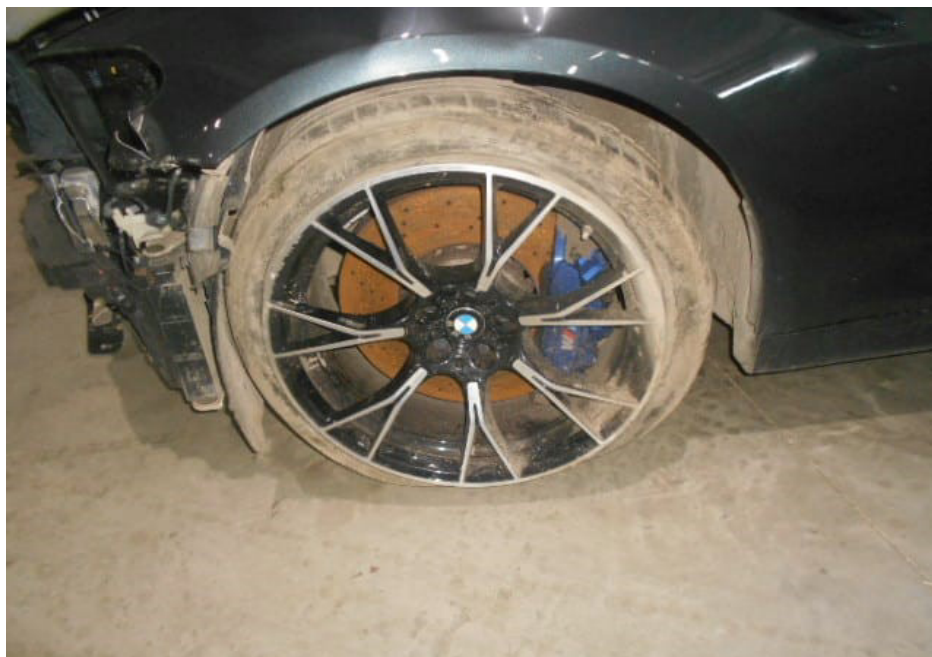
Photo 2 shows the damaged front left wheel and front left fender of the Motor Car (photograph provided to me). The front left tyre had slipped out from the front left wheel rim. Undercarriage parts at the front left wheel of the Motor Car like the front left lower arm, front left shock absorber, front left knuckle arm and front left steering tie rod end amongst others were also possibly damaged given that the front wheels of the Motor Car were orientated in different directions (refer to photograph 4 and 6 below).

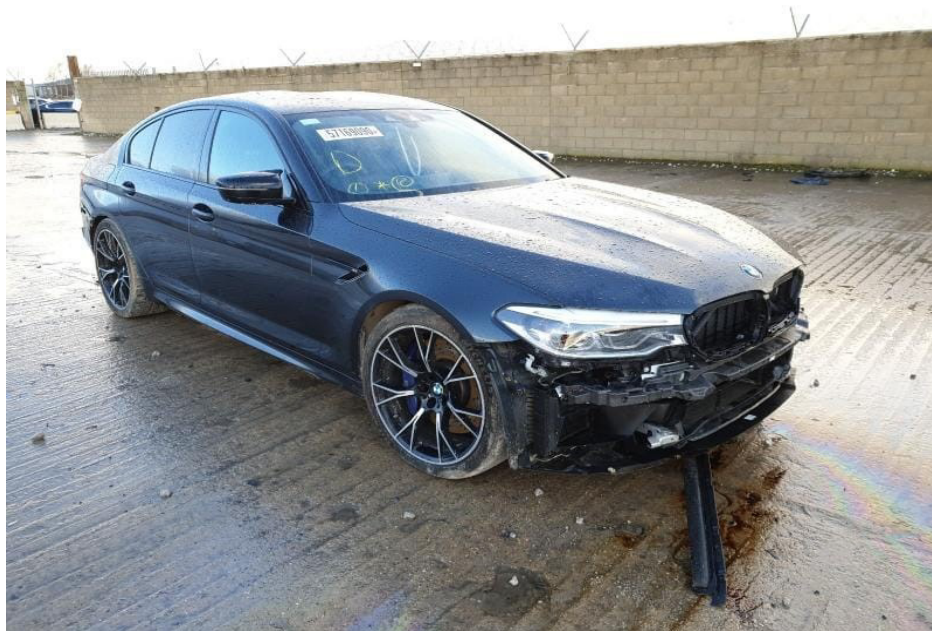
Photo 3 shows the front right body of the Motor Car (photograph provided to me). The Motor Car's right side portion was observed to be without any physical damage. The airbags of the Motor Car were also not deployed as seen from the photographs that were provided to me.

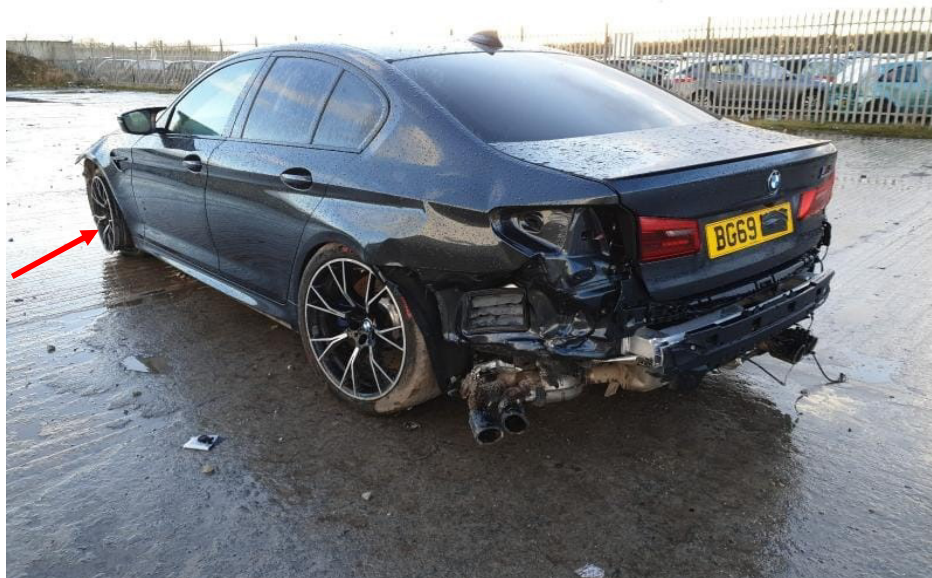
5. With regard to the rear left portion, I had observed damage to the rear left fender, rear left exhaust muffler, rear left exhaust heat shield, rear bumper reinforcement and rear bumper sponge amongst others. The rear left taillamp, rear bumper and all its related parts and attachments like the rear bumper reflectors, rear bumper lower garnish and rear bumper sensors amongst others were damaged/dislodged/missing.
6. The airbags of the Motor Car were not deployed as seen from the photographs that were provided to me. See photo 1 – 6 below.

Photo 4 shows a general view of the rear left body of the Motor Car (photograph provided to me). Apart for the front left portion, I had also observed damage to the rear left portion of the Motor Car. The rear left taillamp, rear bumper and all its related parts and attachments like the rear bumper reflectors, rear bumper lower garnish and rear bumper sensors amongst others were observed to be damaged/dislodged/missing. The front left wheel (arrowed) was seen to be orientated in a straight position whereas the front right wheel (refer to photograph 6 below) was oriented slightly towards the left.

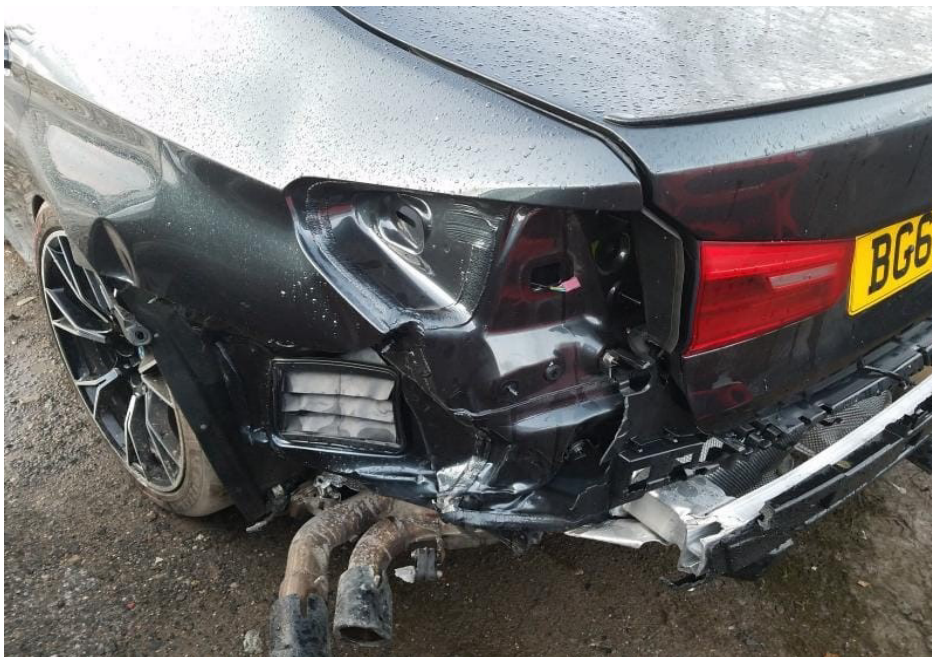
Photo 5 shows a closer view of the damage to the rear left portion of the Motor Car (photograph provided to me). Body parts damaged include the rear left fender, rear left exhaust muffler, rear left exhaust heat shield, rear bumper reinforcement and rear bumper sponge amongst others.

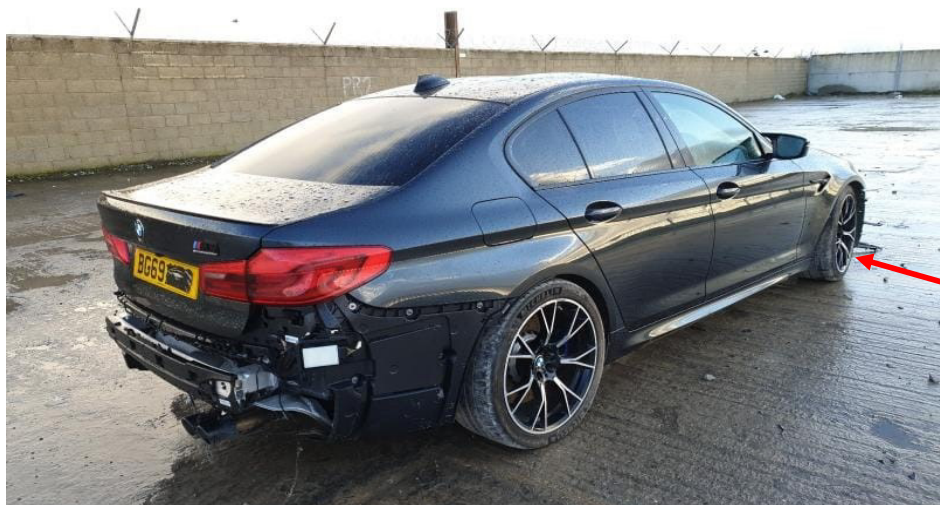
Photo 6 shows the rear right body of the Motor Car (photograph provided to me). The Motor Car's right side portion was observed to be without any physical damage. The front right wheel (arrowed) was seen to be orientated slightly towards the left whereas the front left wheel (refer to photograph 4 above) was orientated in a straight position.

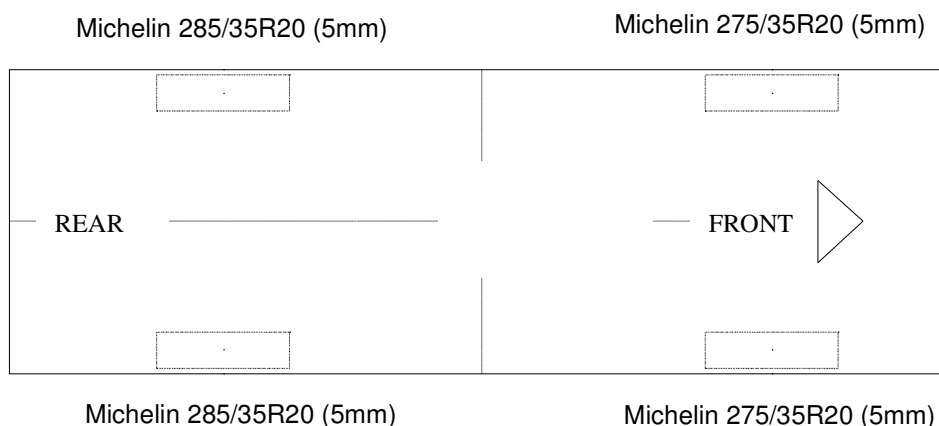
10. It was fitted with 20inch sport wheel rims that were wrapped with tyres that were observed to be of serviceable condition. The tyres were also sufficiently inflated for vehicular operation. The tyre brand, tyre size and approximate remaining tread depth of the 4 tyres of the Motor Car were recorded as follows: -

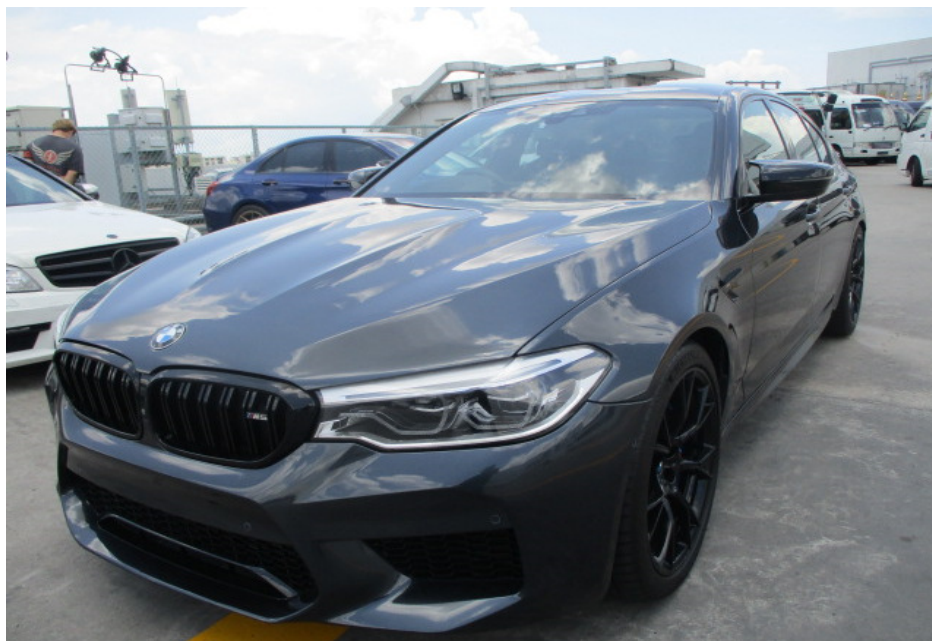
Photo 7 shows a general view of the front left body of the Motor Car at the time of my inspection. The Motor Car was observed to be in a relatively good general condition with no loose exterior fittings observed. The body parts at the front left portion of the Motor Car were visually examined and it was observed that the repair/restoration works carried out to the damaged area of the Motor Car (refer to photograph 1 & 2 above) were reasonably adequate and in order.

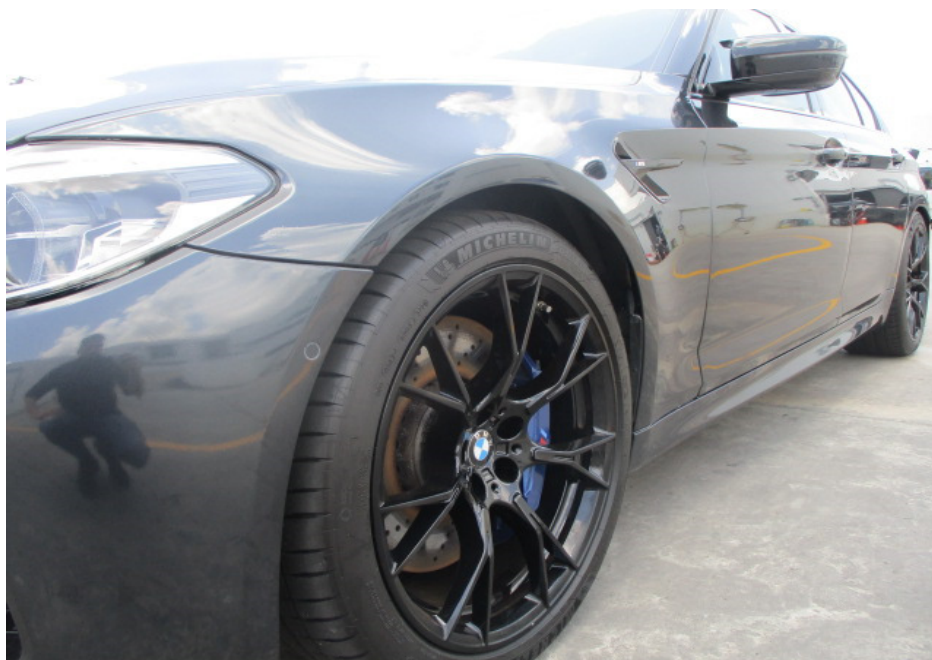
Photo 8 shows a closer view of the Motor Car's front bumper, front left headlamp, front left fender and front left wheel rim. The body parts at the front left portion of the Motor Car were visually examined and it was observed that the repair/restoration works carried out to the damaged area of the Motor Car (refer to photograph 2 above) were reasonably adequate and in order.

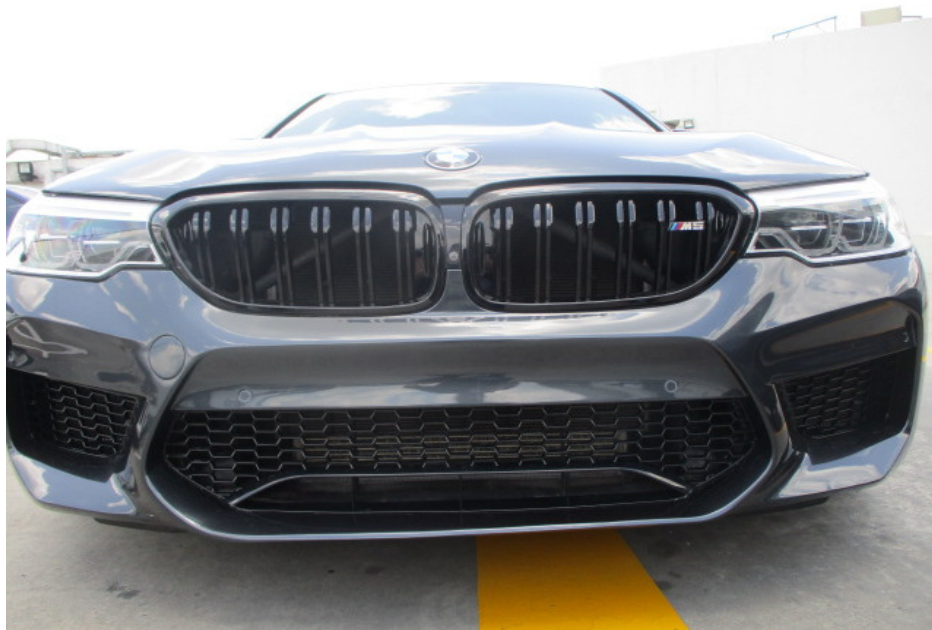
Photo 9 shows a closer view of the Motor Car's front bumper, front bumper centre lower grille, front bumper left lower grille, front bumper right lower grille and radiator grilles. The body parts at the frontal portion of the Motor Car were visually examined and it was observed that the repair/restoration works carried out to the damaged area of the Motor Car (refer to photograph 1 & 3 above) were reasonably adequate and in order.

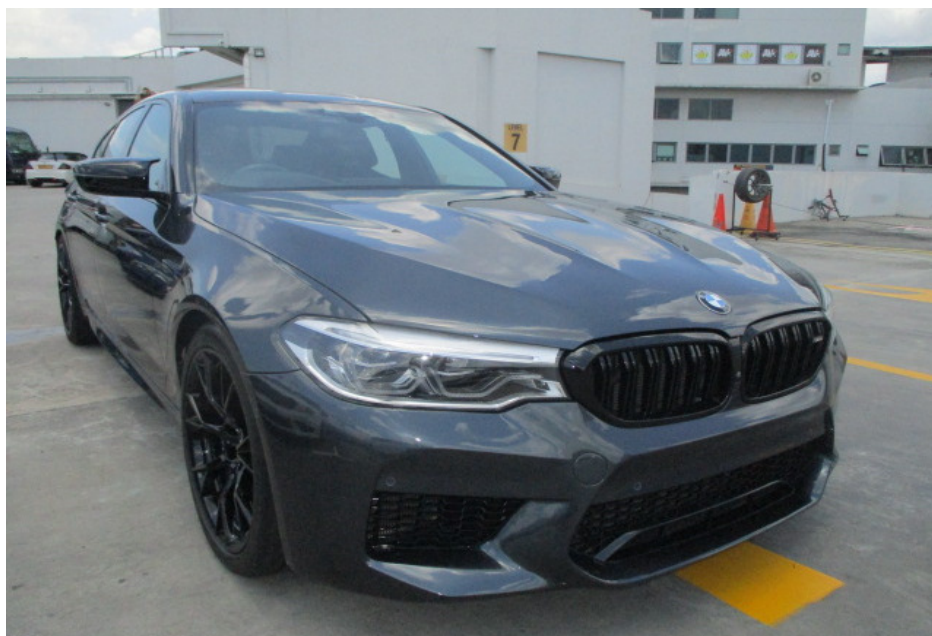
Photo 10 shows a general view of the front right body of the Motor Car at the time of my inspection. The Motor Car was observed to be in a relatively good general condition with no loose exterior fittings observed. The body parts at the frontal portion of the Motor Car were visually examined and it was observed that the repair/restoration works carried out to the damaged area of the Motor Car (refer to photograph 1 & 3 above) were reasonably adequate and in order.

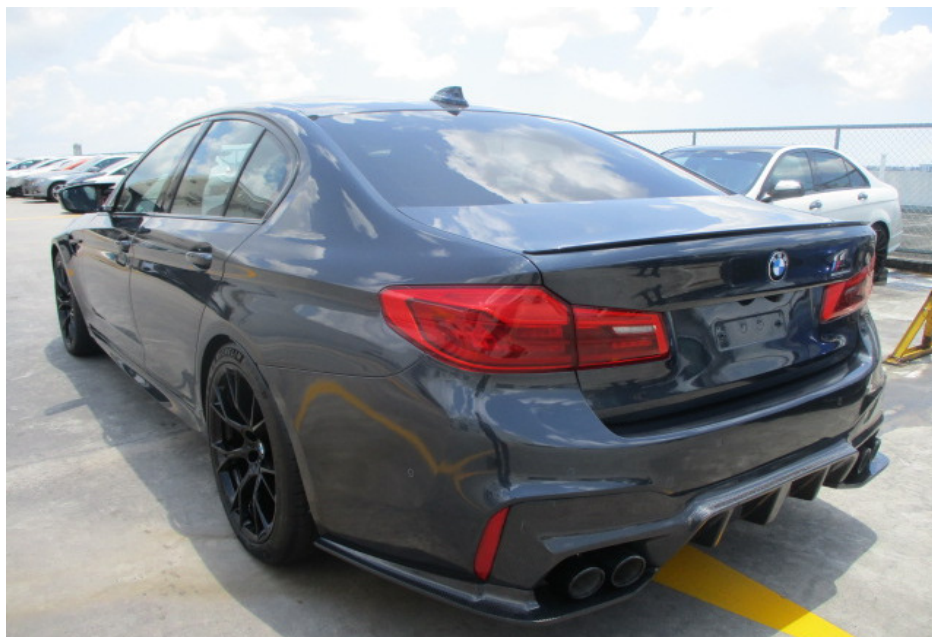
Photo 11 shows a general view of the rear left body of the Motor Car at the time of my inspection. The Motor Car was observed to be in a relatively good general condition with no loose exterior fittings observed. The body parts at the rear left portion of the Motor Car were visually examined and it was observed that the repair/restoration works carried out to the damaged area of the Motor Car (refer to photograph 4 & 5 above) were reasonably adequate and in order.

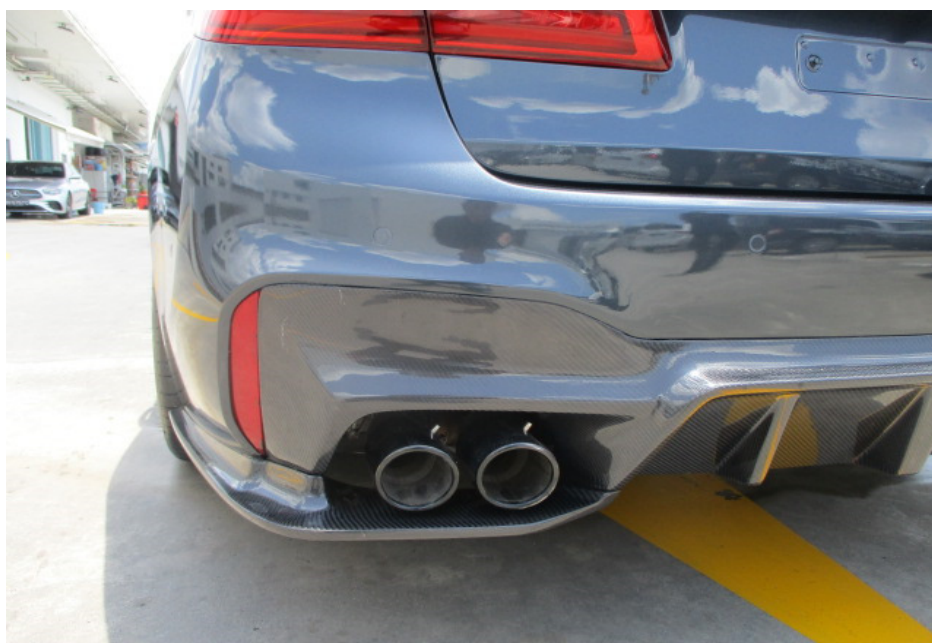
Photo 12 shows a closer view of the Motor Car's rear bumper, rear bumper left reflector, rear bumper lower garnish and rear left exhaust muffler. The body parts at the rear left portion of the Motor Car were visually examined and it was observed that the repair/restoration works carried out to the damaged area of the Motor Car (refer to photograph 4 & 5 above) were reasonably adequate and in order.

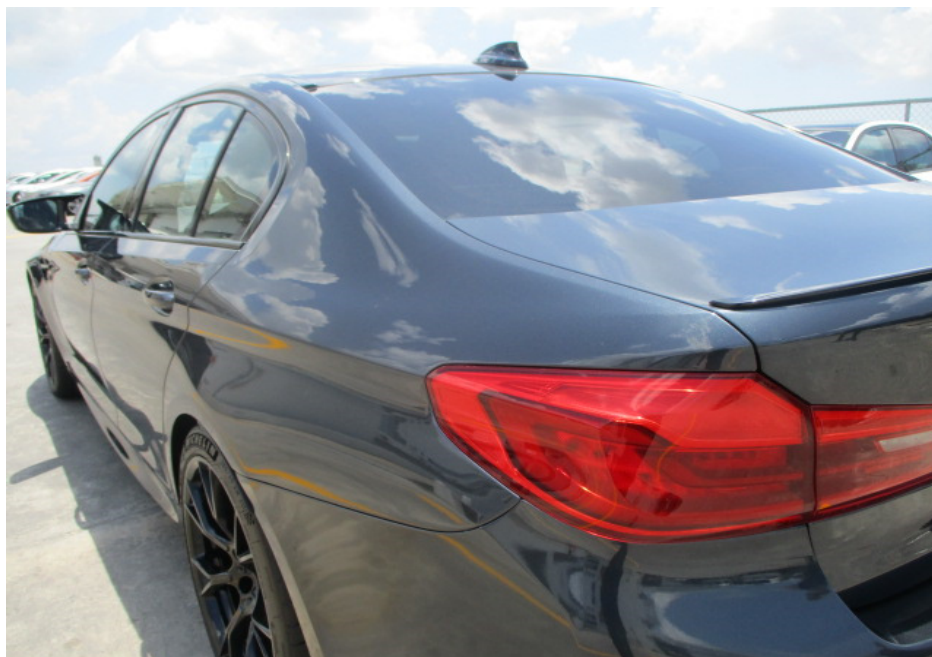
Photo 13 shows a closer view of the Motor Car's rear bumper, rear left taillamp and rear left fender. The body parts at the rear left portion of the Motor Car were visually examined and it was observed that the repair/restoration works carried out to the damaged area of the Motor Car (refer to photograph 4 & 5 above) were reasonably adequate and in order.

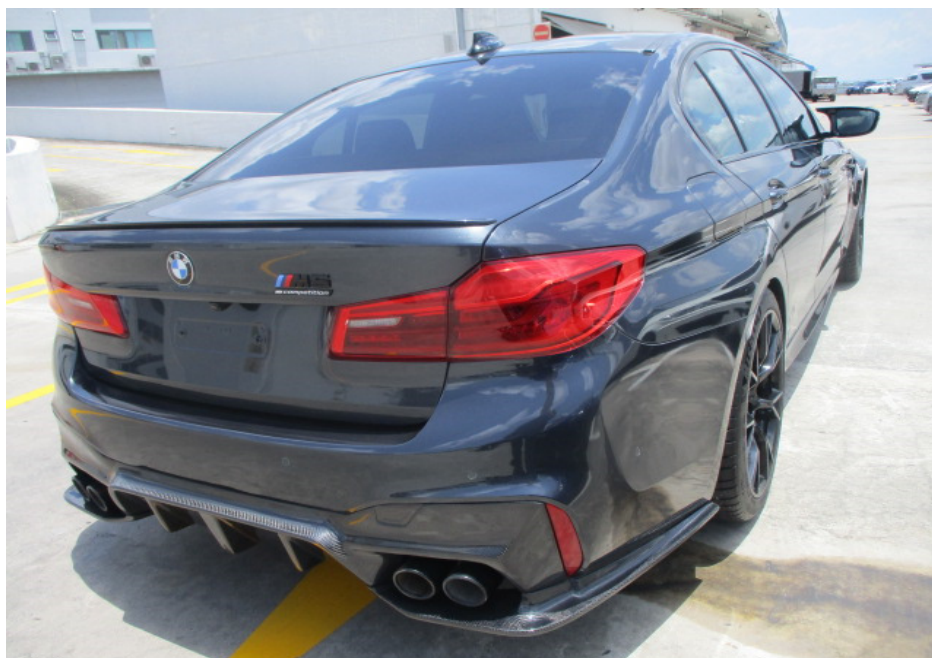
Photo 14 shows a general view of the rear right body of the Motor Car at the time of my inspection. The Motor Car was observed to be in a relatively good general condition with no loose exterior fittings observed. The body parts at the rear portion of the Motor Car were visually examined and it was observed that the repair/restoration works carried out to the damaged area of the Motor Car (refer to photograph 4 & 6 above) were reasonably adequate and in order.

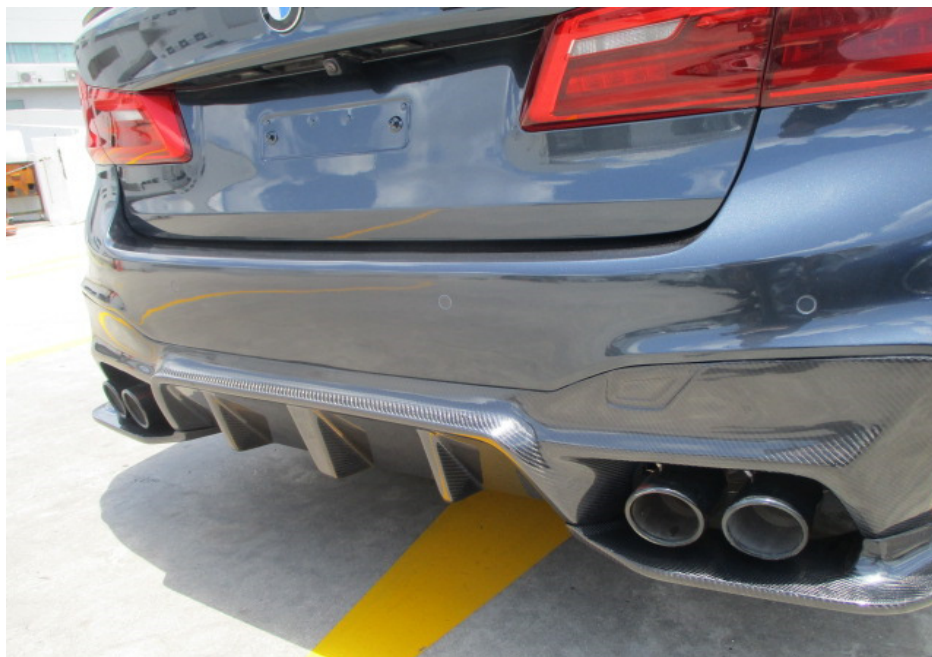
Photo 15 shows a closer view of the Motor Car's rear bumper, rear bumper lower garnish, rear bumper sensors and rear right exhaust muffler. The body parts at the rear portion of the Motor Car were visually examined and it was observed that the repair/restoration works carried out to the damaged area of the Motor Car (refer to photograph 4 & 6 above) were reasonably adequate and in order.

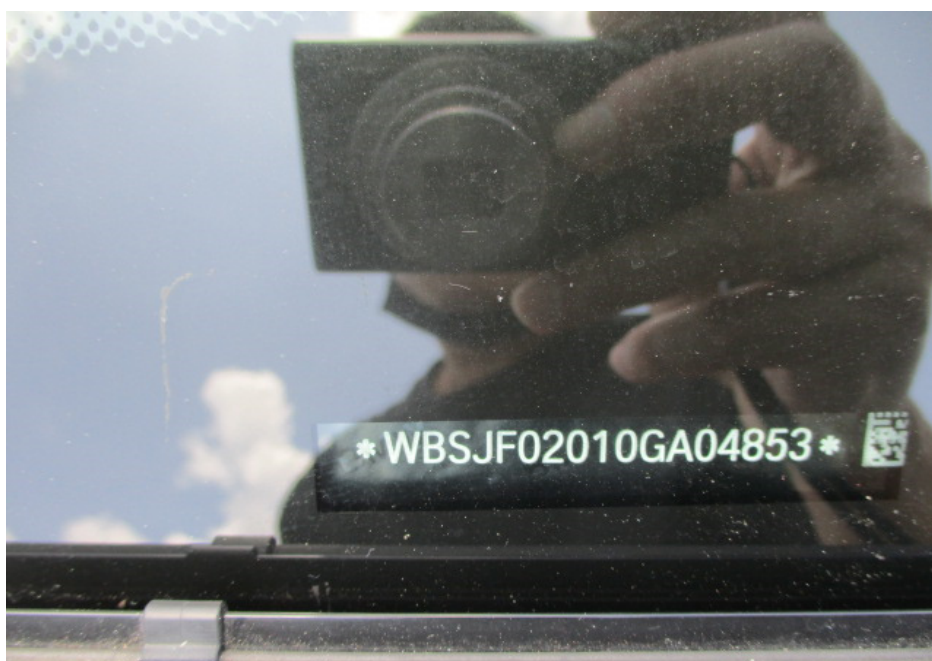
Photo 16 shows the chassis number of the Motor Car. The chassis number recorded was WBSJF02010GA04853.

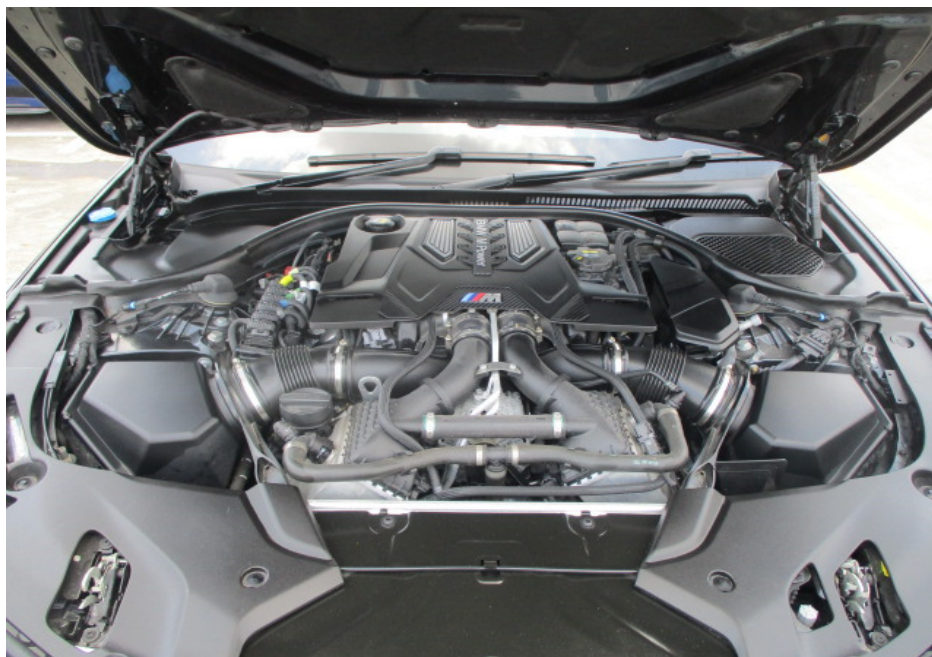
Photo 17 shows a general view of the engine compartment of the Motor Car at the time of my inspection. The various parts and components inside the engine compartment were all observed to be intact and properly fitted. There was also no sign(s) or indication(s) of fluid leak and/or fluid stain found inside the engine compartment.

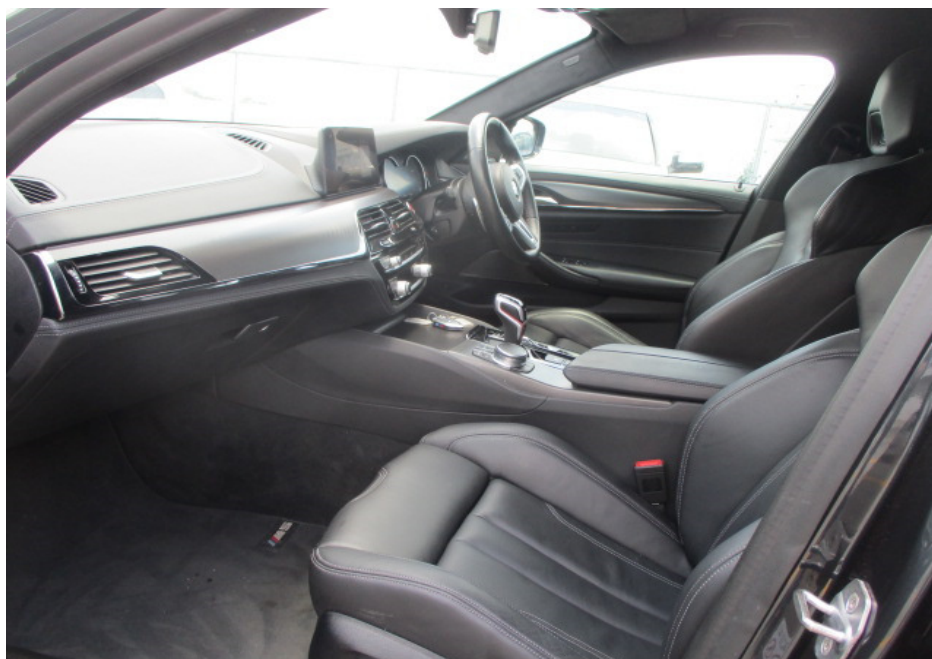
Photo 18 shows the interior compartment of the Motor Car at the time of my inspection. The various parts and components, trims, carpet, and upholstery inside the interior compartment were all observed to be intact and properly fitted.

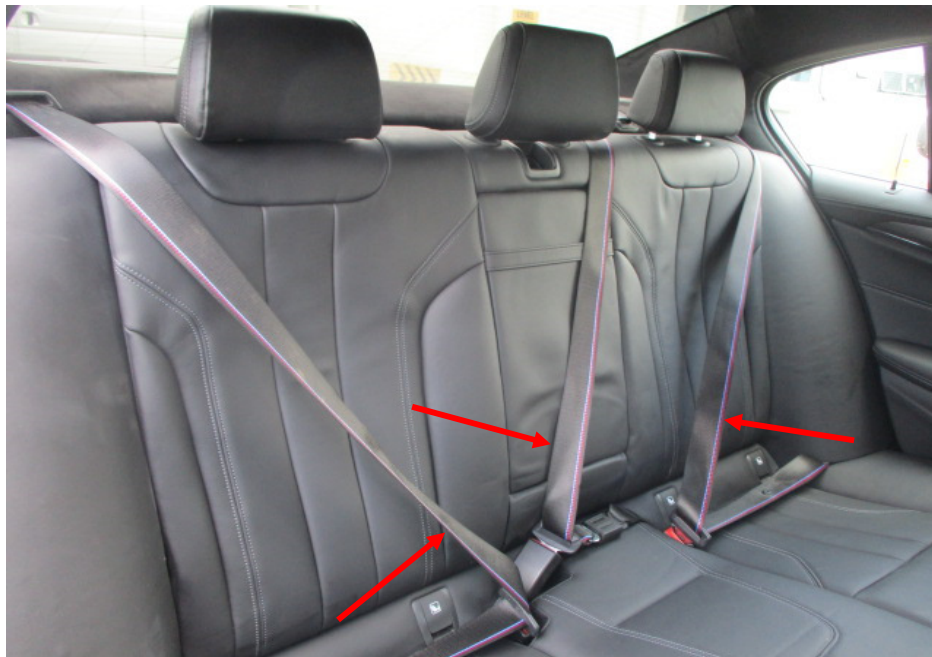
Photo 19 shows the rear seats of the Motor Car. All the seats of the Motor Car were secured via seat rails to the floorboard. They were also fitted with a retractable seat belt reel and a pre-tensioner. The seat belts (arrowed) were tested and were able to be fastened into the respective pre-tensions that were fitted on the side of each individual seat.

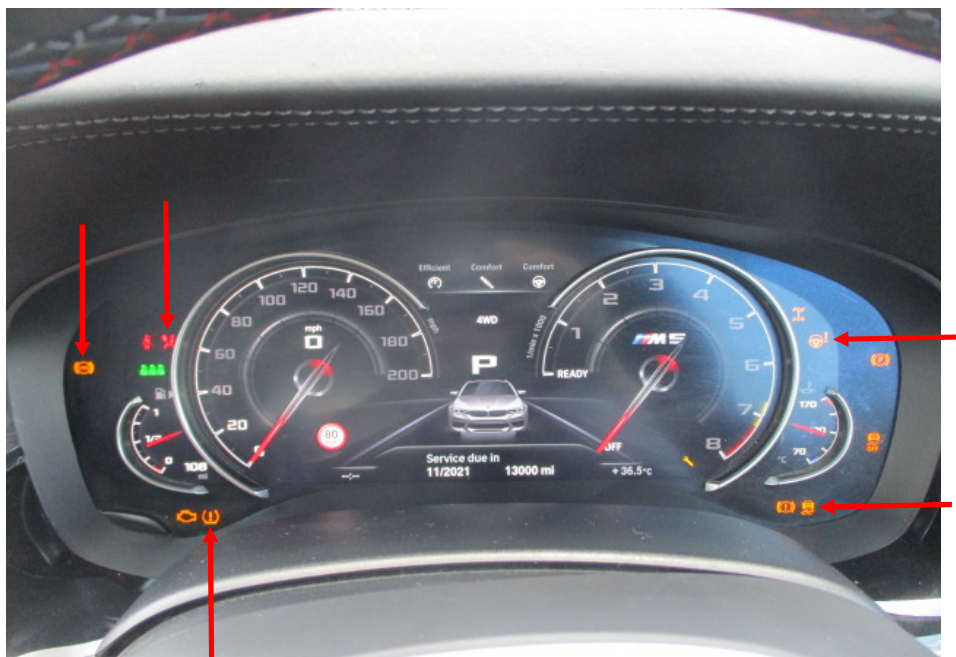
Photo 20 shows the warning lights for the various electronic safety features appearing on the instrument panel of the Motor Car during its self-test when the engine is cranked, in particular the ABS, SRS, IAS, TPM and DSC lights (arrowed).

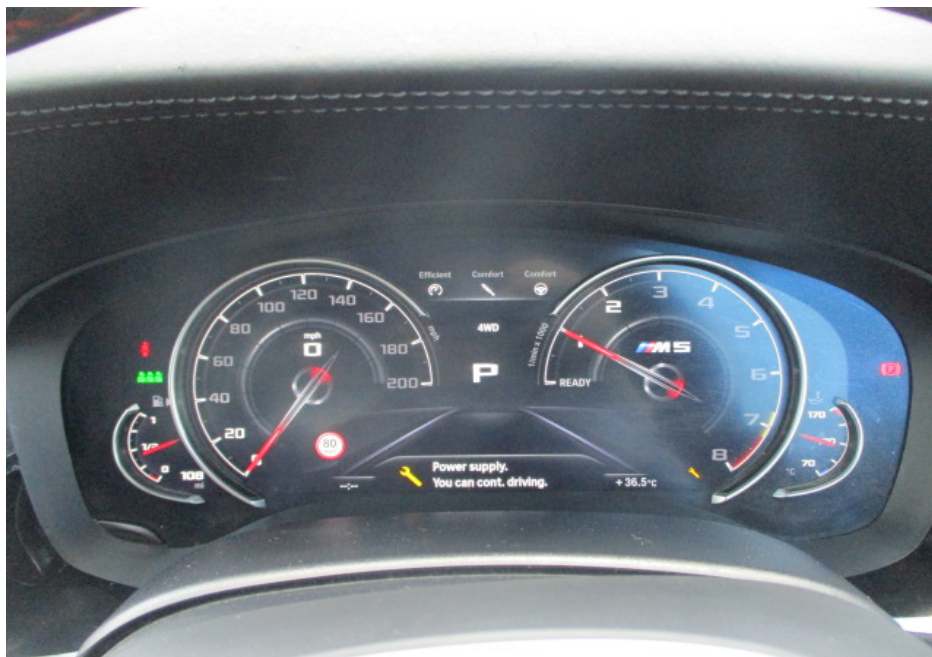
Photo 21 shows the respective warning lights no longer illuminated, indicating that there is no fault detected to the ABS, SRS, IAS, TPM and DSC systems of the Motor Car during the self-test. These electronic systems were hence in working condition at the time of my inspection.

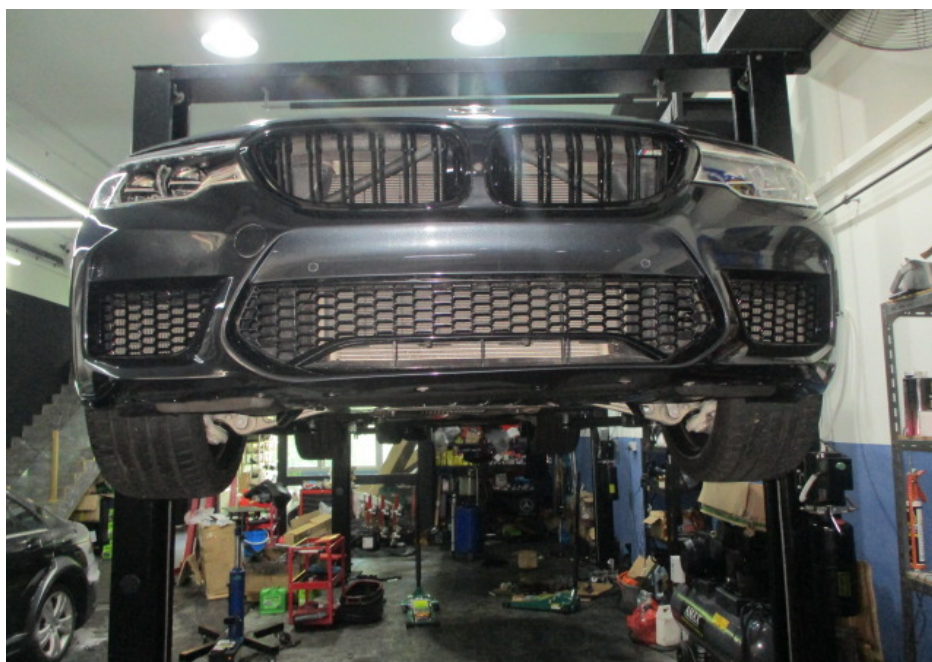
Photo 22 shows the Motor Car hoisted up for checks on its undercarriage. There was no sign(s) or indication(s) of fluid leakage and/or fluid stain(s) on the underside of the Motor Car. The undercarriage components of the Motor Car were also all observed to be intact and secured in an appropriate manner.

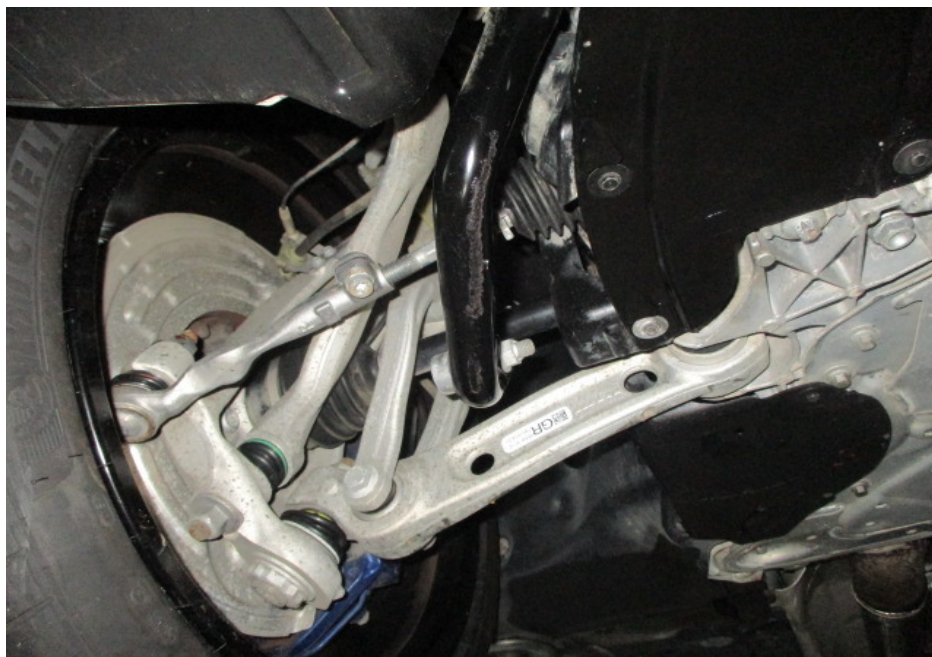
Photo 23 shows the various undercarriage components at the front right wheel of the Motor Car. The mechanical components, control arms and linkages were all found to be intact and secured in an appropriate manner. I also did not observe any fluid leak and/or fluid stain on the underside of the Motor Car.

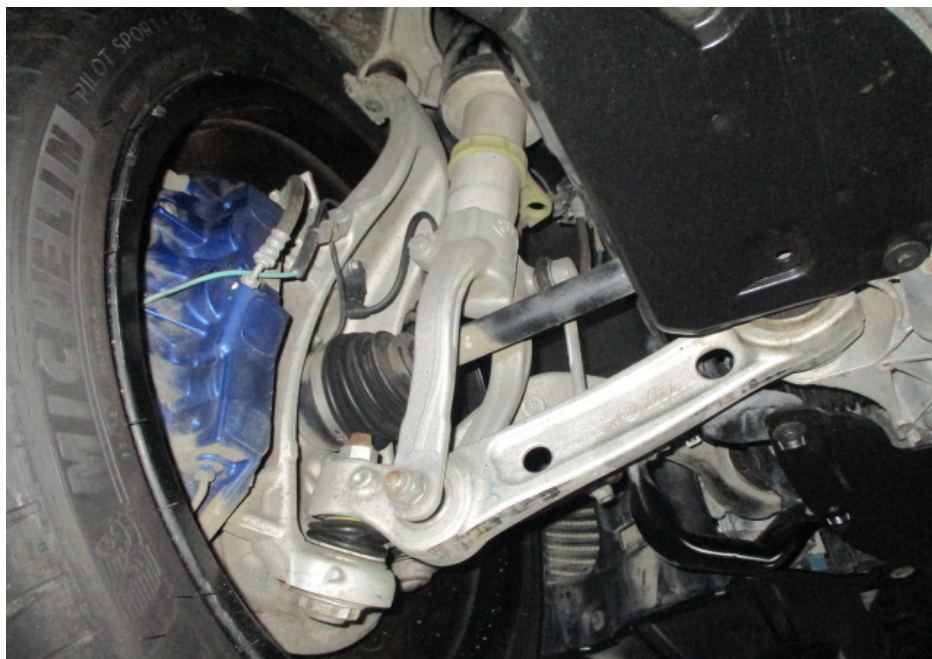
Photo 24 shows the various undercarriage components at the front left wheel of the Motor Car. The mechanical components, control arms and linkages were all found to be intact and secured in an appropriate manner. I also did not observe any fluid leak and/or fluid stain on the underside of the Motor Car.

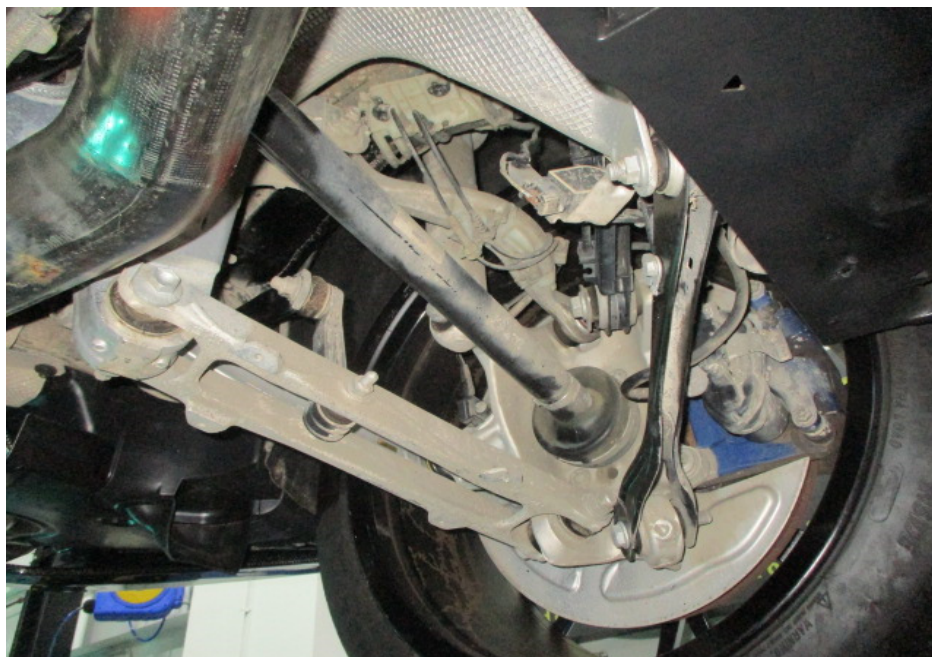
Photo 25 shows the various undercarriage components at the rear left wheel of the Motor Car. The mechanical components, control arms and linkages were all found to be intact and secured in an appropriate manner.

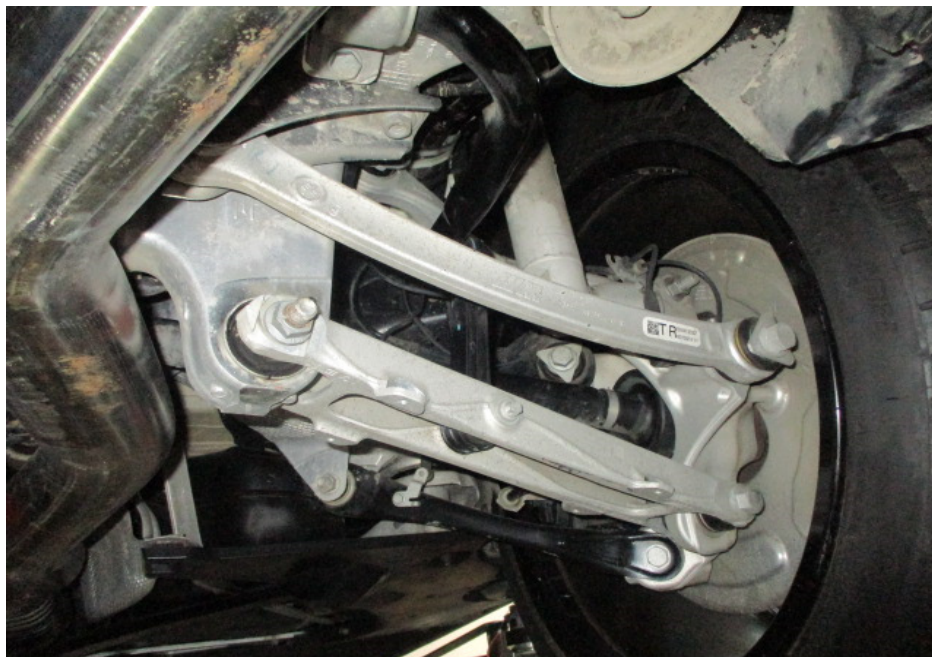
Photo 26 shows the various undercarriage components at the rear right wheel of the Motor Car. The mechanical components, control arms and linkages were all found to be intact and secured in an appropriate manner. I also did not observe any fluid leak and/or fluid stain on the underside of the Motor Car.

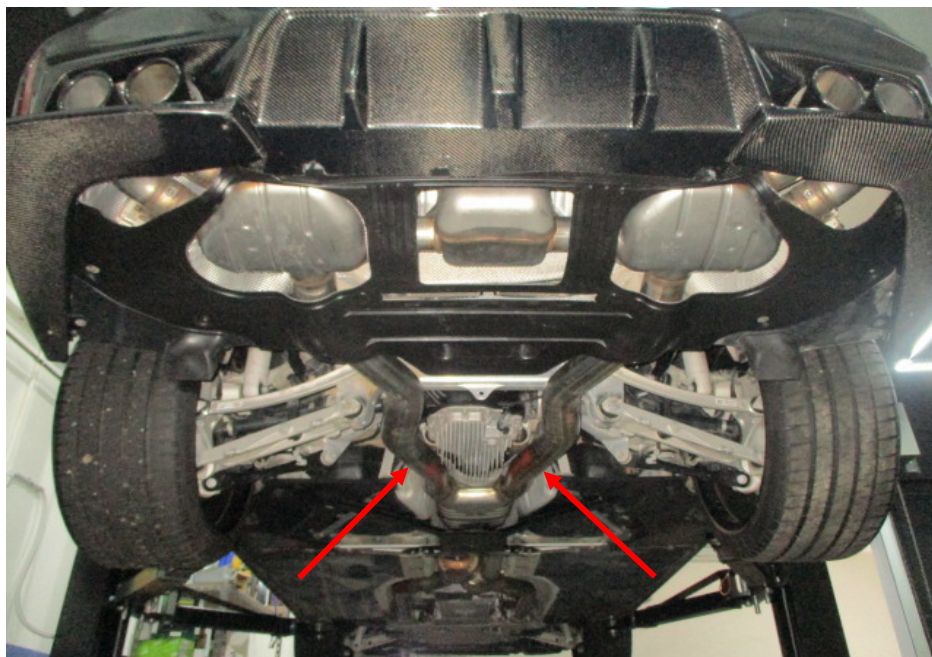
Photo 27 shows the rear section of the Motor Car's exhaust system. My examination of the Motor Car's exhaust system revealed no sign(s) or indication(s) of any cut or weld marks along its exhaust pipes (arrowed), on its rear mufflers, on its centre resonator boxes and on its catalytic converters.

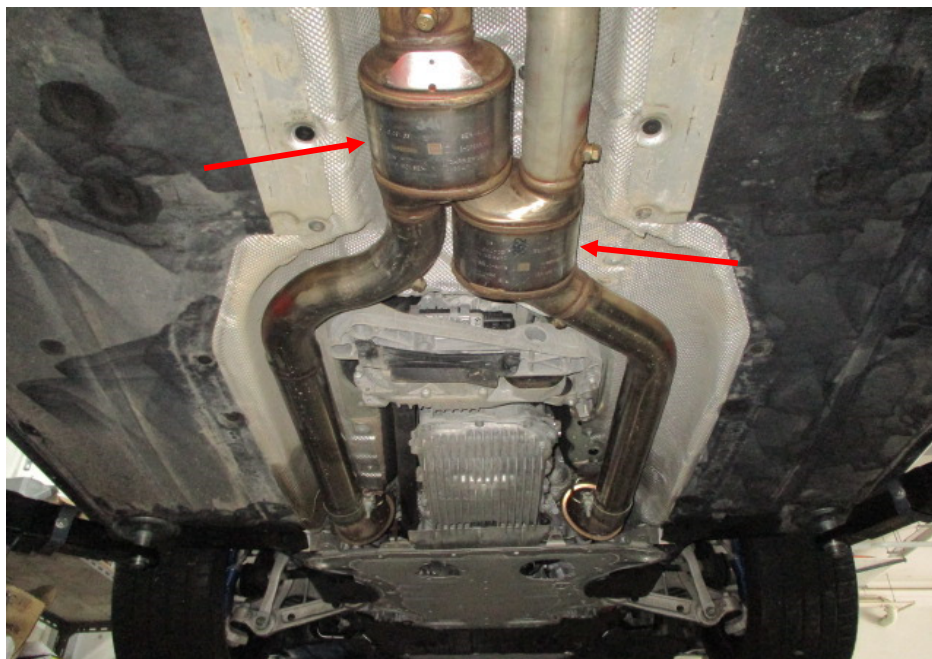
Photo 28 shows the front section of the Motor Car's exhaust system. My examination of the Motor Car's exhaust system revealed no sign(s) or indication(s) of any cut or weld marks along its exhaust pipes, on its rear mufflers, on its centre resonator boxes (arrowed) and on its catalytic converters.

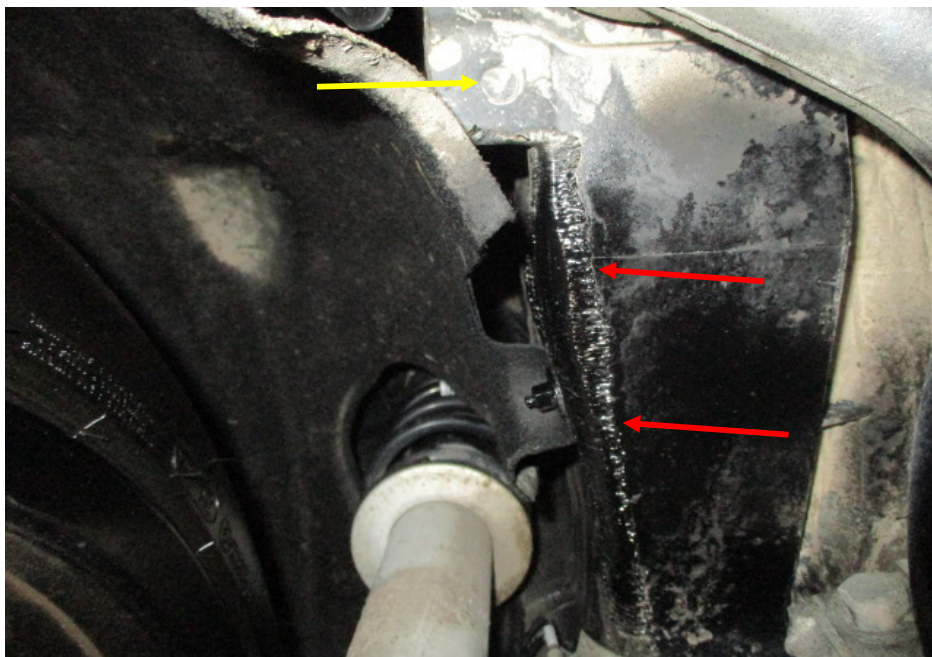
Photo 29 shows the chassis/structural body at the underside rear left of the Motor Car. I did not find any weld marks other than original spot weld marks (yellow arrow) on the chassis/structural body of the Motor Car. The original factory sealant (red arrow) at the joints along the chassis/structural body was also untouched, indicating no work was done on the chassis/structural body of the Motor Car and that the chassis/structural body was originally fitted.

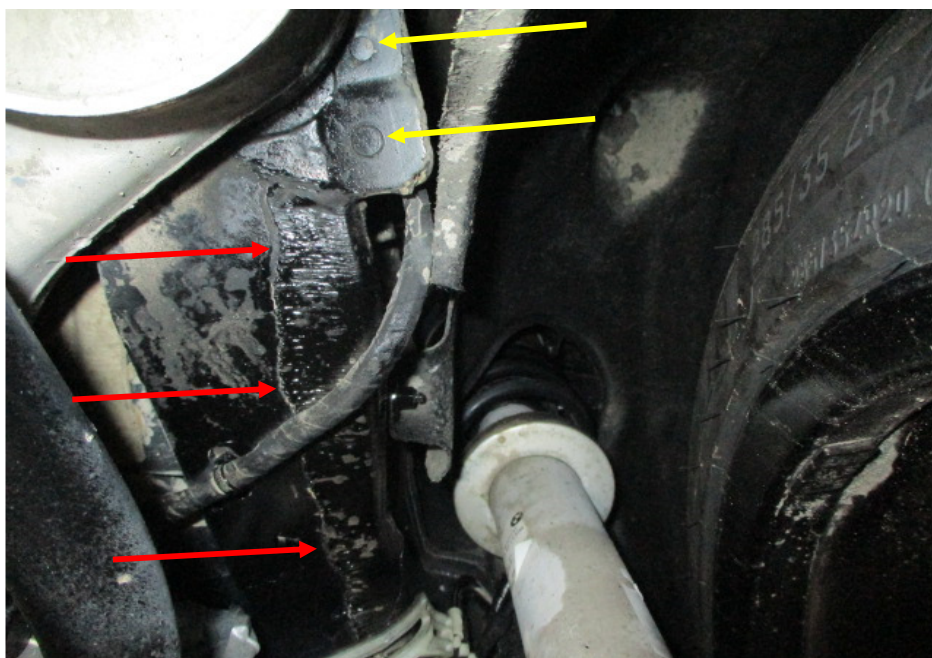
Photo 30 shows the chassis/structural body at the underside rear right of the Motor Car. I did not find any weld marks other than original spot weld marks (arrowed) on the chassis/structural body of the Motor Car, indicating no work was done on the chassis/structural body of the Motor Car and that the chassis/structural body was originally fitted.

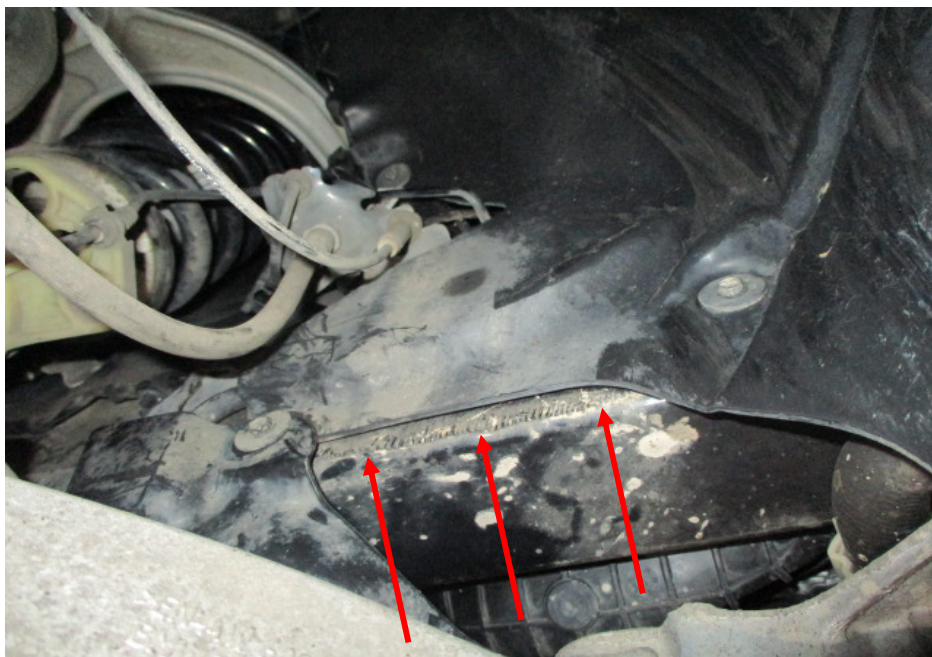
Photo 31 shows the chassis/structural body at the underside front right of the Motor Car. The original factory sealant (arrowed) at the joints along the chassis/structural body was observed to be untouched. In general, I had found no work was carried out on the chassis/structural body of the Motor Car. The chassis/structural body of the Motor Car was originally fitted.
