Your Ref: BMW M5
(chassis number WBSJF02010GA04853)
Our Ref : CI/TP21010277/D

05 October 2021

INSPECTION REPORT OF AN UNREGISTERED BMW M5 MOTOR CAR WITH CHASSIS NUMBER WBSJF02010GA04853

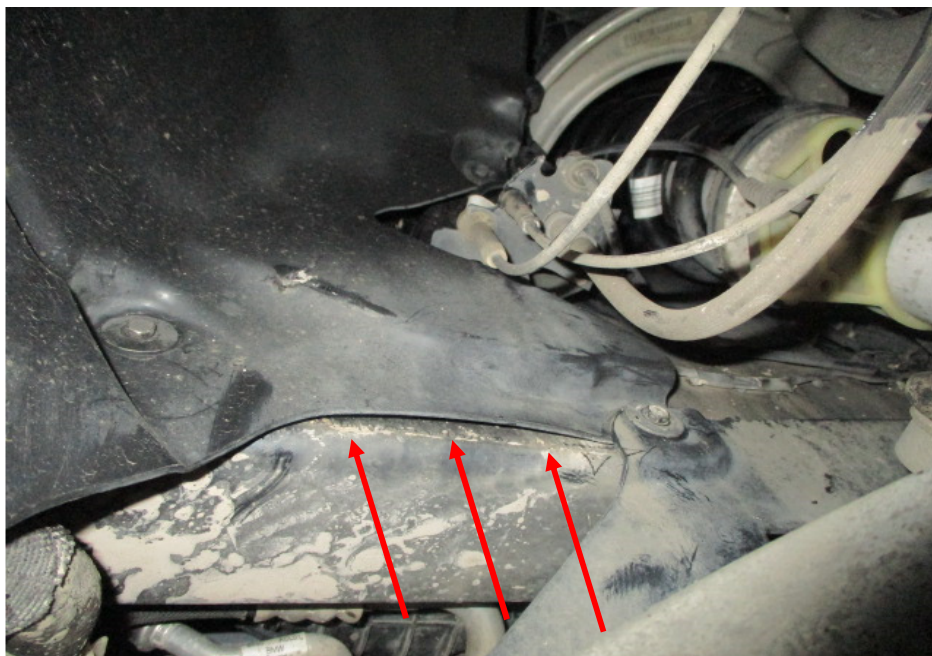
Photo 32 shows the chassis/structural body at the underside front left of the Motor Car. The original factory sealant (arrowed) at the joints along the chassis/structural body was observed to be untouched. In general, I had found no work was carried out on the chassis/structural body of the Motor Car. The chassis/structural body of the Motor Car was originally fitted.

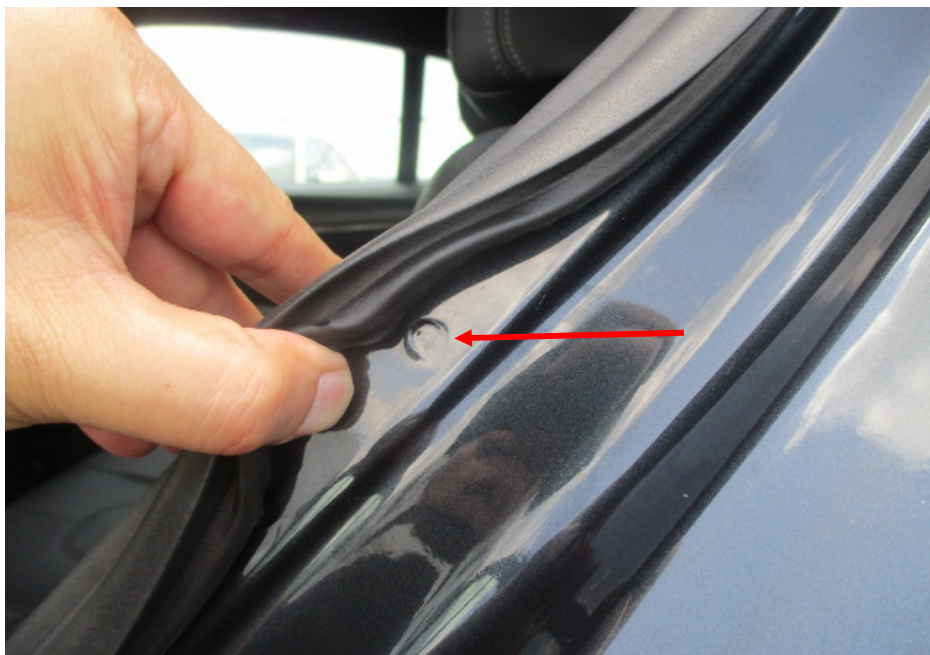
Photo 33 shows the left side “C” pillar of the Motor Car. I did not find any weld marks other than original spot weld marks (arrowed) on the left side “C” pillar of the Motor Car which, indicates that there was no re-welding works carried out. In general, I had found all the non-detachable body panels of the Motor Car to be originally fitted at the time of my inspection.

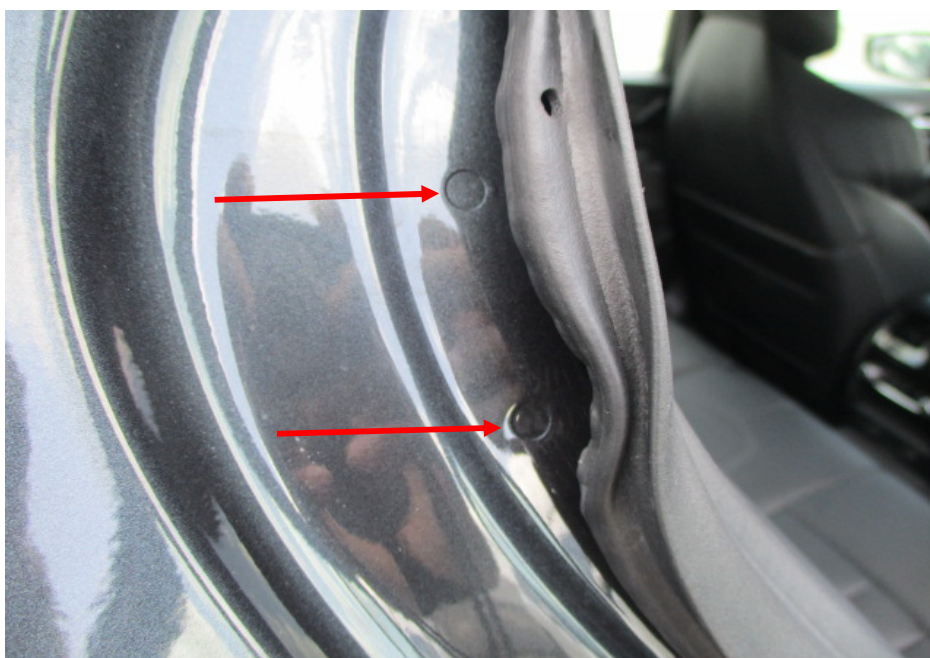
Photo 34 shows the right side “C” pillar of the Motor Car. I did not find any weld marks other than original spot weld marks (arrowed) on the right side “C” pillar of the Motor Car which, indicates that there was no re-welding works carried out. In general, I had found all the non-detachable body panels of the Motor Car to be originally fitted at the time of my inspection.

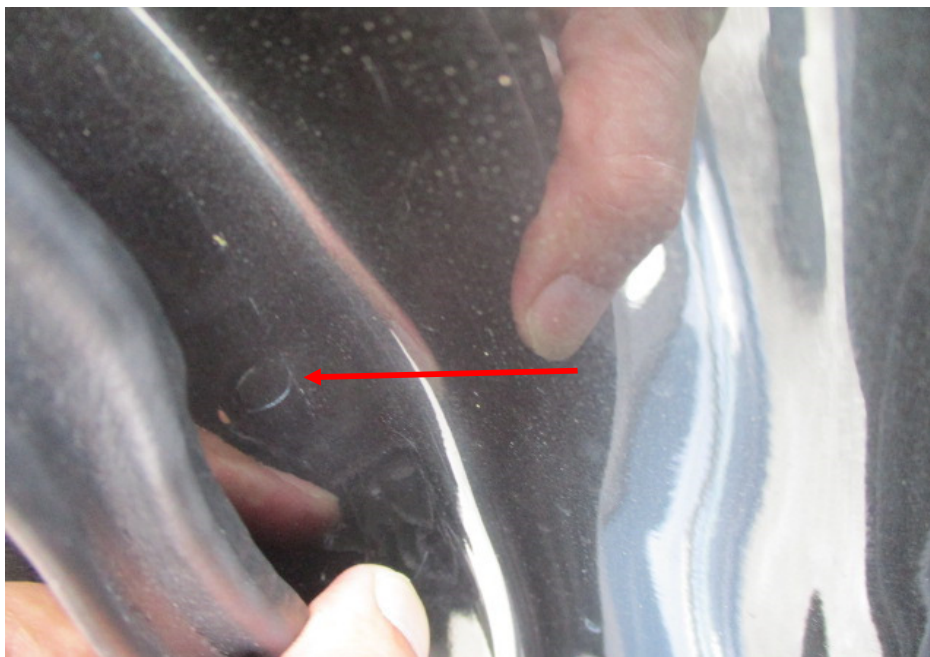
Photo 35 shows the right side "A" pillar of the Motor Car. I did not find any weld marks other than original spot weld marks (arrowed) on the right side "A" pillar of the Motor Car which, indicates that there was no re-welding works carried out. In general, I had found all the non-detachable body panels of the Motor Car to be originally fitted at the time of my inspection.
