Your Ref: BMW 840i  
(chassis number WBAGV22010CE10006)  
Our Ref : CI/TP21010278/D

05 October 2021

**Stockport Private Limited**  
20 Sin Ming Lane #03-61  
Midview City  
Singapore 573968

**INSPECTION REPORT OF AN UNREGISTERED BMW 840i MOTOR CAR  
WITH CHASSIS NUMBER WBAGV22010CE10006**

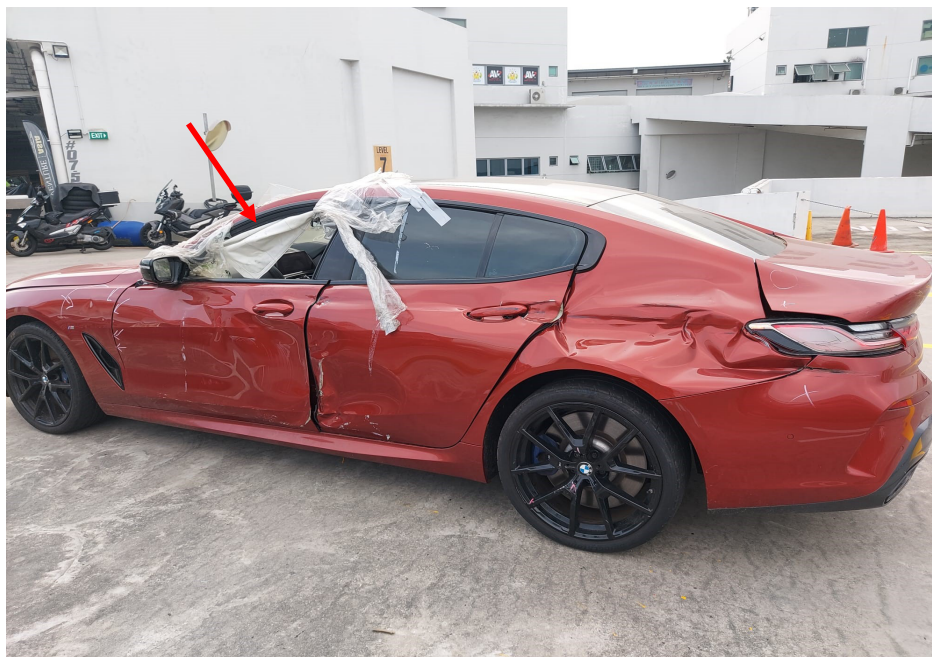
3. The photographs provided to me had showed damage to the entire left side portion of the Motor Car. Body parts damaged include the rear bumper, rear bootlid, rear left taillamp, rear left fender, rear left wheel rim, rear left door, rear left door lock, rear left door outer handle cover, front left door, front left fender, front left wheel rim and front bumper amongst others.
4. Apart for the left side portion, there was no physical damage observed to other areas of the Motor Car. The left side curtain airbag was deployed as seen from the photographs that were provided to me. See photo 1 – 6 below.

**Photo 1** shows the left side portion of the Motor Car (photograph provided to me). The Motor Car was observed to have sustained damage to its entire left side portion. Body parts damaged include the rear bumper, rear bootlid, rear left taillamp, rear left fender, rear left wheel rim, rear left door, rear left door lock, rear left door outer handle cover, front left door, front left fender, front left wheel rim and front bumper amongst others. The left side curtain airbag (arrowed) was also deployed.

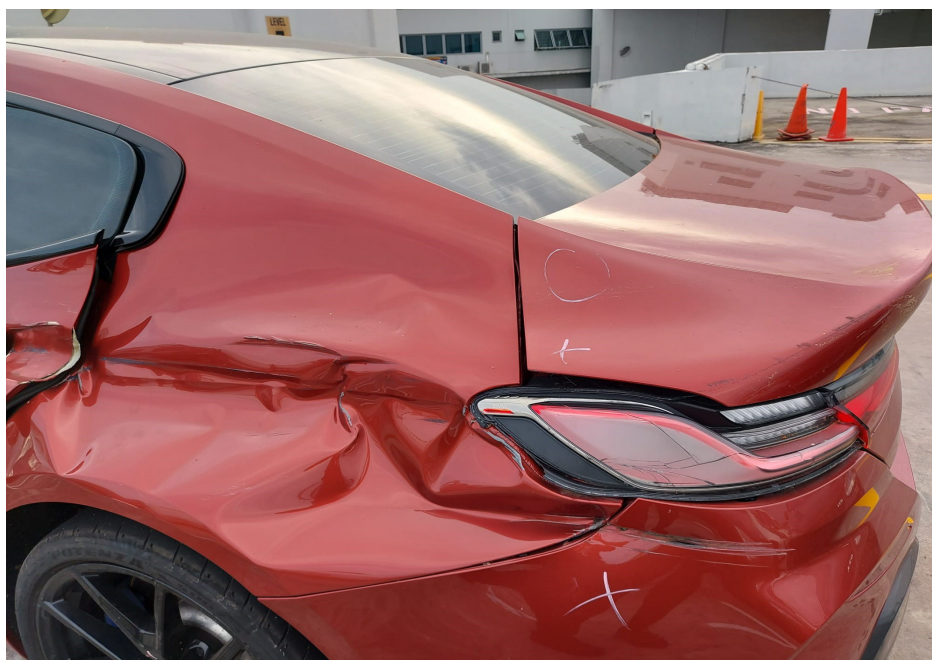
**Photo 2** shows a closer view of the damage to the rear bumper, rear bootlid, rear left taillamp and rear left fender of the Motor Car (photograph provided to me).

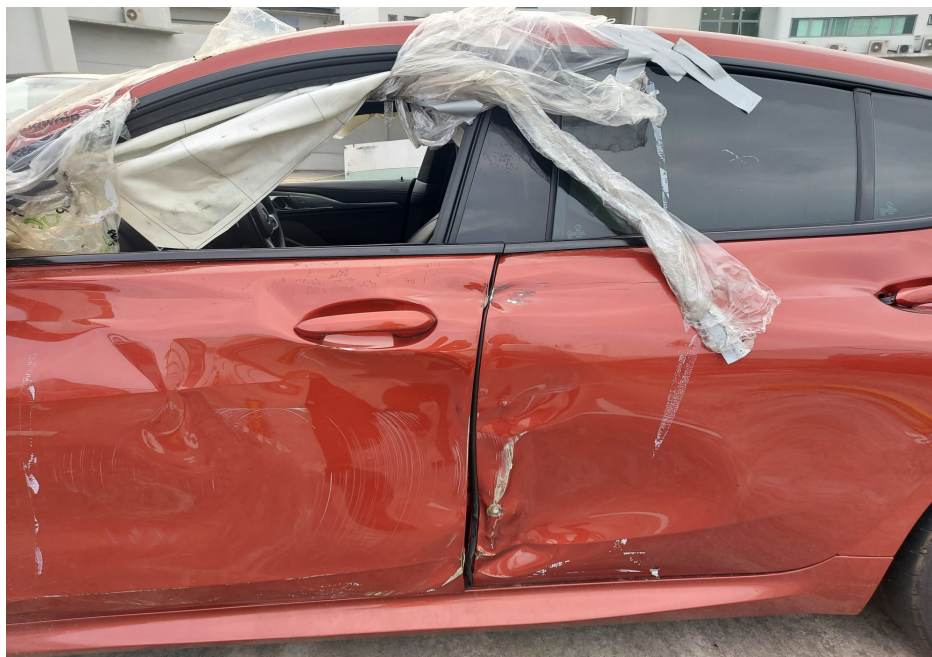
**Photo 3** shows a closer view of the damage to the left rear door and left front door of the Motor Car (photograph provided to me). The left side curtain airbag was deployed as seen from the photographs that were provided to me.

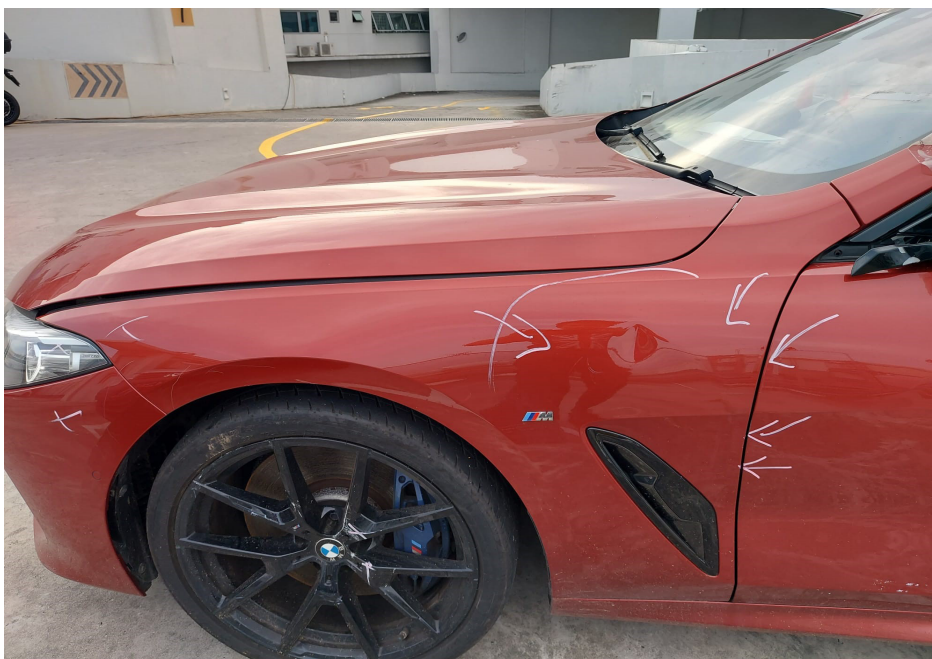
**Photo 4** shows a closer view of the damage to the left front fender, left front wheel rim and front bumper of the Motor Car (photograph provided to me).

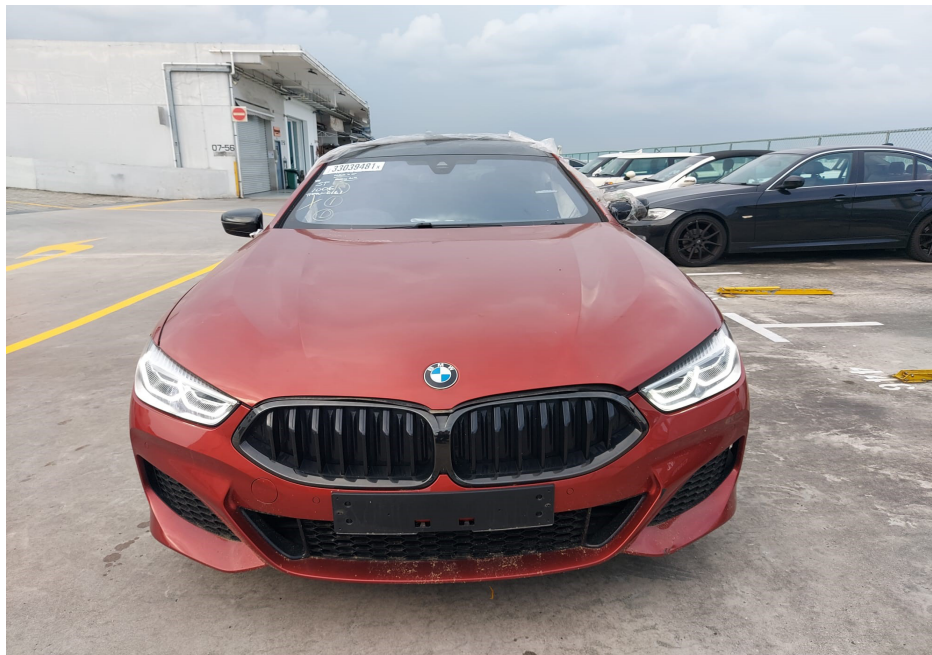
**Photo 5** shows the frontal portion of the Motor Car (photograph provided to me). Apart for the left side portion, there was no physical damage seen to other areas of the Motor Car.

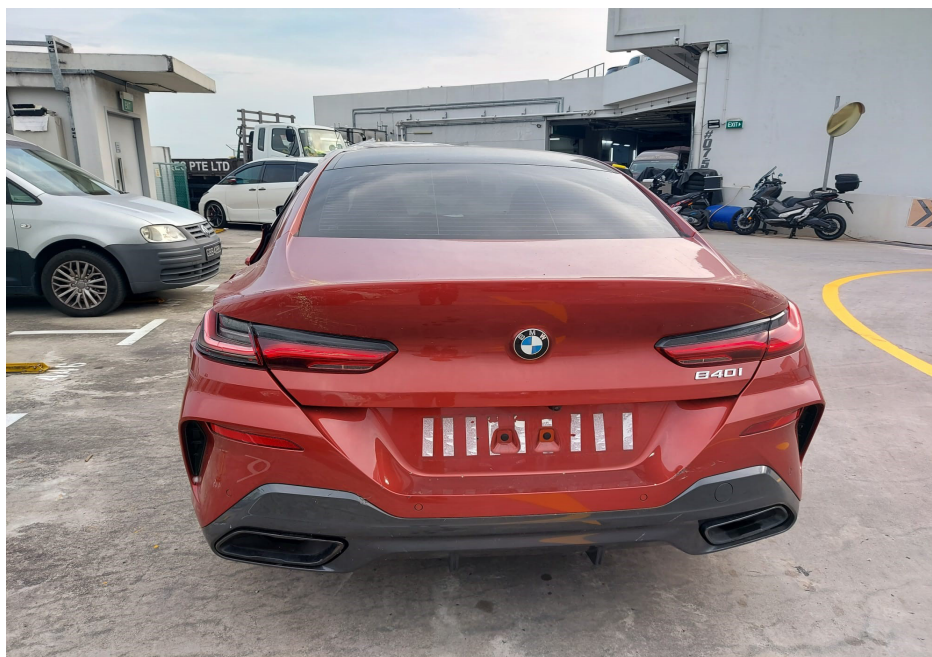
**Photo 6** shows the rear body of the Motor Car (photograph provided to me). Apart for the left side portion, there was no physical damage seen to other areas of the Motor Car.

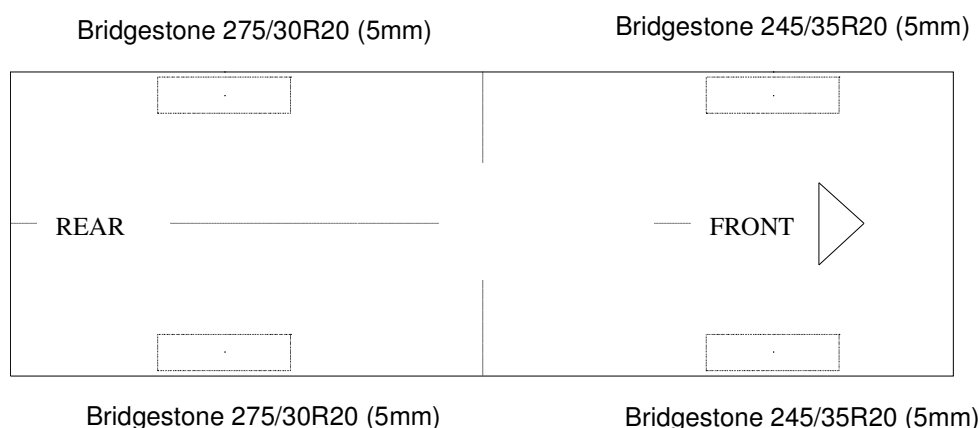
8. It was fitted with 20inch sport wheel rims that were wrapped with tyres that were observed to be of serviceable condition. The tyres were also sufficiently inflated for vehicular operation. The tyre brand, tyre size and approximate remaining tread depth of the 4 tyres of the Motor Car were recorded as follows: -

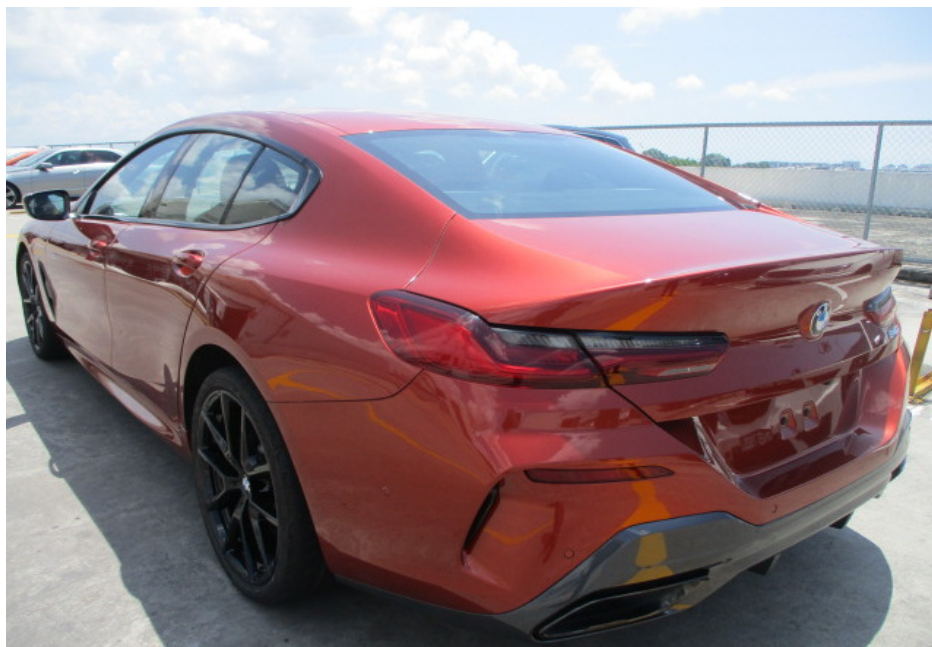
**Photo 7** shows a general view of the rear left body of the Motor Car at the time of my inspection. The Motor Car was observed to be in a relatively good general condition with no loose exterior fittings observed. The body parts along the entire left side portion of the Motor Car were visually examined and it was observed that the repair/restoration works carried out to the damaged area of the Motor Car (refer to photograph 1 - 4 above) were reasonably adequate and in order.

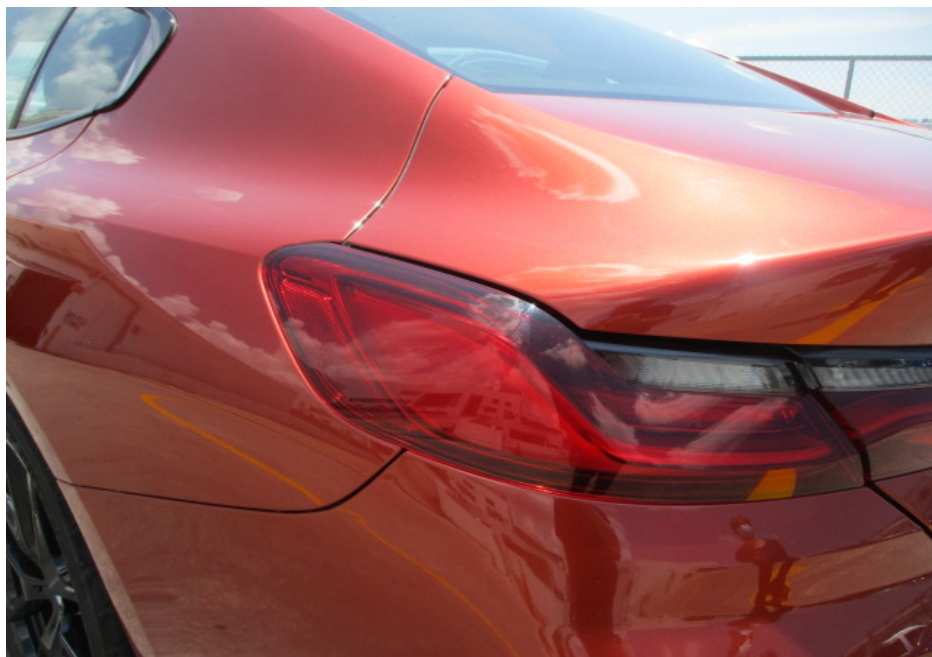
**Photo 8** shows a closer view of the Motor Car's rear bumper, rear bootlid, rear left taillamp and rear left fender. The body parts along the entire left side portion of the Motor Car were visually examined and it was observed that the repair/restoration works carried out to the damaged area of the Motor Car (refer to photograph 1 - 4 above) were reasonably adequate and in order.

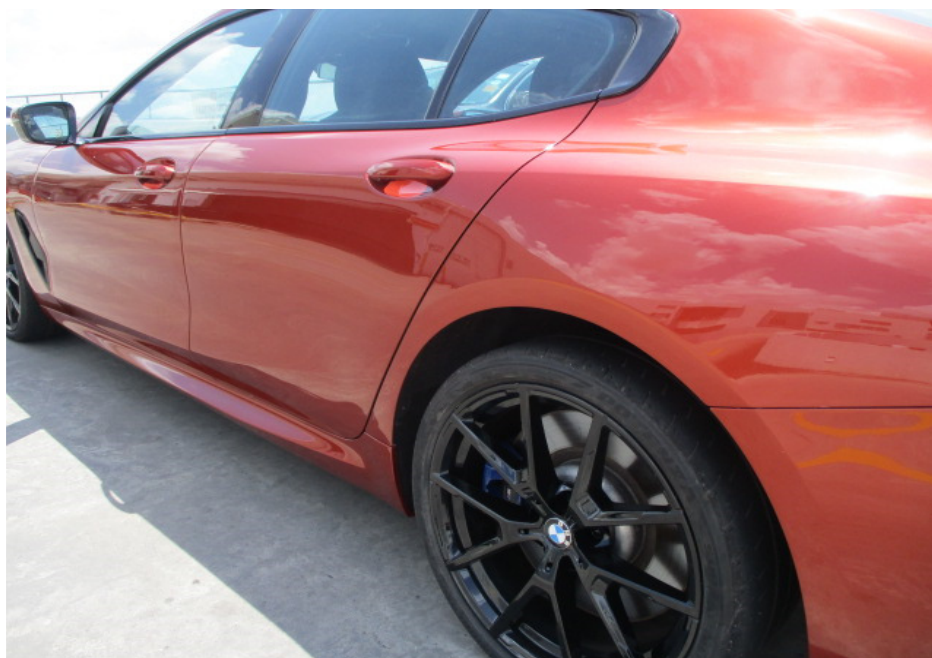
**Photo 9** shows a closer view of the Motor Car's rear left fender, rear left wheel rim and rear left door. The body parts along the entire left side portion of the Motor Car were visually examined and it was observed that the repair/restoration works carried out to the damaged area of the Motor Car (refer to photograph 1 - 4 above) were reasonably adequate and in order.

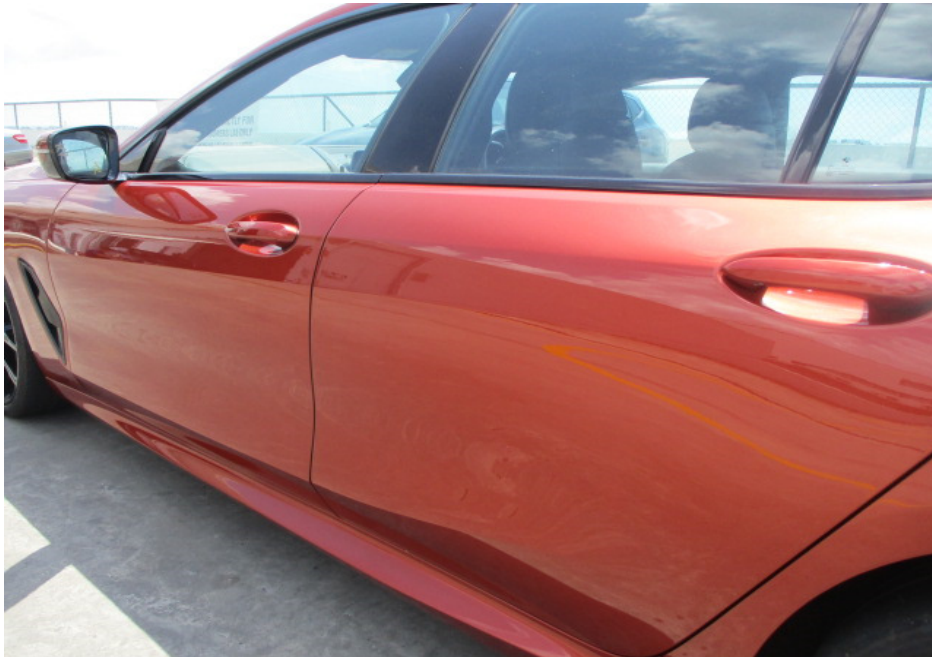
**Photo 10** shows a closer view of the Motor Car's rear left door, rear left door outer handle cover and front left door. The body parts along the entire left side portion of the Motor Car were visually examined and it was observed that the repair/restoration works carried out to the damaged area of the Motor Car (refer to photograph 1 - 4 above) were reasonably adequate and in order.

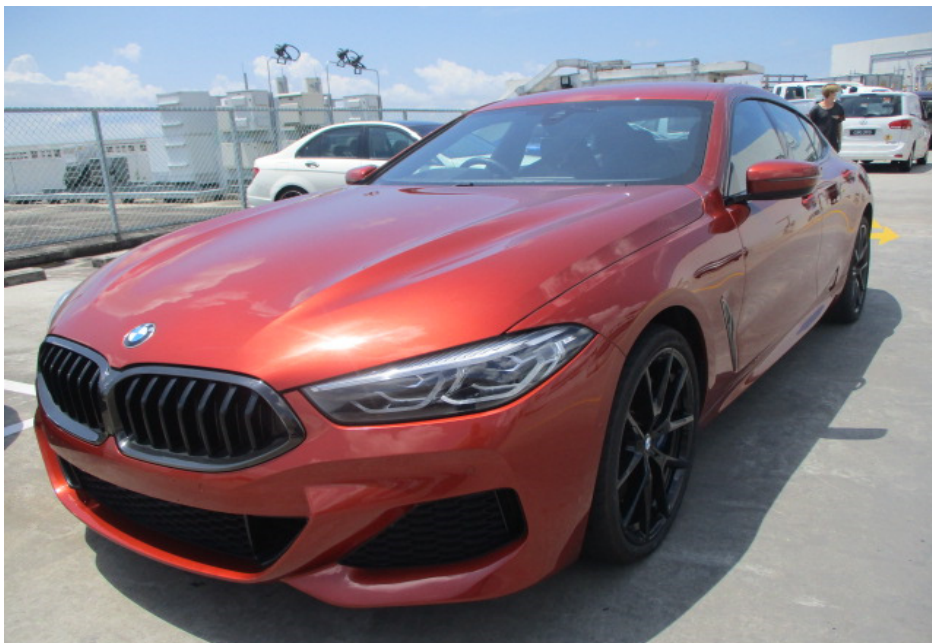
**Photo 11** shows a general view of the front left body of the Motor Car at the time of my inspection. The Motor Car was observed to be in a relatively good general condition with no loose exterior fittings observed. The body parts along the entire left side portion of the Motor Car were visually examined and it was observed that the repair/restoration works carried out to the damaged area of the Motor Car (refer to photograph 1 - 4 above) were reasonably adequate and in order.

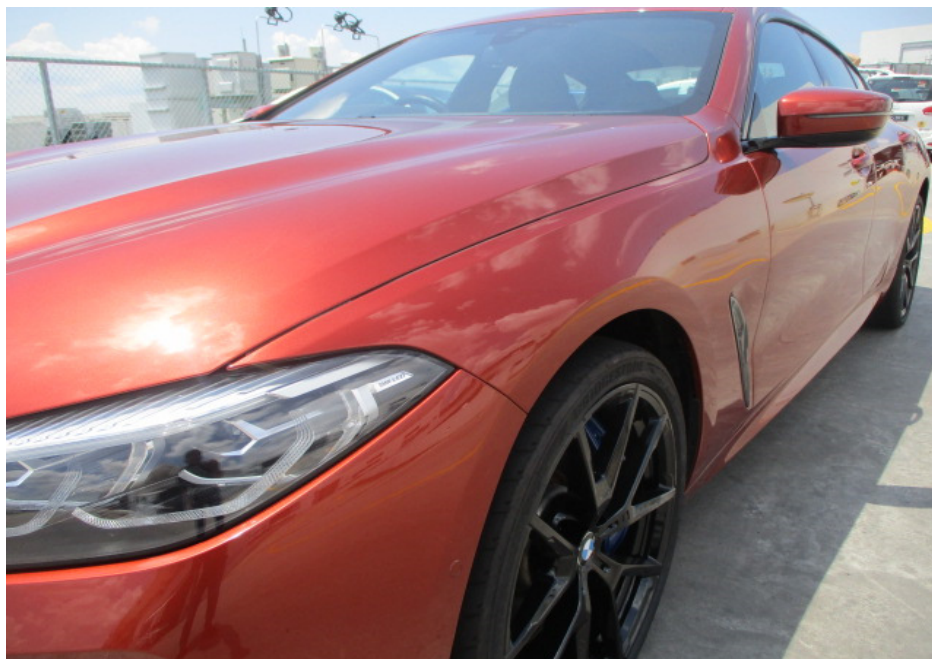
**Photo 12** shows a closer view of the Motor Car's front bumper and front left fender. The body parts along the entire left side portion of the Motor Car were visually examined and it was observed that the repair/restoration works carried out to the damaged area of the Motor Car (refer to photograph 1 - 4 above) were reasonably adequate and in order.

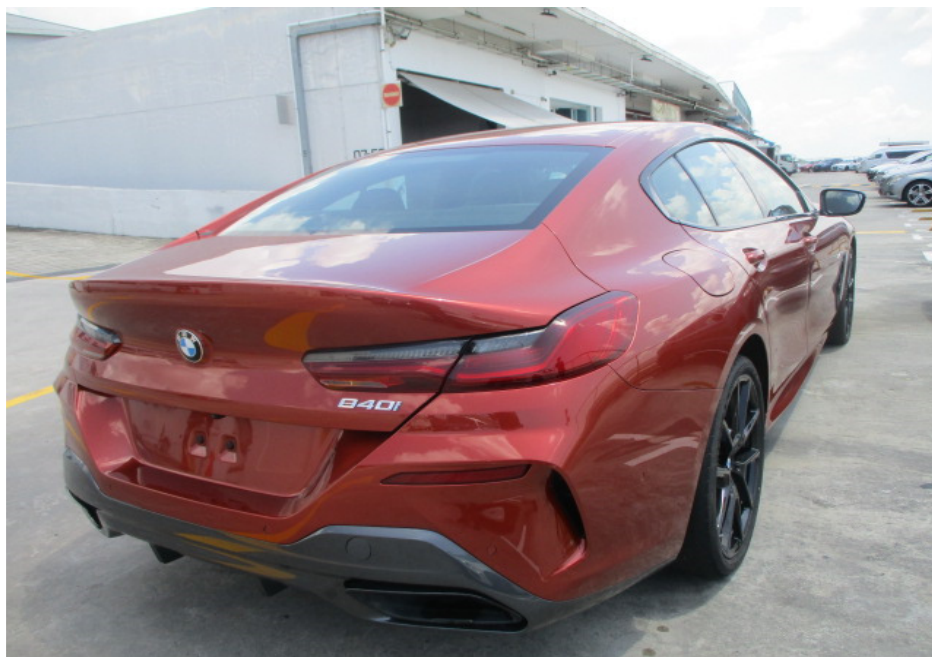
**Photo 13** shows a general view of the rear right body of the Motor Car at the time of my inspection. The Motor Car was observed to be in a relatively good general condition with no loose exterior fittings observed. The mileage of the Motor Car recorded at the time of my inspection was 8,927km.

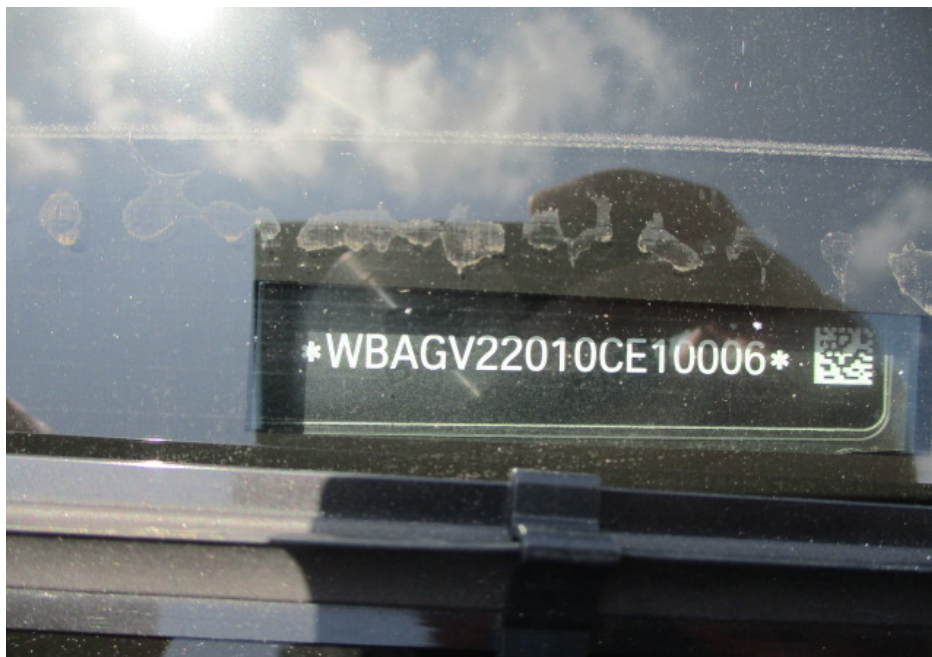
**Photo 14** shows the chassis number of the Motor Car. The chassis number recorded was WBAGV22010CE10006.

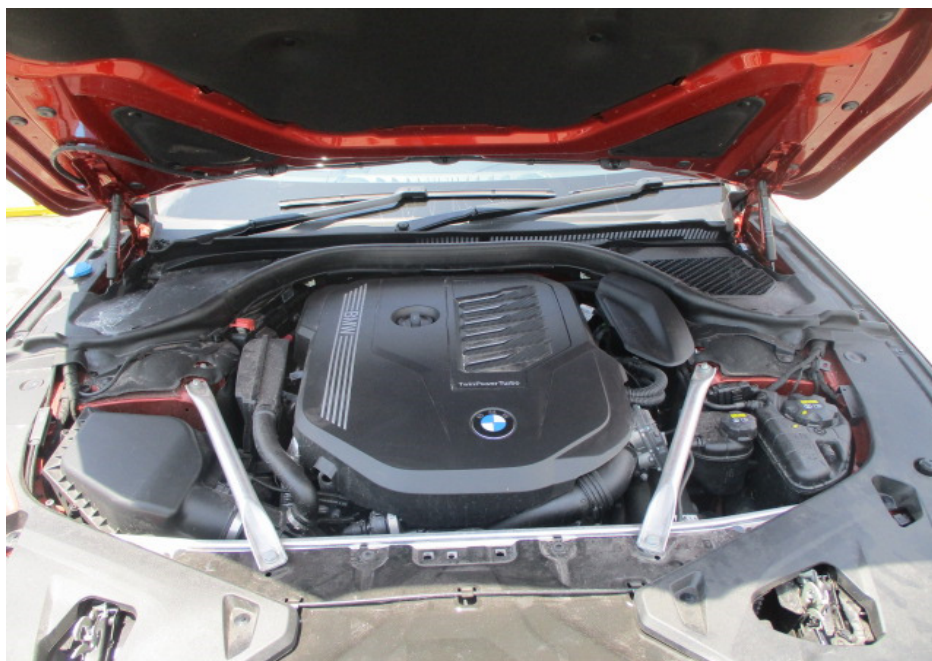
**Photo 15** shows a general view of the engine compartment of the Motor Car at the time of my inspection. The various parts and components inside the engine compartment were all observed to be intact and properly fitted. There was also no sign(s) or indication(s) of fluid leak and/or fluid stain found inside the engine compartment.

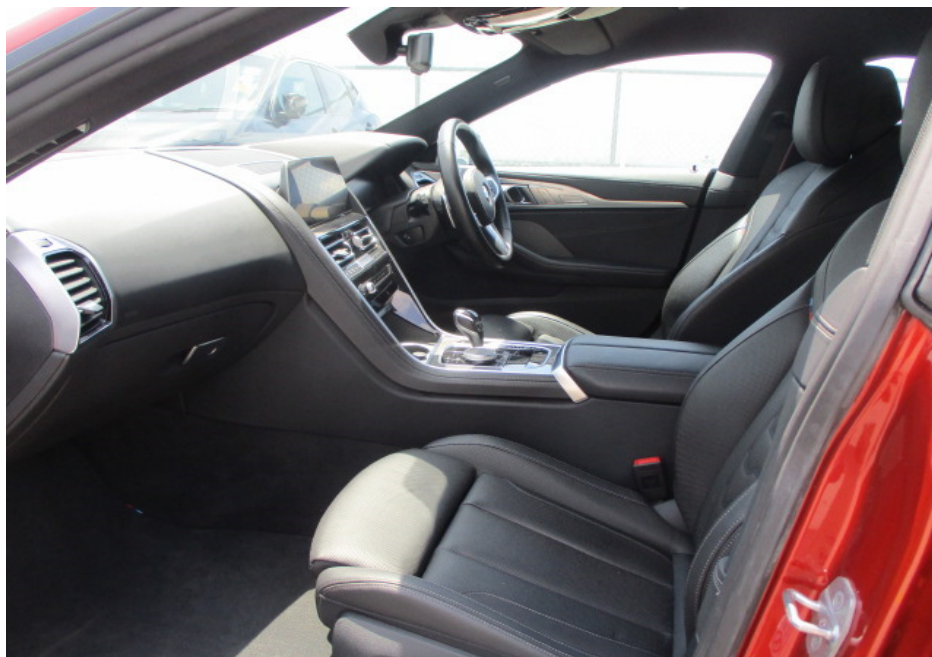
**Photo 16** shows the interior compartment of the Motor Car at the time of my inspection. The various parts and components, trims, carpet, and upholstery inside the interior compartment were all observed to be intact and properly fitted.

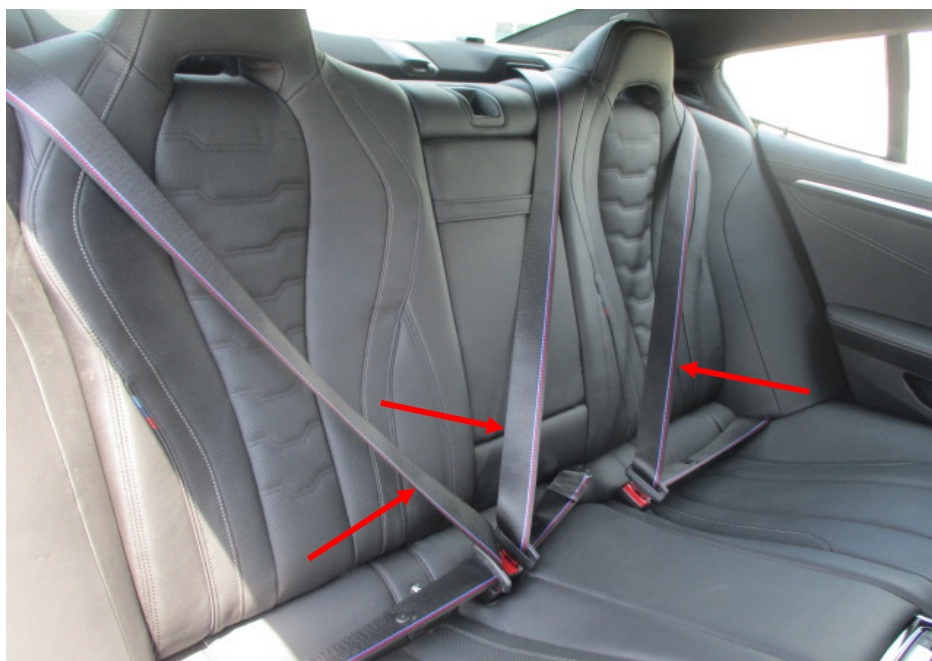
**Photo 17** shows the rear seats of the Motor Car. All the seats of the Motor Car were secured via seat rails to the floorboard. They were also fitted with a retractable seat belt reel and a pre-tensioner. The seat belts (arrowed) were tested and were able to be fastened into the respective pre-tensions that were fitted on the side of each individual seat.

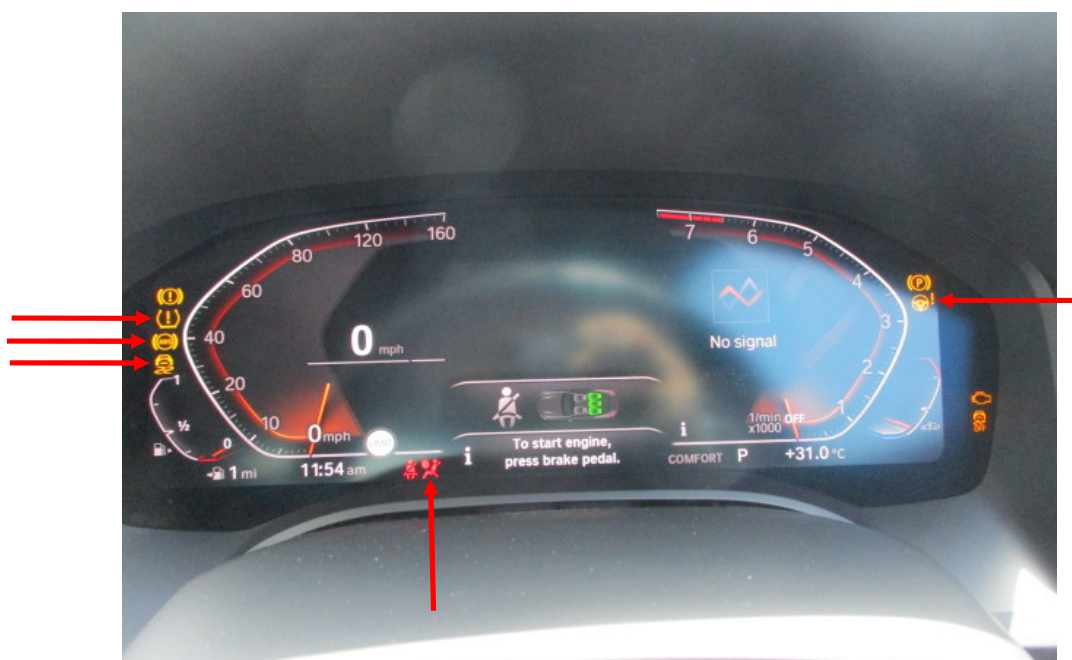
**Photo 18** shows the warning lights for the various electronic safety features appearing on the instrument panel of the Motor Car during its self-test when the engine is cranked, in particular the ABS, SRS, IAS, TPM and DSC lights (arrowed).

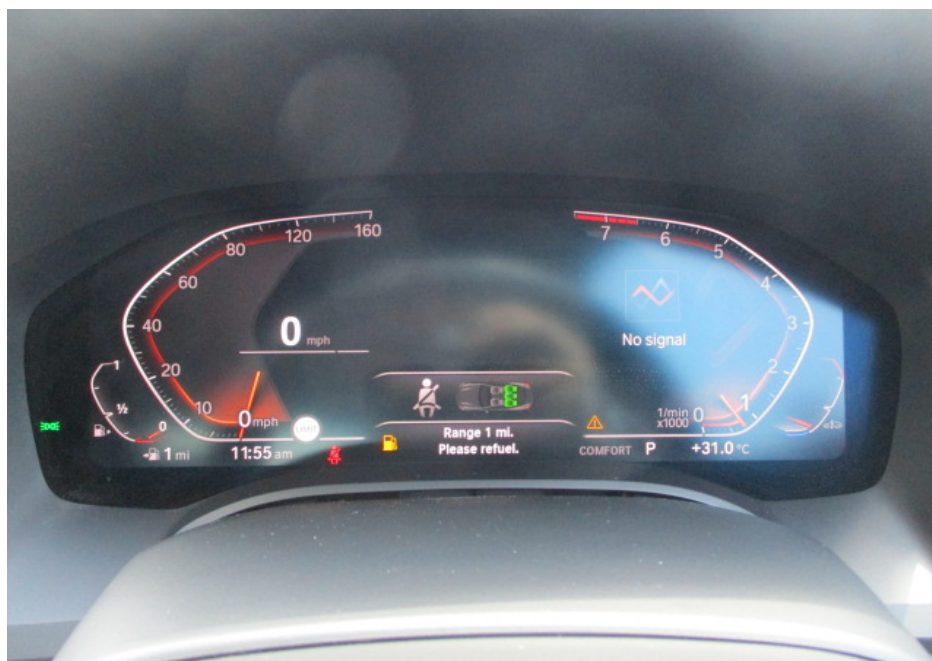
**Photo 19** shows the respective warning lights no longer illuminated, indicating that there is no fault detected to the ABS, SRS, IAS, TPM and DSC systems of the Motor Car during the self-test. These electronic systems were hence in working condition at the time of my inspection.

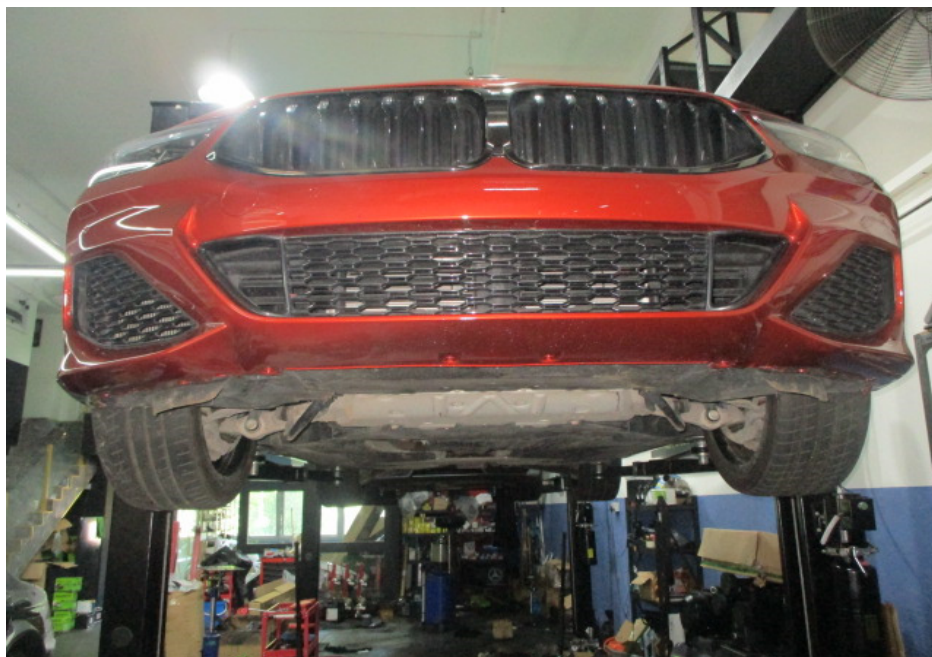
**Photo 20** shows the Motor Car hoisted up for checks on its undercarriage. There was no sign(s) or indication(s) of fluid leakage and/or fluid stain(s) on the underside of the Motor Car. The undercarriage components of the Motor Car were also all observed to be intact and secured in an appropriate manner.

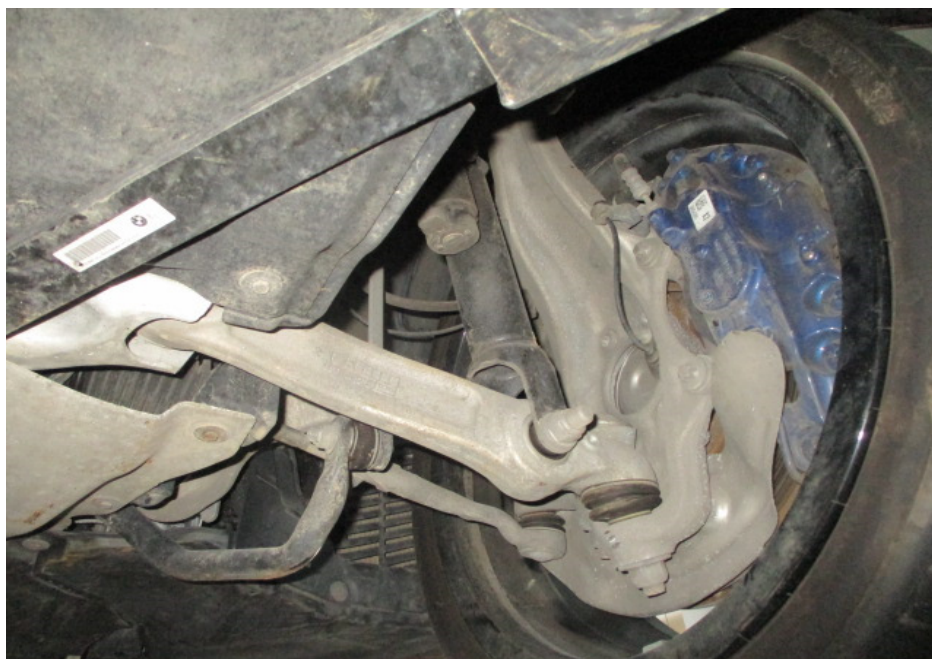
**Photo 21** shows the various undercarriage components at the front right wheel of the Motor Car. The mechanical components, control arms and linkages were all found to be intact and secured in an appropriate manner. I also did not observe any fluid leak and/or fluid stain on the underside of the Motor Car.

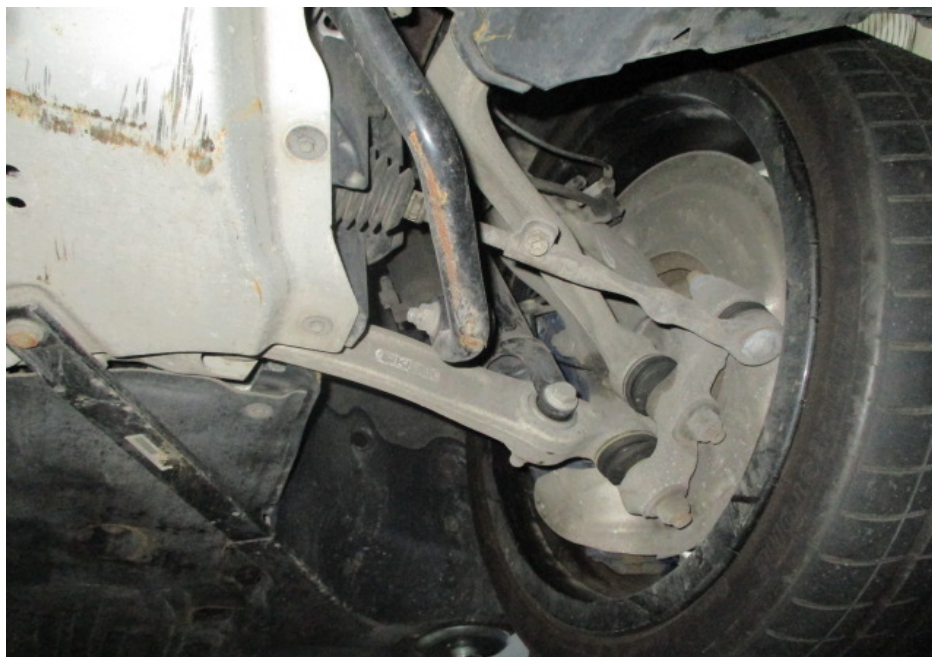
**Photo 22** shows the various undercarriage components at the front left wheel of the Motor Car. The mechanical components, control arms and linkages were all found to be intact and secured in an appropriate manner. I also did not observe any fluid leak and/or fluid stain on the underside of the Motor Car.

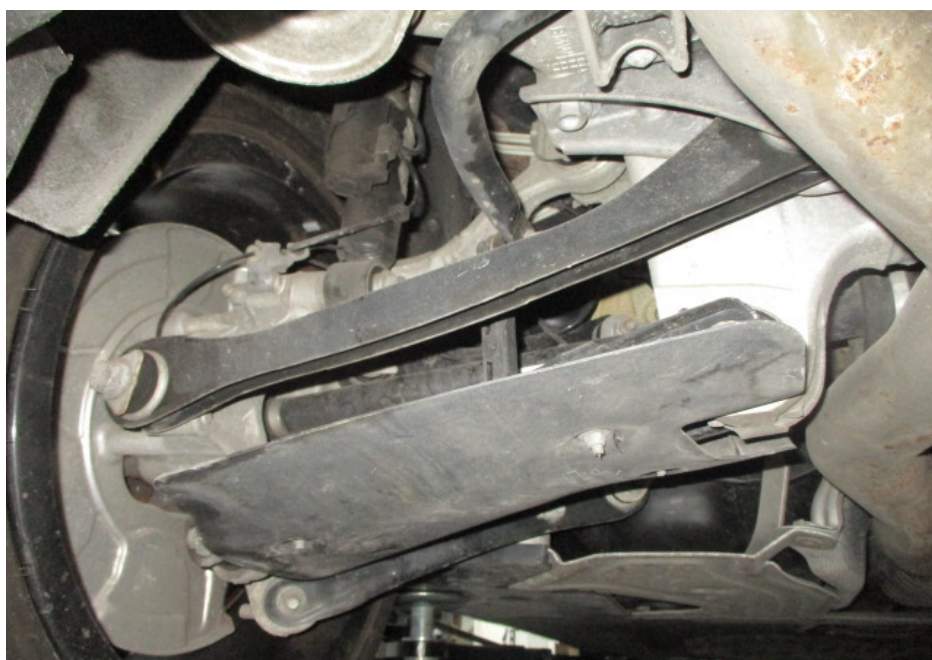
**Photo 23** shows the various undercarriage components at the rear left wheel of the Motor Car. The mechanical components, control arms and linkages were all found to be intact and secured in an appropriate manner.

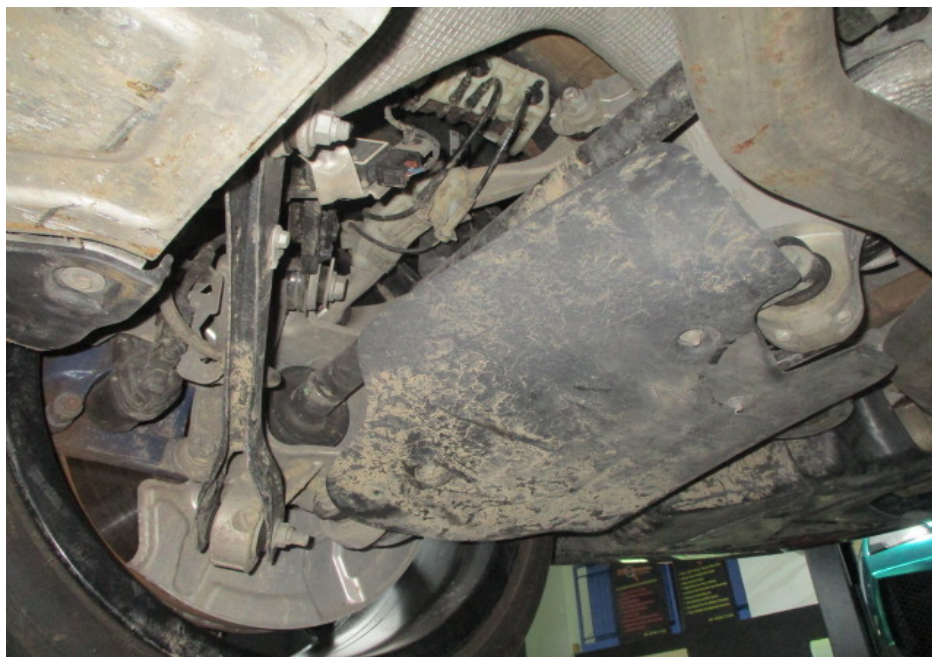
**Photo 24** shows the various undercarriage components at the rear right wheel of the Motor Car. The mechanical components, control arms and linkages were all found to be intact and secured in an appropriate manner. I also did not observe any fluid leak and/or fluid stain on the underside of the Motor Car.

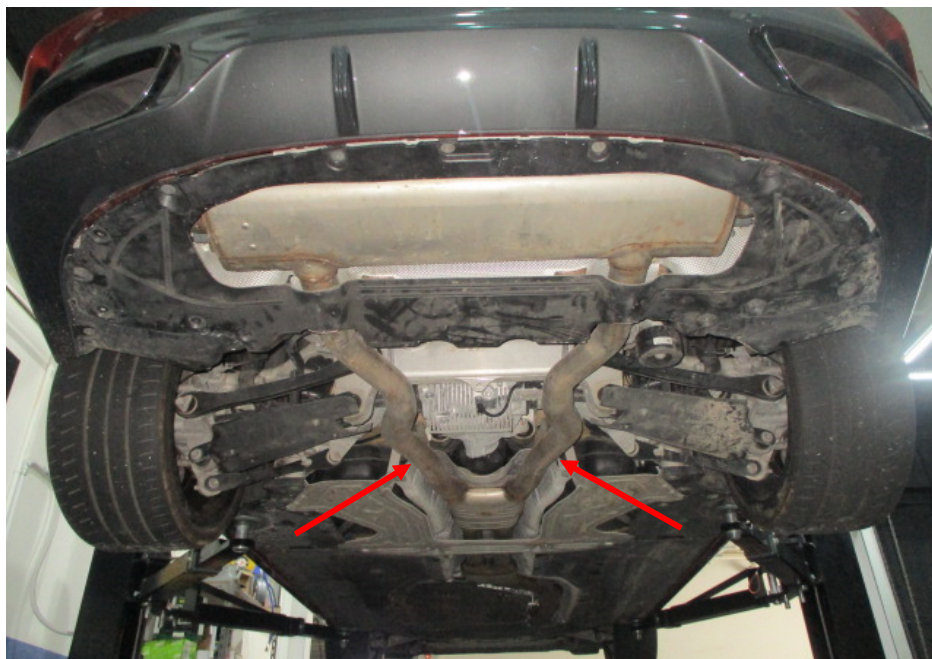
**Photo 25** shows the rear section of the Motor Car's exhaust system. My examination of the Motor Car's exhaust system revealed no sign(s) or indication(s) of any cut or weld marks along its exhaust pipes (arrowed), on its rear muffler, on its centre resonator box and on its catalytic converter.

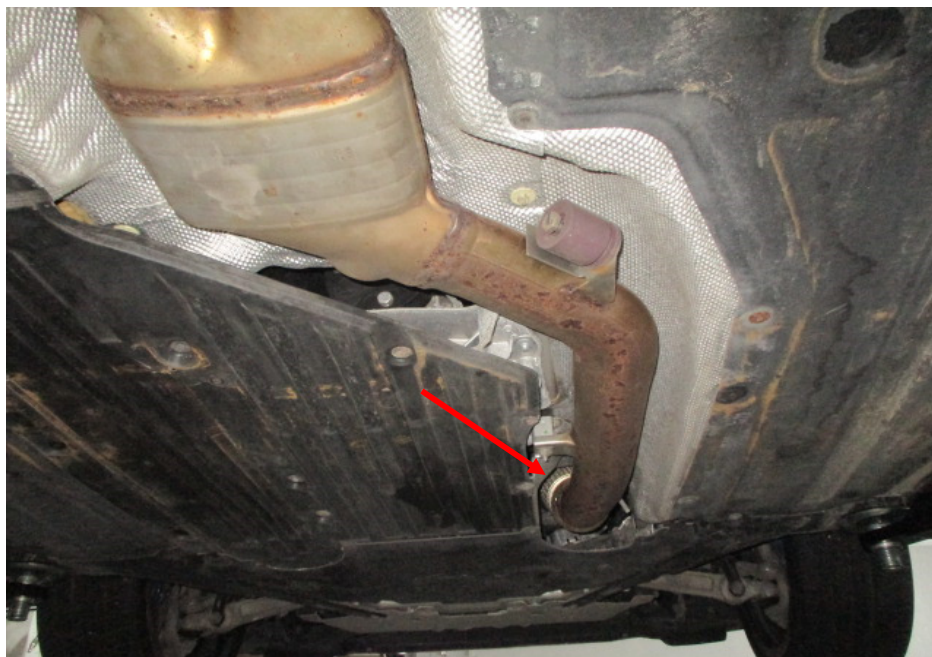
**Photo 26** shows the front section of the Motor Car's exhaust system. My examination of the Motor Car's exhaust system revealed no sign(s) or indication(s) of any cut or weld marks along its exhaust pipes, on its rear muffler, on its centre resonator box and on its catalytic converter (arrowed).

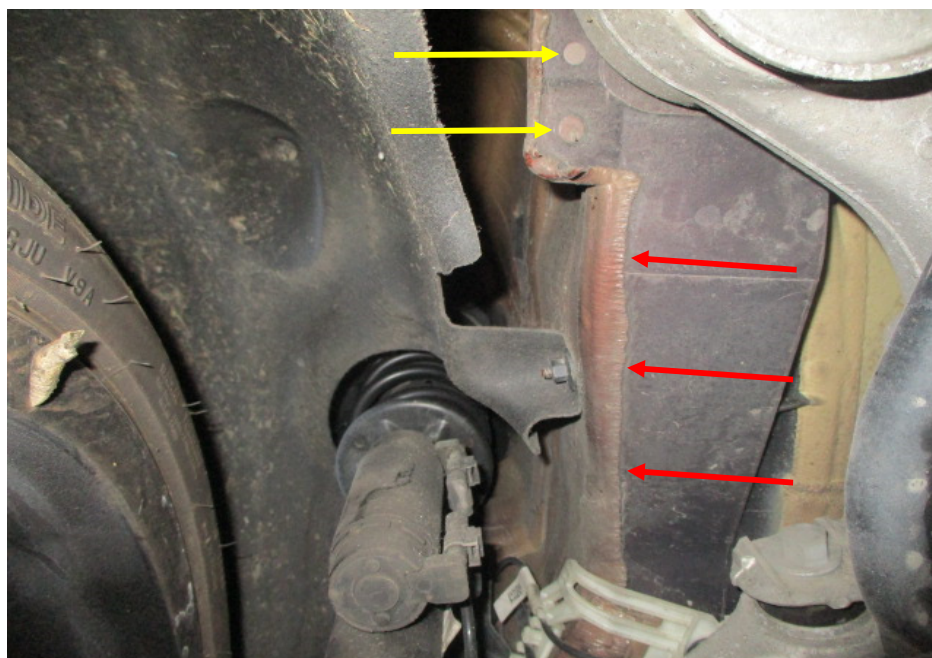
**Photo 27** shows the chassis/structural body at the underside rear left of the Motor Car. I did not find any weld marks other than original spot weld marks (yellow arrow) on the chassis/structural body of the Motor Car. The original factory sealant (red arrow) at the joints along the chassis/structural body was also untouched, indicating no work was done on the chassis/structural body of the Motor Car and that the chassis/structural body was originally fitted.

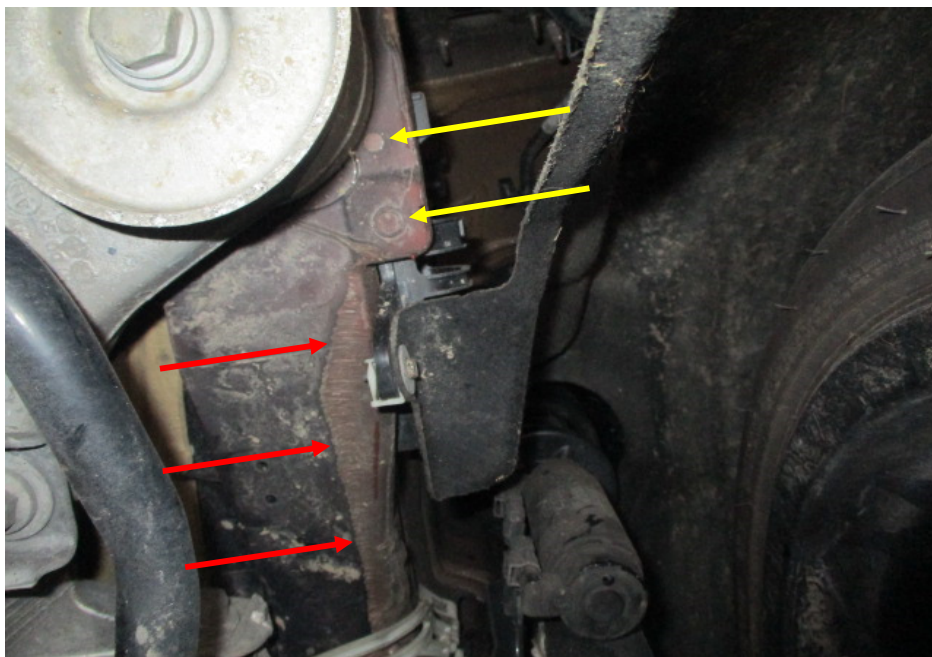
**Photo 28** shows the chassis/structural body at the underside rear right of the Motor Car. I did not find any weld marks other than original spot weld marks (yellow arrow) on the chassis/structural body of the Motor Car. The original factory sealant (red arrow) at the joints along the chassis/structural body was also untouched, indicating no work was done on the chassis/structural body of the Motor Car and that the chassis/structural body was originally fitted.

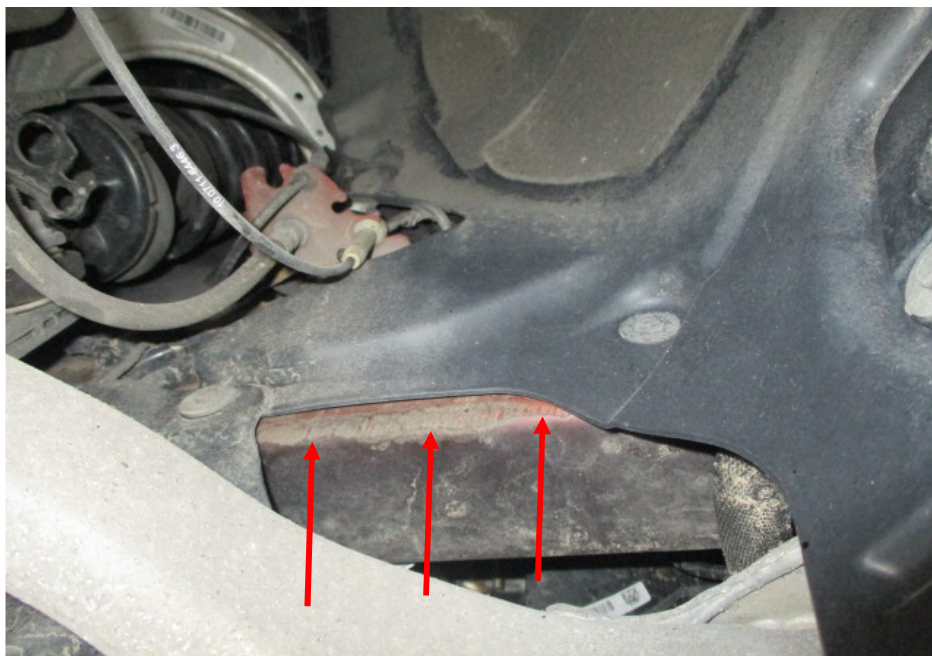
**Photo 29** shows the chassis/structural body at the underside front right of the Motor Car. The original factory sealant (arrowed) at the joints along the chassis/structural body was observed to be untouched. In general, I had found no work was carried out on the chassis/structural body of the Motor Car. The chassis/structural body of the Motor Car was originally fitted.

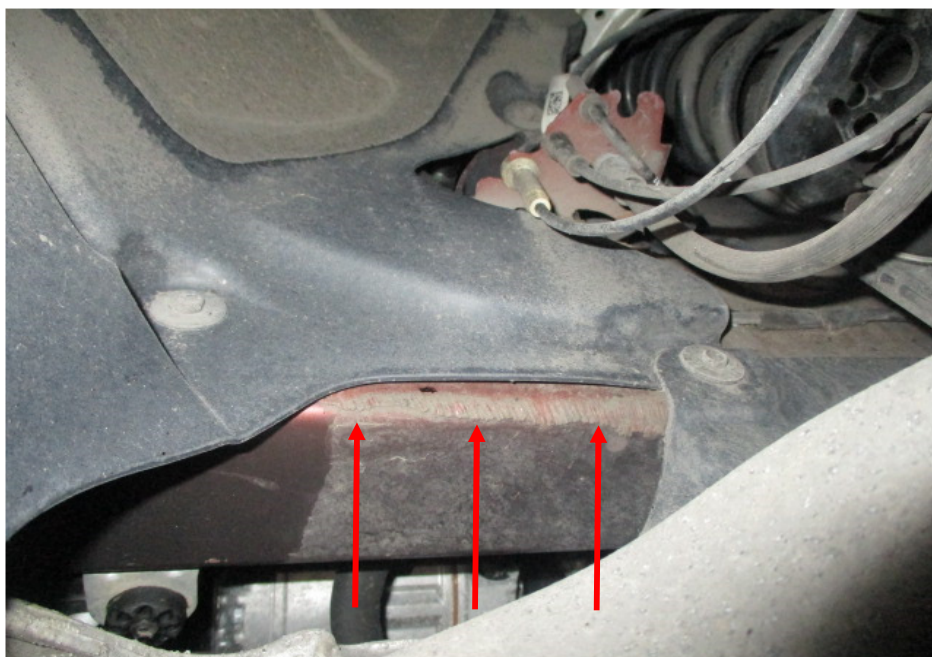
**Photo 30** shows the chassis/structural body at the underside front left of the Motor Car. The original factory sealant (arrowed) at the joints along the chassis/structural body was observed to be untouched. In general, I had found no work was carried out on the chassis/structural body of the Motor Car. The chassis/structural body of the Motor Car was originally fitted.

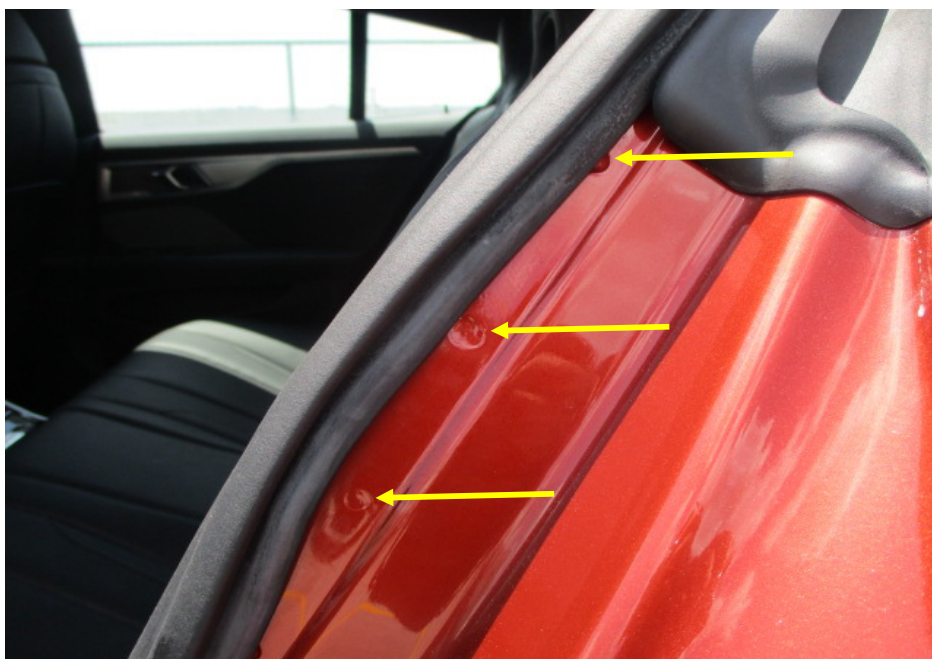
**Photo 31** shows the left side "C" pillar of the Motor Car. I did not find any weld marks other than original spot weld marks (arrowed) on the left side "C" pillar of the Motor Car which, indicates that there was no re-welding works carried out. In general, I had found all the non-detachable body panels of the Motor Car to be originally fitted at the time of my inspection.
