Your Ref: BMW 840i  
(chassis number WBAGV22010CE10006)  
Our Ref : CI/TP21010278/D

05 October 2021

**Stockport Private Limited**  
20 Sin Ming Lane #03-61  
Midview City  
Singapore 573968

**INSPECTION REPORT OF AN UNREGISTERED BMW 840i MOTOR CAR  
WITH CHASSIS NUMBER WBAGV22010CE10006**

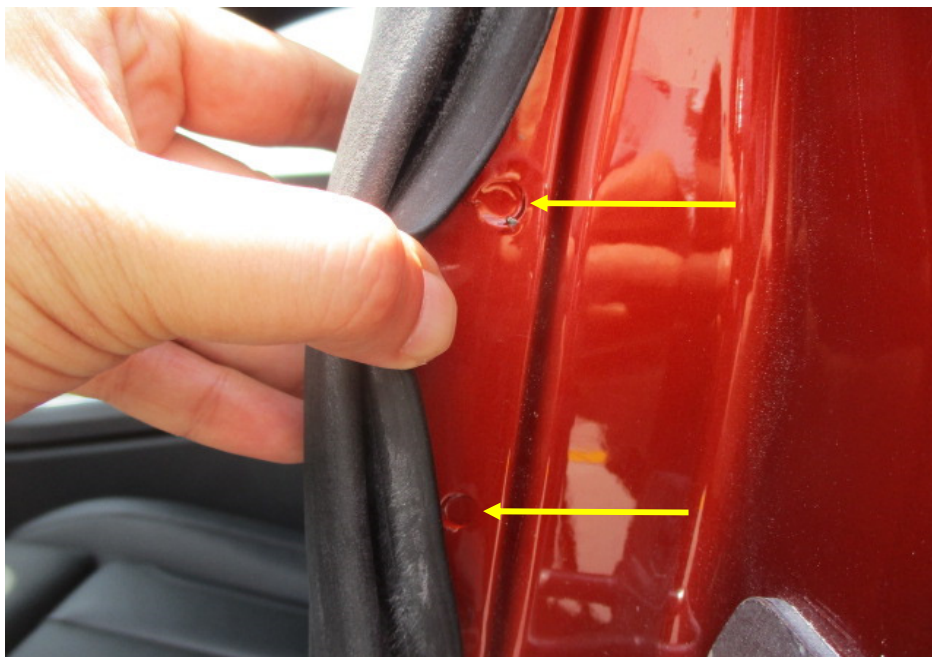
**Photo 32** shows the left side "B" pillar of the Motor Car. I did not find any weld marks other than original spot weld marks (arrowed) on the left side "B" pillar of the Motor Car which, indicates that there was no re-welding works carried out. In general, I had found all the non-detachable body panels of the Motor Car to be originally fitted at the time of my inspection.
