### **INVESTIGATION REPORT:**

Our Ref : CS/CTI21010297/N  
Policy No : DMPCSNW00129022000  
Insured : SJE 17H  
Date of Incident : 26 September 2021  
Location : TPE (PIE) before Loyang Ave exit

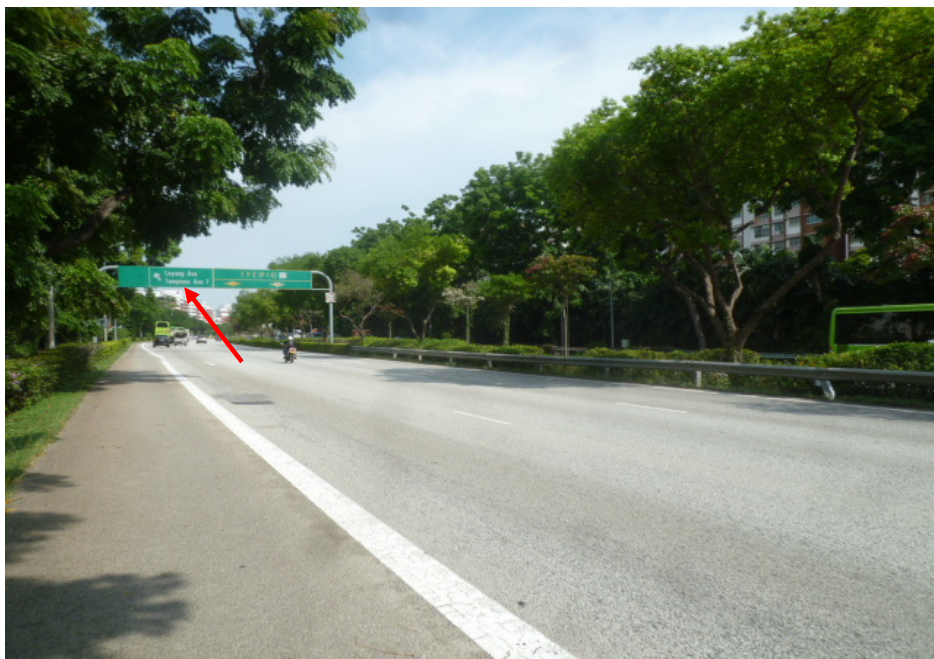
**Photo 1** shows the location where the incident had occurred, along the 1st lane of the TPE (PIE) before the Loyang Avenue exit (arrowed), opposite lamp post 102. We noticed that the vicinity was not monitored by CCTV camera(s).

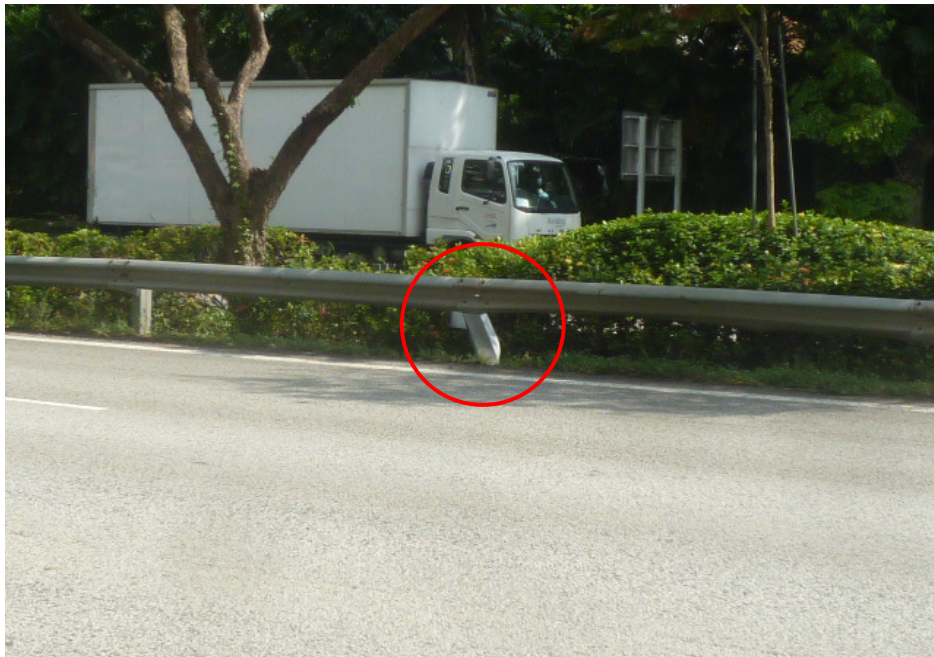
**Photo 2** shows damage to the column of a railing (circled) opposite lamp post 102. We were unable to conduct a closer inspection of the railings as we were not allowed to stop at the 1st lane of the expressway.

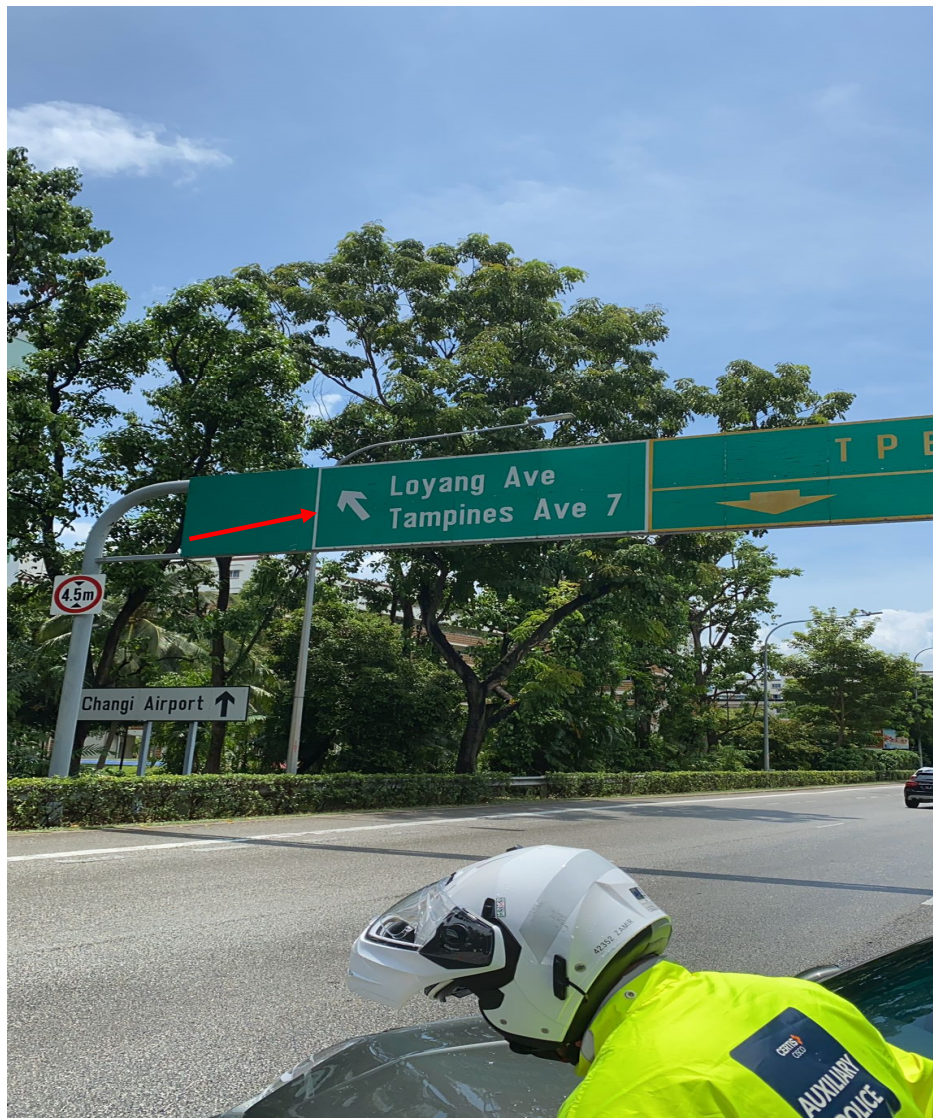
**Photo 3** shows the Insured Vehicle at the incident location post- incident. The incident had occurred along the TPE (PIE) before the Loyang Avenue (arrowed). The ability of Mr Tan to drive to take clear photographs post- incident would suggest that there was no drink driving involved in this particular incident.

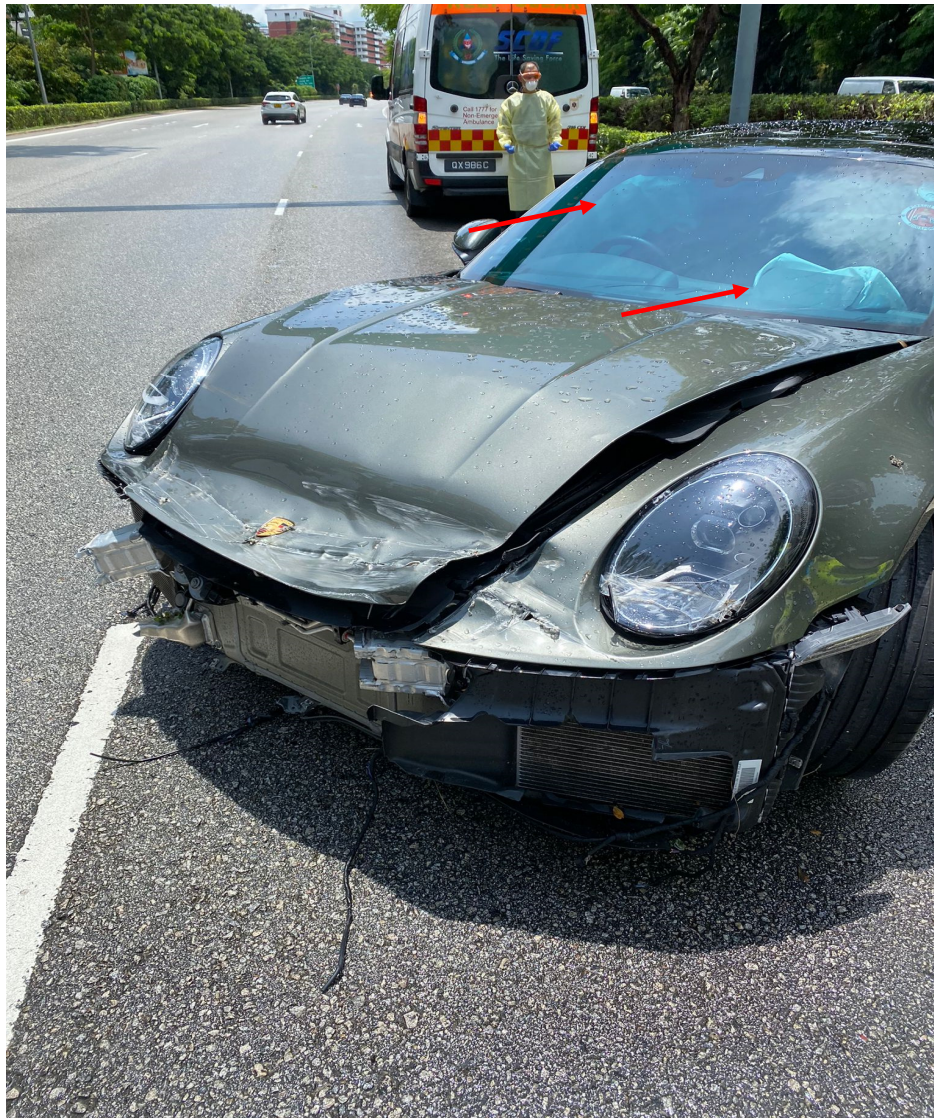
**Photo 4** shows the frontal portion of the Insured Vehicle post- incident. The Insured Vehicle had sustained damages at its frontal portion. The deployed airbags in the Insured Vehicle (arrowed) correlates with Mr Tan's statement that the front and side airbags were deployed after the Insured Vehicle spun out of control and collided into the railings after he drove through a puddle of water.

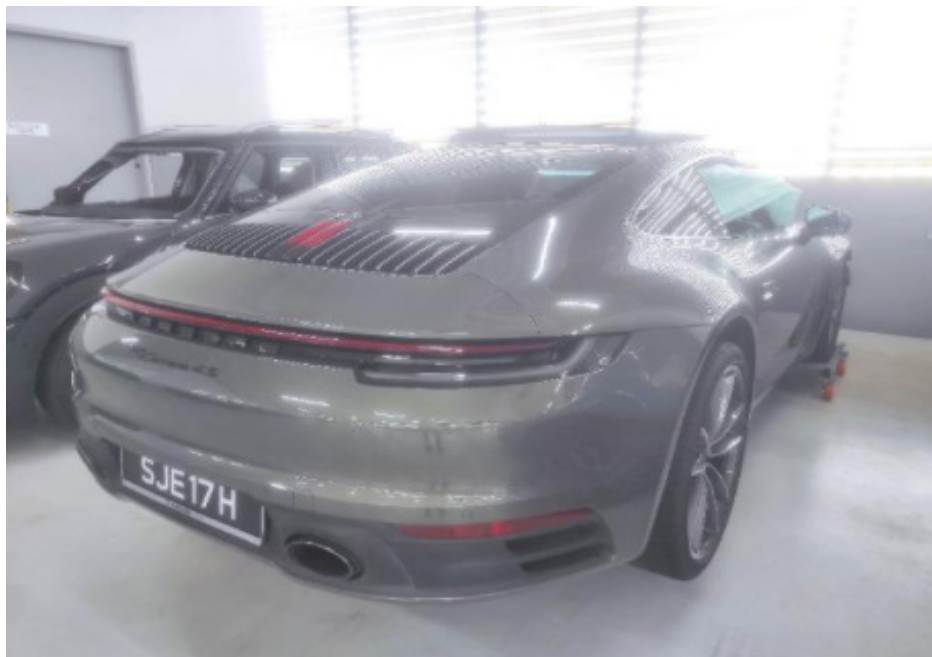
**Photo 5** shows the general rear view of the Insured Vehicle during the physical inspection at Stuttgart. The rear portion of the Insured Vehicle was relatively unaffected by the incident.

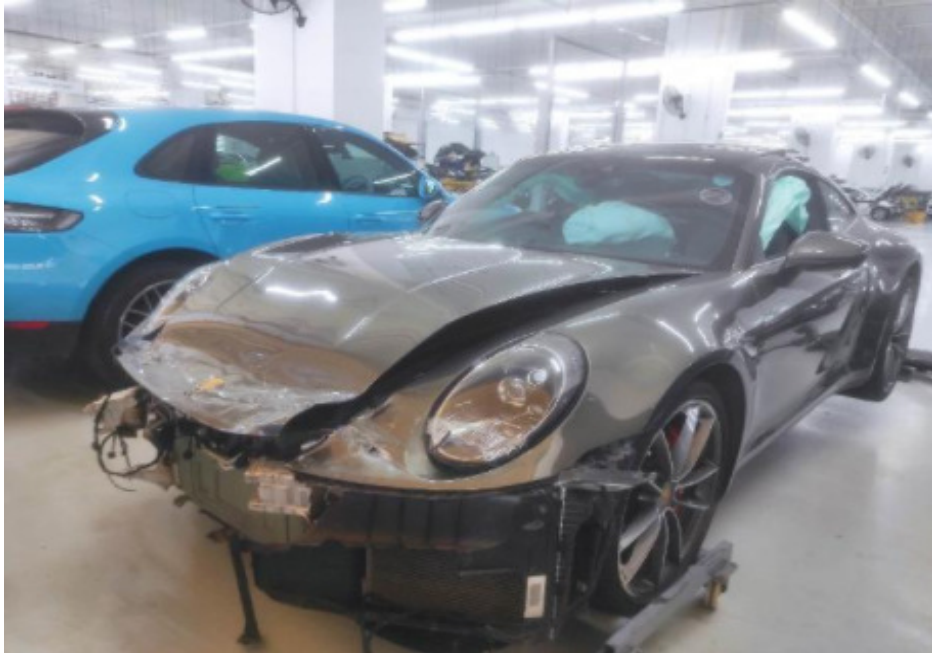
16. Based on the incident scene photographs provided to us by Mr Tan, the Insured Vehicle had sustained significant damages to its frontal portion.
17. Our physical inspection of the Insured Vehicle at Stuttgart revealed that the Insured Vehicle had sustained significant damages to its frontal portion, particularly to its front bonnet, front bumper, front fenders and headlamps. There were also some relatively minor marks of grazing nature observed around the edges of the front left wheel rim of the Insured Vehicle as a result of grazing the railings. There were remains of the front and side airbags in the interior compartment of the Insured Vehicle which corroborates with Mr Tan's statement that the airbags were deployed post- incident. See photos 5 - 10 below.

**Photo 6** shows the frontal portion of the Insured during the physical inspection at Stuttgart. The Insured Vehicle had sustained significant damages to its frontal portion, particularly to its front bonnet, front bumper, front fenders and headlamps as a result of the incident.

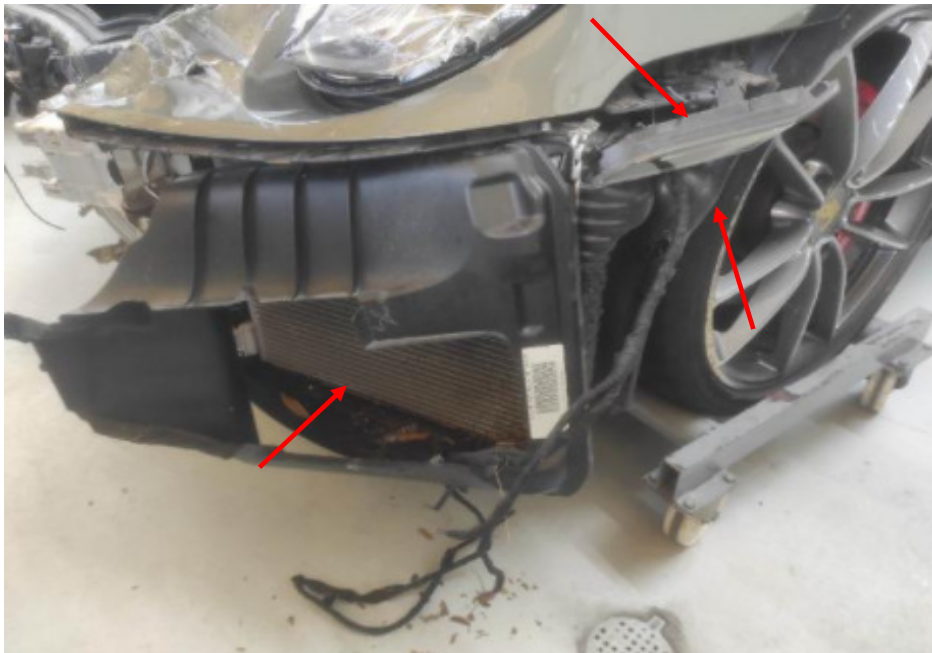
**Photo 7** shows upon closer inspection, the Insured Vehicle also sustained damages to the front bumper retainer, left front fender shield and radiator (arrowed).

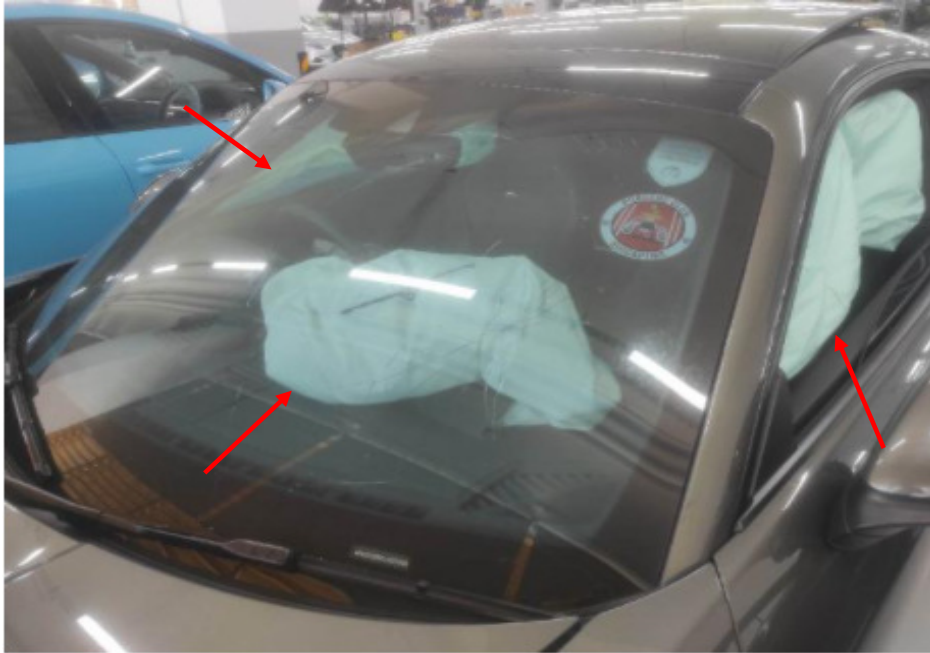
**Photo 8** shows the remains of the front and side airbags in the interior compartment of the Insured Vehicle (arrowed) which corroborates with Mr Tan's statement that the airbags were deployed post- incident.

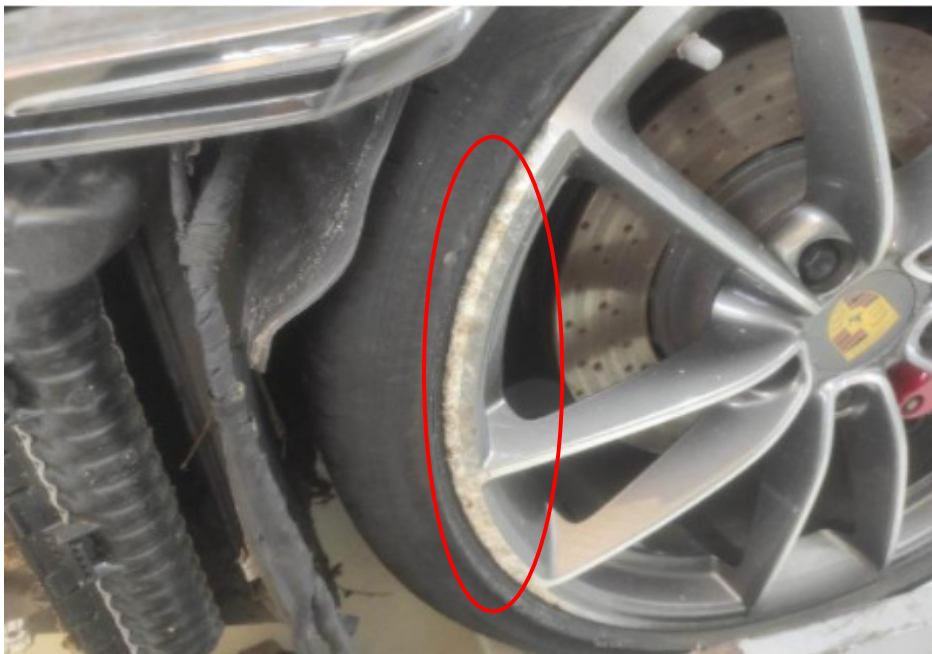
**Photo 9** shows some relatively minor marks of grazing nature observed around the edges of the front left wheel rim (circled) as a result of Mr Tan grazing the railings.

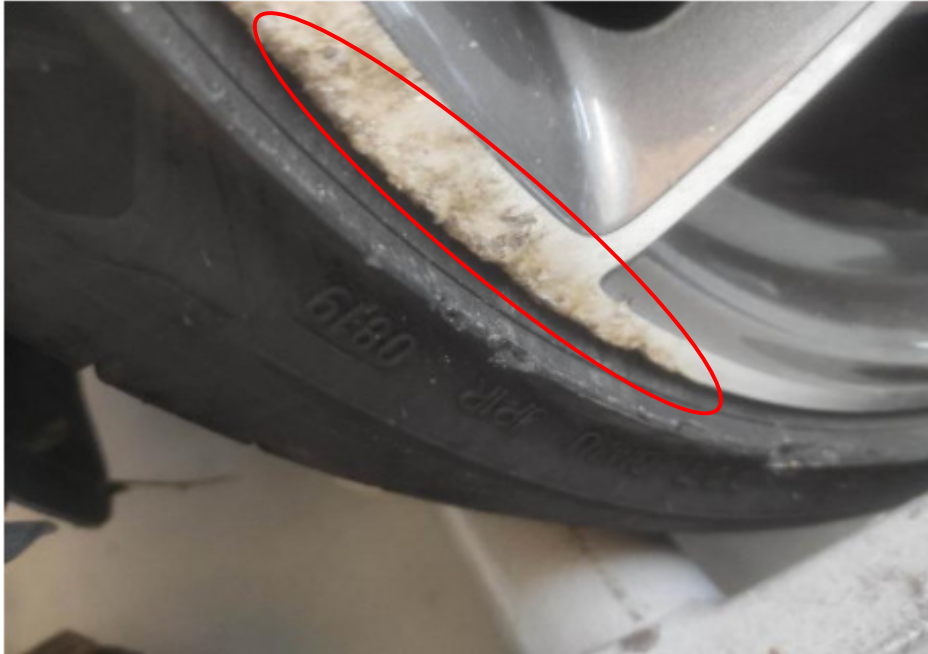
**Photo 10** shows a close up view of the relatively minor marks of grazing nature observed around the edges of the front left wheel rim (circled) as a result of Mr Tan grazing the railings.
