Your Ref: BMW 740Li  
(chassis number WBA7T22040BM60990)  
Our Ref : CI/TP21010350/D

07 October 2021

**INSPECTION REPORT OF AN UNREGISTERED BMW 740Li MOTOR CAR  
WITH CHASSIS NUMBER WBA7T22040BM60990**

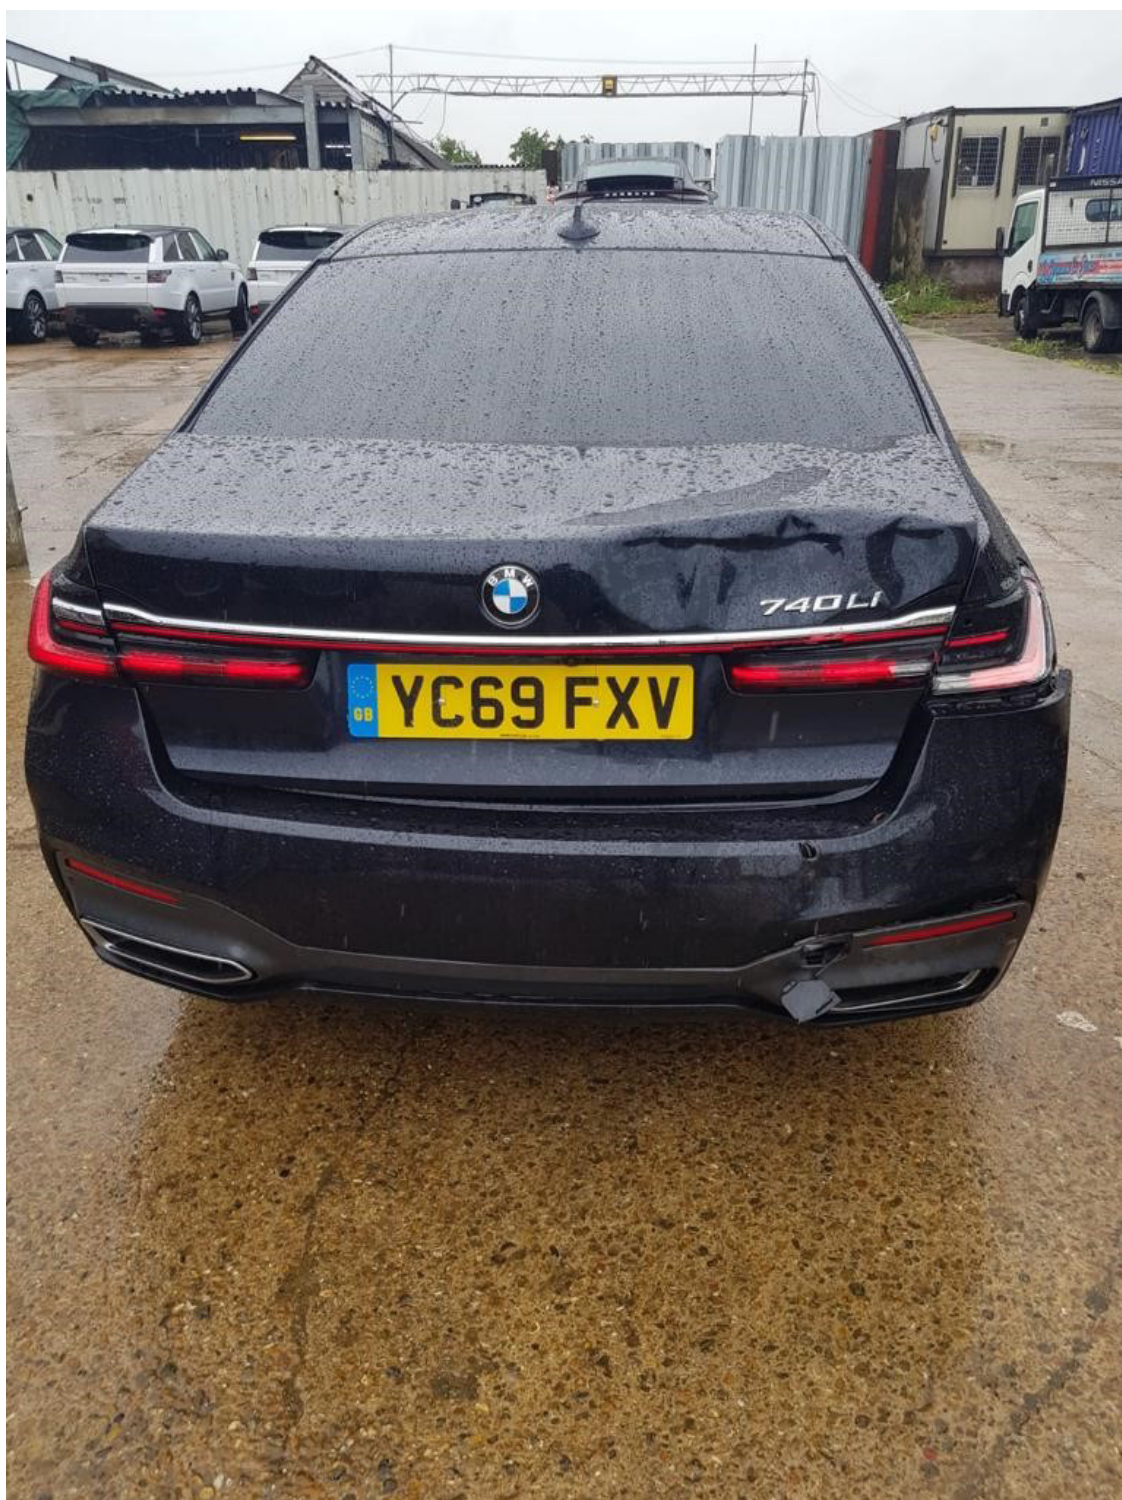
3. The photographs provided to me had showed damage to the rear right portion of the Motor Car. Body parts damaged include the rear bumper, rear bumper lower cover, rear bootlid, rear bootlid upper chrome moulding, rear bootlid upper reflector, rear right bootlid lamp and rear right taillamp amongst others. See photo 1 – 2 below

**Photo 1** shows the rear body of the Motor Car (photograph provided to me). The Motor Car was observed to have sustained damage at its rear right portion. Body parts damaged include the rear bumper, rear bumper lower cover, rear bootlid, rear bootlid upper chrome moulding, rear bootlid upper reflector, rear right bootlid lamp and rear right taillamp amongst others.

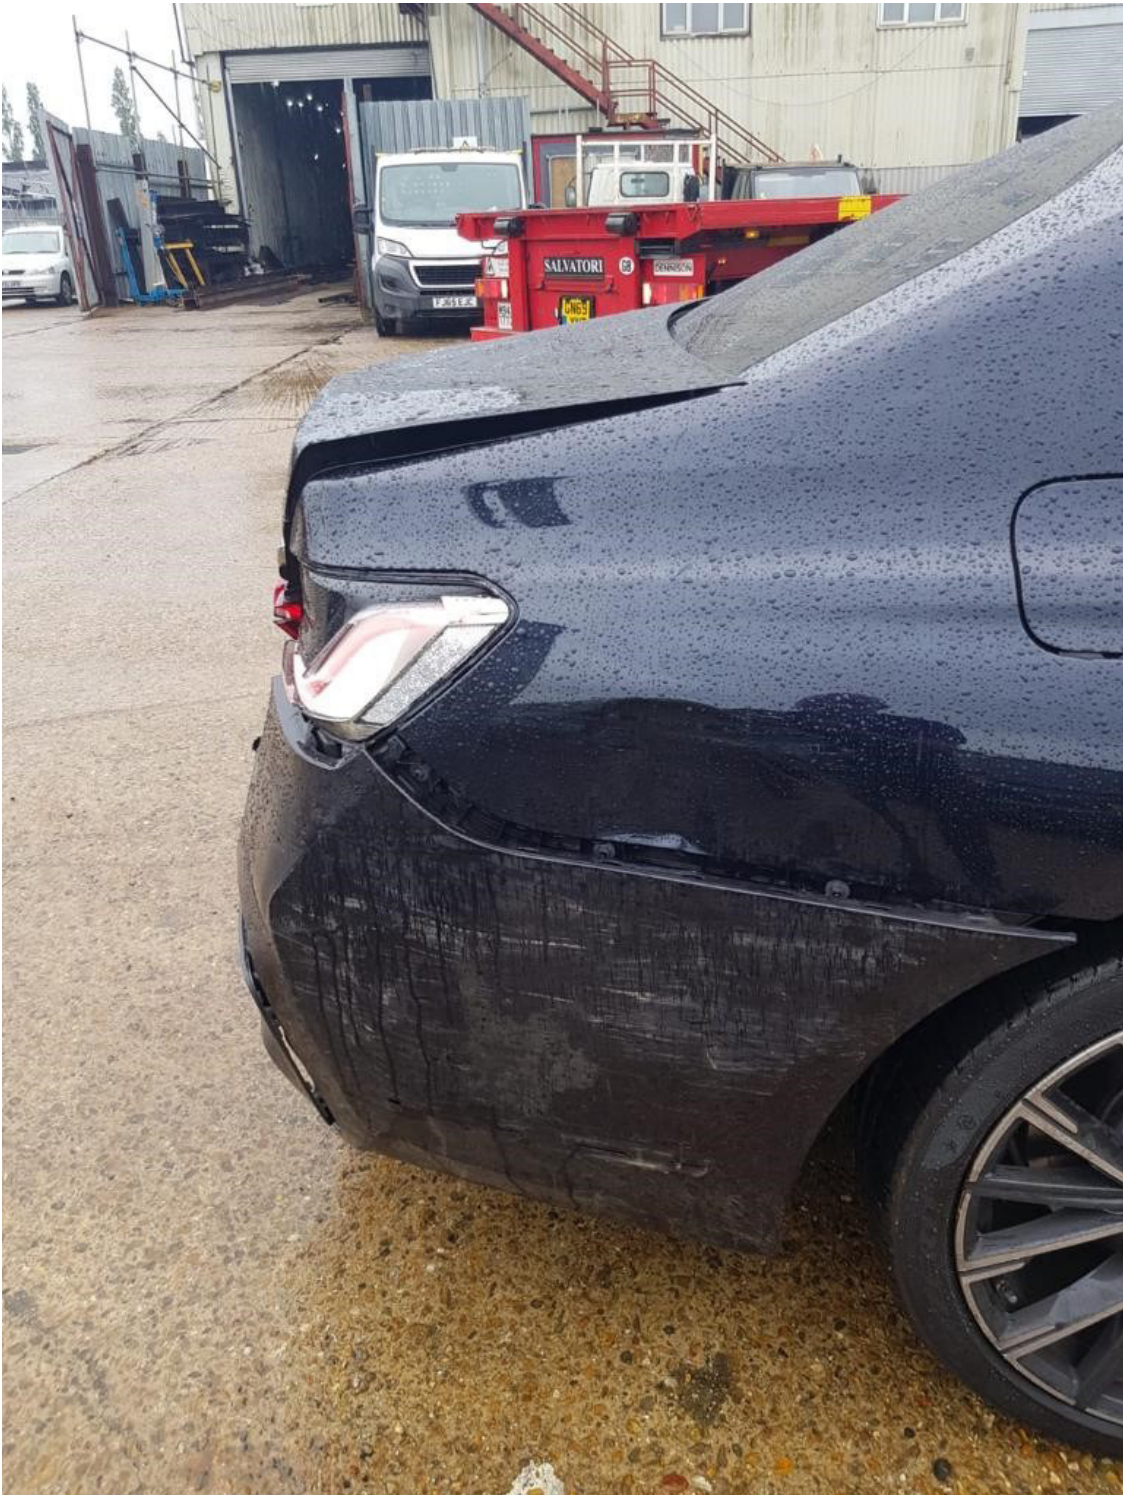
**Photo 2** shows another view of the damaged rear bumper, rear bootlid and rear right taillamp of the Motor Car (photograph provided to me).

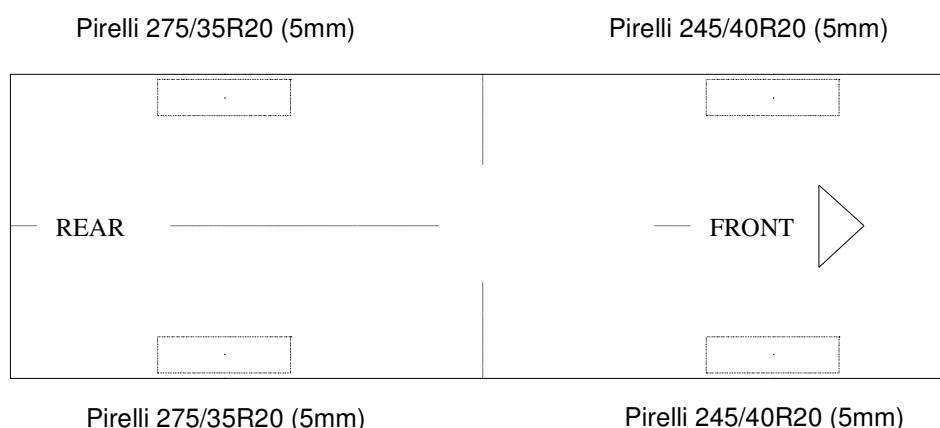
7. It was fitted with 20inch sport wheel rims that were wrapped with tyres that were observed to be of serviceable condition. The tyres were also sufficiently inflated for vehicular operation. The tyre brand, tyre size and approximate remaining tread depth of the 4 tyres of the Motor Car were recorded as follows: -

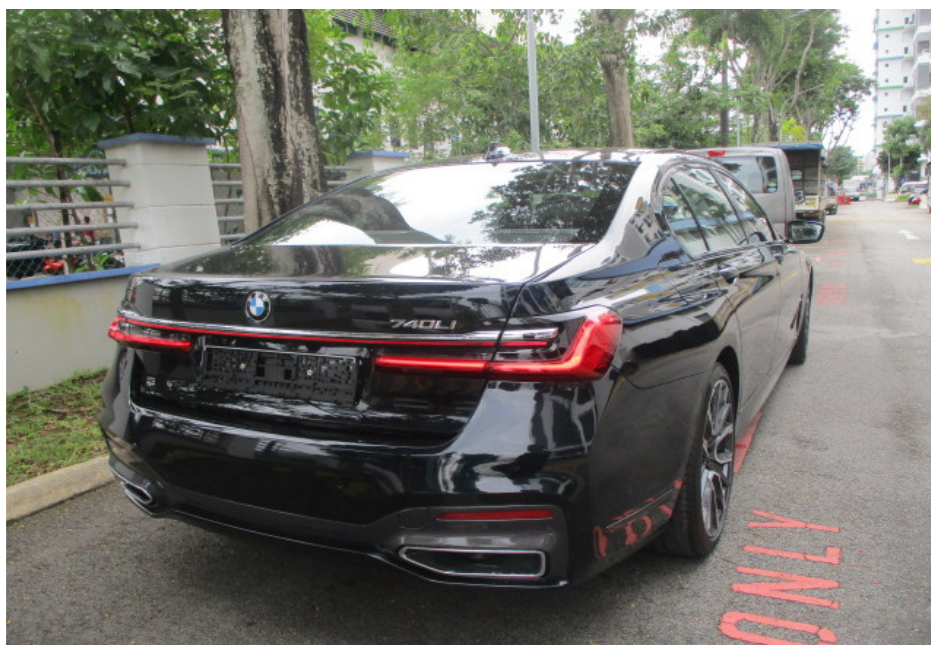
**Photo 3** shows a general view of the rear right body of the Motor Car at the time of my inspection. The Motor Car was observed to be in a relatively good general condition with no loose exterior fittings observed. The body parts at the rear right portion of the Motor Car were visually examined, and it was observed that the repair/restoration works carried out to the damaged area of the Motor Car (refer to photograph 1 & 2) were reasonably adequate and in order.

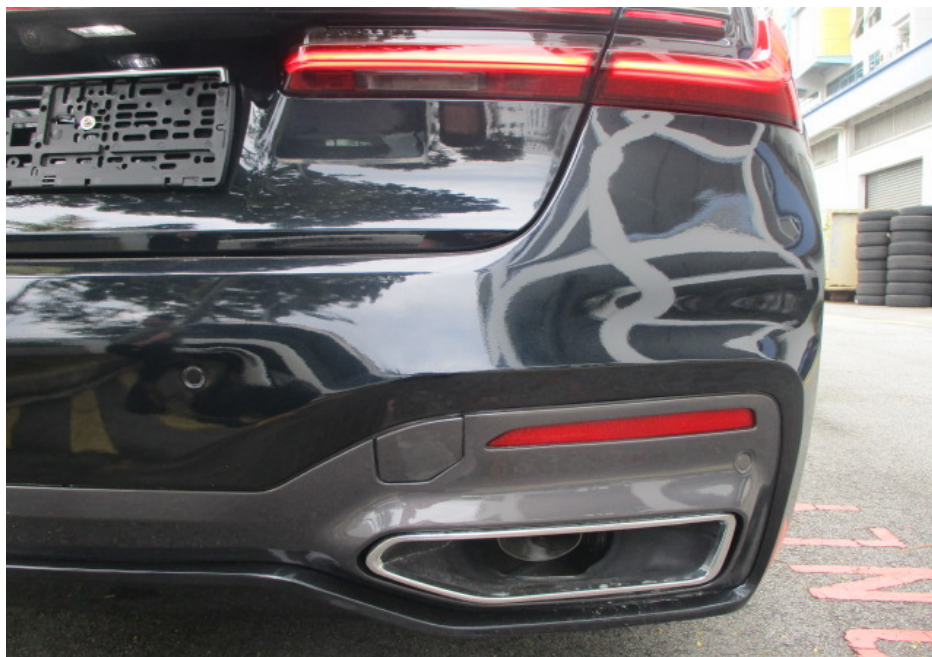
**Photo 4** shows a closer view of the Motor Car's rear bumper, rear bumper lower cover, rear right bootlid lamp and rear right taillamp. The body parts at the rear right portion of the Motor Car were visually examined, and it was observed that the repair/restoration works carried out to the damaged area of the Motor Car (refer to photograph 1 & 2 above) were reasonably adequate and in order.

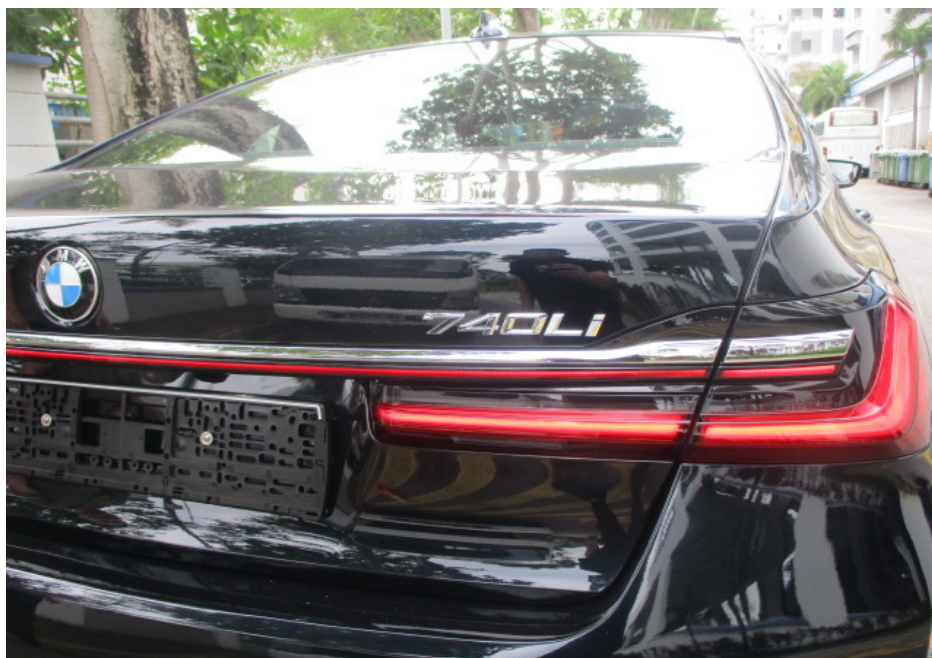
**Photo 5** shows a closer view of the Motor Car's rear bootlid, rear bootlid upper chrome moulding, rear bootlid upper reflector, rear right bootlid lamp and rear right taillamp. The body parts at the rear right portion of the Motor Car were visually examined, and it was observed that the repair/restoration works carried out to the damaged area of the Motor Car (refer to photograph 1 & 2 above) were reasonably adequate and in order.

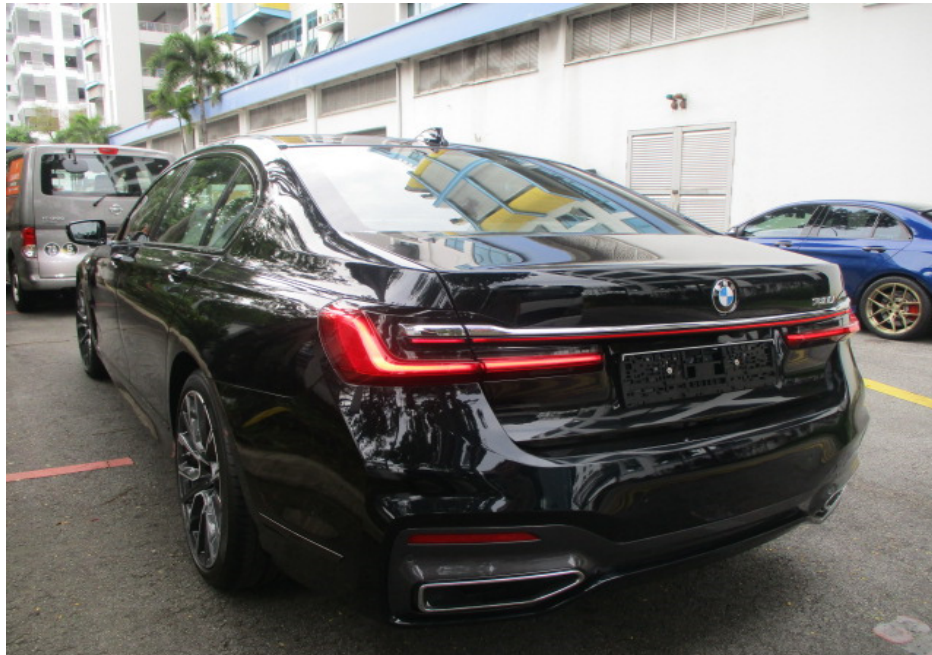
**Photo 6** shows a general view of the rear left body of the Motor Car at the time of my inspection. The Motor Car was observed to be in a relatively good general condition with no loose exterior fittings observed. The mileage of the Motor Car recorded at the time of my inspection was 11,198km.

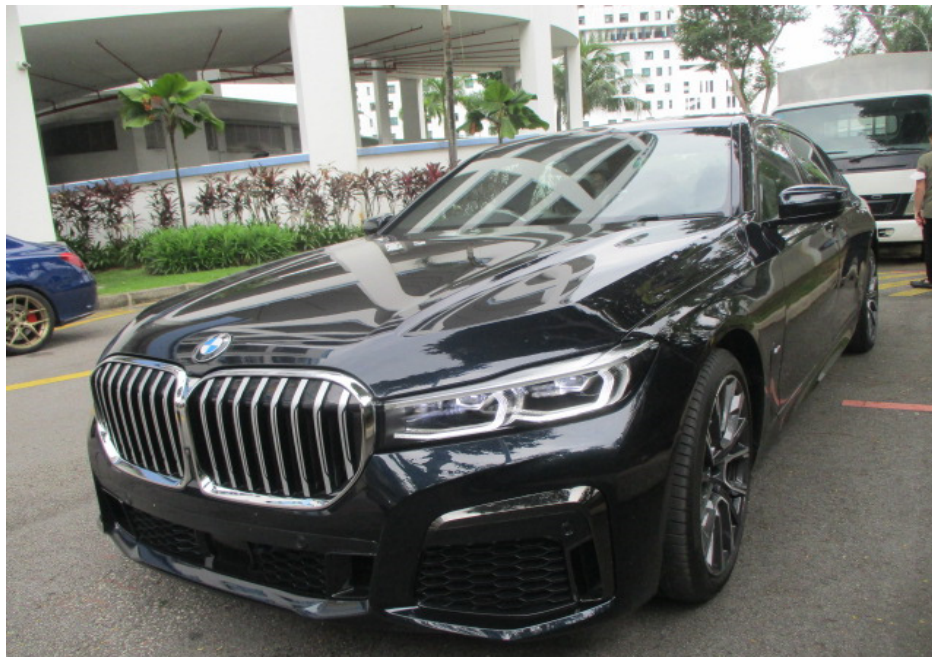
**Photo 7** shows a general view of the front left body of the Motor Car at the time of my inspection. The Motor Car was observed to be in a relatively good general condition with no loose exterior fittings observed. The mileage of the Motor Car recorded at the time of my inspection was 11,198km.

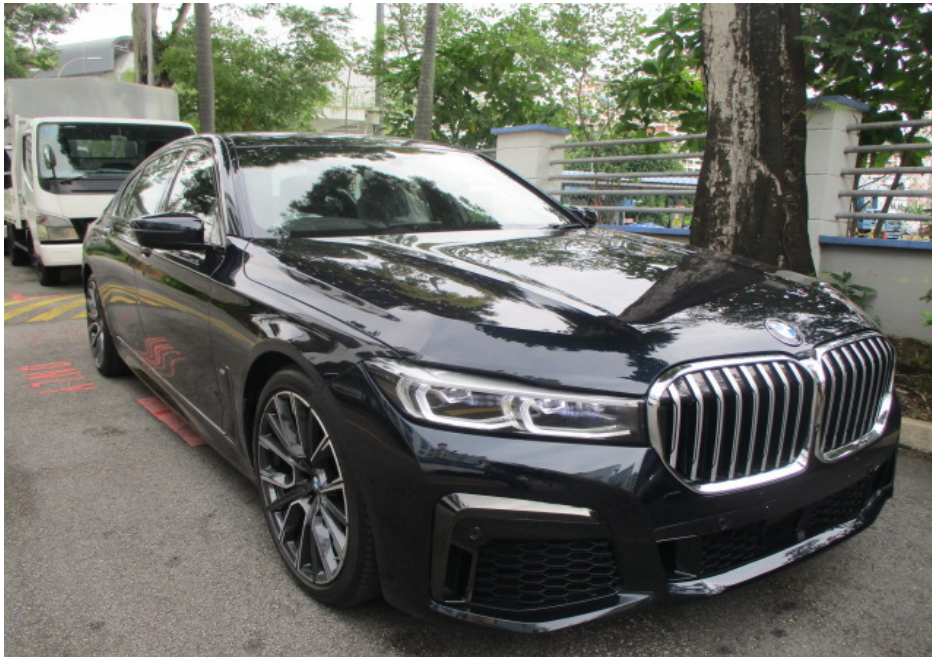
**Photo 8** shows a general view of the front right body of the Motor Car at the time of my inspection. The Motor Car was observed to be in a relatively good general condition with no loose exterior fittings observed. The mileage of the Motor Car recorded at the time of my inspection was 11,198km.

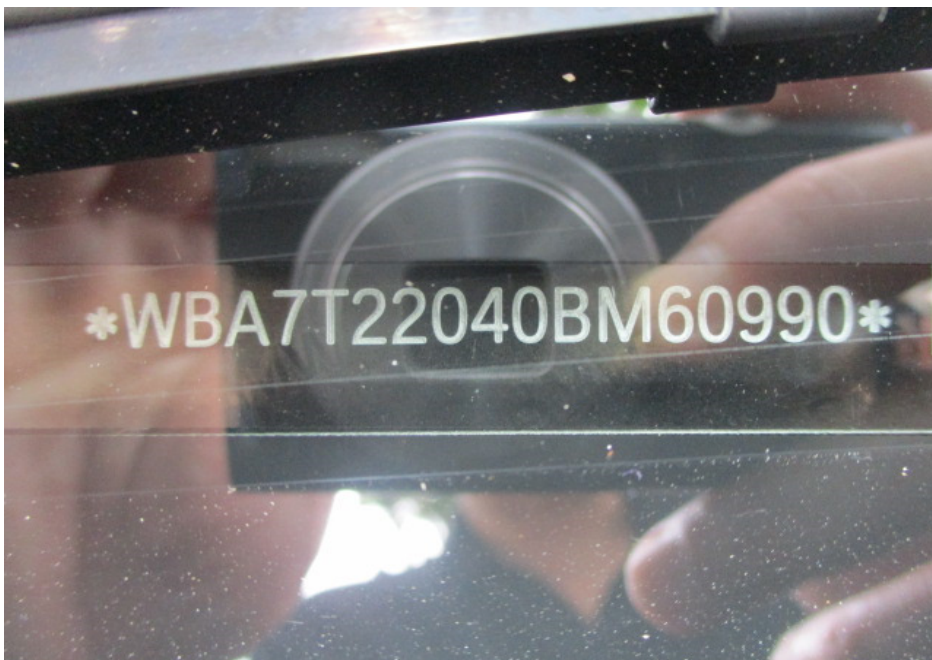
**Photo 9** shows the chassis number of the Motor Car. The chassis number recorded was WBA7T22040BM60990.

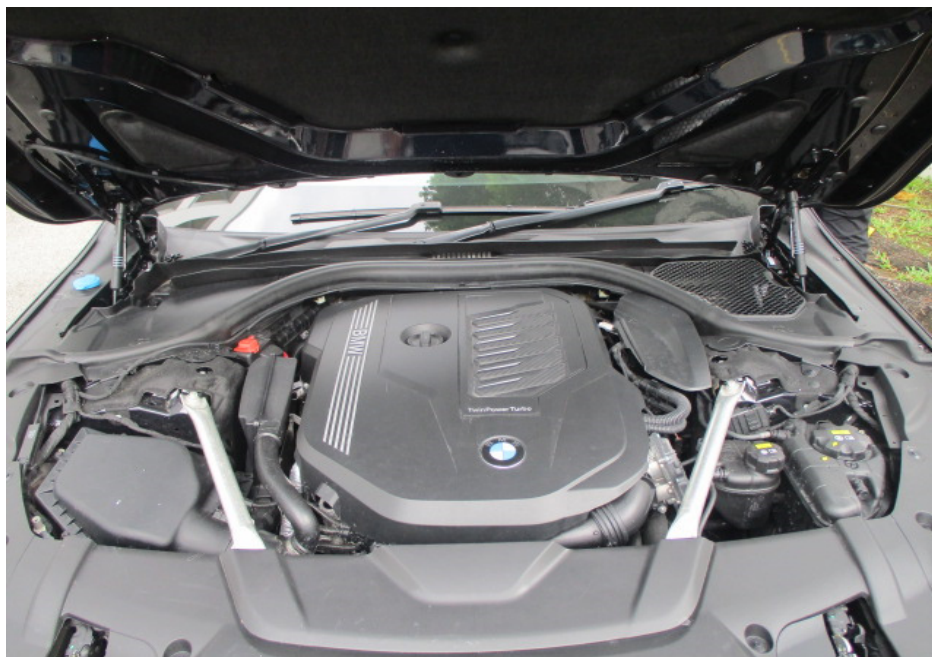
**Photo 10** shows a general view of the engine compartment of the Motor Car at the time of my inspection. The various parts and components inside the engine compartment were all observed to be intact and properly fitted. There was also no sign(s) or indication(s) of fluid leak and/or fluid stain found inside the engine compartment.

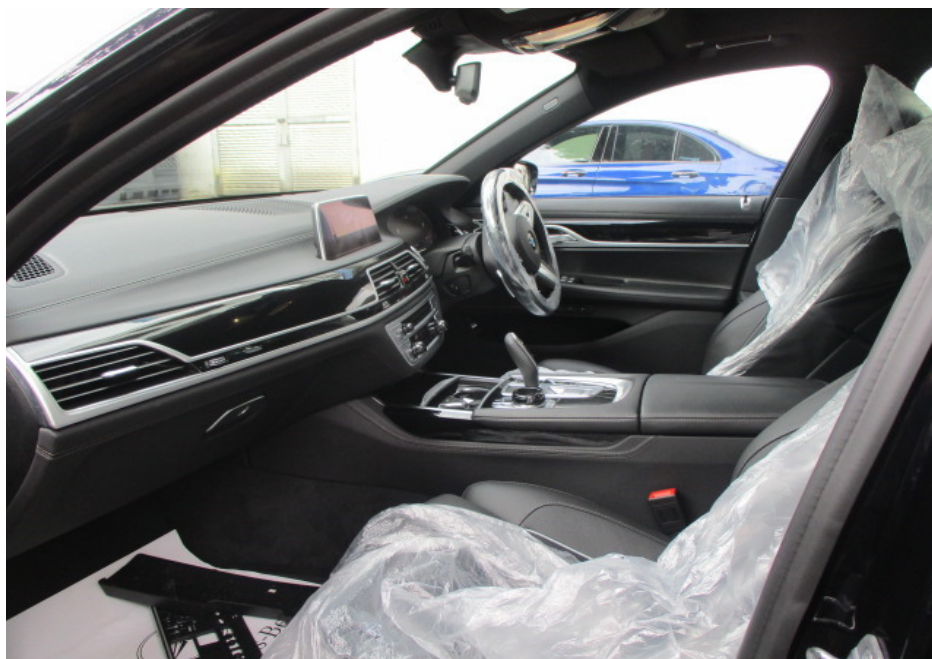
**Photo 11** shows the interior compartment of the Motor Car at the time of my inspection. The various parts and components, trims, carpet and upholstery inside the interior compartment were all observed to be intact and properly fitted.

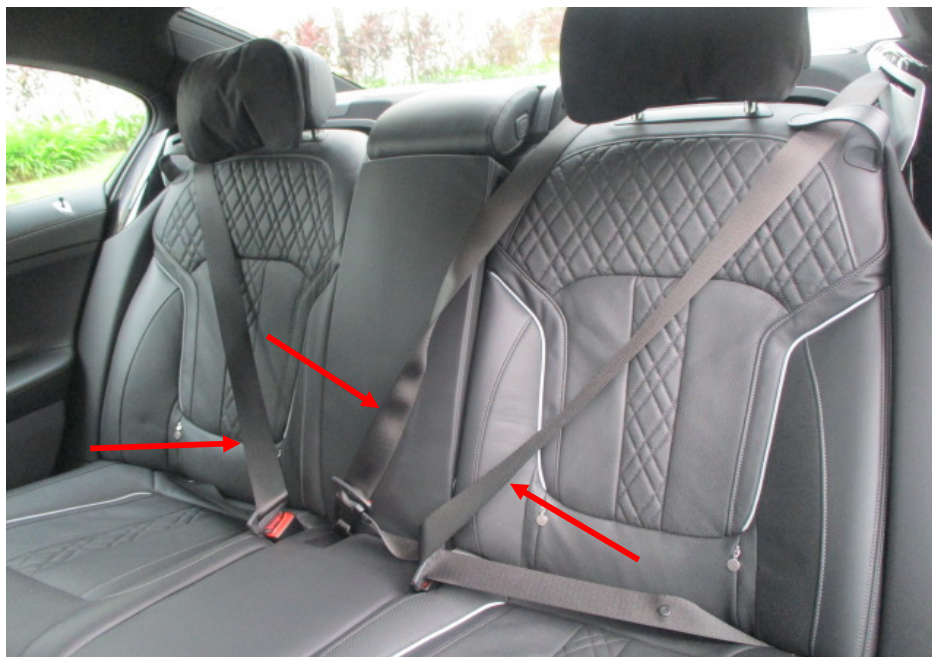
**Photo 12** shows the rear seats of the Motor Car. All the seats of the Motor Car were secured via seat rails to the floorboard. They were also fitted with a retractable seat belt reel and a pre-tensioner. The seat belts (arrowed) were tested and were able to be fastened into the respective pre-tensions that were fitted on the side of each individual seat.

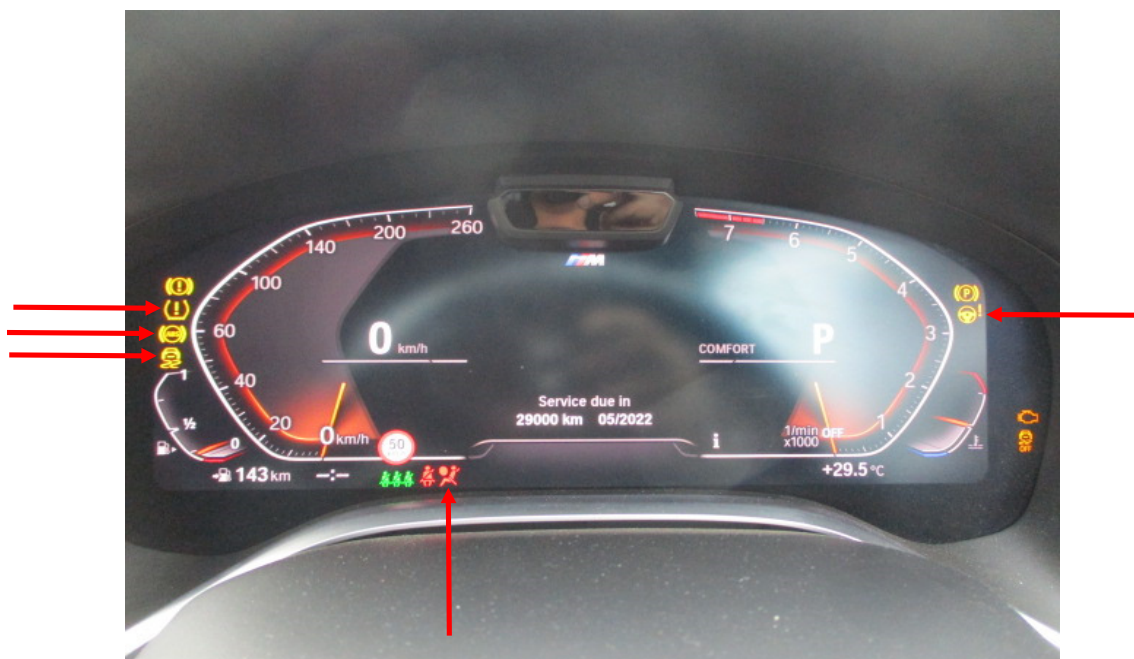
**Photo 13** shows the warning lights for the various electronic safety features appearing on the instrument panel of the Motor Car during its self-test when the engine is cranked, in particular the ABS, SRS, IAS, TPM and DSC lights (arrowed).

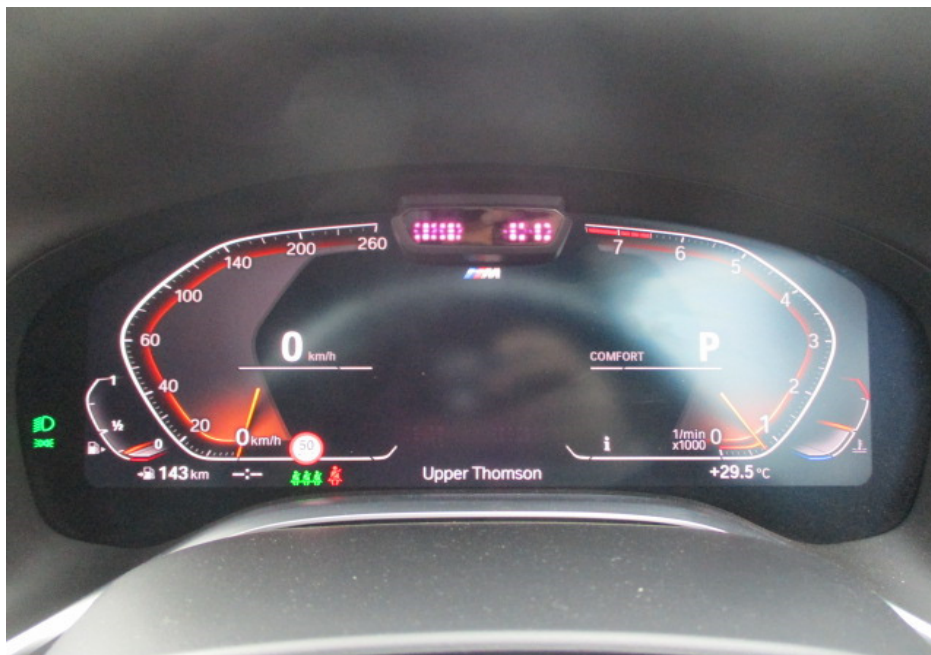
**Photo 14** shows the respective warning lights no longer illuminated, indicating that there is no fault detected to the ABS, SRS, IAS, TPM and DSC systems of the Motor Car during the self-test. These electronic systems were hence in working condition at the time of my inspection.

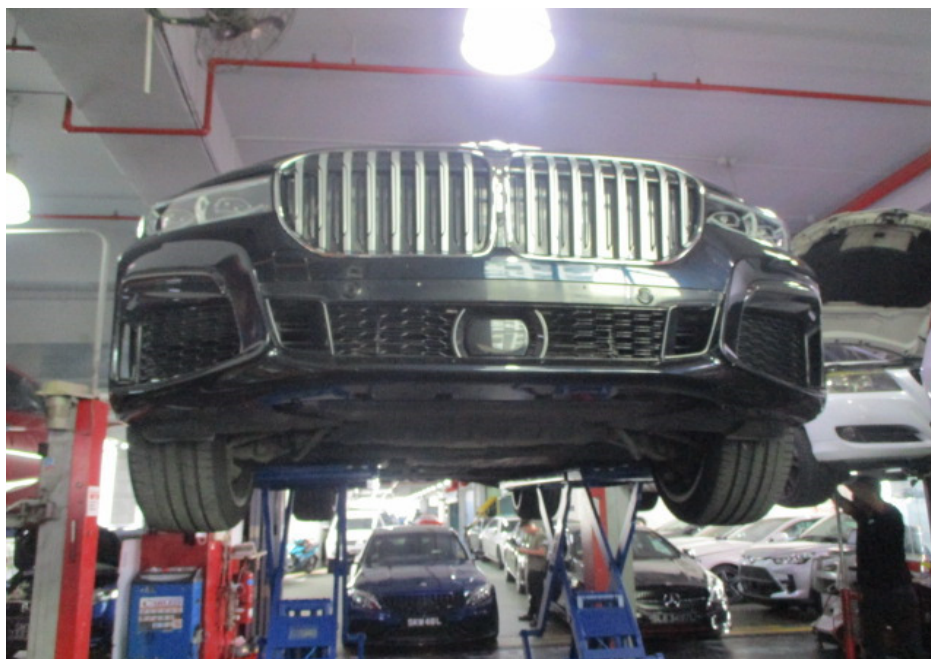
**Photo 15** shows the Motor Car hoisted up for checks on its undercarriage. There was no sign(s) or indication(s) of fluid leakage and/or fluid stain(s) on the underside of the Motor Car. The undercarriage components of the Motor Car were also all observed to be intact and secured in an appropriate manner.

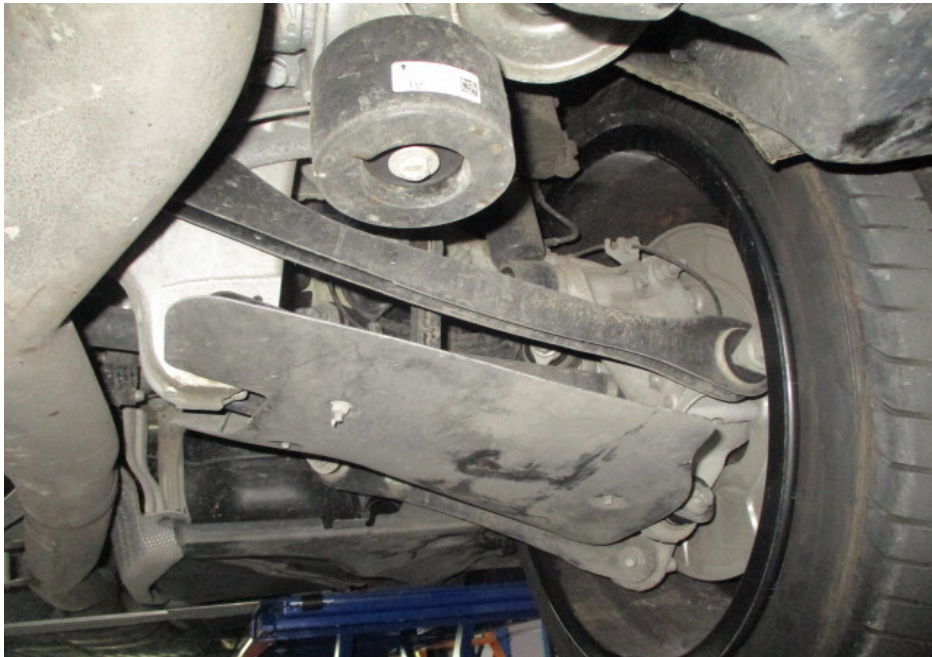
**Photo 16** shows a general view of the control arms and linkages at the rear right wheel of the Motor Car. I did not observe any fluid leak and/or fluid stain on the underside of the Motor Car. All of the Motor Car's undercarriage components were observed to be intact and secured in an appropriate manner.

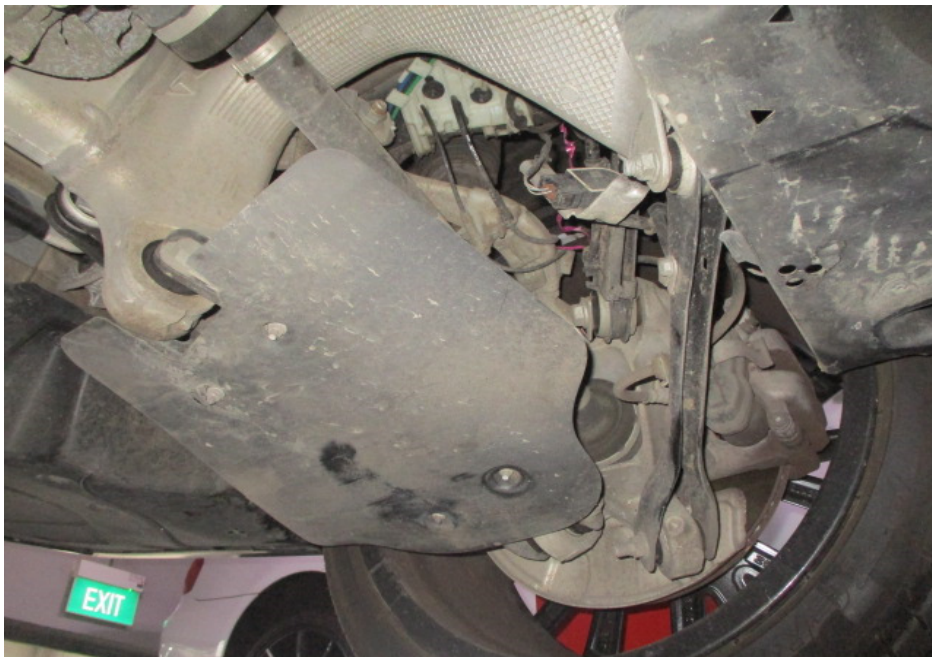
**Photo 17** shows a general view of the control arms and linkages at the rear left wheel of the Motor Car. I did not observe any fluid leak and/or fluid stain on the underside of the Motor Car. All of the Motor Car's undercarriage components were observed to be intact and secured in an appropriate manner.

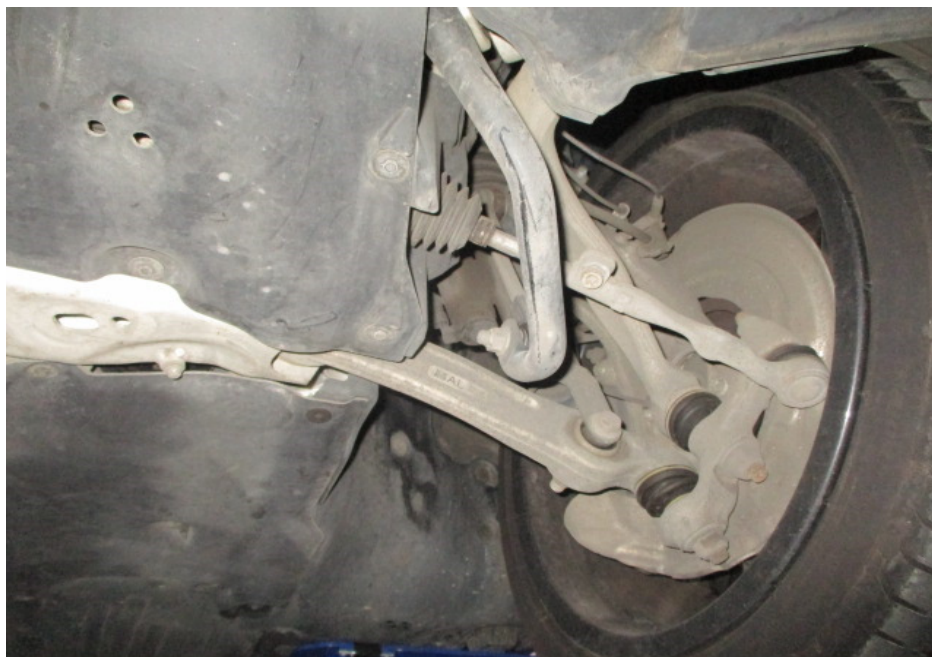
**Photo 18** shows the various undercarriage components at the front left wheel of the Motor Car. The mechanical components, control arms and linkages were all found to be intact and secured in an appropriate manner.

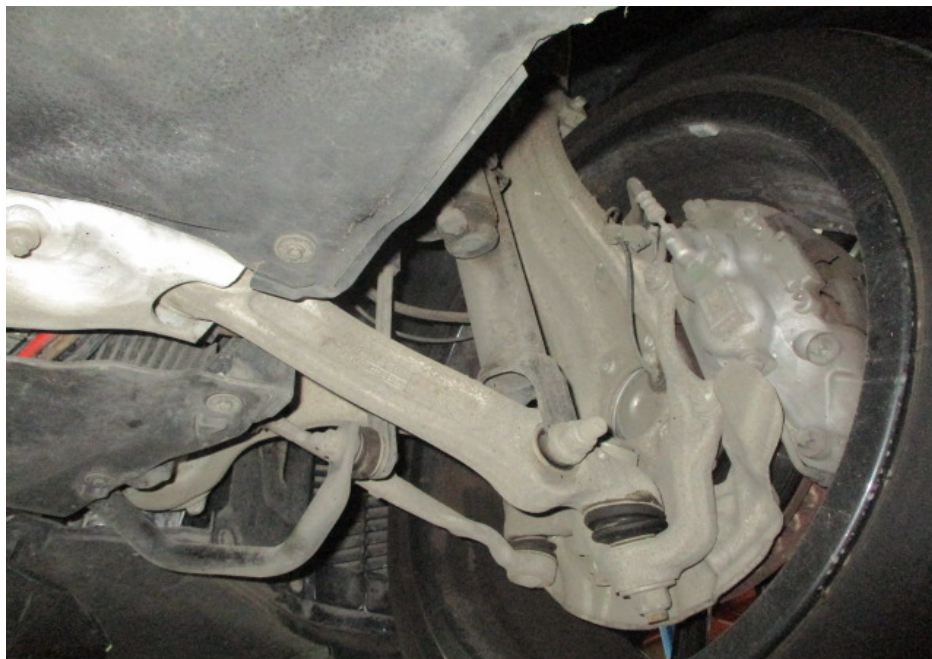
**Photo 19** shows the various undercarriage components at the front right wheel of the Motor Car. The mechanical components, control arms and linkages were all found to be intact and secured in an appropriate manner. I also did not observe any fluid leak and/or fluid stain on the underside of the Motor Car.

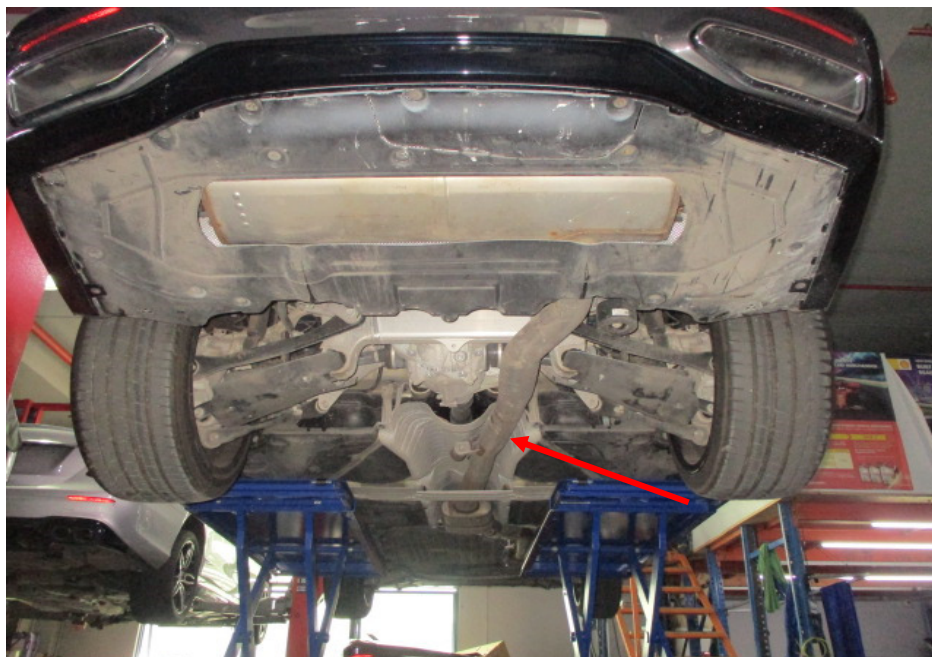
**Photo 20** shows a general view of the rear section of the Motor Car's exhaust system. My examination of the Motor Car's exhaust system revealed no sign(s) or indication(s) of any cut or weld marks along its exhaust pipes (arrowed), on its centre resonator box, on its catalytic converter and on its rear muffler.

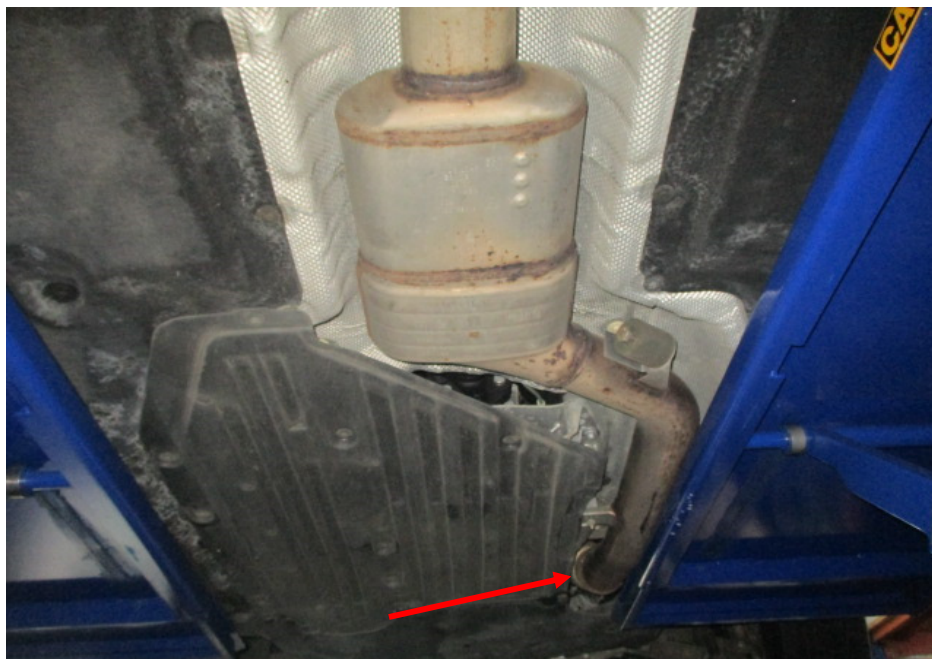
**Photo 21** shows a general view of the front section of the Motor Car's exhaust system. My examination of the Motor Car's exhaust system revealed no sign(s) or indication(s) of any cut or weld marks along its exhaust pipes, on its centre resonator box, on its catalytic converter (arrowed) and on its rear muffler.

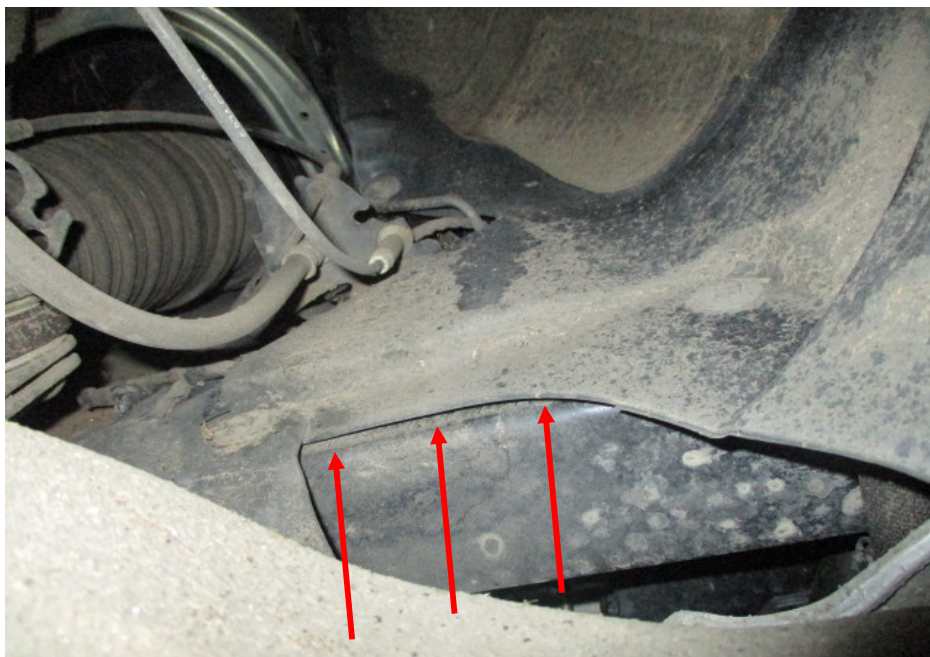
**Photo 22** shows the chassis/structural body at the underside front right of the Motor Car. I did not find any weld marks other than original spot weld marks on the chassis/structural body of the Motor Car. The original factory sealant (arrowed) at the joints along the chassis/structural body was untouched, indicating no work was done on the chassis/structural body of the Motor Car and that the chassis/structural body was originally fitted.

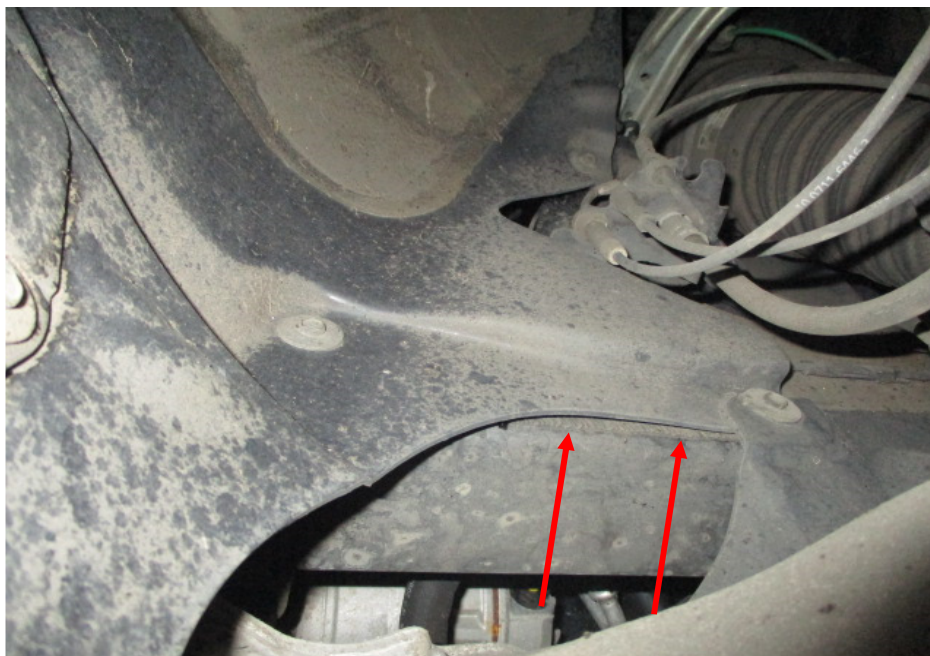
**Photo 23** shows the chassis/structural body at the underside front left of the Motor Car. The original factory sealant (arrowed) at the joints along the chassis/structural body was observed to be untouched. In general, I had found no work was carried out on the chassis/structural body of the Motor Car. The chassis/structural body of the Motor Car was originally fitted.

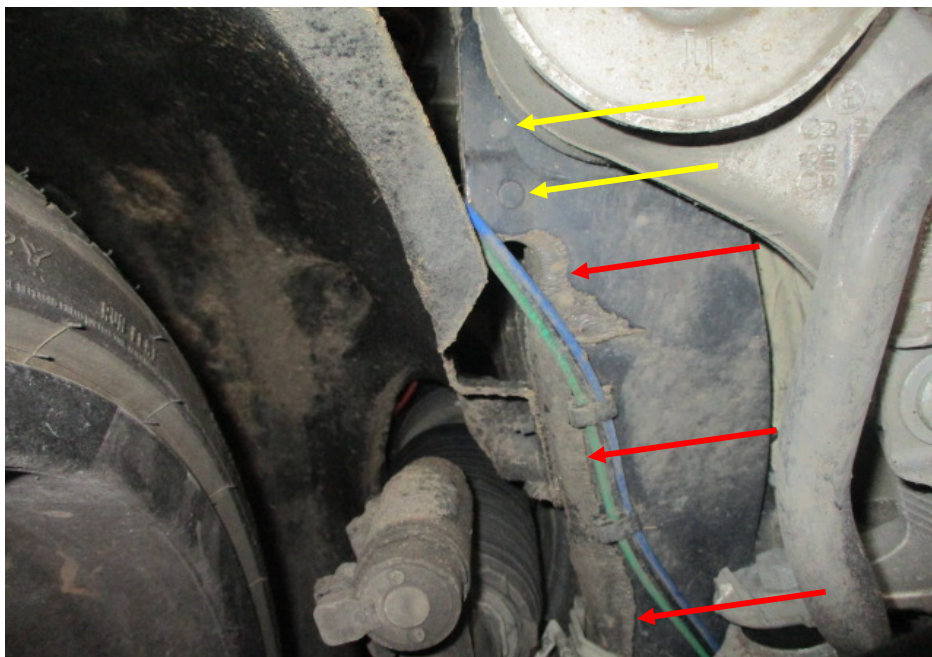
**Photo 24** shows the chassis/structural body at the underside rear left of the Motor Car. I did not find any weld marks other than original spot weld marks (yellow arrow) on the chassis/structural body of the Motor Car. The original factory sealant (red arrow) at the joints along the chassis/structural body was untouched, indicating no work was done on the chassis/structural body of the Motor Car and that the chassis/structural body was originally fitted.

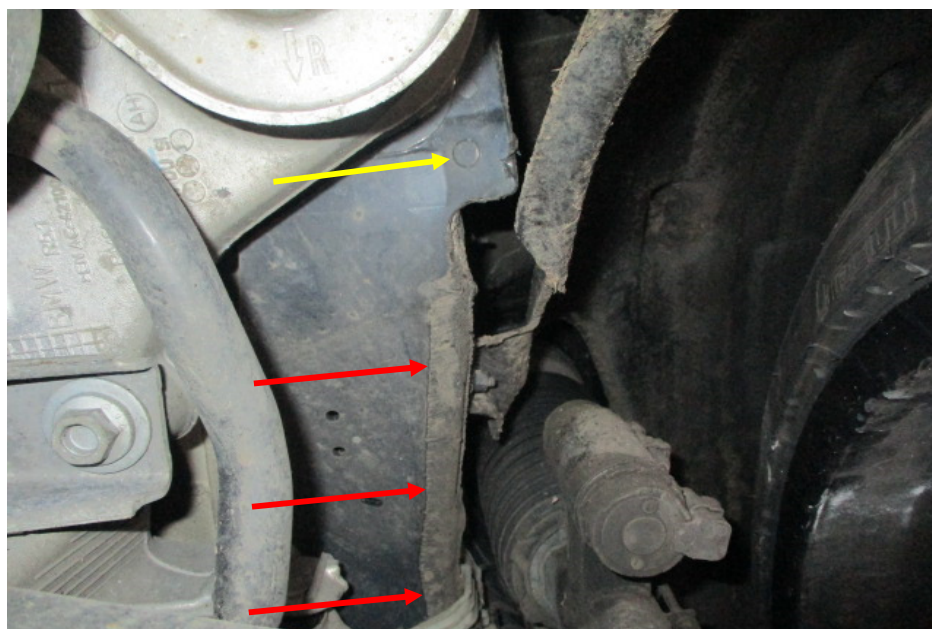
**Photo 25** shows the chassis/structural body at the underside rear right of the Motor Car. I did not find any weld marks other than original spot weld marks (yellow arrow) on the chassis/structural body of the Motor Car. The original factory sealant (red arrow) at the joints along the chassis/structural body was untouched, indicating no work was done on the chassis/structural body of the Motor Car and that the chassis/structural body was originally fitted.

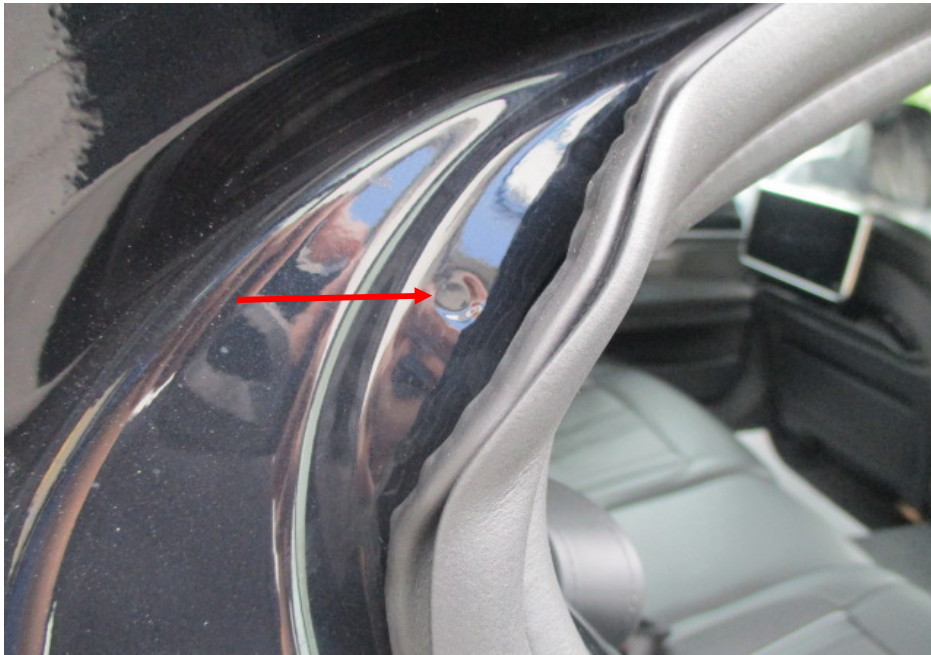
**Photo 26** shows the right side "C" pillar of the Motor Car. I did not find any weld marks other than original spot weld marks (arrowed) on the right side "C" pillar of the Motor Car which, indicates that there was no re-welding works carried out. In general, I had found all the non-detachable body panels of the Motor Car to be originally fitted at the time of my inspection.

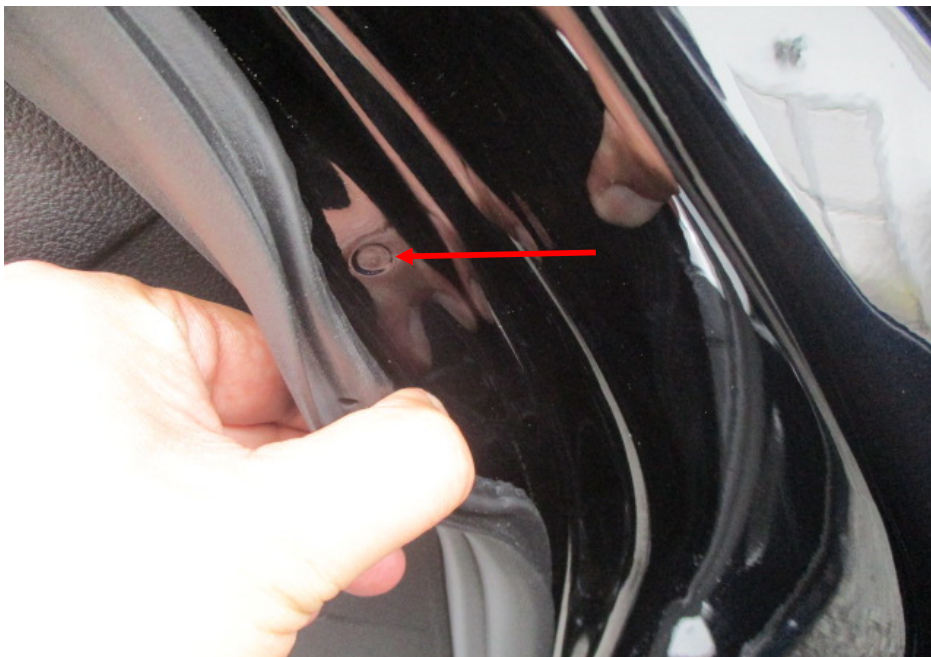
**Photo 27** shows the right side "A" pillar of the Motor Car. I did not find any weld marks other than original spot weld marks (arrowed) on the right side "A" pillar of the Motor Car which, indicates that there was no re-welding works carried out. In general, I had found all the non-detachable body panels of the Motor Car to be originally fitted at the time of my inspection.

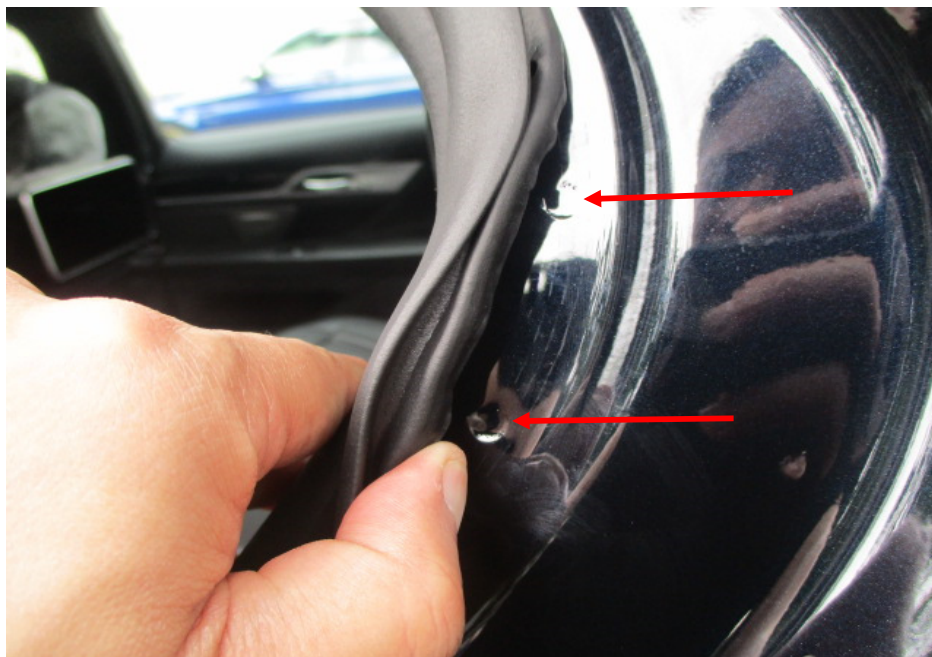
**Photo 28** shows the left side "C" pillar of the Motor Car. I did not find any weld marks other than original spot weld marks (arrowed) on the left side "C" pillar of the Motor Car which, indicates that there was no re-welding works carried out. In general, I had found all the non-detachable body panels of the Motor Car to be originally fitted at the time of my inspection.
