Your Ref: Audi S4  
(chassis number WAUZZZF4XLA058446)  
Our Ref : CI/TP21010542/D

**ST Powered Motoring Pte Ltd**  
128 Woodlands Industrial Park E5  
Singapore 757851

**INSPECTION REPORT OF AN UNREGISTERED AUDI S4 MOTOR CAR WITH CHASSIS NUMBER WAUZZZF4XLA058446**

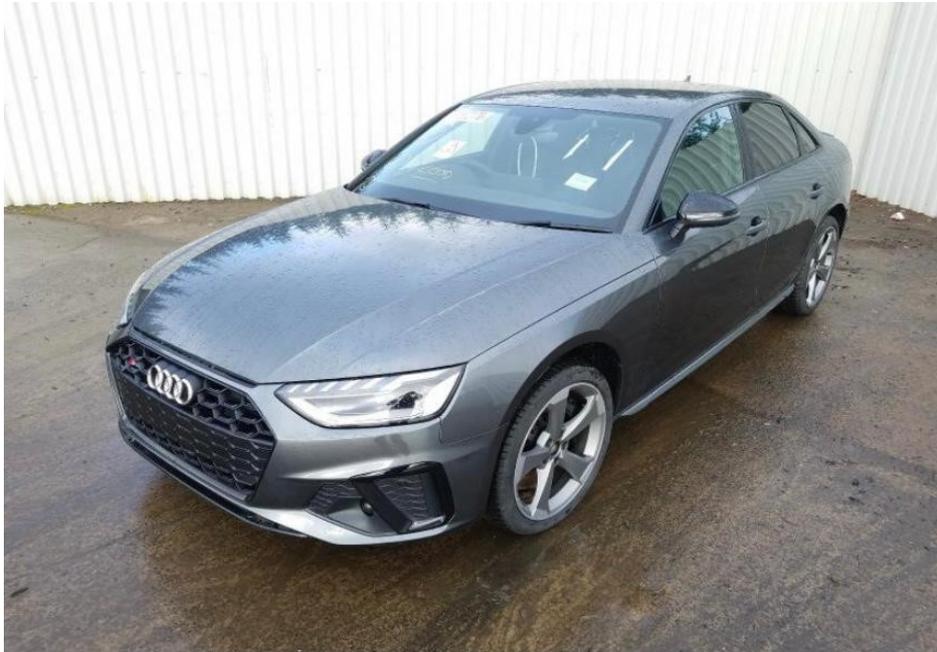
**Photo 1** shows the front left body of the Motor Car (photograph provided to me). The Motor Car did not appear to have sustained any physical damage as seen from the photographs that were provided to me. The airbags were also not deployed.

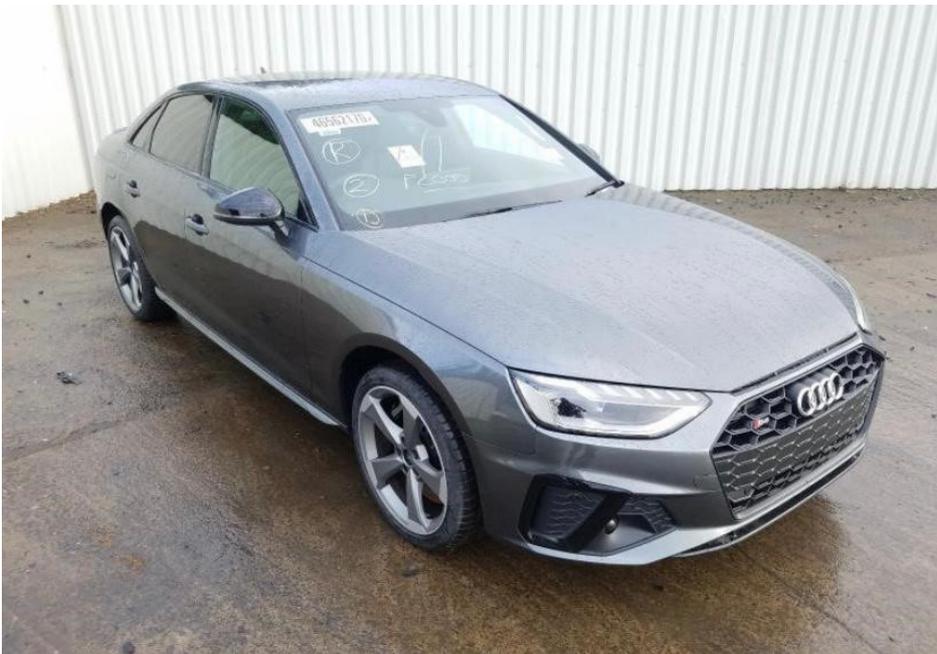
**Photo 2** shows the front right body of the Motor Car (photograph provided to me). The Motor Car did not appear to have sustained any physical damage as seen from the photographs that were provided to me. The airbags were also not deployed.

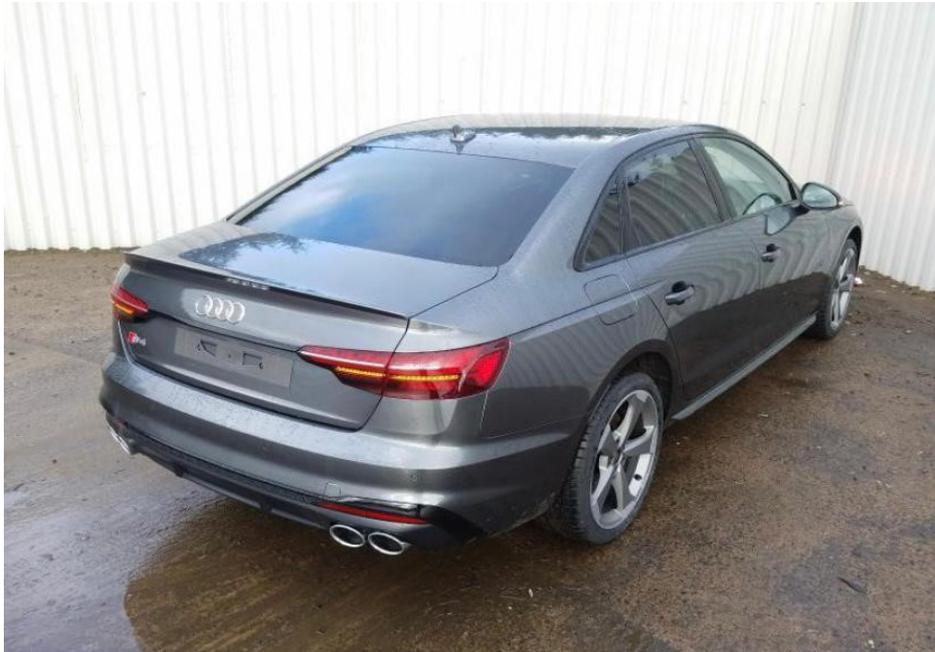
**Photo 3** shows the rear right body of the Motor Car (photograph provided to me). The Motor Car did not appear to have sustained any physical damage as seen from the photographs that were provided to me. The airbags were also not deployed.

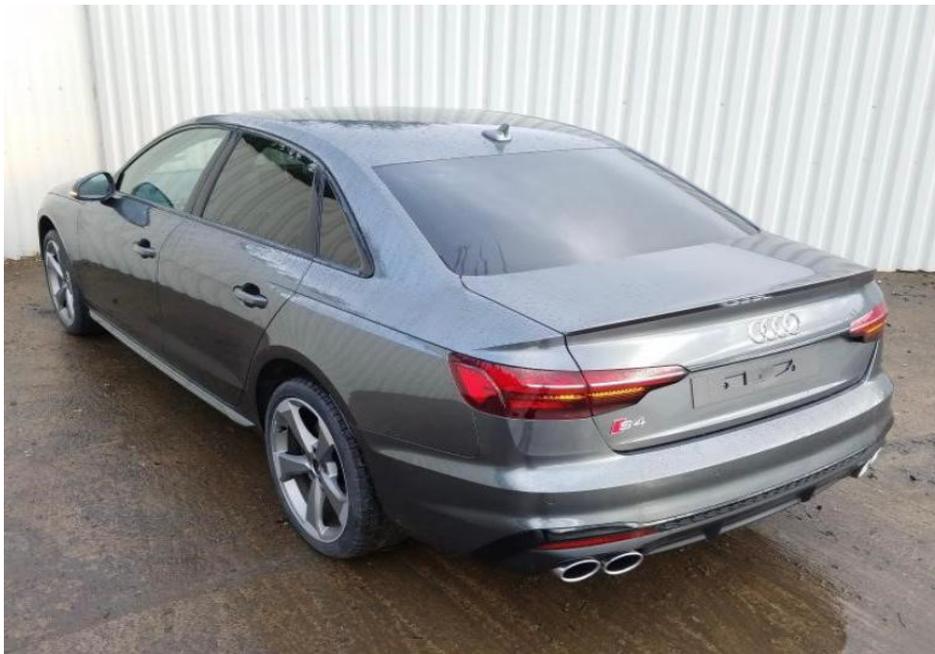
**Photo 4** shows the rear left body of the Motor Car (photograph provided to me). The Motor Car did not appear to have sustained any physical damage as seen from the photographs that were provided to me. The airbags were also not deployed.

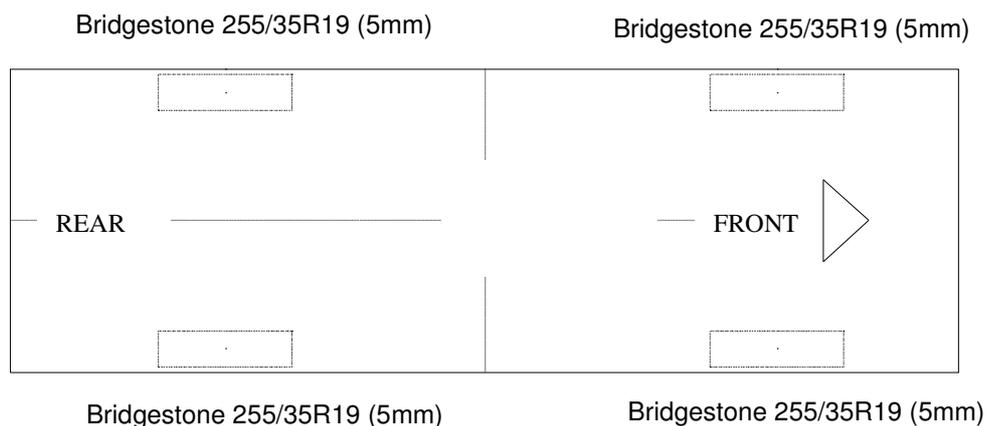
- It was fitted with 19inch sport wheel rims that were wrapped with tyres that were observed to be of serviceable condition. The tyres were also sufficiently inflated for vehicular operation. The tyre brand, tyre size and approximate remaining tread depth of the 4 tyres of the Motor Car were recorded as follows: -

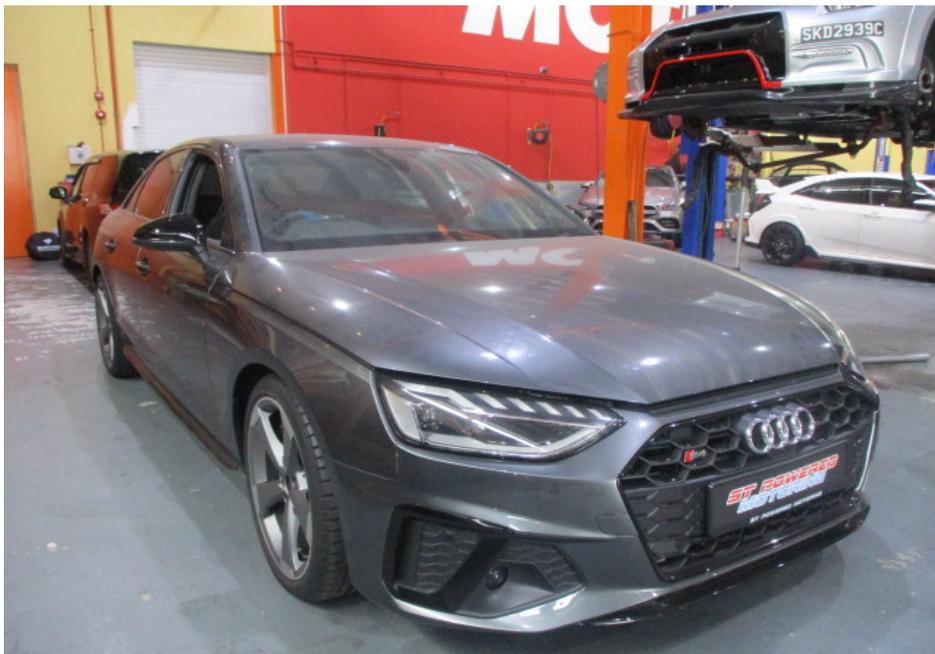
**Photo 5** shows a general view of the front right body of the Motor Car at the time of my inspection. The Motor Car was observed to be in a relatively good general condition with no loose exterior fittings observed. The mileage of the Motor Car recorded at the time of my inspection was 120km.

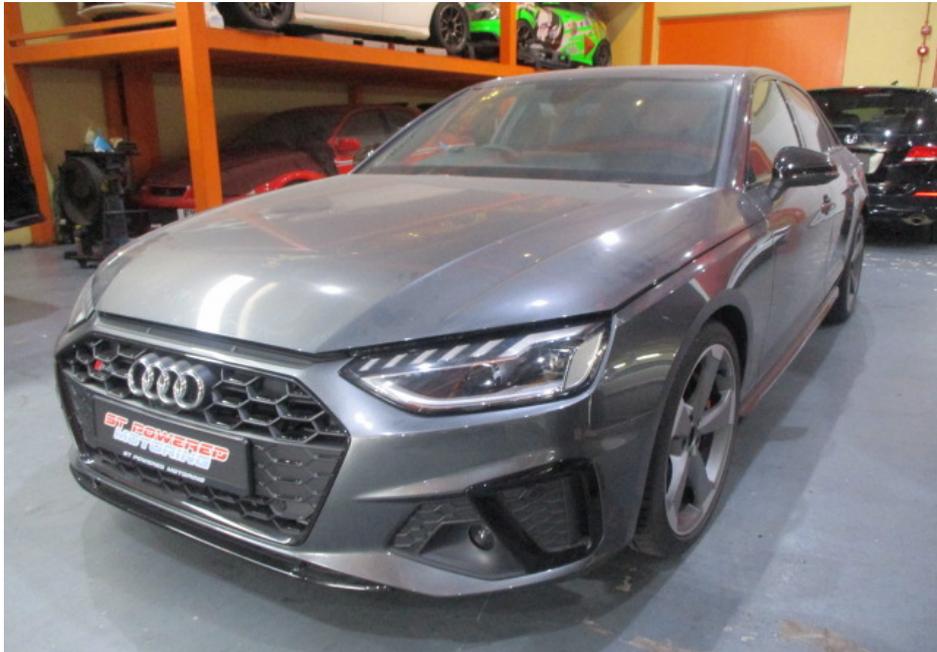
**Photo 6** shows a general view of the front left body of the Motor Car at the time of my inspection. The Motor Car was observed to be in a relatively good general condition with no loose exterior fittings observed. The mileage of the Motor Car recorded at the time of my inspection was 120km.

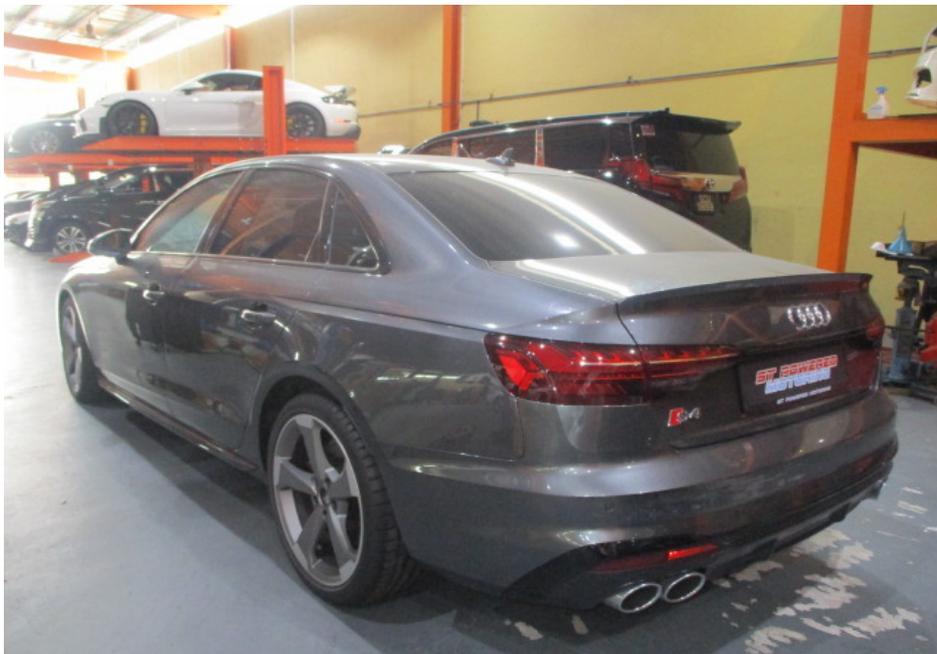
**Photo 7** shows a general view of the rear left body of the Motor Car at the time of my inspection. The Motor Car was observed to be in a relatively good general condition with no loose exterior fittings observed. The mileage of the Motor Car recorded at the time of my inspection was 120km.

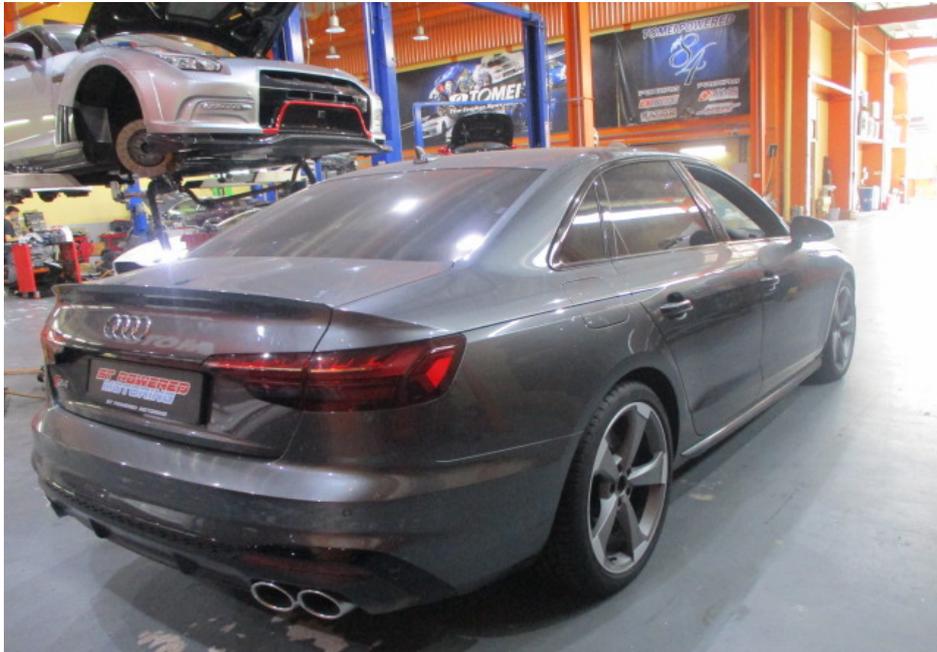
**Photo 8** shows a general view of the rear right body of the Motor Car at the time of my inspection. The Motor Car was observed to be in a relatively good general condition with no loose exterior fittings observed. The mileage of the Motor Car recorded at the time of my inspection was 120km.

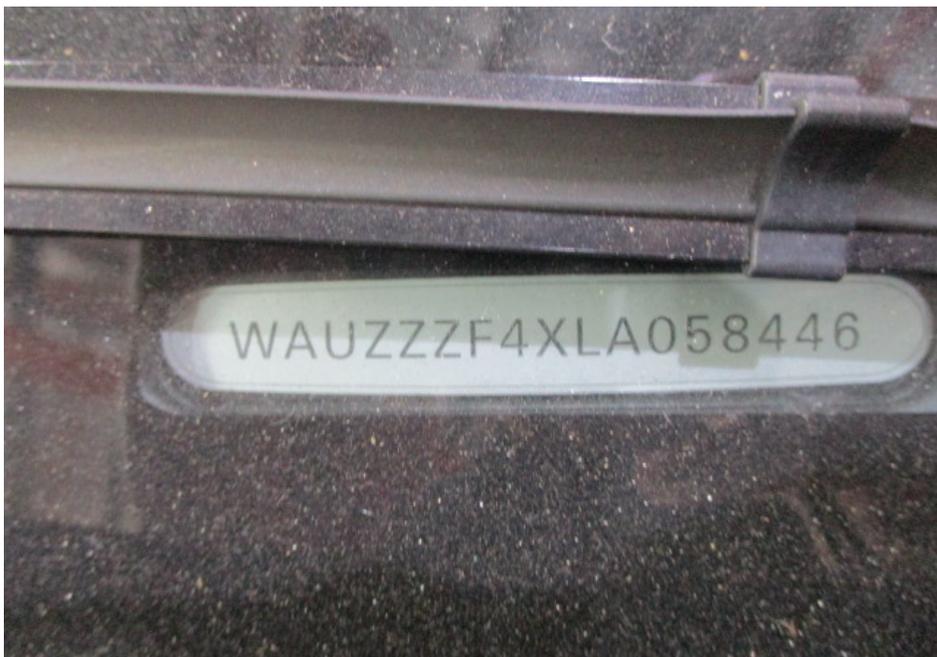
**Photo 9** shows the chassis number of the Motor Car. The chassis number recorded was WAUZZZF4XLA058446.

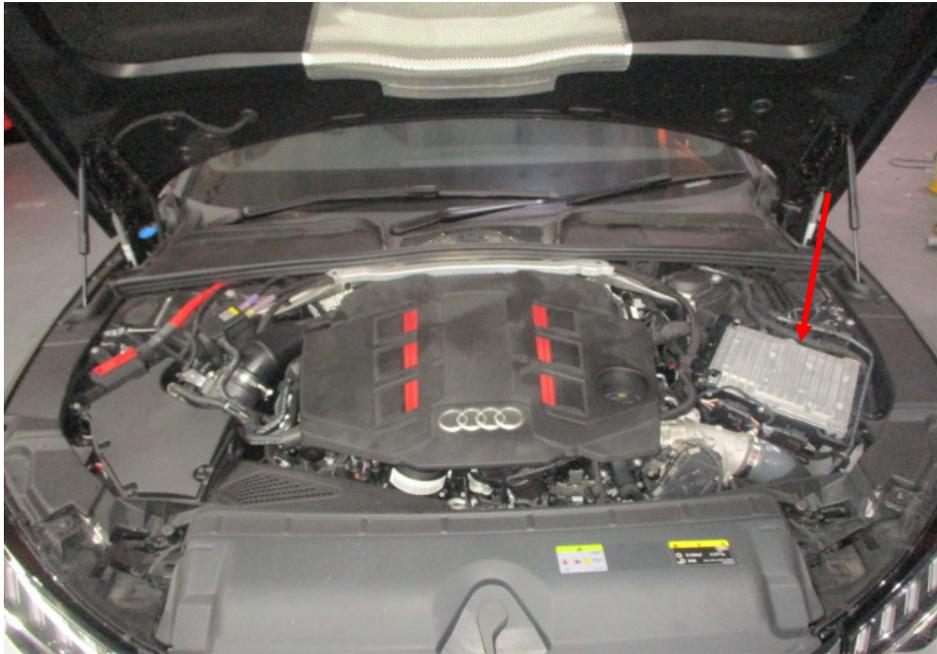
13. My examination of the engine compartment of the Motor Car revealed that the various parts and components inside the engine compartment were all intact and properly fitted. The engine oil, brake fluid and engine coolant were all found to be of sufficient level for operating purposes. Visually, there was also no contamination found to these fluids.

**Photo 10** shows a general view of the engine compartment of the Motor Car at the time of my inspection. The various parts and components inside the engine compartment were all observed to be intact and properly fitted. There was no sign(s) or indication(s) of fluid leak and/or fluid stain found inside the engine compartment. The Engine Control Module (arrowed) was checked and found to be without any signs of removal.

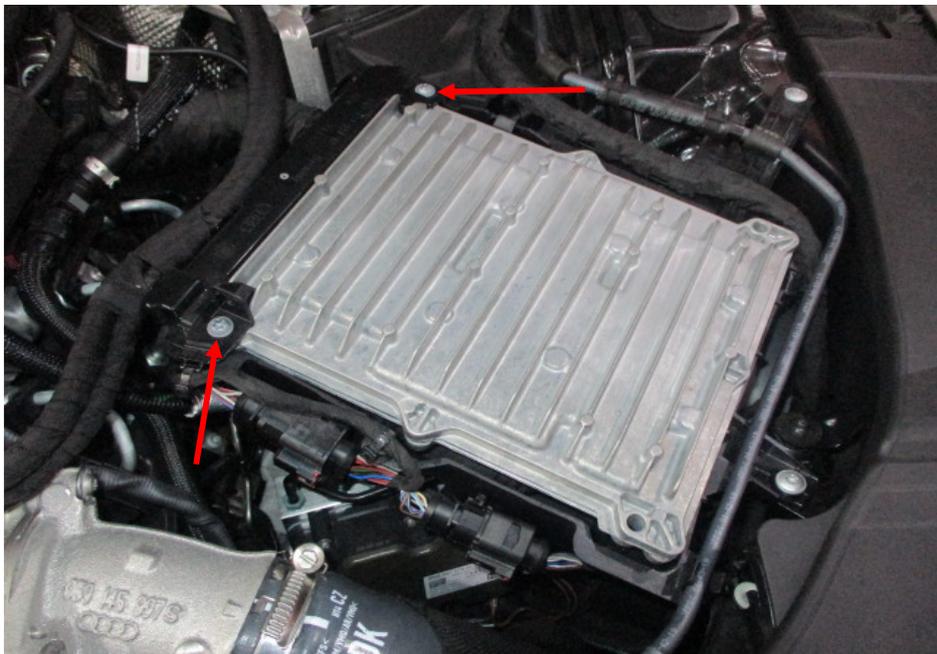
**Photo 11** shows a closer view of the Engine Control Module of the Motor Car. The screws (arrowed) holding the Engine Control Module onto its bracket were found to be without signs of removal, which would suggest that the Engine Control Module of the Motor Car was an originally fitted unit with no work carried out on it.

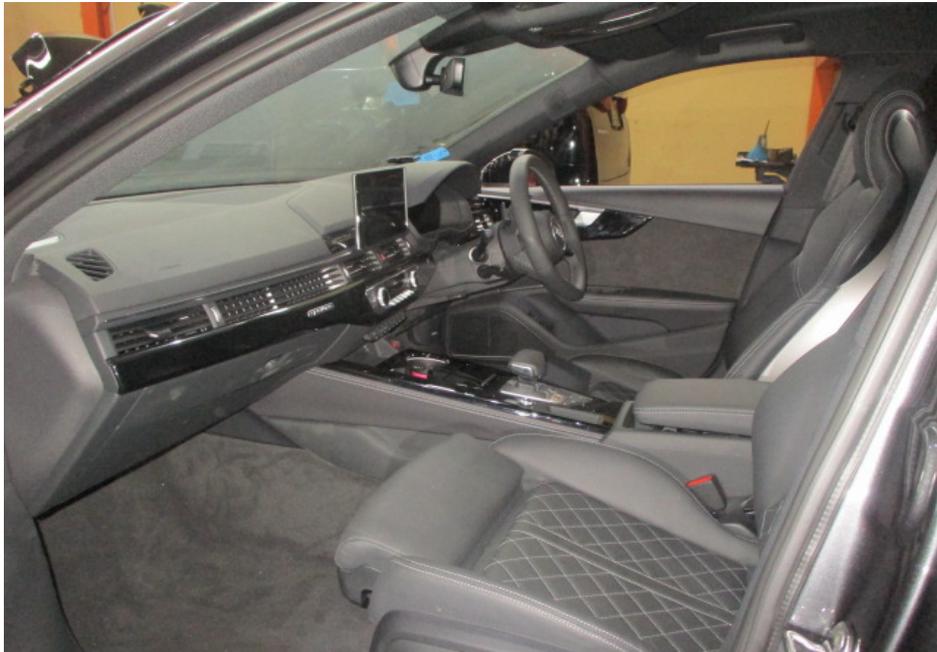
**Photo 12** shows the interior compartment of the Motor Car at the time of my inspection. The various parts and components, trims, carpet, and upholstery inside the interior compartment were all observed to be intact and properly fitted.

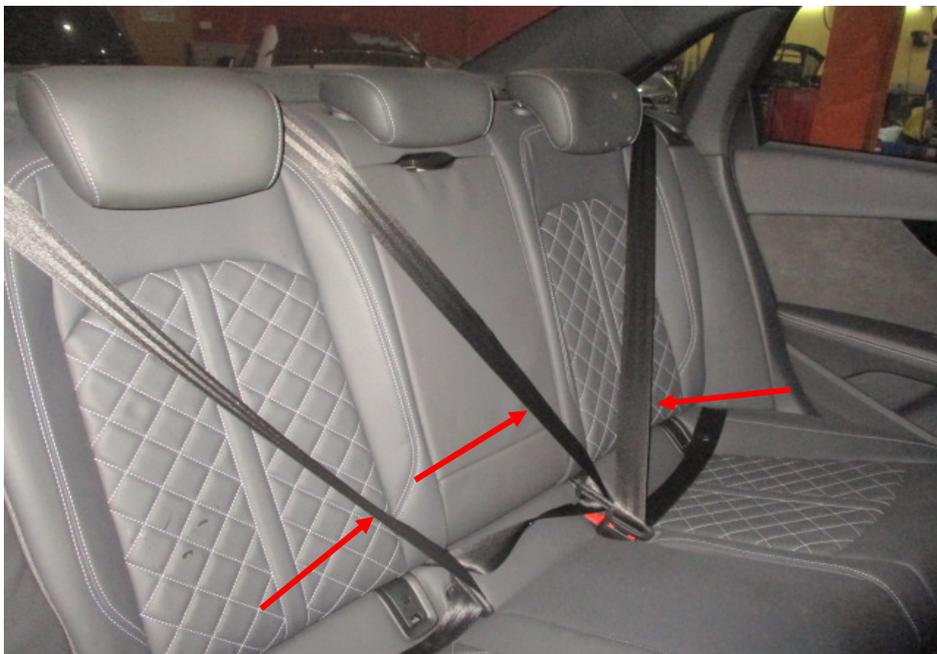
11. The seats of the Motor Car were found to be secured to the floorboard of the Motor Car via seat rails bolted onto the floorboard. Retractable seat belt reels and pre-tensioners were fitted on all seats of the Motor Car. The seat belts were tested and were able to be fastened securely into the respective pre-tensioners that were fixed to the side of all the seats.

**Photo 13** shows the rear seats of the Motor Car. All the seats of the Motor Car were secured via seat rails to the floorboard. They were also fitted with a retractable seat belt reel and a pre-tensioner. The seat belts (arrowed) were tested and were able to be fastened into the respective pre-tensions that were fitted on the side of each individual seat.

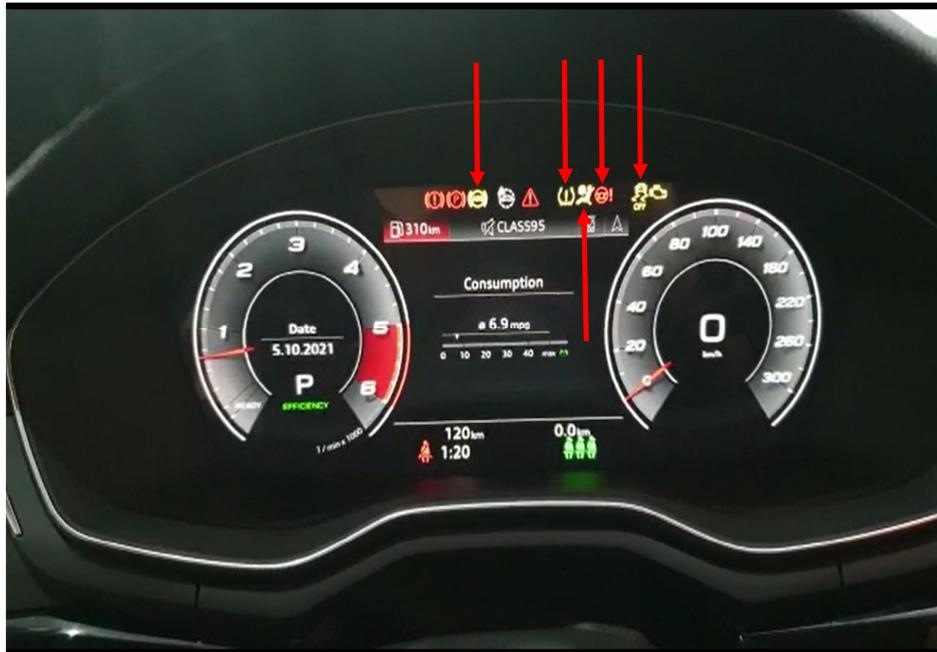
**Photo 14** shows the warning lights for the various electronic safety features appearing on the instrument panel of the Motor Car during its self-test when the engine is cranked, in particular the ABS, SRS, EPS, TPM and ESC lights (arrowed).

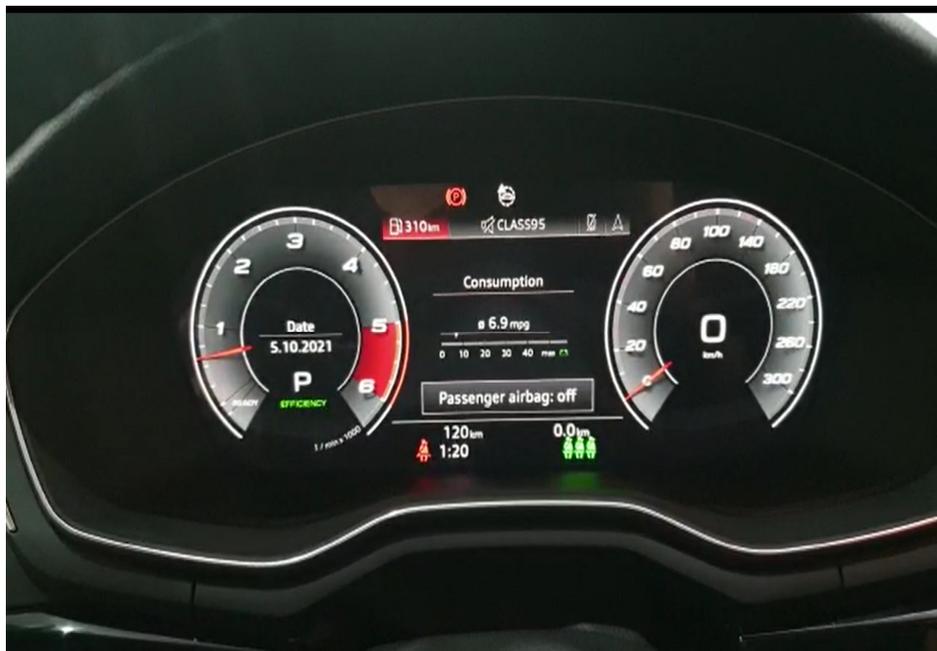
12. The Motor Car's automatic self-test of the functionality of its various electronic safety features like the Anti-Lock Brake System (ABS), Supplemental Restraint System (SRS), Electronic Power Steering (EPS), Tyre Pressure Monitor (TPM) and Electronic Stability Control (ESC) during cranking of the engine had indicated that these electronic systems were in working condition. This was determined from the respective warning lights disappearing from the instrument panel after the self-test.

**Photo 15** shows the respective warning lights no longer illuminated, indicating that there is no fault detected to the ABS, SRS, EPS, TPM and ESC systems of the Motor Car during the self-test. These electronic systems were hence in working condition at the time of my inspection.

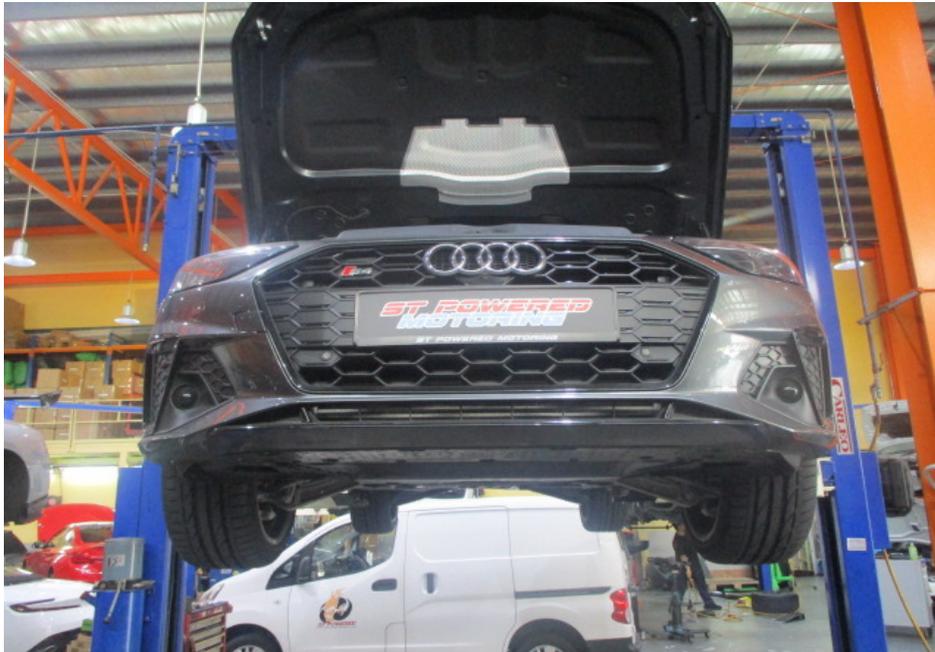
14. My checks on the underside of the Motor Car revealed no sign(s) or indication(s) of fluid leakage and/or fluid stain(s). The engine block and automatic transmission assembly were both secured properly. All undercarriage components of the Motor Car were also observed to be intact and secured in an appropriate manner.

**Photo 16** shows the Motor Car hoisted up for checks on its undercarriage. There was no sign(s) or indication(s) of fluid leakage and/or fluid stain(s) on the underside of the Motor Car. The undercarriage components of the Motor Car were also all observed to be intact and secured in an appropriate manner.

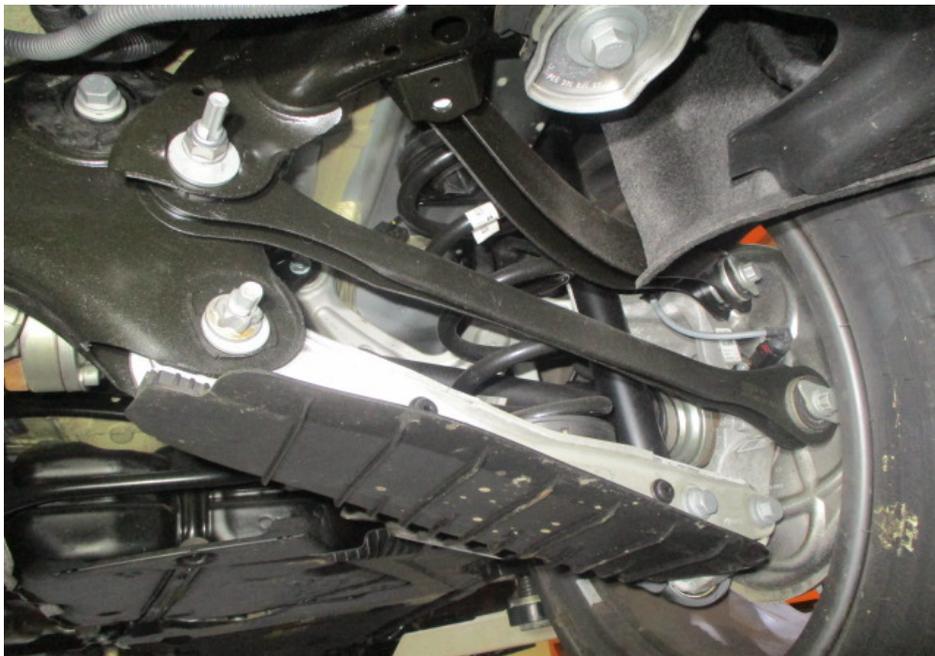
**Photo 17** shows a general view of the control arms and linkages at the rear right wheel of the Motor Car. I did not observe any fluid leak and/or fluid stain on the underside of the Motor Car. All of the Motor Car's undercarriage components were observed to be intact and secured in an appropriate manner.

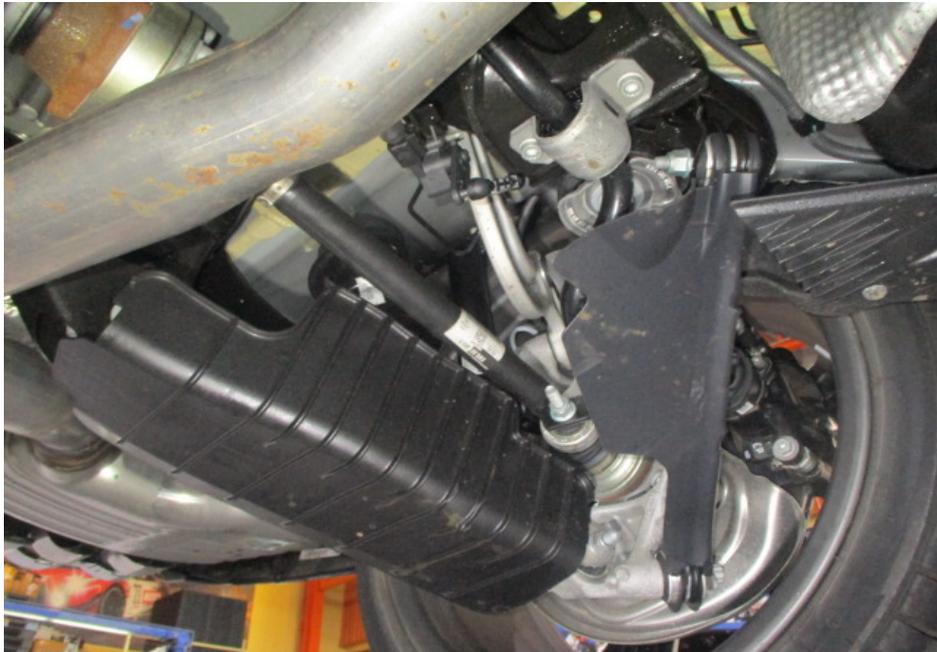
**Photo 18** shows a general view of the control arms and linkages at the rear left wheel of the Motor Car. I did not observe any fluid leak and/or fluid stain on the underside of the Motor Car. All of the Motor Car's undercarriage components were observed to be intact and secured in an appropriate manner.

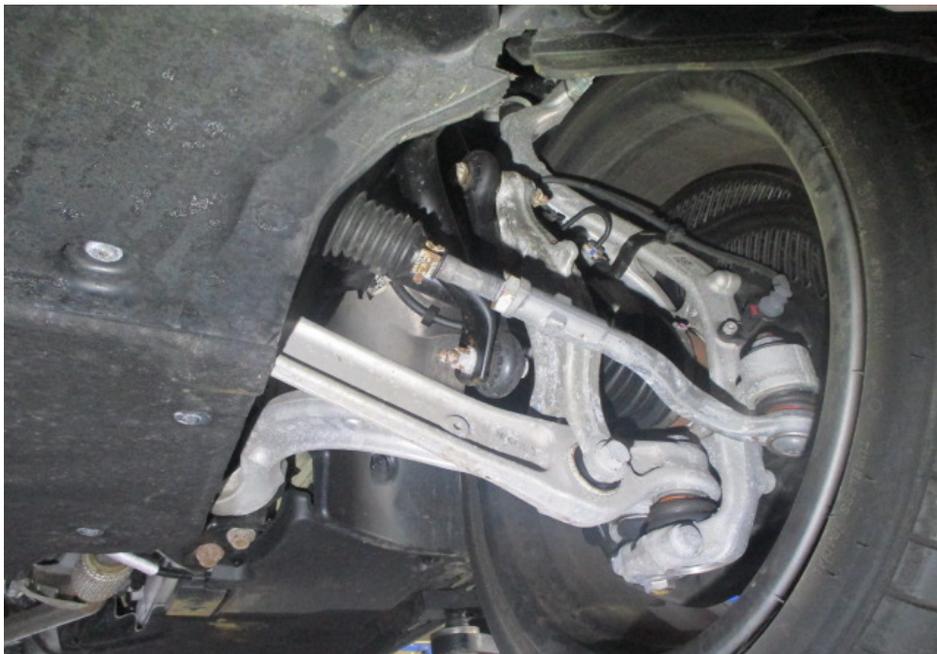
**Photo 19** shows the various undercarriage components at the front left wheel of the Motor Car. The mechanical components, control arms and linkages were all found to be intact and secured in an appropriate manner.

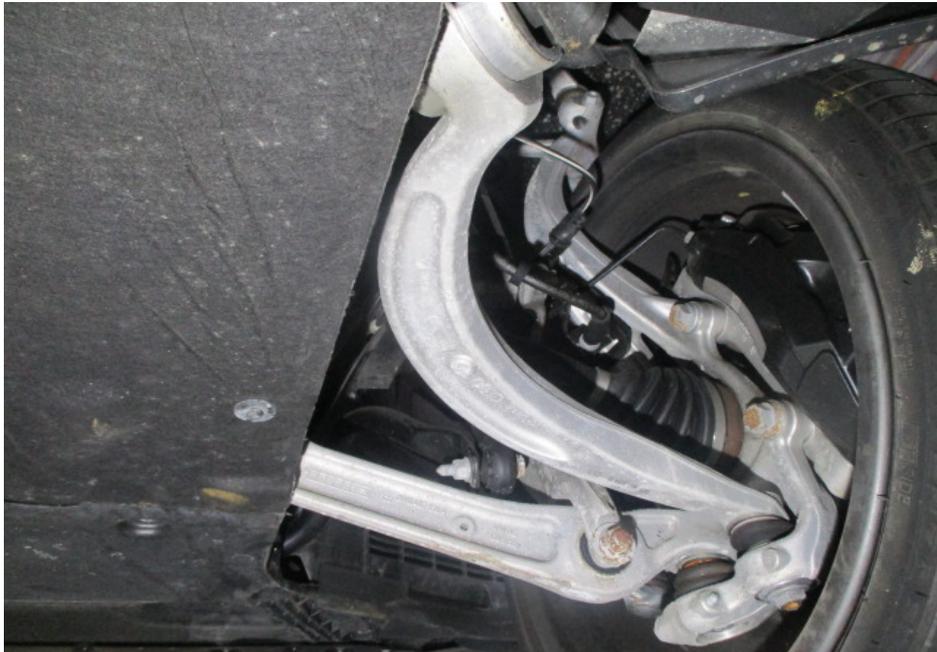
**Photo 20** shows the various undercarriage components at the front right wheel of the Motor Car. The mechanical components, control arms and linkages were all found to be intact and secured in an appropriate manner. I also did not observe any fluid leak and/or fluid stain on the underside of the Motor Car.

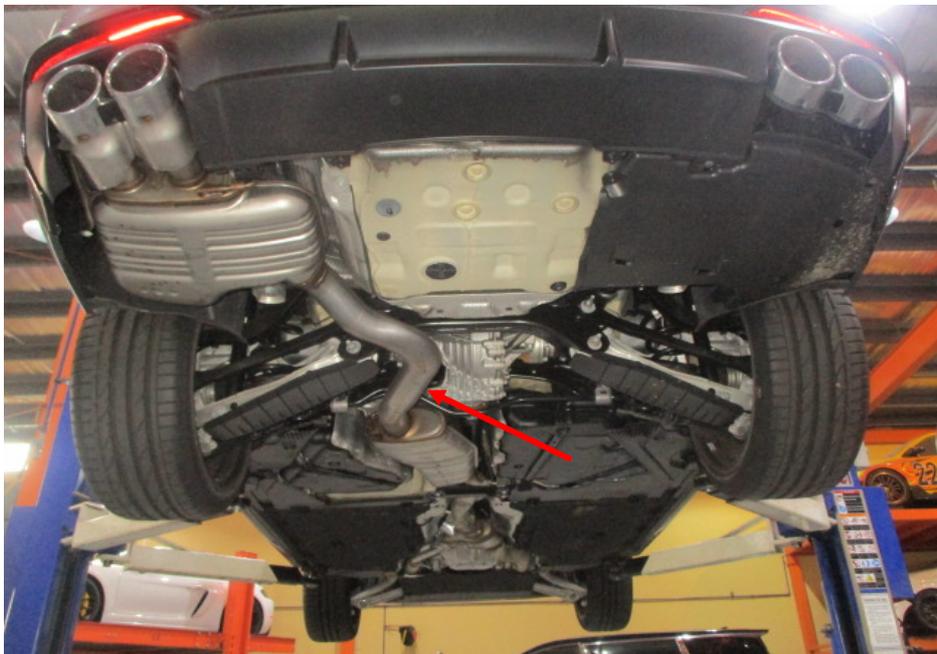
**Photo 21** shows the rear section of the Motor Car's exhaust system. My examination of the Motor Car's exhaust system revealed no sign(s) or indication(s) of any cut or weld marks along its exhaust pipes (arrowed), on its rear muffler, on its centre resonator boxes and on its catalytic converter.

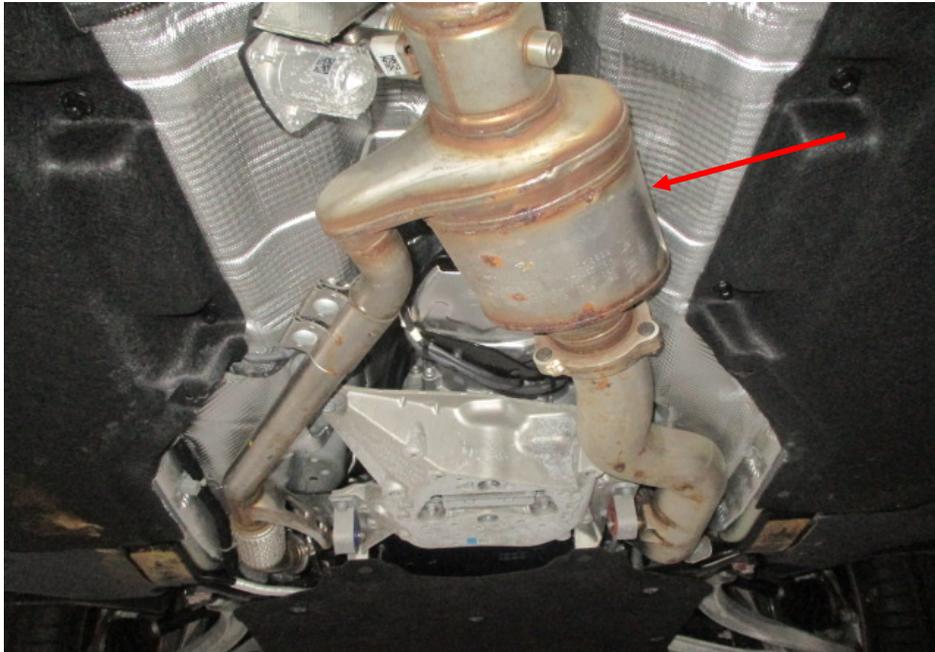
**Photo 22** shows the front section of the Motor Car's exhaust system. My examination of the Motor Car's exhaust system revealed no sign(s) or indication(s) of any cut or weld marks along its exhaust pipes, on its rear muffler, on its centre resonator boxes (arrowed) and on its catalytic converter.

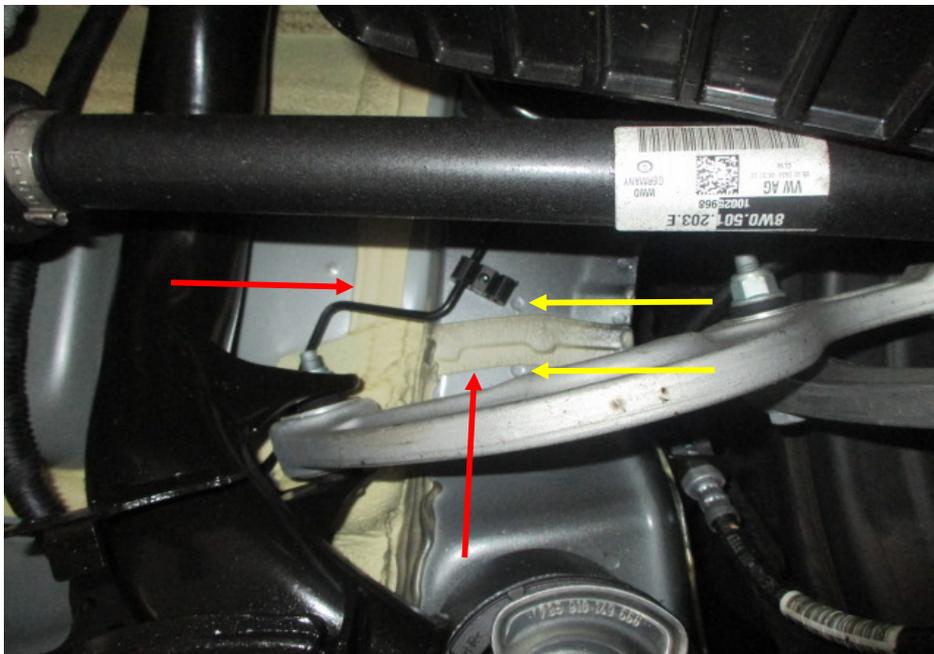
10. Visually, I did not find any weld marks, other than the original spot weld marks, on the chassis/structural body of the Motor Car. The original factory sealant at the joints along the chassis/structural body was also untouched, again indicating that no replacement of the chassis/structural body was carried out; and that the chassis/structural body was originally fitted.

**Photo 23** shows the chassis/structural body at the underside rear right of the Motor Car. I did not find any weld marks other than original spot weld marks (yellow arrow) on the chassis/structural body of the Motor Car. The original factory sealant (red arrow) at the joints along the chassis/structural body was untouched, indicating no work was done on the chassis/structural body of the Motor Car and that the chassis/structural body was originally fitted.

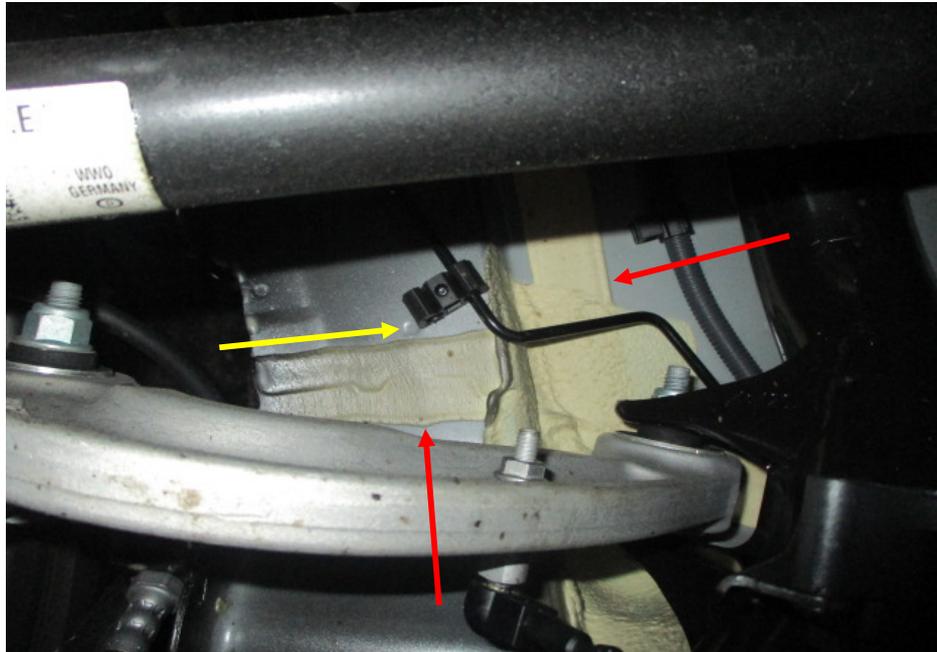
**Photo 24** shows the chassis/structural body at the underside rear left of the Motor Car. I did not find any weld marks other than original spot weld marks (yellow arrow) on the chassis/structural body of the Motor Car. The original factory sealant (red arrow) at the joints along the chassis/structural body was untouched, indicating no work was done on the chassis/structural body of the Motor Car and that the chassis/structural body was originally fitted.

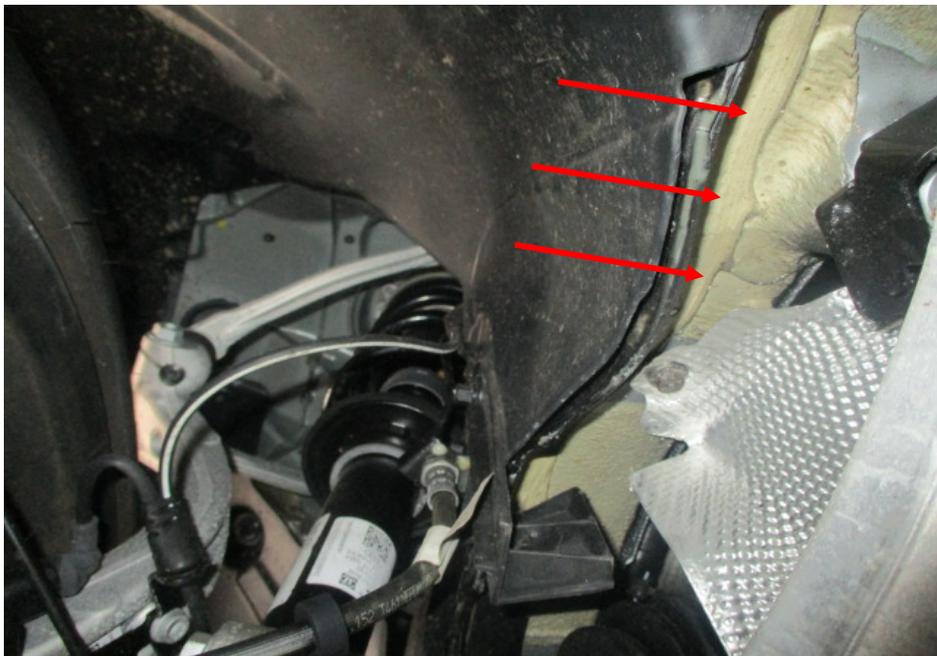
**Photo 25** shows the chassis/structural body at the underside front left of the Motor Car. The original factory sealant (arrowed) at the joints along the chassis/structural body was observed to be untouched. In general, I had found no work was carried out on the chassis/structural body of the Motor Car. The chassis/structural body of the Motor Car was originally fitted.

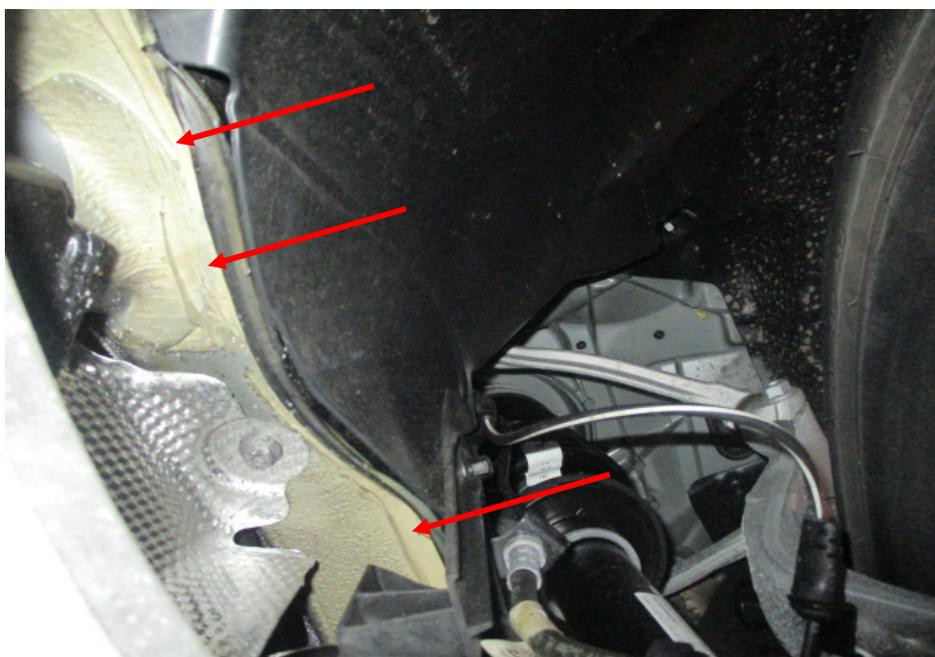
**Photo 26** shows the chassis/structural body at the underside front right of the Motor Car. The original factory sealant (arrowed) at the joints along the chassis/structural body was observed to be untouched. In general, I had found no work was carried out on the chassis/structural body of the Motor Car. The chassis/structural body of the Motor Car was originally fitted.

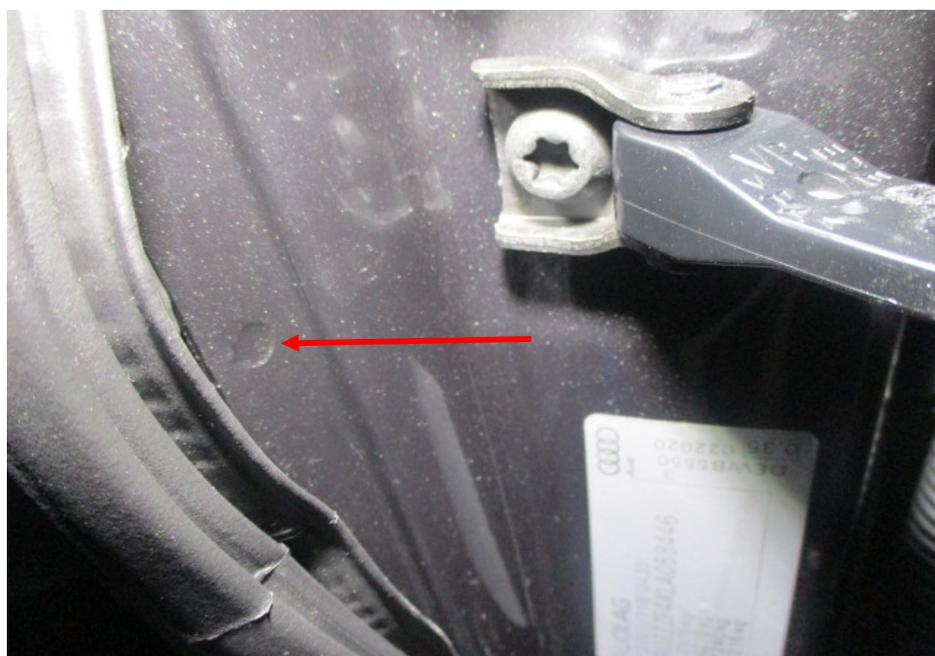
9. Checks on the non-detachable body panels like the rear fenders, floorboard, roof panel, pillars and rocker panels amongst others, revealed that these body panels were spot welded onto the chassis/structural body of the Motor Car. The original factory sealant at the joints of the non-detachable body panels was all untouched indicating no replacement of the non-detachable body panels was carried out; and that these body panels were all originally fitted.

**Photo 27** shows the right side "A" pillar of the Motor Car. I did not find any weld marks other than original spot weld marks (arrowed) on the right side "A" pillar of the Motor Car, which indicates that there was no re-welding works carried out. In general, I had found all the non-detachable body panels of the Motor Car to be originally fitted at the time of my inspection.

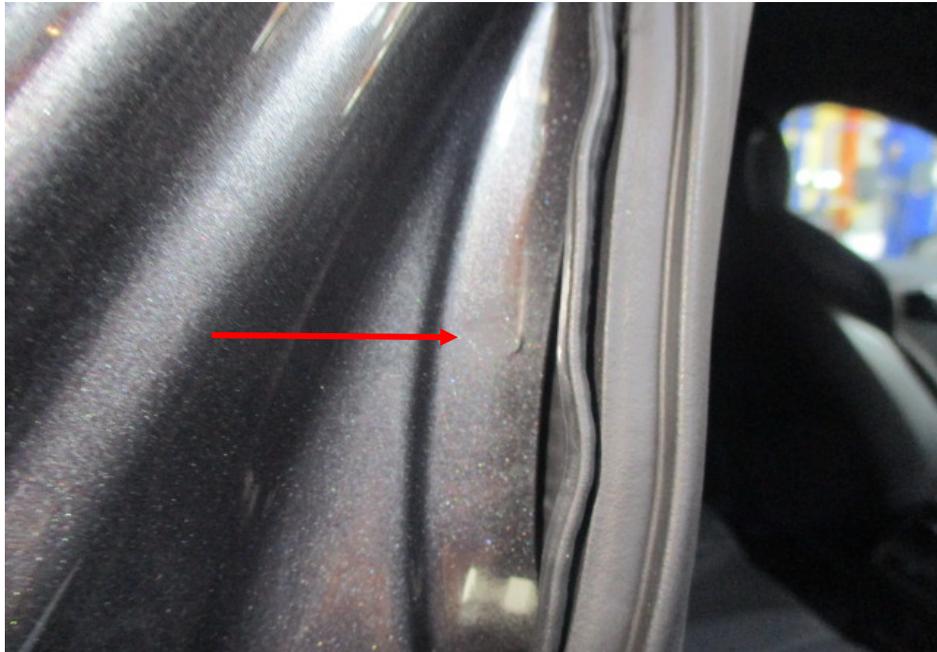
**Photo 28** shows the right side "C" pillar of the Motor Car. I did not find any weld marks other than original spot weld marks (arrowed) on the right side "C" pillar of the Motor Car, which indicates that there was no re-welding works carried out. In general, I had found all the non-detachable body panels of the Motor Car to be originally fitted at the time of my inspection.
