Your Ref: BMW X6
(chassis number WBACY620909D41334)
Our Ref : CI/TP21010543/D

04 October 2021

**INSPECTION REPORT OF AN UNREGISTERED BMW X6 MOTOR CAR WITH
CHASSIS NUMBER WBACY620909D41334**

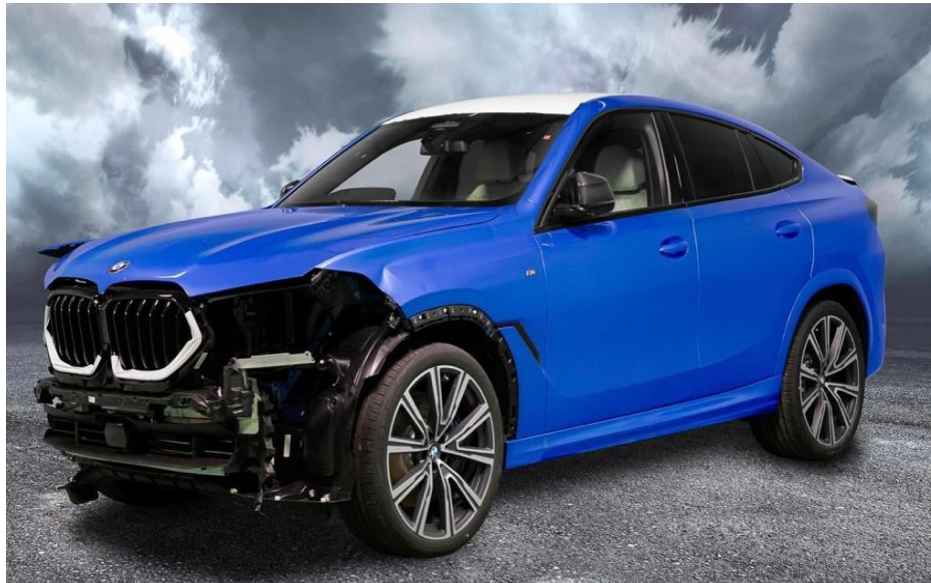
Photo 1 shows the front left body of the Motor Car (photograph provided to me). The photographs provided to me had showed damage to the frontal portion of the Motor Car. Body parts damaged include the front left fender and front left fender wheel arc garnish amongst others. The front left day light, front left headlamp, front bumper and all its related parts and attachments like the front bumper centre lower grille, front bumper left lower grille and front bumper sensors amongst others were observed to be damaged/dislodged/missing.

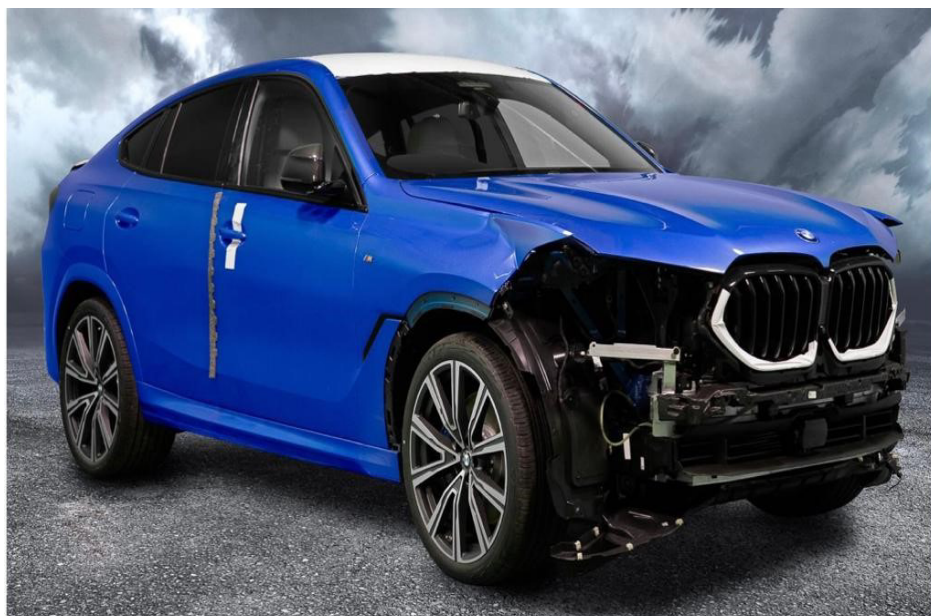
Photo 2 shows the front right body of the Motor Car (photograph provided to me). The photographs provided to me had showed damage to the frontal portion of the Motor Car. Body parts damaged include the front right fender and front right fender wheel arc garnish amongst others. The front right day light, front right headlamp, front bumper and all its related parts and attachments like the front bumper centre lower grille, front bumper right lower grille and front bumper sensors amongst others were observed to be damaged/dislodged/missing.

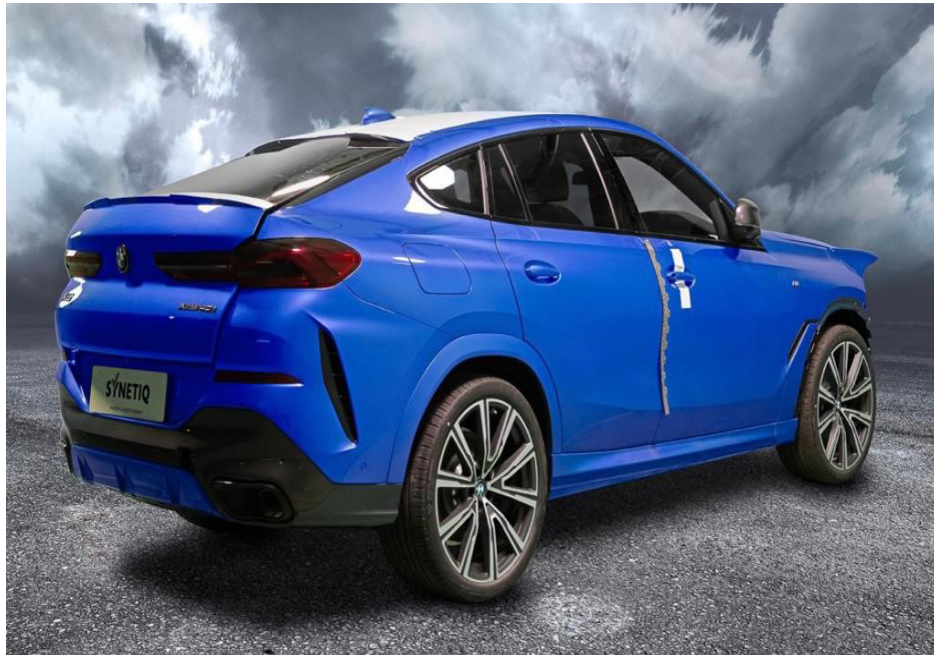
Photo 3 shows the rear right body of the Motor Car (photograph provided to me). Apart for the frontal portion, there was no physical damage observed to other areas of the Motor Car. The airbags of the Motor Car were also not deployed as seen from the photographs that were provided to me.

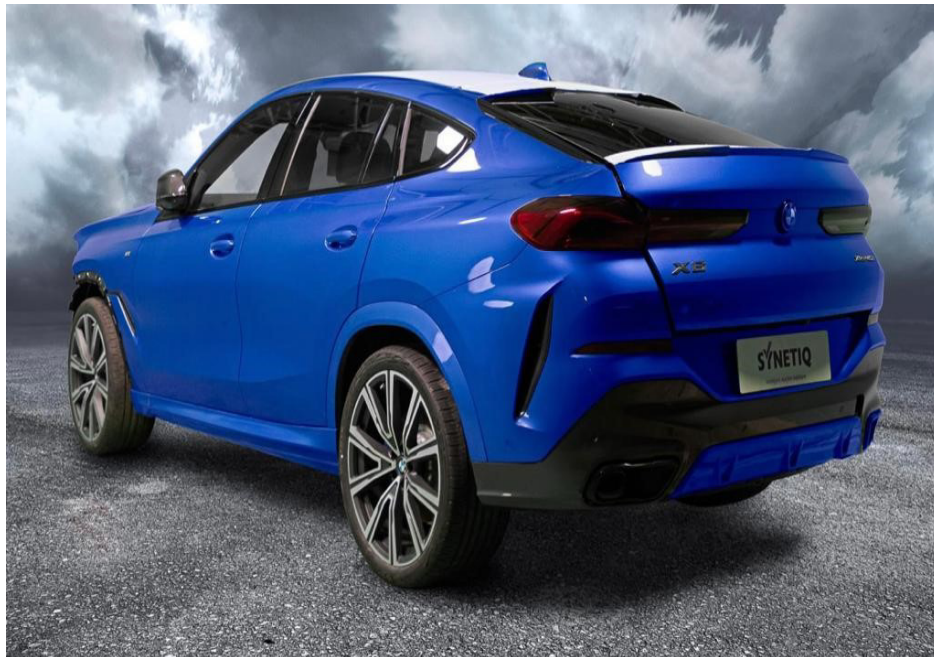
Photo 4 shows the rear left body of the Motor Car (photograph provided to me). Apart for the frontal portion, there was no physical damage observed to other areas of the Motor Car. The airbags of the Motor Car were also not deployed as seen from the photographs that were provided to me.

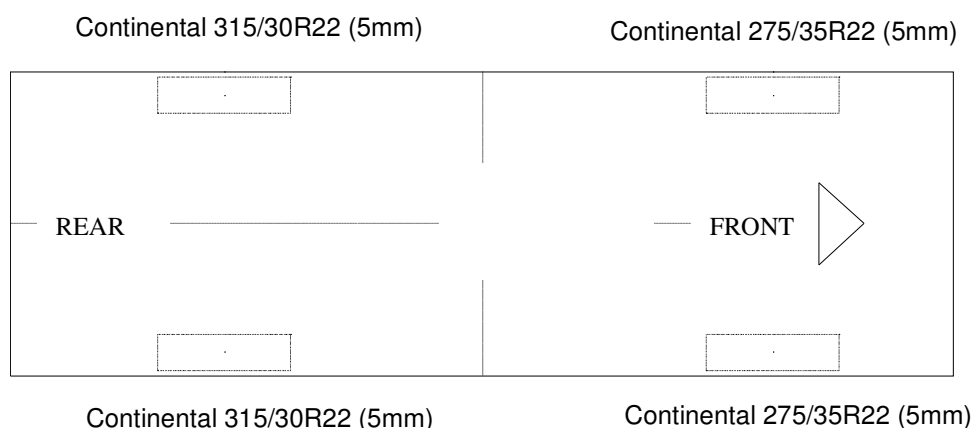
8. It was fitted with 22inch sport wheel rims that were wrapped with tyres that were observed to be of serviceable condition. The tyres were also sufficiently inflated for vehicular operation. The tyre brand, tyre size and approximate remaining tread depth of the 4 tyres of the Motor Car were recorded as follows: -

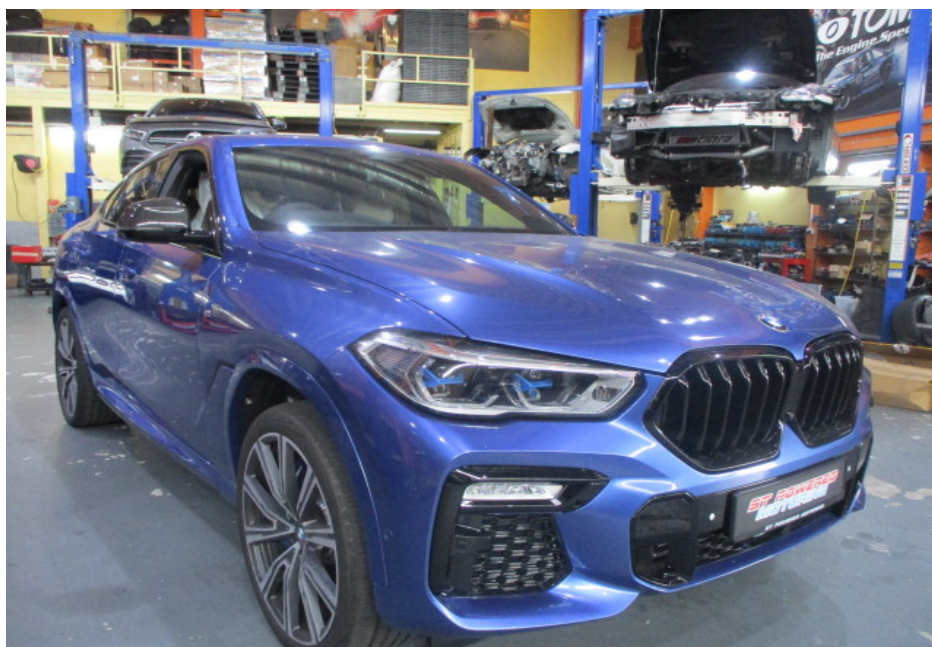
Photo 5 shows a general view of the front right body of the Motor Car at the time of my inspection. The Motor Car was observed to be in a relatively good general condition with no loose exterior fittings observed. The body parts at the frontal portion of the Motor Car were visually examined and it was observed that the repair/restoration works carried out to the damaged area of the Motor Car (refer to photograph 1 & 2 above) were reasonably adequate and in order.

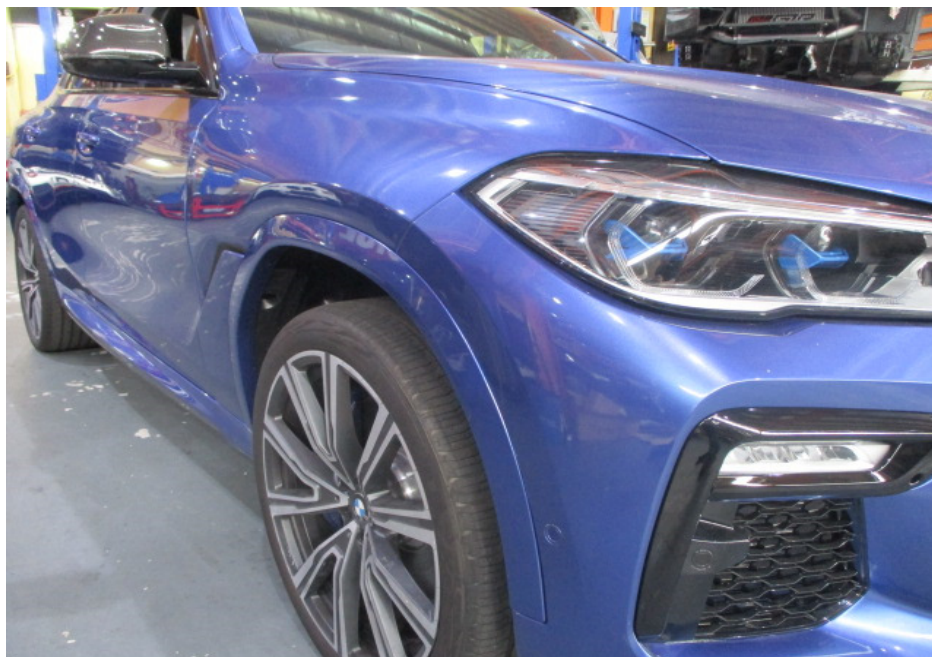
Photo 6 shows a closer view of the Motor Car's front bumper, front bumper right lower grille, front right day light, front right headlamp, front right fender and front right fender wheel arc garnish at the time of my inspection. The body parts at the frontal portion of the Motor Car were visually examined and it was observed that the repair/restoration works carried out to the damaged area of the Motor Car (refer to photograph 1 & 2 above) were reasonably adequate and in order.

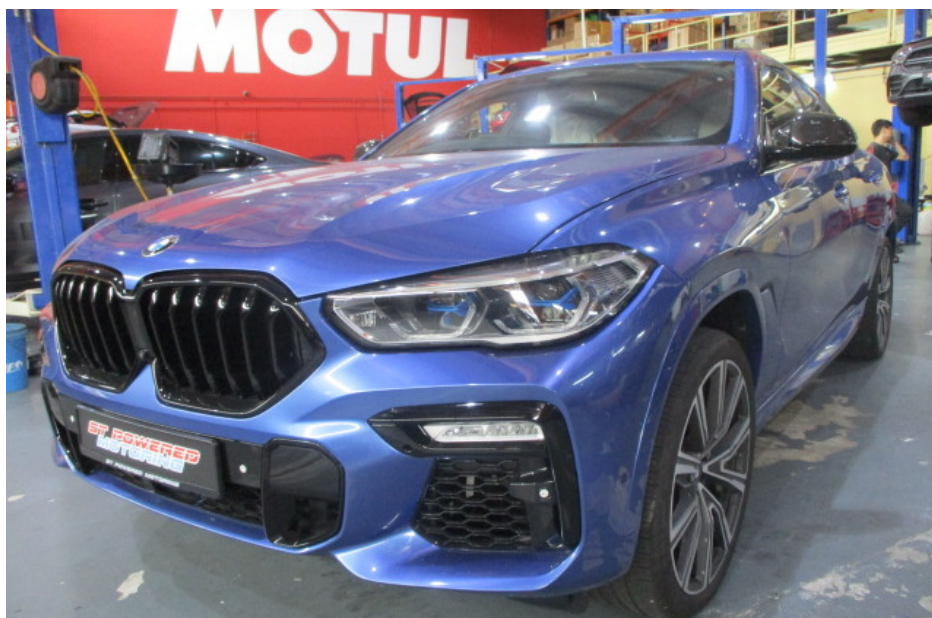
Photo 7 shows a general view of the front left body of the Motor Car at the time of my inspection. The Motor Car was observed to be in a relatively good general condition with no loose exterior fittings observed. The body parts at the frontal portion of the Motor Car were visually examined and it was observed that the repair/restoration works carried out to the damaged area of the Motor Car (refer to photograph 1 & 2 above) were reasonably adequate and in order.

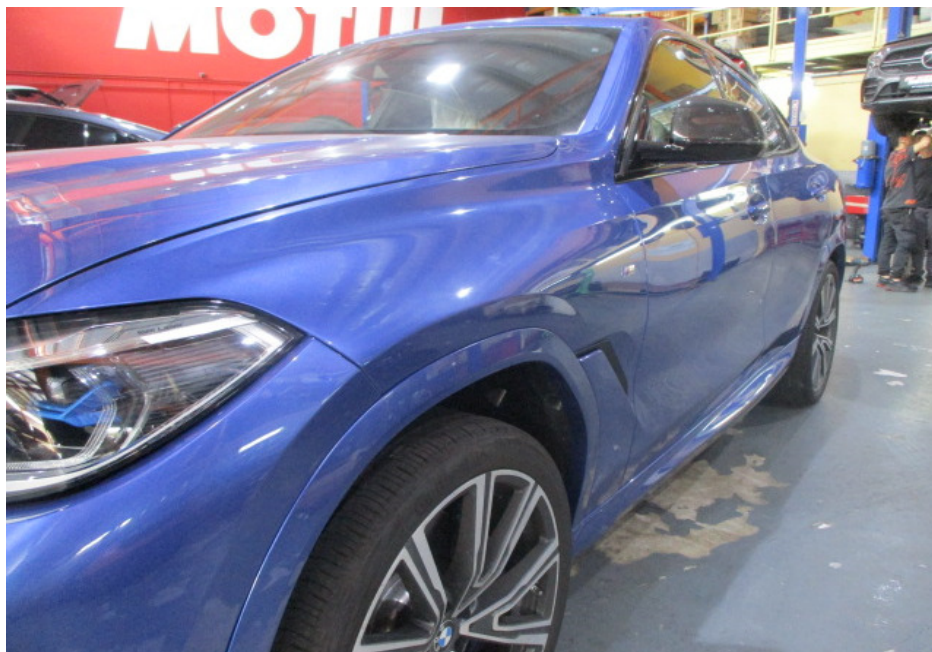
Photo 8 shows a closer view of the Motor Car's front left fender, front left fender wheel arc garnish and front left headlamp at the time of my inspection. The body parts at the frontal portion of the Motor Car were visually examined and it was observed that the repair/restoration works carried out to the damaged area of the Motor Car (refer to photograph 1 & 2 above) were reasonably adequate and in order.

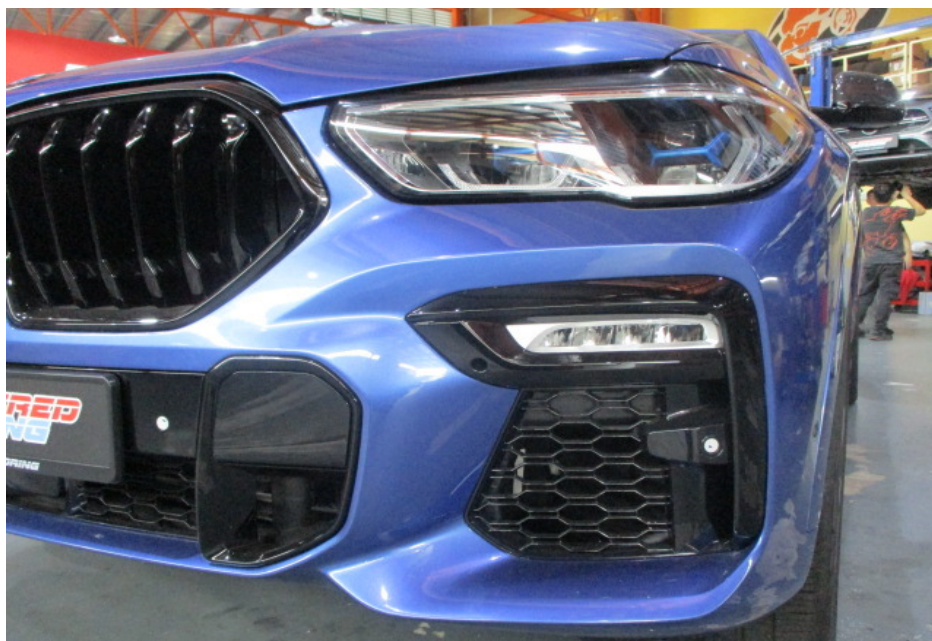
Photo 9 shows a closer view of the Motor Car's front bumper left lower grille, front left day light and front left headlamp. The body parts at the frontal portion of the Motor Car were visually examined and it was observed that the repair/restoration works carried out to the damaged area of the Motor Car (refer to photograph 1 & 2 above) were reasonably adequate and in order.

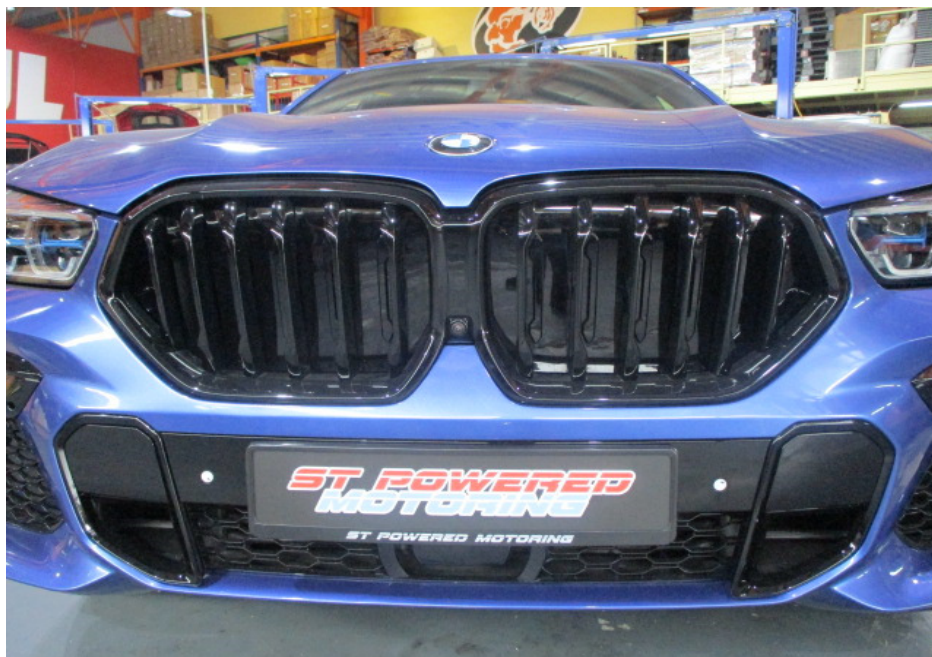
Photo 10 shows a closer view of the Motor Car's front bumper centre garnish, front bumper sensors, front bumper centre lower grille, front radar unit and front radiator grilles at the time of my inspection. The body parts at the frontal portion of the Motor Car were visually examined and it was observed that the repair/restoration works carried out to the damaged area of the Motor Car (refer to photograph 1 & 2 above) were reasonably adequate and in order.

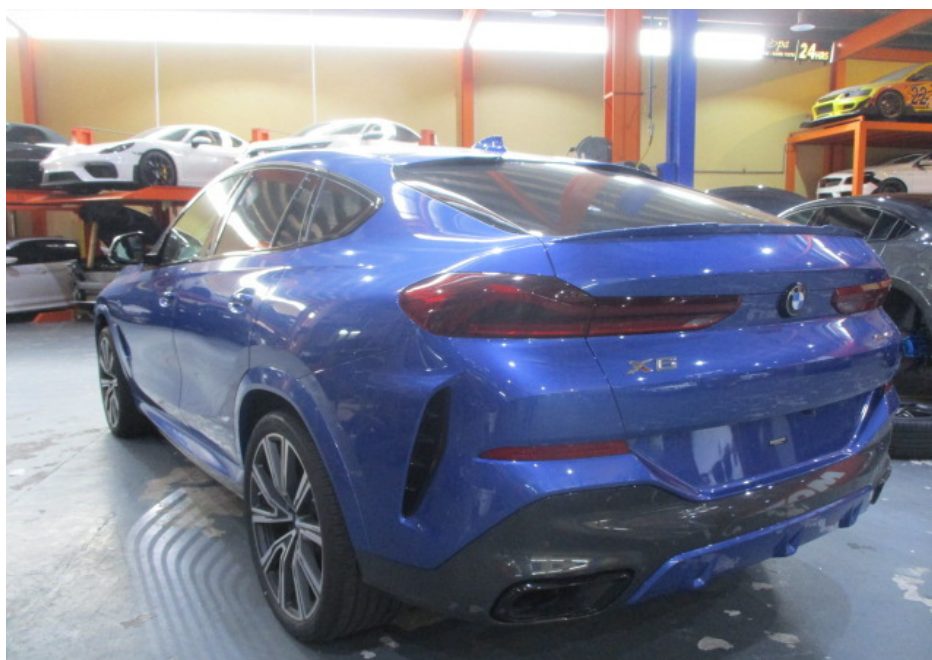
Photo 11 shows a general view of the rear left body of the Motor Car at the time of my inspection. The Motor Car was observed to be in a relatively good general condition with no loose exterior fittings observed. The mileage of the Motor Car recorded at the time of my inspection was 124km.

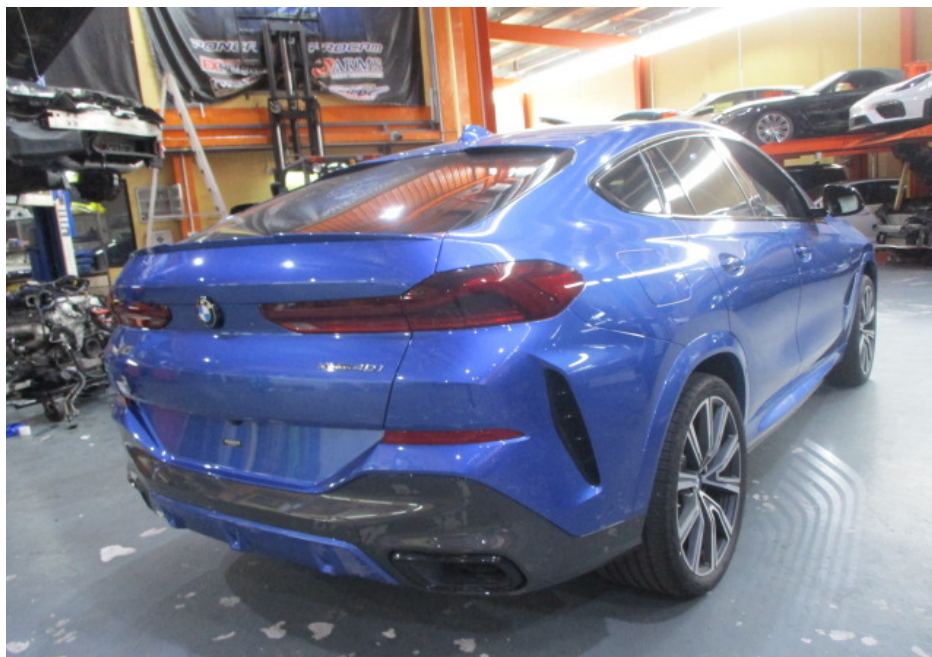
Photo 12 shows a general view of the rear right body of the Motor Car at the time of my inspection. The Motor Car was observed to be in a relatively good general condition with no loose exterior fittings observed. The mileage of the Motor Car recorded at the time of my inspection was 124km.

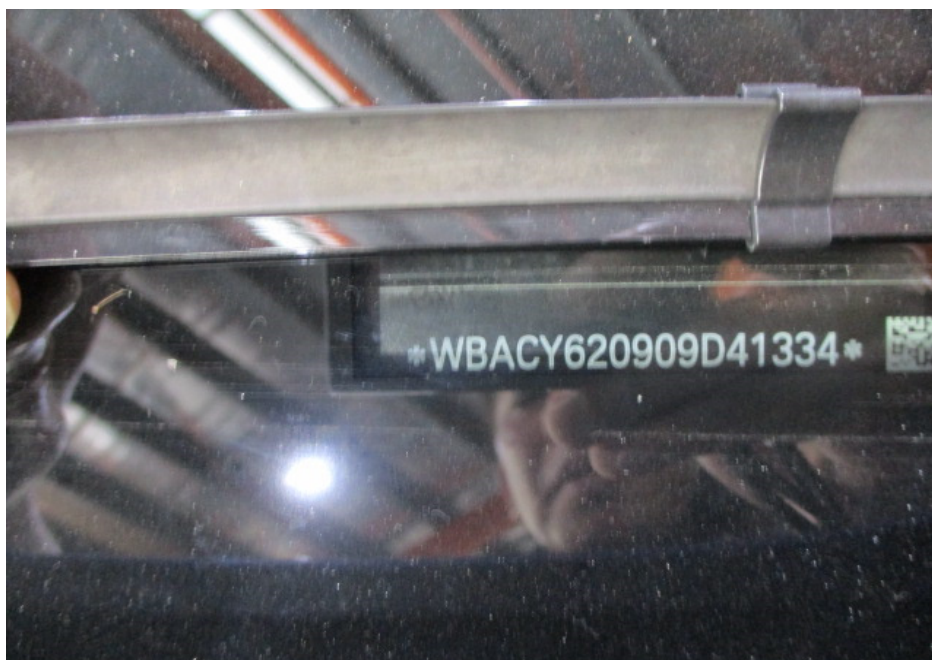
Photo 13 shows the chassis number of the Motor Car. The chassis number recorded was WBACY620909D41334.

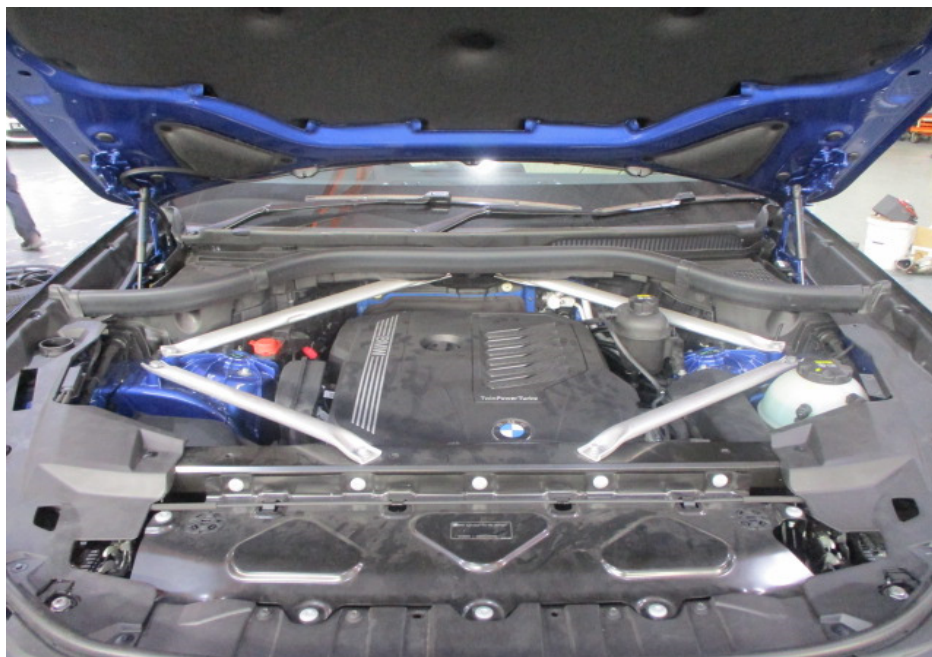
14. My examination of the engine compartment of the Motor Car revealed that the various parts and components inside the engine compartment were all intact and properly fitted. The engine oil, brake fluid and engine coolant were all found to be of sufficient level for operating purposes. Visually, there was also no contamination found to these fluids.

Photo 14 shows a general view of the engine compartment of the Motor Car at the time of my inspection. The various parts and components inside the engine compartment were all observed to be intact and properly fitted. There was also no sign(s) or indication(s) of fluid leak and/or fluid stain found inside the engine compartment.

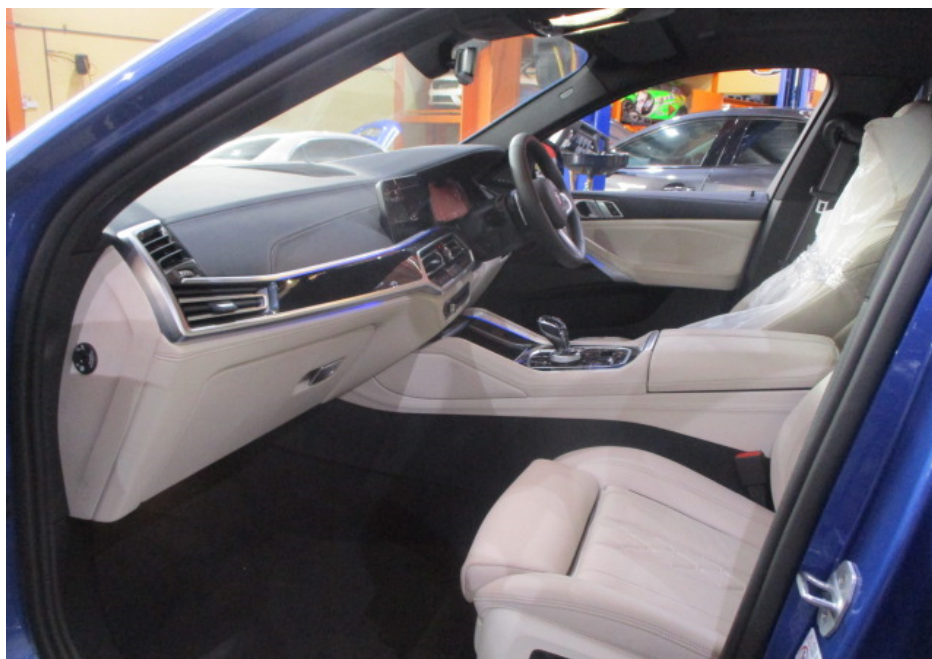
Photo 15 shows the interior compartment of the Motor Car at the time of my inspection. The various parts and components, trims, carpet, and upholstery inside the interior compartment were all observed to be intact and properly fitted.

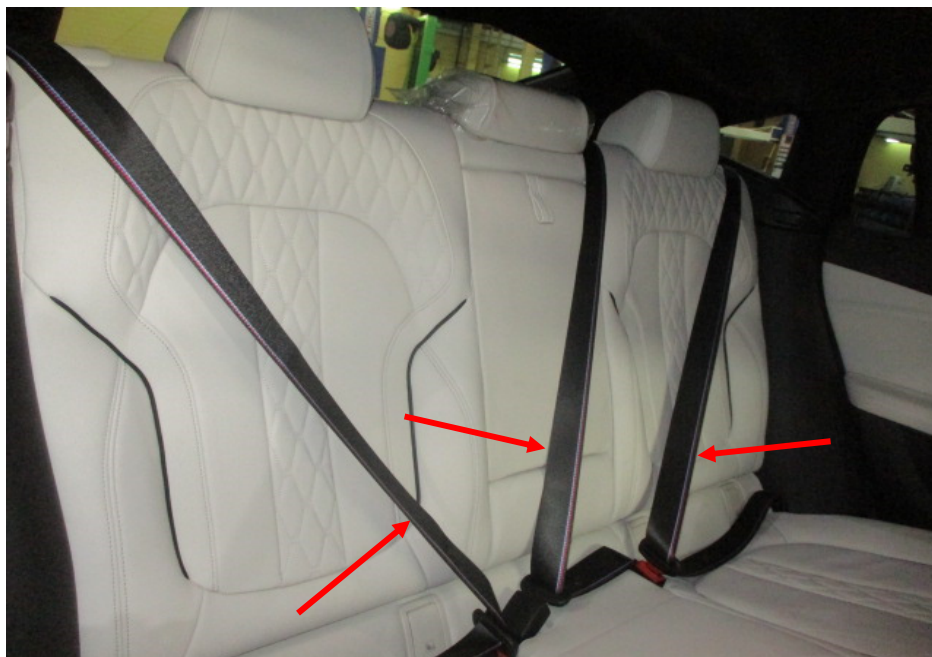
12. The seats of the Motor Car were found to be secured to the floorboard of the Motor Car via seat rails bolted onto the floorboard. Retractable seat belt reels and pre-tensioners were fitted on all seats of the Motor Car. The seat belts were tested and were able to be fastened securely into the respective pre-tensioners that were fixed to the side of all the seats.

Photo 16 shows the rear seats of the Motor Car. All the seats of the Motor Car were secured via seat rails to the floorboard. They were also fitted with a retractable seat belt reel and a pre-tensioner. The seat belts (arrowed) were tested and were able to be fastened into the respective pre-tensions that were fitted on the side of each individual seat.

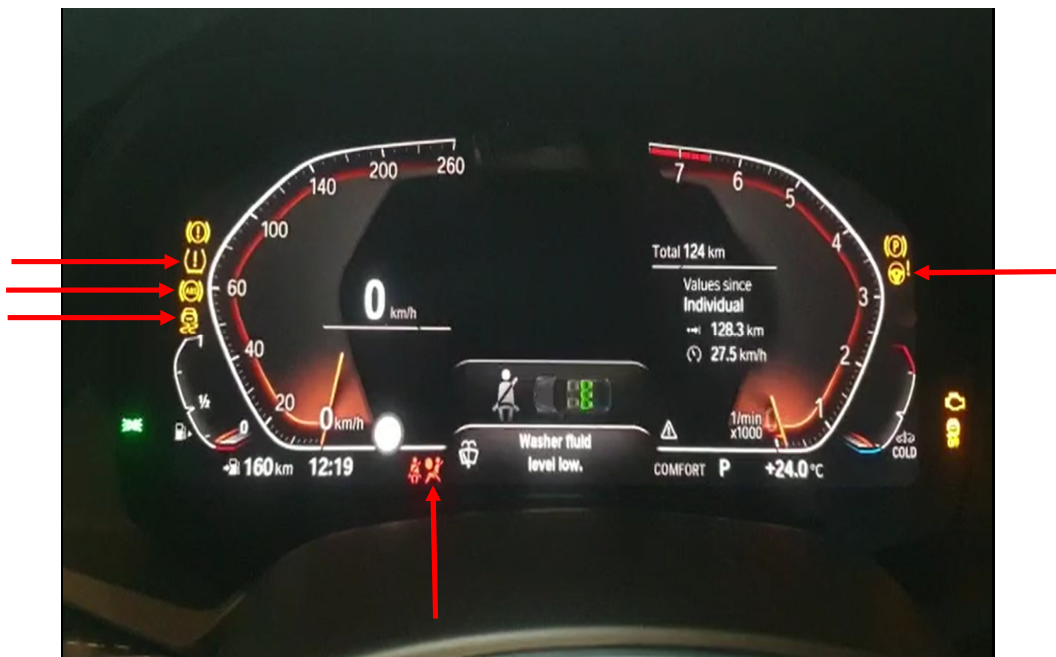
Photo 17 shows the warning lights for the various electronic safety features appearing on the instrument panel of the Motor Car during its self-test when the engine is cranked, in particular the ABS, SRS, IAS, TPM and DSC lights (arrowed).

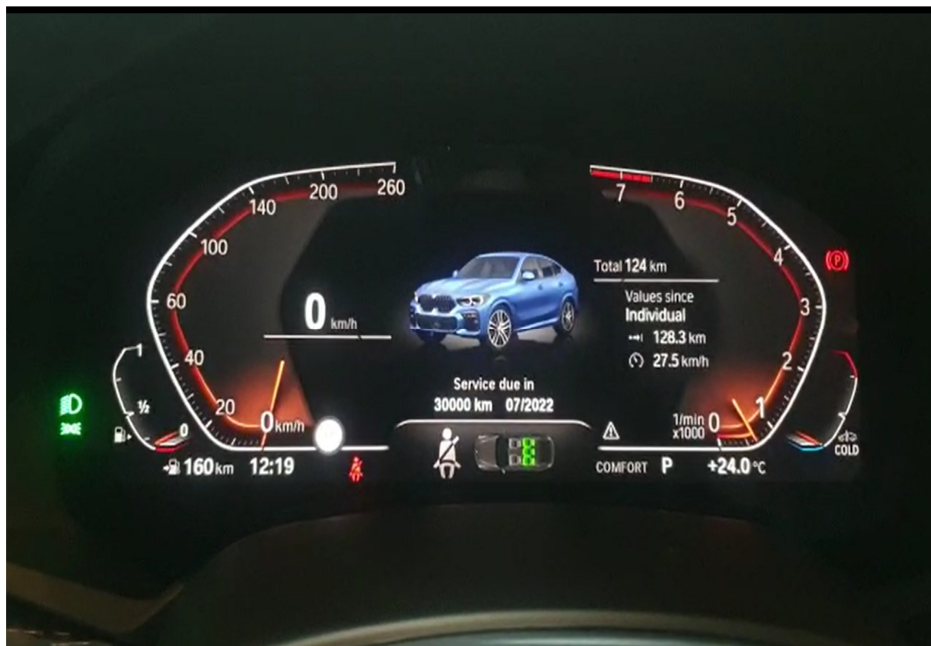
13. The Motor Car's automatic self-test of the functionality of its various electronic safety features like the Anti-Lock Brake System (ABS), Supplemental Restraint System (SRS), Integral Active Steering (IAS), Tyre Pressure Monitor (TPM) and Dynamic Stability Control (DSC) during cranking of the engine had indicated that these electronic systems were in working condition. This was determined from the respective warning lights disappearing from the instrument panel after the self-test.

Photo 18 shows the respective warning lights no longer illuminated, indicating that there is no fault detected to the ABS, SRS, IAS, TPM and DSC systems of the Motor Car during the self-test. These electronic systems were hence in working condition at the time of my inspection.

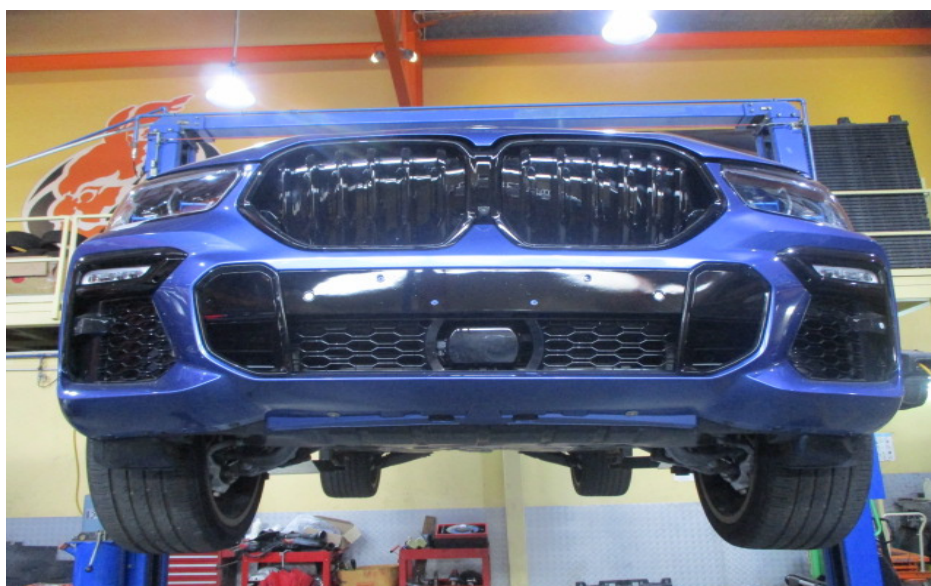
15. My checks on the underside of the Motor Car revealed no sign(s) or indication(s) of fluid leakage and/or fluid stain(s). The engine block and automatic transmission assembly were both secured properly. All undercarriage components of the Motor Car were also observed to be intact and secured in an appropriate manner.

Photo 19 shows the Motor Car hoisted up for checks on its undercarriage. There was no sign(s) or indication(s) of fluid leakage and/or fluid stain(s) on the underside of the Motor Car. The undercarriage components of the Motor Car were also all observed to be intact and secured in an appropriate manner.

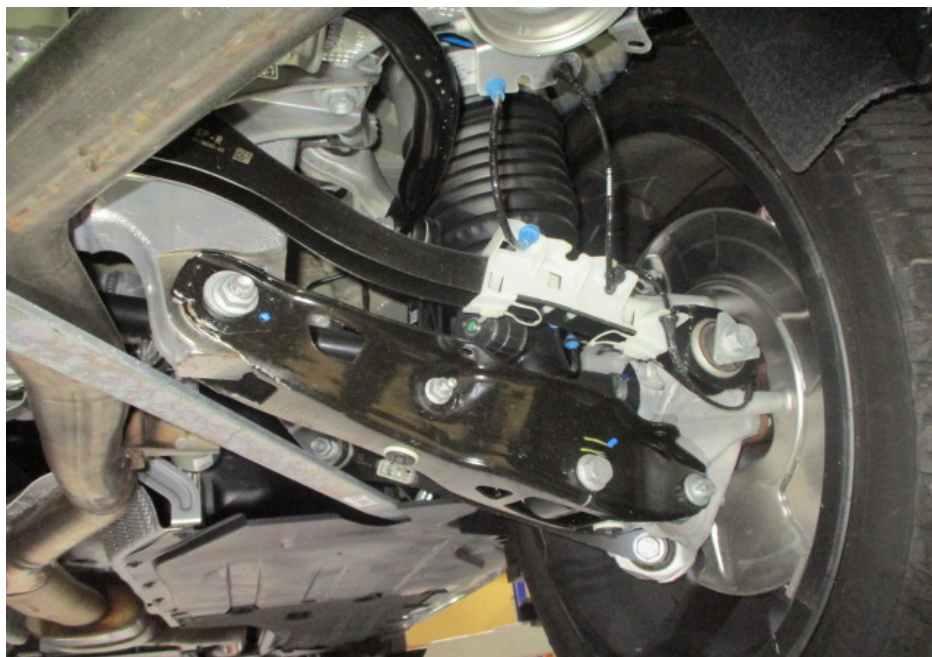
Photo 20 shows a general view of the control arms and linkages at the rear right wheel of the Motor Car. I did not observe any fluid leak and/or fluid stain on the underside of the Motor Car. All of the Motor Car's undercarriage components were observed to be intact and secured in an appropriate manner.

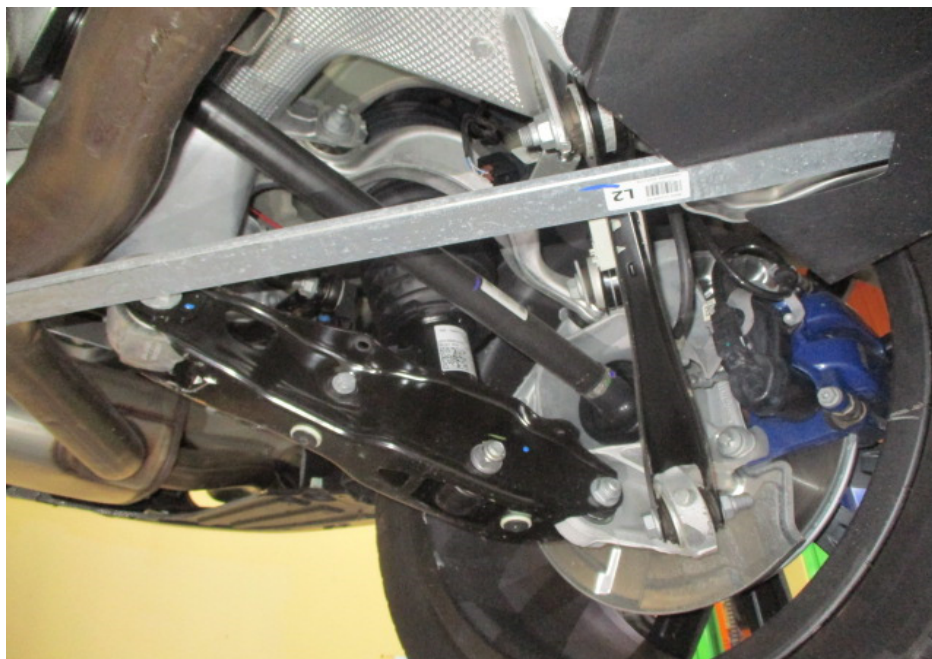
Photo 21 shows a general view of the control arms and linkages at the rear left wheel of the Motor Car. I did not observe any fluid leak and/or fluid stain on the underside of the Motor Car. All of the Motor Car's undercarriage components were observed to be intact and secured in an appropriate manner.

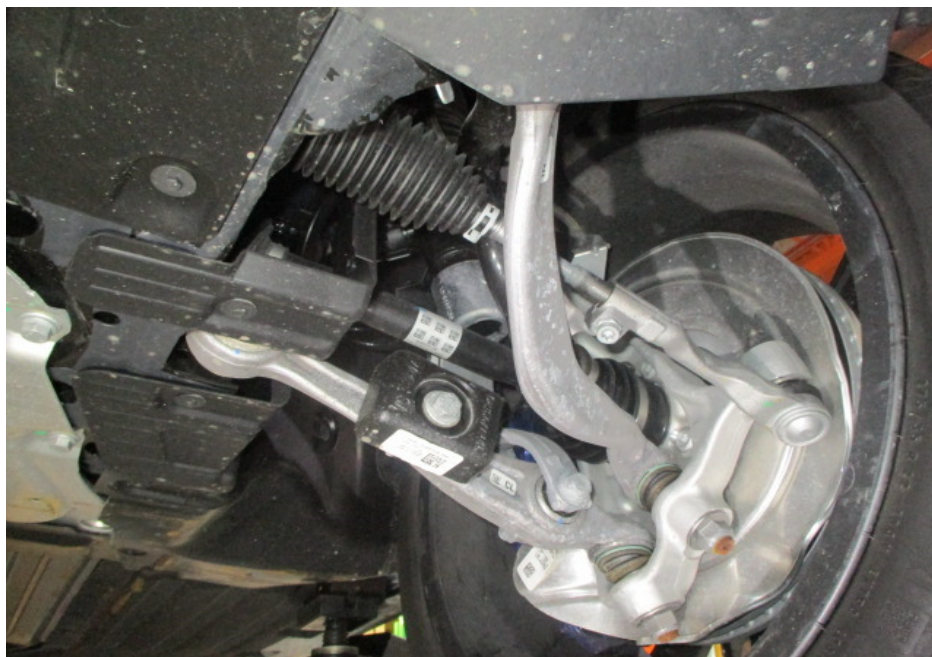
Photo 22 shows the various undercarriage components at the front left wheel of the Motor Car. The mechanical components, control arms and linkages were all found to be intact and secured in an appropriate manner.

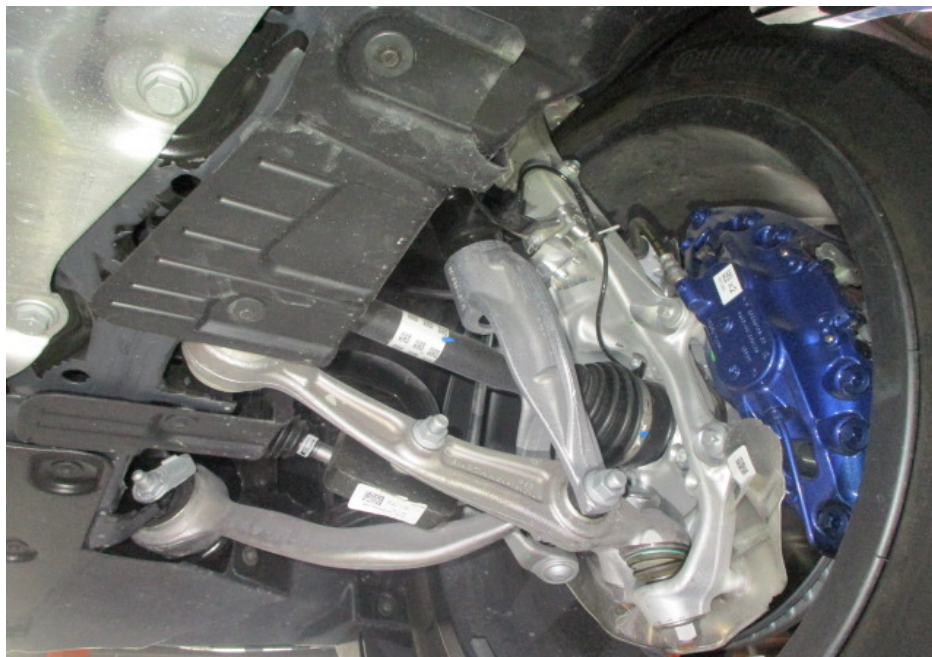
Photo 23 shows the various undercarriage components at the front right wheel of the Motor Car. The mechanical components, control arms and linkages were all found to be intact and secured in an appropriate manner. I also did not observe any fluid leak and/or fluid stain on the underside of the Motor Car.

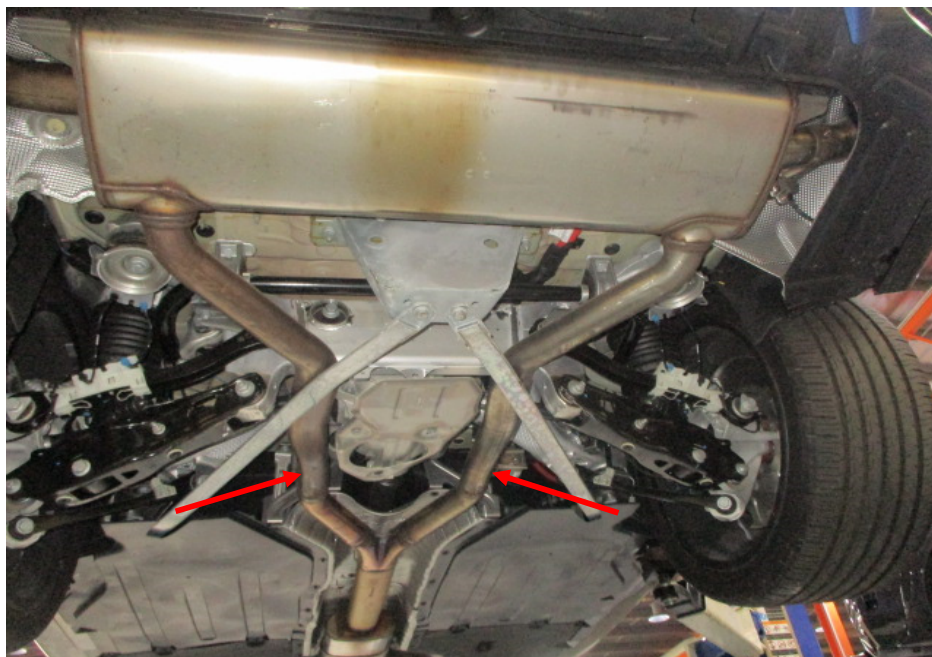
Photo 24 shows the rear section of the Motor Car's exhaust system. My examination of the Motor Car's exhaust system revealed no sign(s) or indication(s) of any cut or weld marks along its exhaust pipes (arrowed), on its rear muffler, on its centre resonator box and on its catalytic converter.

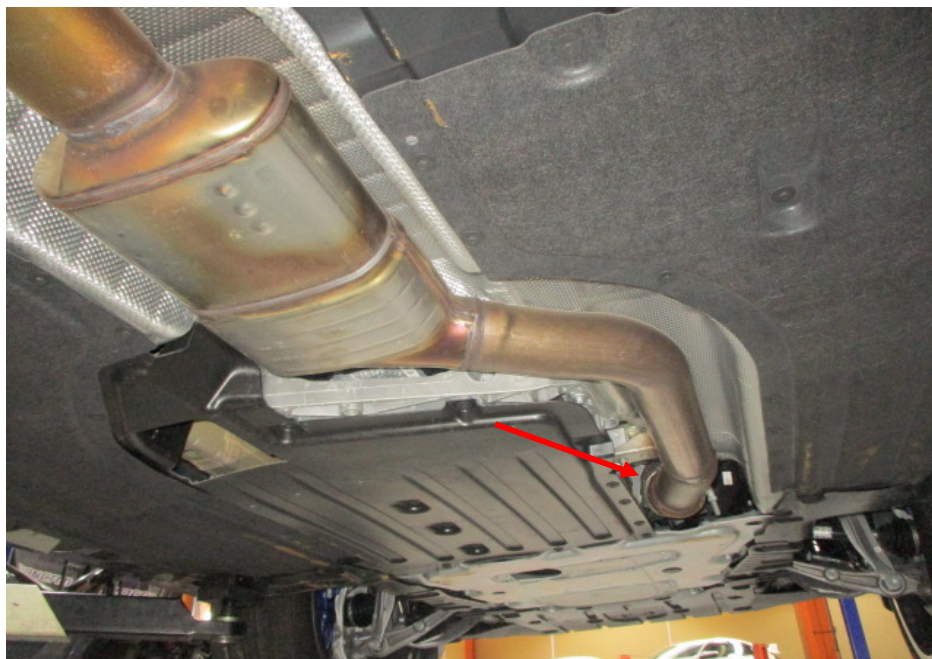
Photo 25 shows the front section of the Motor Car's exhaust system. My examination of the Motor Car's exhaust system revealed no sign(s) or indication(s) of any cut or weld marks along its exhaust pipes, on its rear muffler, on its centre resonator box and on its catalytic converter (arrowed).

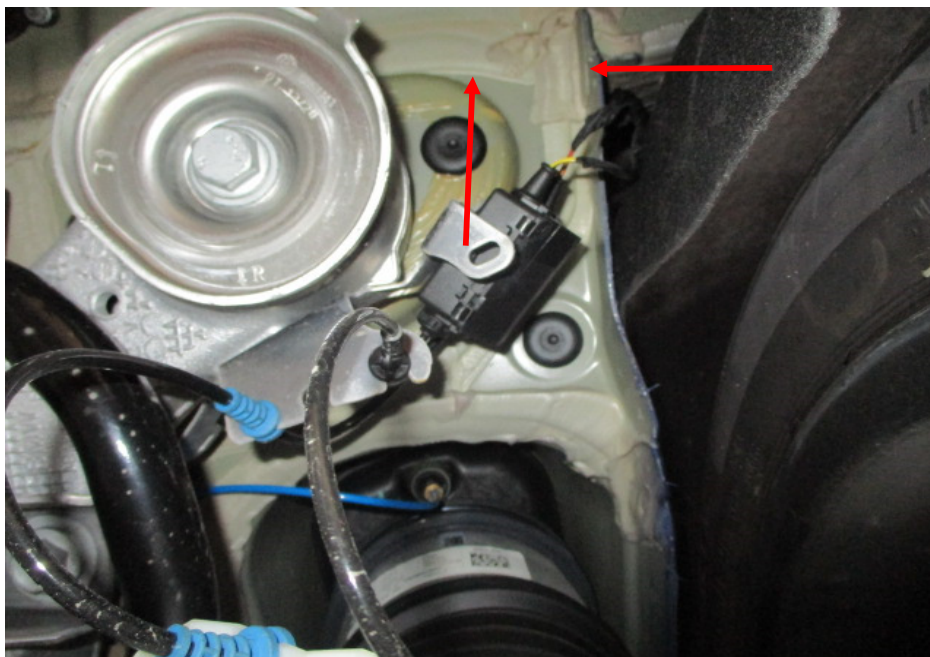
Photo 26 shows the chassis/structural body at the underside rear right of the Motor Car. I did not find any weld marks other than original spot weld marks on the chassis/structural body of the Motor Car. The original factory sealant (arrowed) at the joints along the chassis/structural body was untouched, indicating no work was done on the chassis/structural body of the Motor Car and that the chassis/structural body was originally fitted.

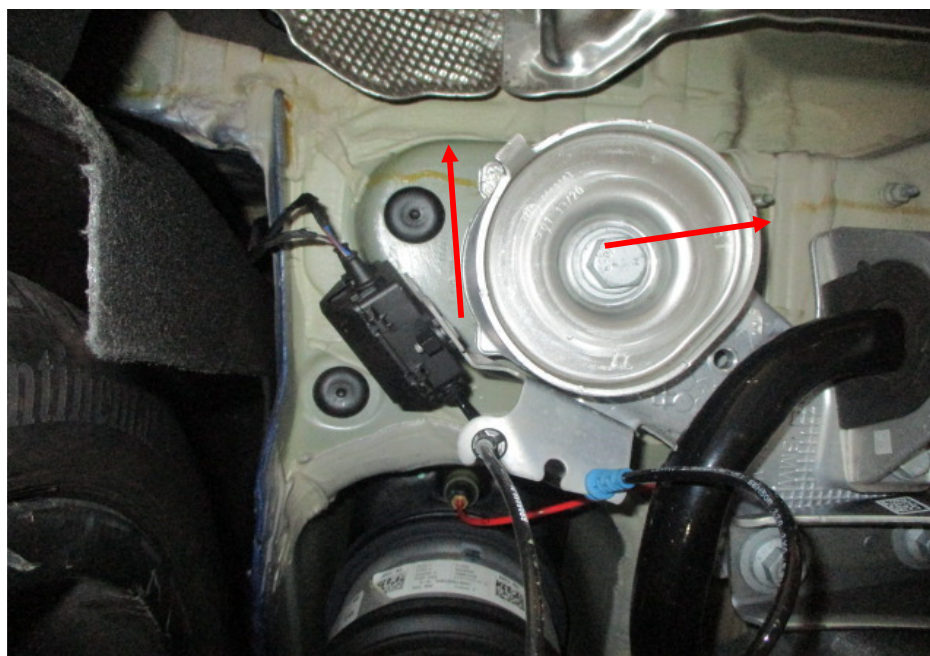
Photo 27 shows the chassis/structural body at the underside rear left of the Motor Car. The original factory sealant (arrowed) at the joints along the chassis/structural body was observed to be untouched. In general, I had found no work was carried out on the chassis/structural body of the Motor Car. The chassis/structural body of the Motor Car was originally fitted.

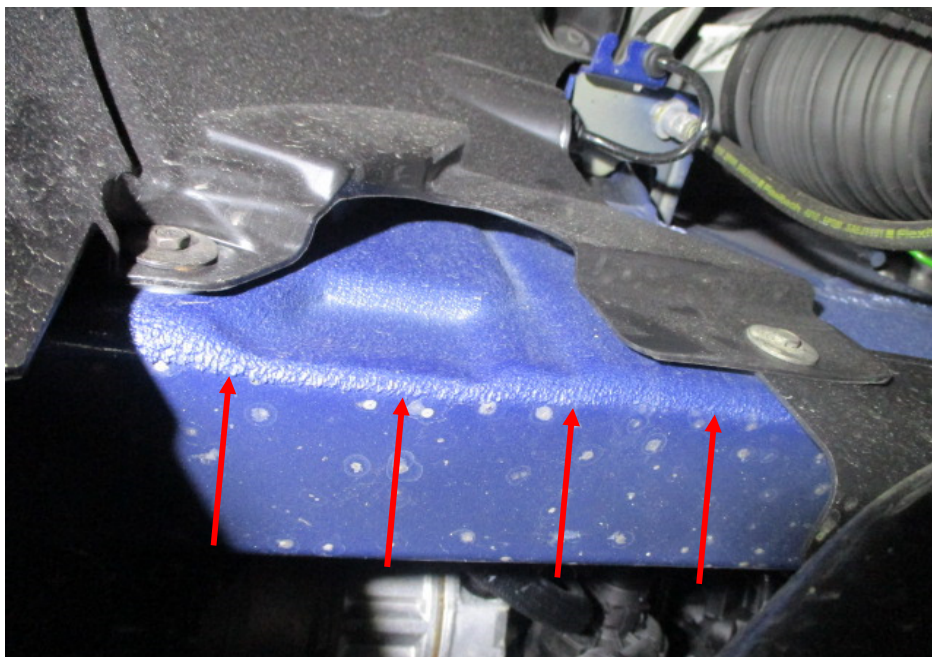
Photo 28 shows the chassis/structural body at the underside front left of the Motor Car. I did not find any weld marks other than original spot weld marks on the chassis/structural body of the Motor Car. The original factory sealant (arrowed) at the joints along the chassis/structural body was untouched, indicating no work was done on the chassis/structural body of the Motor Car and that the chassis/structural body was originally fitted.

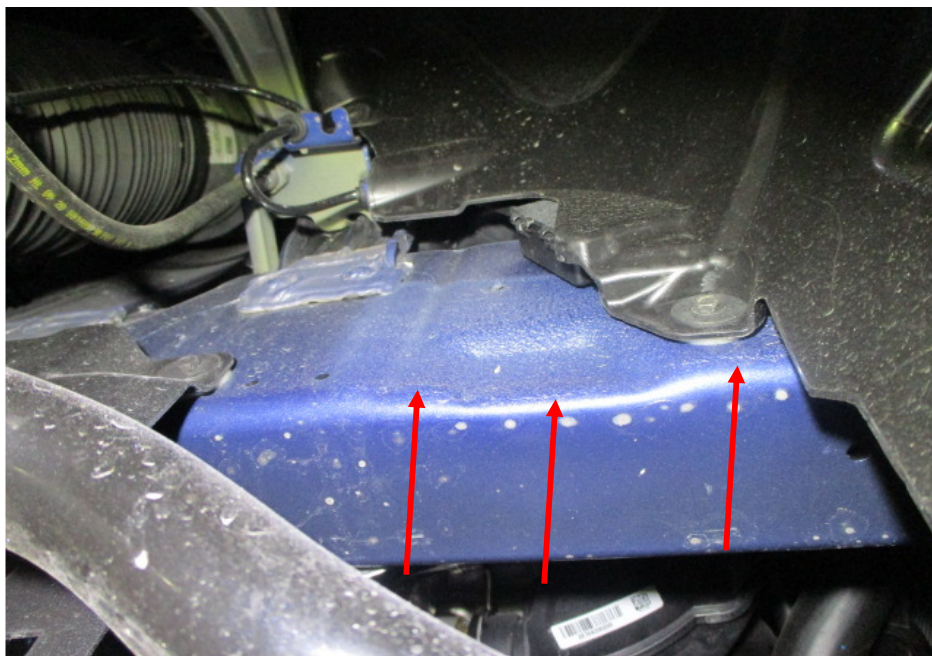
Photo 29 shows the chassis/structural body at the underside front right of the Motor Car. The original factory sealant (arrowed) at the joints along the chassis/structural body was observed to be untouched. In general, I had found no work was carried out on the chassis/structural body of the Motor Car. The chassis/structural body of the Motor Car was originally fitted.

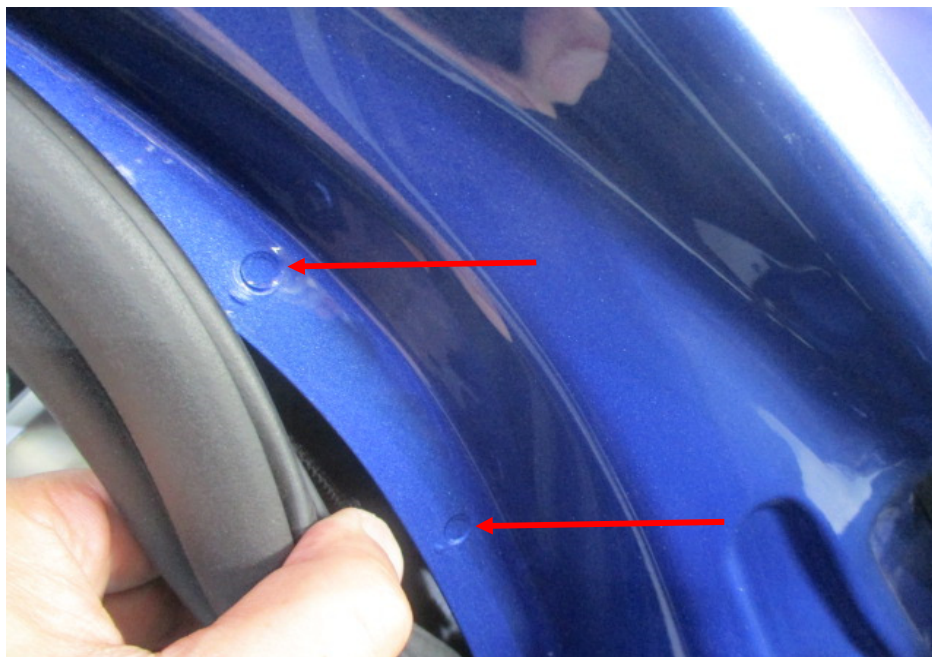
Photo 30 shows the right side “A” pillar of the Motor Car. I did not find any weld marks other than original spot weld marks (arrowed) on the right side “A” pillar of the Motor Car, which indicates that there was no re-welding works carried out. In general, I had found all the non-detachable body panels of the Motor Car to be originally fitted at the time of my inspection.

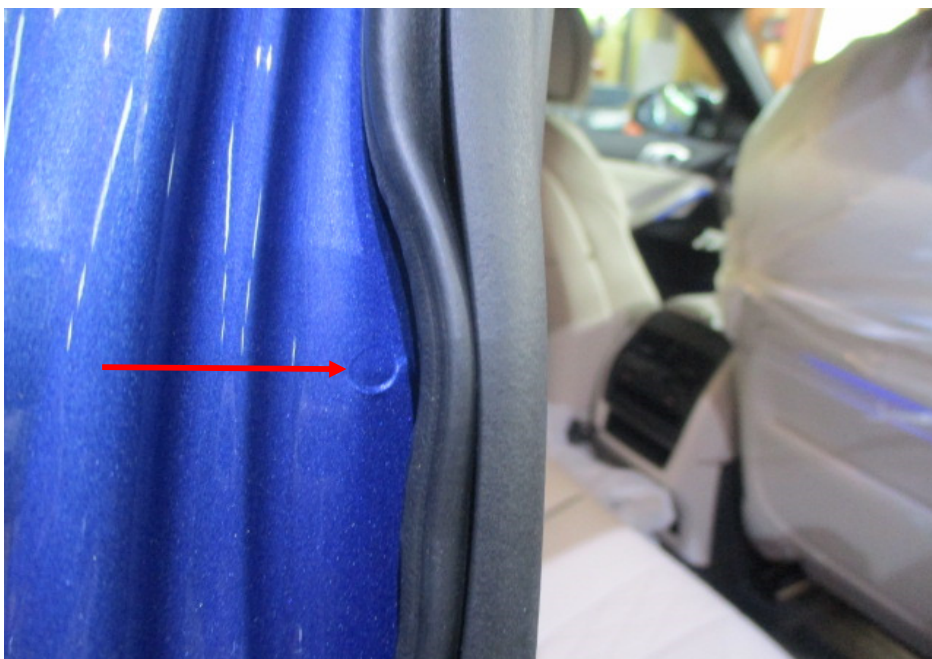
Photo 31 shows the right side “C” pillar of the Motor Car. I did not find any weld marks other than original spot weld marks (arrowed) on the right side “C” pillar of the Motor Car, which indicates that there was no re-welding works carried out. In general, I had found all the non-detachable body panels of the Motor Car to be originally fitted at the time of my inspection.
