Your Ref: BMW X6
(chassis number WBACY620909D41334)
Our Ref : CI/TP21010543/D

04 October 2021

**INSPECTION REPORT OF AN UNREGISTERED BMW X6 MOTOR CAR WITH
CHASSIS NUMBER WBACY620909D41334**

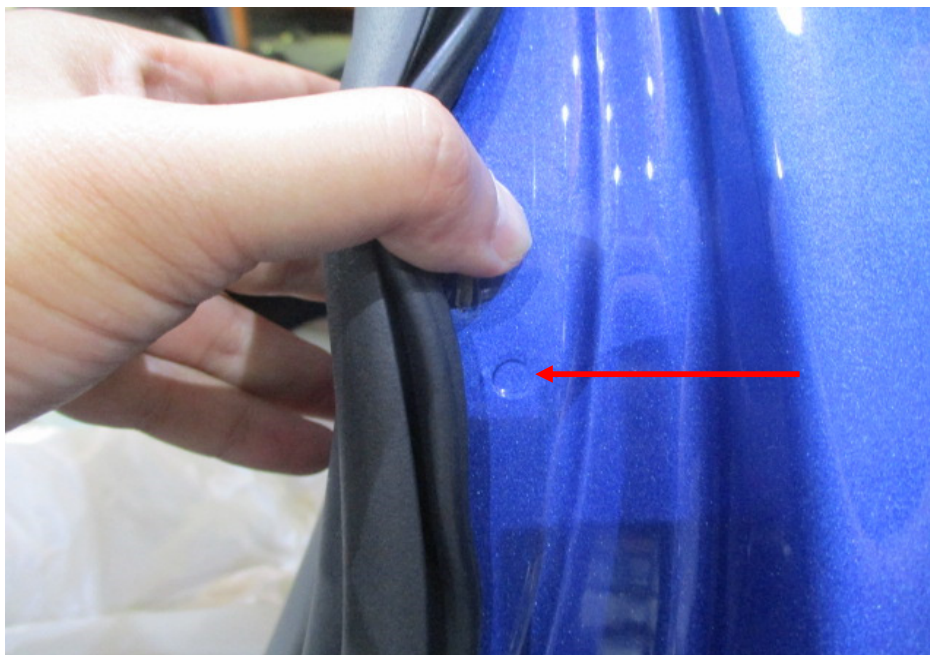
Photo 32 shows the left side "C" pillar of the Motor Car. I did not find any weld marks other than original spot weld marks (arrowed) on the left side "C" pillar of the Motor Car, which indicates that there was no re-welding works carried out. In general, I had found all the non-detachable body panels of the Motor Car to be originally fitted at the time of my inspection.
