Our Ref : CI/ASM21010551/N

AUTOMOBILE INSPECTION REPORT OF INSURED VEHICLE SKX 3559D

Vehicle Registration No. : SKX 3559D

Make / Model : MITSUBISHI LANCER 2.0L MIVEC GLS

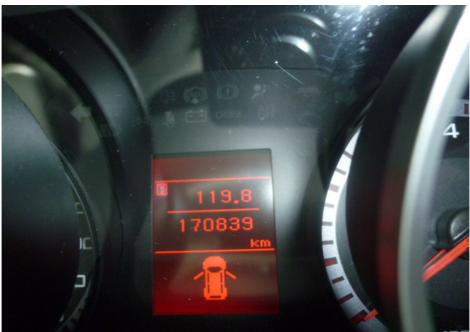
Photo 1 shows the mileage of the Insured Vehicle at the time of our inspection. The mileage observed was 170,839km.

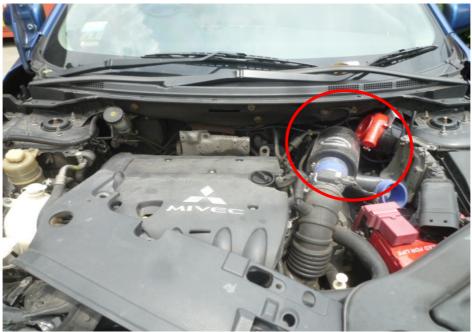
6. At the time of physical inspection of the Insured Vehicle, we had found several modifications and additionally fitted electronic and/or electrical component(s) on the Insured Vehicle. These included a non- standard open-pod air filter, a universal turbine electronic turbo blow- off valve simulator, an electronic throttle controller, an in- vehicle DVD player, a non- standard rear exhaust muffler and aftermarket 17- inch alloy rims. All these fitted components were not the standard type for the Insured Vehicle. See photos 6 – 13 below.

Photo 6 shows a general view of the engine compartment of the Insured Vehicle. Additional non-standard parts were found fitted. This includes a non- standard open- pod air filter and universal turbine electronic turbo blow- off valve simulator (circled).

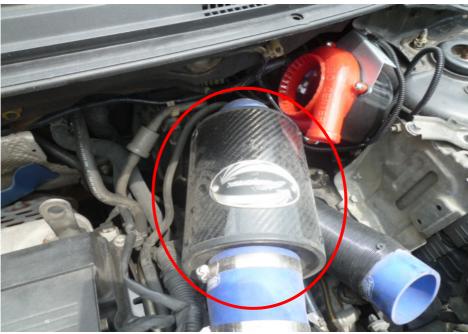
Photo 7 shows a close up view of the non- standard open- pod air filter fitted onto the Insured Vehicle upon our inspection (circled).

Modification/additionally fitted non-standard part	LTA's guideline	Effect(s) on Insured Vehicle
Open- pod air filter	Compliant	Improves air intake
Aftermarket universal turbine electronic turbo blow- off valve simulator	Compliant	Imitates turbo blow- off sound
Aftermarket rear exhaust muffler	Compliant	Increase exhaust flow
In- vehicle DVD player	Compliant	Entertainment purposes
Aftermarket front bumper	Compliant	Cosmetic type of modification
Aftermarket 17- inch alloy rims	Compliant	Cosmetic type of modification

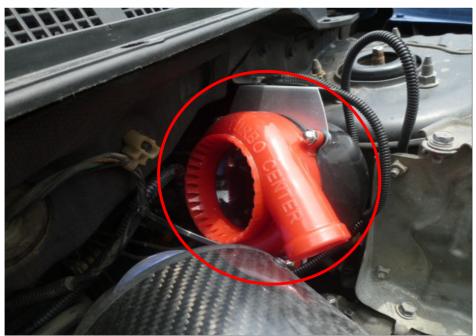
Photo 8 shows a close up view of the non-standard universal turbine electronic turbo blow- off valve simulator fitted onto the Insured Vehicle upon our inspection (circled).

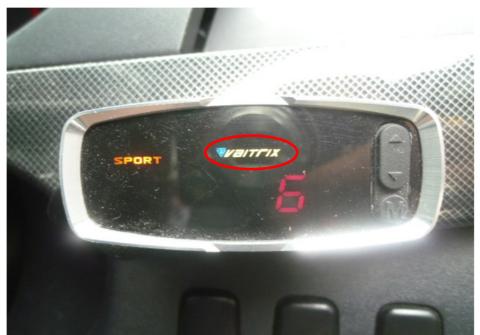
Photo 9 shows the electronic throttle controller additionally fitted onto the Insured Vehicle upon our inspection. The brand of the throttle controller was 'VAITRIX' (circled).

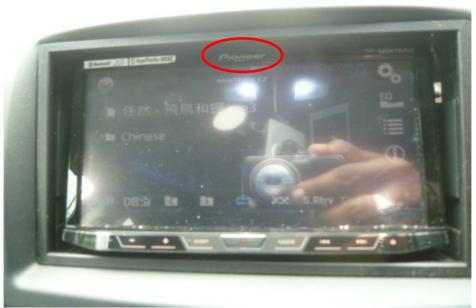
Photo 10 shows the in- vehicle DVD player additionally fitted onto the Insured Vehicle upon our inspection. The brand of the DVD player was 'PIONEER' (circled).

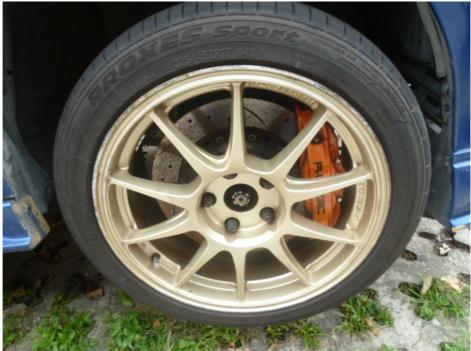
Photo 11 shows the non-standard rim found to be fitted on the Insured Vehicle at the time of our inspection. The 17- inch alloy rims fitted on the Insured Vehicle were not the standard type for the Insured Vehicle.

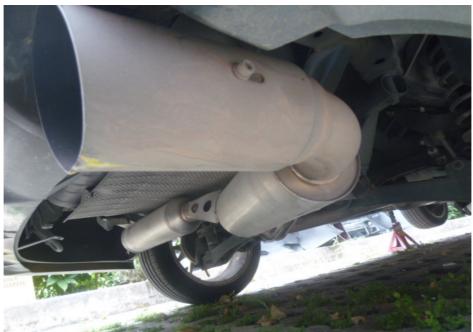
Photo 12 shows a front view of the non-standard rear exhaust muffler that was found to be fitted on the Insured Vehicle at the time of our inspection.

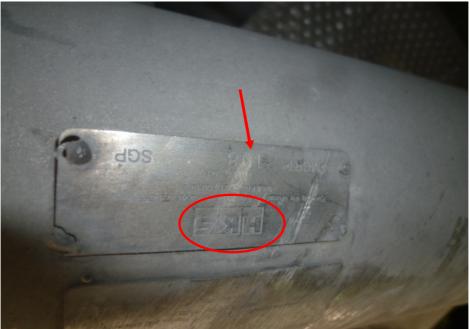
Photo 13 shows a close up view of the underside of the non-standard rear exhaust muffler that was found to be fitted on the Insured Vehicle at the time of our inspection. The brand of the rear exhaust muffler was 'HKS' (circled). The serial number of the rear exhaust muffler was '2108' (arrowed).

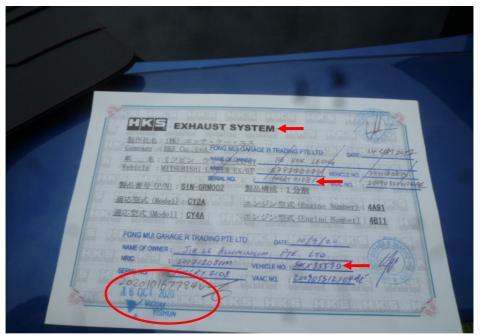
7. As for the non- standard rear exhaust muffler, during our physical inspection of the insured Vehicle we were able to obtain the exhaust authentication certificate as well as the inspection acknowledgement letter issued by the LTA to prove that the after-market rear exhaust muffler had passed the mandatory inspection on 16 October 2020. See photos 14 & 15 below.

Photo 14 shows the HKS rear exhaust muffler authentication certificate. The rear exhaust muffler with serial number '2108' was fitted onto the Insured Vehicle (arrowed) and had passed inspection on 16 October 2020 (circled).

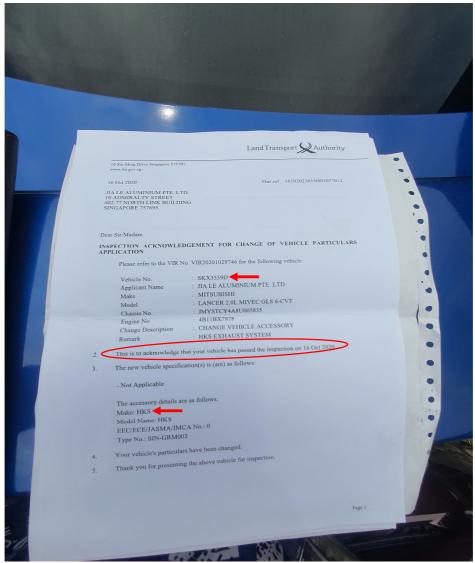
Photo 15 shows the inspection acknowledgement letter issued by the LTA to prove that the HKS rear exhaust muffler fitted onto the Insured Vehicle (arrowed) had passed the mandatory inspection on 16 October 2020 (circled).

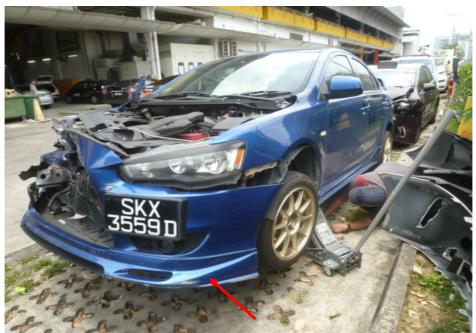
8. Exteriorly, the Insured Vehicle was fitted with an aftermarket front bumper. This is LTA- complaint and generally referred to as cosmetic type of modifications. See photo 16 below.

Photo 16 shows a general view of the aftermarket front bumper found fitted onto the Insured Vehicle at the time of our inspection (arrowed).
