Your Ref: Porsche 718 Boxster GTS
(chassis number WP0ZZZ98ZLS220111)
Our Ref : CI/TP21010652/D

16 October 2021

**INSPECTION REPORT OF AN UNREGISTERED PORSCHE 718 GTS
BOXSTER MOTOR CAR WITH CHASSIS NUMBER WP0ZZZ98ZLS220111**

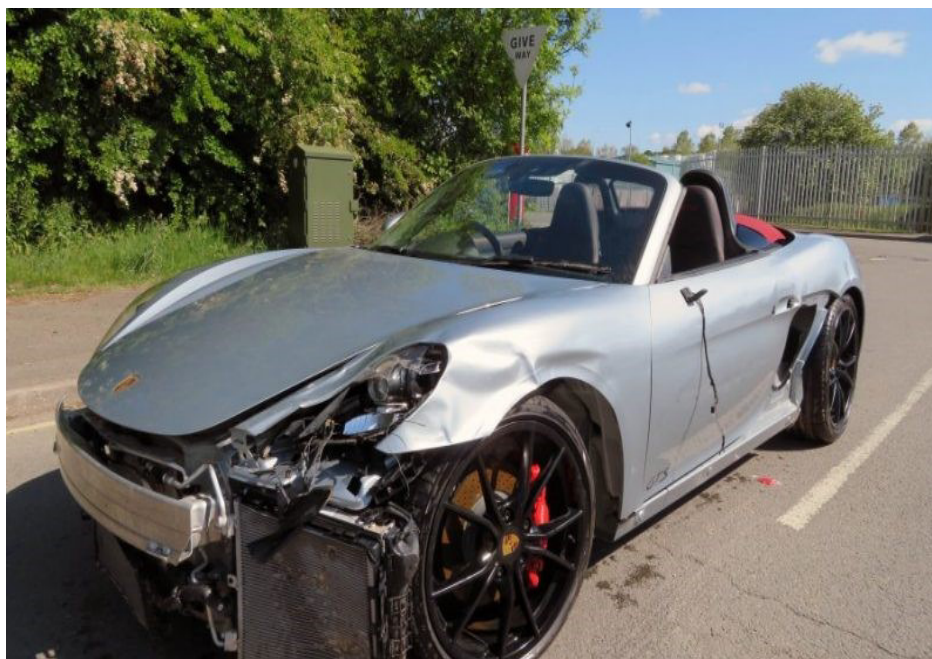
Photo 1 shows the front left body of the Motor Car (photograph provided to me). The Motor Car was observed to have sustained damage at its frontal portion and left side portion. The centre radiator, front left headlamp, front left aircon condenser, front left radiator, front left fender, front left door and front left wing mirror were amongst the body parts that were observed to have been damaged. The front bumper, front bumper lower spoiler, front bumper air guides, front bumper sensors, front signal lamps and front day lights amongst others were observed to be missing/dislodged/damaged.

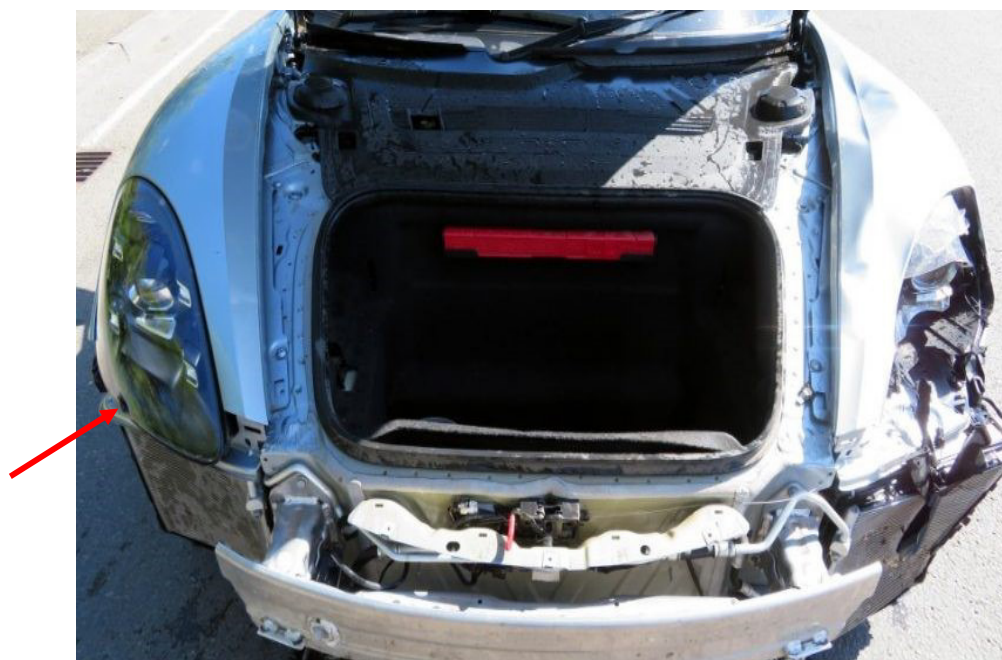
Photo 2 shows the front bonnet compartment of the Motor Car (photograph provided to me). The front right headlamp was observed to be damaged (arrowed) whilst the front bumper and front bonnet compartment inner trims amongst others were observed to be missing/dislodged/damaged.

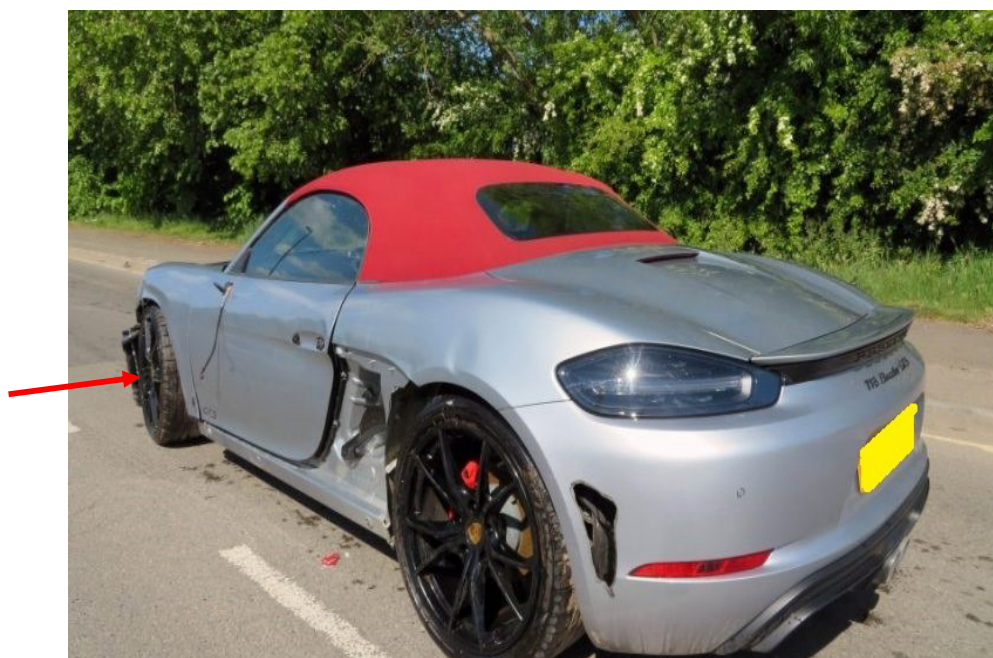
Photo 3 shows the rear left body of the Motor Car (photograph provided to me). The Motor Car was observed to have sustained damage along its entire left side. The rear bumper, rear left fender, front left door, front left door outer handle, front left wing mirror, left side air vent and left side rocker panel garnish were amongst the body parts that were observed to have been damaged. The orientation of the front left wheel (arrowed) and front right wheel (refer to photograph 4 below) suggest damage to the front undercarriage parts of the Motor Car.

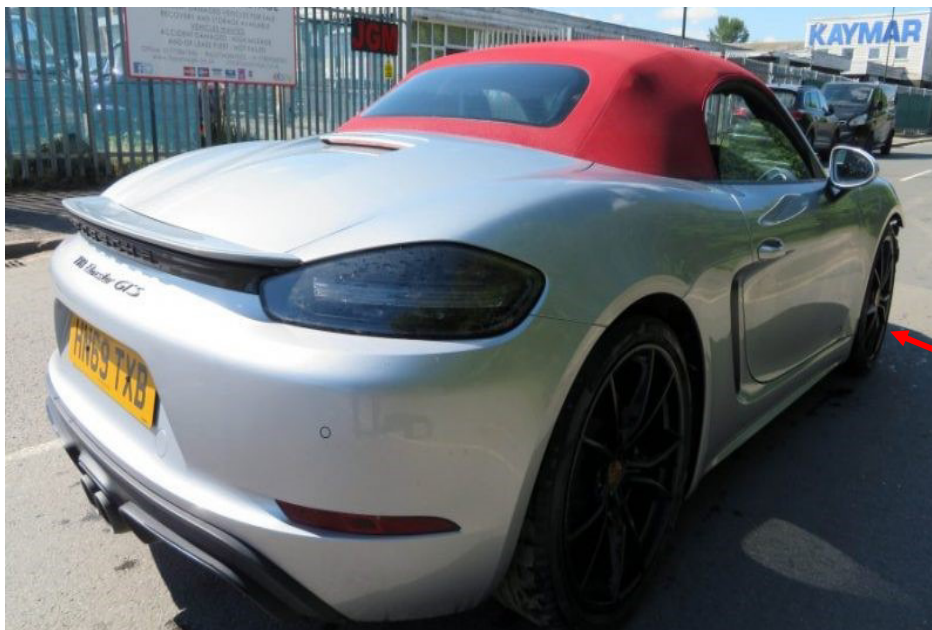
Photo 4 shows the rear right body of the Motor Car (photograph provided to me). The right side of the Motor Car was seen to be without any physical damage. The orientation of the front right wheel (arrowed) and front left wheel (refer to photograph 3 above) suggest damage to the front undercarriage parts of the Motor Car.

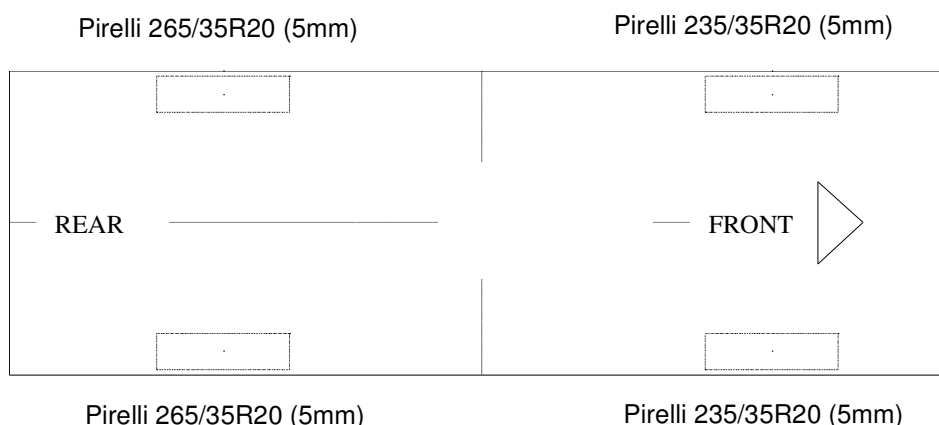
11. It was fitted with 20inch sport wheel rims that were wrapped with tyres that were observed to be of serviceable condition. The tyres were also sufficiently inflated for vehicular operation. The tyre brand, tyre size and approximate remaining tread depth of the 4 tyres of the Motor Car were recorded as follows: -

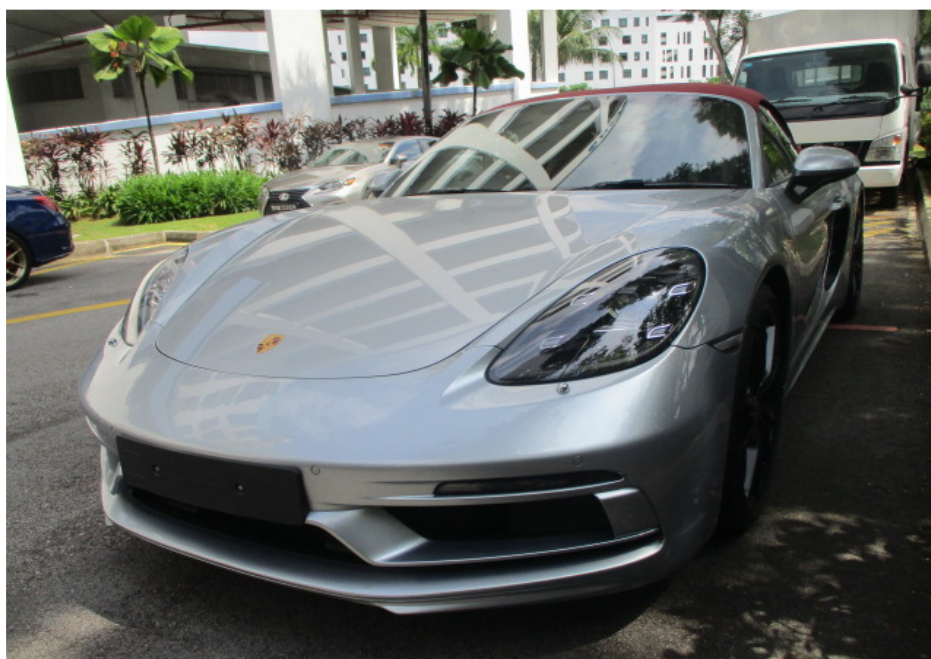
Photo 5 shows a general view of the front left body of the Motor Car at the time of my inspection. The Motor Car was observed to be in a relatively good general condition with no loose exterior fittings observed. The body parts at the frontal portion of the Motor Car were visually examined and it was observed that the repair/restoration works carried out to the damaged area of the Motor Car (refer to photograph 1 & 2 above) were reasonably adequate and in order.

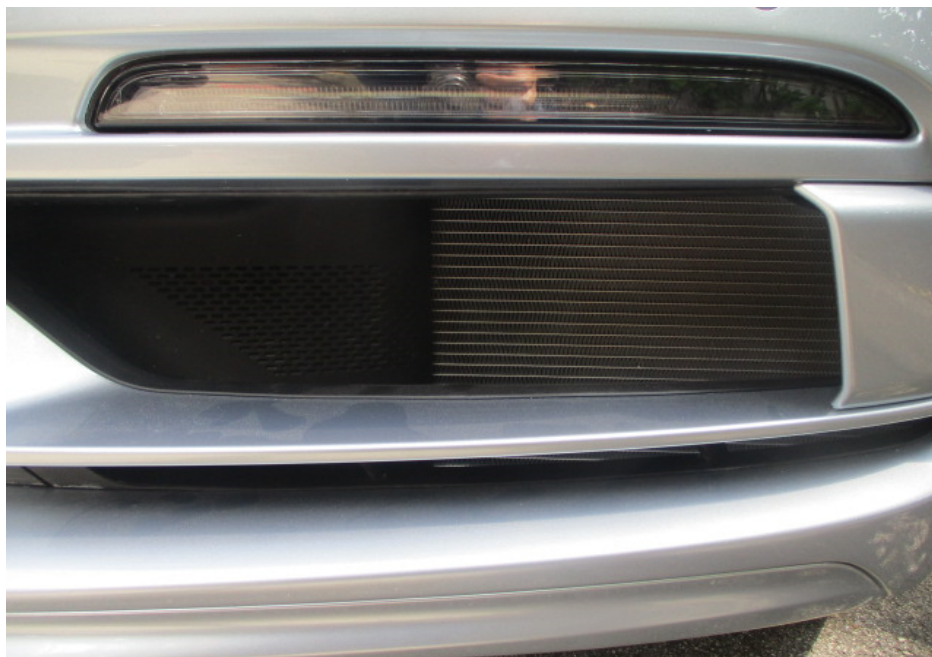
Photo 6 shows a closer view of the Motor Car's front left aircon condenser, front left day light and front bumper left air guide. The body parts at the frontal portion of the Motor Car were visually examined and it was observed that the repair/restoration works carried out to the damaged area of the Motor Car (refer to photograph 1 & 2 above) were reasonably adequate and in order.

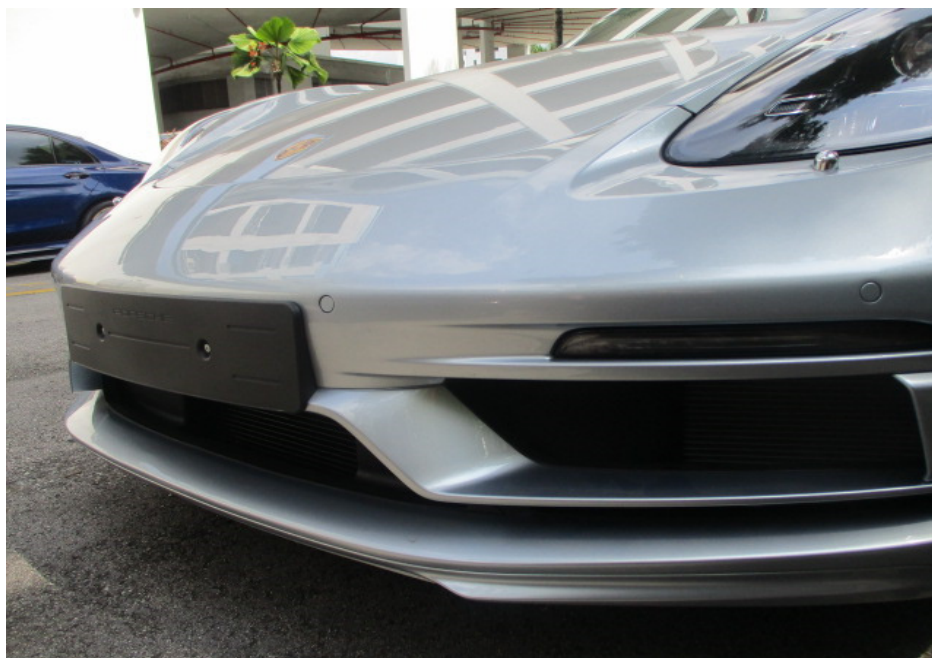
Photo 7 shows a closer view of the Motor Car's front bumper, front bumper lower spoiler, front bumper sensors, front left headlamp and front left day light. The body parts at the frontal portion of the Motor Car were visually examined and it was observed that the repair/restoration works carried out to the damaged area of the Motor Car (refer to photograph 1 & 2 above) were reasonably adequate and in order.

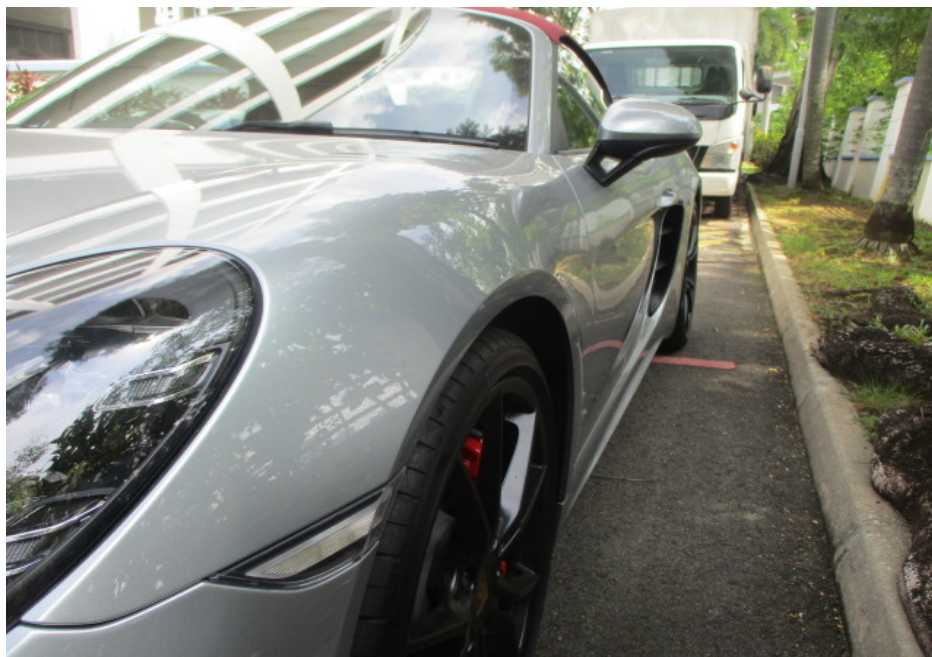
Photo 8 shows a closer view of the Motor Car's front left headlamp, front left signal lamp, front left fender and front left wing mirror. The body parts at the left side portion of the Motor Car were visually examined and it was observed that the repair/restoration works carried out to the damaged area of the Motor Car (refer to photograph 1 & 3 above) were reasonably adequate and in order.

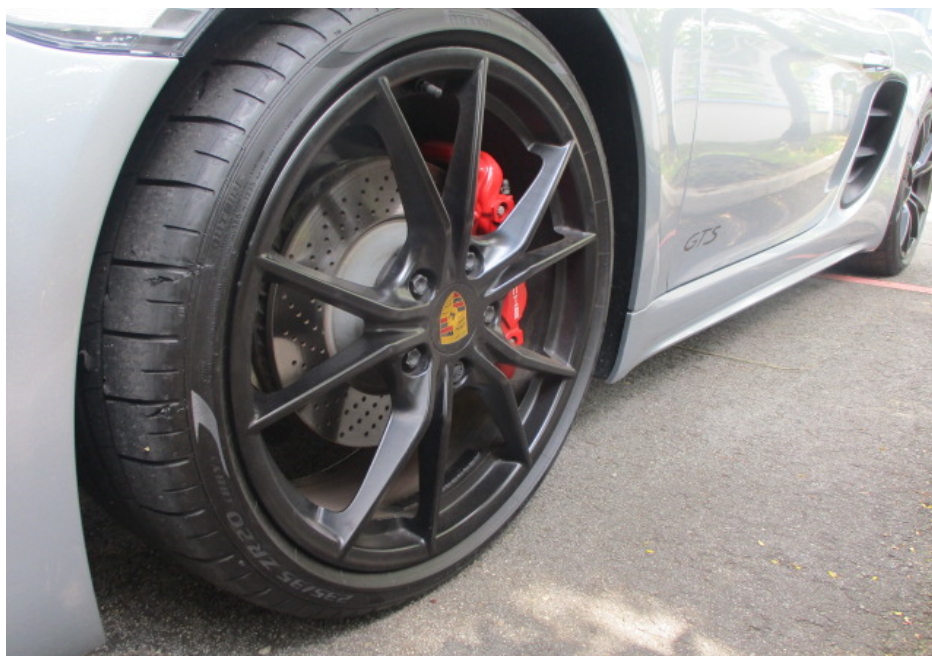
Photo 9 shows a closer view of the Motor Car's front left wheel rim and left side rocker panel garnish. The body parts at the left side portion of the Motor Car were visually examined and it was observed that the repair/restoration works carried out to the damaged area of the Motor Car (refer to photograph 1 & 3 above) were reasonably adequate and in order.

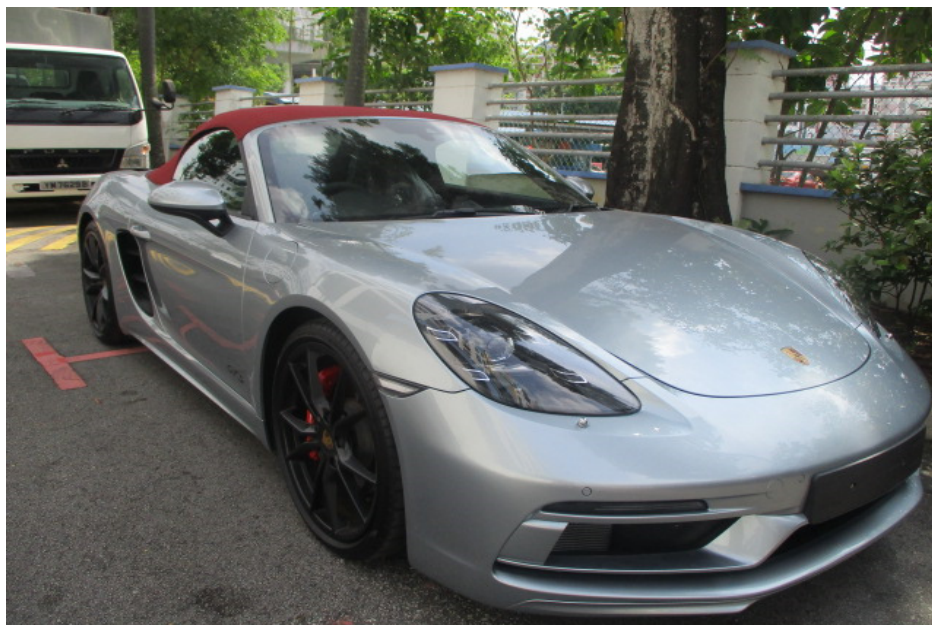
Photo 10 shows a general view of the front right body of the Motor Car at the time of my inspection. The Motor Car was observed to be in a relatively good general condition with no loose exterior fittings observed. The body parts at the frontal portion of the Motor Car were visually examined and it was observed that the repair/restoration works carried out to the damaged area of the Motor Car (refer to photograph 1 & 2 above) were reasonably adequate and in order.

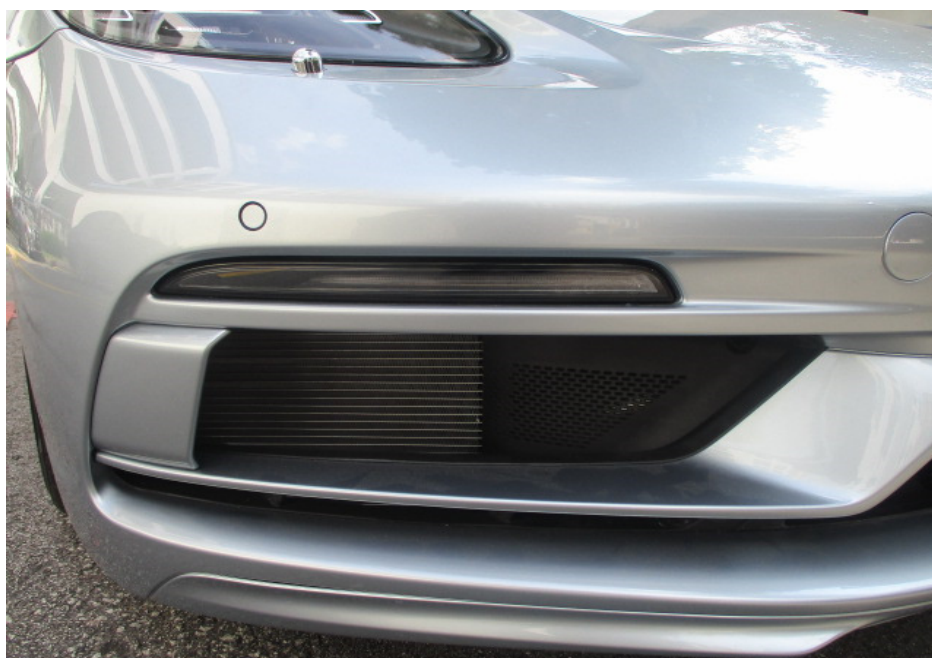
Photo 11 shows a closer view of the Motor Car's front bumper, front bumper lower spoiler, front bumper right air guide, front right headlamp, front right aircon condenser and front right day light. The body parts at the frontal portion of the Motor Car were visually examined and it was observed that the repair/restoration works carried out to the damaged area of the Motor Car (refer to photograph 1 & 2 above) were reasonably adequate and in order.

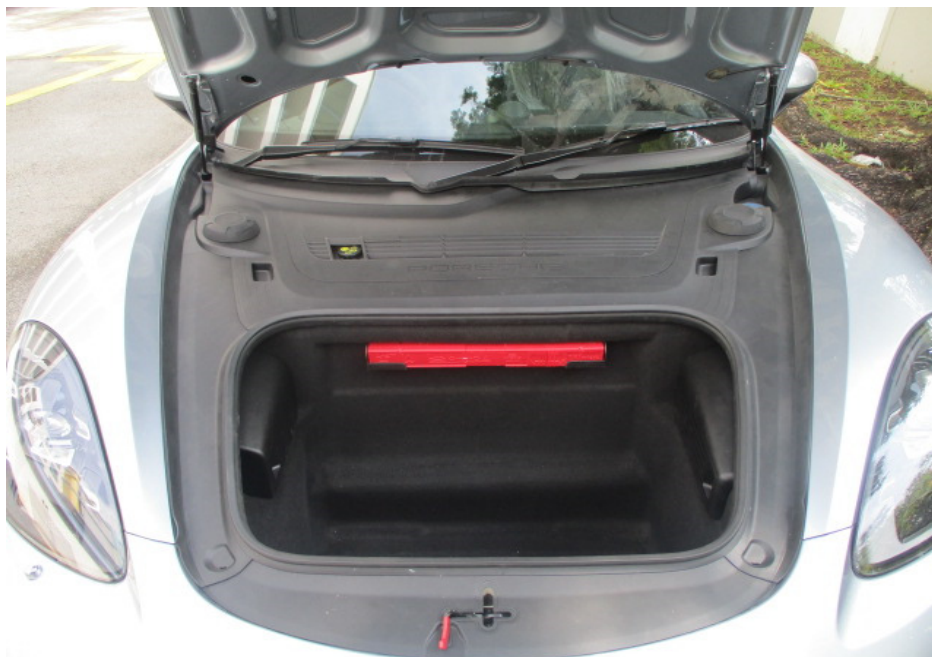
Photo 12 shows a general of the Motor Car's front bonnet compartment at the time of my inspection. All inner trims, garnishes and upholstery etc were observed to be properly fitted. The body parts at the frontal portion of the Motor Car were visually examined and it was observed that the repair/restoration works carried out to the damaged area of the Motor Car (refer to photograph 1 & 2 above) were reasonably adequate and in order.

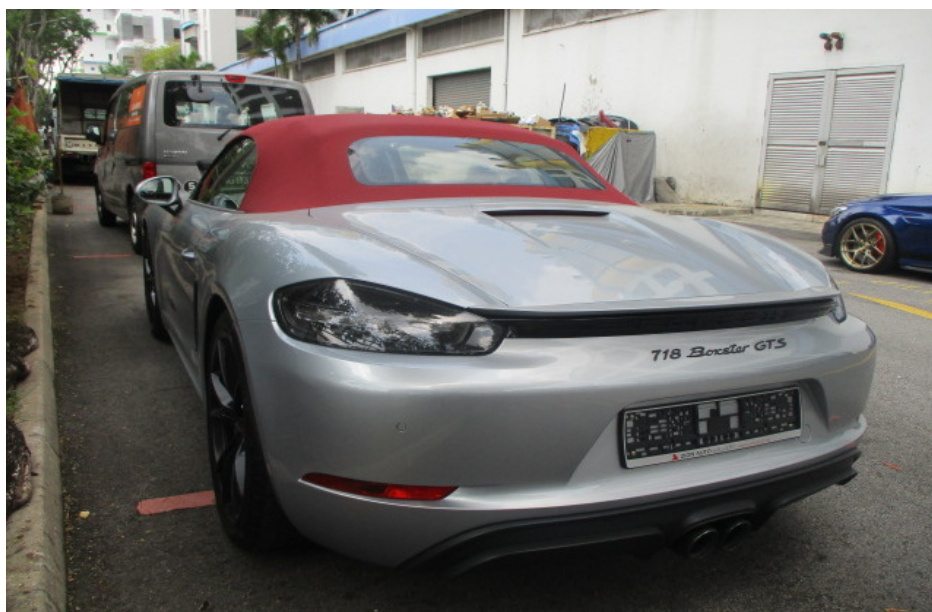
Photo 13 shows a general view of the rear left body of the Motor Car at the time of my inspection. The Motor Car was observed to be in a relatively good general condition with no loose exterior fittings observed. The body parts at the left side portion of the Motor Car were visually examined and it was observed that the repair/restoration works carried out to the damaged area of the Motor Car (refer to photograph 1 & 3 above) were reasonably adequate and in order.

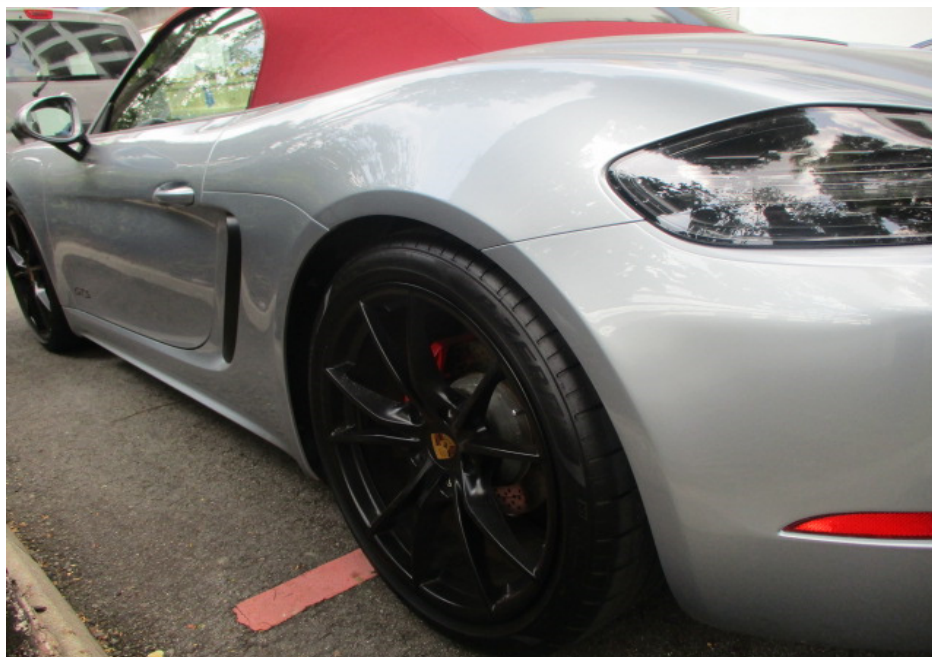
Photo 14 shows a closer view of the Motor Car's rear bumper, rear left fender and rear left wheel rim. The body parts at the left side portion of the Motor Car were visually examined and it was observed that the repair/restoration works carried out to the damaged area of the Motor Car (refer to photograph 3 above) were reasonably adequate and in order.

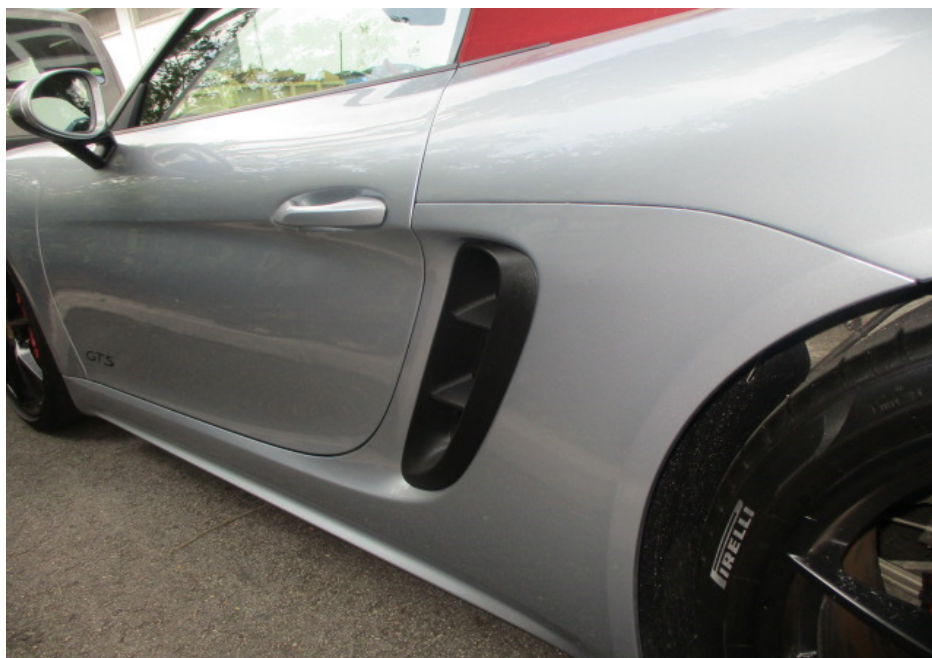
Photo 15 shows a closer view of the Motor Car's rear left fender, front left door, front left door outer handle, left side rocker panel garnish and left side air vent. The body parts at the left side portion of the Motor Car were visually examined and it was observed that the repair/restoration works carried out to the damaged area of the Motor Car (refer to photograph 3 above) were reasonably adequate and in order.

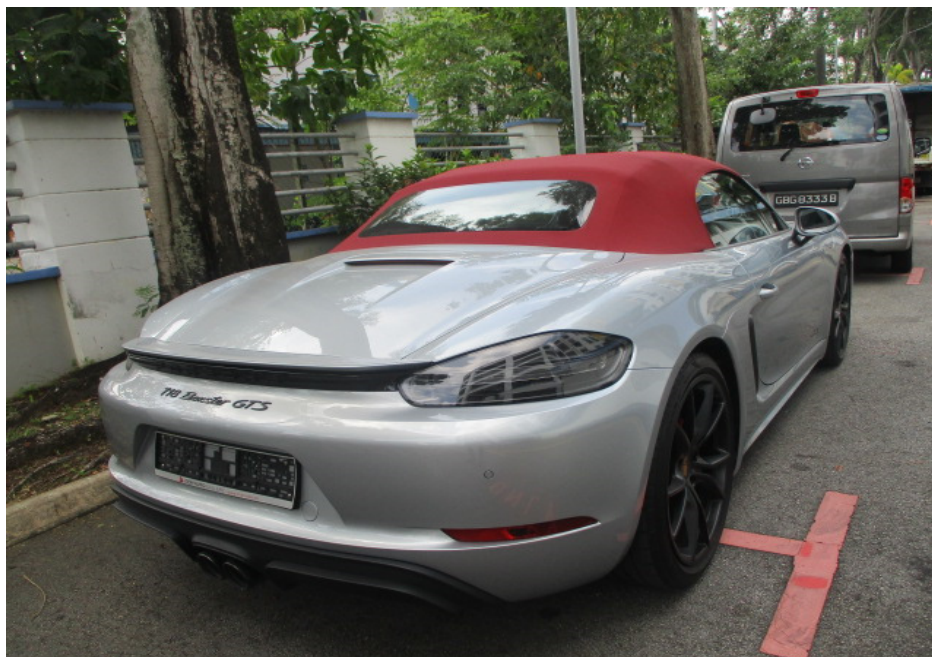
Photo 16 shows a general view of the rear right body of the Motor Car at the time of my inspection. The Motor Car was observed to be in a relatively good general condition with no loose exterior fittings observed. The mileage of the Motor Car recorded at the time of my inspection was 1,685miles.

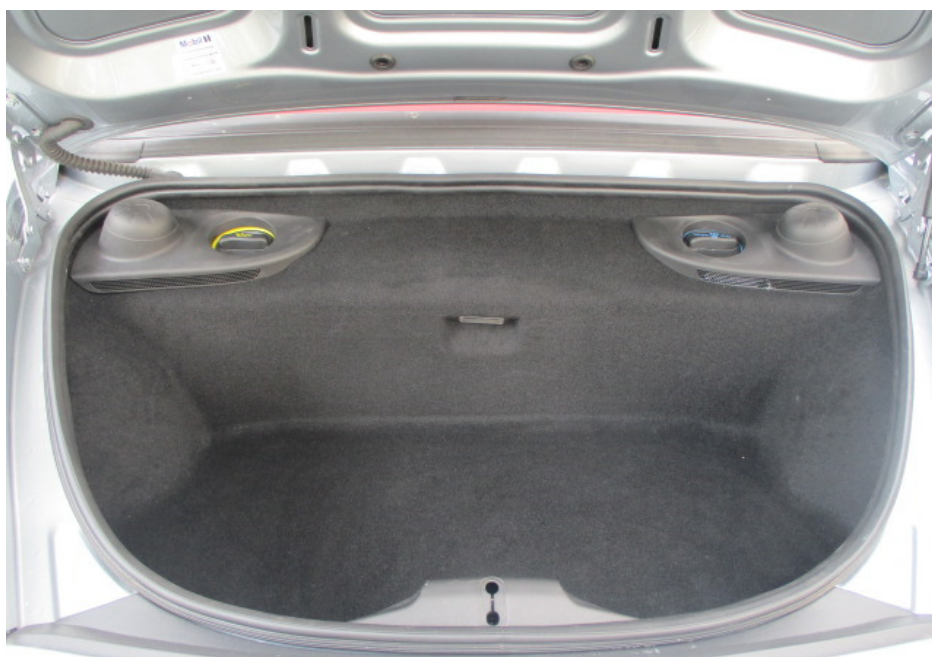
Photo 17 shows a general of the Motor Car's rear boot compartment at the time of my inspection. All inner trims, garnishes and upholstery etc were observed to be properly fitted.

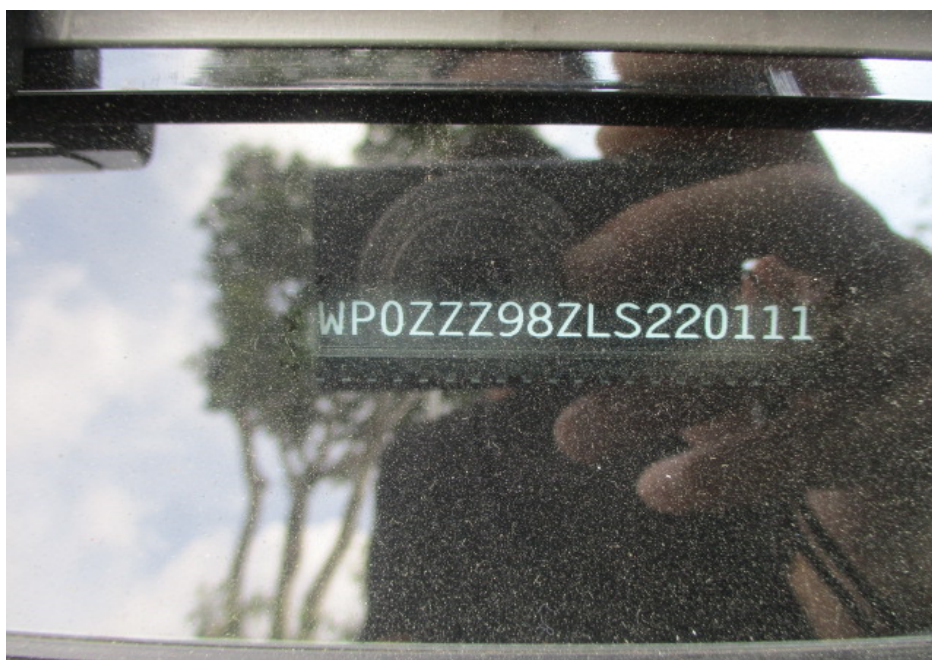
Photo 18 shows the chassis number of the Motor Car. The chassis number recorded WP0ZZZ98ZLS220111.

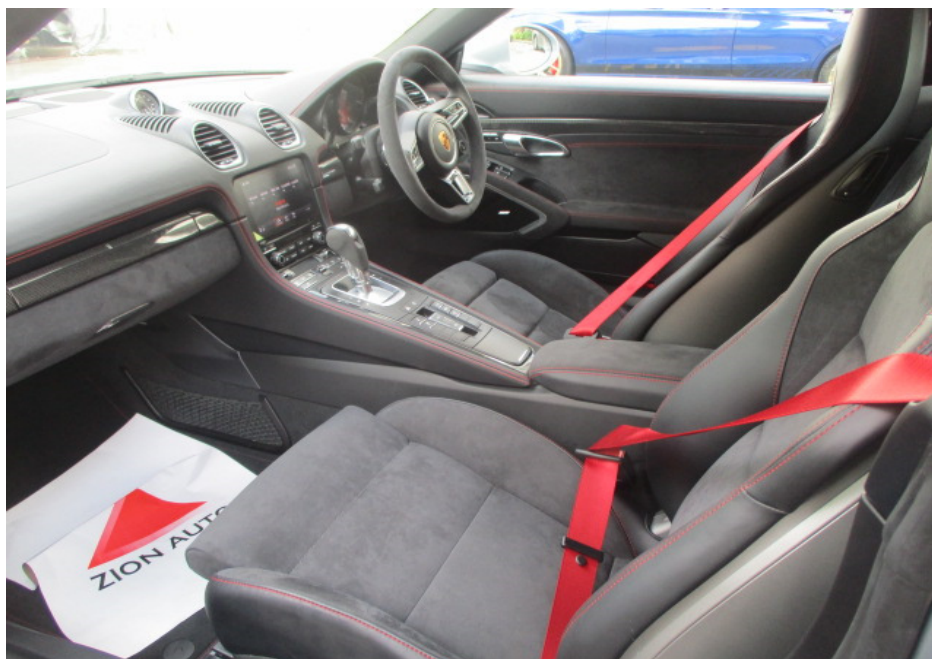
Photo 19 shows the interior compartment of the Motor Car at the time of my inspection. The various parts and components, trims, carpet and upholstery inside the interior compartment were all observed to be intact and properly fitted.

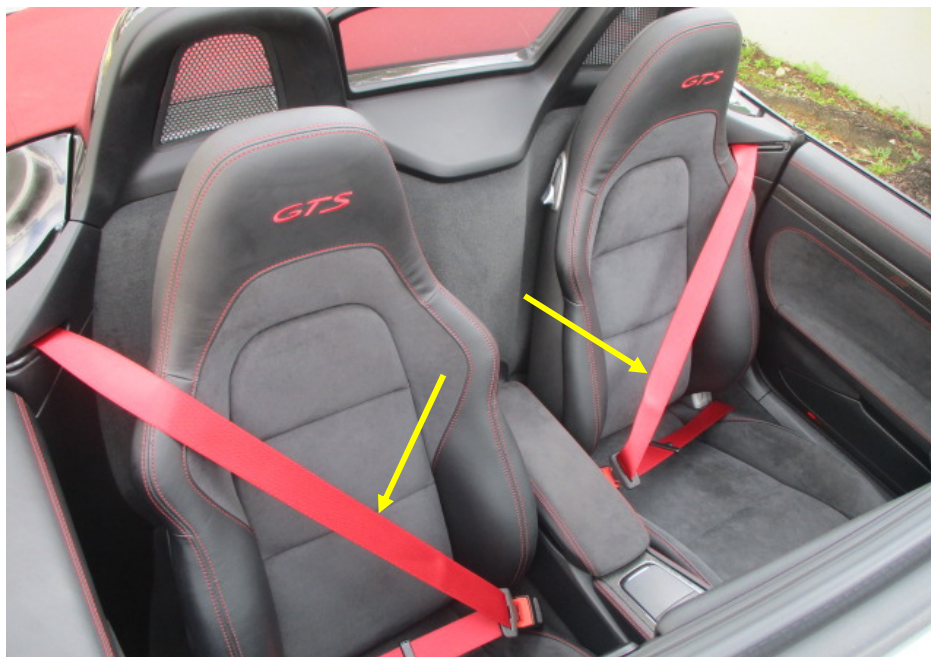
Photo 20 shows the seats of the Motor Car. All the seats of the Motor Car were secured via seat rails to the floorboard. They were also fitted with a retractable seat belt reel and a pre-tensioner. The seat belts (arrowed) were tested and were able to be fastened into the respective pre-tensions that were fitted on the side of each individual seat.

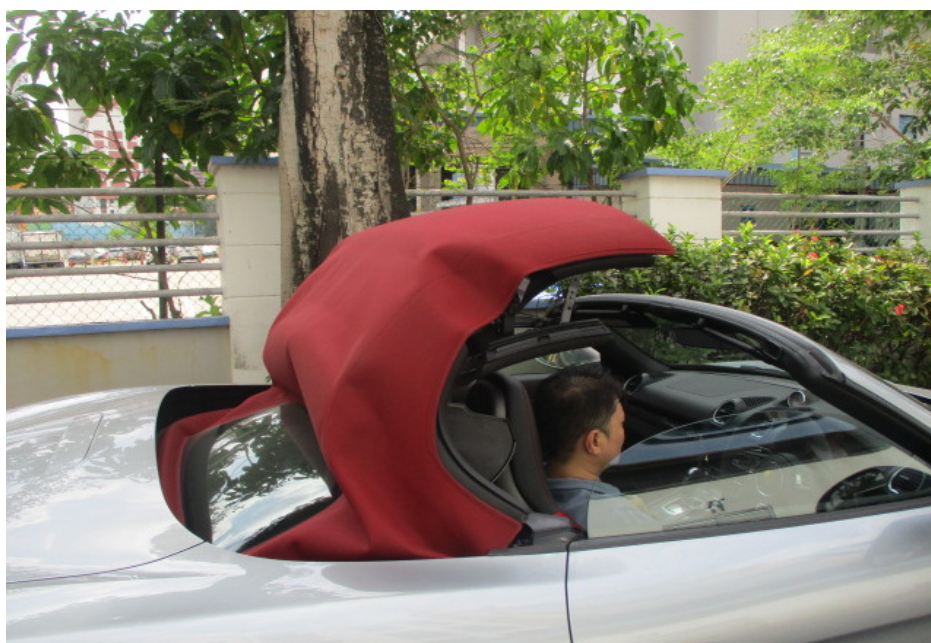
Photo 21 shows the Motor Car's soft top being tested. It was observed that as a safety feature, the soft top roof could only open and close when the Motor Car was in a stationary position. When in an open position, the soft top roof is completely folded into its rear compartment with no parts protruding out of the Motor Car's body. The soft top roof was also found adequately secured to the "A" pillar after closing.

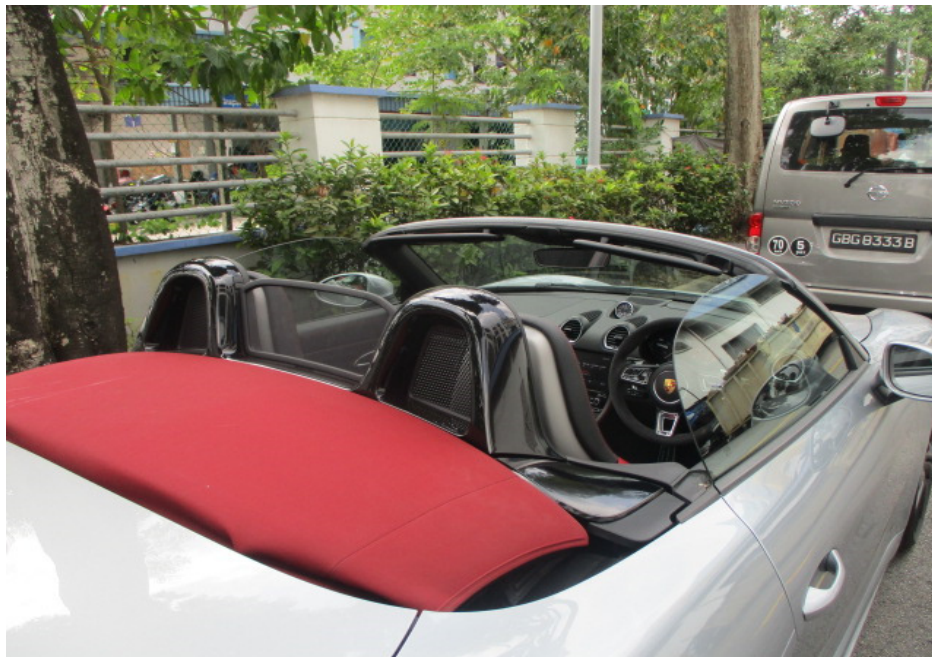
Photo 22 shows the Motor Car with its soft top roof in an open position. When in an open position, the soft top roof is completely folded into its rear compartment with no parts protruding out of the Motor Car's body. The soft top roof was also found adequately secured to the "A" pillar after closing.

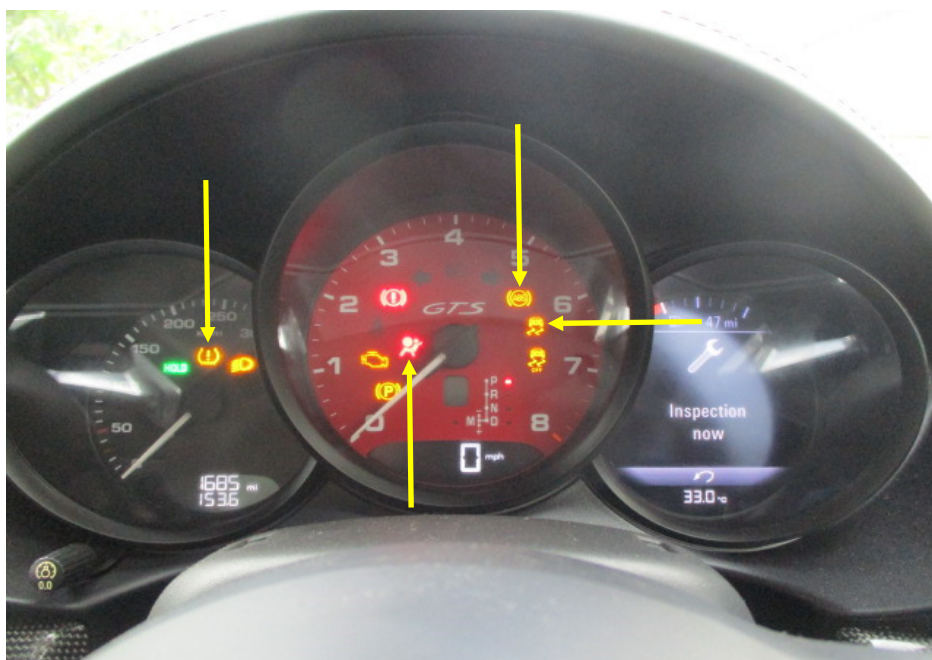
Photo 23 shows the warning lights for the various electronic safety features appearing on the instrument panel of the Motor Car during its self-test when the engine is cranked, in particular the ABS, SRS, TPM and TCS lights (arrowed).

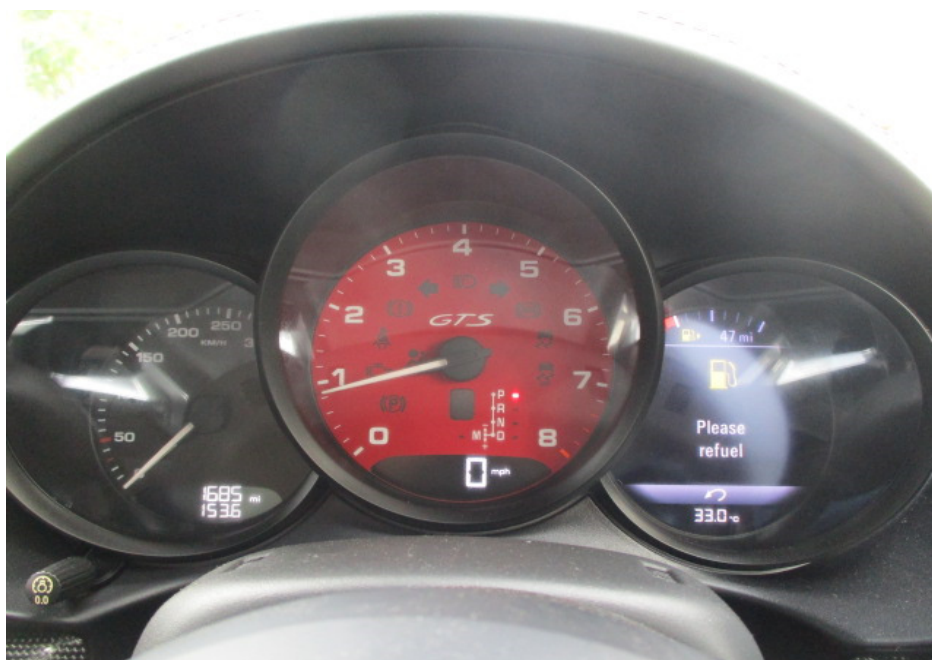
Photo 24 shows the respective warning lights no longer illuminated, indicating that there is no fault detected to the ABS, SRS, TPM and TCS systems of the Motor Car during the self-test. These electronic systems were hence in working condition at the time of my inspection.

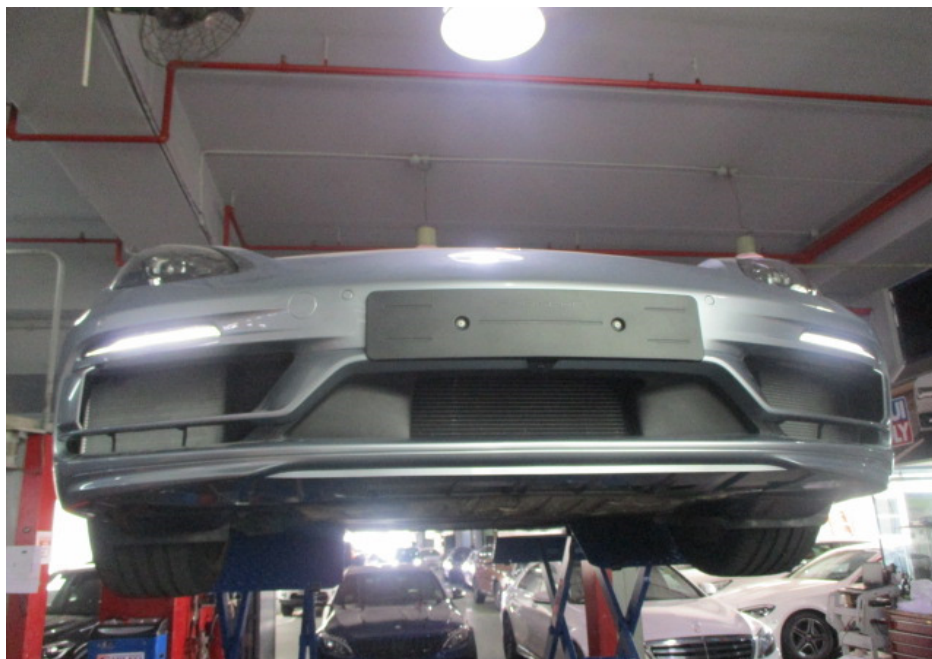
Photo 25 shows the Motor Car hoisted up for checks on its undercarriage. There was no sign(s) or indication(s) of fluid leakage and/or fluid stain(s) on the underside of the Motor Car. The undercarriage components of the Motor Car were also all observed to be intact and secured in an appropriate manner.

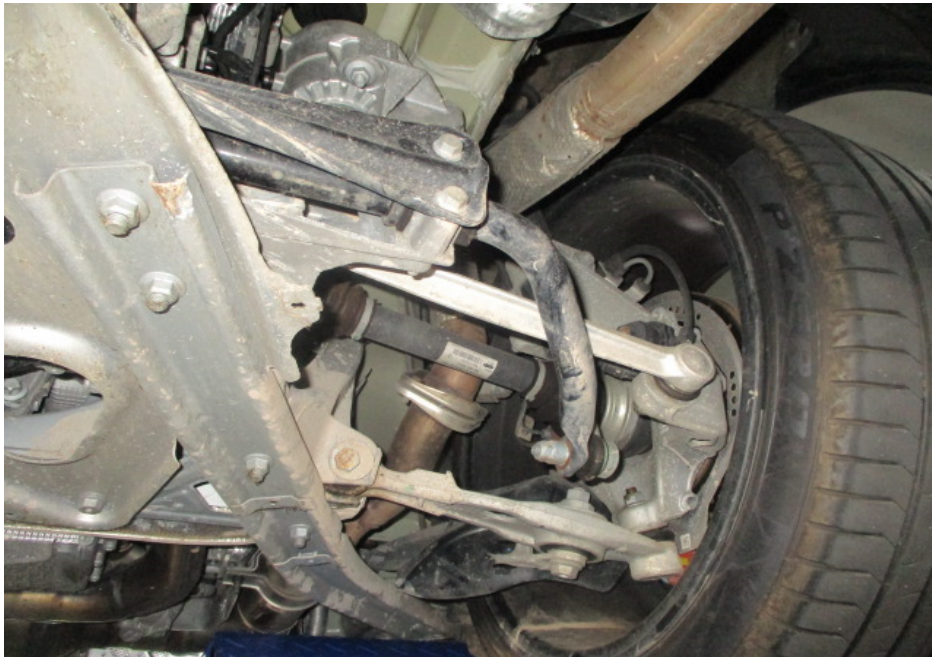
Photo 26 shows a general view of the control arms and linkages at the rear right wheel of the Motor Car. I did not observe any fluid leak and/or fluid stain on the underside of the Motor Car. All of the Motor Car's undercarriage components were observed to be intact and secured in an appropriate manner.

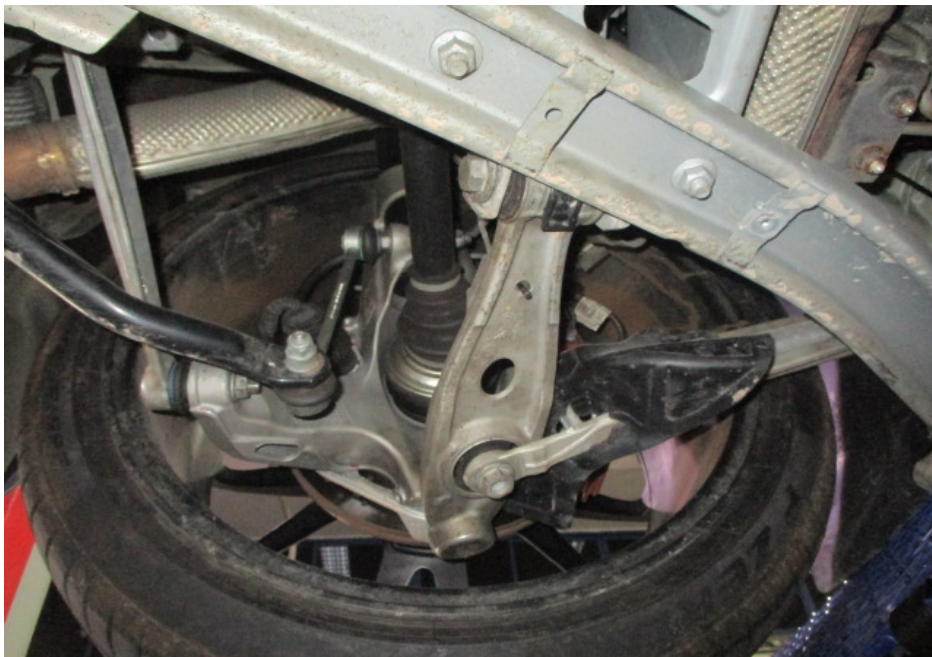
Photo 27 shows a general view of the control arms and linkages at the rear left wheel of the Motor Car. I did not observe any fluid leak and/or fluid stain on the underside of the Motor Car. All of the Motor Car's undercarriage components were observed to be intact and secured in an appropriate manner.

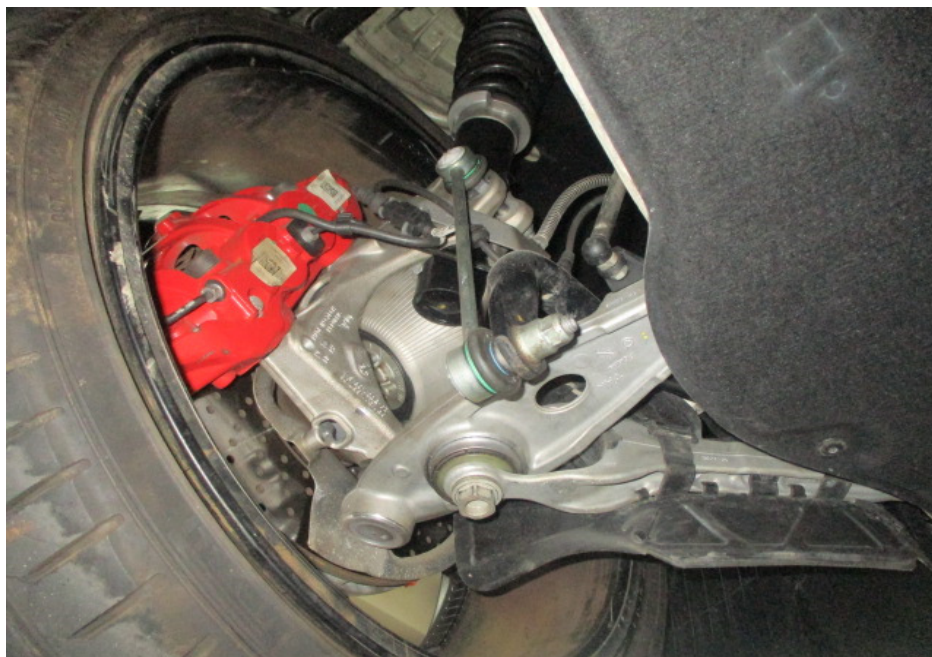
Photo 28 shows the various undercarriage components at the front left wheel of the Motor Car. The mechanical components, control arms and linkages were all found to be intact and secured in an appropriate manner.

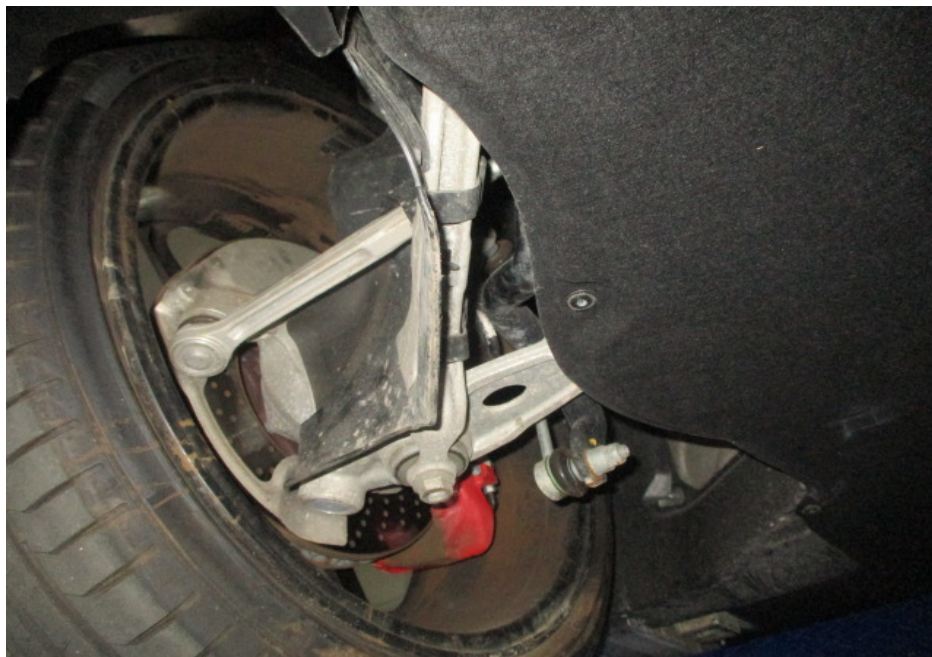
Photo 29 shows the various undercarriage components at the front right wheel of the Motor Car. The mechanical components, control arms and linkages were all found to be intact and secured in an appropriate manner. I also did not observe any fluid leak and/or fluid stain on the underside of the Motor Car.

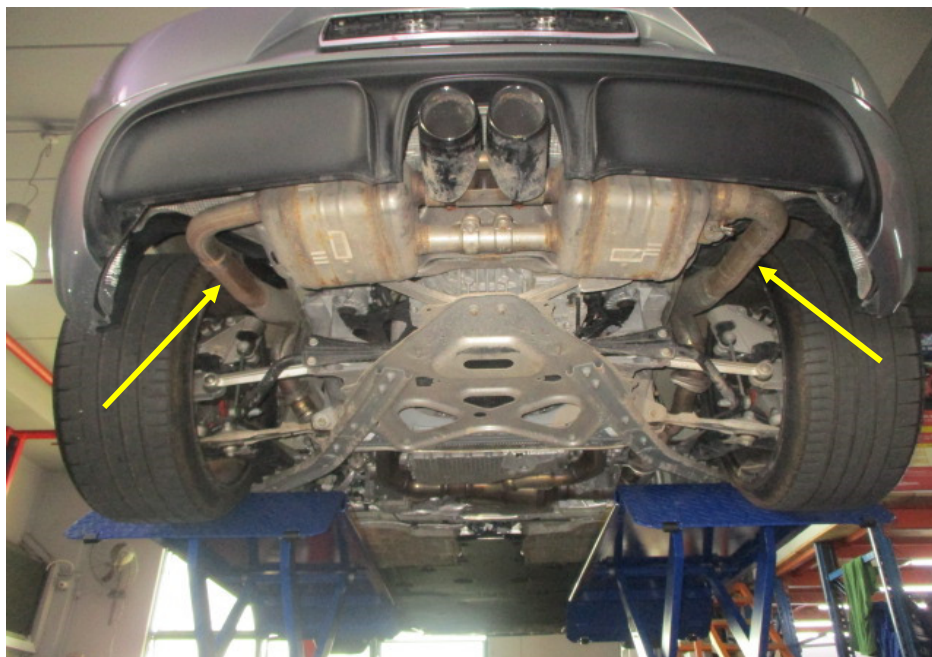
Photo 30 shows the Motor Car's rear mufflers (arrowed). My examination of the Motor Car's exhaust system revealed no sign(s) or indication(s) of any cut or weld marks along its exhaust pipes, on its catalytic converters and on its rear mufflers.

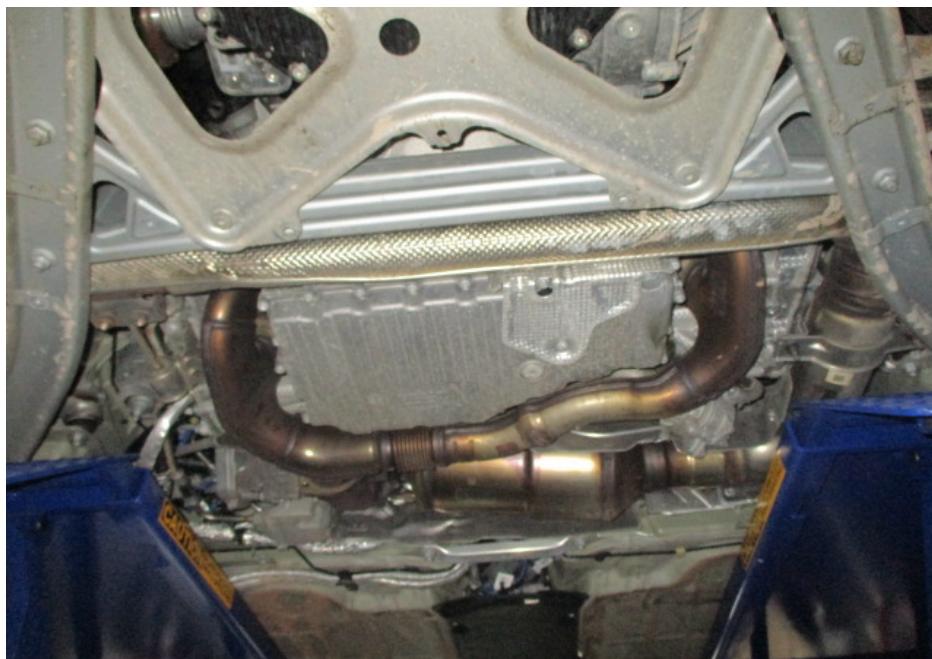
Photo 31 shows the Motor Car's catalytic converters. My examination of the Motor Car's exhaust system revealed no sign(s) or indication(s) of any cut or weld marks along its exhaust pipes, on its catalytic converters and on its rear mufflers.
