Your Ref: Porsche 718 Boxster GTS
(chassis number WP0ZZZ98ZLS220111)
Our Ref : CI/TP21010652/D

16 October 2021

**INSPECTION REPORT OF AN UNREGISTERED PORSCHE 718 GTS
BOXSTER MOTOR CAR WITH CHASSIS NUMBER WP0ZZZ98ZLS220111**

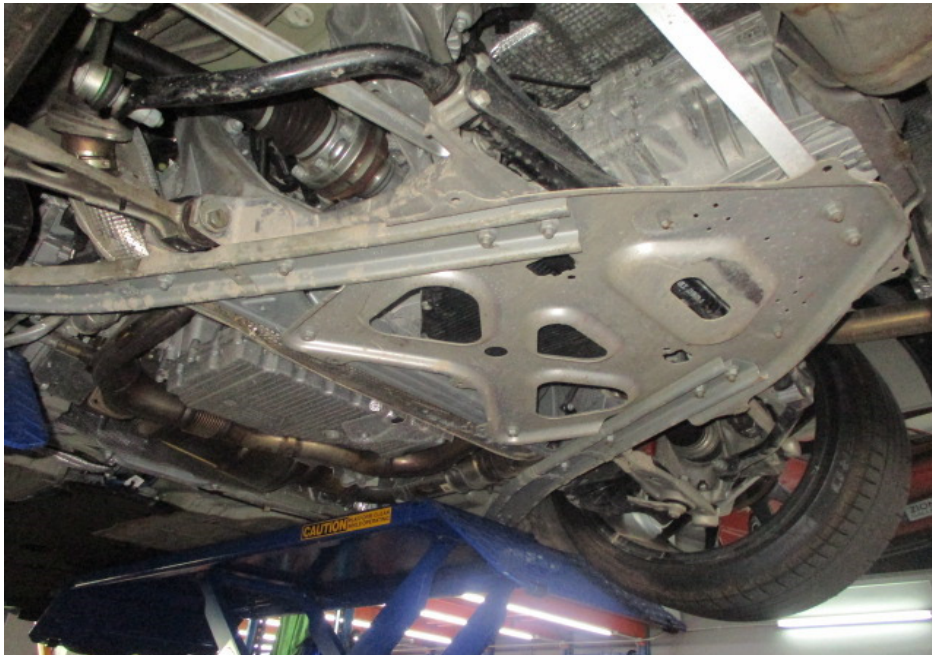
Photo 32 shows a general view of the Motor Car's engine compartment. The engine compartment was at the rear underside of the Motor Car. The various parts and components inside the engine compartment were all observed to be intact and properly fitted. There was also no sign(s) or indication(s) of fluid leak and/or fluid stain found inside the engine compartment.

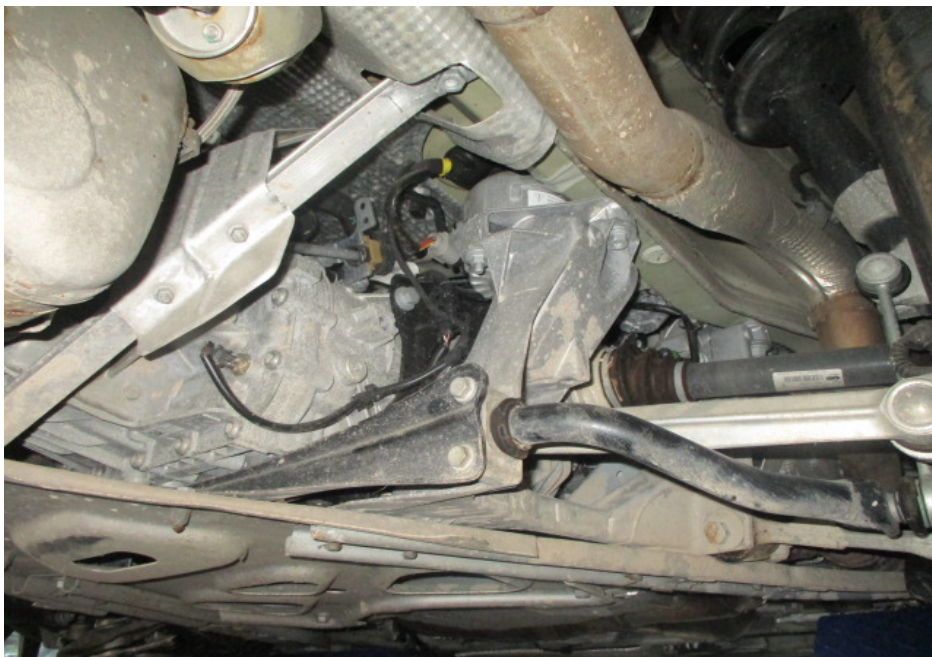
Photo 33 shows another view of the Motor Car's engine compartment. The engine compartment was at the rear underside of the Motor Car. The various parts and components inside the engine compartment were all observed to be intact and properly fitted. There was also no sign(s) or indication(s) of fluid leak and/or fluid stain found inside the engine compartment.

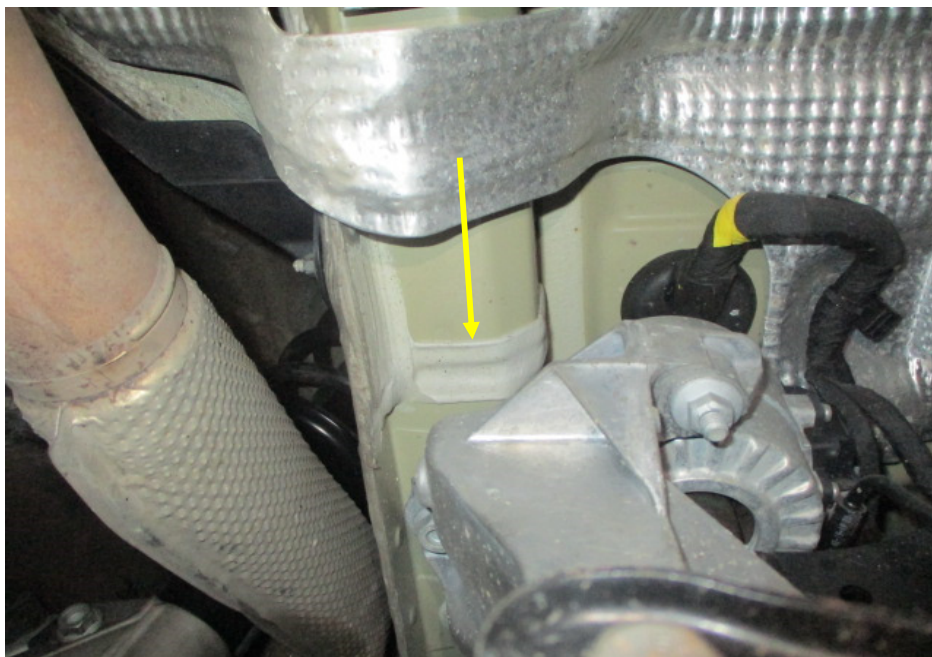
Photo 34 shows the chassis/structural body at the underside rear left of the Motor Car. I did not find any weld marks other than original spot weld marks on the chassis/structural body of the Motor Car. The original factory sealant (arrowed) at the joints along the chassis/structural body was untouched, indicating no work was done on the chassis/structural body of the Motor Car and that the chassis/structural body was originally fitted.

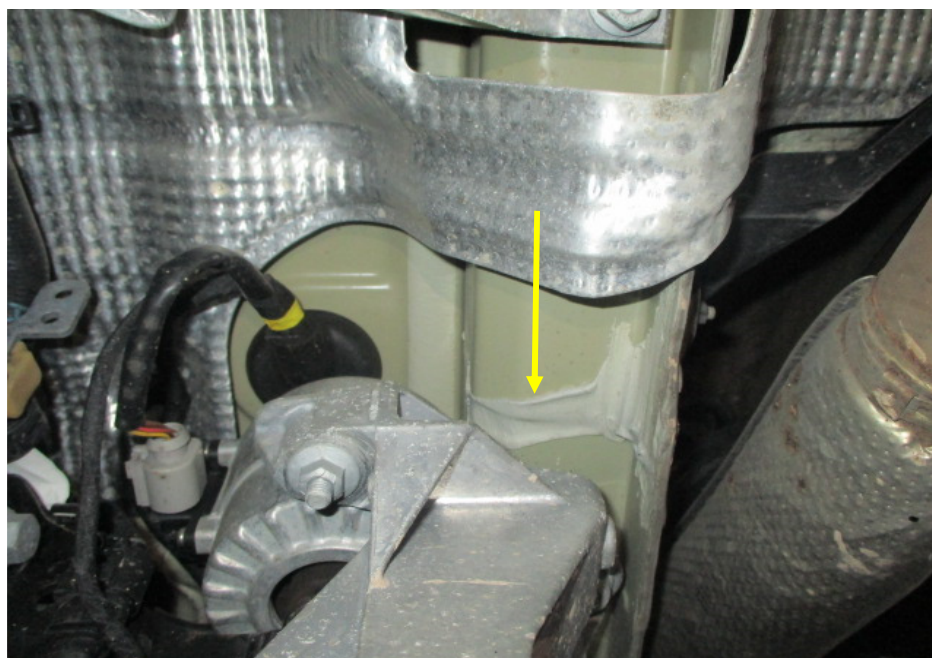
Photo 35 shows the chassis/structural body at the underside rear right of the Motor Car. The original factory sealant (arrowed) at the joints along the chassis/structural body was observed to be untouched. In general, I had found no work was carried out on the chassis/structural body of the Motor Car. The chassis/structural body of the Motor Car was originally fitted.

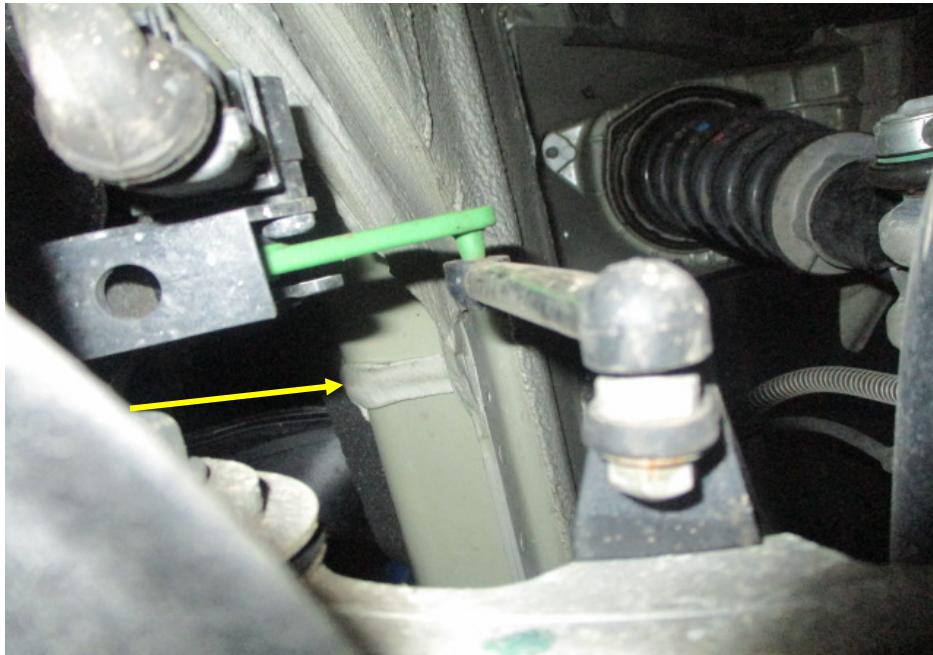
Photo 36 shows the chassis/structural body at the underside front right of the Motor Car. The original factory sealant (arrowed) at the joints along the chassis/structural body was observed to be untouched. In general, I had found no work was carried out on the chassis/structural body of the Motor Car. The chassis/structural body of the Motor Car was originally fitted.

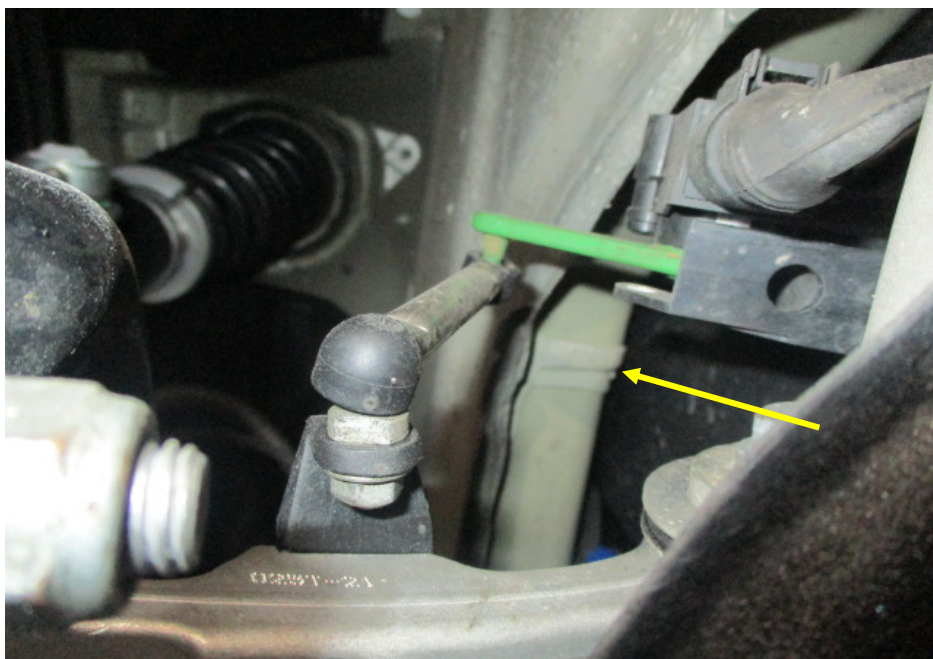
Photo 37 shows the chassis/structural body at the underside front left of the Motor Car. The original factory sealant (arrowed) at the joints along the chassis/structural body was observed to be untouched. In general, I had found no work was carried out on the chassis/structural body of the Motor Car. The chassis/structural body of the Motor Car was originally fitted.

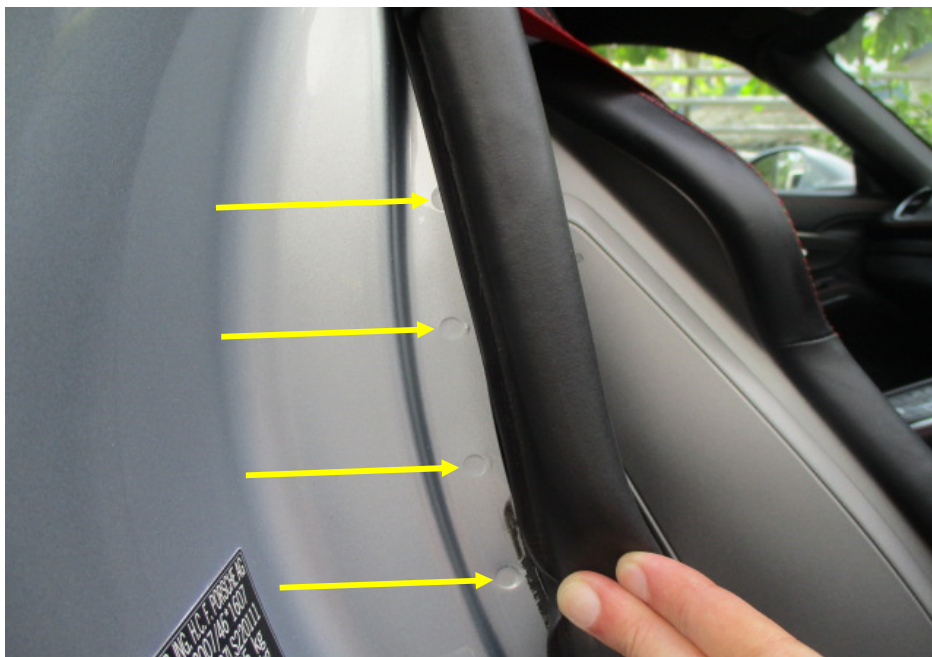
Photo 38 shows the rear right body panel of the Motor Car. I did not find any weld marks other than original spot weld marks (arrowed) on the rear right body panel of the Motor Car, which indicates that there was no re-welding works carried out. In general, I had found all the non-detachable body panels of the Motor Car to be originally fitted at the time of my inspection.

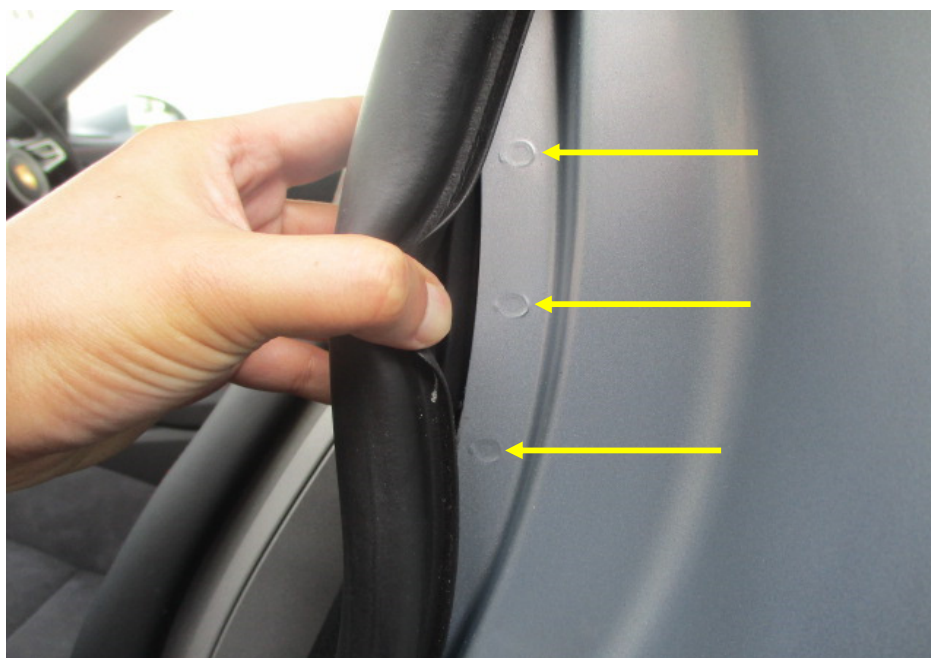
Photo 39 shows the rear left body panel of the Motor Car. I did not find any weld marks other than original spot weld marks (arrowed) on the rear left body panel of the Motor Car, which indicates that there was no re-welding works carried out. In general, I had found all the non-detachable body panels of the Motor Car to be originally fitted at the time of my inspection.

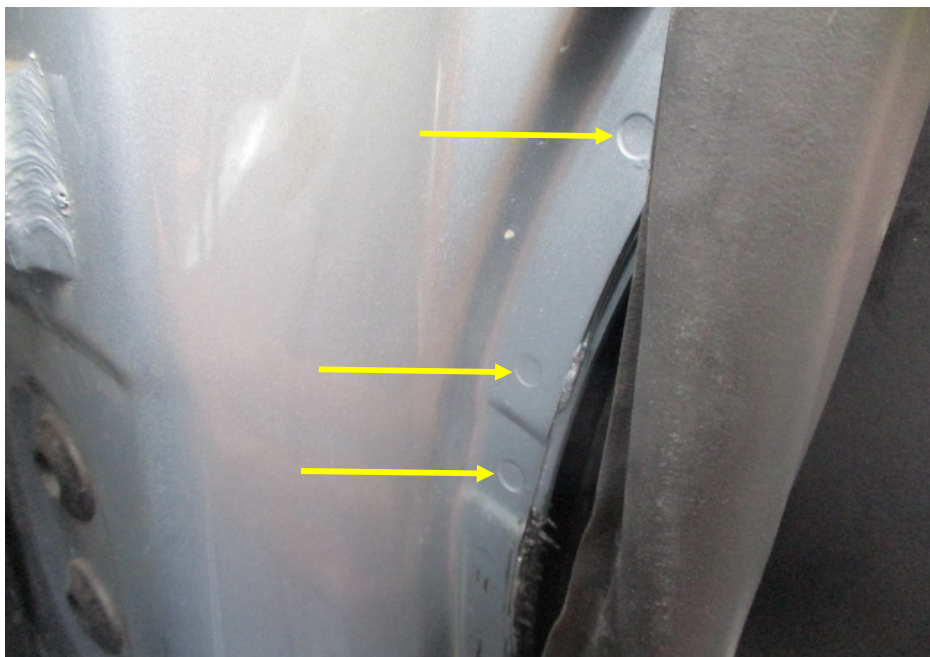
Photo 40 shows the left side "A" pillar of the Motor Car. I did not find any weld marks other than original spot weld marks (arrowed) on the left side "A" pillar of the Motor Car, which indicates that there was no re-welding works carried out. In general, I had found all the non-detachable body panels of the Motor Car to be originally fitted at the time of my inspection.
