Your Ref: Honda Civic Type R  
(chassis number FK81202211)  
Our Ref : CI/TP21010653/D

16 October 2021

**INSPECTION REPORT OF AN UNREGISTERED HONDA CIVIC TYPE R  
MOTOR CAR WITH CHASSIS NUMBER FK81202211**

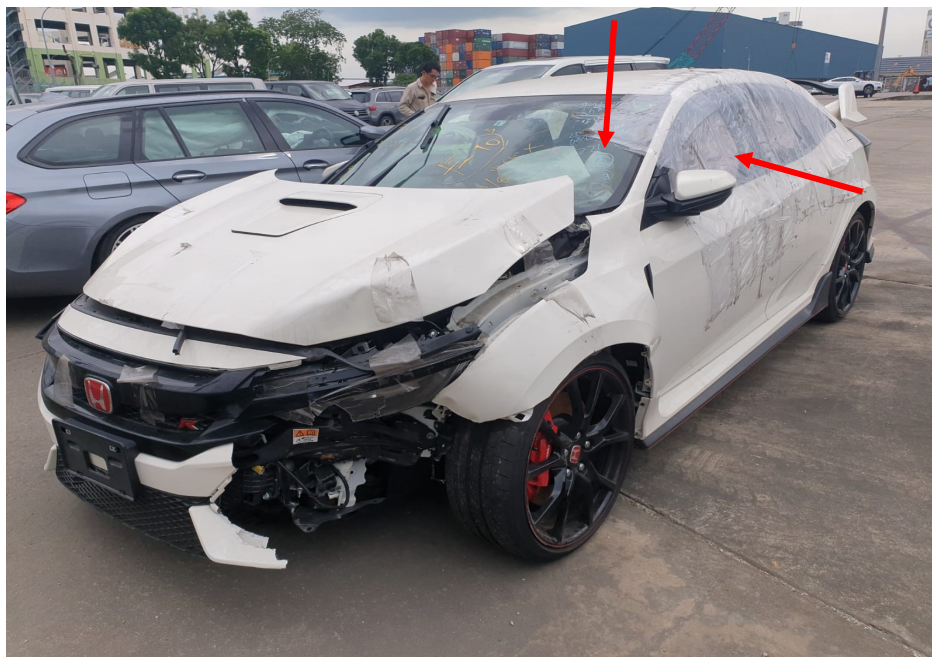
3. The photographs provided to me had showed damage to the frontal portion of the Motor Car. Body parts observed to be damaged include the front bumper, front bumper lower spoiler, front bumper reinforcement, front bumper centre lower grille, front bumper left lower grille, front bumper right lower grille, radiator grille, front bonnet, front bonnet lock, front bonnet hinges, front right fender, front left fender, front left fender inner shield, front left signal lamp, front left fog lamp, front left headlamp and front left headlamp garnish amongst others.
4. No physical damage was observed to other areas of the Motor Car. The driver's airbag, front left passenger airbag and left curtain airbag were deployed as seen from the photographs that were provided to me. See photo 1 – 4 below.

**Photo 1** shows the front left body of the Motor Car (photograph provided to me). The photographs provided to me had showed damage to the frontal portion of the Motor Car. Body parts damaged include the front bumper, front bumper lower spoiler, front bumper reinforcement, front bumper centre lower grille, front bumper left lower grille, radiator grille, front bonnet, front bonnet hinges, front left fender, front left fender inner shield, front left signal lamp, front left fog lamp, front left headlamp and front left headlamp garnish amongst others. The front left passenger airbag and left curtain airbag were deployed (arrowed).

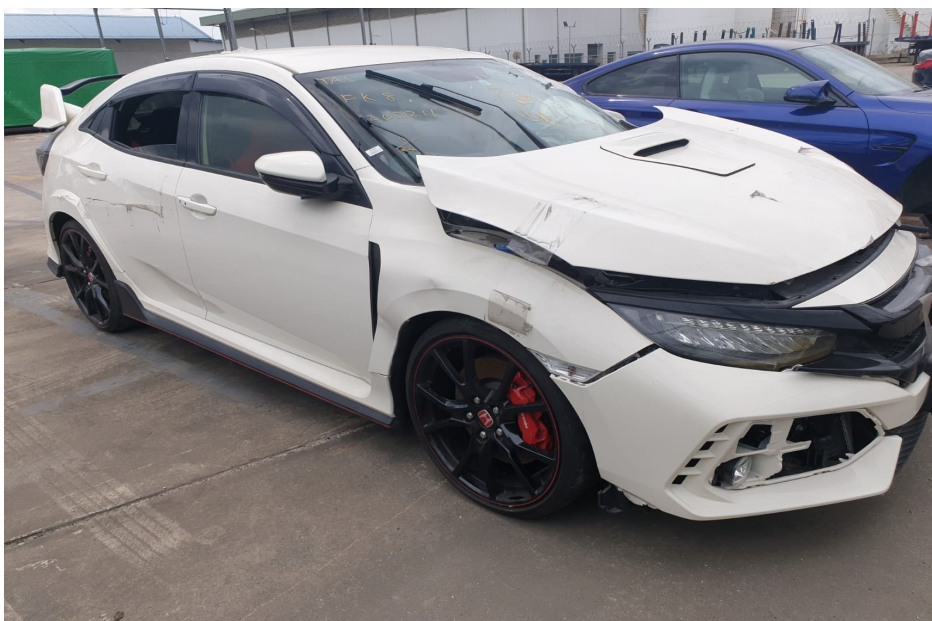
**Photo 2** shows the front right body of the Motor Car (photograph provided to me). The photographs provided to me had showed damage to the frontal portion of the Motor Car. Body parts damaged include the front right fender, front bonnet, front bumper and front bumper right lower grille amongst others.

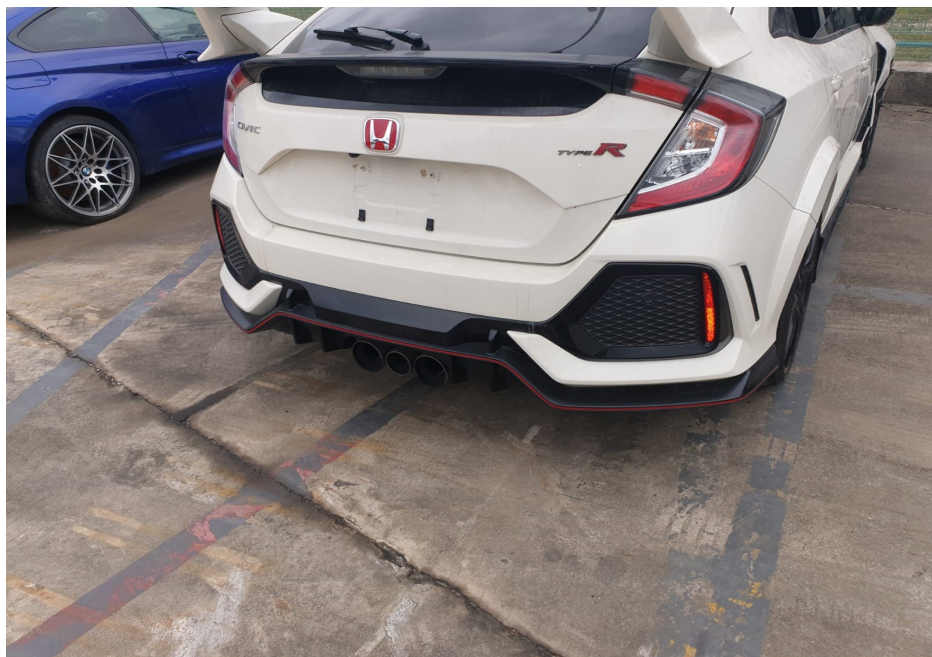
**Photo 3** shows the rear right body of the Motor Car (photograph provided to me). Apart for the frontal portion, there was no physical damage observed to other areas of the Motor Car.

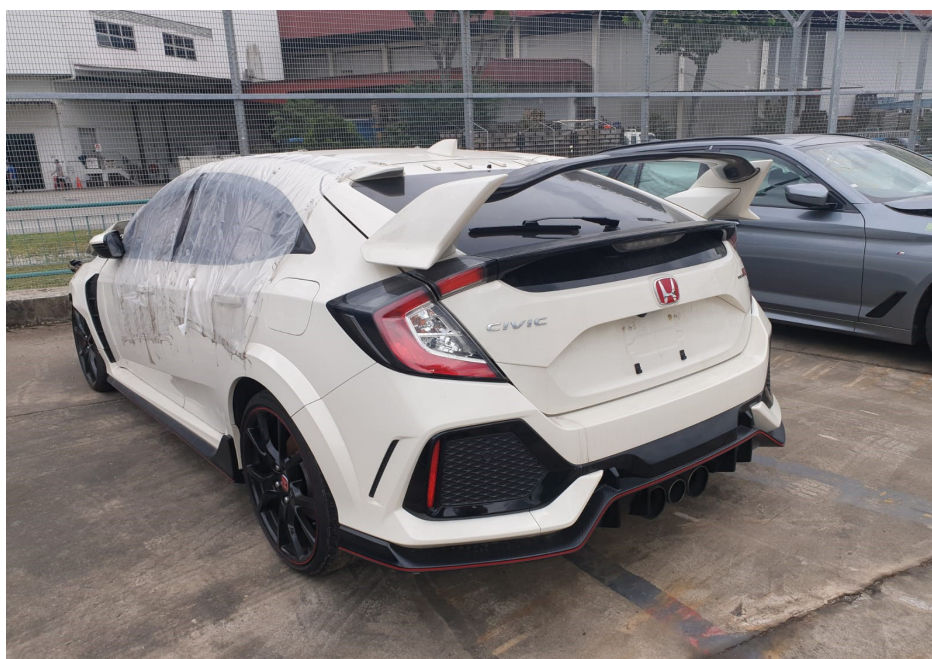
**Photo 4** shows the rear left body of the Motor Car (photograph provided to me). Apart for the frontal portion, there was no physical damage observed to other areas of the Motor Car.

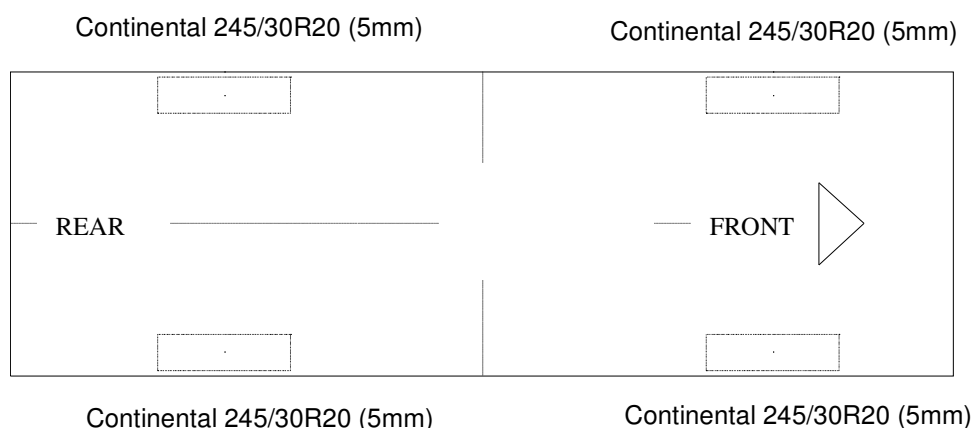
8. It was fitted with 20inch sport wheel rims that were wrapped with tyres that were observed to be of serviceable condition. The tyres were also sufficiently inflated for vehicular operation. The tyre brand, tyre size and approximate remaining tread depth of the 4 tyres of the Motor Car were recorded as follows: -

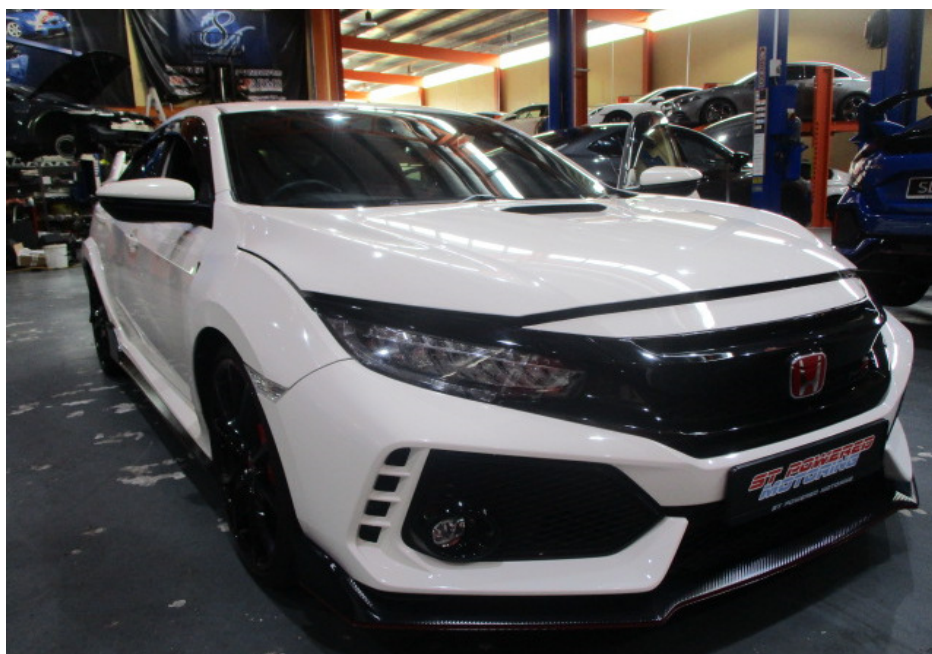
22. The body parts at the frontal portion of the Motor Car were visually examined and it was noted that the repair/restoration works carried out to the damaged area of the Motor Car (refer to photograph 1 & 2 above) were reasonably adequate and in order.

**Photo 5** shows a general view of the front right body of the Motor Car at the time of my inspection. The Motor Car was observed to be in a relatively good general condition with no loose exterior fittings observed. The body parts at the frontal portion of the Motor Car were visually examined and it was observed that the repair/restoration works carried out to the damaged area of the Motor Car (refer to photograph 1 & 2 above) were reasonably adequate and in order.

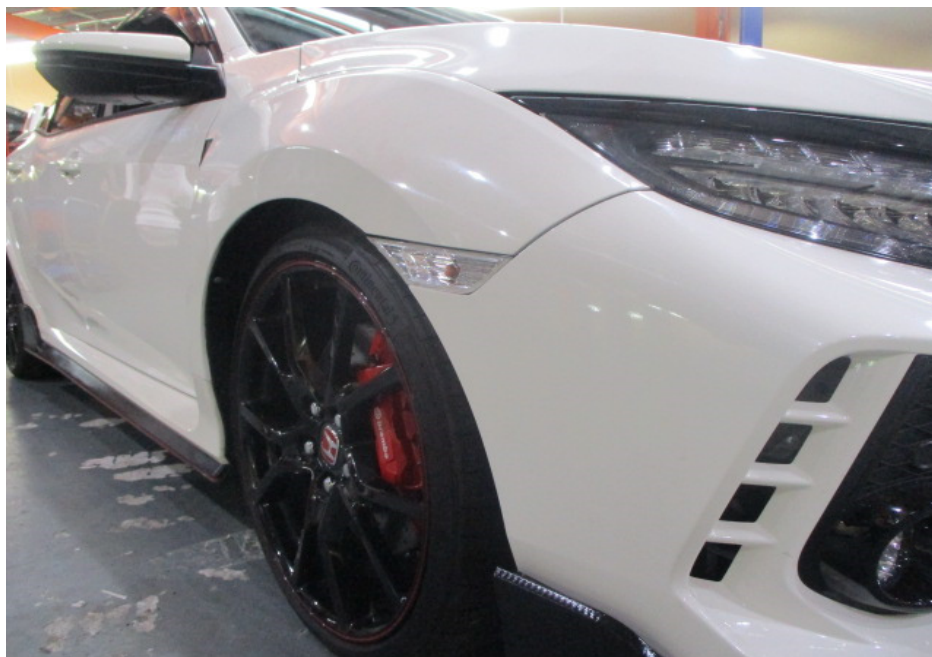
**Photo 6** shows a closer view of the Motor Car's front bumper and front right fender at the time of my inspection. The body parts at the frontal portion of the Motor Car were visually examined and it was observed that the repair/restoration works carried out to the damaged area of the Motor Car (refer to photograph 1 & 2 above) were reasonably adequate and in order.

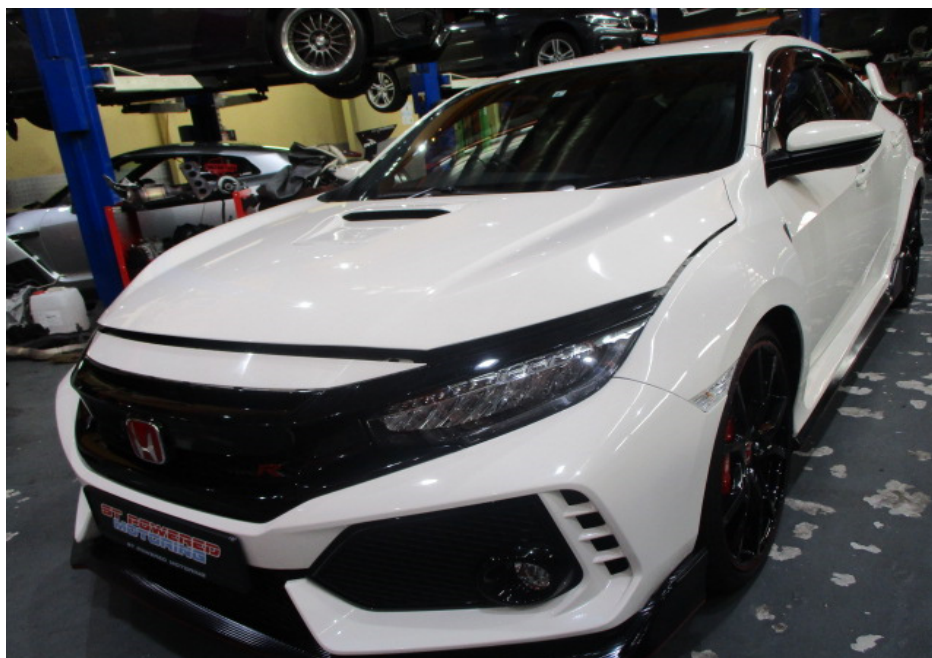
**Photo 7** shows a general view of the front left body of the Motor Car at the time of my inspection. The Motor Car was observed to be in a relatively good general condition with no loose exterior fittings observed. The body parts at the frontal portion of the Motor Car were visually examined and it was observed that the repair/restoration works carried out to the damaged area of the Motor Car (refer to photograph 1 & 2 above) were reasonably adequate and in order.

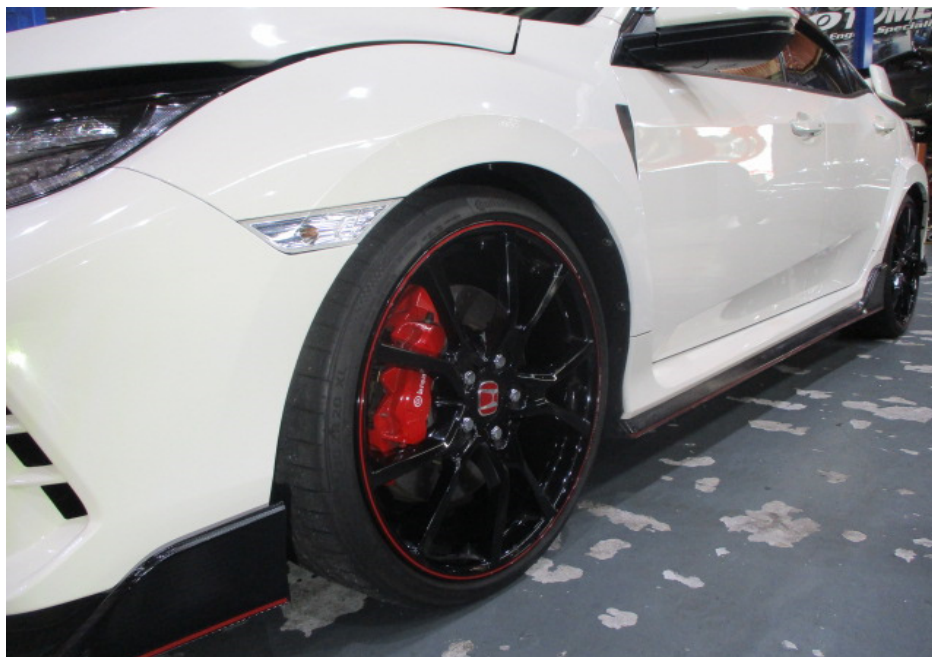
**Photo 8** shows a closer view of the Motor Car's front left fender, front left wheel and front left signal lamp at the time of my inspection. The body parts at the frontal portion of the Motor Car were visually examined and it was observed that the repair/restoration works carried out to the damaged area of the Motor Car (refer to photograph 1 & 2 above) were reasonably adequate and in order.

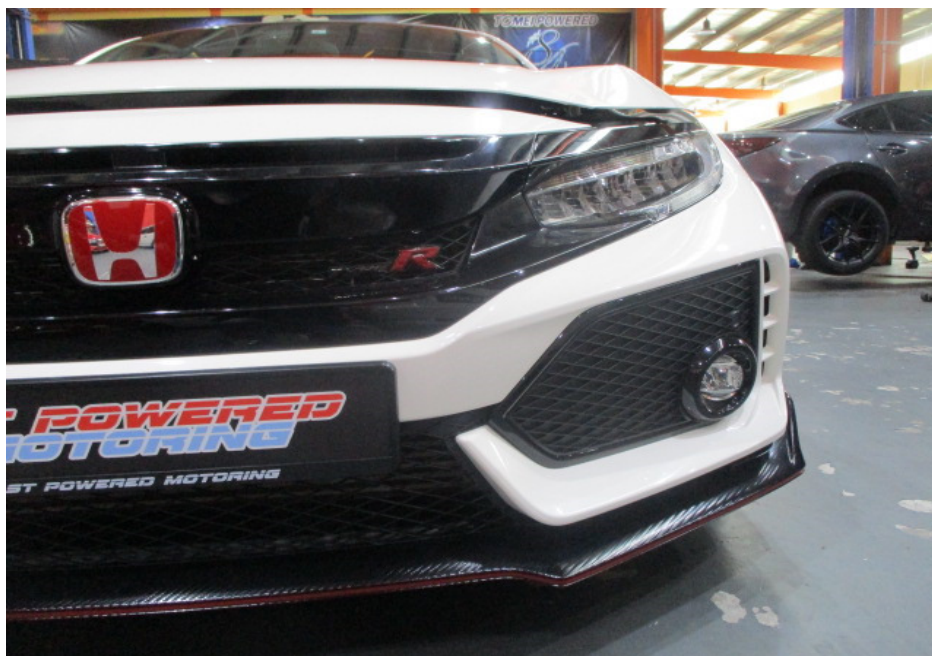
**Photo 9** shows a closer view of the Motor Car's front bumper, front bumper lower spoiler, front bumper left lower grille, front left fog lamp, front left headlamp and radiator grille. The body parts at the frontal portion of the Motor Car were visually examined and it was observed that the repair/restoration works carried out to the damaged area of the Motor Car (refer to photograph 1 & 2 above) were reasonably adequate and in order.

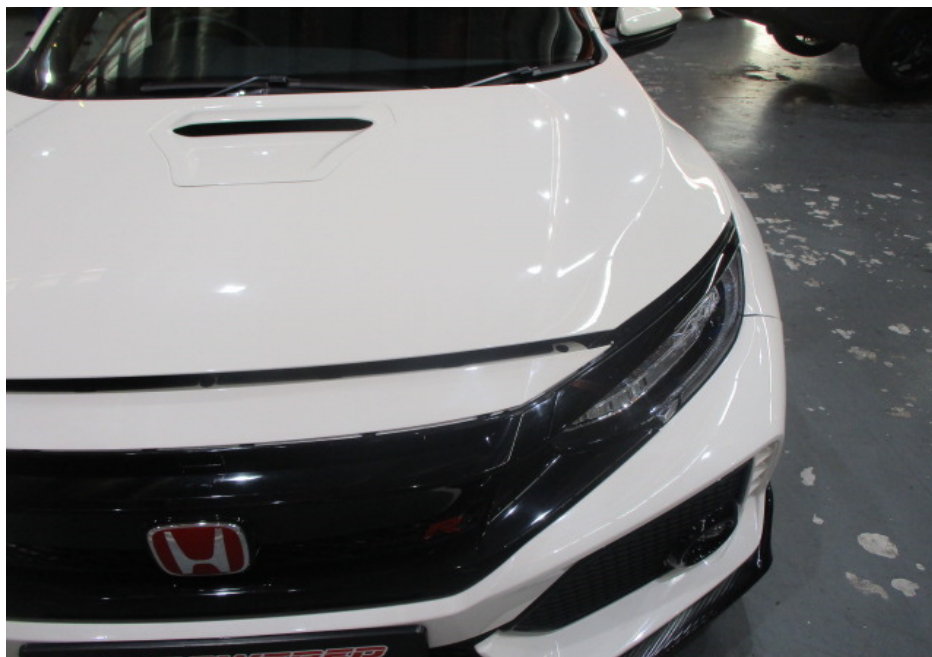
**Photo 10** shows a closer view of the Motor Car's front bumper, front left headlamp, front bonnet and radiator grille at the time of my inspection. The body parts at the frontal portion of the Motor Car were visually examined and it was observed that the repair/restoration works carried out to the damaged area of the Motor Car (refer to photograph 1 & 2 above) were reasonably adequate and in order.

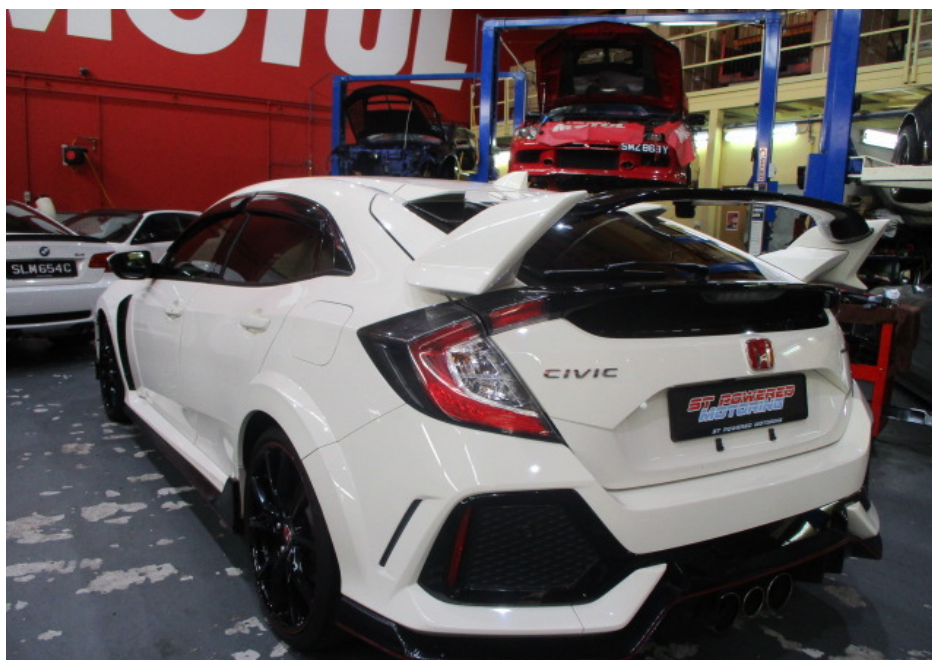
**Photo 11** shows a general view of the rear left body of the Motor Car at the time of my inspection. The Motor Car was observed to be in a relatively good general condition with no loose exterior fittings observed. The mileage of the Motor Car recorded at the time of my inspection was 12,687km.

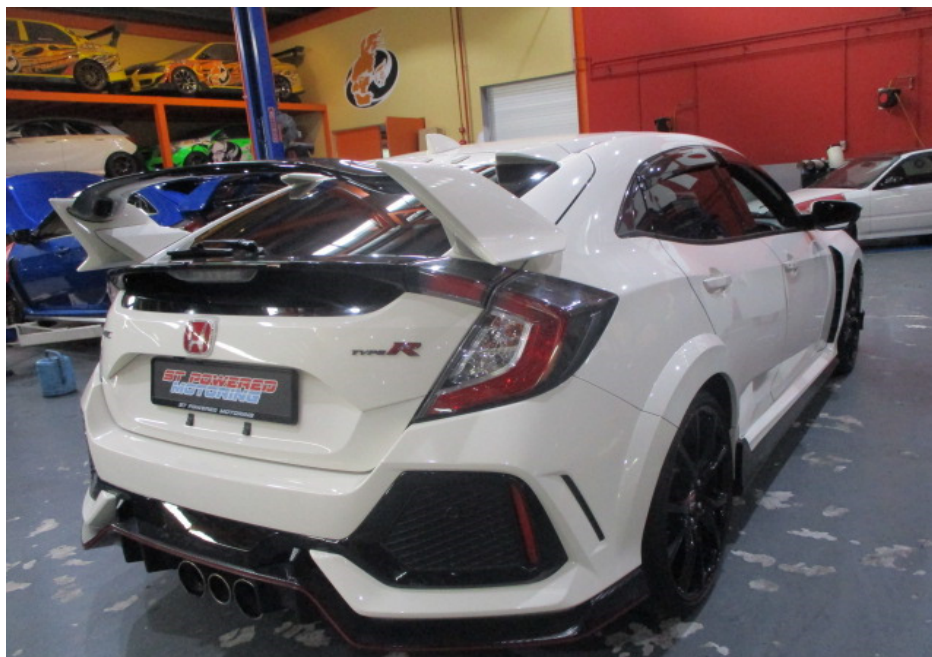
**Photo 12** shows a general view of the rear right body of the Motor Car at the time of my inspection. The Motor Car was observed to be in a relatively good general condition with no loose exterior fittings observed. The mileage of the Motor Car recorded at the time of my inspection was 12,687km.

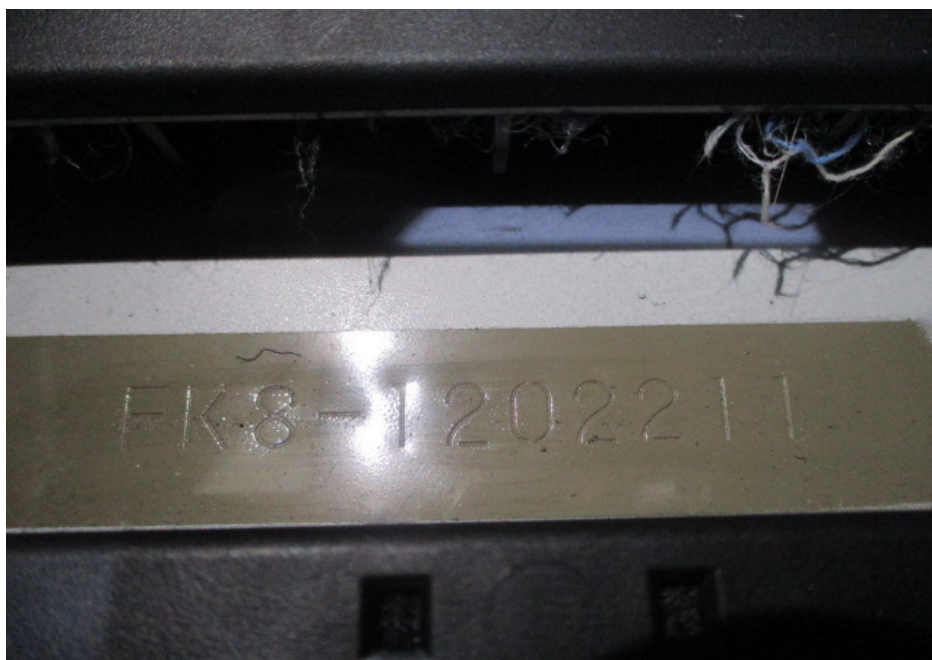
**Photo 13** shows the chassis number of the Motor Car. The chassis number recorded was FK81202211.

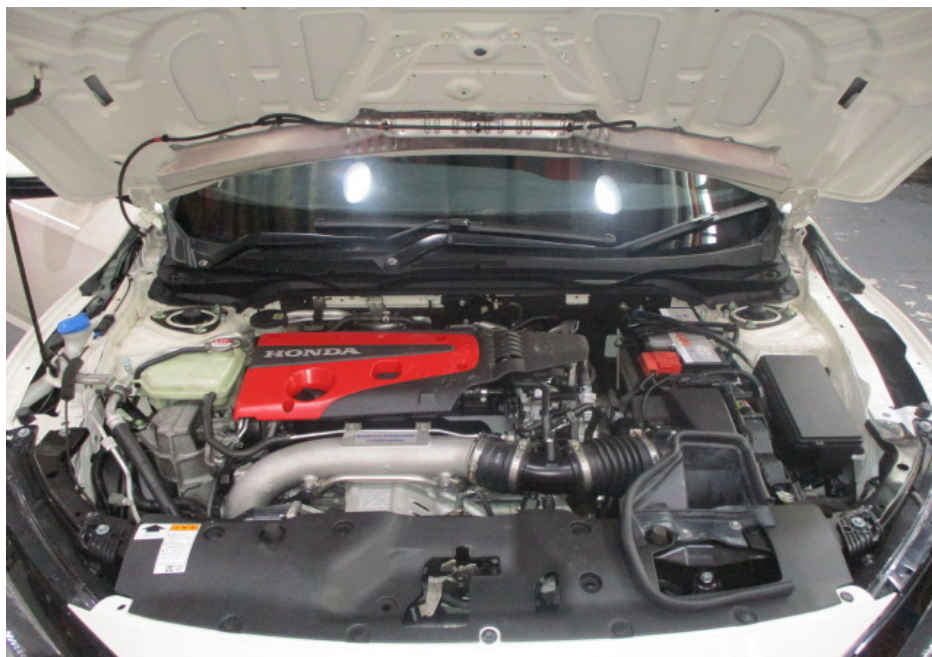
14. My examination of the engine compartment of the Motor Car revealed that the various parts and components inside the engine compartment were all intact and properly fitted. The engine oil, brake fluid and engine coolant were all found to be of sufficient level for operating purposes. Visually, there was also no contamination found to these fluids.

**Photo 14** shows a general view of the engine compartment of the Motor Car at the time of my inspection. The various parts and components inside the engine compartment were all observed to be intact and properly fitted. There was also no sign(s) or indication(s) of fluid leak and/or fluid stain found inside the engine compartment.

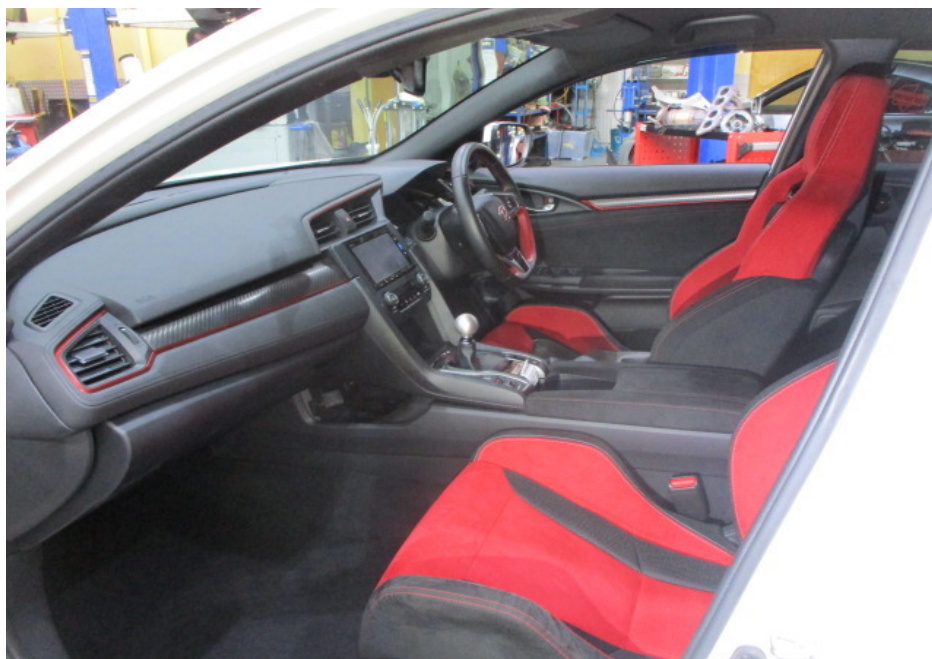
**Photo 15** shows the interior compartment of the Motor Car at the time of my inspection. The various parts and components, trims, carpet, and upholstery inside the interior compartment were all observed to be intact and properly fitted.

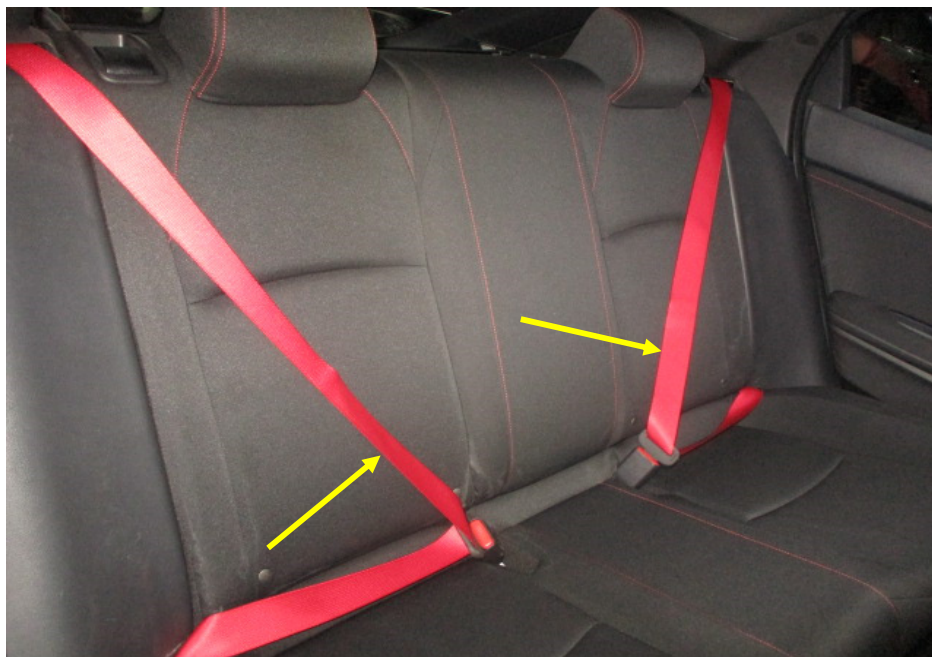
12. The seats of the Motor Car were found to be secured to the floorboard of the Motor Car via seat rails bolted onto the floorboard. Retractable seat belt reels and pre-tensioners were fitted on all seats of the Motor Car. The seat belts were tested and were able to be fastened securely into the respective pre-tensioners that were fixed to the side of all the seats.

**Photo 16** shows the rear seats of the Motor Car. All the seats of the Motor Car were secured via seat rails to the floorboard. They were also fitted with a retractable seat belt reel and a pre-tensioner. The seat belts (arrowed) were tested and were able to be fastened into the respective pre-tensions that were fitted on the side of each individual seat.

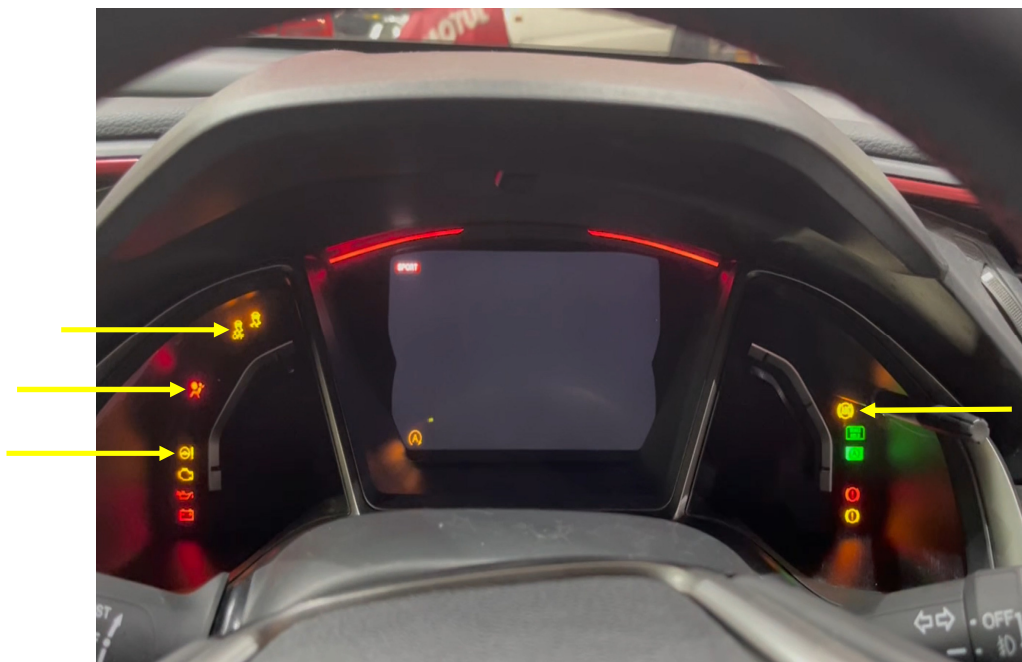
**Photo 17** shows the warning lights for the various electronic safety features appearing on the instrument panel of the Motor Car during its self-test when the engine is cranked, in particular the ABS, SRS, VSA and EPS lights (arrowed).

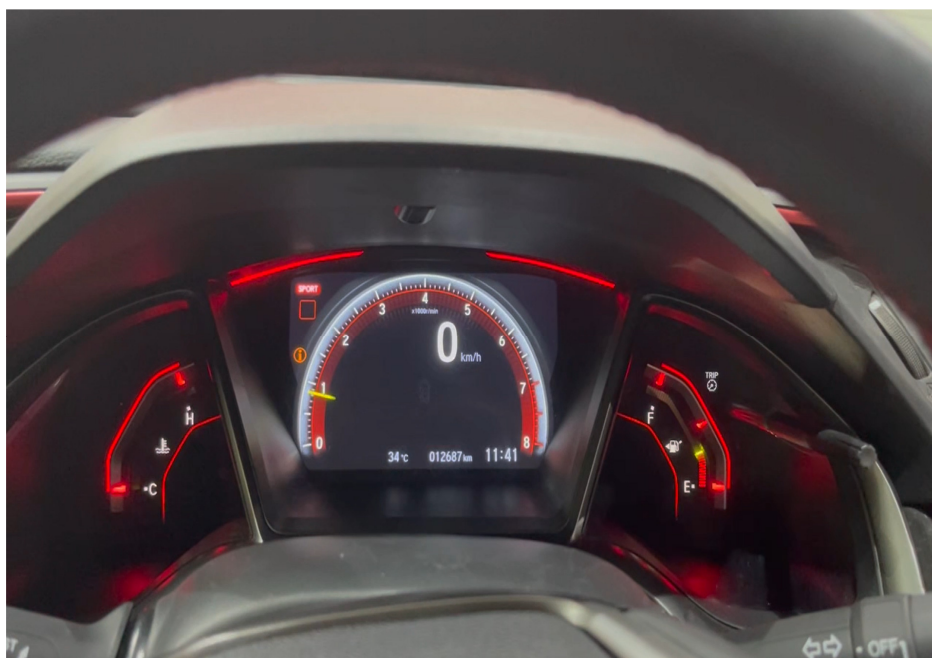
13. The Motor Car's automatic self-test of the functionality of its various electronic safety features like the Anti-Lock Brake System (ABS), Supplemental Restraint System (SRS), Vehicle Stability Assist (VSA) and Electric Power Steering (EPS) during cranking of the engine had indicated that these electronic systems were in working condition. This was determined from the respective warning lights disappearing from the instrument panel after the self-test.

**Photo 18** shows the respective warning lights no longer illuminated, indicating that there is no fault detected to the ABS, SRS, VSA and EPS systems of the Motor Car during the self-test. These electronic systems were hence in working condition at the time of my inspection.

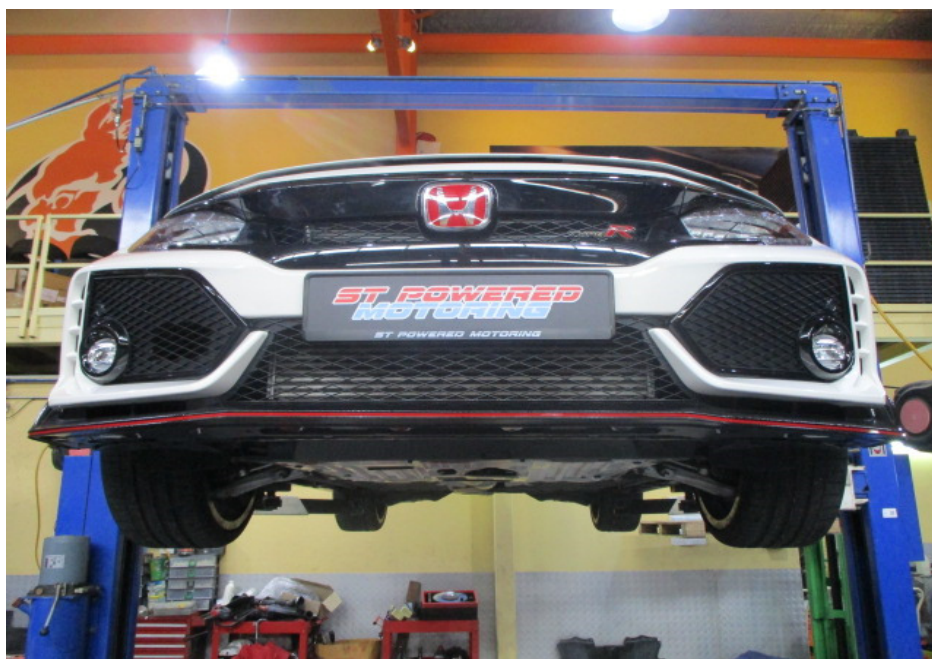
15. My checks on the underside of the Motor Car revealed no sign(s) or indication(s) of fluid leakage and/or fluid stain(s). The engine block and manual transmission assembly were both secured properly. All undercarriage components of the Motor Car were also observed to be intact and secured in an appropriate manner.

**Photo 19** shows the Motor Car hoisted up for checks on its undercarriage. There was no sign(s) or indication(s) of fluid leakage and/or fluid stain(s) on the underside of the Motor Car. The undercarriage components of the Motor Car were also all observed to be intact and secured in an appropriate manner.

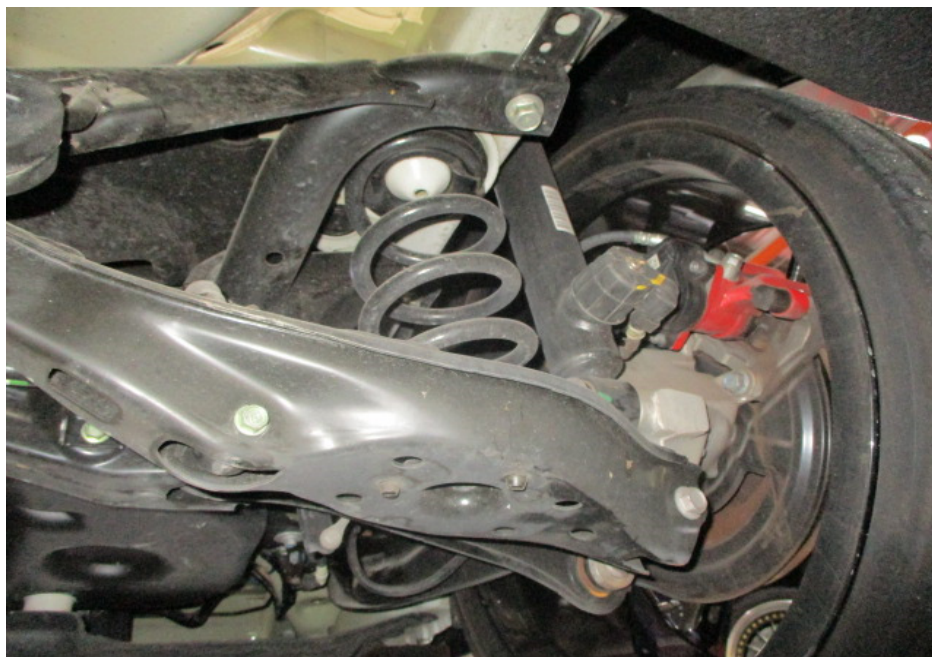
**Photo 20** shows a general view of the control arms and linkages at the rear right wheel of the Motor Car. I did not observe any fluid leak and/or fluid stain on the underside of the Motor Car. All of the Motor Car's undercarriage components were observed to be intact and secured in an appropriate manner.

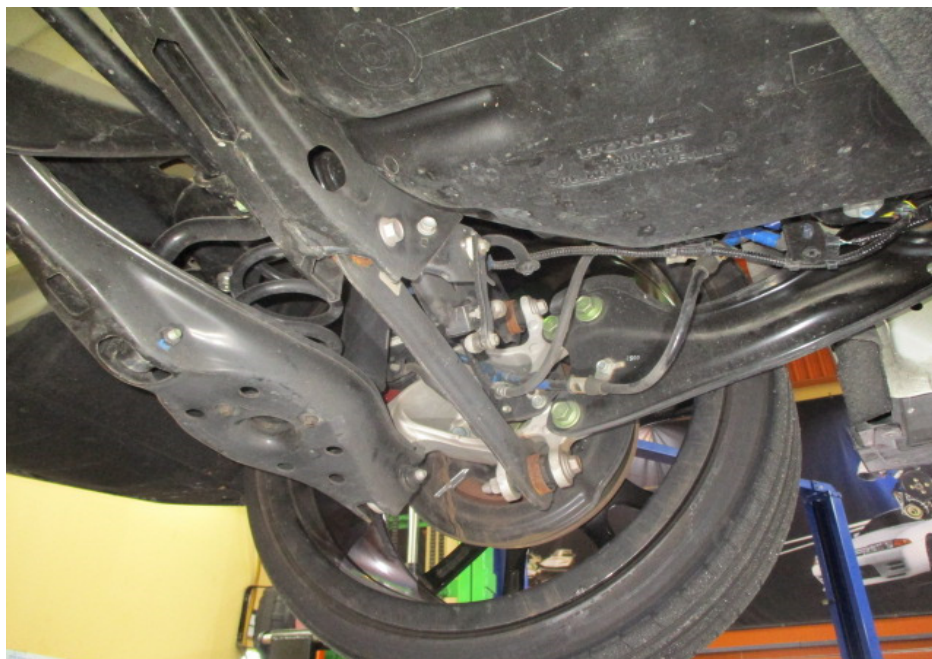
**Photo 21** shows a general view of the control arms and linkages at the rear left wheel of the Motor Car. I did not observe any fluid leak and/or fluid stain on the underside of the Motor Car. All of the Motor Car's undercarriage components were observed to be intact and secured in an appropriate manner.

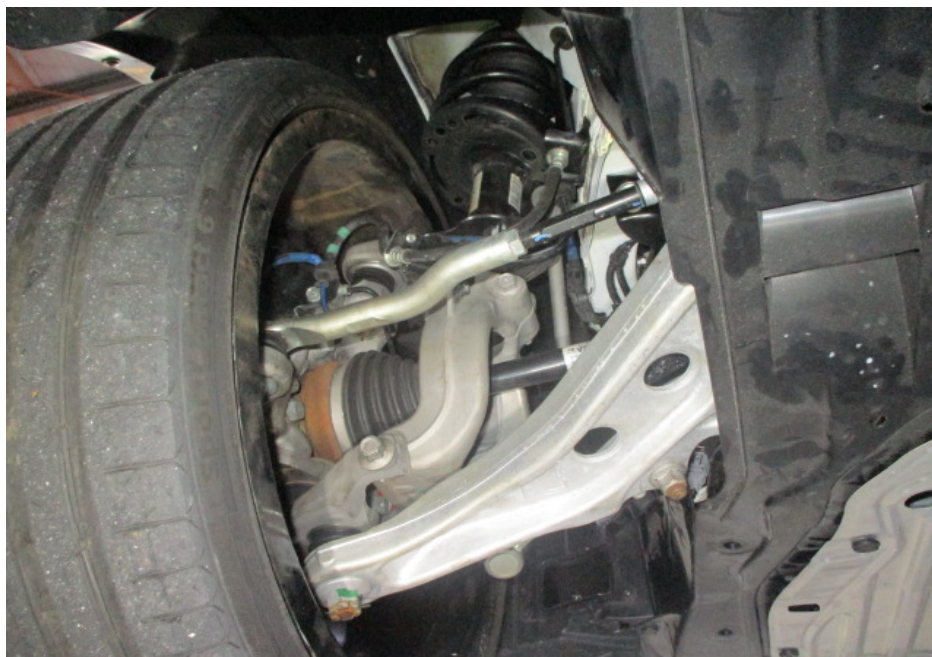
**Photo 22** shows the various undercarriage components at the front left wheel of the Motor Car. The mechanical components, control arms and linkages were all found to be intact and secured in an appropriate manner.

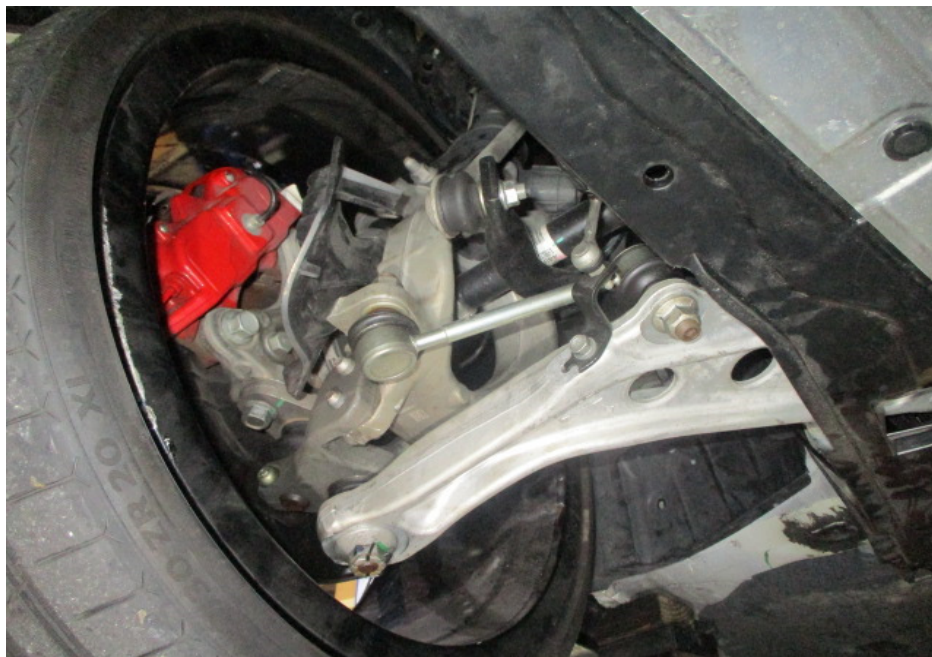
**Photo 23** shows the various undercarriage components at the front right wheel of the Motor Car. The mechanical components, control arms and linkages were all found to be intact and secured in an appropriate manner. I also did not observe any fluid leak and/or fluid stain on the underside of the Motor Car.

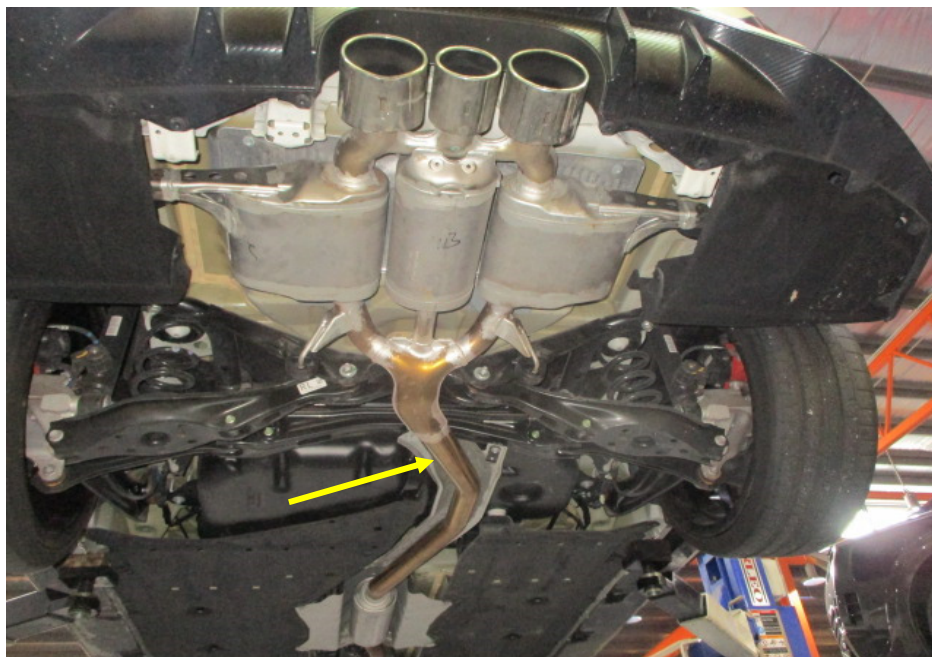
**Photo 24** shows the rear section of the Motor Car's exhaust system. My examination of the Motor Car's exhaust system revealed no sign(s) or indication(s) of any cut or weld marks along its exhaust pipes (arrowed), on its rear mufflers, on its centre resonator boxes and on its catalytic converter.

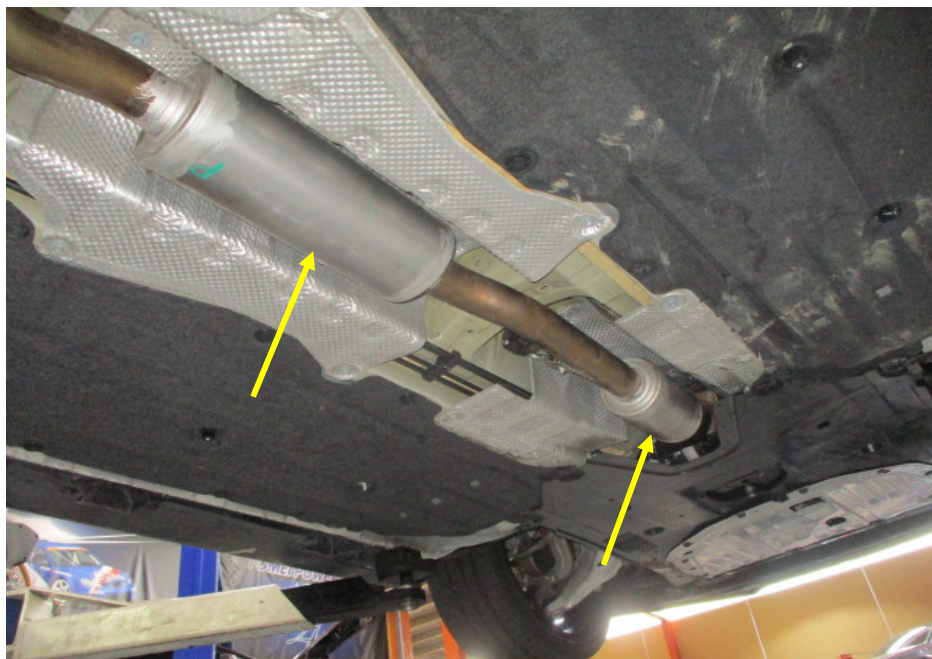
**Photo 25** shows the front section of the Motor Car's exhaust system. My examination of the Motor Car's exhaust system revealed no sign(s) or indication(s) of any cut or weld marks along its exhaust pipes, on its rear mufflers, on its centre resonator boxes (arrowed) and on its catalytic converter.

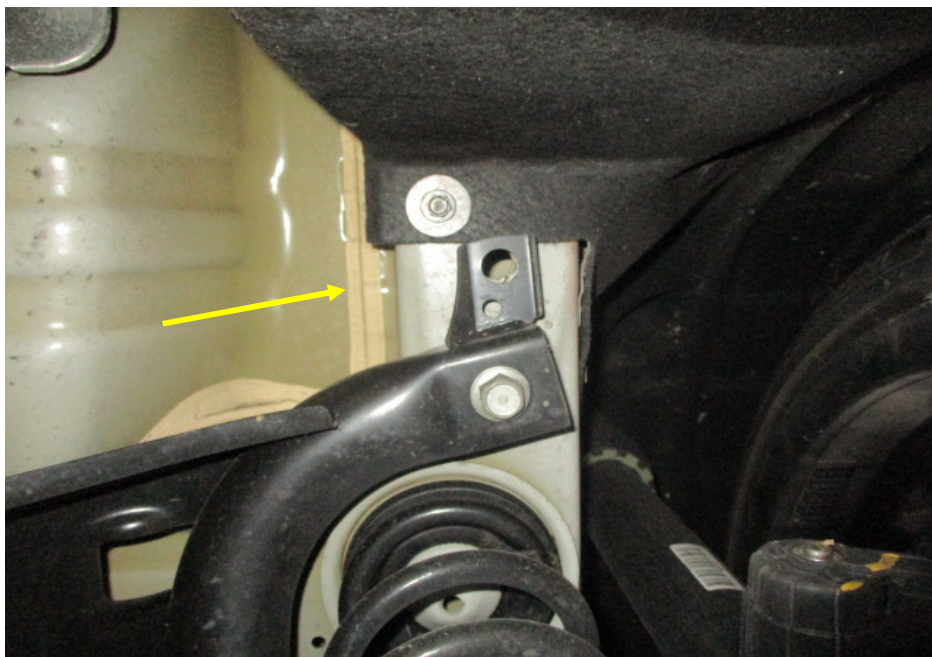
11. Visually, I did not find any weld marks, other than the original spot weld marks, on the chassis/structural body of the Motor Car. The original factory sealant at the joints along the chassis/structural body was also untouched, again indicating that no replacement of the chassis/structural body was carried out; and that the chassis/structural body was originally fitted.

**Photo 26** shows the chassis/structural body at the underside rear right of the Motor Car. I did not find any weld marks other than original spot weld marks on the chassis/structural body of the Motor Car. The original factory sealant (arrowed) at the joints along the chassis/structural body was untouched, indicating no work was done on the chassis/structural body of the Motor Car and that the chassis/structural body was originally fitted.

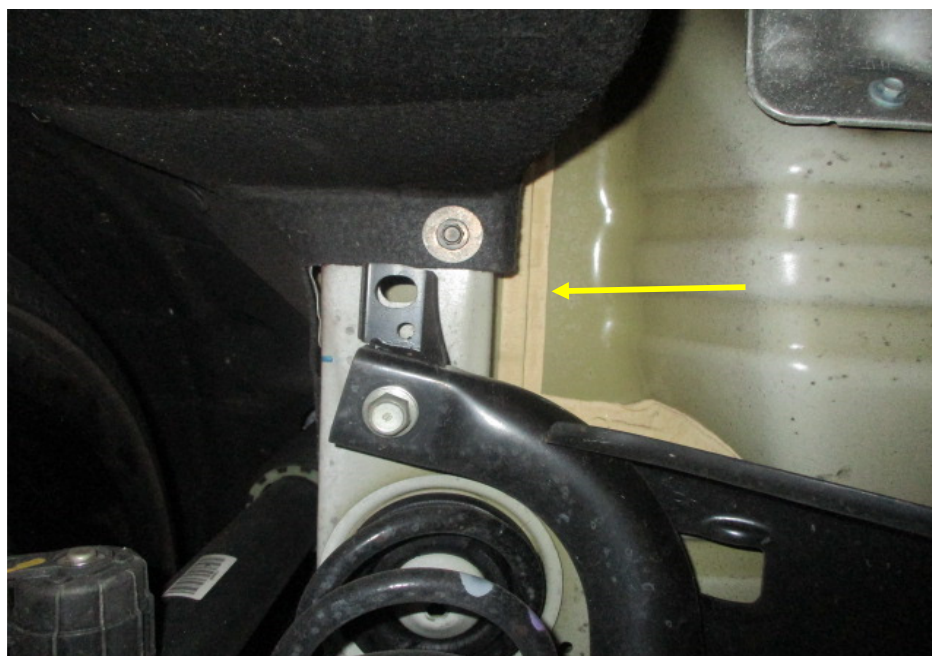
**Photo 27** shows the chassis/structural body at the underside rear left of the Motor Car. The original factory sealant (arrowed) at the joints along the chassis/structural body was observed to be untouched. In general, I had found no work was carried out on the chassis/structural body of the Motor Car. The chassis/structural body of the Motor Car was originally fitted.

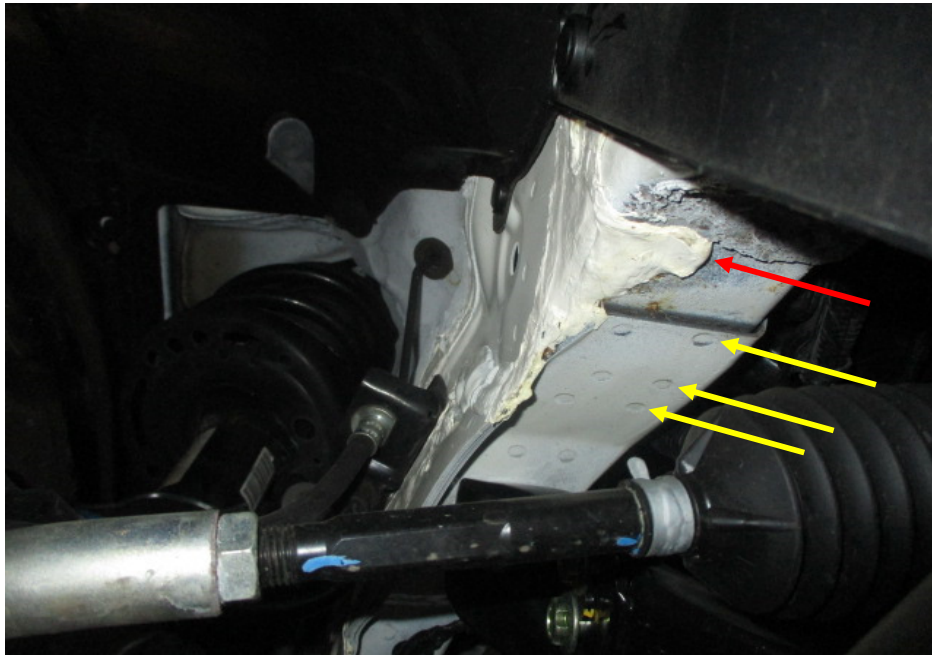
**Photo 28** shows the chassis/structural body at the underside front left of the Motor Car. I did not find any weld marks other than original spot weld marks (yellow arrow) on the chassis/structural body of the Motor Car. The original factory sealant (red arrow) at the joints along the chassis/structural body was untouched, indicating no work was done on the chassis/structural body of the Motor Car and that the chassis/structural body was originally fitted.

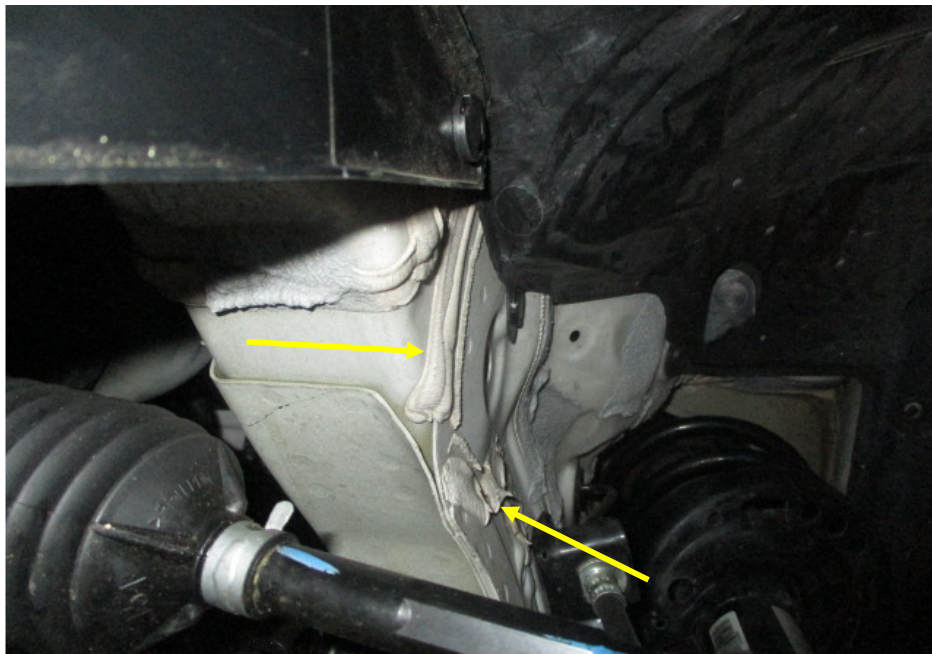
**Photo 29** shows the chassis/structural body at the underside front right of the Motor Car. The original factory sealant (arrowed) at the joints along the chassis/structural body was observed to be untouched. In general, I had found no work was carried out on the chassis/structural body of the Motor Car. The chassis/structural body of the Motor Car was originally fitted.

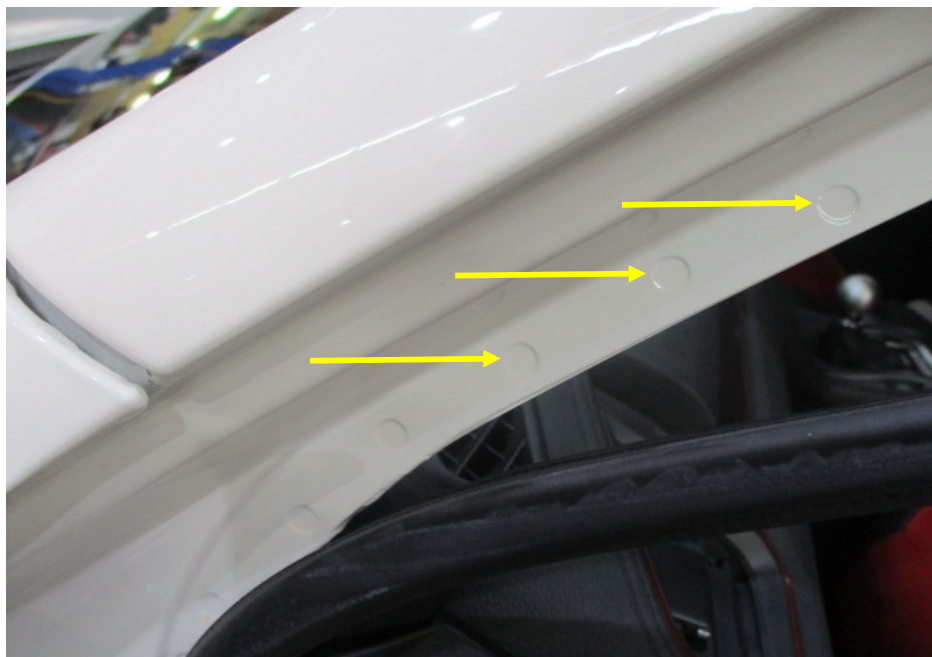
10. Checks on the non-detachable body panels like the rear fenders, floorboard, roof panel, pillars and rocker panels amongst others, revealed that these body panels were spot welded onto the chassis/structural body of the Motor Car. The original factory sealant at the joints of the non-detachable body panels was all untouched indicating no replacement of the non-detachable body panels was carried out; and that these body panels were all originally fitted.

**Photo 30** shows the left side "A" pillar of the Motor Car. I did not find any weld marks other than original spot weld marks (arrowed) on the left side "A" pillar of the Motor Car, which indicates that there was no re-welding works carried out. In general, I had found all the non-detachable body panels of the Motor Car to be originally fitted at the time of my inspection.
