Your Ref: Honda Civic Type R  
(chassis number FK81202211)  
Our Ref : CI/TP21010653/D

16 October 2021

**INSPECTION REPORT OF AN UNREGISTERED HONDA CIVIC TYPE R  
MOTOR CAR WITH CHASSIS NUMBER FK81202211**

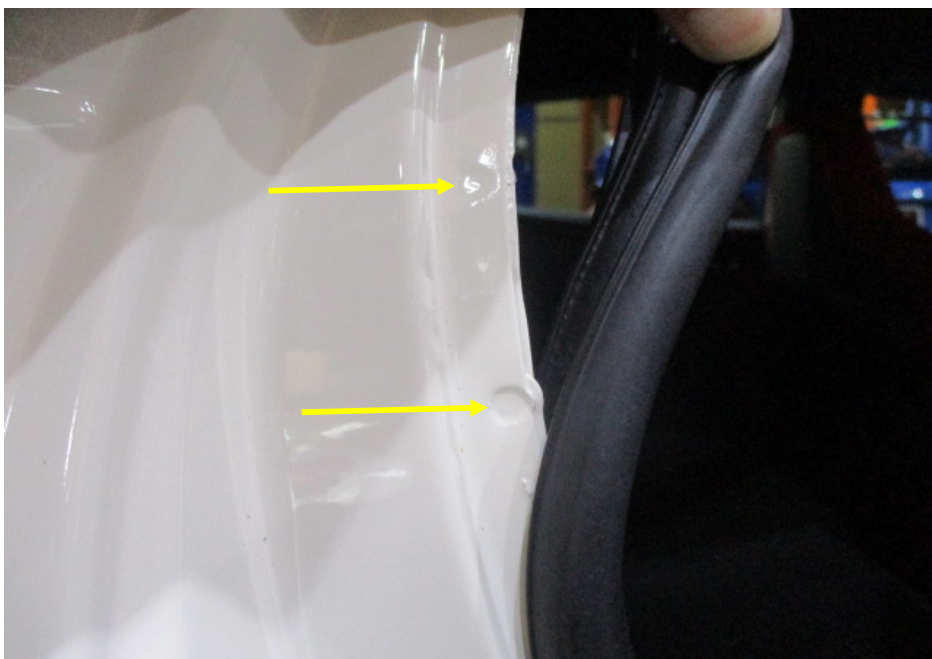
**Photo 31** shows the right side "C" pillar of the Motor Car. I did not find any weld marks other than original spot weld marks (arrowed) on the right side "C" pillar of the Motor Car, which indicates that there was no re-welding works carried out. In general, I had found all the non-detachable body panels of the Motor Car to be originally fitted at the time of my inspection.

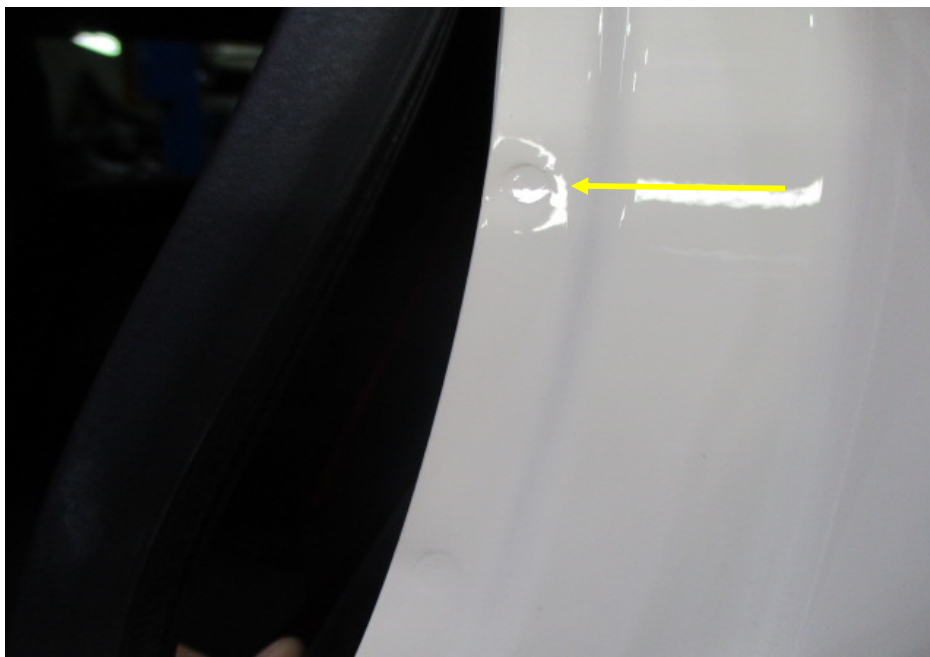
**Photo 32** shows the left side "C" pillar of the Motor Car. I did not find any weld marks other than original spot weld marks (arrowed) on the left side "C" pillar of the Motor Car, which indicates that there was no re-welding works carried out. In general, I had found all the non-detachable body panels of the Motor Car to be originally fitted at the time of my inspection.
