Your Ref: BMW 530e  
(chassis number WBAJA92080CE05590)  
Our Ref : CI/TP21010654/D

**INSPECTION REPORT OF AN UNREGISTERED BMW 530e MOTOR CAR  
WITH CHASSIS NUMBER WBAJA92080CE05590**

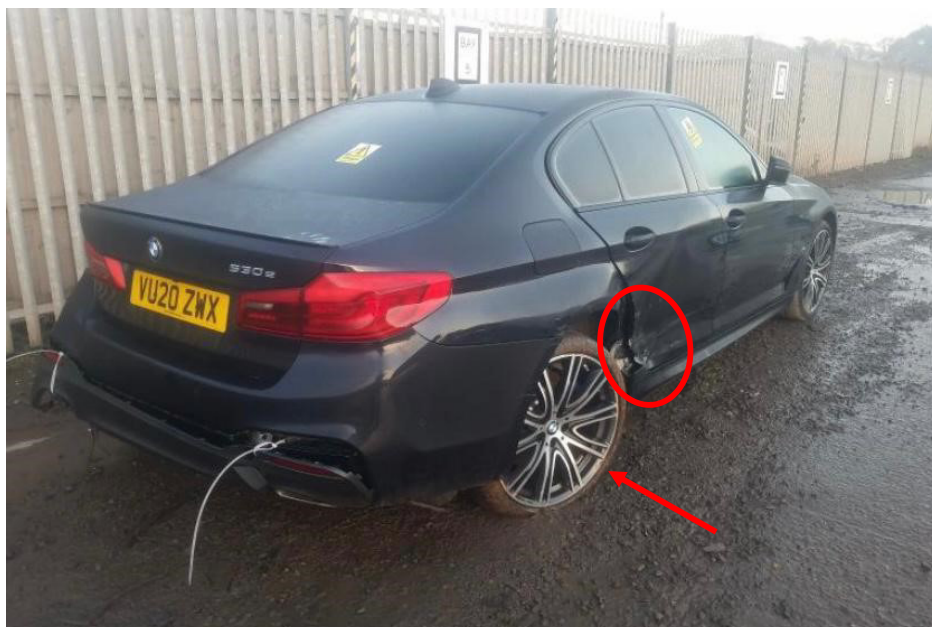
**Photo 2** shows the rear right body of the Motor Car (photograph provided to me). The Motor Car was observed to have sustained damage to its rear right portion (circled). Body parts damaged include the rear right fender and rear right door. The orientation of the rear right wheel (arrowed) and rear left wheel (refer to photograph 4 below) suggest damage to the rear undercarriage parts of the Motor Car. The rear right tyre was also observed to be punctured.

23. The body parts at the rear left portion and rear right portion as well as the undercarriage parts at the rear of the Motor Car were visually examined and it was noted that the repair/restoration works carried out to the damaged area of the Motor Car (refer to photograph 2 & 4 above) were reasonably adequate and in order.

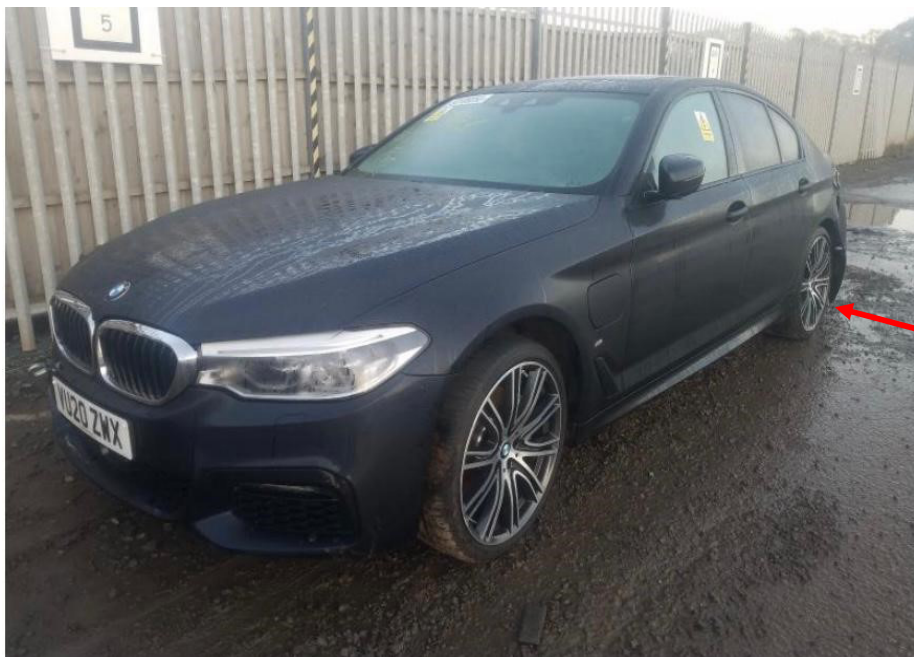
**Photo 3** shows the front left body of the Motor Car (photograph provided to me). No physical damage was observed to the frontal portion of the Motor Car. The orientation of the rear left wheel (arrowed) and rear right wheel (refer to photograph 1 above) suggest damage to the rear undercarriage parts of the Motor Car.

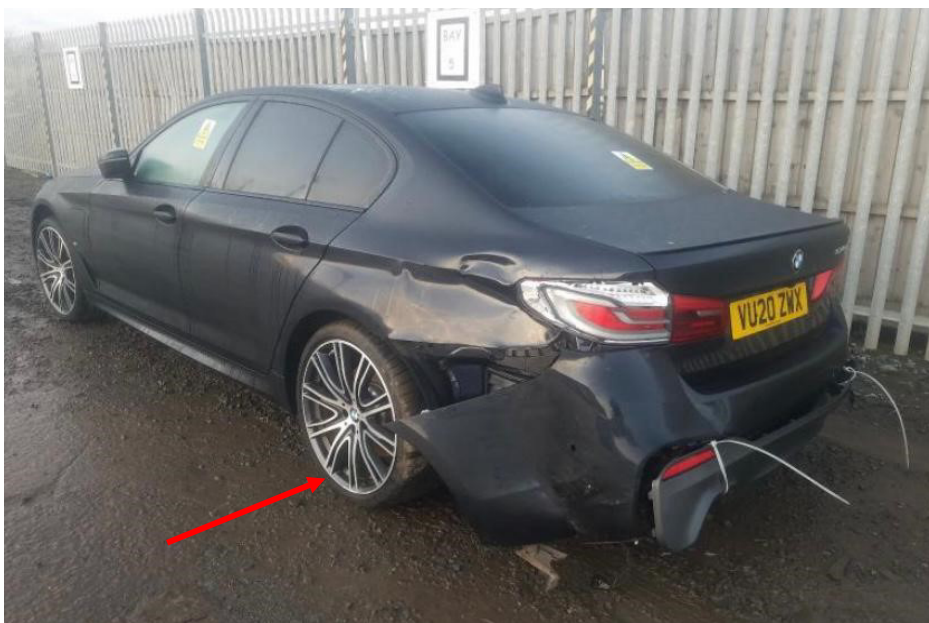
**Photo 4** shows the rear left body of the Motor Car (photograph provided to me). Apart from the rear right portion, the Motor Car had also sustained damage to its rear left portion. The rear bumper, rear left fender, and rear left taillamp were amongst the body parts that were observed to have been damaged. The orientation of the rear left wheel (arrowed) and rear right wheel (refer to photograph 2 above) suggest damage to the rear undercarriage parts of the Motor Car.

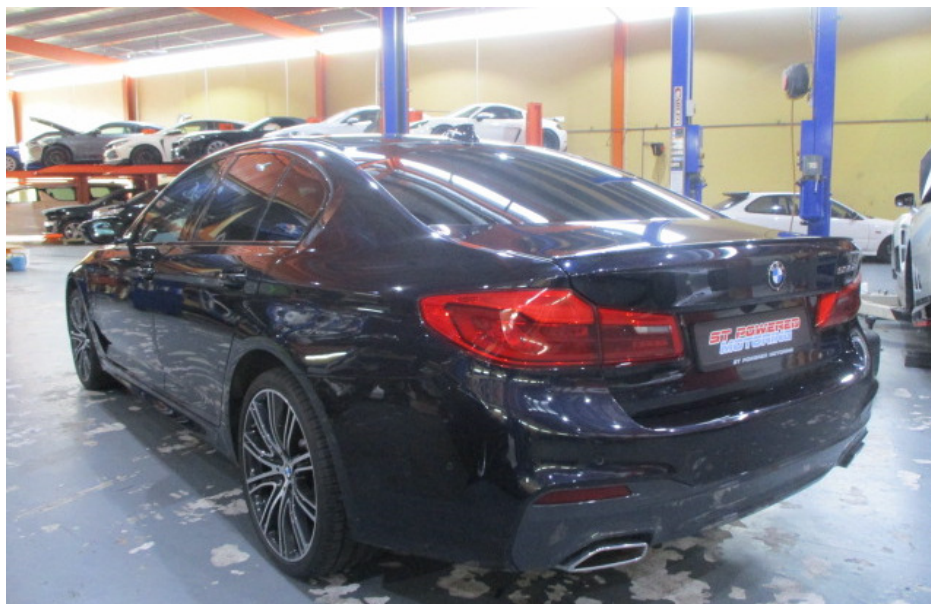
**Photo 5** shows a general view of the rear left body of the Motor Car at the time of my inspection. The Motor Car was observed to be in a relatively good general condition with no loose exterior fittings observed. The body parts at the rear left portion of the Motor Car were visually examined and it was observed that the repair/restoration works carried out to the damaged area of the Motor Car (refer to photograph 4 above) were reasonably adequate and in order.

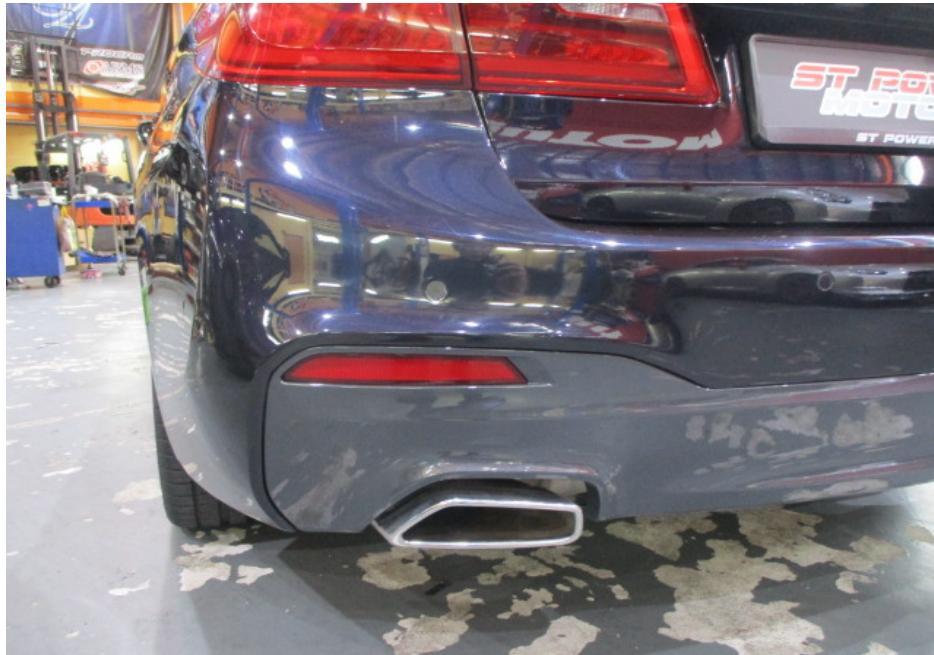
**Photo 6** shows a closer view of the Motor Car's rear bumper, rear bumper lower cover, rear bumper left reflector and rear left taillamp. The body parts at the rear left portion of the Motor Car were visually examined and it was observed that the repair/restoration works carried out to the damaged area of the Motor Car (refer to photograph 4 above) were reasonably adequate and in order.

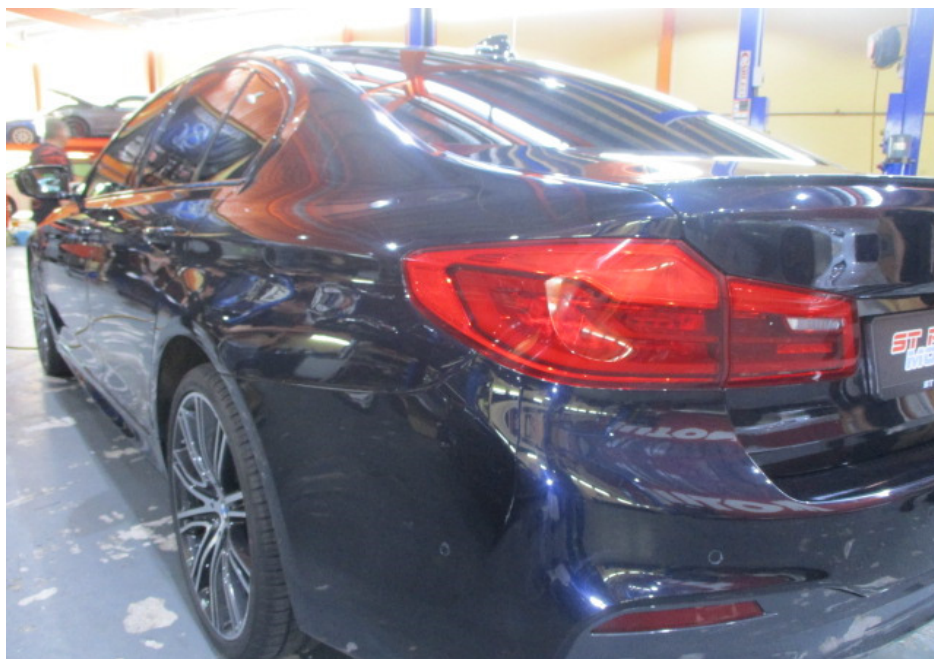
**Photo 7** shows a closer view of the Motor Car's rear bumper, rear left taillamp and rear left fender. The body parts at the rear left portion of the Motor Car were visually examined and it was observed that the repair/restoration works carried out to the damaged area of the Motor Car (refer to photograph 4 above) were reasonably adequate and in order.

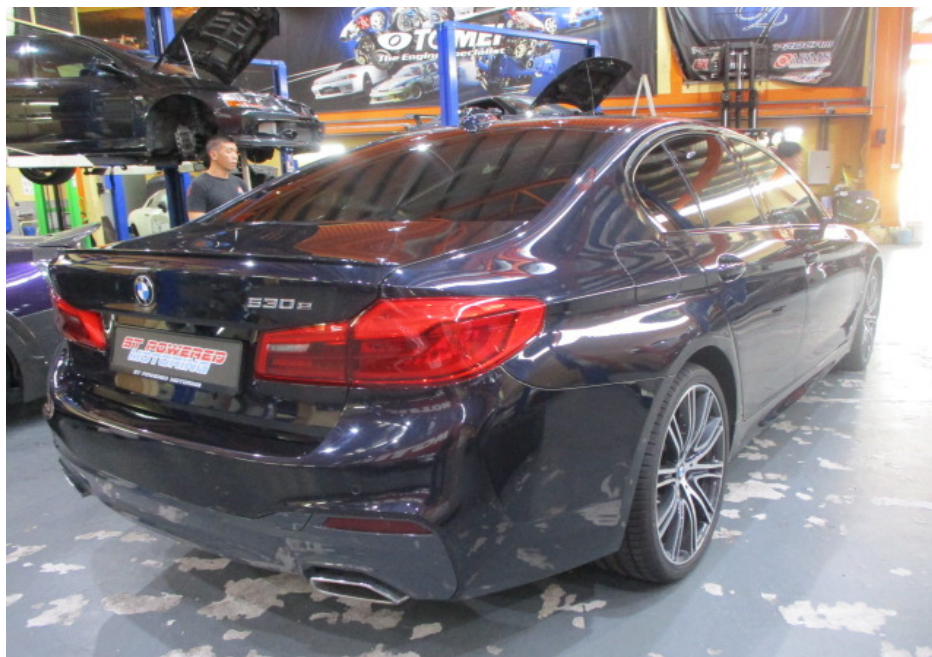
**Photo 8** shows a general view of the rear right body of the Motor Car at the time of my inspection. The Motor Car was observed to be in a relatively good general condition with no loose exterior fittings observed. The body parts at the rear right portion of the Motor Car were visually examined and it was observed that the repair/restoration works carried out to the damaged area of the Motor Car (refer to photograph 1 & 2 above) were reasonably adequate and in order.

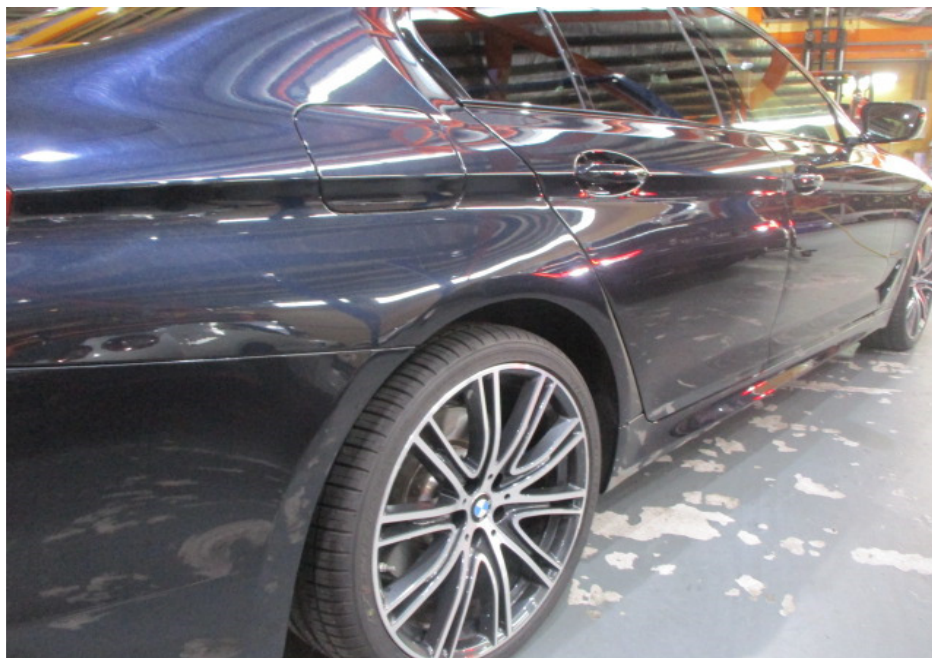
**Photo 9** shows a closer view of the Motor Car's rear right wheel, rear right fender and rear right door. The body parts at the rear right portion of the Motor Car were visually examined and it was observed that the repair/restoration works carried out to the damaged area of the Motor Car (refer to photograph 1 & 2 above) were reasonably adequate and in order.

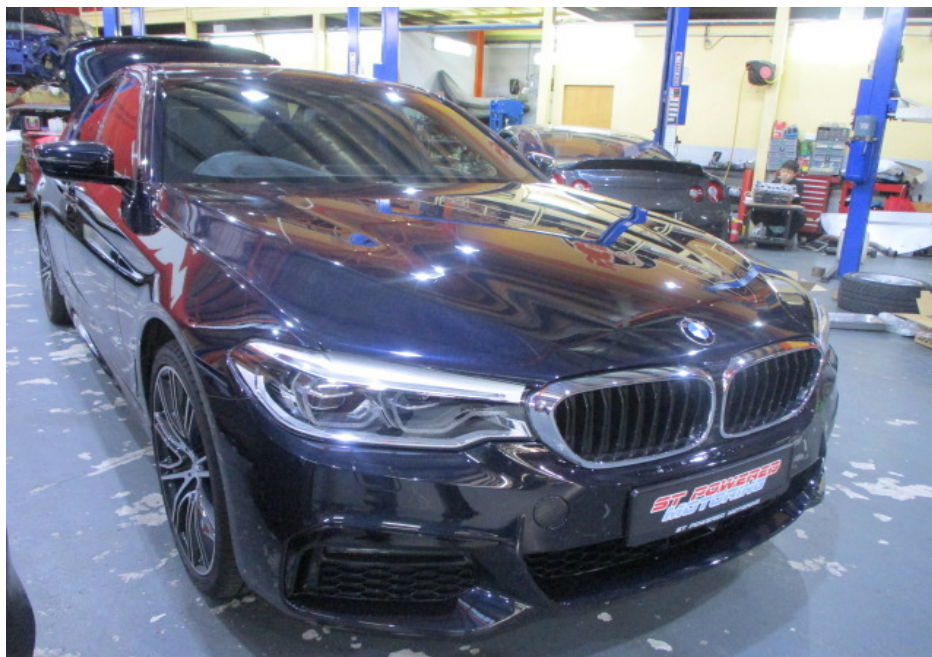
**Photo 10** shows a general view of the front right body of the Motor Car at the time of my inspection. The Motor Car was observed to be in a relatively good general condition with no loose exterior fittings observed. The mileage of the Motor Car recorded at the time of my inspection was 10,114km.

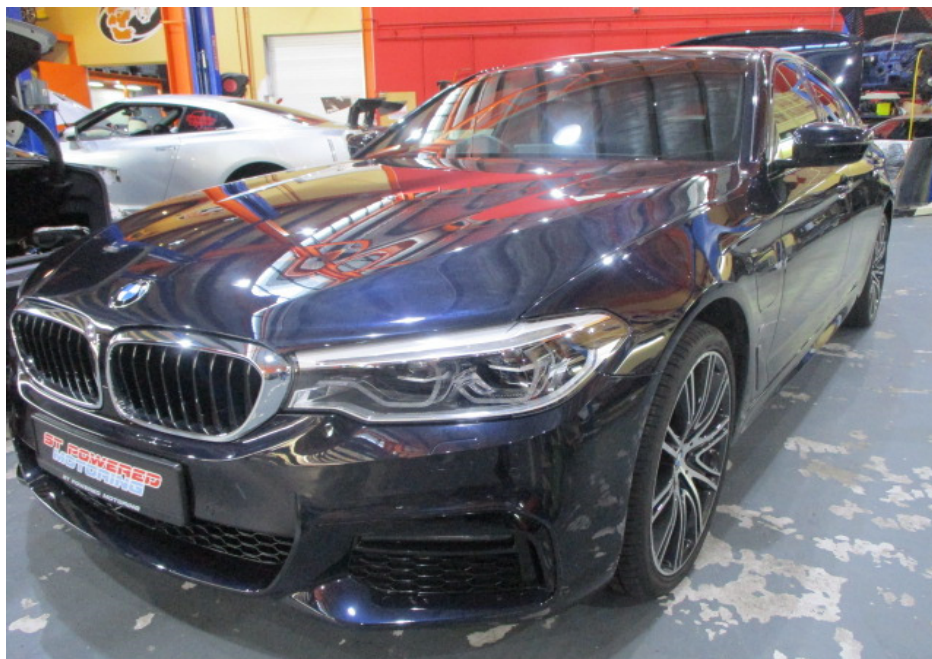
**Photo 11** shows a general view of the front left body of the Motor Car at the time of my inspection. The Motor Car was observed to be in a relatively good general condition with no loose exterior fittings observed. The mileage of the Motor Car recorded at the time of my inspection was 10,114km.

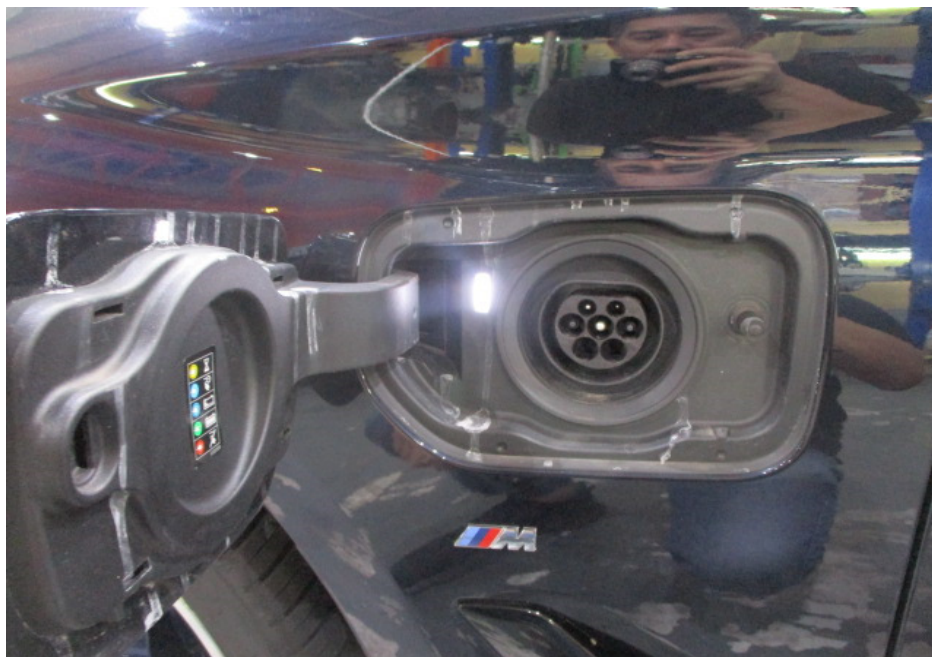
**Photo 12** shows the charging socket and charging socket cover of the Motor Car. The charging socket pins were observed to be undamaged.

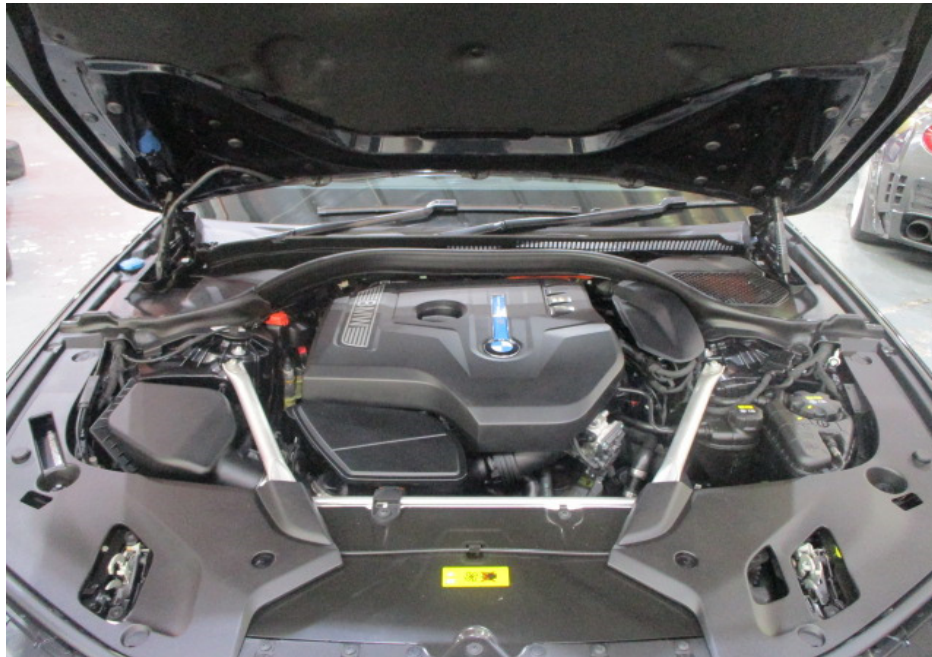
**Photo 14** shows a general view of the engine compartment of the Motor Car at the time of my inspection. The various parts and components inside the engine compartment were all observed to be intact and properly fitted. There was also no sign(s) or indication(s) of fluid leak and/or fluid stain found inside the engine compartment.

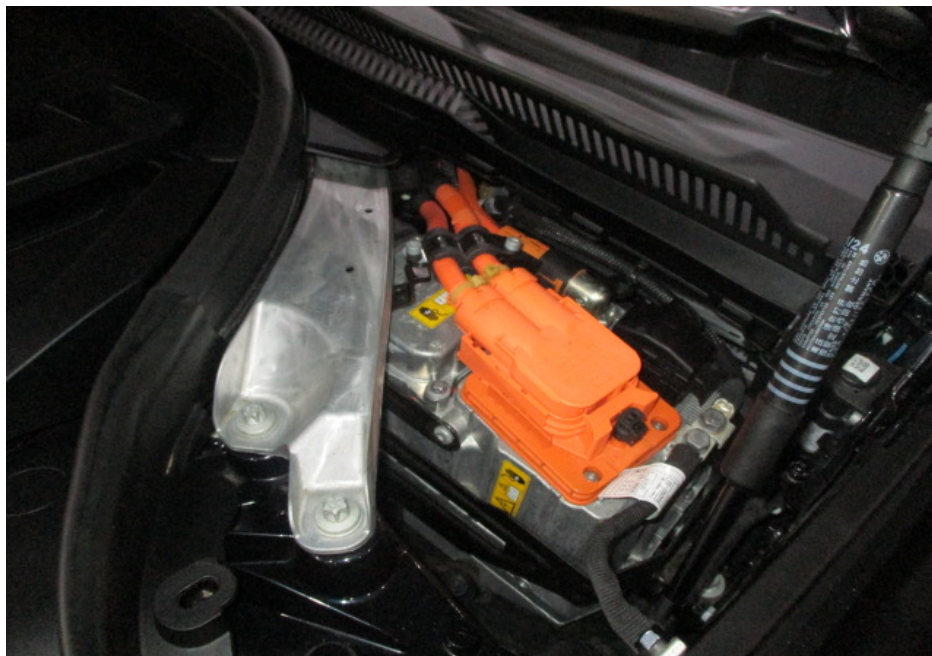
**Photo 15** shows a general view of the electric motor that was fitted in the engine compartment of the Motor Car. The cable connections were checked and found to be securely fitted into the respective connectors. The electric cables connecting the electric motor to the electric battery, located at the underside centre (refer to photograph 27 below), were securely fitted into the respective connectors and protected by dust covers.

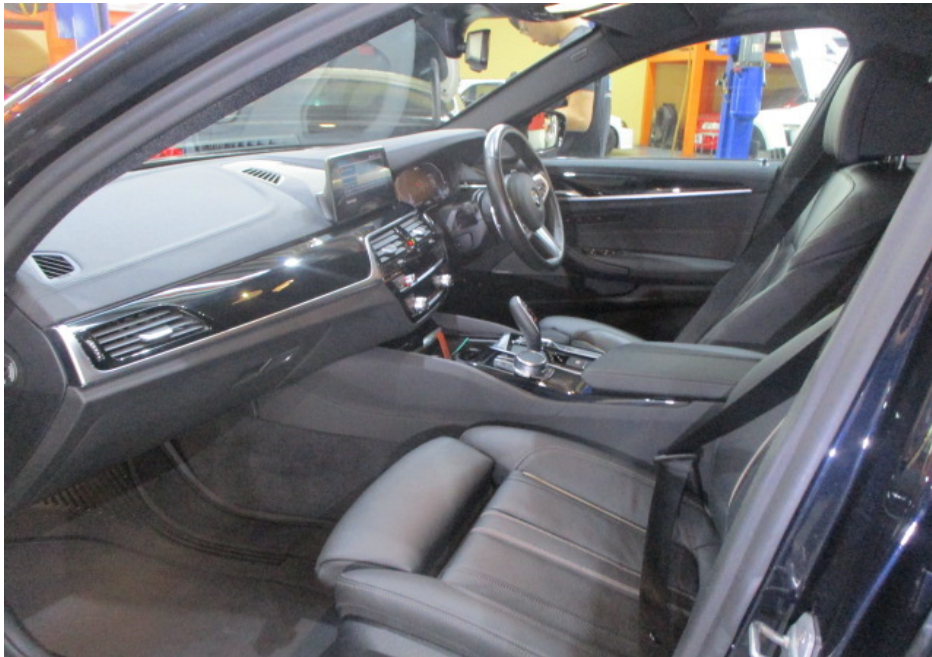
**Photo 16** shows the interior compartment of the Motor Car at the time of my inspection. The various parts and components, trims, carpet and upholstery inside the interior compartment were all observed to be intact and properly fitted.

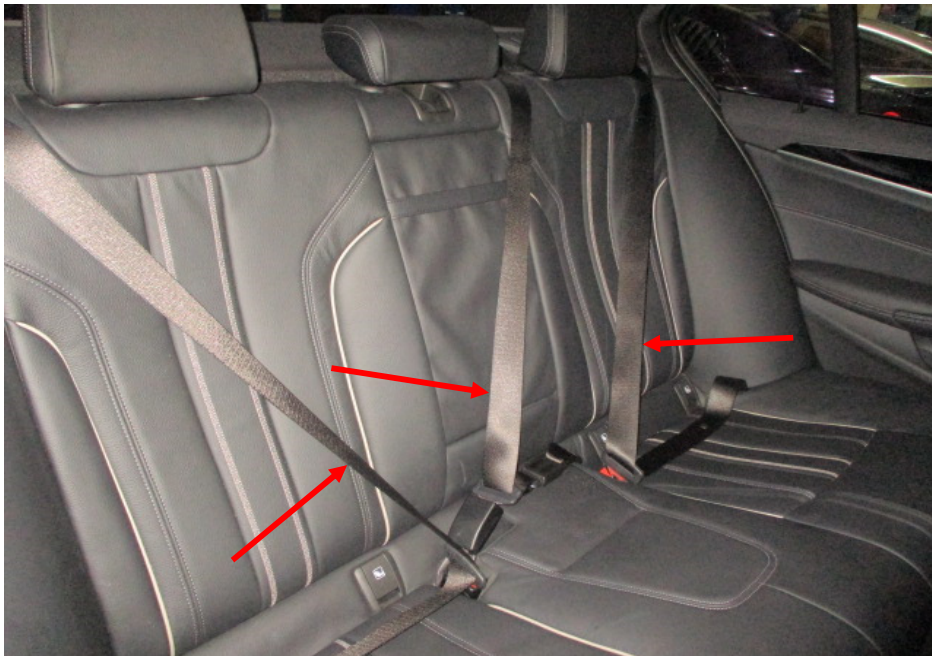
**Photo 17** shows the rear seats of the Motor Car. All the seats of the Motor Car were secured via seat rails to the floorboard. They were also fitted with a retractable seat belt reel and a pre-tensioner. The seat belts (arrowed) were tested and were able to be fastened into the respective pre-tensions that were fitted on the side of each individual seat.

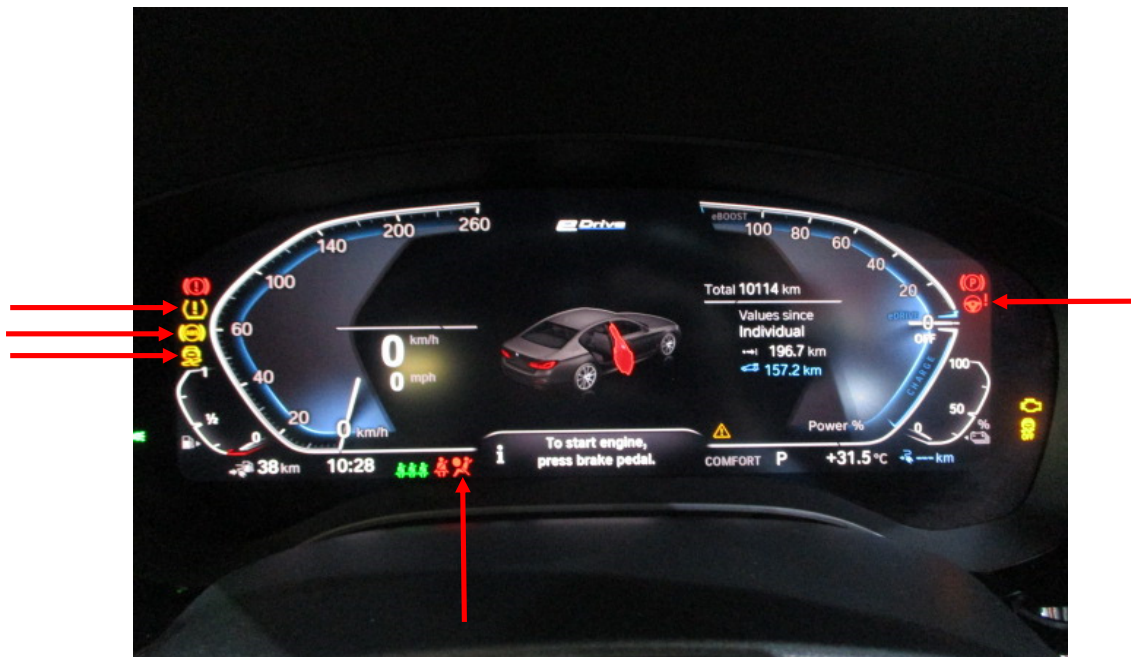
**Photo 18** shows the warning lights for the various electronic safety features appearing on the instrument panel of the Motor Car during its self-test when the engine is cranked, in particular the ABS, SRS, IAS, TPM and DSC lights (arrowed).

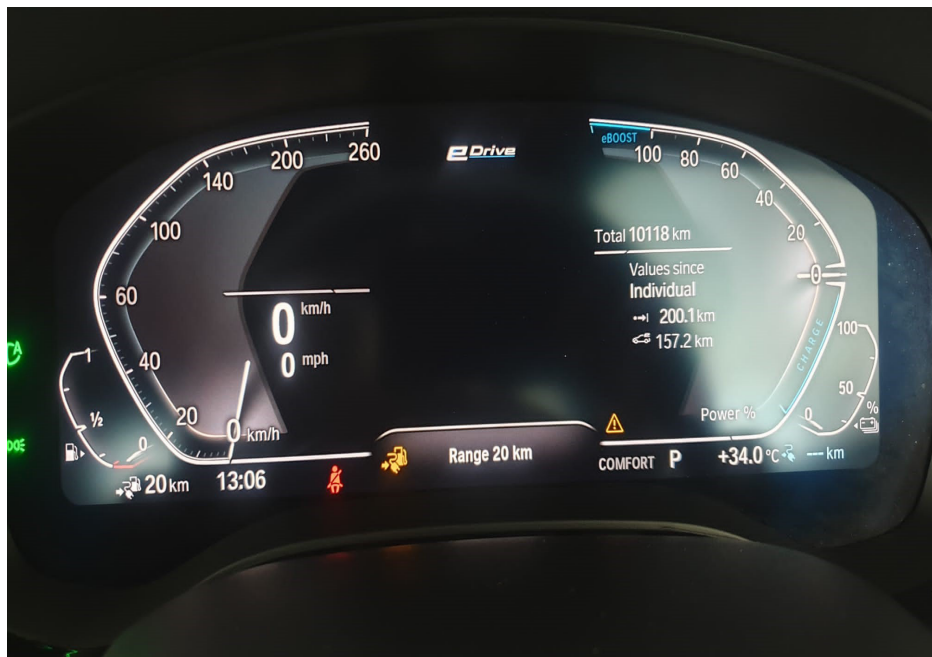
**Photo 19** shows the respective warning lights no longer illuminated, indicating that there is no fault detected to the ABS, SRS, IAS, TPM and DSC systems of the Motor Car during the self-test. These electronic systems were hence in working condition at the time of my inspection.

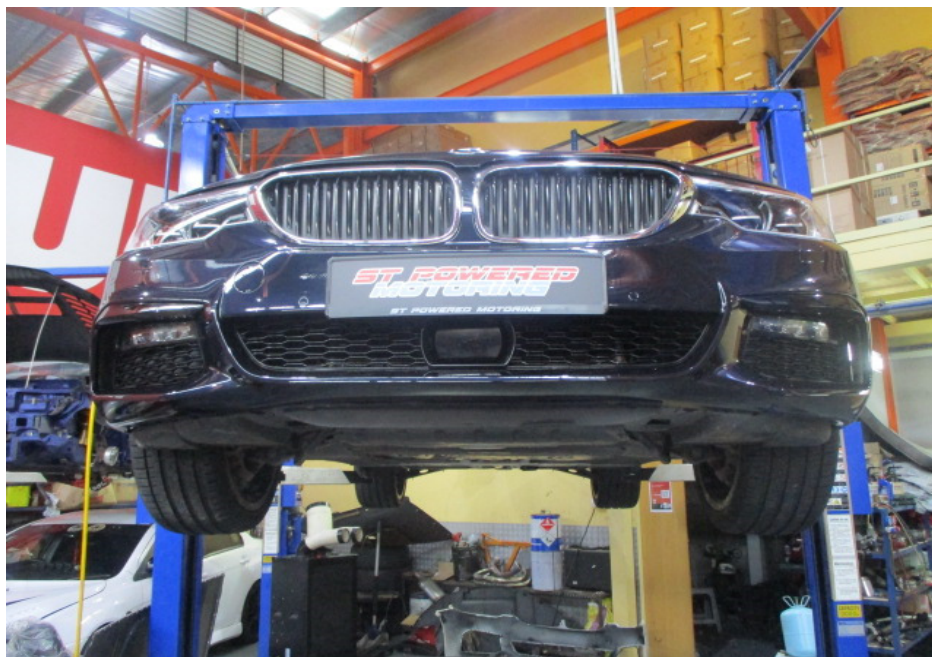
**Photo 20** shows the Motor Car hoisted up for checks on its undercarriage. There was no sign(s) or indication(s) of fluid leakage and/or fluid stain(s) on the underside of the Motor Car. The undercarriage components of the Motor Car were also all observed to be intact and secured in an appropriate manner.

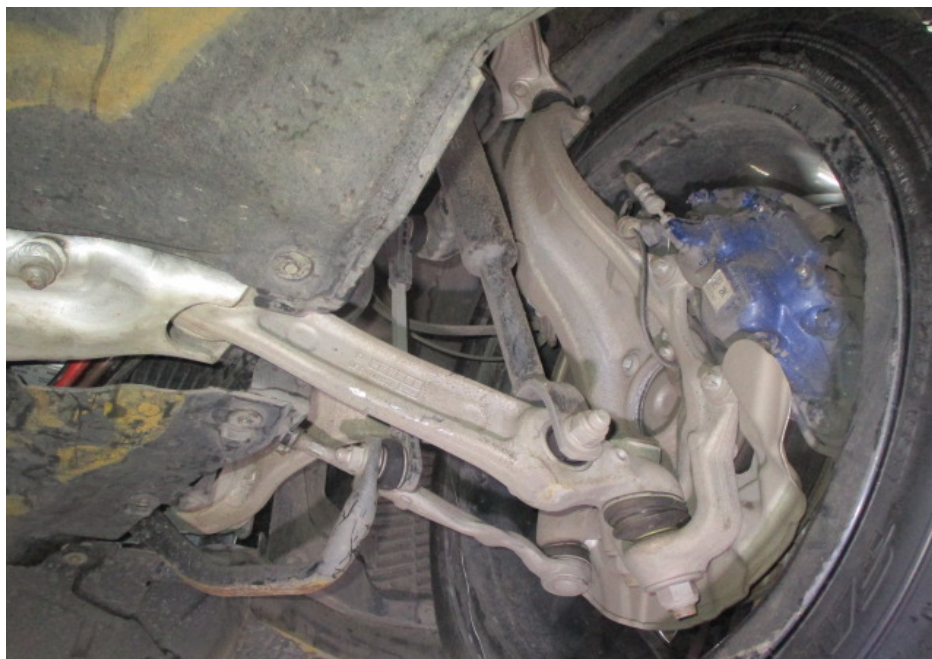
**Photo 21** shows the various undercarriage components at the front right wheel of the Motor Car. The mechanical components, control arms and linkages were all found to be intact and secured in an appropriate manner. I also did not observe any fluid leak and/or fluid stain on the underside of the Motor Car.

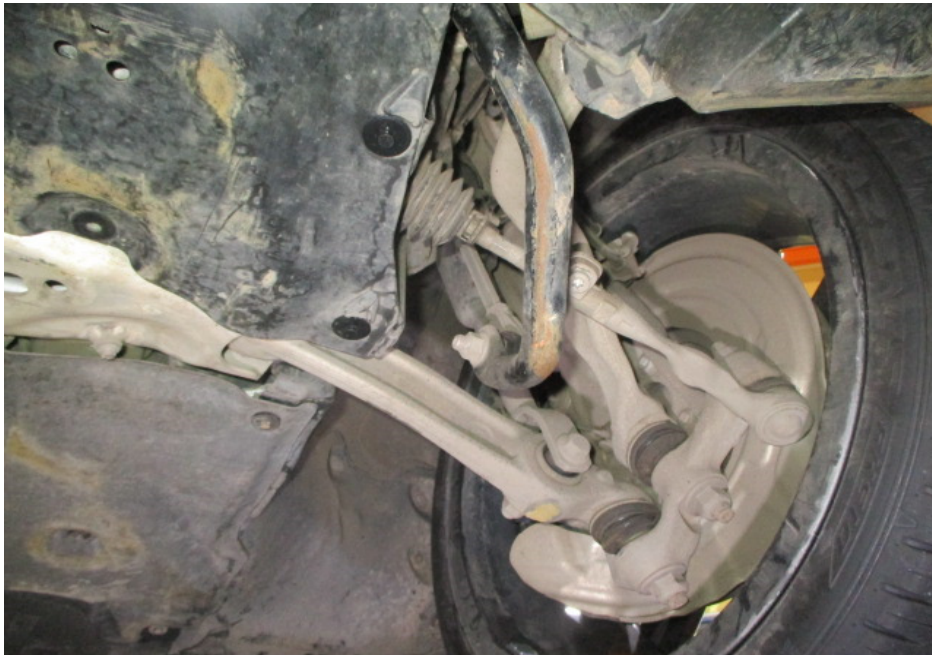
**Photo 22** shows the various undercarriage components at the front left wheel of the Motor Car. The mechanical components, control arms and linkages were all found to be intact and secured in an appropriate manner.

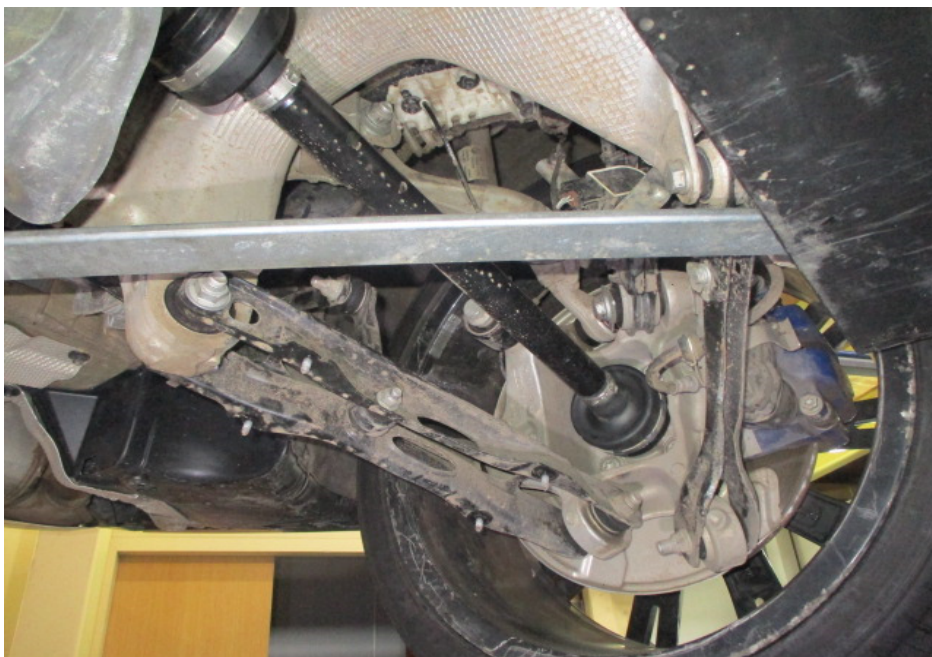
**Photo 23** shows the various undercarriage components at the rear left wheel of the Motor Car. The mechanical components, control arms and linkages were all found to be intact and secured in an appropriate manner.

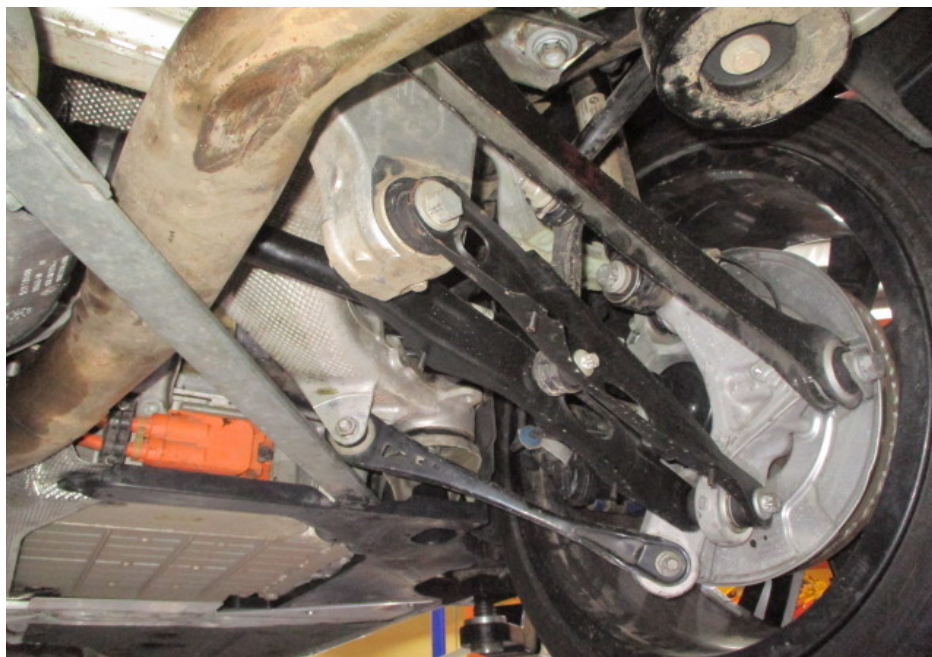
**Photo 24** shows a general view of the control arms and linkages at the rear right wheel of the Motor Car. I did not observe any fluid leak and/or fluid stain on the underside of the Motor Car. All of the Motor Car's undercarriage components were observed to be intact and secured in an appropriate manner.

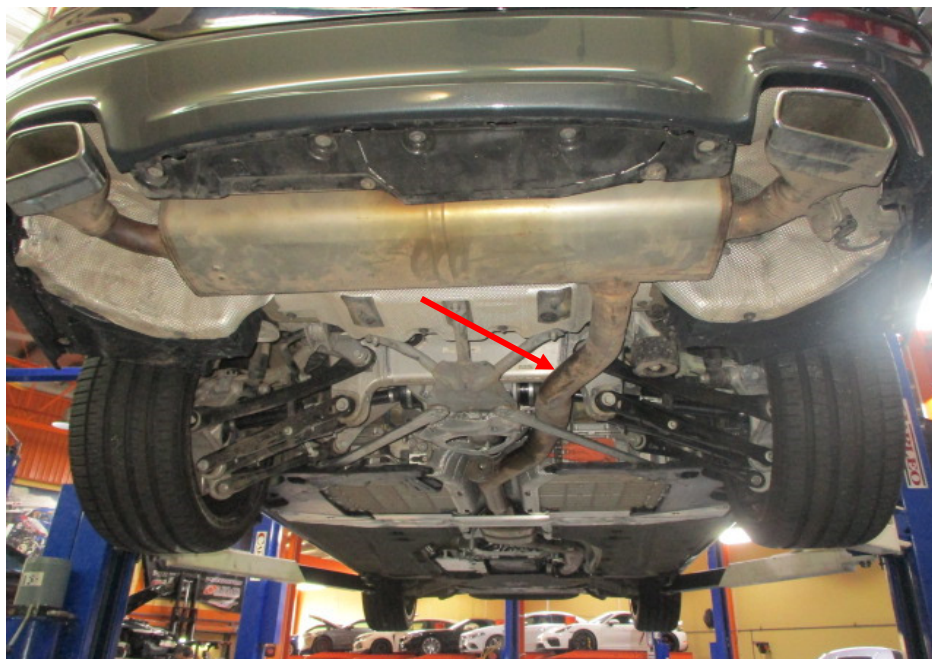
**Photo 25** shows a general view of the Motor Car's exhaust system (rear section). My examination of the Motor Car's exhaust system revealed no sign(s) or indication(s) of any cut or weld marks along its exhaust pipes (arrowed), on its centre resonator box, on its catalytic converter and on its rear muffler.

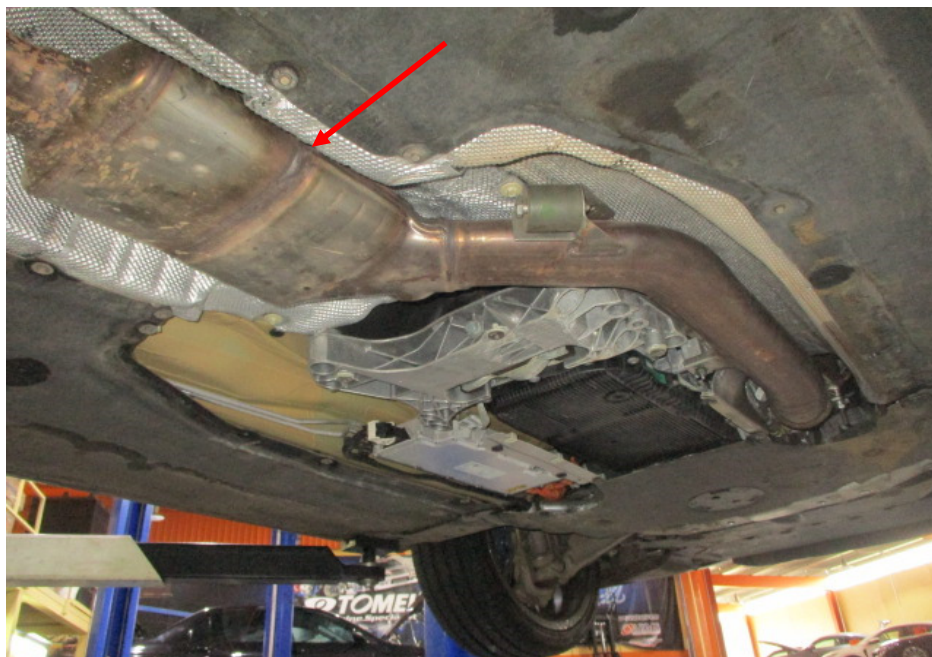
**Photo 26** shows a general view of the Motor Car's exhaust system (front section). My examination of the Motor Car's exhaust system revealed no sign(s) or indication(s) of any cut or weld marks along its exhaust pipes, on its centre resonator box (arrowed), on its catalytic converter and on its rear muffler.

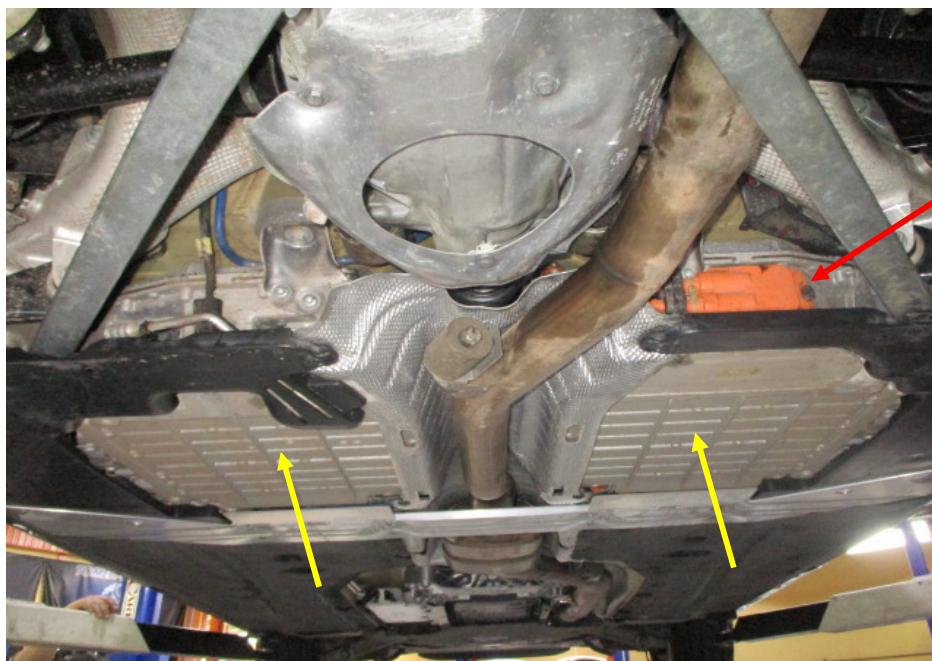
**Photo 27** shows the Motor Car's electric battery (yellow arrow) that was fitted at the underside centre of the Motor Car. The cable connections (red arrow) were checked and found to be securely fitted into the respective connectors. The electric battery was also observed to be fitted securely. The electric cables connecting the electric motor within the engine compartment (refer to photograph 15 above) to the electric battery were securely fitted into the respective connectors and protected by dust covers.

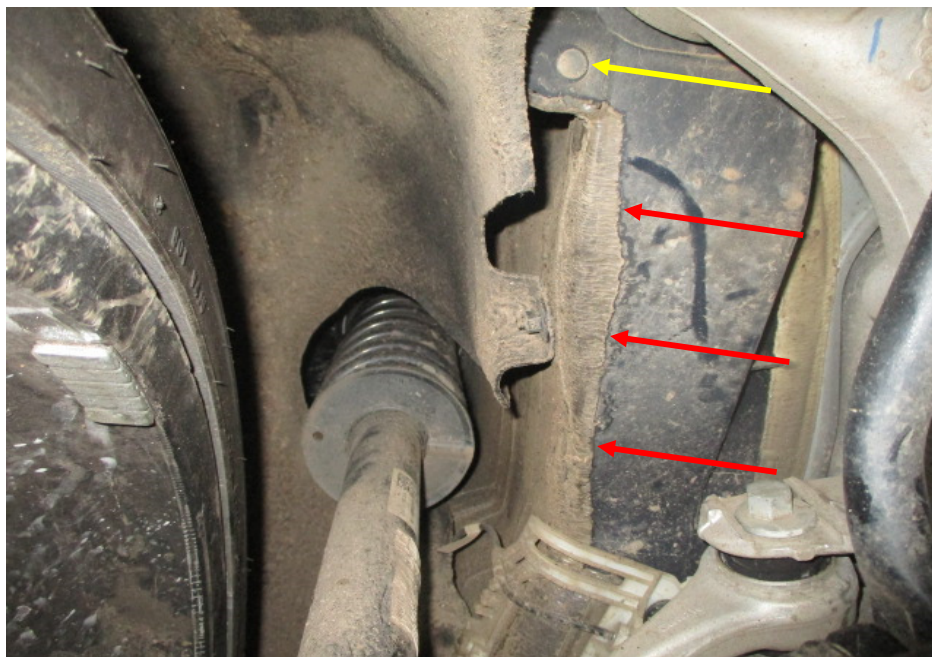
**Photo 28** shows the chassis/structural body at the underside rear left of the Motor Car. I did not find any weld marks other than original spot weld marks (yellow arrow) on the chassis/structural body of the Motor Car. The original factory sealant (red arrow) at the joints along the chassis/structural body was also untouched, indicating no work was done on the chassis/structural body of the Motor Car and that the chassis/structural body was originally fitted.

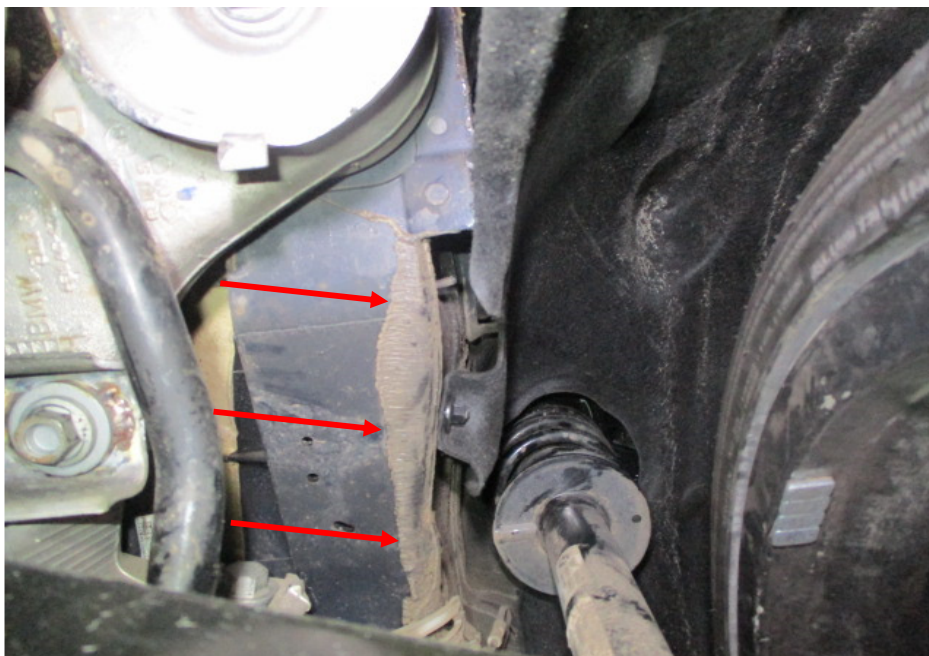
**Photo 29** shows the chassis/structural body at the underside rear right of the Motor Car. The original factory sealant (arrowed) at the joints along the chassis/structural body was observed to be untouched. In general, I had found no work was carried out on the chassis/structural body of the Motor Car. The chassis/structural body of the Motor Car was originally fitted.

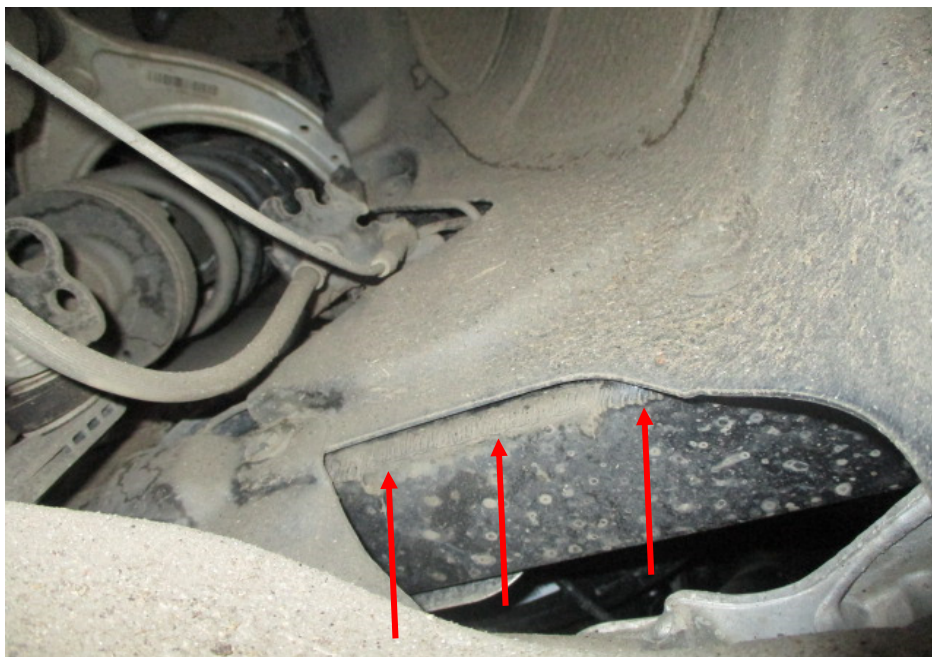
**Photo 30** shows the chassis/structural body at the underside front right of the Motor Car. The original factory sealant (arrowed) at the joints along the chassis/structural body was observed to be untouched. In general, I had found no work was carried out on the chassis/structural body of the Motor Car. The chassis/structural body of the Motor Ca was originally fitted.

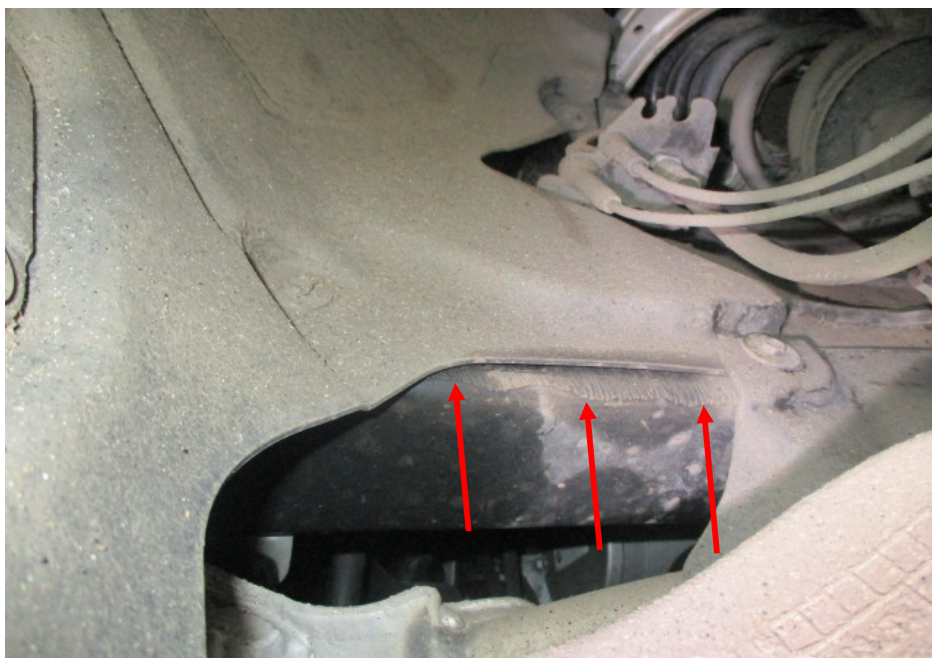
**Photo 31** shows the chassis/structural body at the underside front left of the Motor Car. I did not find any weld marks other than original spot weld marks on the chassis/structural body of the Motor Car. The original factory sealant (arrowed) at the joints along the chassis/structural body was also untouched, indicating no work was done on the chassis/structural body of the Motor Car and that the chassis/structural body was originally fitted.

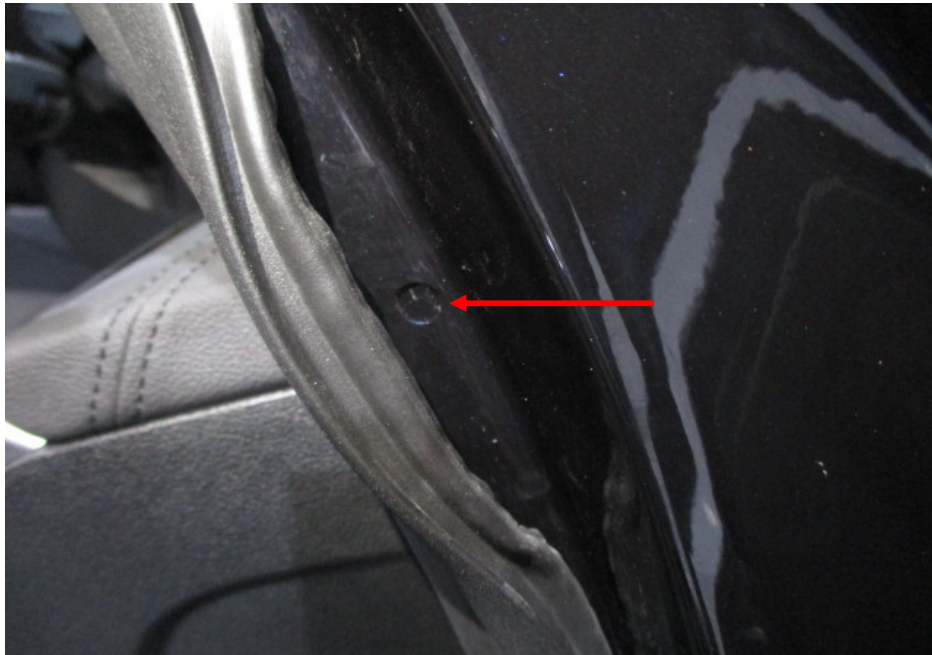
**Photo 32** shows the right side "A" pillar of the Motor Car. I did not find any weld marks other than original spot weld marks (arrowed) on the right side "A" pillar of the Motor Car which, indicates that there was no re-welding works carried out. In general, I had found all the non-detachable body panels of the Motor Car to be originally fitted at the time of my inspection.

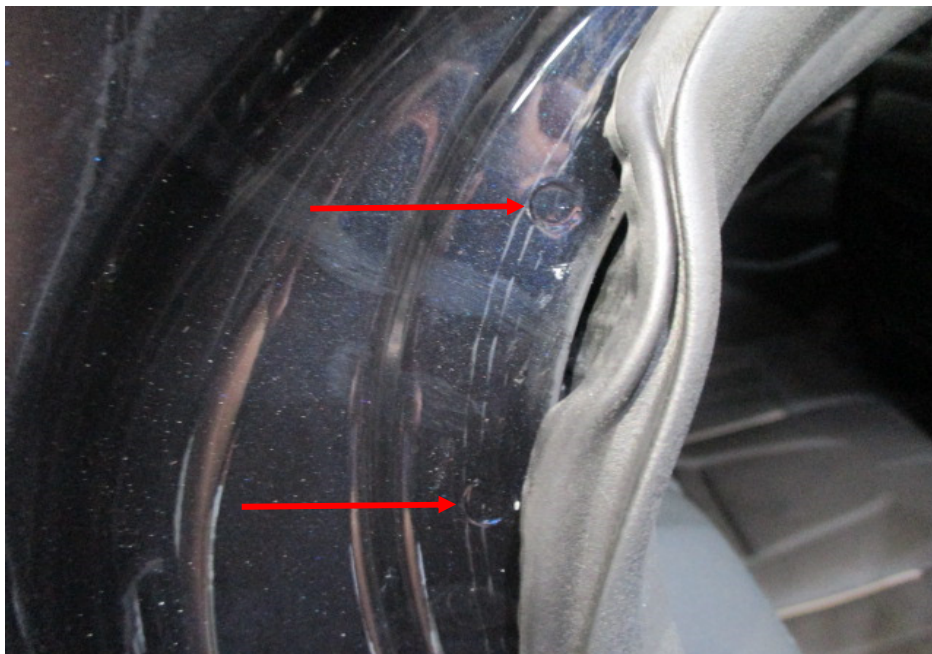
**Photo 33** shows the right side "C" pillar of the Motor Car. I did not find any weld marks other than original spot weld marks (arrowed) on the right side "C" pillar of the Motor Car which, indicates that there was no re-welding works carried out. In general, I had found all the non-detachable body panels of the Motor Car to be originally fitted at the time of my inspection.

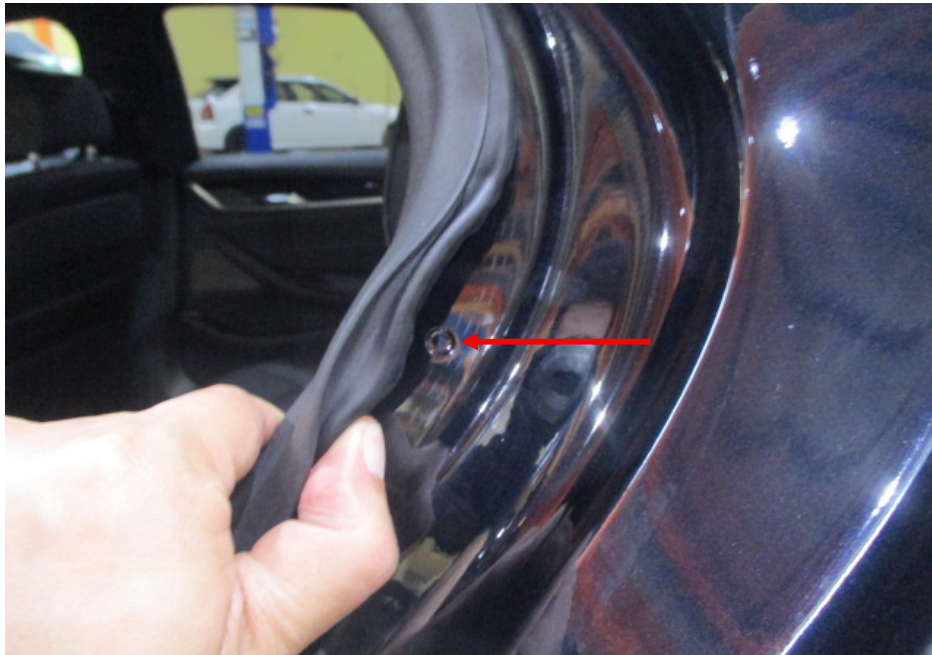
**Photo 34** shows the left side "C" pillar of the Motor Car. I did not find any weld marks other than original spot weld marks (arrowed) on the left side "C" pillar of the Motor Car which, indicates that there was no re-welding works carried out. In general, I had found all the non-detachable body panels of the Motor Car to be originally fitted at the time of my inspection.
