18 October 2021

Your Ref: Honda Engine

Our Ref: CI/TP21010669/D

INSPECTION REPORT OF A HONDA ENGINE WITH NUMBER R18A1715039

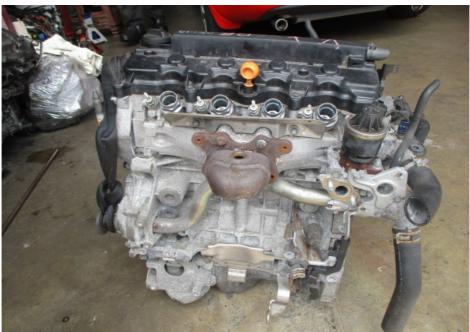
Photo 1 shows a general view of the Honda engine that I had inspected. The Honda engine was observed to be a used engine and was not fitted on any motor car. It was also observed to be a complete assembly with all mechanical parts still intact, within the engine housing.

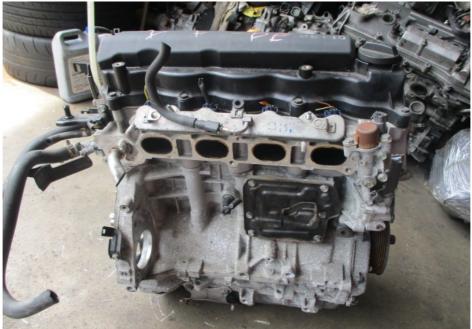
Photo 2 shows a general view of the Honda engine that I had inspected. My visual examination of the engine housing revealed the housing to be of serviceable/satisfactory condition. There was no crack and/or hole observed on the engine housing.

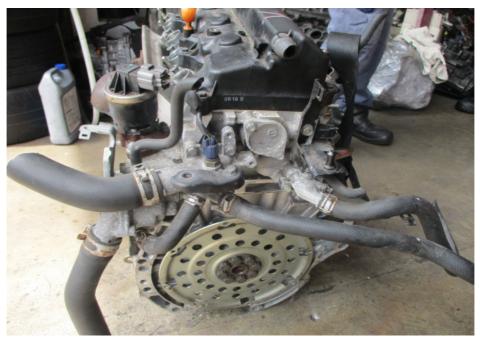
Photo 3 shows another view of the Honda engine that I had inspected. My visual examination of the engine housing revealed the housing to be of serviceable/satisfactory condition. There was no crack and/or hole observed on the engine housing.

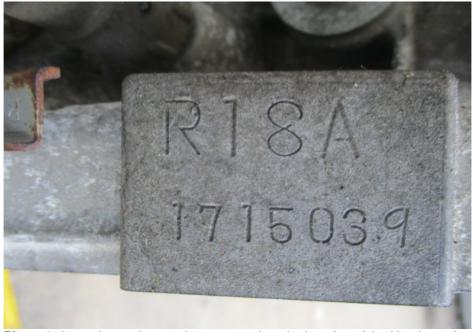
Photo 4 shows the engine number engraved on the housing of the Honda engine that I had inspected. The engine number was R18A1715039.

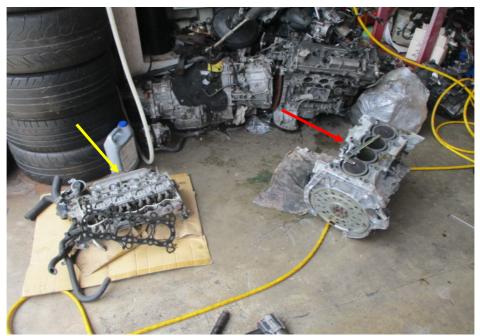
Photo 5 shows the top block (yellow arrow) of the Honda engine separated from its bottom block (red arrow). This was to enable me to carry out measurements of its cylinders, in particular the bore and stroke measurements of each cylinder, which typically can be used to determine the engine displacement or more commonly referred to as engine cc.

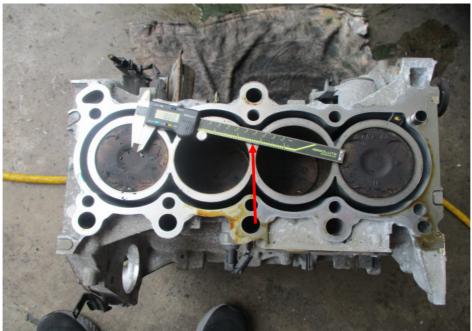
Photo 6 shows the bottom block of the Honda engine and the digital Vernier Caliper (arrowed) that was used to measure the bore and stroke measurements of each cylinder. The digital Vernier Caliper was calibrated before the start of the measurements.

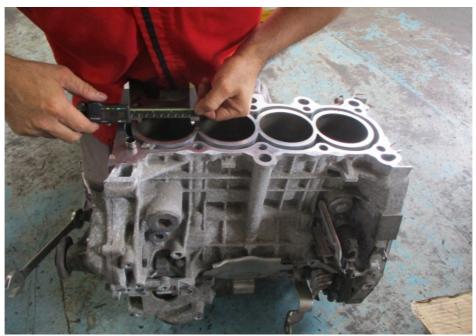
Photo 7 shows measurement being carried out to the bore of cylinder 1 of the Honda engine. The measurements were carried out using a digital Vernier Caliper that was calibrated before the start of the measurements.

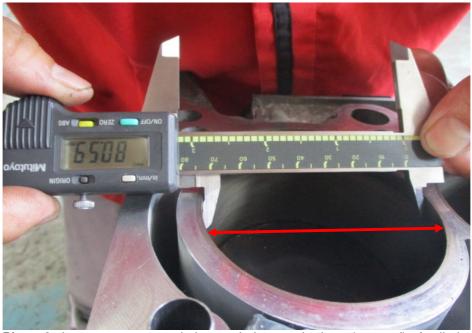
| | Bore (mm) | Stroke (mm) |
|---|---|---|
| Cylinder 1 | 80.59 | 87.23 |

Photo 8 shows measurement being carried out to the bore (arrowed) of cylinder 1 of the Honda engine. The bore measurement of cylinder 1 was recorded to be 80.59mm.

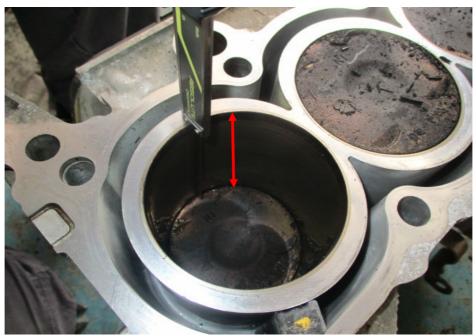
Photo 9 shows measurement being carried out to the stroke (arrowed) of cylinder 1 of the Honda engine. The bore and stroke measurements of the Honda engine were carried out using a digital Vernier Caliper that was calibrated before the start of the measurements.

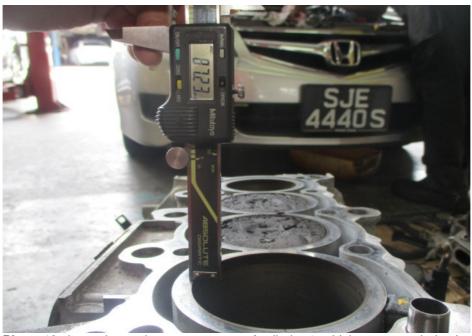
Photo 10 shows the stroke measurement of cylinder 1, which was recorded to be 87.23mm.

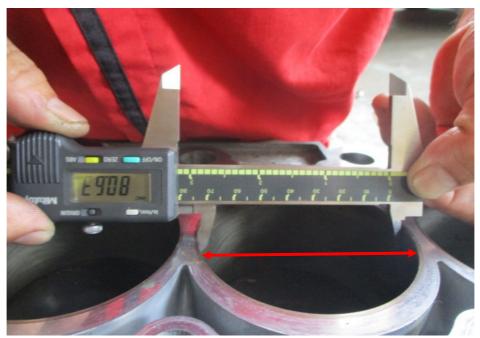
| | Bore (mm) | Stroke (mm) |
|---|---|---|
| Cylinder 2 | 80.63 | 87.28 |

Photo 11 shows measurement being carried out to the bore (arrowed) of cylinder 2 of the Honda engine. The bore measurement of cylinder 2 was recorded to be 80.63mm.

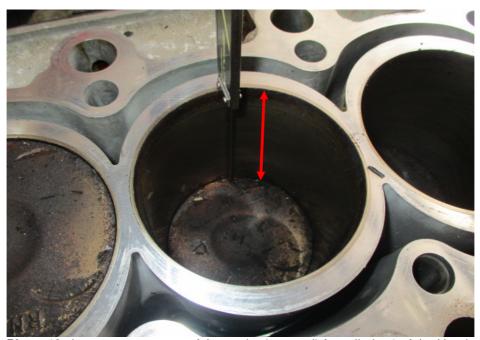
Photo 12 shows measurement of the stroke (arrowed) for cylinder 2 of the Honda engine that I had inspected. The bore and stroke measurements of the Honda engine were carried out using a digital Vernier Caliper that was calibrated before the start of measurements.

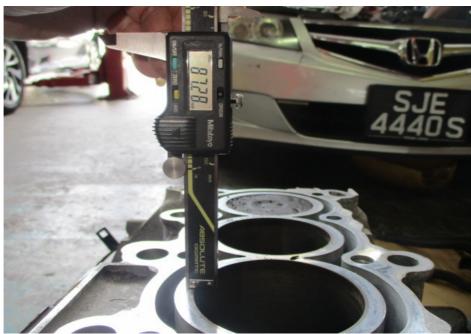
Photo 13 shows the stroke measurement of cylinder 2, which was recorded to be 87.28mm.

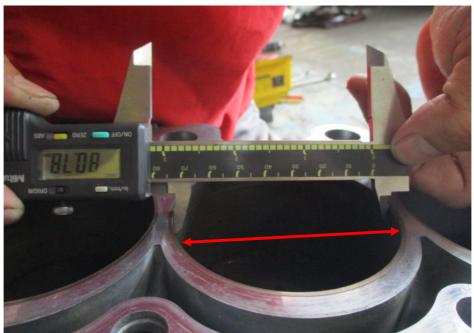
| | Bore (mm) | Stroke (mm) |
|---|---|---|
| Cylinder 3 | 80.78 | 87.25 |

Photo 14 shows measurement being carried out to the bore (arrowed) of cylinder 3 of the Honda engine. The bore and stroke measurements of the Honda engine were carried out using a digital Vernier Caliper that was calibrated before the start of measurements. The bore measurement of cylinder 3 was recorded to be 80.78mm.

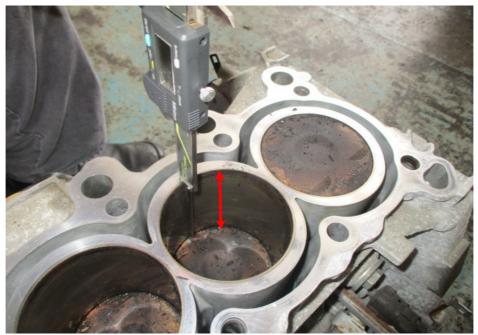
Photo 15 shows measurement of the stroke (arrowed) for cylinder 3 of the Honda engine that I had inspected. The bore and stroke measurements of the Honda engine were carried out using a digital Vernier Caliper that was calibrated before the start of measurements.

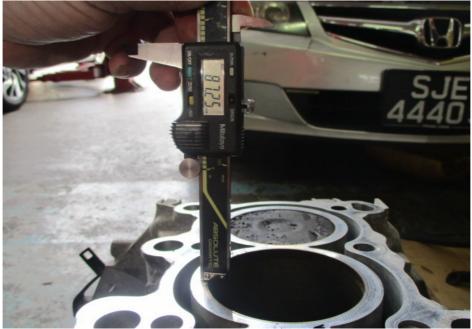
Photo 16 shows the stroke measurement of cylinder 3, which was recorded to be 87.25mm.

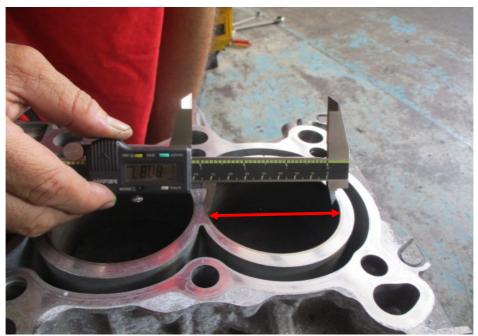
Photo 17 shows measurement being carried out to the bore (arrowed) of cylinder 4 of the Honda engine. The bore and stroke measurements of the Honda engine were carried out using a digital Vernier Caliper that was calibrated before the start of measurements.

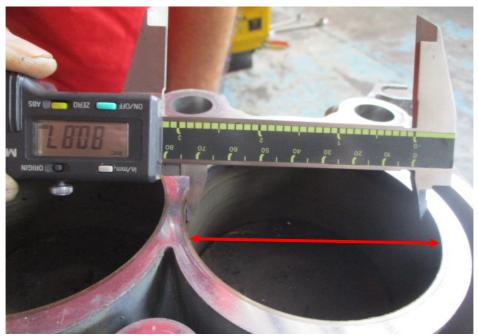
| | Bore (mm) | Stroke (mm) |
|---|---|---|
| Cylinder 4 | 80.87 | 87.28 |

Photo 18 shows measurement being carried out to the bore (arrowed) of cylinder 4 of the Honda engine. The bore measurement of cylinder 4 was recorded to be 80.87mm.

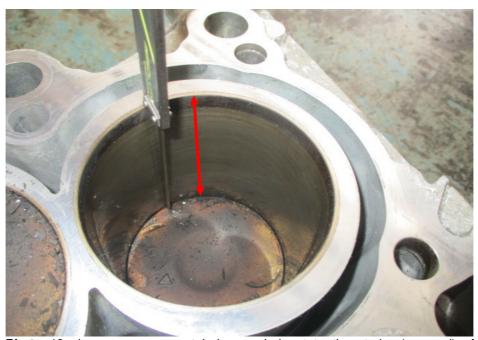
Photo 19 shows measurement being carried out to the stroke (arrowed) of cylinder 4 of the Honda engine. The bore and stroke measurements of the Honda engine were carried out using a digital Vernier Caliper that was calibrated prior to the start of measurements.

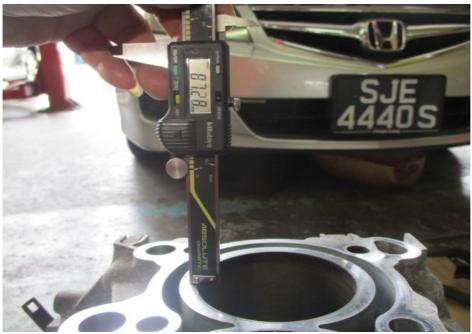
Photo 20 shows the stroke measurement of cylinder 4, which was recorded to be 87.28mm.
