Your Ref: BMW 420i  
(chassis number WBA4H32020BX79105)  
Our Ref : CI/TP21010670/D

**INSPECTION REPORT OF AN UNREGISTERED BMW 420i MOTOR CAR  
WITH CHASSIS NUMBER WBA4H32020BX79105**

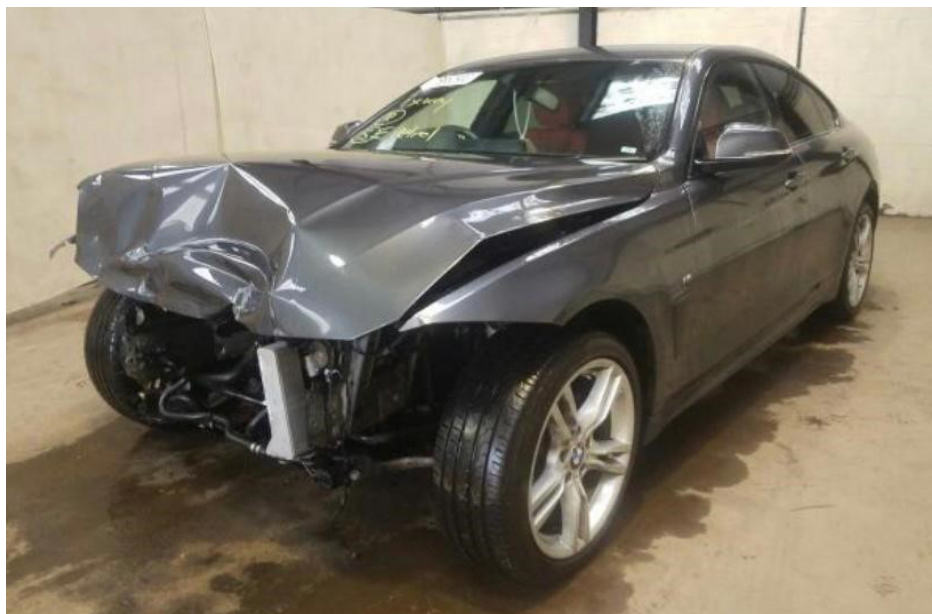
3. The photographs provided to me had showed damage to the frontal portion of the Motor Car. Body parts observed to be damaged include the front bonnet, front bonnet hinges, front bonnet locks, front support panel and front fenders amongst others. The front headlamps, front fog lamps, front engine undercover, front fender inner shields, radiator grilles, radiator, aircon condenser, cooling fan, oil cooler, front bumper and all its related parts and attachments like the front bumper centre lower grille, front bumper left lower grille, front bumper right lower grille, front bumper reinforcement, front bumper sponge and front bumper sensors amongst others were observed to be damaged/dislodged/missing.
4. No physical damage was observed to other areas of the Motor Car. The airbags were not deployed as seen from the photographs that were provided to me. See photo 1 – 4 below.

**Photo 1** shows the front left body of the Motor Car (photograph provided to me). The photographs provided to me had showed damage to the frontal portion of the Motor Car. Body parts damaged include the front bonnet and front left fender amongst others. The front left headlamp, front left fender inner shield, front fog lamp, front bumper and all its related parts and attachments like the front bumper centre lower grille, front bumper left lower grille and front bumper sensors amongst others were observed to be damaged/dislodged/missing.

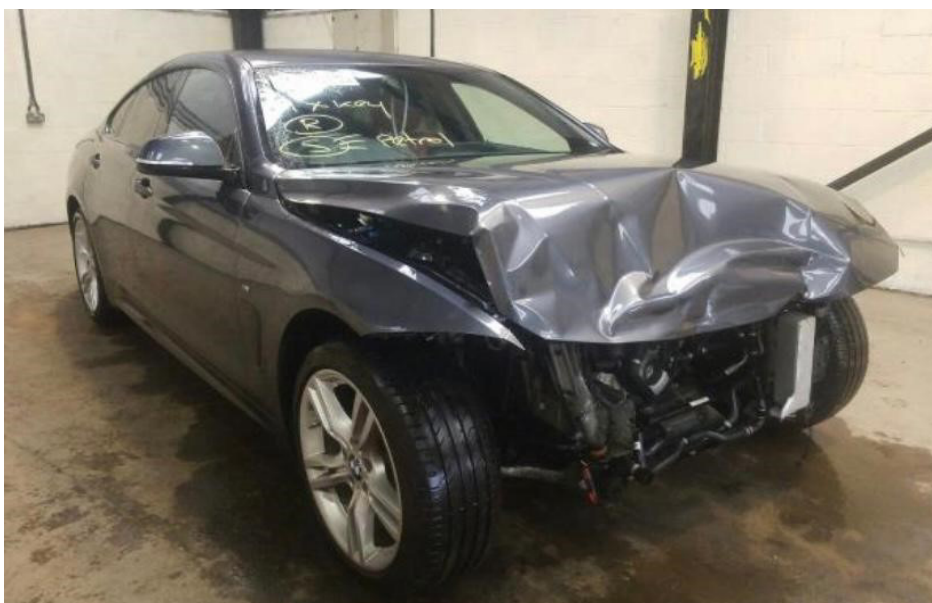
**Photo 2** shows the front right body of the Motor Car (photograph provided to me). The photographs provided to me had showed damage to the frontal portion of the Motor Car. Body parts damaged include the front right fender and front bonnet amongst others. The front right headlamp, radiator grilles, radiator, air con condenser, cooling fan, front engine undercover, front bumper and all its related parts and attachments like the front bumper right lower grille and front bumper reinforcement amongst others were observed to be damaged/dislodged/missing.

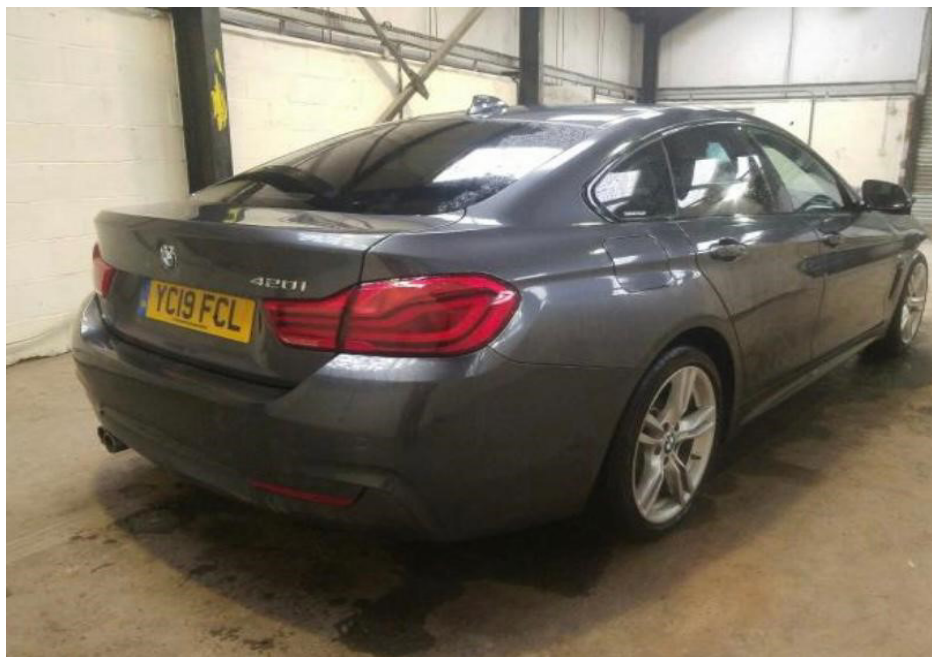
**Photo 3** shows the rear right body of the Motor Car (photograph provided to me). Apart for the frontal portion, there was no physical damage observed to other areas of the Motor Car. The airbags of the Motor Car were also not deployed as seen from the photographs that were provided to me.

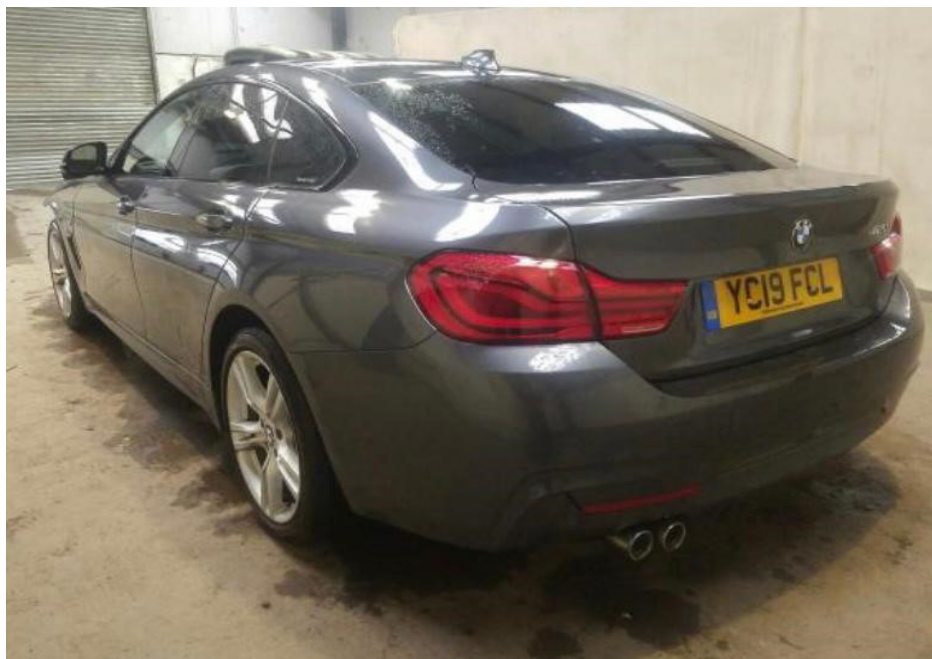
**Photo 4** shows the rear left body of the Motor Car (photograph provided to me). Apart for the frontal portion, there was no physical damage observed to other areas of the Motor Car. The airbags of the Motor Car were also not deployed as seen from the photographs that were provided to me.

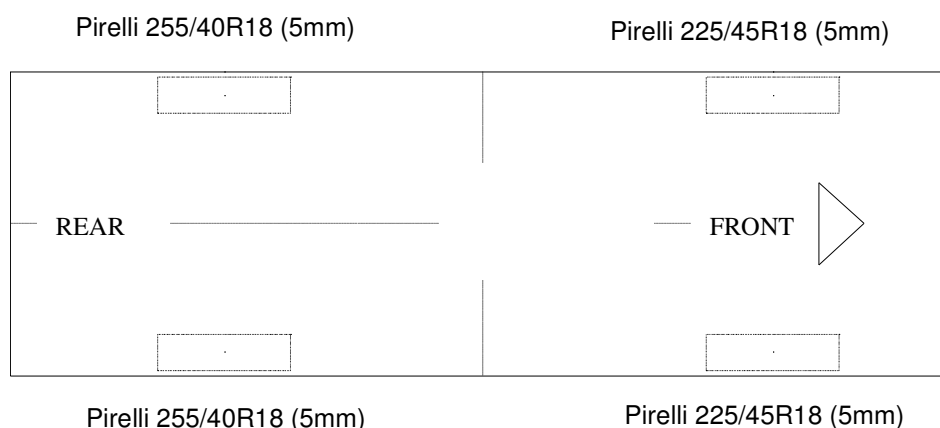
8. It was fitted with 18inch sport wheel rims that were wrapped with tyres that were observed to be of serviceable condition. The tyres were also sufficiently inflated for vehicular operation. The tyre brand, tyre size and approximate remaining tread depth of the 4 tyres of the Motor Car were recorded as follows: -

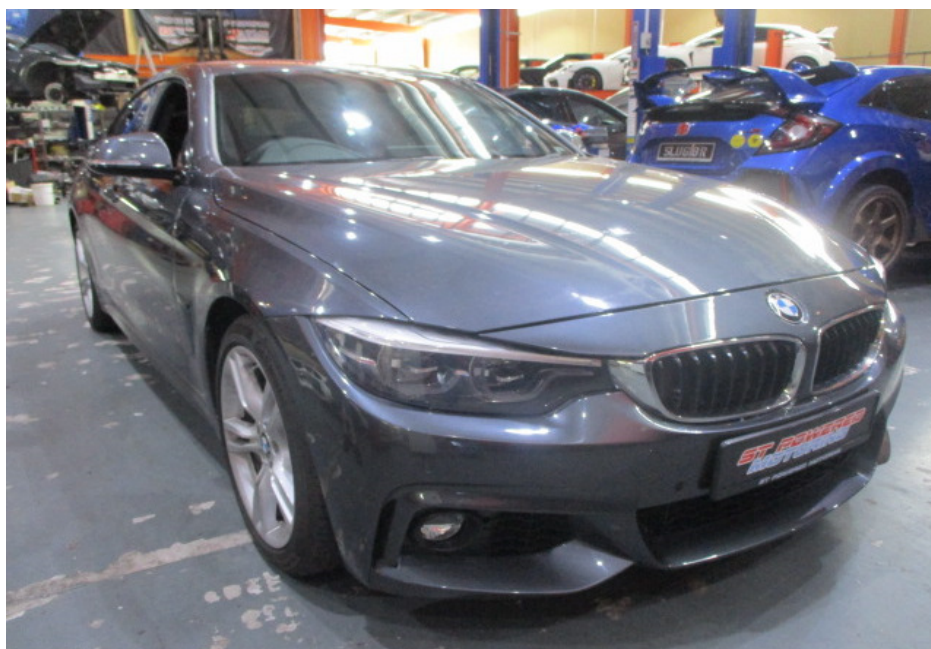
22. The body parts at the frontal portion of the Motor Car were visually examined and it was noted that the repair/restoration works carried out to the damaged area of the Motor Car (refer to photograph 1 & 2 above) were reasonably adequate and in order.

**Photo 5** shows a general view of the front right body of the Motor Car at the time of my inspection. The Motor Car was observed to be in a relatively good general condition with no loose exterior fittings observed. The body parts at the frontal portion of the Motor Car were visually examined and it was observed that the repair/restoration works carried out to the damaged area of the Motor Car (refer to photograph 1 & 2 above) were reasonably adequate and in order.

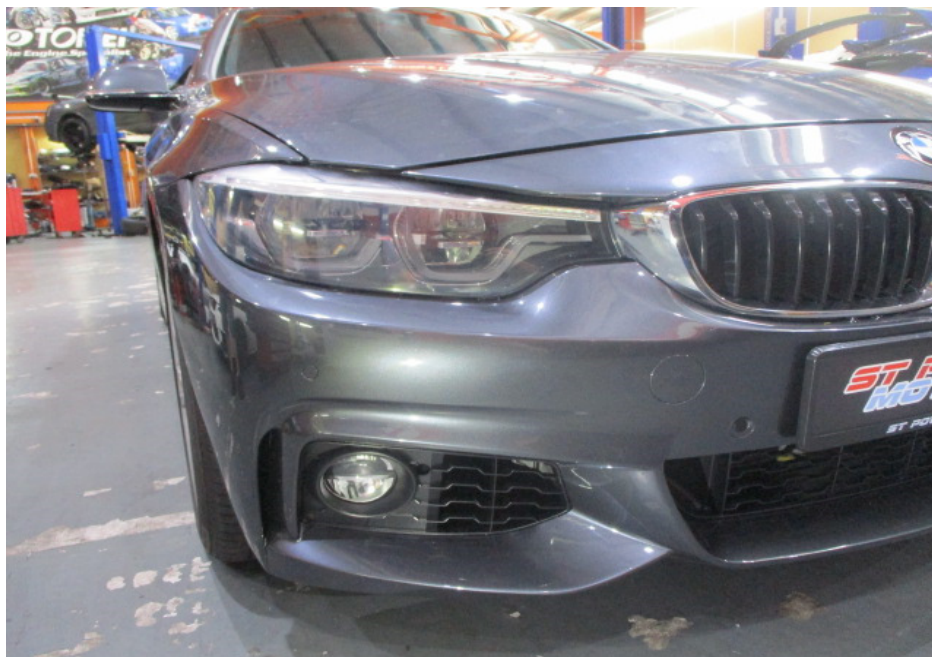
**Photo 6** shows a closer view of the Motor Car's front bumper, front bumper right lower grille, front right fog light, front right headlamp and front bonnet at the time of my inspection. The body parts at the frontal portion of the Motor Car were visually examined and it was observed that the repair/restoration works carried out to the damaged area of the Motor Car (refer to photograph 1 above) were reasonably adequate and in order.

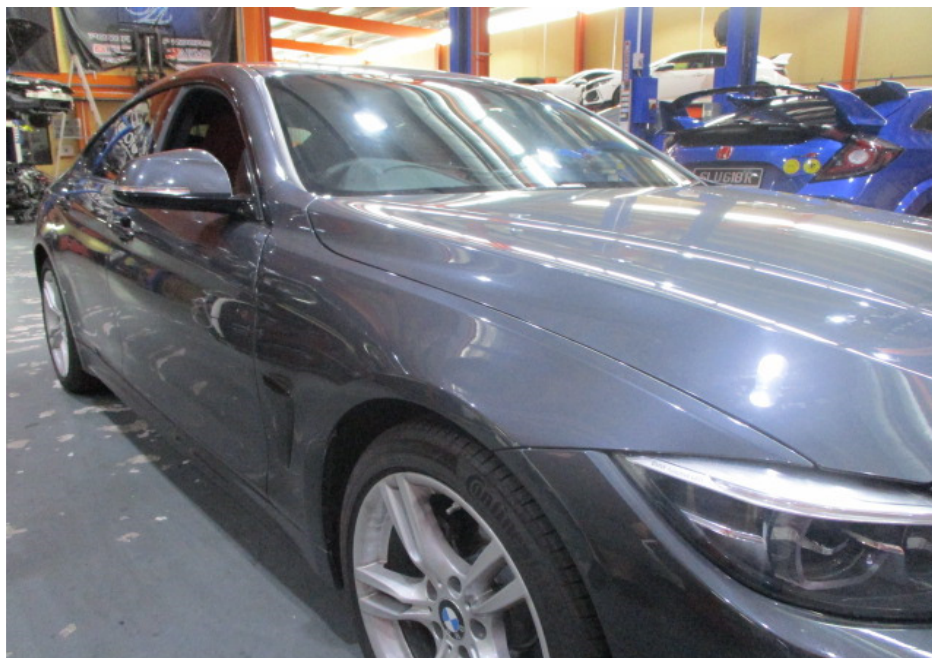
**Photo 7** shows a closer view of the Motor Car's front right fender, front bonnet and front right headlamp at the time of my inspection. The body parts at the frontal portion of the Motor Car were visually examined and it was observed that the repair/restoration works carried out to the damaged area of the Motor Car (refer to photograph 1 above) were reasonably adequate and in order.

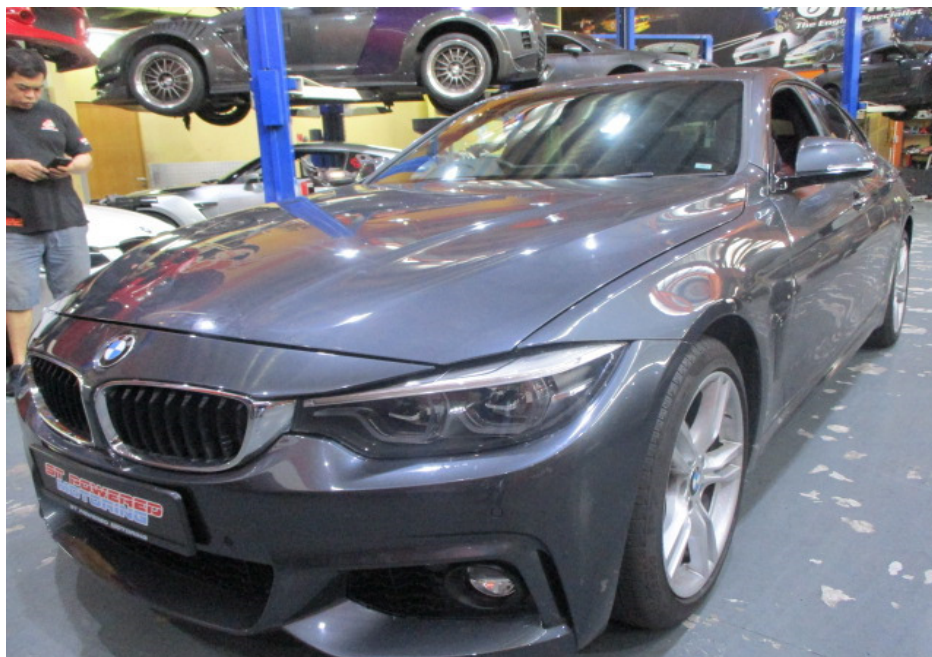
**Photo 8** shows a general view of the front left body of the Motor Car at the time of my inspection. The Motor Car was observed to be in a relatively good general condition with no loose exterior fittings observed. The body parts at the frontal portion of the Motor Car were visually examined and it was observed that the repair/restoration works carried out to the damaged area of the Motor Car (refer to photograph 1 & 2 above) were reasonably adequate and in order.

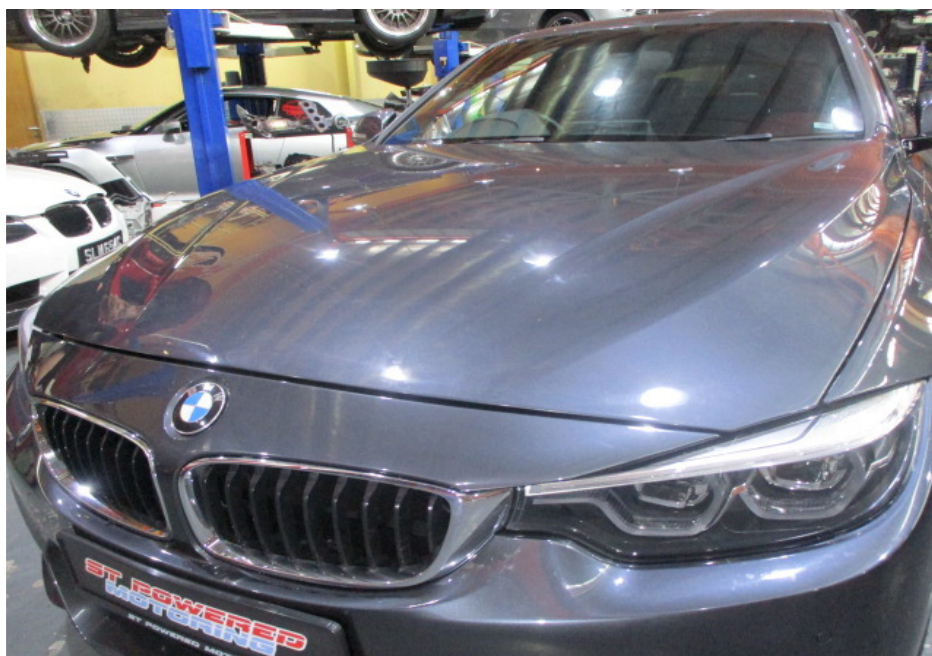
**Photo 9** shows a closer view of the Motor Car's front left headlamp, front bonnet and radiator grilles at the time of my inspection. The body parts at the frontal portion of the Motor Car were visually examined and it was observed that the repair/restoration works carried out to the damaged area of the Motor Car (refer to photograph 2 above) were reasonably adequate and in order.

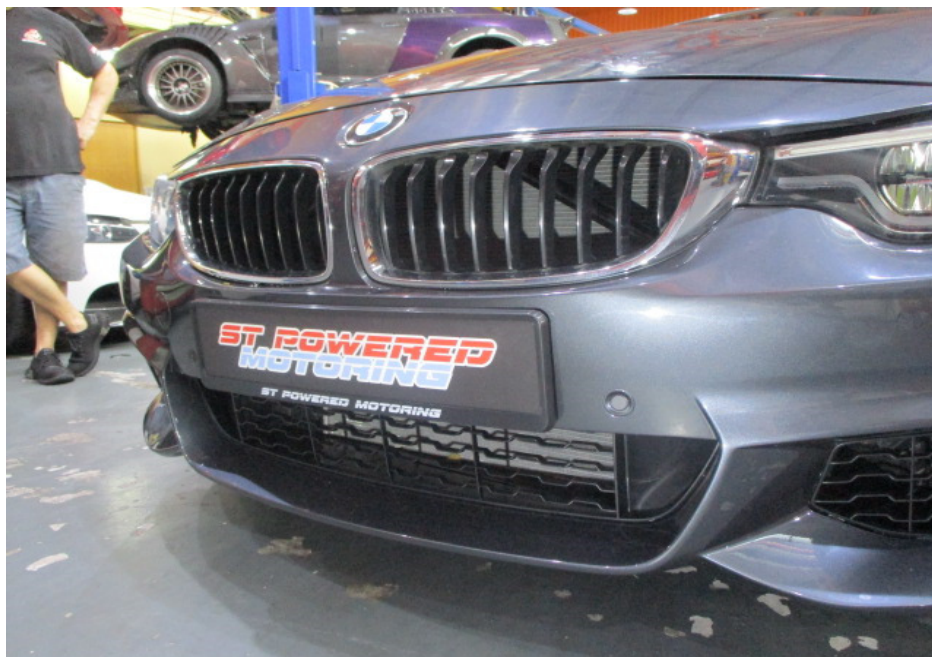
**Photo 10** shows a closer view of the Motor Car's front bumper, front bumper sensors, front bumper centre lower grille, oil cooler and radiator grilles. The body parts at the frontal portion of the Motor Car were visually examined and it was observed that the repair/restoration works carried out to the damaged area of the Motor Car (refer to photograph 1 & 2 above) were reasonably adequate and in order.

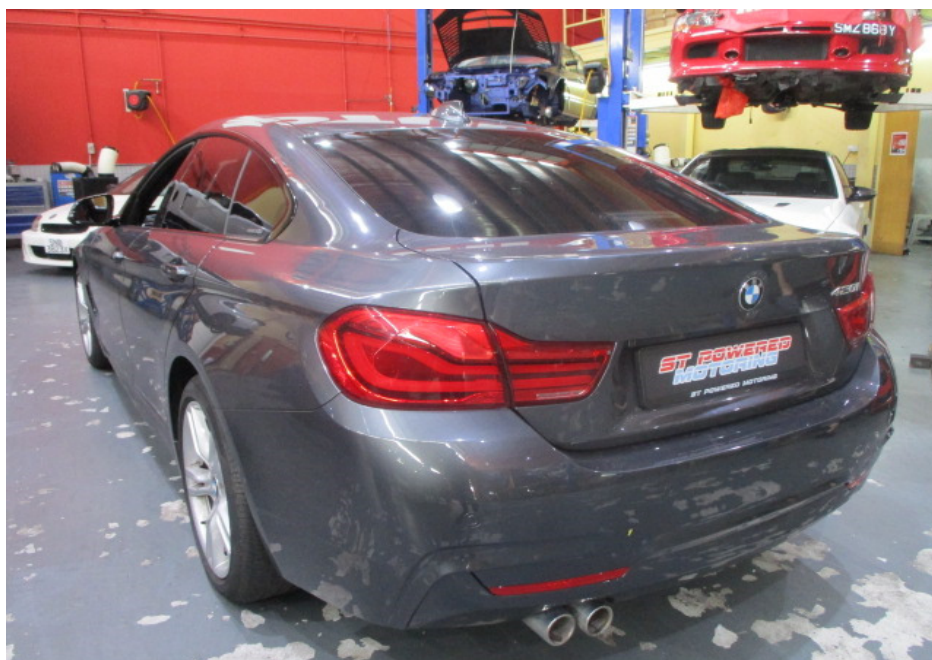
**Photo 11** shows a general view of the rear left body of the Motor Car at the time of my inspection. The Motor Car was observed to be in a relatively good general condition with no loose exterior fittings observed. The mileage of the Motor Car recorded at the time of my inspection was 5,106 miles.

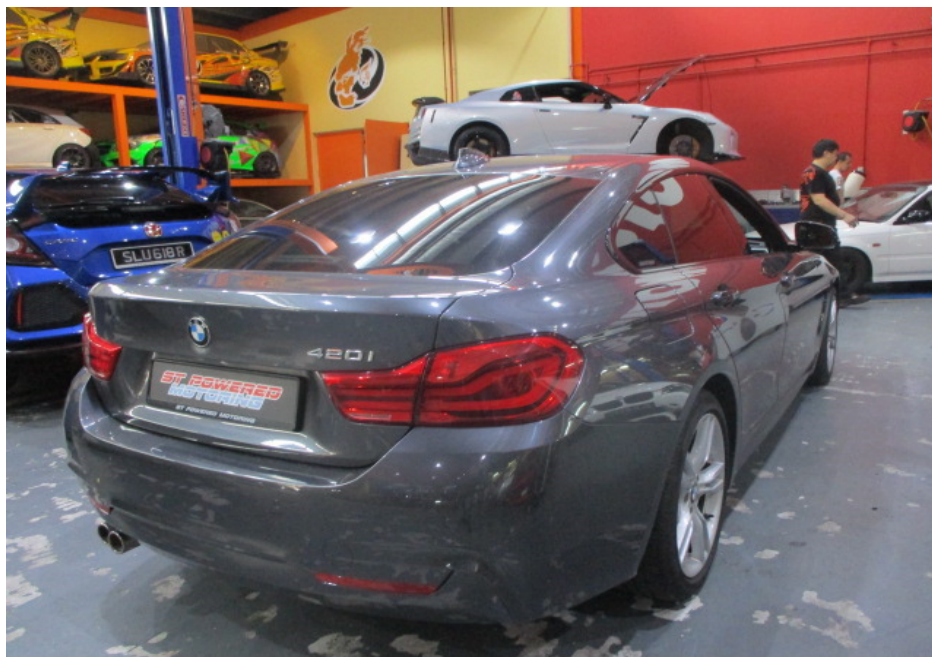
**Photo 12** shows a general view of the rear right body of the Motor Car at the time of my inspection. The Motor Car was observed to be in a relatively good general condition with no loose exterior fittings observed. The mileage of the Motor Car recorded at the time of my inspection was 5,106miles.

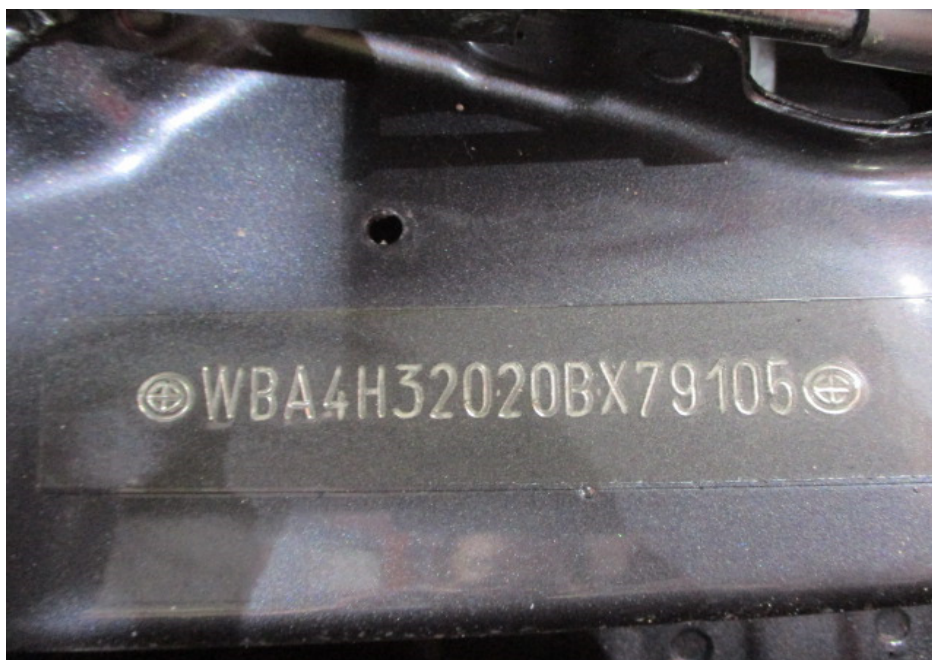
**Photo 13** shows the chassis number of the Motor Car. The chassis number recorded was WBA4H32020BX79105.

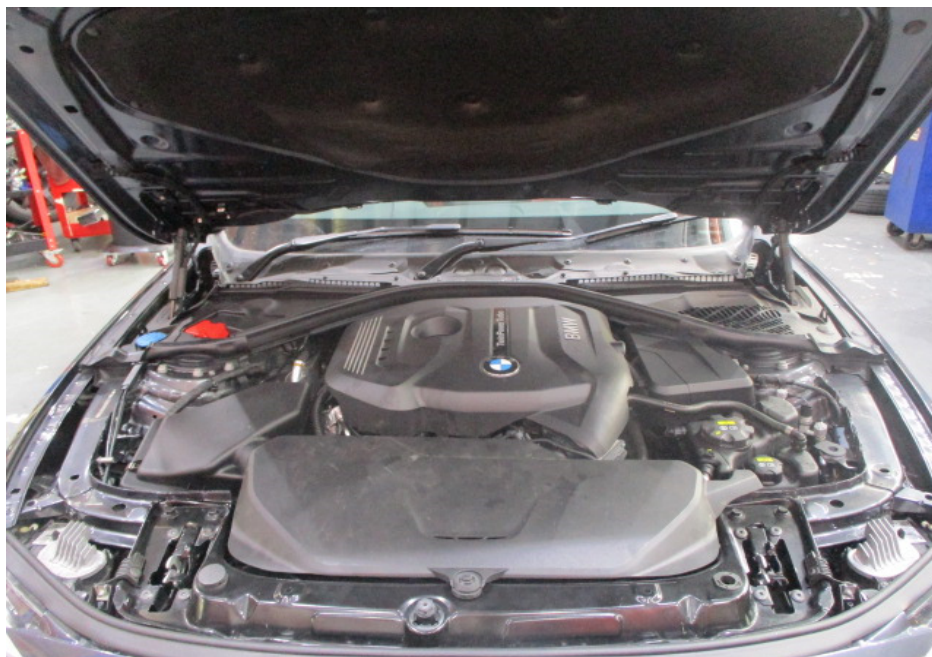
14. My examination of the engine compartment of the Motor Car revealed that the various parts and components inside the engine compartment were all intact and properly fitted. The engine oil, brake fluid and engine coolant were all found to be of sufficient level for operating purposes. Visually, there was also no contamination found to these fluids.

**Photo 14** shows a general view of the engine compartment of the Motor Car at the time of my inspection. The various parts and components inside the engine compartment were all observed to be intact and properly fitted. There was also no sign(s) or indication(s) of fluid leak and/or fluid stain found inside the engine compartment.

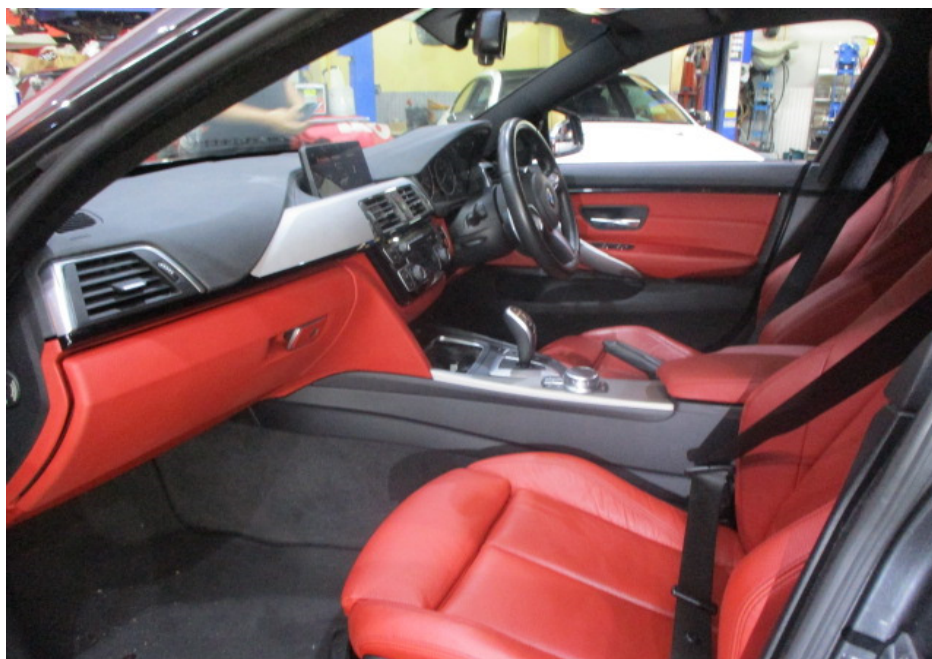
**Photo 15** shows the interior compartment of the Motor Car at the time of my inspection. The various parts and components, trims, carpet, and upholstery inside the interior compartment were all observed to be intact and properly fitted.

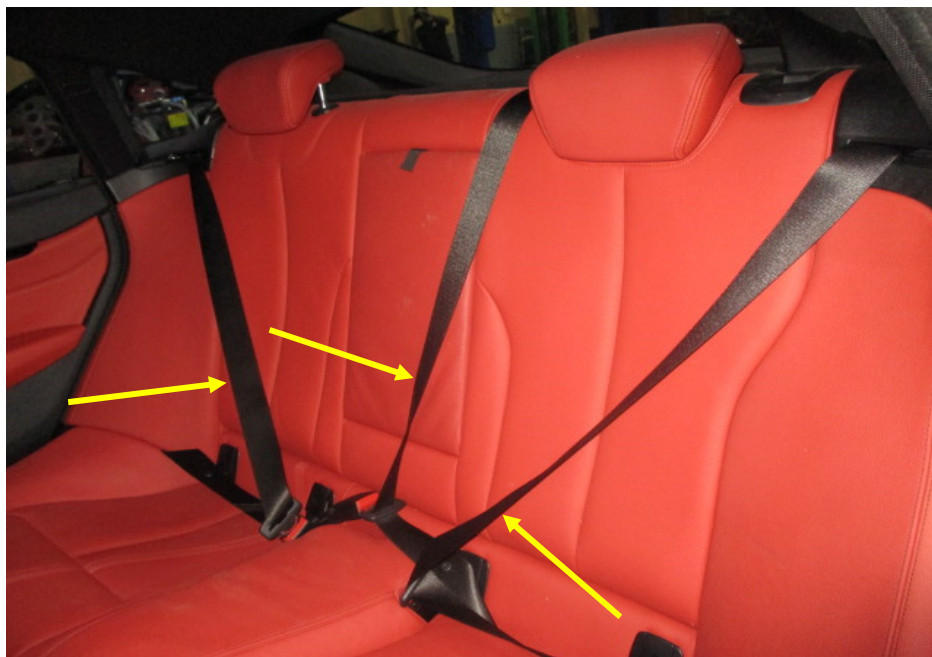
12. The seats of the Motor Car were found to be secured to the floorboard of the Motor Car via seat rails bolted onto the floorboard. Retractable seat belt reels and pre-tensioners were fitted on all seats of the Motor Car. The seat belts were tested and were able to be fastened securely into the respective pre-tensioners that were fixed to the side of all the seats.

**Photo 16** shows the rear seats of the Motor Car. All the seats of the Motor Car were secured via seat rails to the floorboard. They were also fitted with a retractable seat belt reel and a pre-tensioner. The seat belts (arrowed) were tested and were able to be fastened into the respective pre-tensions that were fitted on the side of each individual seat.

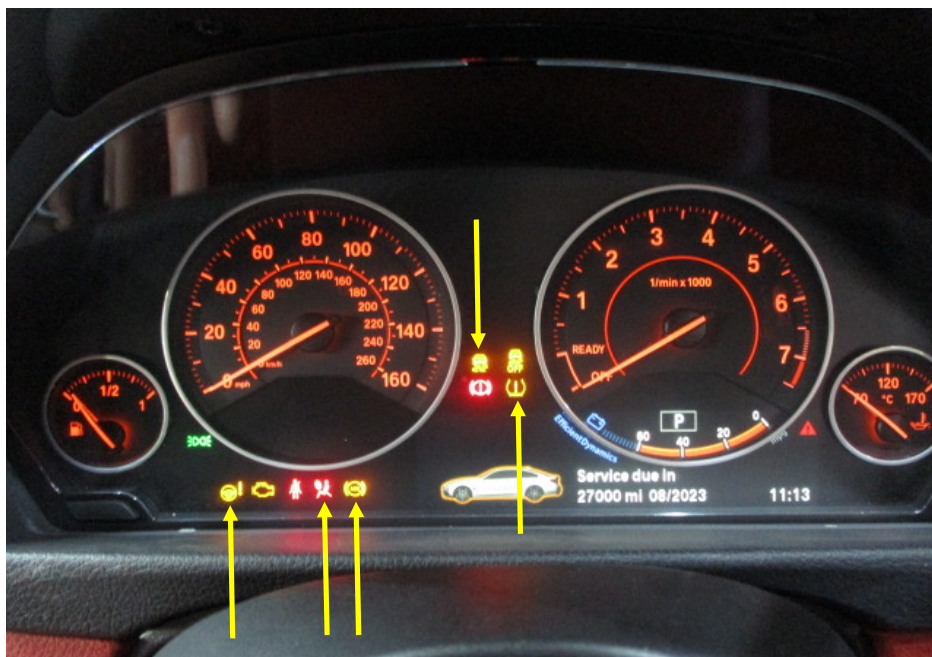
**Photo 17** shows the warning lights for the various electronic safety features appearing on the instrument panel of the Motor Car during its self-test when the engine is cranked, in particular the ABS, SRS, IAS, TPM and DSC lights (arrowed).

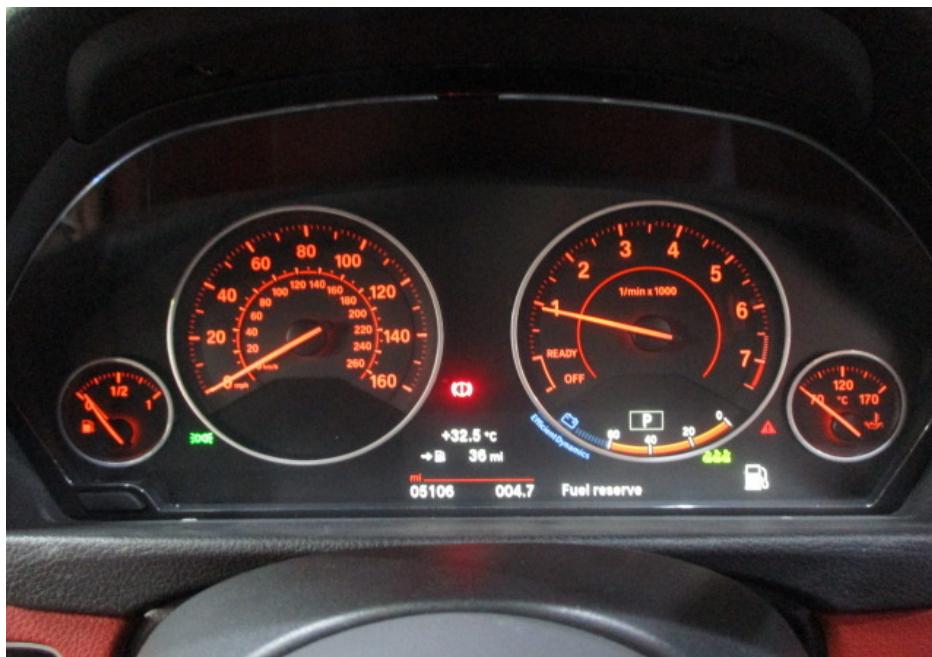
13. The Motor Car's automatic self-test of the functionality of its various electronic safety features like the Anti-Lock Brake System (ABS), Supplemental Restraint System (SRS), Integral Active Steering (IAS), Tyre Pressure Monitor (TPM) and Dynamic Stability Control (DSC) during cranking of the engine had indicated that these electronic systems were in working condition. This was determined from the respective warning lights disappearing from the instrument panel after the self-test.

**Photo 18** shows the respective warning lights no longer illuminated, indicating that there is no fault detected to the ABS, SRS, IAS, TPM and DSC systems of the Motor Car during the self-test. These electronic systems were hence in working condition at the time of my inspection.

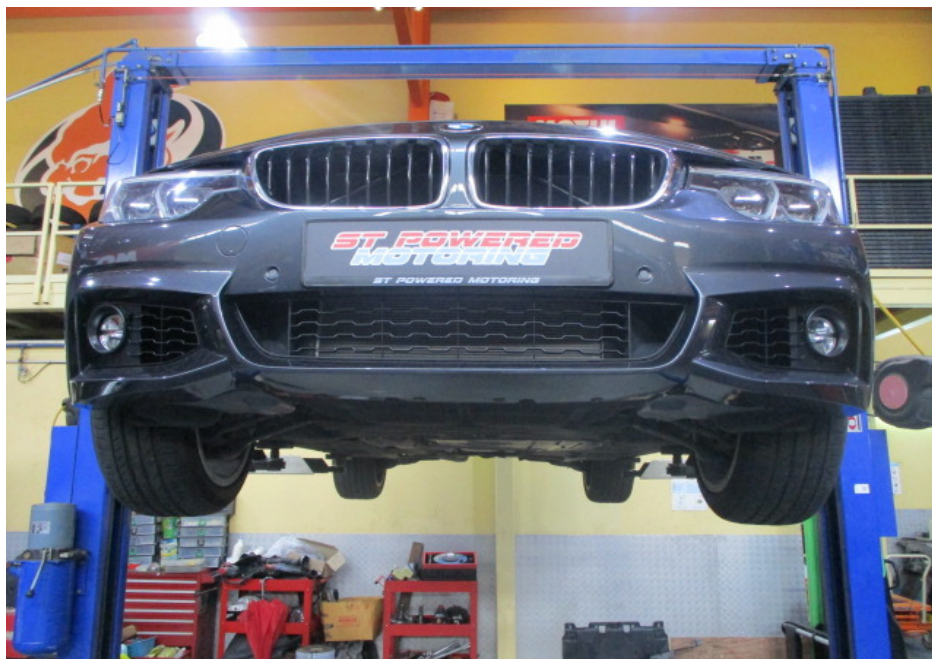
15. My checks on the underside of the Motor Car revealed no sign(s) or indication(s) of fluid leakage and/or fluid stain(s). The engine block and automatic transmission assembly were both secured properly. All undercarriage components of the Motor Car were also observed to be intact and secured in an appropriate manner.

**Photo 19** shows the Motor Car hoisted up for checks on its undercarriage. There was no sign(s) or indication(s) of fluid leakage and/or fluid stain(s) on the underside of the Motor Car. The undercarriage components of the Motor Car were also all observed to be intact and secured in an appropriate manner.

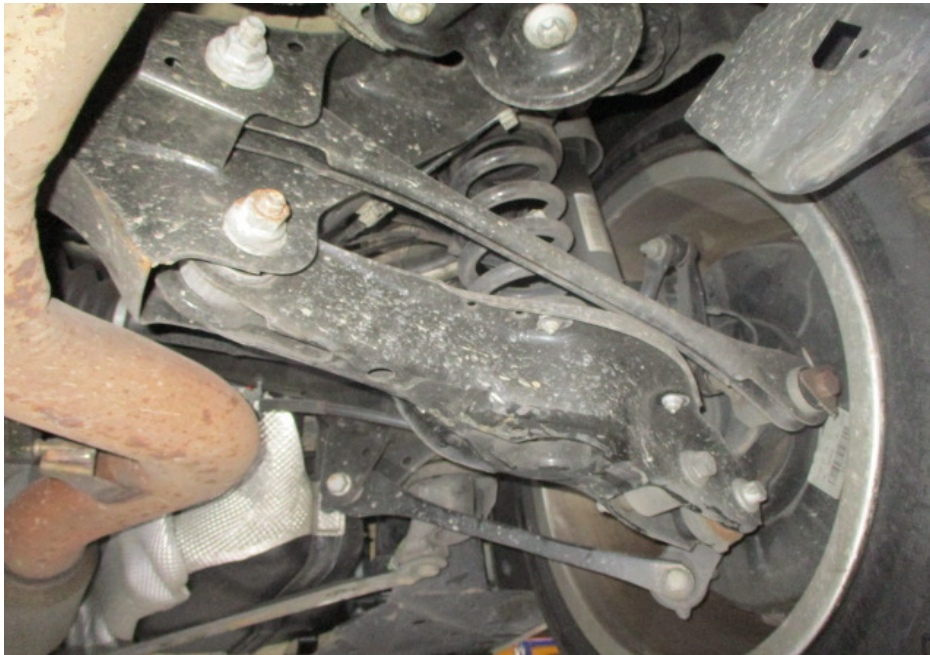
**Photo 20** shows a general view of the control arms and linkages at the rear right wheel of the Motor Car. I did not observe any fluid leak and/or fluid stain on the underside of the Motor Car. All of the Motor Car's undercarriage components were observed to be intact and secured in an appropriate manner.

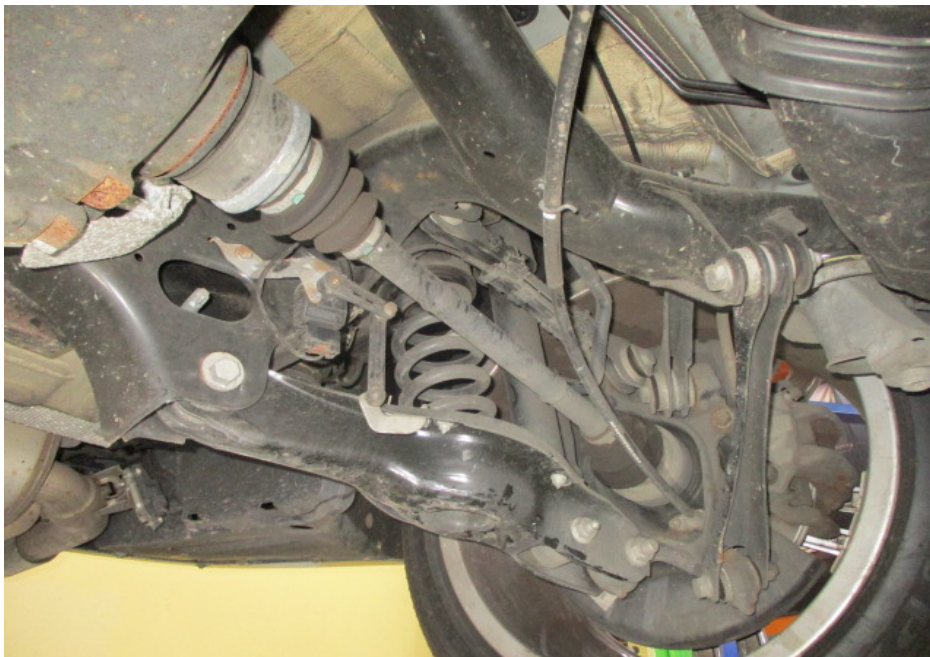
**Photo 21** shows a general view of the control arms and linkages at the rear left wheel of the Motor Car. I did not observe any fluid leak and/or fluid stain on the underside of the Motor Car. All of the Motor Car's undercarriage components were observed to be intact and secured in an appropriate manner.

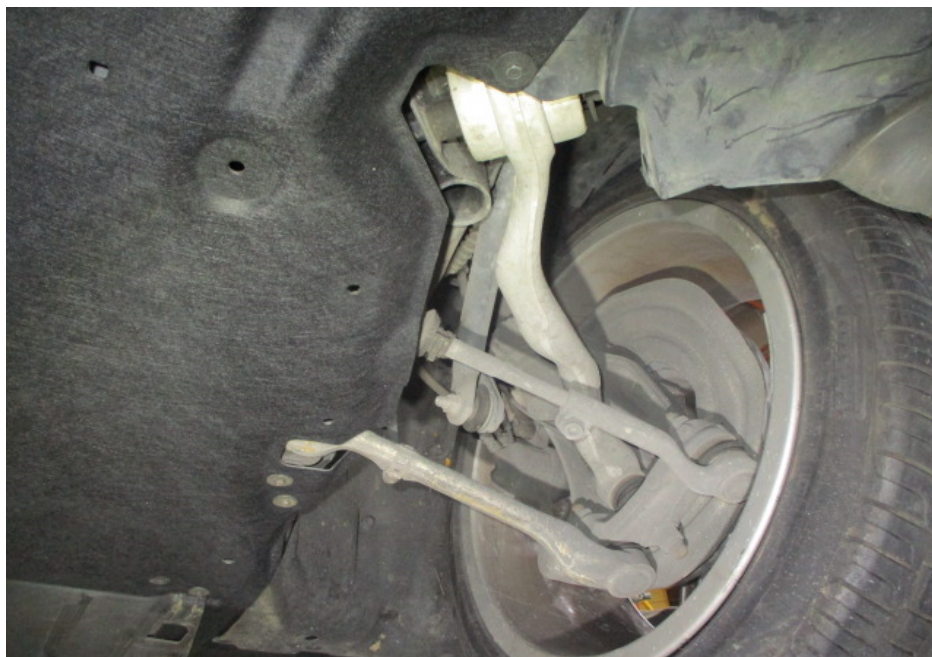
**Photo 22** shows the various undercarriage components at the front left wheel of the Motor Car. The mechanical components, control arms and linkages were all found to be intact and secured in an appropriate manner.

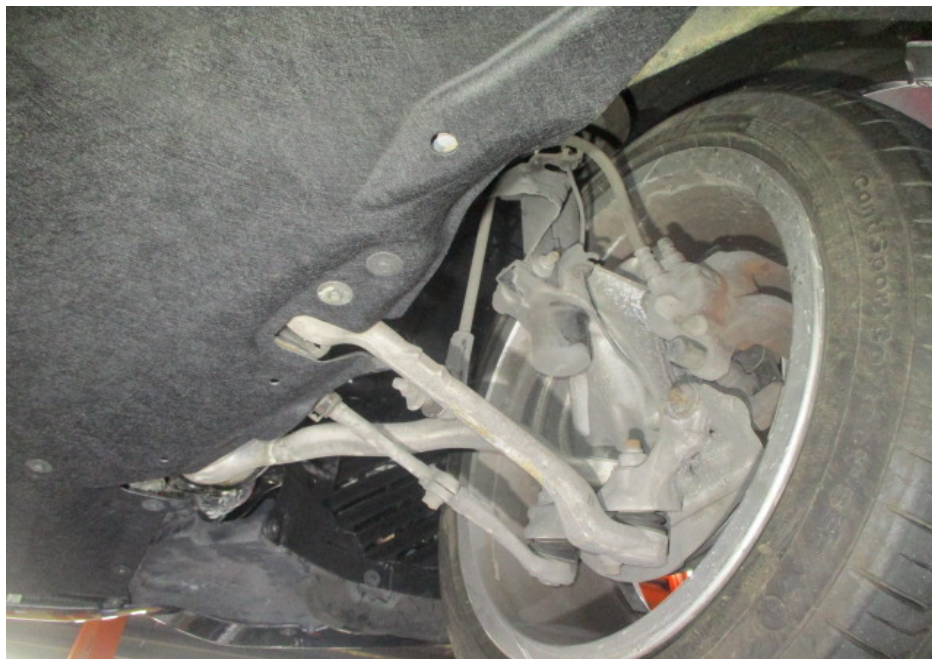
**Photo 23** shows the various undercarriage components at the front right wheel of the Motor Car. The mechanical components, control arms and linkages were all found to be intact and secured in an appropriate manner. I also did not observe any fluid leak and/or fluid stain on the underside of the Motor Car.

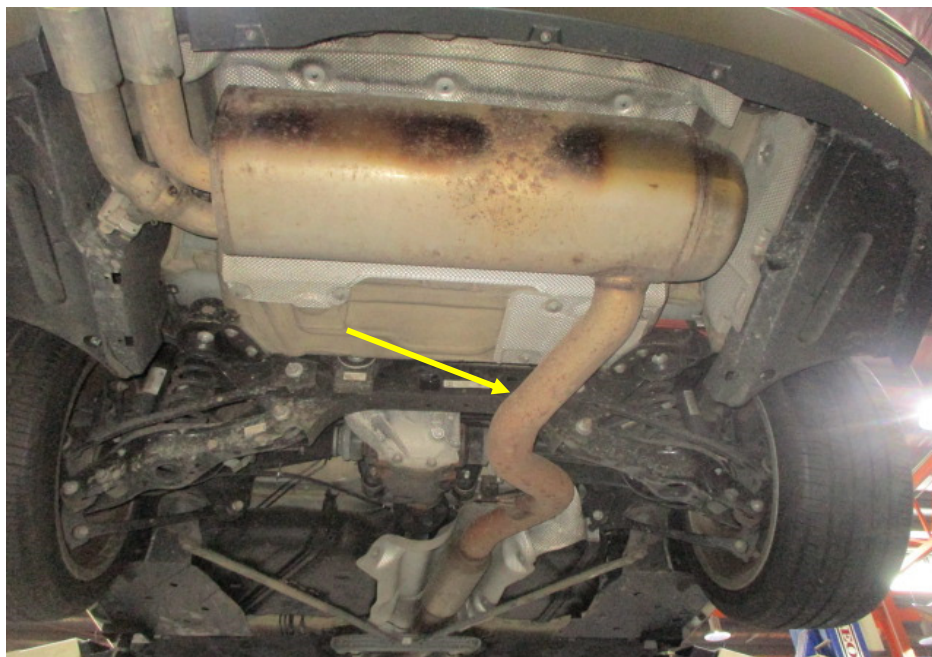
**Photo 24** shows the rear section of the Motor Car's exhaust system. My examination of the Motor Car's exhaust system revealed no sign(s) or indication(s) of any cut or weld marks along its exhaust pipes (arrowed), on its rear muffler, on its centre resonator boxes and on its catalytic converter.

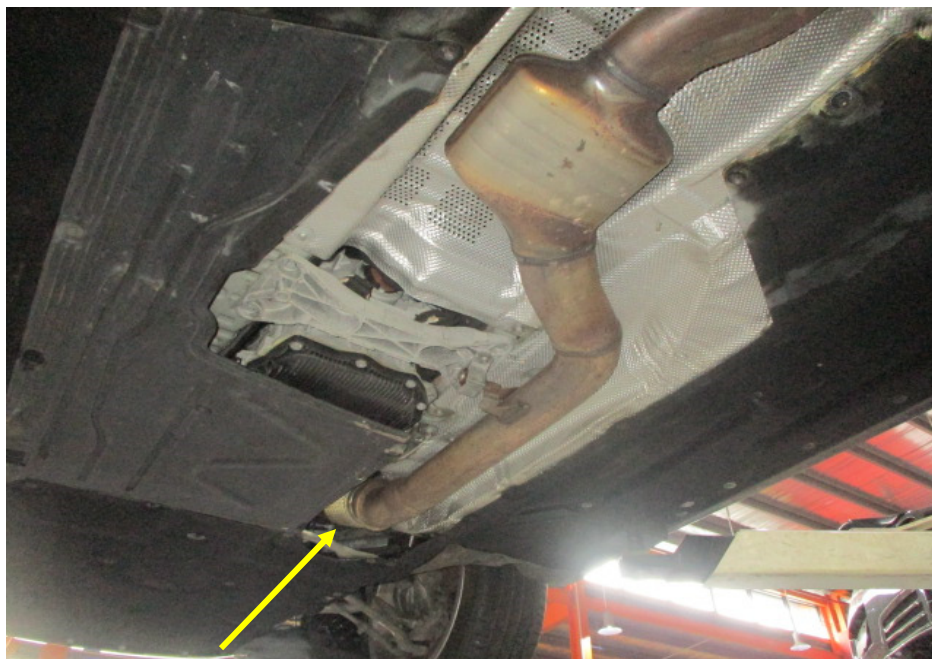
**Photo 25** shows the front section of the Motor Car's exhaust system. My examination of the Motor Car's exhaust system revealed no sign(s) or indication(s) of any cut or weld marks along its exhaust pipes, on its rear muffler, on its centre resonator boxes and on its catalytic converter (arrowed).

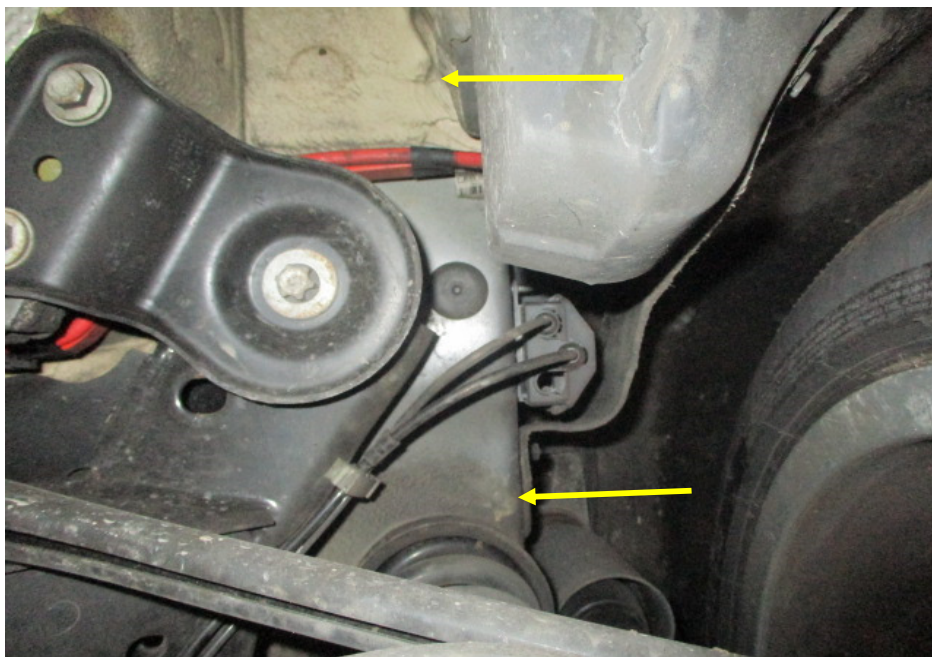
11. Visually, I did not find any weld marks, other than the original spot weld marks, on the chassis/structural body of the Motor Car. The original factory sealant at the joints along the chassis/structural body was also untouched, again indicating that no replacement of the chassis/structural body was carried out; and that the chassis/structural body was originally fitted.

**Photo 26** shows the chassis/structural body at the underside rear right of the Motor Car. I did not find any weld marks other than original spot weld marks on the chassis/structural body of the Motor Car. The original factory sealant (arrowed) at the joints along the chassis/structural body was untouched, indicating no work was done on the chassis/structural body of the Motor Car and that the chassis/structural body was originally fitted.

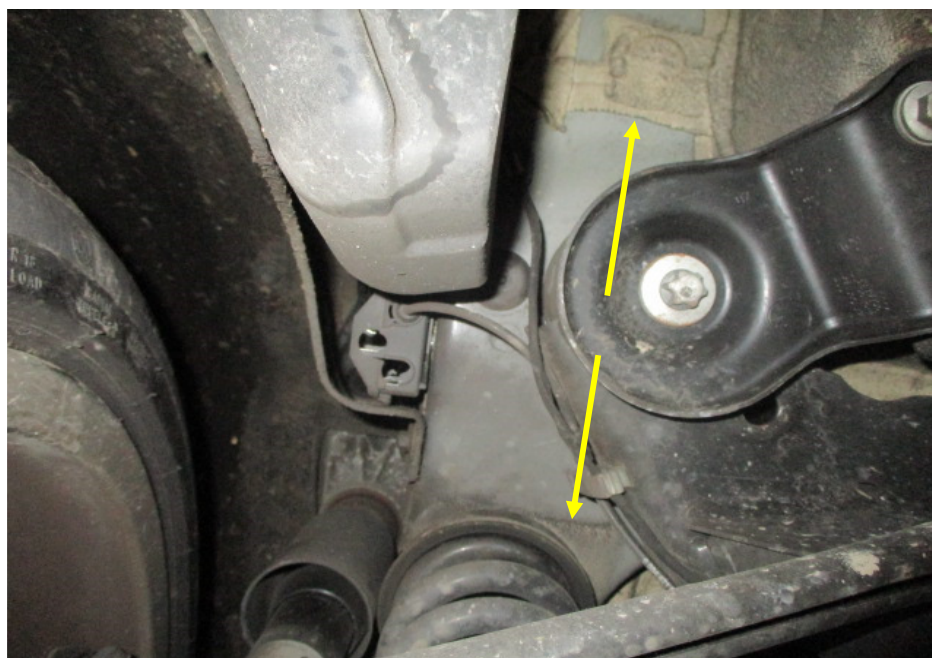
**Photo 27** shows the chassis/structural body at the underside rear left of the Motor Car. The original factory sealant (arrowed) at the joints along the chassis/structural body was observed to be untouched. In general, I had found no work was carried out on the chassis/structural body of the Motor Car. The chassis/structural body of the Motor Car was originally fitted.

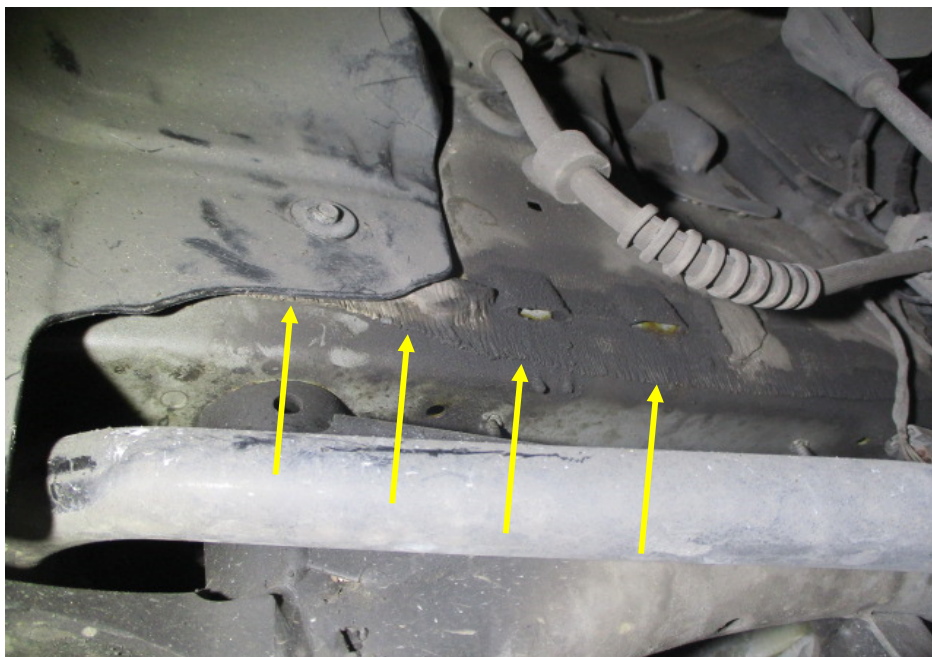
**Photo 28** shows the chassis/structural body at the underside front left of the Motor Car. I did not find any weld marks other than original spot weld marks on the chassis/structural body of the Motor Car. The original factory sealant (arrowed) at the joints along the chassis/structural body was untouched, indicating no work was done on the chassis/structural body of the Motor Car and that the chassis/structural body was originally fitted.

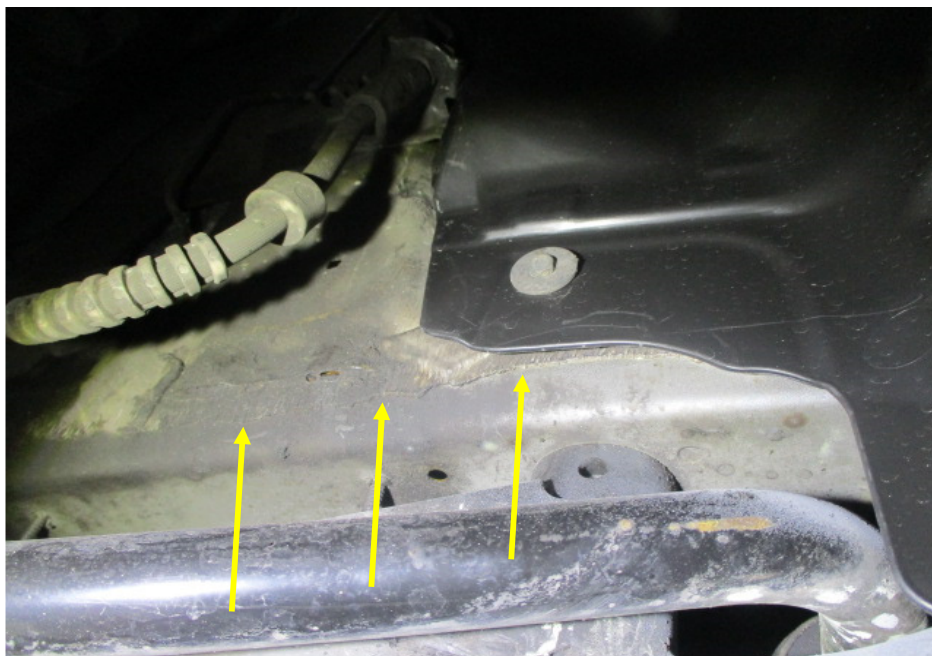
**Photo 29** shows the chassis/structural body at the underside front right of the Motor Car. The original factory sealant (arrowed) at the joints along the chassis/structural body was observed to be untouched. In general, I had found no work was carried out on the chassis/structural body of the Motor Car. The chassis/structural body of the Motor Car was originally fitted.

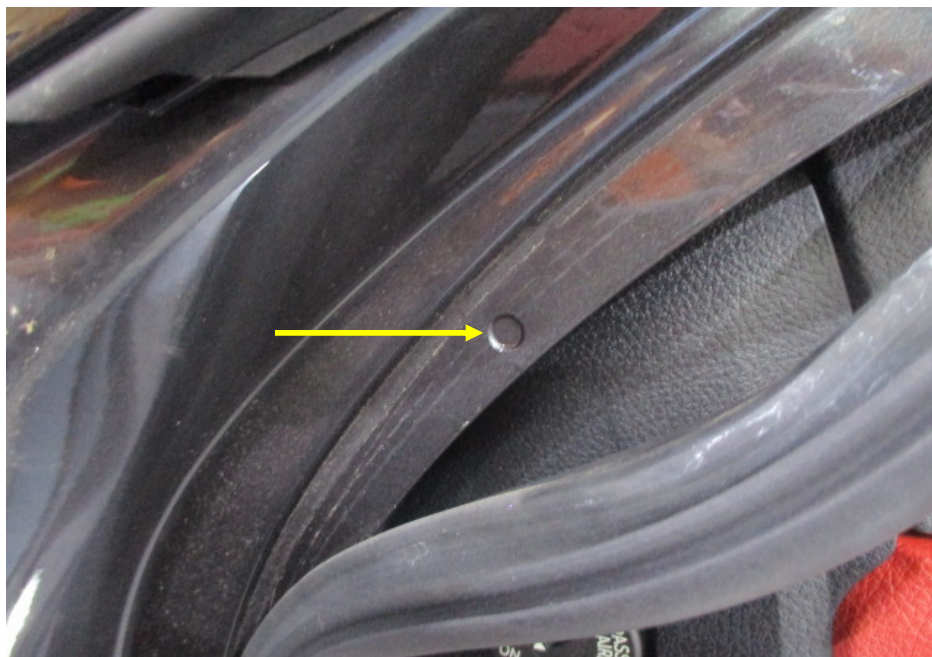
**Photo 30** shows the left side "A" pillar of the Motor Car. I did not find any weld marks other than original spot weld marks (arrowed) on the left side "A" pillar of the Motor Car, which indicates that there was no re-welding works carried out. In general, I had found all the non-detachable body panels of the Motor Car to be originally fitted at the time of my inspection.
