Your Ref: BMW 420i  
(chassis number WBA4H32020BX79105)  
Our Ref : CI/TP21010670/D

**INSPECTION REPORT OF AN UNREGISTERED BMW 420i MOTOR CAR  
WITH CHASSIS NUMBER WBA4H32020BX79105**

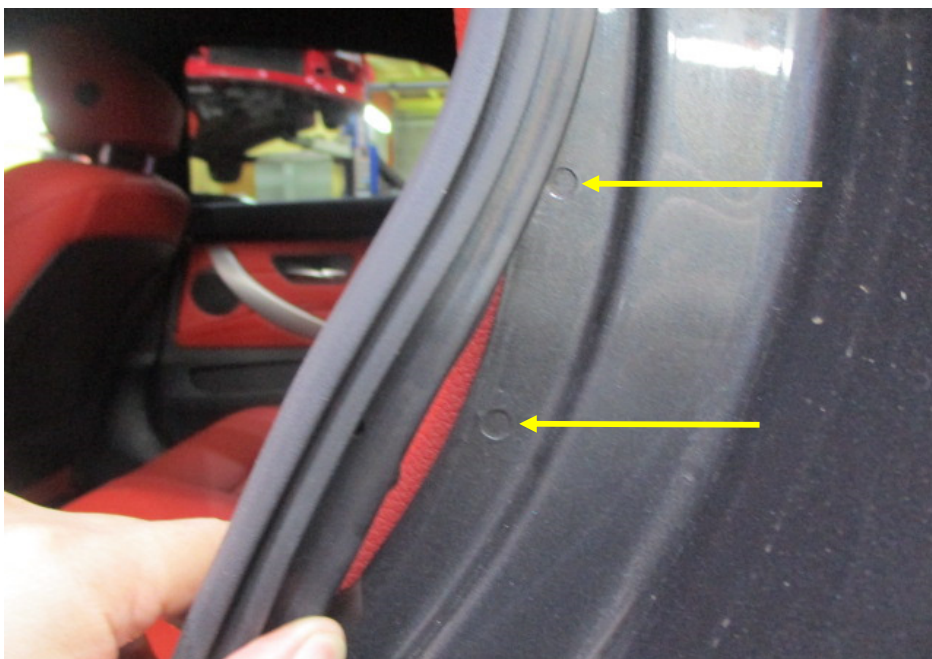
**Photo 31** shows the left side "C" pillar of the Motor Car. I did not find any weld marks other than original spot weld marks (arrowed) on the left side "C" pillar of the Motor Car, which indicates that there was no re-welding works carried out. In general, I had found all the non-detachable body panels of the Motor Car to be originally fitted at the time of my inspection.

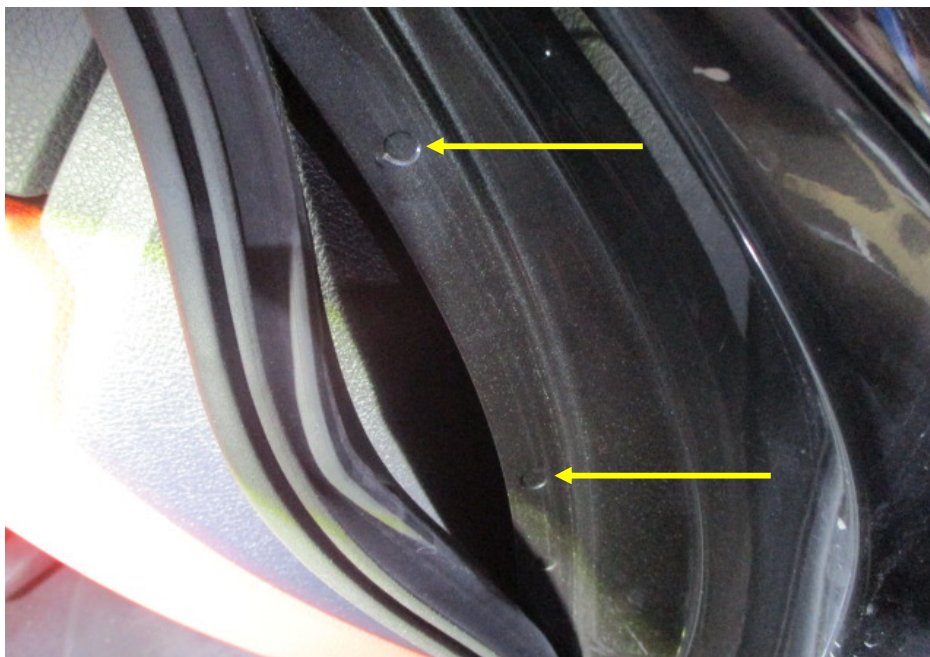
**Photo 32** shows the right side "A" pillar of the Motor Car. I did not find any weld marks other than original spot weld marks (arrowed) on the right side "A" pillar of the Motor Car, which indicates that there was no re-welding works carried out. In general, I had found all the non-detachable body panels of the Motor Car to be originally fitted at the time of my inspection.
