Vehicle PRI Report			
Insurer:	Direct Asia Insurance (Singapore) Pte Ltd	Claim Number:	102273/IL
Workshop:	R&S Engineering Works Pte Ltd	Claim Type:	PRI
Vehicle:	NISSAN NV350 PANEL VAN 2.5 5MT 5DR	Vehicle Registration:	GBH5809K
Date of Loss:	23/11/2020	Engine Capacity:	2488 cc
Vehicle Year:	19/07/2018	Vehicle Mileage:	44718
Chassis No:	JN1MC2E26Z0009318	Engine No:	YD25425090A
Economic Repair Limit	Market Value: 51,652.05 PARF/COE Rebate: 23,009.00 Repair Limit: 28,643.05	Repair Basis:	Part by Part
Workshop Estimate Cost:	No estimate	Surveyor Estimated Repair Cost:	5,374.84
Days to Repair:	6	OD Excess Applicable:	NA
Assessor:	Choo Beng Hai	Date & Time of Assessment:	26/11/2020 11:25
NIMA Protocol:	<input checked="" type="checkbox"/>	1 st Inspection was done with the dismantling of hidden parts	
	<input type="checkbox"/>	1 st Inspection was done without the dismantling of hidden parts	
	<input type="checkbox"/>	2 nd Inspection was done where hidden damaged parts were dismantled in the presence of the Surveyor and not before

Our Ref: DA-09931

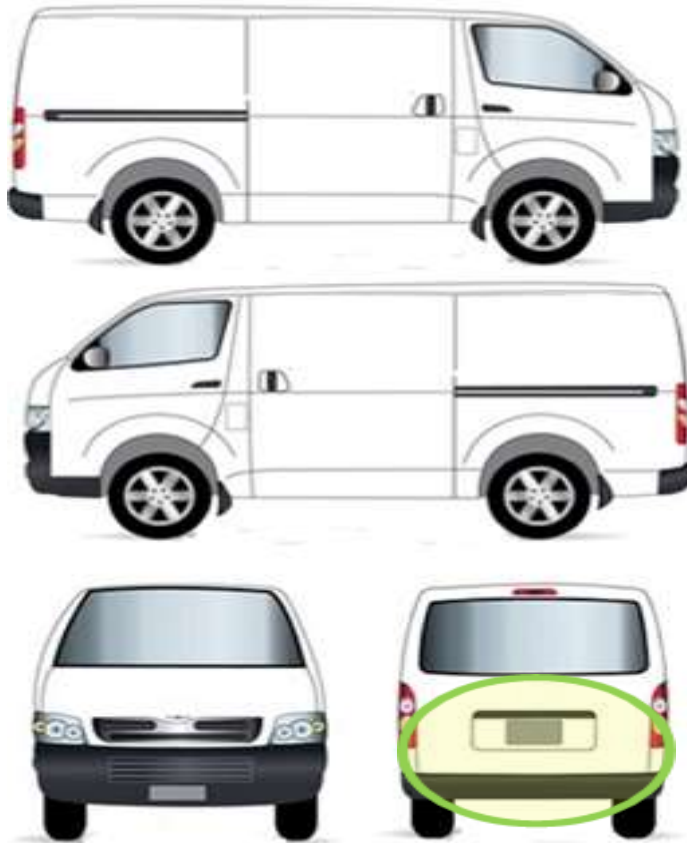
AREA OF DAMAGED

From our assessment, impact damages had been occasioned to the REAR portion of the vehicle, damaging the REAR BUMPER COVER, CENTRE STEP PANEL, REAR END OUTER & INNER PANEL, TAILGATE, INNER LOCK, W/STRIP, REAR FLOOR PAN, TOP COVER BOARD & BOTH REAR SIDE BODY PANELS be CUT / DENTED / DEFORMED / BUCKLED.

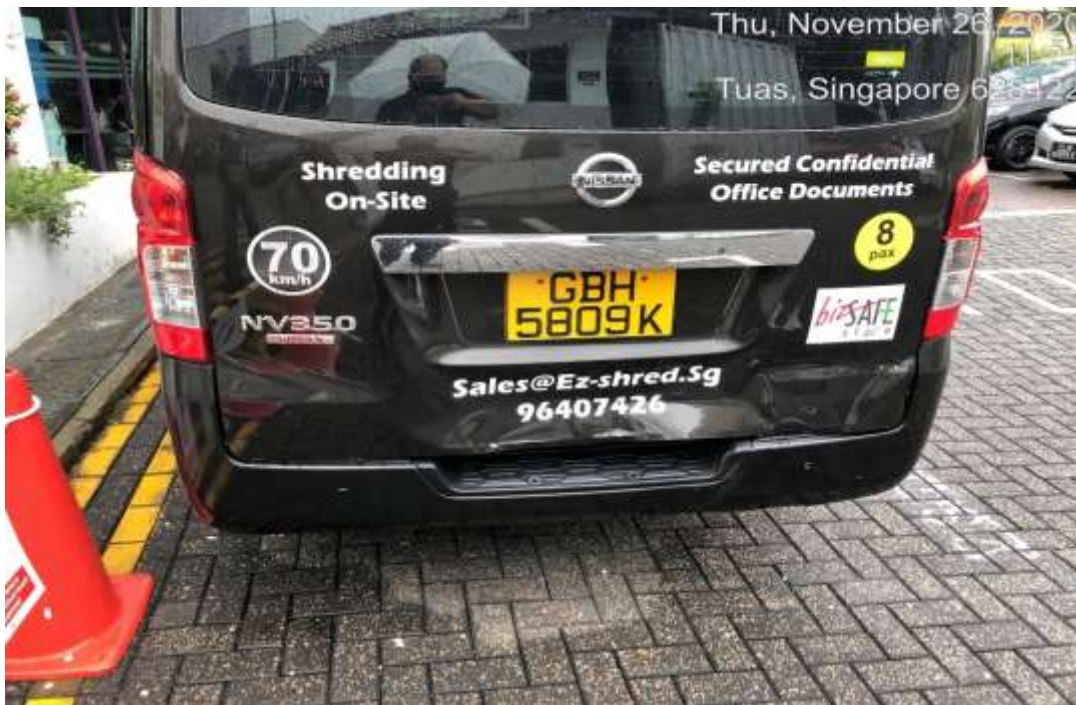
Photo 5 RR END GENERAL DAMAGED VIEW

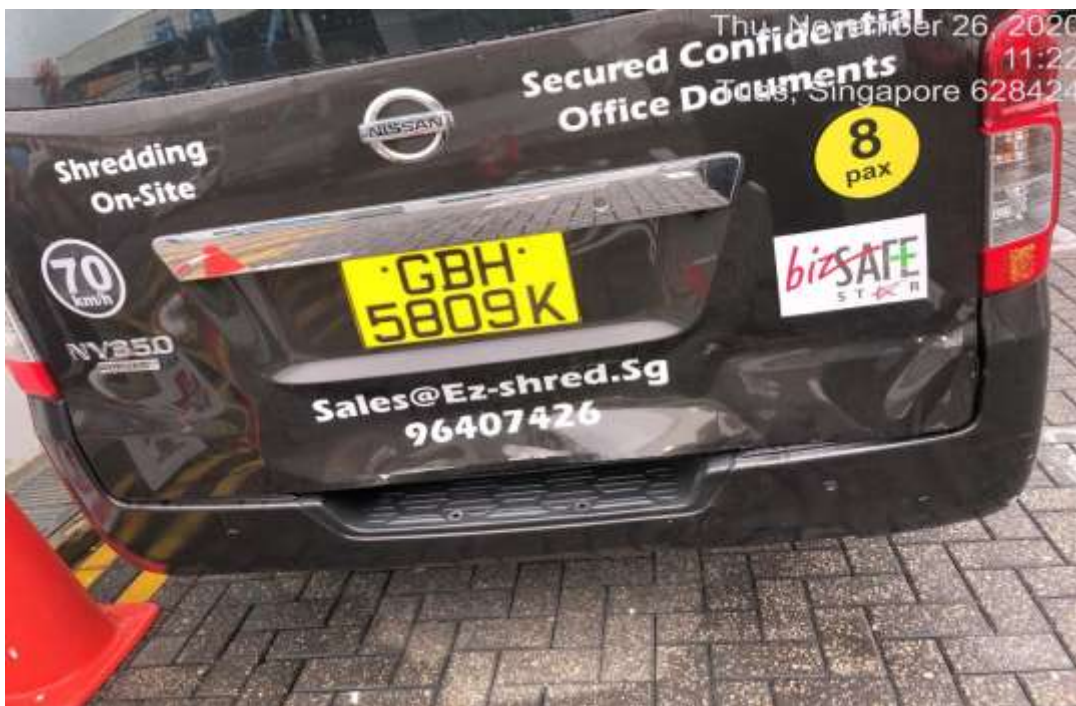
Photo 6 DENTED TAILGATE & DEFORMED RR BUMPER COVER

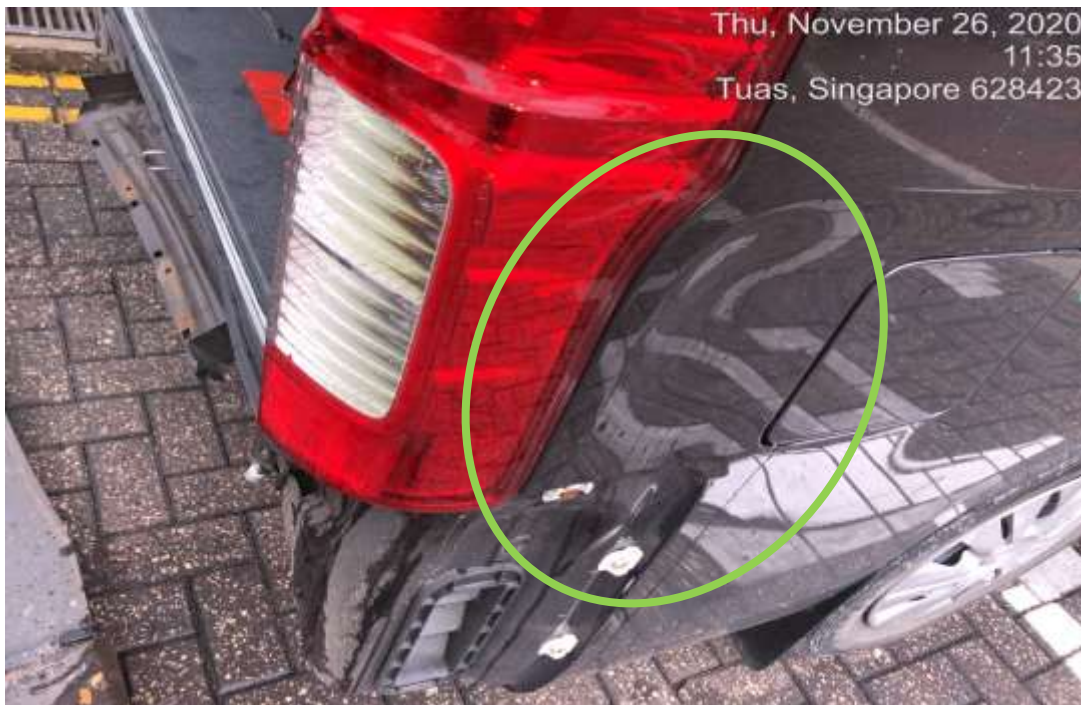
Photo 7 BUCKLED RH RR SIDE PANEL

both rear side body panels

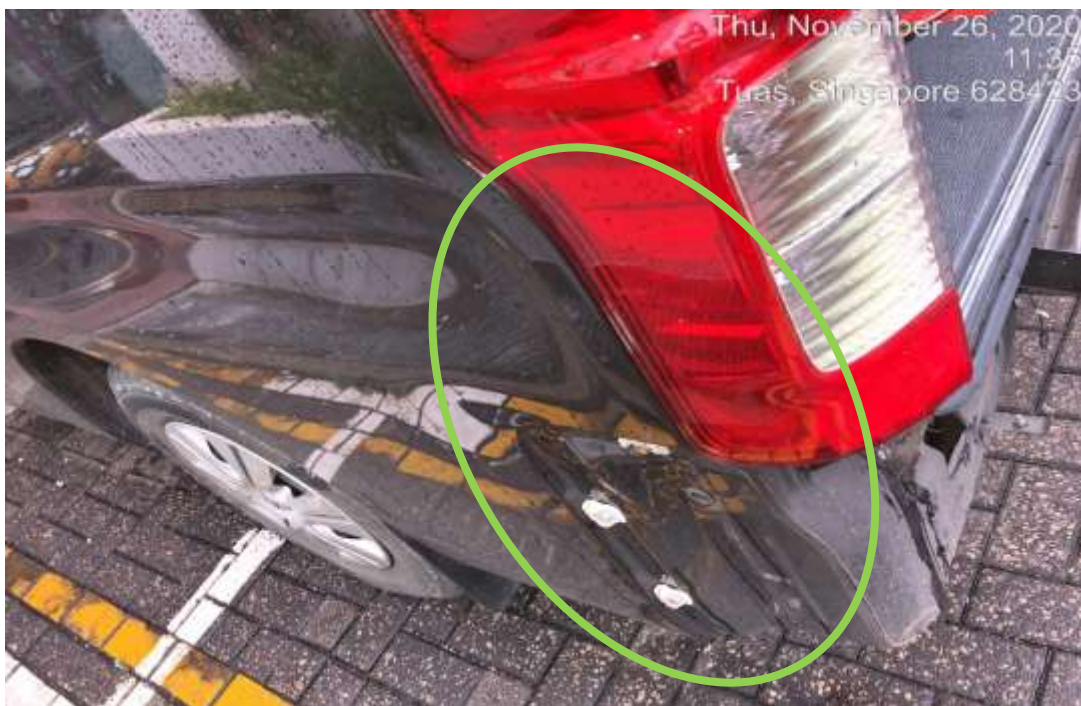
Photo 8 BUCKLED LH RR SIDE PANEL

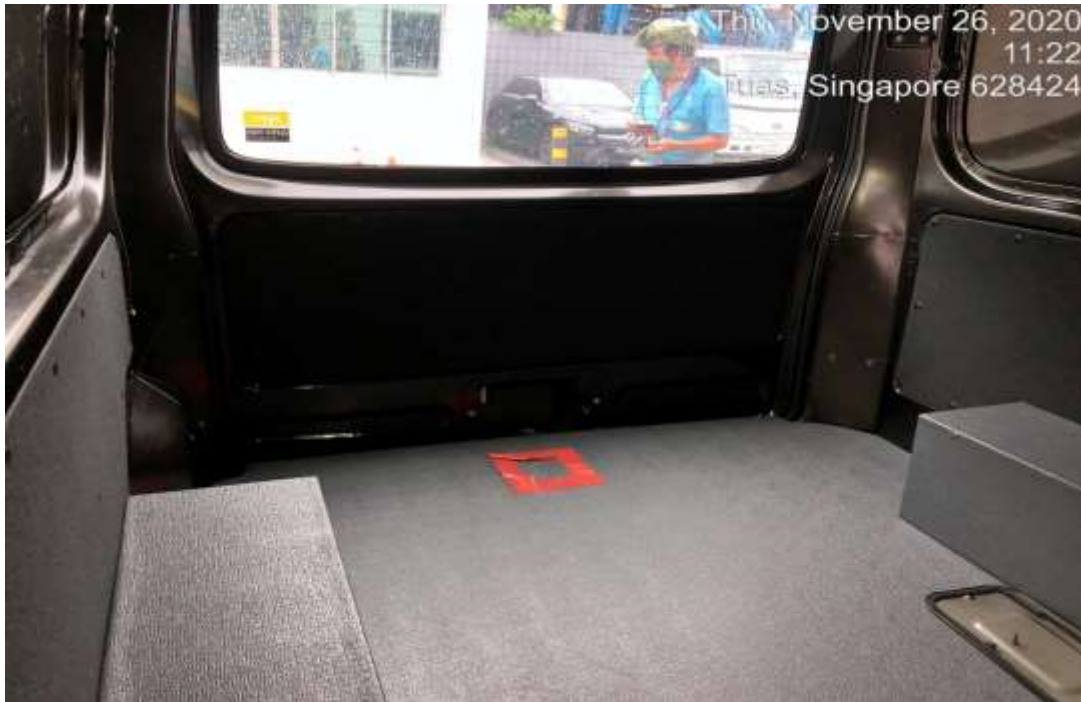
Photo 9 JAMMED TAILGATE

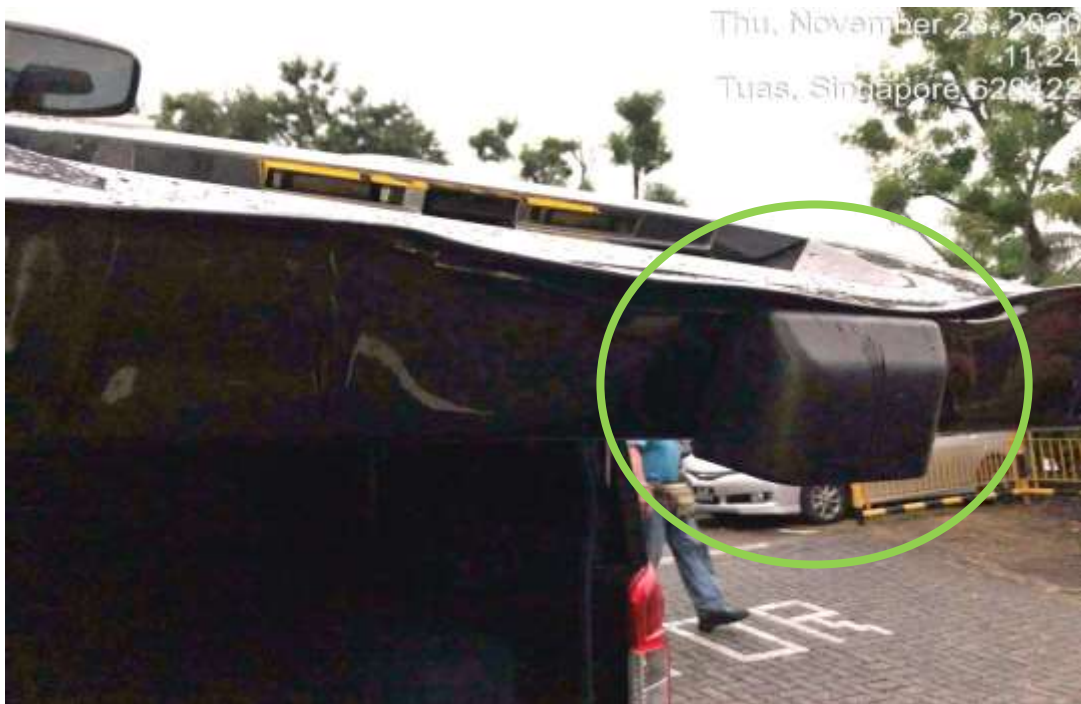
Photo 10 JAMMED TAILGATE LOCK

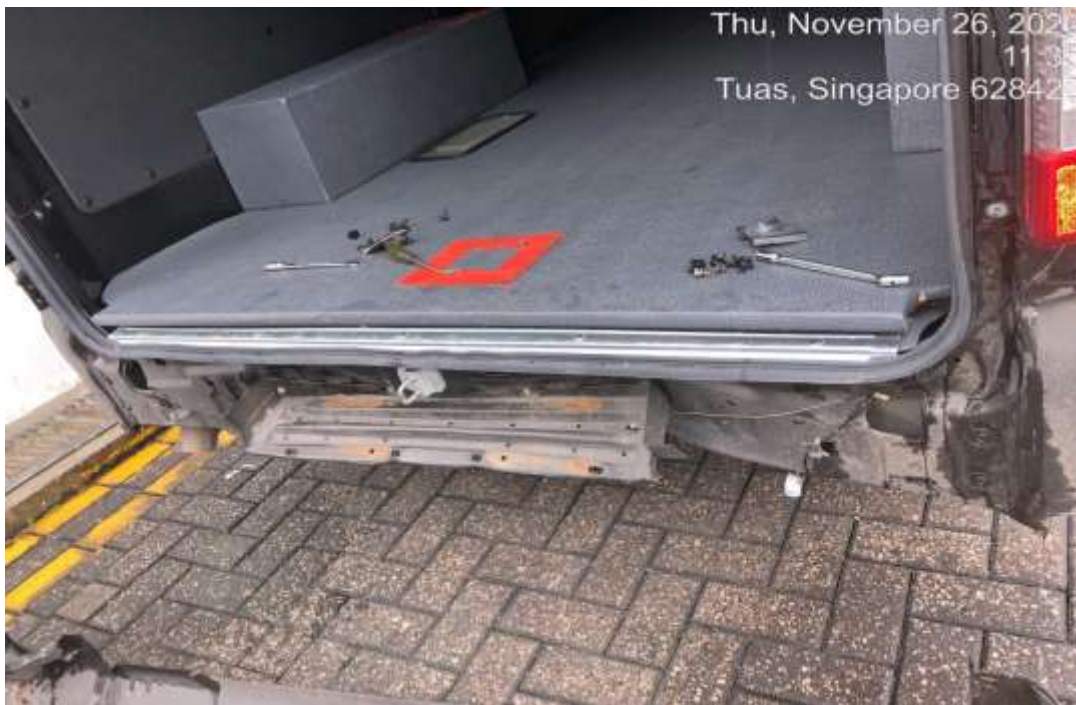
Photo 11 RR END DAMAGED PARTS DISMANTLED

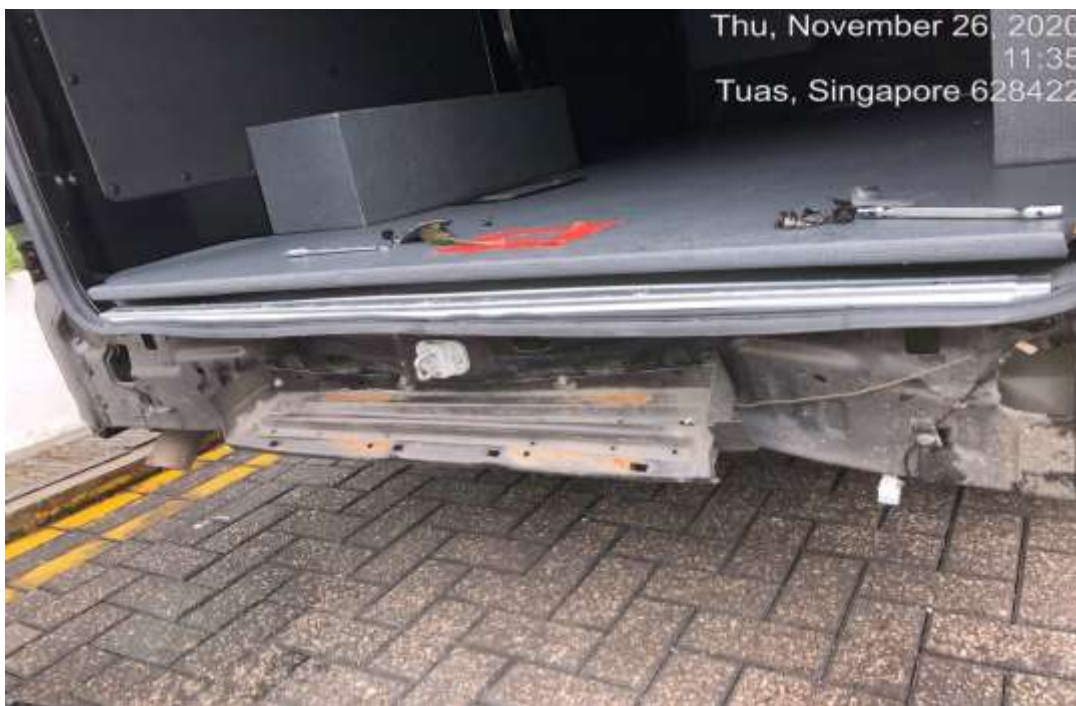
Photo 12 DENTED RR STEP BRACKET & REAR END PANEL

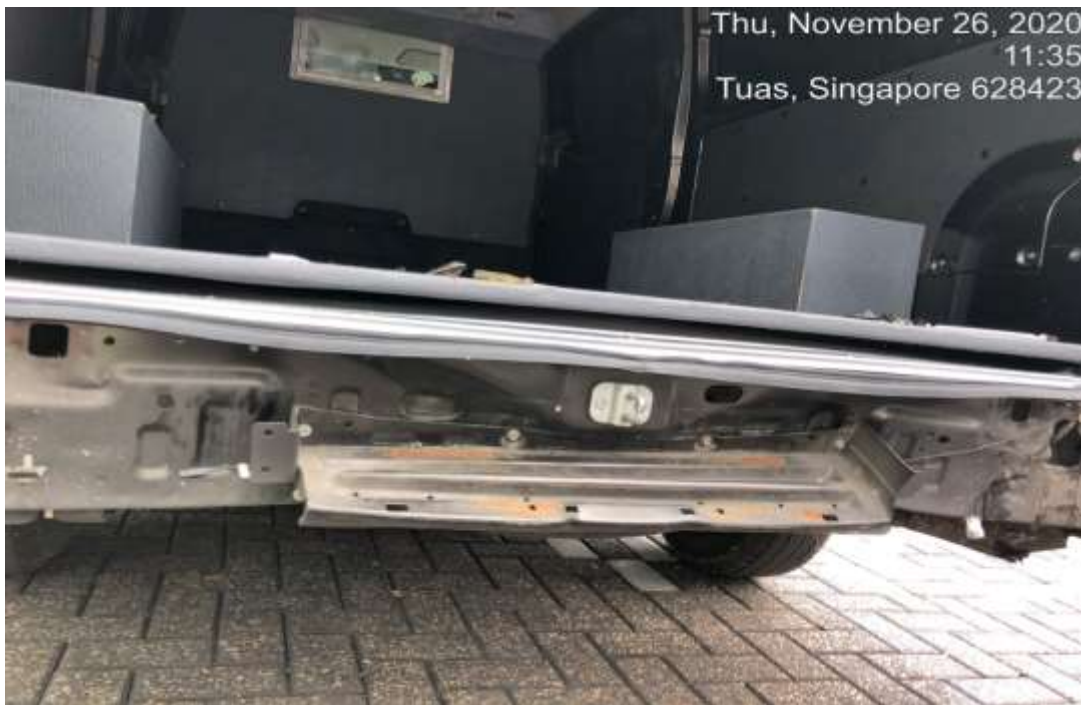
Photo 13 BUCKLED RR FLOOR PAN & TOP COVER BOARD

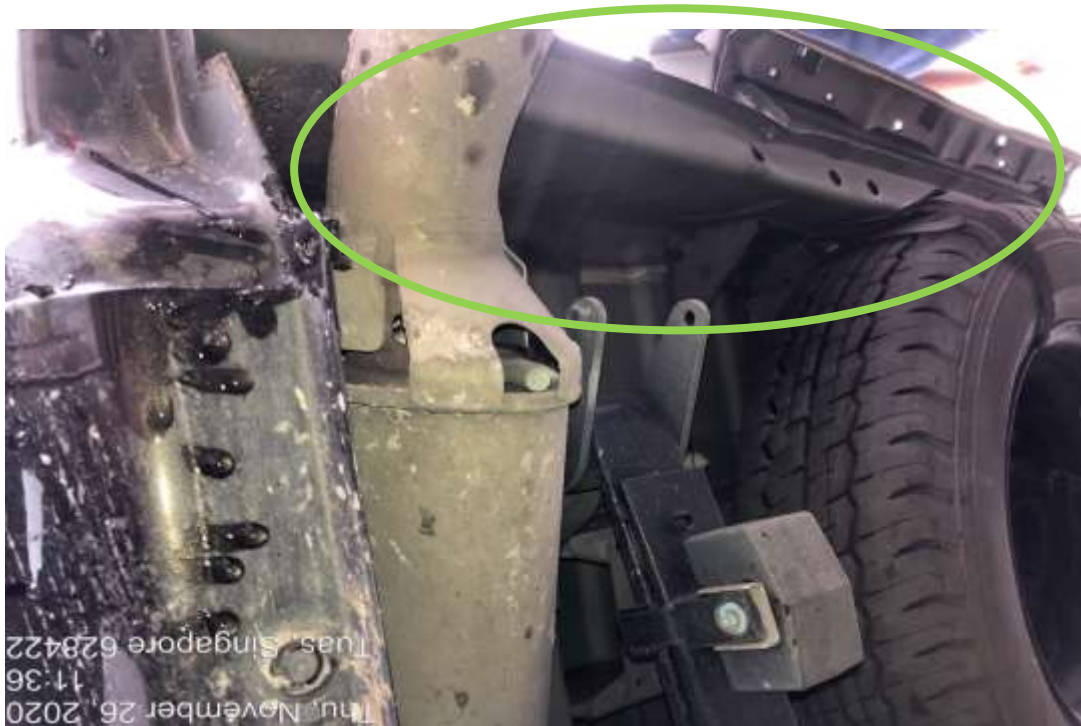
Photo 14 DENTED RR END OUTER & INNER PANELS
