## LKK Auto Consultants Pte Ltd

Vehicle No. SFH 6336D  
Insured Veh. SBS 3337K  
Claim No. D21002915MFBP  
Policy No.  
Accident Date 18/10/2021  
Inspection Date 19/10/2021

## ADJUSTMENT ON REPAIR COST FOR VEHICLE NO. SFH 6336D

### PHOTOGRAPHS FOR VEHICLE NO. SFH 6336D

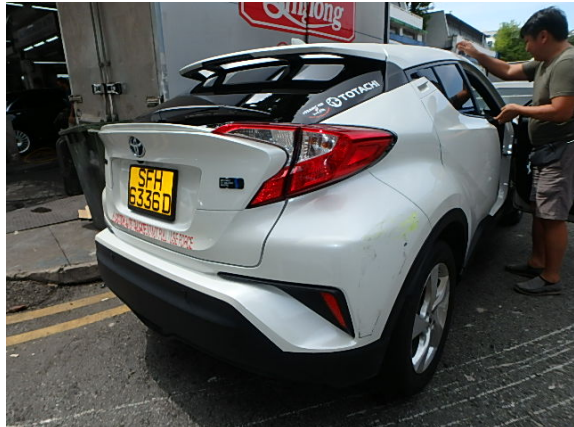
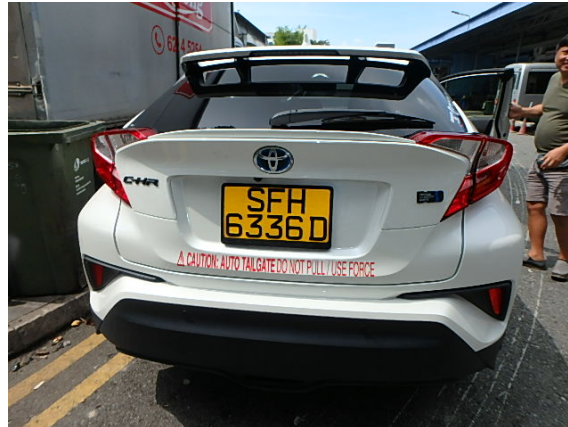
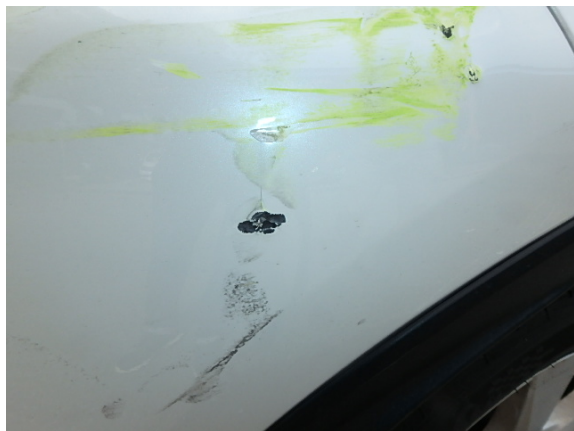
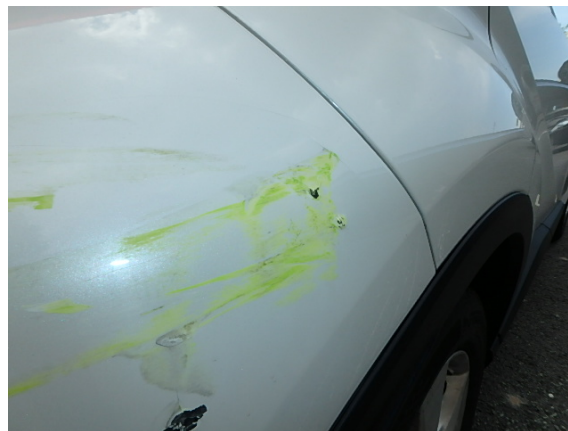
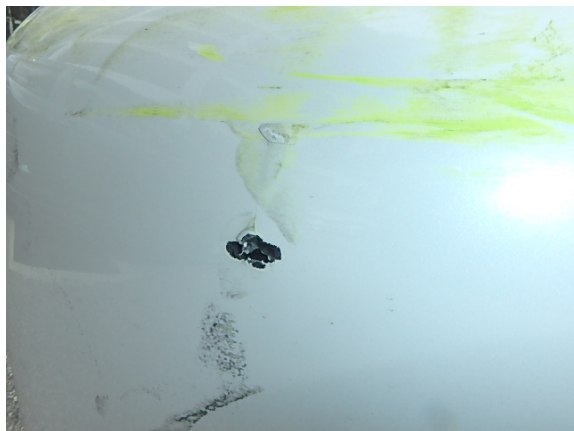
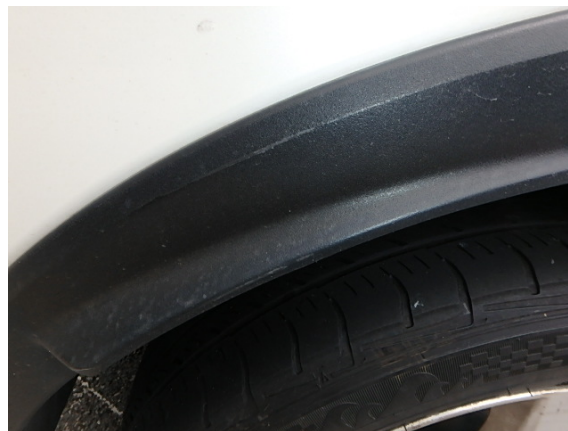
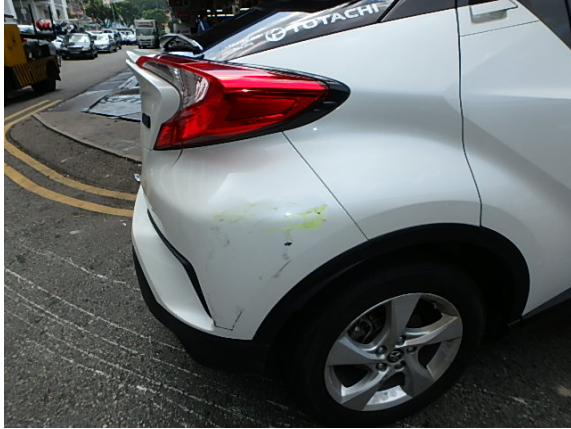
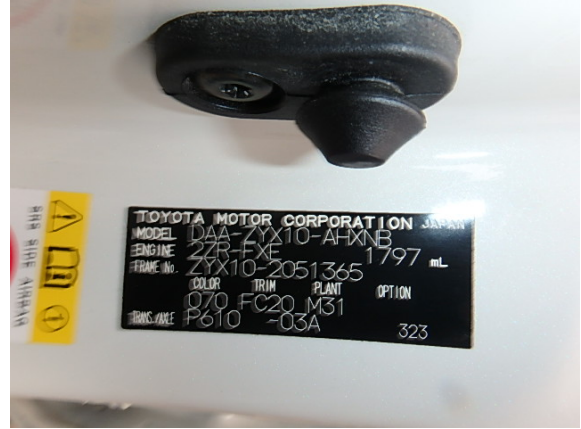
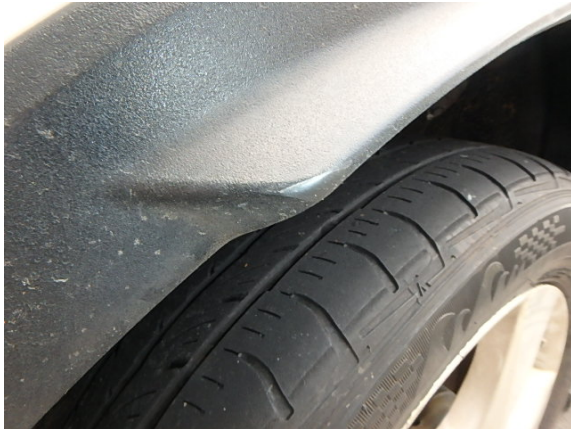
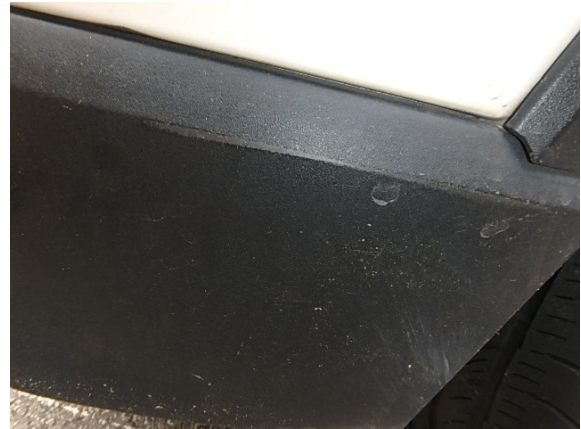
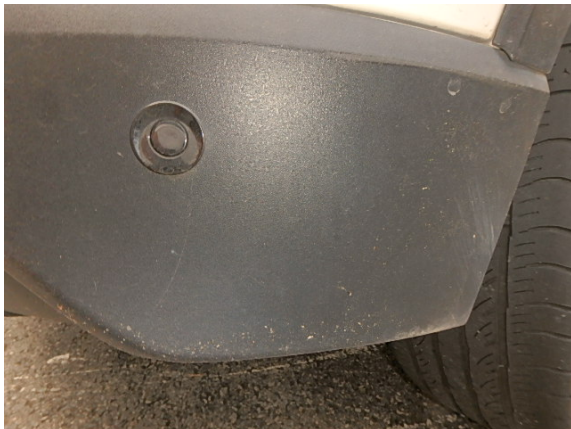
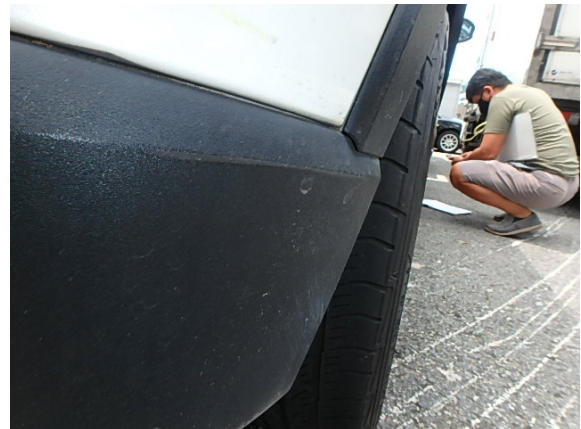
### INSPECTION

<b>4. Description of Damages</b>				
	THE VEHICLE SUSTAINED DAMAGES AT THE REAR O/S PORTION.  DAMAGES SEE DETAILS.			
<b>5. General Information</b>				
	Accident Date	18/10/2021	Inspection Date	19/10/2021
	Survey held at	A T AUTO CONSULTANT 113 TECK WHYE LANE, #05-650, SINGAPORE 680113		
<b>5a. Remarks</b>				
	A)THE INSPECTION WAS CONDUCTED ON A"WITHOUT PREJUDICE" BASIS. B)IN ACCORDANCE TO YOUR INSTRUCTIONS, WE HAVE NOT AUTHORISED REPAIRS.			
<b>5b. Estimate Days of Repair</b>				
	ESTIMATED NORMAL PERIOD FOR REPAIR:		2 Working Days
