Our Reference : KAAS/KT/6279/6767/TP/08.21  
Date : 06 September 2021

## VEHICLE APPRAISAL REPORT

Registration No.	: SNA 6767K	Chassis Frame No.	: GR11020367
Make / Model	: Honda Fit Basic 1.3 CVT	Engine No. ( Logcard )	: L13B1526691
Year of Manufacture/Reg	: 2020	Odometer Reading	: 538 KM
Colour	: Red		
Class / Type	: Hatchback

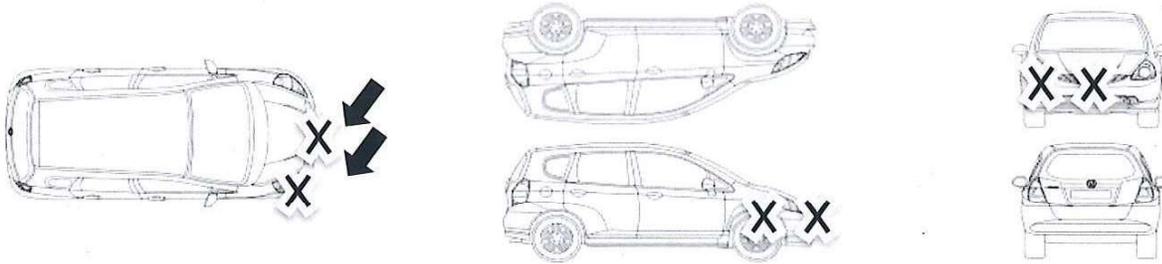
Damages sustained were consistent with the subject vehicle being involved in a collision with another vehicle and the impact was delivered **Diagonally to the RH Front from front to rear; left to right** portion of the vehicle.

The general area of damages is at the **RH Front portion**  
( Please refer to the parts list and photographs as attached for more information )
