Your Ref: TP/IP/28539/2021  
Our Ref : CI/TPD21010812/N

20 October 2021

**Fatal Accident Investigation Team**

**MECHANICAL INSPECTION REPORT OF MOTORCYCLE FBE 1045P**

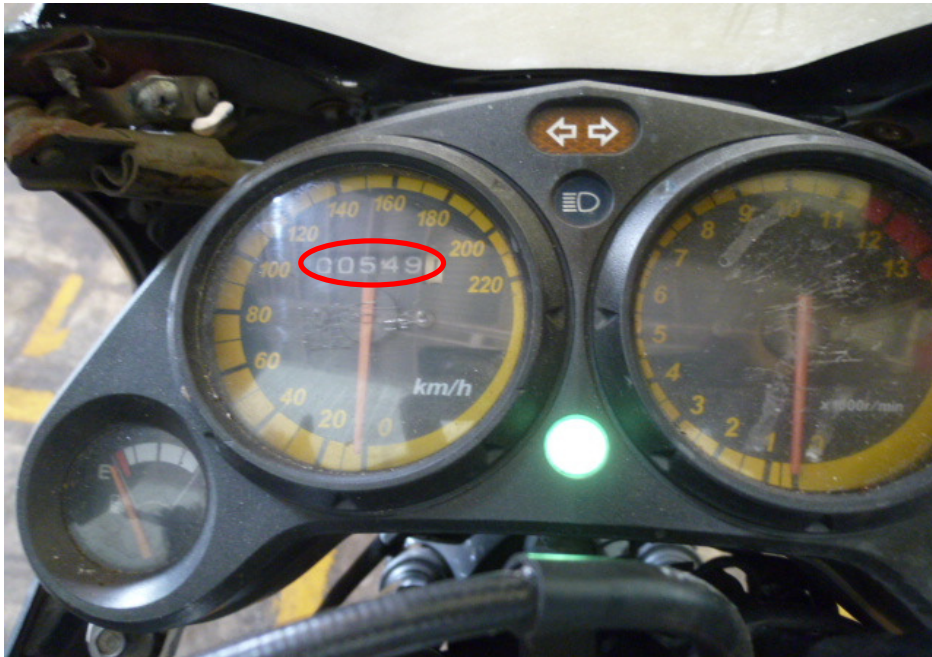
**Photo 1** shows the speedometer gauge of the Motorcycle where the mileage recorded at the time of our inspection was 549km (circled).

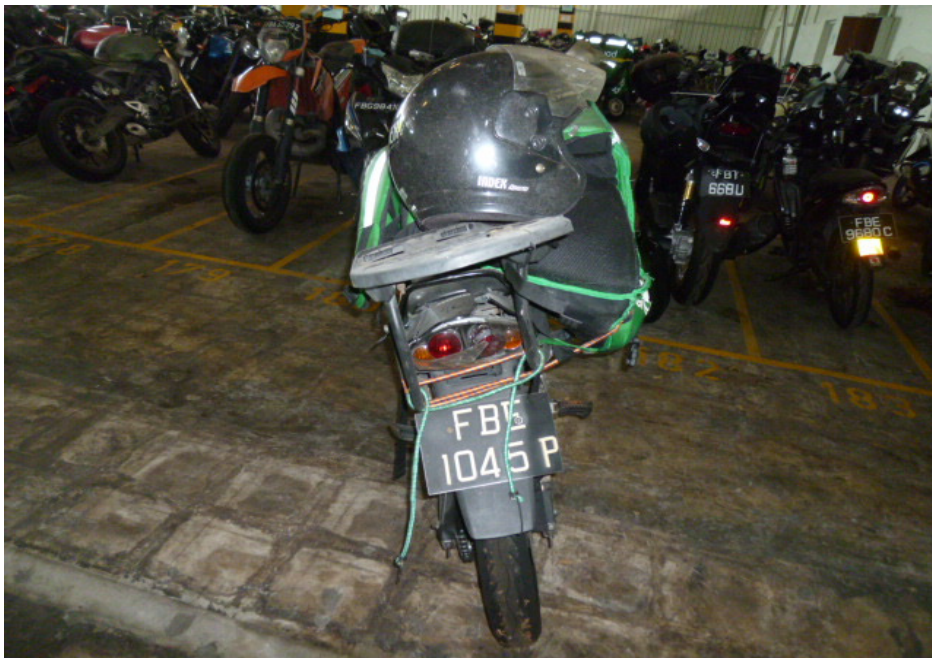
**Photo 2** shows a general view of the rear portion of the Motorcycle at the time of our inspection. The Motorcycle had sustained damages all around.

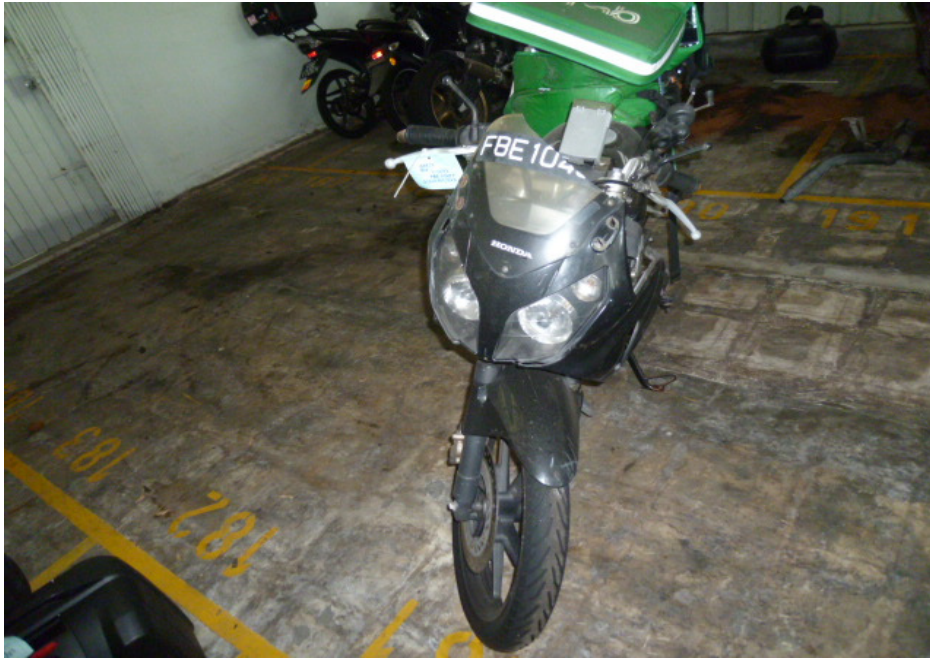
**Photo 3** shows a general view of the frontal portion of the Motorcycle at the time of our inspection. The Motorcycle had sustained damages all around.

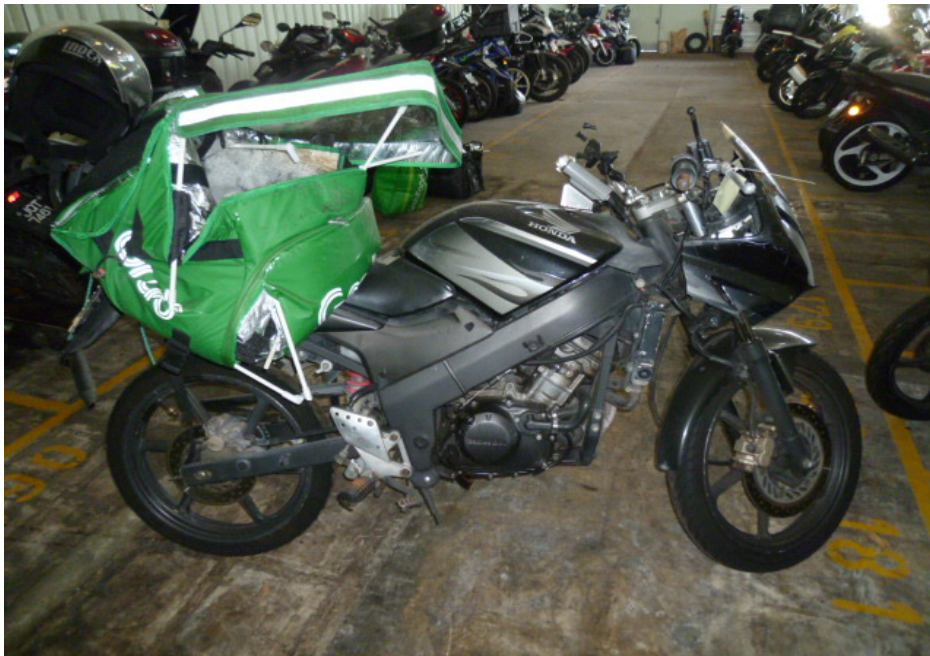
**Photo 4** shows a general view of the right body of the Motorcycle at the time of our inspection. The Motorcycle had sustained damages all around. Body parts that were found to have been damaged include its windshield, front cowling, side cowlings, front mudguard, right side mirror, right handlebar end, front brake lever, left rear side cover, rear brake pedal, right front footrest bracket, tail light assembly, exhaust muffler and right pillion foot peg bracket, amongst others.

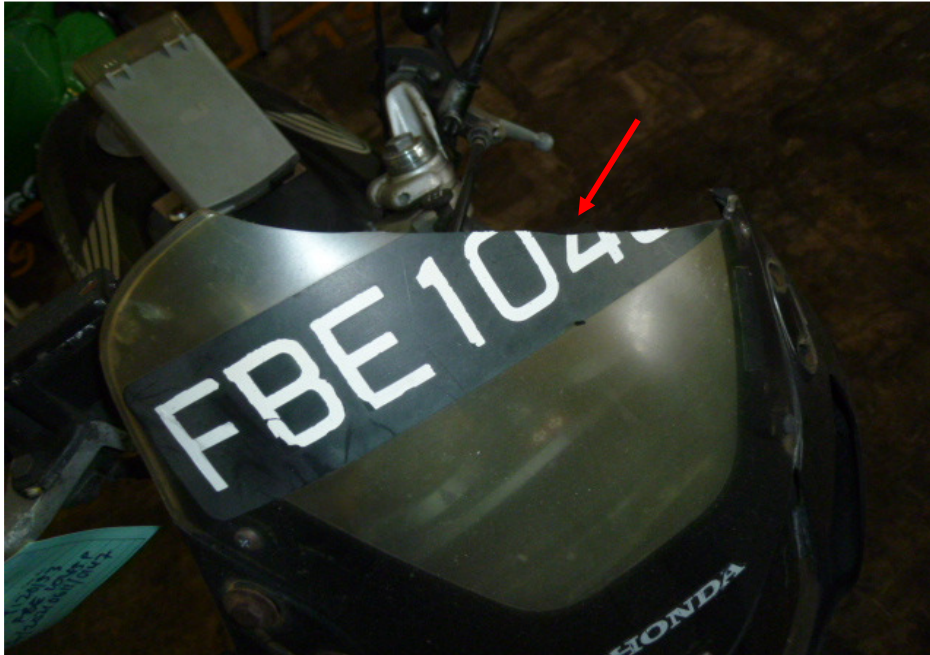
**Photo 5** shows the general view of the windshield (arrowed) of the Motorcycle which was amongst the body parts of the Motorcycle that had sustained damage as a result of the accident.

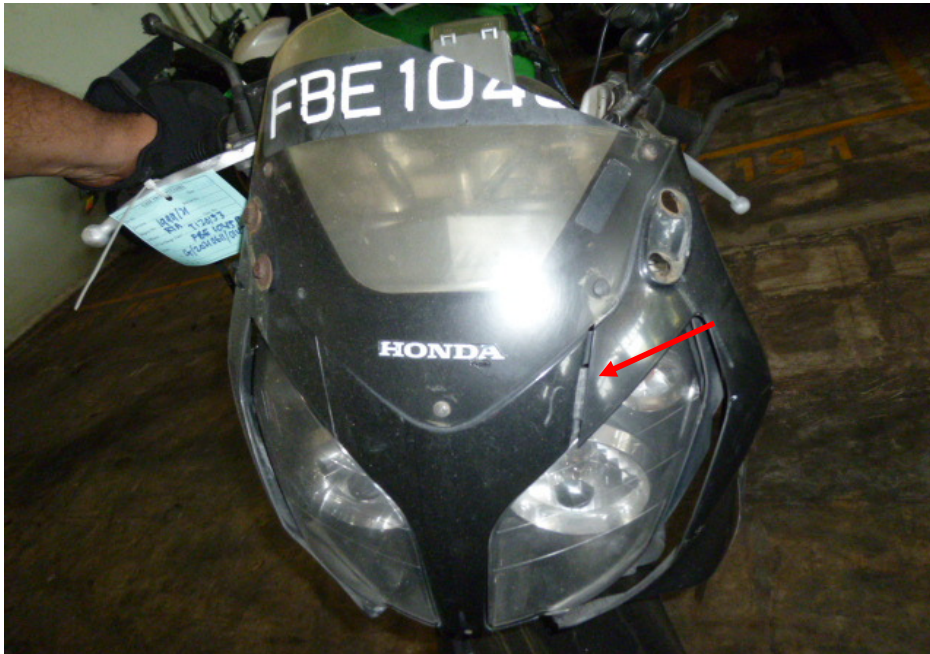
**Photo 6** shows the general view of the front cowling of the Motorcycle which was amongst the body parts of the Motorcycle that had sustained damage as a result of the accident (arrowed).

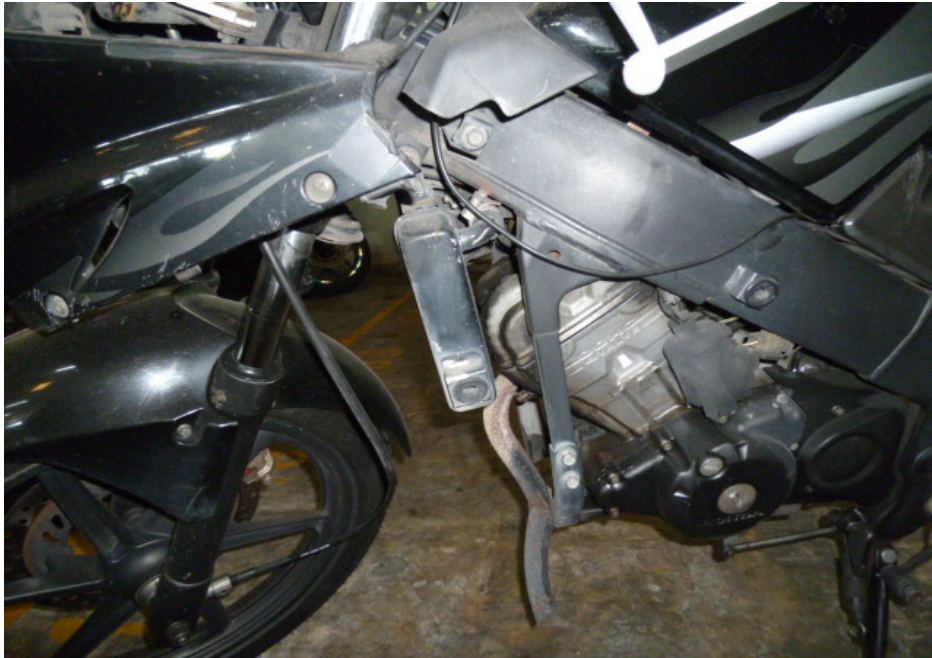
**Photo 7** shows the missing left cowling of the Motorcycle as a result of the accident.

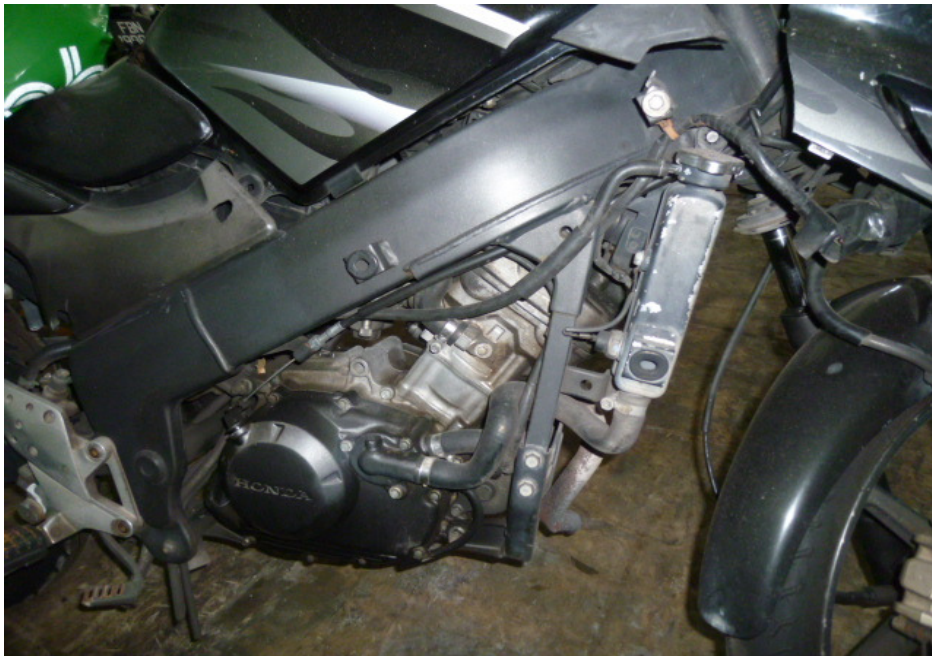
**Photo 8** shows the missing right cowling of the Motorcycle as a result of the accident.

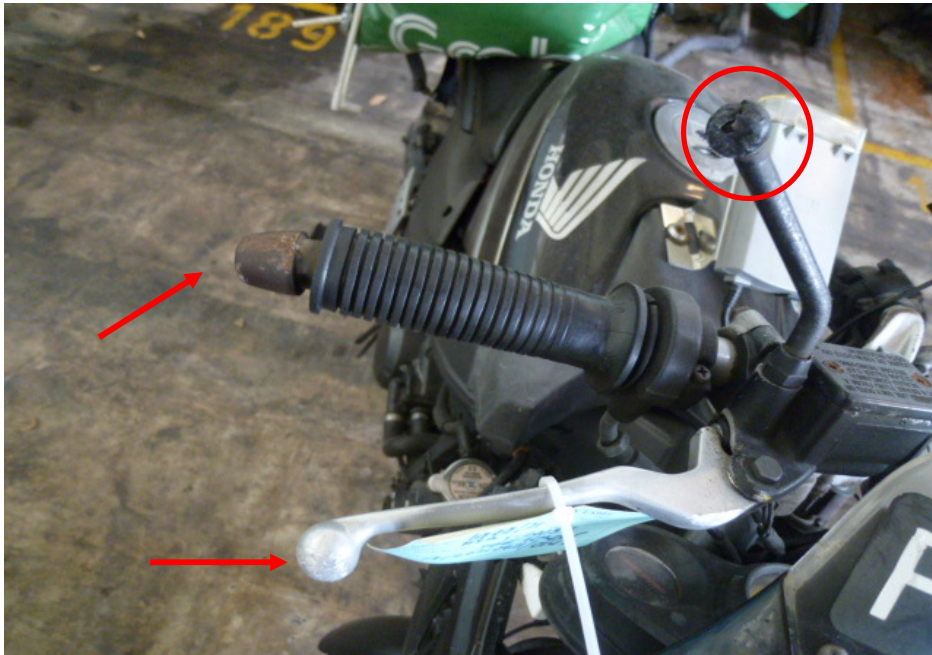
**Photo 9** shows a close up view of the right handlebar end and front brake lever (arrowed) as well as the missing right side mirror (circled) of the Motorcycle. These parts were amongst the body parts of the Motorcycle which were damaged as a result of the accident.

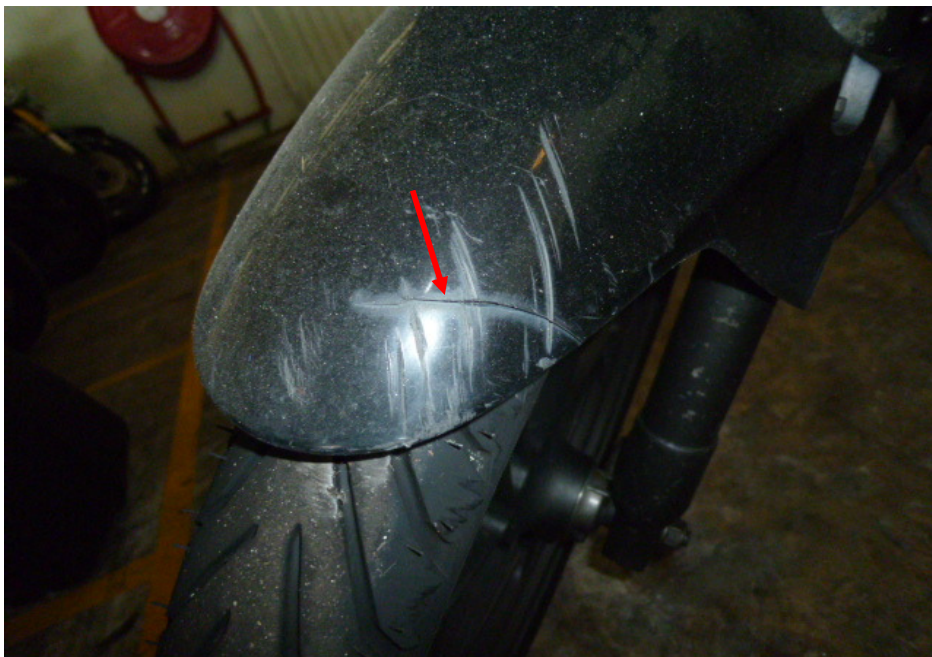
**Photo 10** shows a close up view of the cracked front mudguard of the Motorcycle as a result of the accident (arrowed).

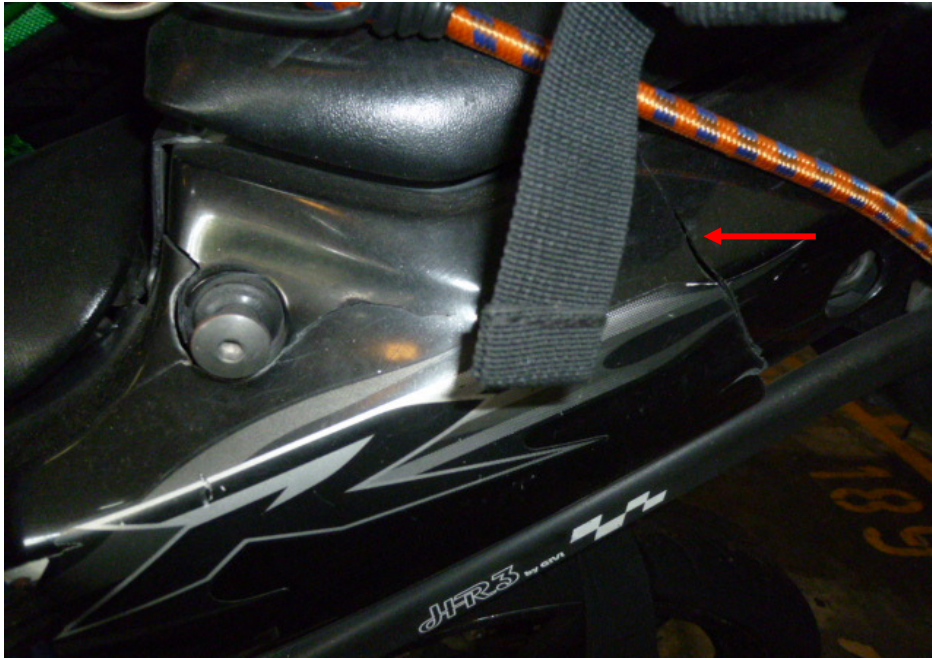
**Photo 11** shows a closer view of the cracked left rear side cover of the Motorcycle as a result of the accident (arrowed).

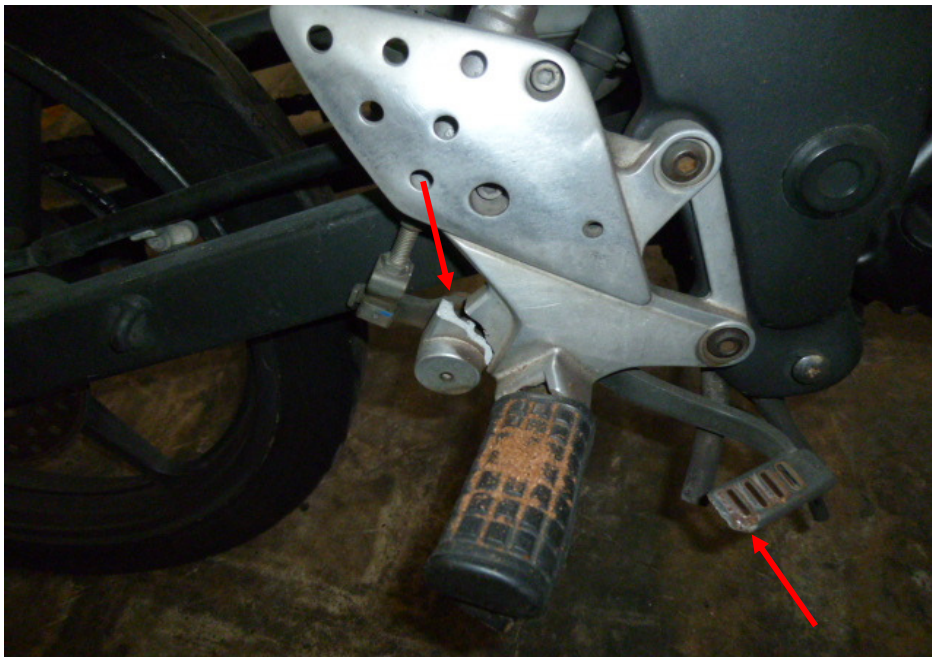
**Photo 12** shows the bent rear brake pedal and broken right front footrest which were amongst the body parts of the Motorcycle that had sustained damage as a result of the accident (arrowed).

15. For this case, we were not able to carry out any operational tests to the rear braking system of the Motorcycle due to the broken right front footrest bracket. See photos 22 – 26 below.

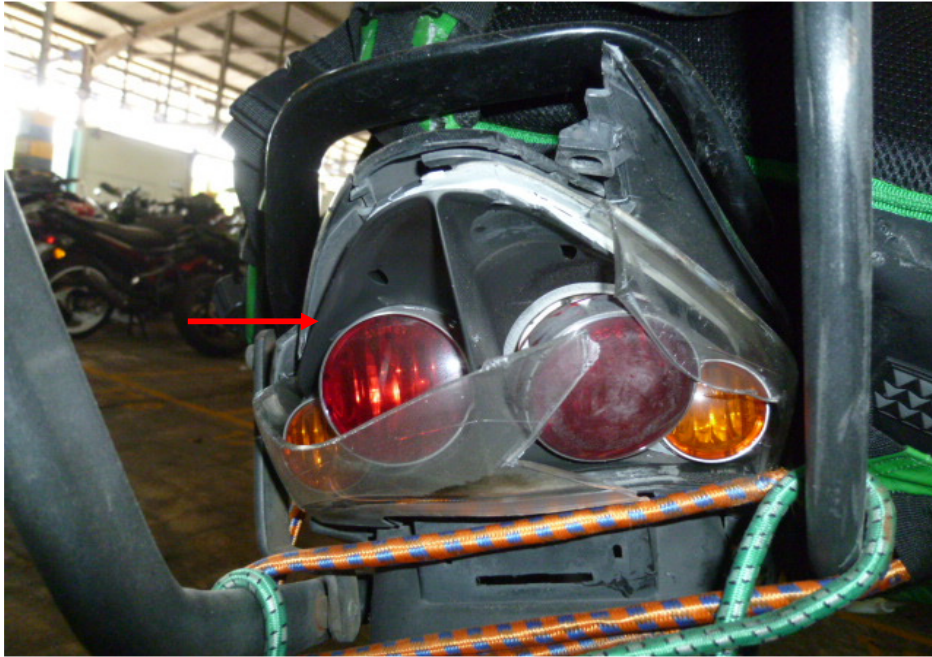
**Photo 13** shows the broken tail light assembly which was amongst the body parts of the Motorcycle that had sustained damage as a result of the accident (arrowed).

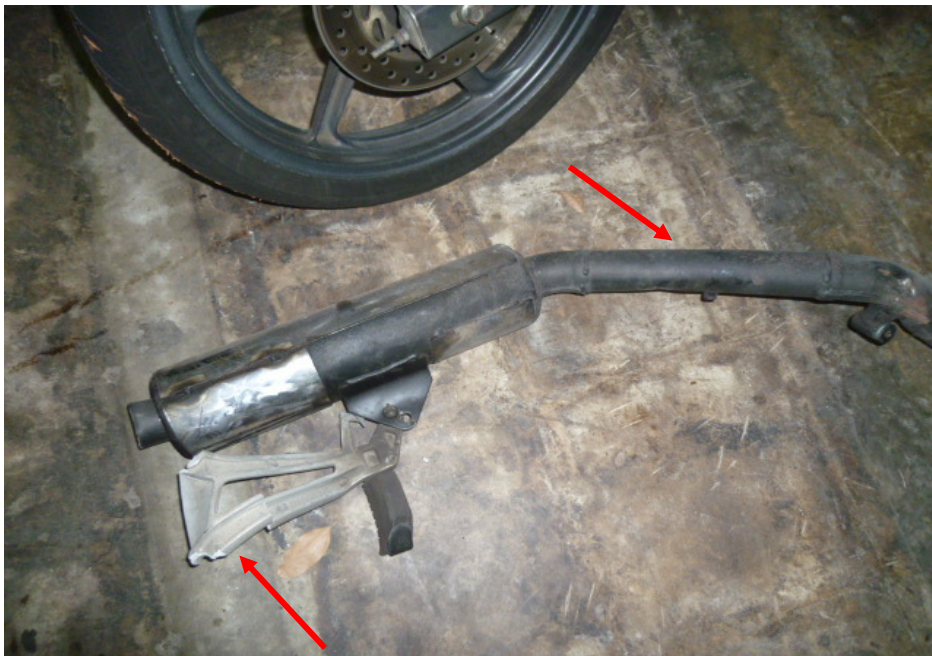
**Photo 14** shows the broken exhaust muffler and right pillion foot peg bracket (arrowed) of the Motorcycle as a result of the accident.

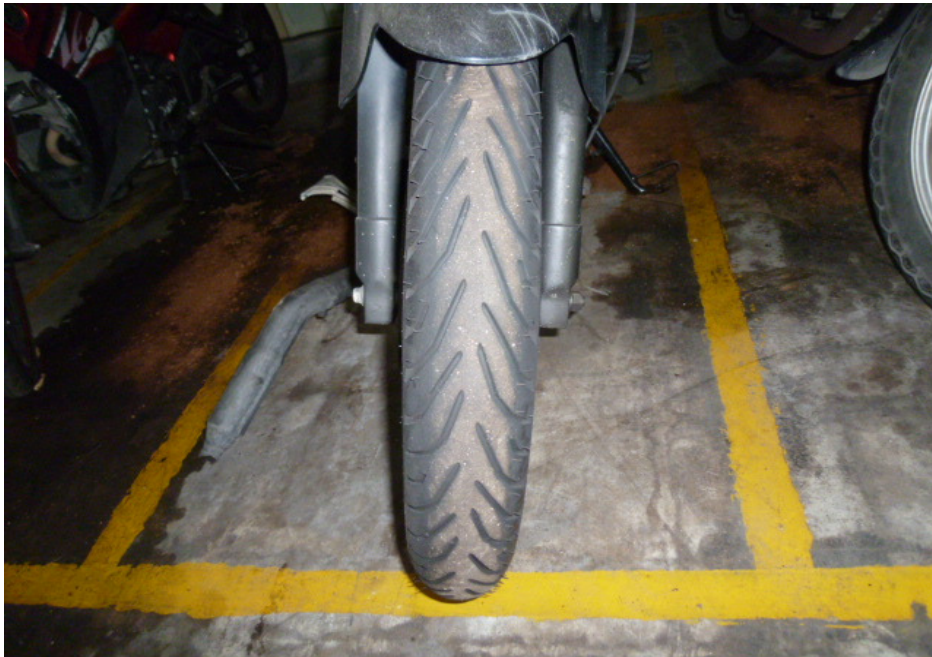
**Photo 15** shows the condition of the Motorcycle's front tyre. The front tyre was observed to be in serviceable condition with remaining tread depth of approximately 5mm. We did not observe any tear, burst mark(s) and/or punctured hole(s) on the sidewalls as well as across the tread of the front tyre. The front tyre was also observed to be sufficiently inflated for vehicular operation.

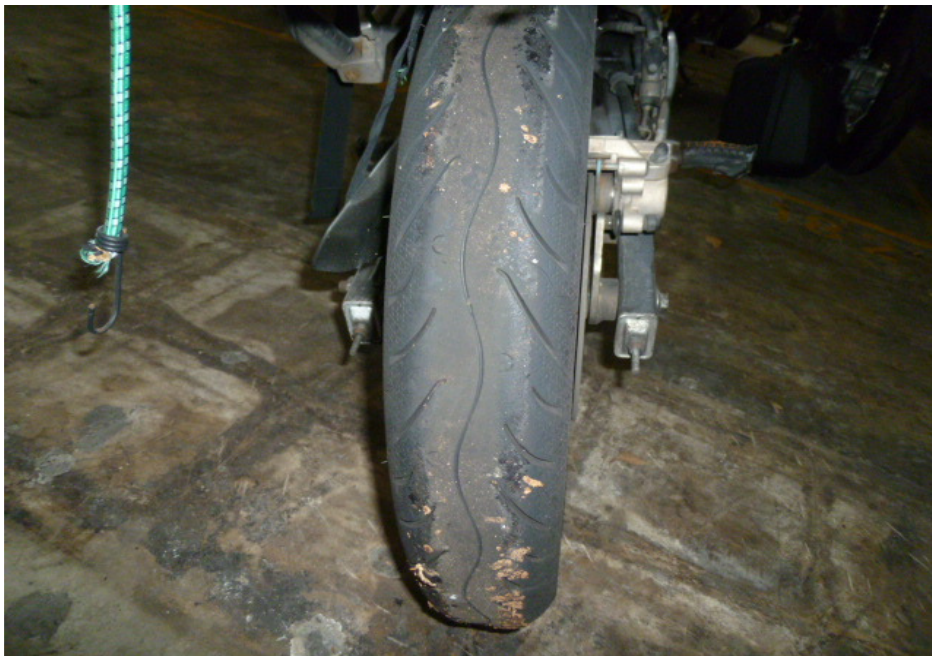
**Photo 16** shows the condition of the Motorcycle's rear tyre. The rear tyre was observed to be in serviceable condition with remaining tread depth of approximately 2mm. We did not observe any tear, burst mark(s) and/or punctured hole(s) on the sidewalls as well as across the tread of the rear tyre. However the front tyre was observed to be deflated as a result of the accident.

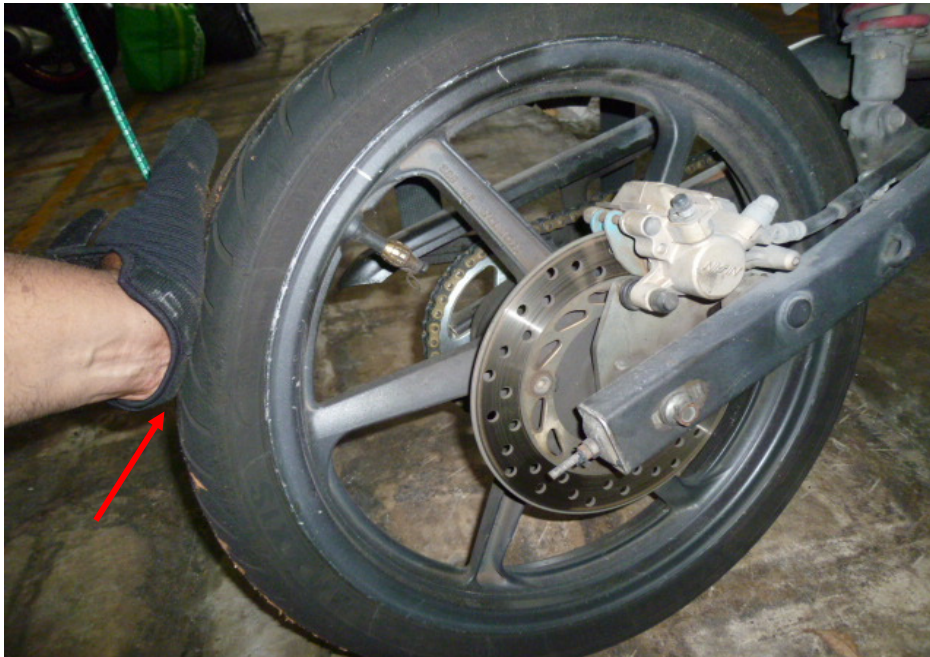
**Photo 17** shows a closer view of the deflated rear tyre of the Motorcycle as a result of the accident (arrowed).

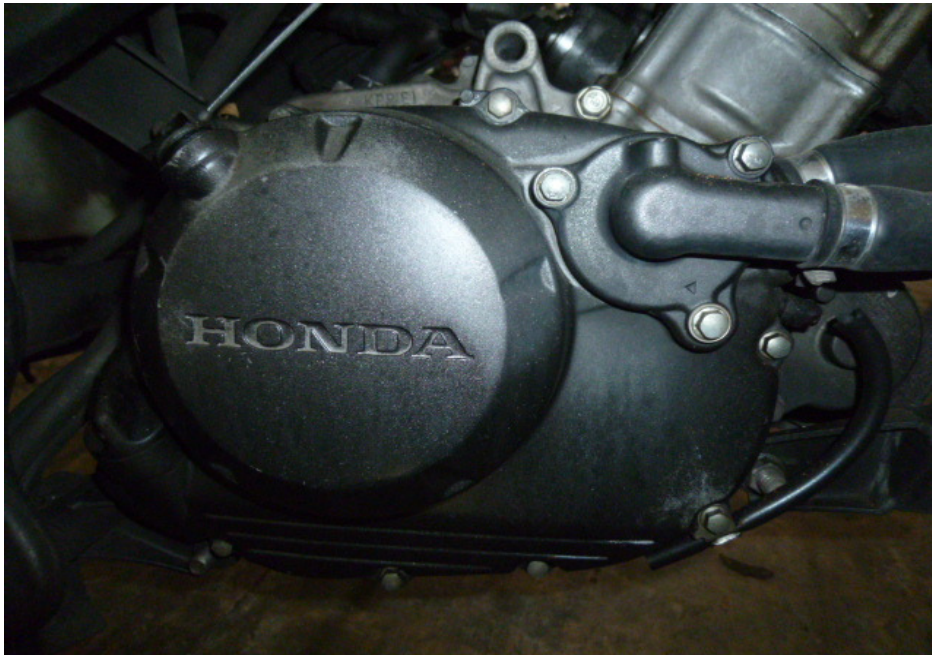
**Photo 18** shows the right side of the engine of the Motorcycle at the time of our inspection. The various engine related parts and components were found to be intact with no visible damage. There was also no sign(s) or indication(s) of fluid leak observed around the right engine area of the Motorcycle.

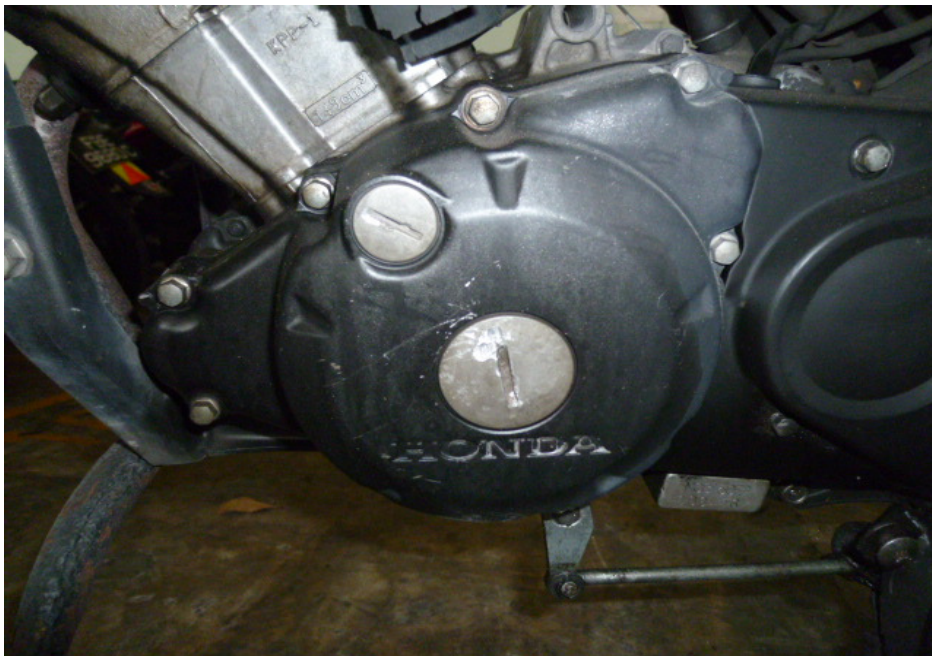
**Photo 19** shows the left side of the engine of the Motorcycle at the time of our inspection. The various engine related parts and components were found to be intact with no visible damage. There was also no sign(s) or indication(s) of fluid leak observed around the left engine area of the Motorcycle.

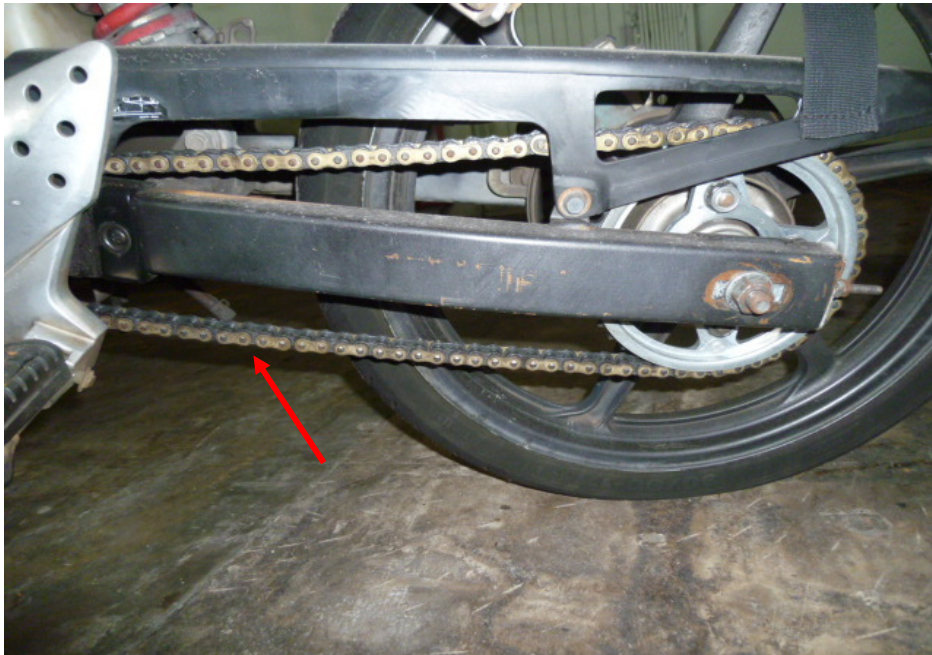
**Photo 20** shows the general view of the gear train (arrowed) of the Motorcycle, which was observed to be intact with no misalignment. It was also adequately lubricated for operating purposes.

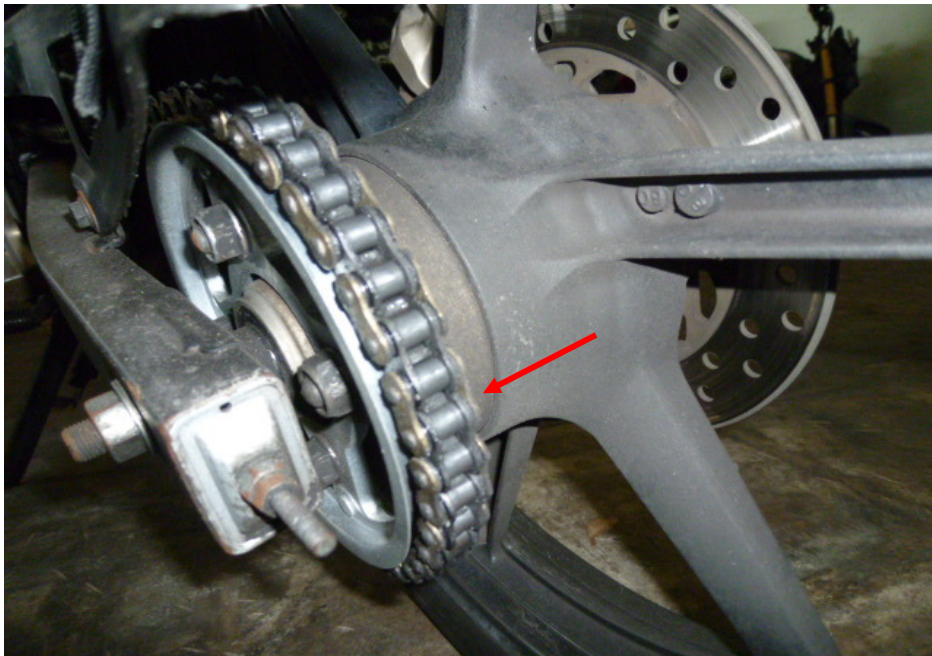
**Photo 21** shows a closer view of the gear train (arrowed) of the Motorcycle, which was observed to be intact with no misalignment. It was also adequately lubricated for operating purposes.

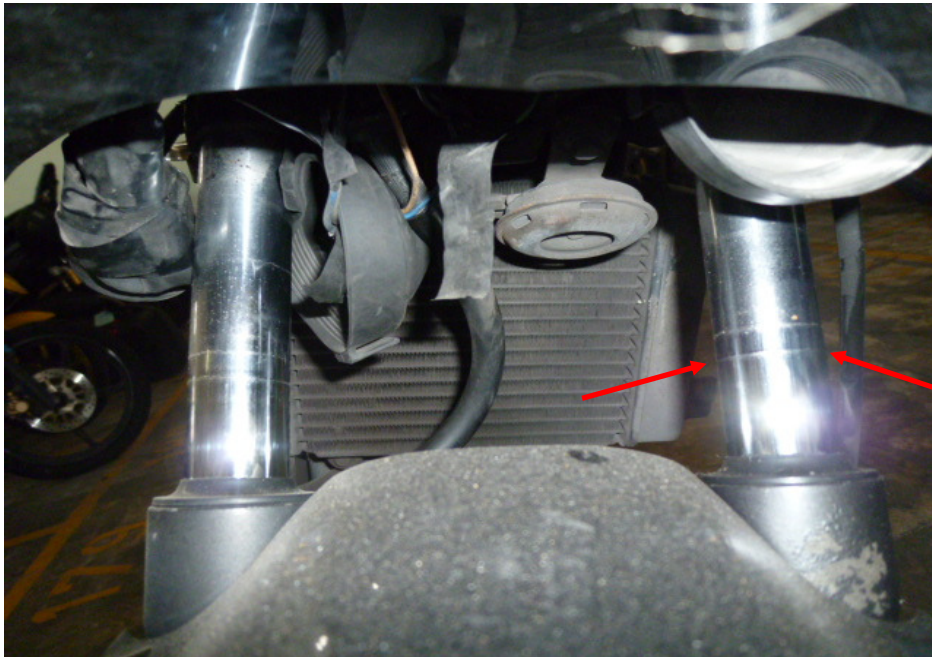
10. For this case, we were not able to conduct any test(s) on the steering system of the Motorcycle due to the damage to its front fork assembly. The left front fork was found to be bent as a result of the accident.

**Photo 22** shows the front fork assembly of the Motorcycle. The front left fork (arrowed) was observed to be bent as a result of the accident. We were hence not able to conduct any tests on the steering system of the Motorcycle.

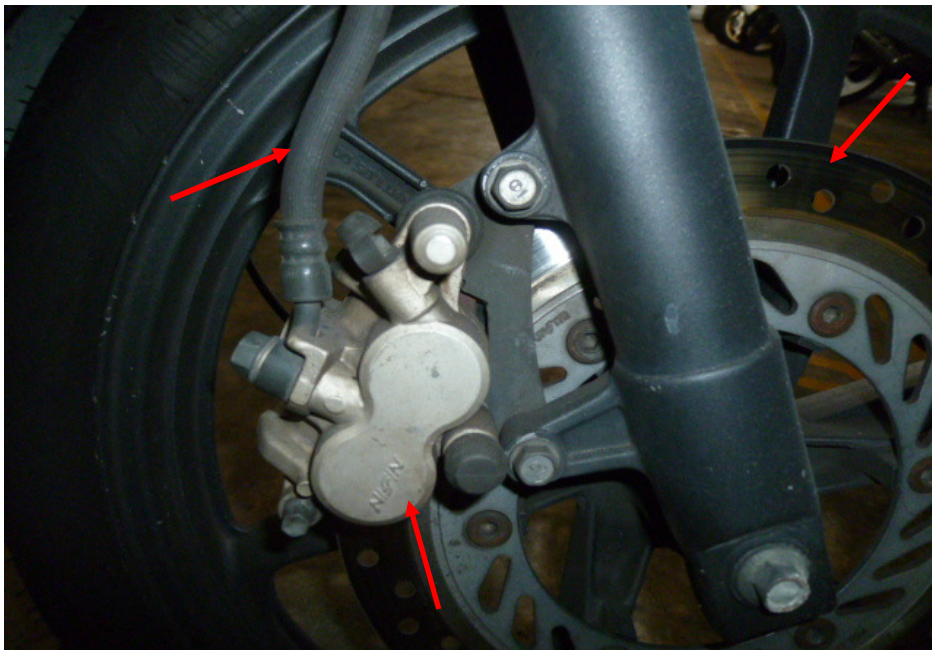
**Photo 23** shows a close up view of the front brake caliper, front brake disc and front brake hose (arrowed) of the Motorcycle, which are all part of the components in the hydraulic front brake system of the Motorcycle. Our visual checks of these various components had revealed all to be intact with no visible damage. No leakage of brake fluid was also observed.

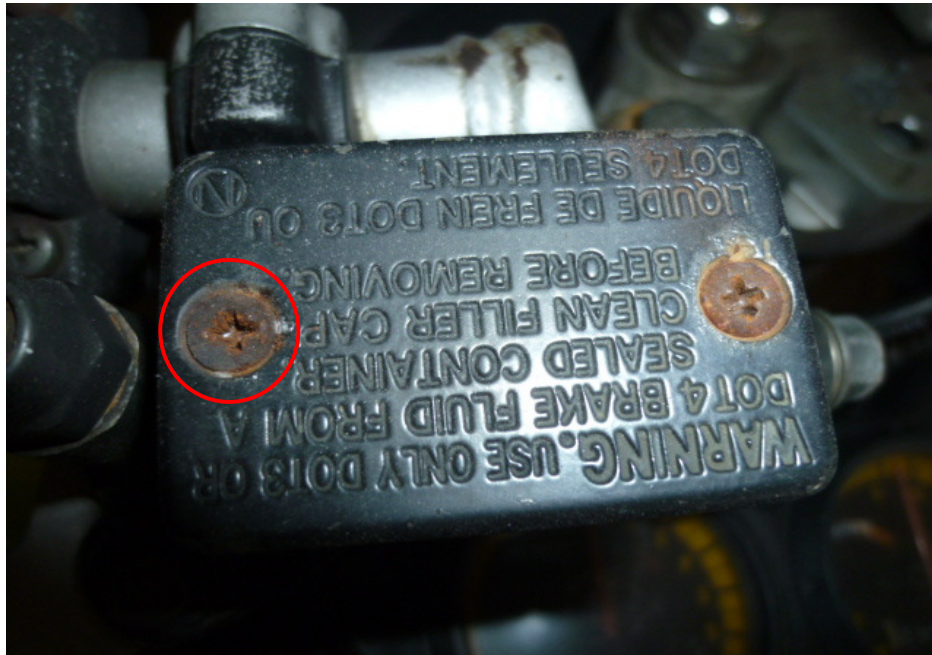
**Photo 24** shows the brake fluid reservoir cover for the front brake of the Motorcycle. We were unable to examine whether the brake fluid was of sufficient level and without contamination for operational purposes due to the worn out screw (circled).

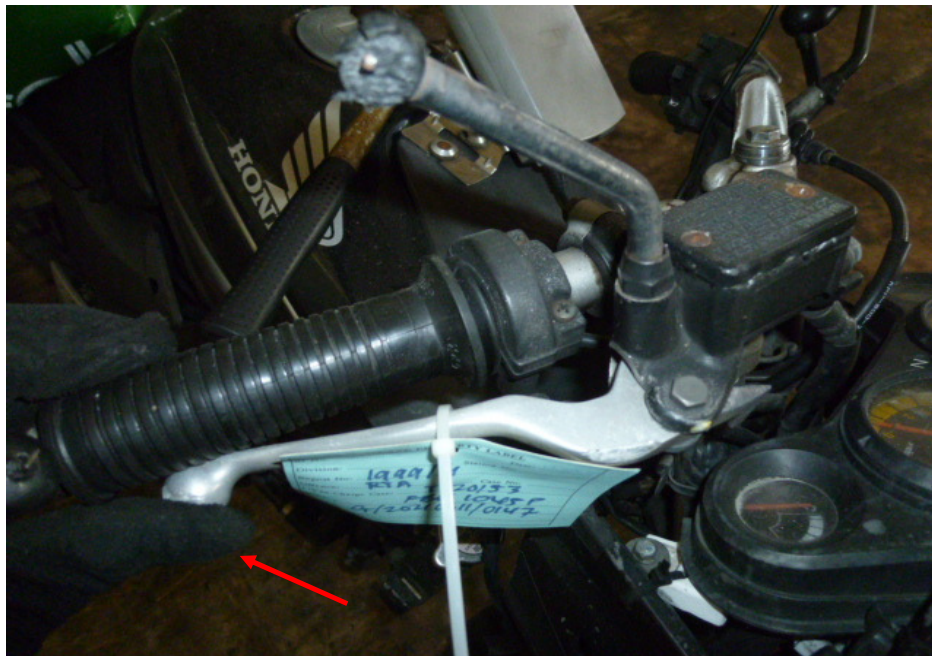
13. Static brake tests conducted on the Motorcycle had appear to indicate that the front braking system of the Motorcycle was not in serviceable condition. There was no resistance felt (spongy like feel) upon pressing the brake lever. This would indicate that there may be a leakage of pressure/vacuum in the front brake system.

14. We subsequently carried out an operational test of the Motorcycle's front braking system. This was done by manually pushing the Motorcycle forward and backward, simulating the Motorcycle in motion, and thereafter engaging the front brake of the Motorcycle. At the end of the short operational test, we observed that the front wheel of the Motorcycle was unable to stop rotating upon depressing the brake lever.

**Photo 25** shows the front brake lever being depressed. There was no resistance felt (spongy like feel) upon pressing the front brake lever (arrowed). This would indicate that there may be a leakage of pressure/vacuum in the front brake system.

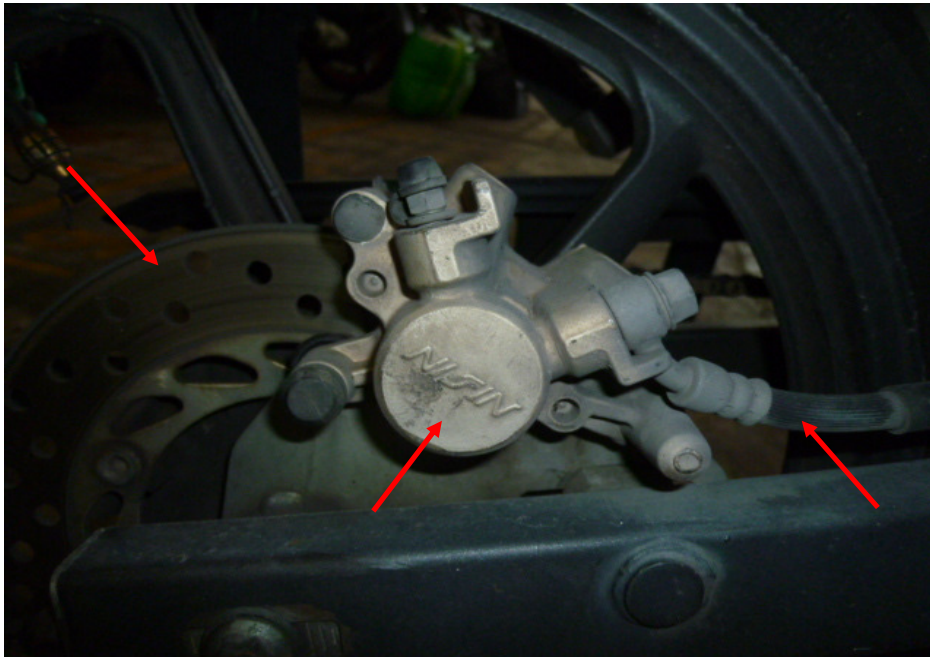
**Photo 26** shows a close up view of the rear brake caliper, rear brake disc and rear brake hose (arrowed) of the Motorcycle, which are all part of the components in the hydraulic rear brake system of the Motorcycle. Our visual checks of these various components had revealed all to be intact with no visible damage. No leakage of brake fluid was also observed.
