Your Ref: TP/IP/31841/2021
Our Ref : CI/TPD21010813/N

25 October 2021

MECHANICAL INSPECTION REPORT OF MOTORCYCLE FBC 2692A

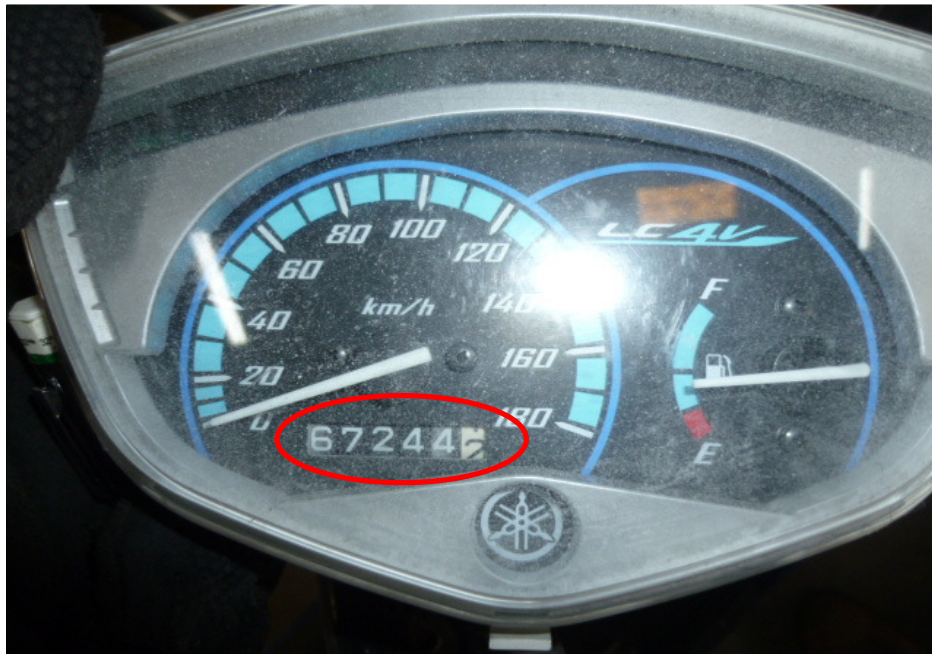
Photo 1 shows the speedometer gauge of the Motorcycle where the mileage recorded at the time of our inspection was 67, 244km (circled).

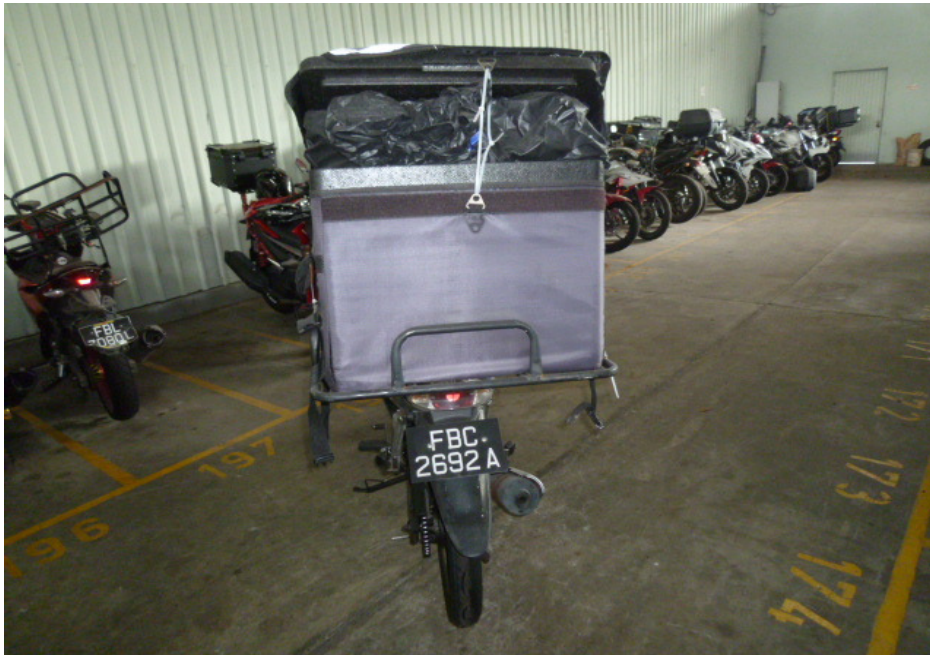
Photo 2 shows a general view of the rear portion of the Motorcycle at the time of our inspection. The Motorcycle had sustained damages all around.

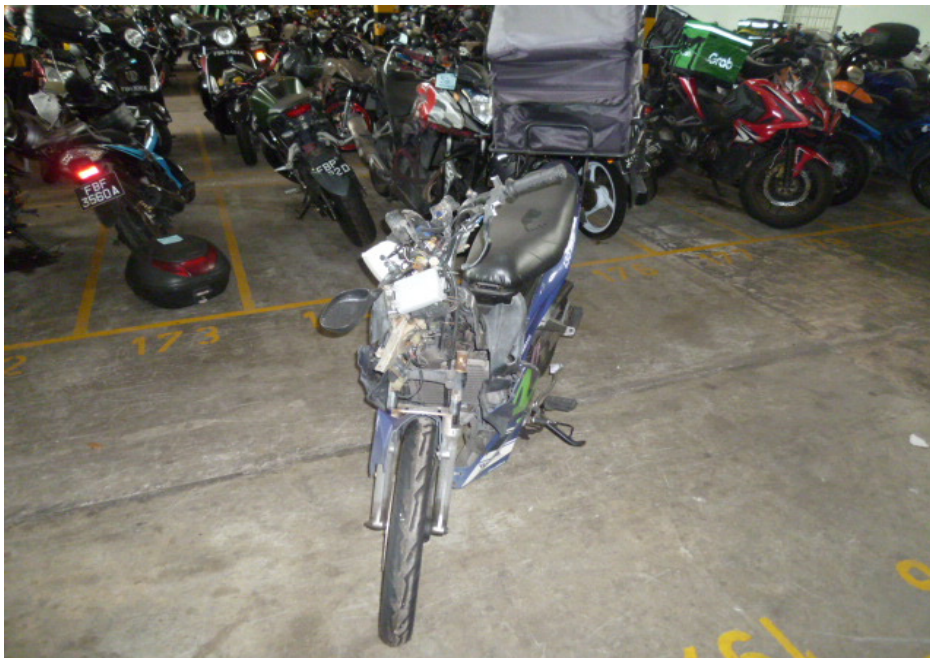
Photo 3 shows a general view of the frontal portion of the Motorcycle at the time of our inspection. The Motorcycle had sustained damages all around.

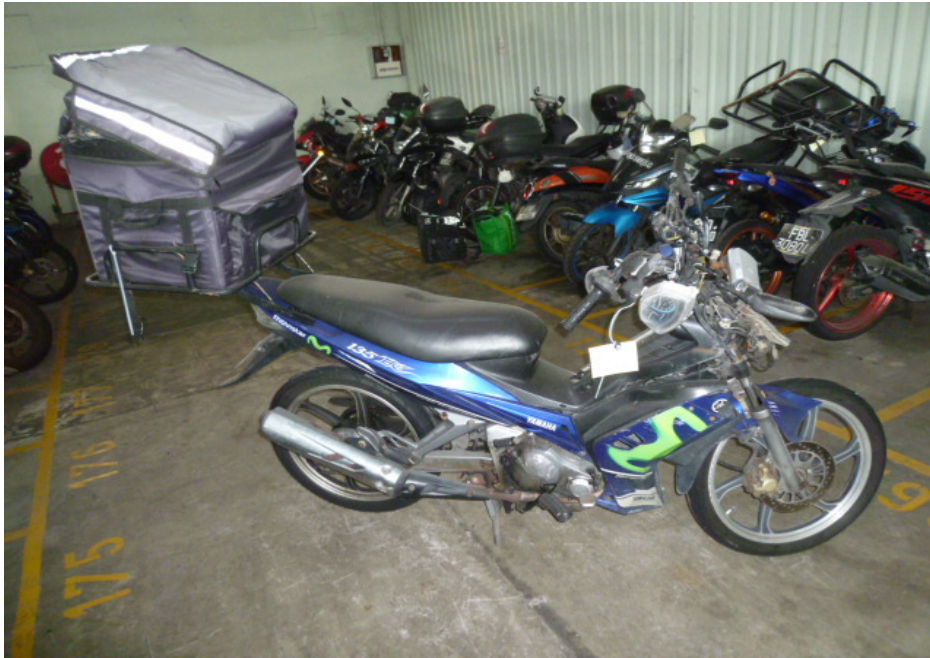
Photo 4 shows a general view of the right body of the Motorcycle at the time of our inspection. The Motorcycle had sustained damages all around. Body parts that were found to have been damaged include its headlight assembly, front cowlings, steering stem, front mudguard, handlebar, side mirrors, side cowlings, front brake lever, clutch lever, right rear side cover, rear brake pedal, right front footrest, top box rack and exhaust muffler heat shield, amongst others.

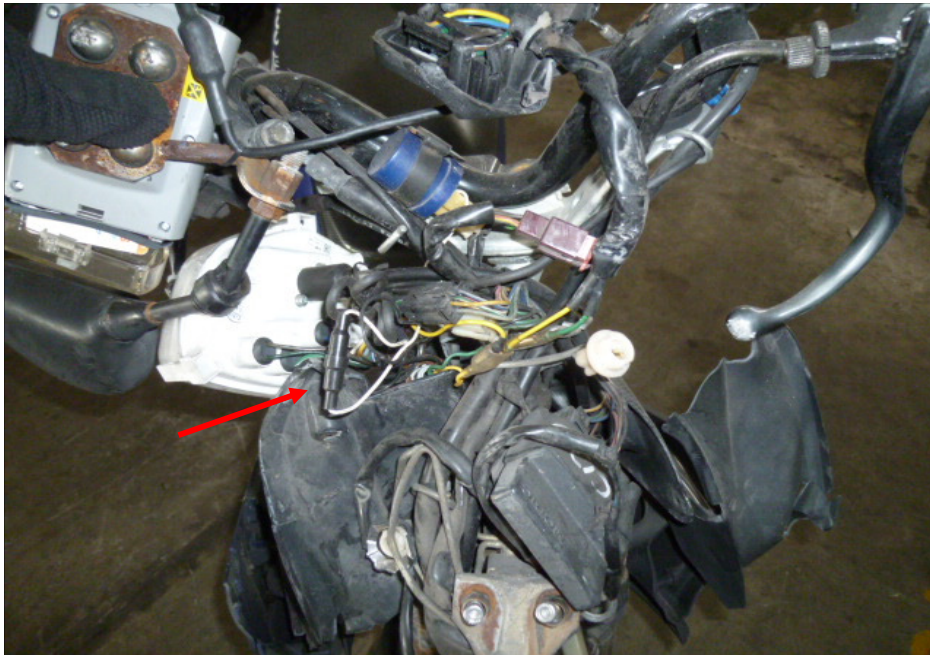
Photo 5 shows a closer view of the missing headlight assembly of the Motorcycle as a result of the accident (arrowed).

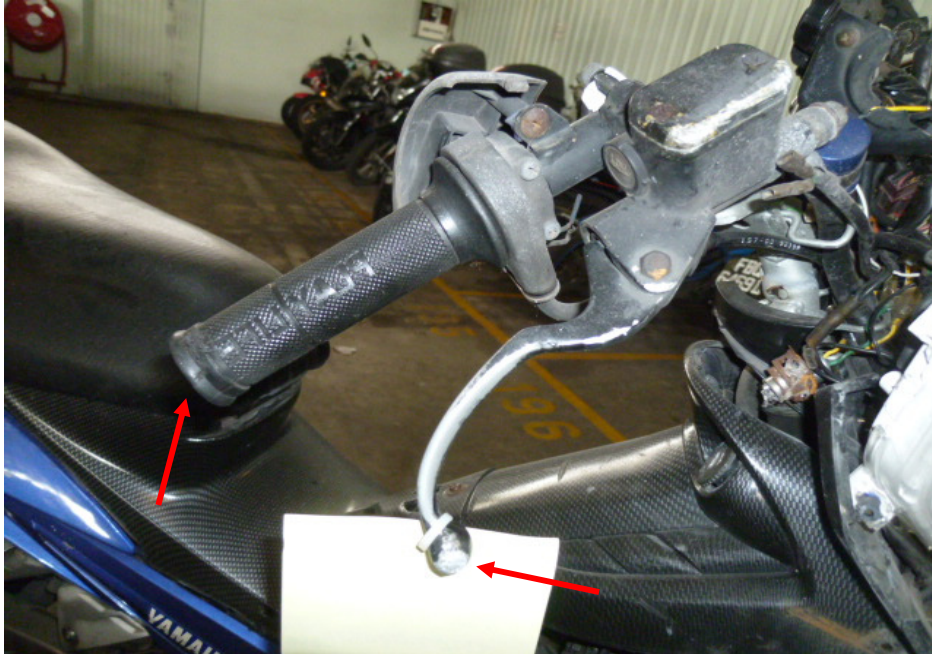
Photo 6 shows a closer view of the front brake lever and left handlebar end of the Motorcycle (arrowed). These parts were amongst the body parts of the Motorcycle which were damaged as a result of the accident.

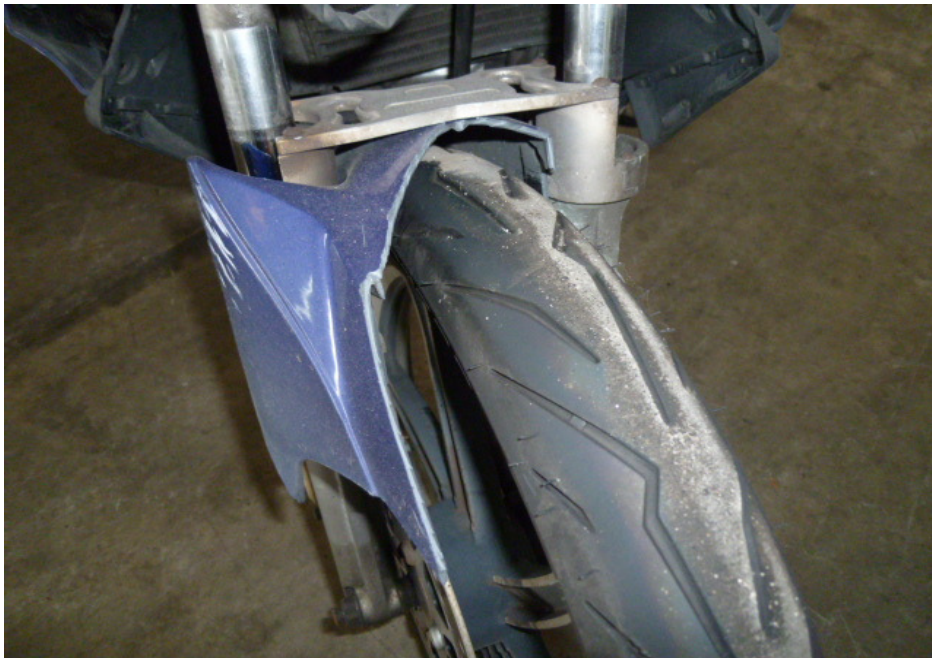
Photo 7 shows a closer view of the front mudguard, which was amongst the body parts of the Motorcycle that had sustained damage as a result of the accident.

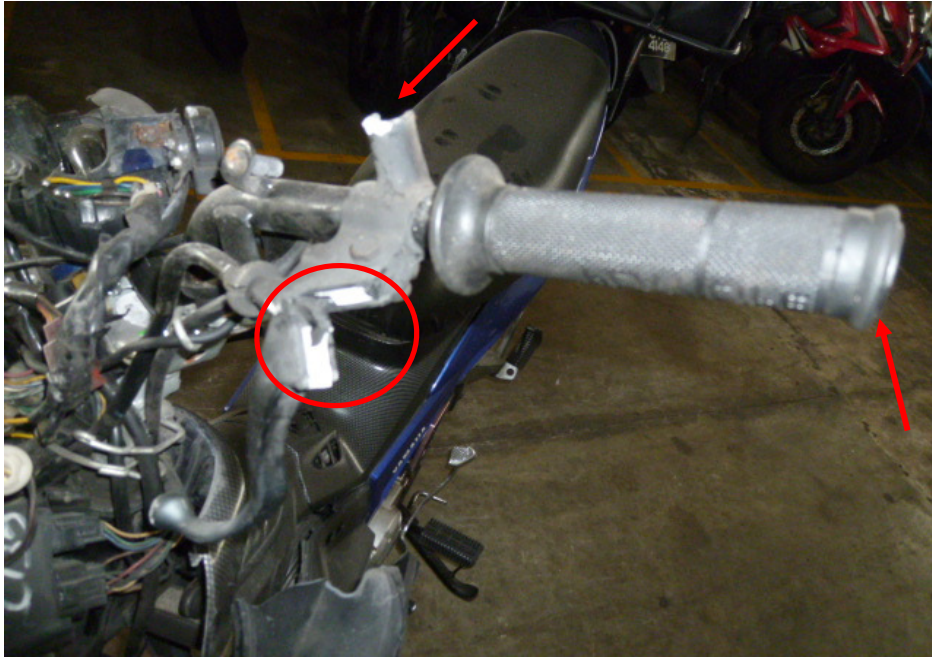
Photo 8 shows a closer view of the broken clutch lever (circled), left side mirror and left handlebar end of the Motorcycle (arrowed). These parts were amongst the body parts of the Motorcycle which were damaged as a result of the accident.

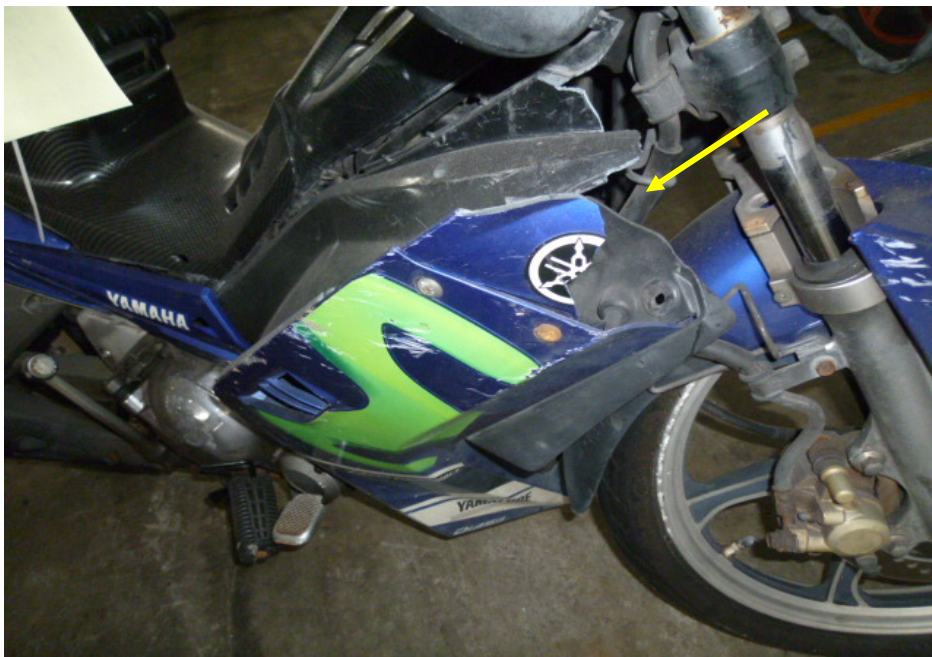
Photo 9 shows a closer view of the right cowling which was amongst the body parts at the front body of the Motorcycle that had sustained damages as a result of the accident (arrowed).

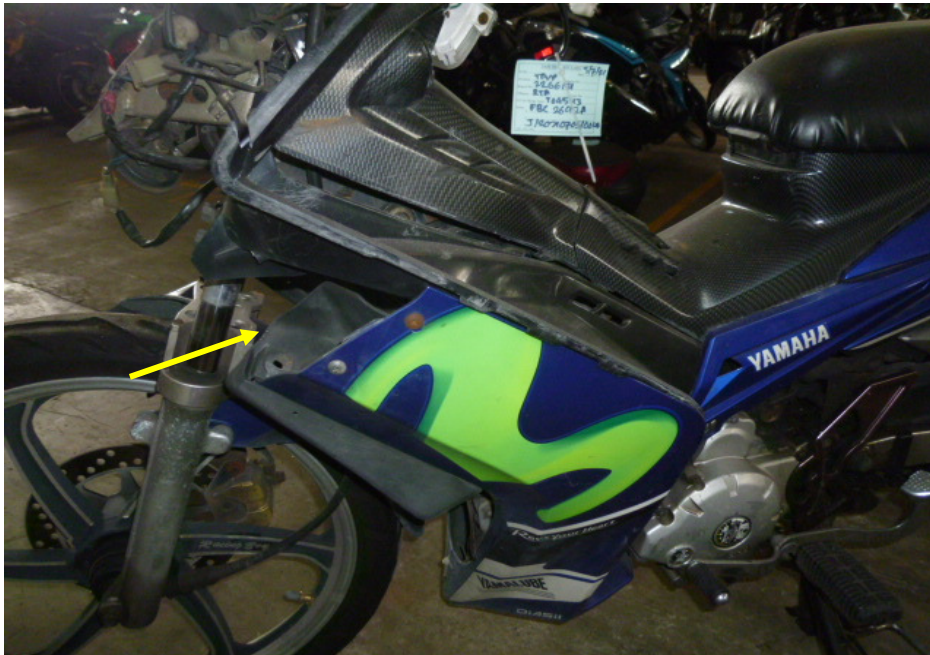
Photo 10 shows a closer view of the cracked left cowling which was amongst the body parts at the front body of the Motorcycle that had sustained damages as a result of the accident (arrowed).

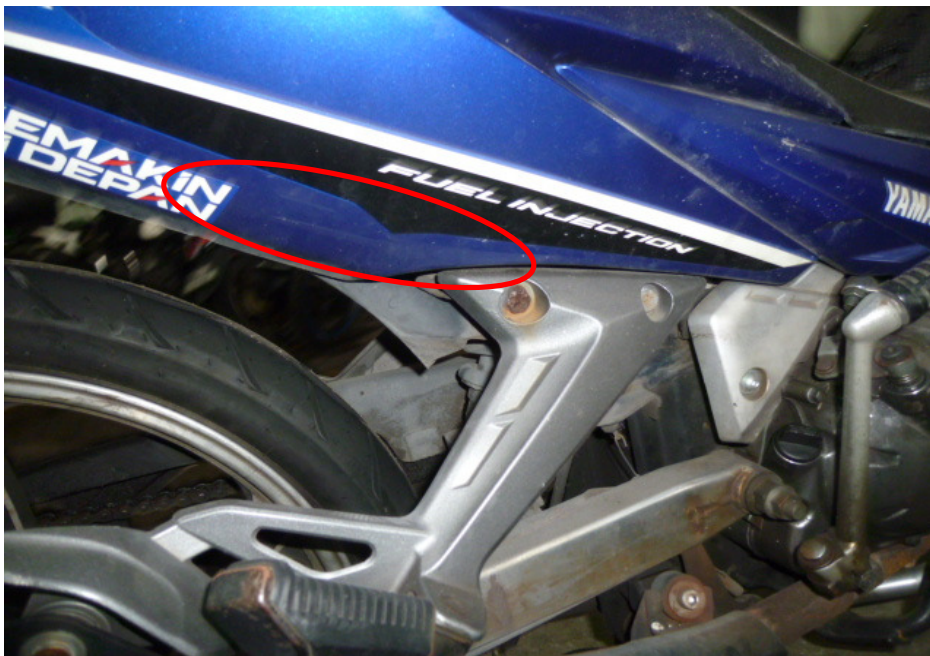
Photo 11 shows a closer view of the right rear side cover which was amongst the body parts of the Motorcycle that had sustained damages of grazing nature as a result of the accident (circled).

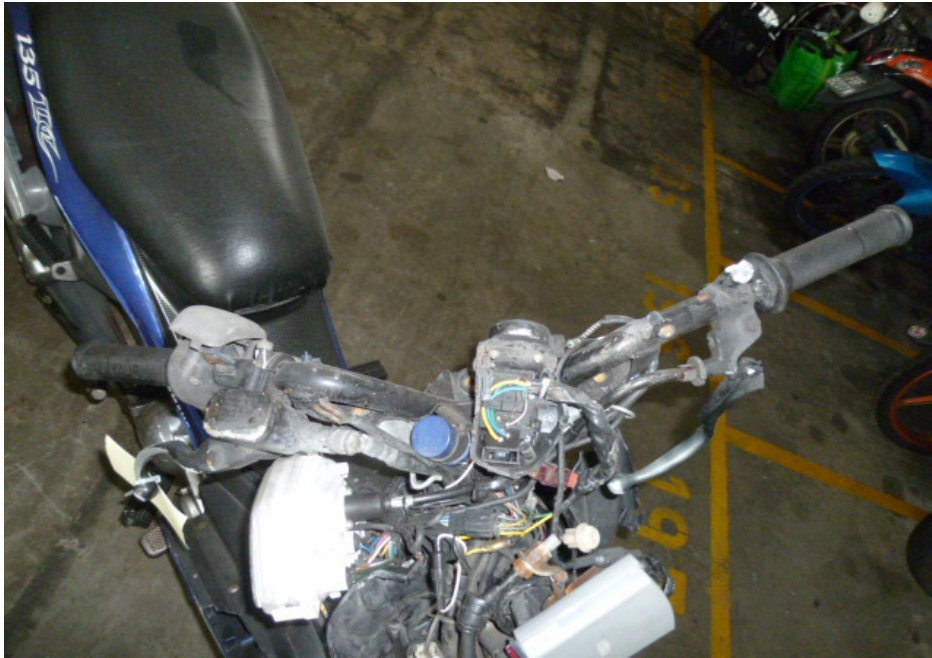
Photo 12 shows a closer view of the bent handlebar which were amongst the body parts of the Motorcycle that had sustained damage as a result of the accident.

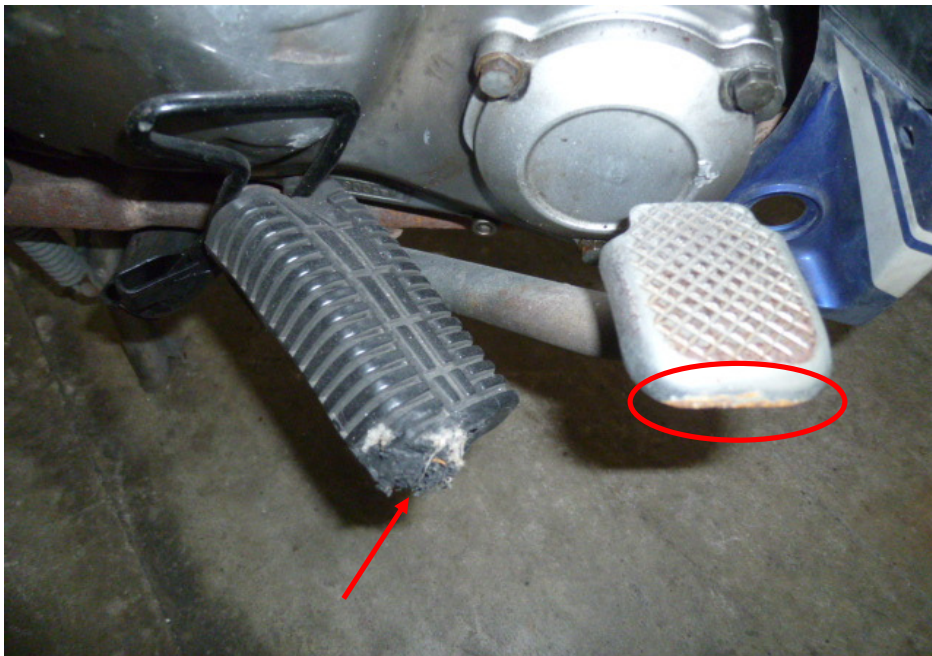
Photo 13 shows a closer view of the rear brake pedal (circled) and right front footrest (arrowed) which were amongst the body parts of the Motorcycle that had sustained damage as a result of the accident.

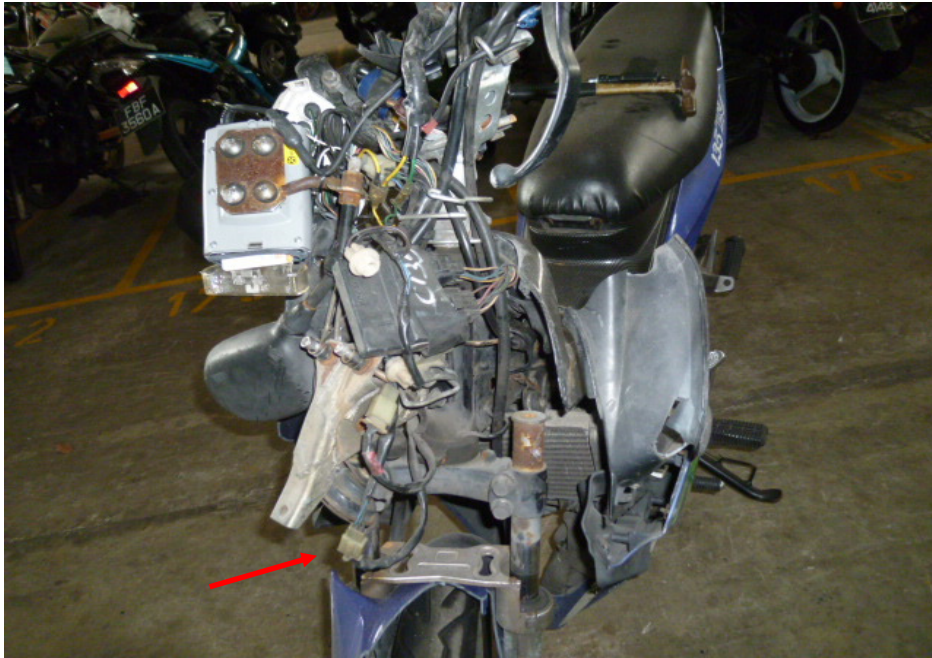
Photo 14 shows the missing front cowling of the Motorcycle at the time of our inspection (arrowed).

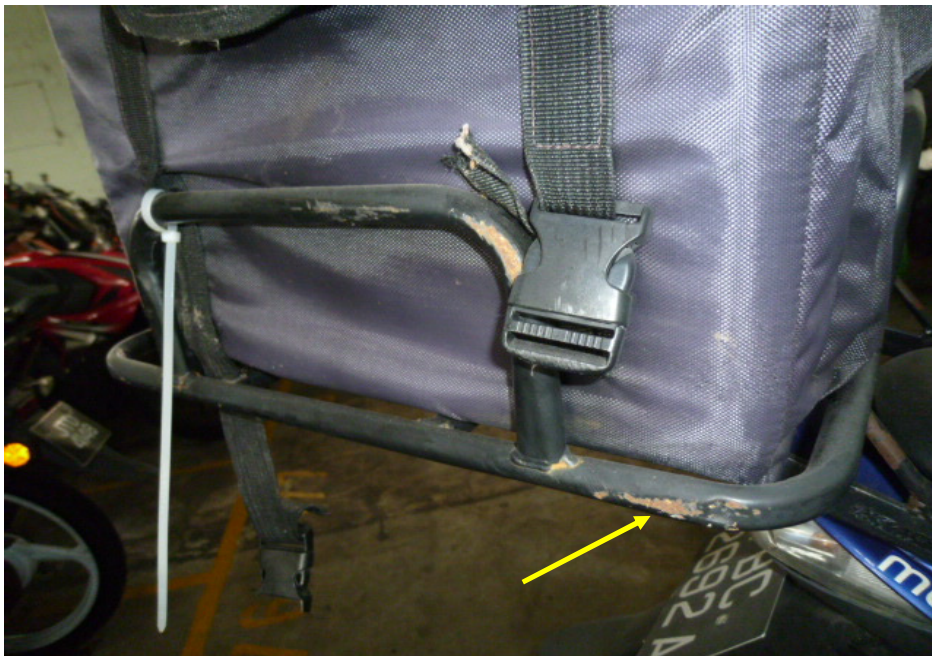
Photo 15 shows a closer view of the top box rack which was amongst the body parts of the Motorcycle that had sustained damages of grazing nature as a result of the accident (arrowed).

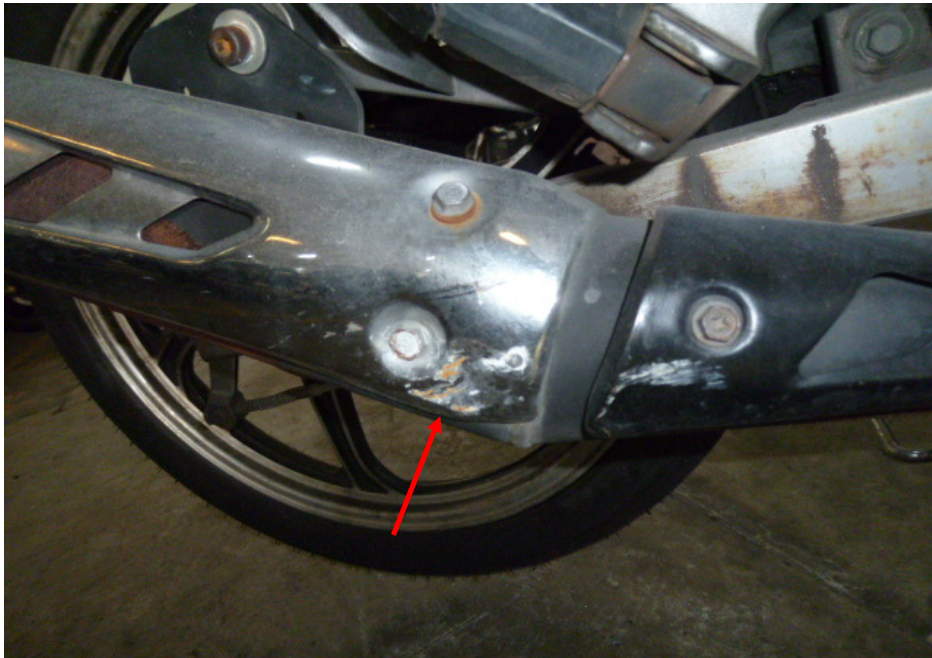
Photo 16 shows a closer view of the grazed exhaust muffler heat shield of the Motorcycle as a result of the accident (arrowed).

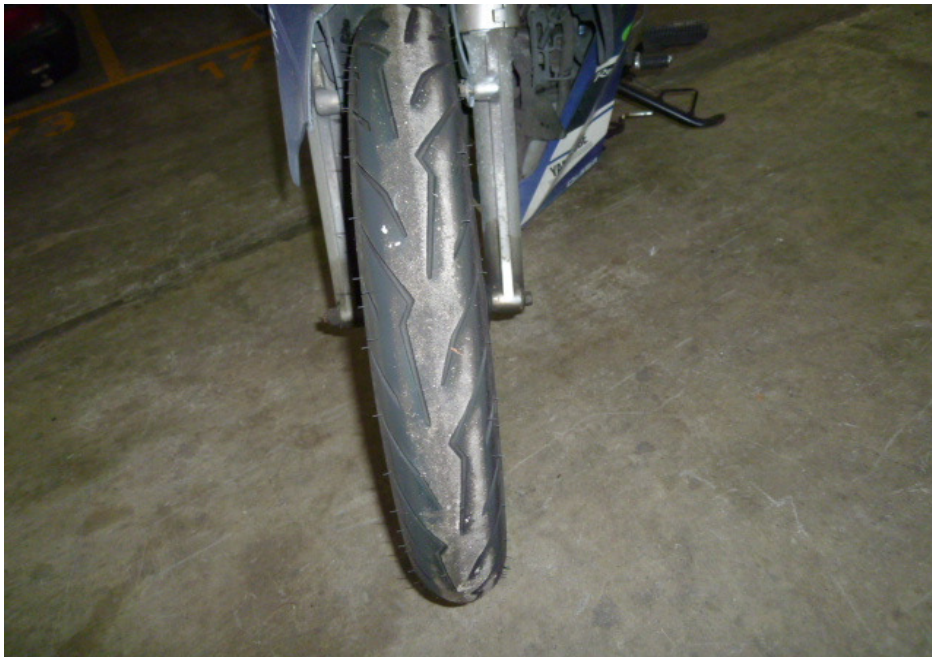
Photo 17 shows the front tyre of the Motorcycle at the time of our inspection. The front tyre was observed to be in serviceable condition with remaining tread depth of approximately 3mm. The pattern of the tread was also clearly visible. There was no tear, burst mark(s) and/or punctured hole(s) on the sidewalls as well as across the tread of the front tyre.

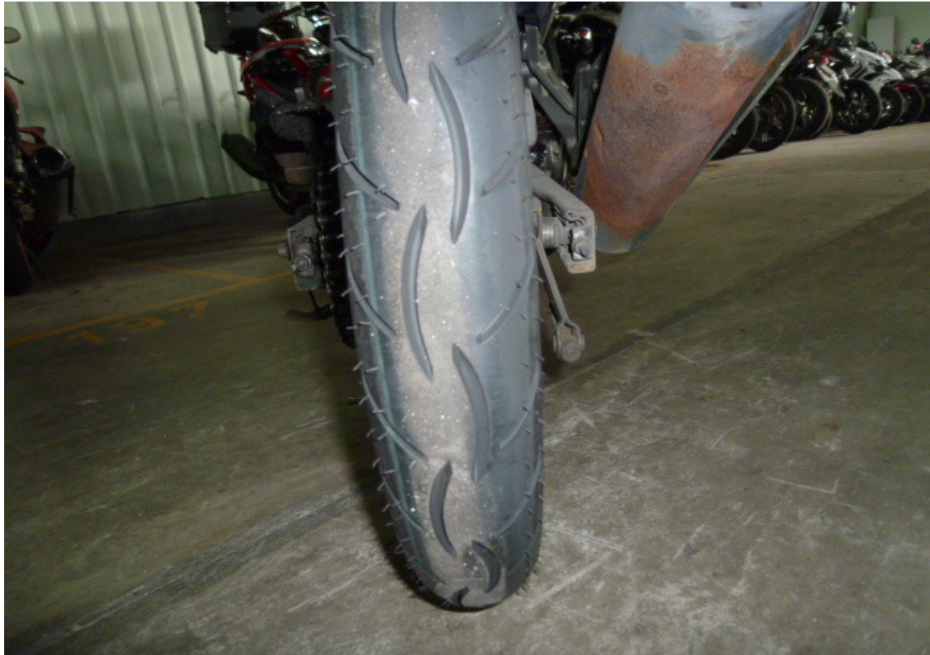
Photo 18 shows the condition of the Motorcycle's rear tyre. The rear tyre was observed to be in serviceable condition with remaining tread depth of approximately 7mm. The tyre was also observed to be sufficiently inflated for vehicular operation. We did not observe any tear, burst mark(s) and/or punctured hole(s) on the sidewalls as well as across the tread of the rear tyre.

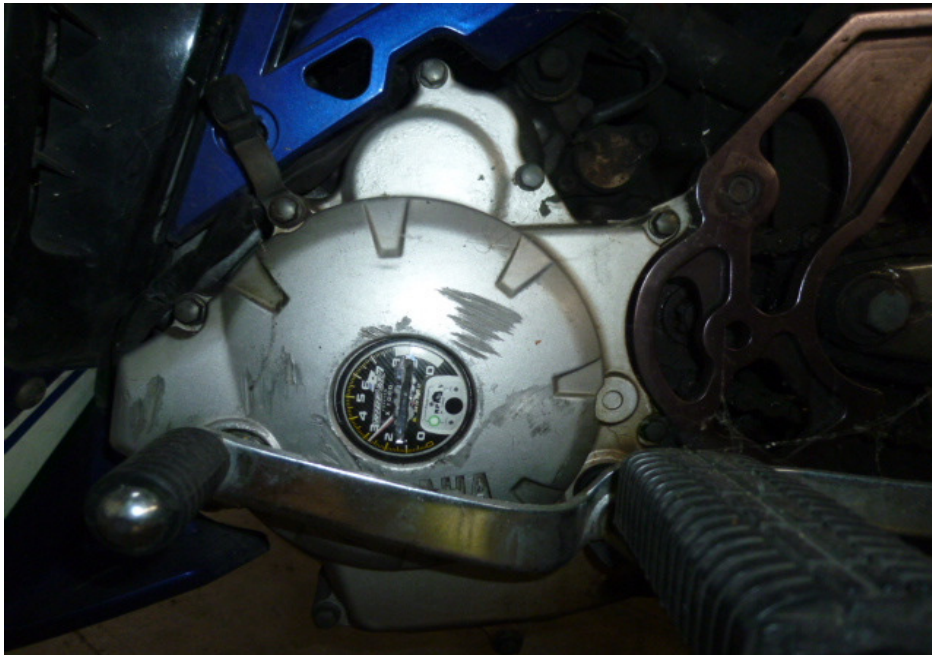
Photo 19 shows the left side of the engine of the Motorcycle at the time of our inspection. The various engine related parts and components were found to be intact with no visible damage. There was also no sign(s) or indication(s) of fluid leak observed around the left engine area of the Motorcycle.

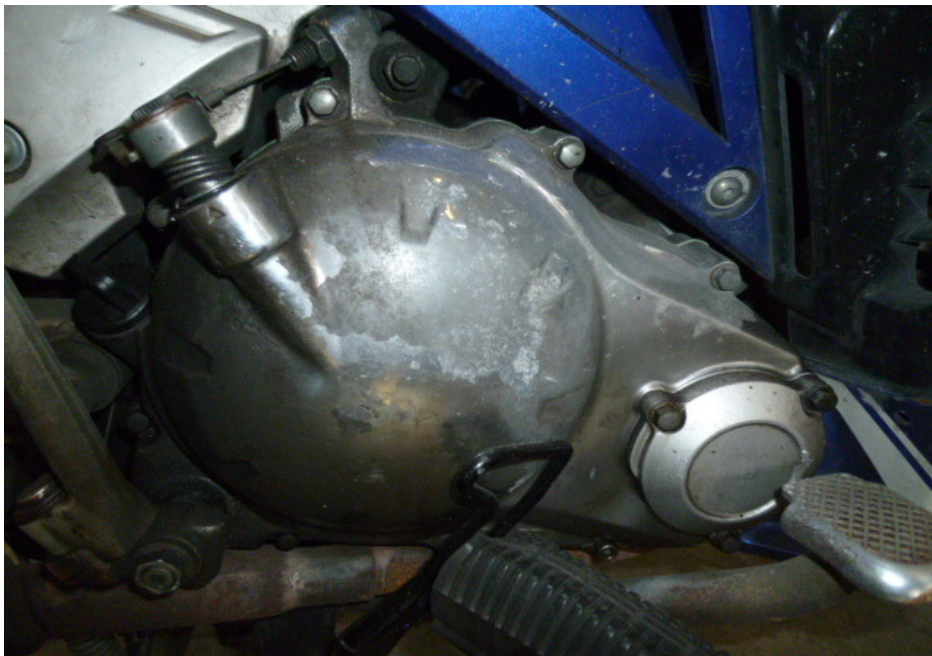
Photo 20 shows the right side of the engine of the Motorcycle at the time of our inspection. The various engine related parts and components were found to be intact with no visible damage. There was also no sign(s) or indication(s) of fluid leak observed around the right engine area of the Motorcycle.

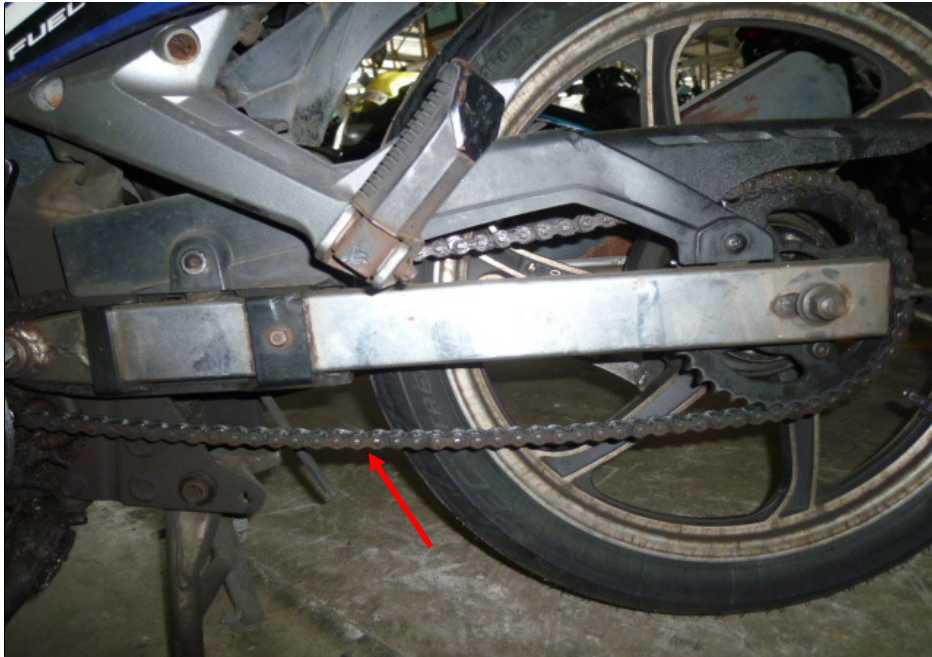
Photo 21 shows the gear chain (arrowed) of the Motorcycle, which was observed to be intact with no misalignment. It was also adequately lubricated for operating purposes. The gear train rotates the rear wheel of the Motorcycle.

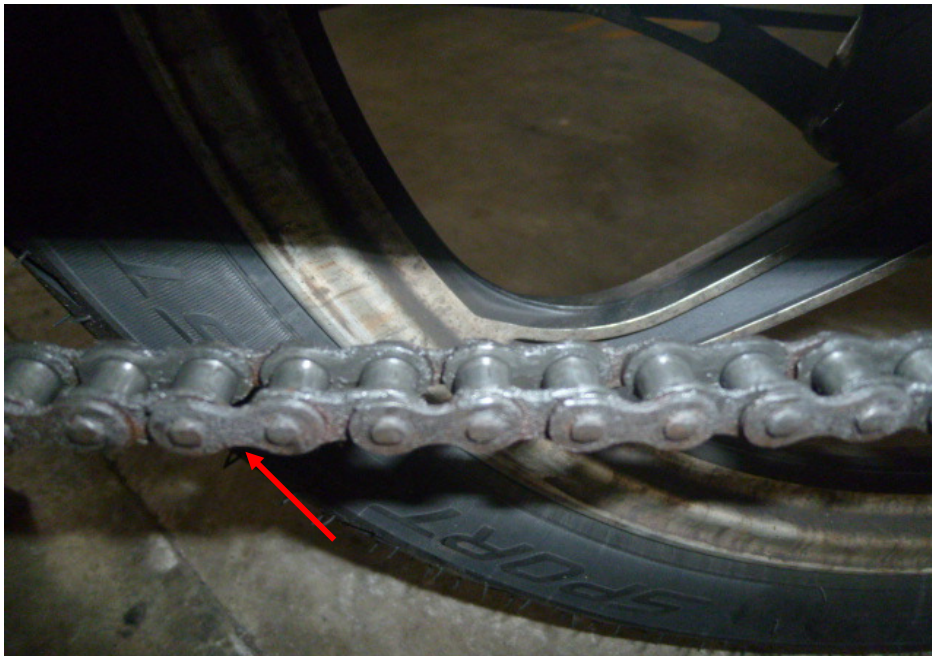
Photo 22 shows the closer view of the gear train (arrowed) of the Motorcycle, which was observed to be intact with no misalignment. It was also adequately lubricated for operating purposes.

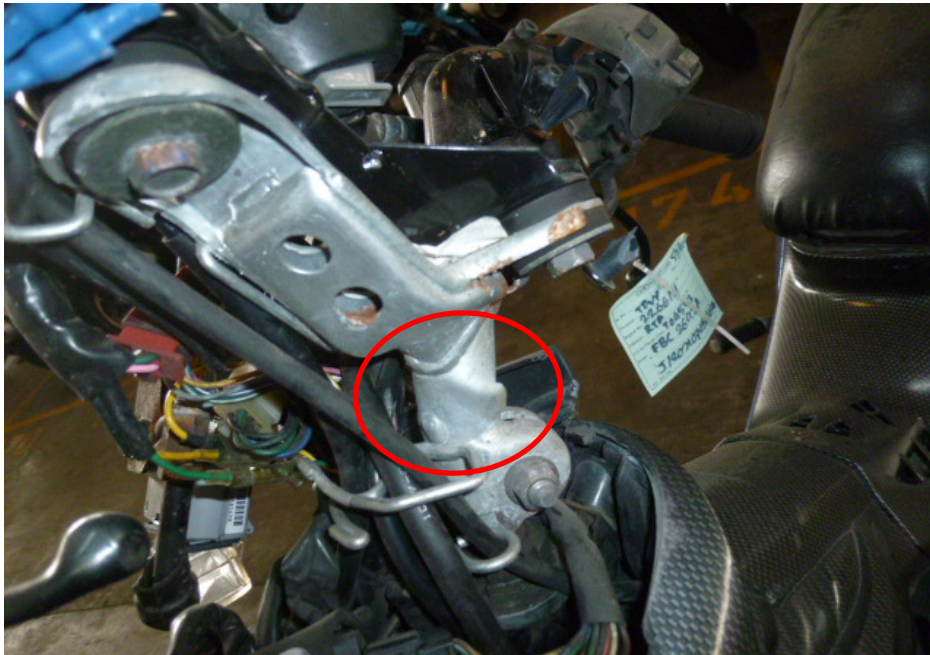
11. For this case, we were not able to conduct any test(s) on the steering system of the Motorcycle due to the damage to its steering stem. The steering stem was observed to be broken as a result of the accident.

Photo 23 shows the steering stem of the Motorcycle. The steering stem (circled) was observed to be broken as a result of the accident. We were hence not able to conduct any tests on the steering system of the Motorcycle.

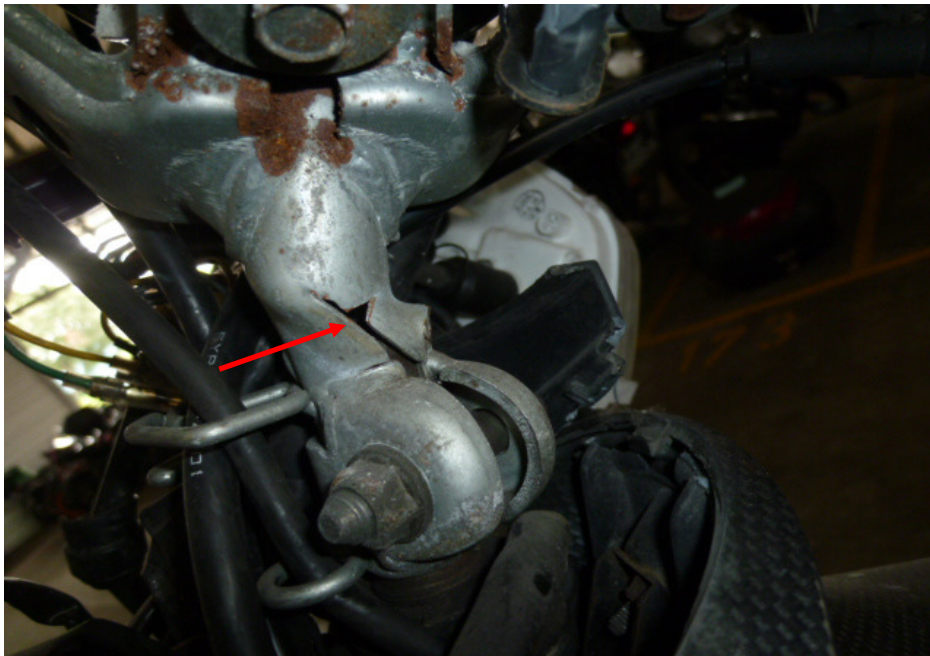
Photo 24 shows a close up view of the steering stem of the Motorcycle. The steering stem (arrowed) was observed to be broken as a result of the accident. We were hence not able to conduct any tests on the steering system of the Motorcycle.

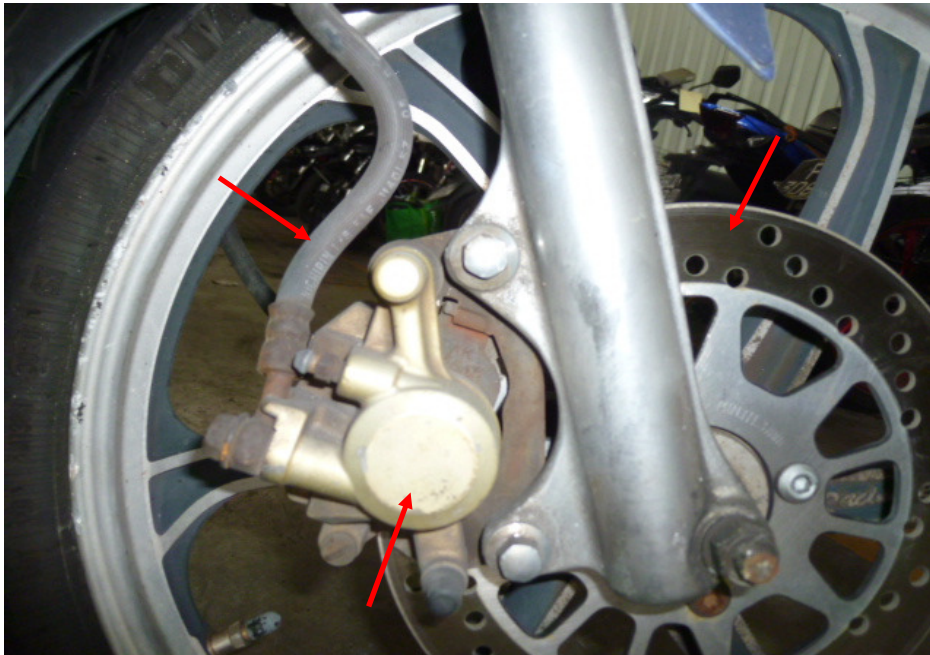
Photo 25 shows a close up view of the front brake caliper, front brake disc and front brake hose (arrowed) of the Motorcycle, which are all part of the components in the hydraulic front brake system of the Motorcycle. Our visual checks of these various components had revealed all to be intact with no visible damage. No leakage of brake fluid was also observed.

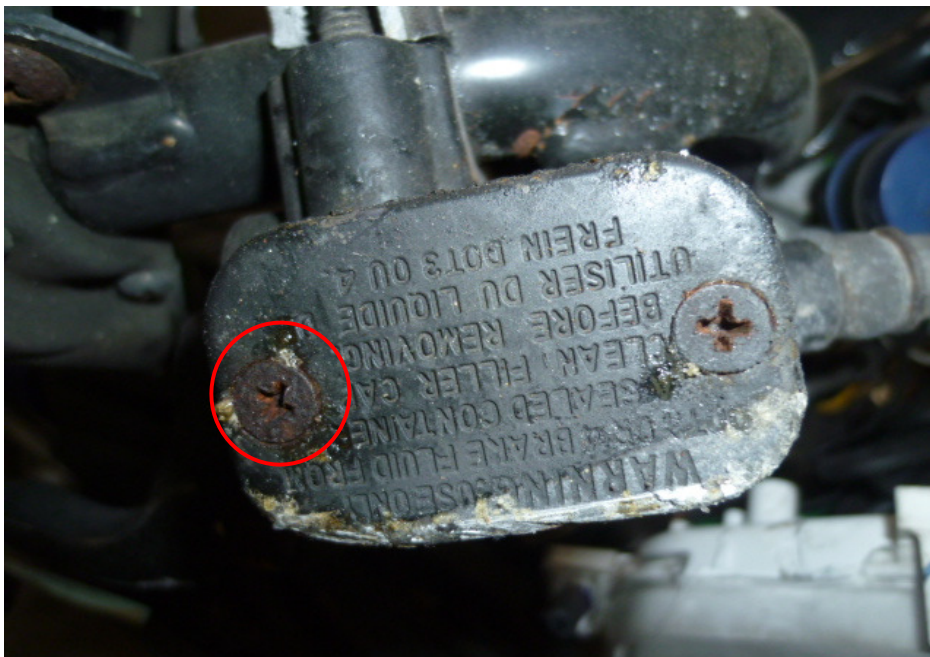
Photo 26 shows the brake fluid reservoir cover for the front brake of the Motorcycle. We were unable to examine whether the brake fluid was of sufficient level and without contamination for operational purposes due to the worn out screw (circled).

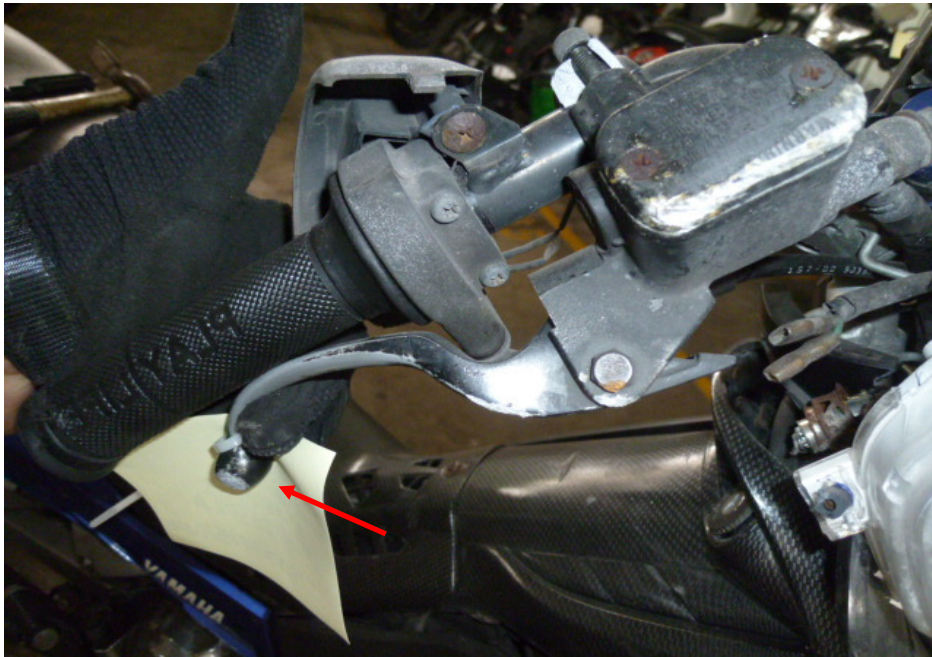
13. Static brake tests conducted on the Motorcycle had appear to indicate that the front braking system of the Motorcycle was not in serviceable condition. There was no resistance felt (spongy like feel) upon pressing the brake lever. This would indicate that there may be a leakage of pressure/vacuum in the front braking system.

Photo 27 shows the front brake lever being depressed. There was no resistance felt (spongy like feel) upon pressing the front brake lever (arrowed). This would indicate that there may be a leakage of pressure/vacuum in the front brake system.

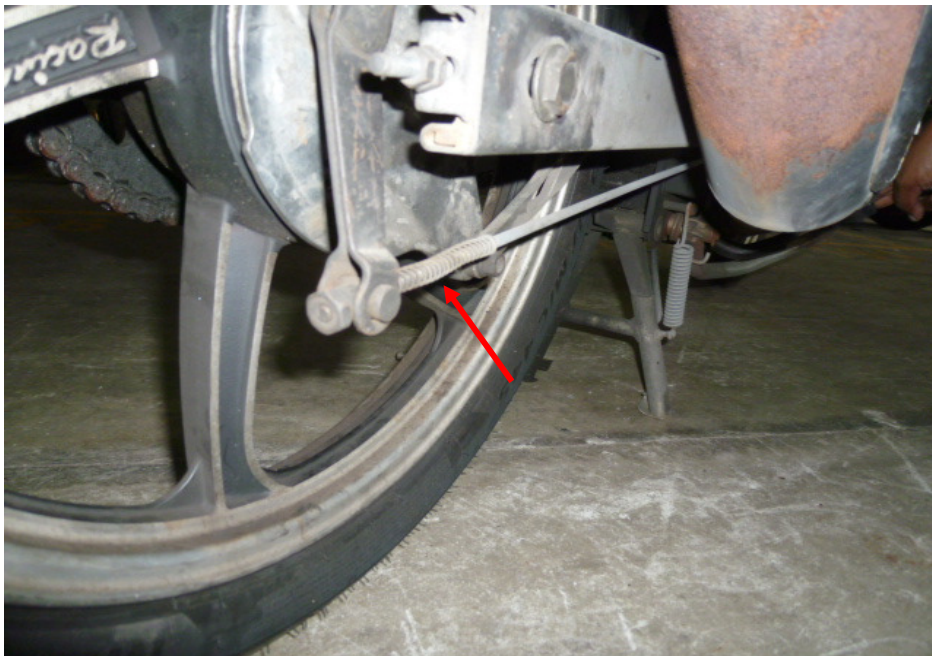
Photo 28 shows the rear wheel of the Motorcycle. The type of brake system for the rear wheel was of a mechanical type, controlled by the brake foot pedal of the Motorcycle. Our checks of the cable (arrowed), spring and drum which are all part of the components in the rear brake system of the Motorcycle reveal all to be intact and without damage.
