Your Ref: TP/IP/32687/2021
Our Ref : CI/TPD21010814/N

Fatal Accident Investigation Team

INSPECTION REPORT OF MOTORCYCLE FBK 2349A

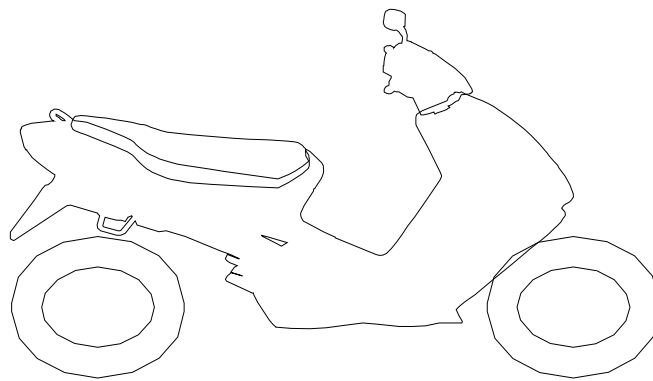
Bridgestone 190/55 - 17 (6mm)

Bridgestone 120/70 - 17 (4mm)
Cut / Deflated

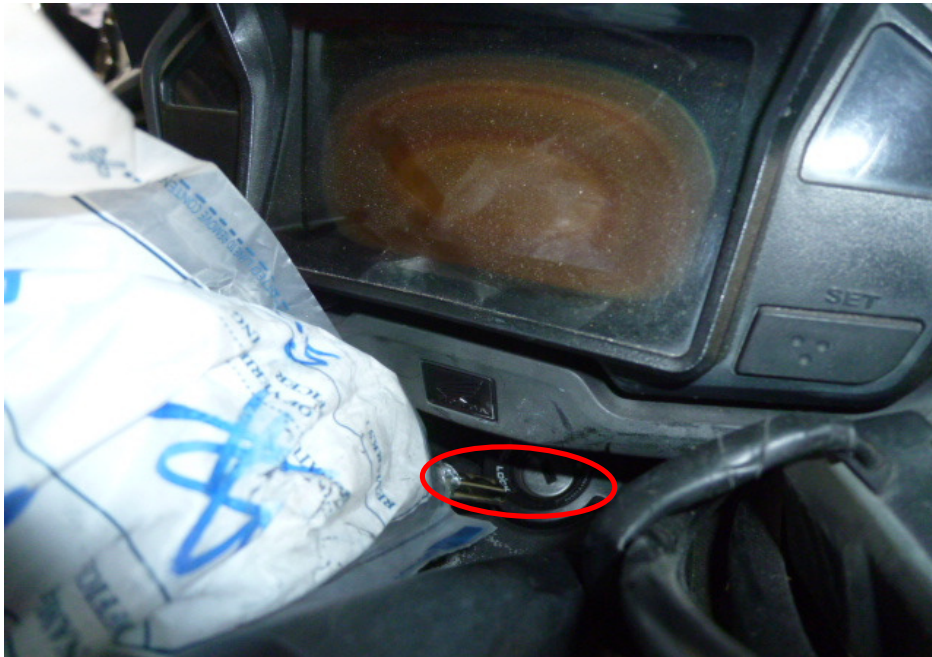
Photo 1 shows mileage of the Motorcycle which could not be recorded at the time of our inspection due to the damages sustained to the speedometer gauge. (circled).

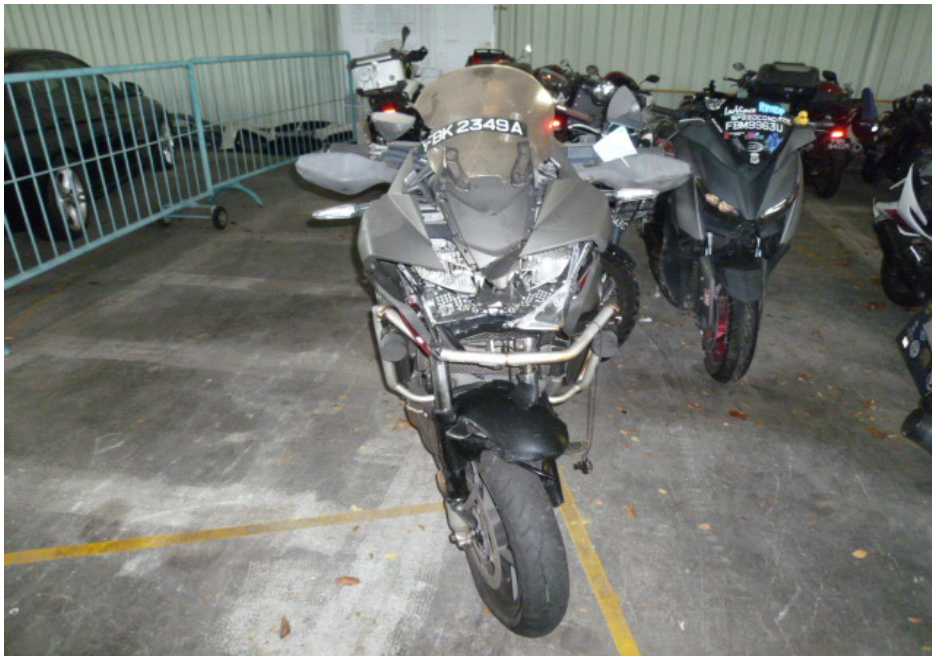
Photo 2 shows a general view of the frontal portion of the Motorcycle at the time of our inspection. The Motorcycle was observed to have sustained damages at its frontal portion and right body.

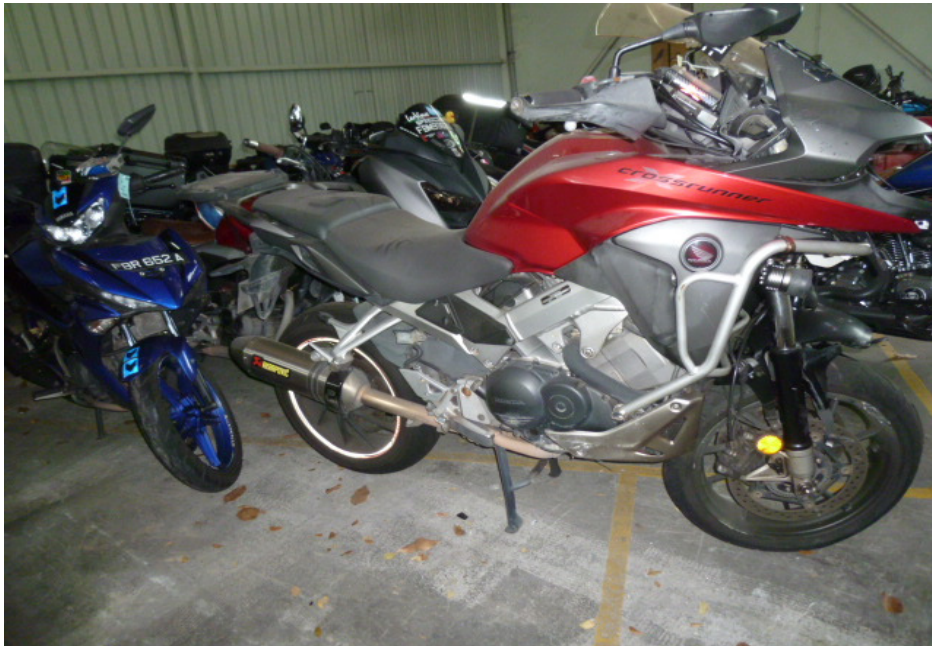
Photo 3 shows a general view of the right body of the Motorcycle at the time of our inspection. The Motorcycle was observed to have sustained damages at its frontal portion and right body.

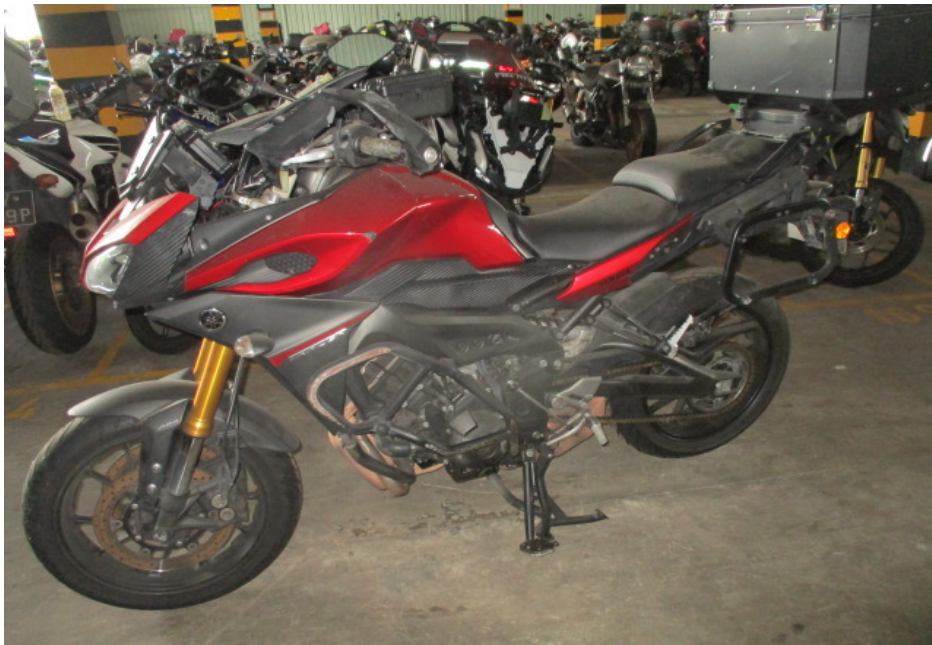
Photo 4 shows a general view of the left body of the Motorcycle at the time of our inspection. The Motorcycle was observed to have sustained damages at its frontal portion and right body. The body parts that were found to have been damaged include its windshield, headlight assembly, front cowling, front mudguard, right cowling, petrol tank, front brake lever guard, right side mirror, rear brake pedal, right front footrest and exhaust muffler protector, amongst others.

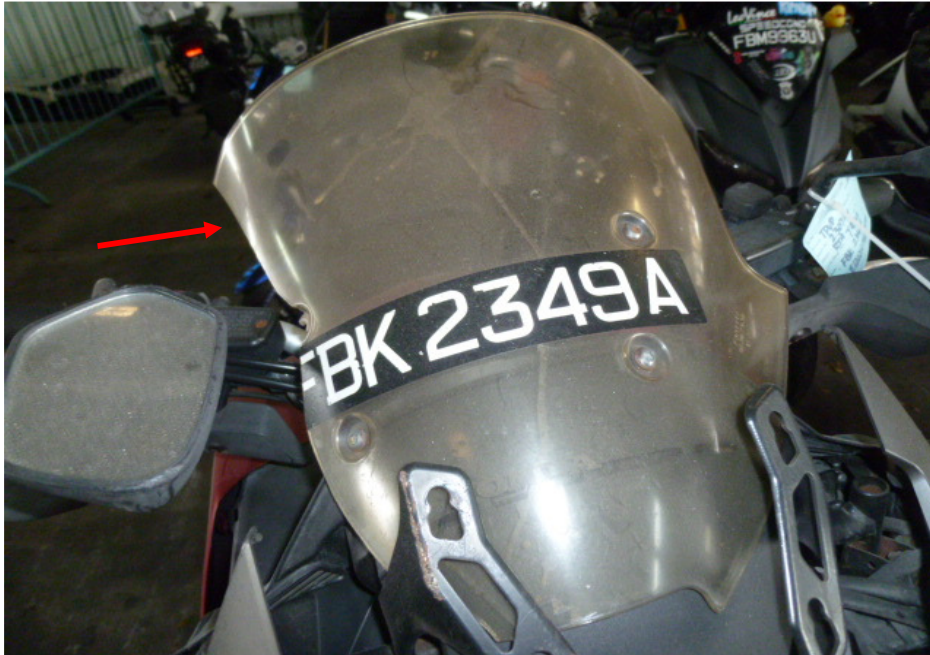
Photo 5 shows a close up view of the broken windshield was amongst the body parts of the Motorcycle that had sustained damage as a result of the accident (arrowed).

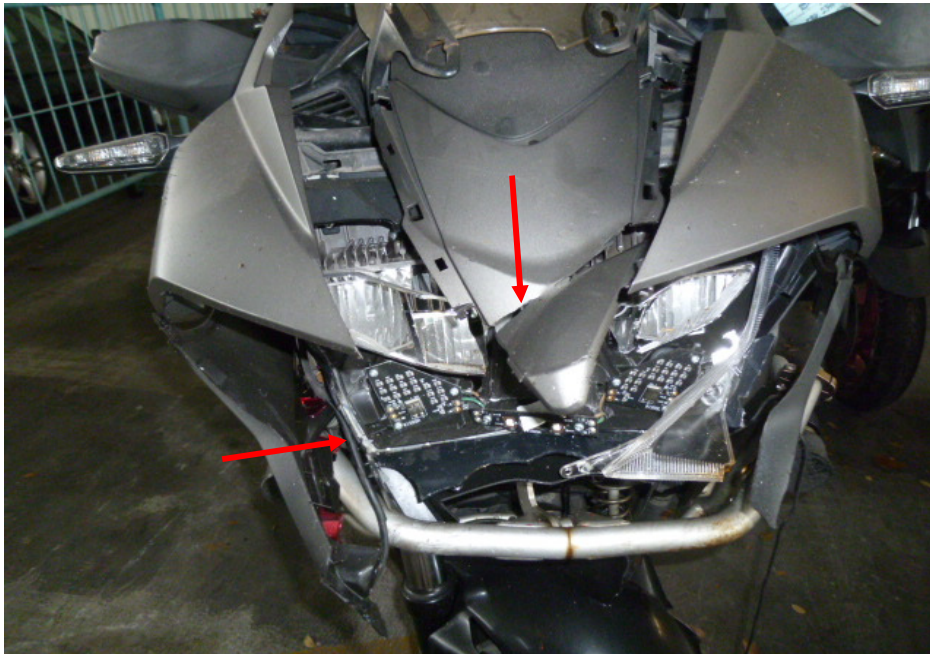
Photo 6 shows a closer view of the cracked headlight assembly and front cowl which were amongst the body parts at the front body of the Motorcycle that had sustained damage as a result of the accident (arrowed).

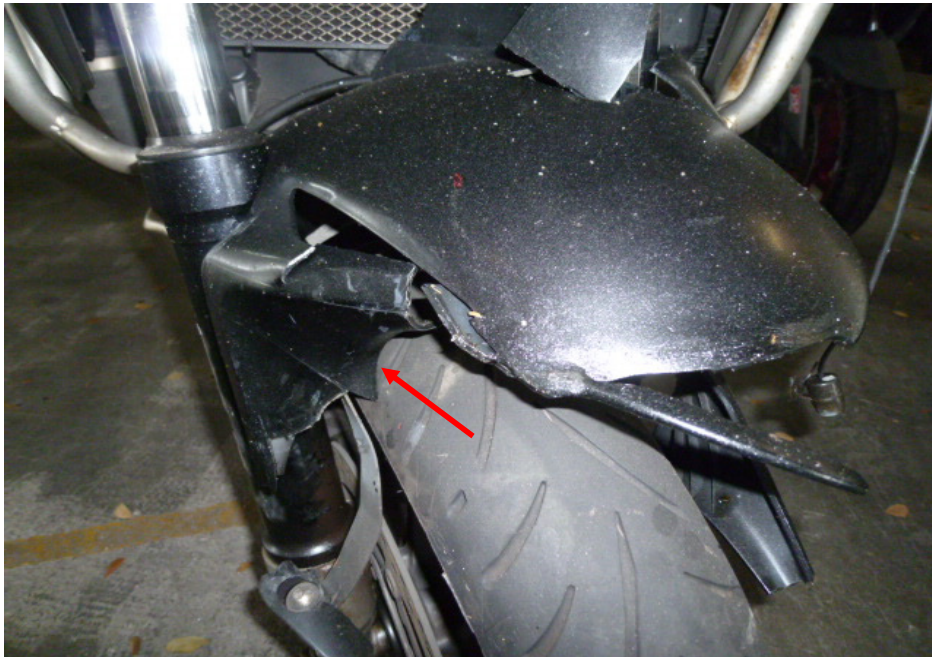
Photo 7 shows a closer view of the cracked front mudguard of the Motorcycle as a result of the accident (arrowed).

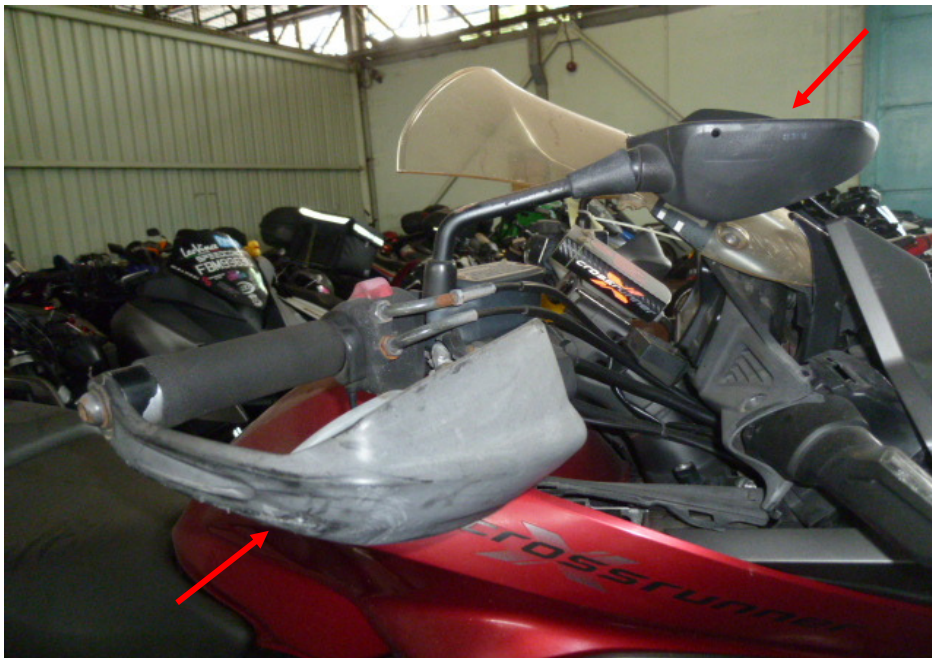
Photo 8 shows a closer view of the front brake lever guard and right side mirror (arrowed) which were amongst the body parts of the Motorcycle that had sustained damage as a result of the accident.

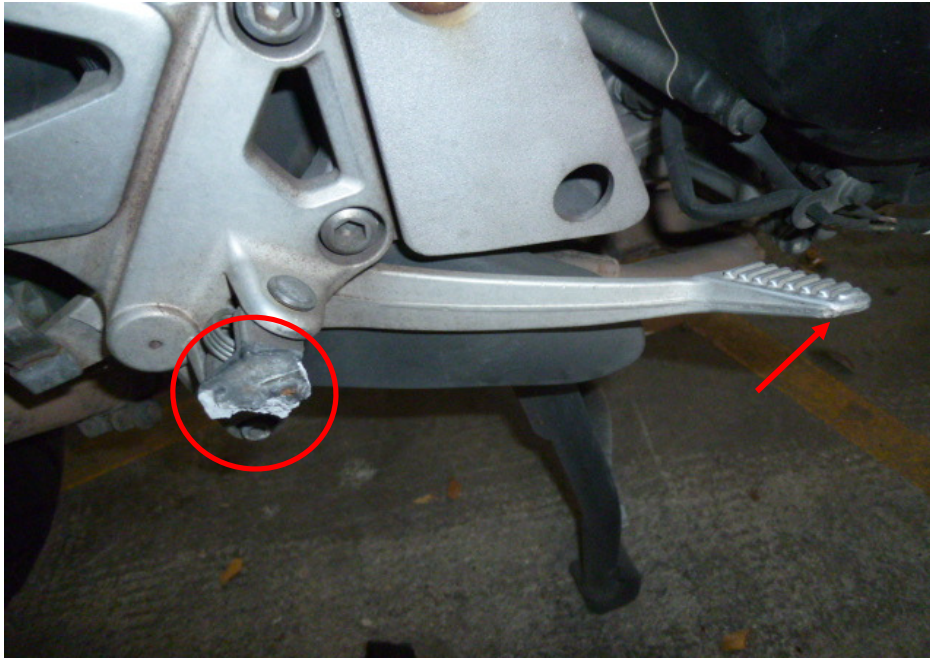
Photo 9 shows a closer view of the rear brake pedal (arrowed) and broken right front footrest (circled) which were amongst the body parts of the Motorcycle that had sustained damage as a result of the accident.

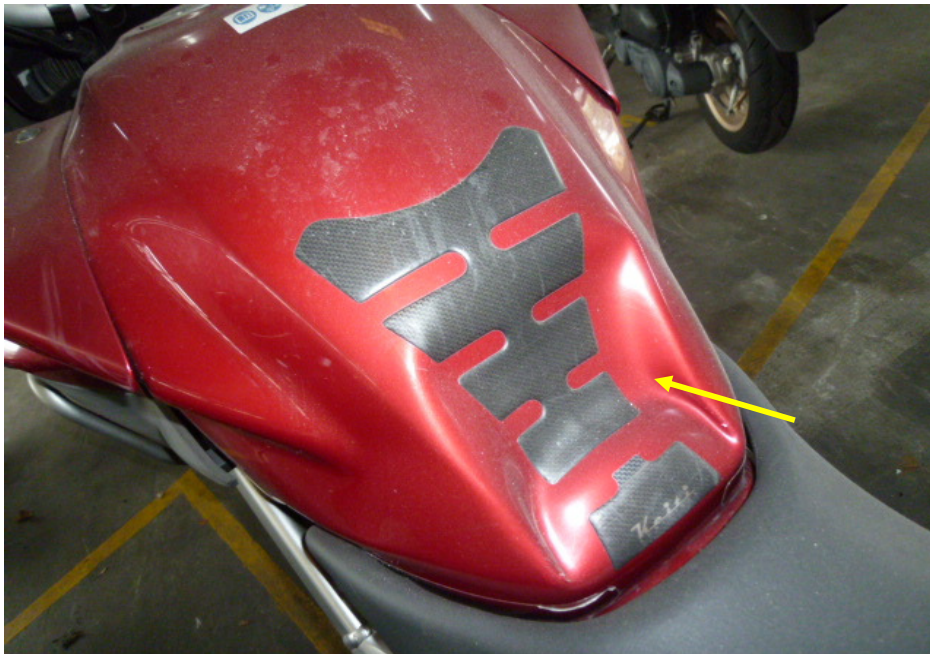
Photo 10 shows a closer view of the dented petrol tank of the Motorcycle as a result of the accident (arrowed).

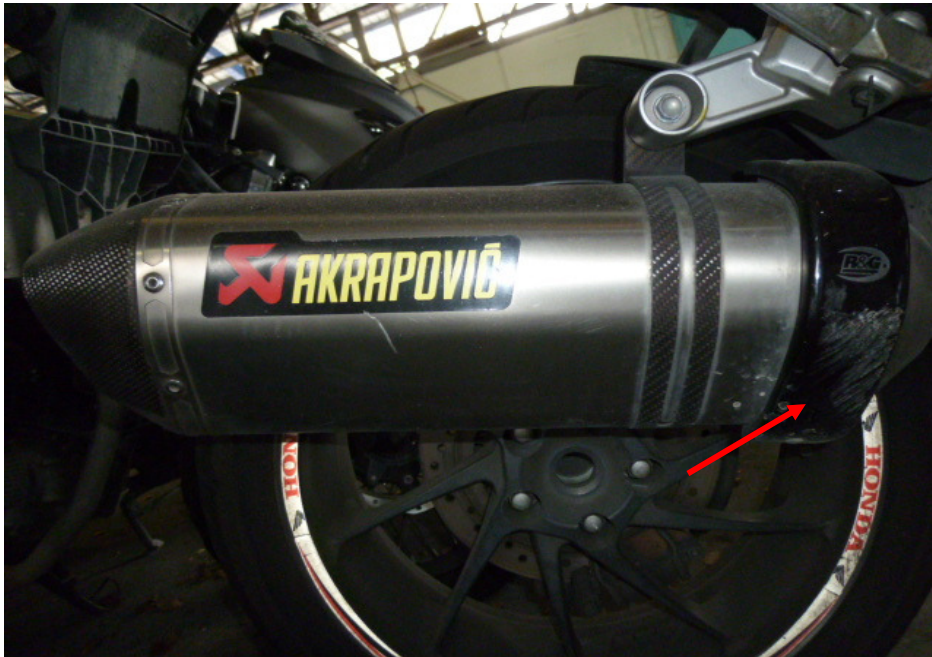
Photo 11 shows a closer view of the exhaust muffler protector which was amongst the body parts of the Motorcycle that had sustained damages of grazing nature as a result of the accident (arrowed).

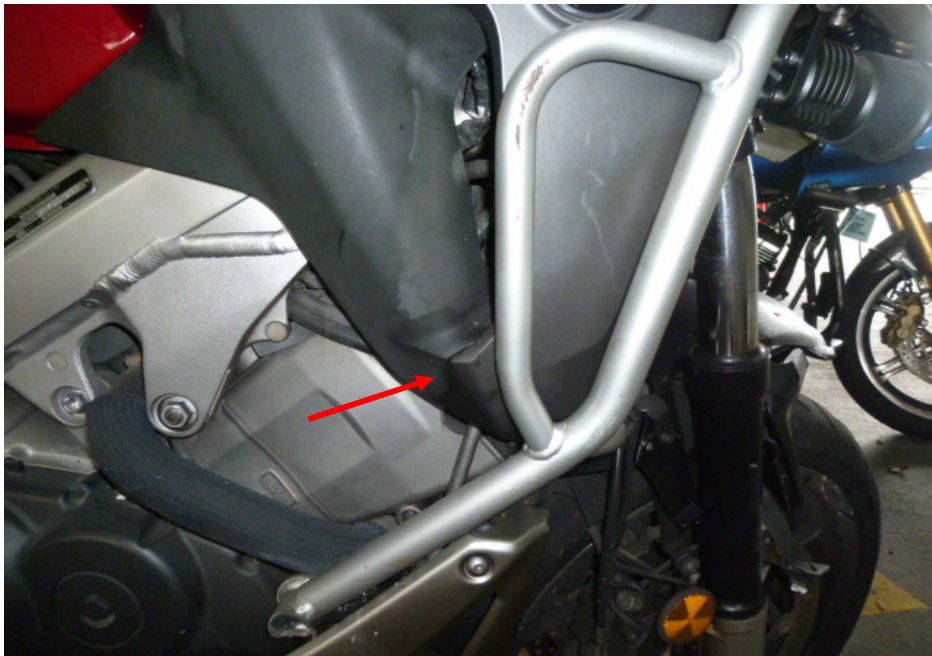
Photo 12 shows a closer view of the cracked right cowling of the Motorcycle as a result of the accident (arrowed).

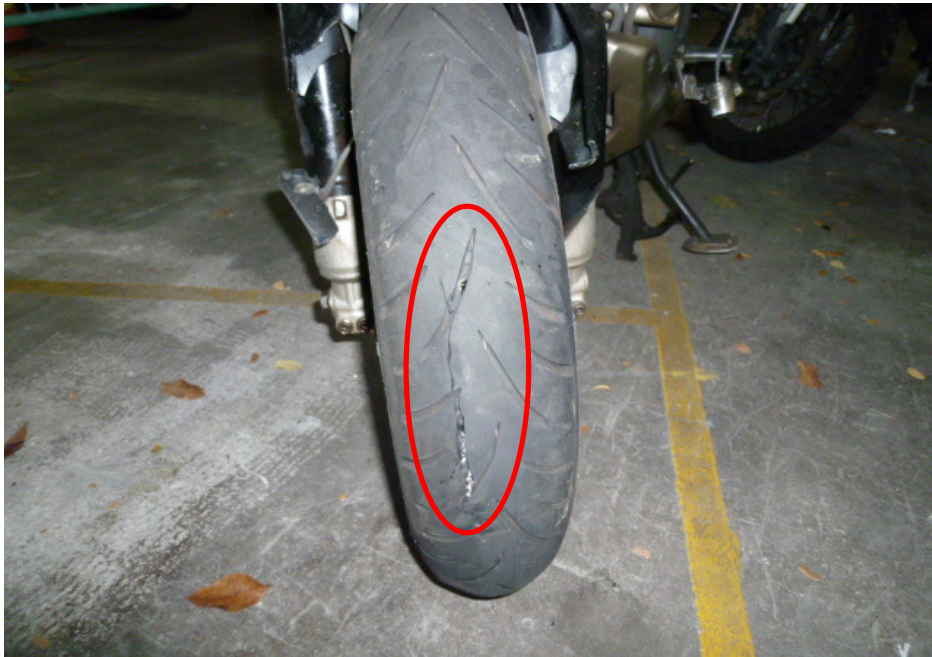
Photo 13 shows the condition of the Motorcycle's front tyre. The front tyre was observed to be in serviceable condition with remaining tread depth of approximately 4mm. The tyre was observed to be deflated. We also observed a tear on the front tyre as a result of the accident (circled).

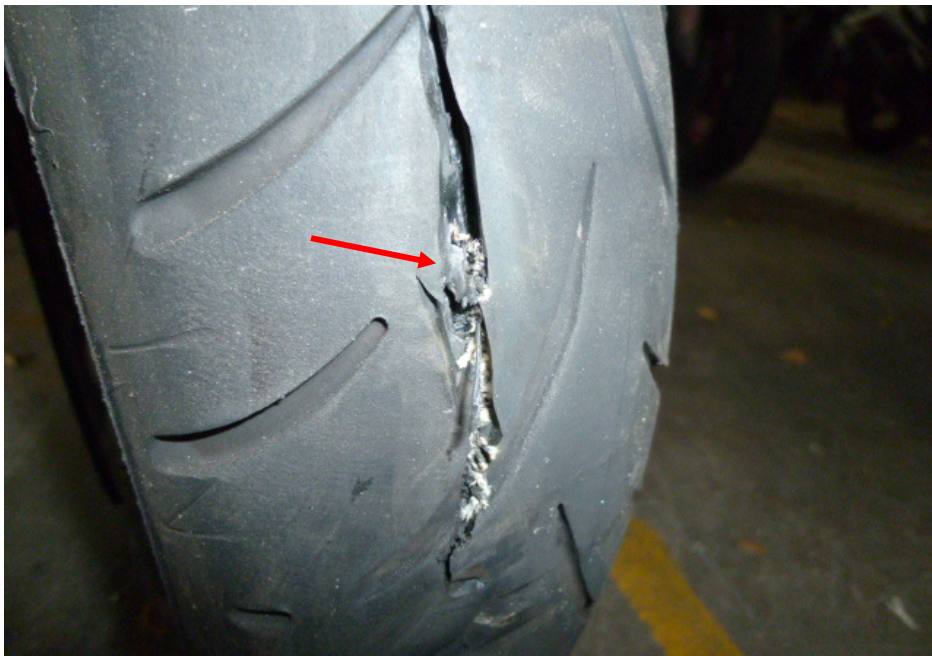
Photo 14 shows a closer view of the tear on the front tyre as a result of the accident (arrowed).

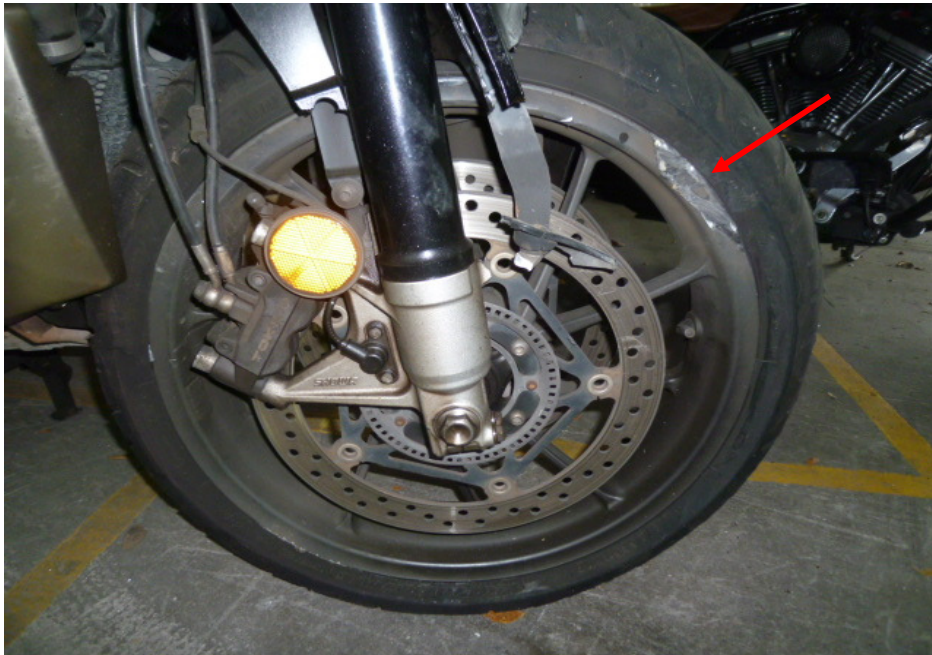
Photo 15 shows the deflated front tyre and grazed front wheel rim (arrowed) of the Motorcycle as a result of the accident at the time of our inspection.

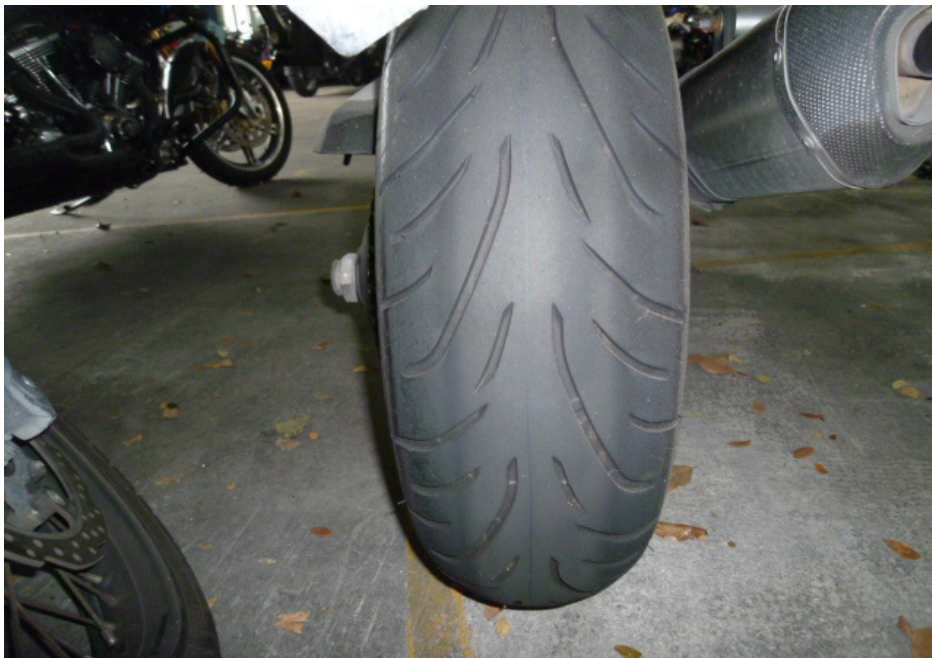
Photo 16 shows the condition of the Motorcycle's rear tyre. The rear tyre was observed to be in serviceable condition with remaining tread depth of approximately 6mm. The tyre was also observed to be sufficiently inflated for vehicular operation. We did not observe any tear, burst mark(s) and/or punctured hole(s) on the sidewalls as well as across the tread of the rear tyre.

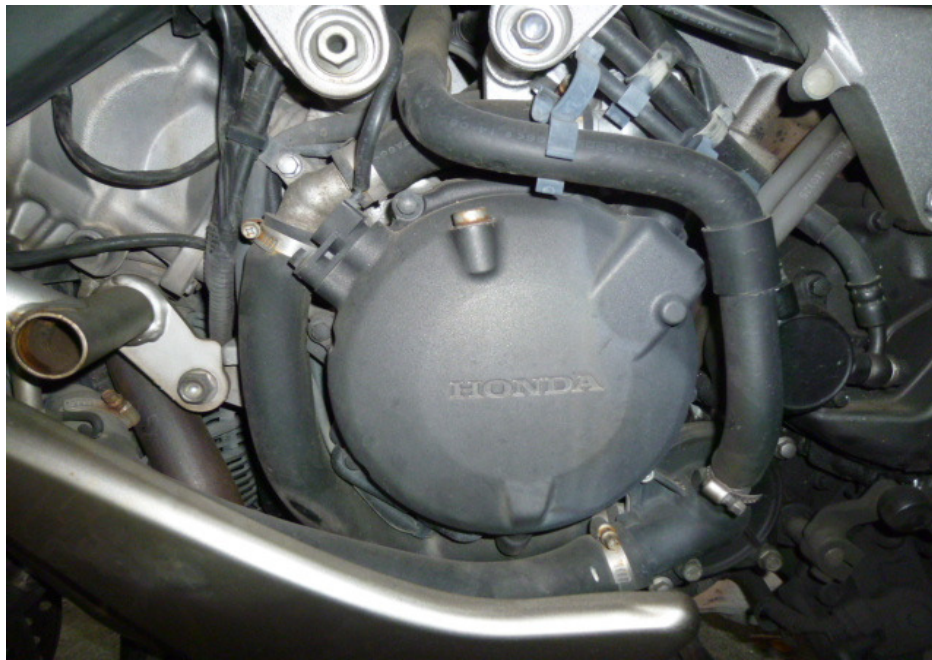
Photo 17 shows the left side of the engine of the Motorcycle at the time of our inspection. The various engine related parts and components were found to be intact with no visible damage. There was also no sign(s) or indication(s) of fluid leak observed around the left engine area of the Motorcycle.

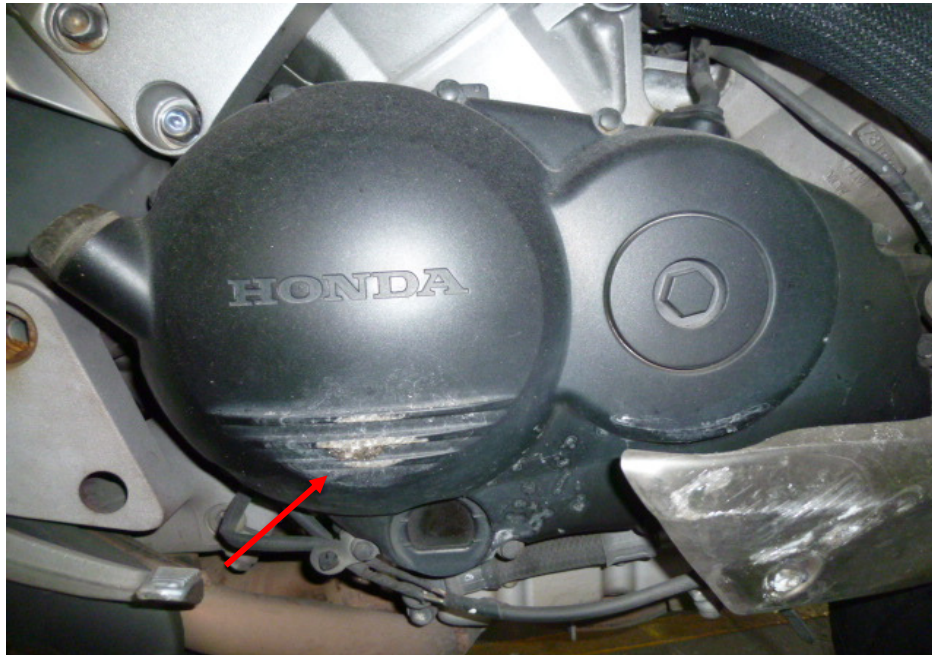
Photo 18 shows the right side of the engine of the Motorcycle at the time of our inspection. The various left engine components had sustained damage of grazing nature as a result of the accident (arrowed) however the engine components were still intact. There was also no fluid leak and/or fluid stain found around the right engine area of the Motorcycle.

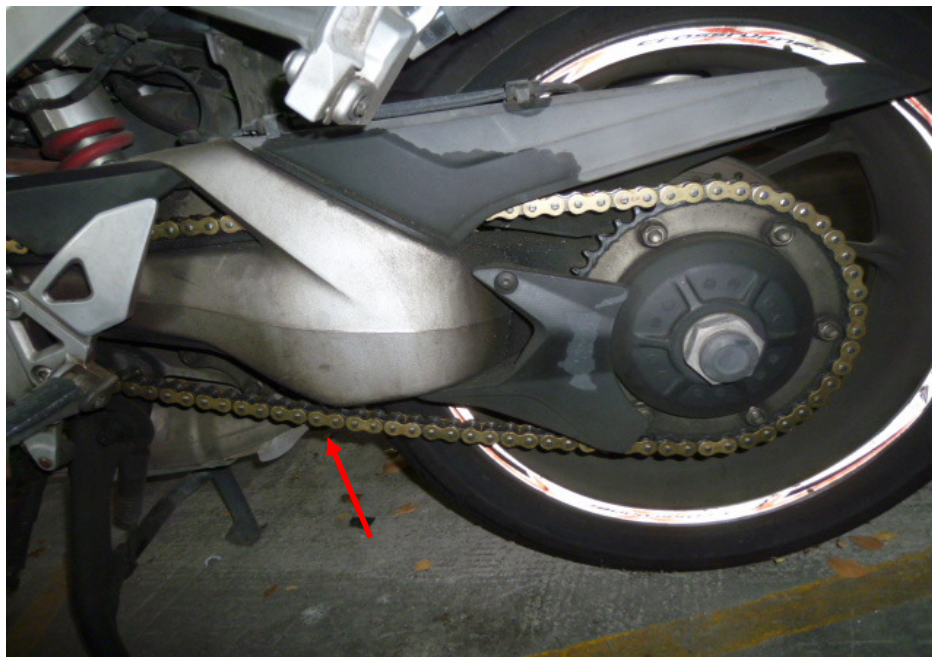
Photo 19 shows the general view of the gear chain (arrowed) of the Motorcycle, which was observed to be intact with no misalignment. It was also adequately lubricated for operating purposes.

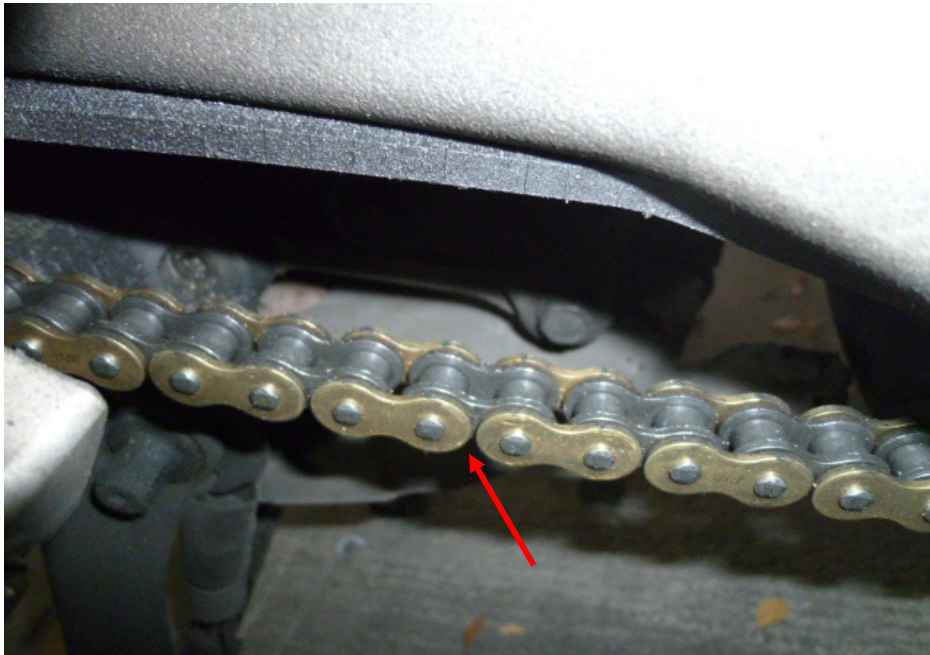
Photo 20 shows a closer view of the gear chain (arrowed) of the Motorcycle, which was observed to be intact with no misalignment. It was also adequately lubricated for operating purposes.

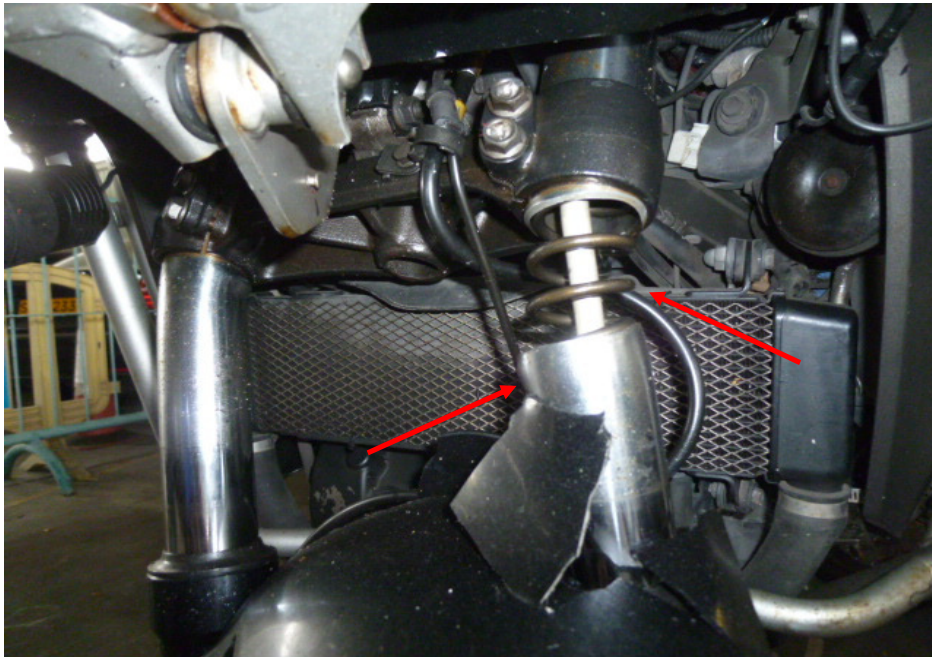
12. For this case, we were not able to conduct any test(s) on the steering system of the Motorcycle due to the damage of its front fork assembly. The front left fork was found to be broken as a result of the accident which had rendered the Motorcycle immobile.

Photo 21 shows the front fork assembly of the Motorcycle. The left front fork was found to be broken as a result of the accident (arrowed) which had rendered the Motorcycle immobile. Hence we were not able to conduct any test(s) on the steering system of the Motorcycle.

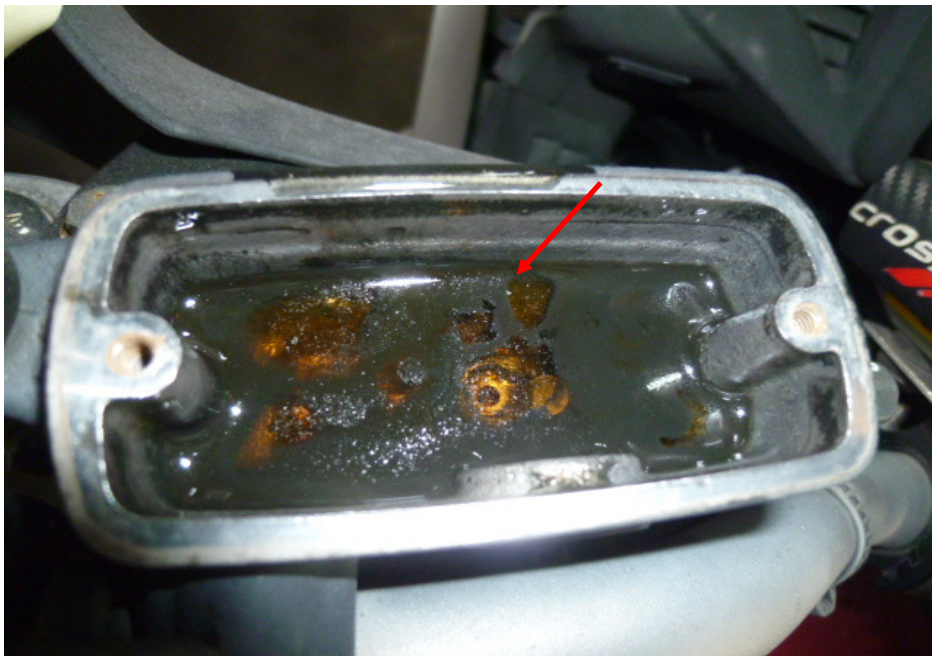
Photo 22 shows the hydraulic clutch fluid reservoir for the hydraulic clutch system of the Motorcycle. The hydraulic clutch fluid was observed to be of sufficient level for operational purposes. However it was also found to be slightly contaminated (arrowed).

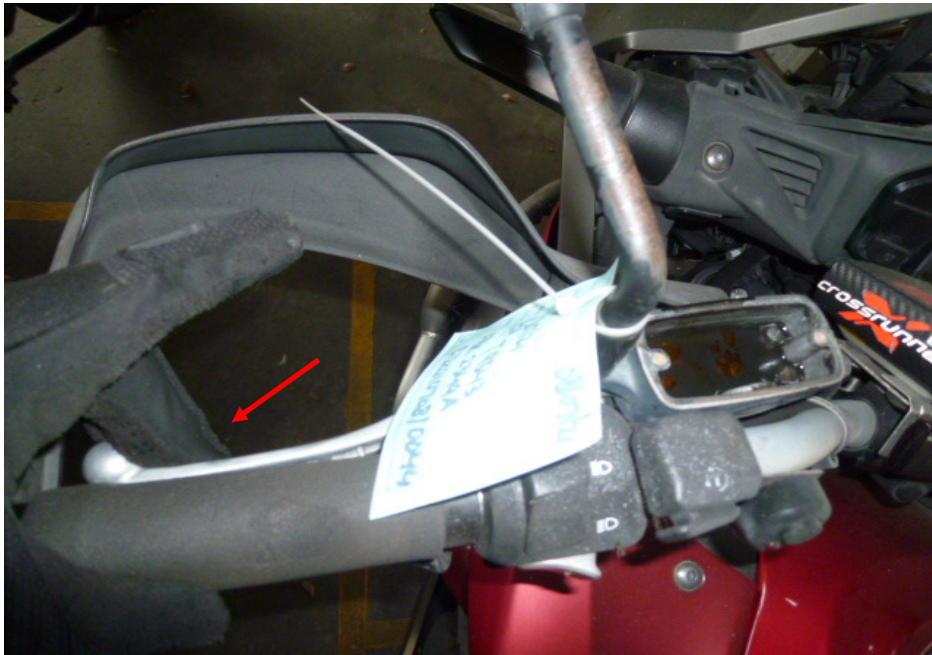
Photo 23 shows the clutch lever being depressed. There was some resistance felt (spongy like feel) upon pressing the clutch lever (arrowed). This would indicate that there is no leakage of pressure/vacuum in the hydraulic clutch system.

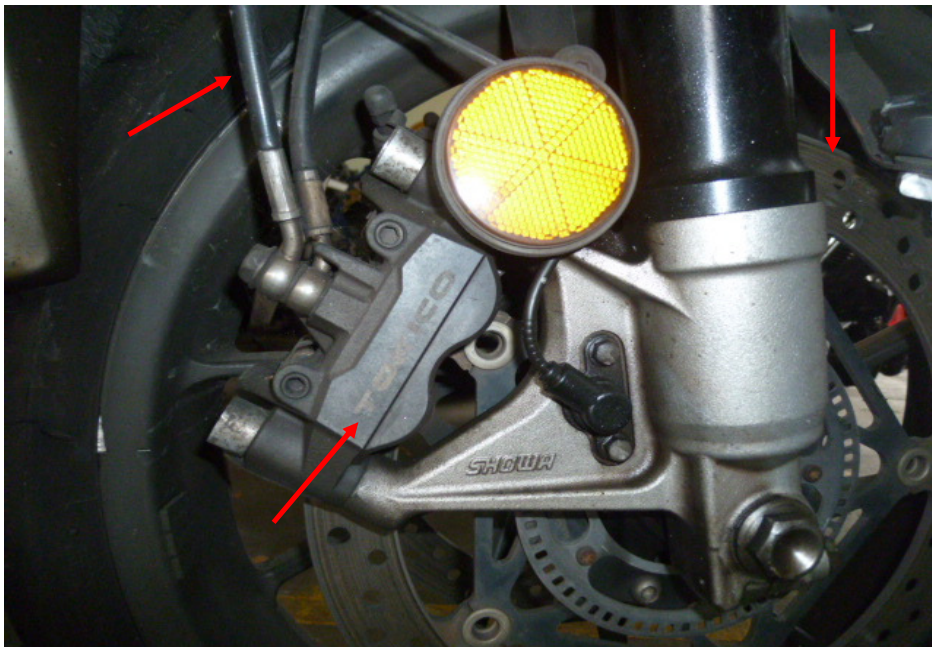
Photo 24 shows a close up view of the front brake caliper, front brake disc and front brake hose (arrowed) at the right side of the Motorcycle's front wheel, which are all part of the components in the hydraulic front brake system of the Motorcycle. Our visual checks of these various components had revealed all to be intact with no visible damage. No leakage of brake fluid was also observed.

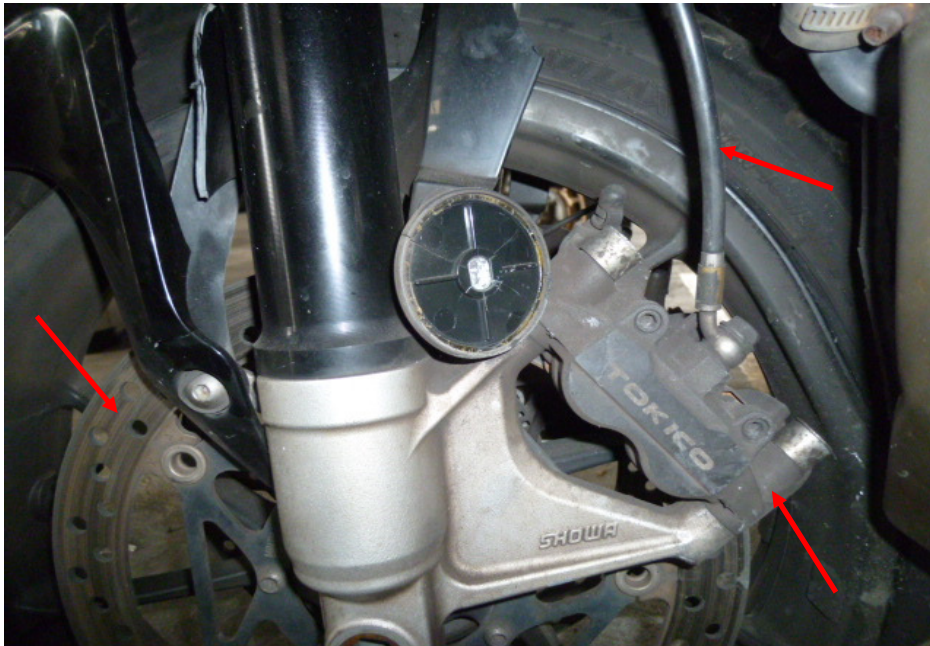
Photo 25 shows a close up view of the front brake caliper, front brake disc and front brake hose (arrowed) at the left side of the Motorcycle's front wheel, which are all part of the components in the hydraulic front brake system of the Motorcycle. Our visual checks of these various components had revealed all to be intact with no visible damage. No leakage of brake fluid was also observed.

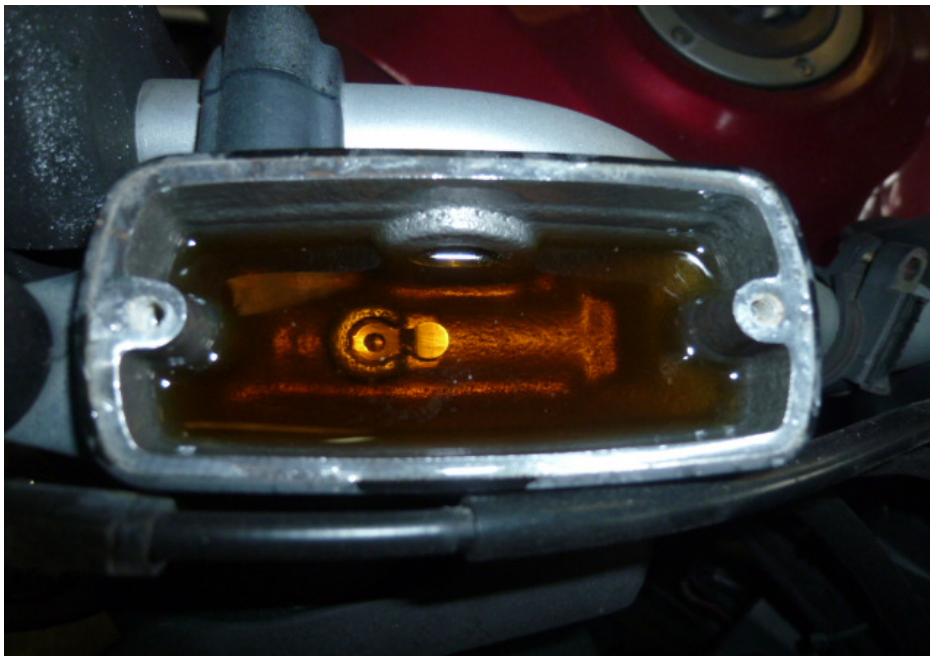
Photo 26 shows the brake fluid reservoir for the front brake of the Motorcycle. The brake fluid was observed to be of sufficient level for operational purposes and without contamination.

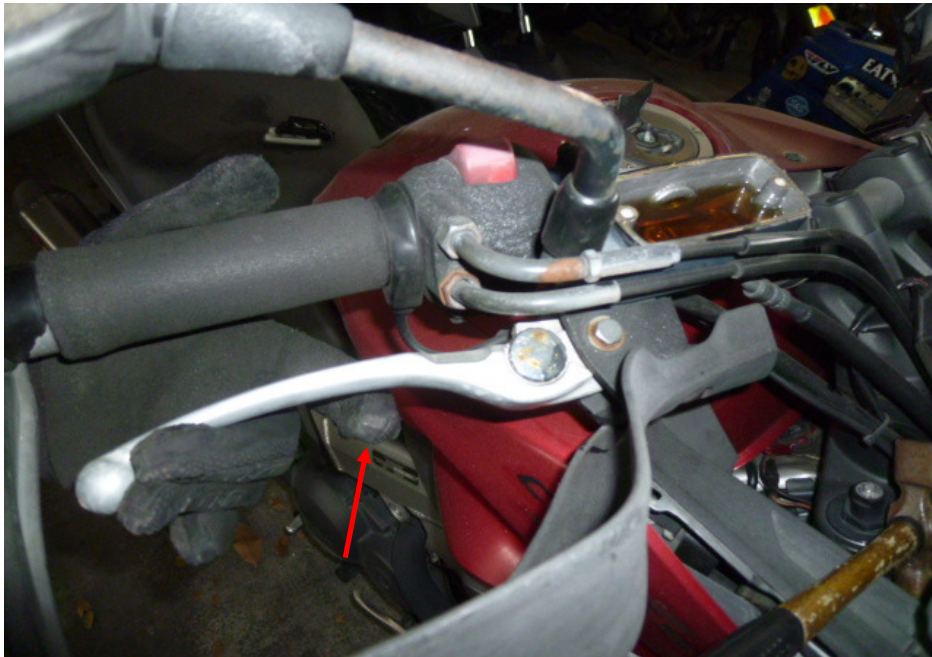
Photo 27 shows the front brake lever being depressed. There was some resistance felt (spongy like feel) upon pressing the front brake lever (arrowed). This would indicate that there is no leakage of pressure/vacuum in the brake system.

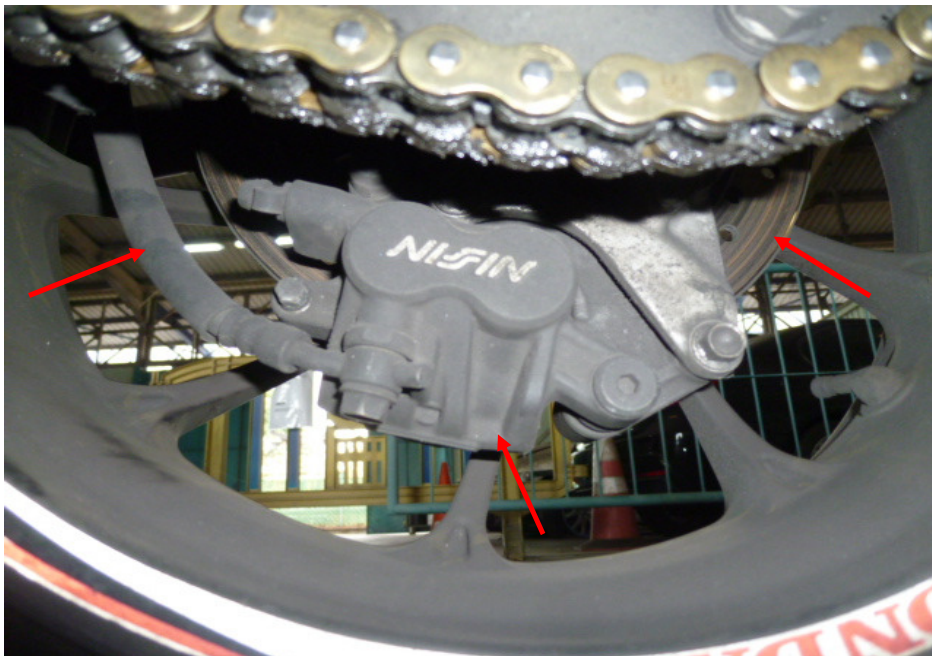
Photo 28 shows a close up view of the rear brake caliper, rear brake disc and rear brake hose (arrowed) of the Motorcycle, which are all part of the components in the hydraulic rear brake system of the Motorcycle. Our visual checks of these various components had revealed all to be intact with no visible damage. No leakage of brake fluid was also observed.
