Your Ref: TP/IP/25247/2021
Our Ref : CI/TPD21010815/N

15 October 2021

Fatal Accident Investigation Team

MECHANICAL INSPECTION REPORT OF MOTORCYCLE FBG 9095G

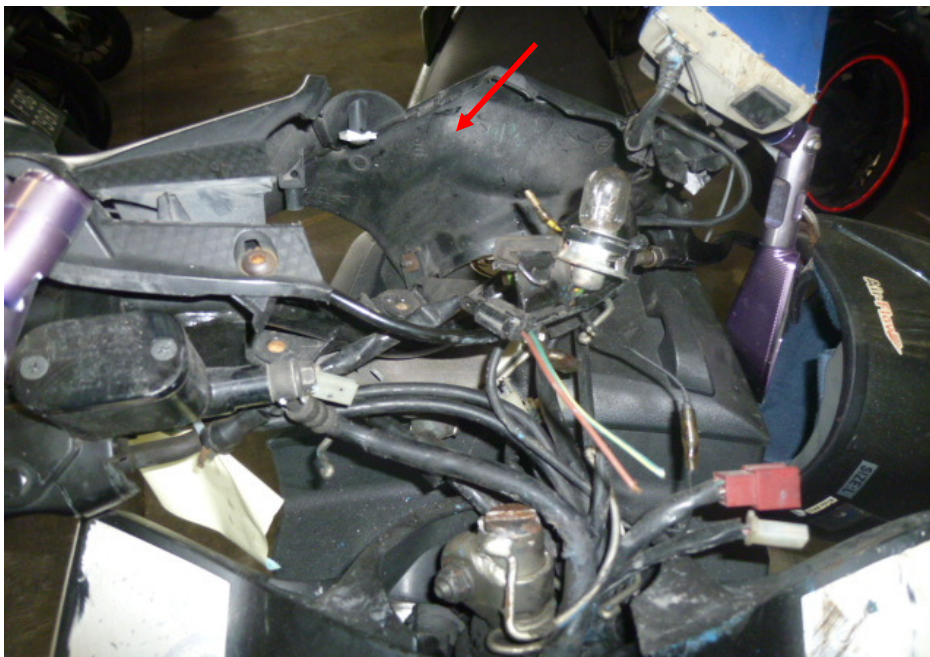
4. The mileage of the Motorcycle could not be recorded at the time of our inspection due to a missing speedometer gauge.
5. The Motorcycle had sustained damages all around. Body parts that were found to have been damaged include its head cowl, front cowl, speedometer gauge, front mudguard, side cowlings, side mirrors, front brake lever, clutch lever, rear brake pedal and top box, amongst others.

Photo 1 shows the missing speedometer gauge of the Motorcycle as a result of the accident (arrowed). Hence the mileage of the Motorcycle could not be recorded at the time of our inspection

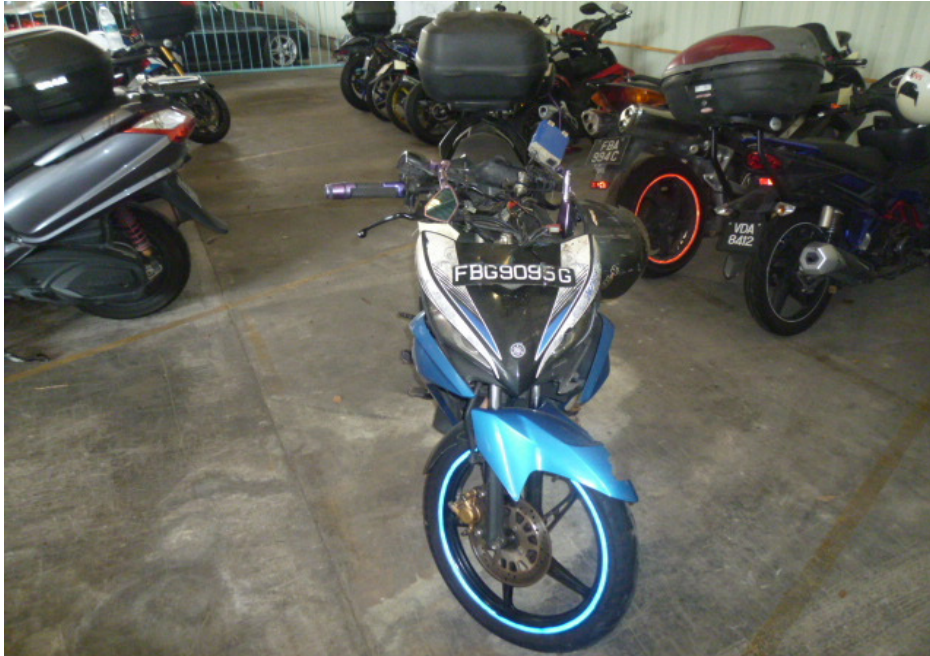
Photo 2 shows a general view of the frontal portion of the Motorcycle at the time of our inspection. The Motorcycle had sustained damages all around. Body parts that were found to have been damaged include its head cowling, front cowling, speedometer gauge, front mudguard, side cowlings, side mirrors, front brake lever, clutch lever, rear brake pedal and top box, amongst others.

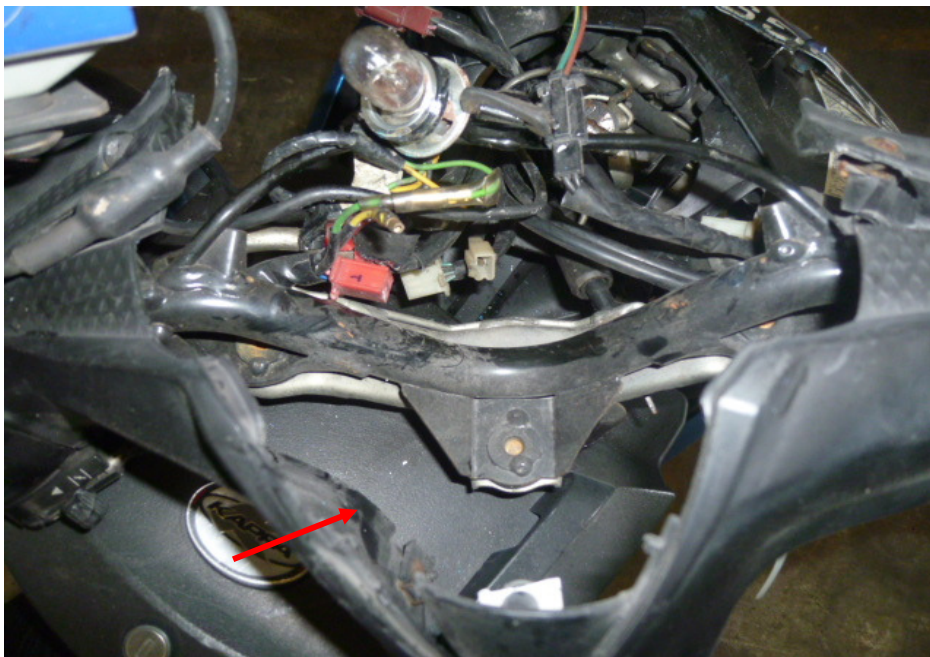
Photo 3 shows a closer view of the cracked head cowling (arrowed) which was amongst the body parts at the front body of the Motorcycle that had sustained damage as a result of the accident (circled).

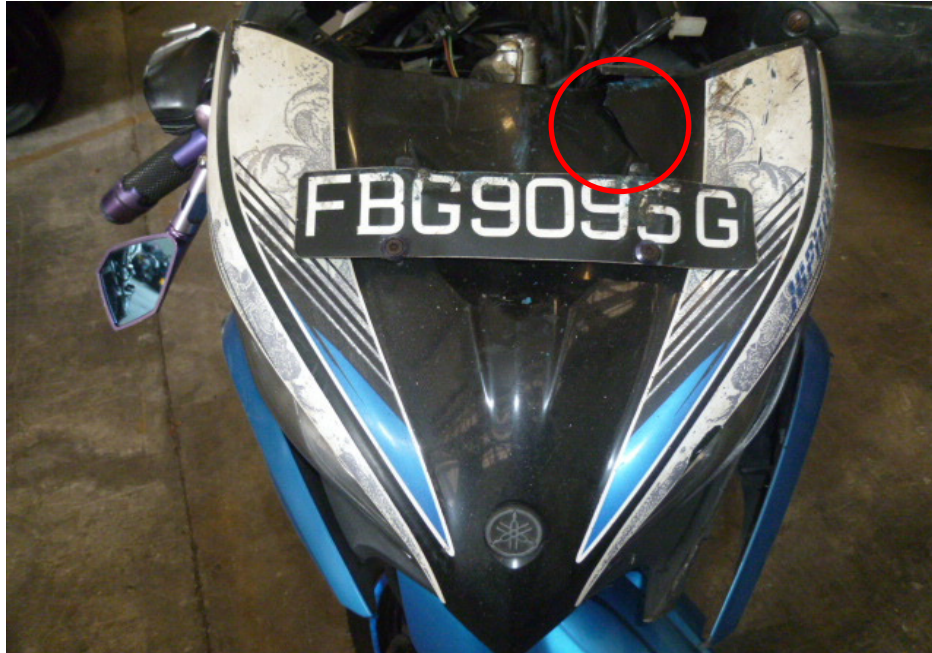
Photo 4 shows a closer view of the front cowling (arrowed) which was amongst the body parts at the front body of the Motorcycle that had sustained damage as a result of the accident (circled).

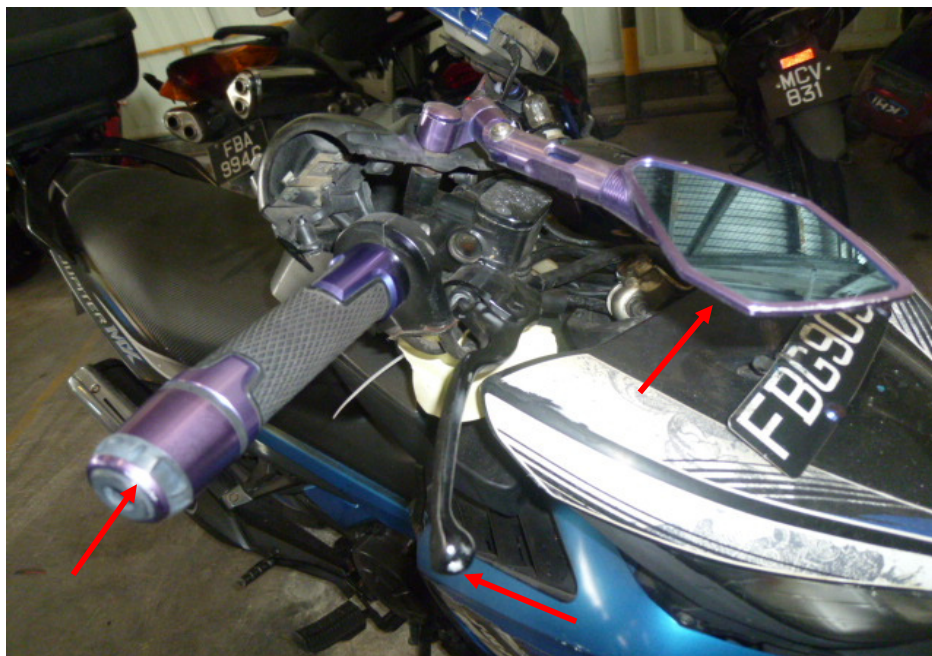
Photo 5 shows a closer view of the front brake lever, right side mirror and right handlebar end of the Motorcycle (arrowed). These parts were amongst the body parts of the Motorcycle which were damaged as a result of the accident.

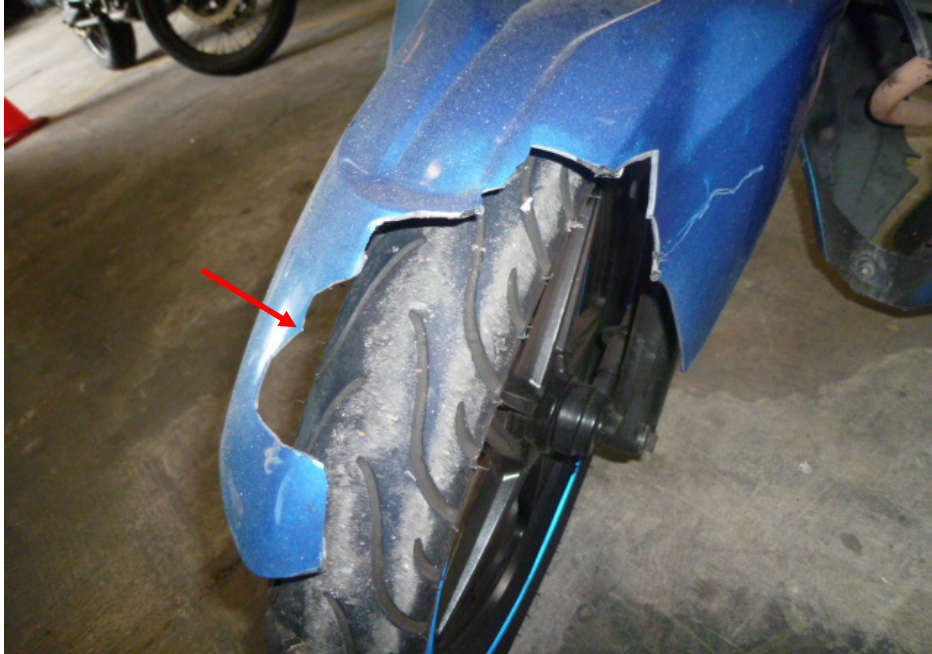
Photo 6 shows a closer view of the front mudguard, which was amongst the body parts of the Motorcycle that had sustained damage as a result of the accident (arrowed).

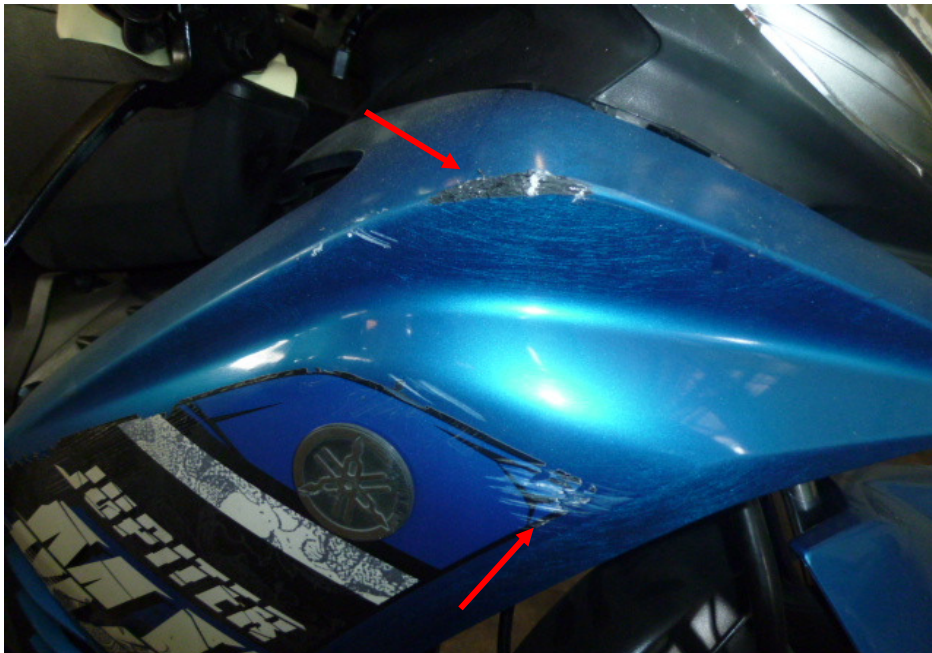
Photo 7 shows a closer view of the right cowling which was amongst the body parts at the front body of the Motorcycle that had sustained damages as a result of the accident (arrowed).

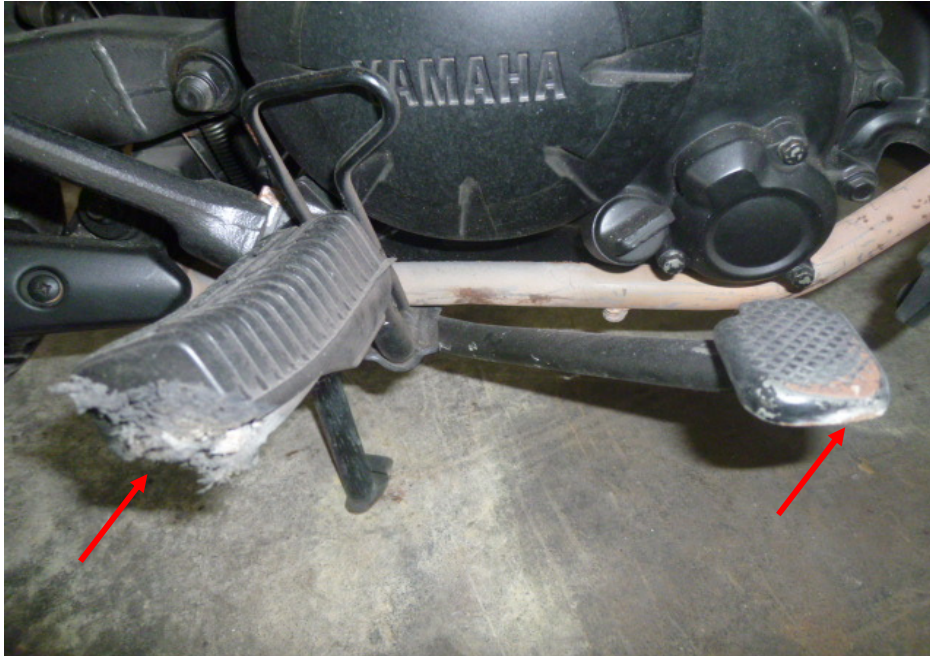
Photo 8 shows a closer view of the right front foot rest and rear brake pedal (arrowed) which were amongst the body parts of the Motorcycle that had sustained damages as a result of the accident.

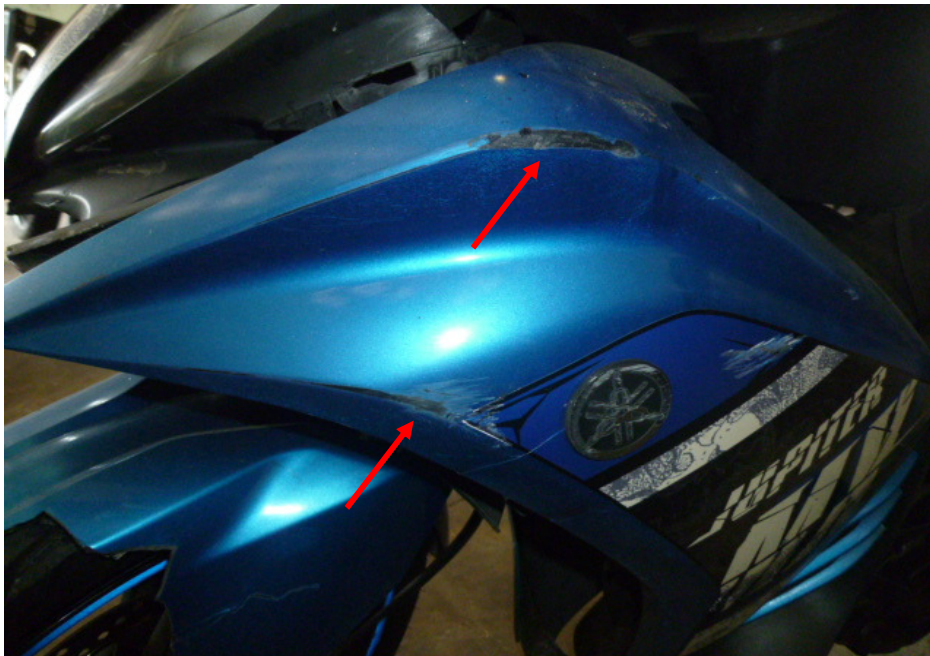
Photo 9 shows a closer view of the left cowling which was amongst the body parts at the front body of the Motorcycle that had sustained damages as a result of the accident (arrowed).

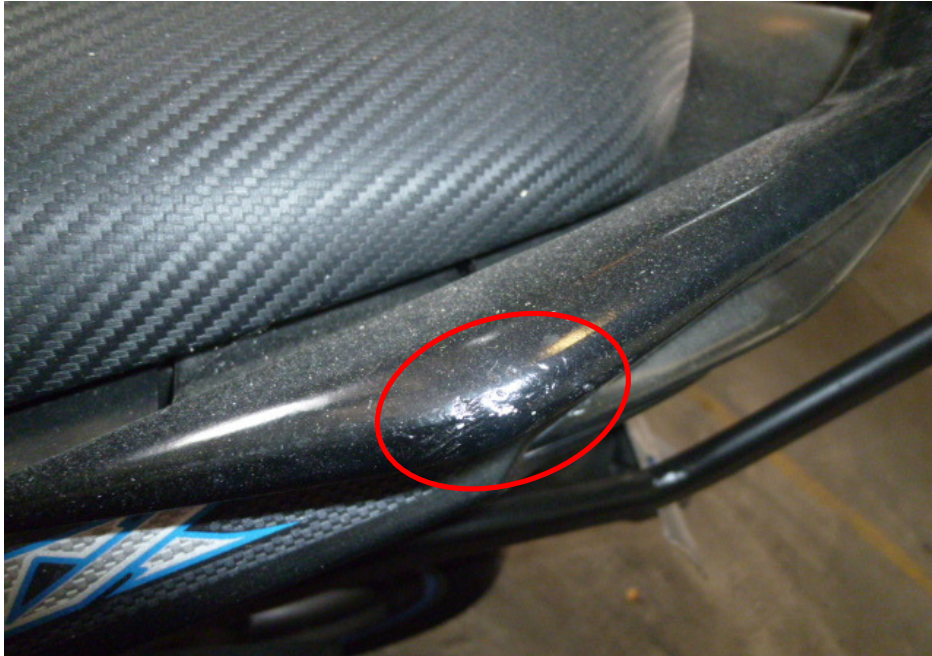
Photo 10 shows a closer view of the grazed left pillion grab rail which was amongst the body parts of the Motorcycle as a result of the accident (circled).

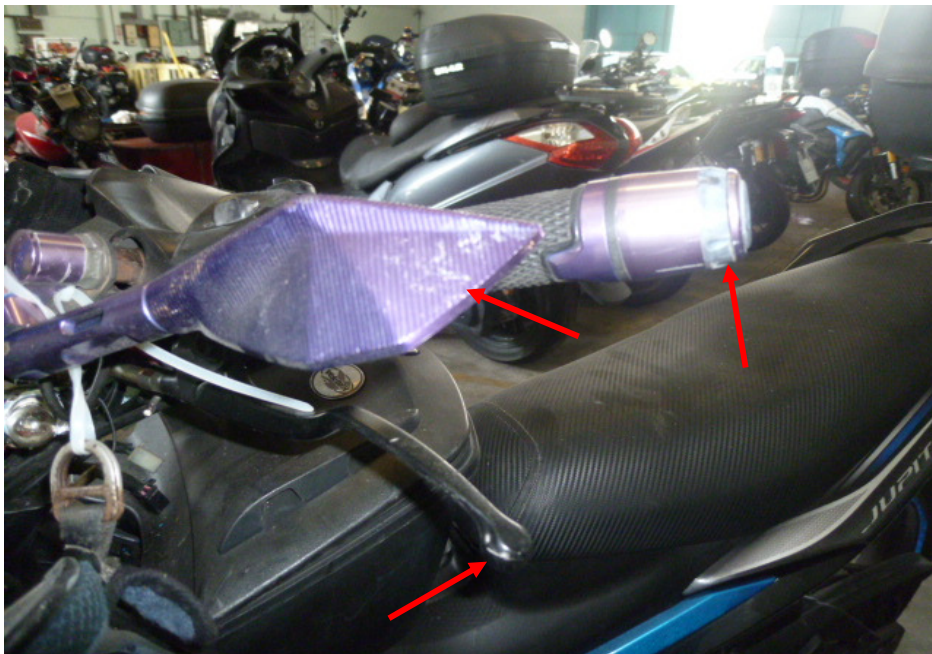
Photo 5 shows a closer view of the clutch lever, left side mirror and left handlebar end of the Motorcycle (arrowed). These parts were amongst the body parts of the Motorcycle which were damaged as a result of the accident.

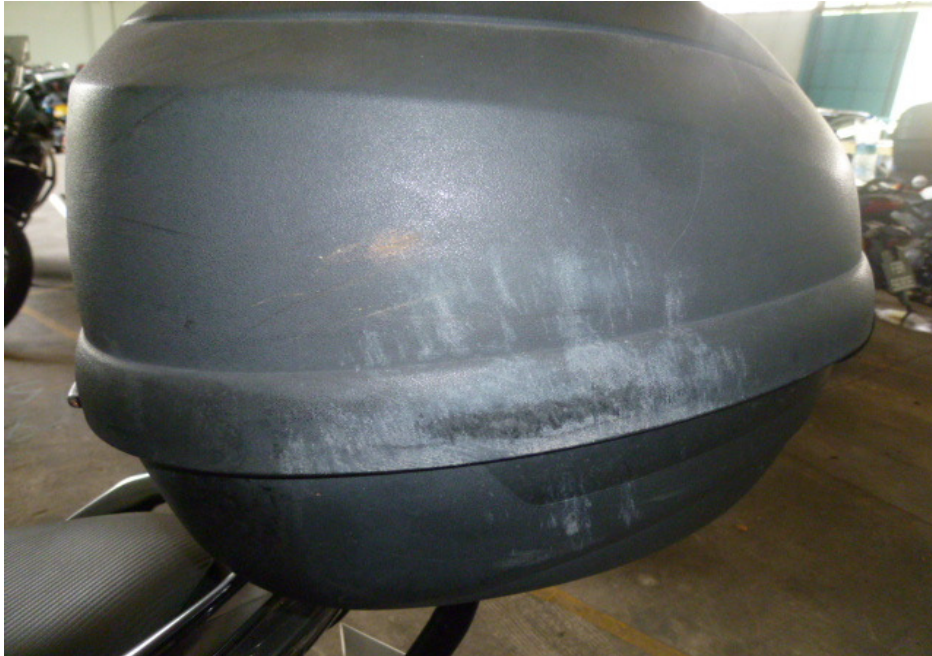
Photo 12 shows the grazed top box of the Motorcycle at the time of our inspection.

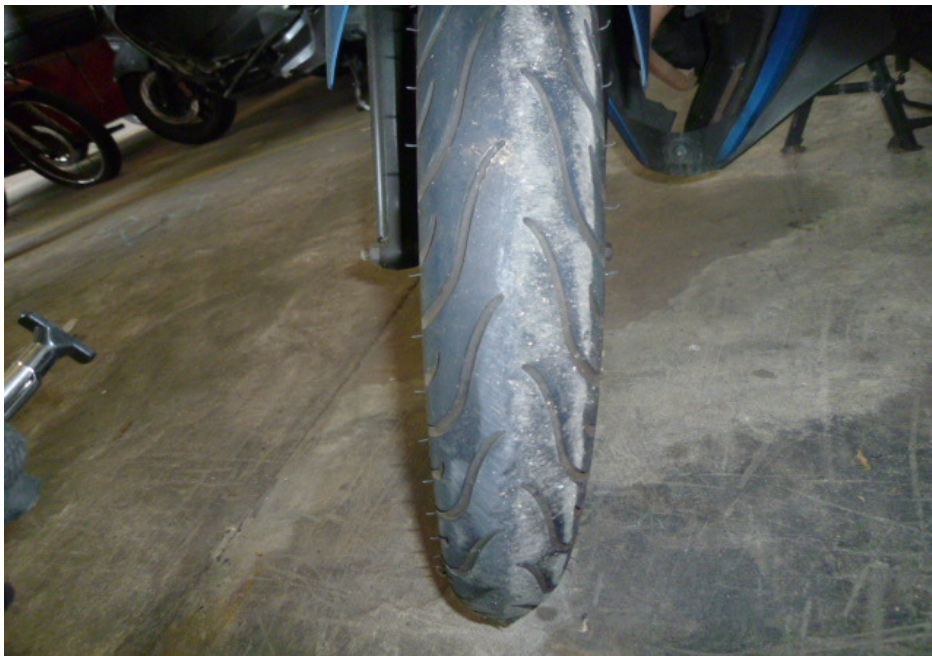
Photo 13 shows the condition of the Motorcycle's front tyre. The front tyre was observed to be in serviceable condition with remaining tread depth of approximately 4mm. The tyre was also observed to be sufficiently inflated for vehicular operation. We did not observe any tear, burst mark(s) and/or punctured hole(s) on the sidewalls as well as across the tread of the front tyre.

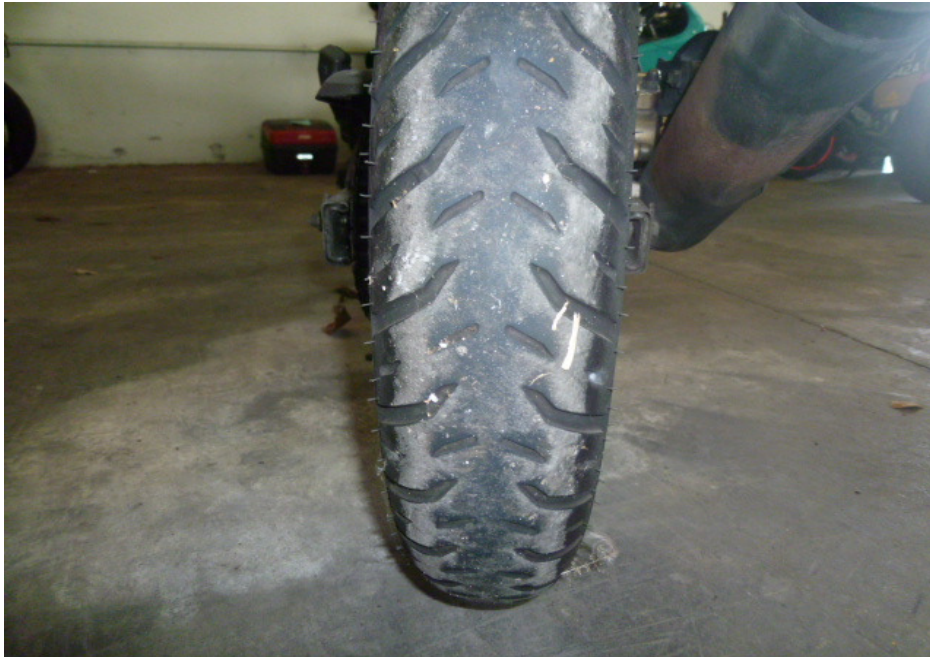
Photo 14 shows the condition of the Motorcycle's rear tyre. The rear tyre was observed to be in serviceable condition with remaining tread depth of approximately 4mm. The tyre was also observed to be sufficiently inflated for vehicular operation. We did not observe any tear, burst mark(s) and/or punctured hole(s) on the sidewalls as well as across the tread of the rear tyre.

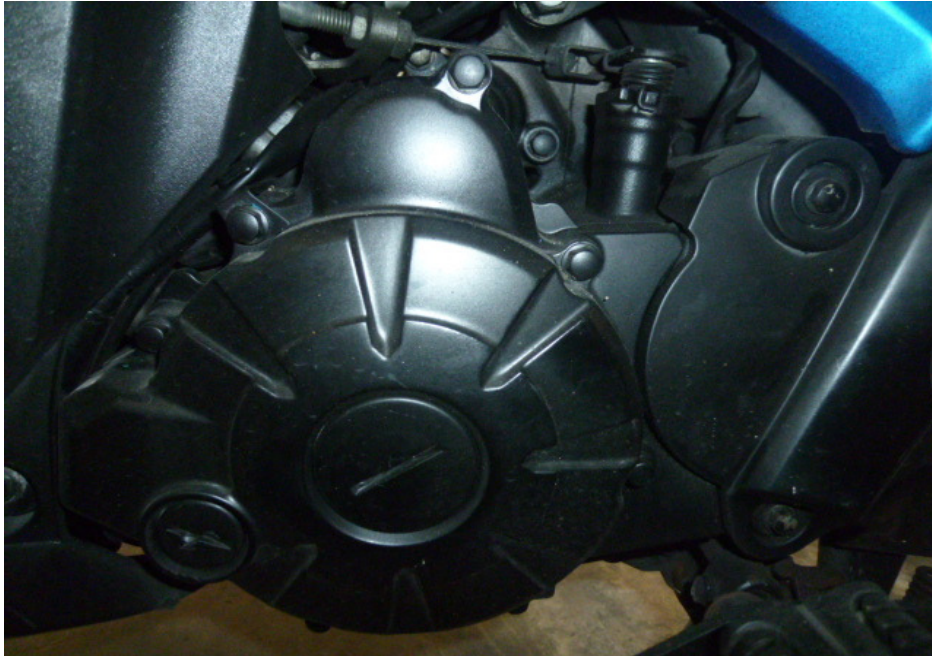
Photo 15 shows the left side of the engine of the Motorcycle at the time of our inspection. The various engine related parts and components were found to be intact with no visible damage. There was also no sign(s) or indication(s) of fluid leak observed around the left engine area of the Motorcycle.

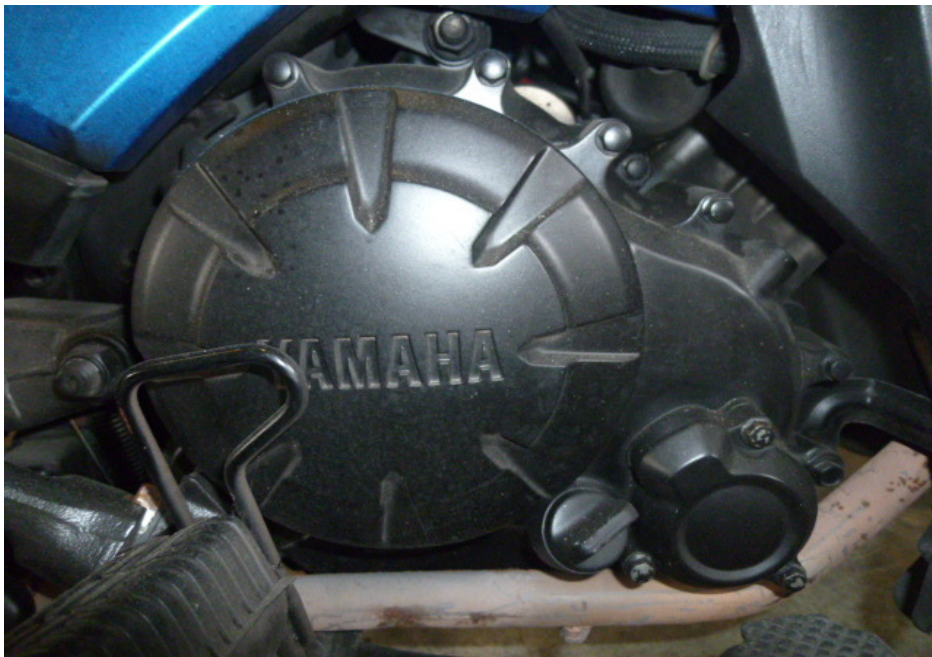
Photo 16 shows the right side of the engine of the Motorcycle at the time of our inspection. The various engine related parts and components were found to be intact with no visible damage. There was also no sign(s) or indication(s) of fluid leak observed around the right engine area of the Motorcycle.

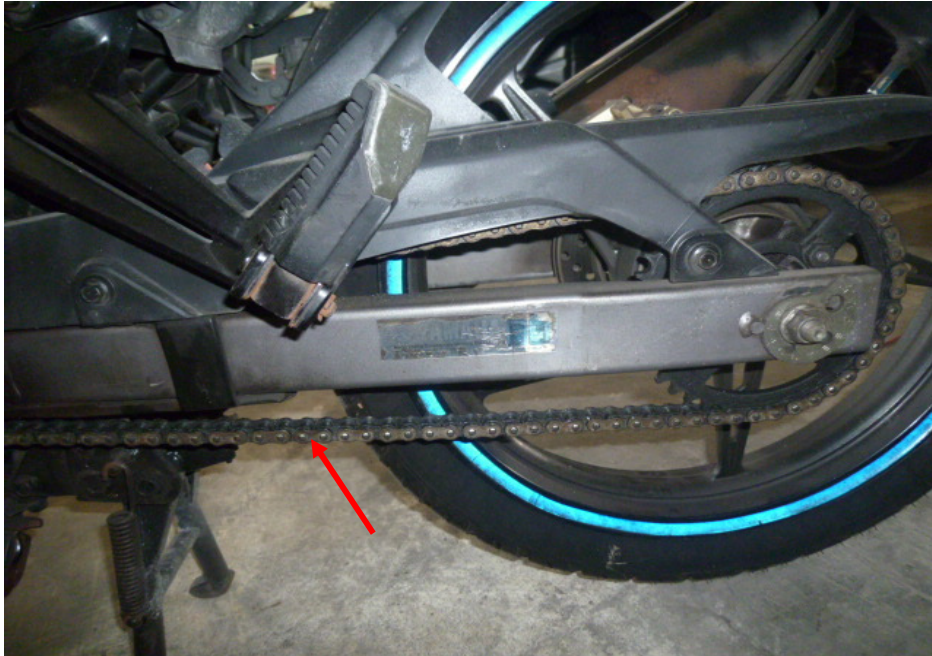
Photo 17 shows the gear chain (arrowed) of the Motorcycle, which was observed to be intact with no misalignment. It was also adequately lubricated for operating purposes. The gear chain rotates the rear wheel of the Motorcycle.

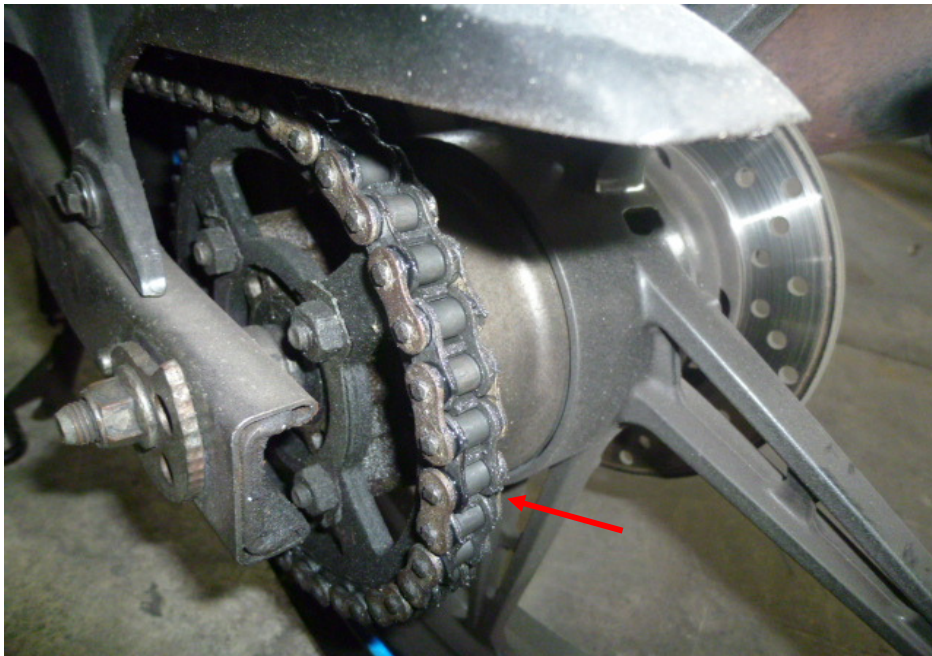
Photo 18 shows the closer view of the gear chain (arrowed) of the Motorcycle, which was observed to be intact with no misalignment. It was also adequately lubricated for operating purposes.

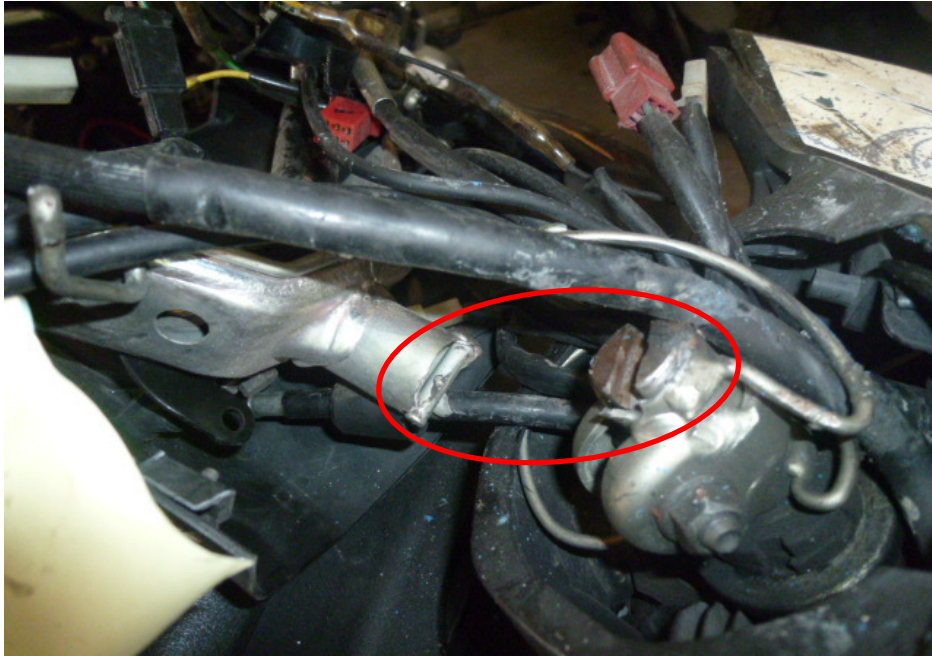
11. For this case, we were not able to conduct any test(s) on the steering system of the Motorcycle due to the damage to its steering stem. The steering stem was observed to be broken as a result of the accident.

Photo 19 shows the steering stem of the Motorcycle. The steering stem (circled) was observed to be broken as a result of the accident. We were hence not able to conduct any tests on the steering system of the Motorcycle.

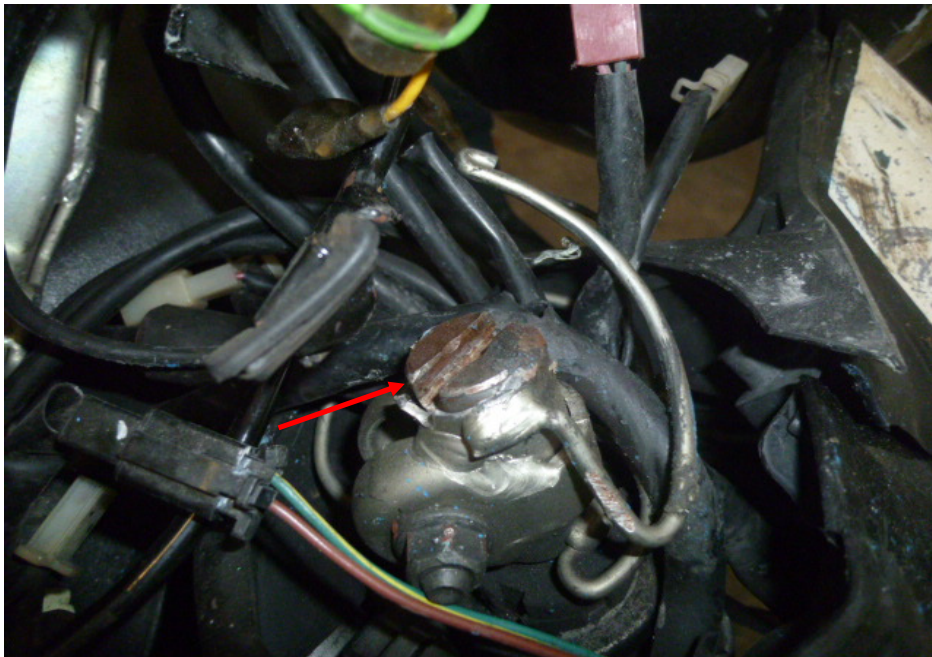
Photo 20 shows a close up view of the steering stem of the Motorcycle. The steering stem (arrowed) was observed to be broken as a result of the accident.

We were hence not able to conduct any tests on the steering system of the Motorcycle.

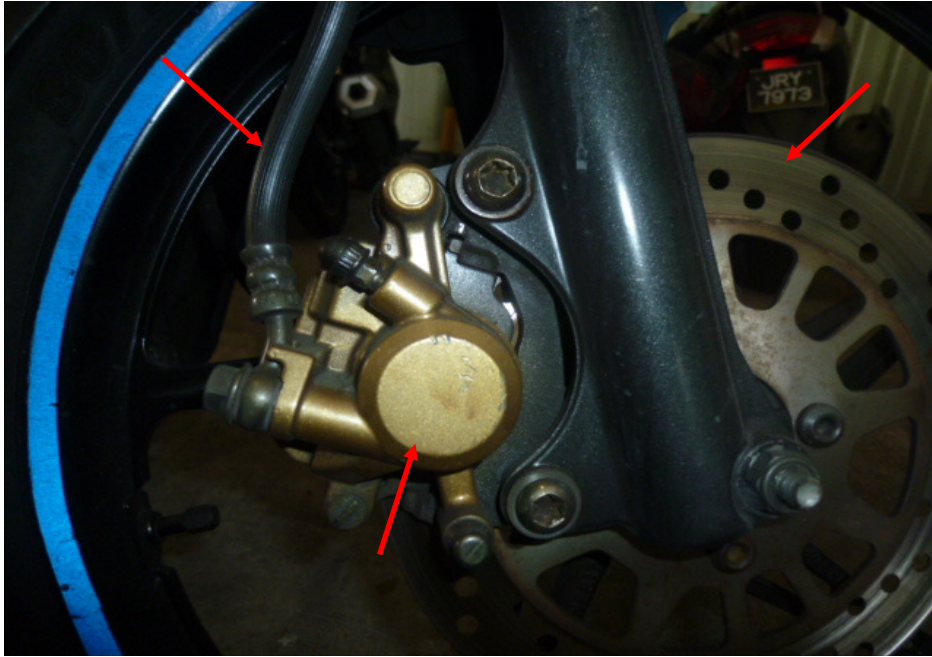
Photo 21 shows a close up view of the front brake caliper, front brake disc and front brake hose (arrowed) of the Motorcycle, which are all part of the components in the hydraulic front brake system of the Motorcycle. Our visual checks of these various components had revealed all to be intact with no visible damage. No leakage of brake fluid was also observed.

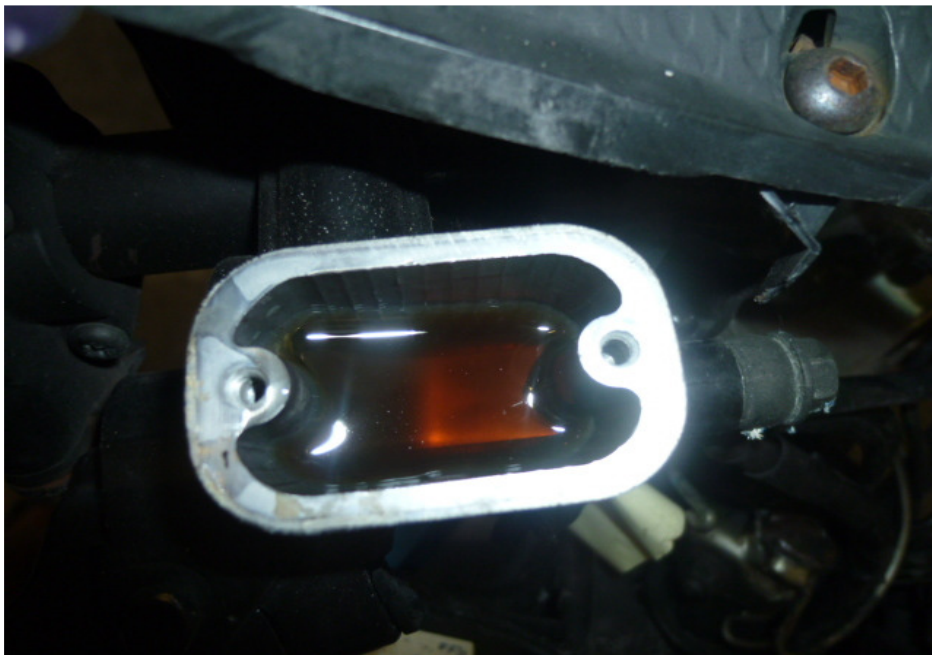
Photo 22 shows the brake fluid reservoir for the front brake of the Motorcycle. The brake fluid was observed to be without contamination and of sufficient level for operational purposes.

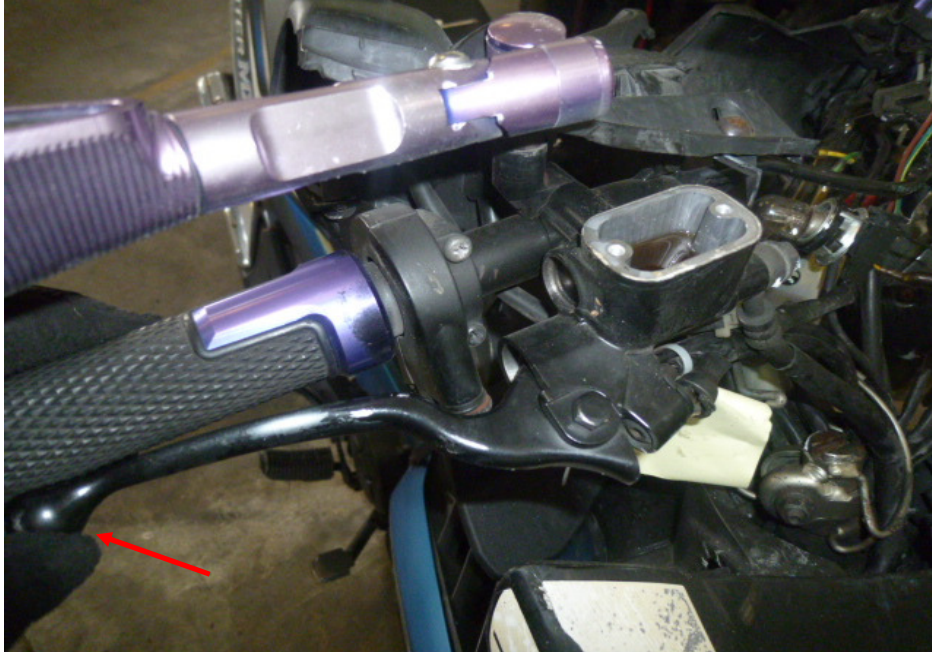
14. Static brake tests conducted on the Motorcycle had appeared to indicate that the front brake system of the Motorcycle was not in serviceable condition. There was no resistance felt (spongy like feel) upon pressing the front brake lever. This would indicate that there may be a leakage of pressure/vacuum in the front brake system.

Photo 23 shows the front brake lever being depressed. There was no resistance felt (spongy like feel) upon pressing the front brake lever (arrowed). This would indicate that there may be a leakage of pressure/vacuum in the front brake system.

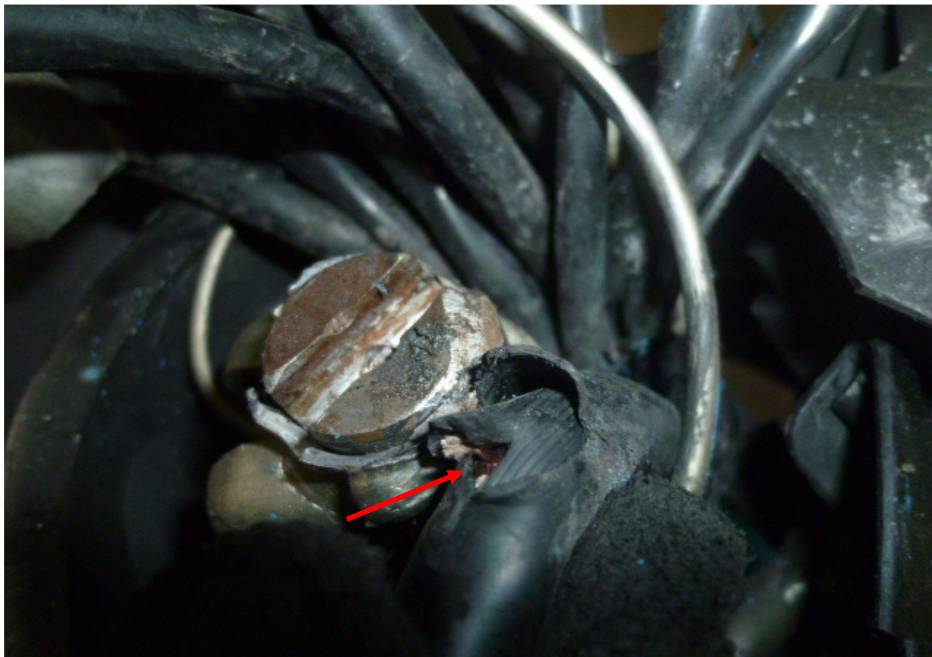
13. Our visual examination of the various components in the Motorcycle's braking system like the brake discs, brake calipers, brake lever, brake foot pedal and rear brake hose revealed all to be intact and without damage. There was also no leakage of brake fluid observed along the brake hoses. This was from the respective brake fluid reservoirs to the front brake caliper and rear brake caliper of the Motorcycle. The brake fluid for the front brake and rear brake was also found to be of sufficient level for operational purposes and without any contamination. However, we had observed that the front brake hose had been cut as a result of the accident.

Photo 24 shows upon closer examination, we observed that the front brake hose was cut as a result of the accident (arrowed).

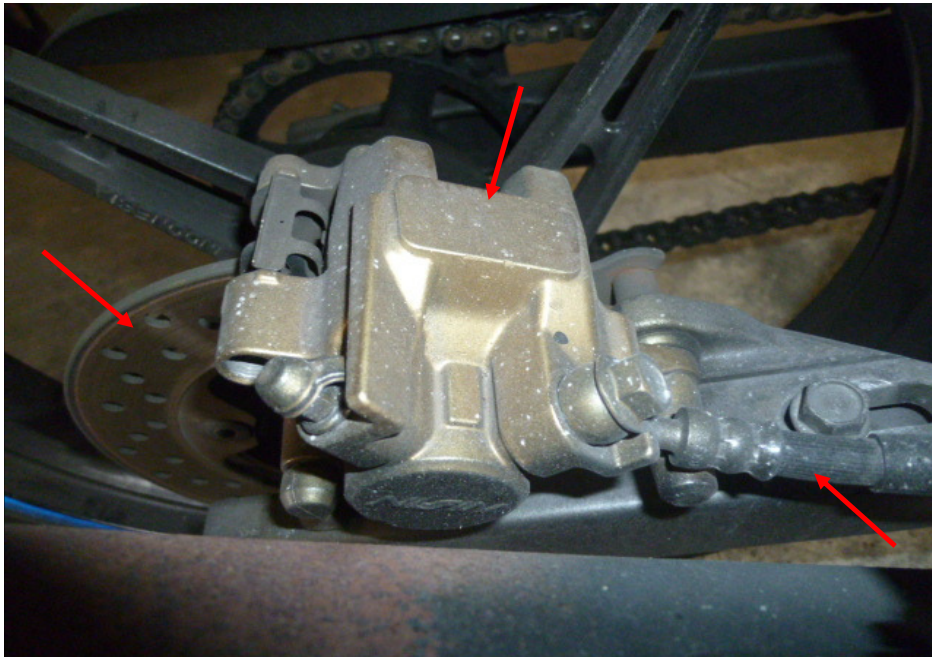
15. Static brake tests conducted on the Motorcycle had appeared to indicate that the rear brake system of the Motorcycle was in serviceable condition. There was some resistance felt (spongy like feel) upon stepping on the rear brake pedal. This would indicate that there's no leakage of pressure/vacuum in the rear brake system.

Photo 25 shows a close up view of the rear brake caliper, rear brake disc and rear brake hose (arrowed) of the Motorcycle, which are all part of the components in the hydraulic rear brake system of the Motorcycle. Our visual checks of these various components had revealed all to be intact with no visible damage. No leakage of brake fluid was also observed.

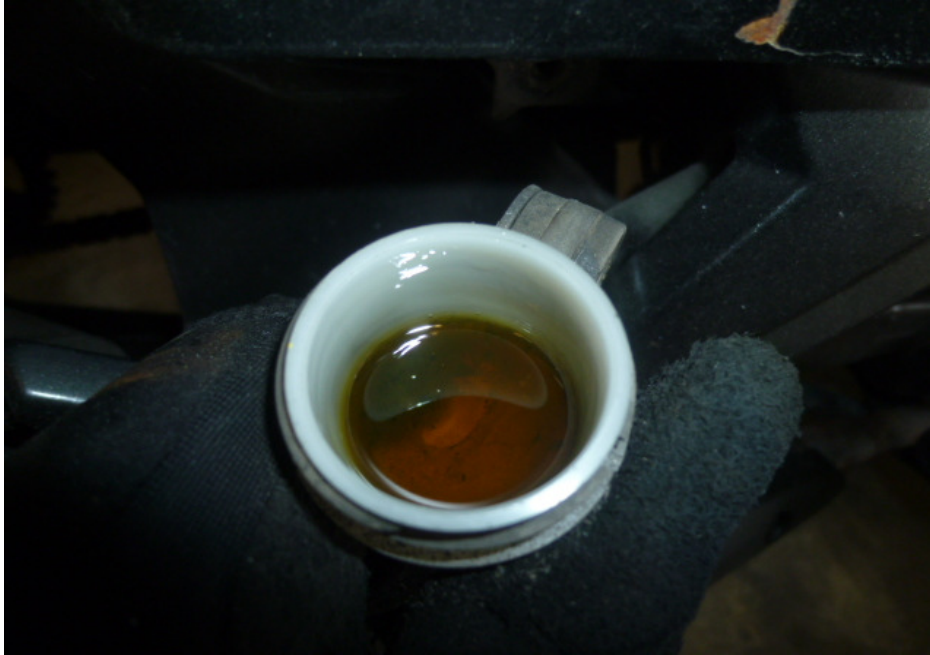
Photo 26 shows the brake fluid reservoir for the rear brake of the Motorcycle. The brake fluid was observed to be without contamination and of sufficient level for operational purposes.
