Your Ref: TP/IP/26221/2021  
Our Ref : CI/TPD21010816/N

15 October 2021

**Fatal Accident Investigation Team**

**MECHANICAL INSPECTION REPORT OF MOTORCYCLE FBN 8422R**

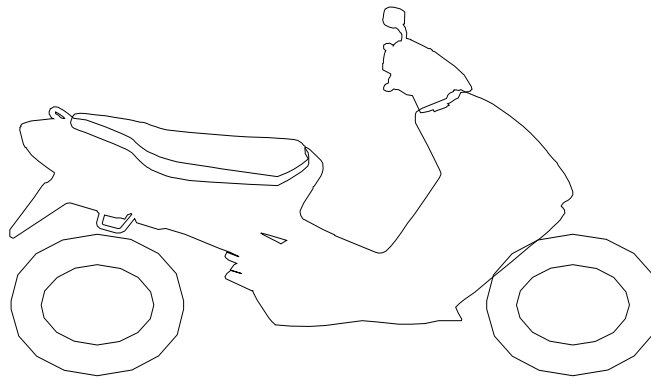
6. The condition of the 2 tyres of the Motorcycle was observed to be in serviceable condition. We did not observe any tear, burst mark(s) and/or punctured hole(s) on the sidewalls as well as across the tread of the 2 tyres. Both tyres were observed to be sufficiently inflated for vehicular operation. The tyre brand, tyre size and remaining tread depth of the 2 tyres of the Motorcycle were recorded as follows:-

Exato 110/70 R17 (4mm)

Bridgestone 90/80 R17 (4mm)

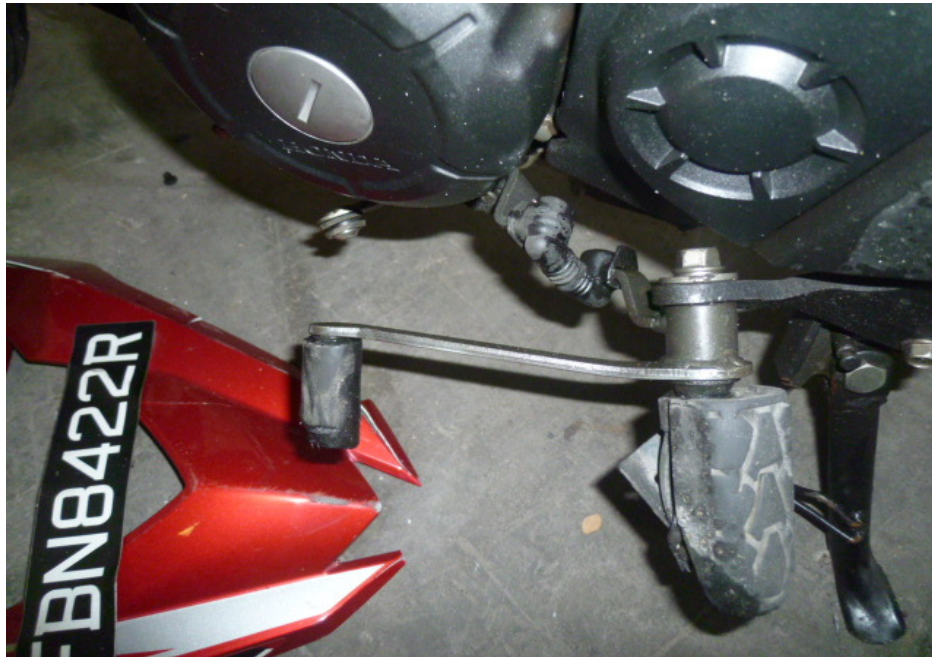
4. The mileage of the Motorcycle was not recorded at the time of our inspection as we were unable to engage the Neutral gear to kickstart the Motorcycle due to a broken gear shift pedal.
5. The Motorcycle had sustained damages all around. Body parts that were found to have been damaged include its headlight assembly, head cowl, front cowl, side cowlings, front mudguard, left side mirror, left handlebar end, clutch lever, front basket, radiator, left rear side cover, rear brake pedal, right front footrest and top box rack, amongst others.

**Photo 1** shows the broken gear shift pedal of the Motorcycle as a result of the accident. Hence the mileage was not recorded at the time of our inspection as we were unable to engage the Neutral gear to kickstart the Motorcycle.

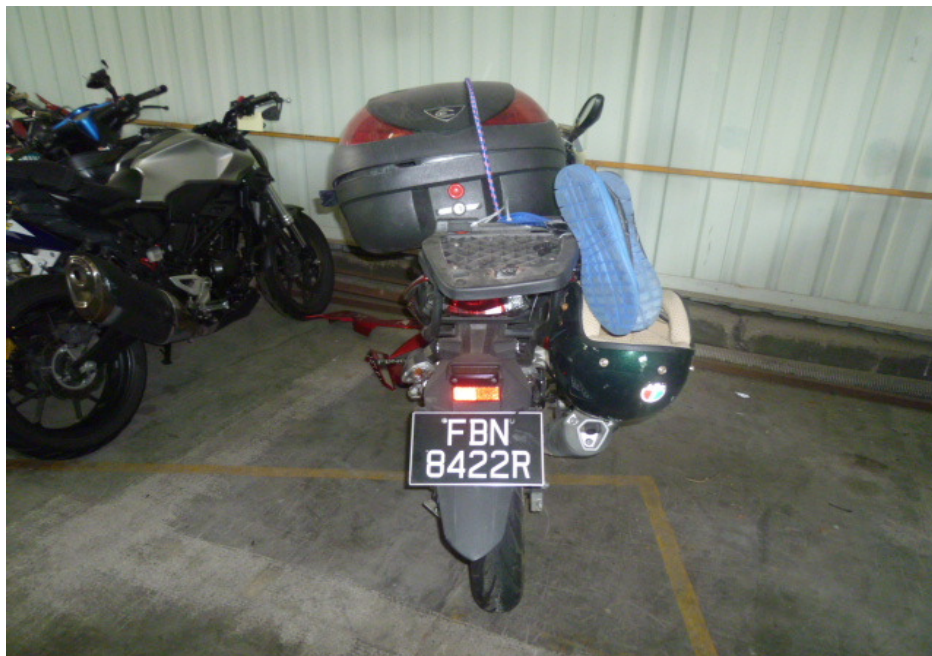
**Photo 2** shows a general view of the rear portion of the Motorcycle at the time of our inspection. The Motorcycle had sustained damages all around.

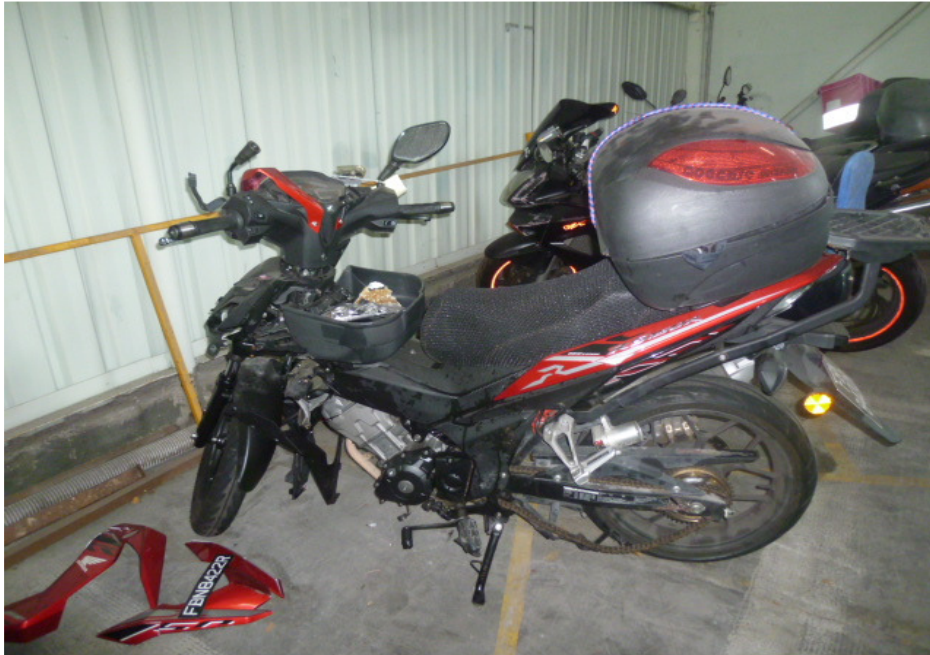
**Photo 3** shows a general view of the left body of the Motorcycle at the time of our inspection. The Motorcycle had sustained damages all around. Body parts that were found to have been damaged include its headlight assembly, head cowling, front cowling, side cowlings, front mudguard, left side mirror, left handlebar end, clutch lever, front basket, radiator, left rear side cover, rear brake pedal, right front footrest and top box rack, amongst others.

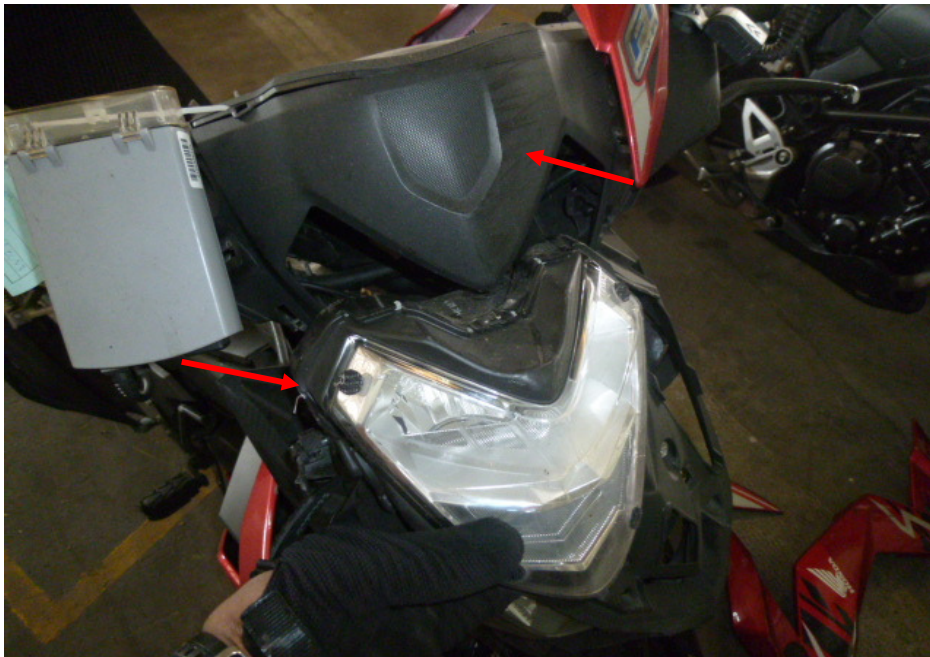
**Photo 4** shows the general view of the headlight assembly and head cowling (arrowed) of the Motorcycle which was amongst the body parts of the Motorcycle that had sustained damage as a result of the accident.

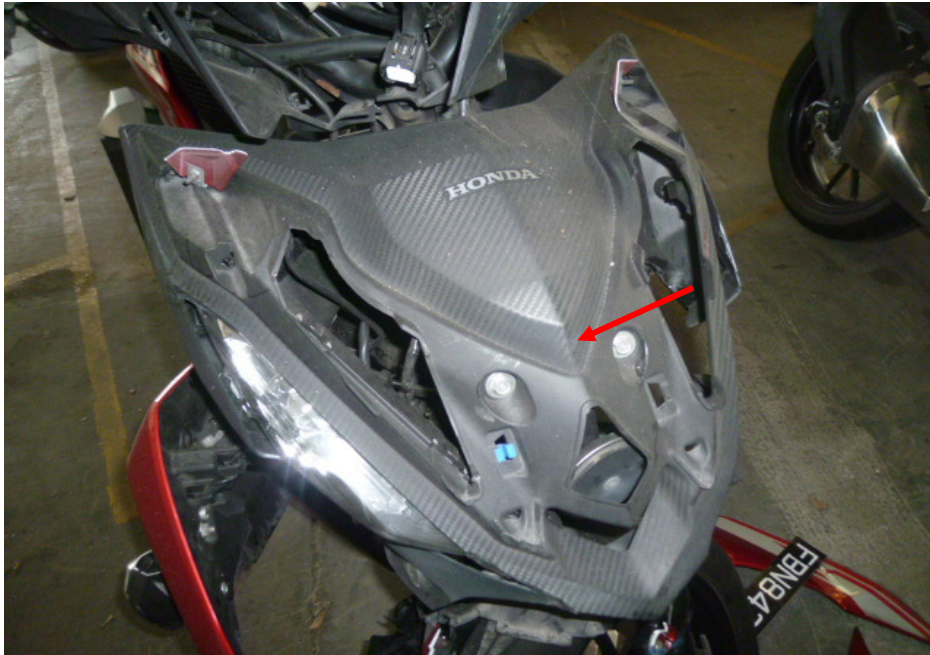
**Photo 5** shows the general view of the front cowling of the Motorcycle which was amongst the body parts of the Motorcycle that had sustained damage as a result of the accident (arrowed).

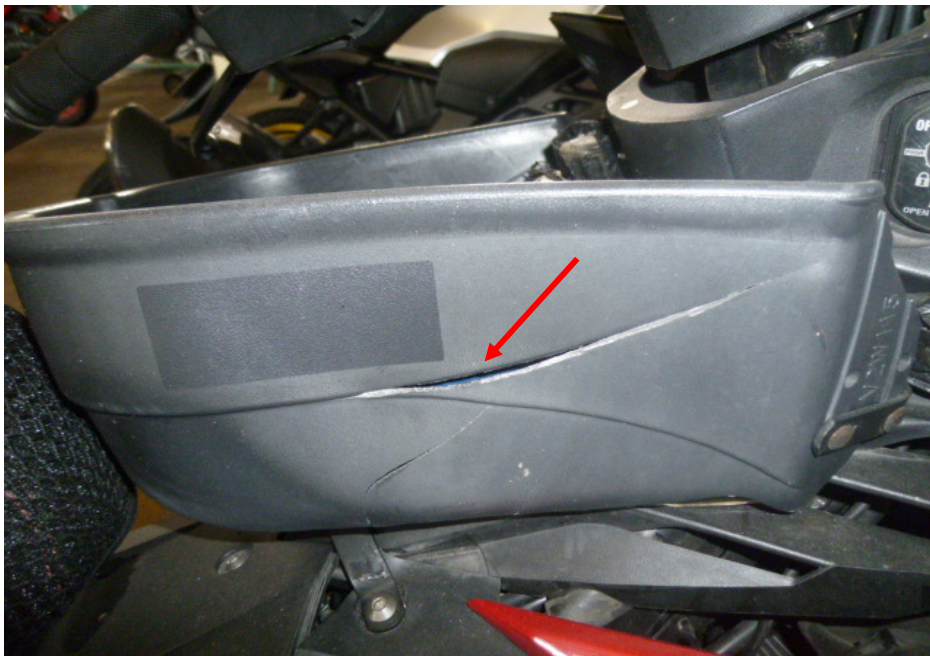
**Photo 6** shows the cracked front basket of the Motorcycle as a result of the accident (arrowed).

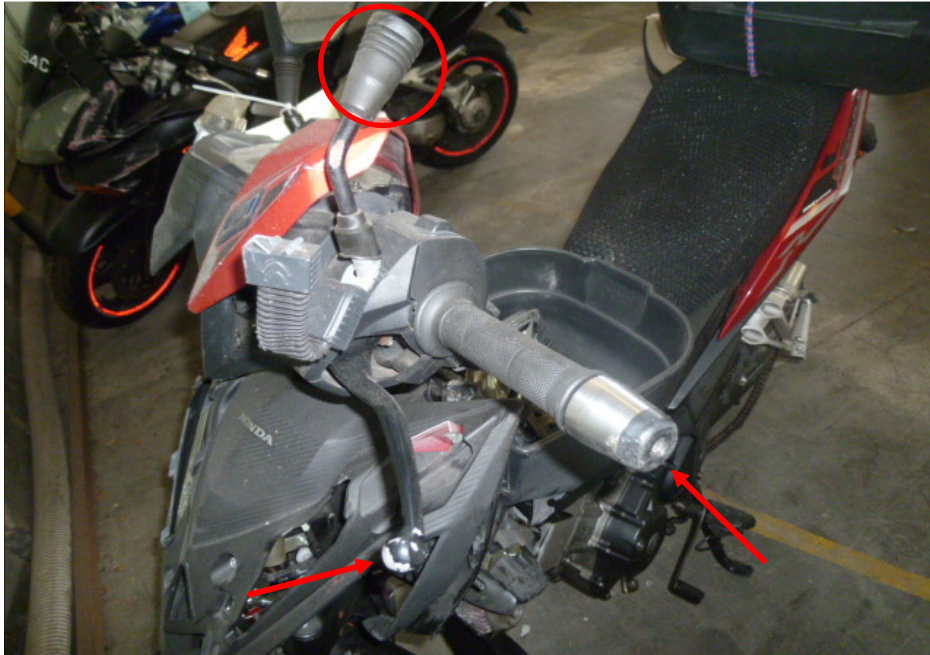
**Photo 7** shows a close up view of the missing left side mirror (circled) as well as the clutch lever and left handlebar end (arrowed) of the Motorcycle. These parts were amongst the body parts of the Motorcycle which were damaged as a result of the accident.

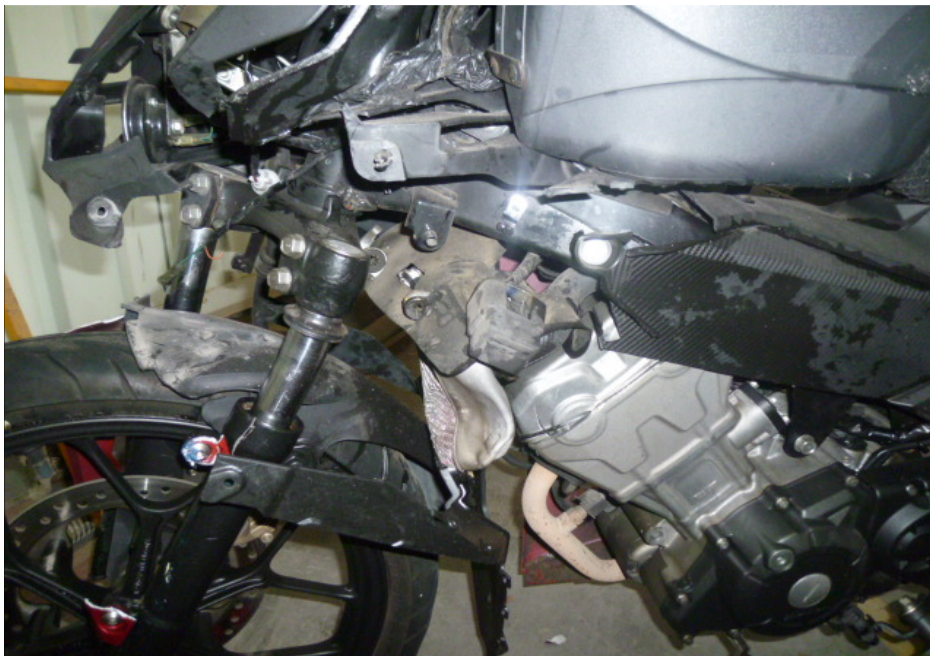
**Photo 8** shows the missing left cowling of the Motorcycle as a result of the accident.

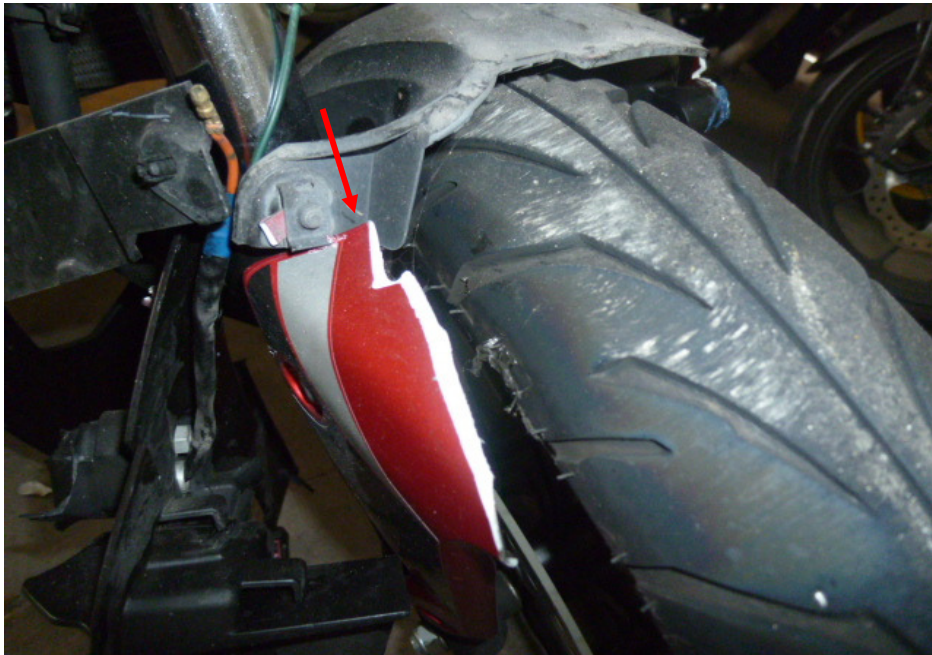
**Photo 9** shows a close up view of the cracked front mudguard of the Motorcycle as a result of the accident (arrowed).

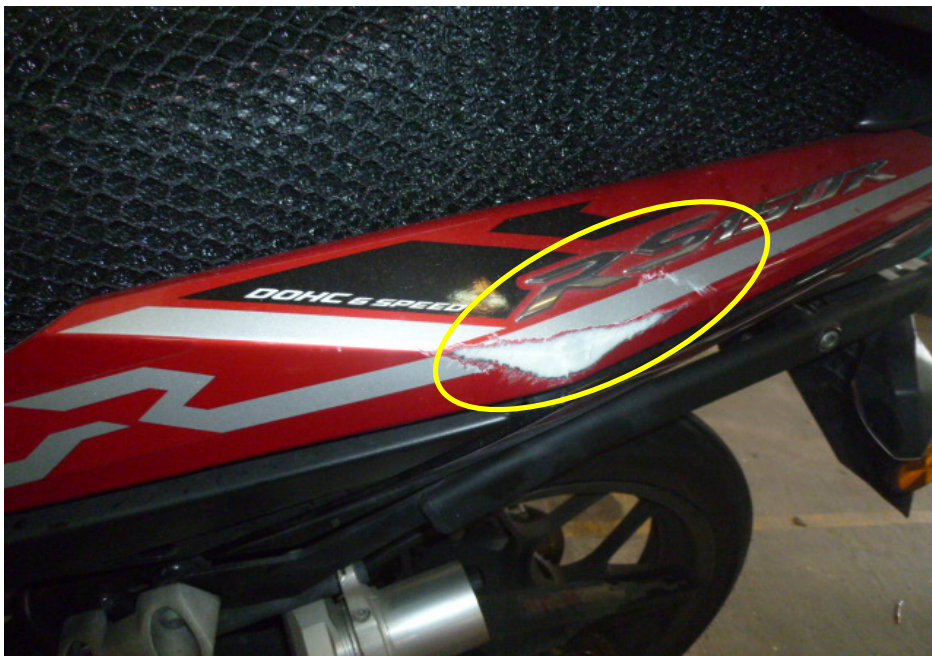
**Photo 10** shows a closer view of the left rear side cover, which was amongst the body parts of the Motorcycle that had sustained damages of grazing nature as a result of the accident (circled).

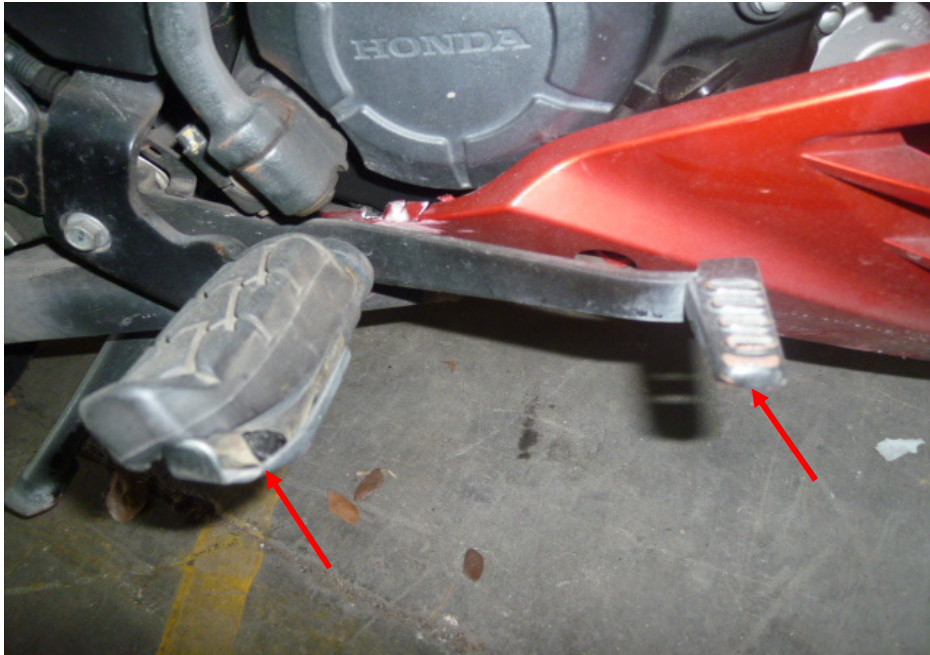
**Photo 11** shows the damaged rear brake pedal and right front footrest which were amongst the body parts of the Motorcycle as a result of the accident (arrowed).

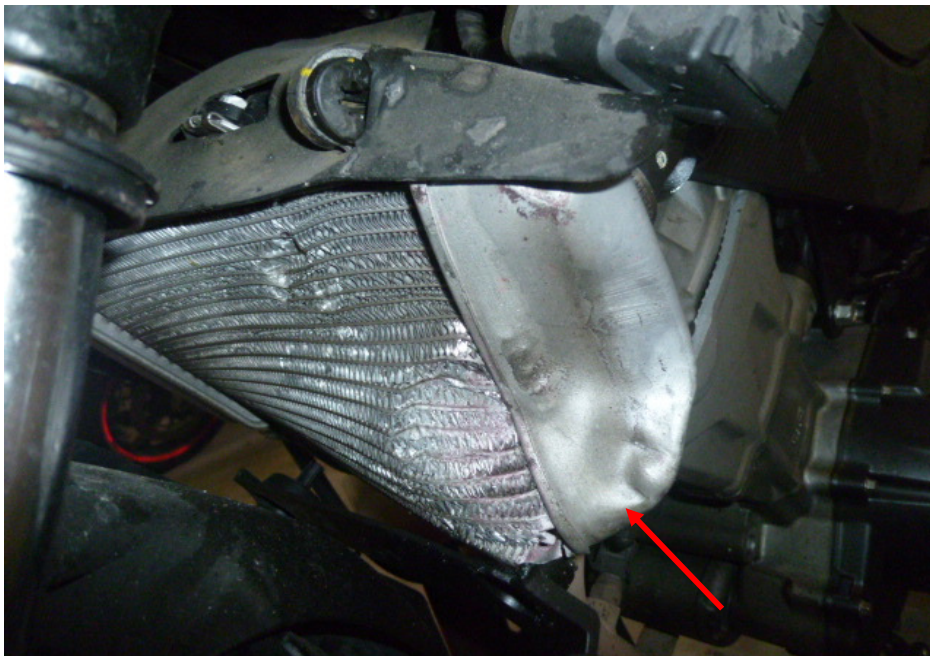
**Photo 12** shows the deformed radiator which was amongst the body parts of the Motorcycle as a result of the accident (arrowed).

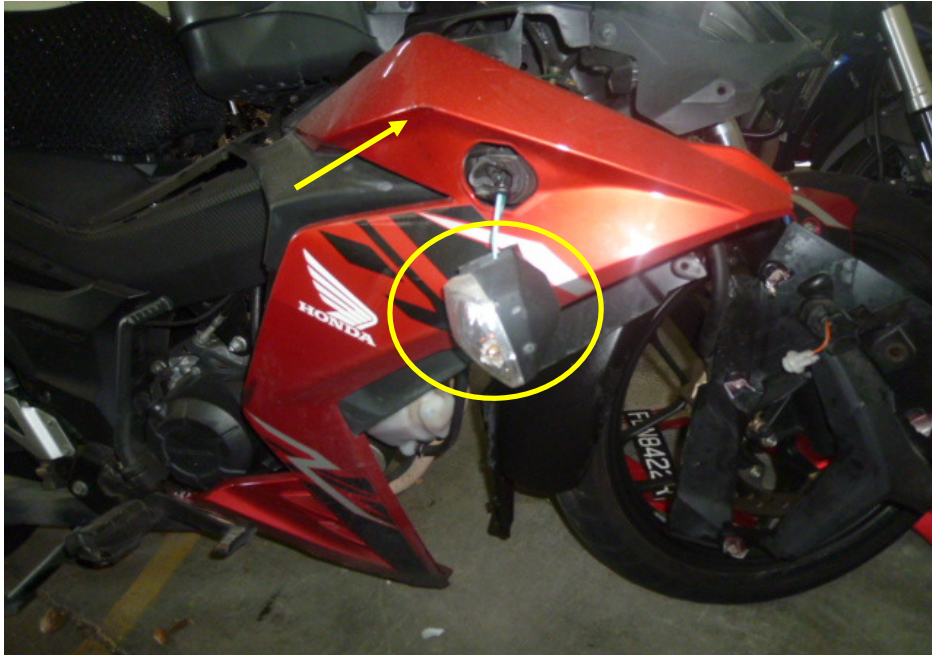
**Photo 13** shows the grazed right cowling (arrowed) and broken right front signal lamp (circled) of the Motorcycle as a result of the accident.

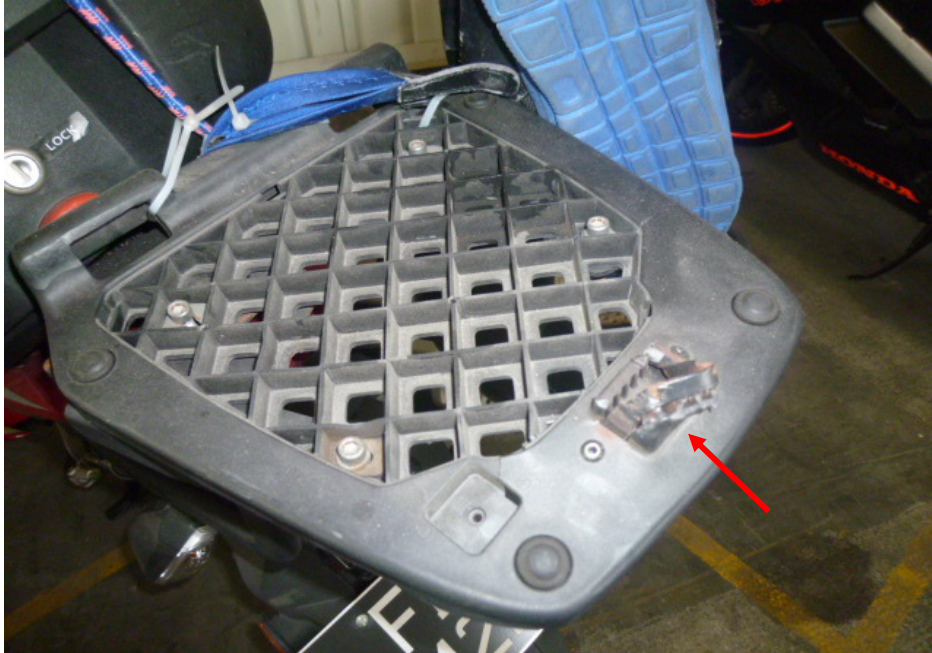
**Photo 14** shows a closer view of the broken top box rack of the Motorcycle as a result of the accident (arrowed).

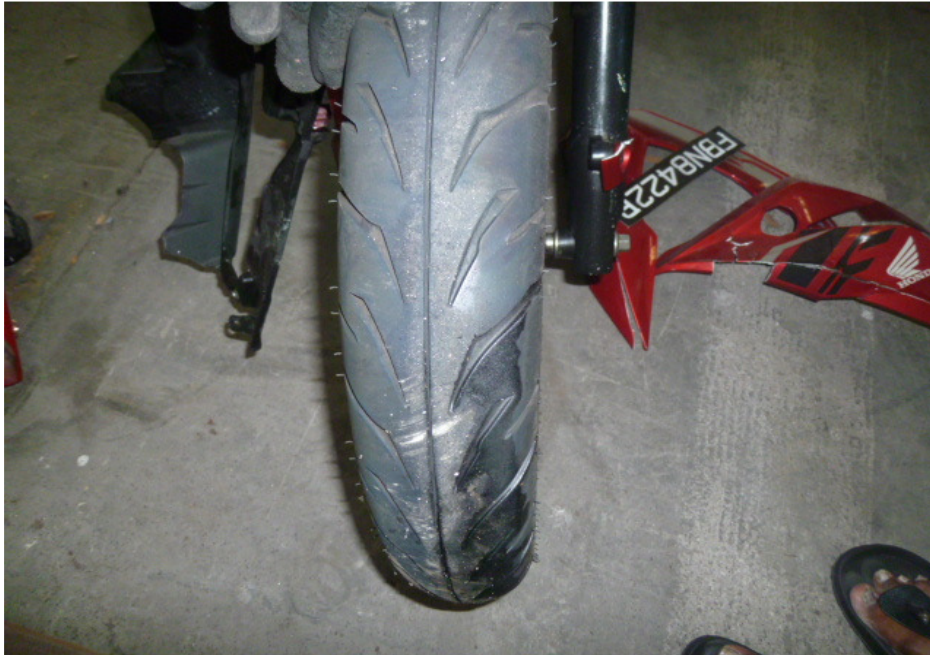
**Photo 15** shows the condition of the Motorcycle's front tyre. The front tyre was observed to be in serviceable condition with remaining tread depth of approximately 4mm. We did not observe any tear, burst mark(s) and/or punctured hole(s) on the sidewalls as well as across the tread of the front tyre. The front tyre was also observed to be sufficiently inflated for vehicular operation.

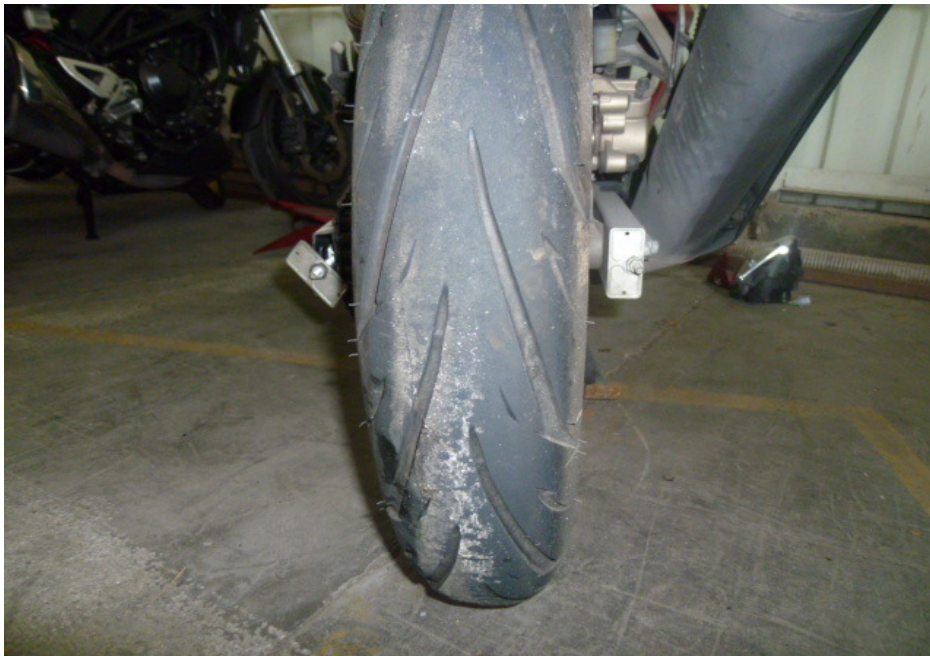
**Photo 16** shows the condition of the Motorcycle's rear tyre. The rear tyre was observed to be in serviceable condition with remaining tread depth of approximately 4mm. The rear tyre was also observed to be sufficiently inflated for vehicular operation. We did not observe any tear, burst mark(s) and/or punctured hole(s) on the sidewalls as well as across the tread of the rear tyre.

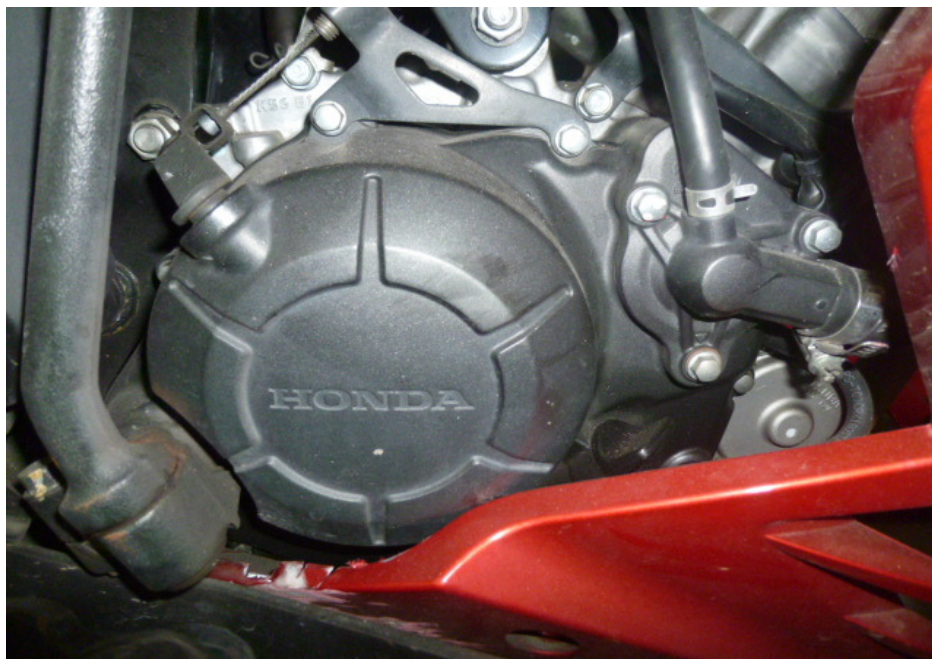
**Photo 17** shows the right side of the engine of the Motorcycle at the time of our inspection. The various engine related parts and components were found to be intact with no visible damage. There was also no sign(s) or indication(s) of fluid leak observed around the right engine area of the Motorcycle.

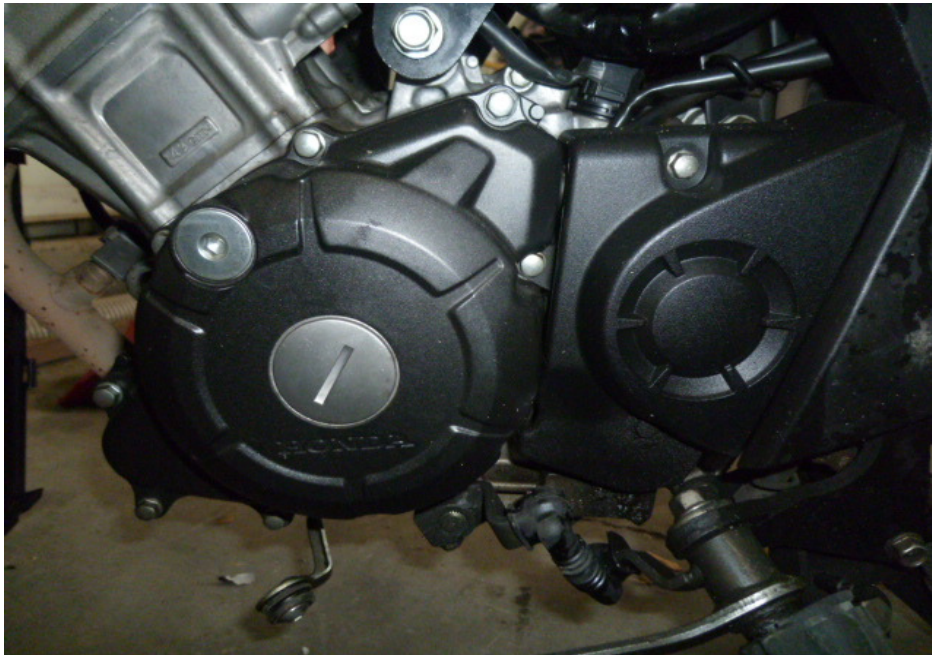
**Photo 18** shows the left side of the engine of the Motorcycle at the time of our inspection. The various engine related parts and components were found to be intact with no visible damage. There was also no sign(s) or indication(s) of fluid leak observed around the left engine area of the Motorcycle.

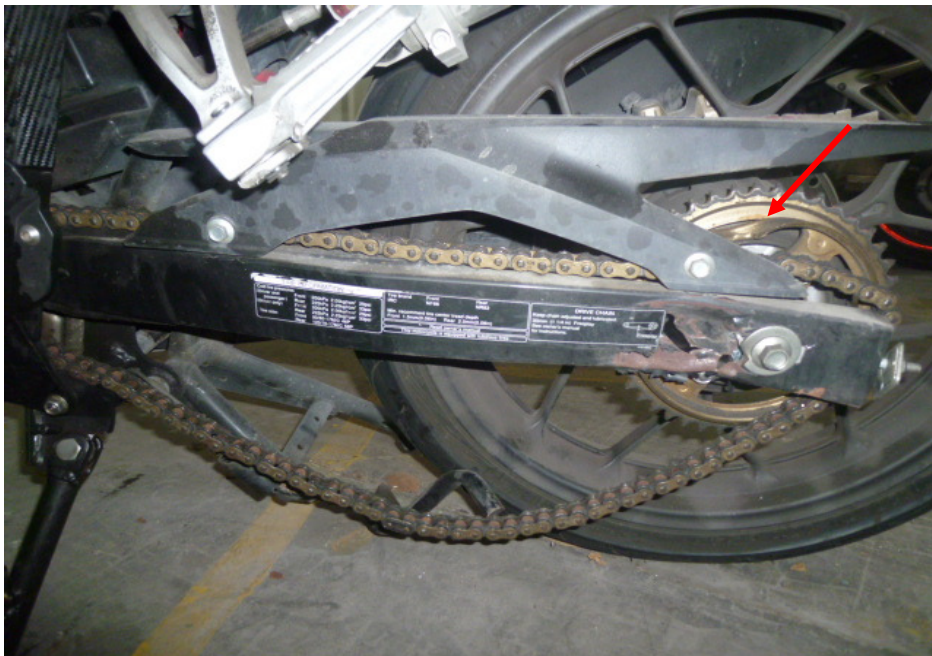
**Photo 19** shows the general view of the gear train of the Motorcycle which was found to be damaged as a result of the accident. The chain was also observed to be dislodged from the gear train due to the deformed rear sprocket most likely as a result of the accident (arrowed). The chain was also found not to be adequately lubricated for operating purposes.

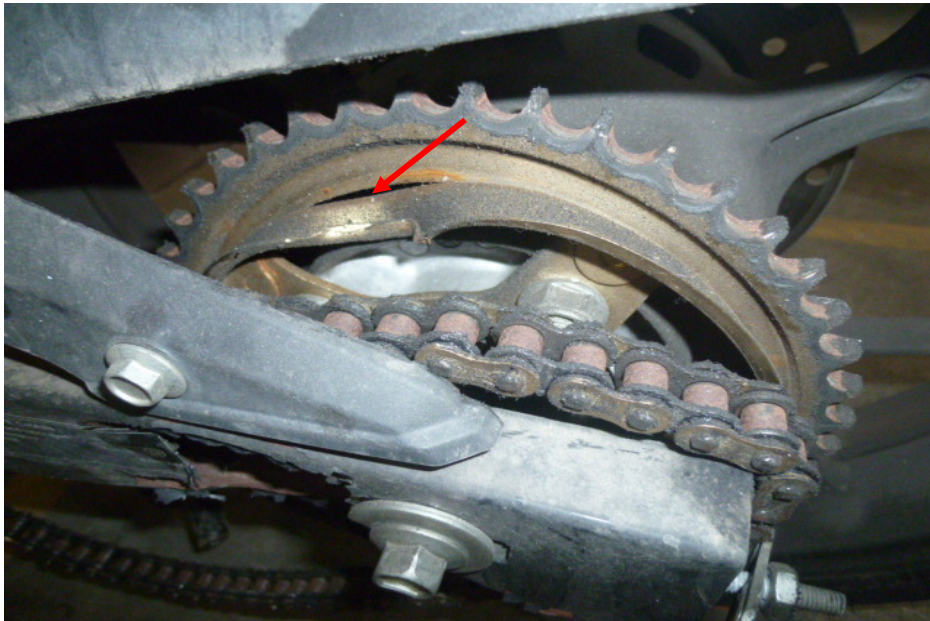
**Photo 20** shows a closer view of the dislodged chain from the gear train due to the deformed rear sprocket most likely as a result of the accident (arrowed). The chain was also found not to be adequately lubricated for operating purposes.

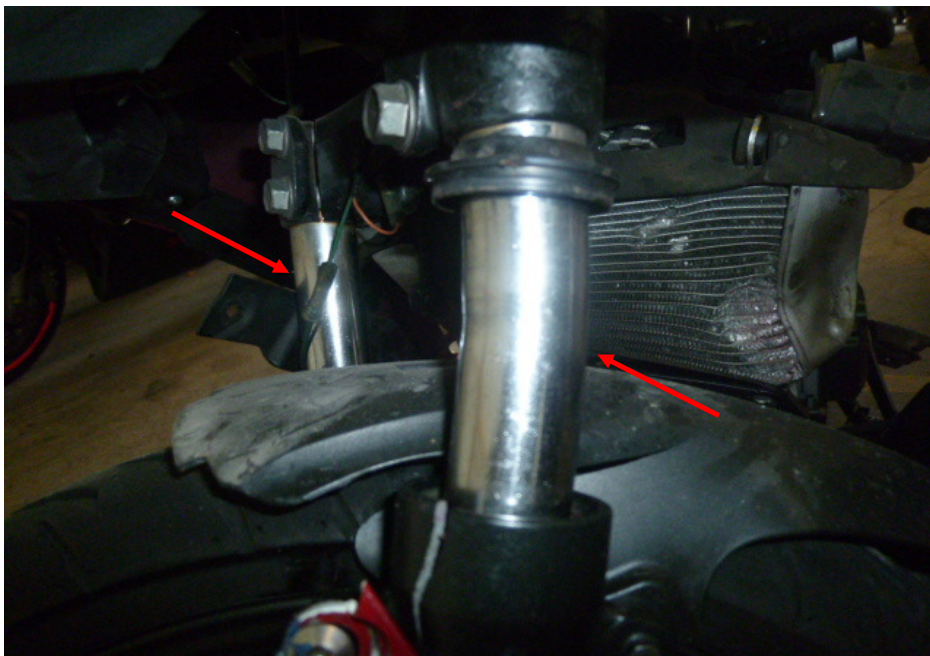
10. For this case, we were not able to conduct any test(s) on the steering system of the Motorcycle due to the damage of its front fork assembly. The front forks were found to be bent inwards as a result of the accident which had rendered the Motorcycle immobile.

**Photo 21** shows the front fork assembly of the Motorcycle. The front forks (arrowed) were observed to be bent inwards as a result of the accident. We were hence not able to conduct any tests on the steering system of the Motorcycle.

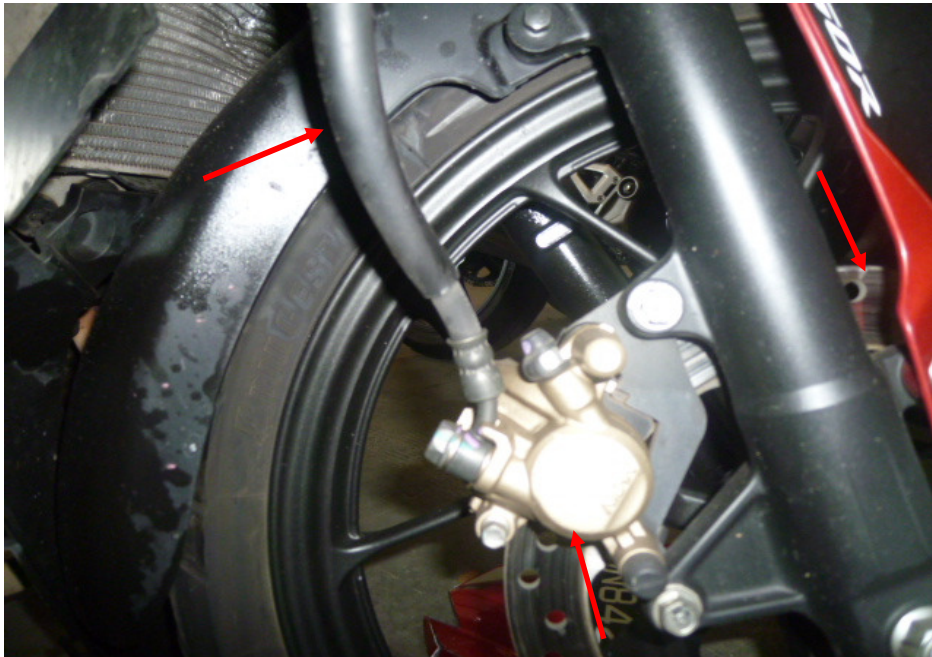
**Photo 22** shows a close up view of the front brake caliper, front brake disc and front brake hose (arrowed) of the Motorcycle, which are all part of the components in the hydraulic front brake system of the Motorcycle. Our visual checks of these various components had revealed all to be intact with no visible damage. No leakage of brake fluid was also observed.

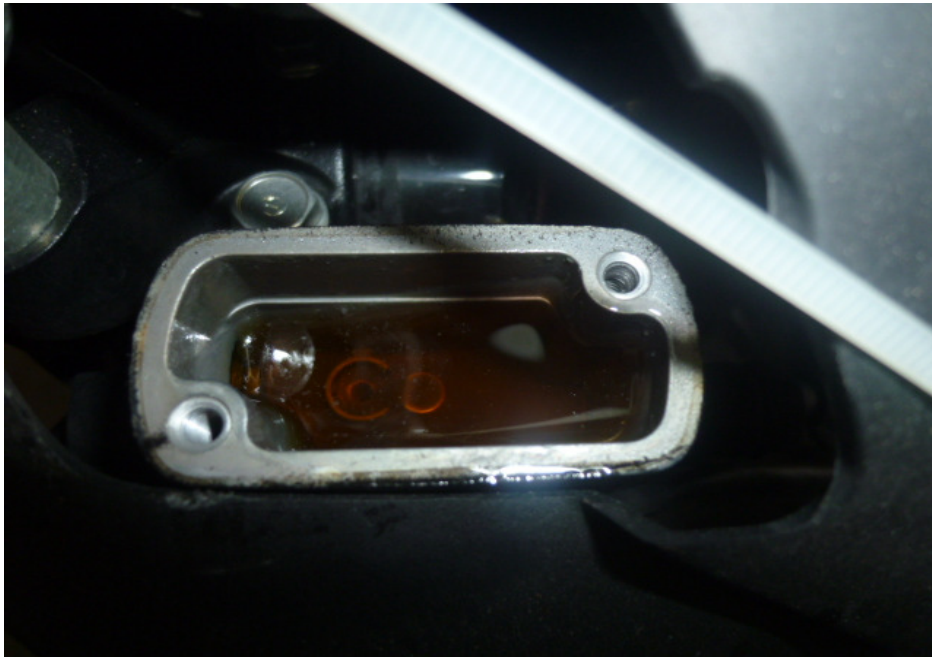
**Photo 23** shows the brake fluid reservoir for the front brake of the Motorcycle. The brake fluid was observed to be of sufficient level for operational purposes and without contamination.

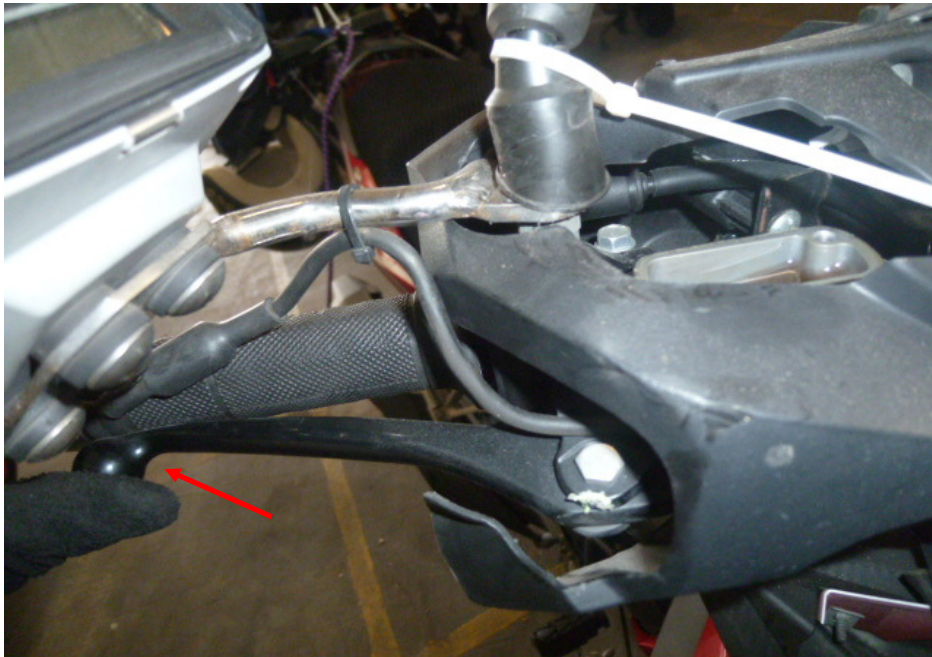
13. Static brake tests conducted on the Motorcycle had appear to indicate that the front braking system of the Motorcycle was not in serviceable condition. There was no resistance felt (spongy like feel) upon pressing the brake lever. This would indicate that there may be a leakage of pressure/vacuum in the front brake system.

**Photo 24** shows the front brake lever being depressed. There was no resistance felt (spongy like feel) upon pressing the front brake lever (arrowed). This would indicate that there may be a leakage of pressure/vacuum in the front brake system.

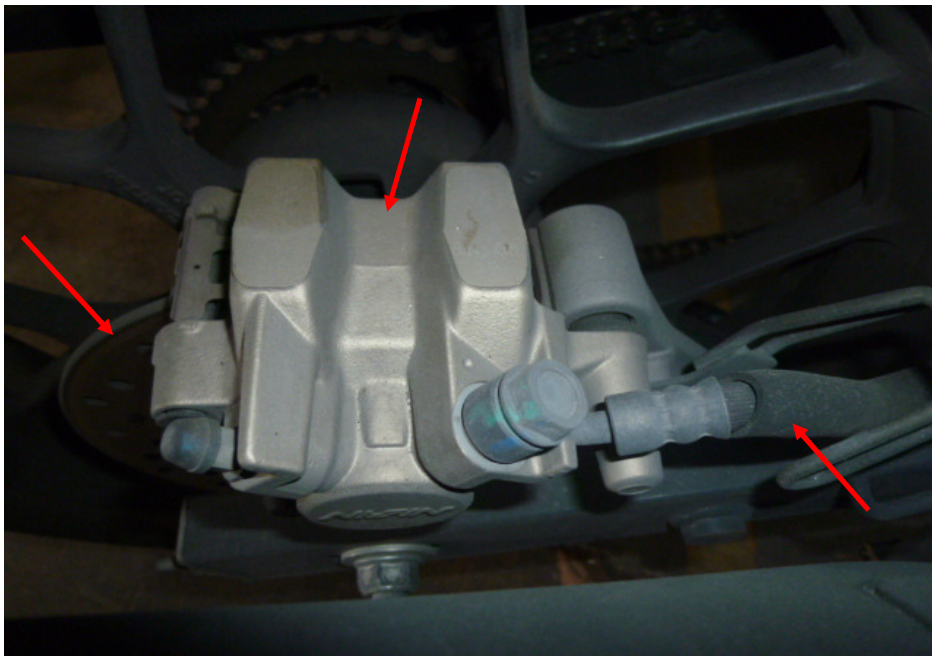
**Photo 25** shows a close up view of the rear brake caliper, rear brake disc and rear brake hose (arrowed) of the Motorcycle, which are all part of the components in the hydraulic rear brake system of the Motorcycle. Our visual checks of these various components had revealed all to be intact with no visible damage. No leakage of brake fluid was also observed.
