Your Ref: TP/IP/43987/2021  
Our Ref : CI/TPD21010817/N

3 December 2021

**Fatal Accident Investigation Team**

**INSPECTION REPORT OF MOTORCYCLE FBA 7474R**

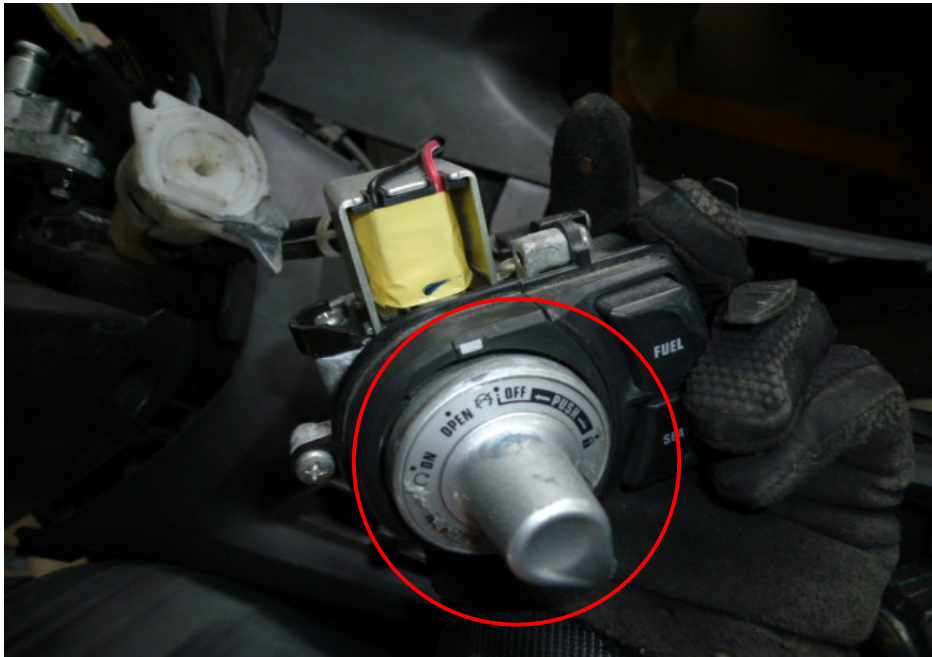
4. The mileage of the Motorcycle could not be recorded at the time of our inspection due to a broken ignition.
5. The Motorcycle was observed to have sustained minor damages all around. The body parts that were found to have been damaged include its windshield, headlight assembly, head cowl, front cowl, front mudguard, front fork assembly, front wheel rim, ignition, side cowlings, right bottom side cowl, right side cover, left rear side cover and exhaust muffler heat shield, amongst others as a result of the accident. See photos 1 – 14 below.

**Photo 1** shows the broken ignition of the Motorcycle as a result of the accident (circled).

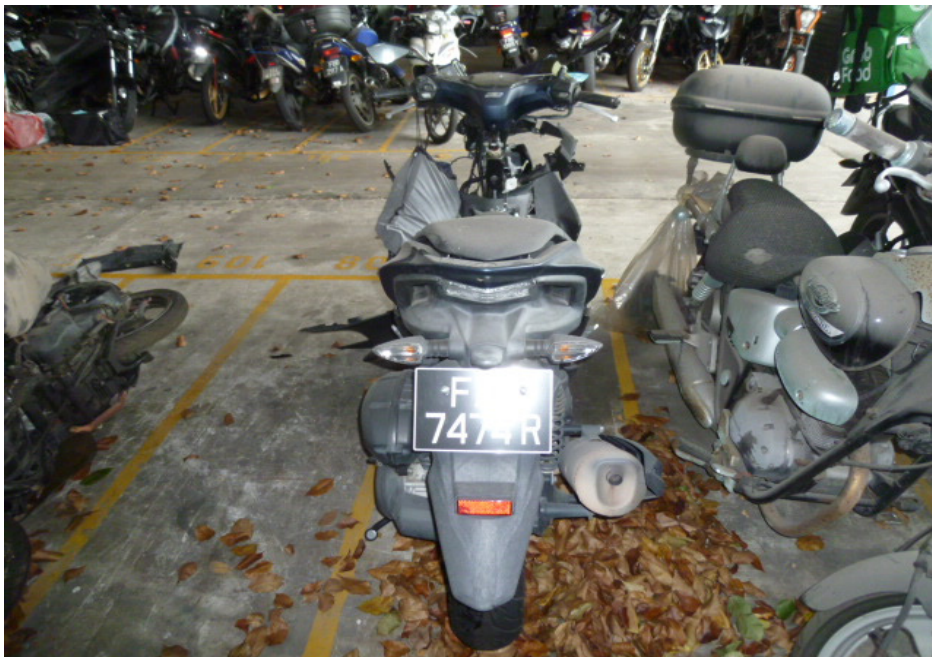
**Photo 2** shows a general view of the rear portion of the Motorcycle at the time of our inspection. The Motorcycle was observed to have sustained damages all around.

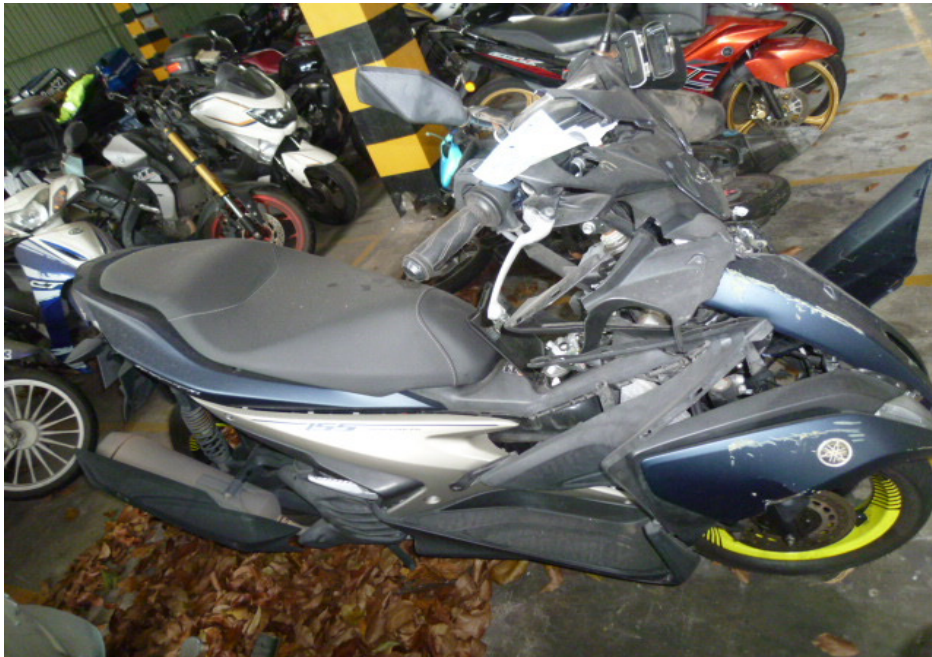
**Photo 3** shows a general view of the right body of the Motorcycle at the time of our inspection. The Motorcycle was observed to have sustained damages all around.

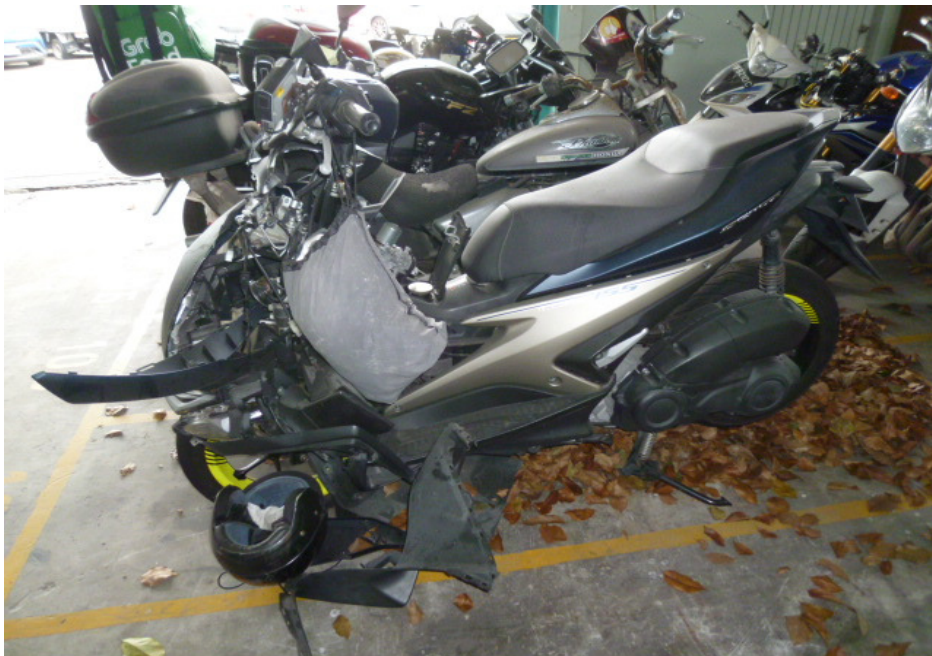
**Photo 4** shows a general view of the left portion of the Motorcycle at the time of our inspection. The Motorcycle was observed to have sustained damages all around.

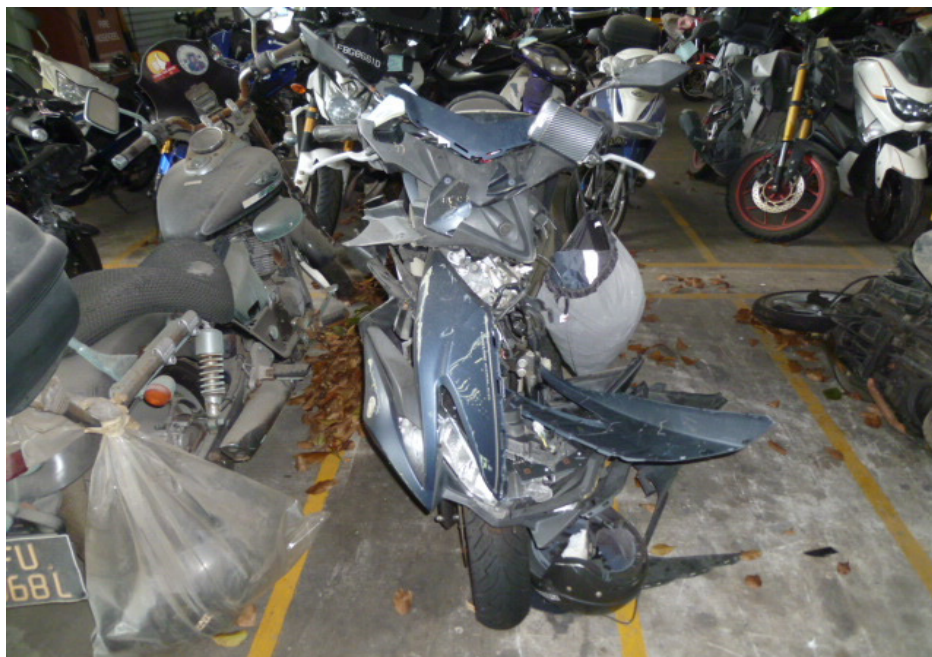
**Photo 5** shows a general view of the frontal portion of the Motorcycle at the time of our inspection. The Motorcycle was observed to have sustained damages all around. The body parts that were found to have been damaged include its windshield, headlight assembly, head cowl, front cowl, front mudguard, front fork assembly, front wheel rim, ignition, side cowlings, right bottom side cowl, right side cover, left rear side cover and exhaust muffler heat shield, amongst others as a result of the accident.

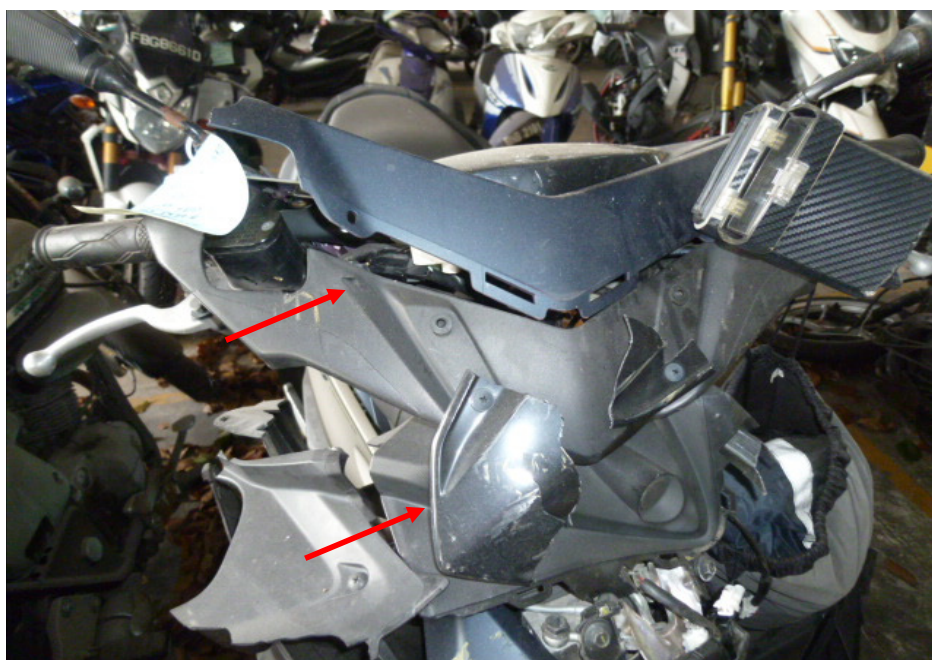
**Photo 6** shows a closer view of the cracked windshield and head cowl of the Motorcycle at the time of our inspection (arrowed).

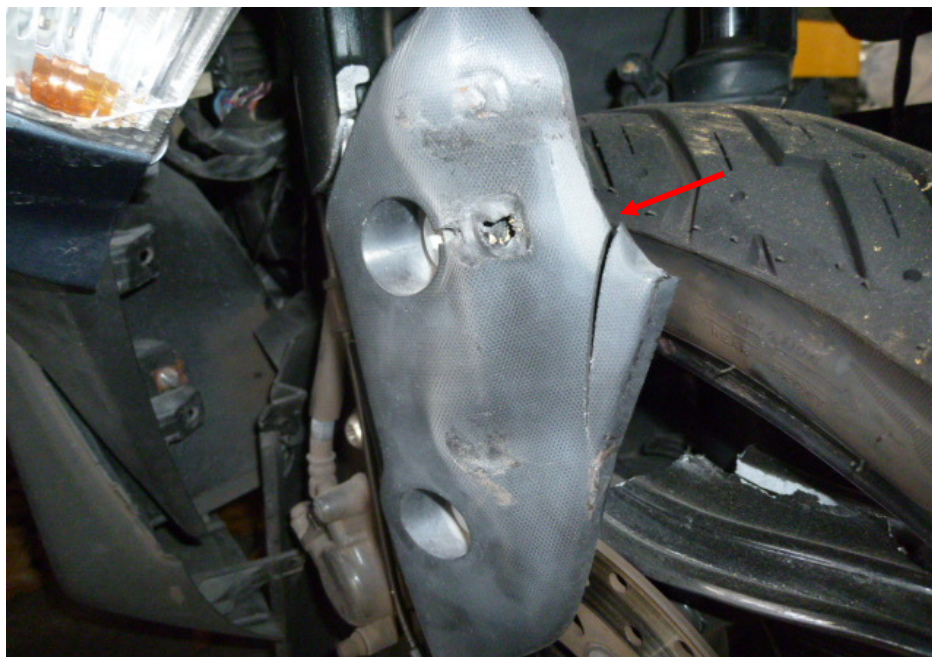
**Photo 7** shows a closer view of the cracked front mudguard which was amongst the body parts at the front body of the Motorcycle that had sustained damage as a result of the accident (arrowed).

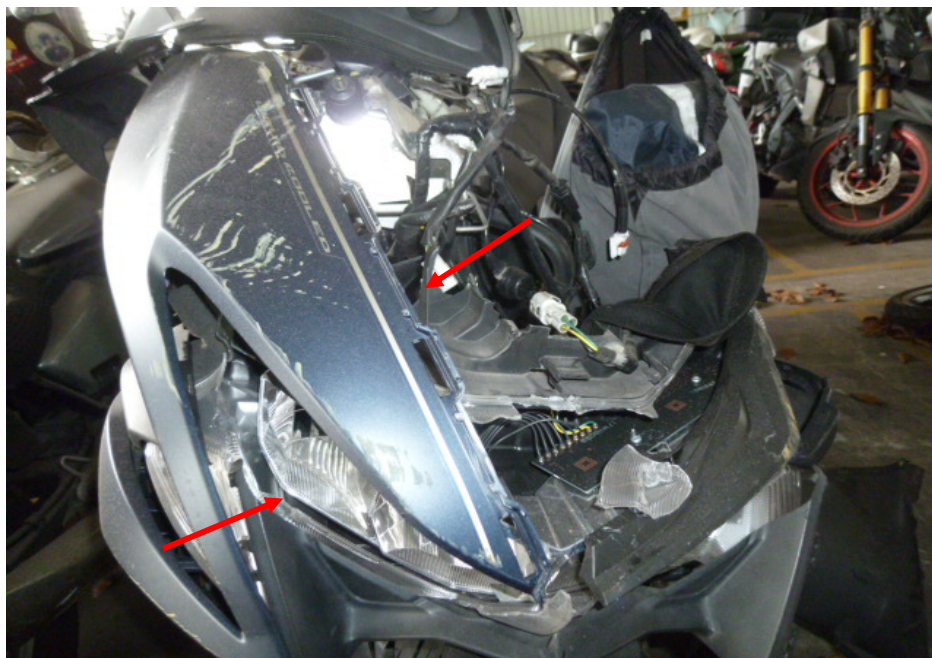
**Photo 8** shows a closer view of the cracked headlight assembly and front cowling of the Motorcycle which were observed to be damaged due to the accident (arrowed).

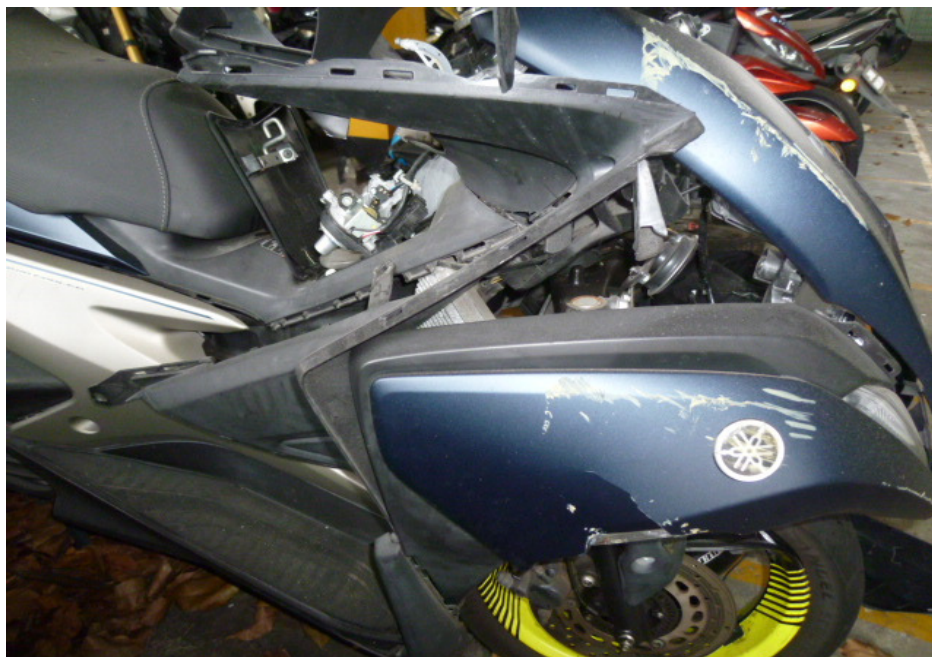
**Photo 9** shows the broken right side cowling of the Motorcycle as a result of the accident.

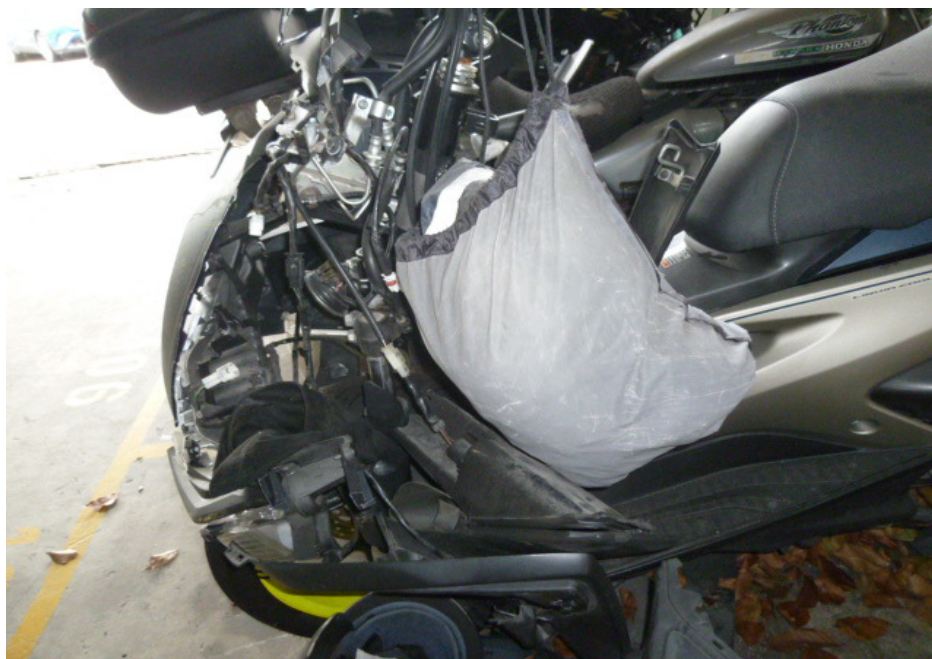
**Photo 10** shows the broken left side cowling of the Motorcycle as a result of the accident.

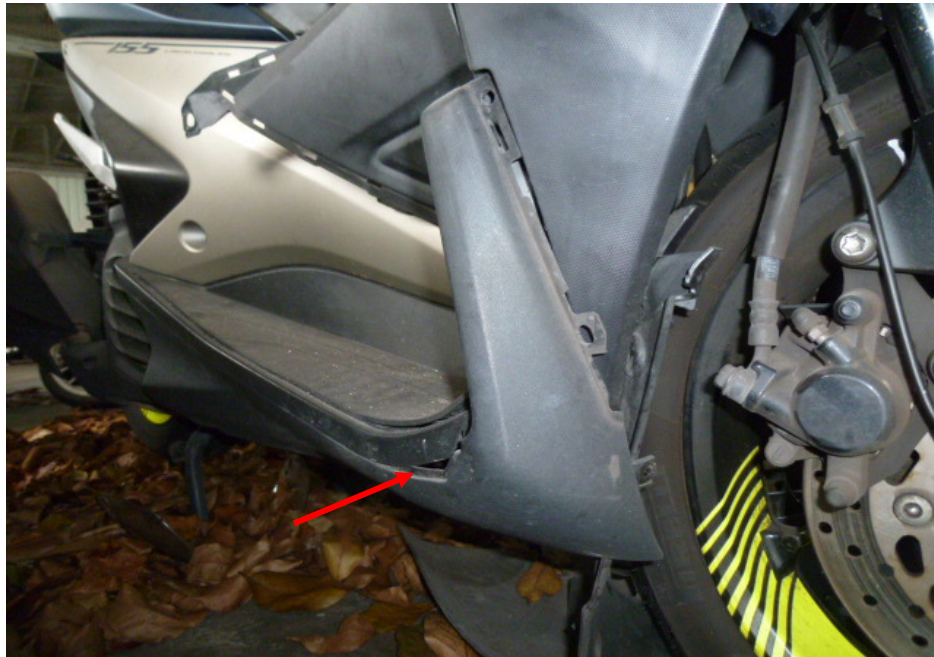
**Photo 11** shows a closer view of the cracked right bottom side cowling of the Motorcycle as a result of the accident (arrowed).

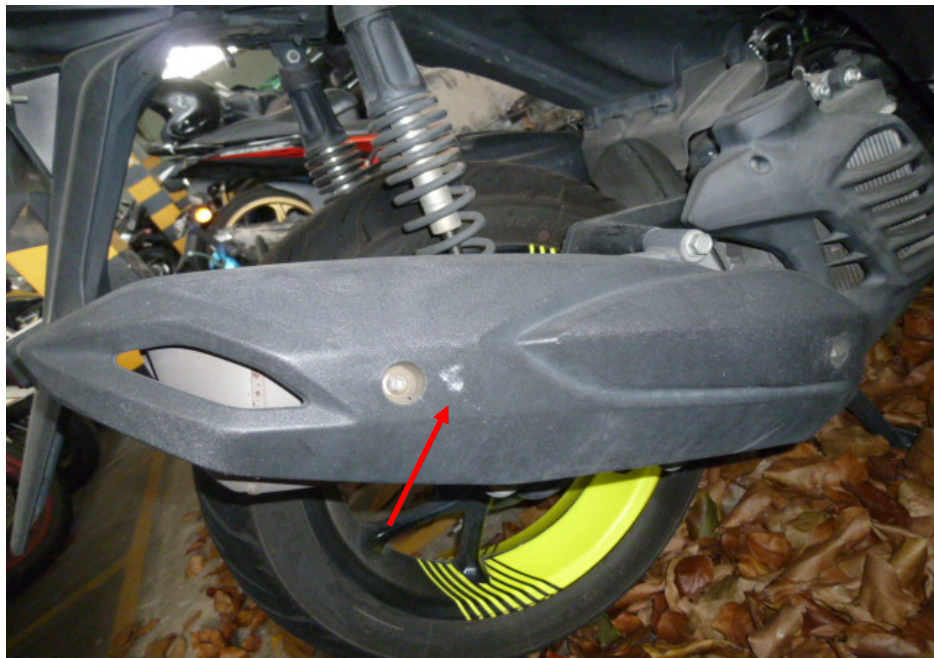
**Photo 12** shows a closer view of the grazed exhaust muffler heat shield of the Motorcycle at the time of our inspection (arrowed).

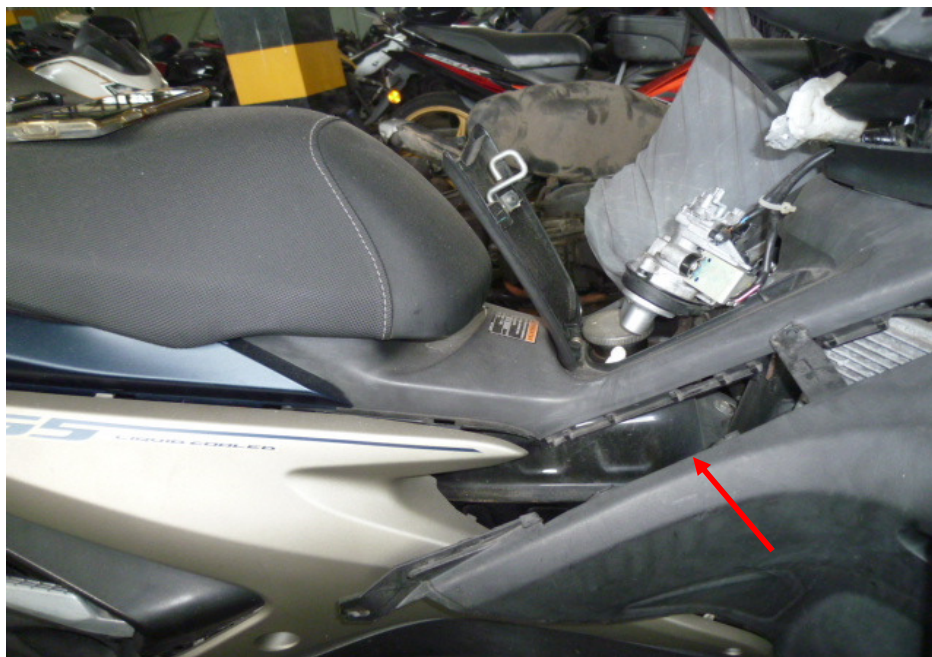
**Photo 13** shows a closer view of the deformed right side cover of the Motorcycle at the time of our inspection (arrowed).

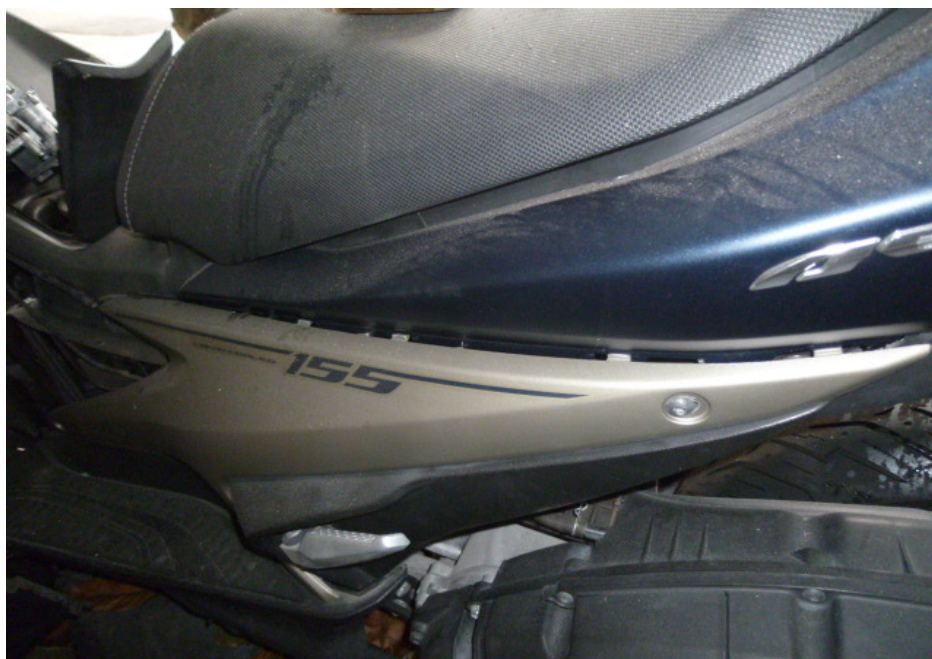
**Photo 14** shows a closer view of the deformed left rear side cover of the Motorcycle as a result of the accident (circled).

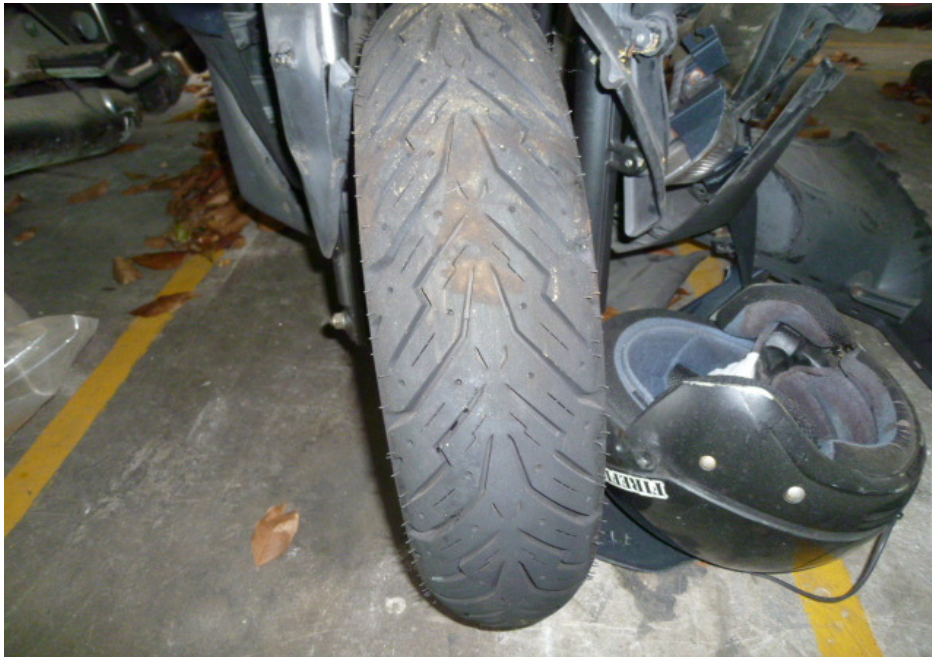
**Photo 15** shows the condition of the Motorcycle's front tyre. The front tyre was observed to be in serviceable condition with remaining tread depth of approximately 8mm. There was no tear, burst mark(s) and/or punctured hole(s) on the sidewalls as well as across the tread of the front tyre. However the front tyre was observed to be deflated.

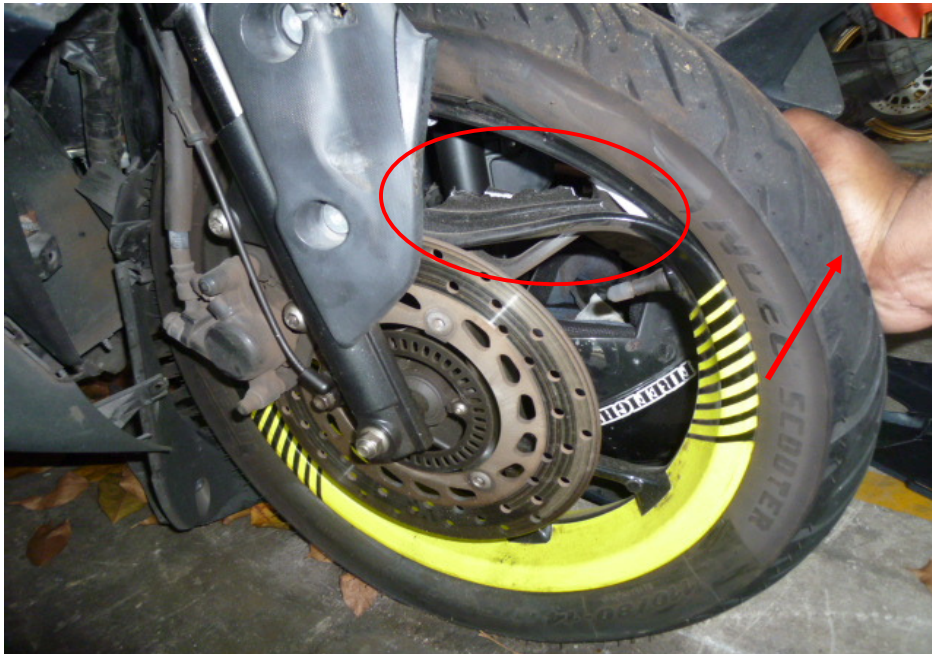
7. The 2 tyres were wrapped around alloy wheel rims. At the time of our inspection, we did not observe any visible damage on the rear wheel rim of the Motorcycle. However we did observe that the front wheel rim was bent. See photos 15 - 17 below.

**Photo 16** shows the bent front wheel rim (circled) and deflated front tyre (arrowed) of the Motorcycle at the time of our inspection.

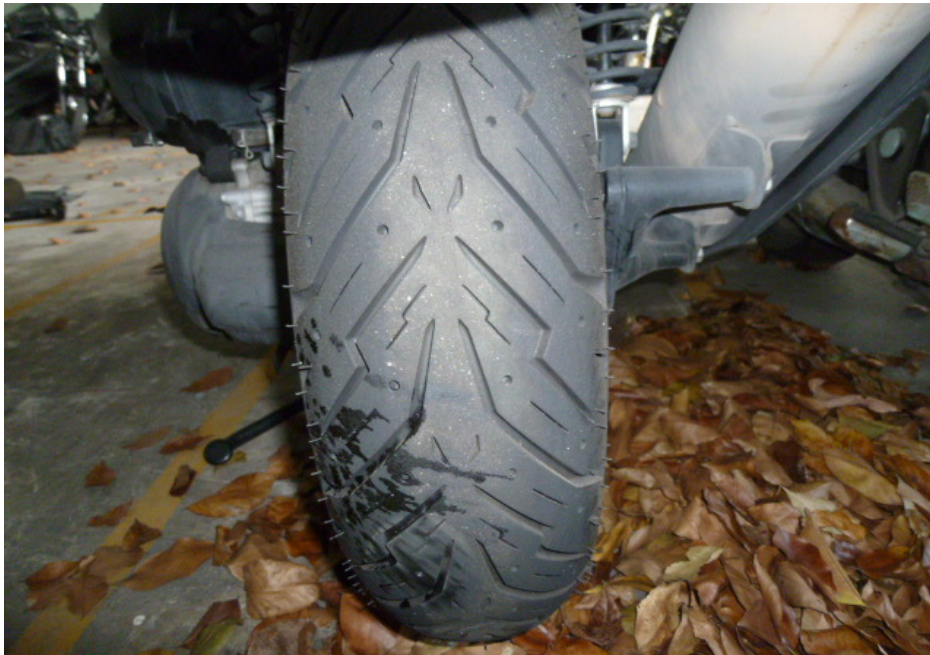
**Photo 17** shows the condition of the Motorcycle's rear tyre. The rear tyre was observed to be in serviceable condition with remaining tread depth of approximately 6mm. The tyre was also observed to be sufficiently inflated for vehicular operation. We did not observe any tear, burst mark(s) and/or punctured hole(s) on the sidewalls as well as across the tread of the rear tyre.

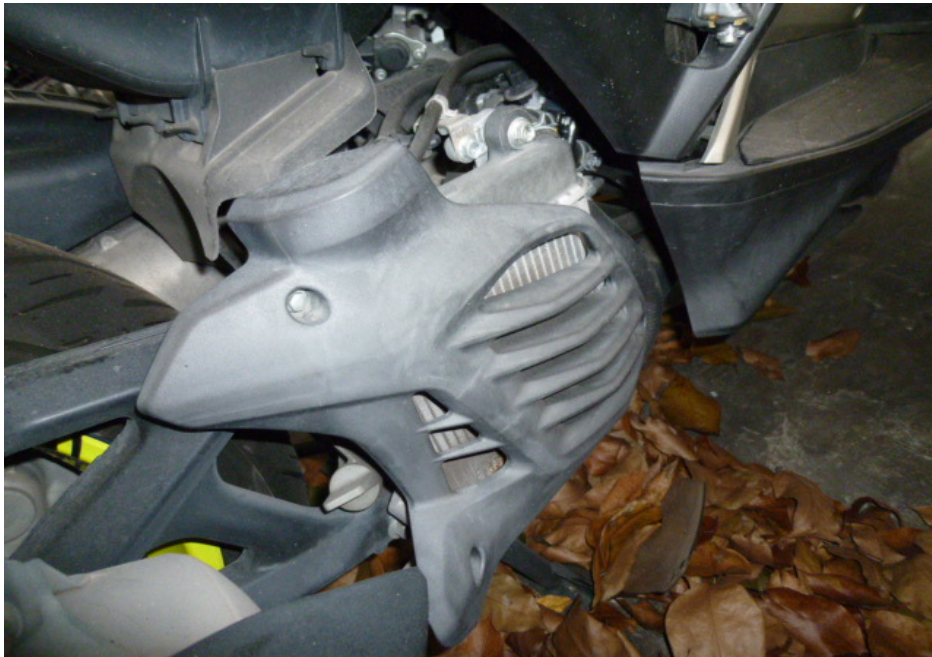
**Photo 18** shows the radiator of the Motorcycle at the time of our inspection. The radiator was found to be intact with no visible damage. There was also no sign(s) or indication(s) of fluid leak observed around the radiator of the Motorcycle.

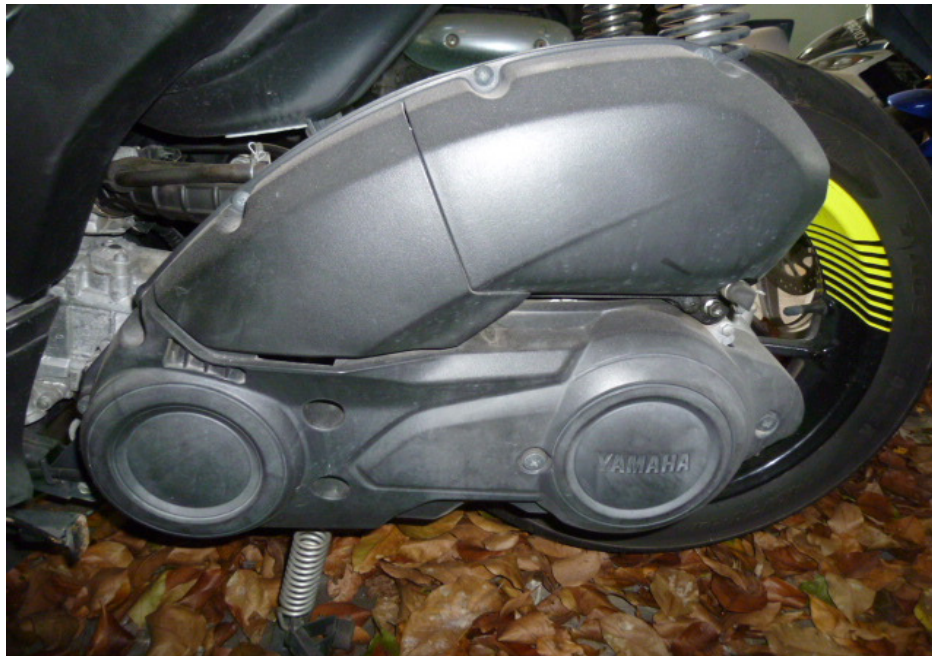
**Photo 19** shows the drive train cover of the Motorcycle which was found to be intact without any misalignment.

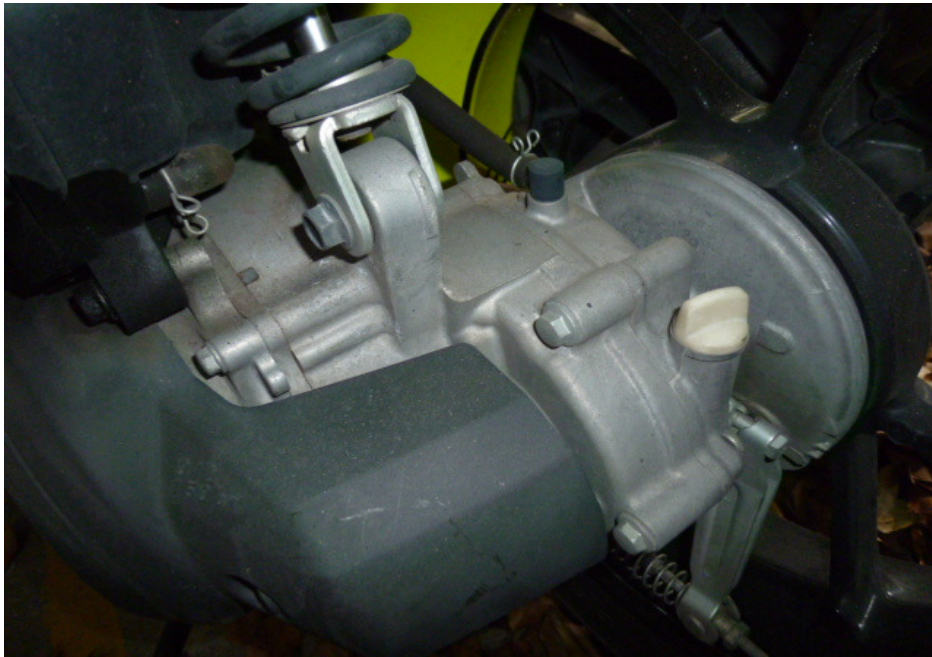
**Photo 20** shows the drive train of the Motorcycle which was found to be intact without any misalignment.

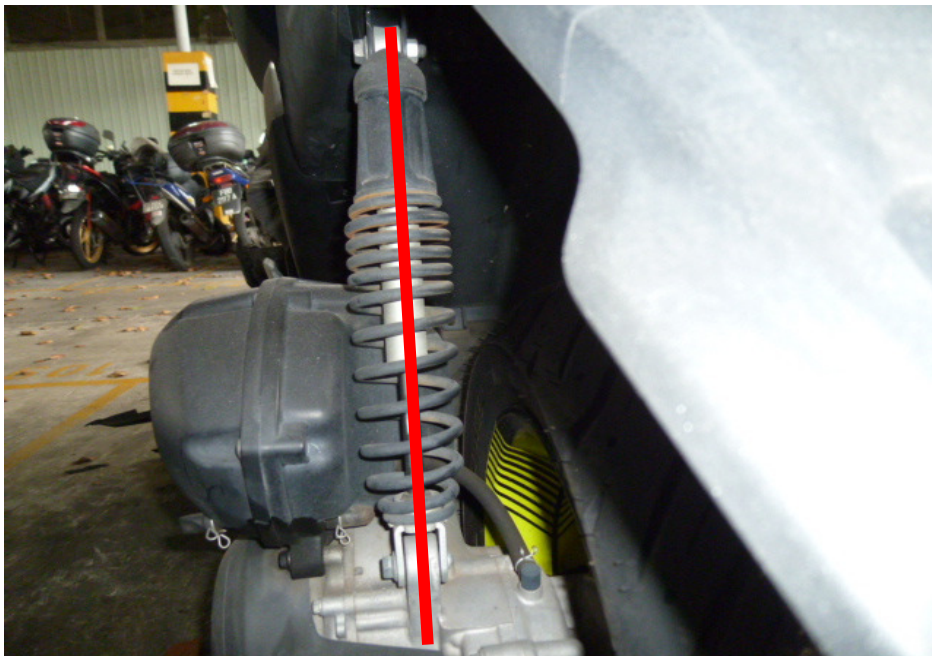
**Photo 21** shows the left shock absorber of the Motorcycle which was found to be intact without any misalignment.

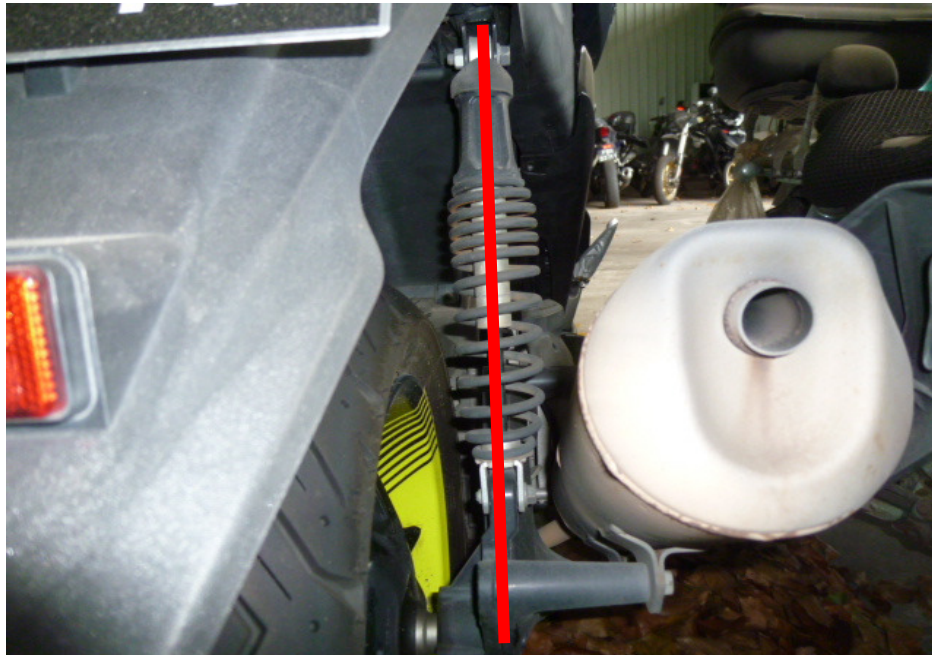
**Photo 22** shows the right shock absorber of the Motorcycle which was found to be intact without any misalignment.

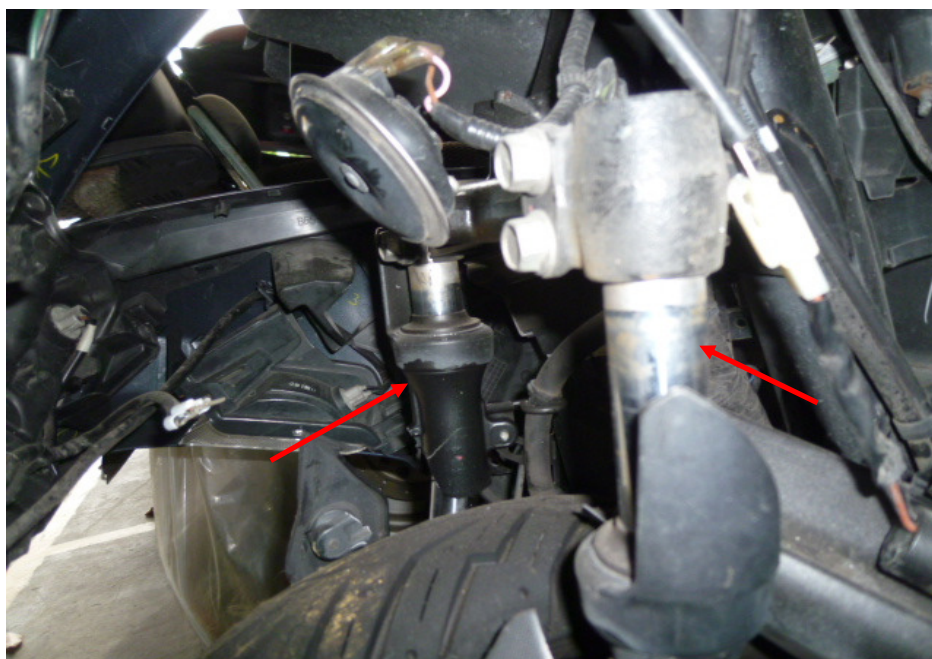
10. For this case, we were not able to conduct any test(s) on the steering system of the Motorcycle due to the damage of its front fork assembly. The front forks and steering stem were found to be bent as a result of the accident.

**Photo 23** shows the front fork assembly of the Motorcycle. The front forks were observed to be bent (arrowed) as a result of the accident. We were hence not able to conduct any tests on the steering system of the Motorcycle.

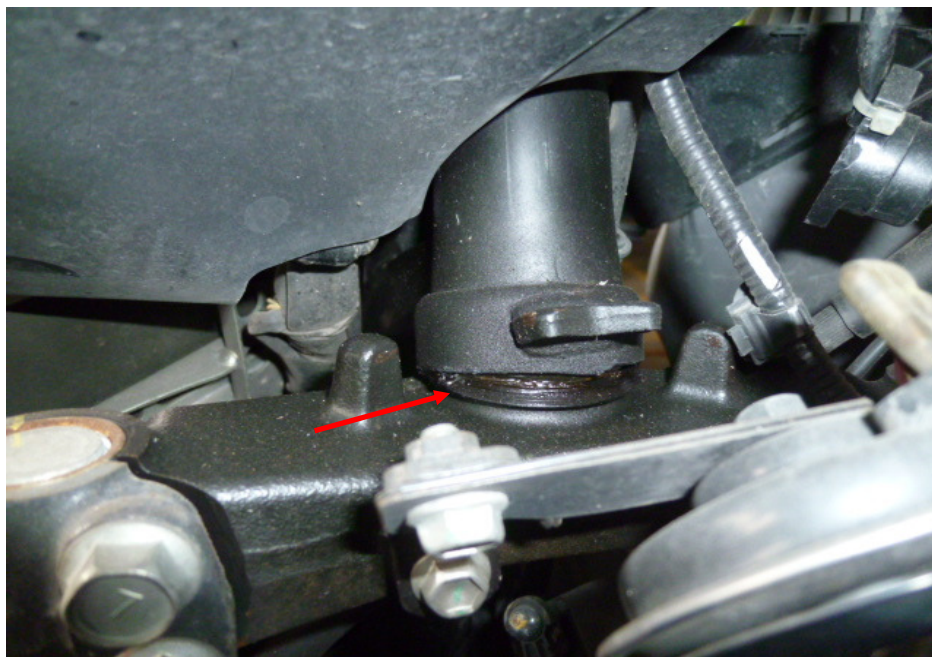
**Photo 24** shows the steering stem of the Motorcycle. The steering stem observed to be bent (arrowed) as a result of the accident. We were hence not able to conduct any tests on the steering system of the Motorcycle.

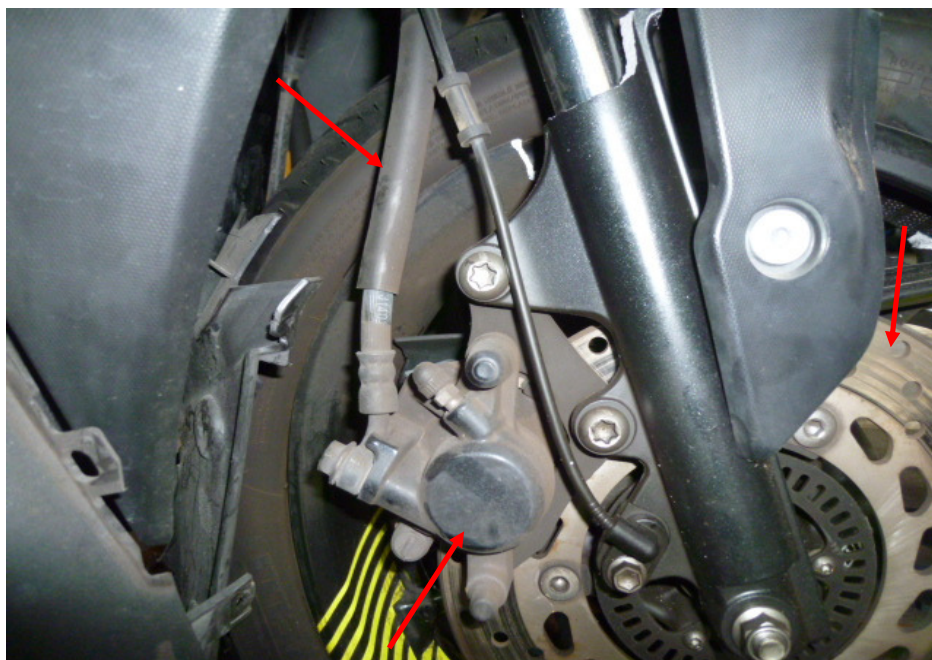
**Photo 25** shows a close up view of the front brake caliper, front brake disc and front brake hose (arrowed) of the Motorcycle, which are all part of the components in the hydraulic front brake system of the Motorcycle. Our visual checks of these various components had revealed all to be intact with no visible damage. No leakage of brake fluid was also observed.

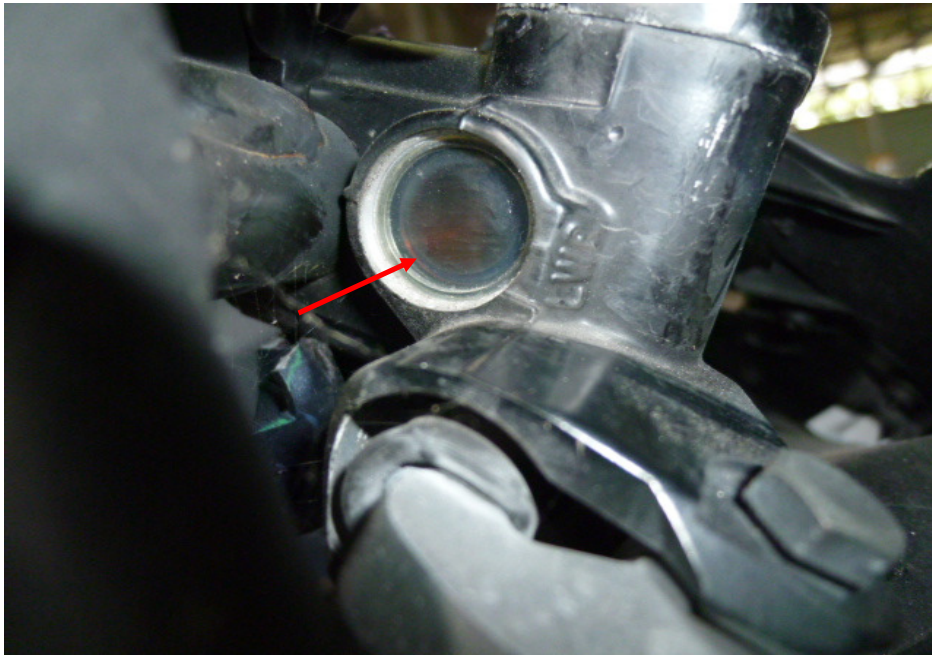
**Photo 26** shows the brake fluid reservoir for the front brake of the Motorcycle. The brake fluid was observed to be of sufficient level for operational purposes and without any contamination (arrowed).

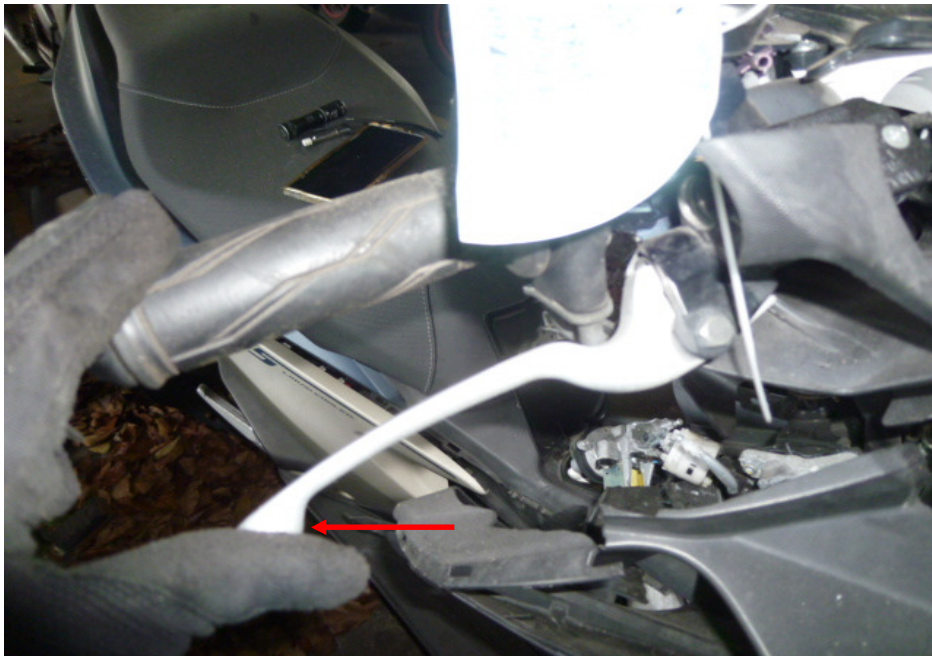
12. Static brake tests conducted on the Motorcycle had appeared to indicate that the front brake system of the Motorcycle was in serviceable condition. There was some resistance felt (spongy like feel) upon pressing the front brake lever. This would indicate that there is no leakage of pressure/vacuum in the front brake system.
13. For this case, we were not able to carry out any operational tests to the steering system and braking system of the Motorcycle due to the damage of its front fork assembly, which had rendered the Motorcycle immobile for the operational tests. We were not able to push the Motorcycle manually forward and backward, simulating movement of the Motorcycle, for the operational tests. See photos 23 – 28 below.

**Photo 27** shows the front brake lever being depressed. There was some resistance felt (spongy like feel) upon pressing the front brake lever (arrowed). This would indicate that there is no leakage of pressure/vacuum in the front brake system.

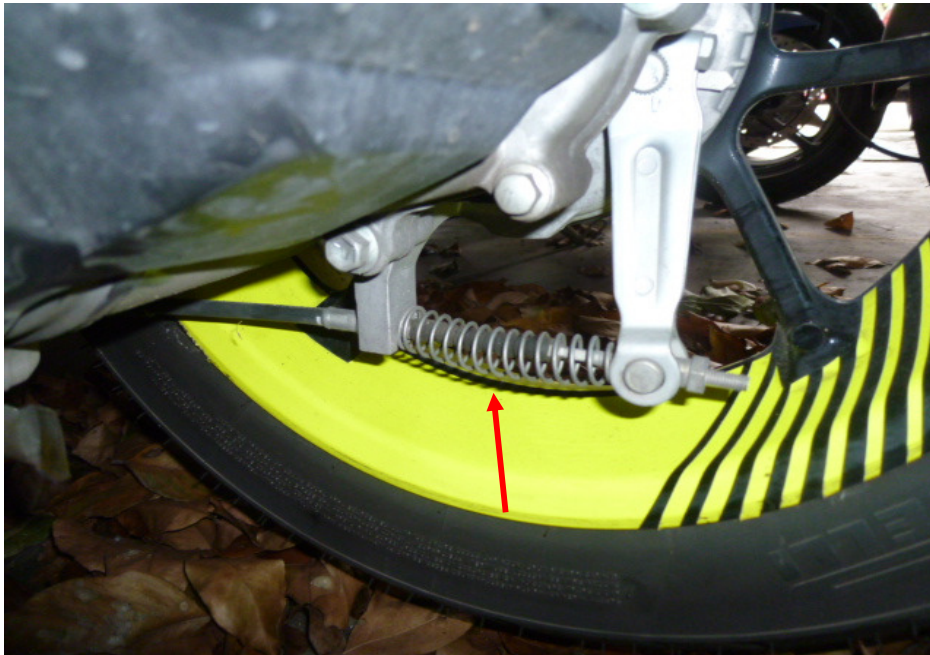
**Photo 28** shows the rear wheel of the Motorcycle. The type of brake system for the rear wheel was of a mechanical type, controlled by the brake foot pedal of the Motorcycle. Our checks of the cable (arrowed), spring and drum which are all part of the components in the rear brake system of the Motorcycle reveal all to be intact and without damage.
