Your Ref: TP/IP/35321/2021
Our Ref : CI/TPD21010818/N

21 October 2021

INSPECTION REPORT OF MOTORCYCLE FBJ 3860M

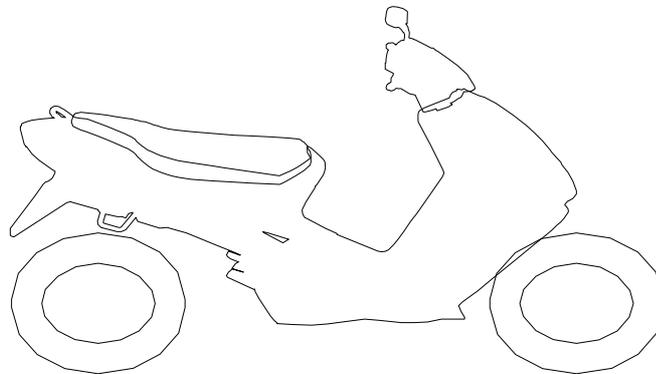
Pirelli 130/70 - 17 (4mm)

Dunlop 90/80 - 17 (3mm)

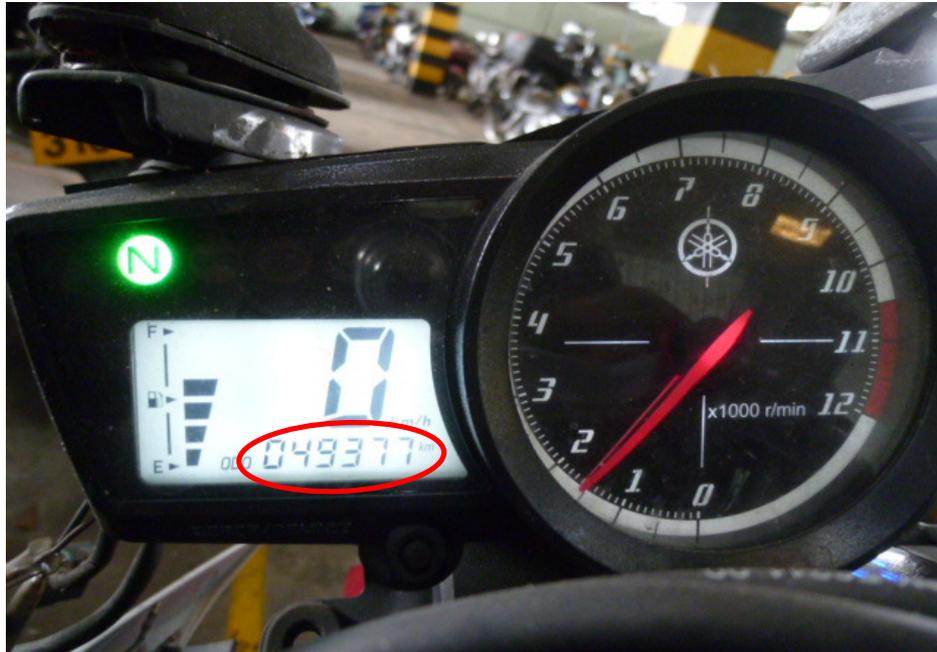
Photo 1 shows the speedometer gauge of the Motorcycle where the mileage recorded at the time of our inspection was 49, 377km (circled).

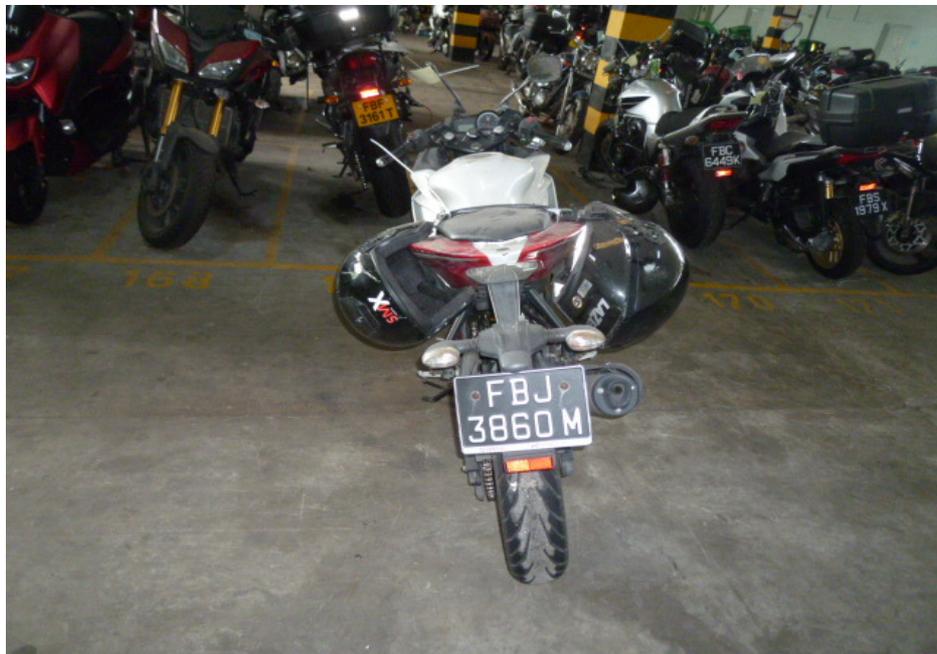
Photo 2 shows a general view of the rear portion of the Motorcycle at the time of our inspection. The Motorcycle was observed to have sustained damages all around.

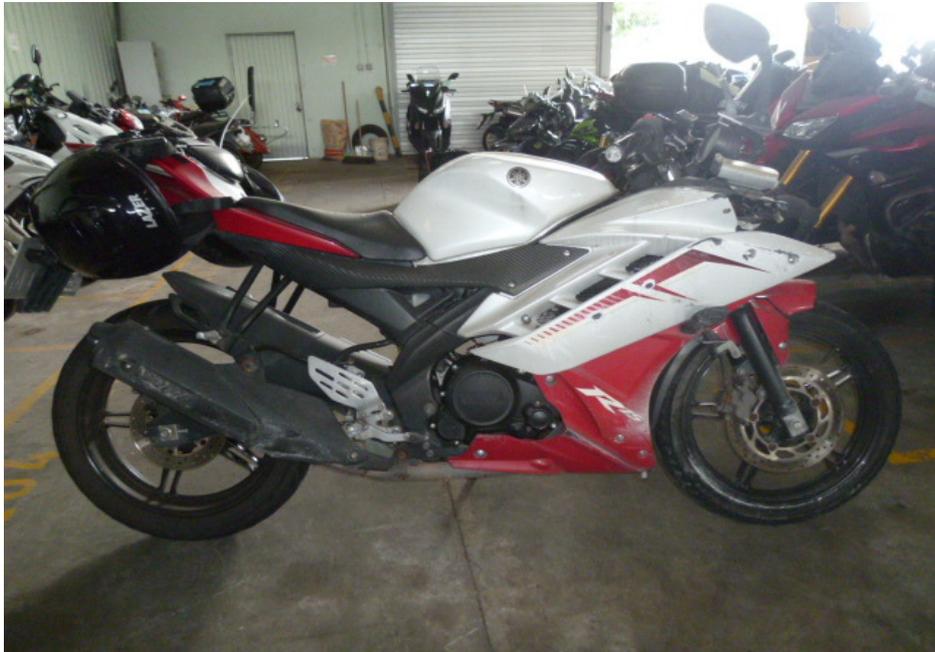
Photo 3 shows a general view of the right body of the Motorcycle at the time of our inspection. The Motorcycle was observed to have sustained damages all around.

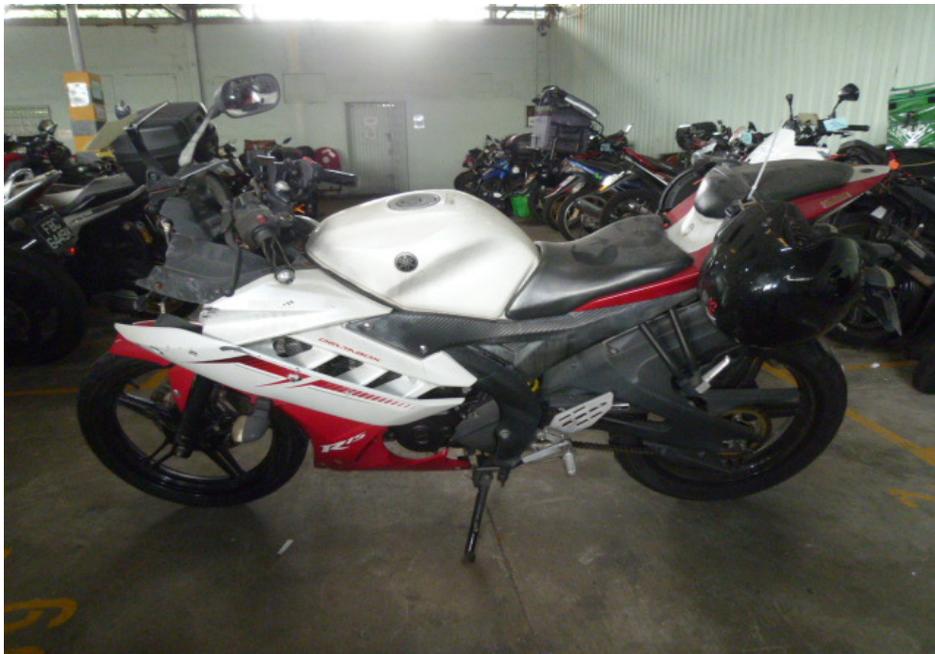
Photo 4 shows a general view of the left body of the Motorcycle at the time of our inspection. The Motorcycle was observed to have sustained damages all around.

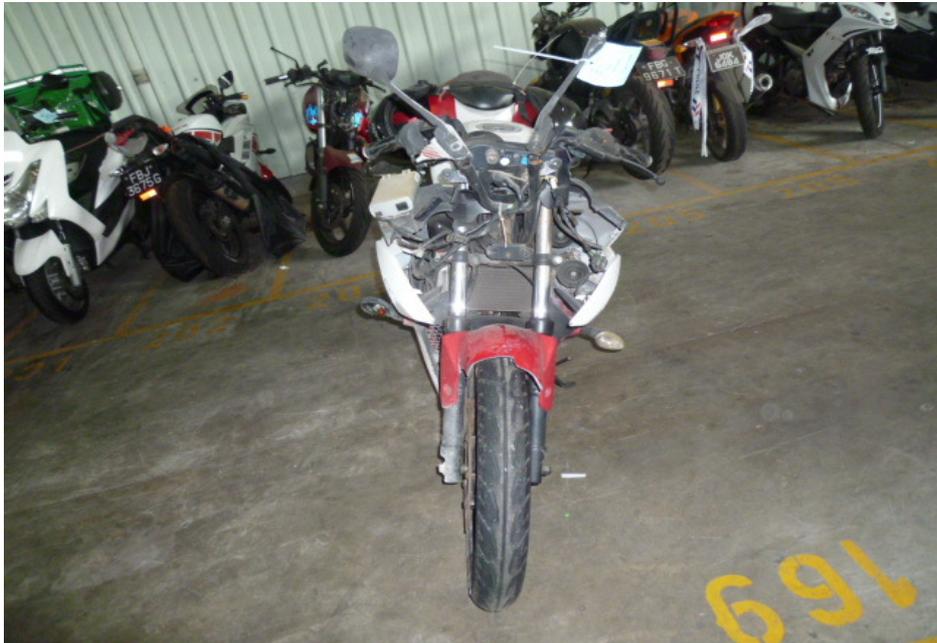
Photo 5 shows a general view of the frontal portion of the Motorcycle at the time of our inspection. The Motorcycle was observed to have sustained damages all around. Amongst the body parts that were found to have been damaged include its headlight assembly, head cowl, front mudguard, front wheel rim, side cowlings, right handlebar end, right side mirror, front brake lever, rear brake pedal, right front footrest, right rear side cover and exhaust muffler heat shield, amongst others.

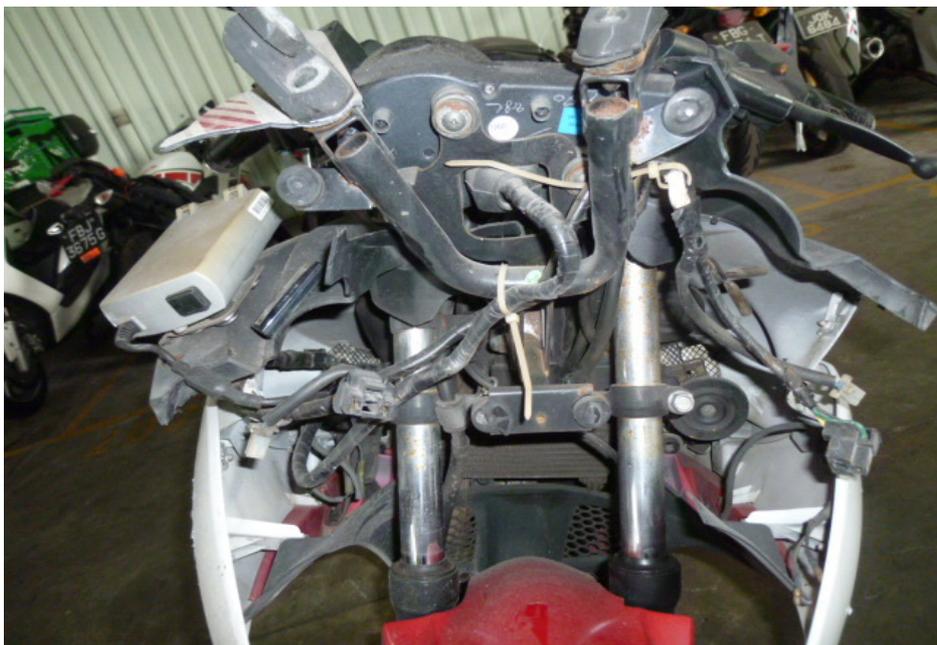
Photo 6 shows a closer view of the missing headlight assembly and head cowl which were amongst the body parts at the front body of the Motorcycle that had sustained damage as a result of the accident.

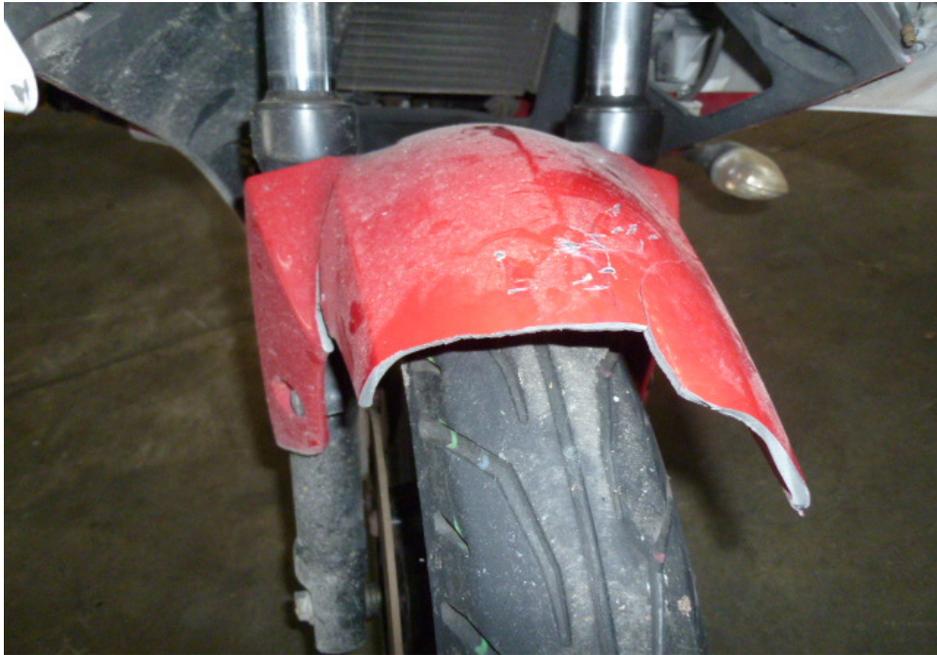
Photo 7 shows a close up view of the cracked front mudguard which was amongst the body parts of the Motorcycle that had sustained damage as a result of the accident.

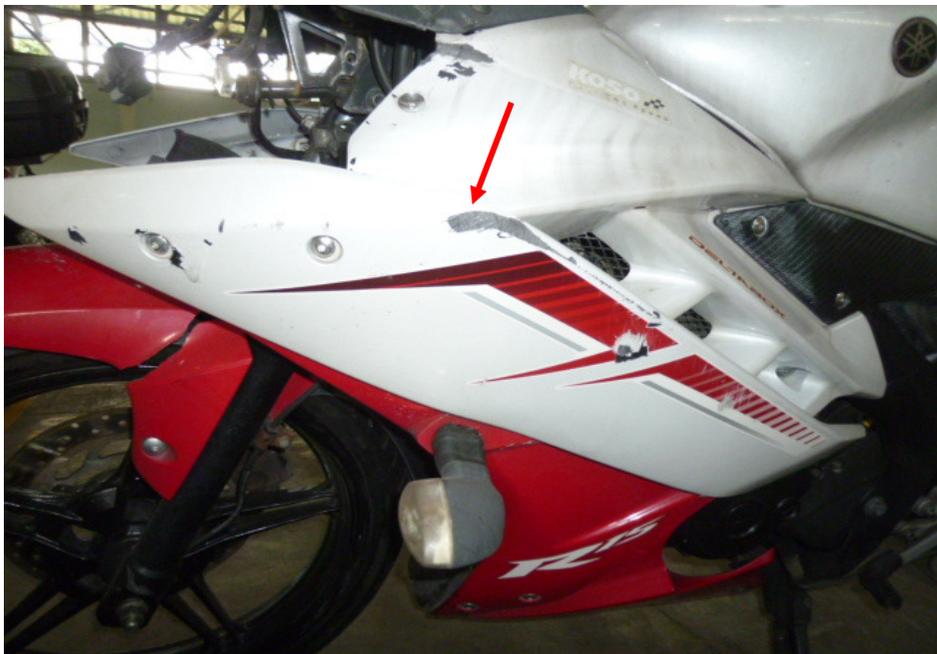
Photo 8 shows a closer view of the grazed left cowling of the Motorcycle as a result of the accident (arrowed).

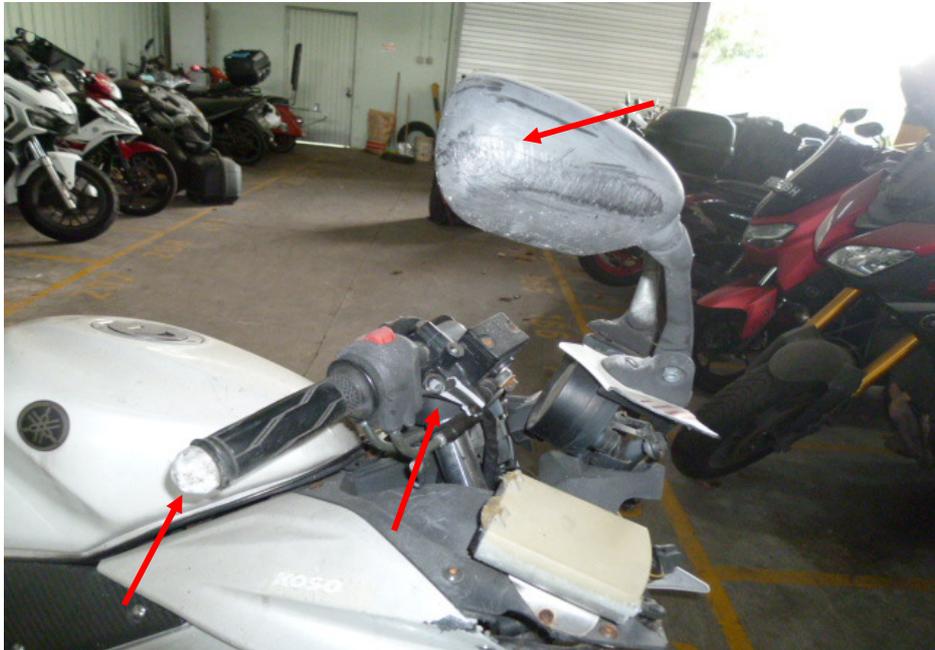
Photo 9 shows a closer view of the right handlebar end, front brake lever and right side mirror (arrowed) which were amongst the body parts of the Motorcycle that had sustained damage as a result of the accident.

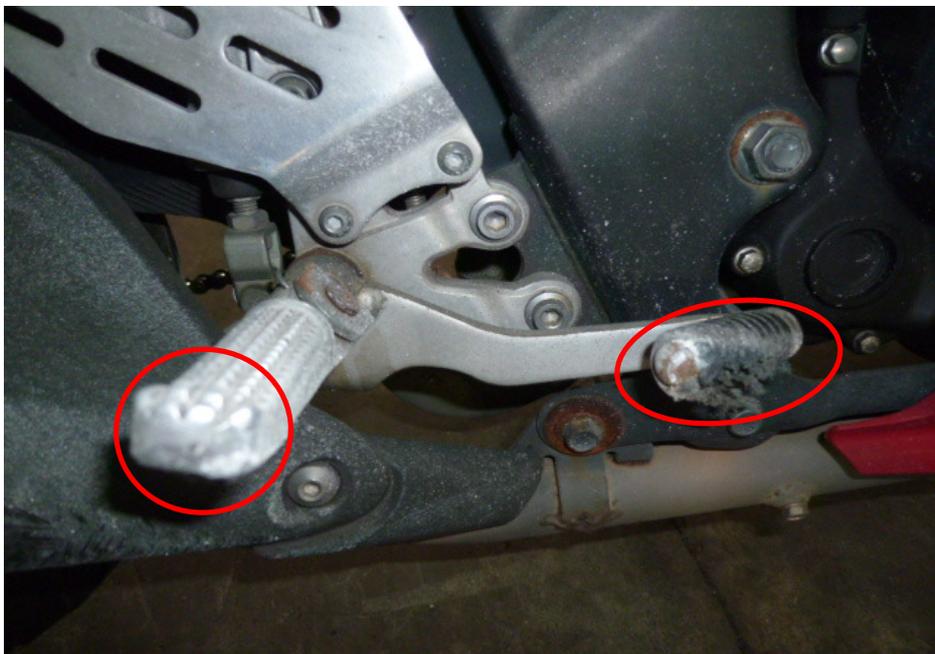
Photo 10 shows a closer view of the rear brake pedal and right front footrest (circled) which were amongst the body parts of the Motorcycle that had sustained damage as a result of the accident.

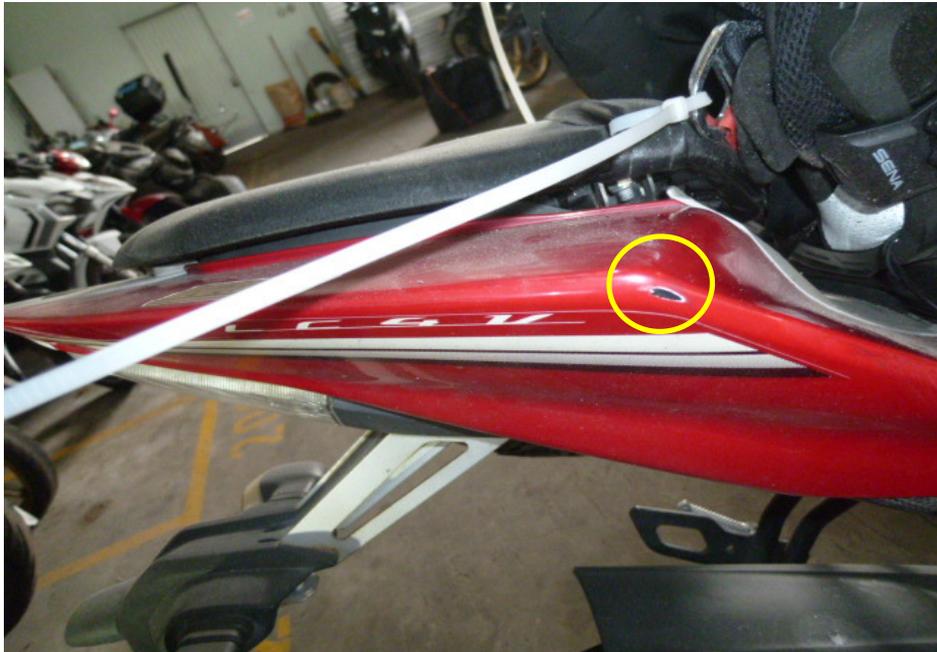
Photo 11 shows the right rear side cover of the Motorcycle which was amongst the body parts of the Motorcycle that had sustained damages of grazing nature as a result of the accident (circled).

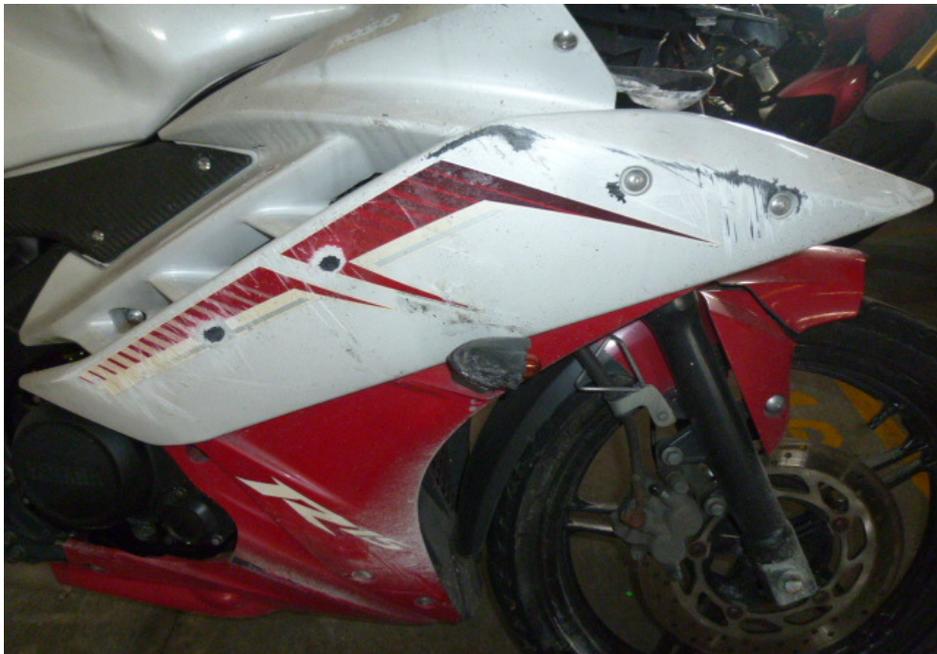
Photo 12 shows a closer view of the grazed right cowling of the Motorcycle as a result of the accident.

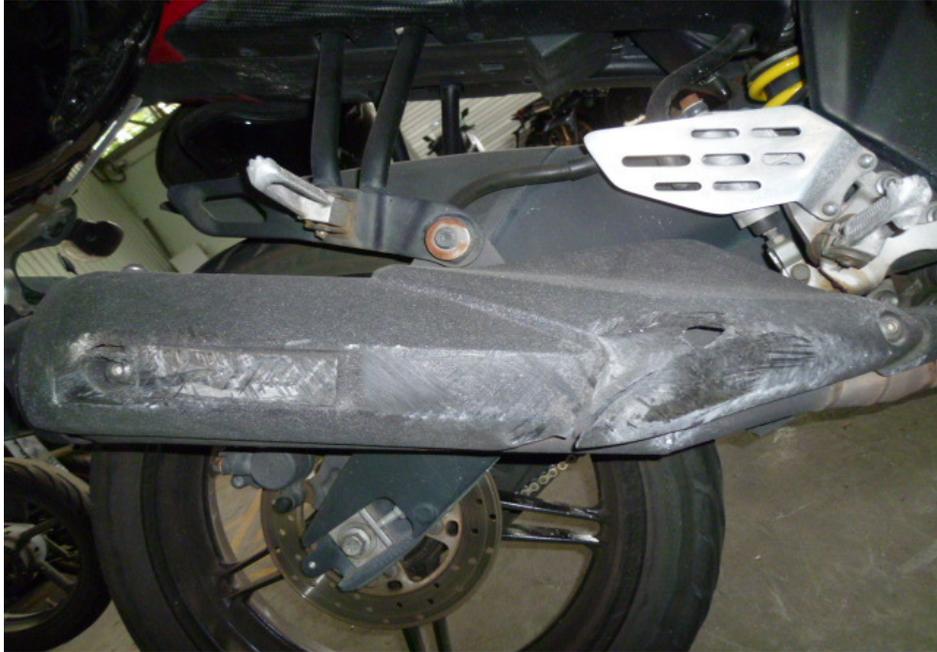
Photo 13 shows a closer view of the exhaust muffler heat shield of the Motorcycle that had sustained damages of grazing nature as a result of the accident.

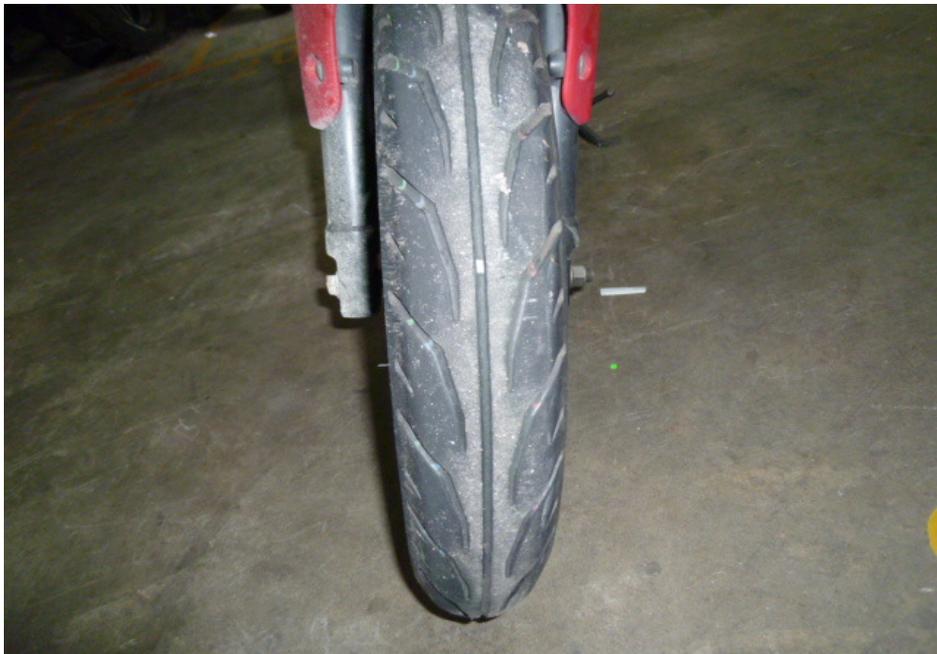
Photo 14 shows the condition of the Motorcycle's front tyre. The front tyre was observed to be in serviceable condition with remaining tread depth of approximately 3mm. There was no tear, burst mark(s) and/or punctured hole(s) on the sidewalls as well as across the tread of the front tyre.

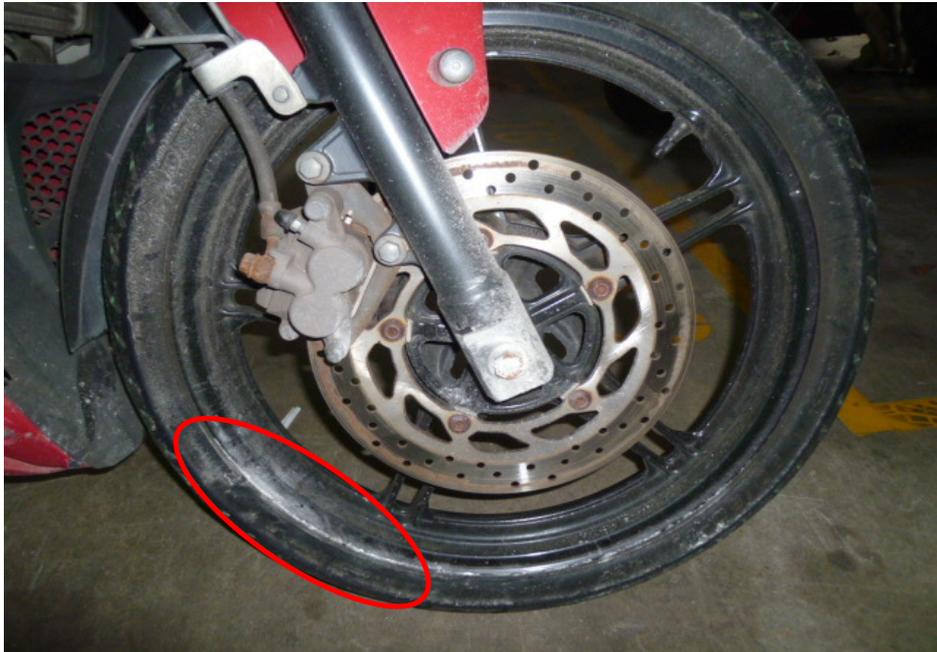
8. At the time of our inspection, we did not observe any visible damage on the rear wheel rim of the Motorcycle. We had however found some relatively minor marks of grazing nature on the edges of the front wheel rim, at the right side of the Motorcycle. See photos 1 – 16 below.

Photo 15 shows the front wheel rim of the Motorcycle at the time of our inspection. Some relatively minor marks of grazing nature were observed on the edges of the front wheel rim (circled), at the right side of the Motorcycle.

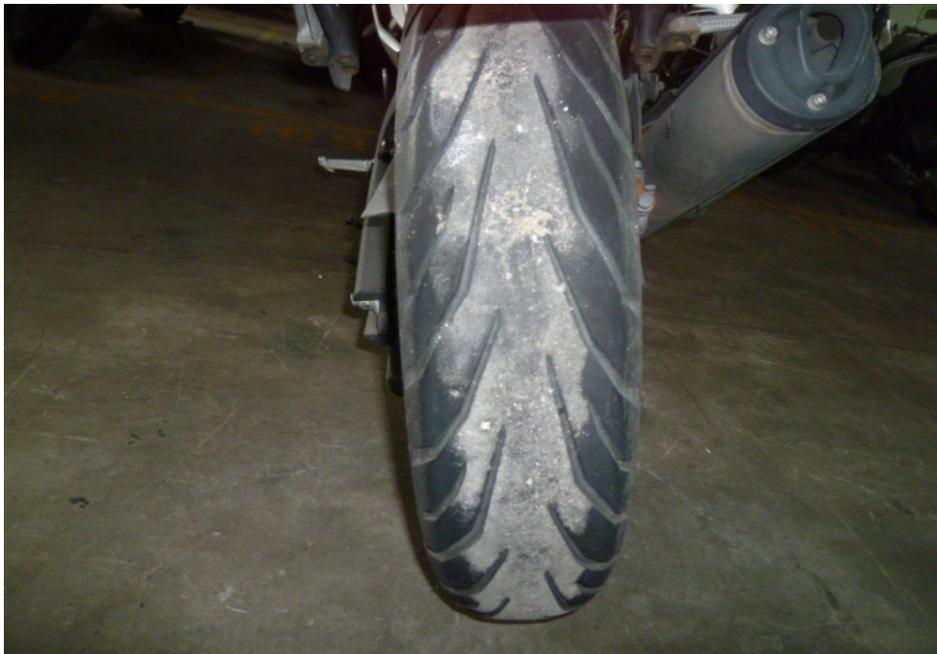
Photo 16 shows the condition of the Motorcycle's rear tyre. The rear tyre was observed to be in serviceable condition with remaining tread depth of approximately 4mm. The tyre was also observed to be sufficiently inflated for vehicular operation. We did not observe any tear, burst mark(s) and/or punctured hole(s) on the sidewalls as well as across the tread of the rear tyre.

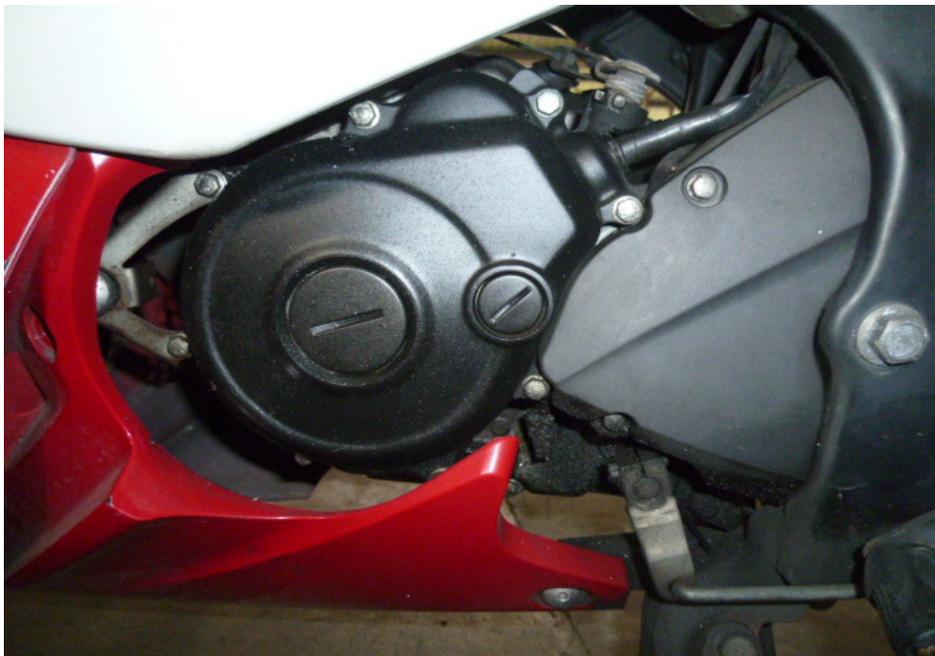
Photo 17 shows the left side of the engine of the Motorcycle at the time of our inspection. The various engine related parts and components were found to be intact with no visible damage. There was also no sign(s) or indication(s) of fluid leak observed around the left engine area of the Motorcycle.

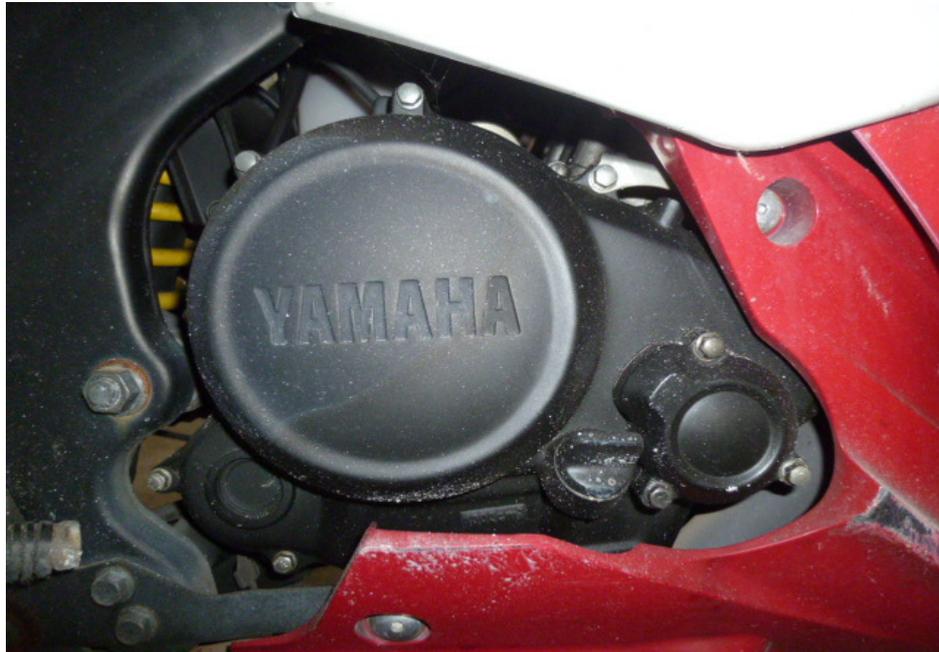
Photo 18 shows the right side of the engine of the Motorcycle at the time of our inspection. The various engine related parts and components were found to be intact with no visible damage. There was also no sign(s) or indication(s) of fluid leak observed around the right engine area of the Motorcycle.

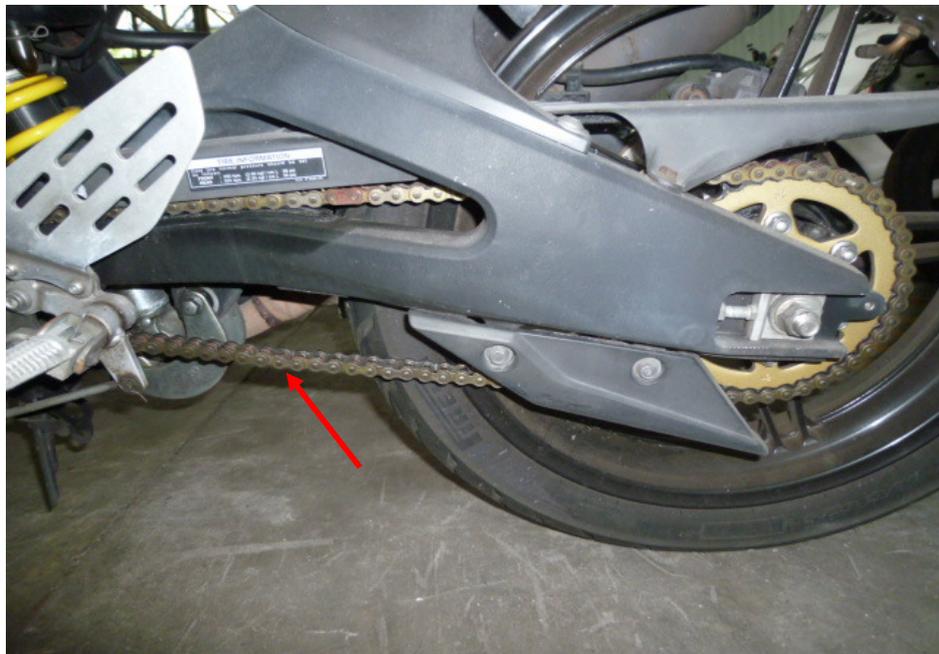
Photo 19 shows the general view of the gear train (arrowed) of the Motorcycle, which was observed to be intact with no misalignment. It was also adequately lubricated for operating purposes.

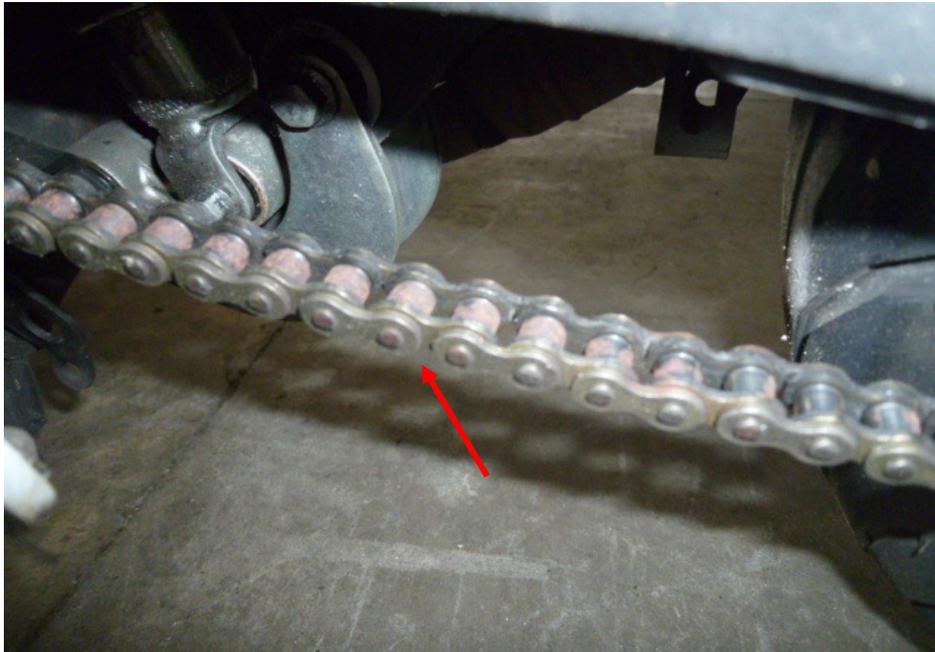
Photo 20 shows a closer view of the gear train (arrowed) of the Motorcycle, which was observed to be intact with no misalignment. It was also adequately lubricated for operating purposes.

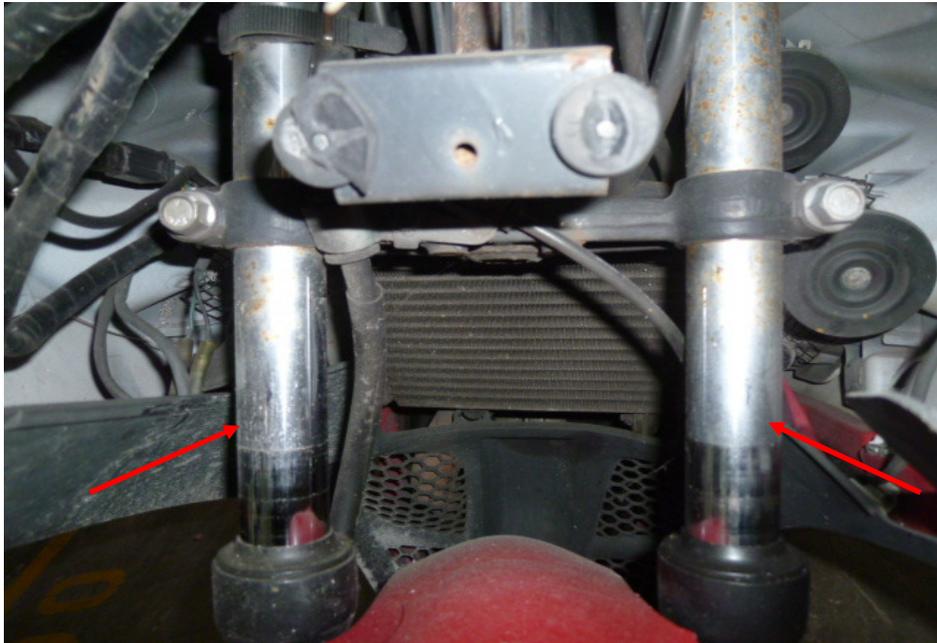
Photo 21 shows the front fork (arrowed) of the Motorcycle. The front fork and fork bracket of the Motorcycle were both found to be intact and undamaged. Turning the Motorcycle's handle bar towards the left and right did not produce any abnormal free play and/or resistance. The steering system of the Motorcycle was in serviceable condition at the time of our inspection.

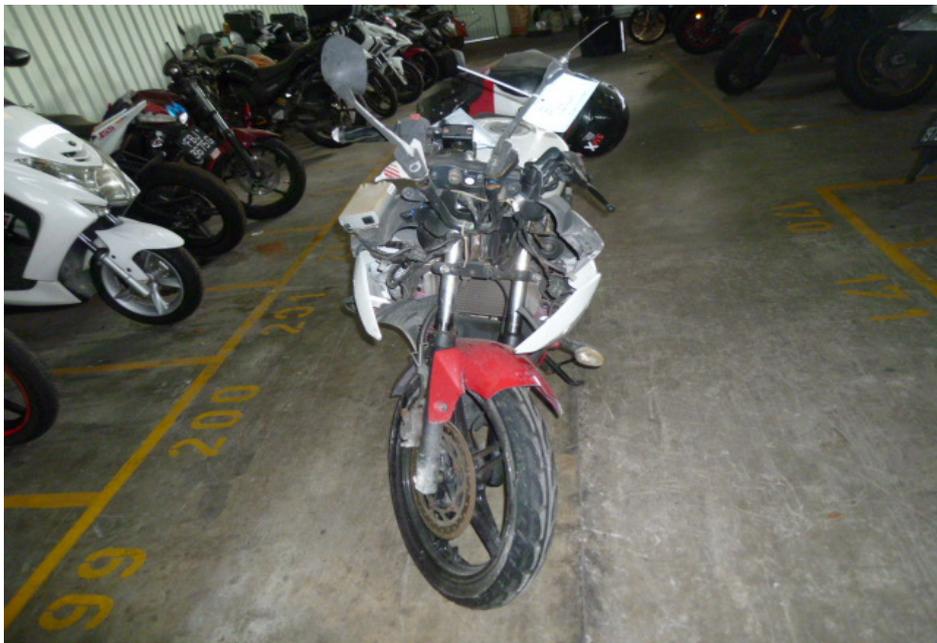
Photo 22 shows the front wheel of the Motorcycle turned towards its full left. Turning the Motorcycle's handle bar towards the left and right did not produce any abnormal free play and/or resistance. This would indicate that the steering system of the Motorcycle was in serviceable condition at the time of our inspection.

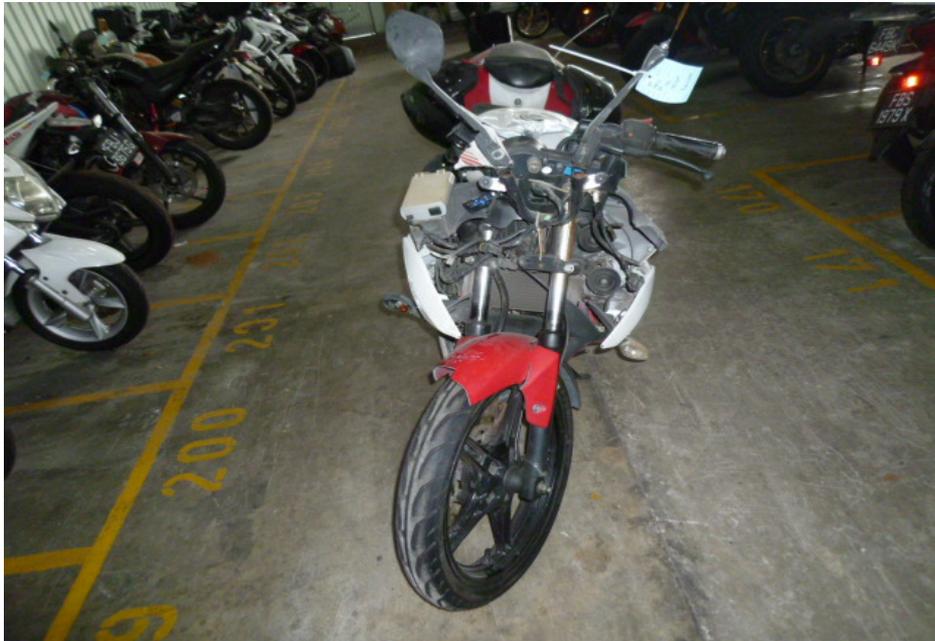
Photo 23 shows the front wheel of the Motorcycle turned towards its full right. Turning the Motorcycle's handle bar towards the left and right did not produce any abnormal free play and/or resistance. This would indicate that the steering system of the Motorcycle was in serviceable condition at the time of our inspection.

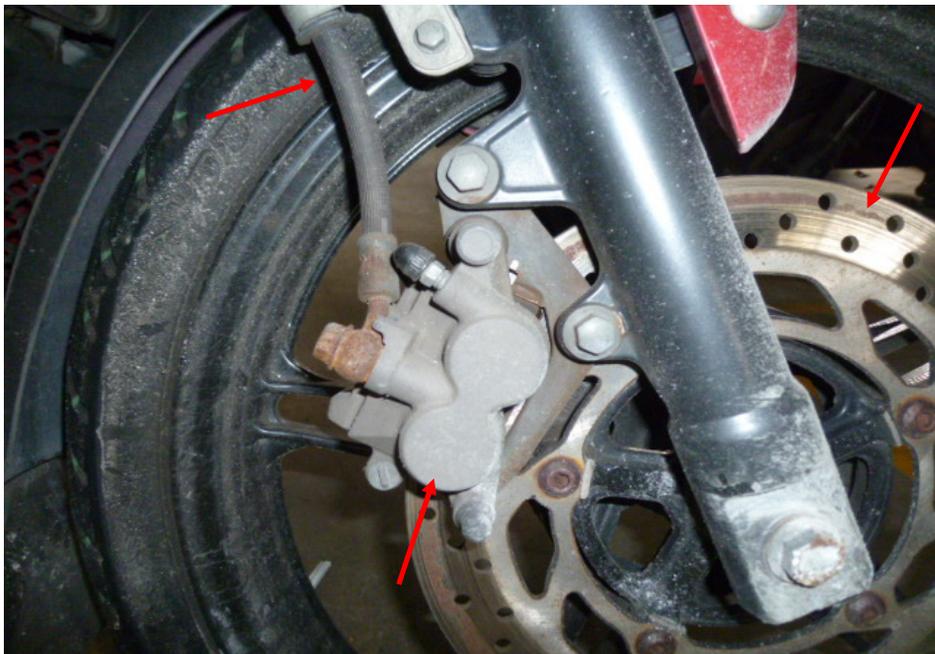
Photo 24 shows a close up view of the front brake caliper, front brake disc and front brake hose (arrowed) of the Motorcycle, which are all part of the components in the hydraulic front brake system of the Motorcycle. Our visual checks of these various components had revealed all to be intact with no visible damage. No leakage of brake fluid was also observed.

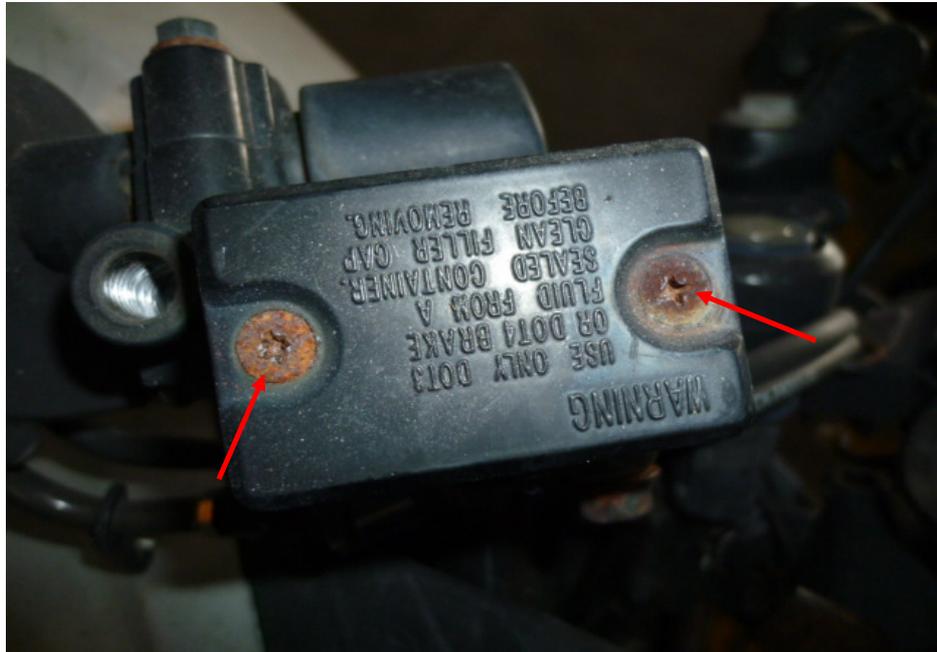
14. However we observed that part of the front brake lever had broken off as a result of the accident. We were also unable to remove the front brake reservoir cover to examine whether the brake fluid was of sufficient level and without contamination for operational purposes due to worn out screws. Hence static as well as operational brake tests could not be conducted on the Motorcycle's front braking system. We were unable to determine if there was any leakage of pressure/vacuum in the front braking system.

Photo 25 shows the brake fluid reservoir cover for the front brake of the Motorcycle. We were unable to examine whether the brake fluid was of sufficient level and without contamination for operational purposes due to the worn out screws (arrowed).

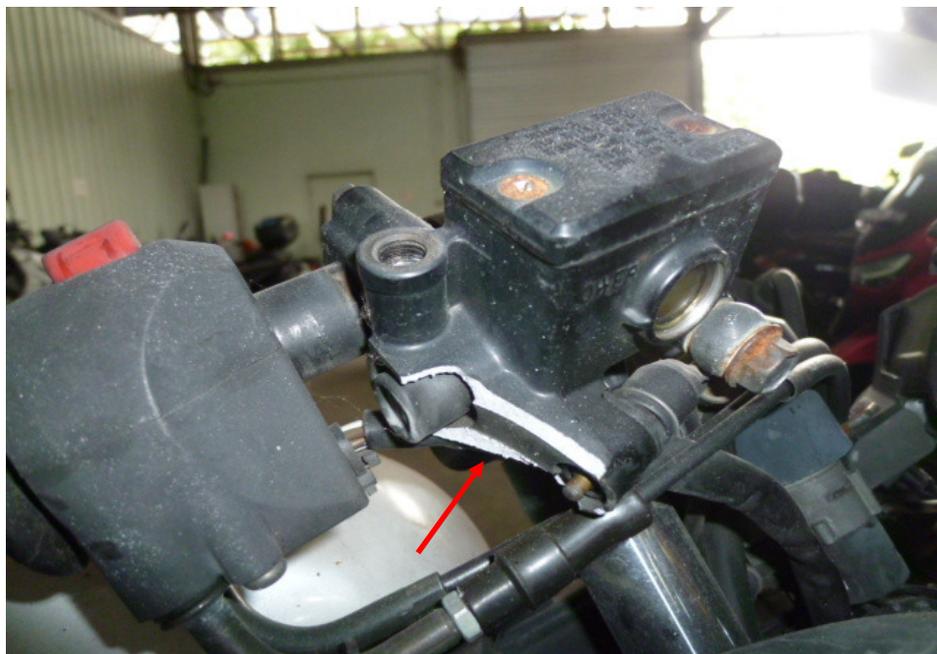
Photo 26 shows the front brake reservoir. We were unable to depress the front brake lever as part of it had broken off as a result of the accident (arrowed). Hence we were unable to determine if there was any leakage of pressure/vacuum in the front brake system.

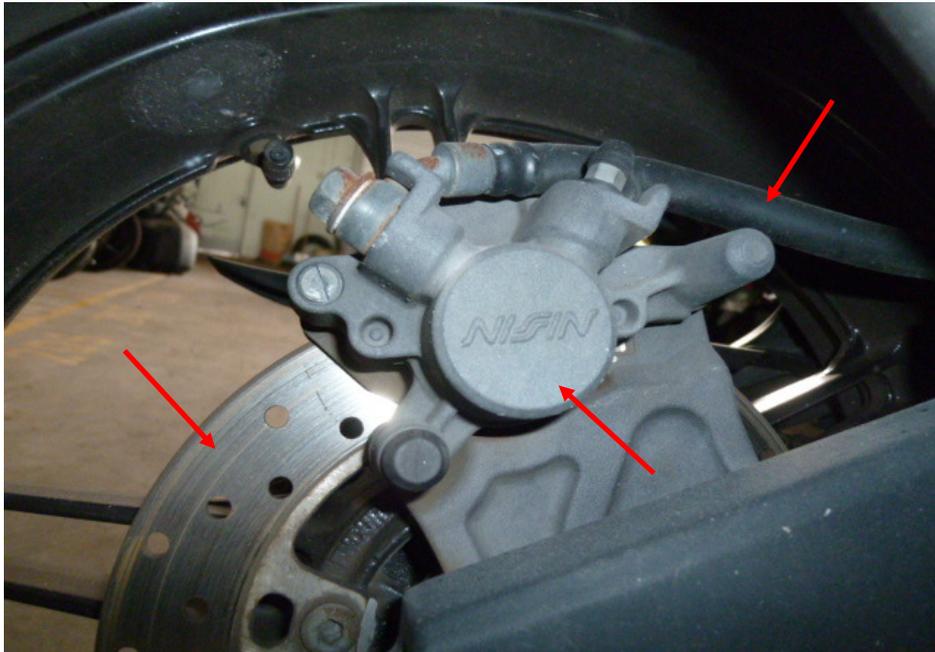
Photo 27 shows a close up view of the rear brake caliper, rear brake disc and rear brake hose (arrowed) of the Motorcycle, which are all part of the components in the hydraulic rear brake system of the Motorcycle. Our visual checks of these various components had revealed all to be intact with no visible damage. No leakage of brake fluid was also observed.
