Your Ref: TP/IP/35321/2021
Our Ref : CI/TPD21010819/N

21 October 2021

INSPECTION REPORT OF MOTORCYCLE FBR 5386K

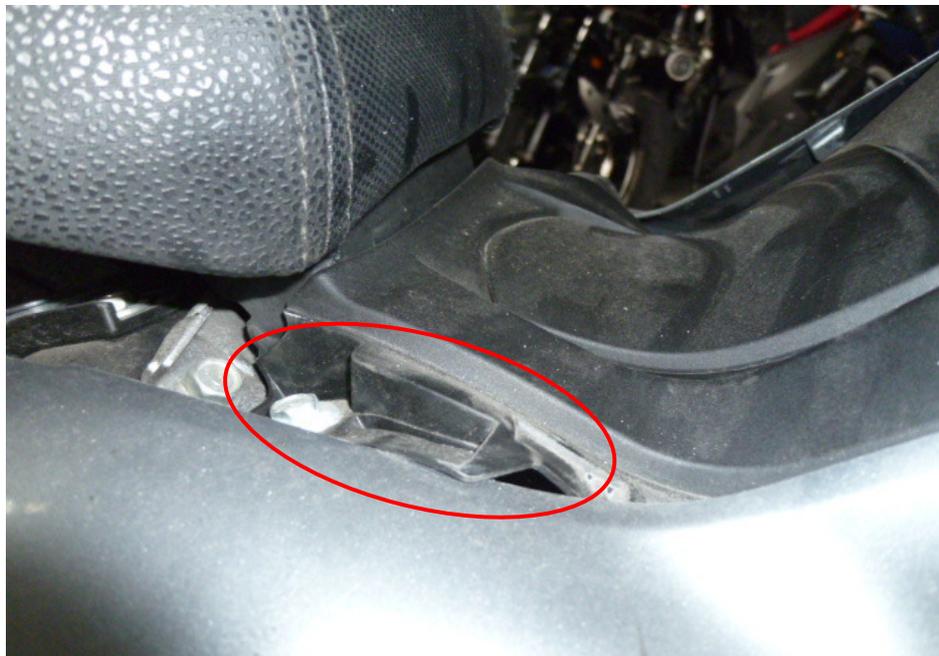
4. The mileage of the Motorcycle could not be recorded at the time of our inspection due to damages sustained to the seat which prevented access to the battery compartment. Hence we were unable to jumpstart the battery.
5. The Motorcycle was observed to have sustained damages all around. The body parts that were found to have been damaged include its windshield, head cowling, front mudguard, rear brake lever, left side mirror, left handlebar end, left side cowling, left lower side cowling, seat, rear side covers and exhaust muffler, amongst others as a result of the accident. See photos 1 – 16 below.

Photo 2 shows the damages sustained to the seat of the Motorcycle which prevented access to the battery compartment (circled). Hence we were unable to jumpstart the battery to record the mileage of the Motorcycle at the time of our inspection.

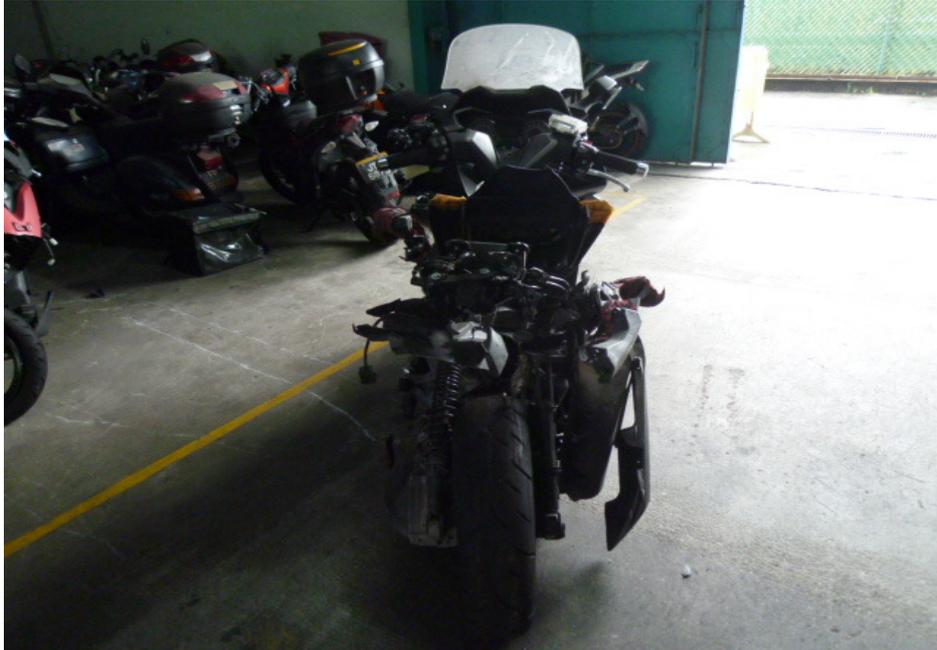
Photo 3 shows a general view of the rear portion of the Motorcycle at the time of our inspection. The Motorcycle was observed to have sustained damages all around.

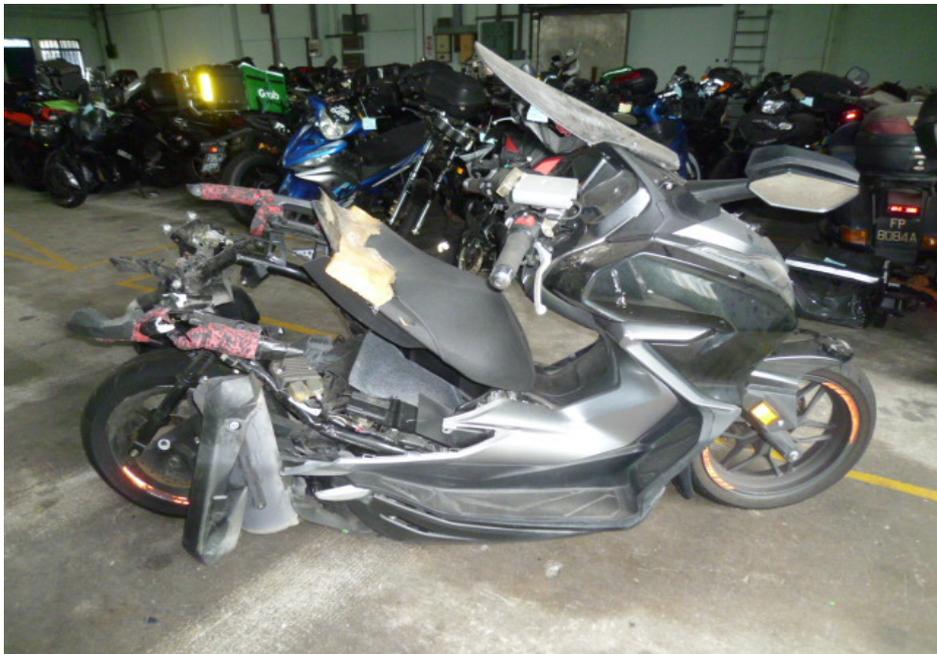
Photo 4 shows a general view of the right body of the Motorcycle at the time of our inspection. The Motorcycle was observed to have sustained damages all around.

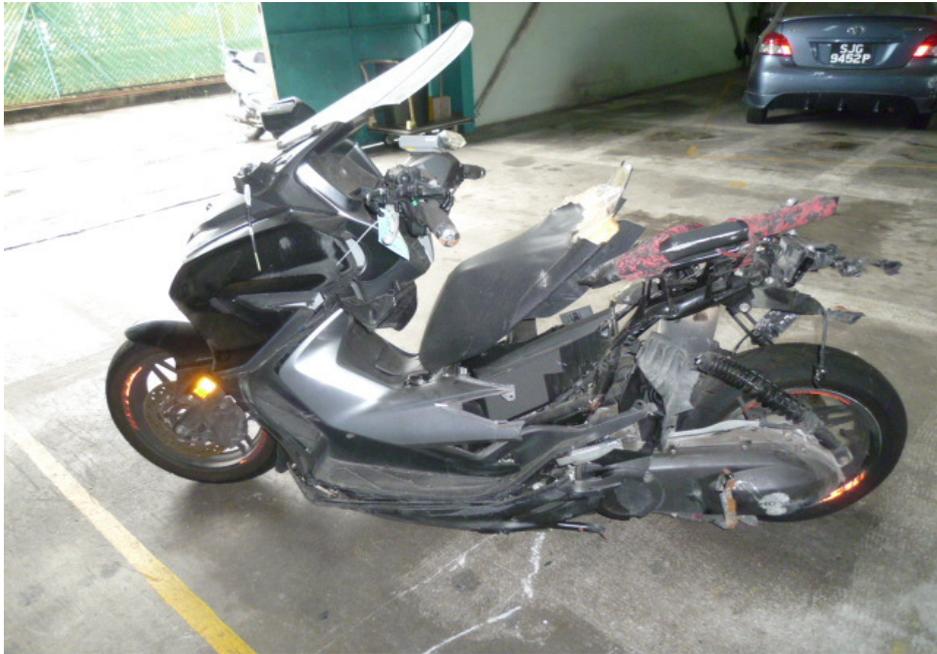
Photo 5 shows a general view of the left body of the Motorcycle at the time of our inspection. The Motorcycle was observed to have sustained damages all around.

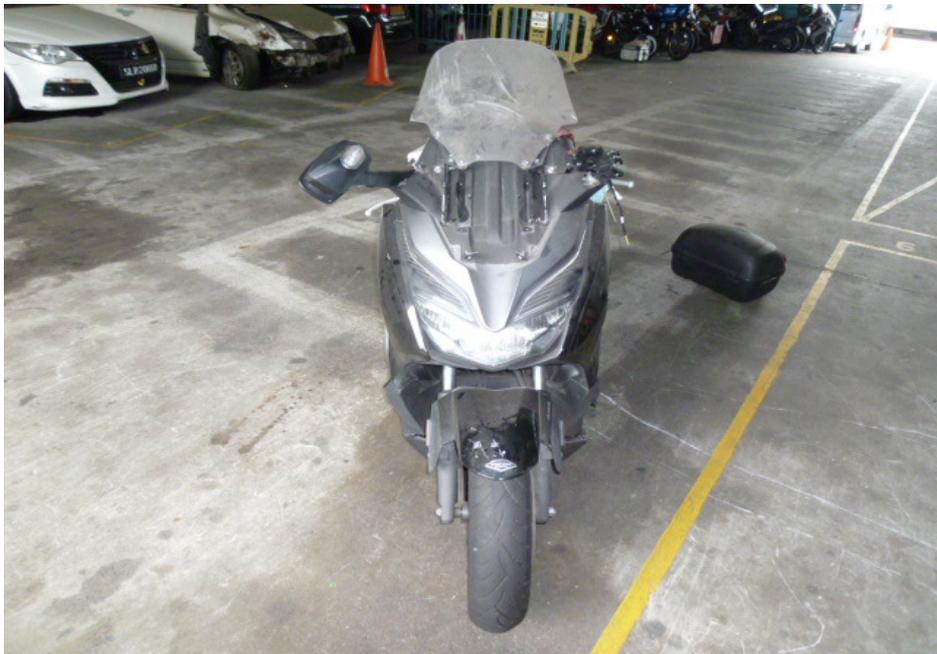
Photo 6 shows a general view of the frontal portion of the Motorcycle at the time of our inspection. The Motorcycle was observed to have sustained damages all around. The body parts that were found to have been damaged include its windshield, head cowl, front mudguard, rear brake lever, left side mirror, left handlebar end, left side cowling, left lower side cowling, seat, rear side covers and exhaust muffler, amongst others as a result of the accident.

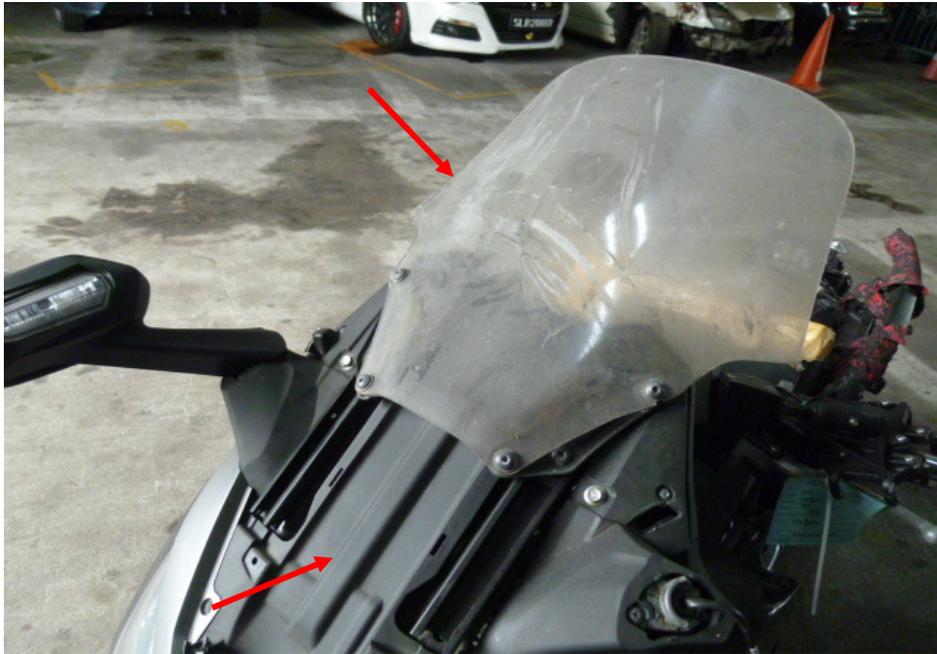
Photo 7 shows a closer view of the deformed head cowl and windshield of the Motorcycle at the time of our inspection (arrowed).

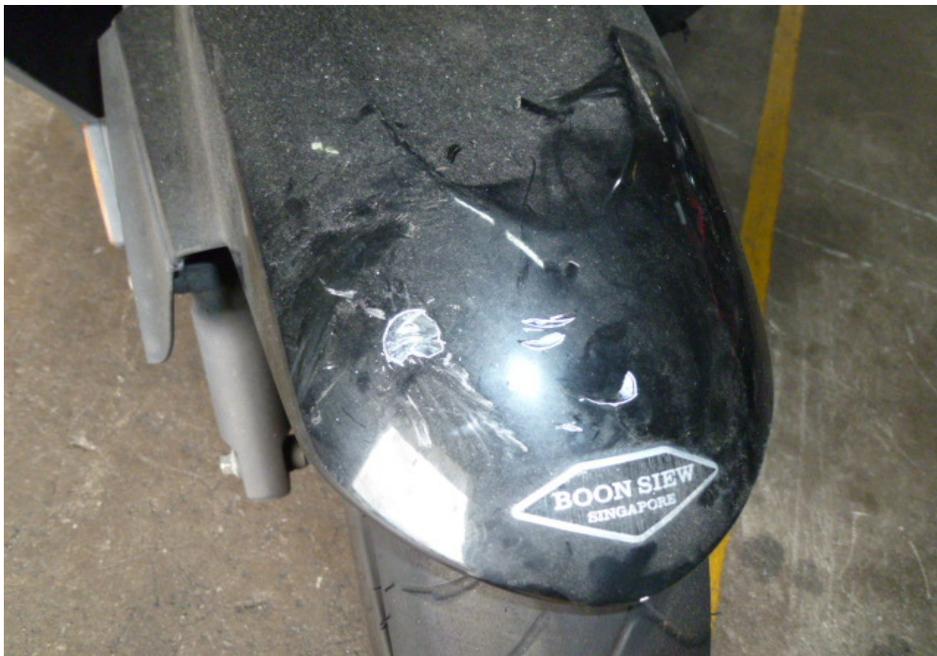
Photo 8 shows a closer view of the grazed front mudguard which was amongst the body parts at the front body of the Motorcycle that had sustained damage as a result of the accident.

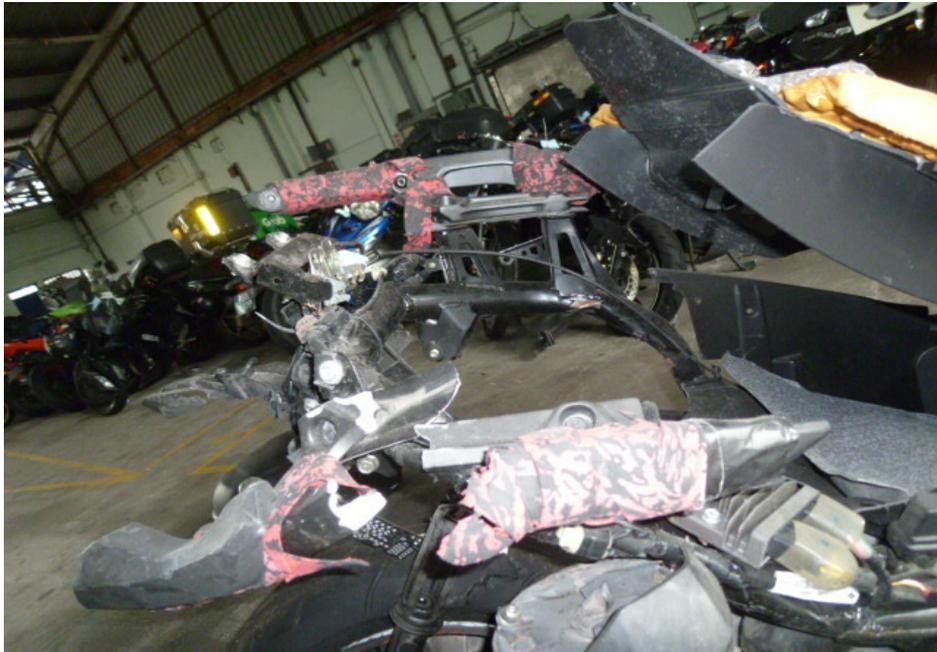
Photo 9 shows a closer view of the missing right rear side cover of the Motorcycle as a result of the accident.

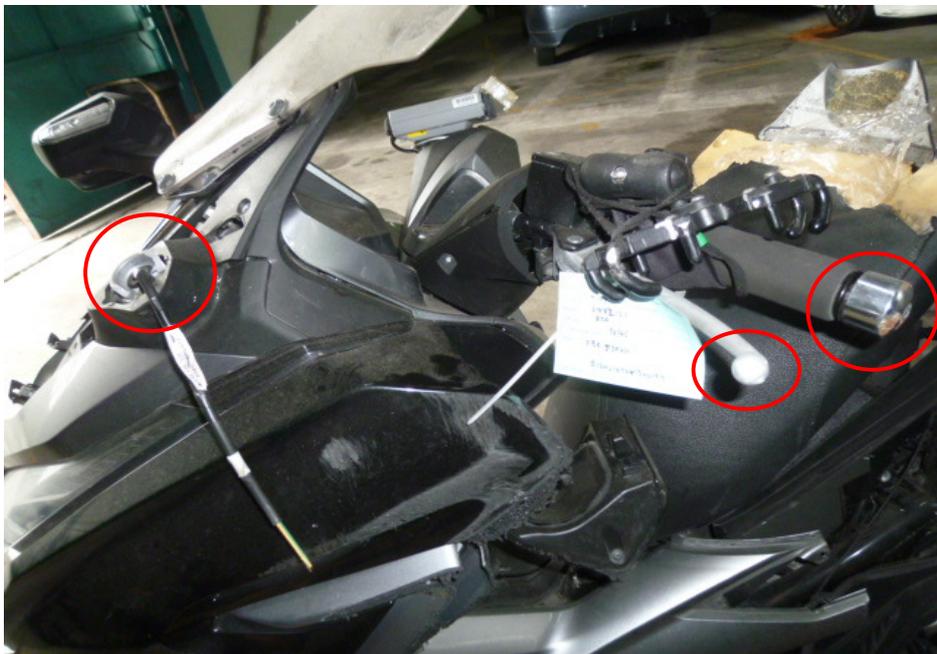
Photo 10 shows a closer view of the left side mirror, left handlebar end and rear brake lever of the Motorcycle which were observed to be damaged due to the accident (circled).

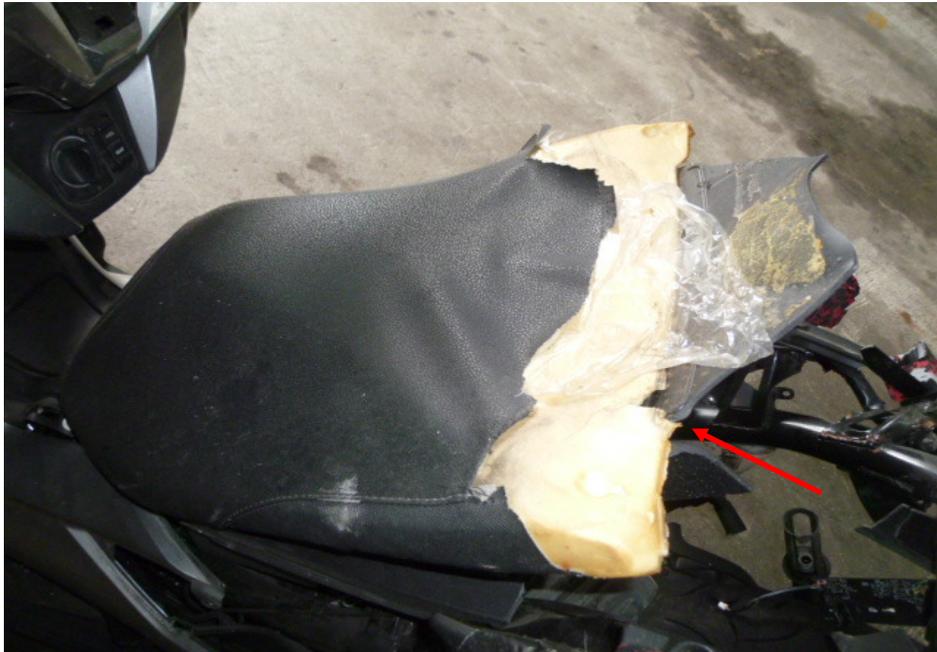
Photo 11 shows a general view of broken seat of the Motorcycle as a result of the accident (arrowed).

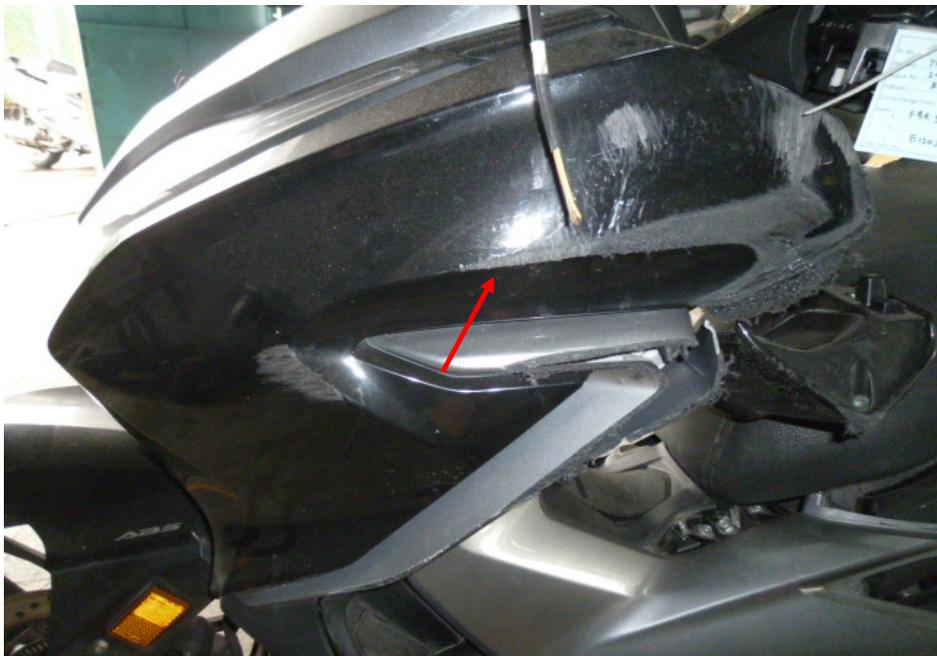
Photo 12 shows the grazed left side cowling of the Motorcycle as a result of the accident (arrowed).

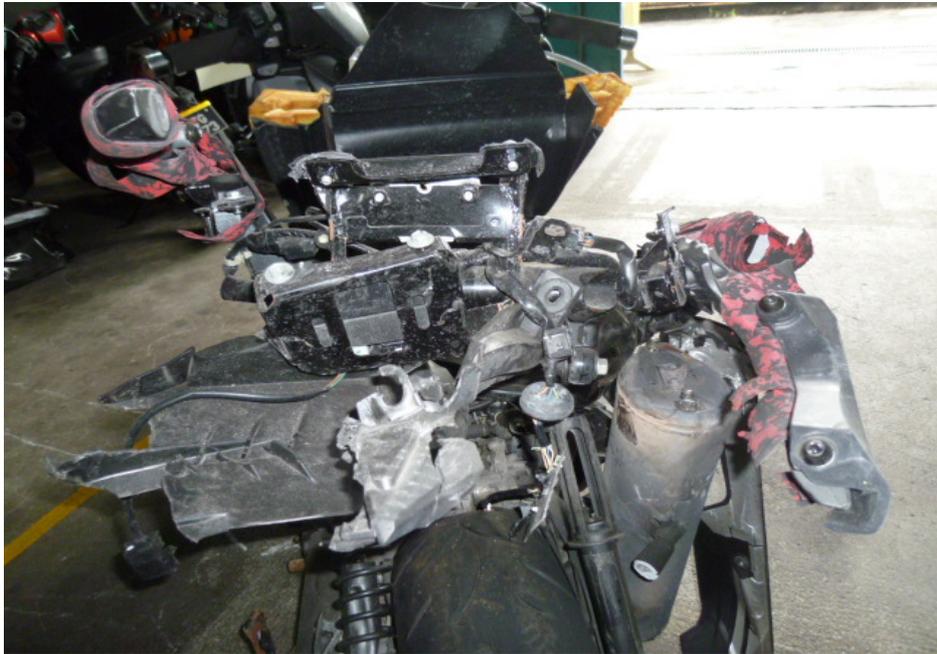
Photo 13 shows a close-up view of the tail light assembly of the Motorcycle as a result of the accident.

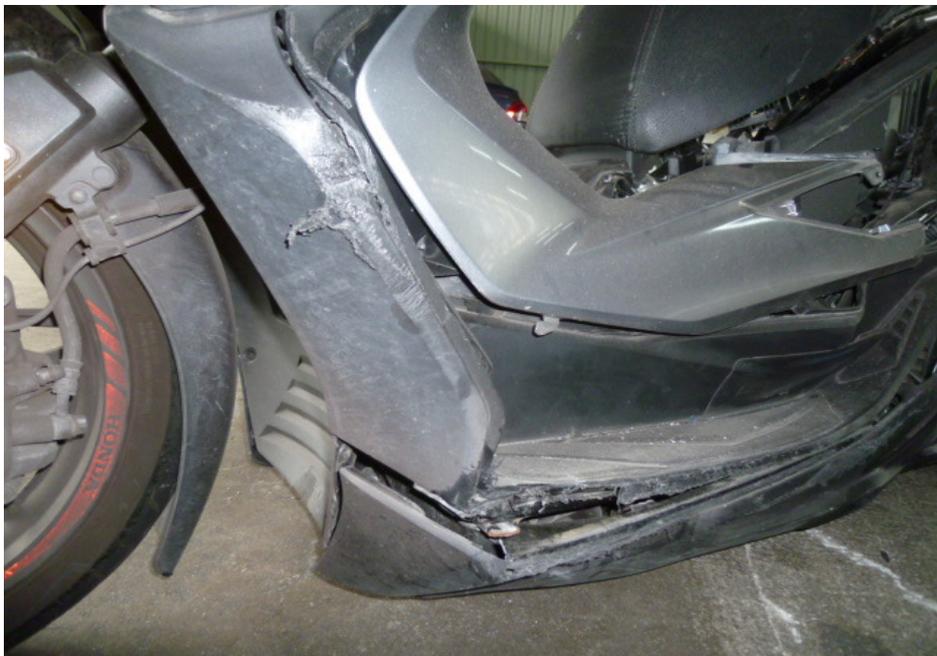
Photo 14 shows a close-up view of the cracked left lower side cowling of the Motorcycle as a result of the accident.

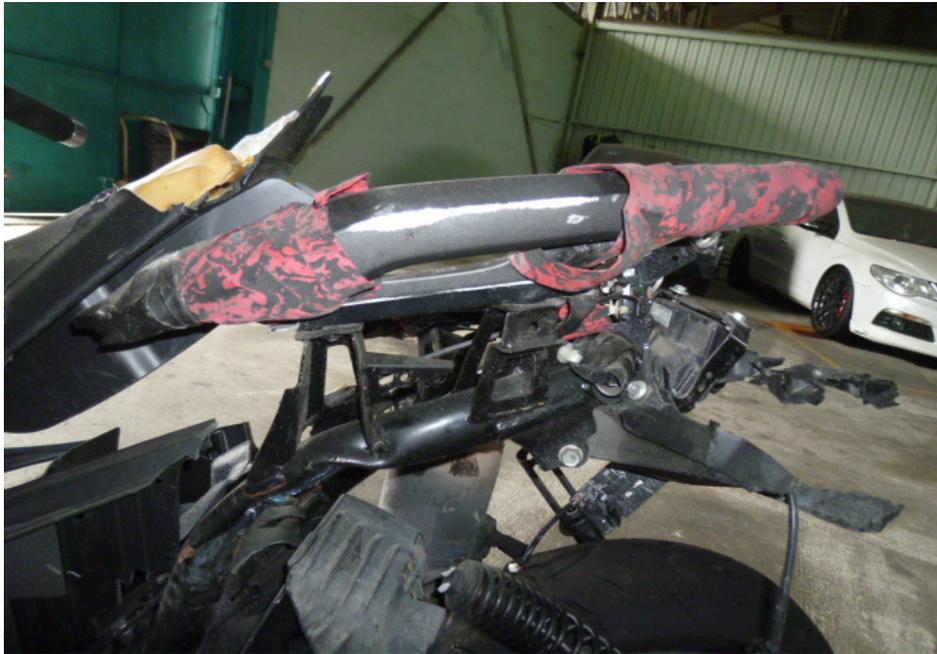
Photo 15 shows a closer view of the missing left rear side cover of the Motorcycle as a result of the accident.

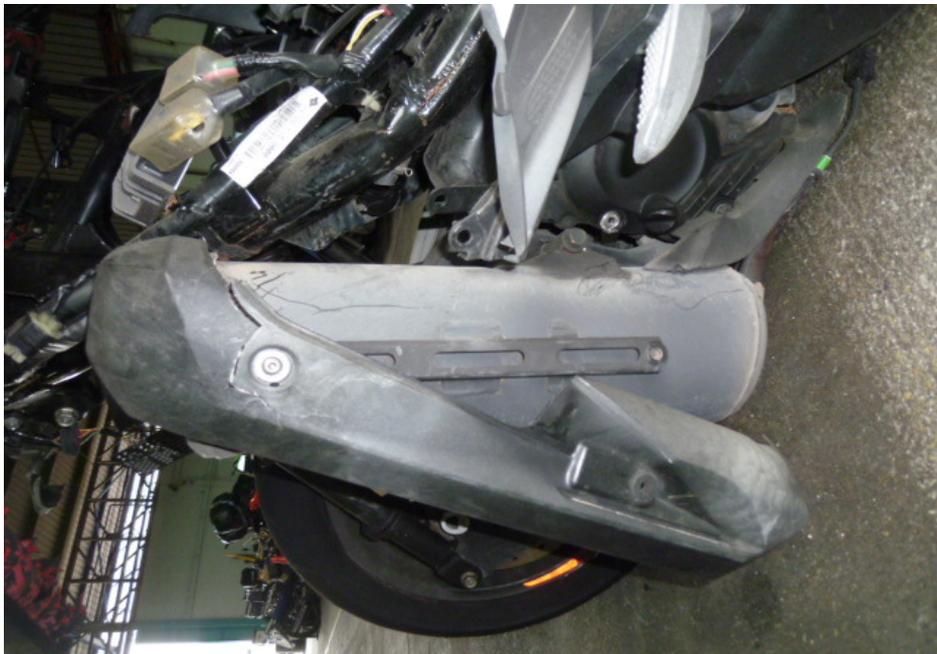
Photo 16 shows a closer view of the deformed exhaust muffler of the Motorcycle as a result of the accident.

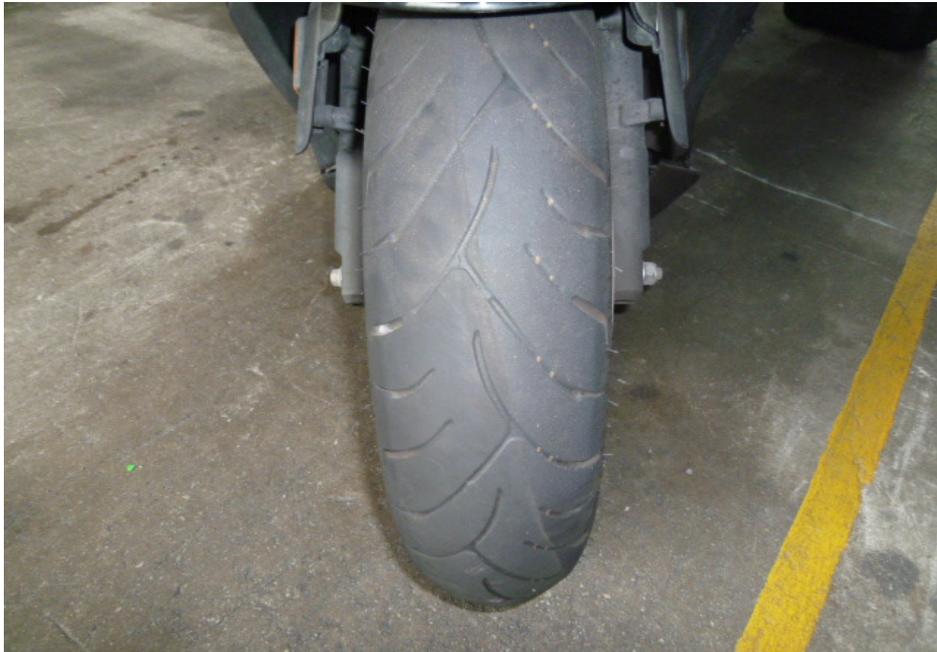
Photo 17 shows the condition of the Motorcycle's front tyre. The front tyre was observed to be in serviceable condition with remaining tread depth of approximately 3mm. There was no tear, burst mark(s) and/or punctured hole(s) on the sidewalls as well as across the tread of the front tyre.

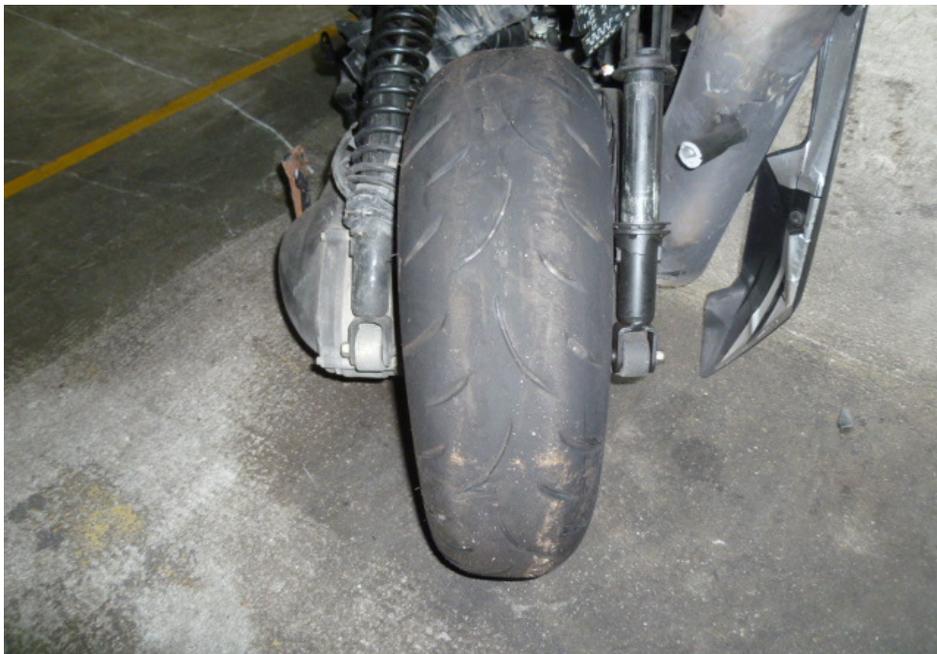
6. The condition of the front tyre of the Motorcycle was observed to be in serviceable condition. We did not observe any tear, burst mark(s) and/or punctured hole(s) on the sidewalls as well as across the tread of the front tyre. The front tyre was observed to be sufficiently inflated for vehicular operation. However we observed a tear on the rear tyre. The rear tyre was also observed to be deflated as a result of the accident. The tyre brand, tyre size and remaining tread depth of the 2 tyres were

Photo 18 shows the condition of the Motorcycle's rear tyre. The rear tyre was observed to be in serviceable condition with remaining tread depth of approximately 4mm. However the tyre was observed to be deflated. We also observed a tear on the front tyre as a result of the accident.

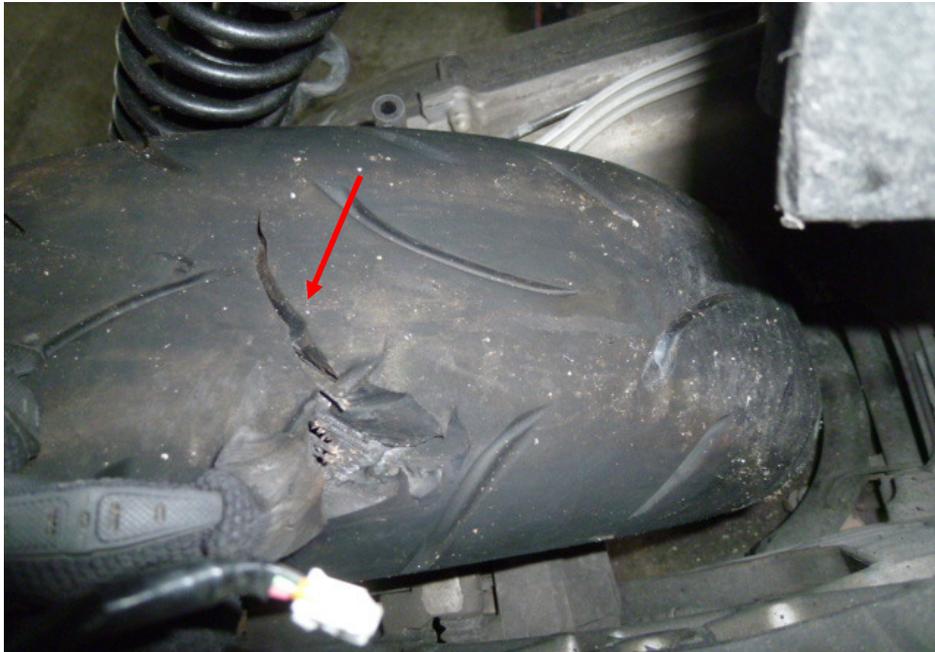
Photo 19 shows a closer view of the tear on the rear tyre as a result of the accident (arrowed).

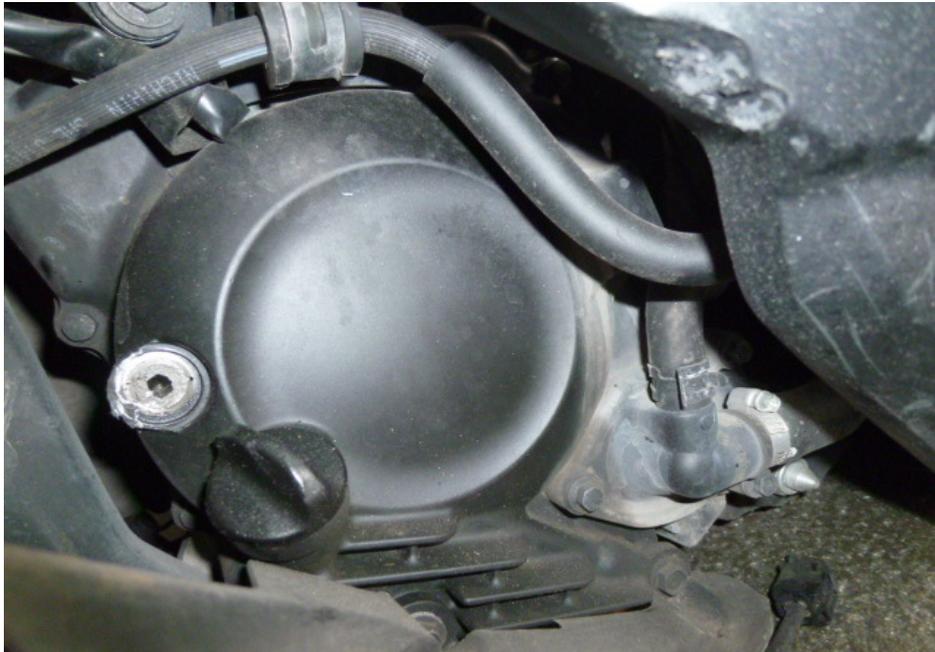
Photo 20 shows the right side of the engine of the Motorcycle at the time of our inspection. The various engine related parts and components were found to be intact with no visible damage. There was also no sign(s) or indication(s) of fluid leak observed around the right engine area of the Motorcycle.

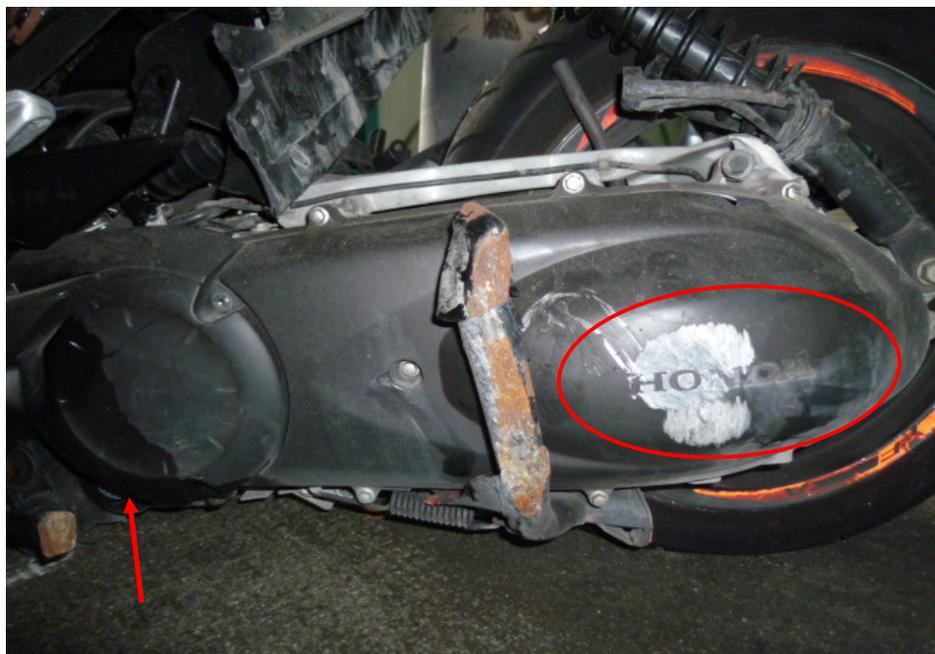
8. Upon examination of the Motorcycle's engine area, we had observed fluid leak around the left engine area of the Motorcycle.
9. The drive train of the Motorcycle was found to be intact without any misalignment. However the drive train cover had sustained damages of grazing nature as a result of the accident. There was no visible tear or cut observed on the connecting hoses and cables. The shock absorbers were also observed to be damaged as a result of the accident. See photos 20 - 24 below.

Photo 21 shows the drive train of the Motorcycle which was found to be intact without any misalignment. However the drive train cover had sustained damages of grazing nature as a result of the accident (circled). Upon closer examination of the Motorcycle's left engine area, we had observed fluid leak around the left engine area of the Motorcycle (arrowed).

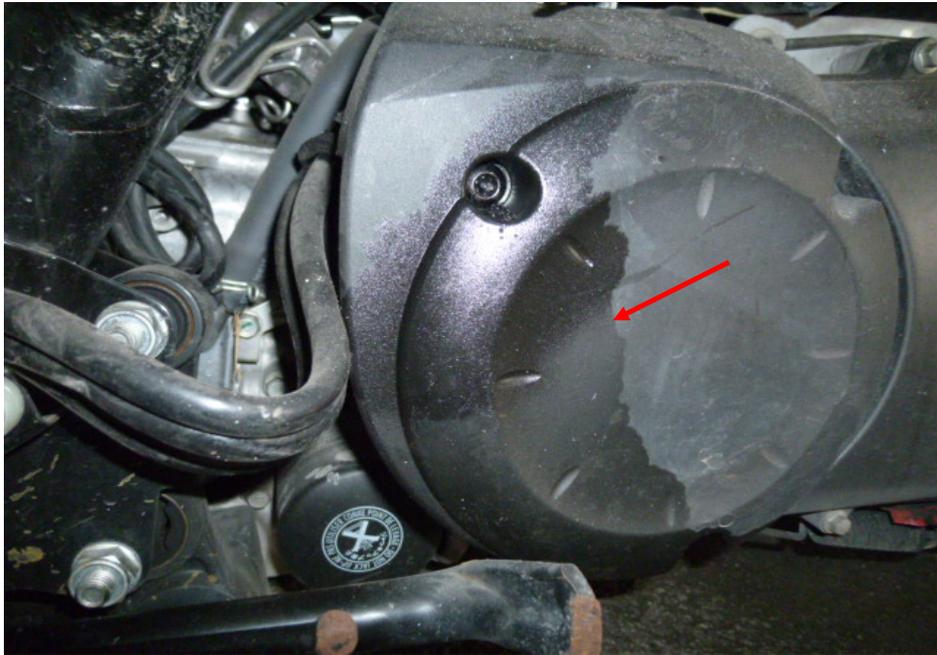
Photo 22 shows the fluid leak observed around the left engine area of the Motorcycle (arrowed).

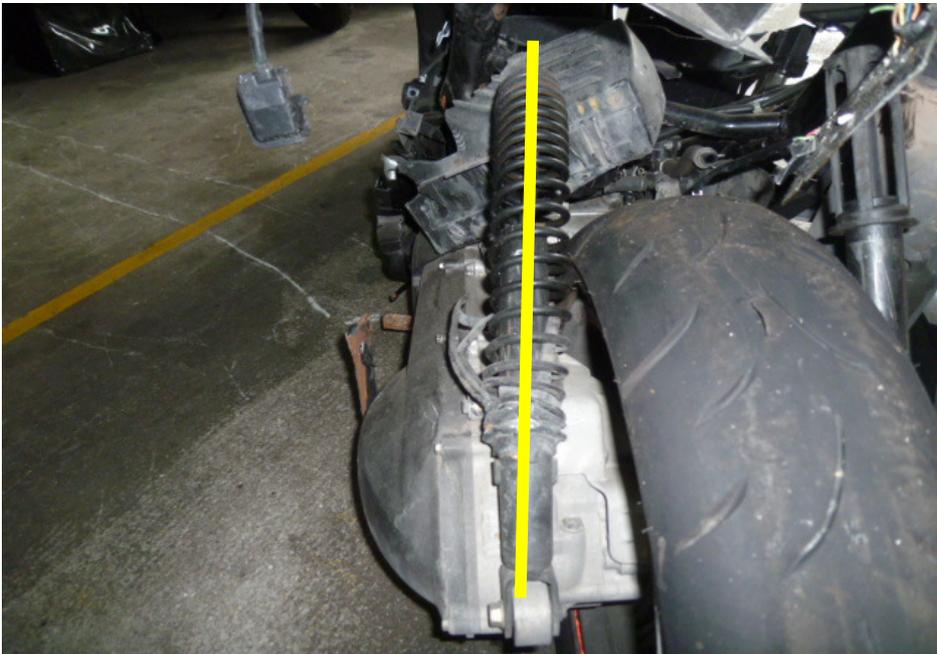
Photo 23 shows the damaged left shock absorber of the Motorcycle as a result of the accident.

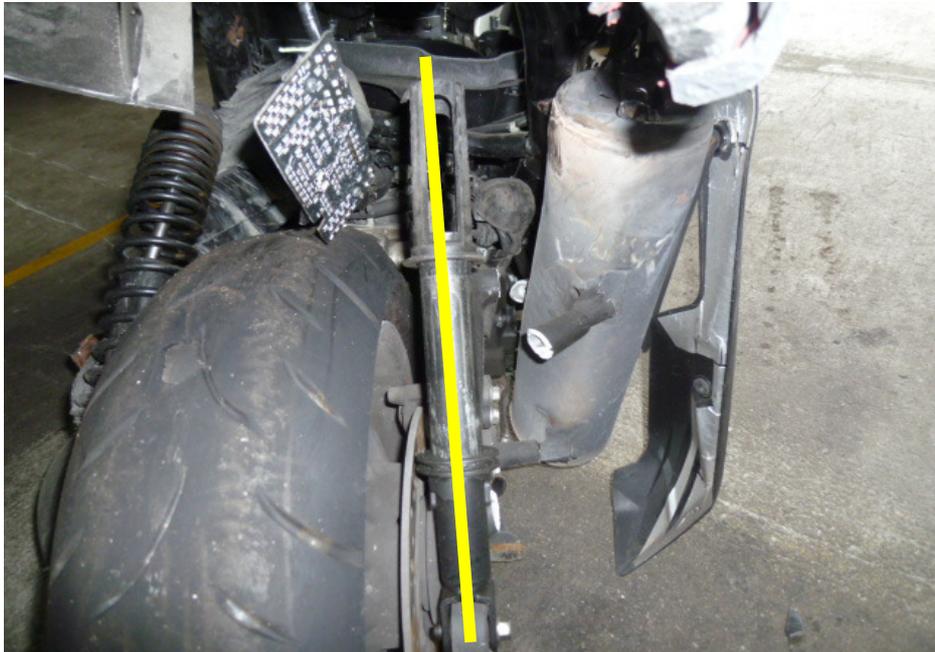
Photo 24 shows the damaged right shock absorber of the Motorcycle as a result of the accident.

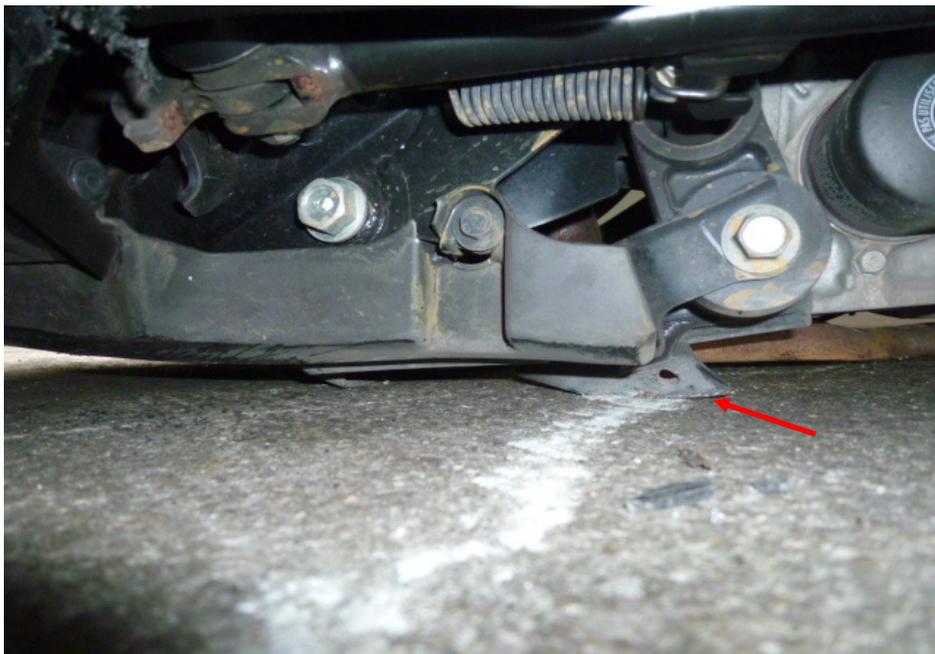
14. For this case, we were not able to carry out any operational tests to the steering system and braking system of the Motorcycle due to the damage to its rear swingarm, which had rendered the Motorcycle immobile for the operational tests. We were not able to push the Motorcycle manually forward and backward, simulating movement of the Motorcycle, for the operational tests. See photos 25 – 31 below.

Photo 25 shows the damage to the rear swingarm of the Motorcycle (arrowed) which had rendered the Motorcycle immobile for any static or operational tests on its steering system and braking system.

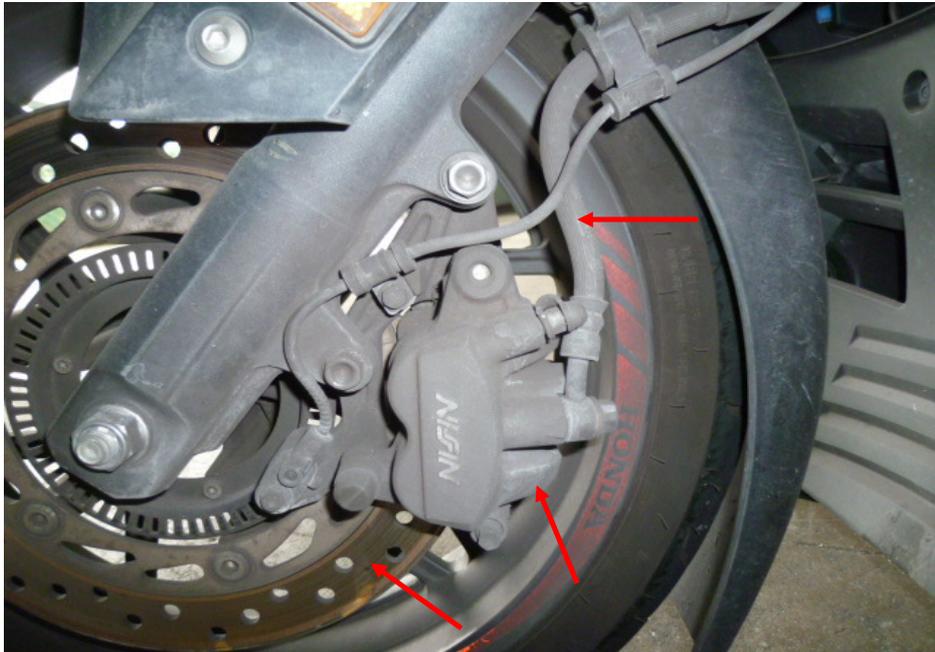
Photo 26 shows a close up view of the front brake caliper, front brake disc and front brake hose (arrowed) of the Motorcycle, which are all part of the components in the hydraulic front brake system of the Motorcycle. Our visual checks of these various components had revealed all to be intact with no visible damage. No leakage of brake fluid was also observed.

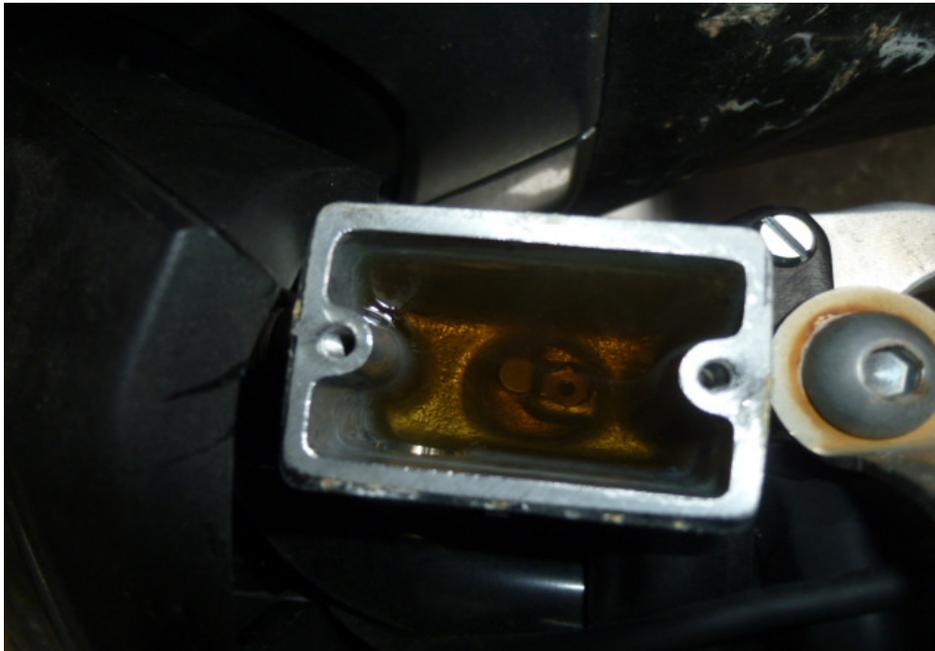
Photo 27 shows the brake fluid reservoir for the front brake of the Motorcycle. The brake fluid was observed to be without contamination and of sufficient level for operational purposes.

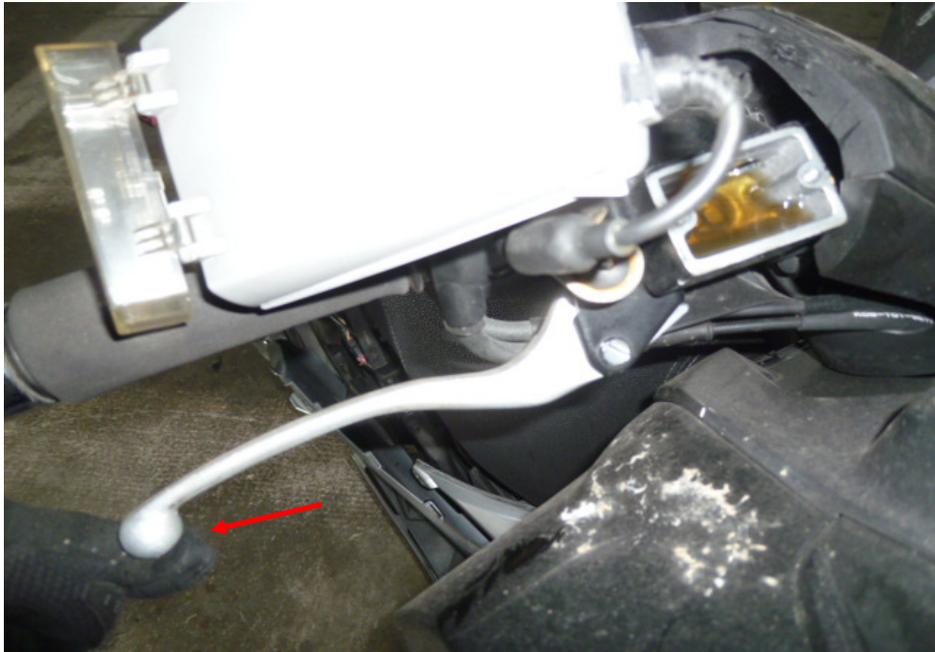
Photo 28 shows the front brake lever being depressed. There was some resistance felt (spongy like feel) upon pressing the front brake lever (arrowed). This would indicate that there is no leakage of pressure/vacuum in the front brake system.

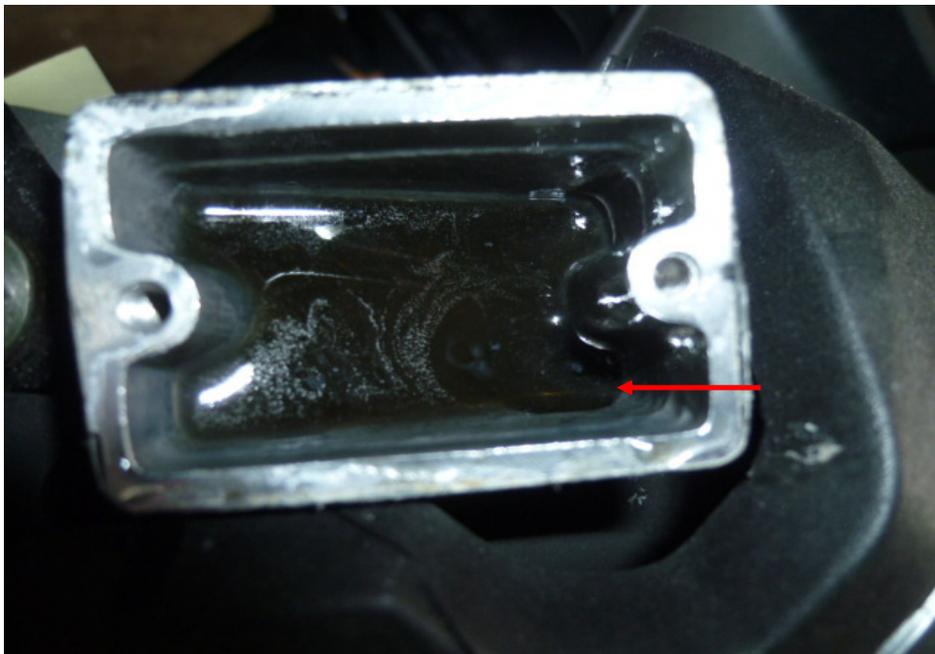
13. Static brake tests conducted on the Motorcycle had appeared to indicate that the rear brake system of the Motorcycle was in serviceable condition. There was some resistance felt (spongy like feel) upon pressing the left hand brake lever. This would indicate that there's no leakage of pressure/vacuum in the rear brake system. Our checks on the brake fluid had also indicated that the brake fluid was observed to be of sufficient level for operational purposes. However it was found to be slightly contaminated.

Photo 29 shows the brake fluid reservoir for the rear brake of the Motorcycle. The brake fluid was observed to be of sufficient level for operational purposes. However it was found to be slightly contaminated (arrowed).

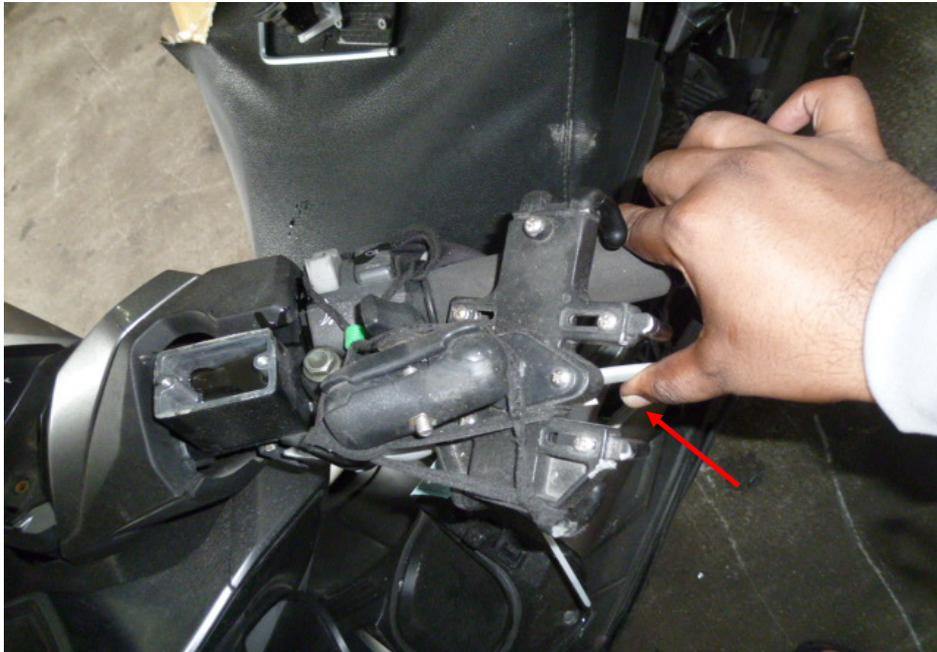
Photo 30 shows the rear brake lever being depressed. There was some resistance felt (spongy like feel) upon pressing the rear brake lever (arrowed). This would indicate that there is no leakage of pressure/vacuum in the rear brake system.

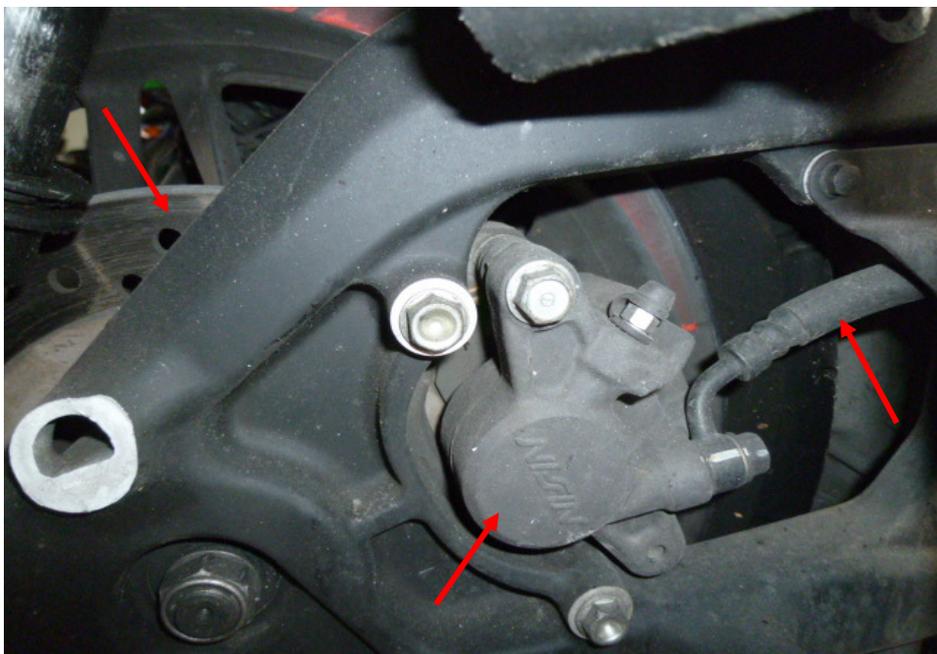
Photo 31 shows a close up view of the rear brake caliper, rear brake disc and rear brake hose (arrowed) of the Motorcycle, which are all part of the components in the hydraulic rear brake system of the Motorcycle. Our visual checks of these various components revealed all to be intact with no visible damage. No leakage of brake fluid was also observed.
