Your Ref: TP/IP/38483/2021  
Our Ref : CI/TPD21010820/N

**Fatal Accident Investigation Team**

**INSPECTION REPORT OF BICYCLE (SILVER) - TRAFFIC POLICE POUND  
REPORT NO. 2688/21**

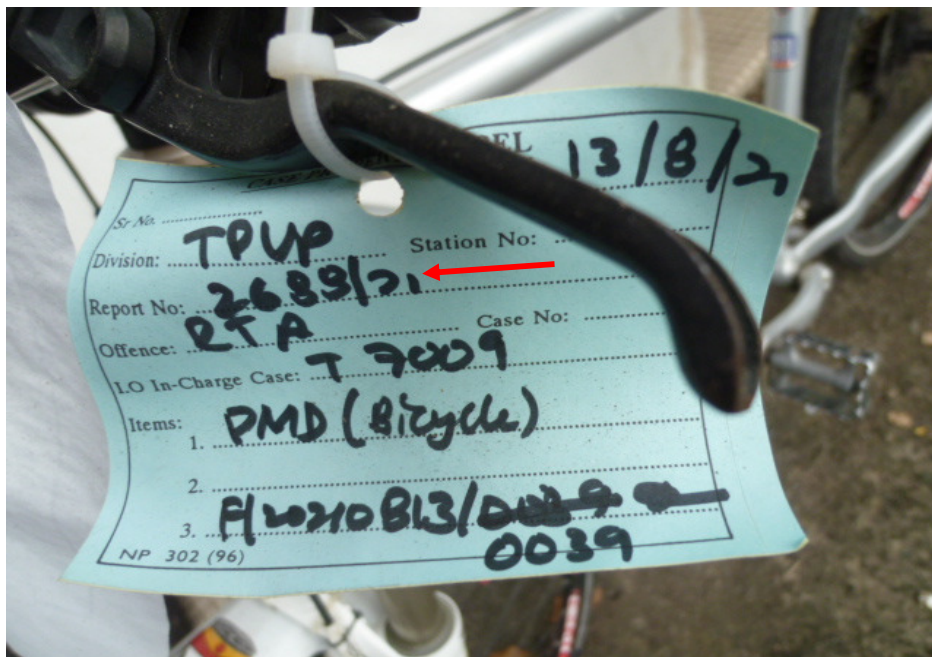
**Photo 1** shows the identification of the Bicycle with reference to Traffic Police Pound Report No. 2688/21 (arrowed).

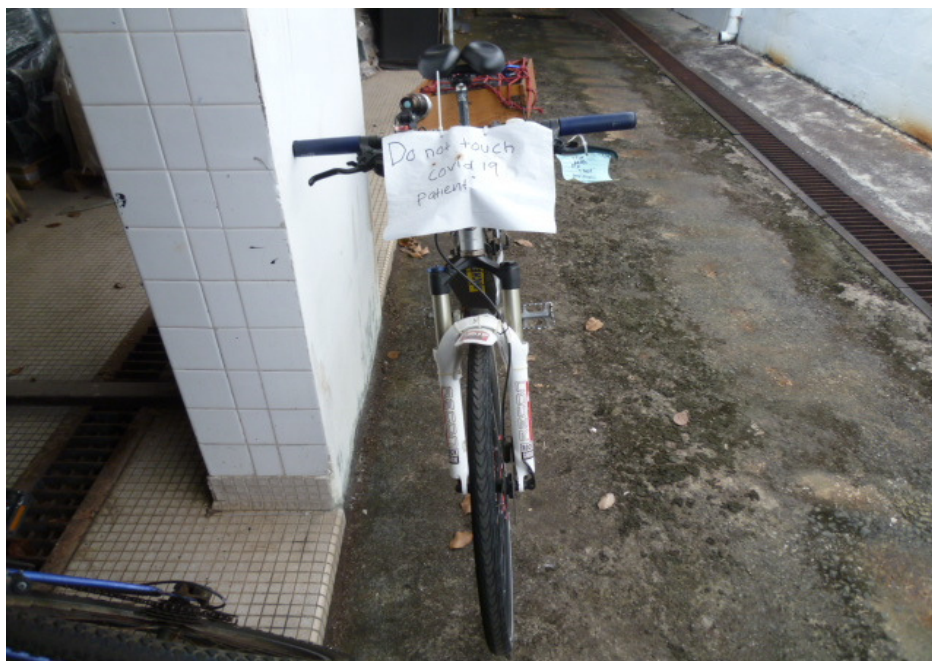
**Photo 2** shows the frontal portion of the Bicycle at time of our inspection. The Bicycle had sustained damages all around.

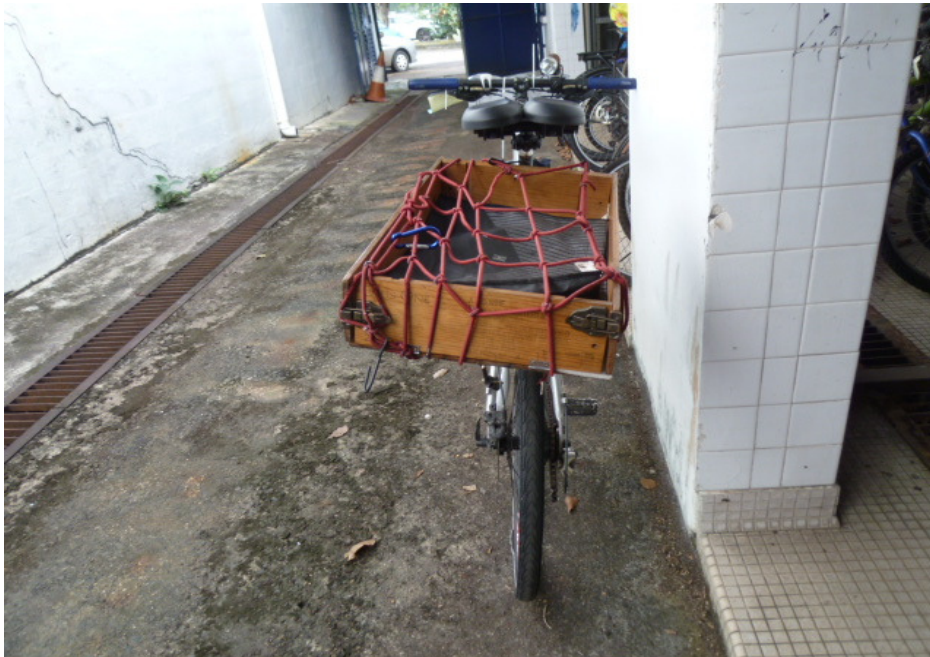
**Photo 3** shows the rear portion of the Bicycle at time of our inspection. The Bicycle had sustained damages all around.

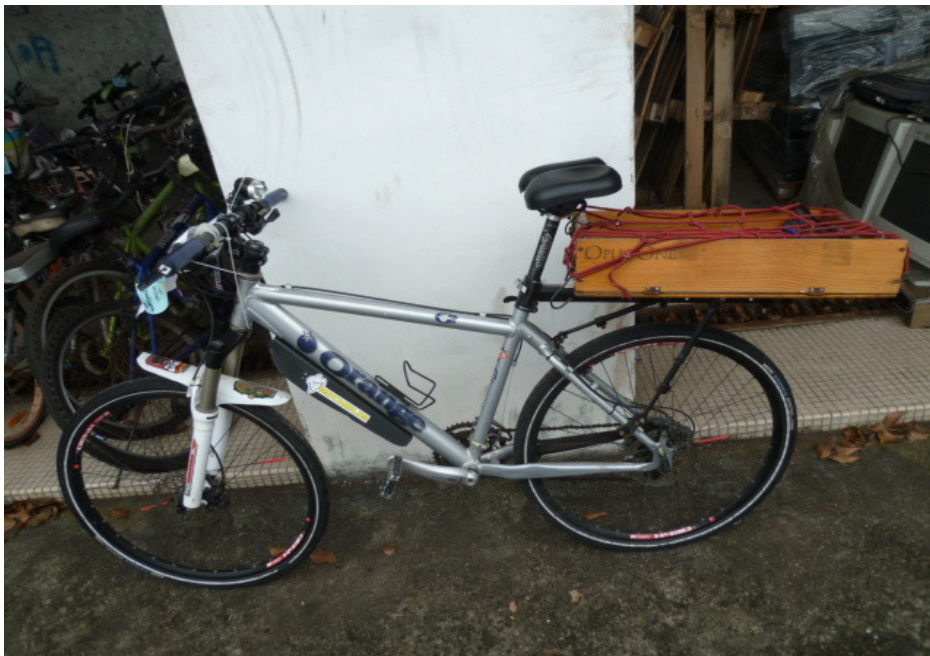
4. The Bicycle was observed to have sustained damages all around. The body parts that were found to have been damaged include its right hand brake lever, right handlebar grip, left fork stem, right pedal, left rear frame and rack, amongst others as a result of the accident. See photos 1 – 10 below.

**Photo 4** shows the left body of the Bicycle at time of our inspection. The Bicycle had sustained damages all around. The body parts that were found to have been damaged include its right hand brake lever, right handlebar grip, left fork stem, right pedal, left rear frame and rack, amongst others as a result of the accident.

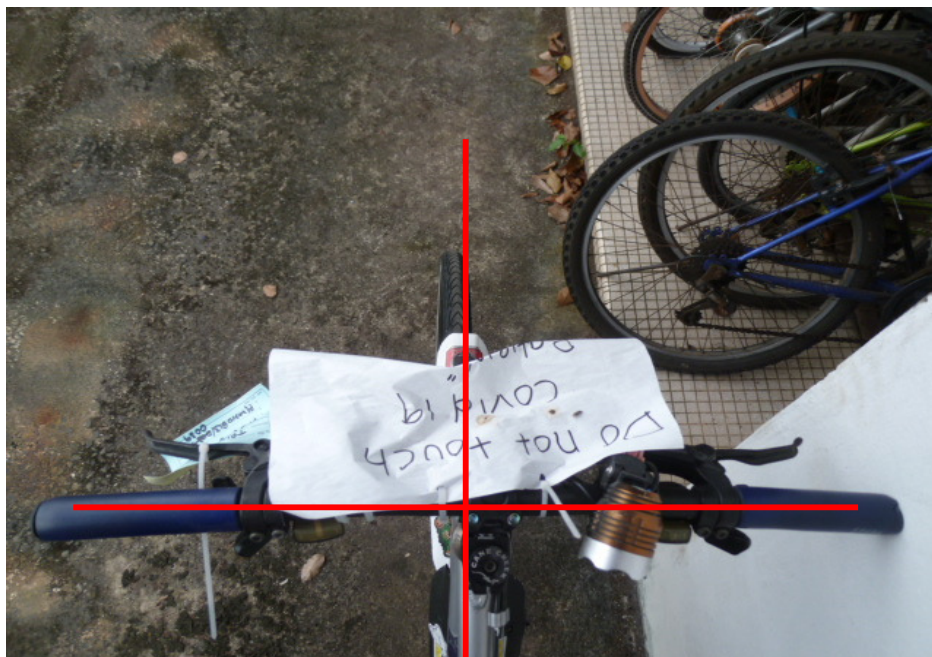
**Photo 5** shows the frontal portion of the Bicycle (top view) at the time of our inspection. There was no misalignment of the handle bar & front tyre observed.

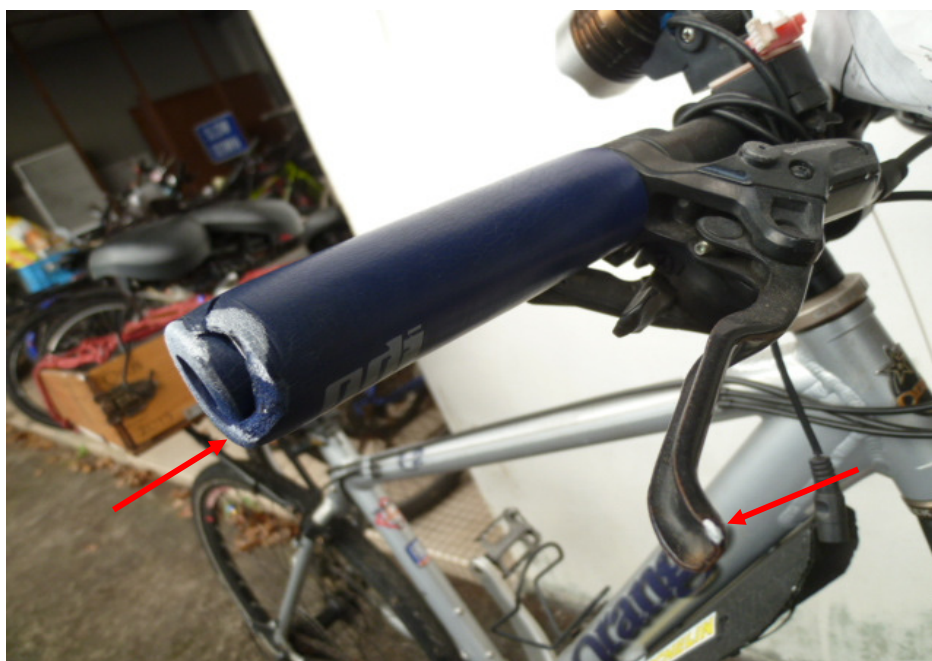
**Photo 6** shows the damaged right hand brake lever and right handlebar grip (arrowed) of the Bicycle at the time of our inspection.

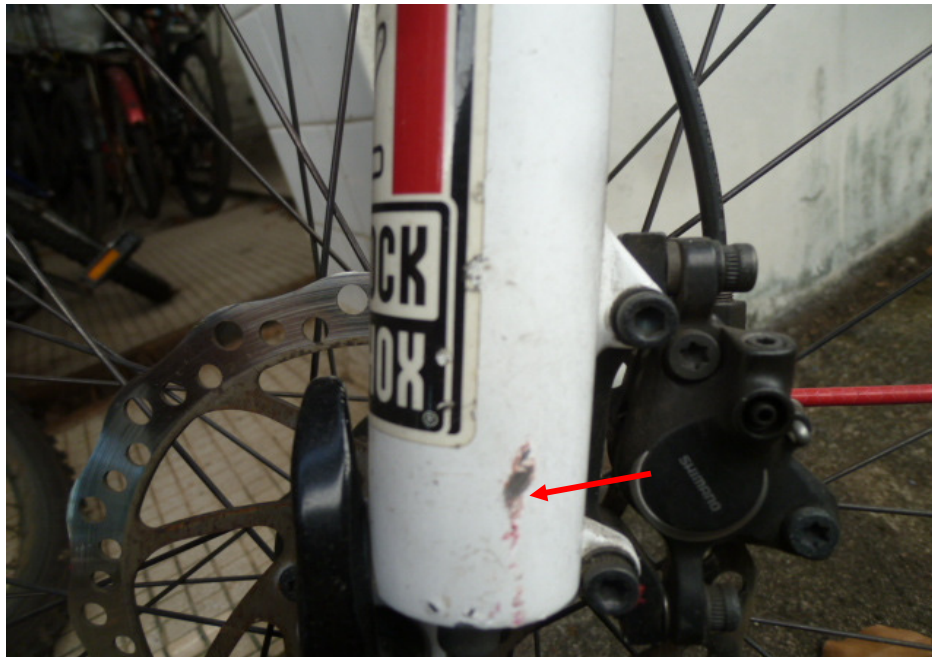
**Photo 7** shows the damages of grazing nature on the left fork stem (arrowed) of the Bicycle at the time of our inspection.

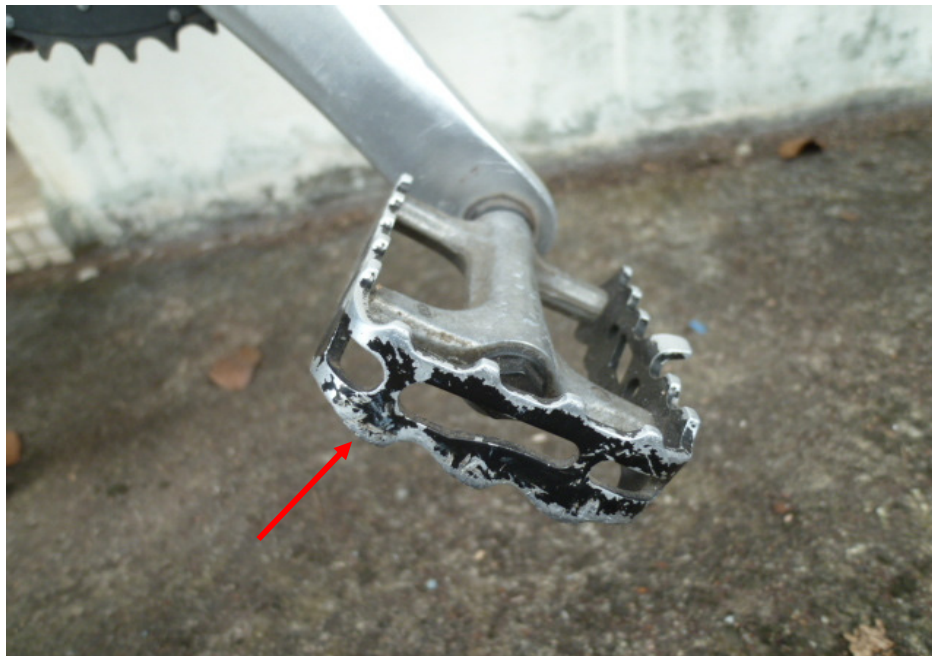
**Photo 8** shows the damages of grazing nature on the right pedal of the Bicycle at the time of our inspection.

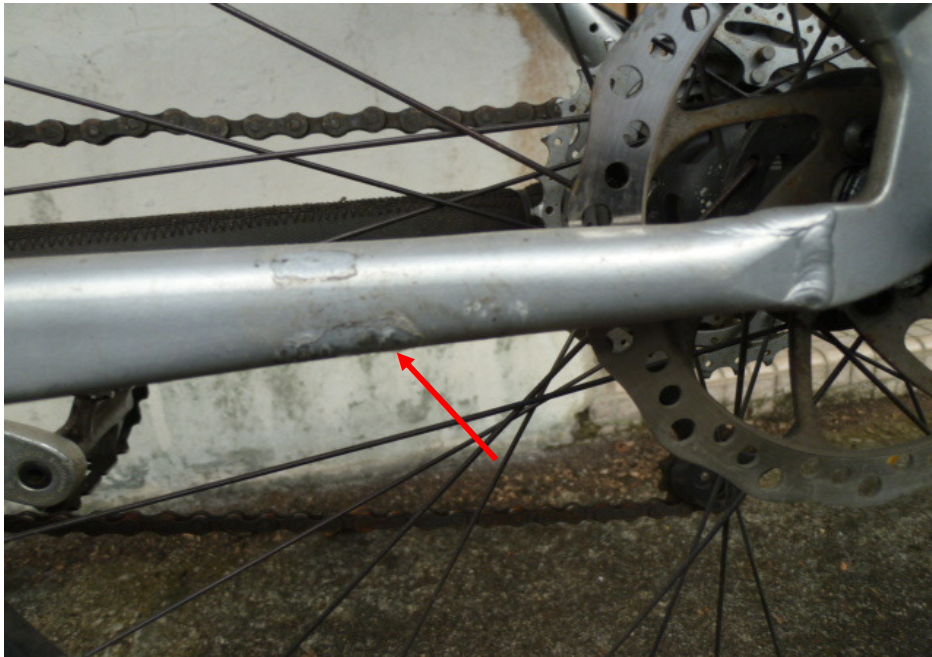
**Photo 9** shows the damages of grazing nature on the left rear frame of the Bicycle at the time of our inspection (arrowed).

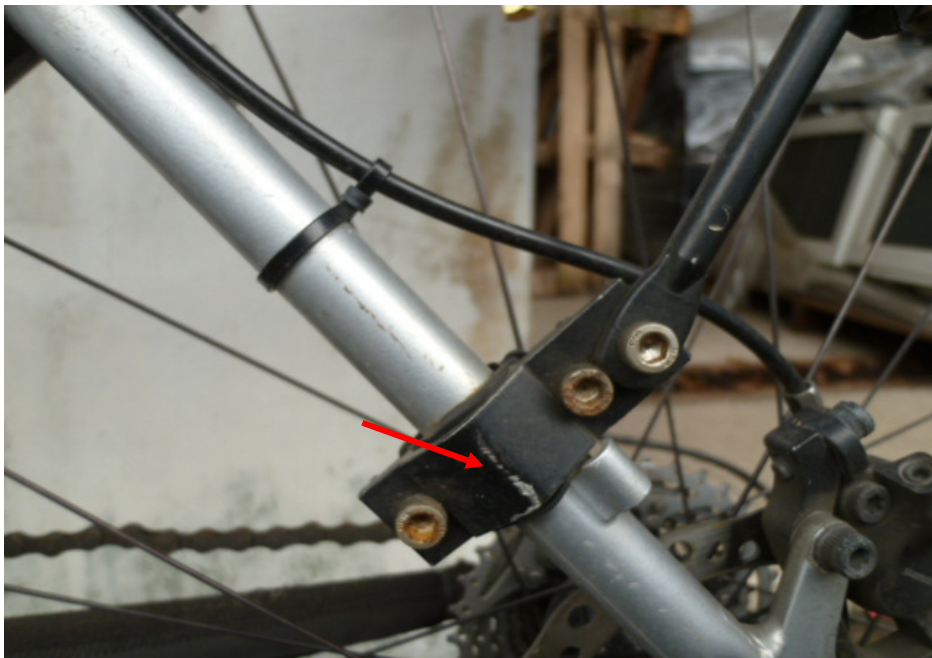
**Photo 10** shows a close-up view of the damages of grazing nature on the rack (arrowed) of the Bicycle as a result of the accident.

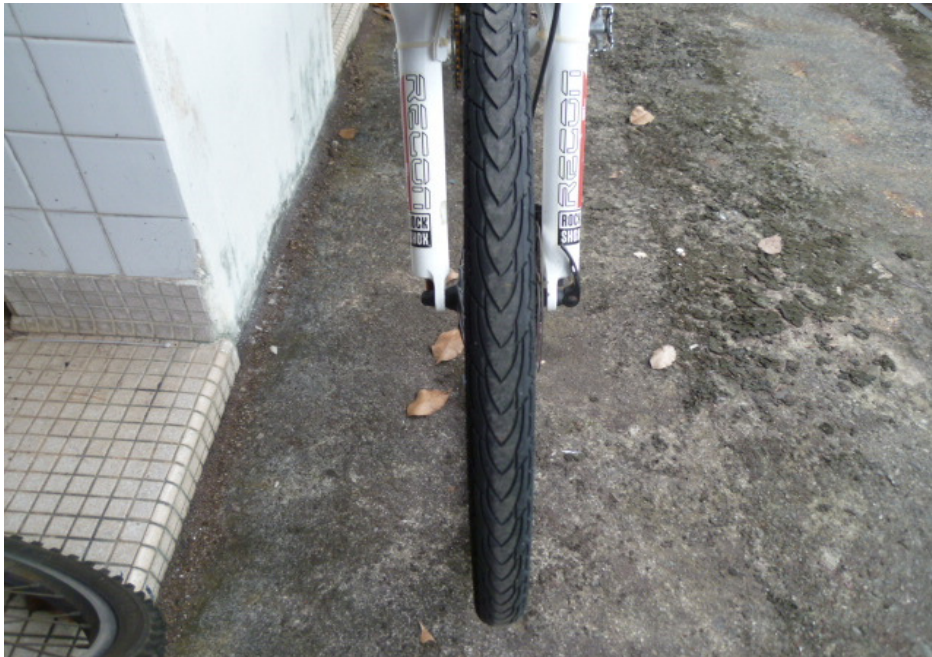
**Photo 11** shows the front tyre of the Bicycle. The pattern of the tread was clearly visible. There was no tear, burst mark(s) and/or punctured hole(s) on the sidewalls as well as across the tread of the front tyre. The front tyre was also observed to be sufficiently inflated for vehicular operation.

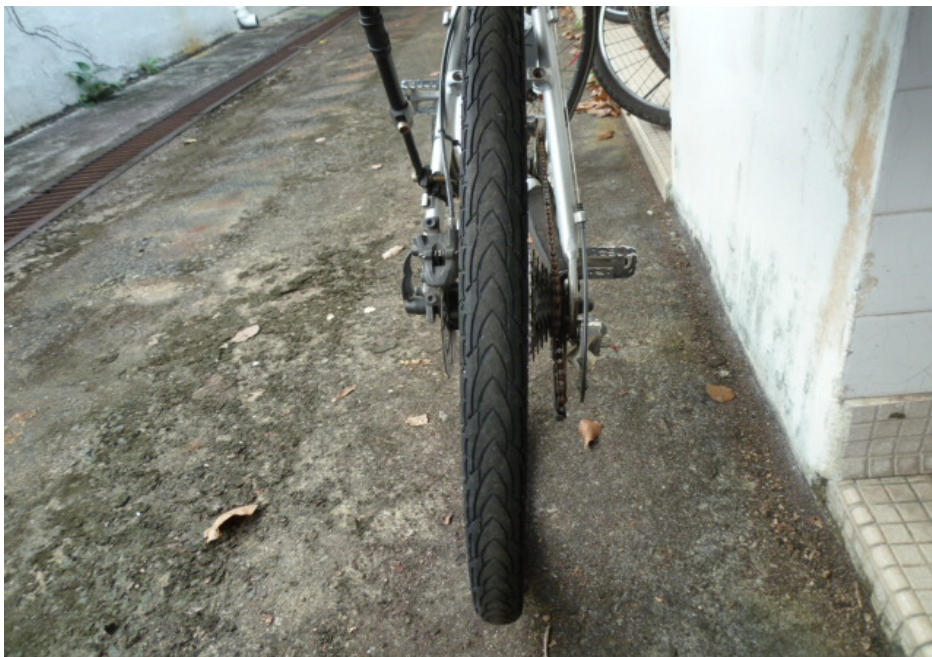
**Photo 12** shows the rear tyre of the Bicycle. The pattern of the tread was clearly visible. There was no tear, burst mark(s) and/or punctured hole(s) on the sidewalls as well as across the tread of the front tyre. However the rear tyre was observed to be deflated.

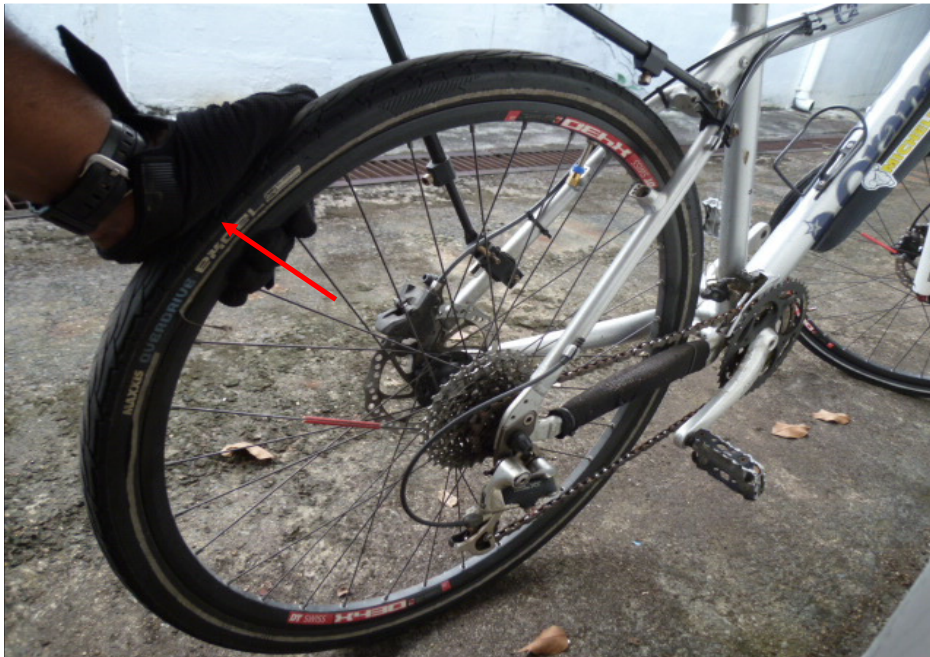
**Photo 13** shows the deflated rear tyre of the Bicycle (arrowed).

14. The 2 tyres of the Bicycle were found to be in serviceable condition (which had included the deflated rear tyre). There was no tear, cut or burst mark(s) on the outer and the inner sidewalls as well as across the tread of the 2 tyres. The front tyre was observed to be sufficiently inflated for vehicular operation.

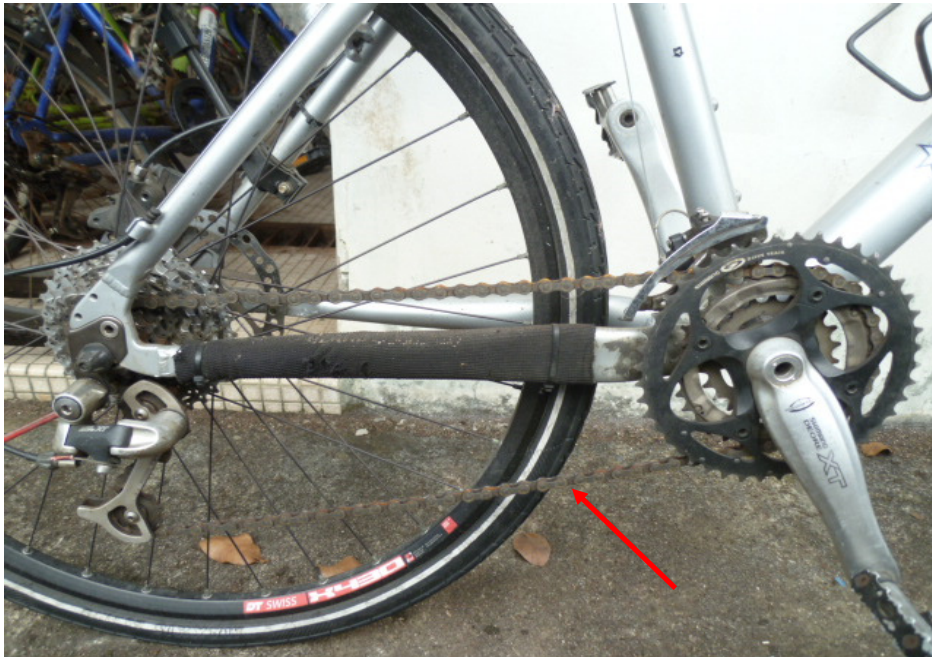
7. The gear train of the Bicycle was found to be intact without any misalignment. It was also adequately lubricated for operating purposes. See photos 14 & 15 below.

**Photo 14** shows the general view of the gear train of the Bicycle, which was observed to be intact with no misalignment (arrowed). It was also adequately lubricated for operating purposes.

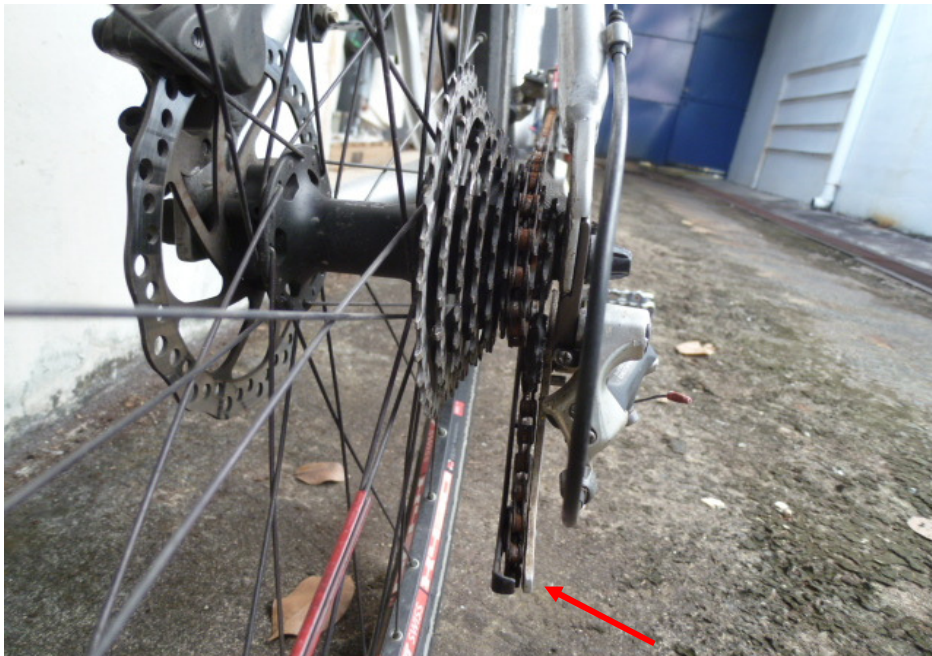
**Photo 15** shows a closer view of the gear train of the Bicycle, which was observed to be intact with no misalignment (arrowed). It was also adequately lubricated for operating purposes.

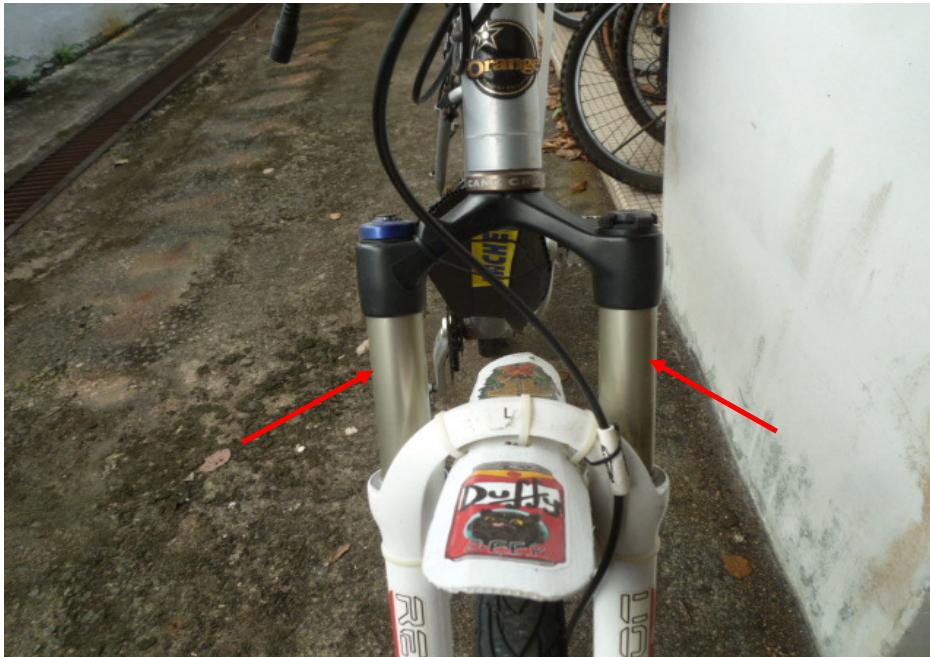
8. Our checks on the various steering components of the Bicycle revealed that its steering system was in serviceable condition. Its front fork assembly was found to be intact and undamaged. Turning the handle bar towards the left and right did not produce any abnormal free play and/or resistance.

**Photo 16** shows the front fork assembly (arrowed) of the Bicycle. The front forks and fork bracket of the Bicycle were both found to be intact and undamaged. Turning the Bicycle's handle bar towards the left and right did not produce any abnormal free play. The steering system of the Bicycle was in serviceable condition at the time of our inspection.

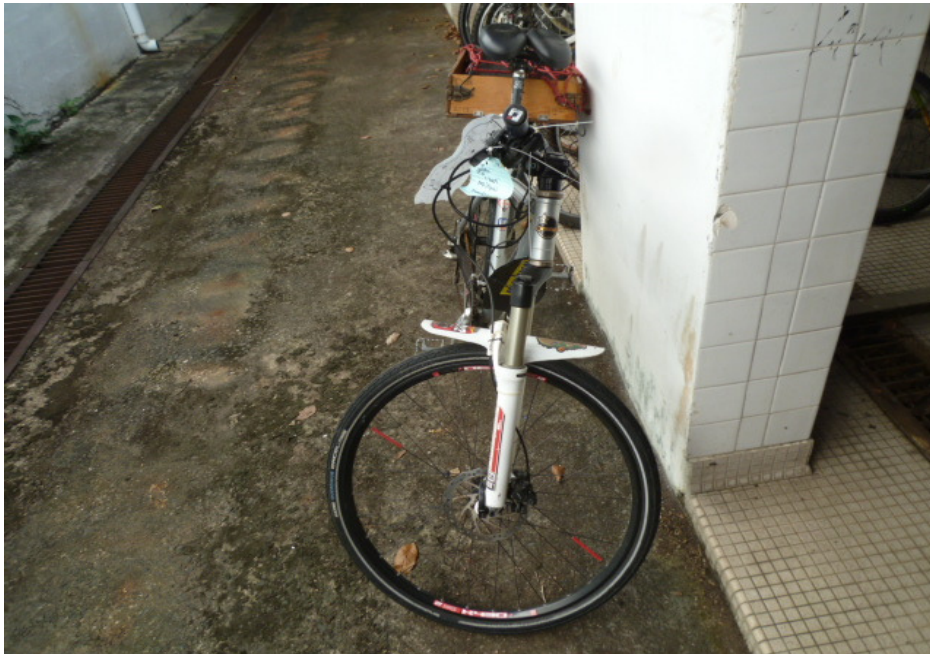
**Photo 17** shows the front wheel of the Bicycle turned towards its full right. Turning the Bicycle's handle bar towards the right did not produce any abnormal free play and/or resistance. This would indicate that the steering system of the Bicycle was in serviceable condition at the time of our inspection.

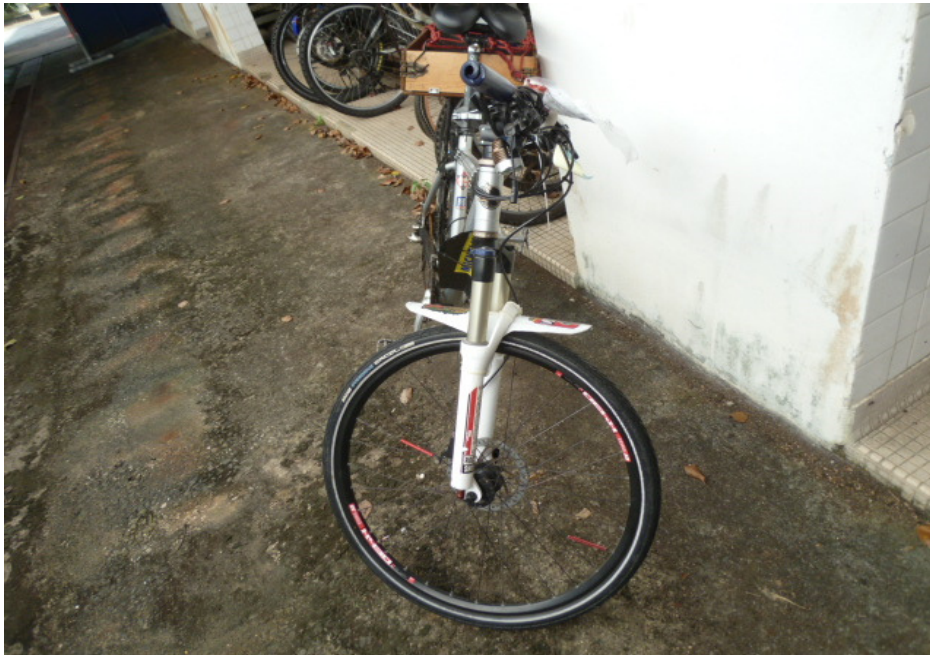
**Photo 18** shows the front wheel of the Bicycle turned towards its full left. Turning the Bicycle's handle bar towards the left did not produce any abnormal free play and/or resistance. This would indicate that the steering system of the Bicycle was in serviceable condition at the time of our inspection.

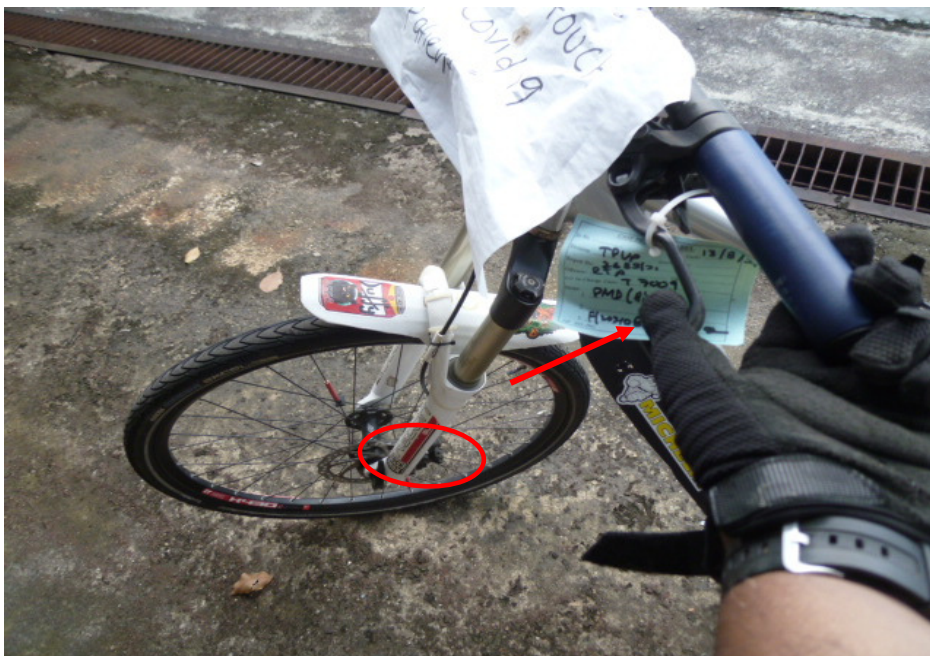
10. A static brake test was conducted on the front brake of the Bicycle. There was some resistance felt upon pressing the left hand brake lever. This was further confirmed by looking at the front brake pads while we pressed the left hand brake lever. It shows that the front brake pads responded to the gripping action. The front brake pads pressed against the front brake disc. This had appeared to indicate that the front brake of the Bicycle was in serviceable condition.

**Photo 19** shows a static brake test conducted on the Bicycle's front brake. There was some resistance felt upon pressing the left hand brake lever (arrowed). It also shows that the front brake pads responded to the gripping action (circled) after depressing the right hand brake lever.

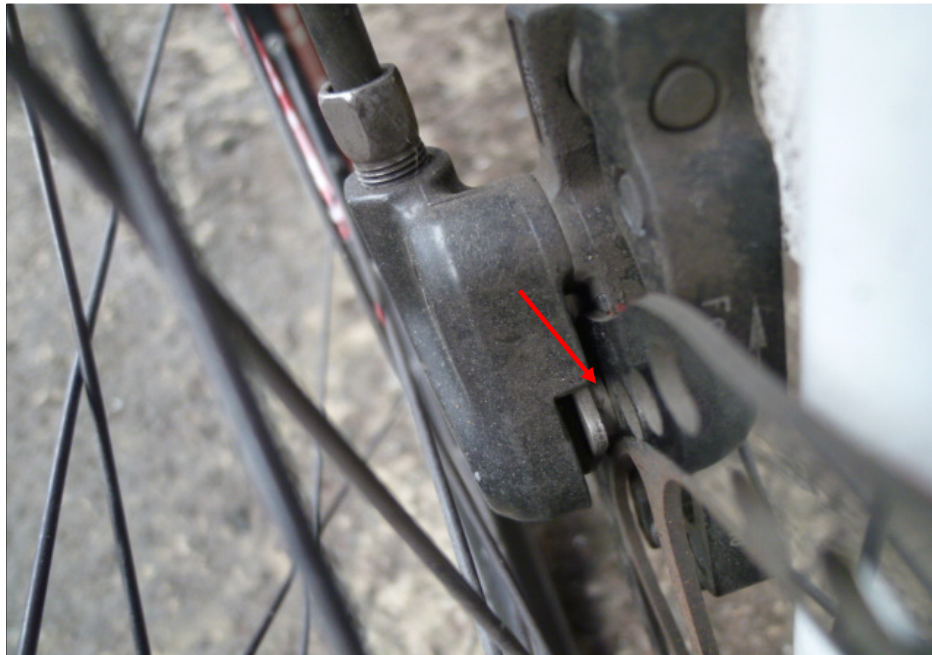
**Photo 20** shows a close up view of the front brake pads responding to the gripping action. The front brake pads pressed against the front brake disc (arrowed) upon depressing the left hand brake lever. This had appeared to indicate that the front brake of the Bicycle was in serviceable condition.

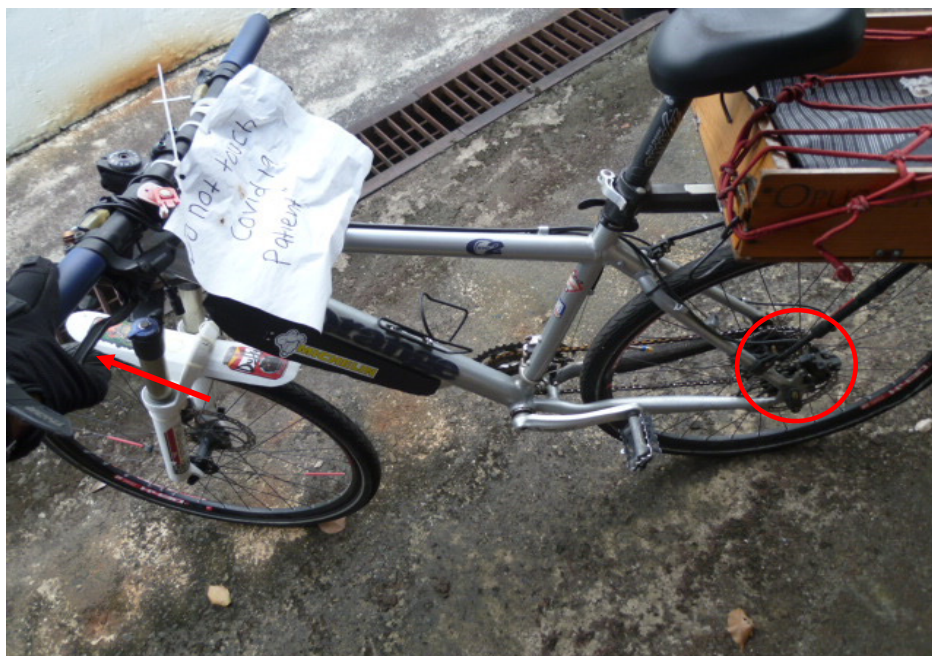
11. A static brake test was conducted on the rear brake of the Bicycle. There was some resistance felt upon pressing the right hand brake lever. This was further confirmed by looking at the rear brake pads while we pressed the right hand brake lever. It shows that the rear brake pads responded to the gripping action. The rear brake pads pressed against the rear brake disc. This had appeared to indicate that the rear brake of the Bicycle was in serviceable condition.

**Photo 21** shows a static brake test conducted on the Bicycle's rear brake. There was some resistance felt upon pressing the right hand brake lever (arrowed). It also shows that the rear brake pads responded to the gripping action (circled) after depressing the right hand brake lever.

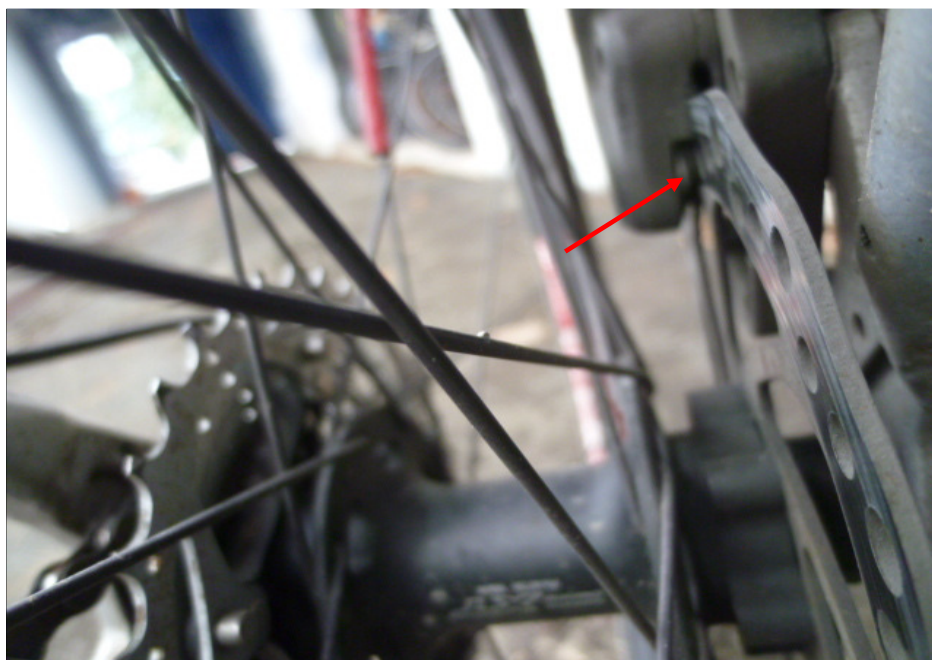
**Photo 22** shows a close up view of the rear brake pads responding to the gripping action. The rear brake pads pressed against the rear brake disc (arrowed) upon depressing the right hand brake lever. This had appeared to indicate that the rear brake of the Bicycle was in serviceable condition.
