Your Ref: Aston Martin DB11 Cabriolet  
(chassis number SCFRLFCW4KGM08224)

26 October 2021

Our Ref : CI/TP21010906/D

**INSPECTION REPORT OF AN UNREGISTERED ASTON MARTIN DB11  
CABRIOLET MOTOR CAR WITH CHASSIS NUMBER  
SCFRLFCW4KGM08224**

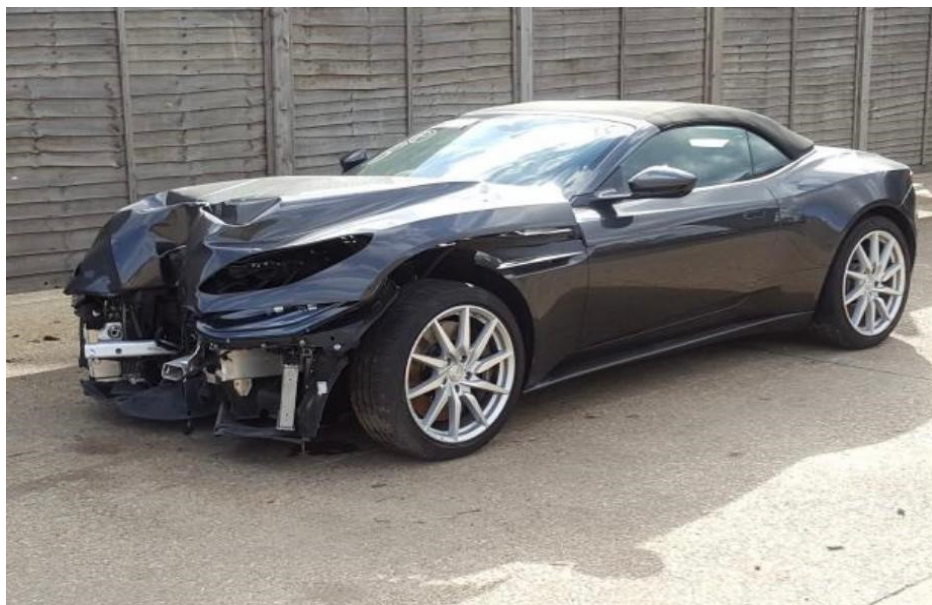
**Photo 1** shows the front left body of the Motor Car (photograph provided to me). The Motor Car was observed to have sustained damage at its frontal portion. Body parts damaged include the front bonnet, front bonnet hinges, front bumper reinforcement and front engine undercover amongst others. The radiator grille, front bumper and all its related parts and attachments like the front bumper lower grille, front bumper lower skirt and front bumper sensors amongst others were observed to be damaged/missing/dislodged.

23. The body parts at the frontal portion of the Motor Car were visually examined and it was noted that the repair/restoration works carried out to the damaged area of the Motor Car (refer to photograph 1 & 2 above) were reasonably adequate and in order.

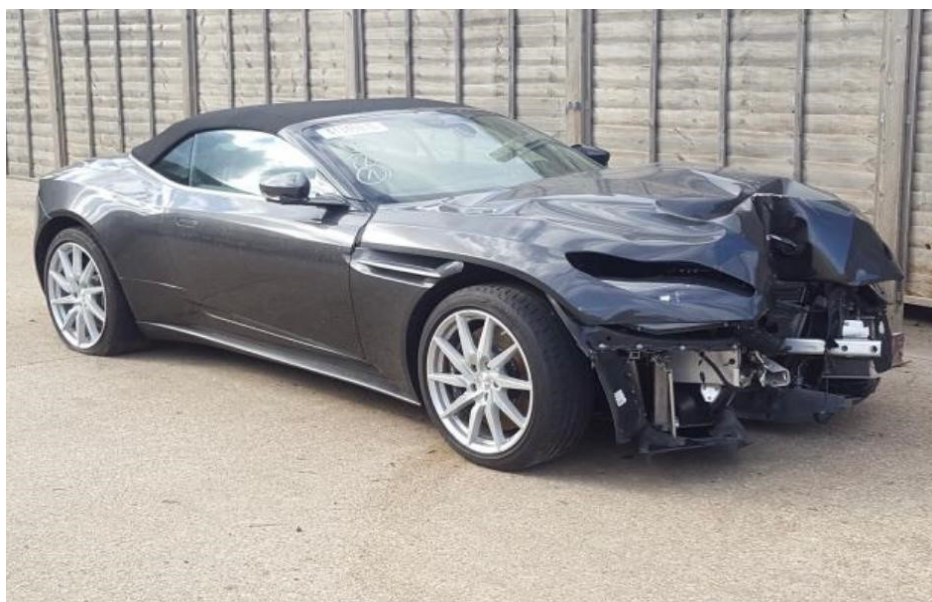
**Photo 2** shows the front right body of the Motor Car (photograph provided to me). The Motor Car was observed to have sustained damage at its frontal portion. Body parts damaged include the front bonnet, front bumper reinforcement, front engine undercover, oil cooler, aircon condenser and radiator amongst others. The front bumper and all its related parts and attachments like the front bumper lower grille, front bumper lower skirt and front bumper sensors amongst others were observed to be damaged/missing/dislodged.

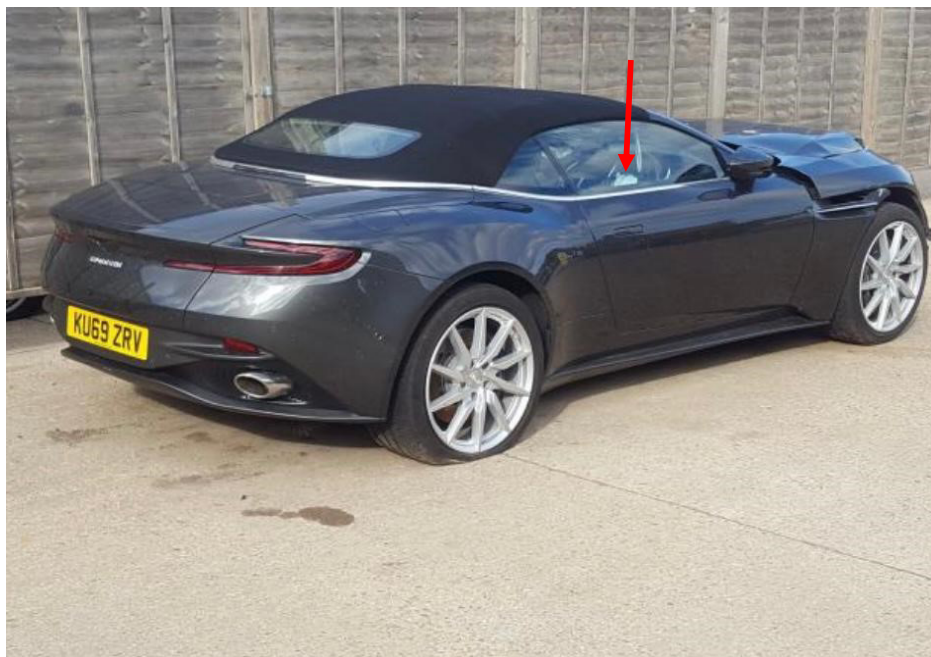
**Photo 3** shows the rear right body of the Motor Car (photograph provided to me). Apart for the frontal portion, there was no physical damage seen to other areas of the Motor Car. The driver's airbag (arrowed) was deployed.

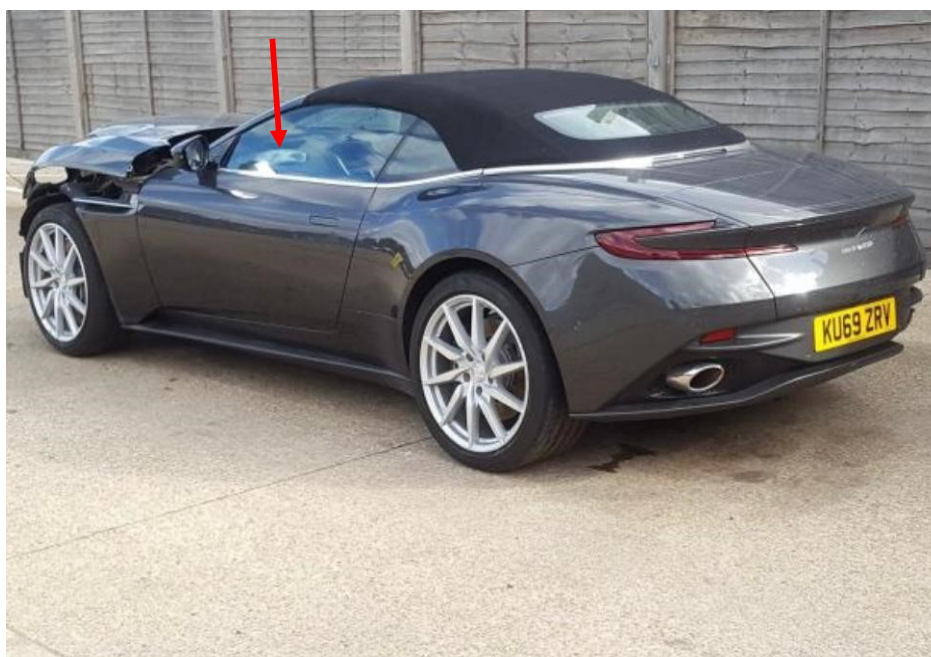
**Photo 4** shows the rear left body of the Motor Car (photograph provided to me). Apart for the frontal portion, there was no physical damage seen to other areas of the Motor Car. The front left passenger airbag (arrowed) was deployed.

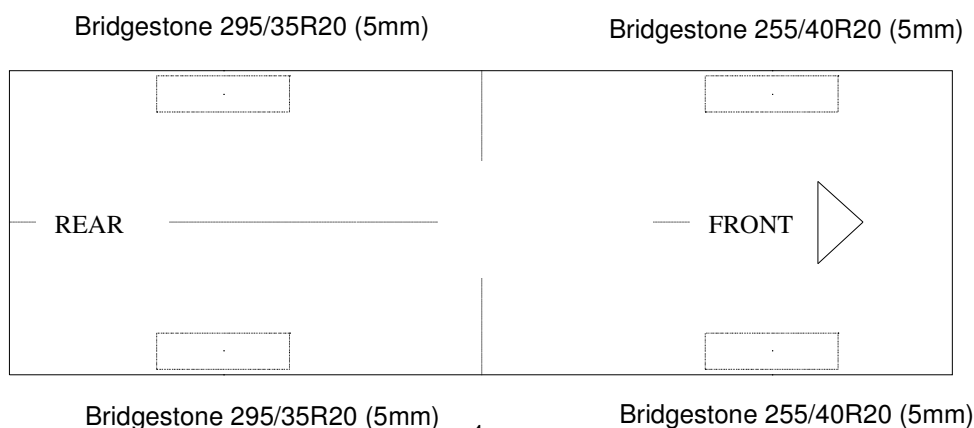
9. The Motor Car was fitted with 20inch sport wheel rims that were wrapped with tyres that were observed to be of serviceable condition. The tyres were also sufficiently inflated for vehicular operation. The tyre brand, tyre size and approximate remaining tread depth of the 4 tyres of the Motor Car were recorded as follows: -

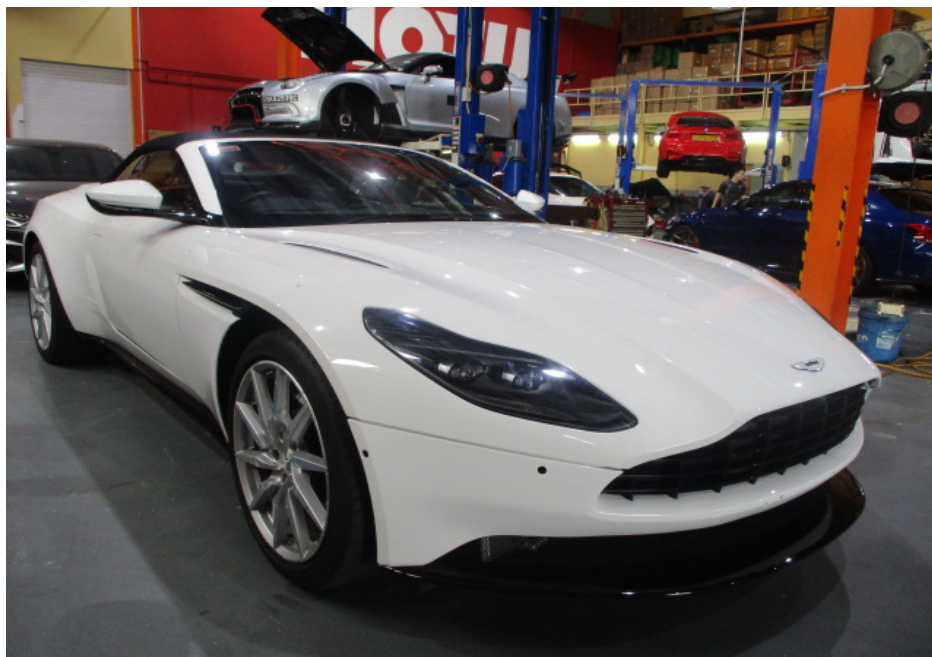
**Photo 5** shows a general view of the front right body of the Motor Car at the time of my inspection. The Motor Car was observed to be in a relatively good general condition with no loose exterior fittings observed. The body parts at the frontal portion of the Motor Car were visually examined and it was observed that the repair/restoration works carried out to the damaged area of the Motor Car (refer to photograph 1 & 2 above) were reasonably adequate and in order.

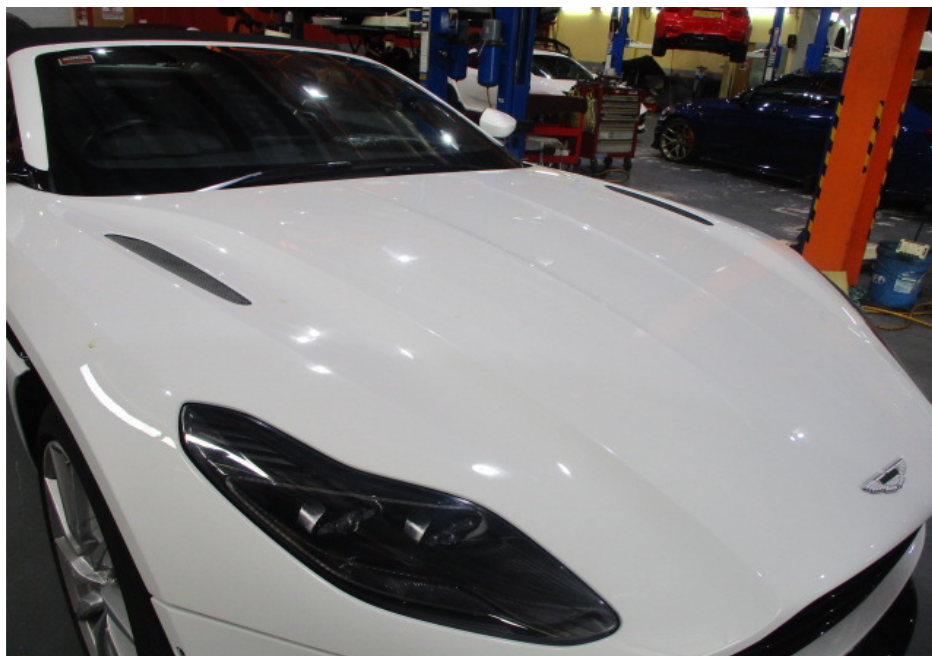
**Photo 6** shows a closer view of the Motor Car's front bonnet and front right headlamp. The body parts at the frontal portion of the Motor Car were visually examined and it was observed that the repair/restoration works carried out to the damaged area of the Motor Car (refer to photograph 1 & 2 above) were reasonably adequate and in order.

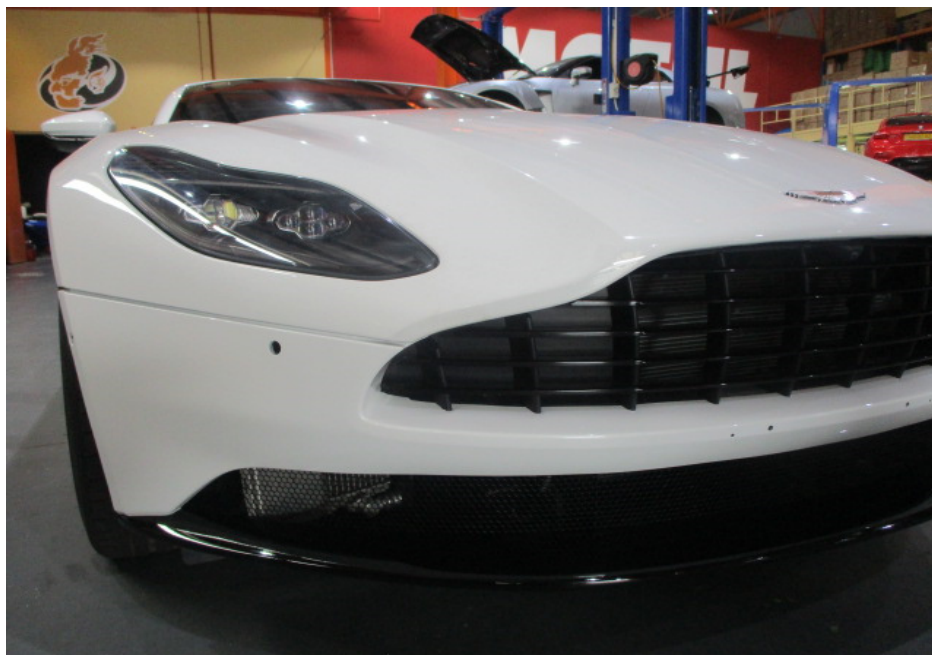
**Photo 7** shows a closer view of the Motor Car's front bumper, front bumper lower skirt, front right headlamp and radiator grille. The body parts at the frontal portion of the Motor Car were visually examined and it was observed that the repair/restoration works carried out to the damaged area of the Motor Car (refer to photograph 1 & 2 above) were reasonably adequate and in order.

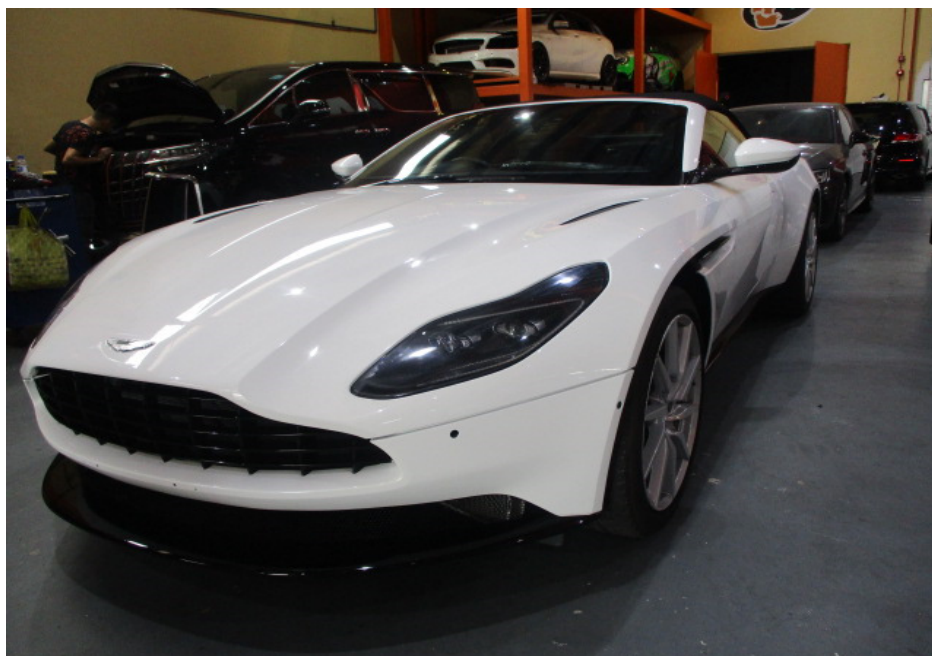
**Photo 8** shows a general view of the front left body of the Motor Car at the time of my inspection. The Motor Car was observed to be in a relatively good general condition with no loose exterior fittings observed. The body parts at the frontal portion of the Motor Car were visually examined and it was observed that the repair/restoration works carried out to the damaged area of the Motor Car (refer to photograph 1 & 2 above) were reasonably adequate and in order.

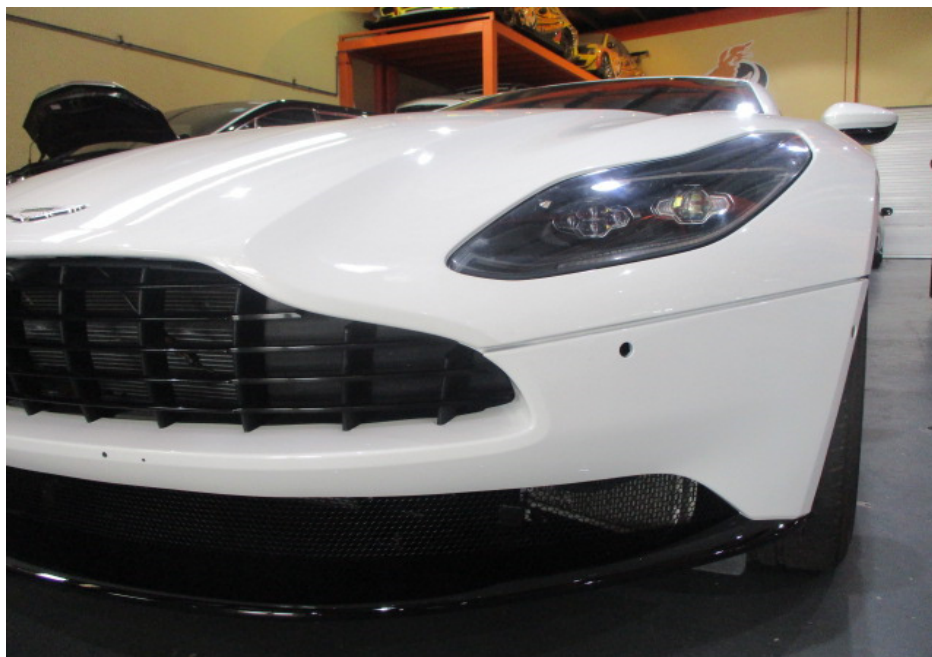
**Photo 9** shows a closer view of the Motor Car's front bumper, front bumper sensors, front bumper lower skirt, front left headlamp and radiator grille. The body parts at the frontal portion of the Motor Car were visually examined and it was observed that the repair/restoration works carried out to the damaged area of the Motor Car (refer to photograph 1 & 2 above) were reasonably adequate and in order.

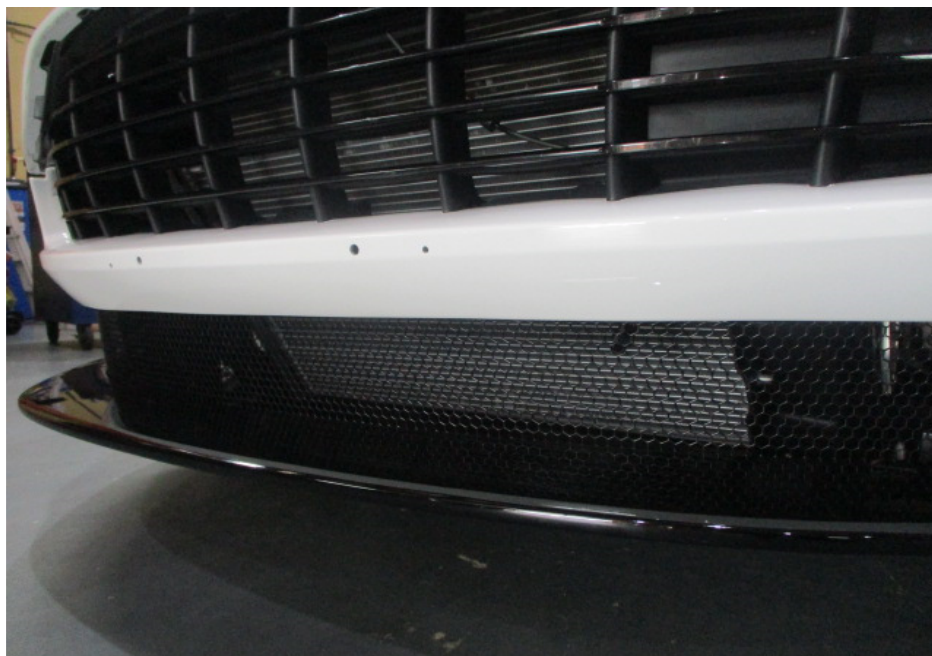
**Photo 10** shows a closer view of the Motor Car's front bumper lower skirt, radiator grille, oil cooler and aircon condenser. The body parts at the frontal portion of the Motor Car were visually examined and it was observed that the repair/restoration works carried out to the damaged area of the Motor Car (refer to photograph 1 & 2 above) were reasonably adequate and in order

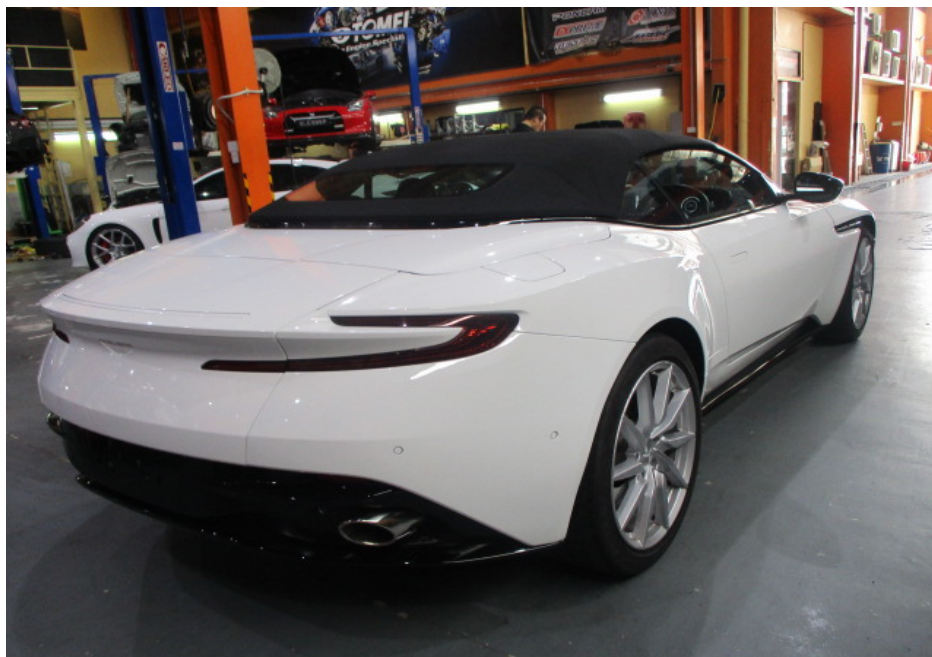
**Photo 11** shows a general view of the rear right body of the Motor Car at the time of my inspection. The Motor Car was observed to be in a relatively good general condition with no loose exterior fittings observed. The mileage of the Motor Car recorded at the time of my inspection was 8,748km.

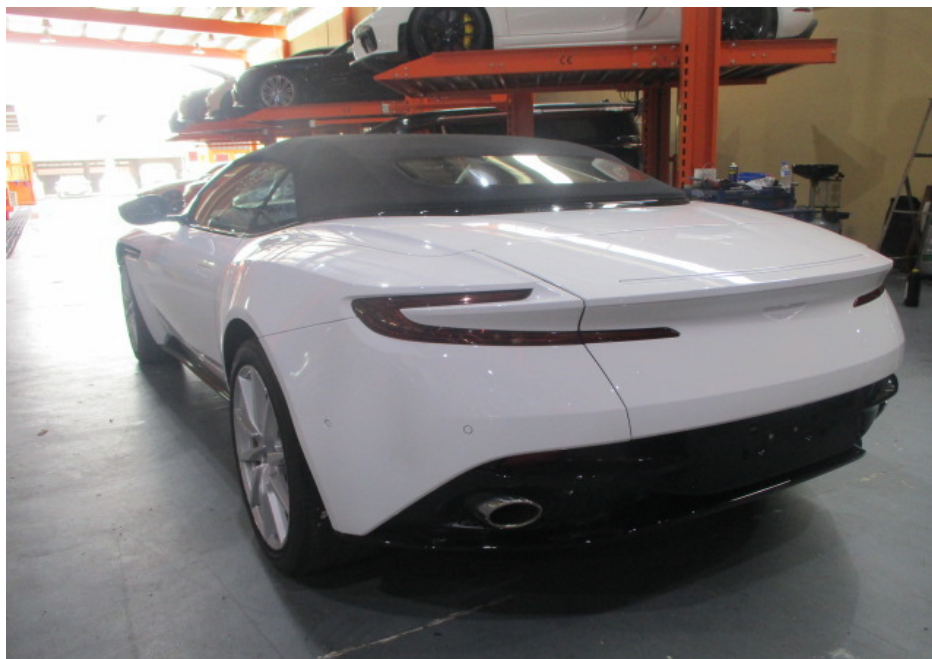
**Photo 12** shows a general view of the rear left body of the Motor Car at the time of my inspection. The Motor Car was observed to be in a relatively good general condition with no loose exterior fittings observed. The mileage of the Motor Car recorded at the time of my inspection was 8,748km.

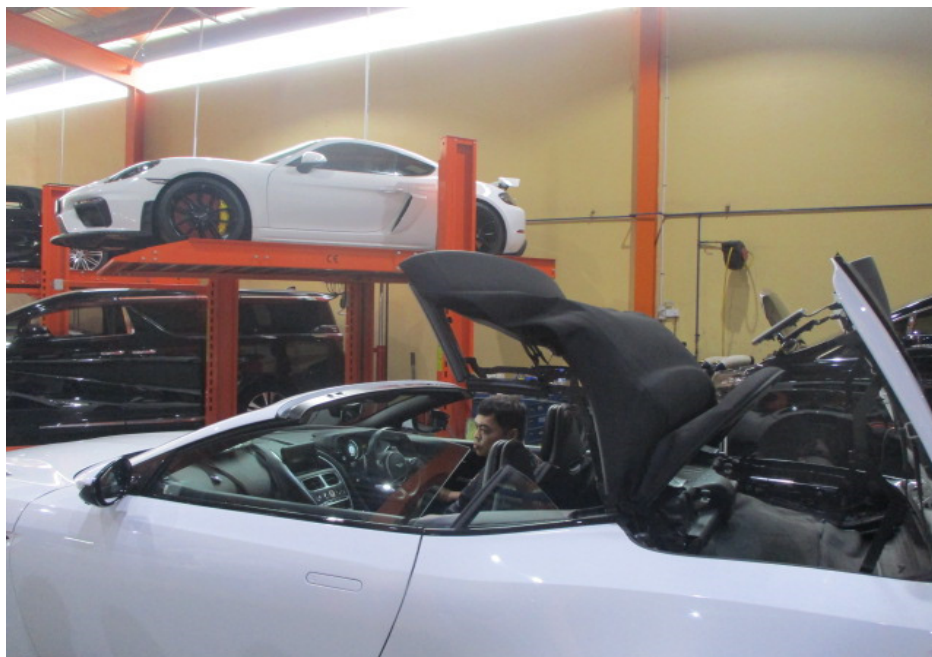
**Photo 13** shows the Motor Car's soft top being tested. It was observed that as a safety feature, the soft top could only open and close when the Motor Car was in a stationary position. When opened, the soft top is completely folded into the rear storage compartment with no parts protruding out of the Motor Car's body. The soft top was also found adequately secured to the "A" pillar after closing.

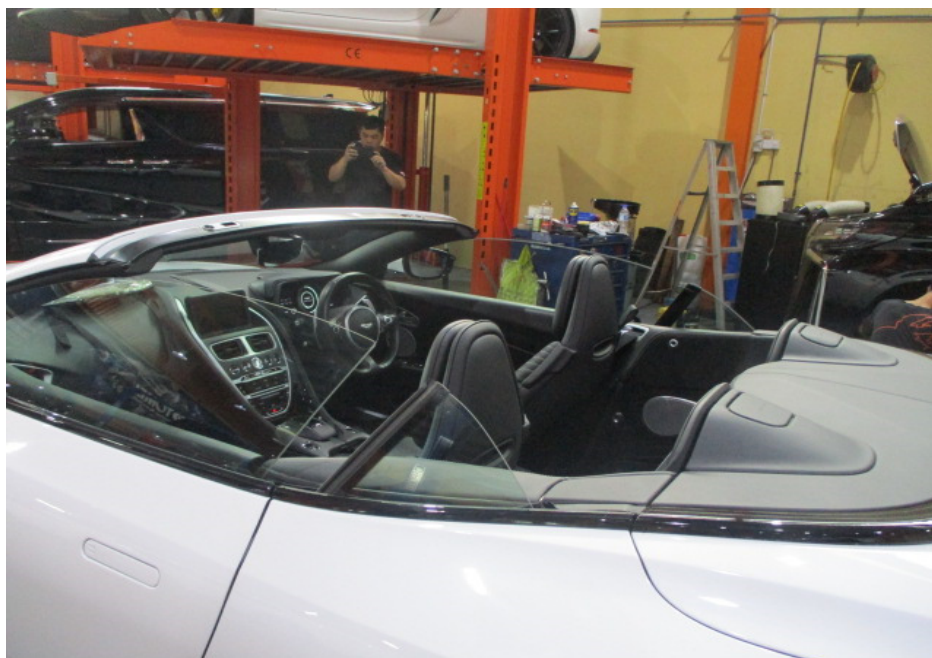
**Photo 14** shows the Motor Car with its soft top in a completely opened position. It was observed that as a safety feature, the soft top could only open and close when the Motor Car was in a stationary position. When opened, the soft top is completely folded into the rear storage compartment with no parts protruding out of the Motor Car's body. The soft top was also found adequately secured to the "A" pillar after closing.

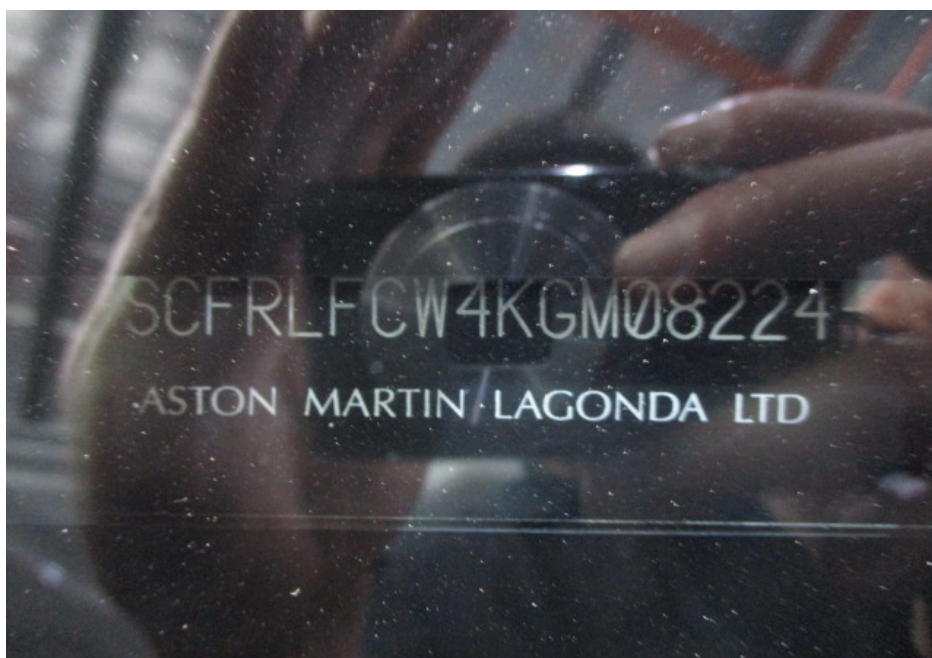
**Photo 15** shows the chassis number of the Motor Car. The chassis number recorded was SCFRLFCW4KGM08224.

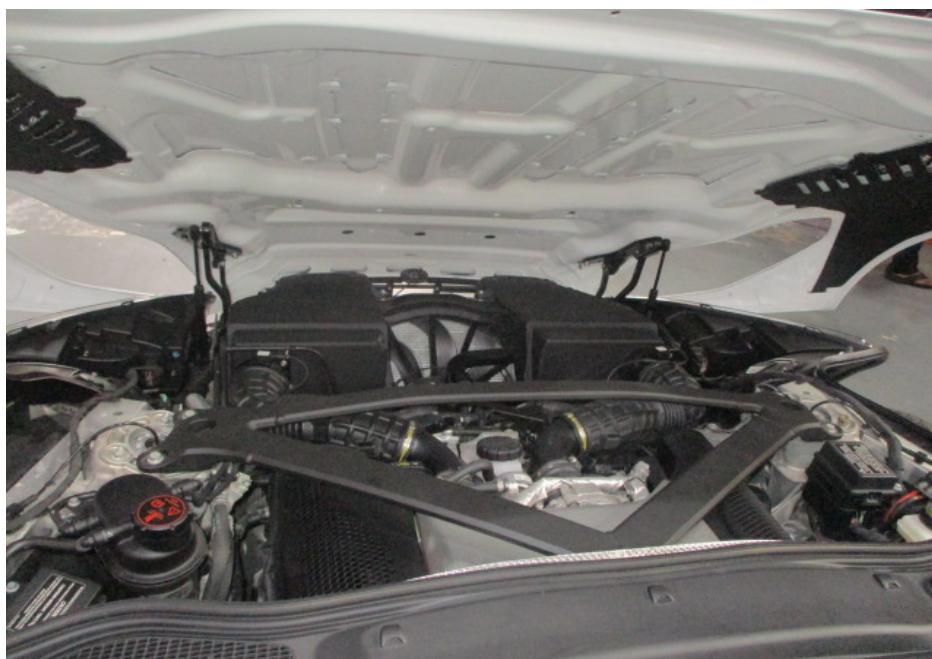
**Photo 16** shows a general view of the engine compartment of the Motor Car at the time of my inspection. The various parts and components inside the engine compartment were all observed to be intact and properly fitted. There was also no sign(s) or indication(s) of fluid leak and/or fluid stain found inside the engine compartment. The repair/restoration works carried out to the various parts within the engine compartment like the aircon condenser, radiator, cooling fan, air intake boxes and front support panel amongst others were reasonably adequate and in order.

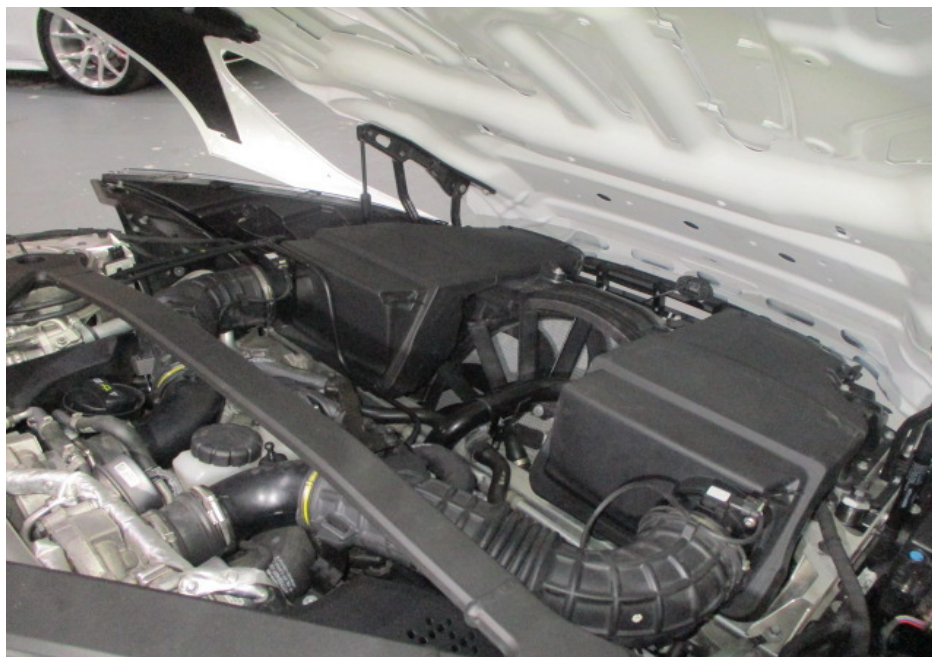
**Photo 17** shows another view of the engine compartment of the Motor Car at the time of my inspection. The various parts and components inside the engine compartment were all observed to be intact and properly fitted. There was also no sign(s) or indication(s) of fluid leak and/or fluid stain found inside the engine compartment. The repair/restoration works carried out to the various parts within the engine compartment like the aircon condenser, radiator, cooling fan, air intake boxes and front support panel amongst others were reasonably adequate and in order.

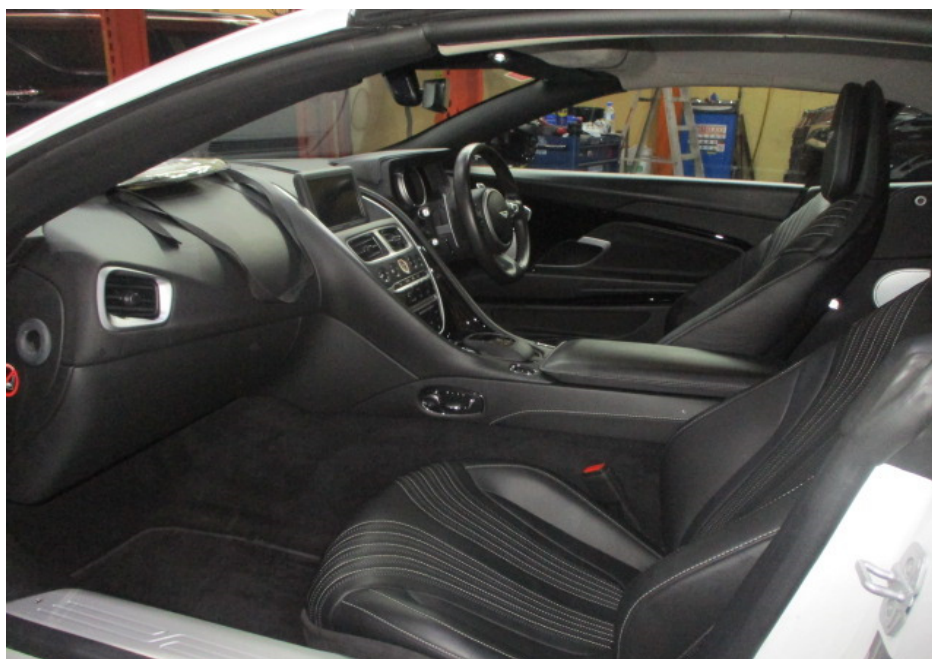
**Photo 18** shows the interior compartment of the Motor Car at the time of my inspection. The various parts and components, trims, carpet and upholstery inside the interior compartment were all observed to be intact and properly fitted.

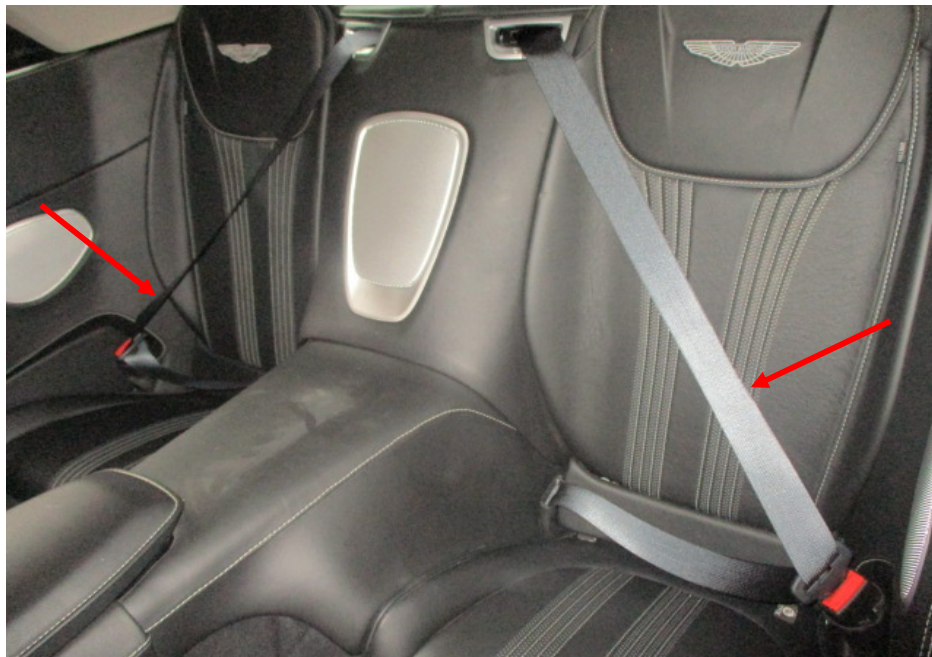
**Photo 19** shows the rear seats of the Motor Car. All the seats of the Motor Car were secured via seat rails to the floorboard. They were also fitted with a retractable seat belt reel and a pre-tensioner. The seat belts (arrowed) were tested and were able to be fastened into the respective pre-tensions that were fitted on the side of each individual seat.

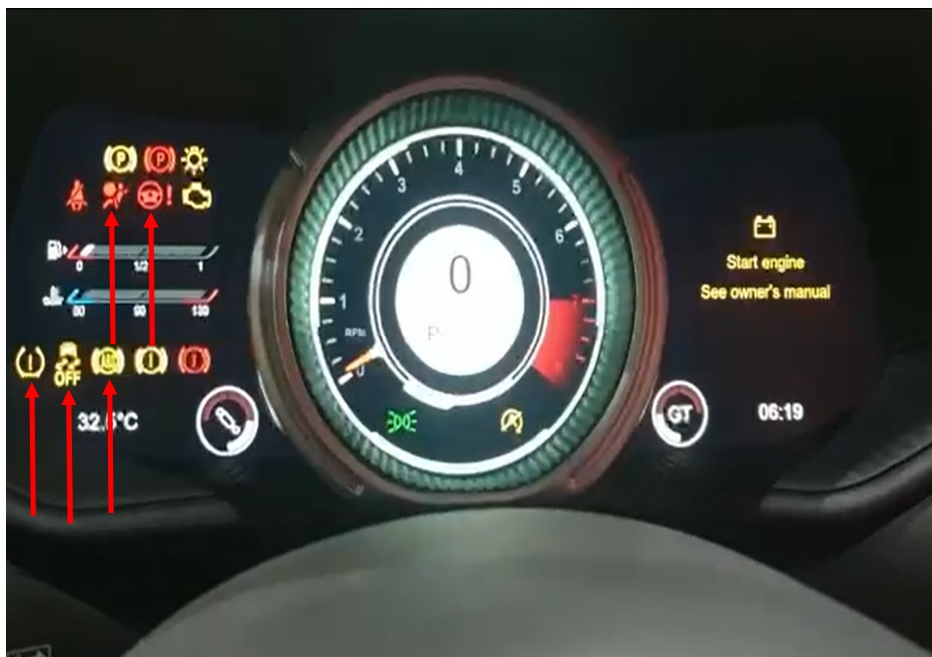
**Photo 20** shows the warning lights for the various electronic safety features appearing on the instrument panel of the Motor Car during its self-test when the engine is cranked, in particular the ABS, SRS, PSS, TPM and TCS lights (arrowed).

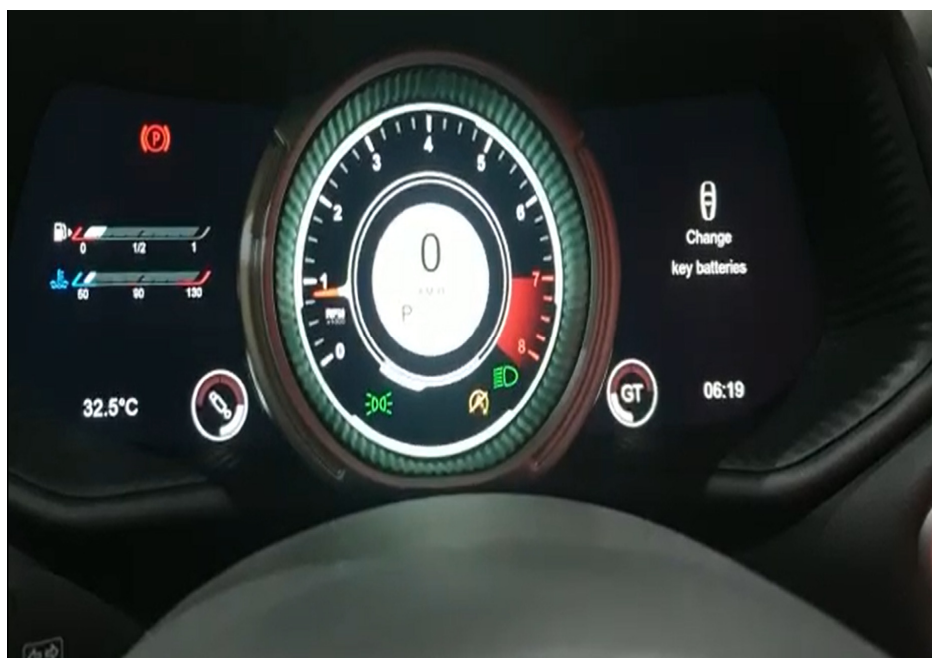
**Photo 21** shows the respective warning lights no longer illuminated, indicating that there is no fault detected to the ABS, SRS, PSS, TPM and TCS systems of the Motor Car during the self-test. These electronic systems were hence in working condition at the time of my inspection.

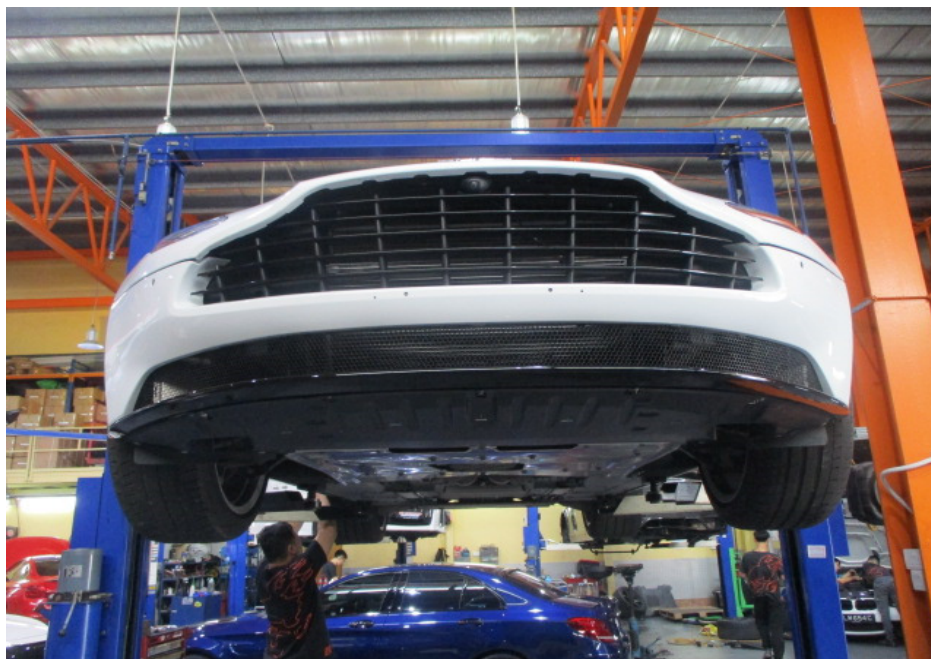
**Photo 22** shows the Motor Car hoisted up for checks on its undercarriage. There was no sign(s) or indication(s) of fluid leakage and/or fluid stain(s) on the underside of the Motor Car. The undercarriage components of the Motor Car were also all observed to be intact and secured in an appropriate manner.

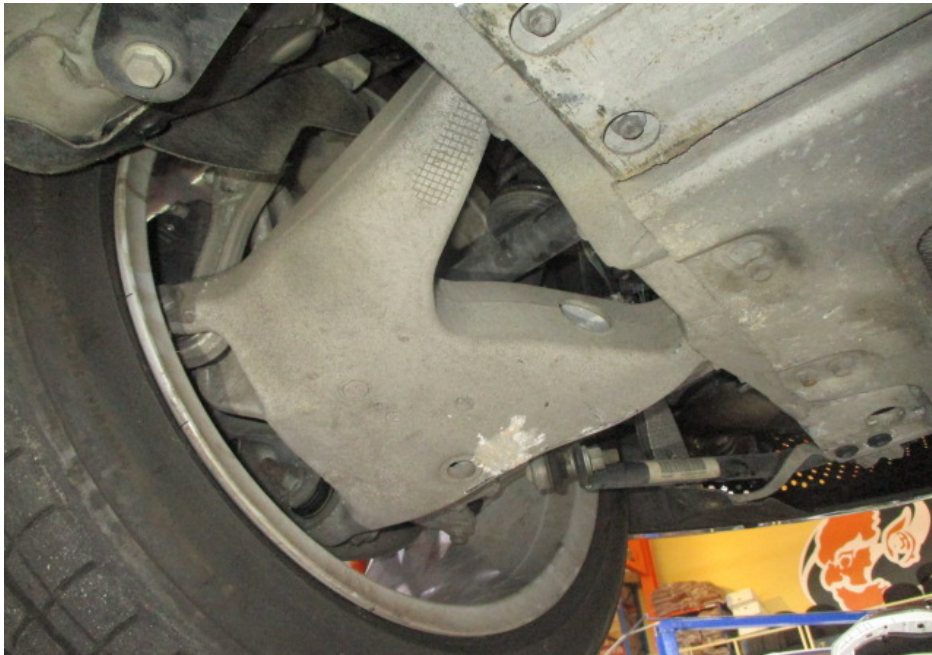
**Photo 23** shows a general view of the control arms and linkages at the rear right wheel of the Motor Car. I did not observe any fluid leak and/or fluid stain on the underside of the Motor Car. All of the Motor Car's undercarriage components were observed to be intact and secured in an appropriate manner.

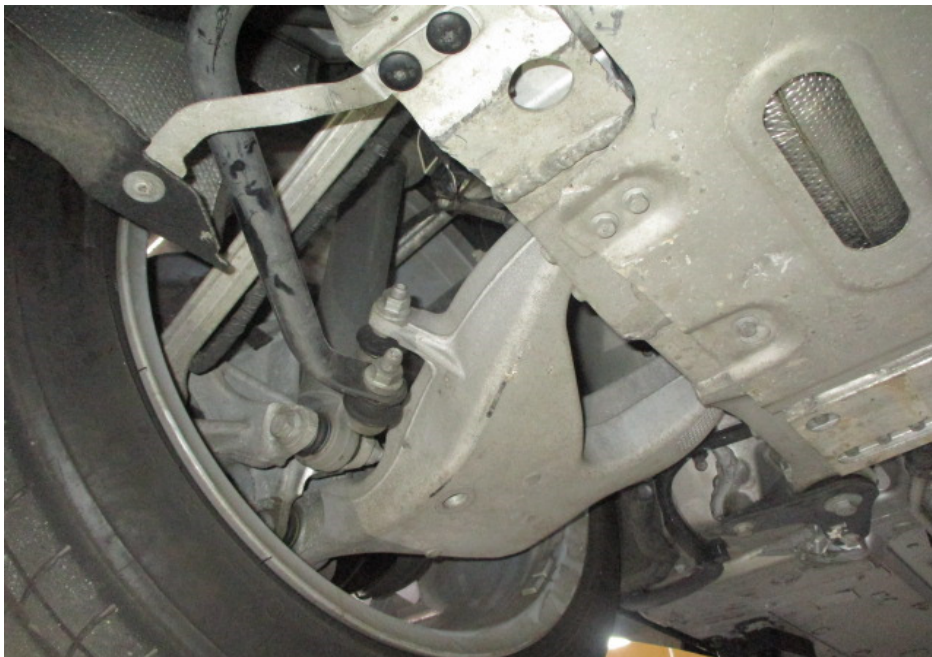
**Photo 24** shows a general view of the control arms and linkages at the rear left wheel of the Motor Car. I did not observe any fluid leak and/or fluid stain on the underside of the Motor Car. All of the Motor Car's undercarriage components were observed to be intact and secured in an appropriate manner.

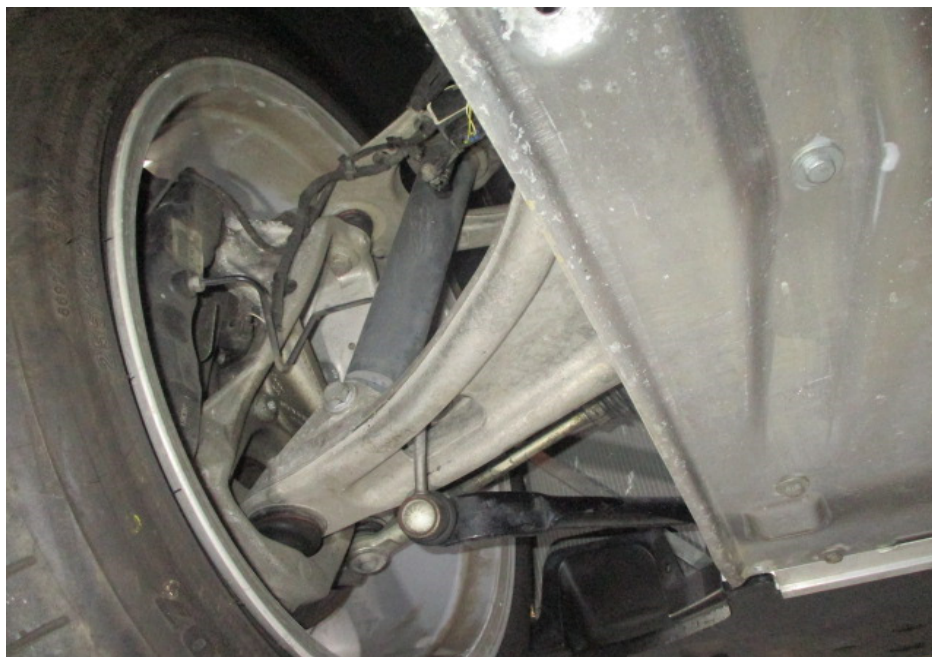
**Photo 25** shows the various undercarriage components at the front left wheel of the Motor Car. The mechanical components, control arms and linkages were all found to be intact and secured in an appropriate manner.

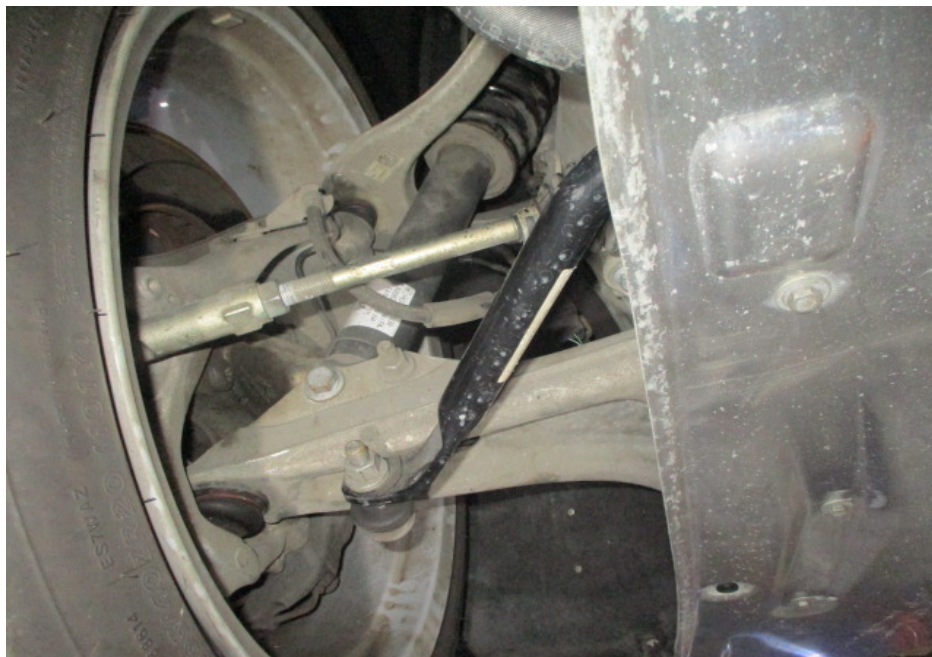
**Photo 26** shows the various undercarriage components at the front right wheel of the Motor Car. The mechanical components, control arms and linkages were all found to be intact and secured in an appropriate manner. I also did not observe any fluid leak and/or fluid stain on the underside of the Motor Car.

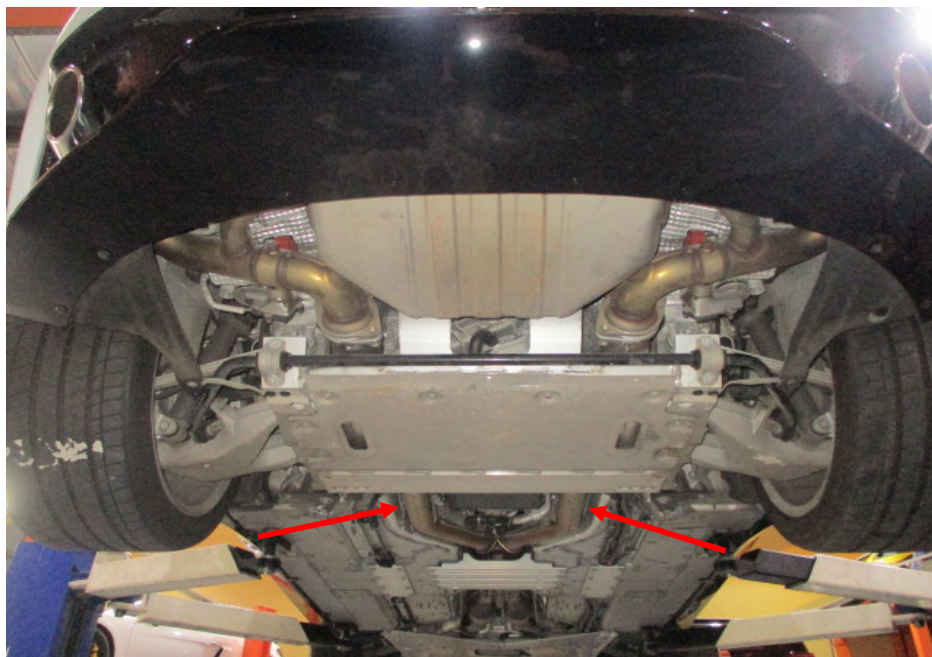
**Photo 27** shows the rear section of the Motor Car's exhaust system. My examination of the Motor Car's exhaust system revealed no sign(s) or indication(s) of any cut or weld marks along its exhaust pipes (arrowed), on its centre resonator boxes, on its rear mufflers and on its catalytic converters.

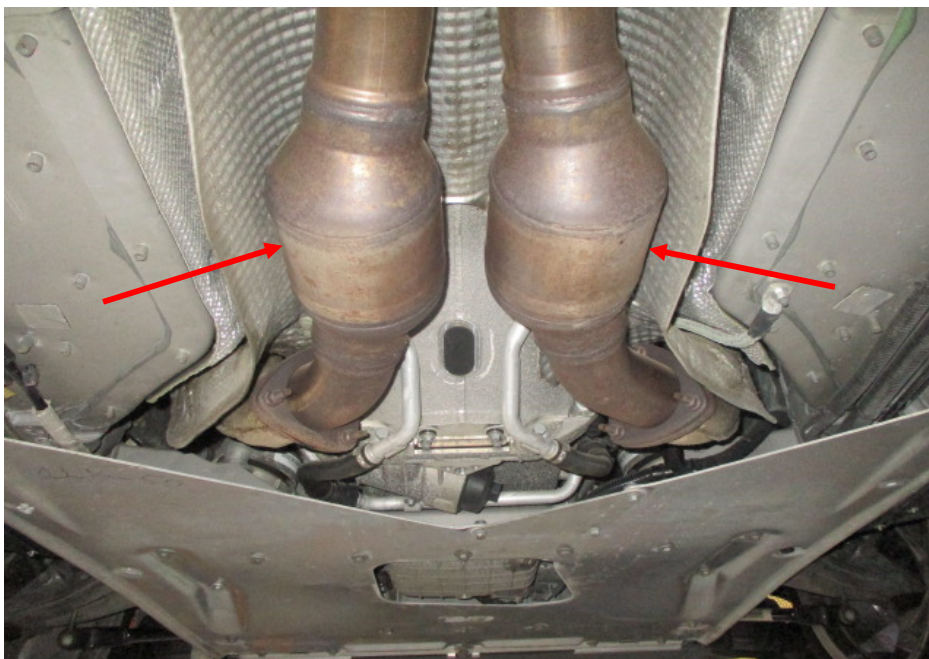
**Photo 28** shows the front section of the Motor Car's exhaust system. My examination of the Motor Car's exhaust system revealed no sign(s) or indication(s) of any cut or weld marks along its exhaust pipes, on its centre resonator boxes, on its rear mufflers and on its catalytic converters (arrowed).

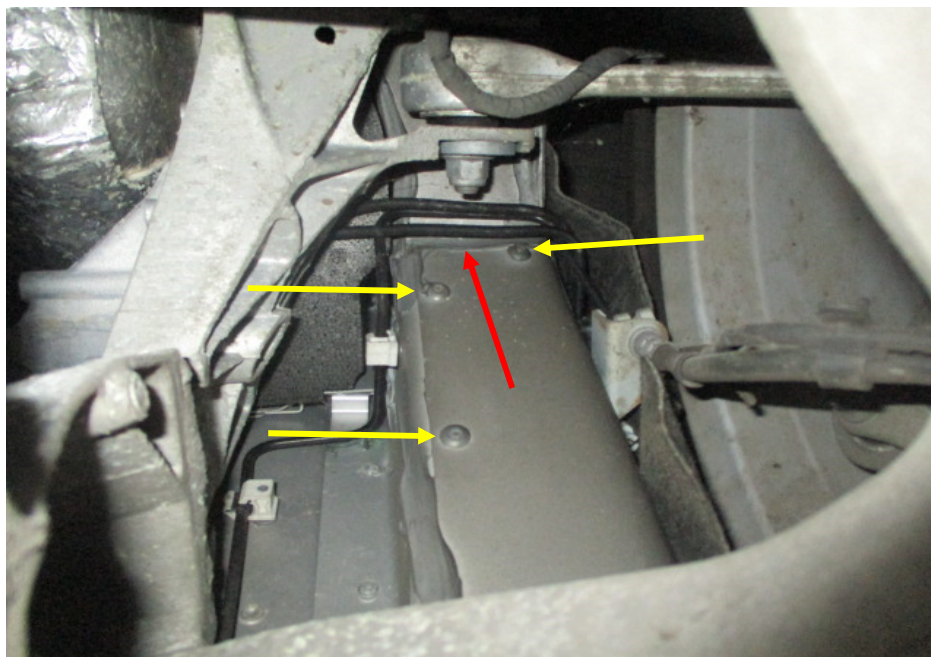
**Photo 29** shows the chassis/structural body at the underside rear right of the Motor Car. I did not find any weld marks other than original spot weld marks (yellow arrow) on the chassis/structural body of the Motor Car. The original factory sealant (red arrow) at the joints along the chassis/structural body was also untouched, indicating no work was done on the chassis/structural body of the Motor Car and that the chassis/structural body was originally fitted.

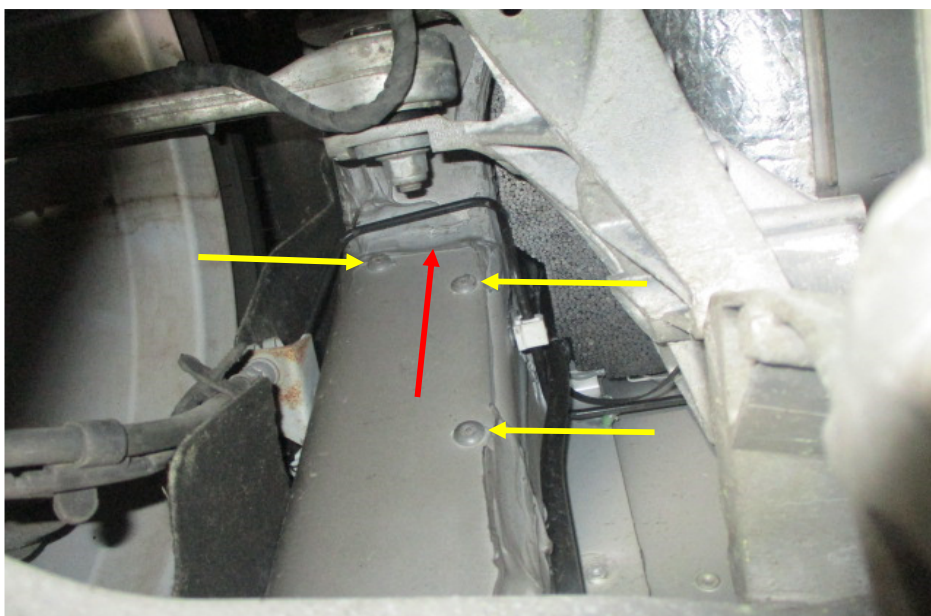
**Photo 30** shows the chassis/structural body at the underside rear left of the Motor Car. I did not find any weld marks other than original spot weld marks (yellow arrow) on the chassis/structural body of the Motor Car. The original factory sealant (red arrow) at the joints along the chassis/structural body was also untouched, indicating no work was done on the chassis/structural body of the Motor Car and that the chassis/structural body was originally fitted.

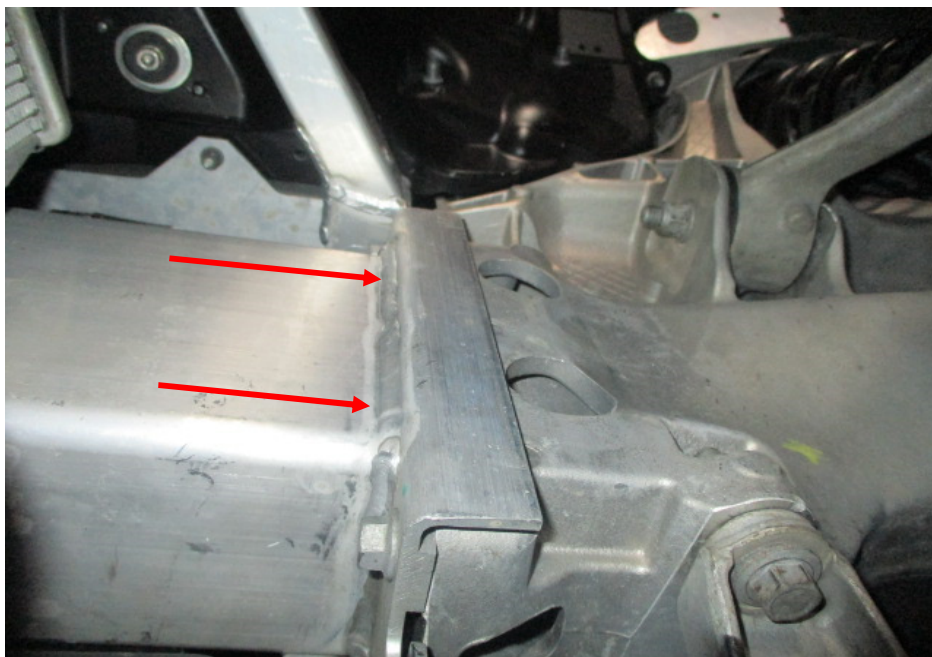
**Photo 31** shows the chassis/structural body at the underside front left of the Motor Car. The original factory sealant (arrowed) at the joints along the chassis/structural body was observed to be untouched. In general, I had found no work was carried out on the chassis/structural body of the Motor Car. The chassis/structural body of the Motor Car was originally fitted.
